Review of Physical Evidence of Double Fatal Collision on Coatsworth Road, Essex County, Ontario

Posting Date: 09 Feb 2012

Gorski Consulting
London, Ontario, Canada

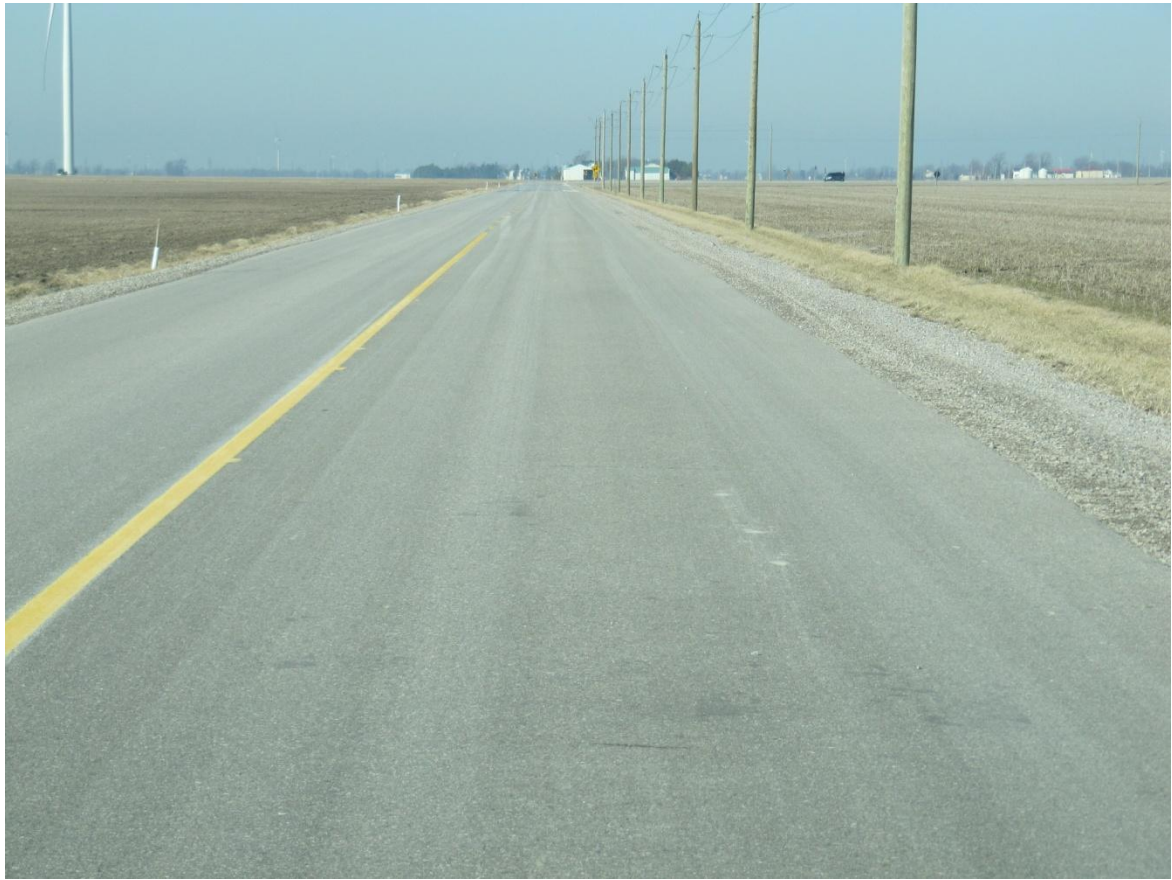
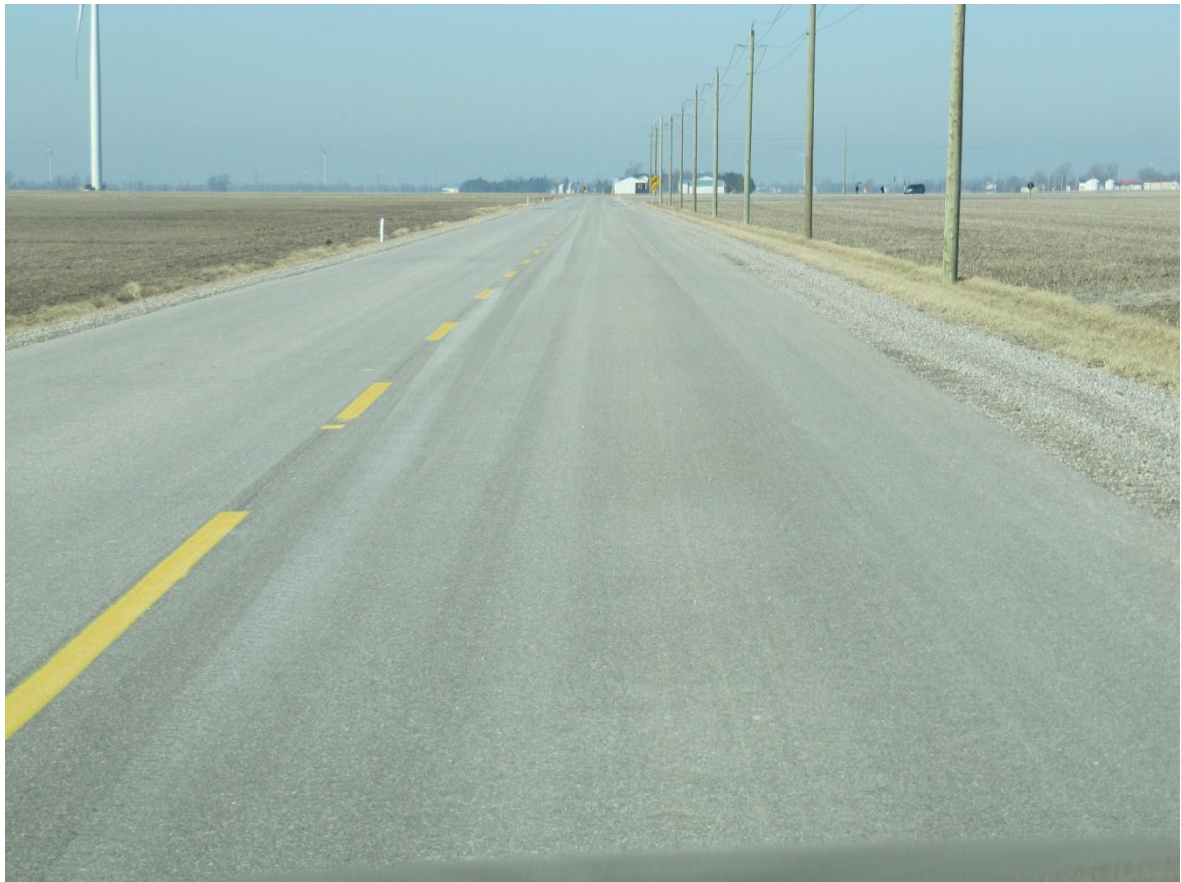
As the roadway straightens out the centre-line marking changes. Where the marking was a single solid line in the curve it then changes into a hatched line indicating that passing is allowed from both directions of travel, as shown in the top photo on the following page. This change in the roadway marking is more clearly seen in the bottom photo on that following a page.

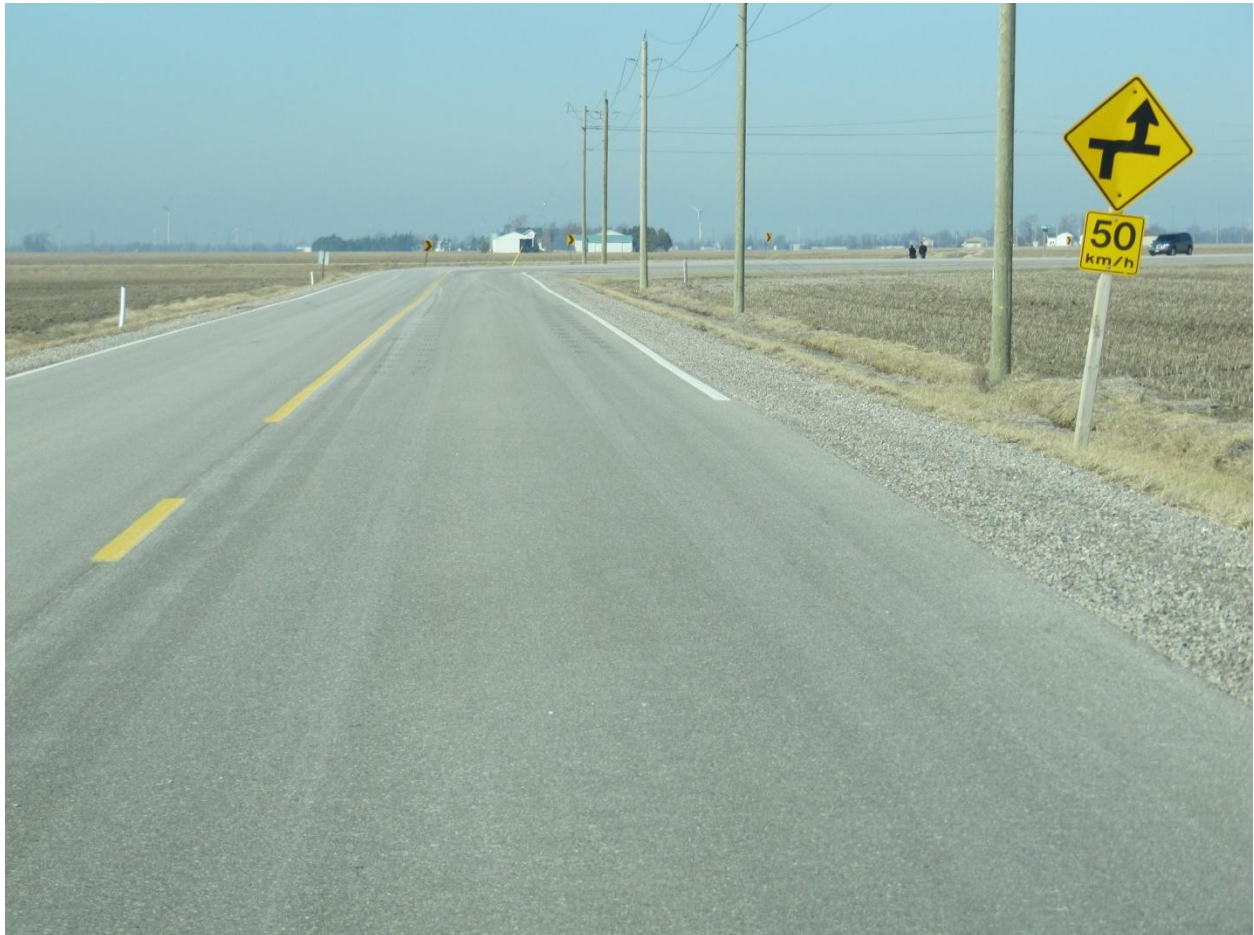
As we approach the accident site we see that the collision occurred at a point where the road curves sharply to the right. There is a warning sign depicting the status of the curve and it can be seen in the photo below.

Not only does the warning sign indicate the extremity of the curve but there is a "Speed Advisory Tab" which indicates "50 km/h". That tab is supposed to tell the driver that indeed you should be reducing your speed dramatically if you are travelling at the posted maximum of 80 km/h, and if you are travelling 20 or even 40 km/h above that maximum, and if you are travelling in fog, then clearly it should register that disaster awaits you if you do not do something very quickly to reduce your speed. A warning sign like this is usually posted between 140 and 200 metres prior the curve in question and there is no reason to believe that it has not been posted at the correct location.

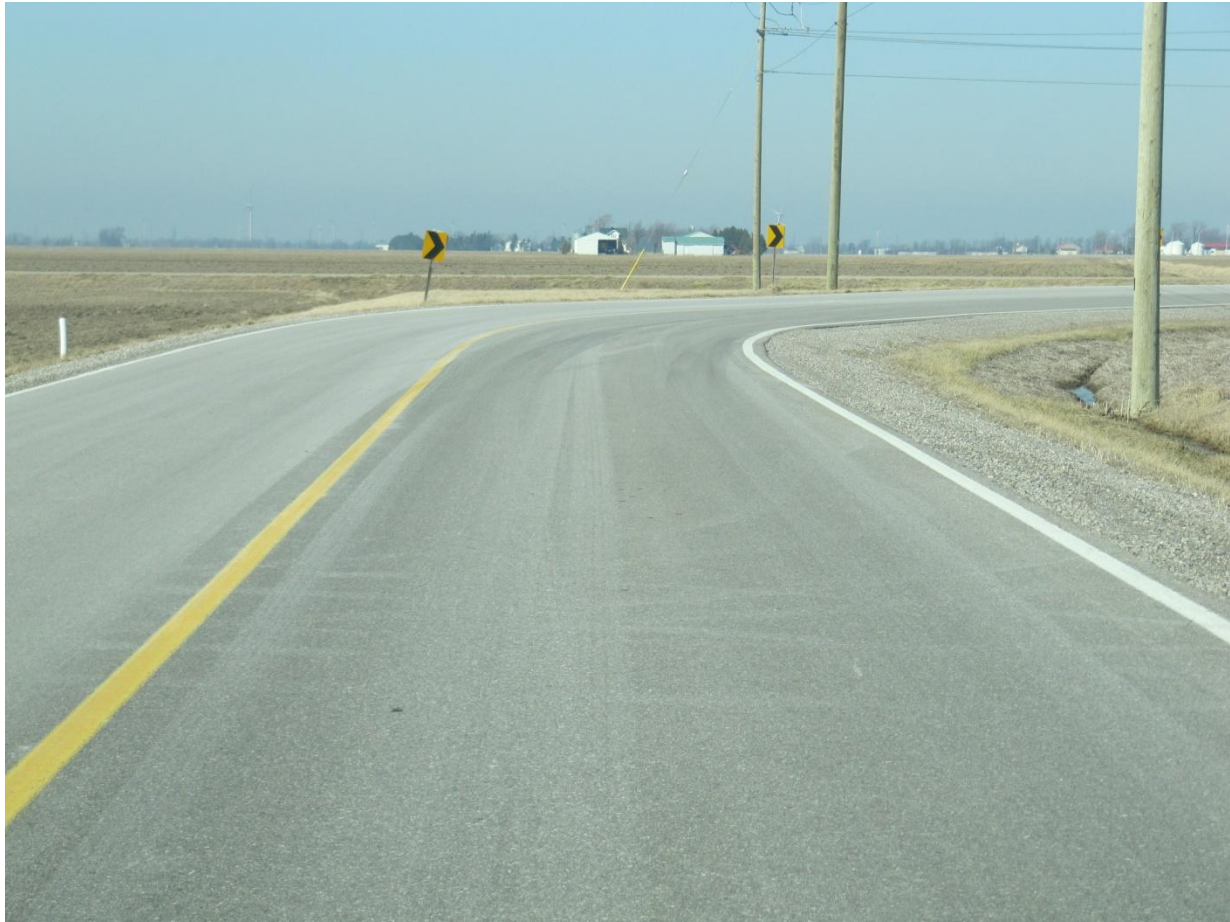
There are other warnings available to the driver about the approach of the curve. On the right side of the lane there is a white edge line that has been painted to help the driver through the curve.

Also, in the background, on the opposite side of the road, several chevron arrow signs are posted to direct the driver to the right. The positioning of these arrow chevrons is the one criticism we have about the condition of the site. These chevrons are positioned too far apart. As we get closer to the curve we see that there should be a chevron sign positioned so that it is directly in the middle of the travel lane as the driver is approaching so that the pointing of the vehicle headlights will reflect the light off the sign back to the driver's eyes in the most efficient manner. But as we see in the top photo on the following page, the chevrons are to the left and right of the pointing angle of the headlights. In

limited visibility that slight inappropriateness of location of the signs could make a difference in whether the driver appreciates where the curve is located.

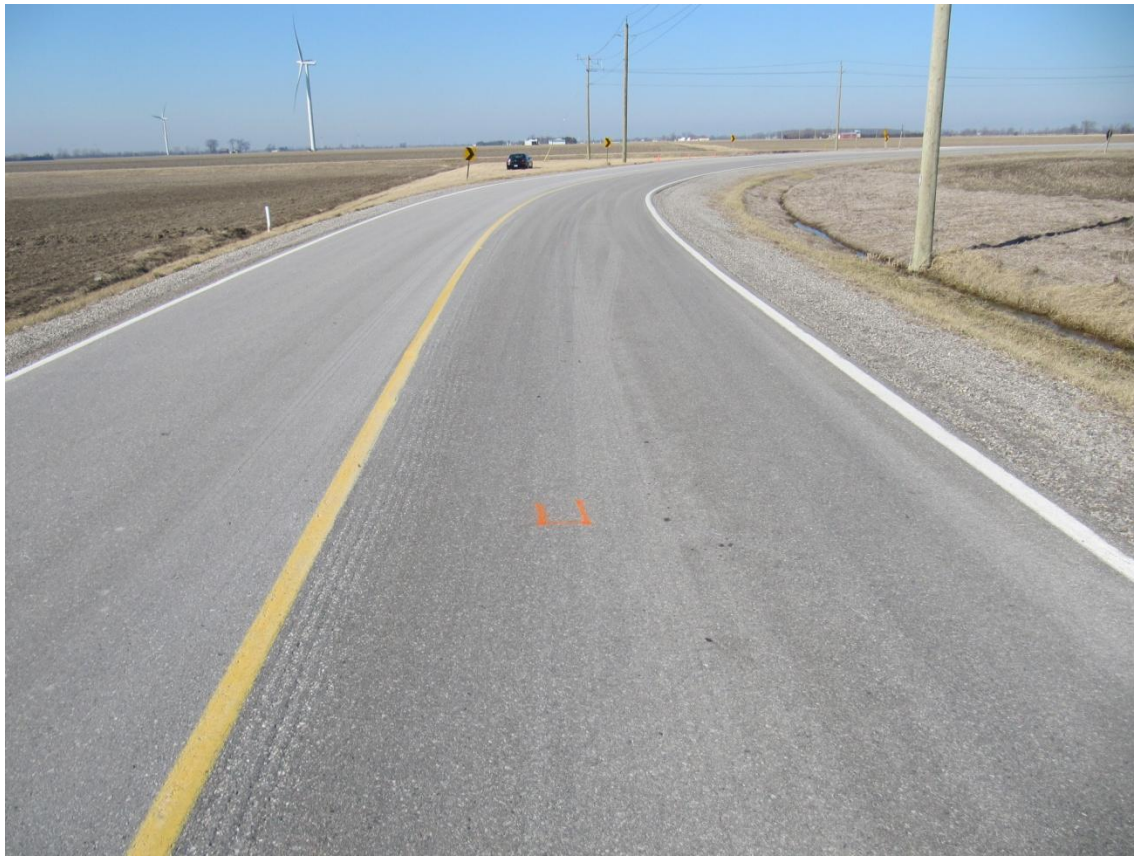
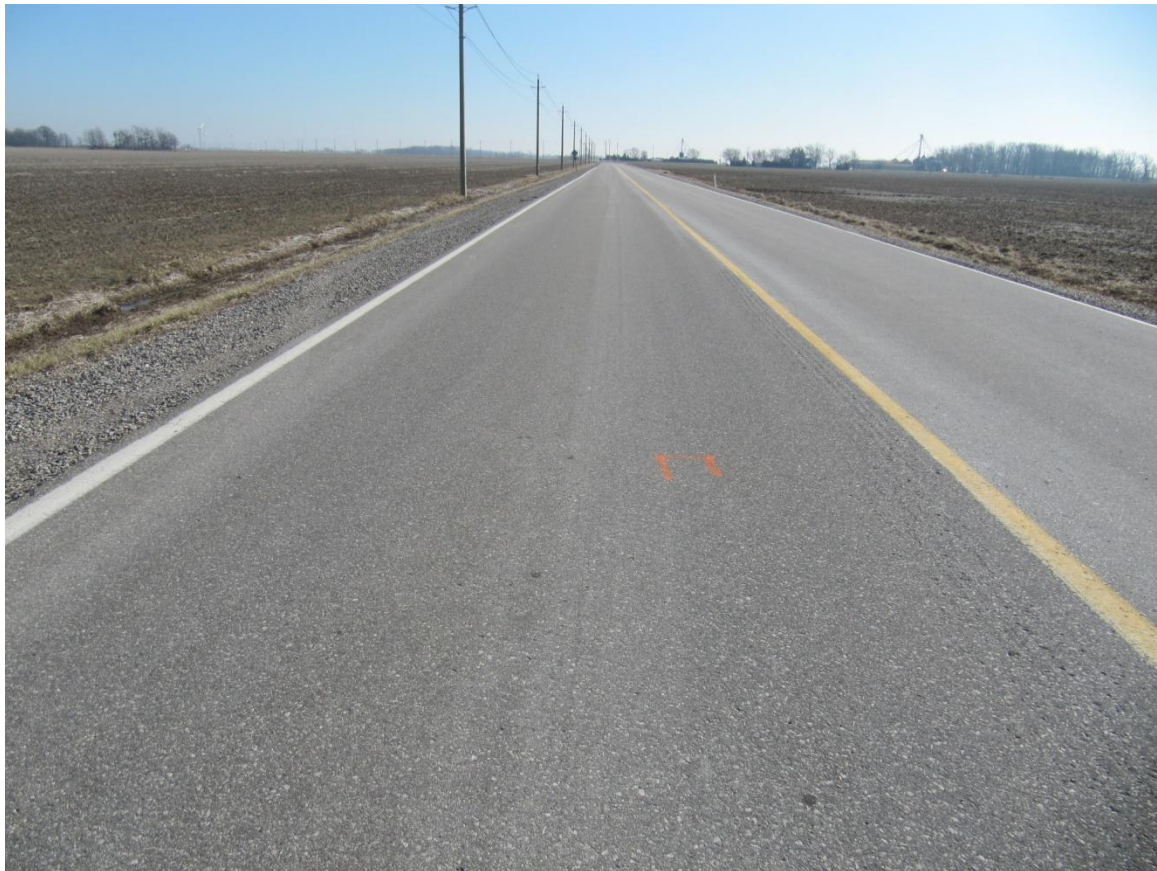
In the top photo on the following page is the first indication of a tire mark caused by the accident involved vehicle. The orange paint identifies the position of the left side tires of the vehicle as it approaches the curve. This tire mark is about 1 metre to the right of the roadway centre-line or just slightly further away than would be expected if a vehicle was travelling down a straight roadway. The reason for this might be because the driver was beginning his steering into the curve.

But we might ask: Why is there a visible tire mark at this location? Well, no, the mark is not very visible now but it was obviously visible about 24 hours earlier when the police marked this point. When we travel around a curve our vehicle does not normally produce visible tire marks. But we know that, if our vehicle travels around a curve fast enough our tires begin to slip slightly and that slippage produces the visible tire mark. So the presence of a visible tire mark at this point tells us that the vehicle is already showing signs of lateral slipping, but it really has not entered the curve. So why is that occurring? Speed? Well, yes, to an extent. But the vehicle is not yet in a location where it is supposed to be changing direction in any substantial way.

To demonstrate our point, we can turn around and look at the beginning of the tire mark with respect to the road along which the vehicle approaches the curve and this is shown in the bottom photograph on the following page. Clearly, as the vehicle travels to the point where it begins to produce the visible tire mark the road is essentially straight. So why do we see a tire mark starting at this location? The vehicle should not be changing its direction of travel at this location, at least not to any significant degree.

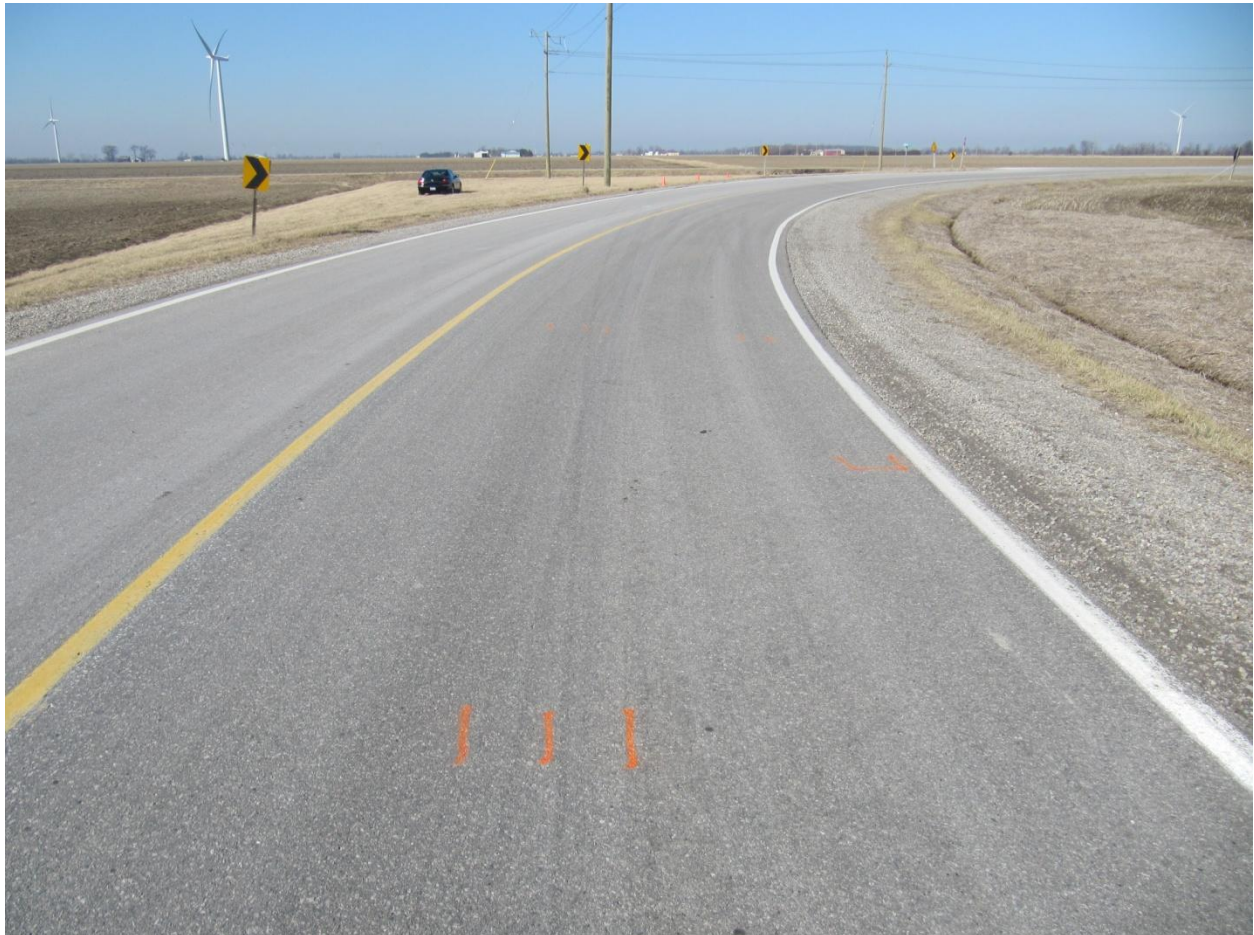
As we proceed further into the curve we can see where the two tires on the left side of the vehicle begin to diverge onto their separate paths as shown in the middle of the photo below. You may also see the orange paint near the right edge of the lane where one of the tire marks from the right side of the vehicle has been identified.

So clearly this vehicle is beginning a clockwise rotation, or yaw, in preparation toward sliding off the road surface. You should now be able to see a number of orange cones in the background on the left roadside where we will show you the tire marks of the vehicle as it slid off the road surface. However, at this point, on the pavement, the tire marks are not particularly visible. Generally they tend to become more visible as the vehicle rotates further into the yaw.

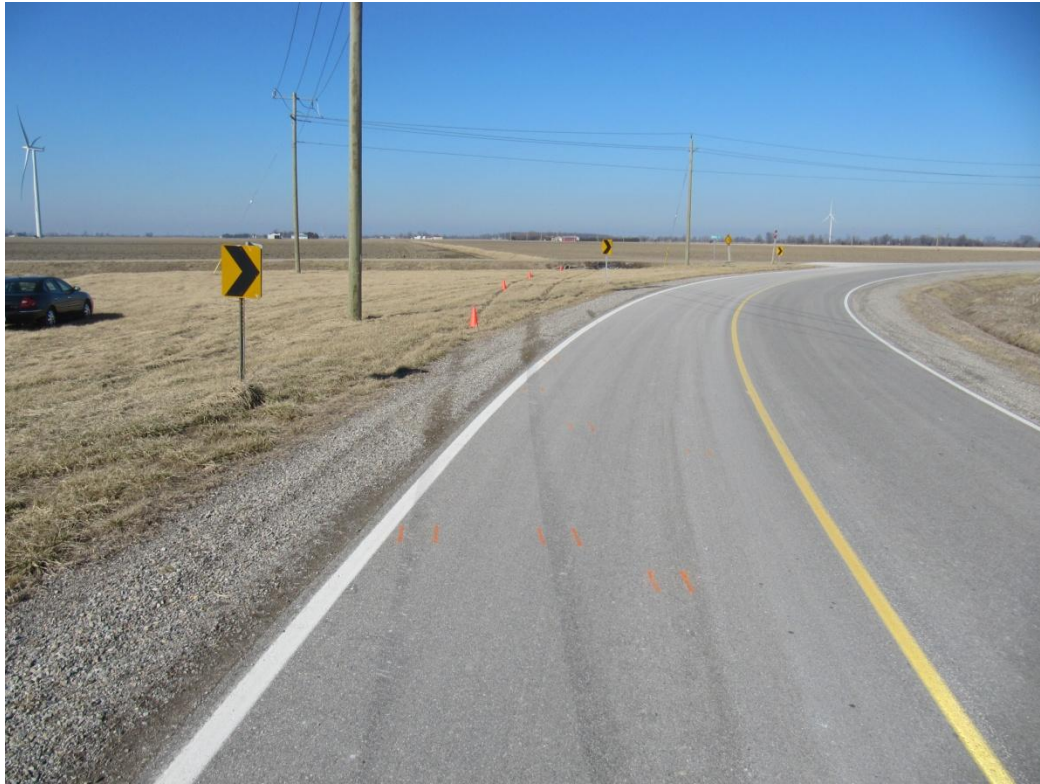
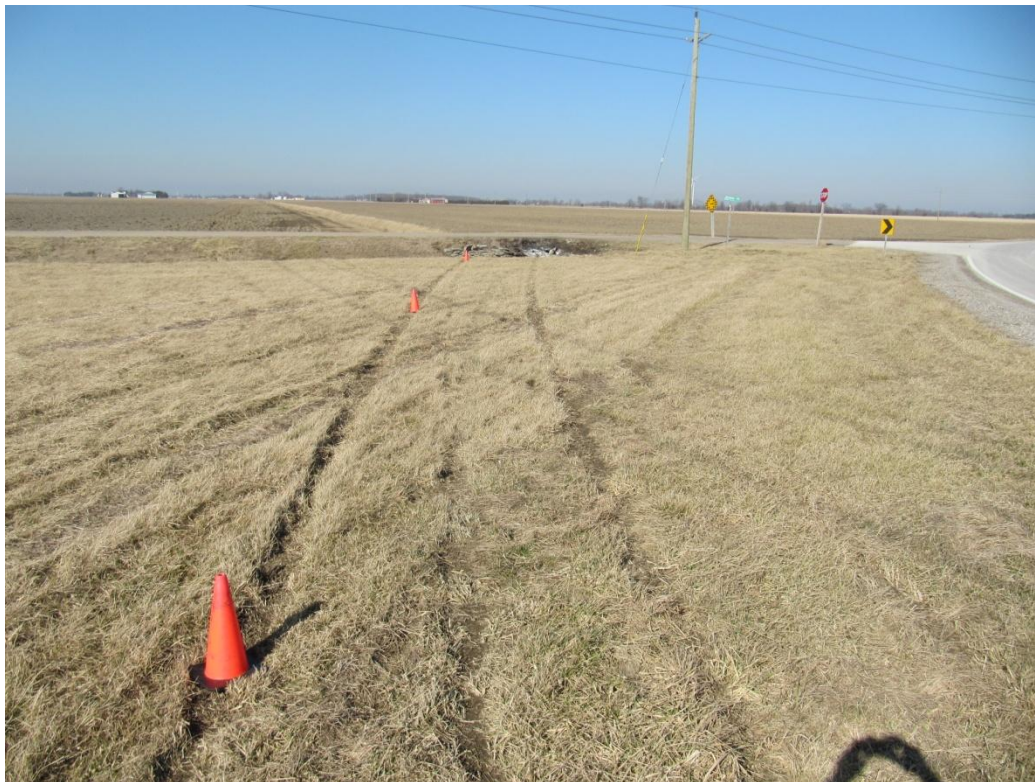
At the top of the following page you can clearly see the tire marks and the associated orange markings that were painted by the police to help visualize their location. The two left side tire marks are caused by the left tires of the vehicle, the outermost tire mark is caused by the left rear tire so you can visualize the angle of the vehicle as it is sliding off the road surface and into the ditch. To help you visualize the motion we have also placed some orange cones along the left rear tire mark on the roadside in the background. At this point however the tire marks are fairly obvious.

In the bottom photo of the following page you can see how the vehicle continues its clockwise rotation and heads toward a culvert which abuts an intersecting, secondary roadway. As the vehicle approaches that culvert you may be able to detect how the mark produced by the left front tire crosses with the mark produced by the right rear tire. Just look in the centre of the tire marks and you should be able to see how the left front tire mark starts to divert from the

right rear. This is an indication of the extent of the rotation and that, by the time the vehicle reaches the culvert it is essentially sliding sideways, leading with its left side.

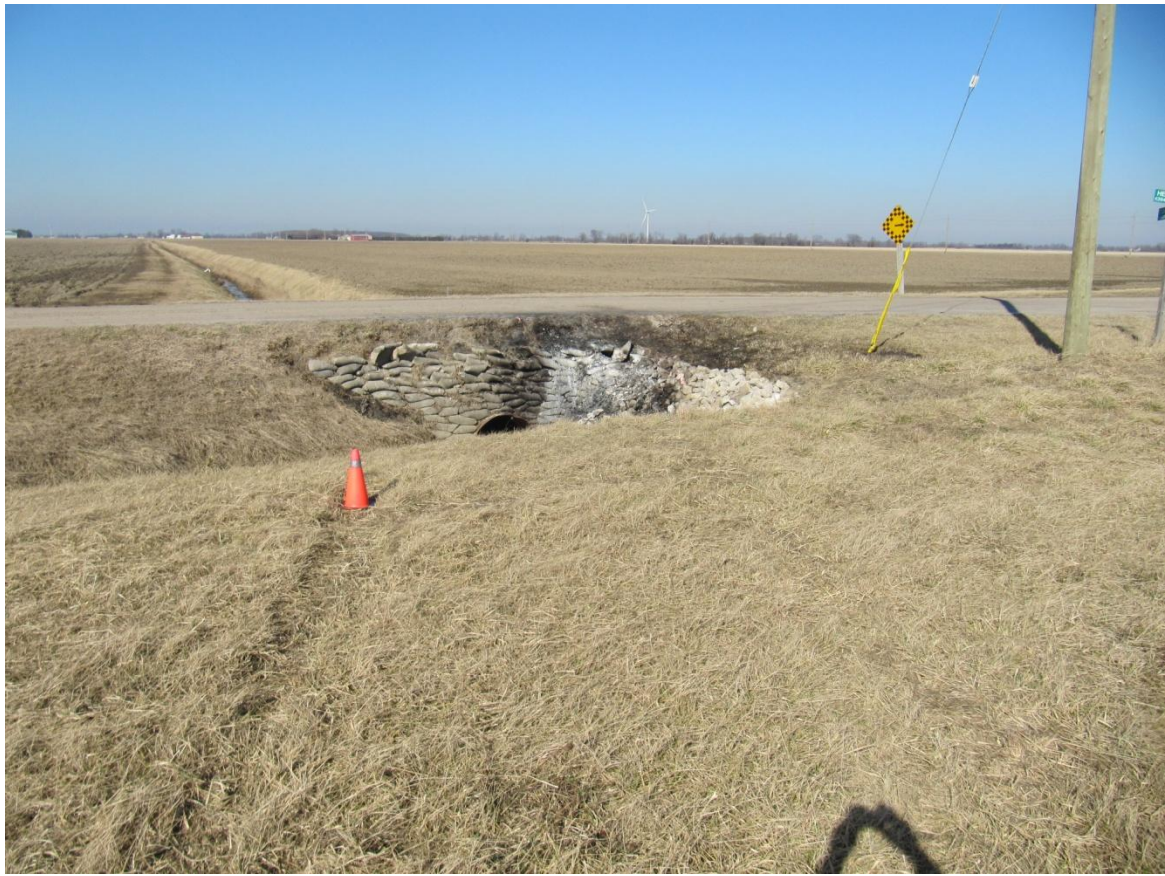
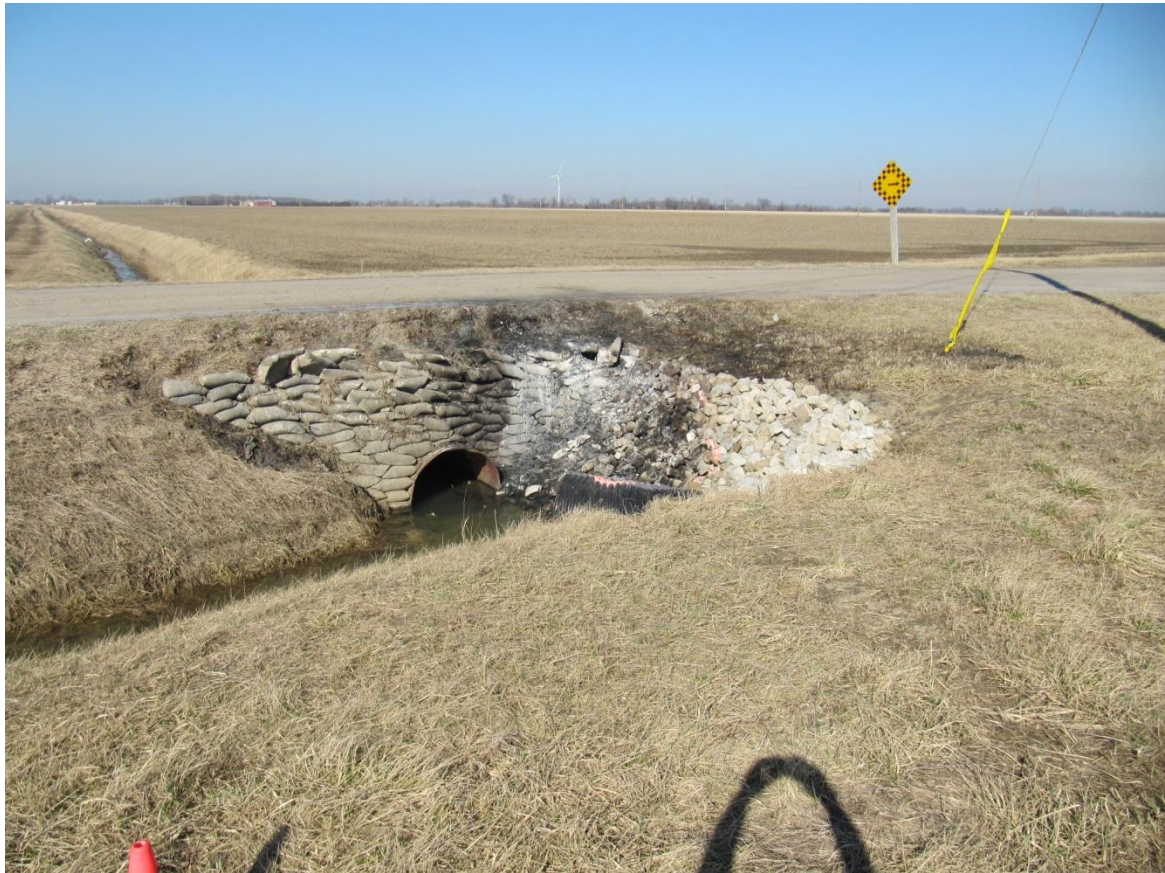
The sideways slide continues until the vehicle reaches the area of the culvert as shown in the two photos on the following page.

The black and grey deposits indicate where the vehicle came to rest on the wall of the culvert and then caught fire.

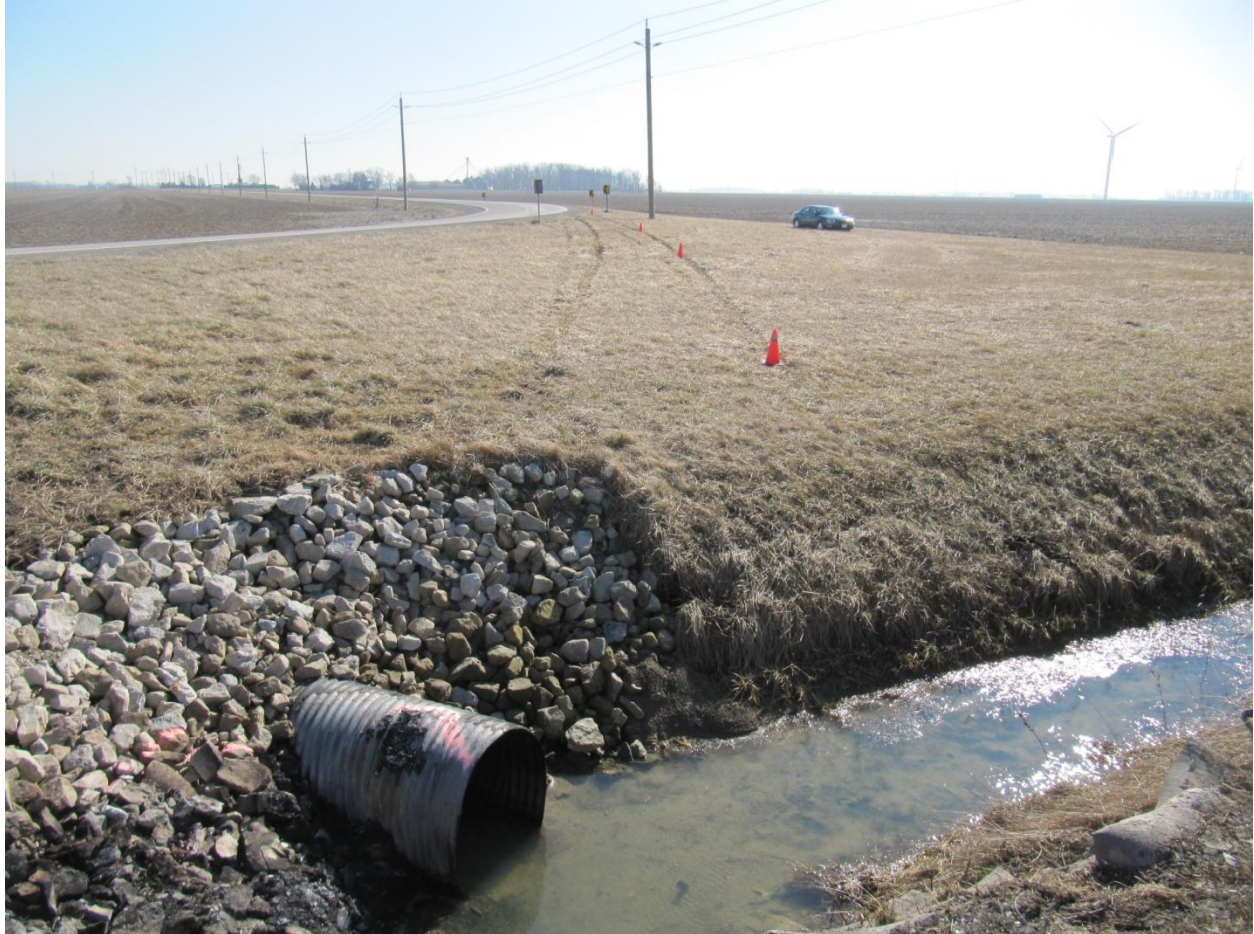
Below is a view from the opposite side of the culvert and looking back at the tire marks as they approach that culvert. You should be able to recognize how the two tire marks from the front tires of the vehicle are located on the left of this view and the tire marks caused by the rear wheels are on the right side of this view as the marks approach the culvert.

If you look into the ditch area you should be able to detect the orange paint markings that outline the final rest position of the vehicle in the above photo.

It is an unfortunate turn of events that the vehicle entered into this deep crevice because this caused the vehicle to strike a fairly vertical wall of stone and frozen sand bags. This caused the vehicle to come to a sudden stop. We can recall that the change in velocity or "Delta-V" of an impact is related to injury. The higher the change-in-velocity the higher the probability that there will be more severe injuries. Of course, there are some caveats. It is actually how quickly the "change-in-velocity" occurs that is the real determiner of injury. Thus if we reduce our velocity rather slowly the rate of acceleration (deceleration) is lower and there is less probability of incurring the more severe levels of injury. But when a vehicle comes into an immovable barrier such as the wall of this culvert the change-in-velocity occurs rather suddenly. So both the vehicle structure and the occupants within have to deal with dissipating all that kinetic energy they possess and this is done in a very short time, thus the accelerations are high. The result is that damage to the vehicle structure is different than if the velocity change occurred over a different time and that cannot always be controlled by a manufacturer of a vehicle.

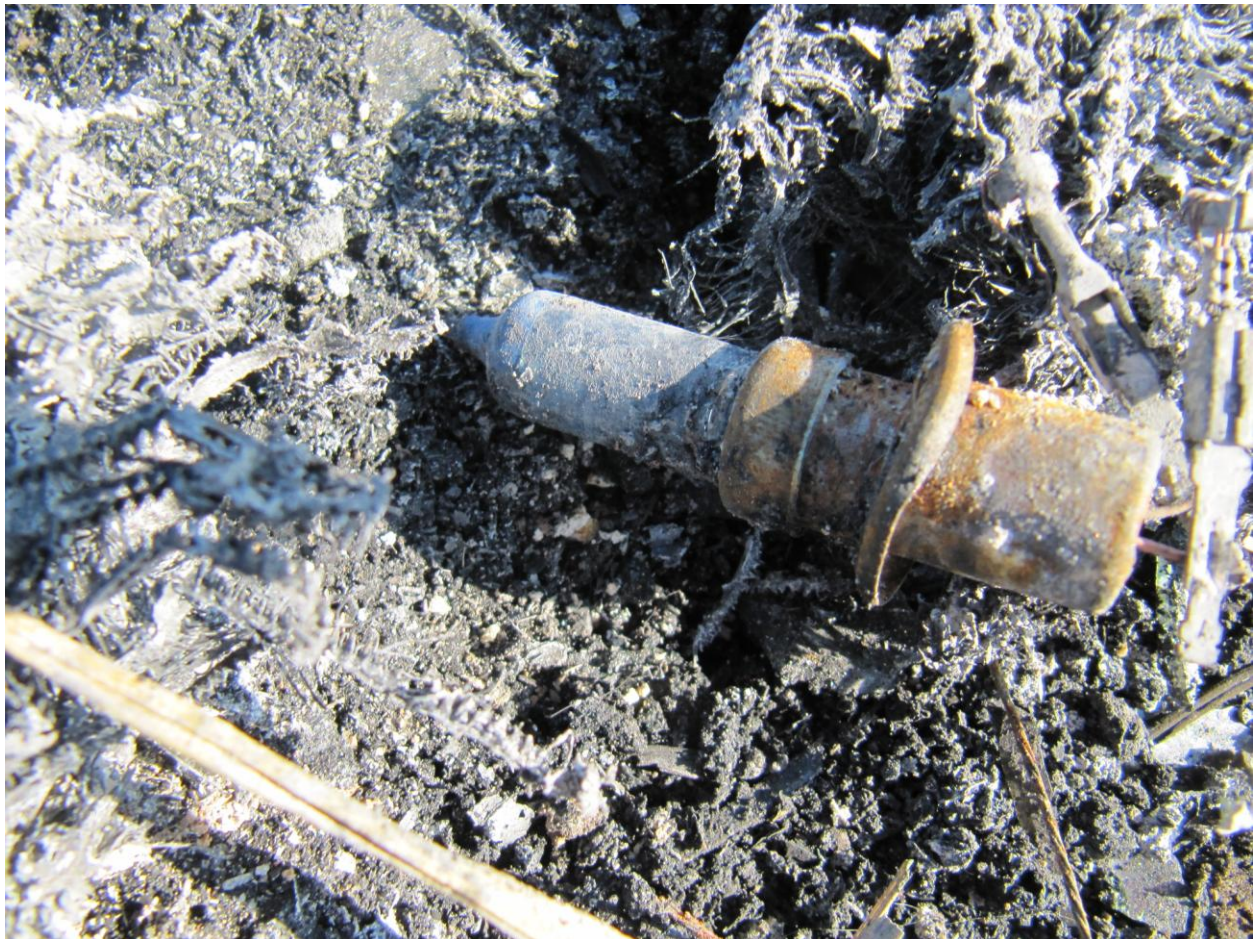
Below is a photo of one of the head-light bulbs that was lying on the wall of the culvert.

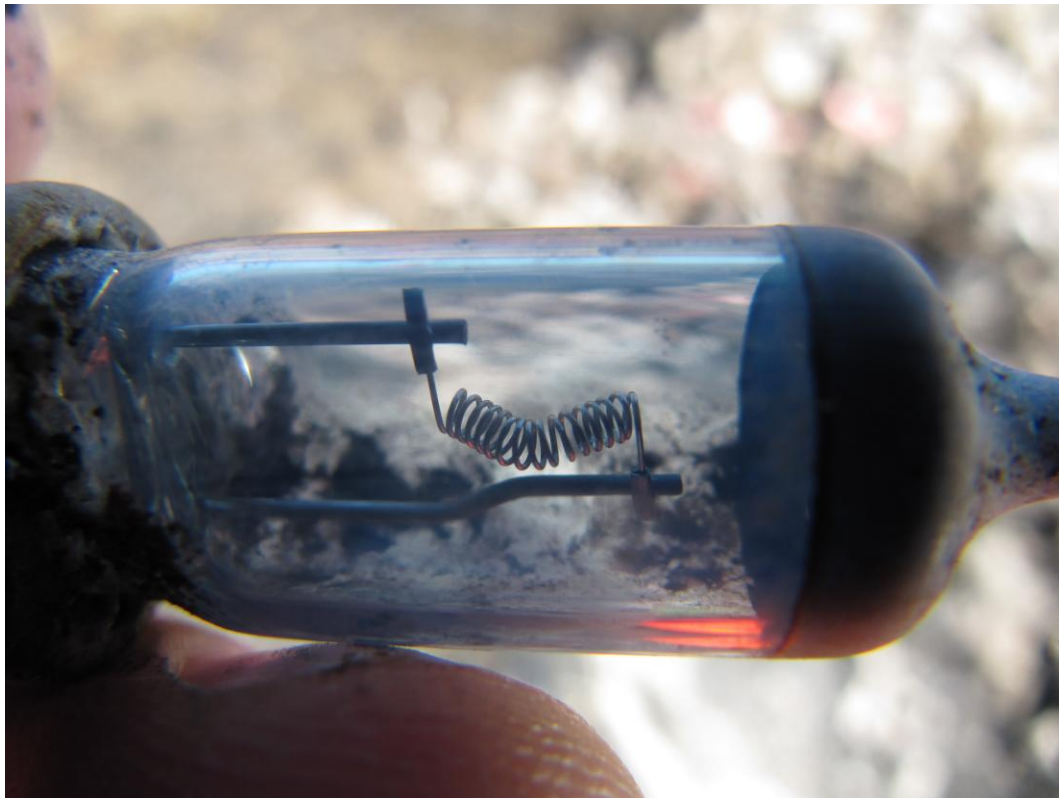
It only requires that the soot clinging to the exterior glass be brushed away to expose the condition of the bulb filament as demonstrated in the top photograph on the following page.

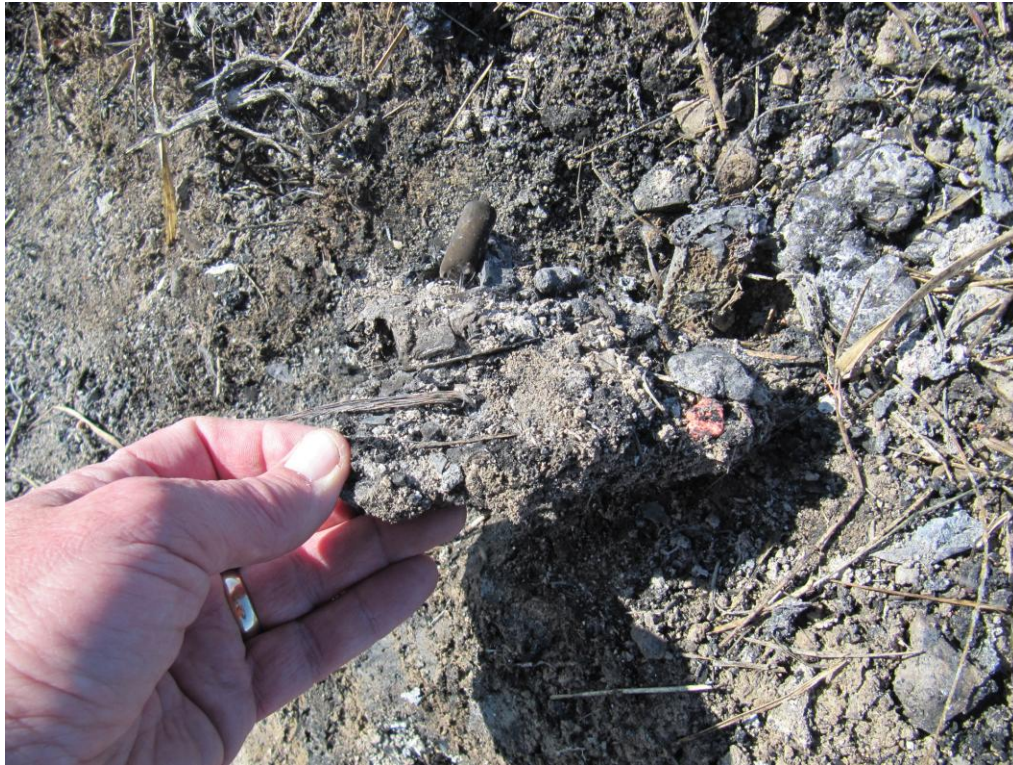
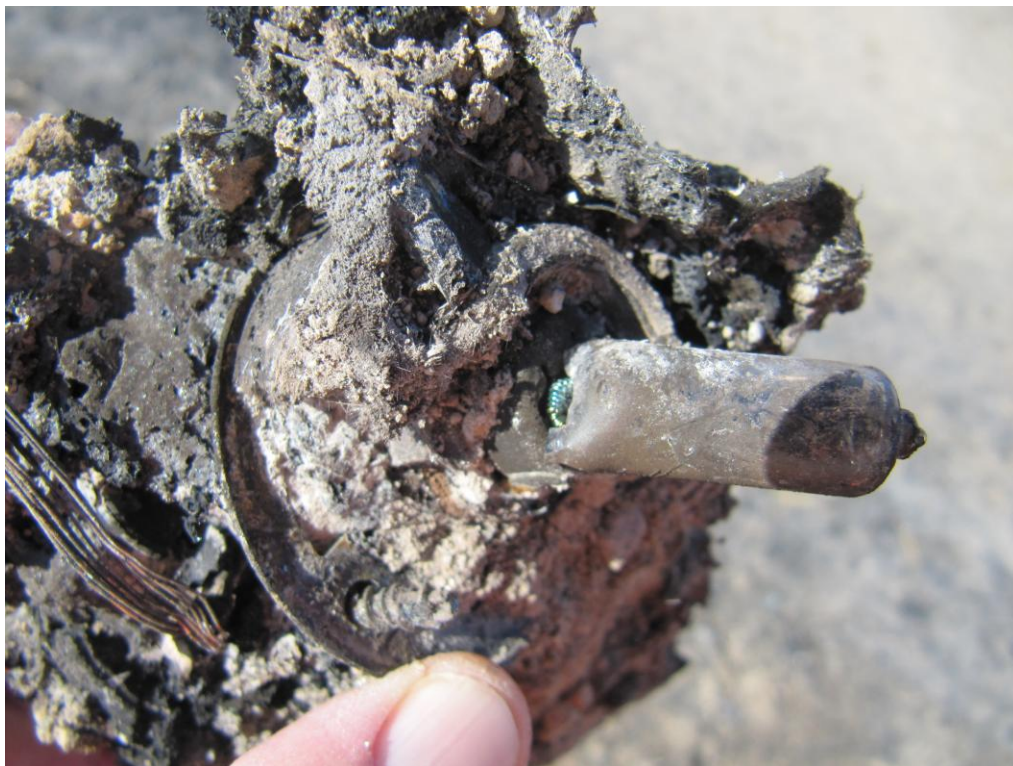
There is nothing particularly obvious about the piece of melted material that I have lifted off the ground. But as we lift that material and look at it more closely you begin to recognize that it contains the other headlight filament, as shown in the two photos below.

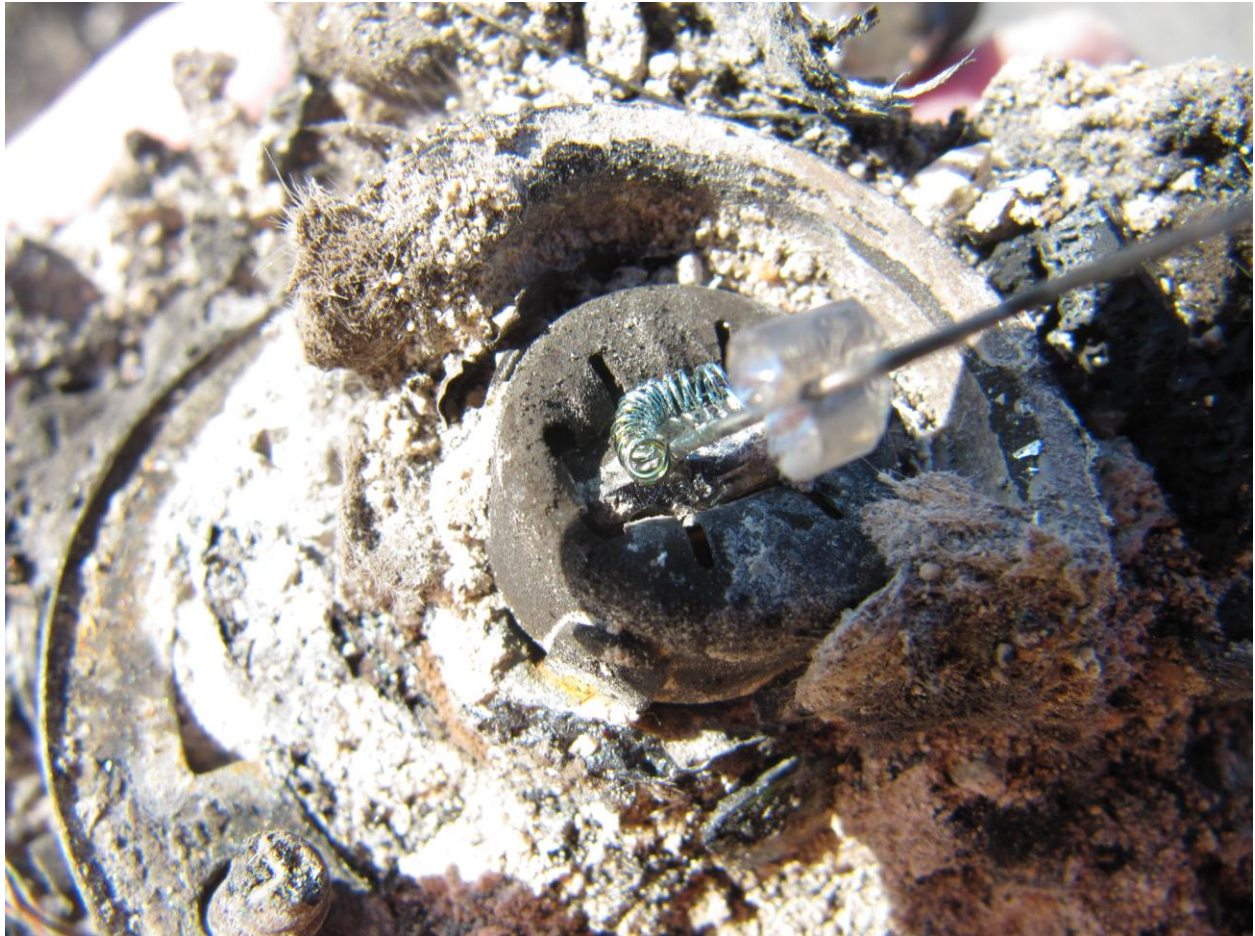
There is nothing revolutionary about what we have done. It is just a case of gaining familiarity with the evidence you seek and understanding what it should look like and where it is likely to be. When we remove the glass casing of the bulb the filament is exposed and its characteristics can be interpreted, as shown in the photograph below.

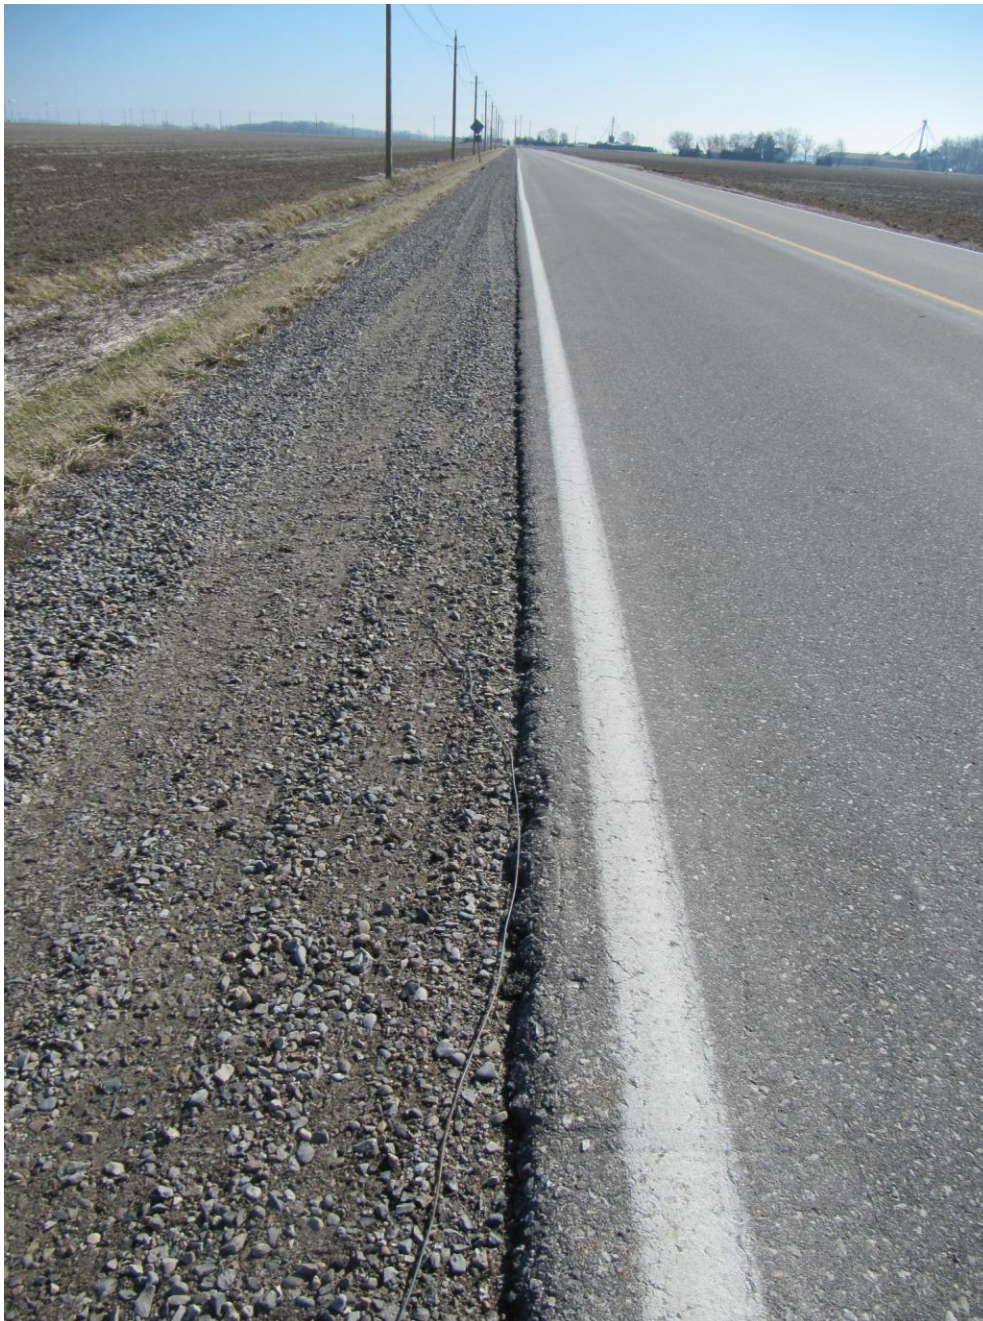
The drop off of a pavement edge into a lower gravel shoulder has been noted as one of the factors that can cause a driver lose directional control when the wheels of the vehicle pass over that drop off. The detection of significant edge drop offs is not easy. Consider the photograph below which is looking back toward the direction from which the vehicle came, and it shows the east shoulder of Coastsworth Road just prior to the noted curve. Is there a significant drop off of the gravel shoulder from that asphalt edge?

We believe you would be more likely to say that the edge drop off was at the east shoulder in the first photo. You might say this because you can see the shadow that is cast onto the shoulder at the edge of the pavement and that same
