Review of Physical Evidence of Double Fatal Collision on Coatsworth Road, Essex County, Ontario

Posting Date: 09 Feb 2012

Gorski Consulting
London, Ontario, Canada

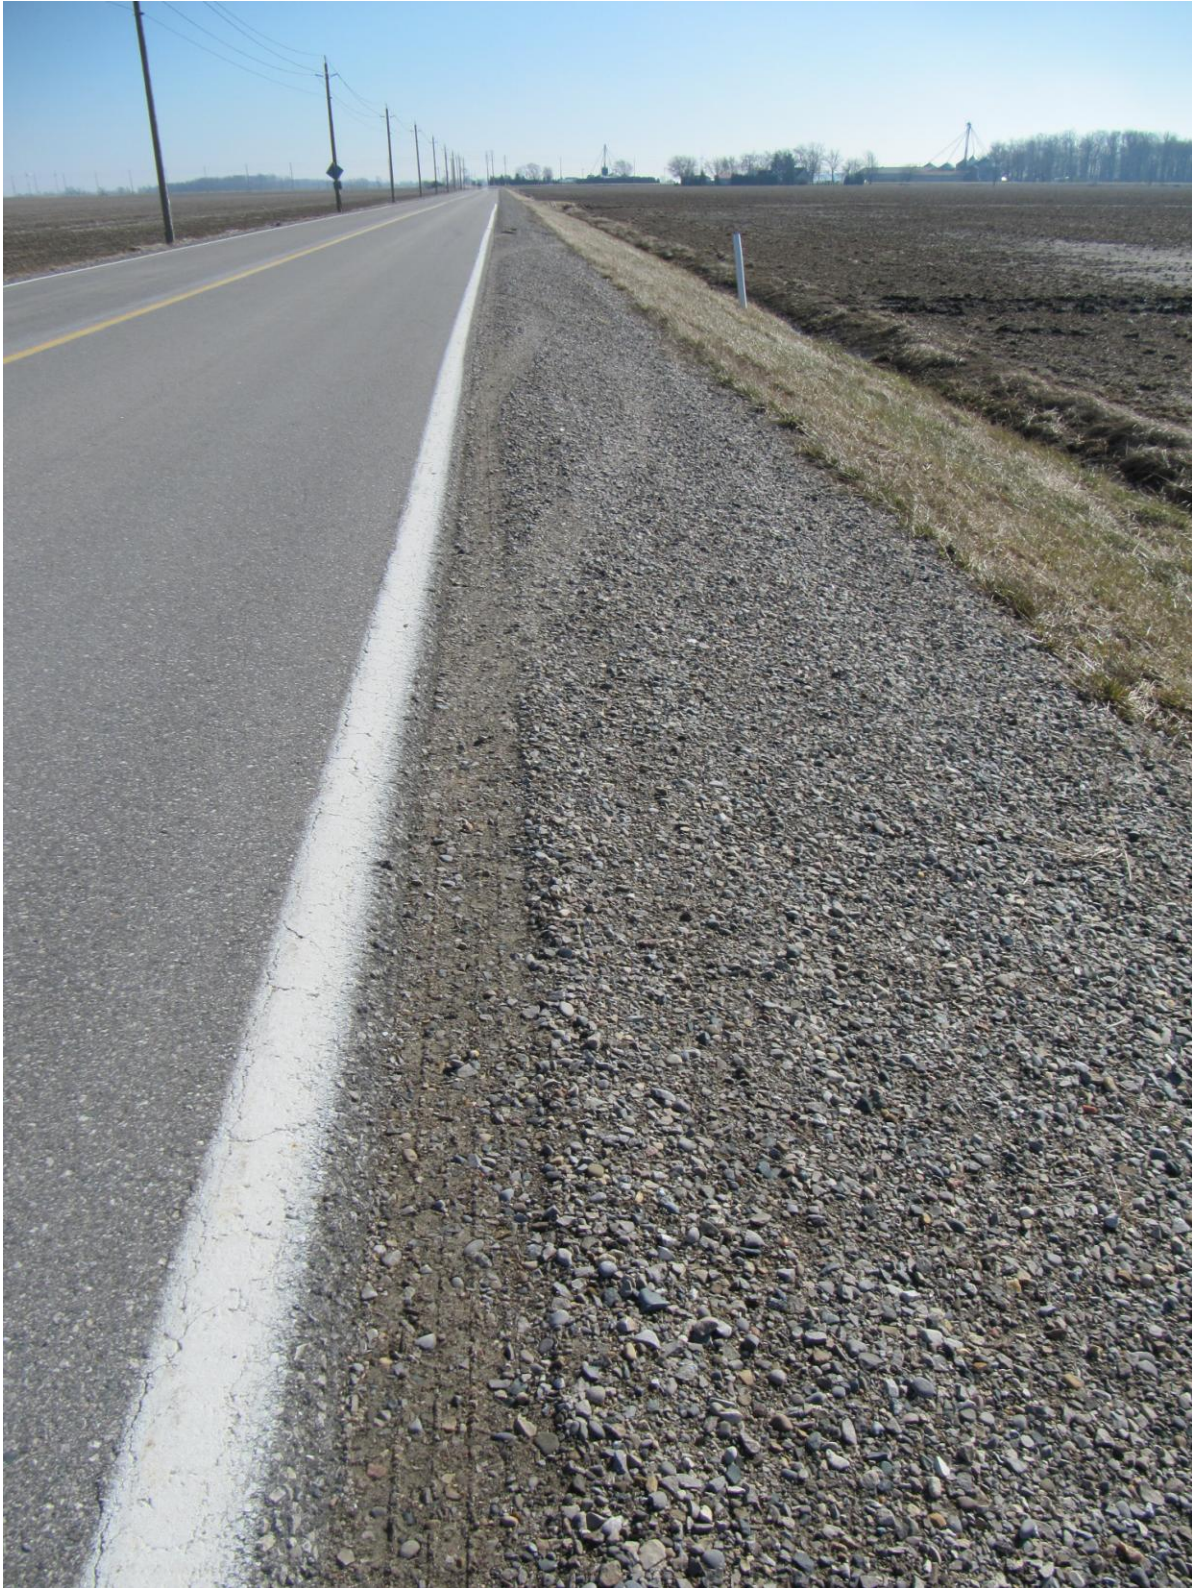
Now consider the opposite shoulder, as shown in the photo below.

shadow is not visible on the west shoulder. And here is where the problem lies. The sun plays tricks on us. It is the west shoulder that contains the significant drop off. The shadow is not present because of the orientation of the sun with respect to the drop off. We can prove this by placing a carpenter's level next to the edge drop off and measuring the vertical height. The drop off was 4 inches or 10 centimetres. The location where we took that measurement is shown below and the view is pointing back in the direction of the curve. But as you can see, the edge drop off is not very noticeable.
