Gorski Consulting Website

Archived News - 2013 - July

July 27, 2013

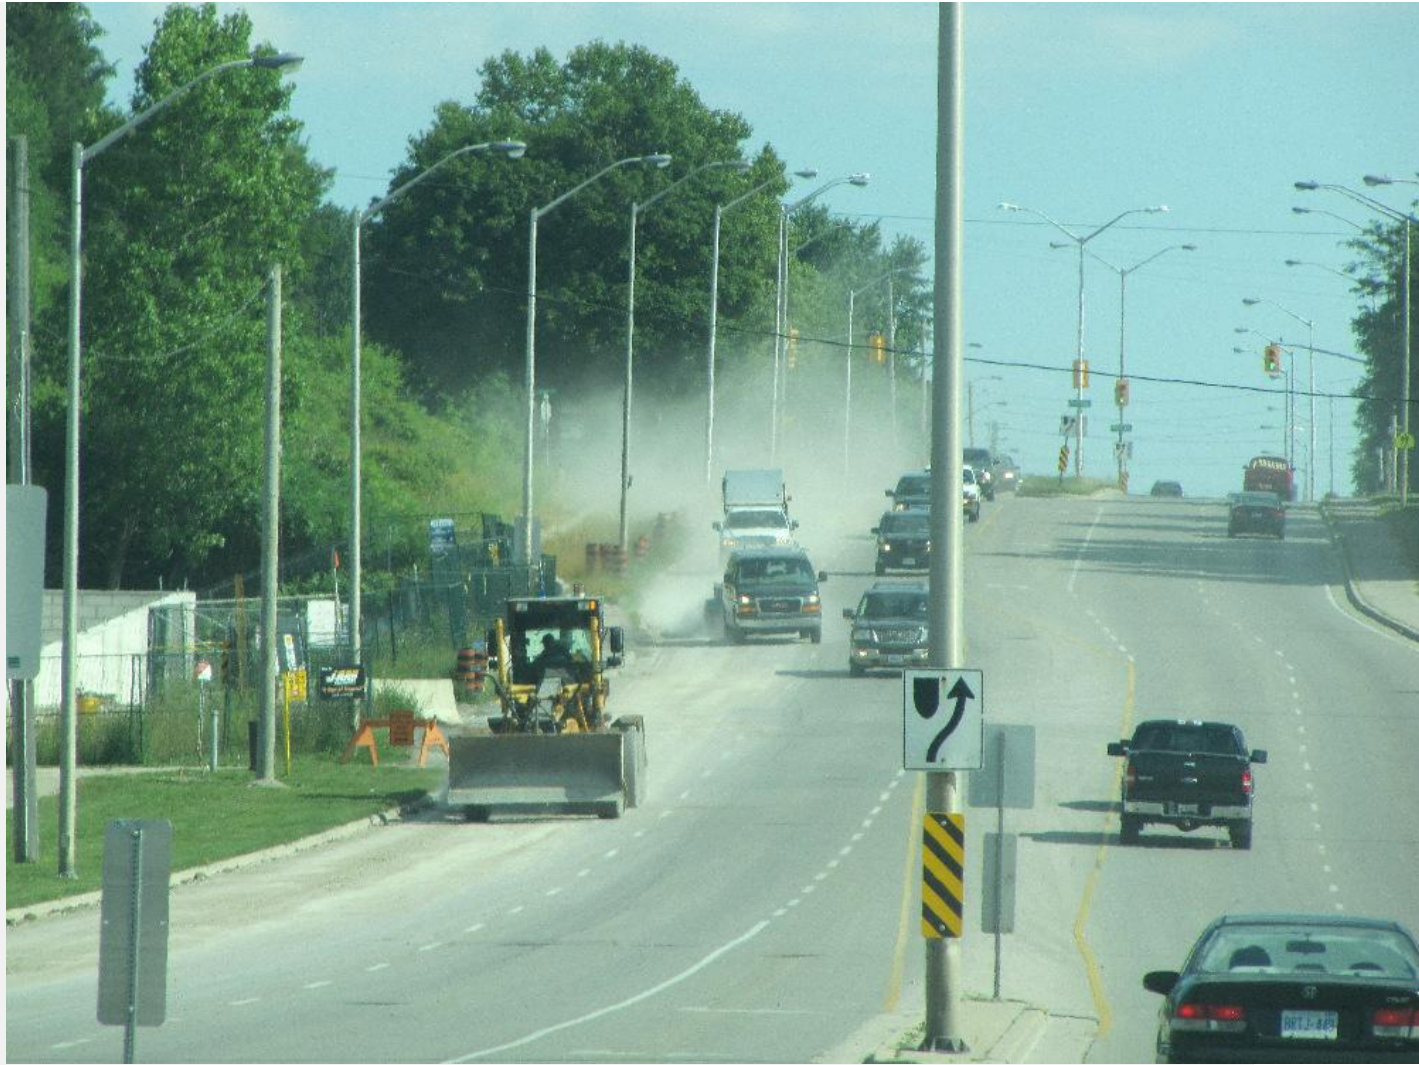
View, looking south along Highbury Avenue, toward the newly re-opened, northbound curb lane where dirt/sand is stirred up into a blinding cloud.

The dust cloud can be unpredictable, sometimes being minimal while at other times becoming blinding as different vehicles and different vehicle paths make the results unpredictable. In many cases drivers can pass by safely but a sudden blinding cloud of dust which develops at a time when a driver needs to detect some unexpected obstacle can result in a dangerous situation.

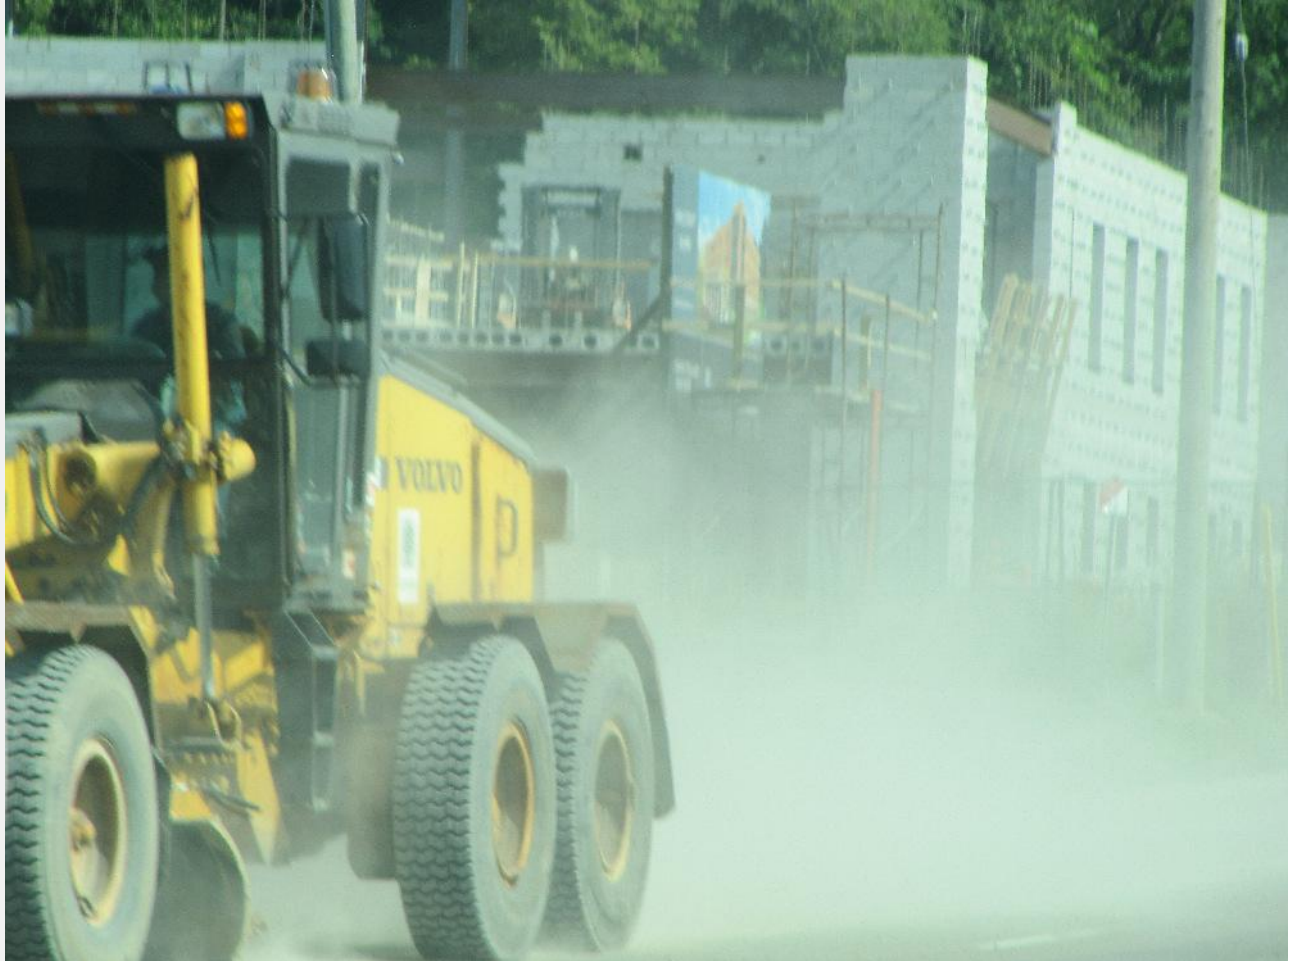
Transient existence of a dust cloud can catch drivers by surprise or prevent them from seeing important obstacles ahead.

In wet weather the dirt and sand can cause the road surface to become slippery, especially in this vicinity where there is a substantial downgrade in the road.

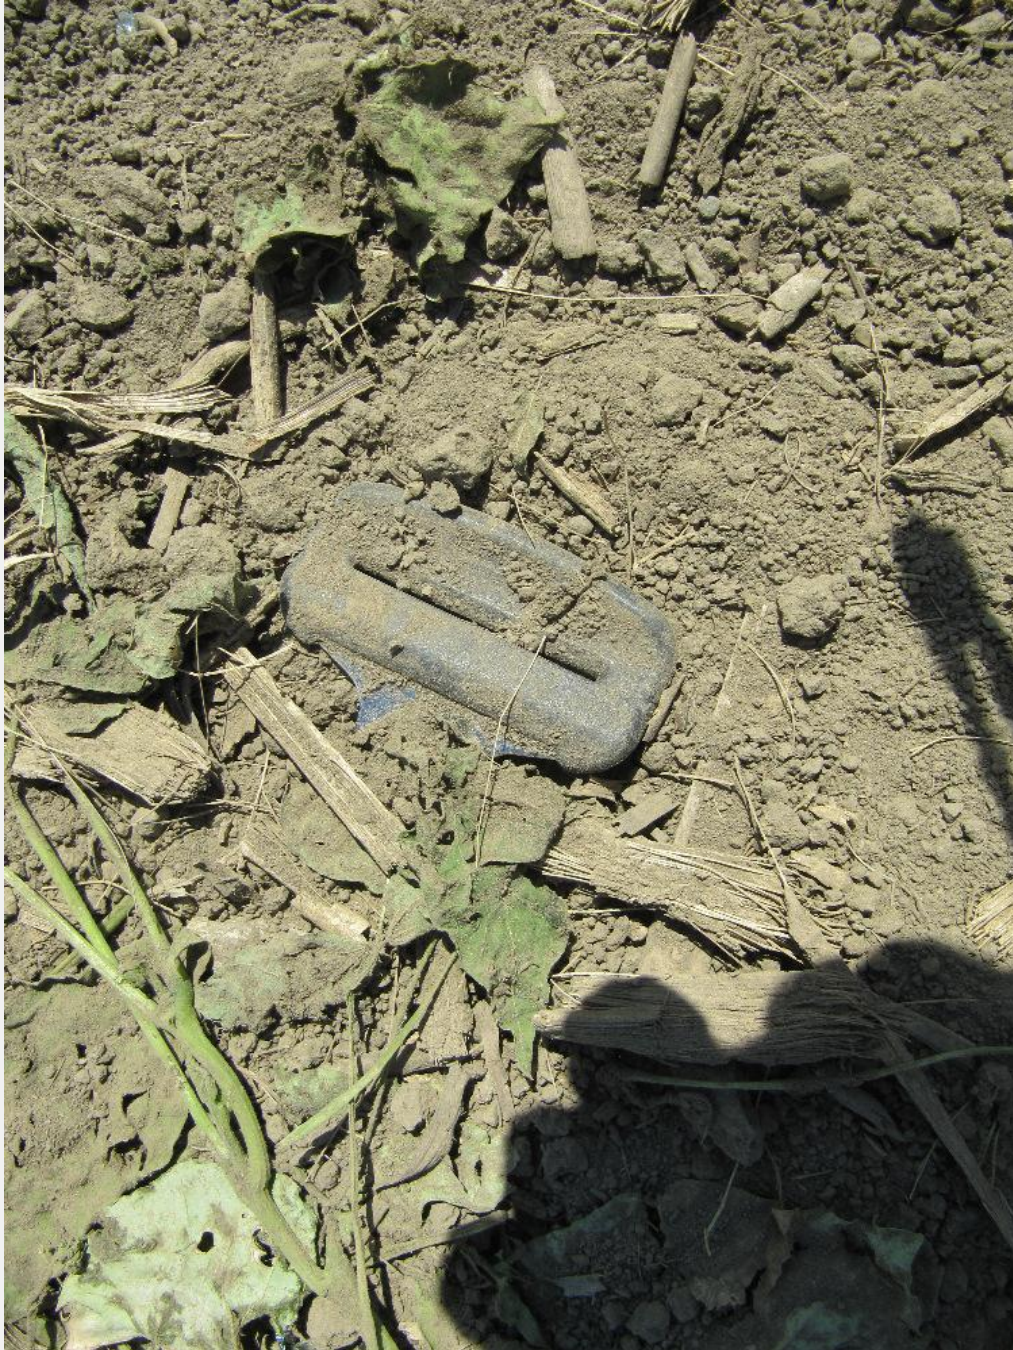
View of sliding tongue from a seat belt system lying on the ground at the final rest position of a collision-involved vehicle.

We might wonder how this evidence came to be located here. For example, such a tongue does not just fall off a restraint system because its webbing passes through the access hole of the tongue. Thus, in order for the separation to occur there has to be some kind of separation of the seatbelt webbing. This separation could be from the collision forces but that would be rare. It takes tremendous force to cause a separation, or there

could be a sharp exposed piece of metal that could cause it, but those are extremely rare in the vicinity of a vehicle occupant where modern safety standards would prohibit such a happening. So, it is far more likely that the separation occurred because emergency personnel used their knife or scissors to cut the webbing to gain access to an injured occupant for transportation to an ambulance.

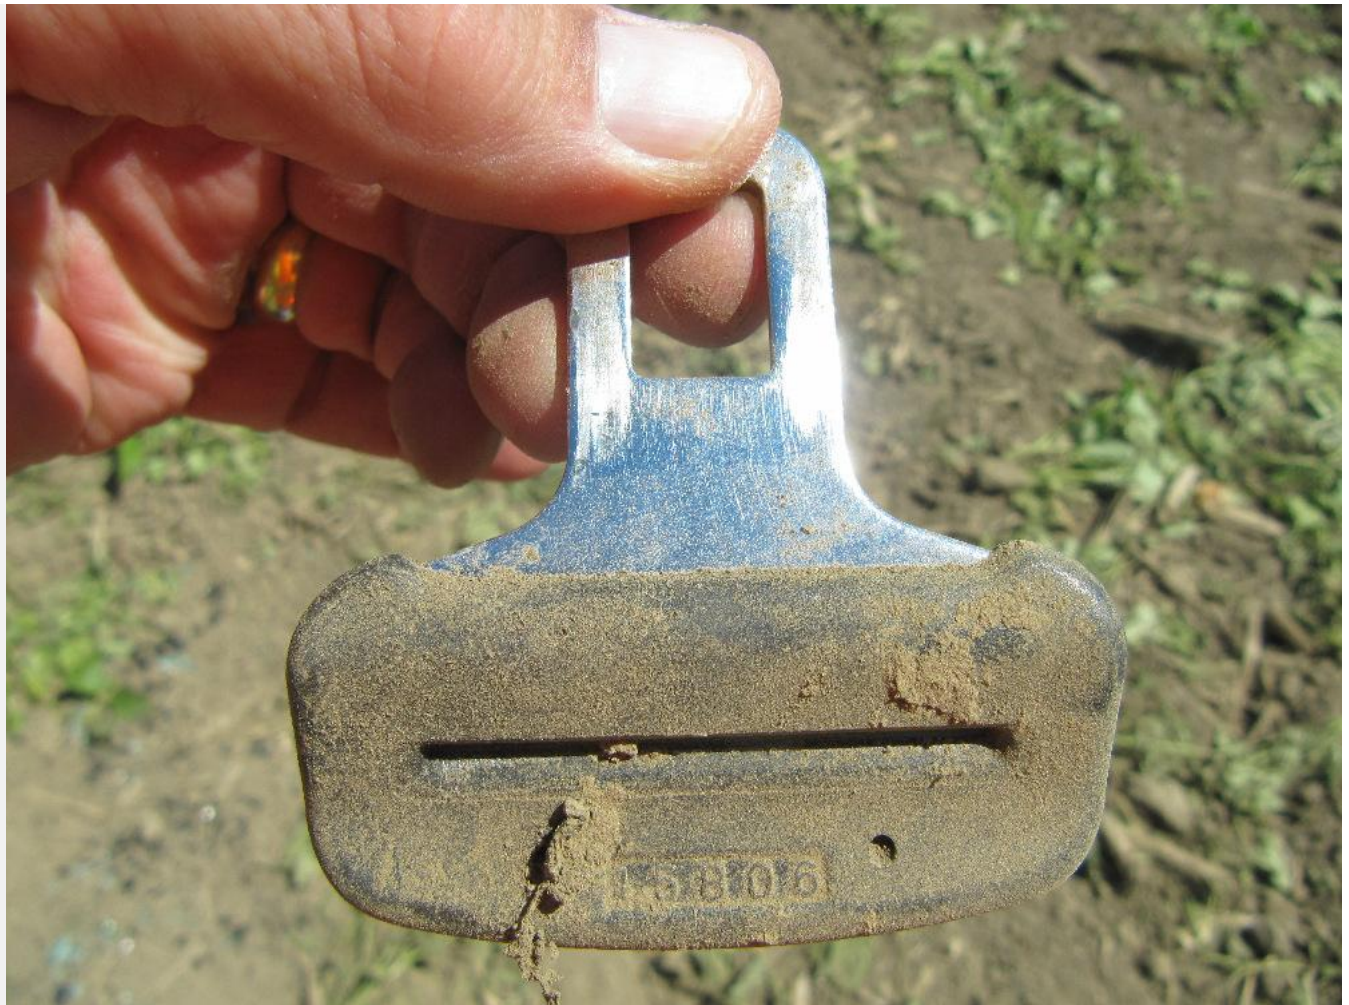
Closer view of sliding tongue.

But before that, look at the condition of this sliding tongue. It has dirt caked all over it. We can state that we examined this site only a few hours after the occurrence. So the evidence should be fresh. However, if you are aware of collision evidence you will be aware that, as this evidence sits for longer periods of time weathering occurs in the form of debris and dirt progressively lying over the evidence. So why is this tongue so caked with dirt? A likely conclusion is that, after cutting the seatbelt webbing emergency personnel spent some time at this location, tramping on the earth and stepping on this sliding tongue. So there was some concentrated action going on in the vicinity.

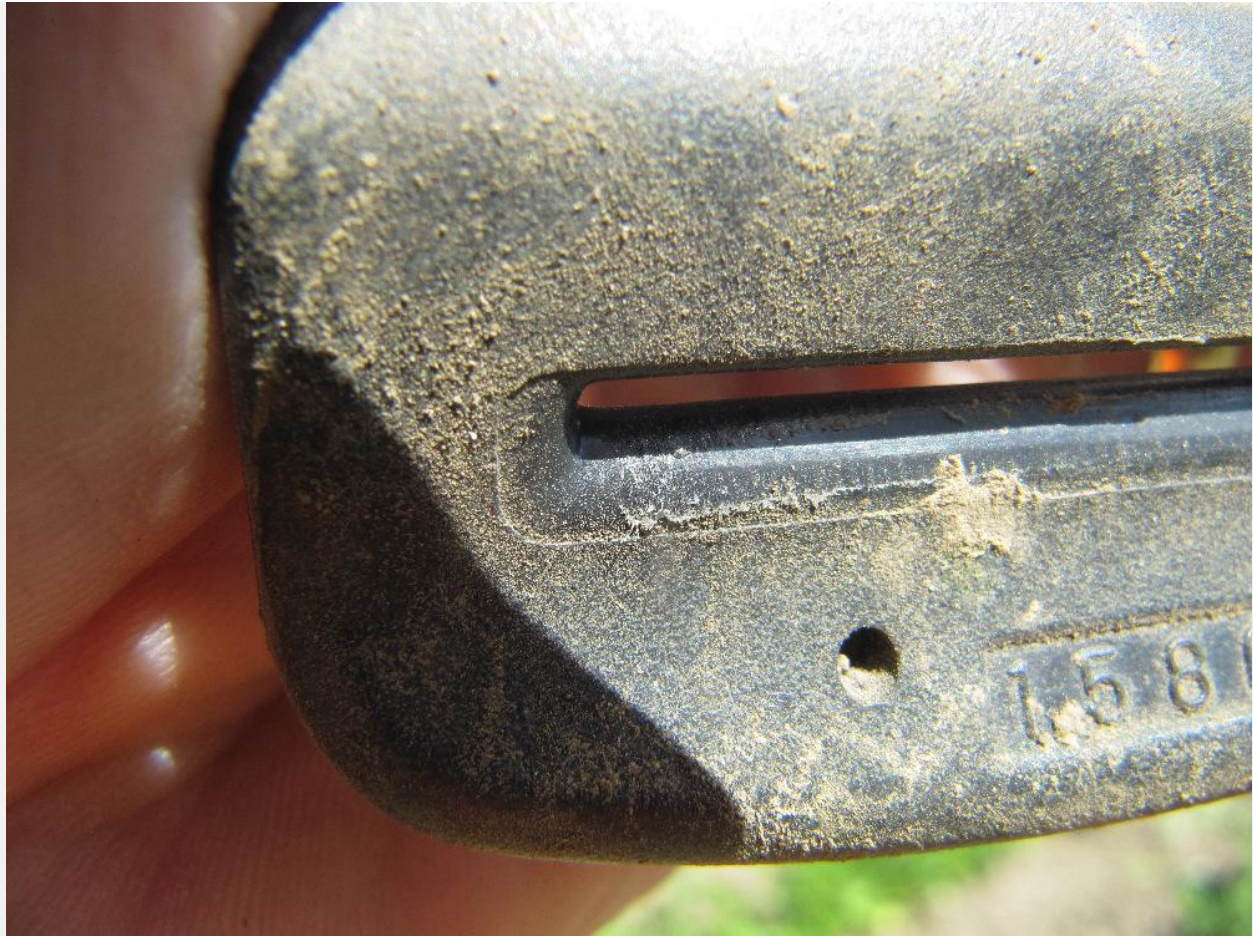
Closer view of the loading mark visible on the backside of the sliding tongue.

We do not want to prolong the discussion but, for the time-being, you should recognize that the loading mark you see in the above photos is from the driver's restraint system. But it would be difficult to recognize that it came from a vehicle that was struck in its side. Partly because this vehicle had a substantial forward speed producing a substantial deceleration along its longitudinal axis, thereby mimicking the conditions of a vehicle struck in its front end.

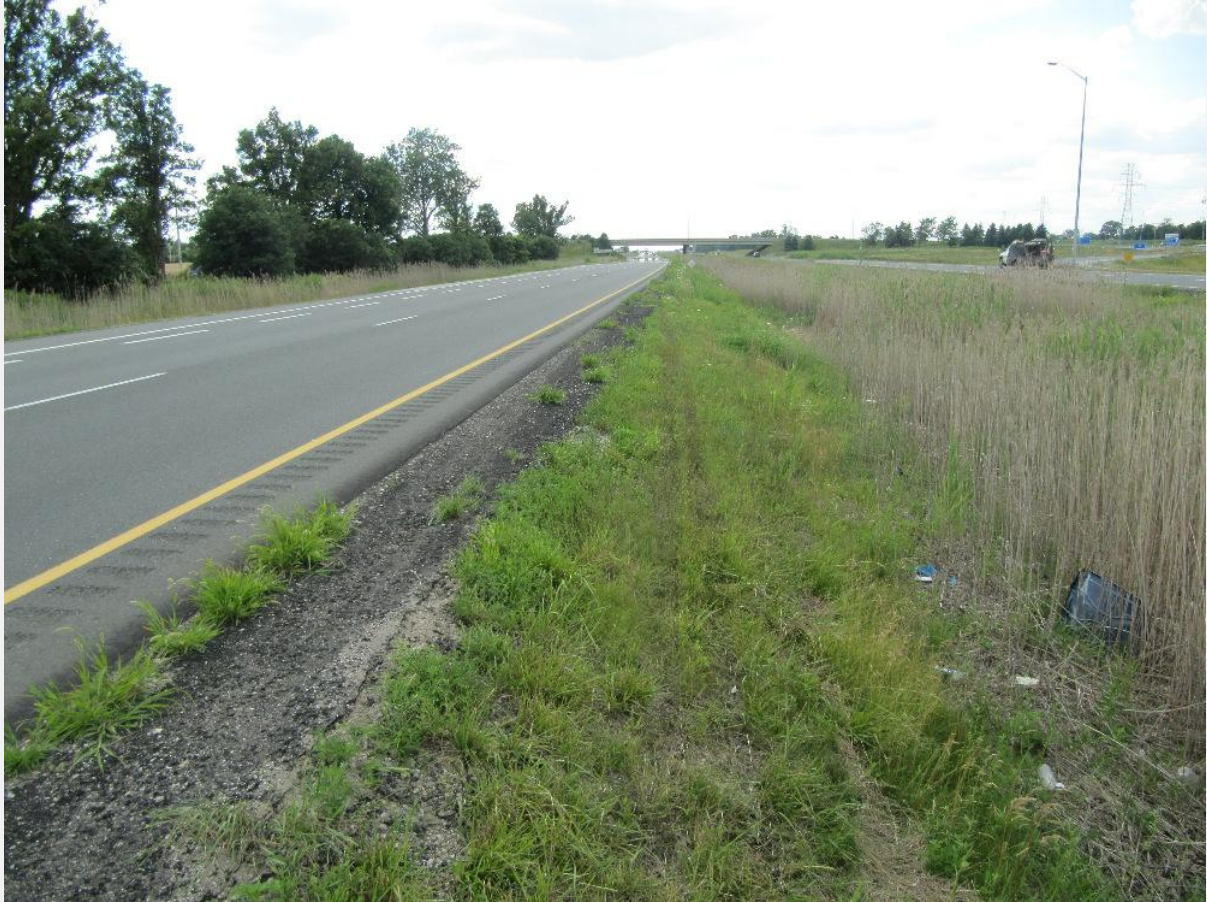
View, looking west, along the median next to the eastbound lanes of Highway 402 where a tire mark is visible in the grass indicating the exit of the Suzuki from the road surface.

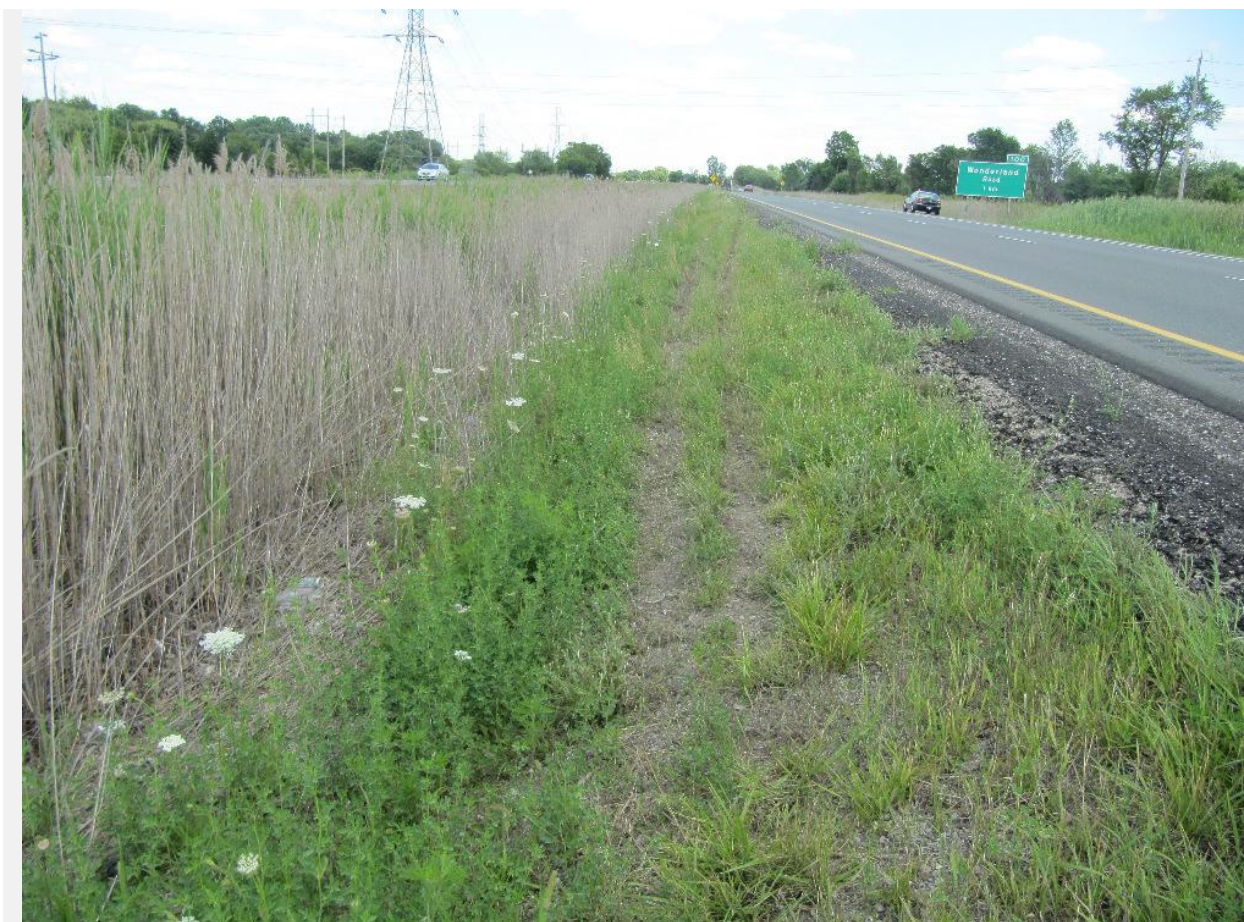
View, looking east, along the median next to the eastbound lanes of Highway 402 showing the tire marks, from the left side tires of the Suzuki, visible in the grass.

What is not readily apparent in the above photo is that there is a steep slope to the grass median that would normally pull the vehicle into the centre of the median. It is surprising therefore that the driver was capable of bringing the vehicle back out of the steep slope and back toward the road surface while the vehicle continued to rotate clockwise.

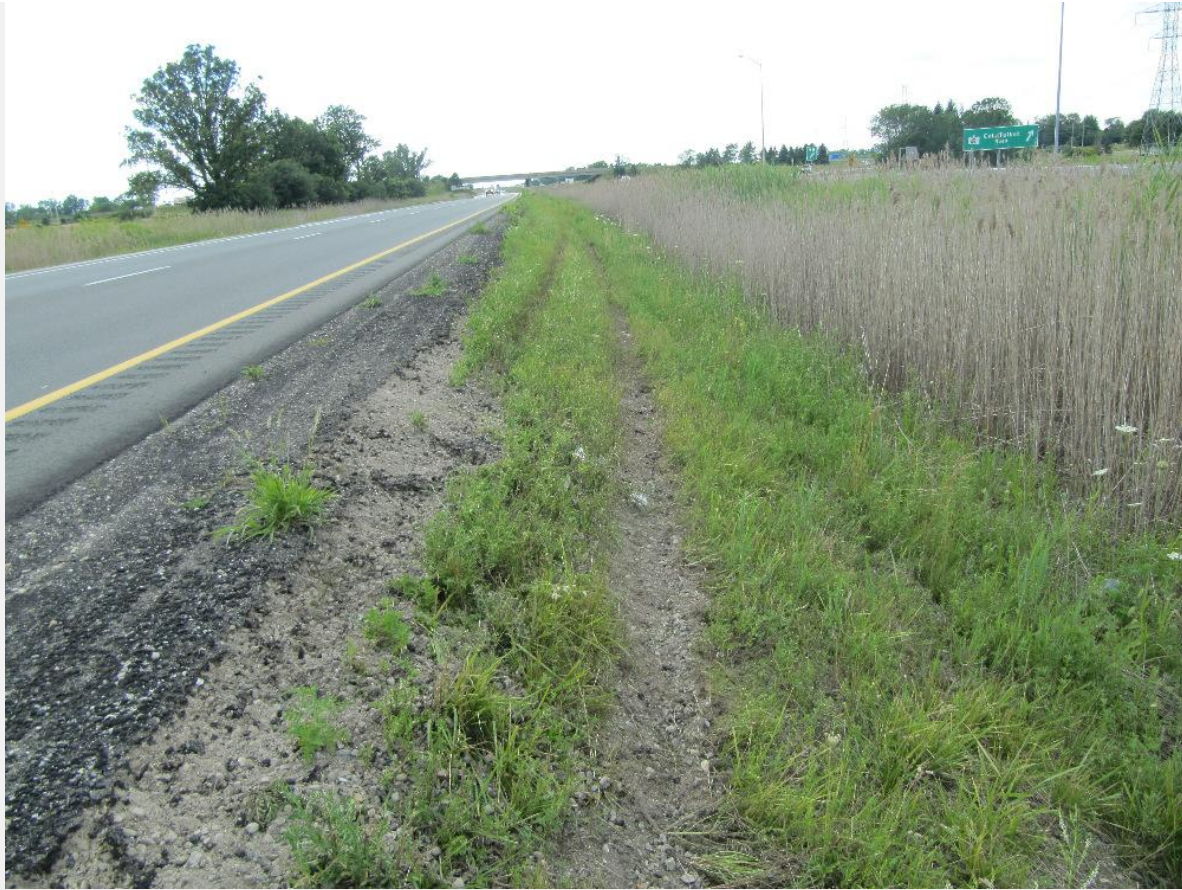
View, looking west, from a distance further east, along the median next to the eastbound lanes of Highway 402. Now the two tire marks from the left side tires have diverged substantially indicating the increased pointing angle of the Suzuki as it is rotating clockwise and out of control back toward the road surface.

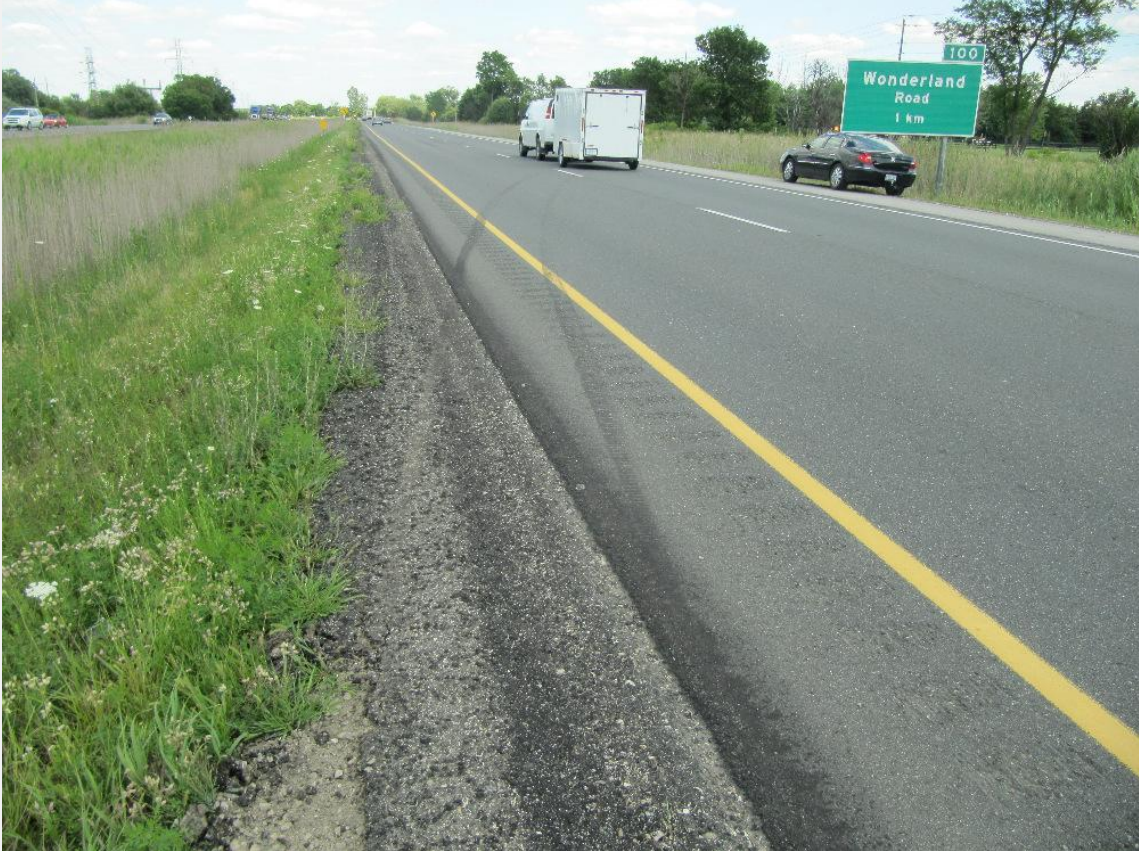
View, looking east, as the two tire marks diverge, indicating the continuing clockwise rotation of the Suzuki as moves back onto the eastbound lanes and heads across the lanes to its point of rollover on the south roadside.

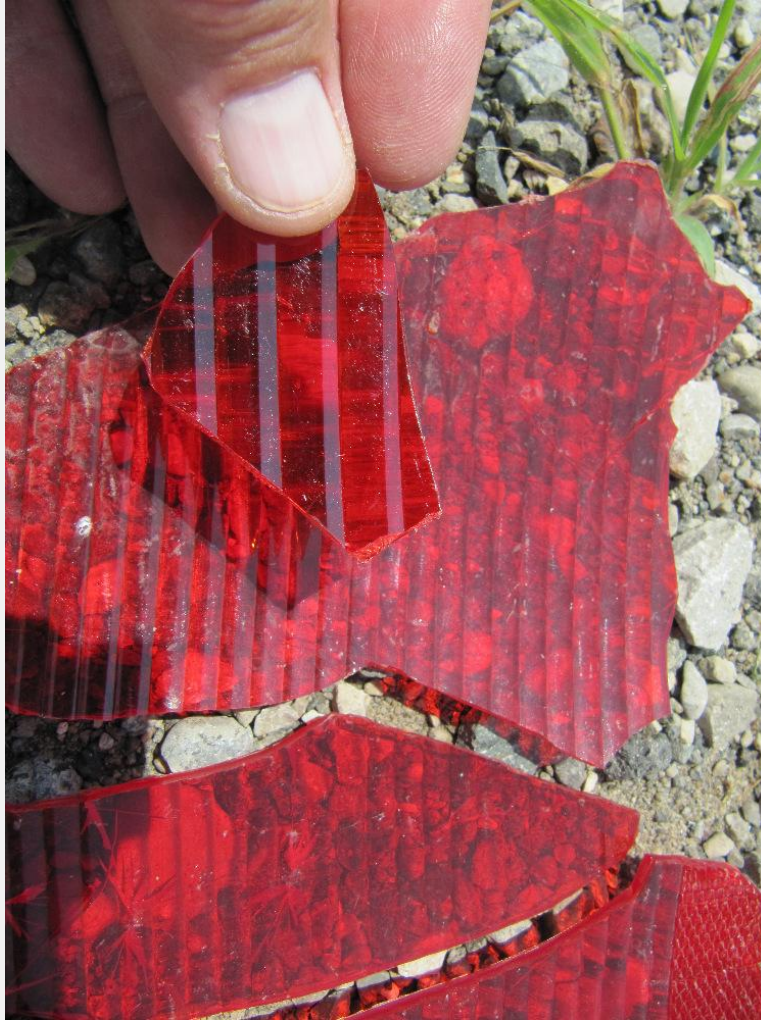
Close up view of comparison being made between the two samples of red lens material indicating that they do not match.

So whatever caused the red lens material to be strewn across the south shoulder of the highway is not known but we know that it did not come from the taillights of the Equinox. Obviously there could be numerous explanations for the existence of this evidence but we hope this is an interesting exercise to demonstrate what can be done to reconstruct motor vehicle collisions.

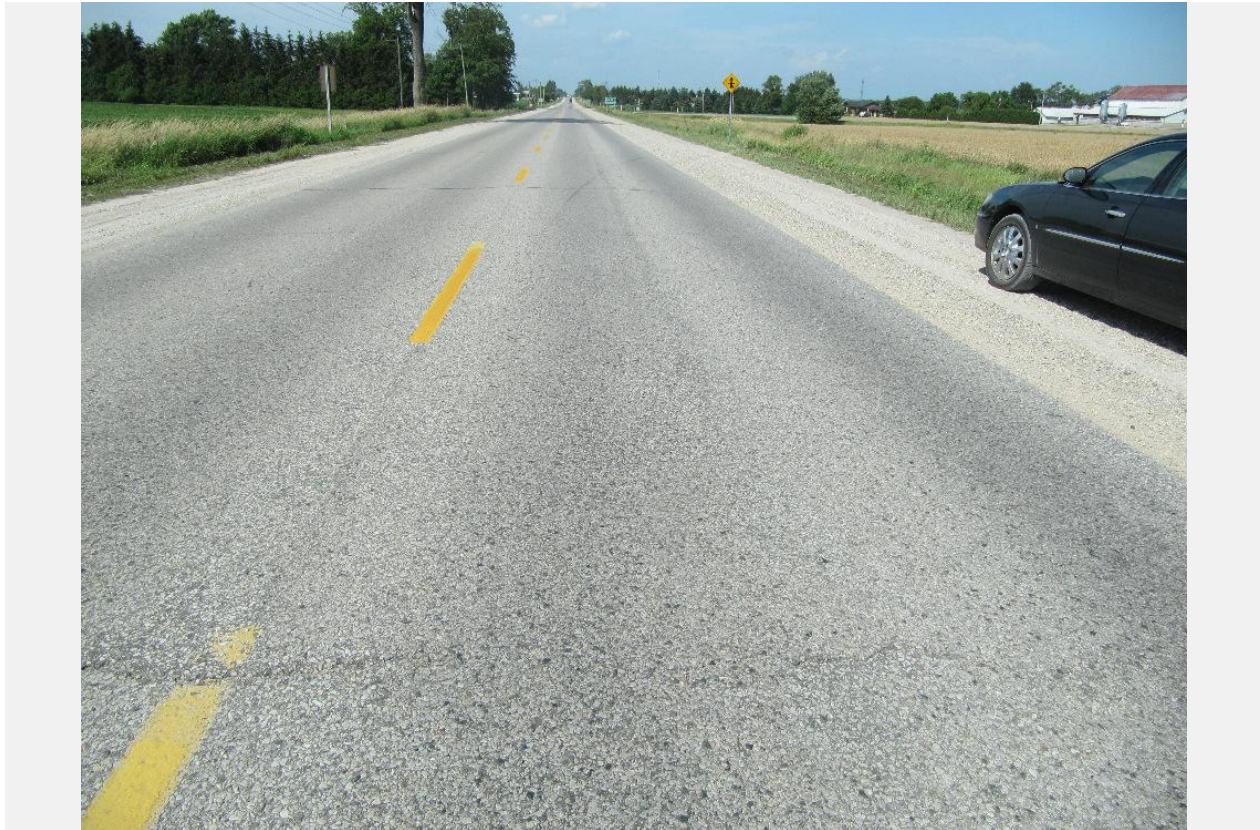
View, looking north in the northbound lane of Perth Road 23 showing the beginning of the yaw marks caused by the Kia rotated counter-clockwise and into the east (right) roadside.

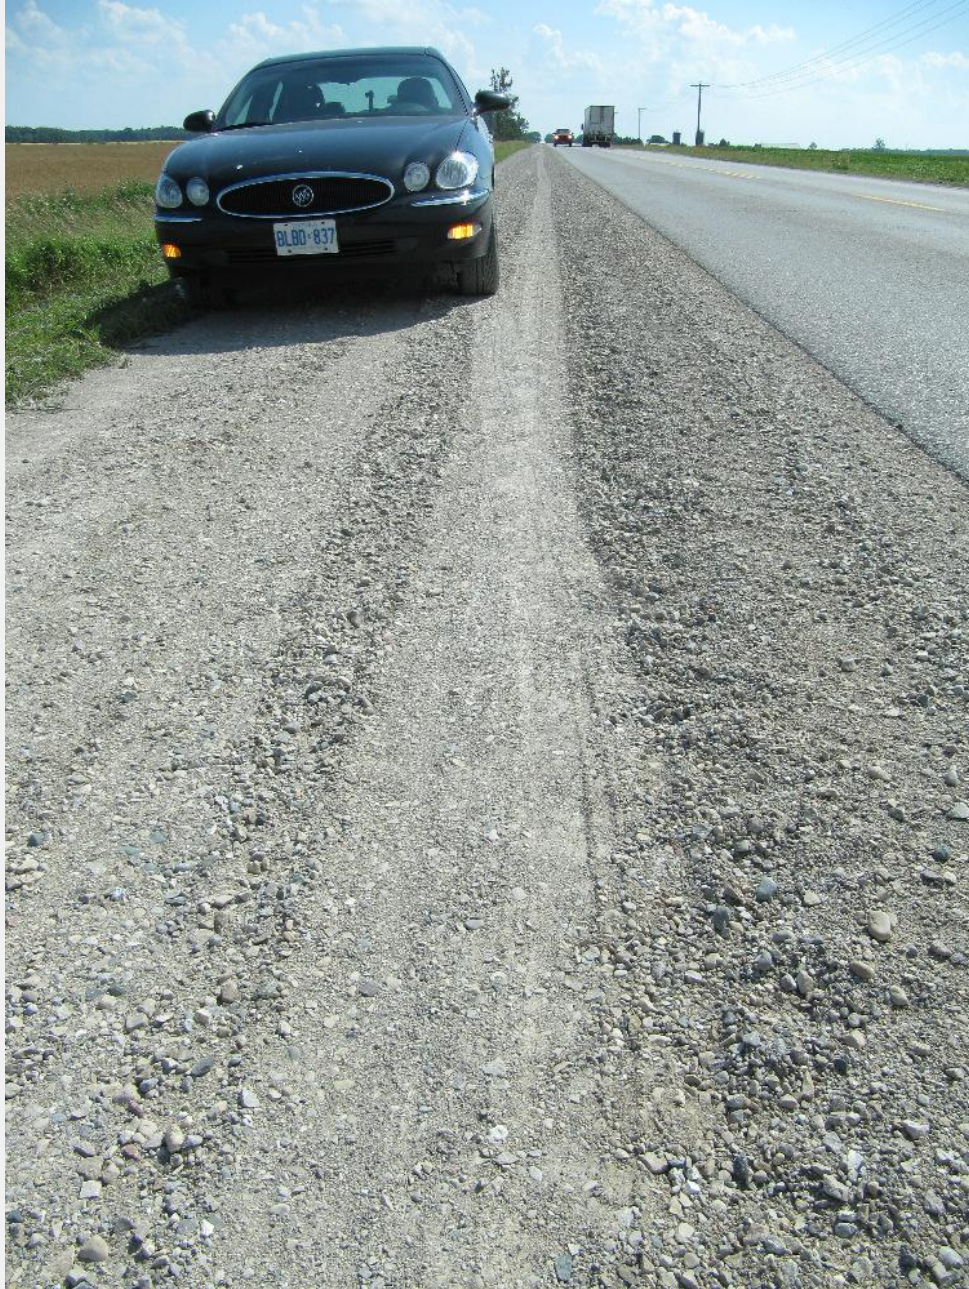
View of details visible in the tire mark of our vehicle's reversing into its parked position. This is a classic indicator that the gravel shoulder was soft and freshly graded.
