Gorski Consulting Website

Archived News - 2014 - September

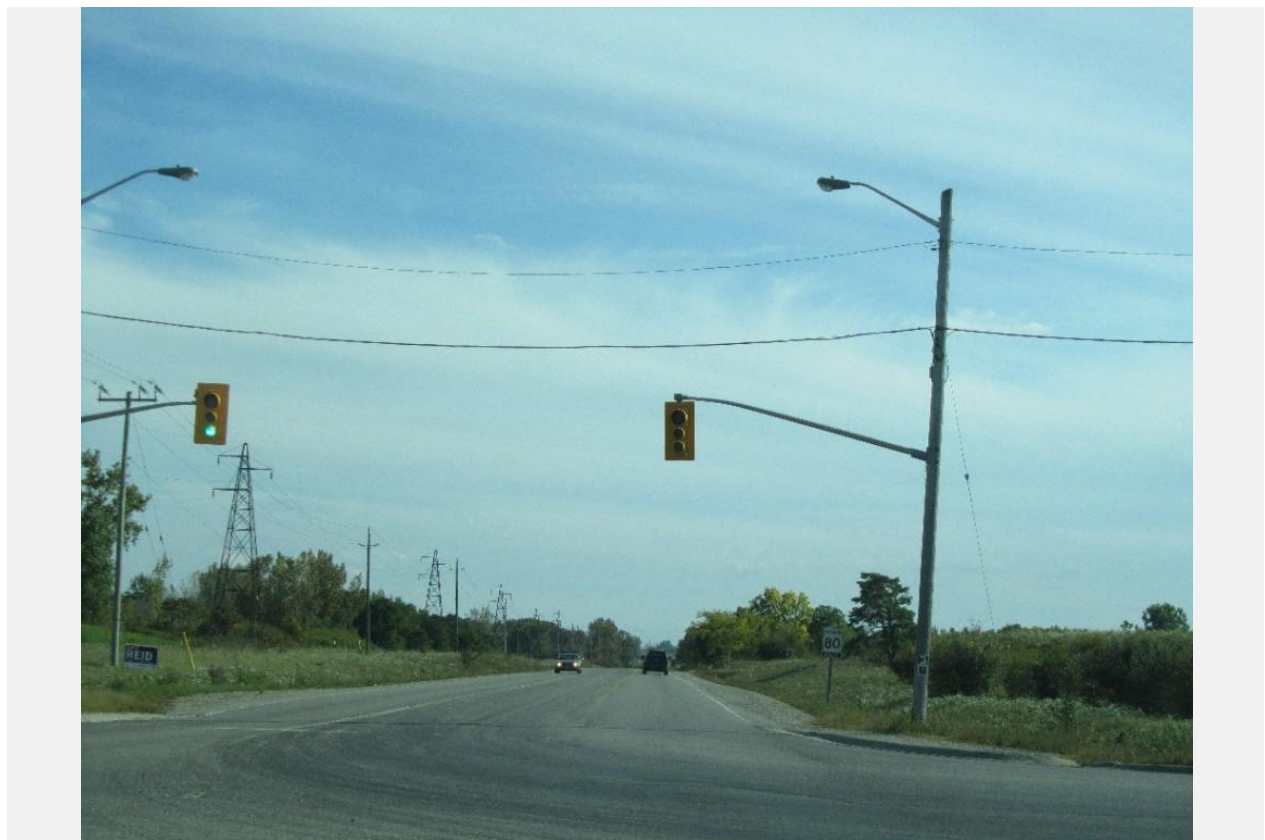
Much like the railway crossing malfunction discussed a couple of days ago, we also observed a traffic signal malfunction on the evening of September 28, southbound on Clarke Road at the intersection of Fanshawe Park Road, as indicated in the photo below.

Fortunately, a traffic-signal-controlled intersection contains at least two signal heads for a particular direction of travel. As indicated above, one of the signal heads for southbound traffic on Clarke Road at Fanshawe Park Road was not functioning on Sunday evening, September 28th, 2014.

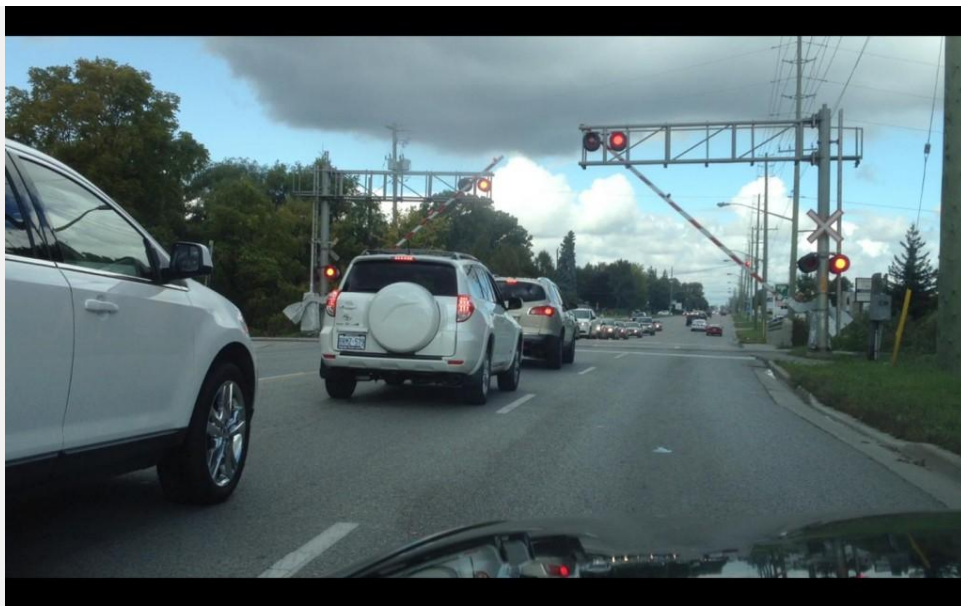
10 minutes after calling 911, the barricades are magically raised and traffic begins to move forward.

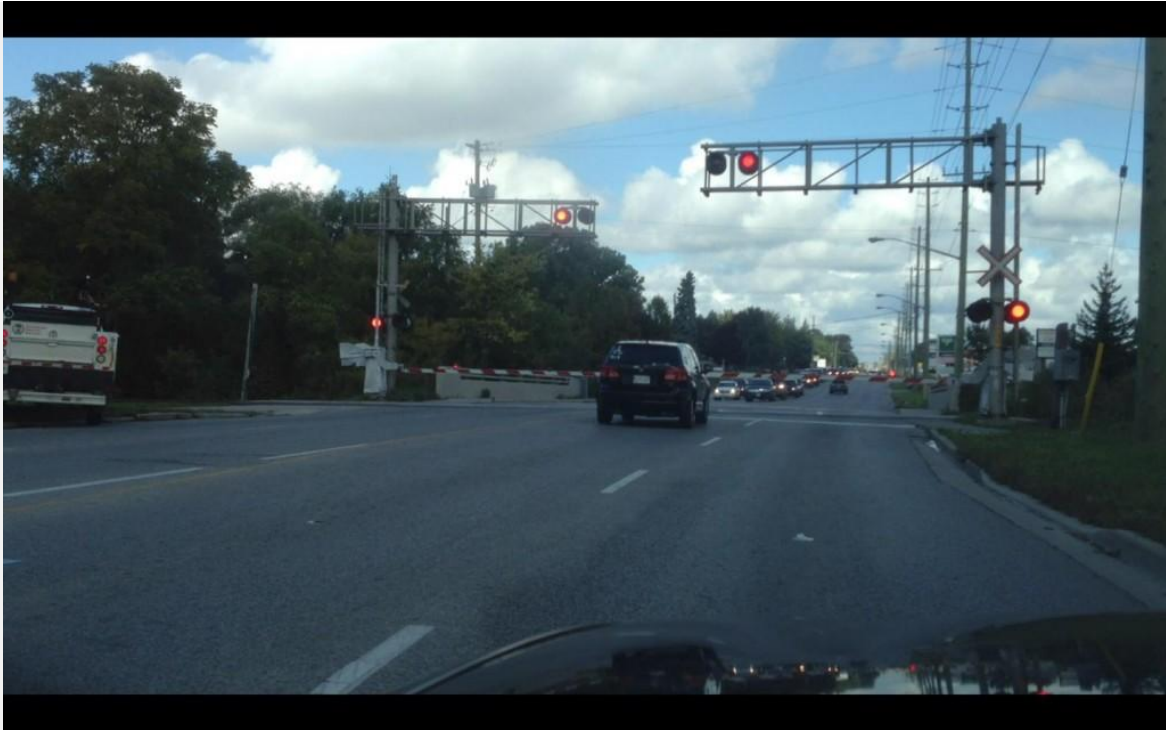
Then over a half hour after our call to 911, a white railway truck arrives on scene, as shown in the left corner of the photo below.

The barricades come down again, stranding motorists.

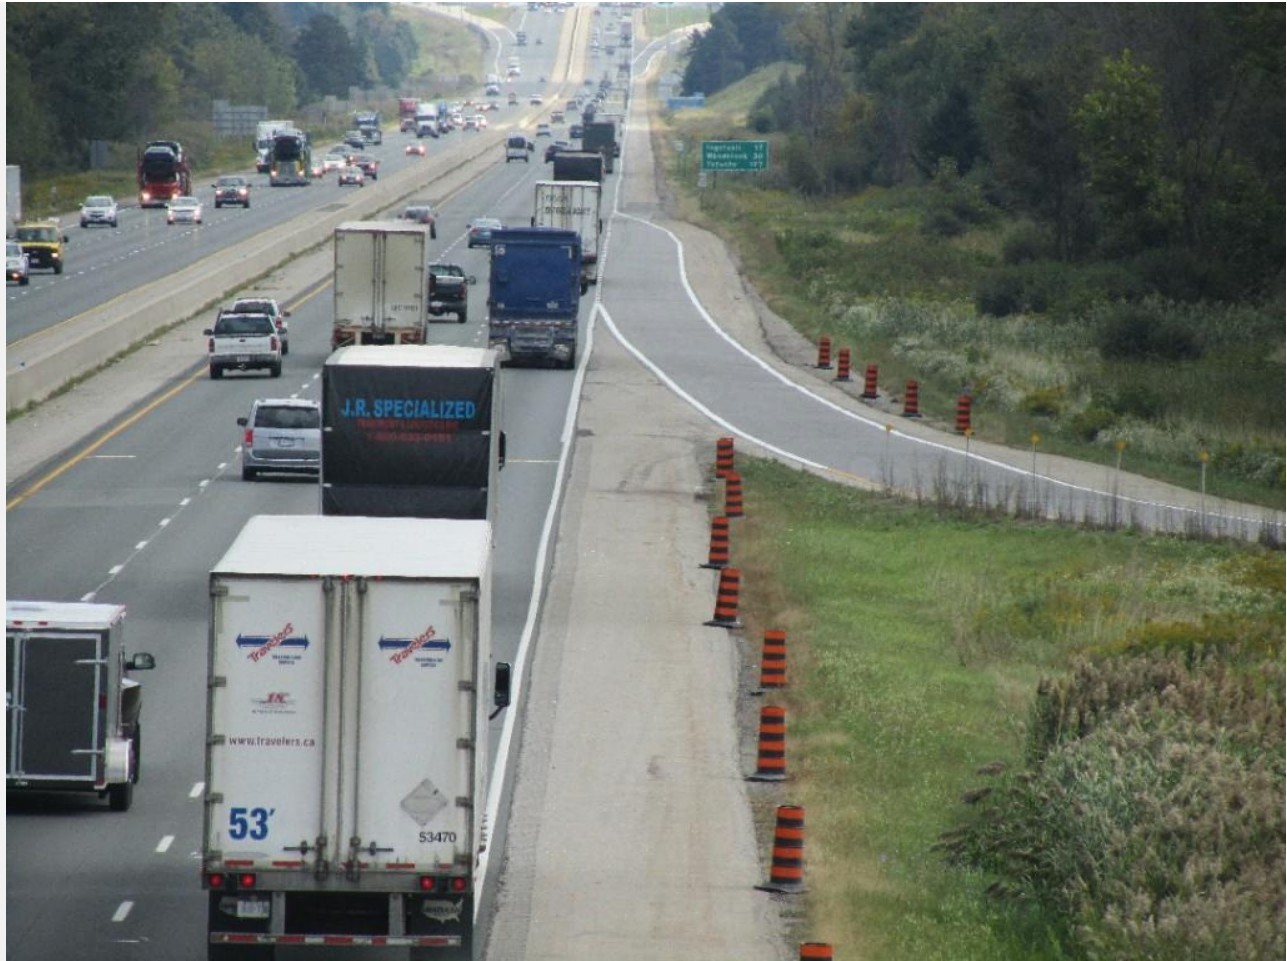
View, looking east, toward the area of impact that occurred in the “V” that joins the eastbound curb lane of Highway 401 and the eastbound entrance ramp from Elgin Road.

A close look in the above photo will indicate some dark stains and tire marks that identify the area of impact. That evidence is more clearly visible in the photo below which is taken from just east of the area of impact and looking back, westward, toward Elgin Road.

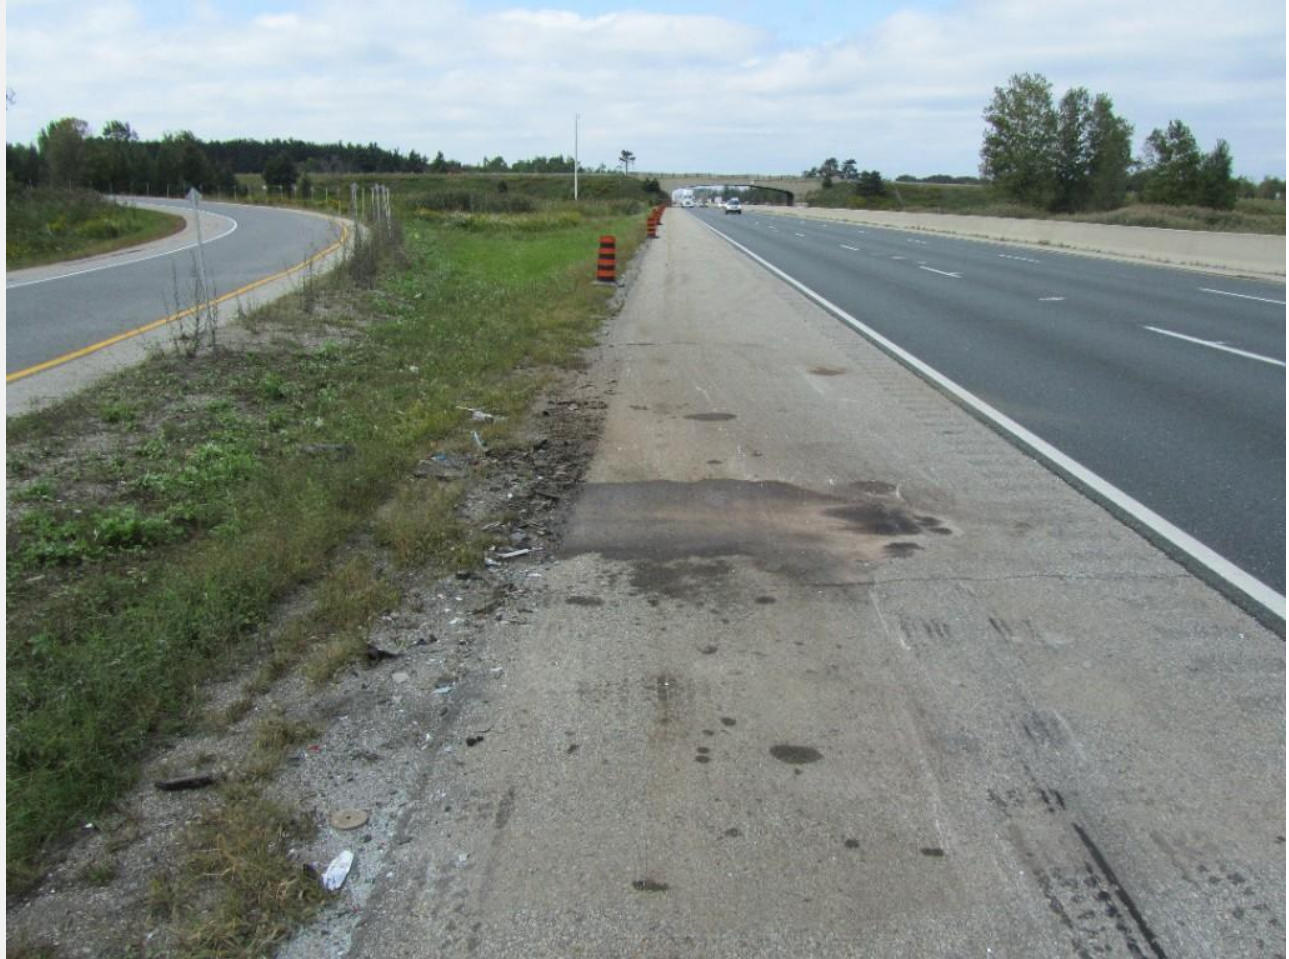
View, looking westward from the area of impact along the paved shoulder next to the eastbound lanes of Highway 401. The stains and tire marks are indicative of the area of impact. There is no evidence of any pre-impact skid marks from the striking vehicle.

There was no evidence of any pre-impact skid-marks on the part of the striking vehicle.

Our belief is that the only major improvement in the status quo is to develop parking or stopping areas near most interchanges. Such areas could be positioned next to the shoulder of a highway and wide and large enough to accommodate large, heavy traffic as well as light vehicles and emergency vehicles. Presently, disabled vehicles or emergency vehicles have no choice but to stop on a relatively narrow shoulder that is too close to the very high speed vehicles. Drivers on Highways such as the 401 habituate to the belief that the speed of traffic will continue to be the same because, for very long stretches of time and distance, this is exactly what occurs. Asking these drivers to be more attentive by imposing penalties is not likely to solve the problem. Large parking or stopping areas may be expensive and difficult to achieve at many locations however we believe they can also be of substantial benefit by taking more stopped vehicles away from the conflict zone of high speed traffic.

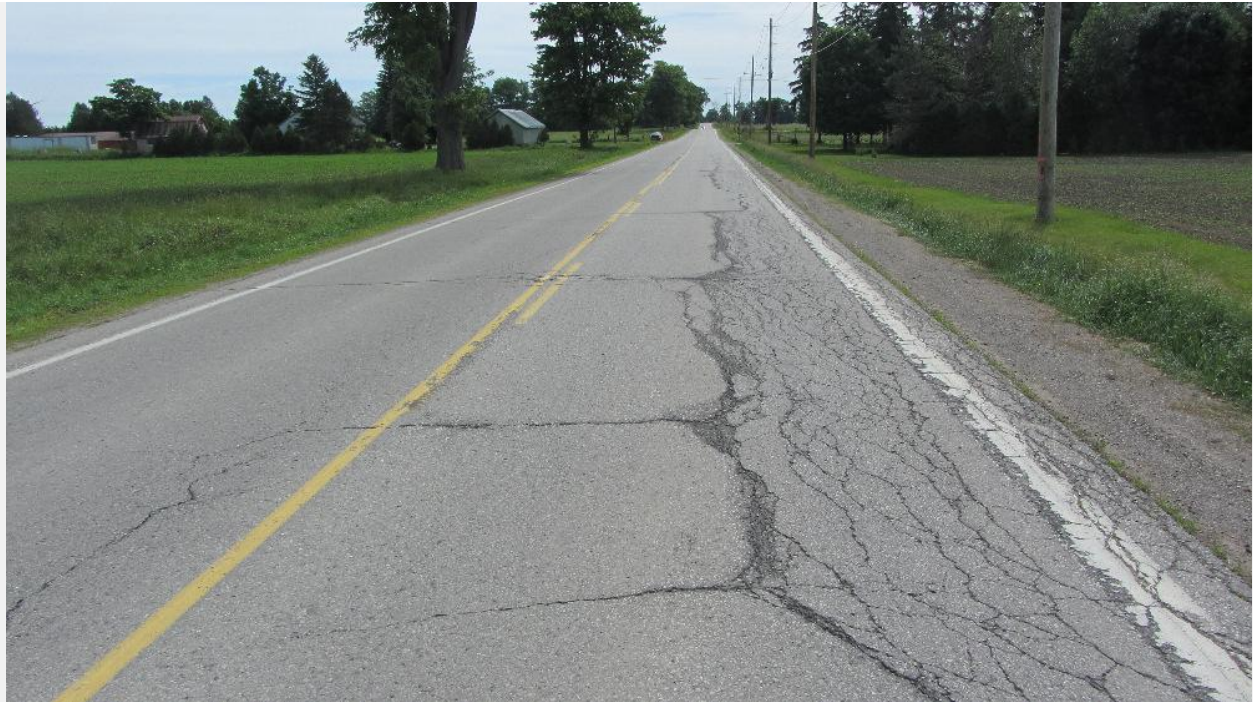
The testing was performed in response to a fatal, single vehicle collision that occurred on Napperton Drive just east of Kerwood Road. The vehicle had been eastbound when it reportedly “lost” one of its tires and subsequently crashed into a utility pole. In fact the surface of the eastbound lane exhibited substantial alligator cracking and a pronounced change in cross-slope at the outer right third of the lane in the vicinity of where the eastbound vehicle would have entered into a state of loss-of-control.

View, looking eastward along Napperton Drive, at the extensive alligator cracking of the south 1/3 of the eastbound lane at the location where the eastbound vehicle would have entered into a state of loss-of-control.

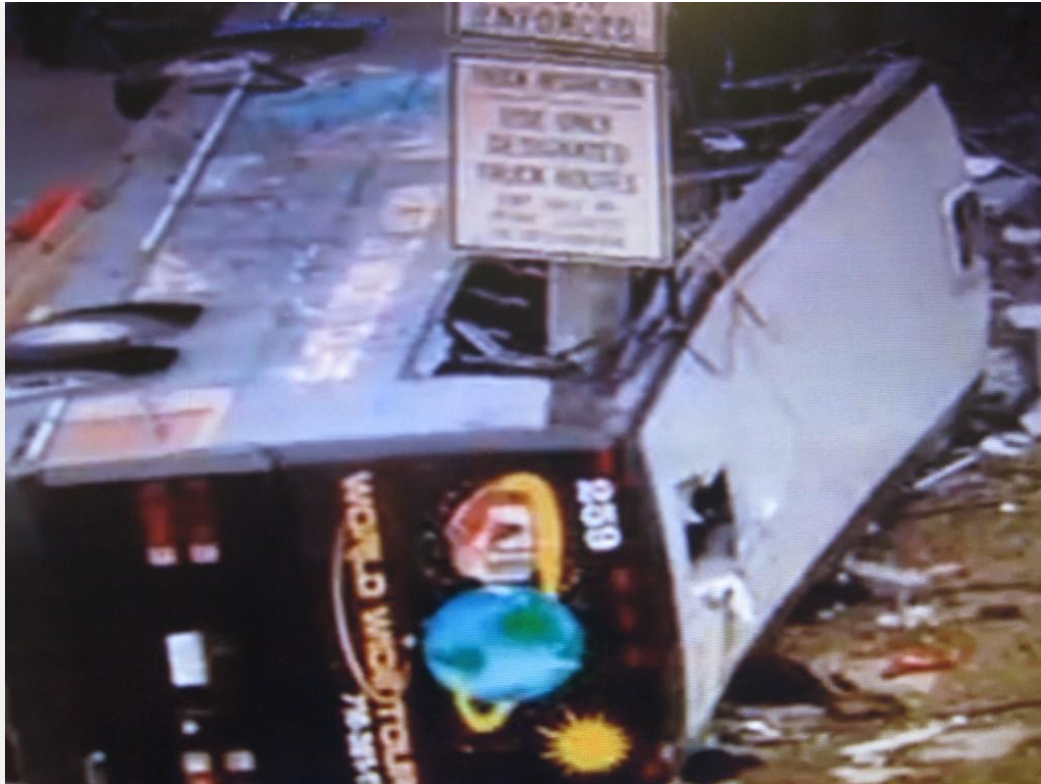
View of World Tours bus whose roof was peeled back by its sideways impact with a stanchion on the I-95 near New York on March 12, 2011.

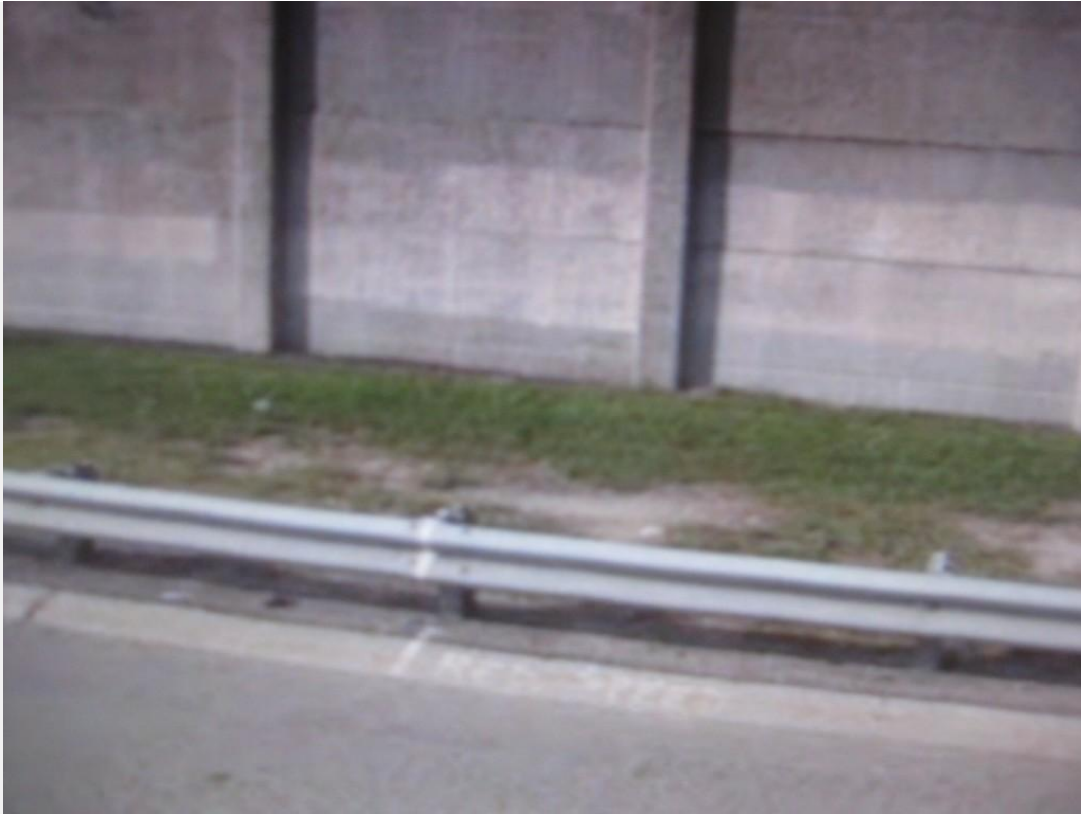
An example is the World Tours bus crash on I-95 at the Hutchinson Parkway outside of New York City in 2011. There was considerable wonder how a roadside stanchion could penetrate the bus's roof and peel it back almost to its rear. At least 13 people died in that crash. Yet no one mentioned the obvious question whether it was reasonable for the bus to have fallen onto its side before it struck the stanchion. A review of the guardrail on Google Maps would reveal that the guardrail leading up the stanchion was much too low and that this rail simply "tripped" the bus onto its side rather than re-directing it.

View of guardrail leading up the stanchion struck by the World Tours bus in 2011. By comparing the height of the “W” section to the height below it one can easily see that the guard-rail was too low and caused the bus to roll over it.

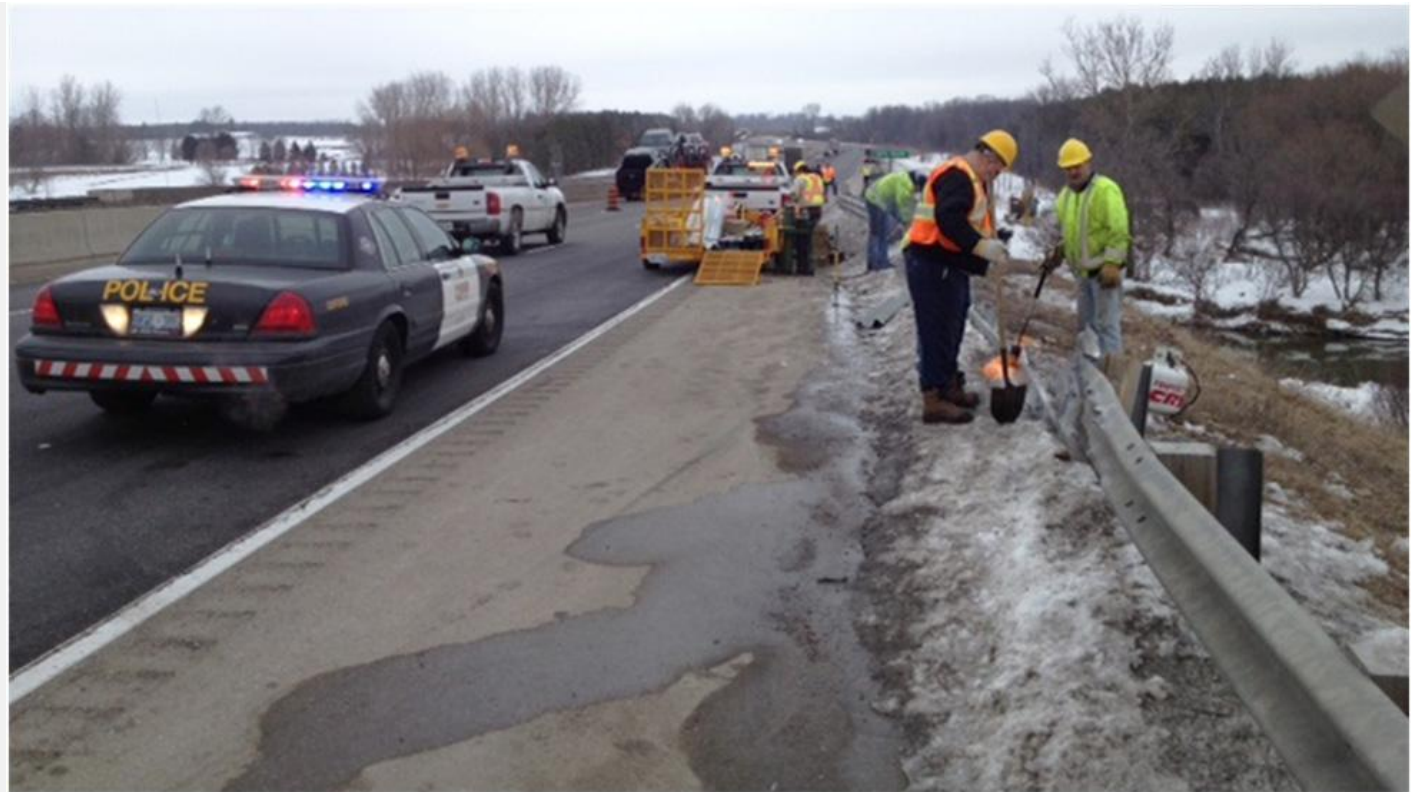
Photo taken by CTV news, showing the site where an eastbound transport truck crashed through a guardrail and fell into the Nith River.

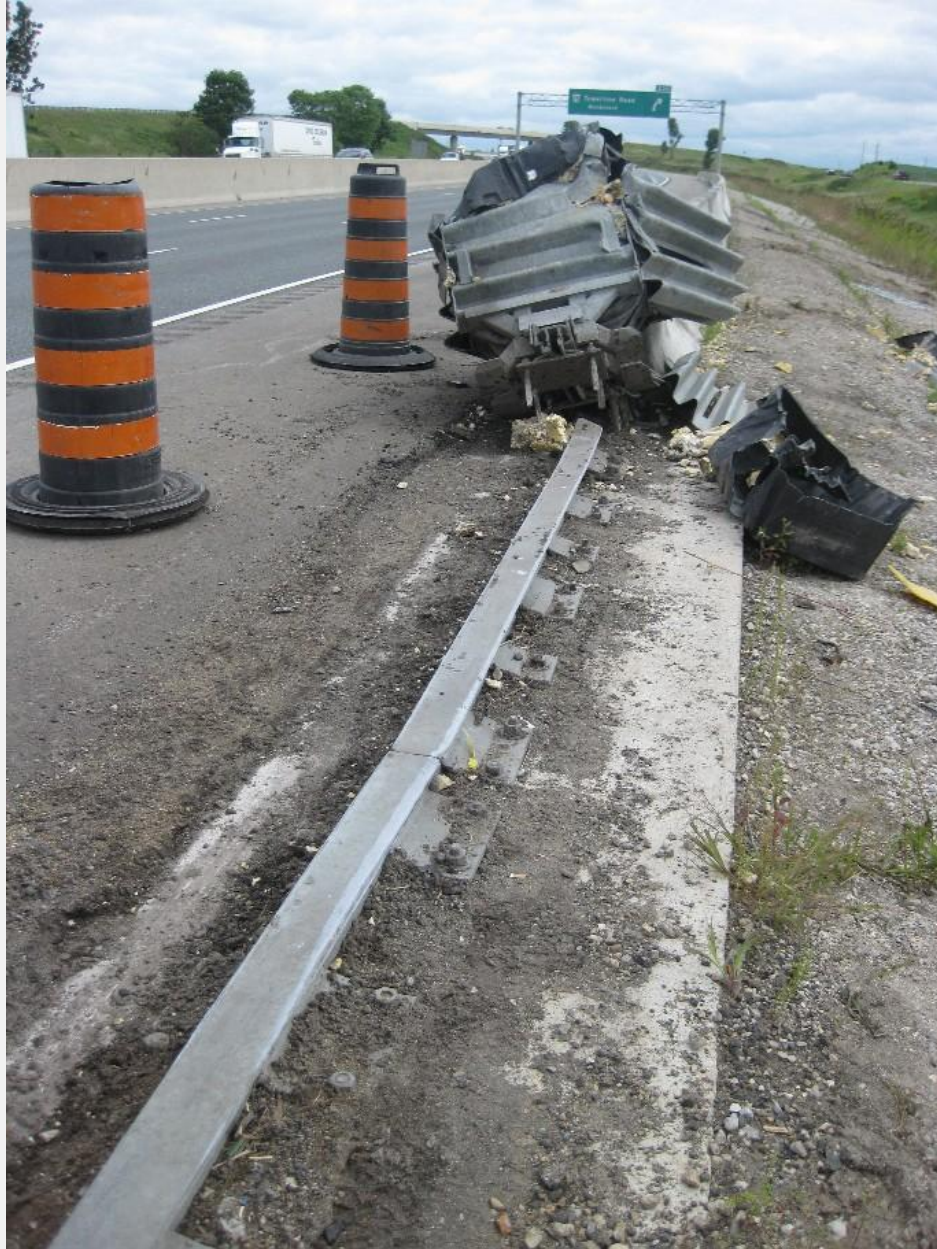
View of fully-compressed end-treatment to a New Jersey barrier as a result of the bus impact.

Although the barrier performed as it was designed it could not manage the excessive kinetic energy of the bus that remained after its full compression. As a result, the bus climbed over top of the compressed barrier and slid along the top of the New Jersey barrier, leaving an oil stain as indicated in the figure below, before falling onto the south side and rolling over.

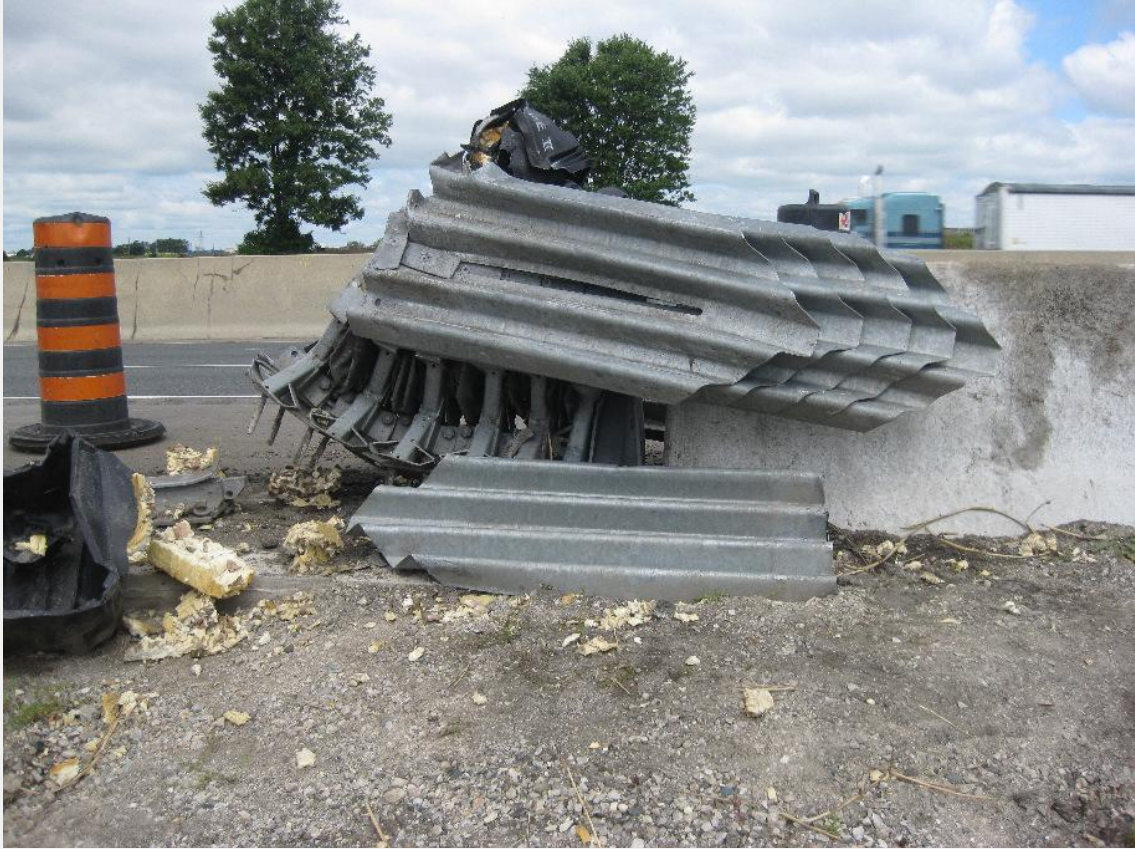
View of the barrier that was fully-compressed by the bus impact.

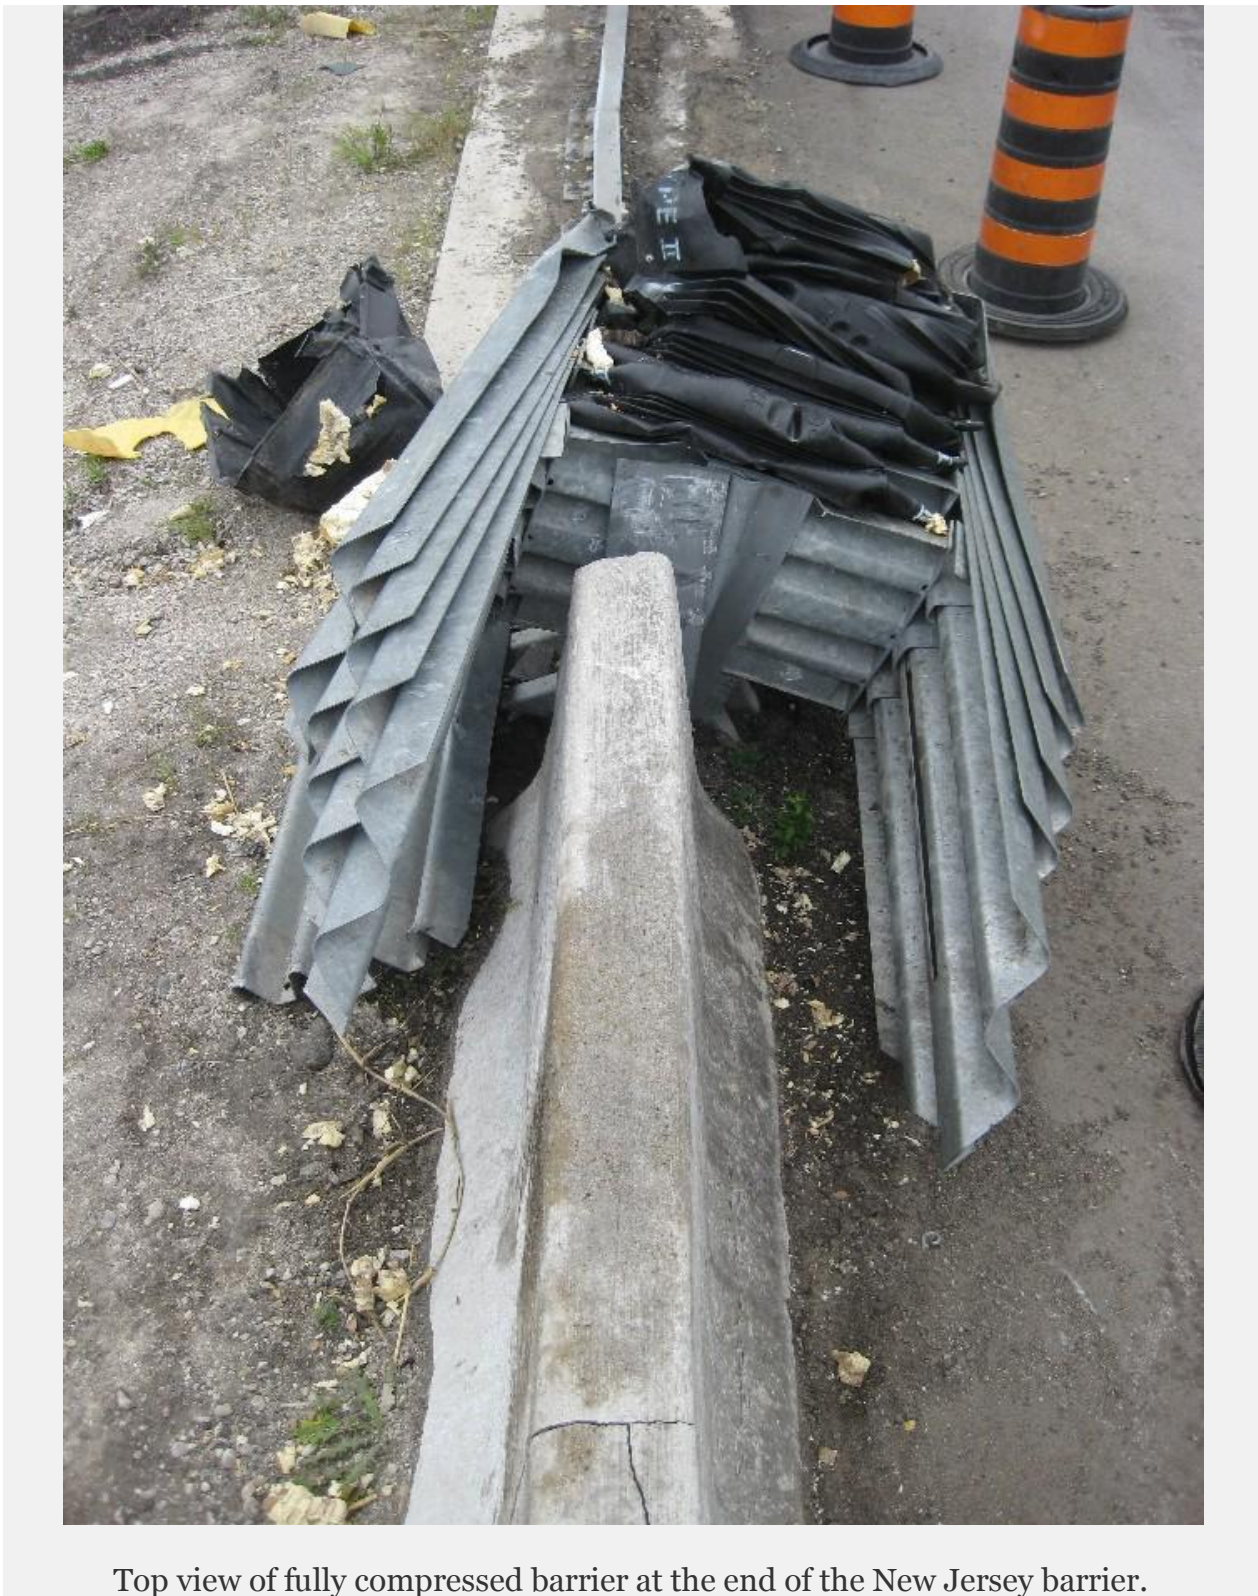
Top view of fully compressed barrier at the end of the New Jersey barrier.

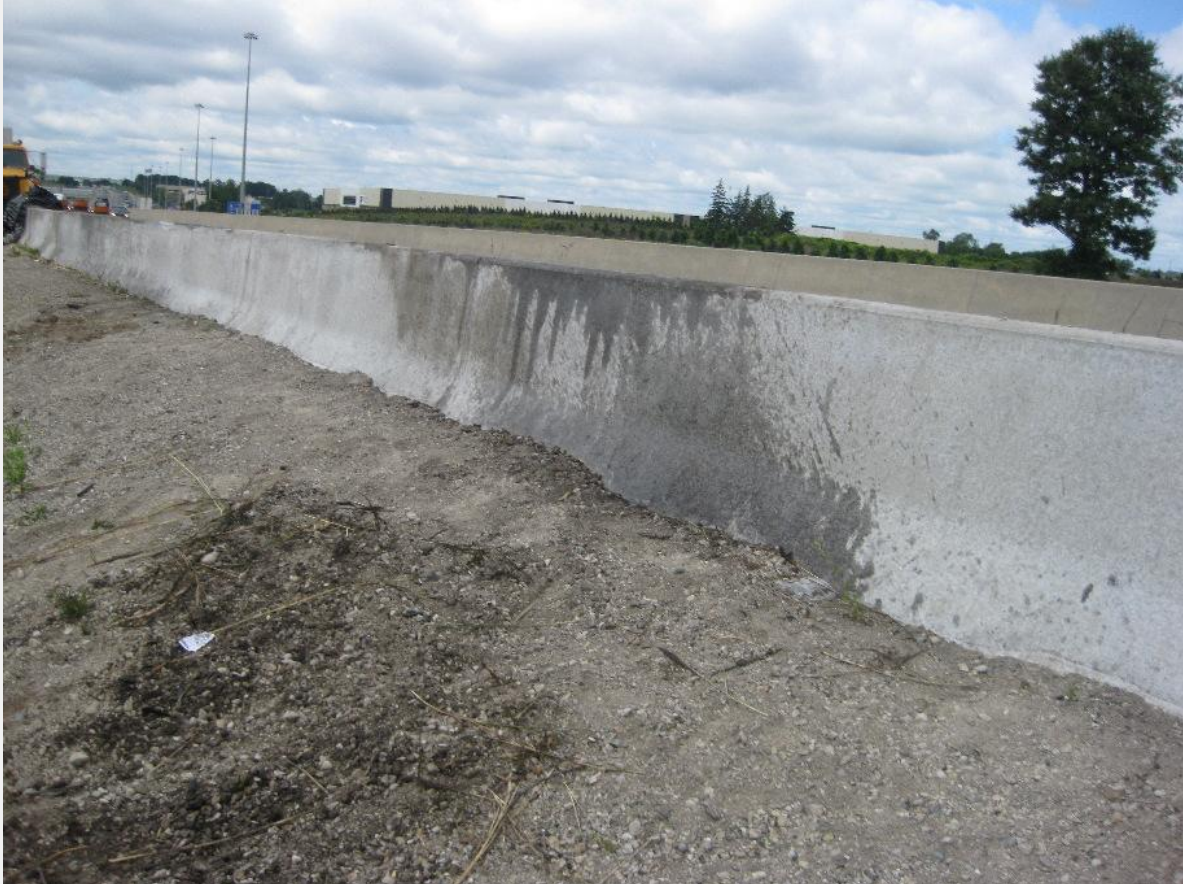
View of oil stain the New Jersey barrier indicating that the bus slid over top of it before rolling over.

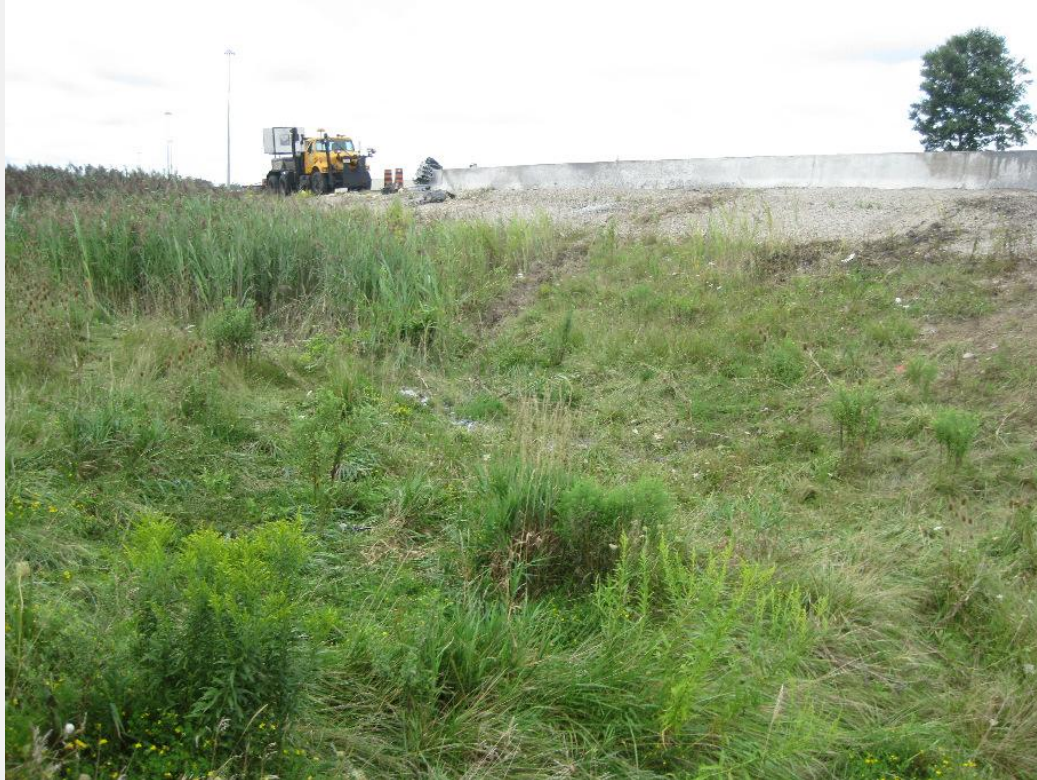
Overall view of south ditch where the rolling bus came to rest. In the background is the end of the New Jersey barrier where the initial impact occurred.
