# Ambulances Blocked From Emergency Response By Malfunctioning CP Rail Barrier

*Posting Date: 2-Dec 2014*

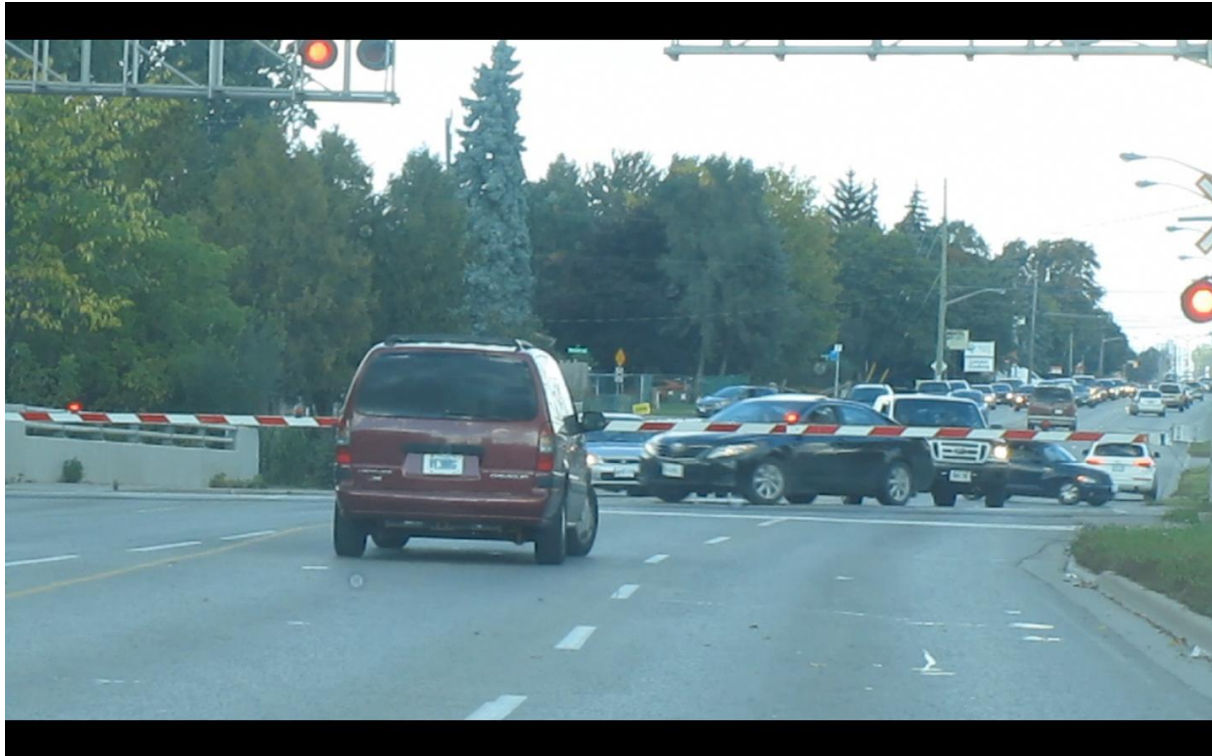
On September 26, 2014 we came across an unusual situation occurring at this crossing. As reported in the News page of the Gorski Consulting website, we approached the crossing travelling northbound on Clarke and while passing through the intersection of Dundas Street we observed that, several hundred metres ahead of us, the barricades for the Canadian Pacific (CP) rail crossing were lowered. This was not of initial concern until, as we came closer, it was apparent that a number of drivers were turning their vehicles around while others were driving through the barricades. In our experience such actions do not occur until drivers have been waiting for a considerable time without the appearance of a train. Figure 1 is a frame captured from the video that we took at the time that the events were unfolding. Not only were vehicles passing through the lowered barricades but pedestrians were do so as well, as shown in the video frame of Figure 2.

Figure 1: Frame captured from video showing vehicles passing through the lowered barricades of the CP rail crossing on Clarke Road north of Dundas Street in London, Ontario.

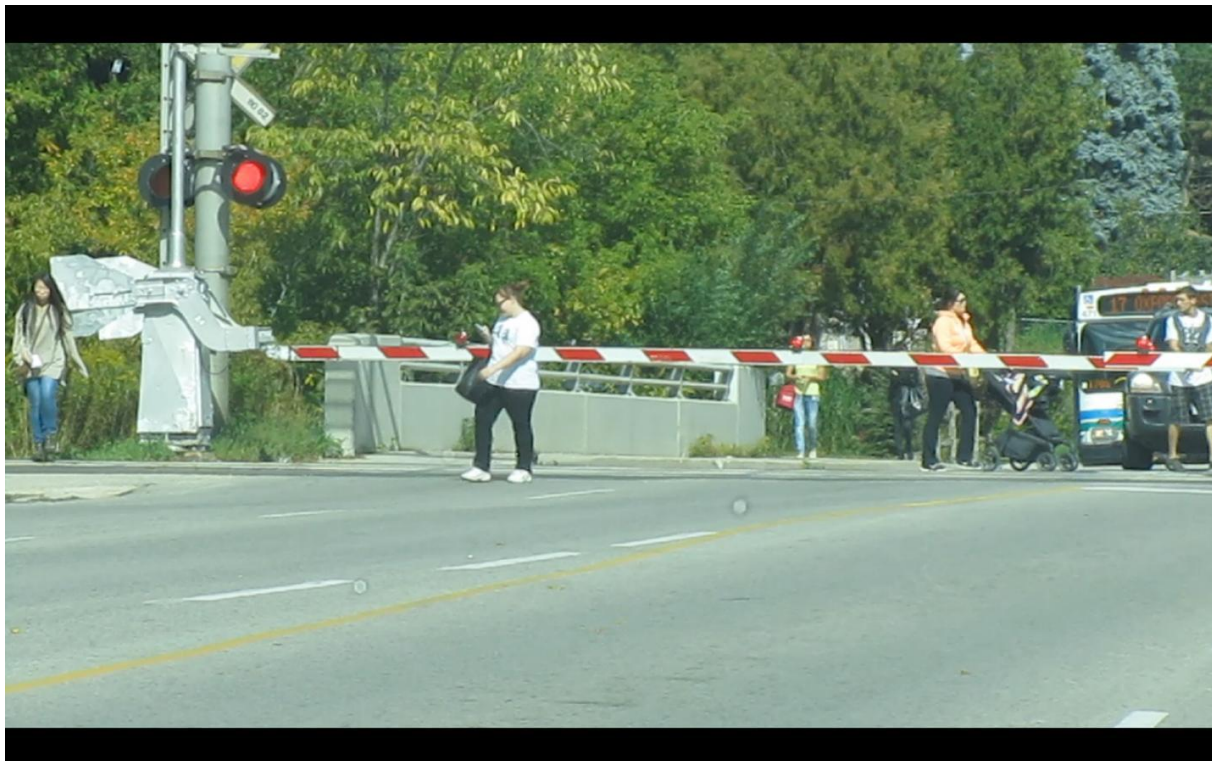
Figure 2: View of pedestrians crossing the lowered barricades.

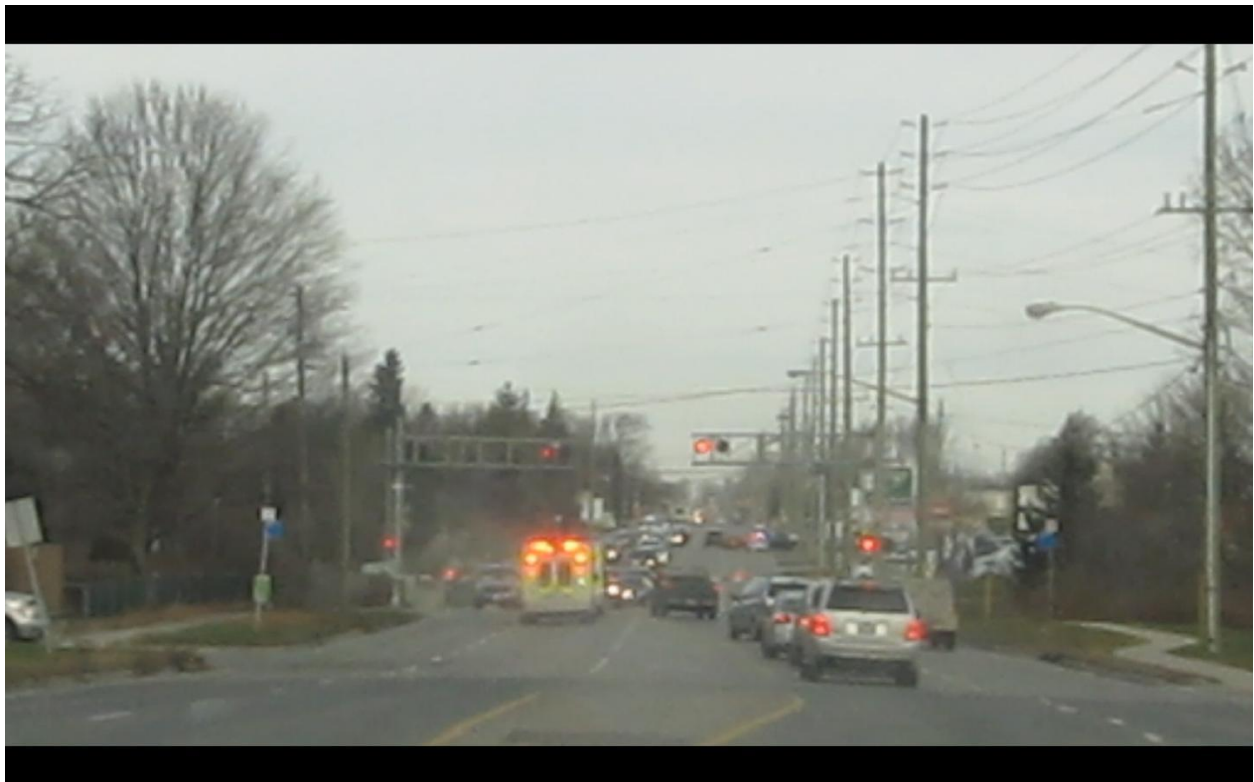
Just a little over two months passed when we encountered another incidence of the malfunctioning barricade. On the morning of December 2, 2014 we were eastbound on Dundas Street and entering the northbound, left- turn lane at Clarke Road when we observed two northbound ambulances on Clarke Road, pass through the intersection with their emergency lights activated. As we made our turn onto Clarke we, once again, observed that the barricades at the CP rail crossing were down. Yet, several hundred metres north of the crossing we observed other emergency lights, from police and fire, confirming that a collision had occurred at that location. The problem was that the two ambulances were on the south side of the lowered barricades, as shown in northward view, taken from our dash-mounted video camera, in Figure 3.

**Figure 3:** View, looking north, of the two northbound ambulances that are blocked from passing through the CP rail crossing because the barricades are lowered.

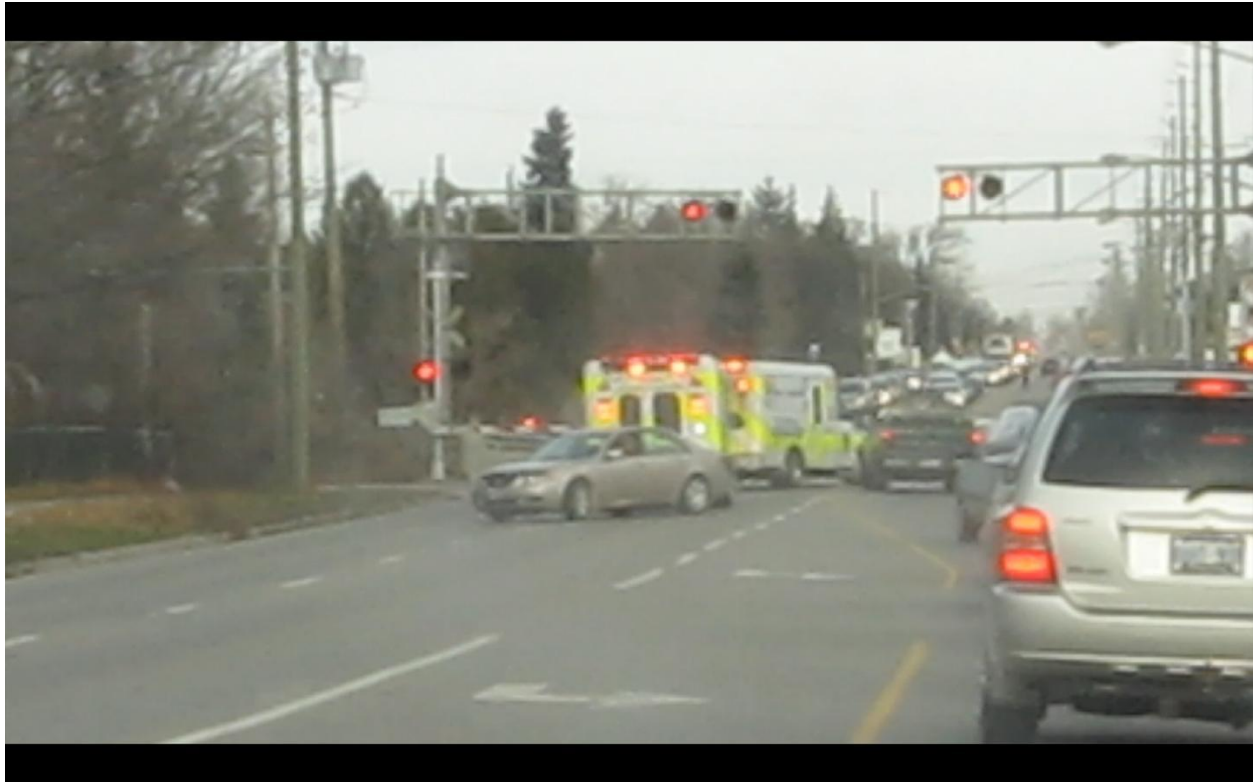
The relatively small number of northbound vehicles at the barricades were a disguise of the problem because, just like on September 26th, drivers were either turning around or driving through the lowered barricades. So the ambulance drivers were likely fooled into thinking there would be a minimal delay and that there was no malfunction. However, as one came closer to the crossing, as shown in Figure 4, it was clear that drivers were taking actions not to have to stay at the lowered barricades.

Figure 4: View showing various vehicles making u-turns or driving through the lowered barricades.

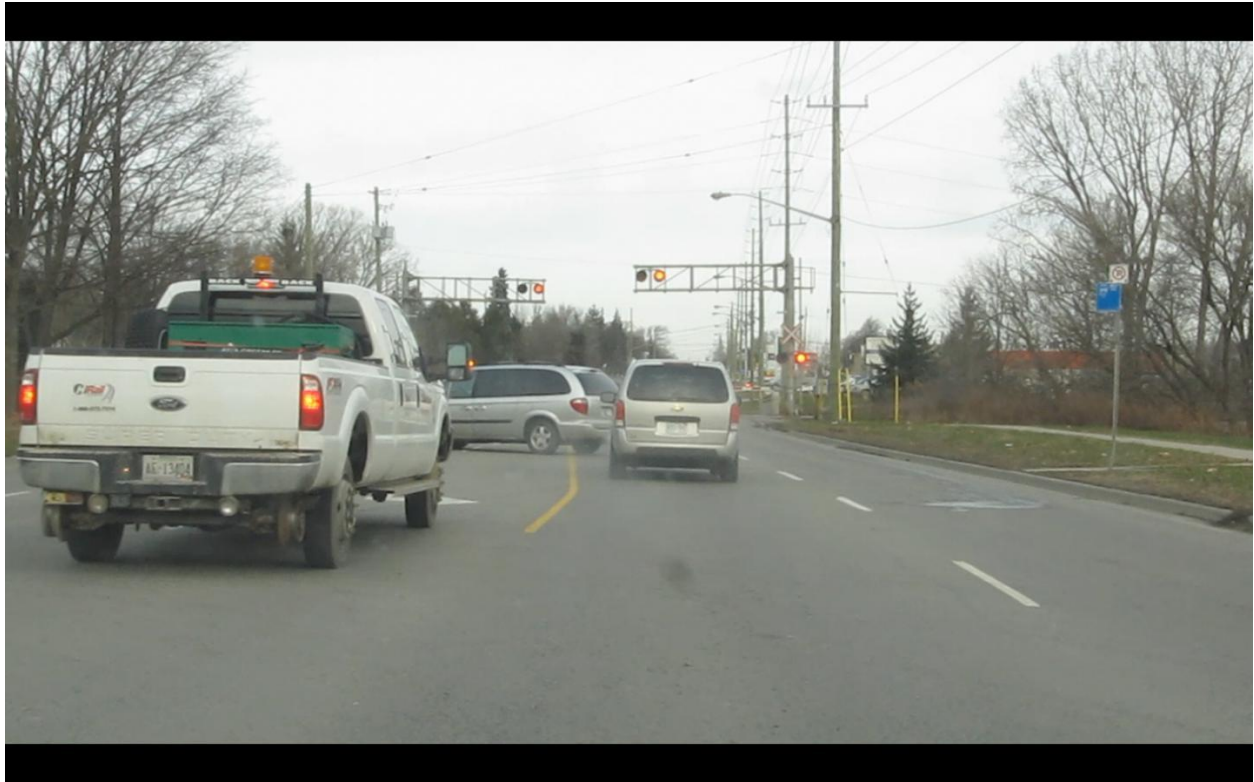
Figure 11: Shortly after the ambulances depart a northbound CP rail truck arrives.

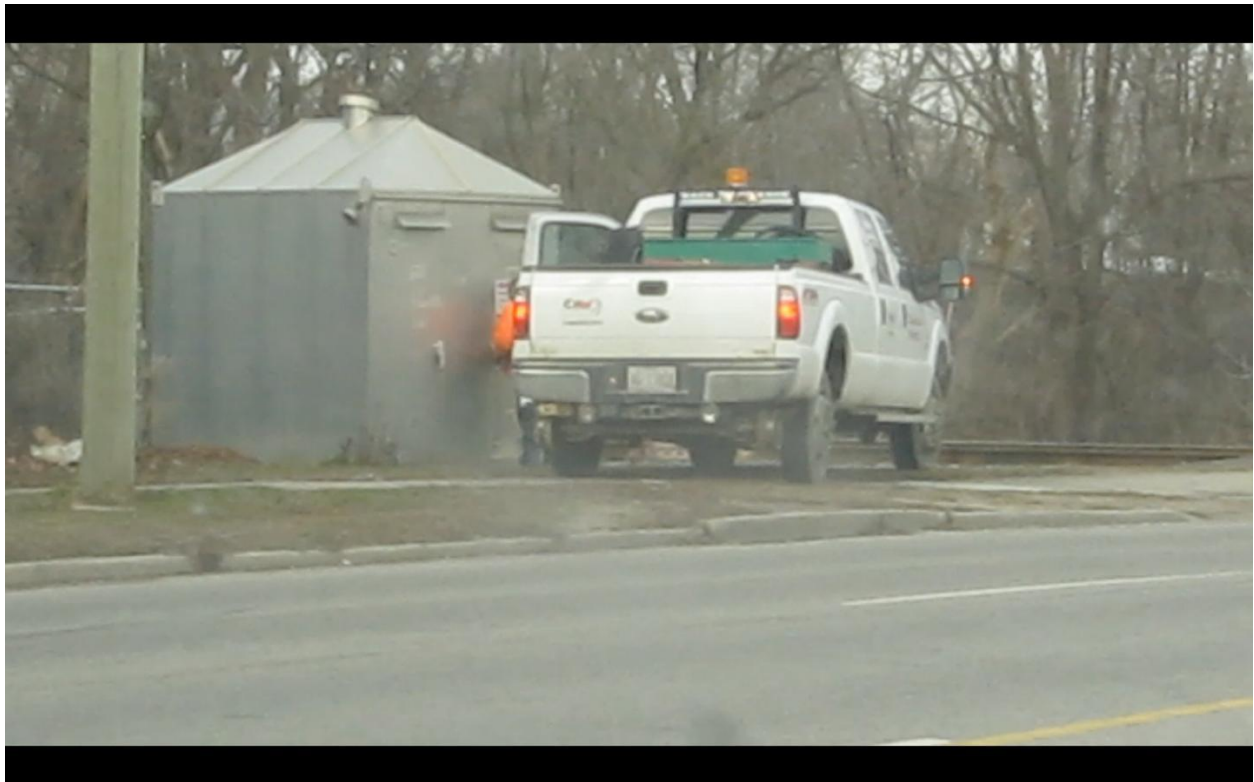
Figure 12: CP employee enters the hut adjacent to the rail crossing.

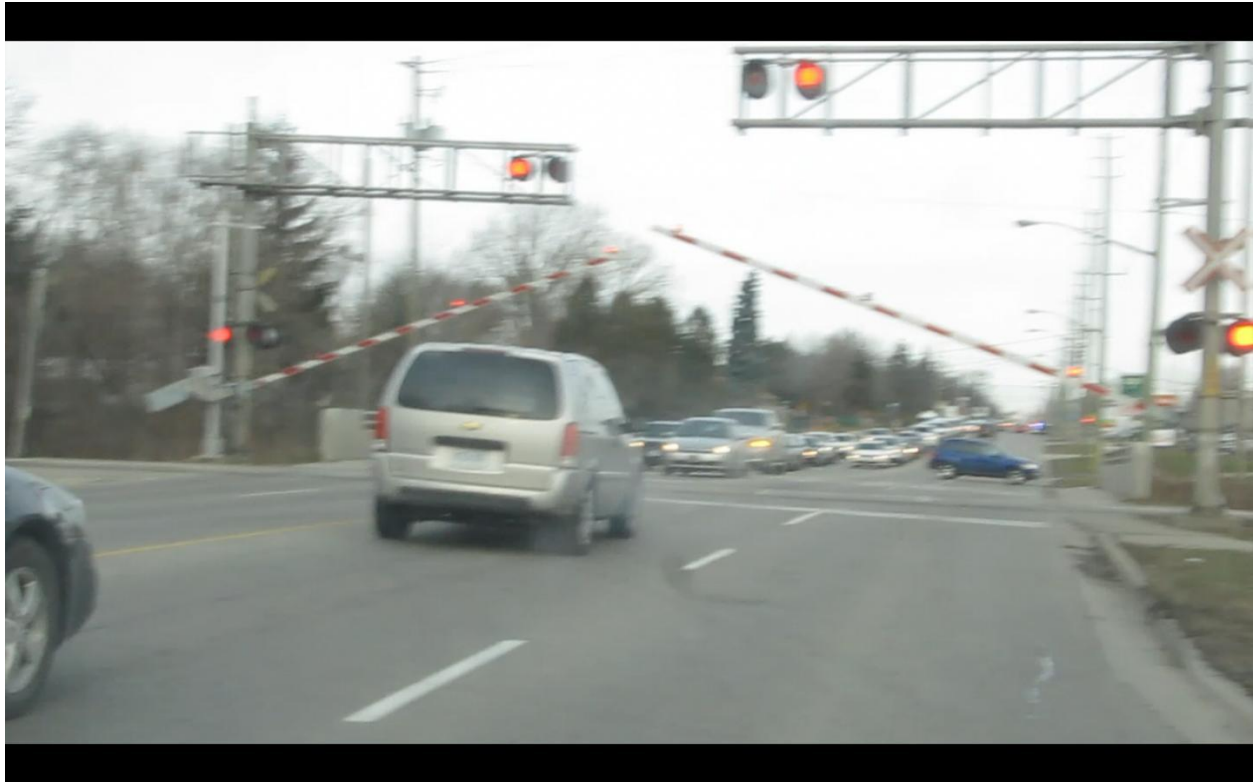
Figure 13: A short time after the CP employee enters the hut, the barricades are lifted.

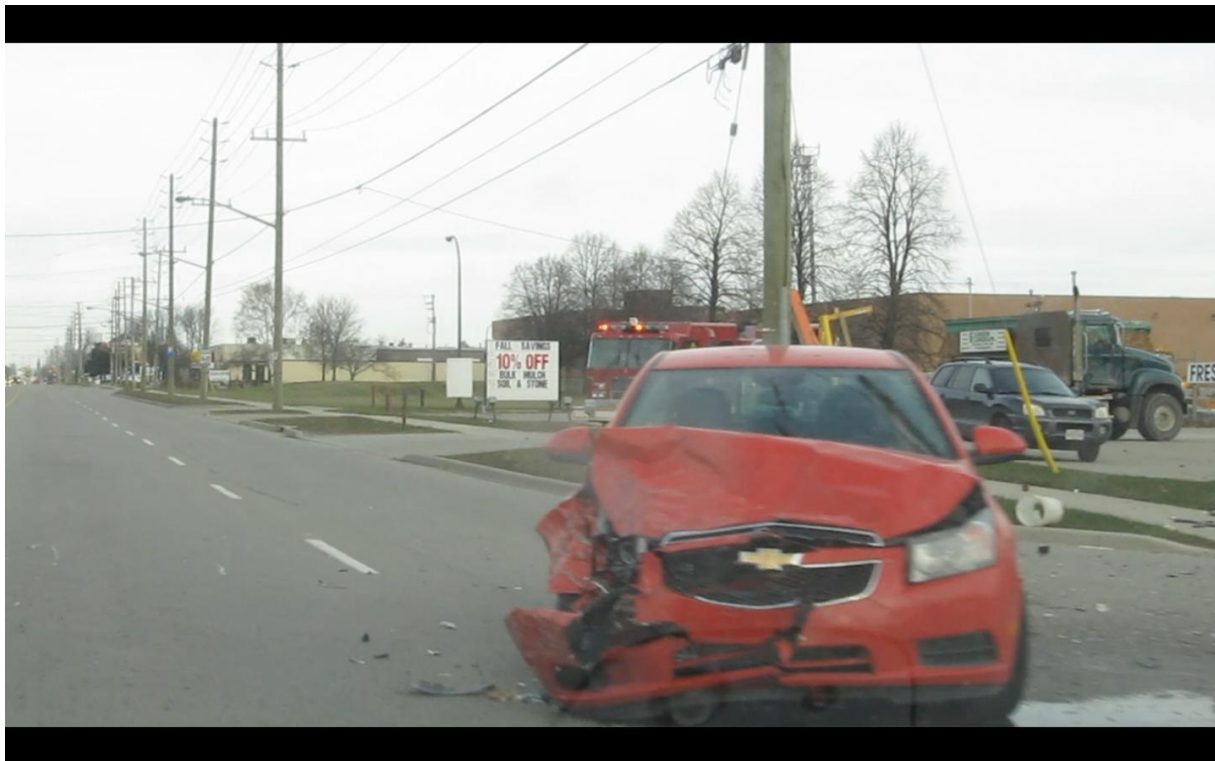
Figure 16: Damage to the red Chevrolet indicates that this collision was not inconsequential and could, potentially, have resulted in significant injuries if the circumstances became unfavourable.
