ET-Plus Terminal Impact - Evaluation of Its In-Service Performance

Posting Date: 7-Feb-2016

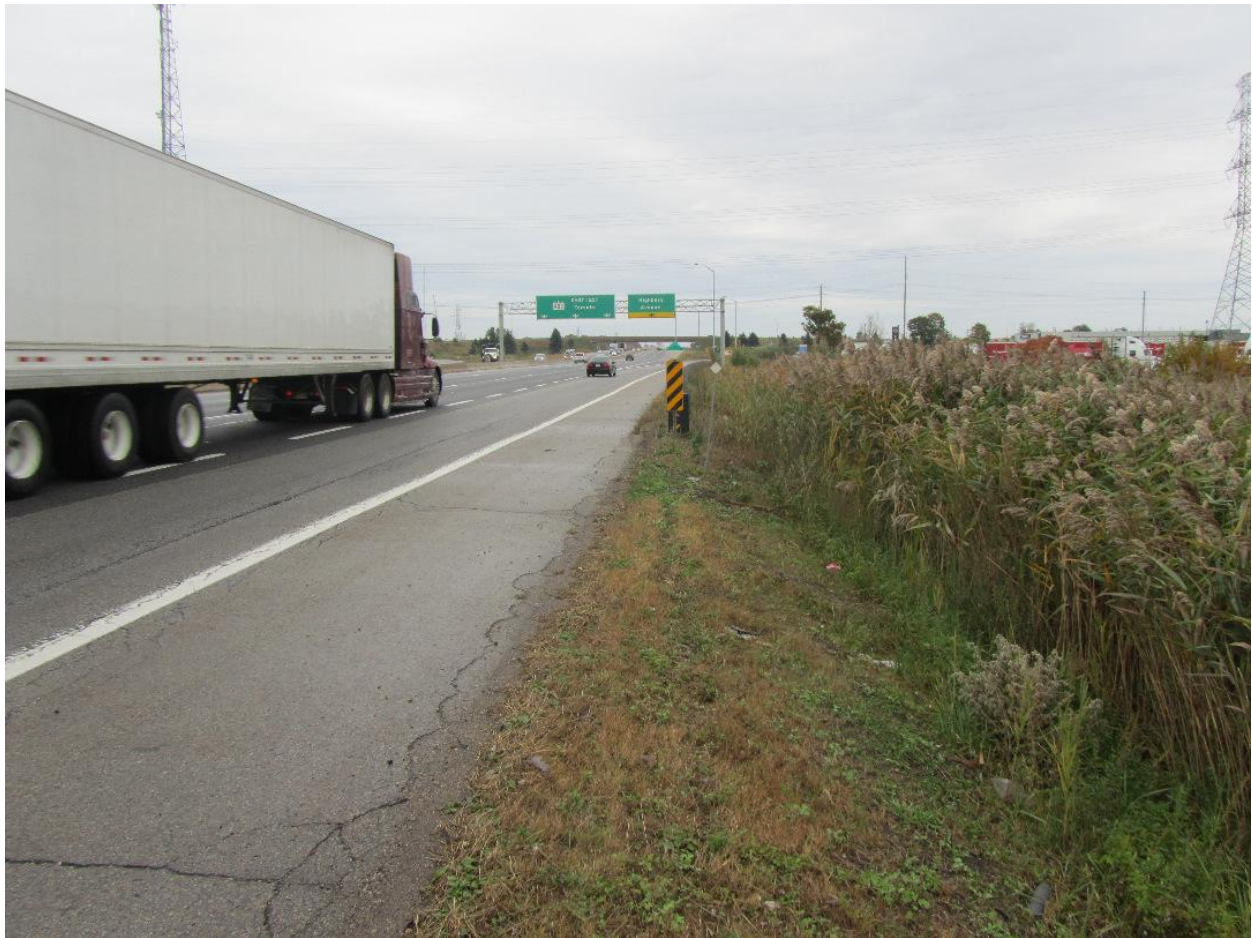
Figure 1: View, looking east, along the south side of Highway 401, just west of Highbury Avenue. This is a view of the ET-Plus terminal that was damaged in an impact a few days prior to January 27, 2016. This view is of its undamaged condition during its examination by Gorski Consulting on October 14, 2014.

As typical, Figure 1 shows that there is a yellow/black hazard marker placed in front of the terminal. The controlled, compliance testing of the ET-Plus does not include the installation of the hazard marker and while such an apparently small object might seem to be of little relevance its effect on the functioning of the system cannot be fully known if it is not present during compliance testing.

As typical, one can also see that there is a significant slope to the right (away from the road) which is also not introduced during compliance testing.

Finally, there is a split in surfaces such that the left side wheels of the striking vehicle would ride on the paved shoulder while the right side wheels of the vehicle would be riding on the grassy slope. Again this is different from the compliance testing as the entrance to impact involves a single, uniform surface.

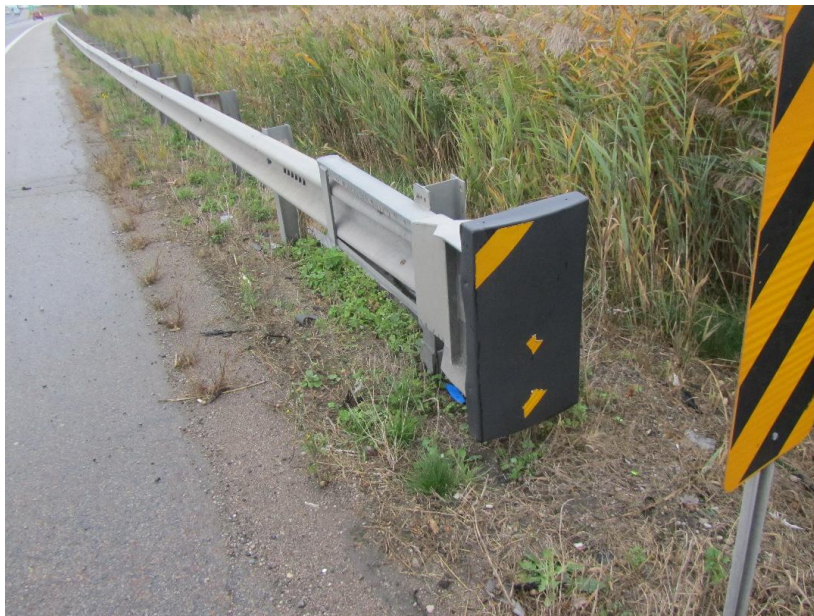
Figure 5 shows the head of the ET-Plus terminal which is covered by a black vinyl cover.

Figure 5: View of the ET-Plus terminal showing the black vinyl cover on the head.

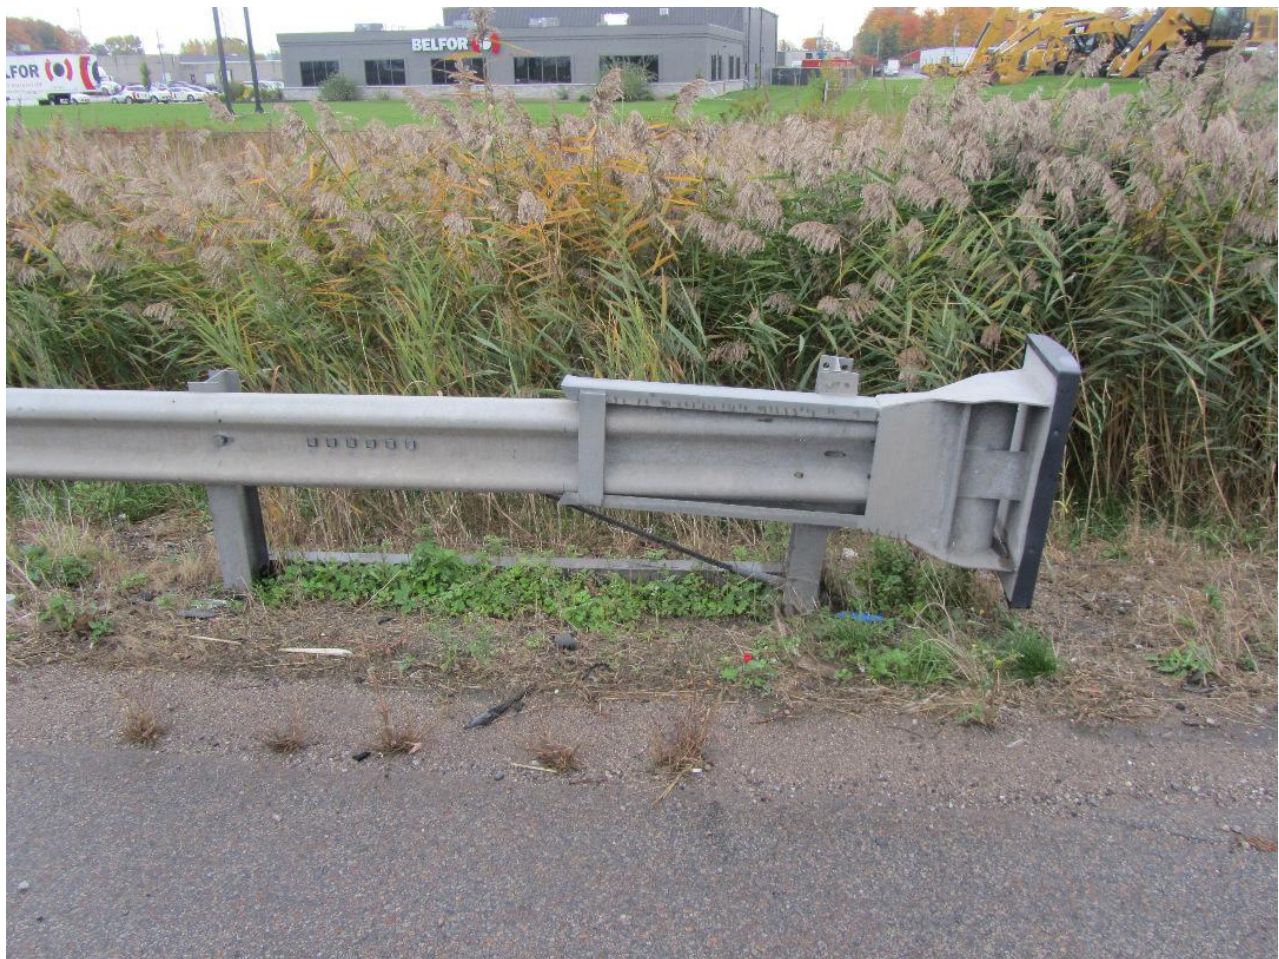
Figure 6 shows a side view from the road surface, showing the ET-Plus and its channel and the guardrail on which the terminal is supposed to slide when impacted by a vehicle. On a number of occasions Gorski Consulting has documented that the terminal rests at a significant angle with respect to the rail such that the head is lower and the rear edge of the channel is higher. This angle is not replicated in the controlled testing nor has any comment been made by the manufacturer or the FHWA whether this difference in angle is a concern. In examinations by Gorski Consulting it has been observed that the rear edge of the channel appears to be forced down onto the rail during the initial stage of impact resulting in a dent to the upper edge of the rail. As the rail passes into the head there is a concern that this dented rail will not pass through the head as designed and therefore will jam without allowing the head to ride properly on the rail as designed.

Figure 6: Side view of the ET-Plus looking from the road toward the ditch.

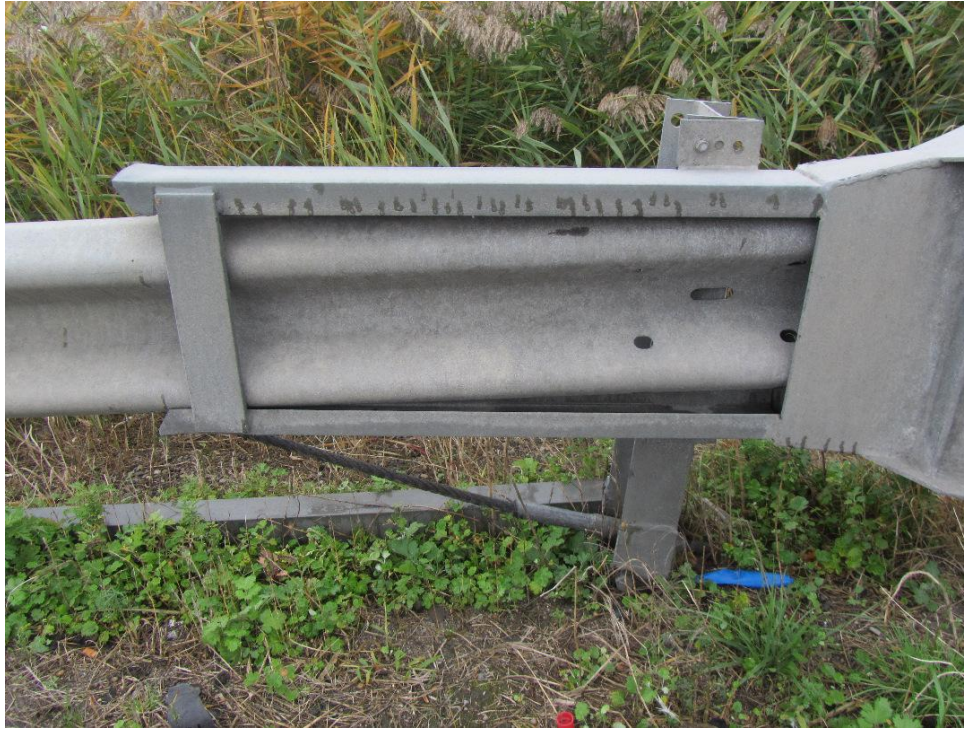
Figure 7 provides a closer side view of the ET-Plus and its channel. It can be seen that the terminal and channel are rotated downward with respect to the angel of the rail. This difference in angle has been seen in many in-service installations during surveys conducted by Gorski Consulting.

Figure 7: Note the substantial difference in horizontal angle between the channel and the rail. This angle difference is not incorporated in the system's compliance testing.

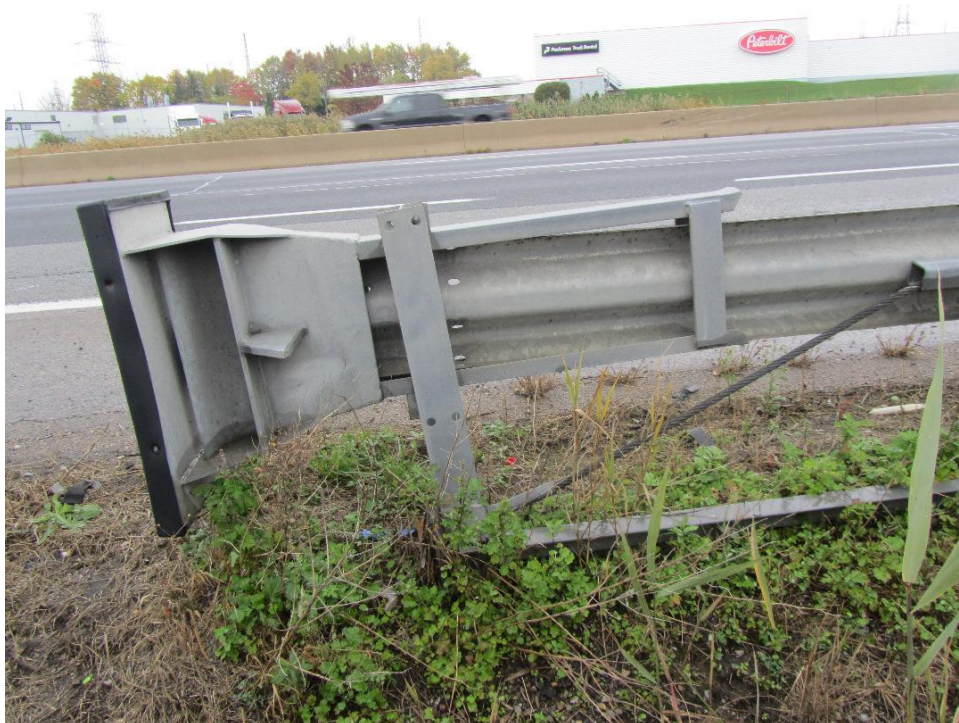
Figure 8: Ditch side view of the ET-Plus terminal.

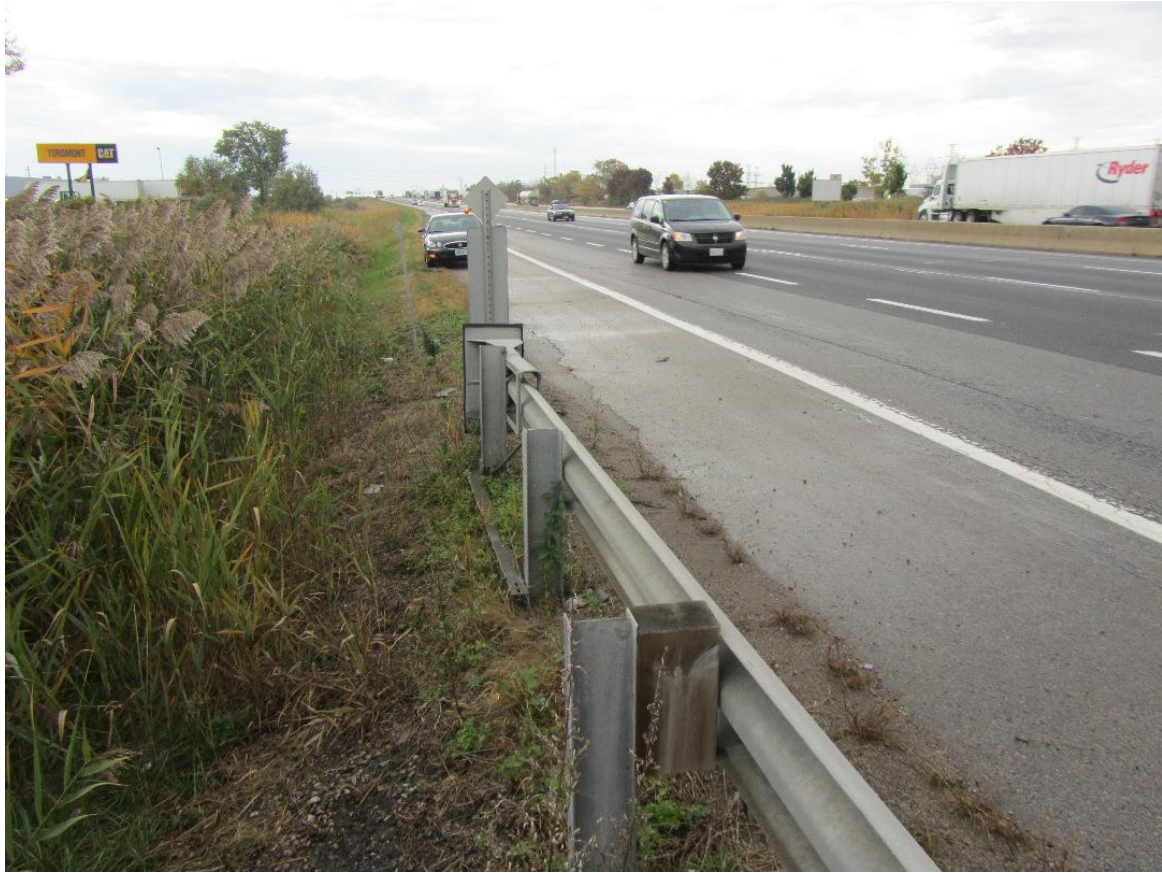
Figure 9: View looking along the length of the guardrail toward the ET-Plus terminal.

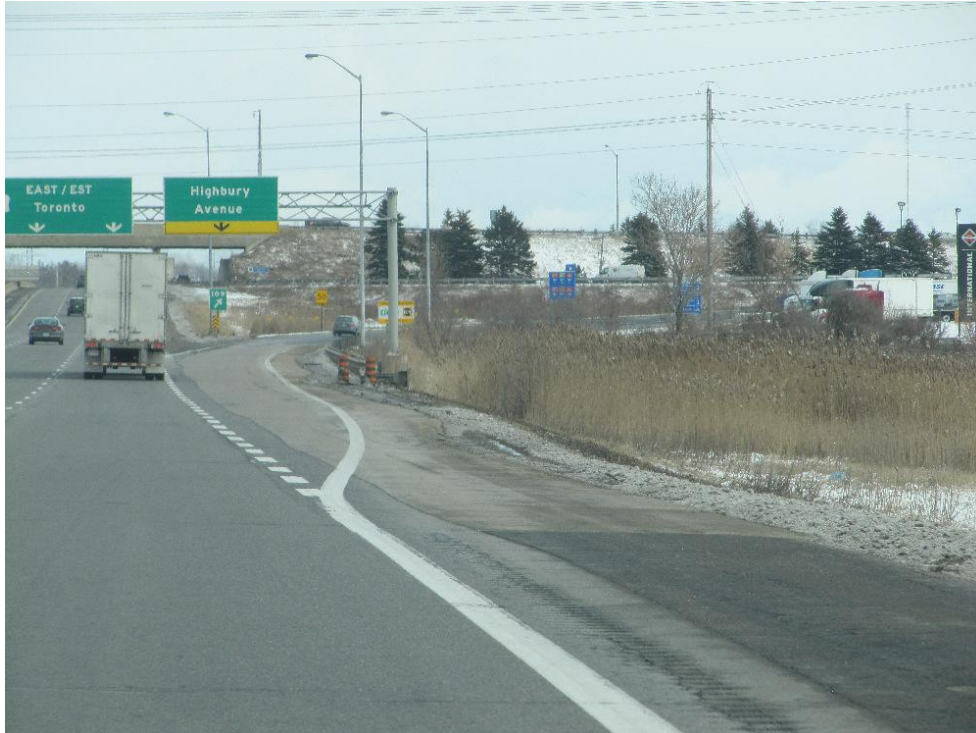
Figure 10: View, looking east, along Highway 401 toward the damaged ET-Plus terminal on the south side of the eastbound exit ramp to Highbury Ave. This photo was taken on January 27, 2016 during an inspection of the system by Gorski Consulting.

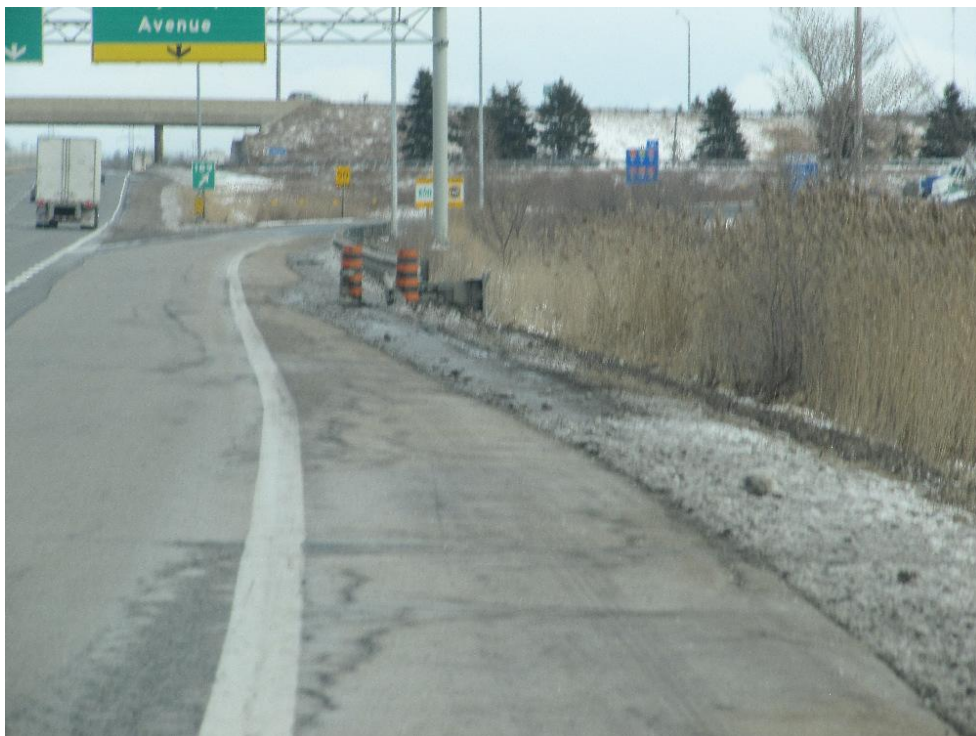
Figure 11: View looking east at the damaged ET-Plus terminal.

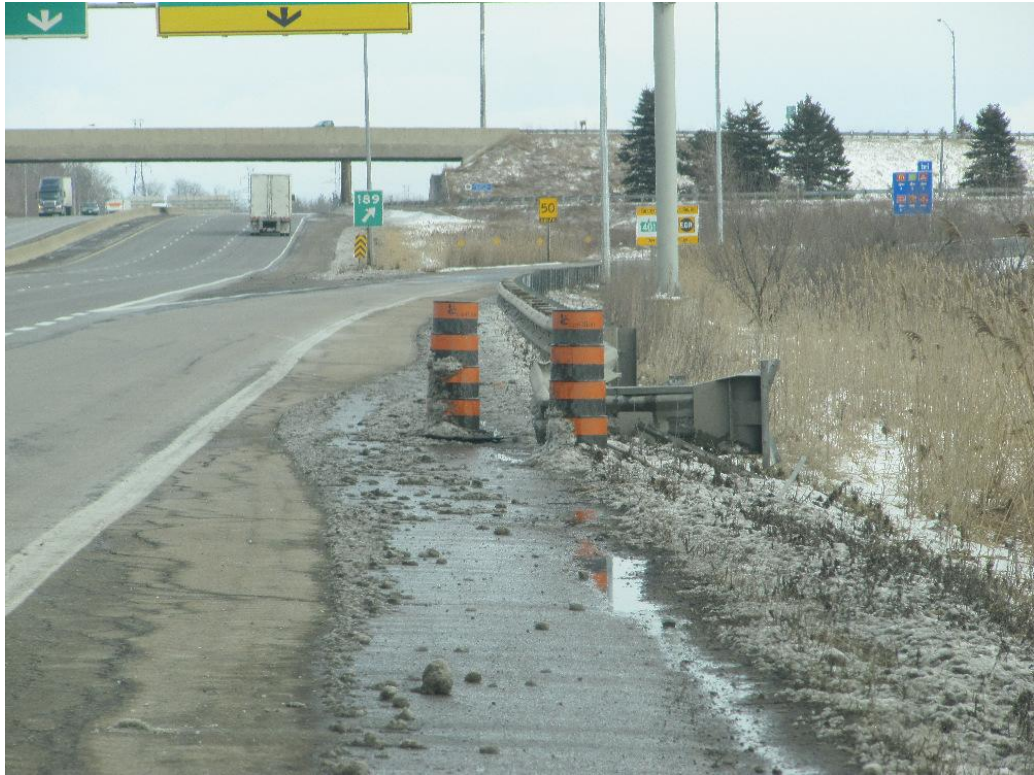
Figure 12: View looking east at the damaged ET-Plus terminal.

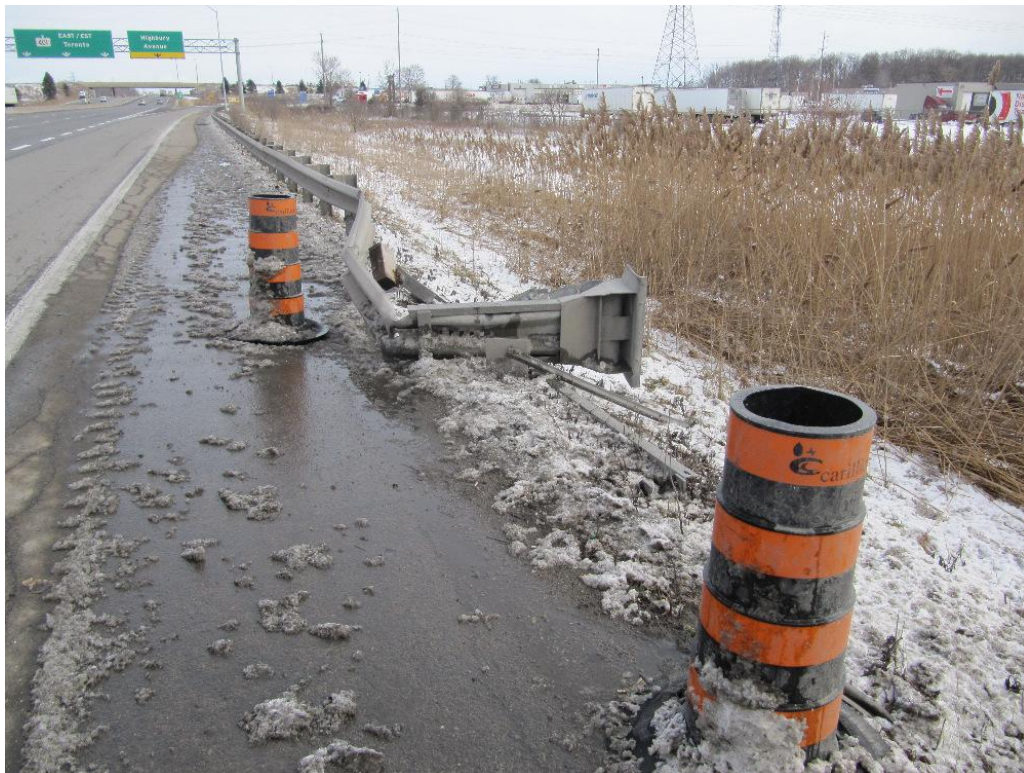
Figures 13 and 14 show how the damaged ET-Plus terminal has rotated 90 degrees toward the ditch. This was caused by an obvious kink in the rail near the rear edge of the channel. Such kinking jams the rail from continuing to pass through the terminal head. If the deformation had continued in a more severe impact there is a strong likelihood that the channel would double over the rail such that the channel and terminal head would be facing backwards, and this would produce the reinforced "spear" sometimes referred to in allegations from Mr. Joshua Harmon in his civil suit against Trinity Highway Products. Such a spear has been shown to pierce an impacting vehicle such that the rail enters into the occupant compartment causing injuries to occupants within.

Figure 13: View of the ET-Plus terminal which has rotated 90 degrees toward the ditch.

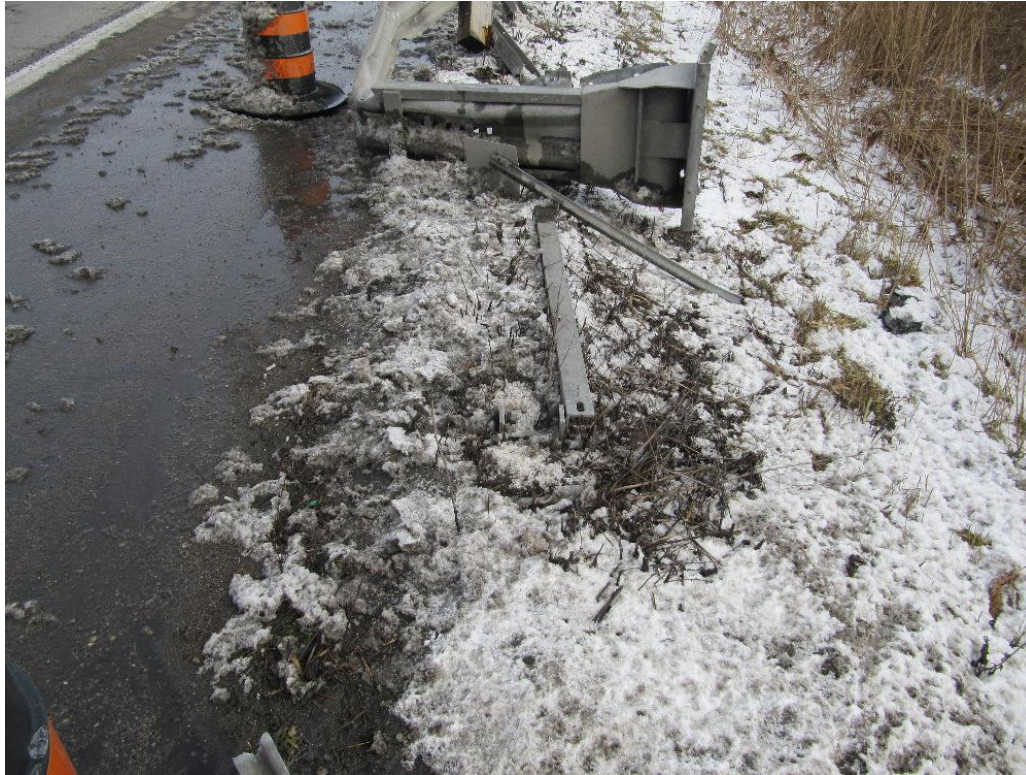
Figure 14: View of the ET-Plus terminal which has rotated 90 degrees toward the ditch.

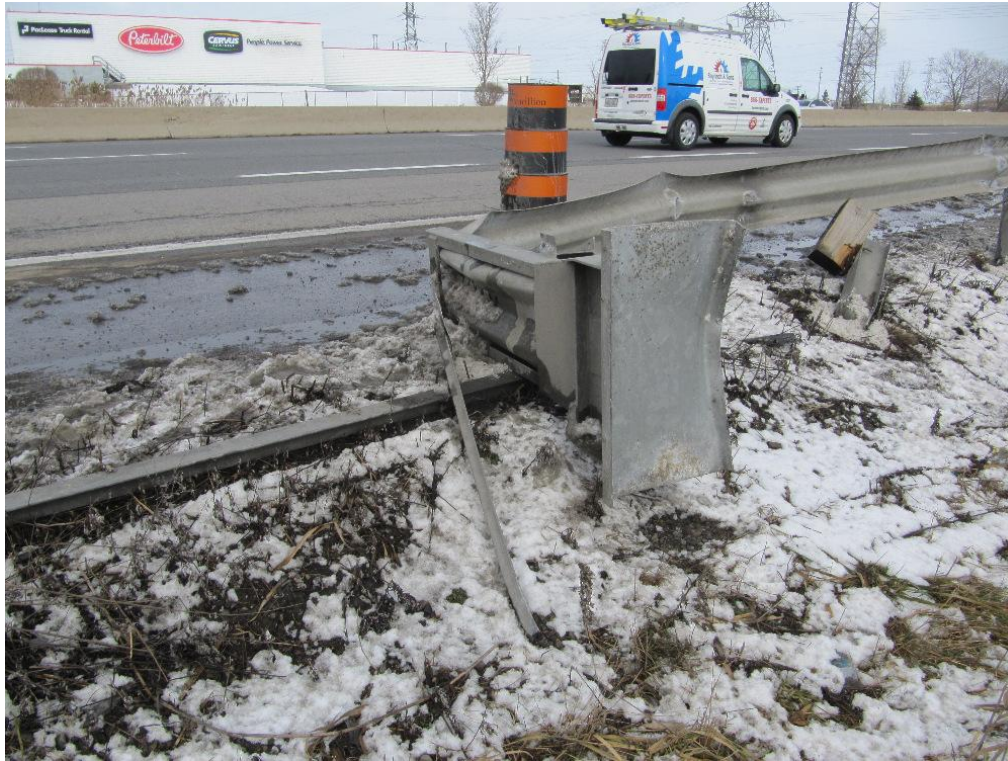
Before examining that specific issue there are a number of photographs available that document the condition of the damaged system. Figure 15 provides a view of the terminal head showing that there is more deformation to its right edge and this provides some indication that the impacting vehicle or object may have travelled to the ditch side of the system where it came to rest. Figures 16,17 and 18 show the area where the rail has been extruded through the terminal head. Figure 19 shows the length of the rail and the extent of its deformation. Figure 20 provides a close-up view of the portion of the rail that contains the 90 degree bend.

Figure 15: View of the front face of the terminal.

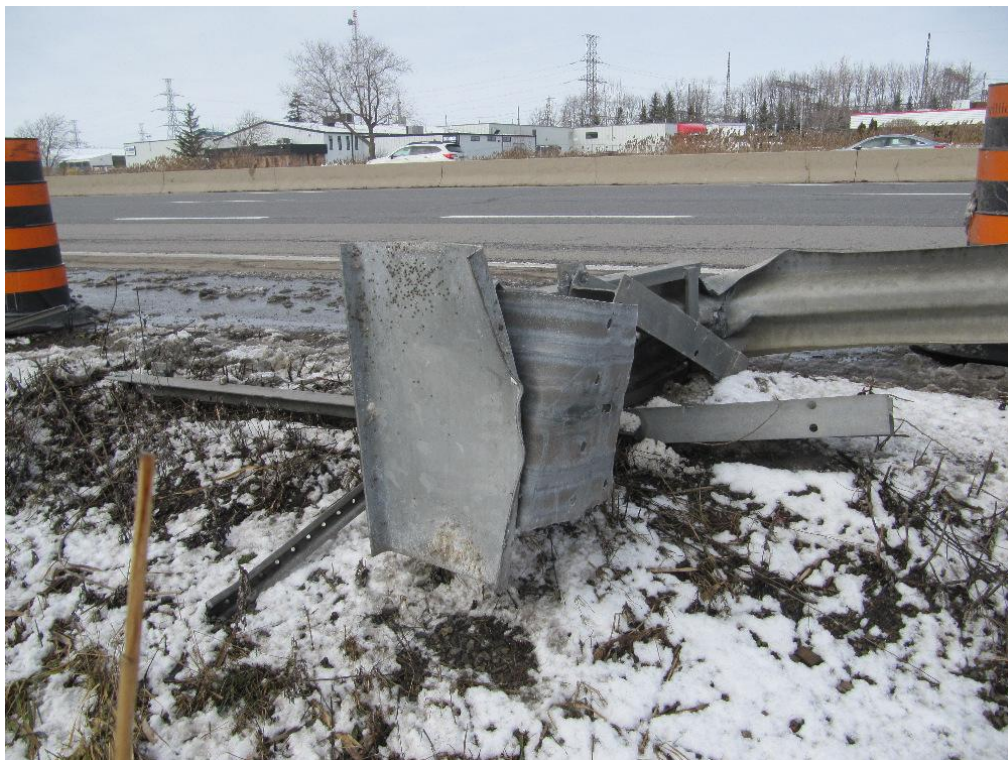
Figure 16: View of the terminal showing the short length of rail that has been extruded out of its side.

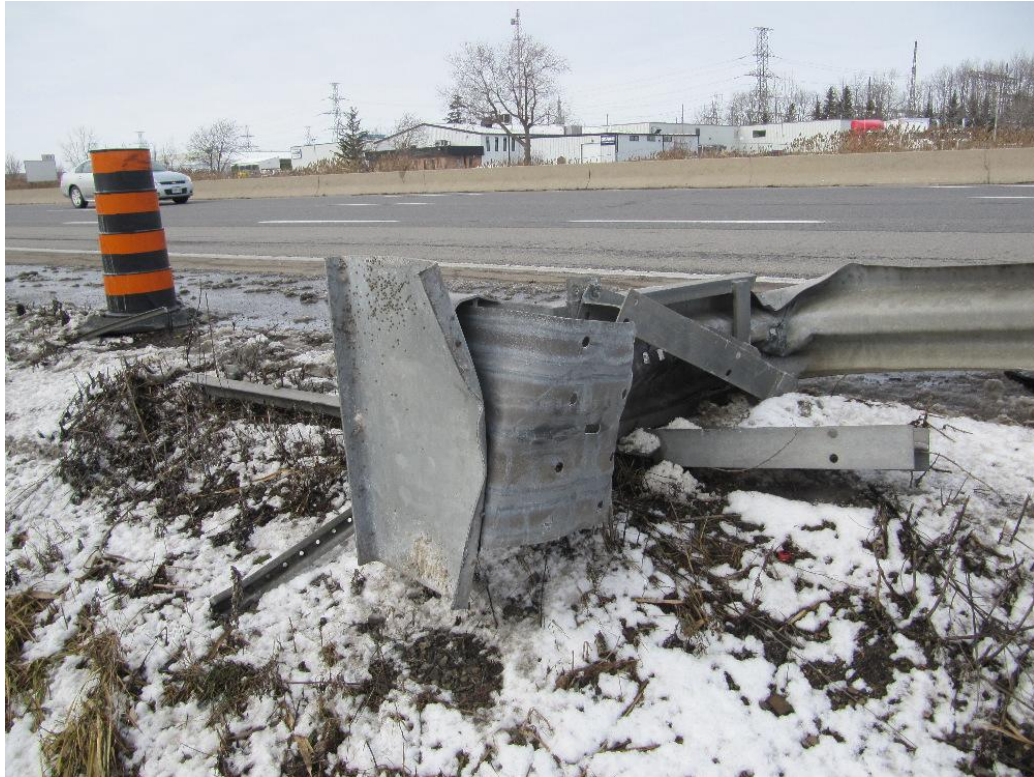
Figure 17: View showing the short length of rail that has been extruded through the terminal head.

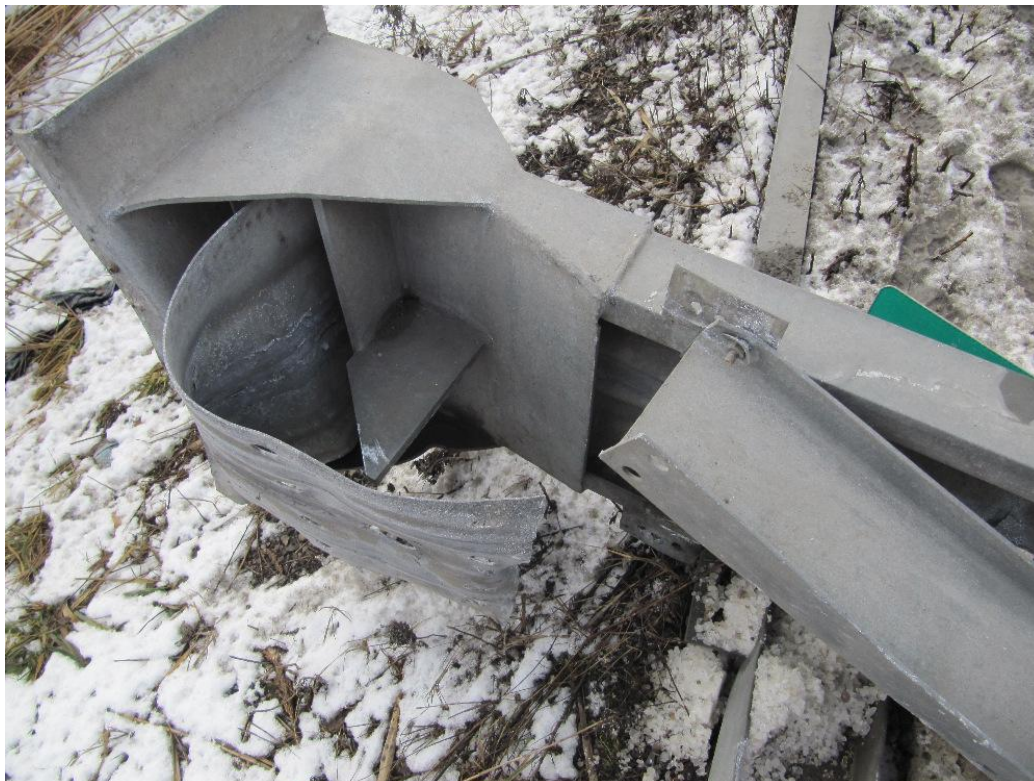
Figure 18: Top view showing the short length of rail that has been extruded through the terminal head.

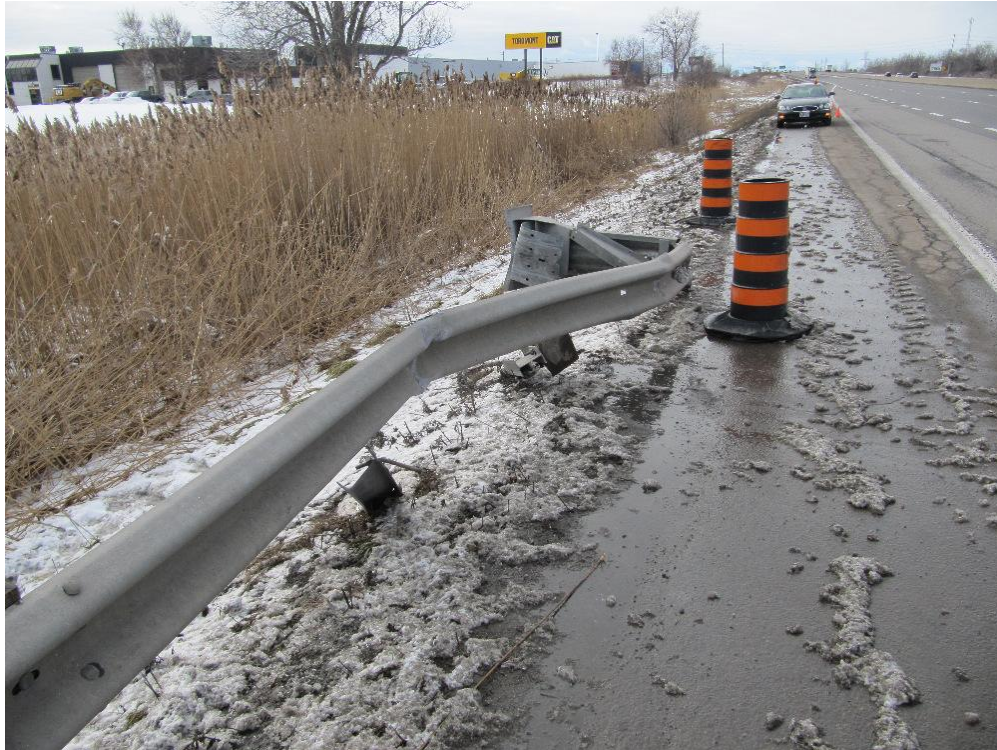
Figure 19: View looking west showing the extent of deformation to the rail.

But how does this compare to our scenario of the damaged system on Highway 401? In the real life situation there was very little rail that passed through the terminal head and there was a great deal of deformation in the rail behind the terminal that had not yet passed through the terminal. And if the system had been struck at any higher speed there was no hope that any additional rail would pass through the terminal head because, as we see in the 90 degree bend of the rail, the terminal was already at a 90 degree angle to the length of the rail. Any additional energy that might have existed in a higher severity impact would just result in more deformation of the rail behind the terminal and there would be no additional energy dissipation by extruding the rail through the head. Clearly this real life example shows a reason for concern. It shows that there is a difference between how the system has been shown to perform in the controlled tests at the South West Research Institute and how the system performed in this real life scenario.

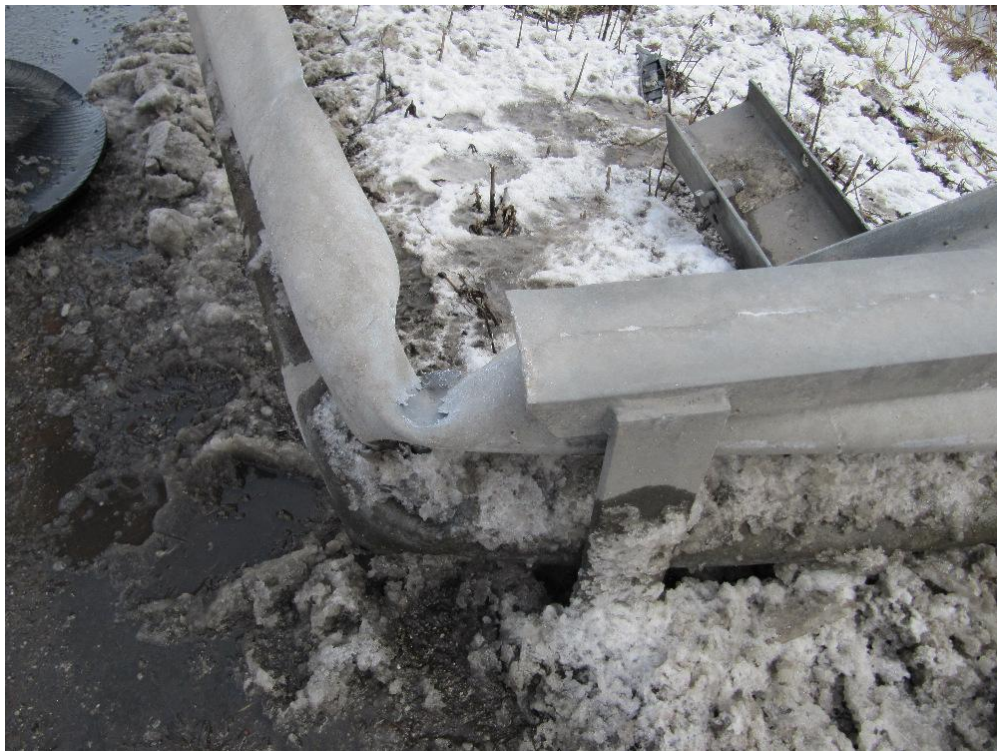
Figure 20: Close-up view of the portion of the rail that contains the 90 degree bend.

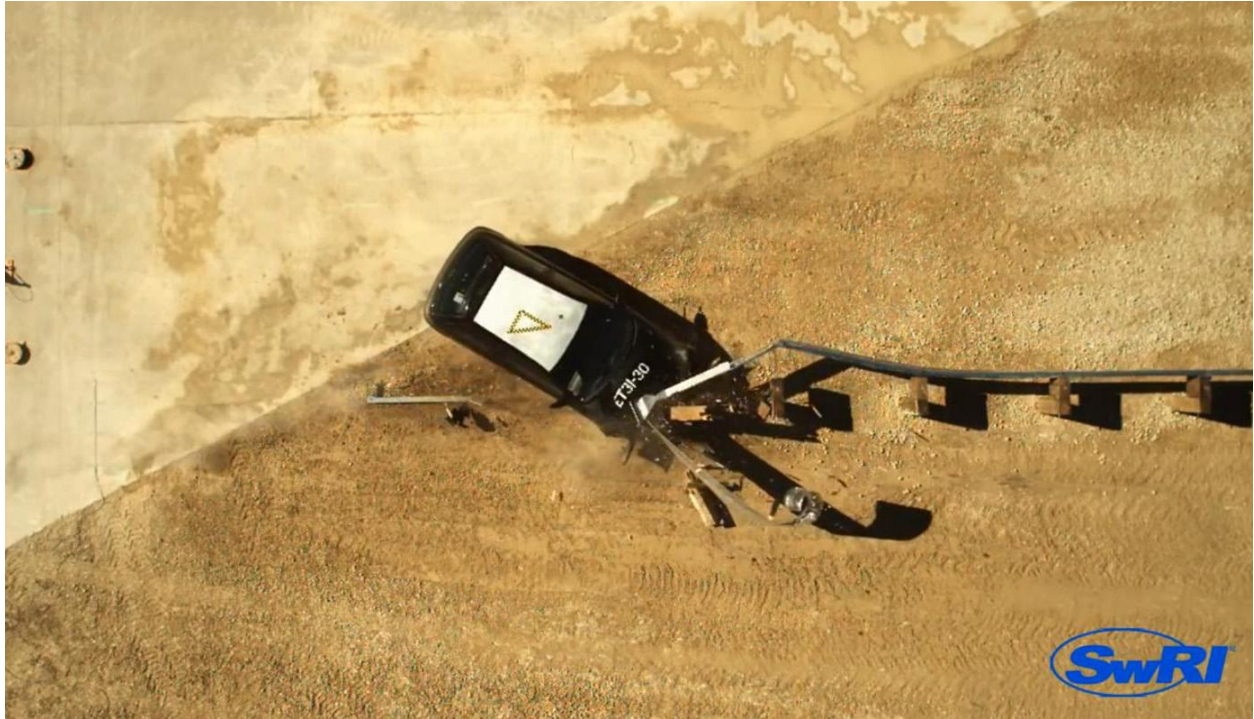
Figures 23 through 26 show the results of the compliance test as the Geo Metro rotates and the rail begins to buckle. Here we see that the rail forms a spear that penetrates the driver's side door and enters into the driver's seating space. This is an obvious injury producing consequence whose consequences to a live driver in a real-life collision could be potentially fatal if the wrong set of factors are assembled.

Figure 23: The rail begins to buckle the Metro rotates.

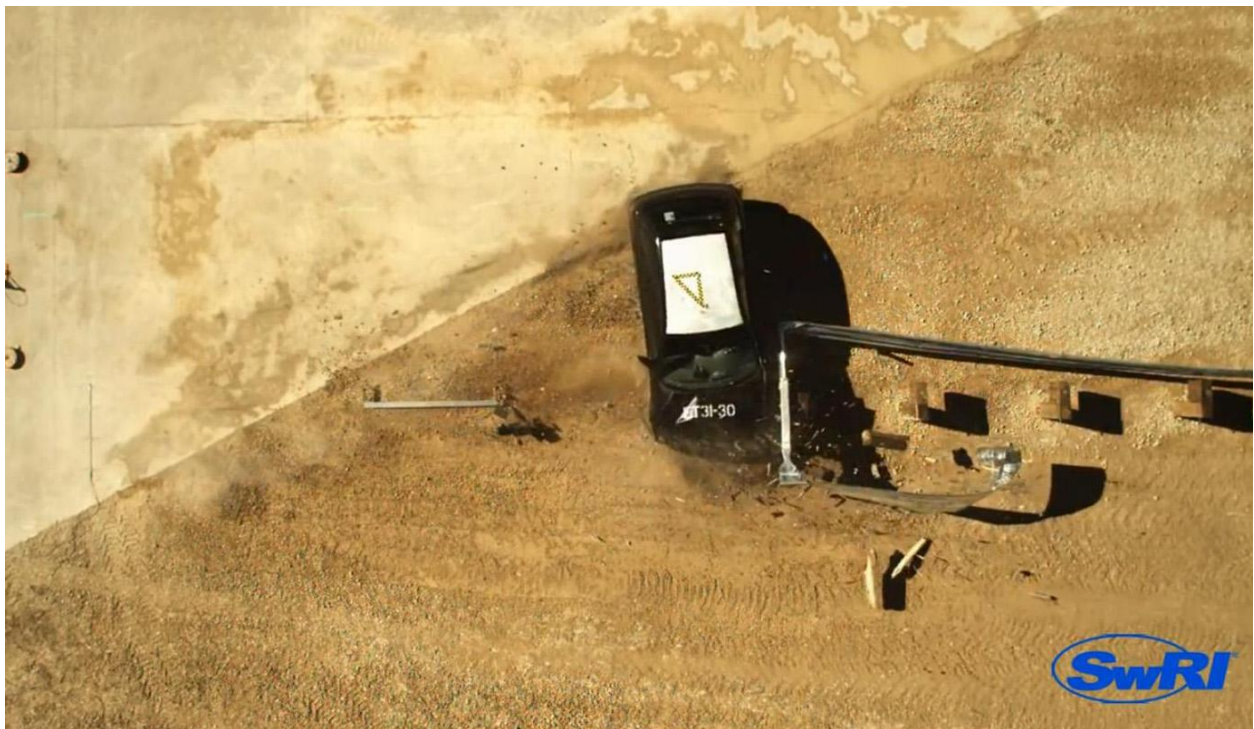
Figure 24: The rail continues to buckle as the Metro continues to rotate.

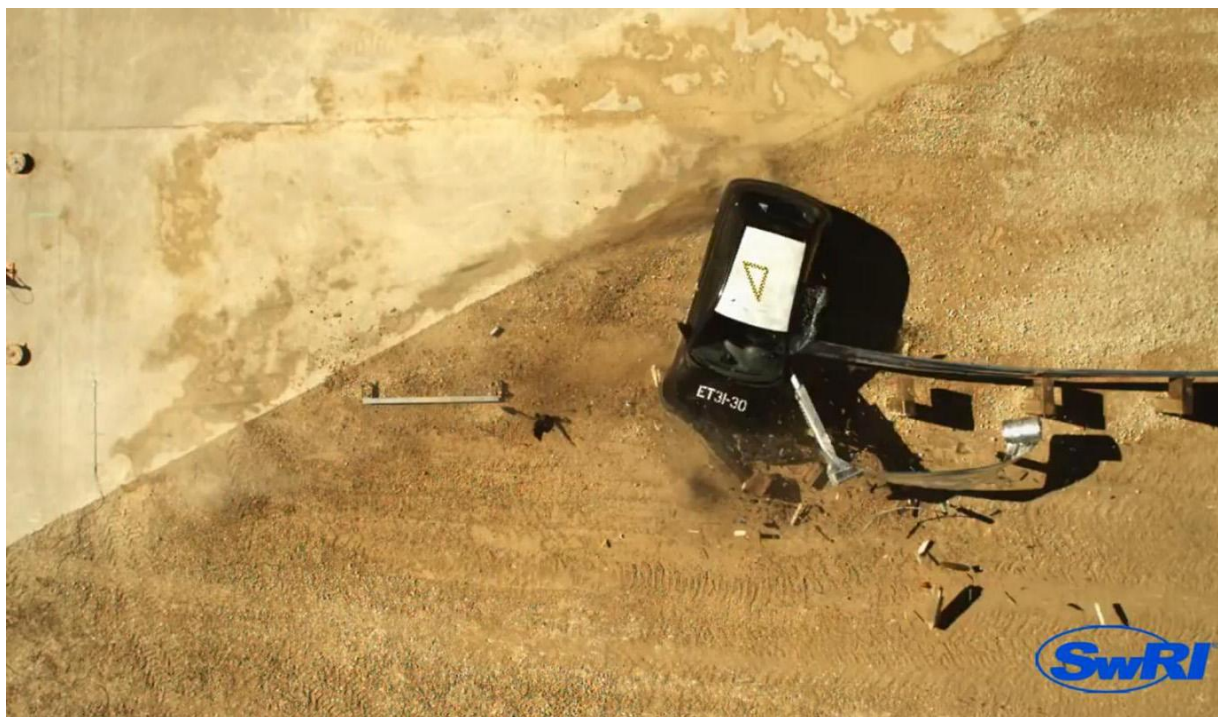
Figure 25: The rail doubles over just behind the terminal forming a spear that penetrates into the driver's door.

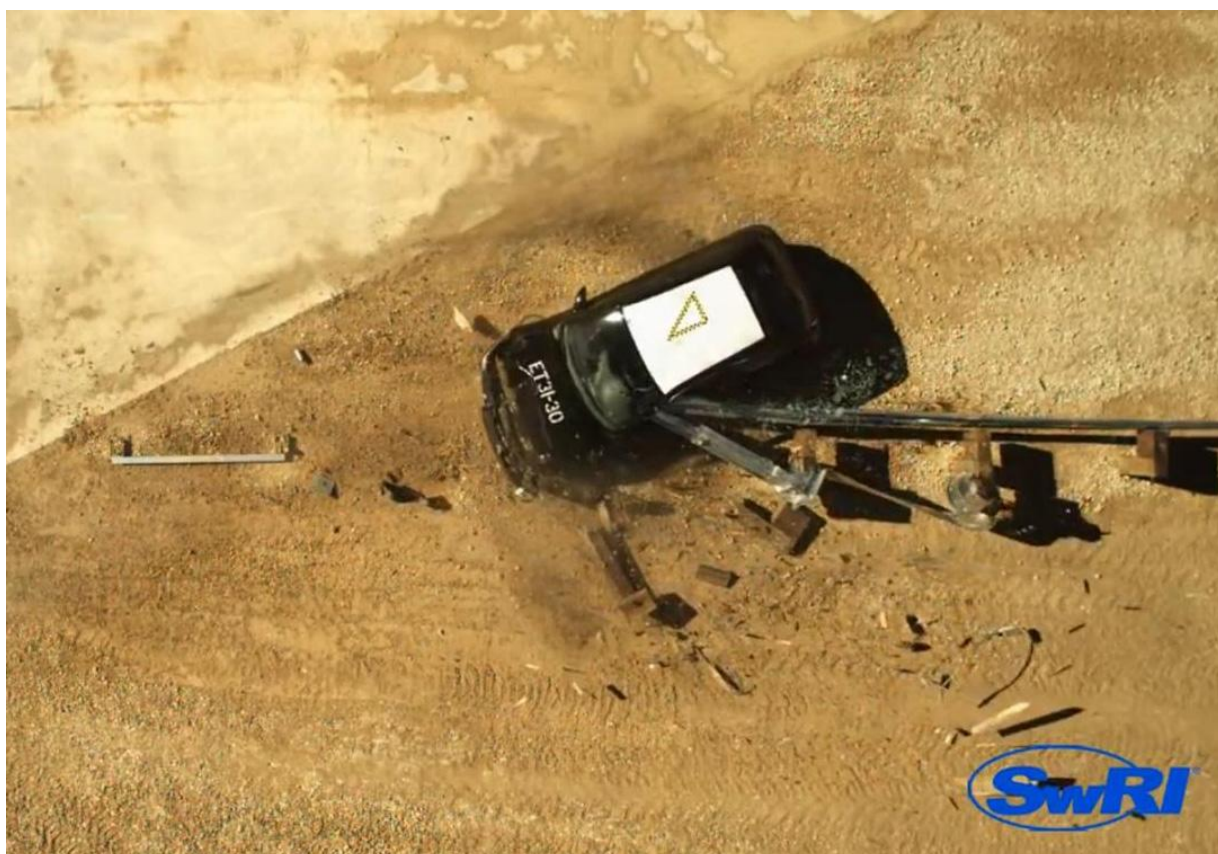
Figure 26: As the Metro continues to rotate the rail forms a spear that penetrates the driver's interior.
