# Escaping Police Also Results in Miraculous Escape From Death

*Posting Date: 27-Aug 2014*

Gorski Consulting  
London, Ontario, Canada

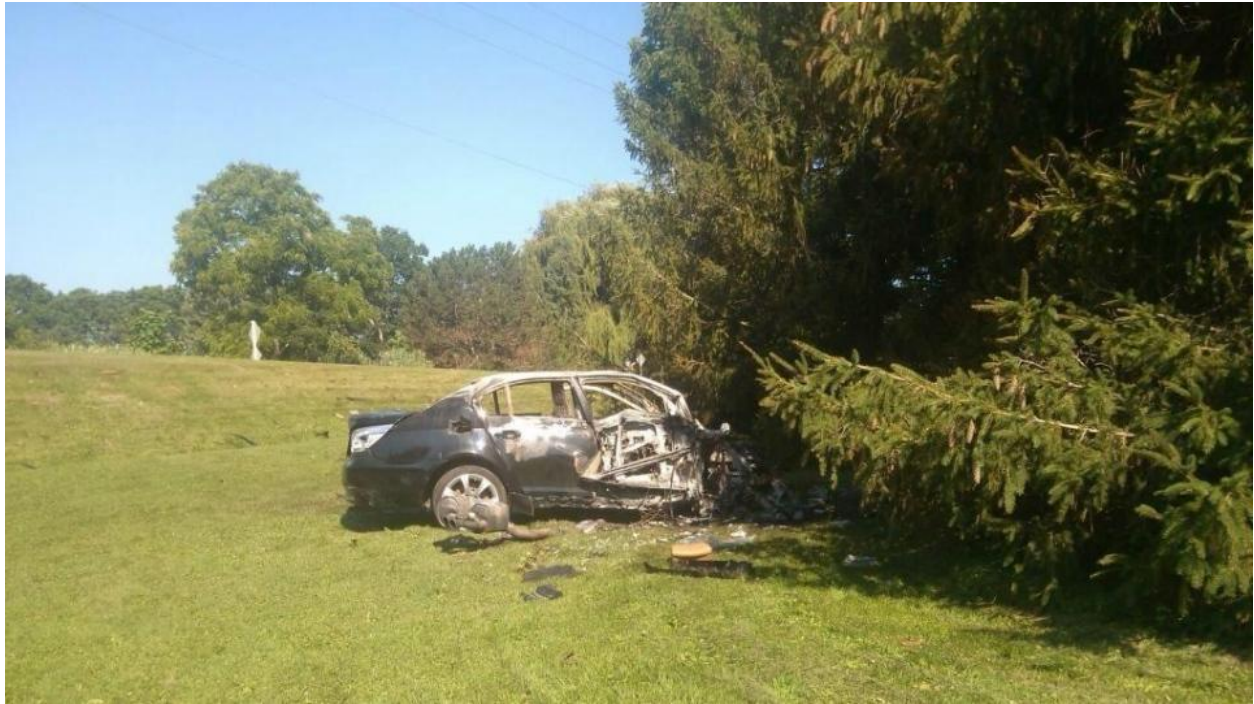
The fleeing vehicle was reportedly found at approximately 0200 hours on the morning of August 25, 2014. The London Free Press provided the photo in Figure 1 (below) in its article on the incident. The photo shows the vehicle at its final rest position. Most of the front and middle of the vehicle would appear to have been consumed by fire. The vehicle appears to be located on a lawn with no real indication of the location of the road where the vehicle had travelled. Police had the site closed off until almost 1800 hours on that day, presumably to allow the SIU to complete their investigations. We attended the site shortly after it was opened for public travel and documented the following evidence.

Figure 1: Photo taken by the London Free Press newspaper showing the vehicle at its final rest position.

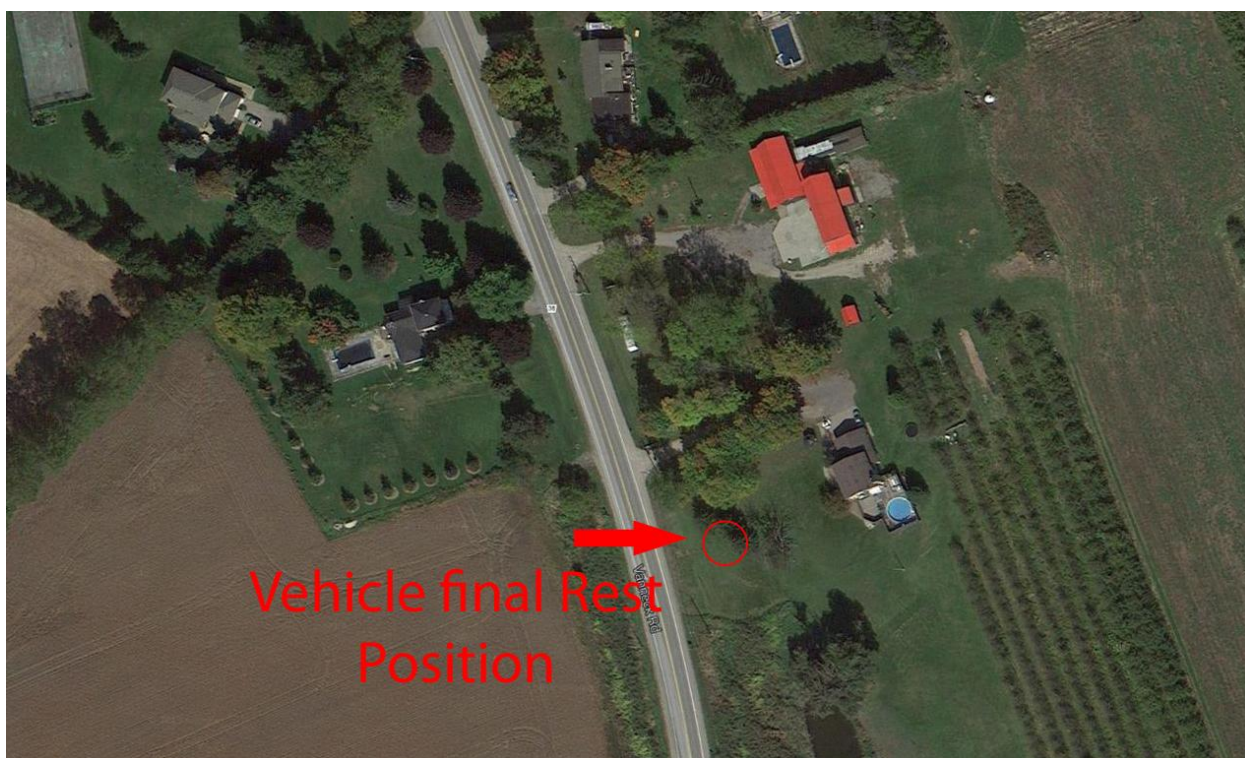
Figures 2 through 5 provide Google Maps, aerial views of the site, showing images that are zoomed-in progressively closer to the actual site. The vehicle was reportedly travelling southbound on Vanneck Road, crossed the intersection of Gainsborough Road and then came to rest on the east roadside of Vanneck Road as indicated in Figure 6.

Figure 6: View of final rest position of vehicle.

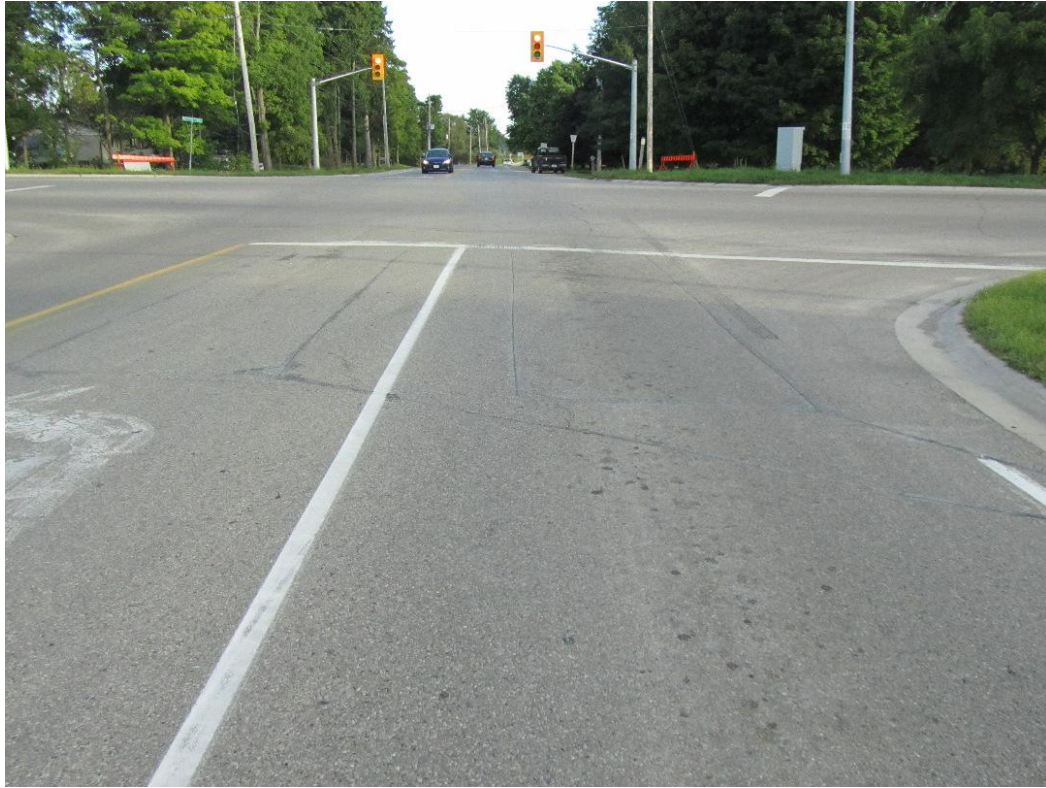
Our examination of the site took us to a point on Vanneck Road just north of its intersection with Gainsborough Road. This is where the vehicle passed through before it went out of control. Figures 7 and 8 show a view looking south from just north of the intersection. There is a small "hump" in the pavement as southbound vehicles cross over the intersection. It is because this vehicle was travelling southward extremely quickly that, as it travelled over this hump it was lifted upward. As can be seen from the opposite direction of Figure 9, Vanneck Road also contains a slight change in direction just as it crosses the intersection.

Figure 7: View, looking south along Vanneck Road from just north of its intersection with Gainsborough Road.

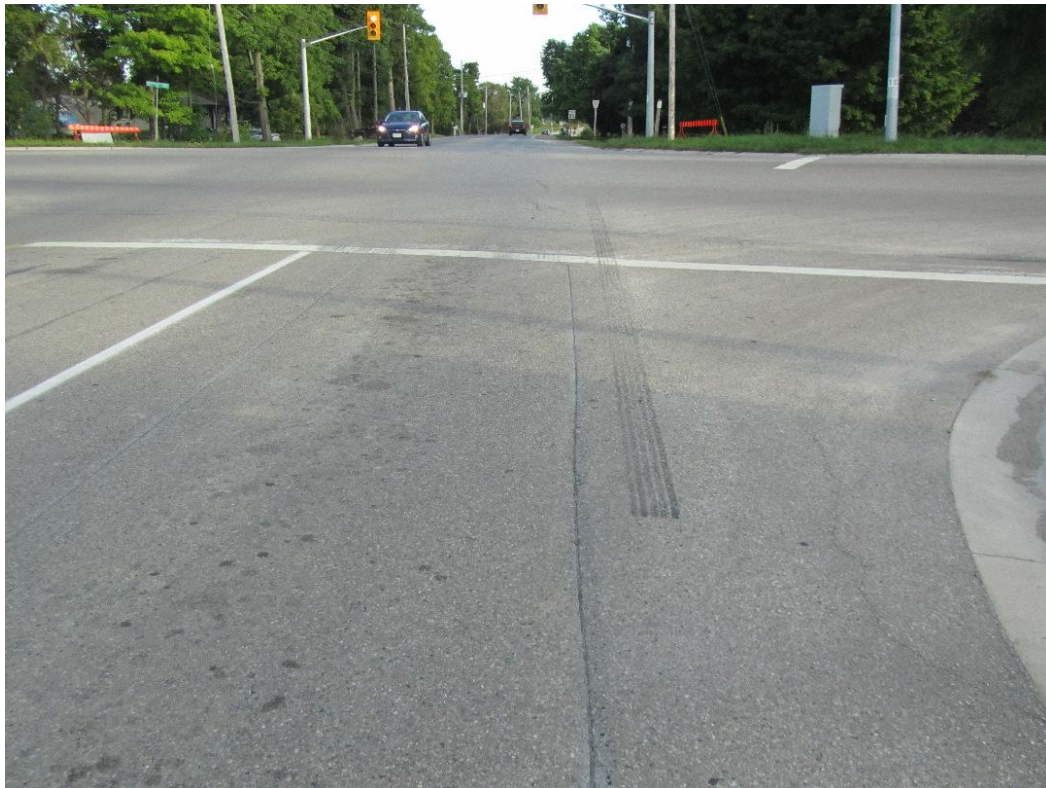
Figure 8: View, looking south along Vanneck Road from just north of its intersection with Gainsborough Road.

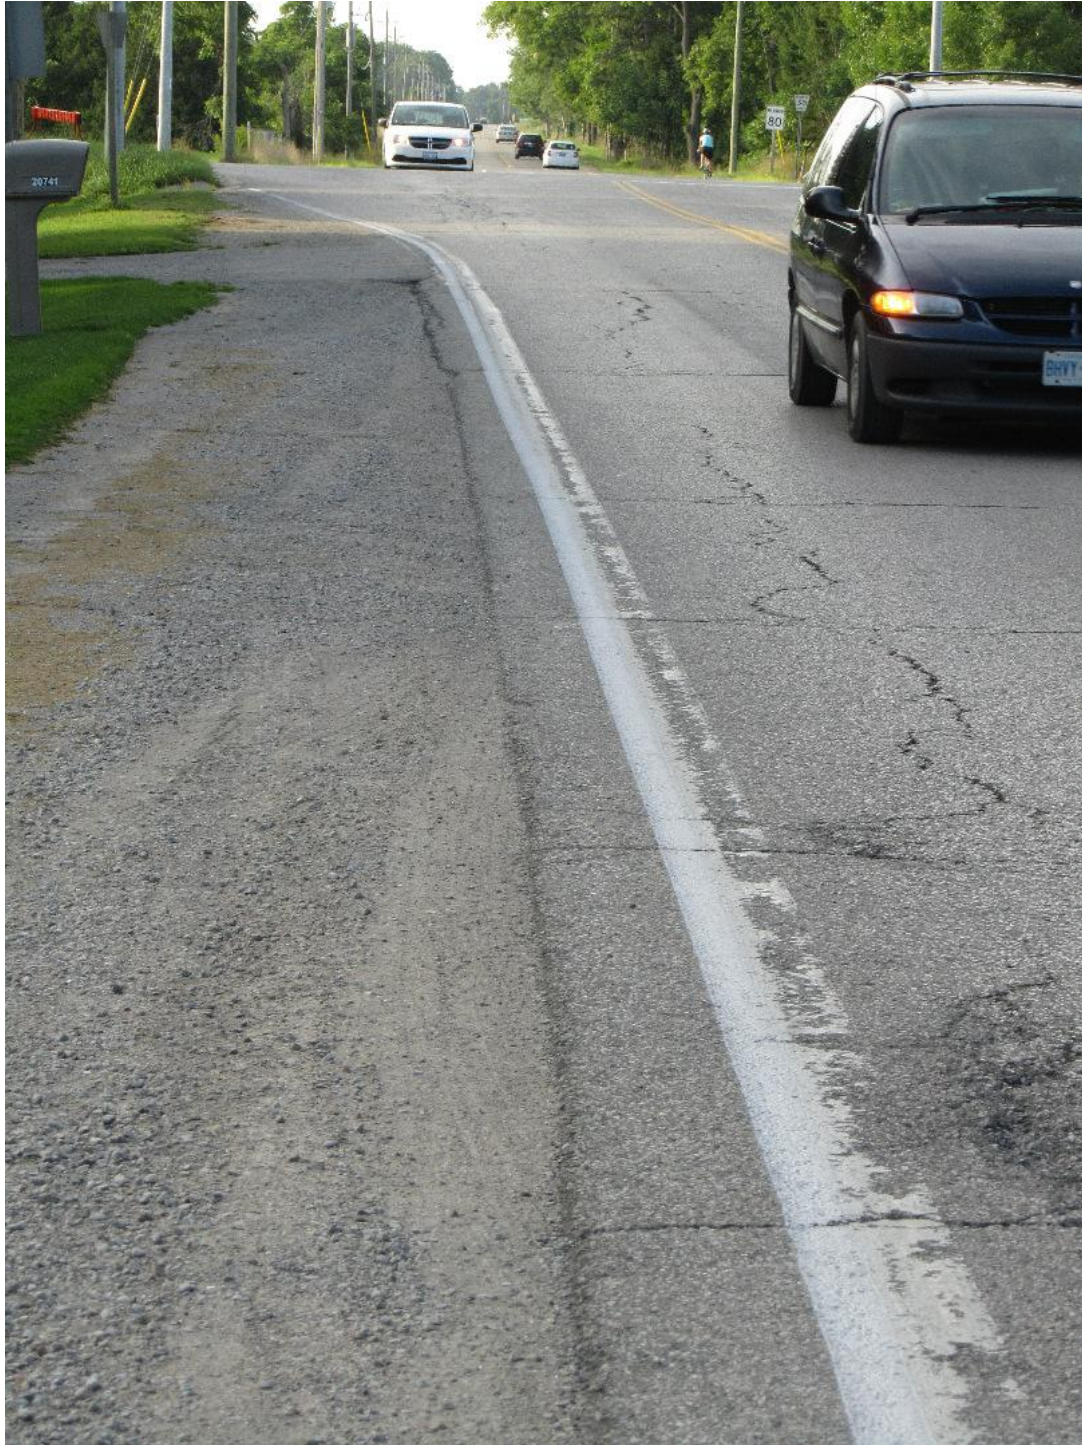
Figure 9: View, looking north along the west side of Vanneck Road toward the intersection with Gainsborough Road.

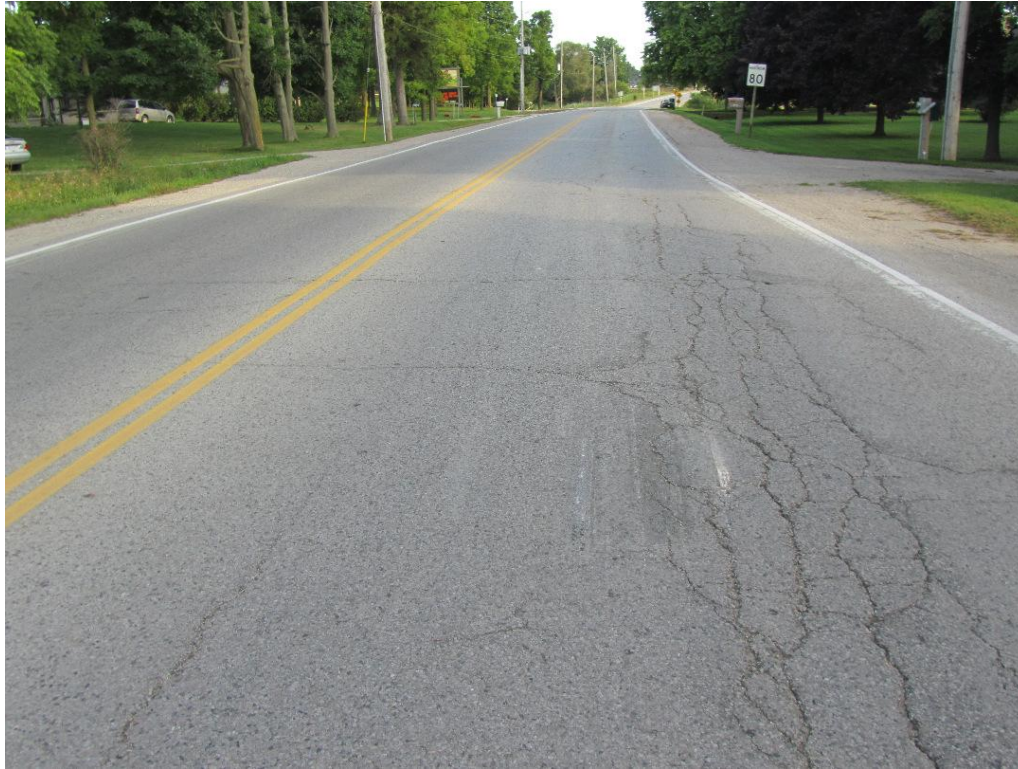
So, as the wheels of the vehicle were lifted due its high speed, the driver was no longer in control of the vehicle. A short distance south of the intersection there was evidence that the underside of the vehicle came down hard and produced some scrapes in the pavement, as shown in Figures 10, 11 and 12.

Figure 10: View, looking south, from just south of the intersection of Gainsborough Road. Fresh scrapes are visible in the southbound lane, in the foreground, where the underside of the vehicle came down after being lifted at the intersection.

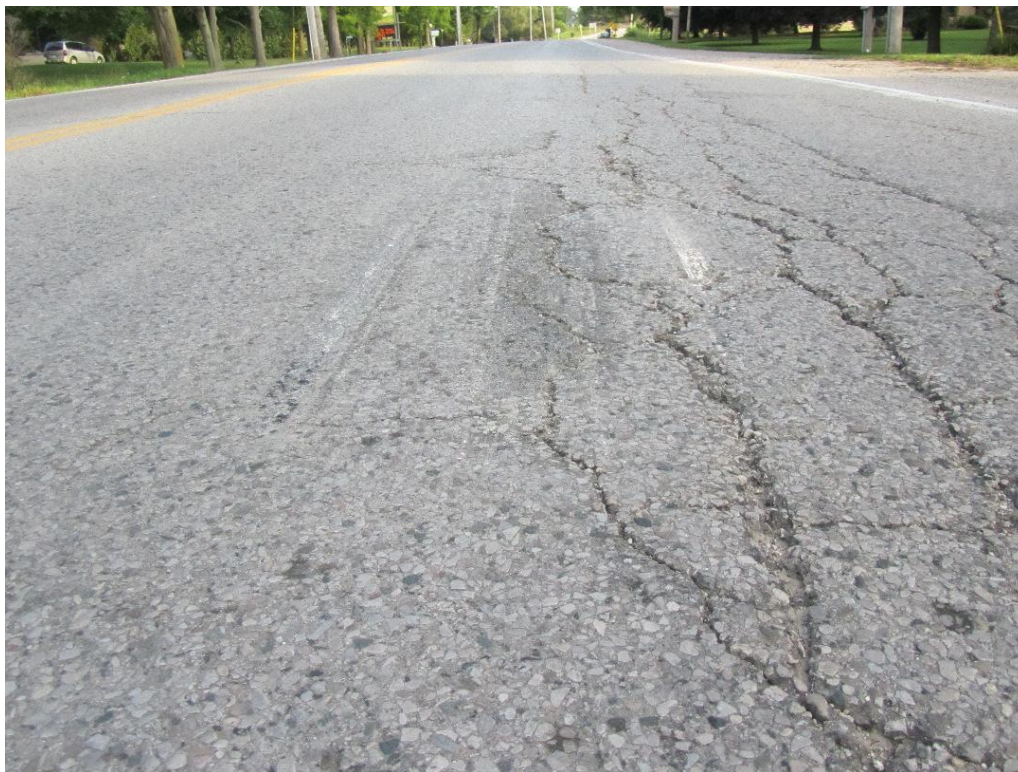
Figure 11: Closer view of fresh scrapes in the pavement of the southbound lane of Vanneck Road.

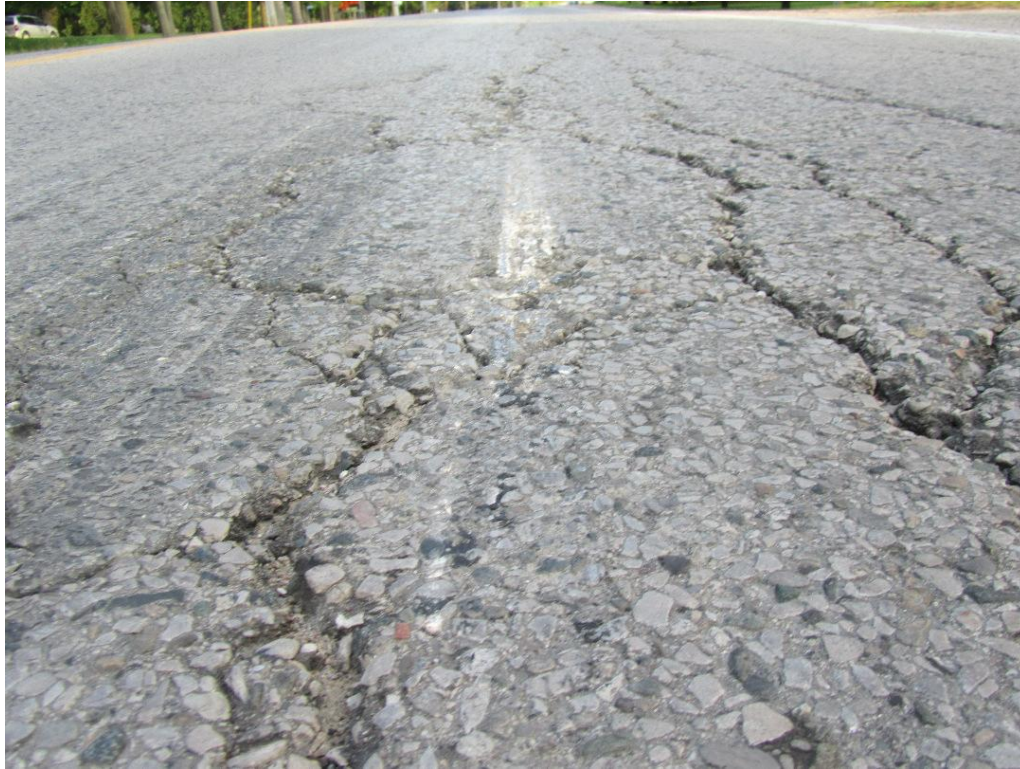
Figure 12: Close-up view of the fresh scrapes in the pavement where the vehicle came down after being lifted at the intersection.

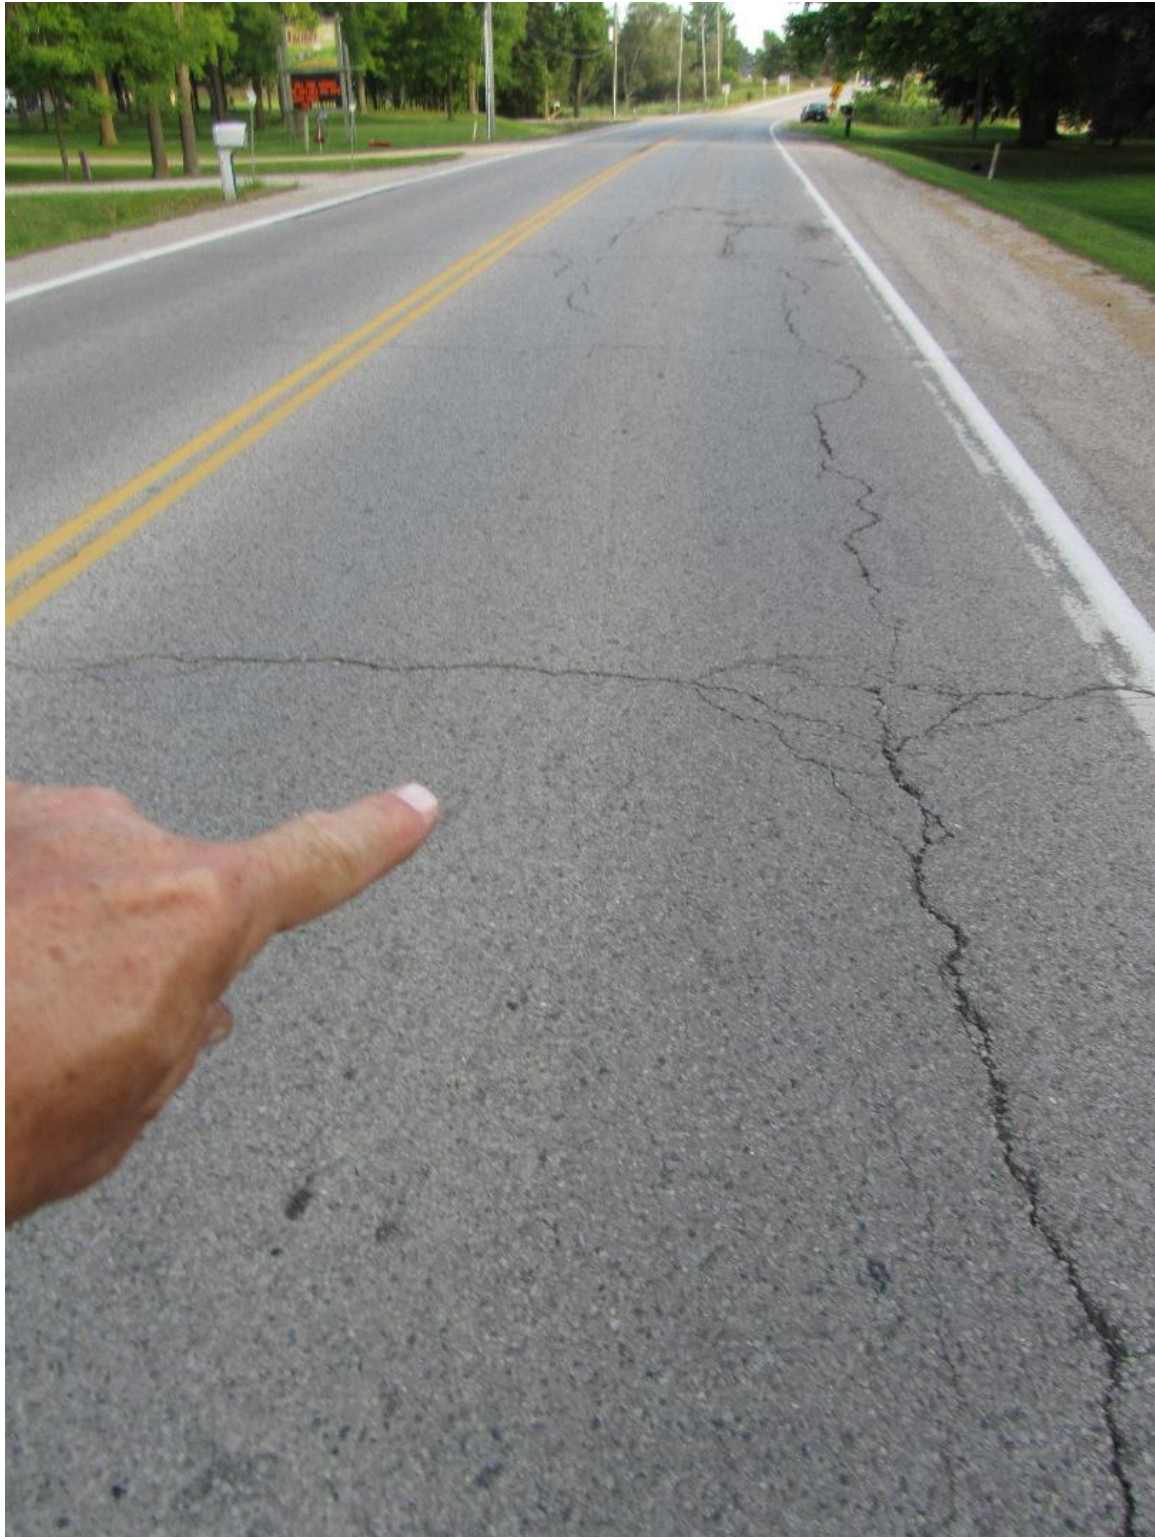
There was a faint, curved tire mark exiting the location where the underside of the vehicle contacted the pavement. In Figure 13 we attempt to indicate its general location in the southbound lane but it is too faint to be detected in the photo. This tire mark indicated that the vehicle commenced to rotate counter-clockwise and was moving from the southbound lane, across the roadway centre-line and toward the east shoulder.

Figure 13: The finger is attempting to indicate the general location where a thin, curved tire mark was present in the southbound lane indicating that car began to rotate counter-clockwise.

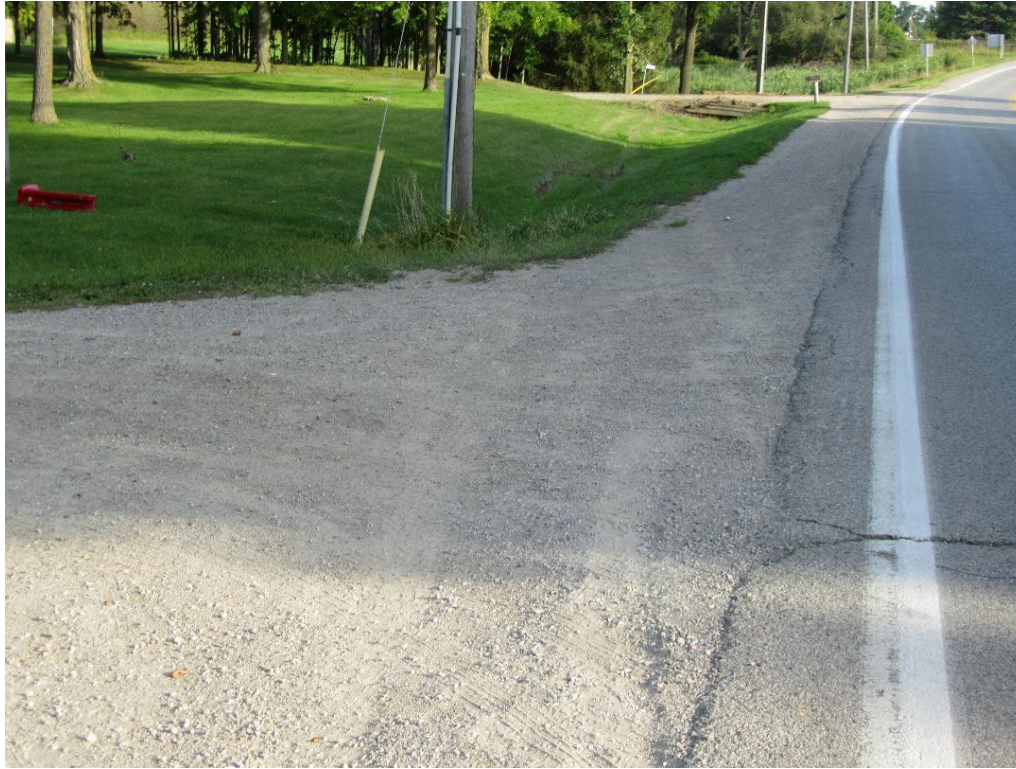
As the vehicle continued to exit onto the east shoulder Figure 14 shows the tire marks that were visible in the gravel. Here the vehicle just missed striking the utility pole however it managed to impact a red mail box whose pieces were strewn across the nearby lawn, as shown in Figure 15.

Figure 14: View, looking south along the east shoulder of Vanneck Road at the fresh tire marks in the gravel shoulder.

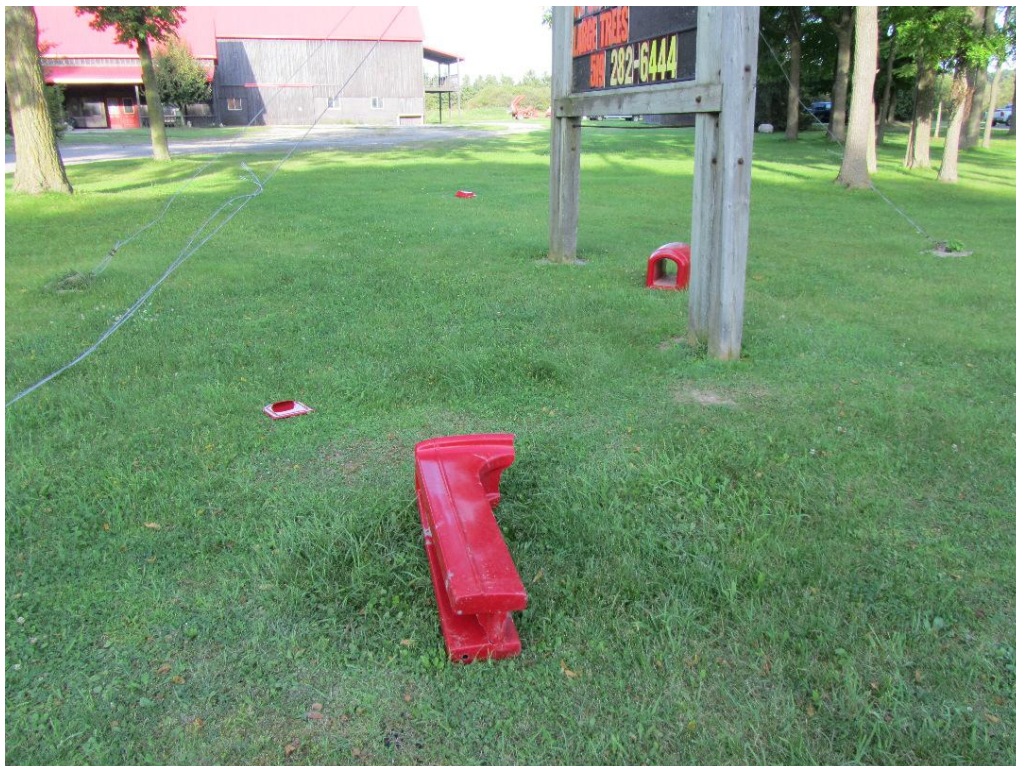
Figure 15: View of the pieces of a red mail box that was struck as the vehicle exited the east shoulder and entered the east ditch.

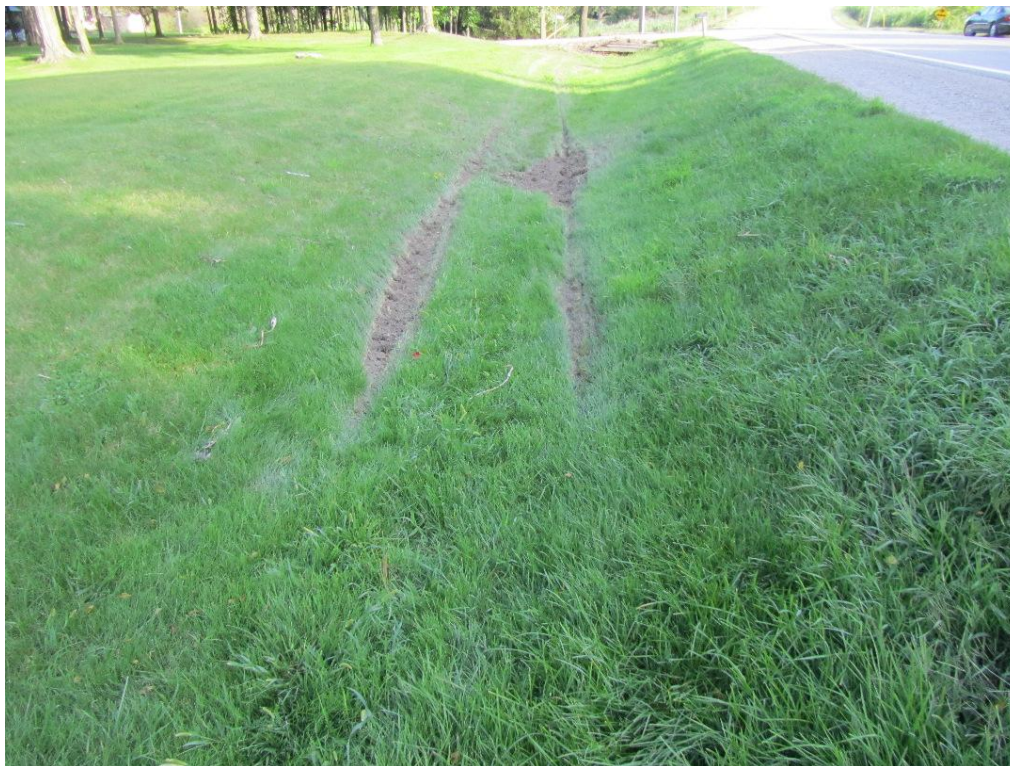
After striking the red mail box the vehicle continued travelling at exceptional speed down into the east ditch where its underside began to tear up the lawn, as shown in Figure 16.

Figure 16: View of gouges in the lawn of the east ditch caused by the underside of the vehicle.

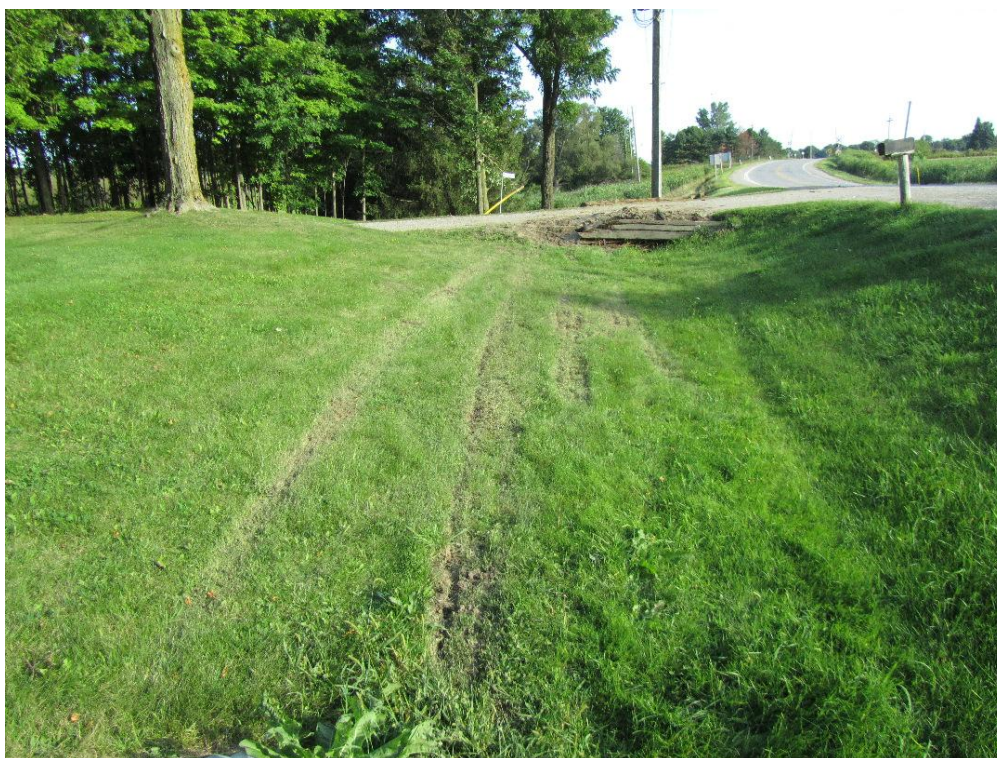
Eventually the vehicle approached a driveway that crossed the east ditch. A small culvert located beneath the driveway was sided by wooden rails. The vehicle crashed into this culvert and sent the wooden rails flying in various directions, as shown in Figures 17, 18 and 19.

Figure 17: View of tire marks headed toward a driveway and a culvert that was sided by wooden rails.

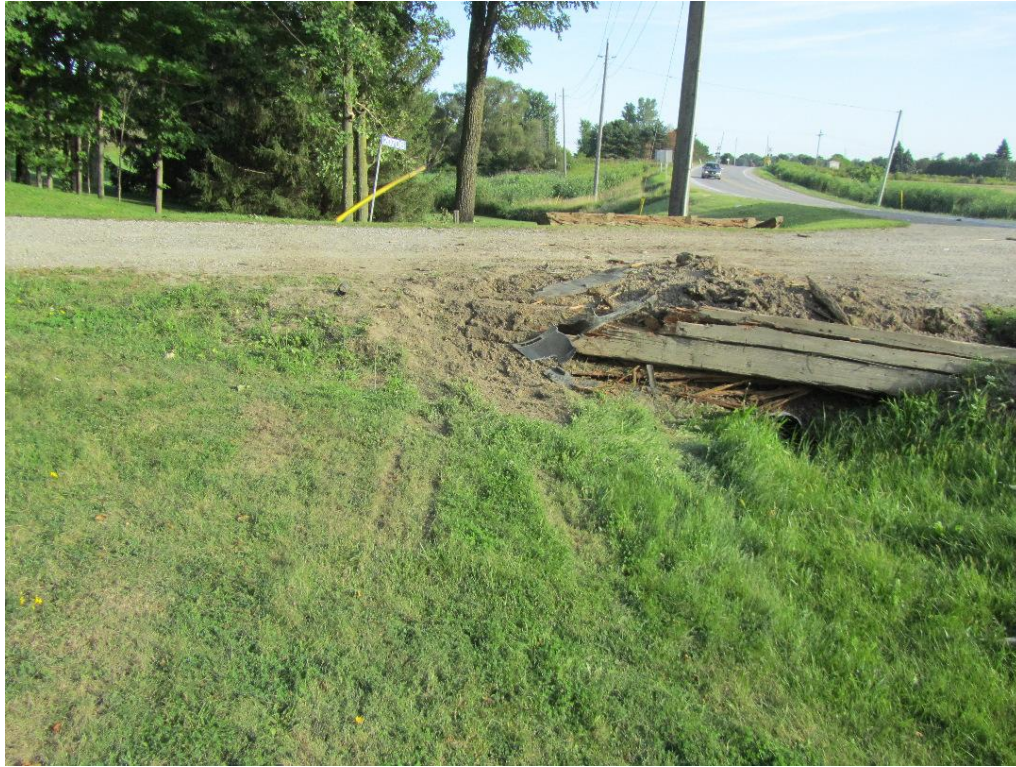
Figure 18: View of impact damage to the wood rails along the side of the driveway.

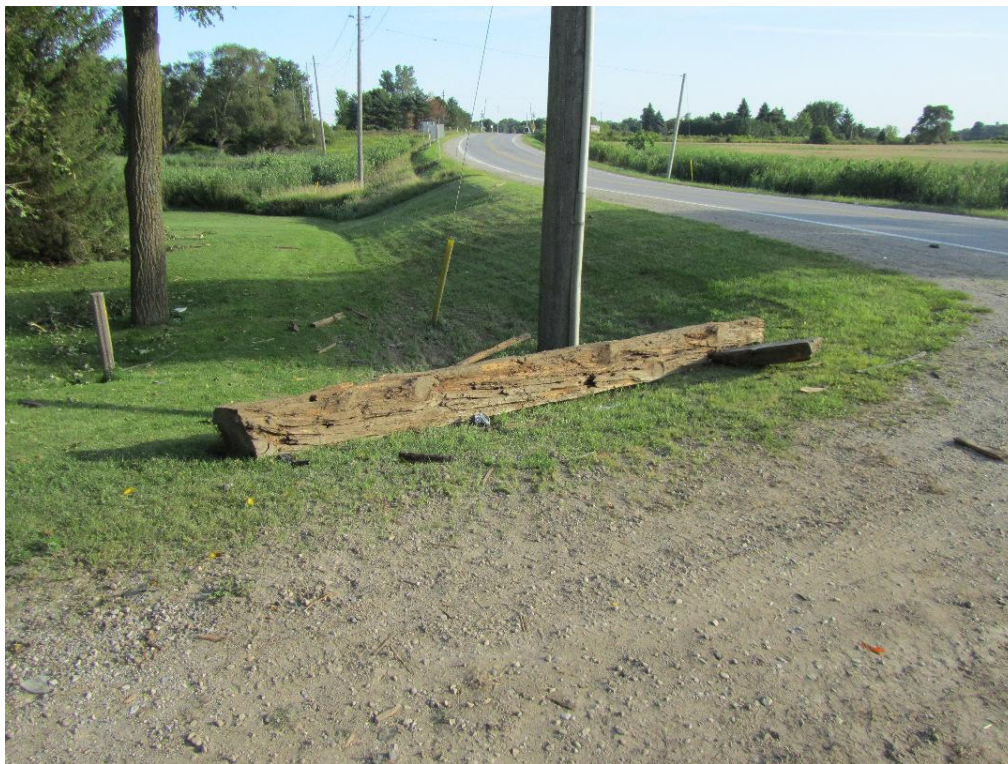
Figure 19: View of one of the wooden rails that was thrown to the other side of the driveway as a result of the vehicle impact.

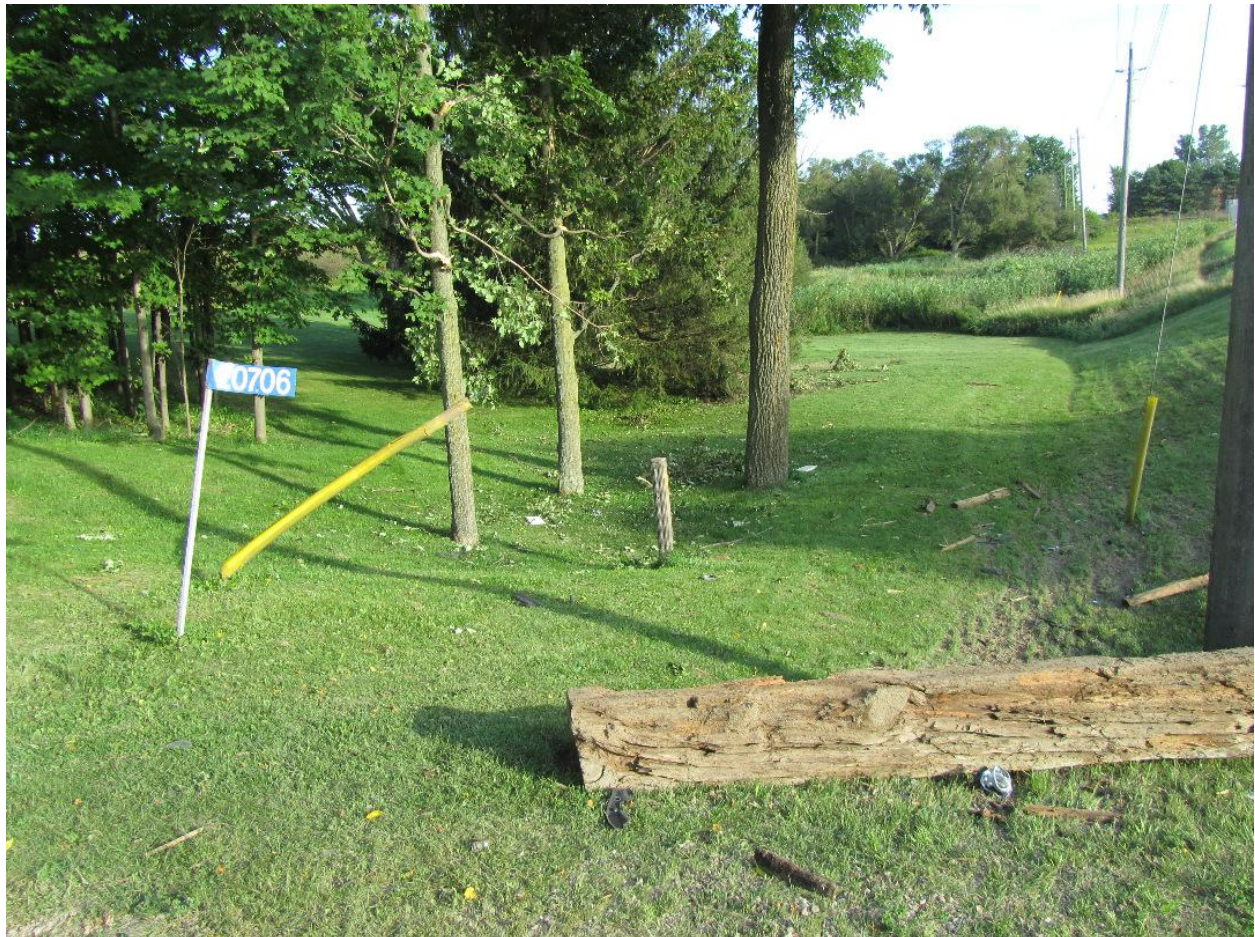
Upon initially reaching the area of the driveway we looked beyond it toward the south to locate the next bit of evidence which would indicate the continuation of the vehicle's travel path. However we were momentarily confused by the lack of any further evidence on the ground. As indicated in Figure 20, there was a clump of trees straight ahead along the vehicle's path but there did not appear to be any contact to those trees, and there were no tire marks on the lawn anywhere around the trees, as shown in the northward view of Figure 21 which looks back in the direction from which the vehicle came.

Figure 20: View of east ditch just past the driveway showing no sign of any markings on the grass or any signs of impact to the trees that were in a direct line with the path of the vehicle.

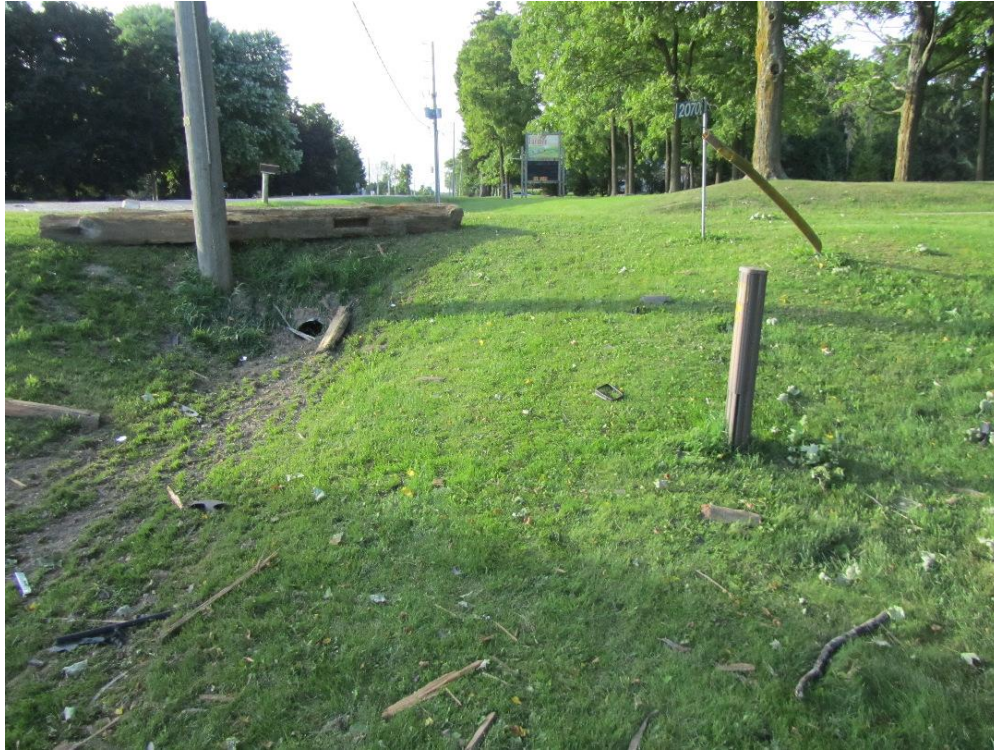
Figure 21: View looking north toward the driveway in the direction from which the vehicle came. There are no signs of any tire marks on the grass yet the vehicle had to have passed through this area.

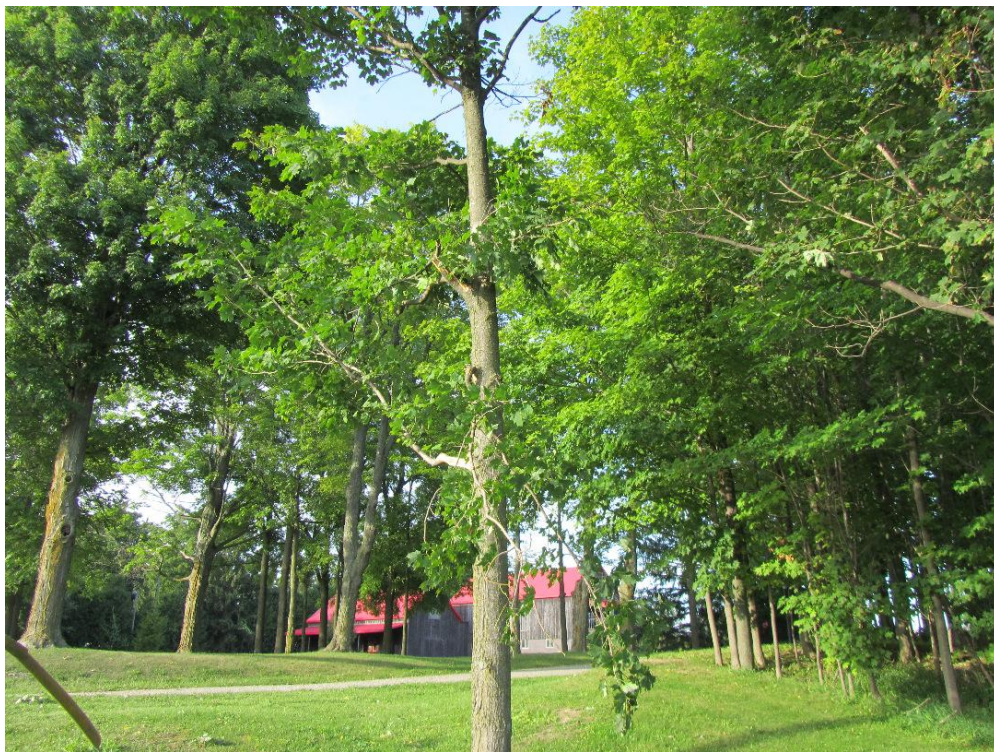
After a short while we confirmed that there were car parts still strewn throughout the area and we eventually began to examine other parts of the trees. At this point the vehicle's actions became apparent as we looked into the branches of the trees, as shown in Figures 22 through 25. The vehicle had vaulted so high after its impact with the culvert that it rose into the branches of these trees and broke them.

Figure 22: View of first tree along the vehicle's path. Looking up into the branches there was evidence of some fresh damage.

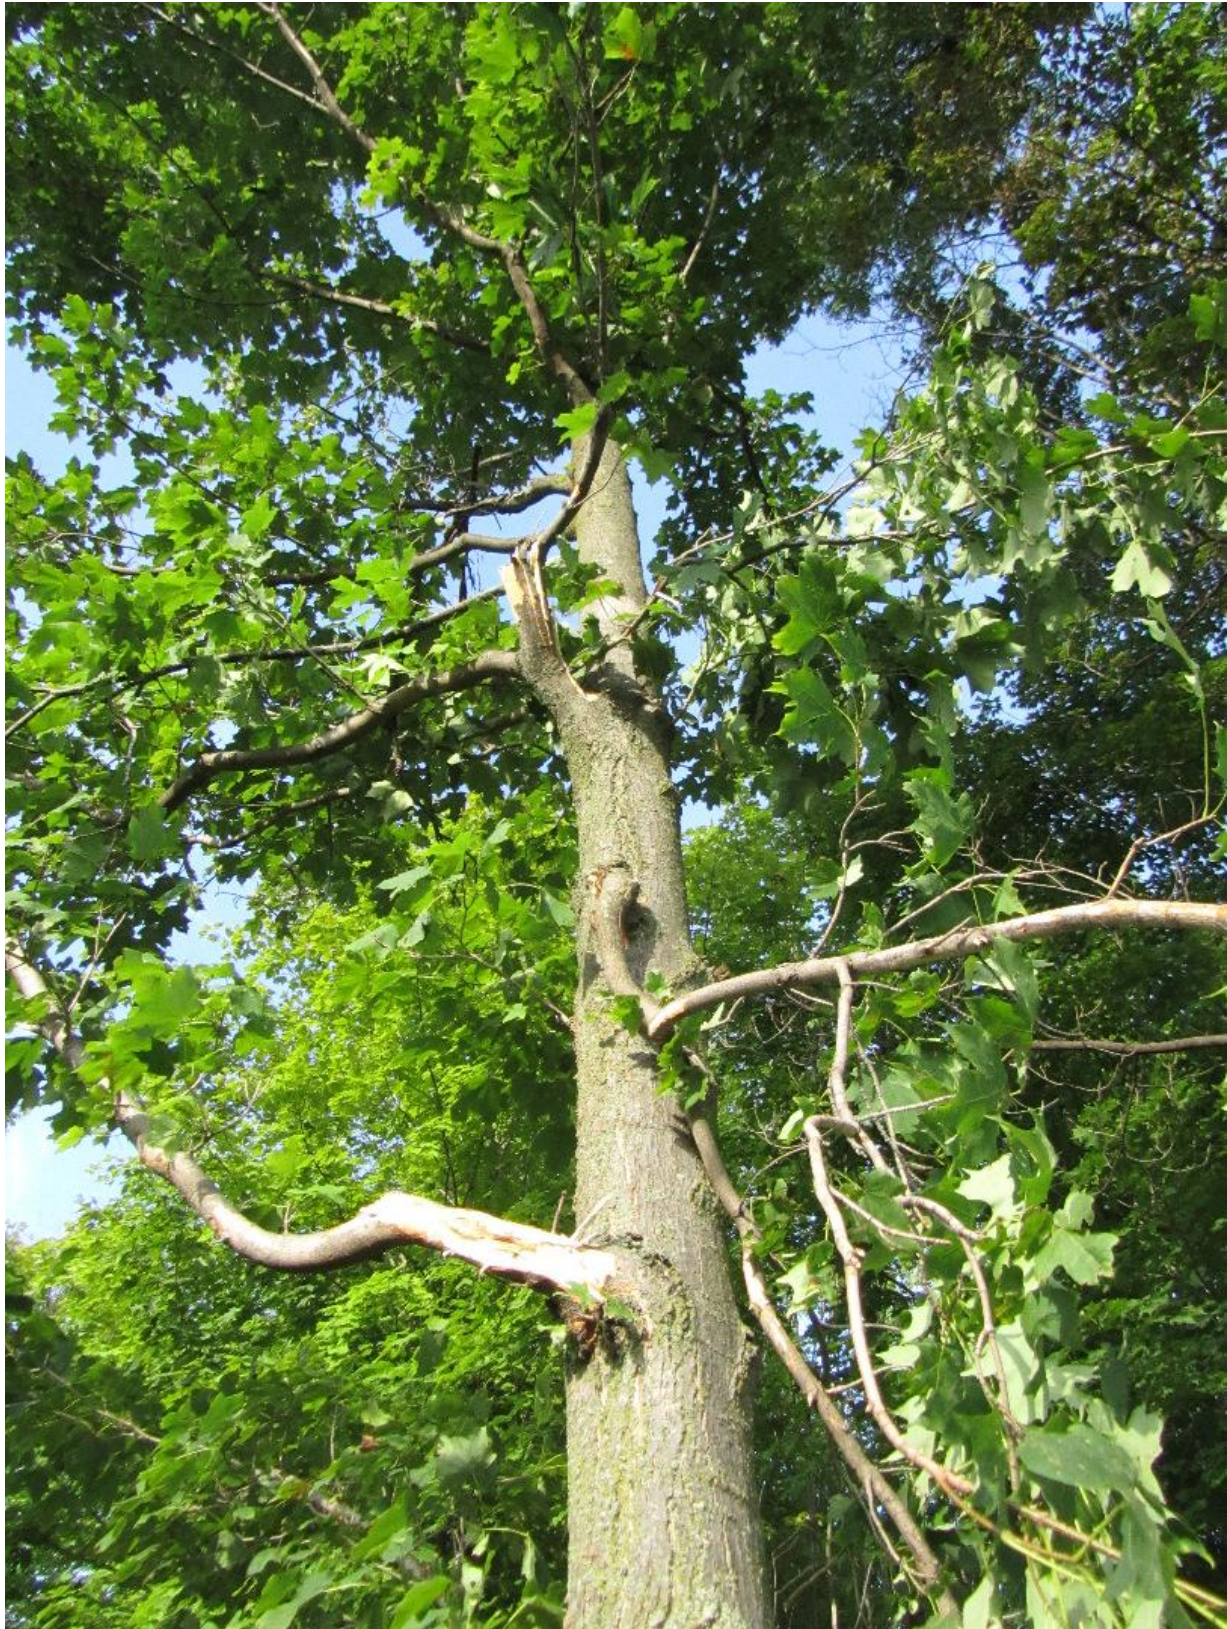
Figure 23: View showing evidence of fresh damage to the tree branches of the first tree along the vehicle's path.

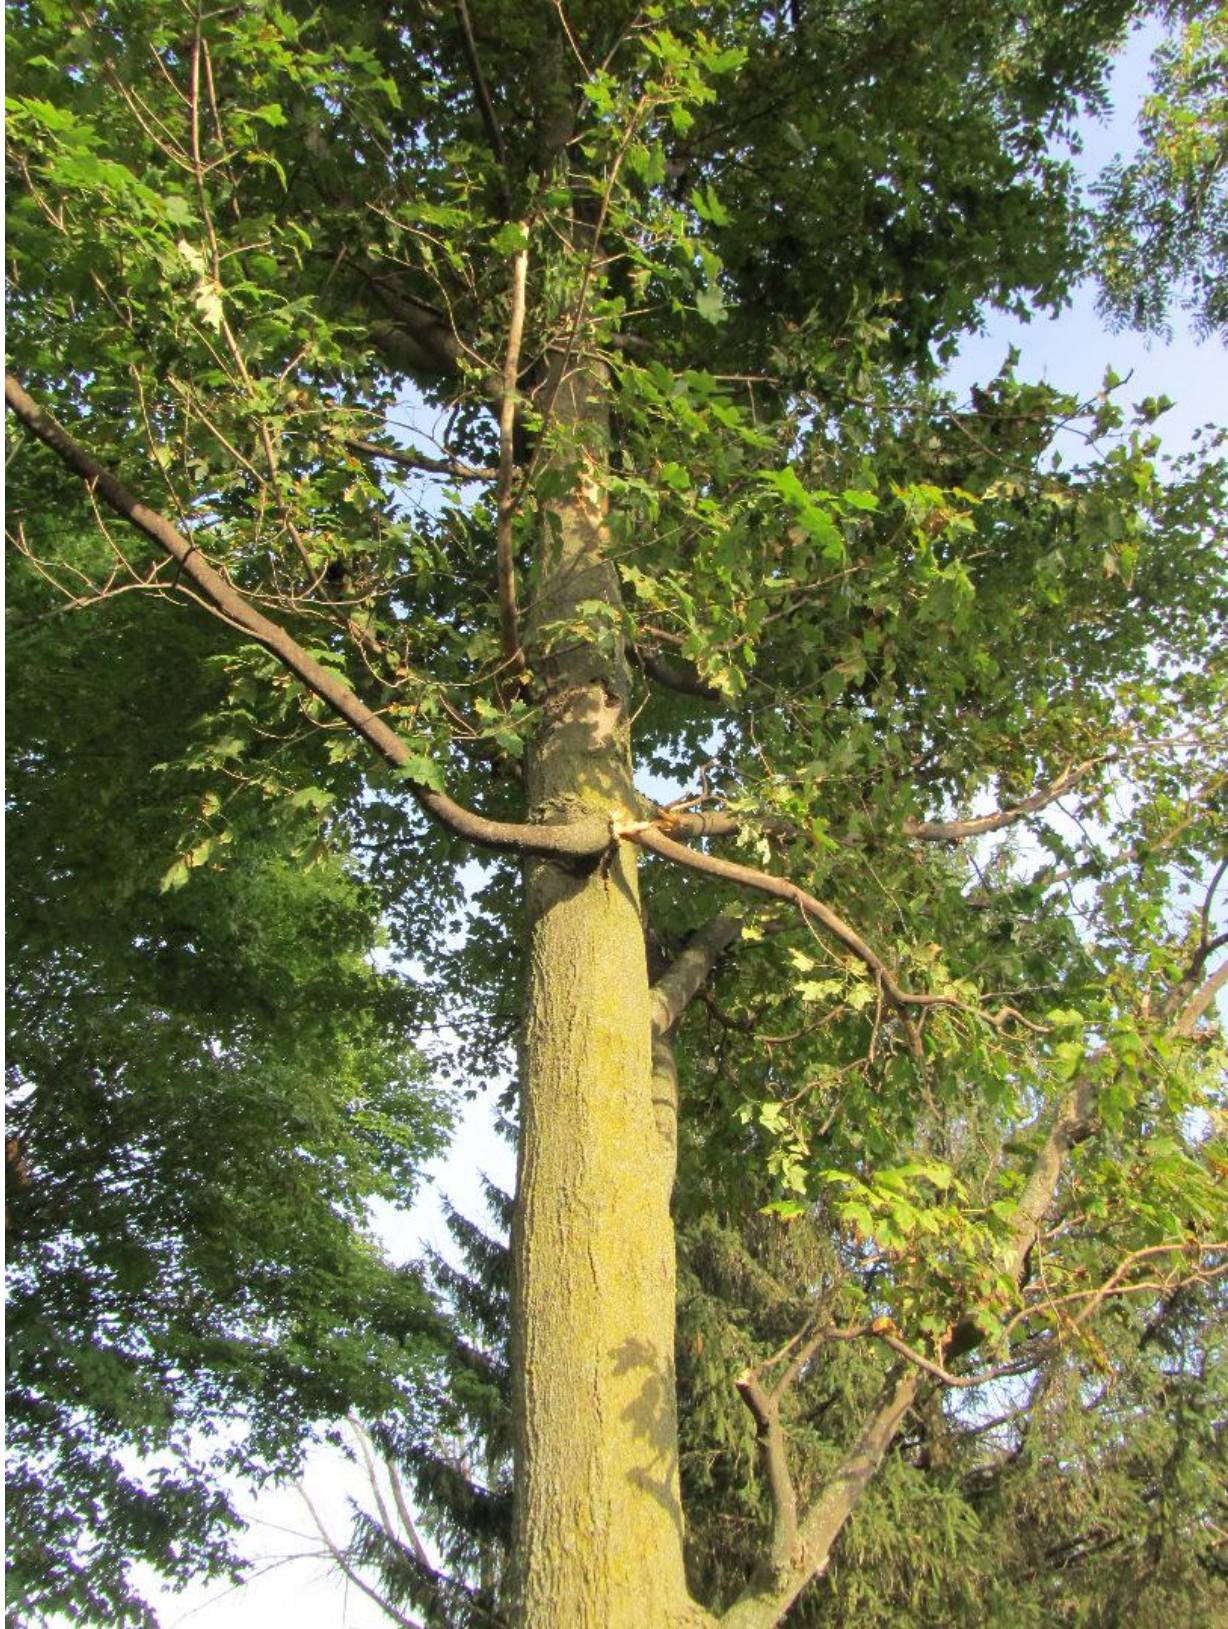
Figure 24: View of second tree along the vehicle's path and the indications of fresh damage to its branches.
