# Escaping Police Also Results in Miraculous Escape From Death

*Posting Date: 27-Aug 2014*

Gorski Consulting  
London, Ontario, Canada

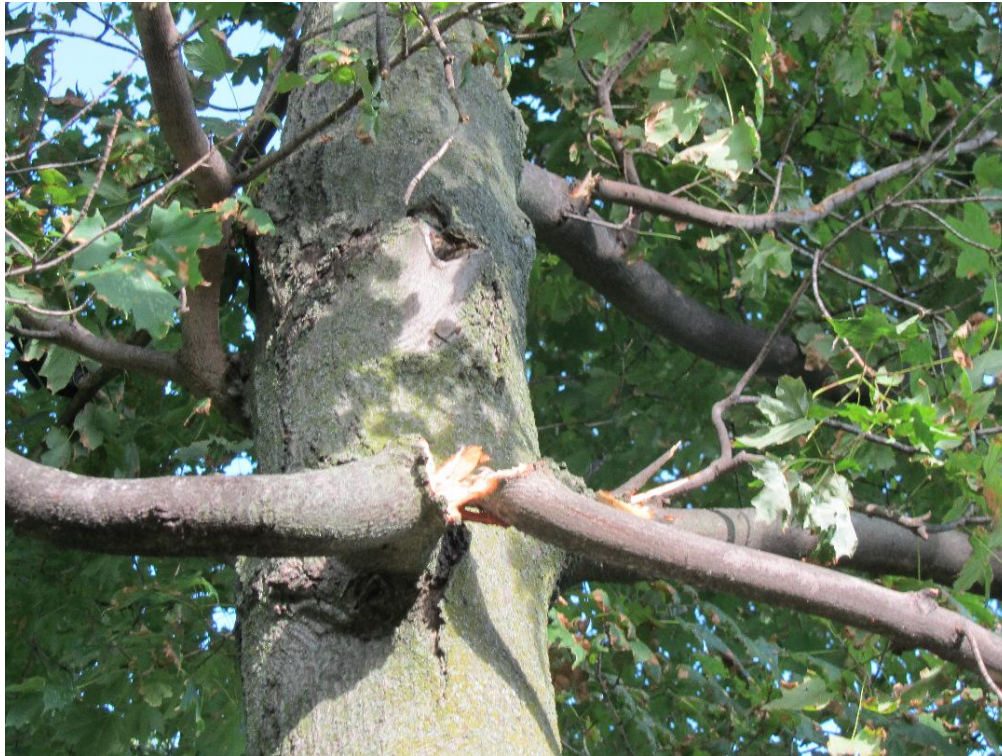
After a short while we confirmed that there were car parts still strewn throughout the area and we eventually began to examine other parts of the trees. At this point the vehicle's actions became apparent as we looked into the branches of the trees, as shown in Figures 22 through 25. The vehicle had vaulted so high after its impact with the culvert that it rose into the branches of these trees and broke them.

Figure 25: Close-up view of fresh damage to the branches of the second tree along the vehicle's path.

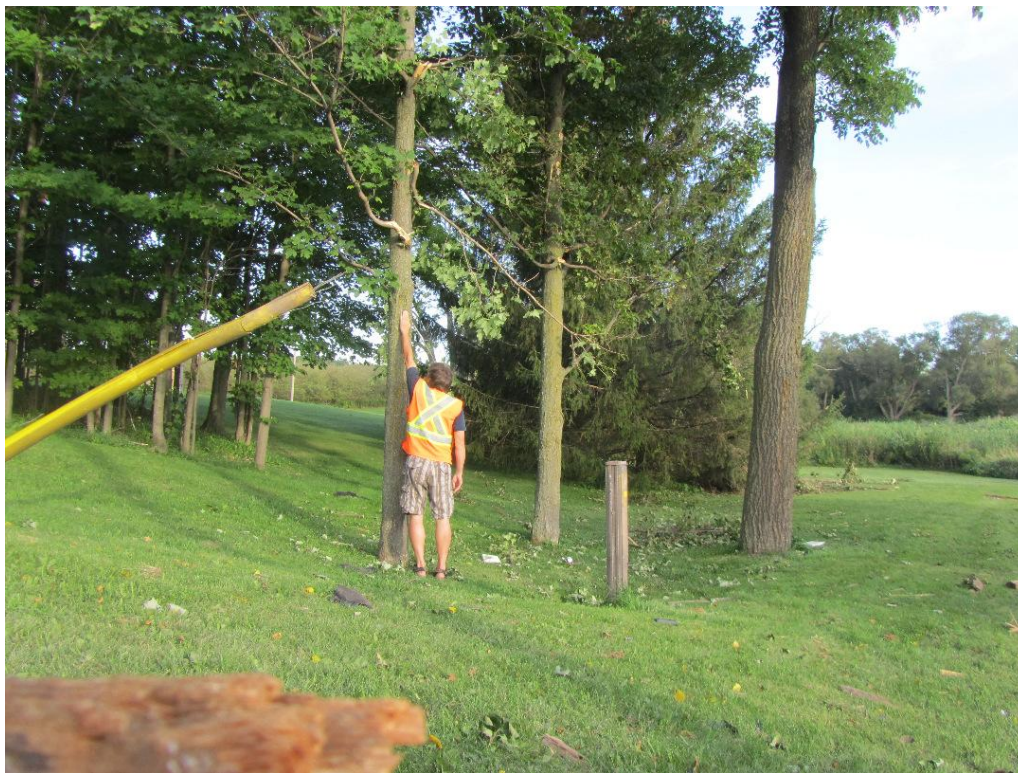
To gain an appreciation of the height of this tree damage, we stood next to the first tree with our arm raised, as shown in Figure 26. The tips of our fingers were at a height of about 7 feet 8 inches (about 2.34 meters). The damaged branches are much higher.

Figure 26: View of investigator standing next to the first tree with his arm raised to indicate the height of the tree damage.

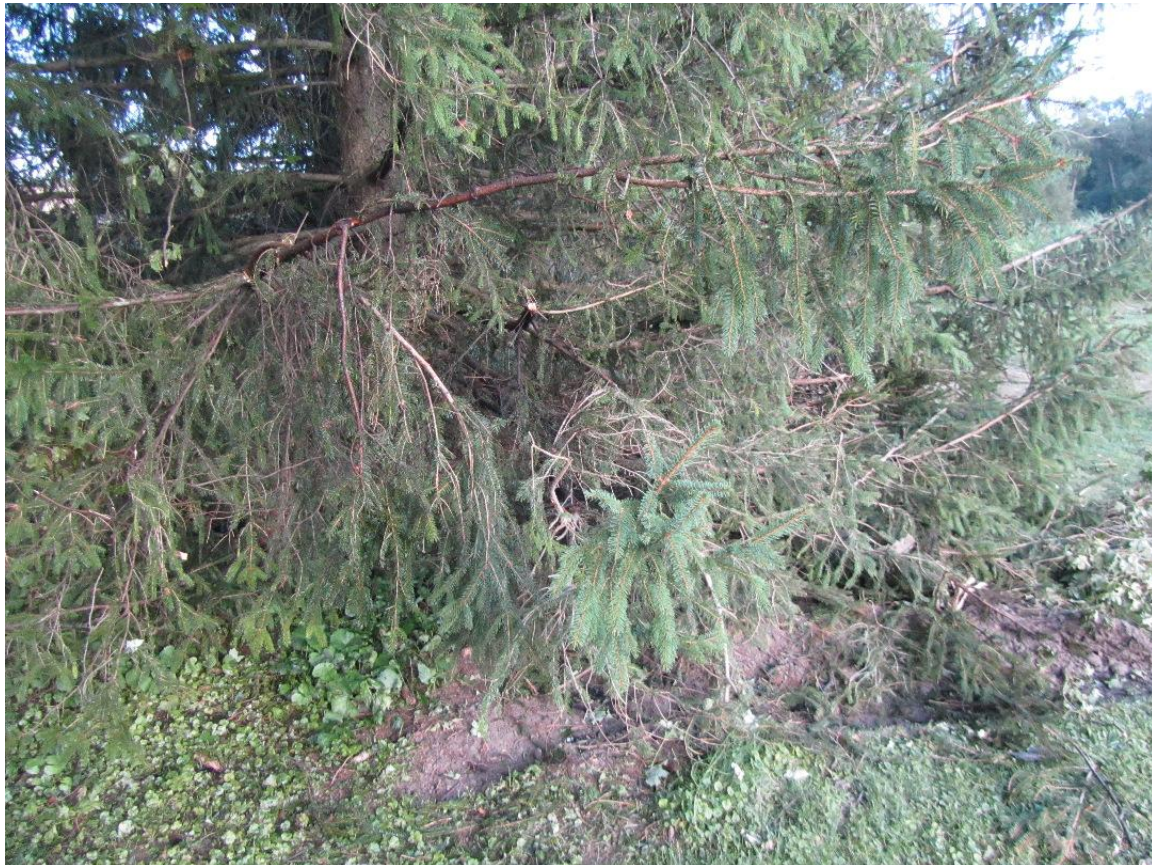
However, as the saying goes, what goes up must come down, and so the next exercise was to locate the touchdown of this airborne jet. The point of touchdown was near the base of a large evergreen as shown in Figure 27. There was a long and narrow gouge in the earth at this location.

Figure 27: View of point of landing of the vehicle near the base of a large evergreen tree.

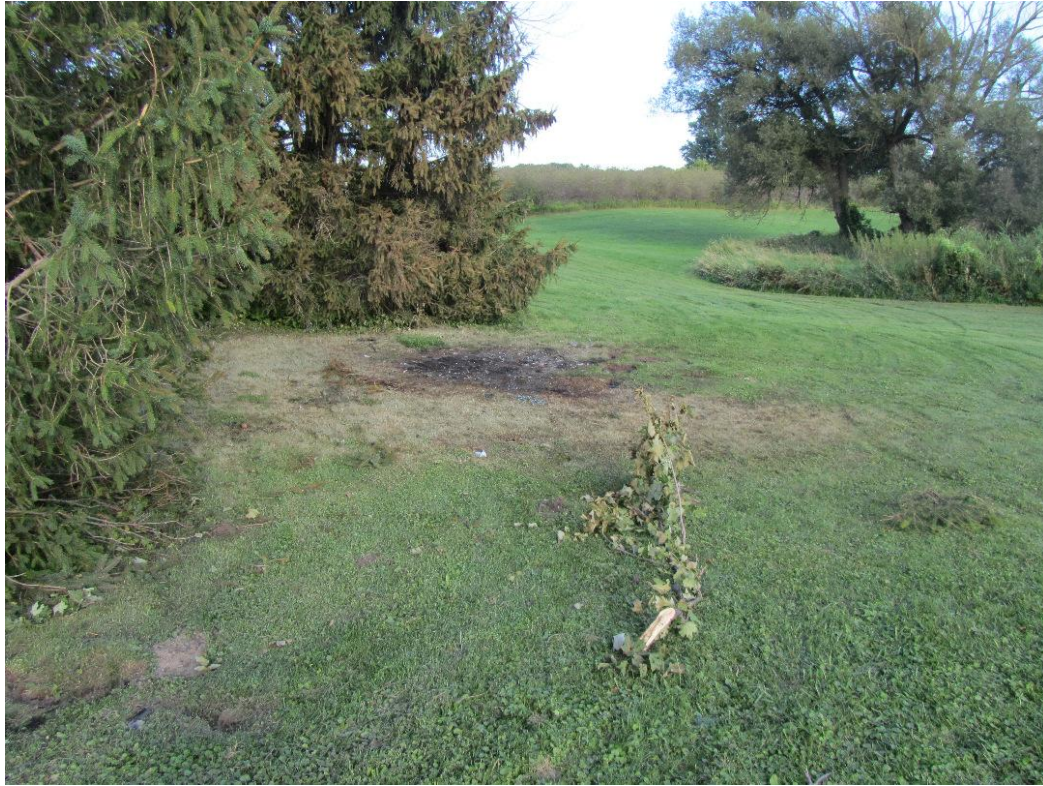
The vehicle then broke through the branches of the evergreen and came out the other side, as shown in Figures 28 and 29, where it came to rest and caught fire. Even with the occurrence of the fire the driver must have been able to escape the vehicle as he was reported to sustain "non-life-threatening injuries".

Figure 28: View of burned out grass at the final rest position of the vehicle.

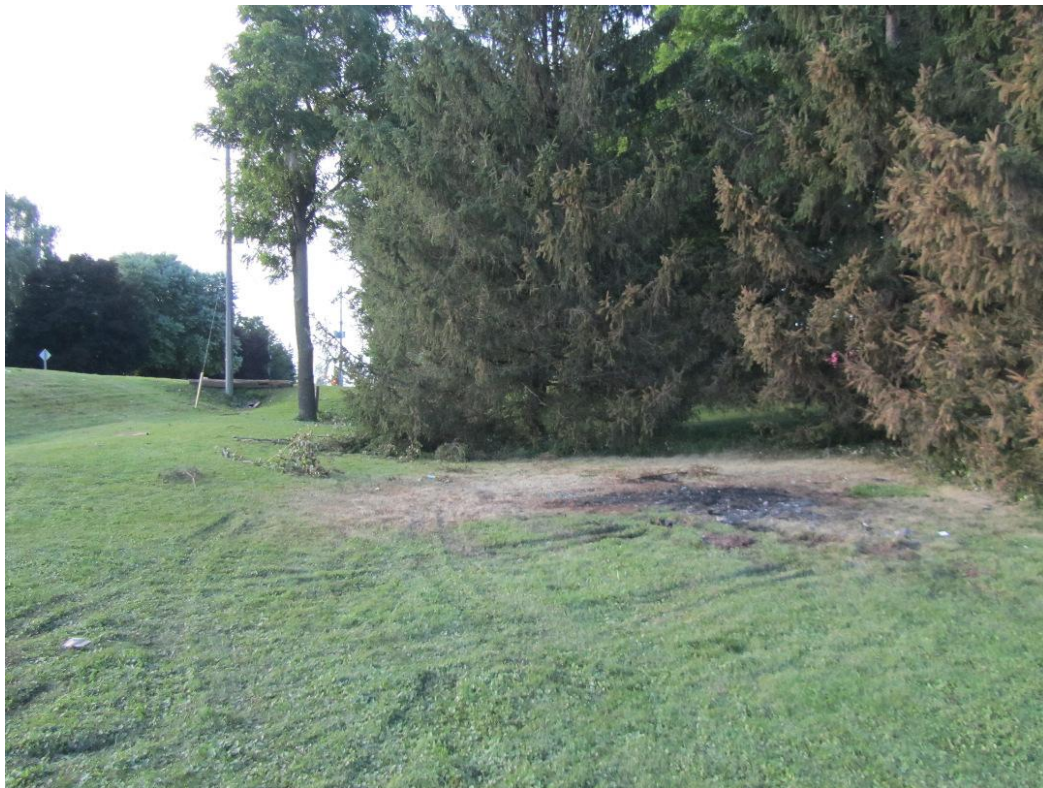
Figure 29: View looking back northward showing the vehicle rest position and the roadway along the left side of the photo.

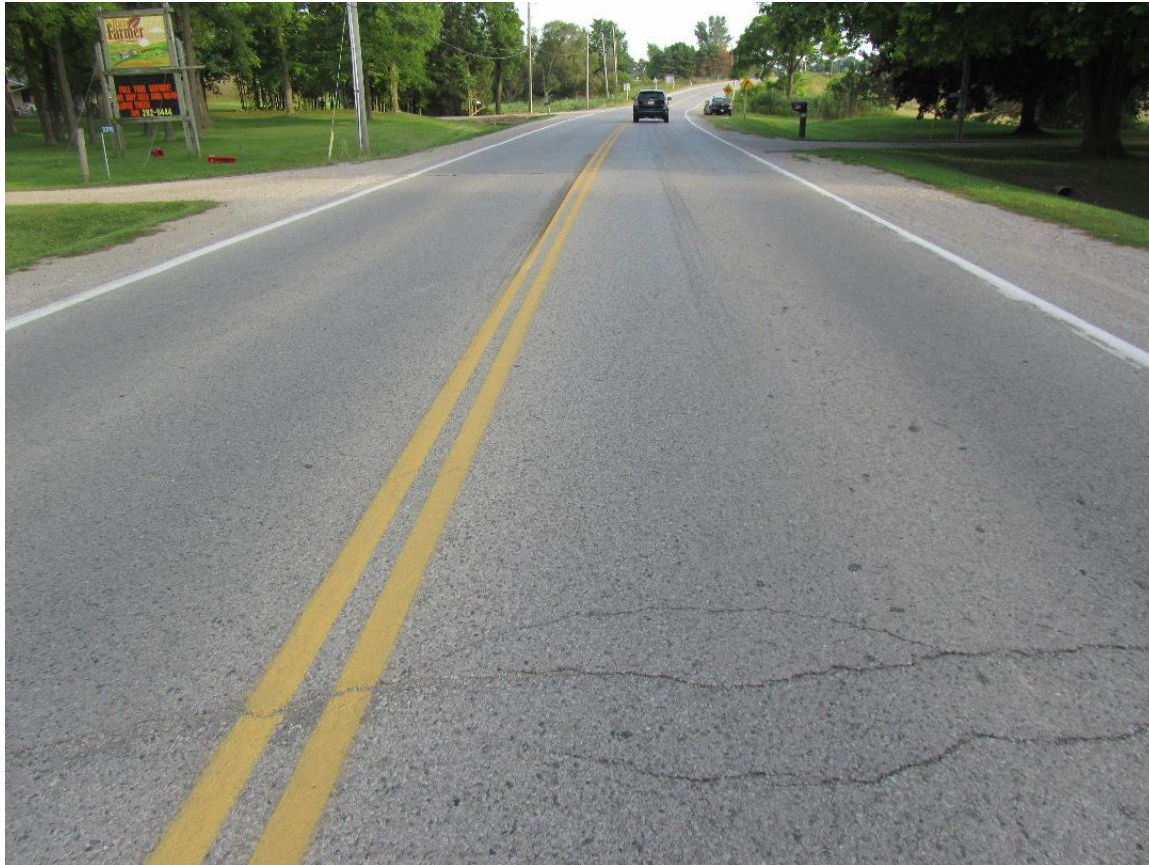
First, a set of skid marks was present in the southbound lane, in the general vicinity of where the vehicle struck the red mail box, as shown in Figure 30.

Figure 30: View of skid marks present in the southbound lane adjacent to the struck, red mail box.

The left side tire mark was across the roadway centre-line. The marks were about 18 metres long and would result in a speed loss in the general range of about 56 to 68 km/h. One would want to know who produced those marks and why.

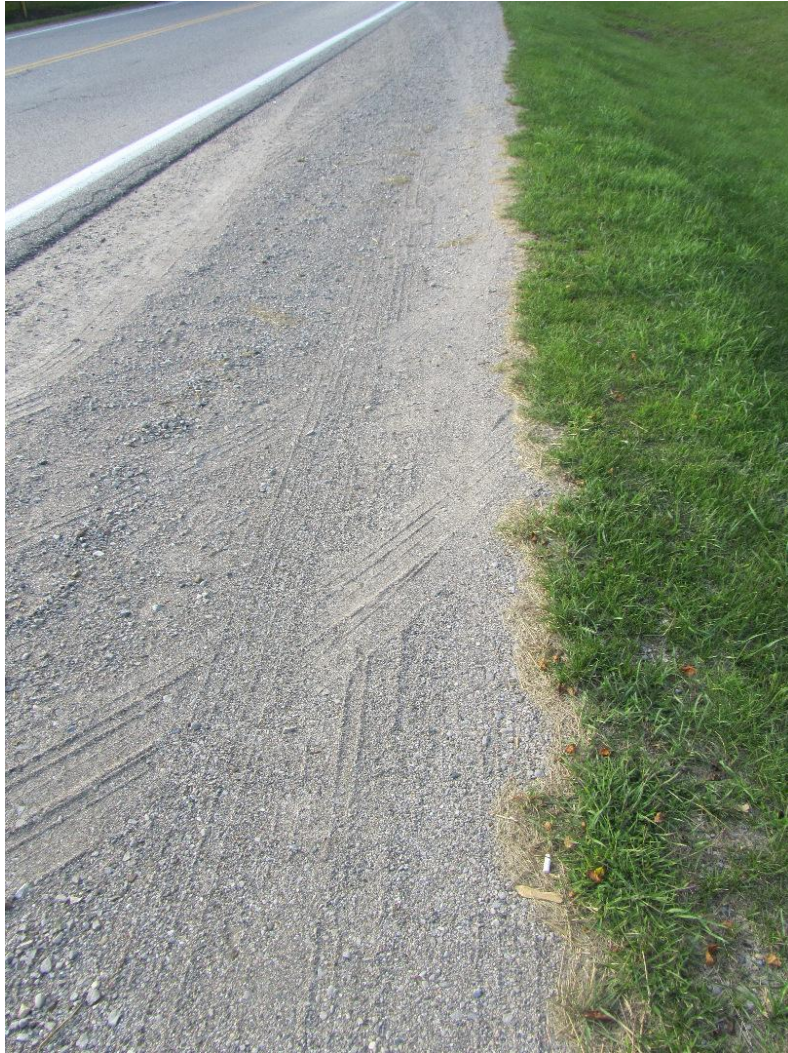
As an example, Figure 31 shows some tire marks on the east shoulder near the vicinity of where the vehicle initially exited the road. These tire marks are from vehicles

tracking through the gravel as opposed to performing emergency actions. If investigators found such evidence it could be interpreted and perhaps additional questions could be answered about the activities of vehicles and drivers, some of which might originate from the time when the vehicle left the road. It is a source of additional evidence with which few investigators have sufficient training and experience.

Figure 31: Example of tire marks on the east shoulder that could be studied.
