Man Sustains Fatal Injuries From Impact of Concrete Bridge Abutment South of Tavistock, Ontario

Posting Date: 16 September 2012

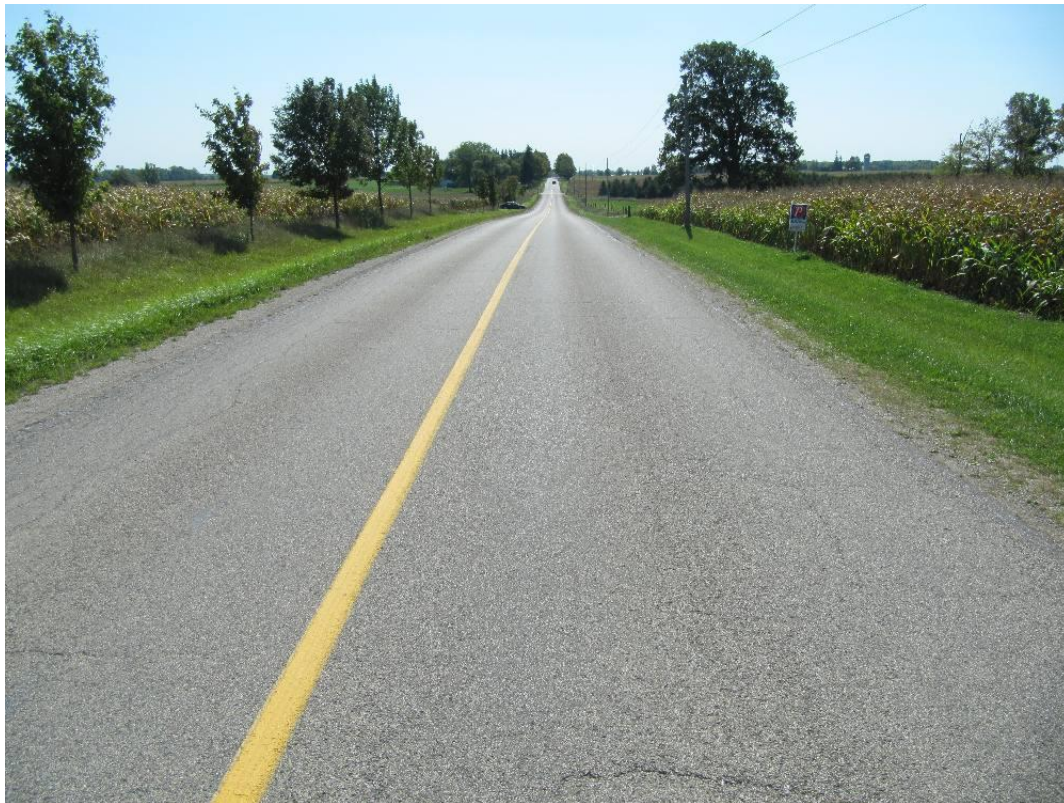
It can be seen that the roadway contains a slight downgrade for the few hundred metres leading up to a small bridge. Generally the road is straight and the surface is in good condition. The weather conditions on the afternoon of September 15th were good.

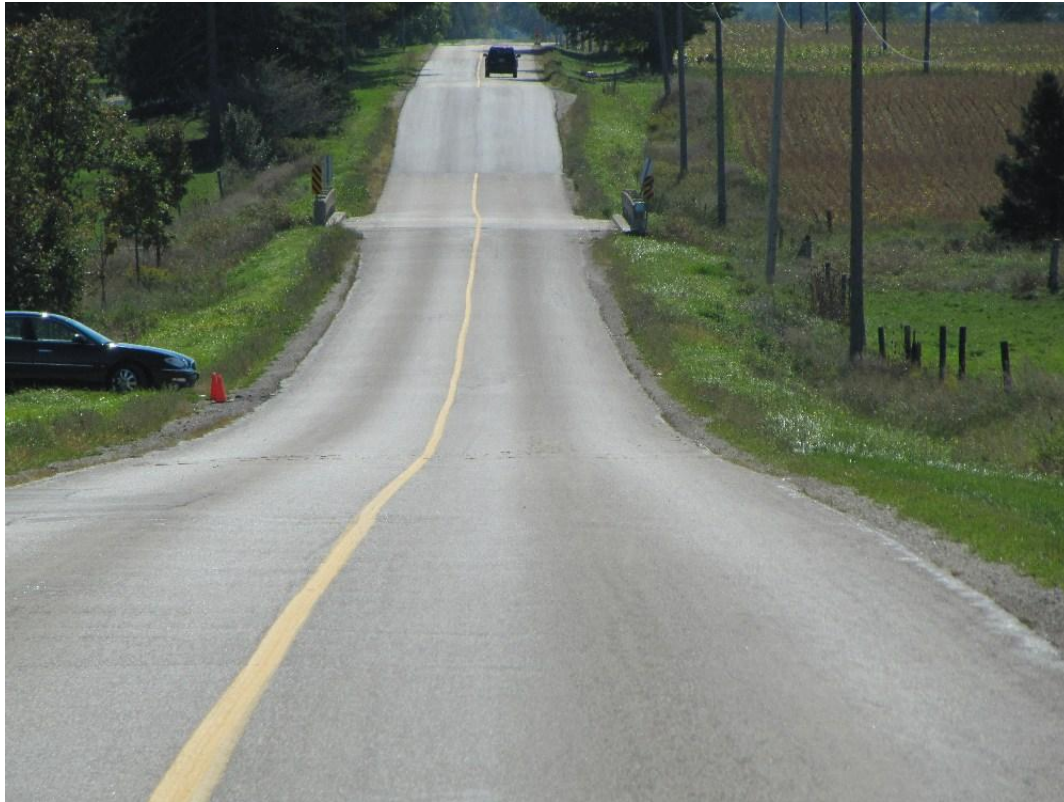
As can be seen in the above photo there does not appear to be anything unusual in the character of the road as one approaches the bridge. Even from this location one can appreciate that the bridge is relatively wide considering that this is a low volume road and a high level of service would not be expected.

One drawback is that the bridge abutments do not contain any guardrails. Such a rail, if it was firmly attached to the concrete abutment, would have provided the deflection of the vehicle and would likely have resulted in relatively minor consequences. However the reality is that many bridges on low volume roads in southern Ontario are unprotected like this.

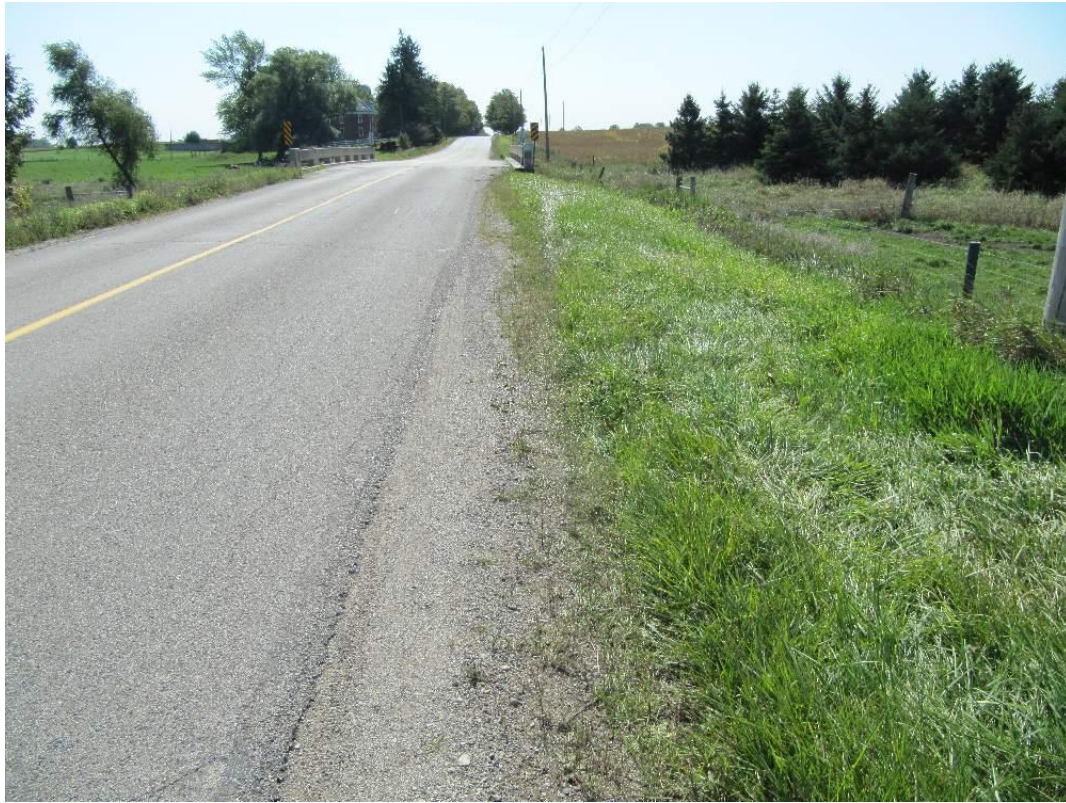
As we get nearer to the bridge we can find how the vehicle travelled off the road surface and onto the grass at a relatively shallow angle, as shown in the southbound view of the photo below. It may not be easy to detect the tire marks on the grass because the vehicle has only pushed the grass down rather than pulling it out or tearing it. Signs of damage such as pulling/tearing is often indicative of a tire that is either being accelerated or braked. So the absence of any obvious evidence of this damage would suggest that the vehicle simply travelled, at highway speed, off the road surface. There could be several reasons why this would occur but drawing a conclusion from only this evidence could lead to an erred interpretation of what actually occurred.

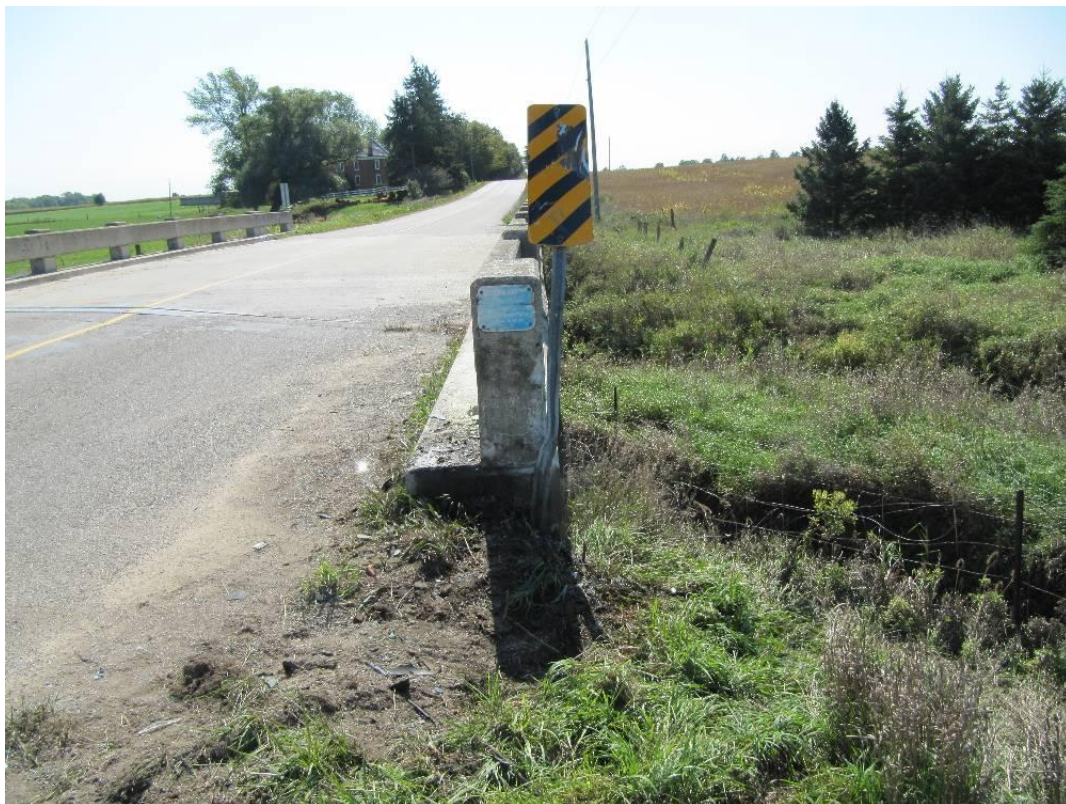
The photo at the bottom of the previous page shows a closer view of the concrete bridge abutment where the impact occurred. It is not unusual to observe very little damage to such an abutment even though a collision might be quite severe. There was a hazard warning sign attached at the abutment and it appeared to be of newer vintage with reasonable reflectivity. The physical evidence indicates that the vehicle struck the abutment fairly centrally with its front end as it did not travel any appreciable distance after impact.

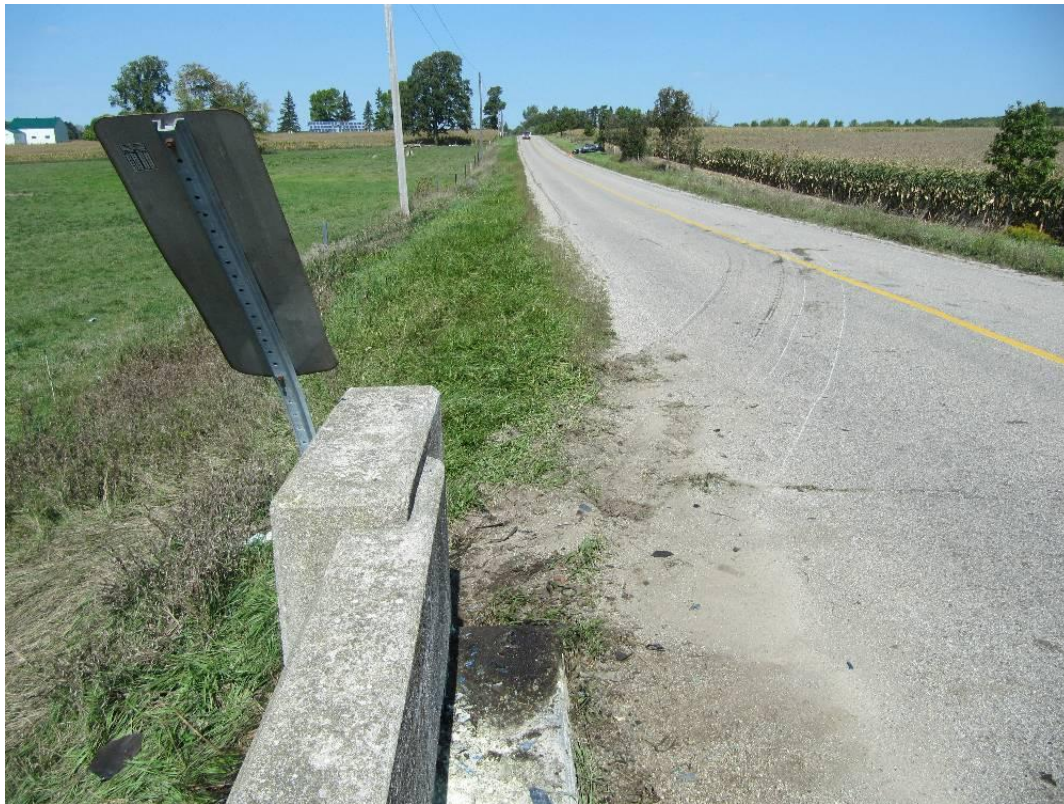
Looking back northward from the location of the abutment, as shown in the photo below, you can see the tire marks in the grass and the conditions of the roadway leading up to the impact.

The evidence of scraping on the roadway was caused after the impact as the vehicle was dragged from its rest position, likely to be transported by a tow truck.

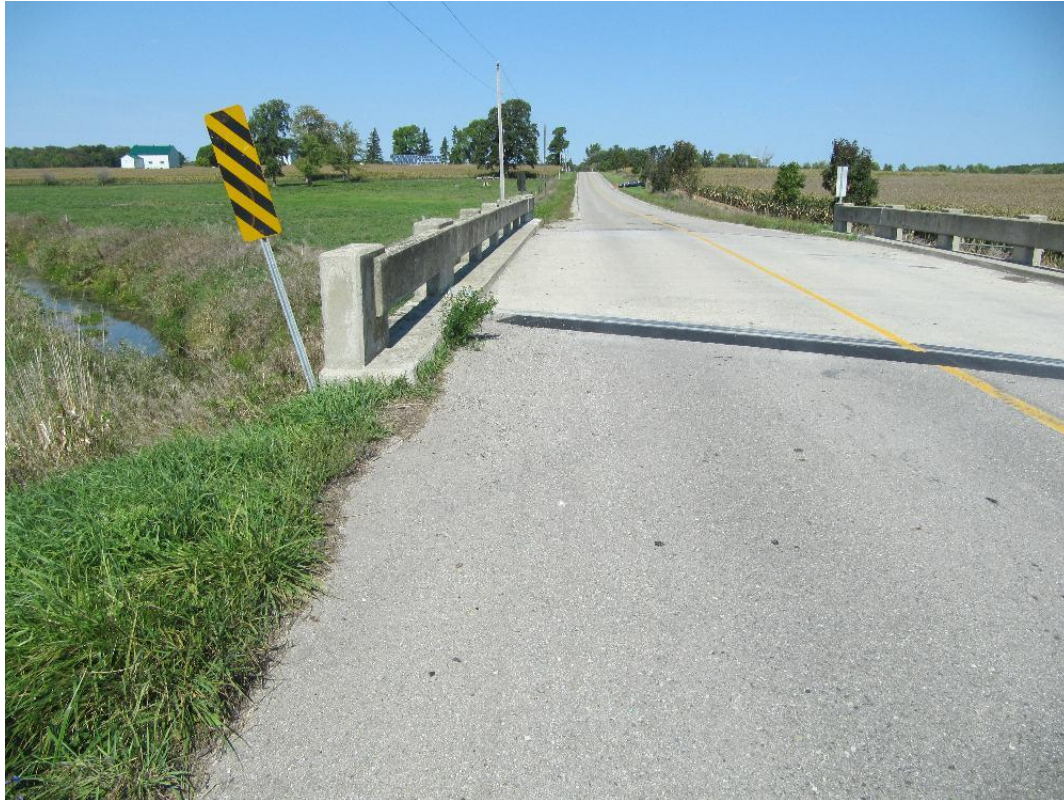
The photo on the following page is taken from south of the bridge, looking northward along its west side. It can be appreciated that the bridge wall indicates that the bridge is substantially wide.

Measurements indicate that the width from this west bridge wall to the roadway centre-line was about 4.3 metres and the overall bridge deck was just over 8.6 metres. The width of the southbound travel lane just north of the bridge was about 3.25 metres. Thus the wall of the bridge was a good metre outside of the edge of the lane. These numbers do not indicate anything unusual or substandard.
