# Publicity Given To Fortunate Result in Rollover But Nothing Said About Freshly Graded Soft Shoulder That Might Have Caused Crash

*Posting Date: 18-July 2013*

On the afternoon of July 17, 2013, a 2005 Kia SUV was northbound on Perth Road 23 just south of Mitchell, Ontario when the vehicle reportedly "...flipped end over end and landed in a wheat field" (Stratford Beacon Herald newspaper).

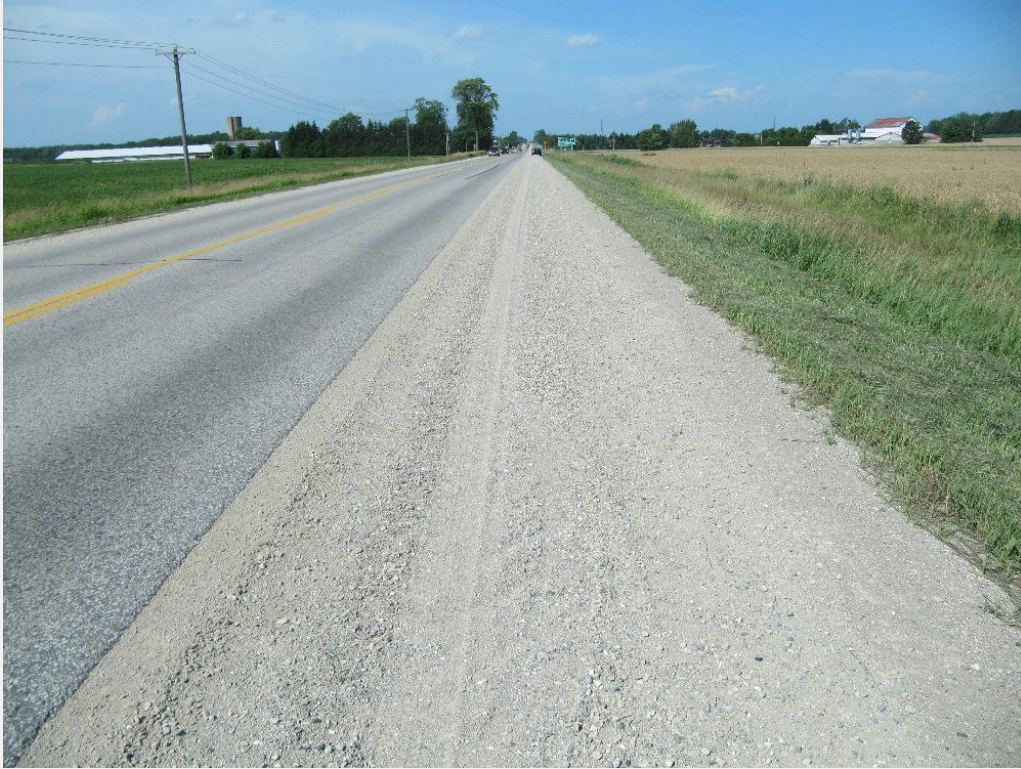
The photo below was taken from several hundred metres south of where the Kia rolled over. This northerly view of the east shoulder shows only one prominent tire mark in the gravel which is from the left side tires of our vehicle as we drove along it searching for the location where the vehicle rolled over.

View, looking north, along the east shoulder of Perth Road 23 (Same travel direction as the Kia) from several hundred metres south of the location where the Kia left the road surface and rolled over.

In fact, you can see our parked vehicle in the background and the point where the Kia exited the pavement is just in front of our parked vehicle. If you had studied any of our discussions about tire marks left on freshly graded gravel shoulders then you would immediately recognize what we recognized based on the visibility of the marks produced by the tires of our vehicle as we rode slowly along this shoulder. But let's look further...

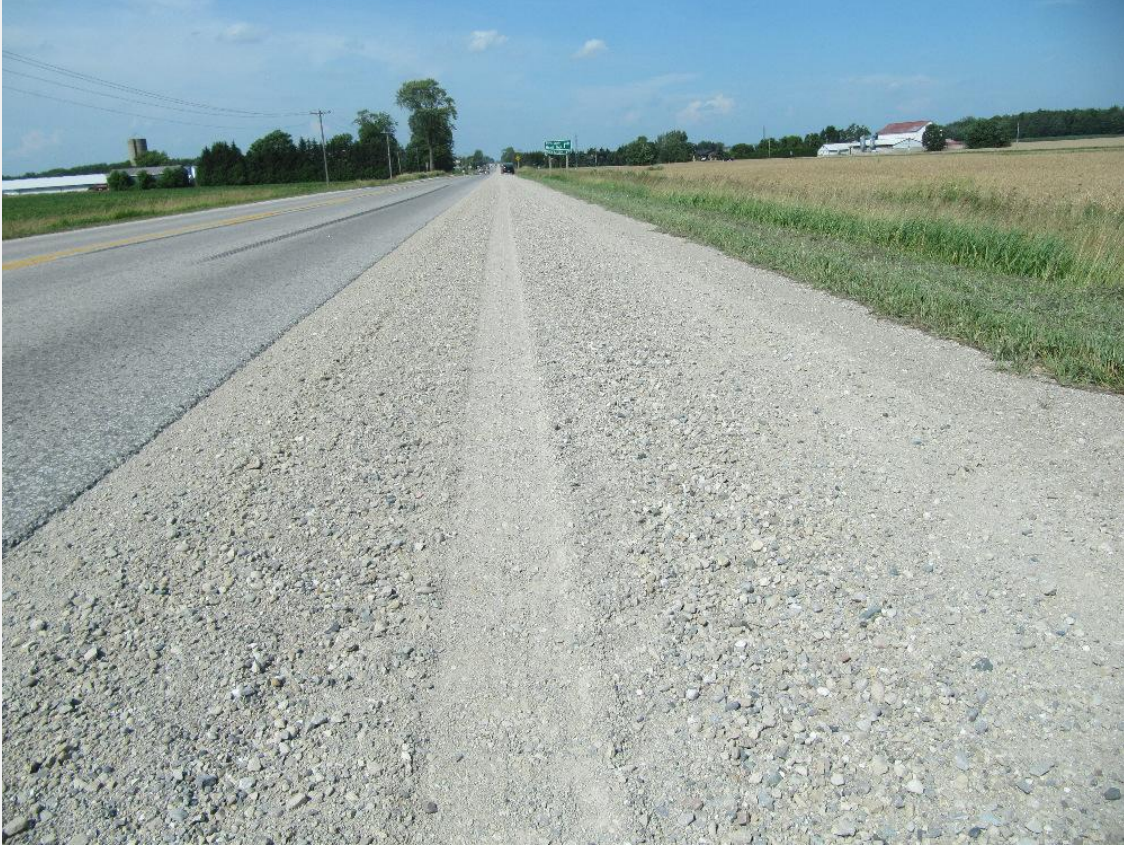
If the previous photo was not obvious enough for you then the following photo should be even more revealing. Look how visible the tire mark is produced by the left side tires of our vehicle as we slowly rode along the shoulder searching for the collision evidence.

View, looking further northward along the east gravel shoulder toward the location where the Kia left the roadway.

Having conducted extensive observations of tire marks on freshly graded shoulders our response is definitive: NO. A typical gravel shoulder that has been undisturbed will be hard-packed over that length of time and tire marks will not be that visible. This gravel shoulder was freshly graded, probably within a day or two of the collision date. But let us move on...

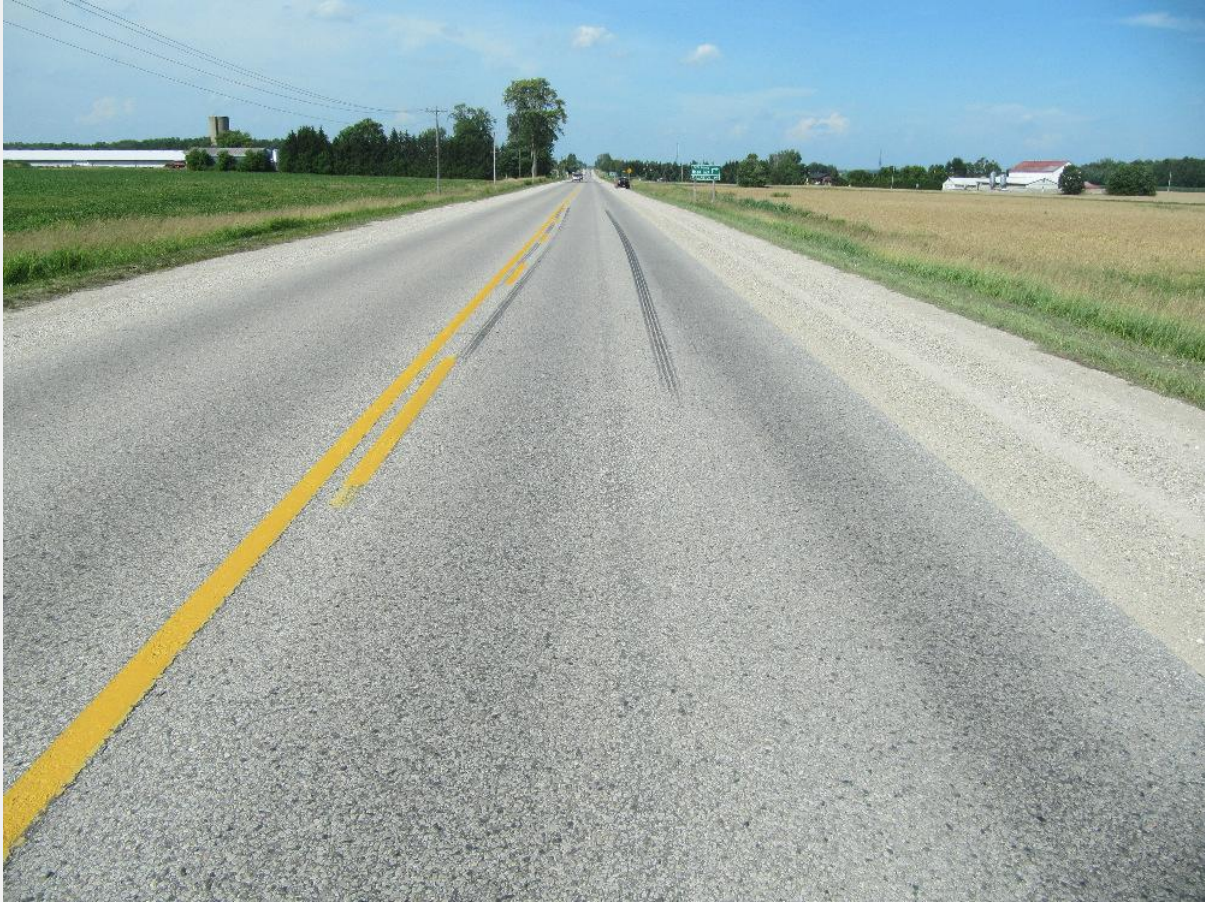
Interestingly, as we approached closer to the area of the Kia's roadway departure there was an obvious braking skid mark from a tandem-axled truck in the northbound lane as shown in the photo below.

View, looking north, showing a set of truck skid marks in the northbound lane of Perth Road 23.

Although we have seen a great deal of physical evidence over the years we are not magicians and there is no way for us to know whether these tire marks have anything to do with the collision events. For example, the Kia could have been passing the TT and it could have lost control during that process causing the truck driver to apply hard braking. There is no way for us to know this without having some kind of knowledge of what drivers and/or witnesses observed at the time of the collision. We can form some opinion however when there is some observable evidence on the collision site but that does not take place until very shortly before the Kia exited the roadway.

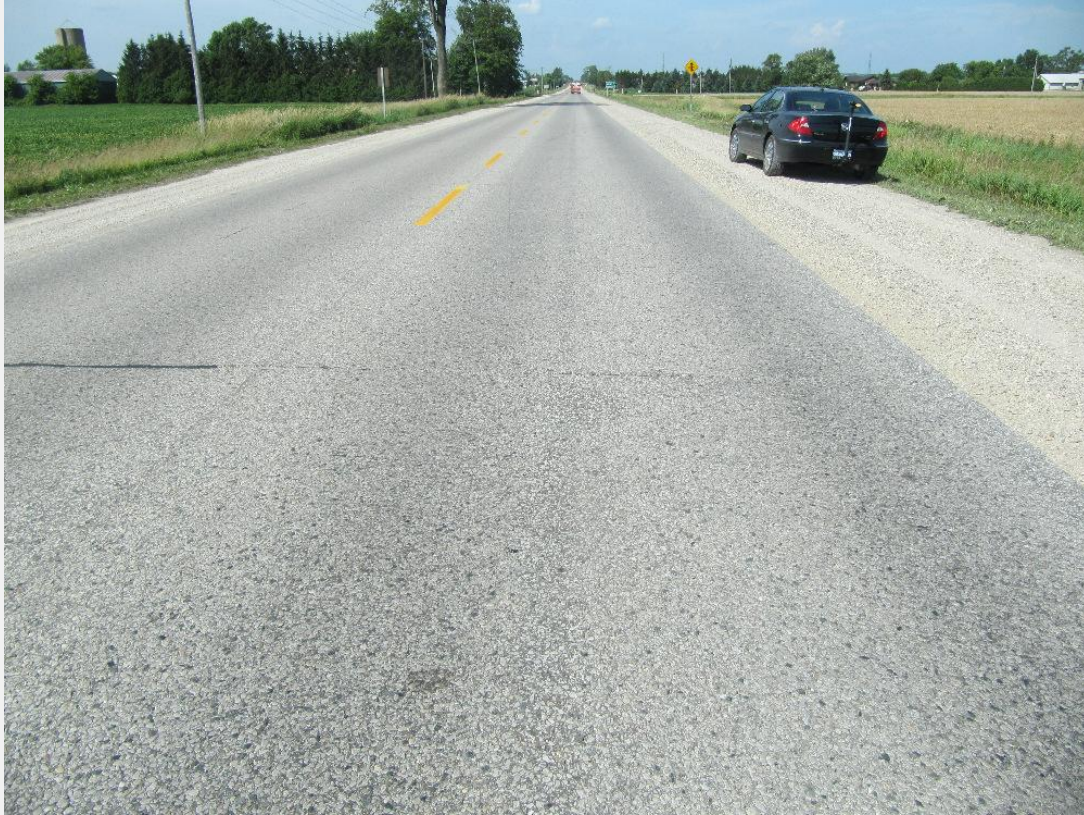
View, looking north along Perth Road 23 at a point just south of the parked position of our vehicle and just south of the yaw marks produced by the Kia as it rotated counter-clockwise off the east (right) side of the road.

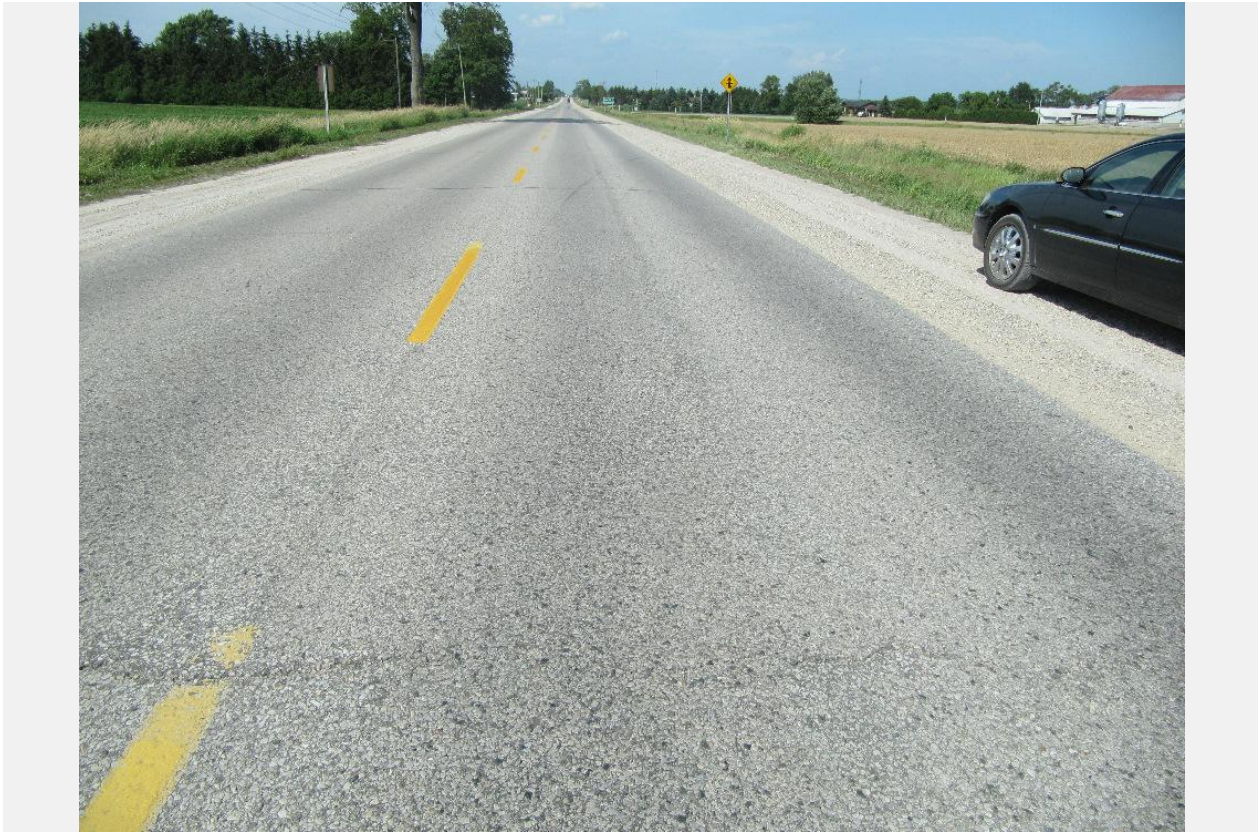
The earliest evidence produced by the Kia was in the form of yaw marks which began to be visible just north of the parked position of our parked vehicle, as shown in the above photo. The photo below shows a closer view of the beginning of those yaw marks in the northbound lane.

View, looking north in the northbound lane of Perth Road 23 showing the beginning of the yaw marks caused by the Kia rotated counter-clockwise and into the east (right) roadside.

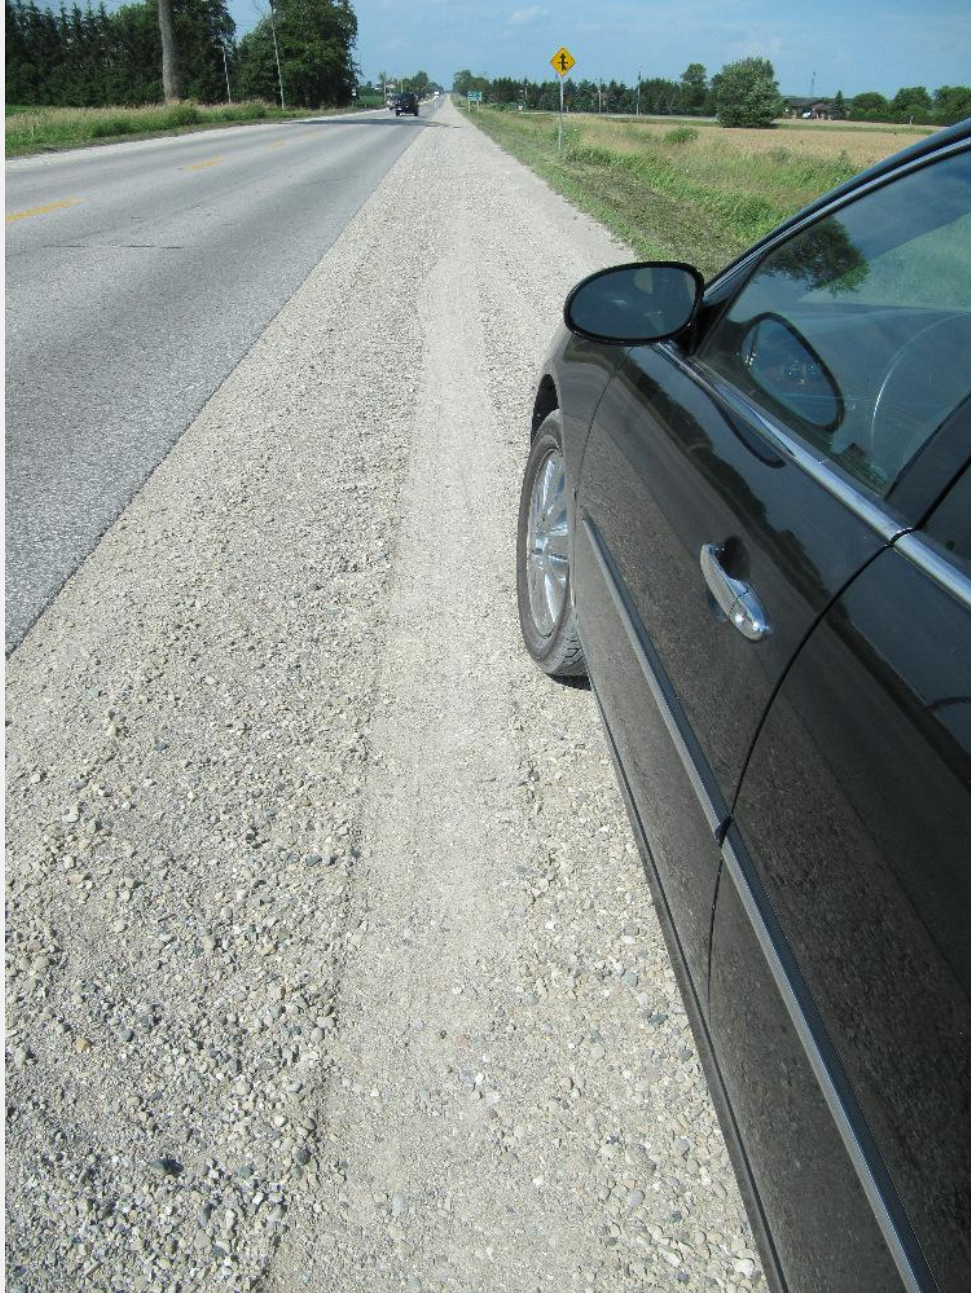
In the photo below it can be seen how we had been travelling forward along the shoulder and, upon discovering the loss-of-control tire marks of the Kia, we stopped our vehicle, placed it in the reverse gear, and backed-up our vehicle a few metres. Look how clear the tire marks are which show that motion.

View, looking along side of the parked position of our vehicle toward the tire marks produced by that vehicle as it moved forward and then was reversed backward to its parked position.

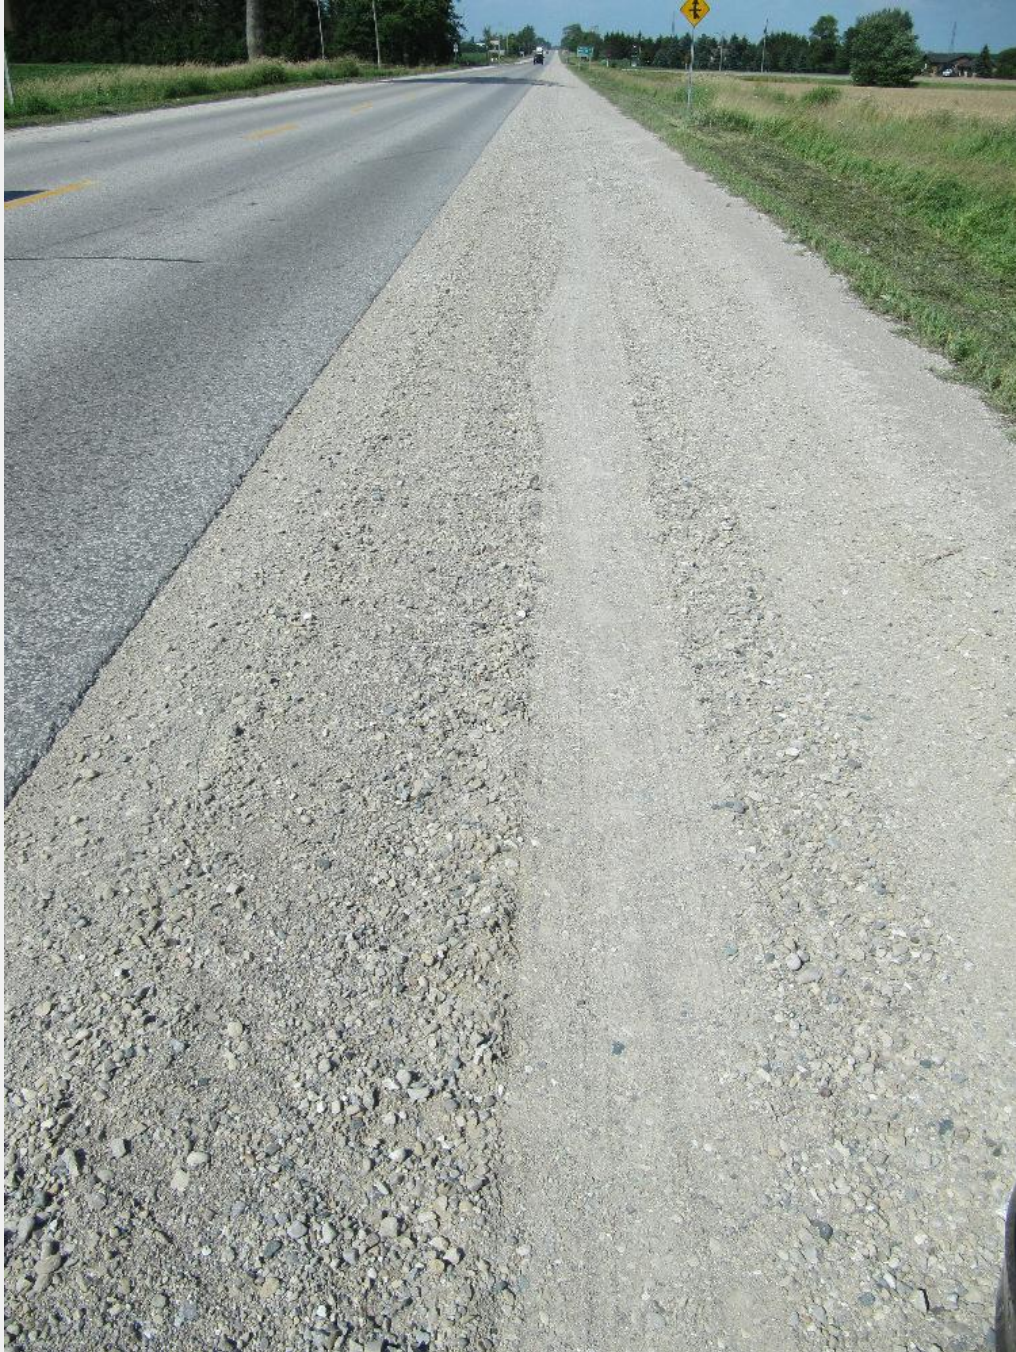
The photo below is another view of the tire mark produced by the left side tires of our vehicle at a location just in front of the final stopped position of our vehicle. Look how clearly the tire mark is visible showing that motion of moving forward, stopping, and then backing up on the gravel.

View of tire mark just in front of our parked vehicle showing how the vehicle had rolled forward to halt and then was reversed on a slightly altered path before coming to a final halt behind the camera.

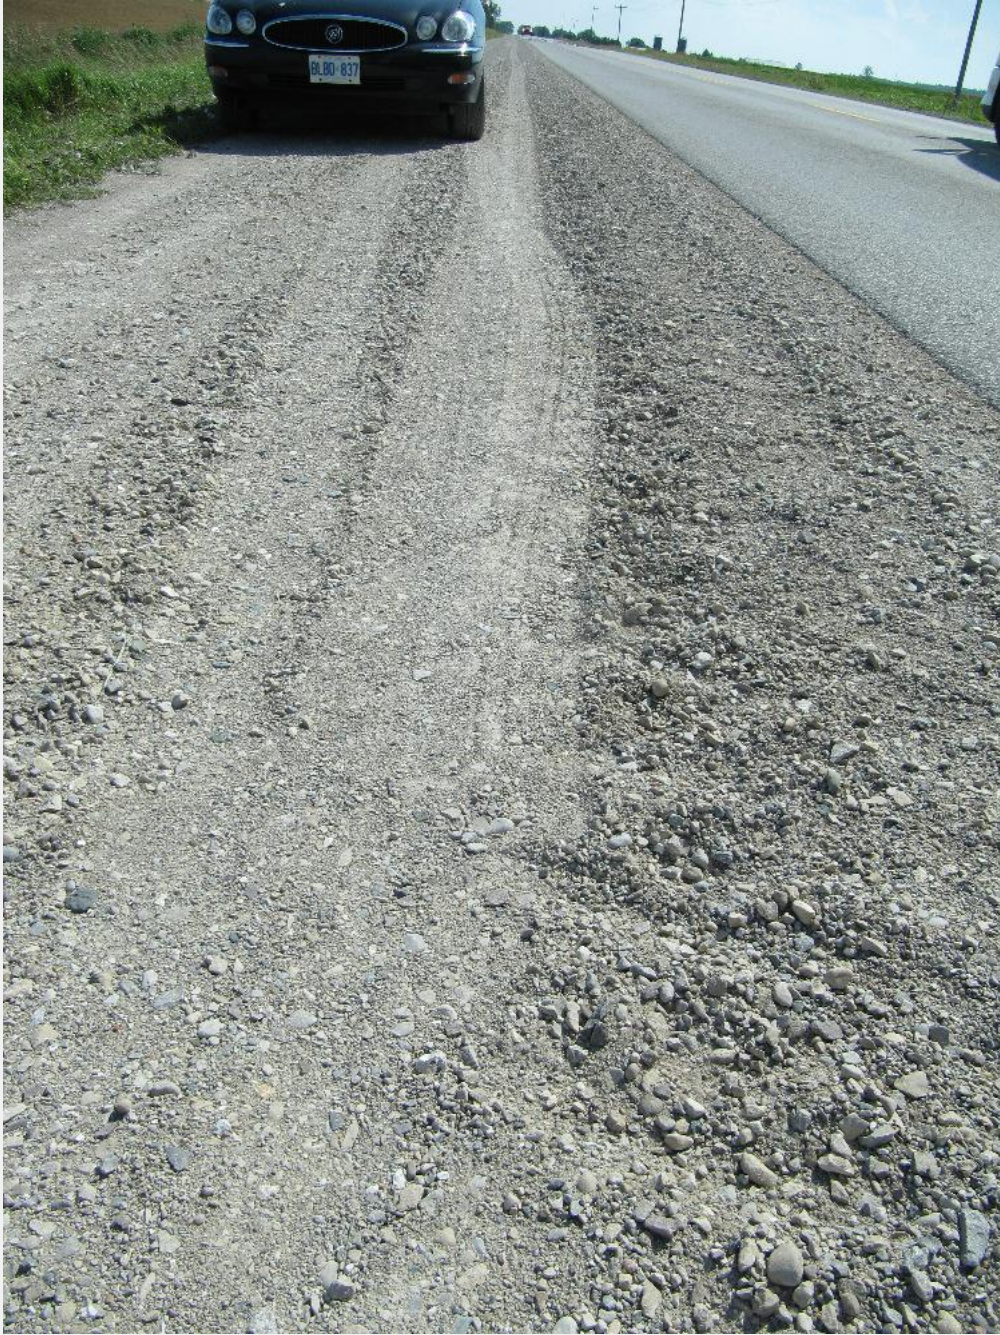
Is this the kind of imprinting you could expect from a gravel shoulder that has been hardened by months of environmental conditions? And look again in the photo below which is looking back at our parked car and our tire mark visible in the foreground.

View, looking southward, showing the tire mark produced by our vehicle as it was backed into its parked position on the east gravel shoulder.

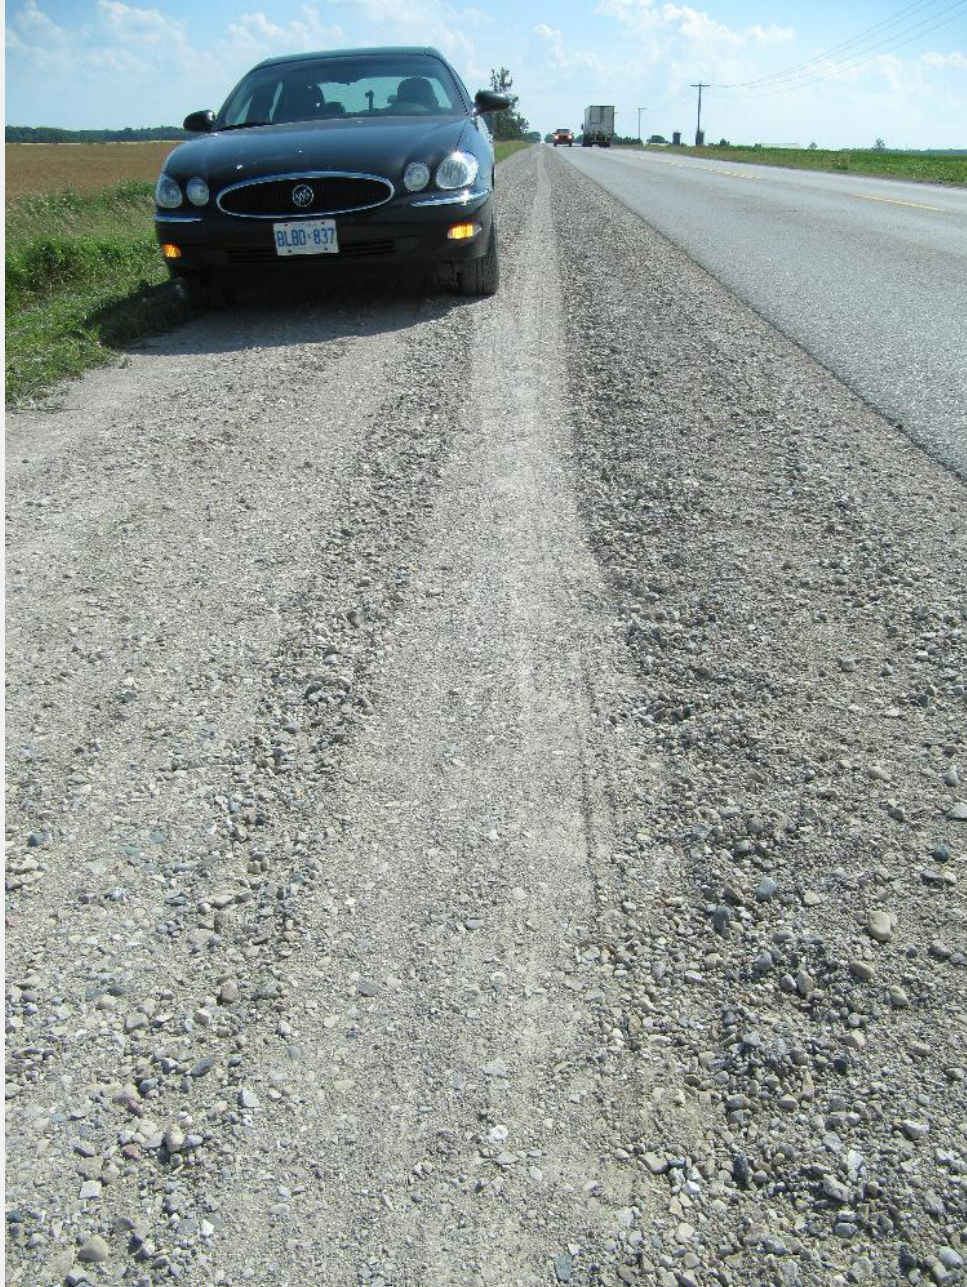
View of details visible in the tire mark of our vehicle's reversing into its parked position. This is a classic indicator that the gravel shoulder was soft and freshly graded.

You can clearly see our tire mark in the distant background behind our vehicle and also the change in direction in the foreground. This evidence is classic of a soft shoulder condition created by fresh grading of the shoulder.

More importantly the police and news media have a responsibility to inform the public of true dangers that exist on the roadway. Absolutely nothing was posted on the roadside informing the driver of this vehicle that the gravel shoulder was freshly graded, soft and dangerous to enter at highway speed. The Manual of Uniform Traffic Control Devices (MUTCD) is the standard followed throughout North America to ensure that all traffic signage is consistent. In that manual it clearly identifies a "Soft Shoulders" sign (Wa-29) which should be erected under the following conditions:

*"The 'Soft Shoulders' sign shall be used where soft shoulders present a hazard to vehicles that may leave the pavement.*

*This sign should be erected at regular intervals (about 300m apart over short stretches and 900m apart on long sections) and beyond major intersections. The sign is intended for temporary application only, and shall only be in place as long as the soft shoulder condition exists. It should be removed after the shoulders have become thoroughly compacted."*
