# Recognition Of Harpooning Danger Is A Very Long And Slow Learning Curve

*Posting Date: 6-Nov-2016*

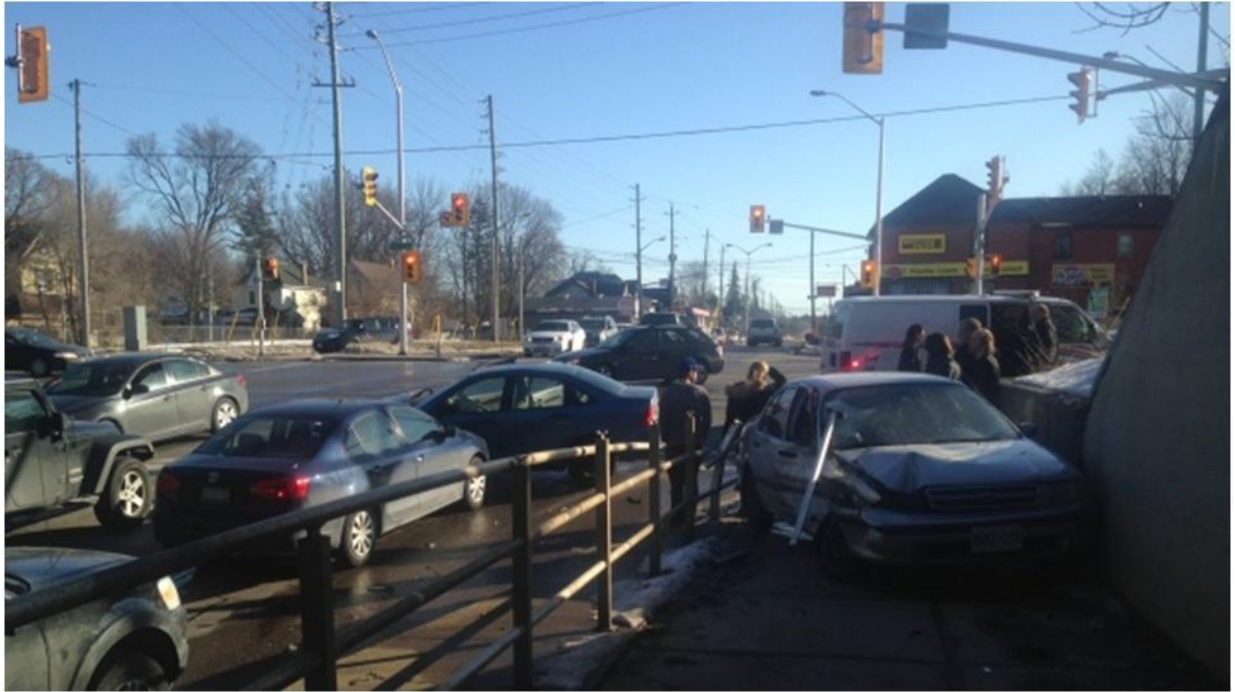
Figure 1: News media photo from February 21, 2016 of a car that was harpooned by a horizontal railing at the intersection of Horton Street and Wharncliffe Road in London, Ontario.

As an example, Figure 1 is a photo taken by a local news agency describing an unimportant collision that resulted in no major injuries. Yet no one focused on the fact that a horizontal pole from a roadside railing had penetrated the right portion of the vehicle's windshield. If there had been a right-front occupant present, and if the circumstances were lined up, the end of the penetrating railing could have struck the

In assessing the safety performance of the railing one needs to consider the severity of the impact and the kinetic energy that was required to be dissipated. While Figure 1 provides a poor view of the extent of damage to the car, it seems to show a relatively minor deformation at the bumper level with a minor vertical crease in the right front hood area which might have been created by contact with one of the vertical anchorage posts of the railing.

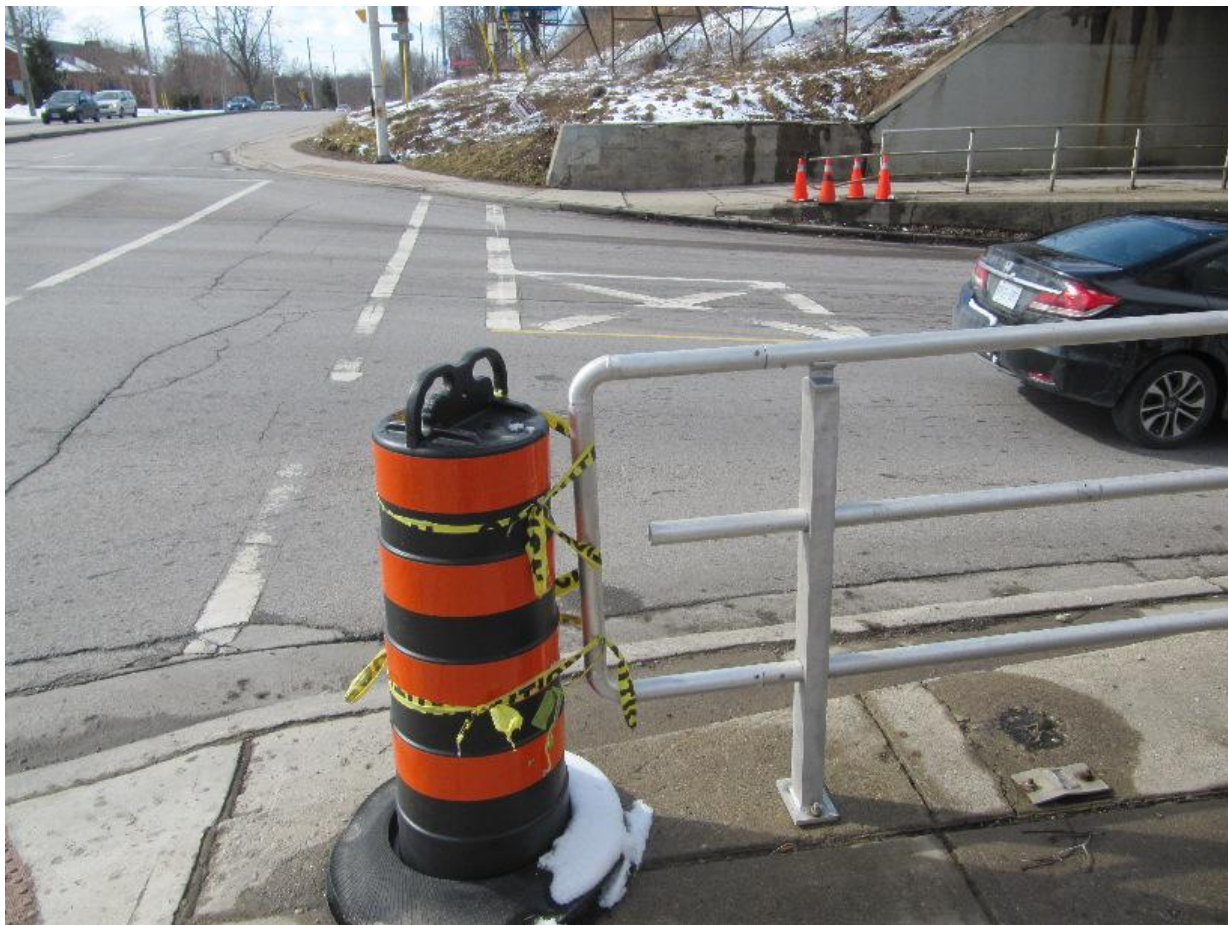
Figure 2 shows a westward view of the north side of the intersection of Wharncliffe Road and Horton Street, taken on February 26, 2016, or just a few days after the collision. In the foreground is a view of a non-struck railing while in the background is the damaged railing that was struck by the above-mentioned car. Looking at the undamaged railing one would conclude that there appears to be sufficient protection from a harpooning incident because there is a curved portion of the rail in front of the horizontal railing ends. But what is the actual situation and how did this railing perform in the actual collision? Let's take a look on the other side of the road at the damaged railing...

Figure 2: Photo taken on February 26, 2016 of non-struck railing in the foreground and the struck railing in the background.

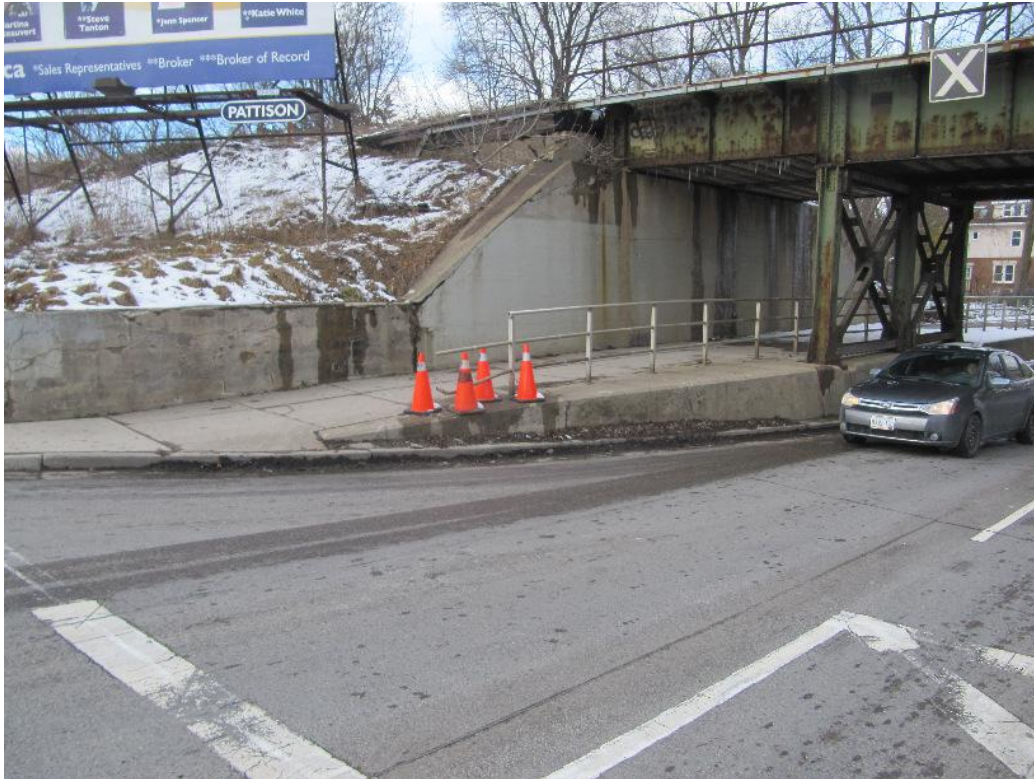
Figure 3: Overall view of the north-west corner of the intersection looking at the damaged railing.

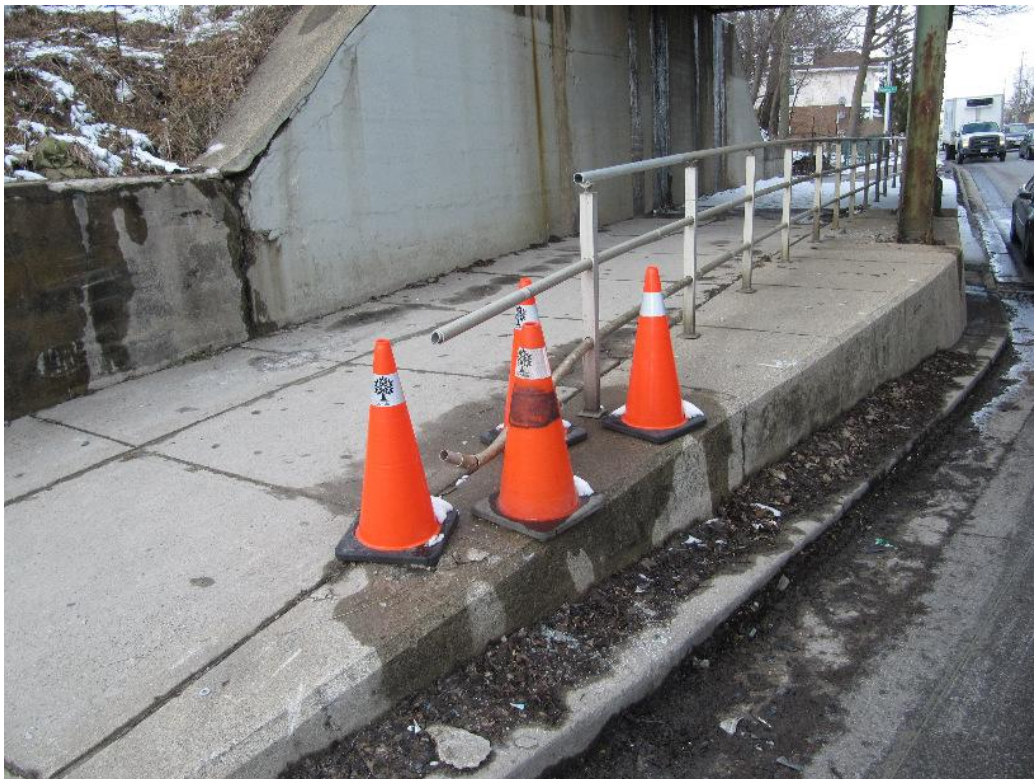
Figure 4: A closer view of the damaged end of the railing.

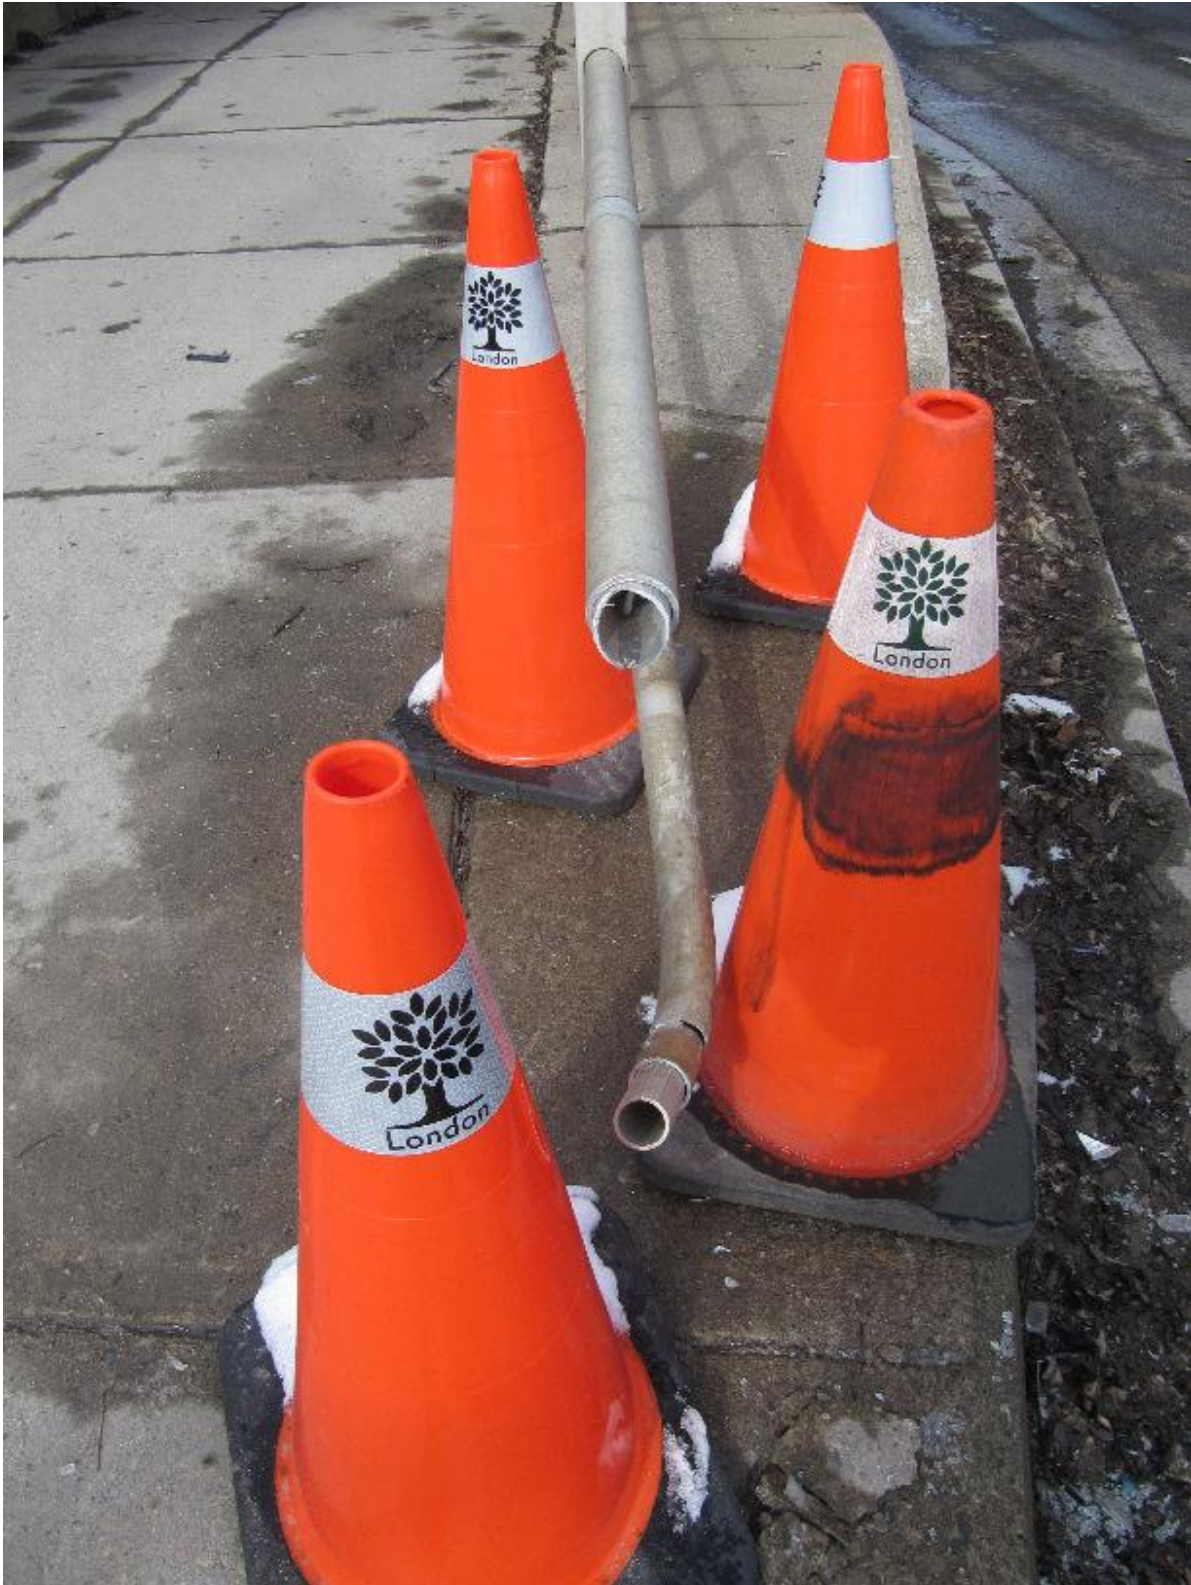
Figure 5: View of the deformed ends of the damaged railing.

The extent of energy dissipation in the railing also appears to be relatively minor. Energy would be dissipated by the bending of the various posts/poles of the system. Although there is some evidence of this at the junctions of the posts/poles, there is no evidence of bending/buckling in the lengths of the posts/poles. What is needed is a unified and controlled bending and buckling throughout the system that involves components further away from where the original force was applied. Instead what is observed is a disintegration of the system by way of fractures and separations in the immediate vicinity of where the contact was made. This disintegration is uncontrolled, leaving the very obvious ends of the poles protruding horizontally toward the windshield and other parts the vehicles where penetration into the interior could occur. Overall this

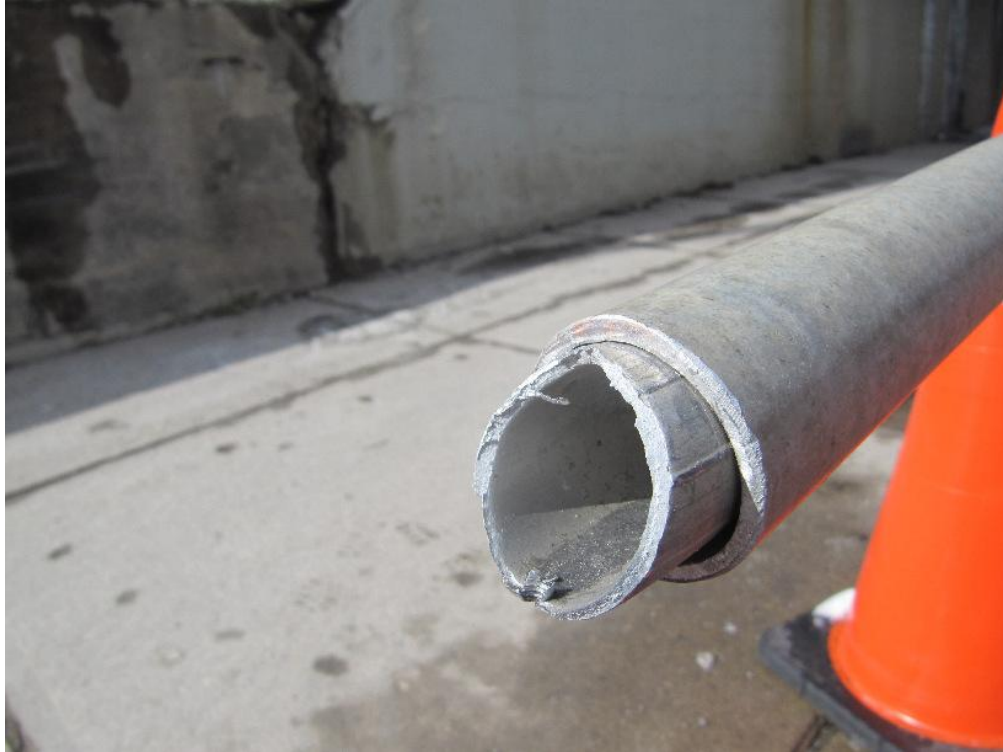
Figure 6: View of the damaged end of one of the horizontal poles of the damaged railing.

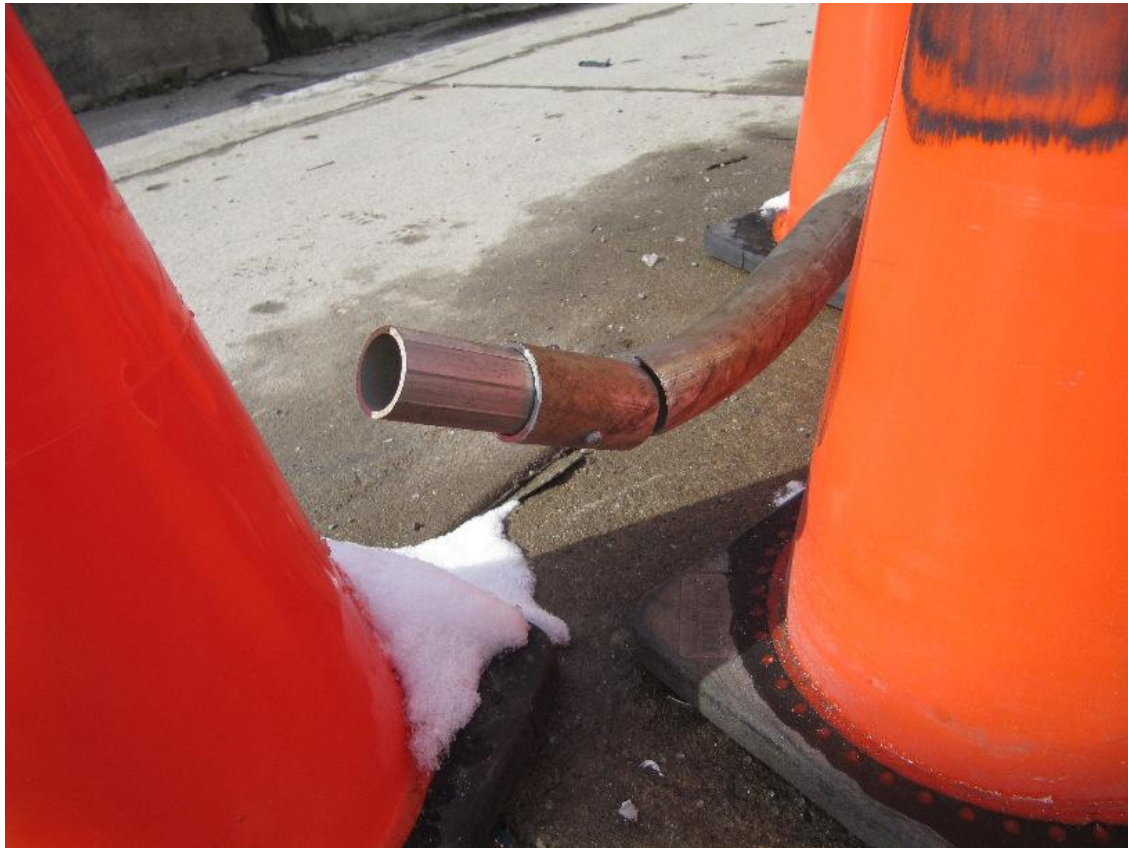
Figure 7: View of the bottom of the three Horizontal poles of the damaged railing.

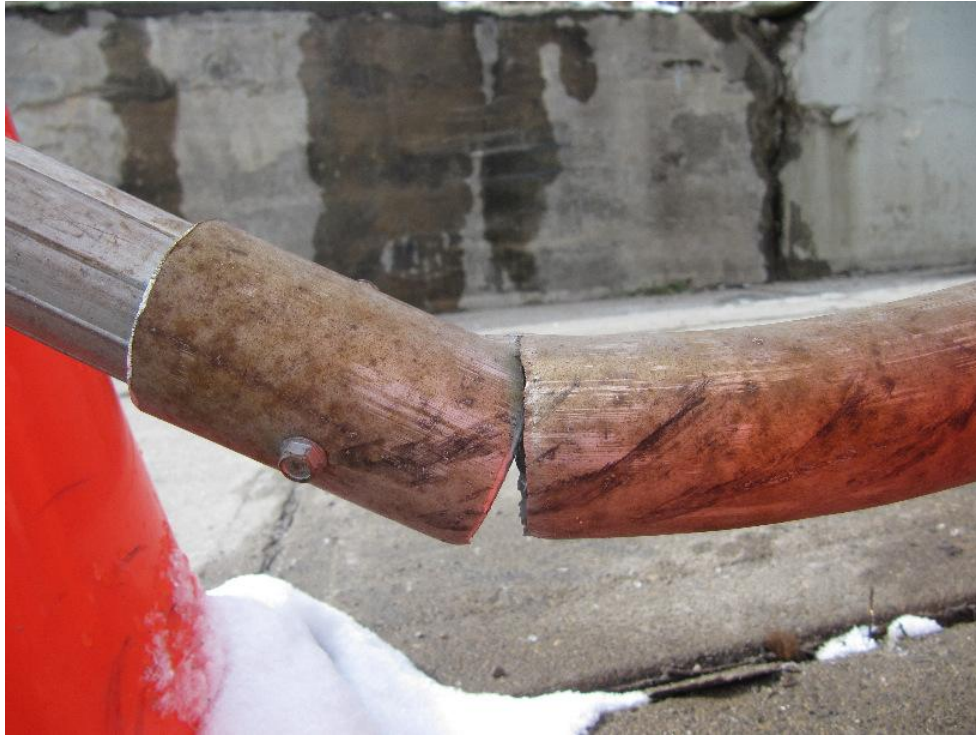
Figure 8: View of the bottom of the three horizontal poles.

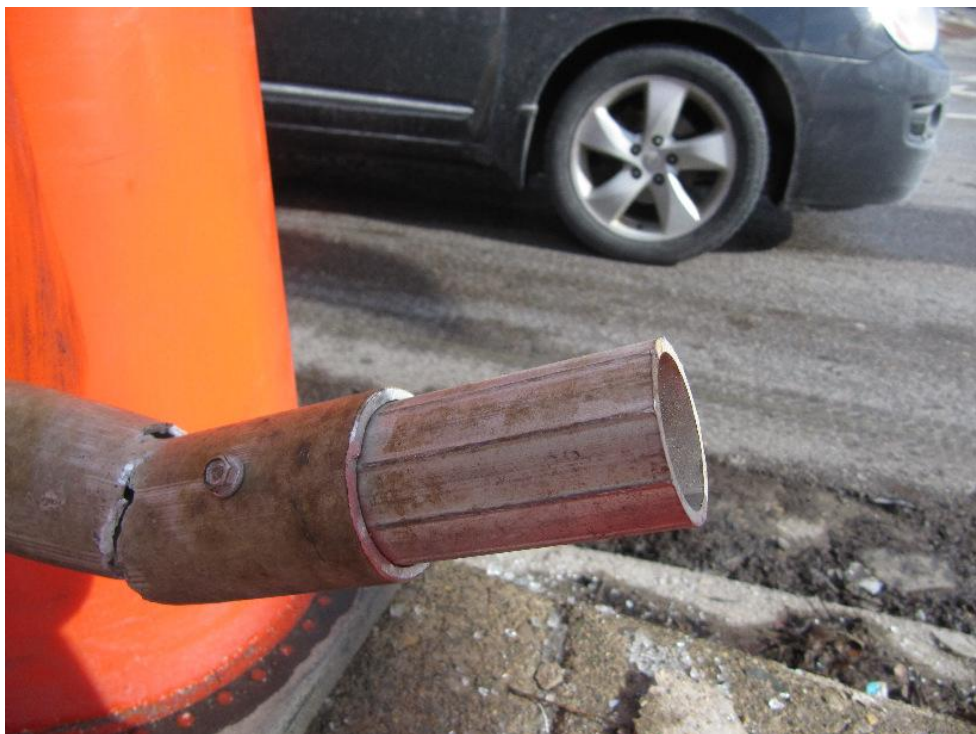
Figure 9: View of the bottom of the three horizontal poles.

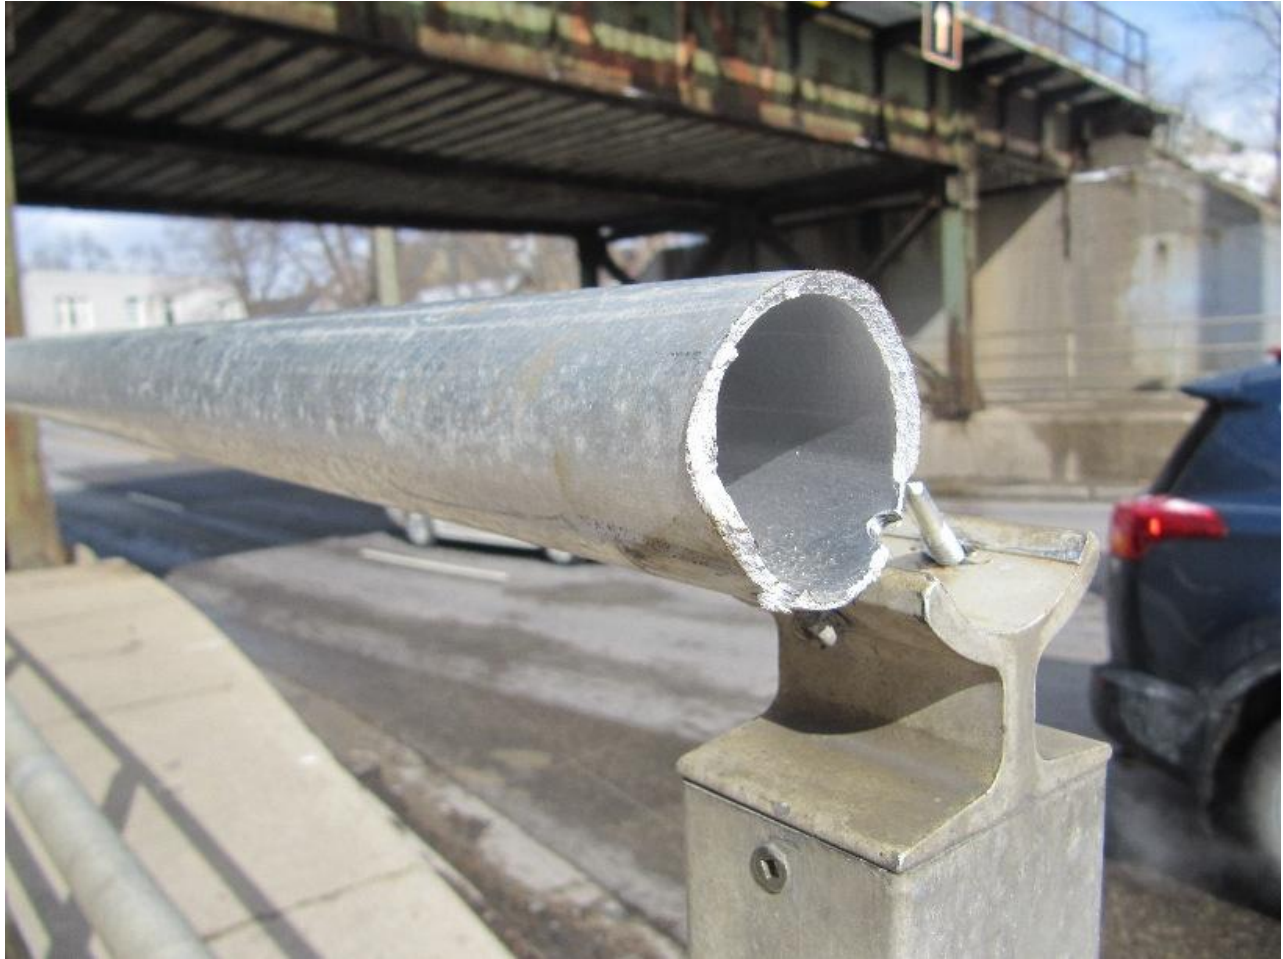
Figure 3 shows an overall view of the area at the damaged railing. Figure 4 takes us closer to the damaged end of the struck railing. Figure 5 shows the deformed ends of the damaged railing. Figure 6 shows a close-up view of the end of the middle of the three horizontal poles of the railing. Figures 7, 8 and 9 show the end of the bottom of the three poles of the railing. Figure 10 shows the top pole which was the one that harpooned the windshield of the striking vehicle.

Figure 10: View of the top of the three horizontal poles.

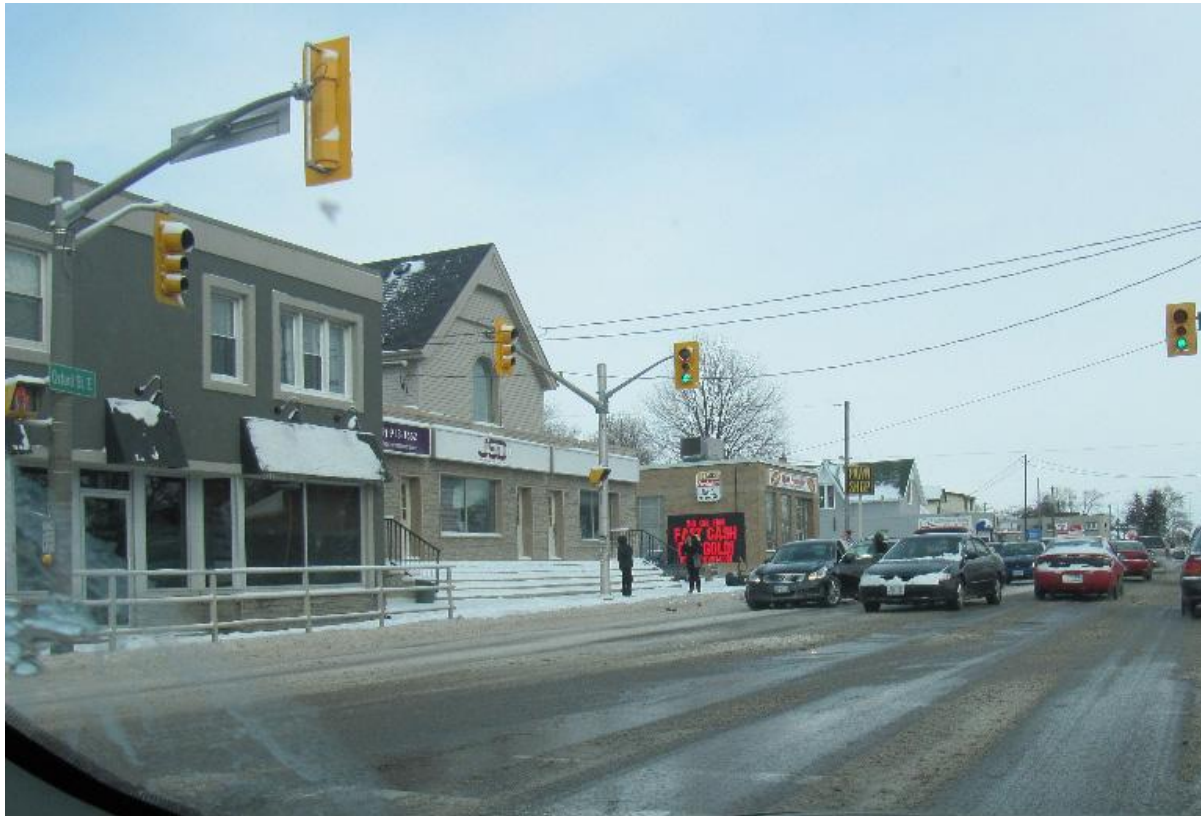
As an example, the intersection of Oxford Street and Quebec Street contains a similar railing. Figure 11 shows a view of the railing from a photo taken on February 11, 2012.

Figure 11: View, looking north-east, at the railing installed on the north side of Oxford Street, north of the T-intersection with Quebec Street in London, Ontario.

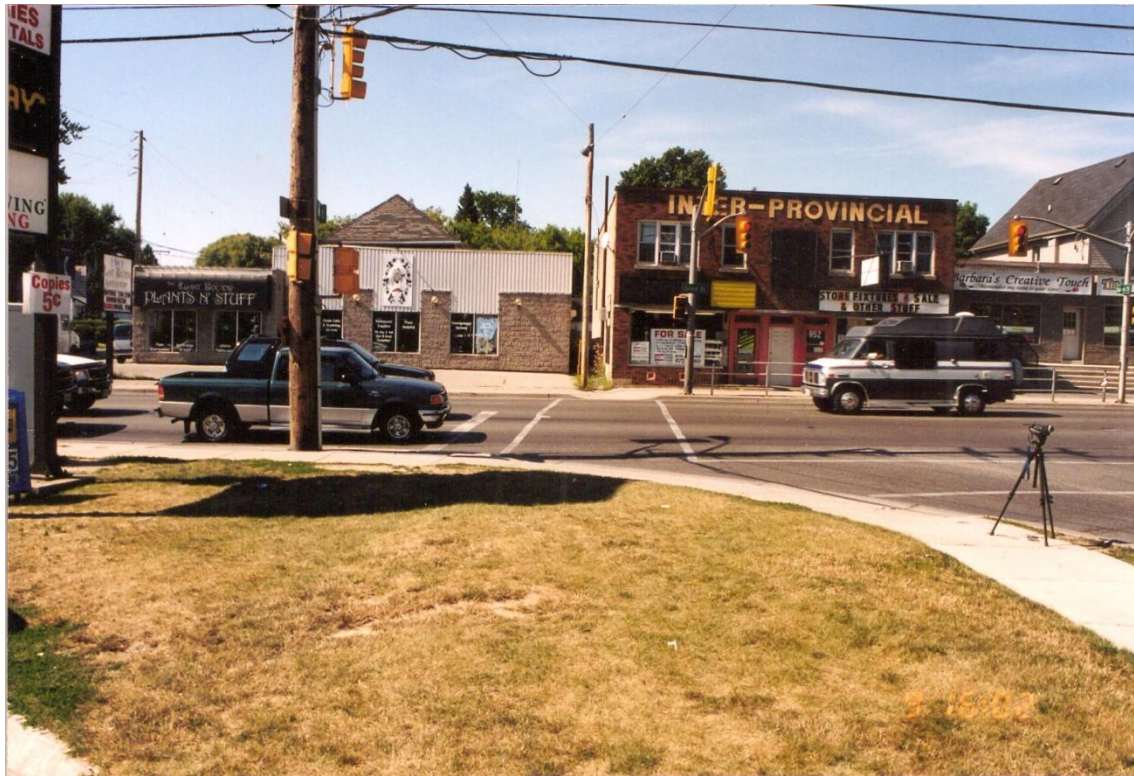
Figures 12 and 13 show views of the same railing taken on August 9, 2002. Although these photos do not show a clear view of the railing they seem to show that the railing extended further to the east, at least up to the post of the traffic signal shown in Figure 11.

Figure 12: View, looking north from the south-west of the intersection of Oxford Street and Quebec street. The railing on the north side of Oxford Street seems to extend eastward to the post of the traffic signal.

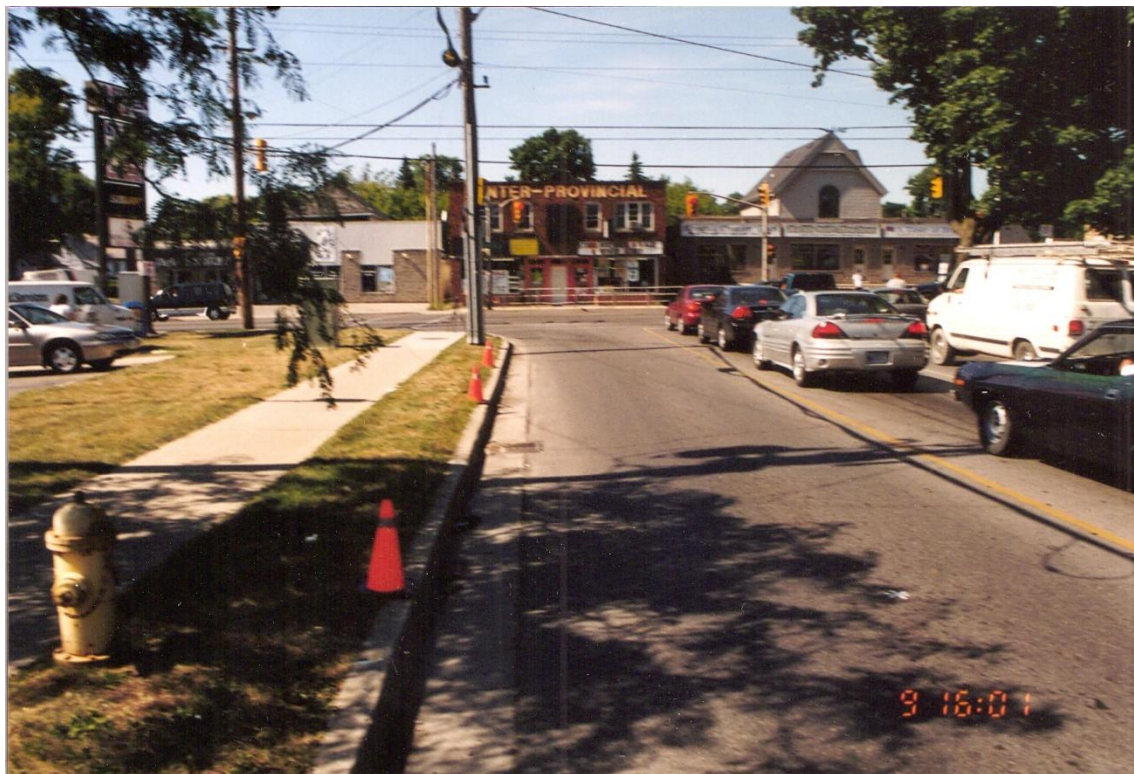
Figure 13: View from August 9, 2002, looking north along Quebec Street toward the intersection with Oxford Street.

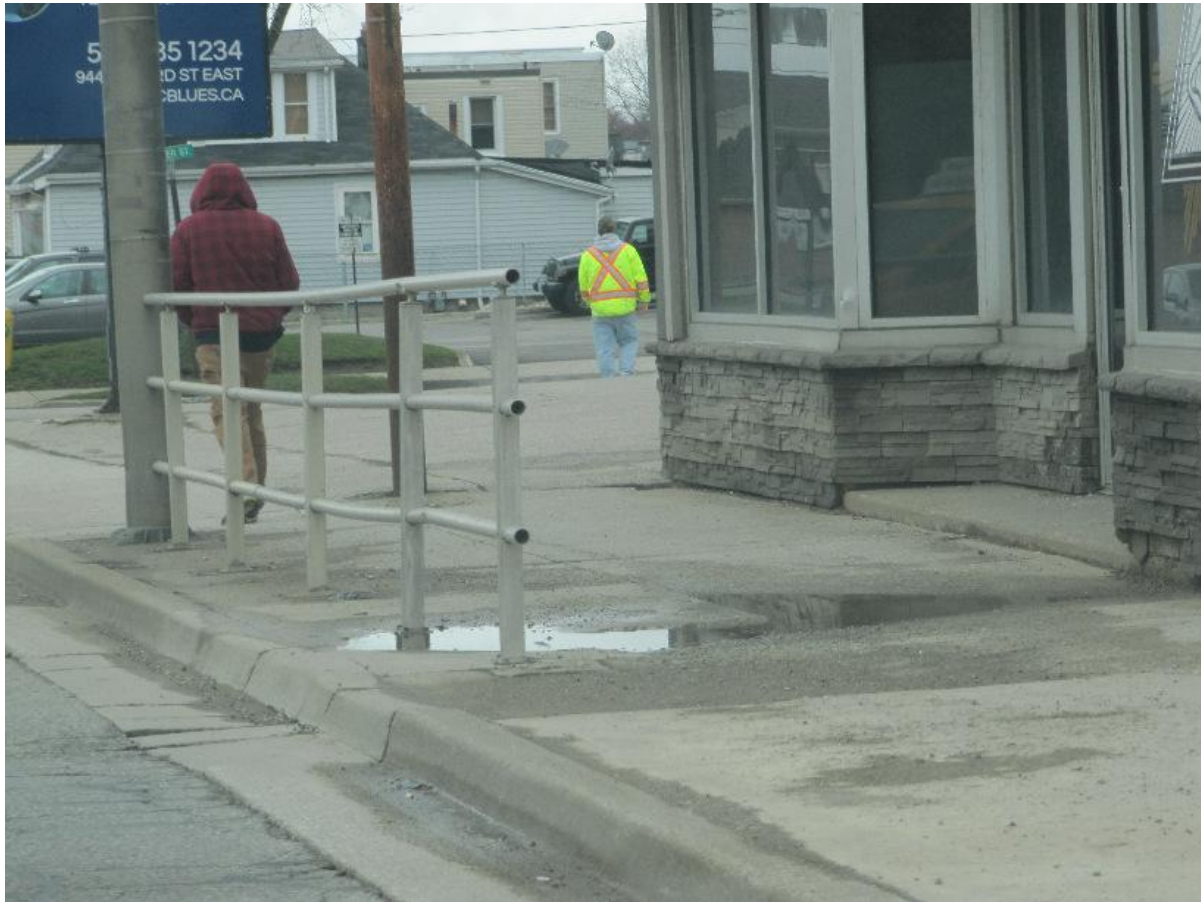
Figure 14 shows another view of the same railing taken on April 7, 2016. Unlike the installation on Horton-Wharnccliffe, the installation here does not contain any protective bar in front of the ends of the horizontal poles of the railing. One would reason that, if a harpooning of a vehicle occurred at Horton-Wharnccliffe then such a result would be more likely at Oxford-Quebec where the ends of the horizontal poles are more exposed.

Figure 14: View from April 7, 2016, looking west, at the railing on the north side of Oxford Street. The ends of the horizontal poles of the railing are exposed to oncoming, westbound traffic.

One can see from the photos that the present installation at Oxford-Quebec has existed at least since August of 2002. There could have been changes to the east end of the railing as the photos suggest that the railing may have extended further eastward before 2012. It is possible that the railing was struck sometime before February 2012 and the damaged eastern portion was removed, leaving the shortened, undamaged section shown in Figure 14. If so, then no one would have appreciated the danger of leaving the remaining section of railing with the east end of the poles exposed to oncoming traffic.
