Trinity ET-PLUS Guardrail Terminals - Review of Real-Life Collision Performance Data

Posting Date: 11-Oct-2015

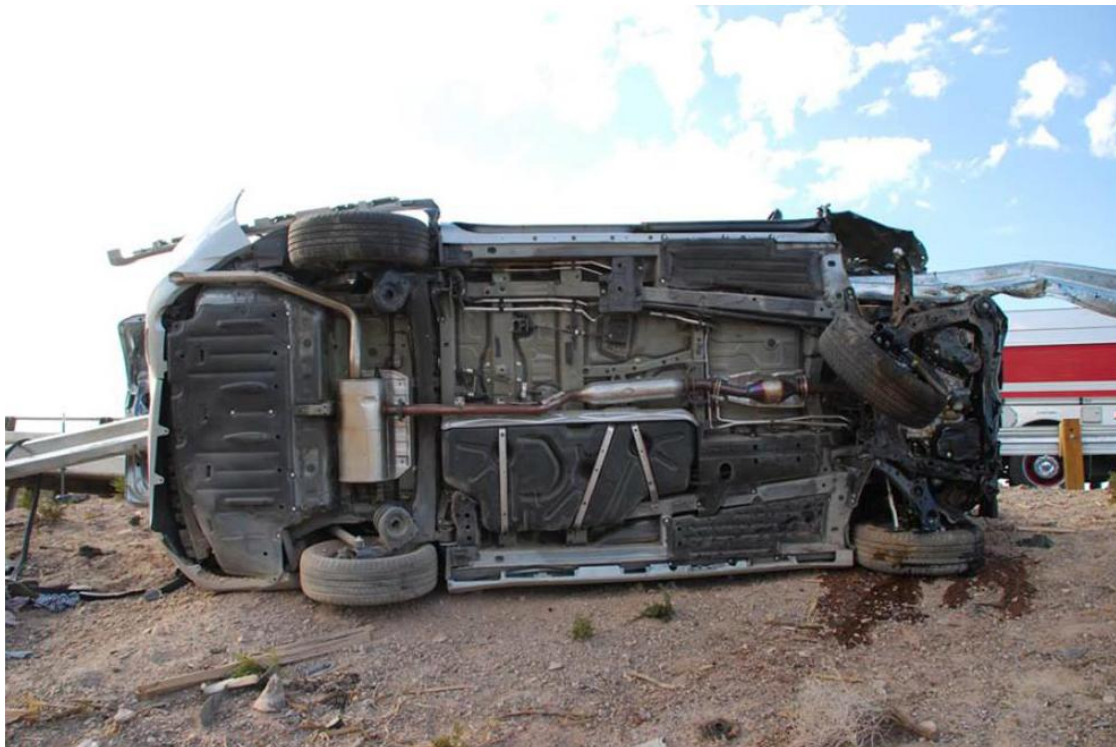
Figure 1: Vehicles that strike an ET-Plus terminal have been harpooned by the attached guardrail resulting in severe injuries and deaths.

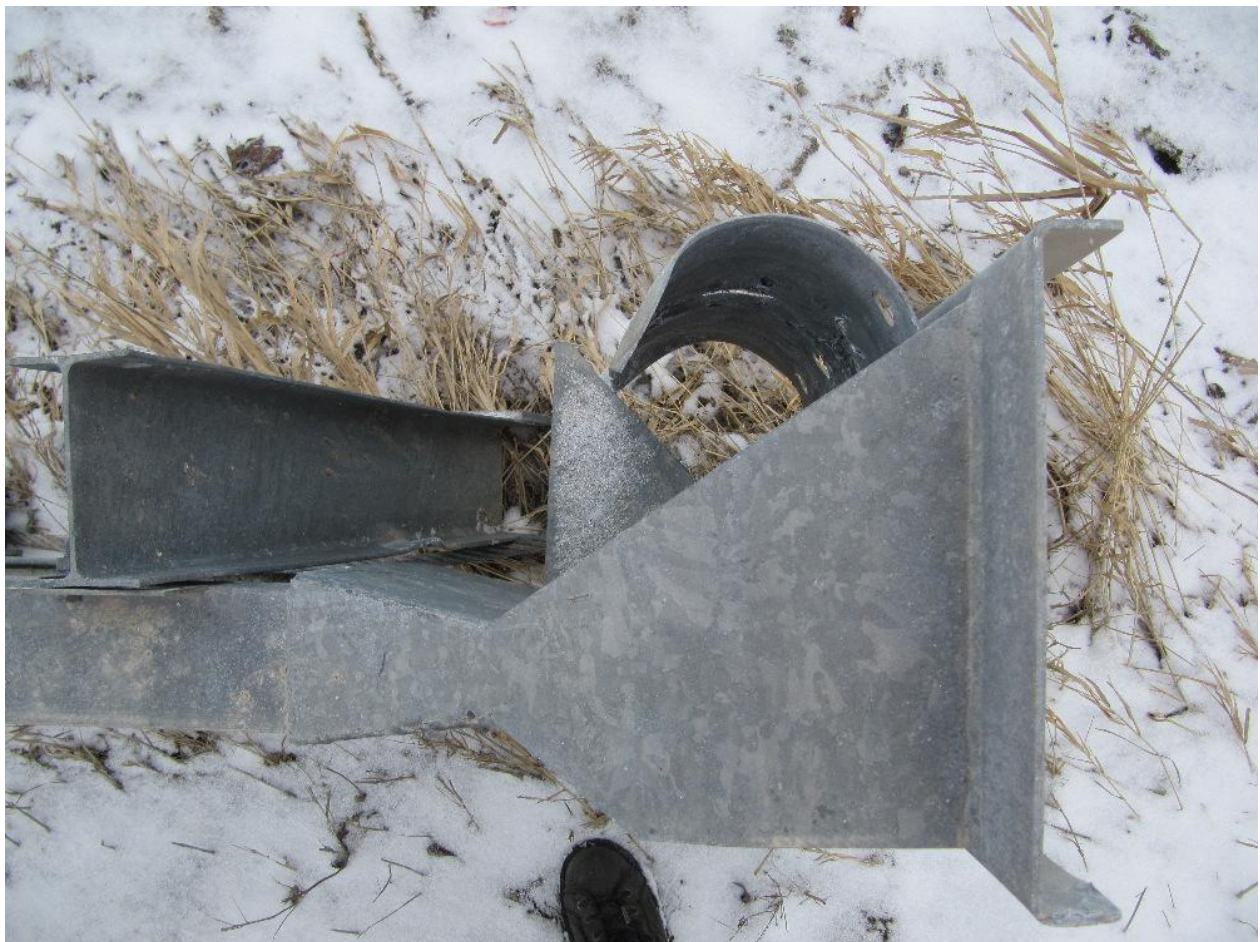
Figures 4 and 5 show an example of an ET-PLUS terminal on Dingman Drive in London, Ontario that was struck and sustained minor damage. Figure 4 shows a top view where the end of the flattened guardrail can be seen extruding from the side of the terminal head. Figure 5 shows the same terminal from a ditch-side view and we can also see a small portion of the guardrail as it has passed through the head and become flattened and curled by its squeezing action.

Figure 4: Top view of the ET-PLUS terminal showing how a minor impact has caused the head and channel to be displaced along the guardrail. Consequently the end of the guardrail has been squeezed out the side of the head.

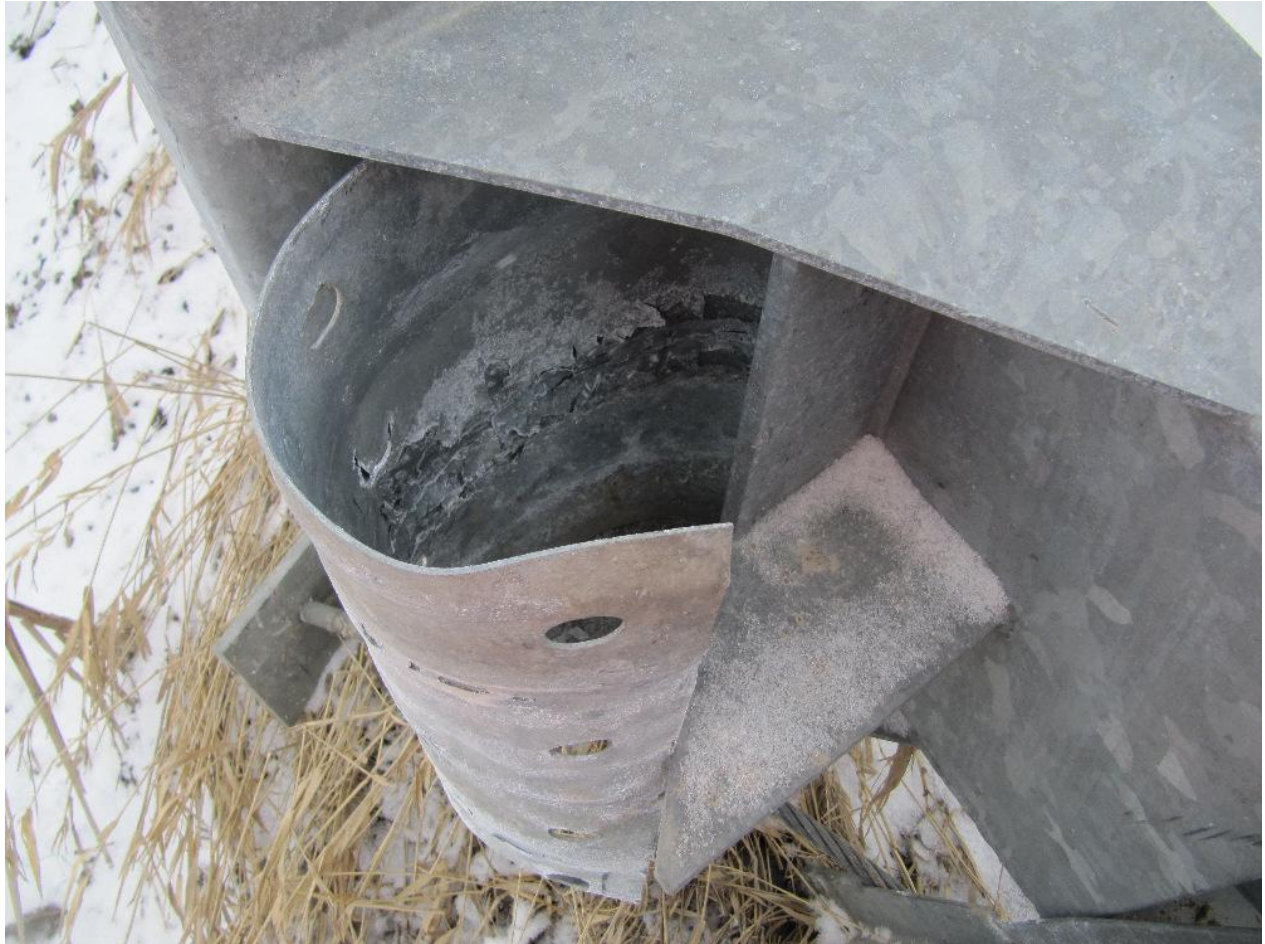
Figure 5: Ditch-side view of the end of the guardrail as it has been squeezed and deformed from passing through the narrow opening in the head.

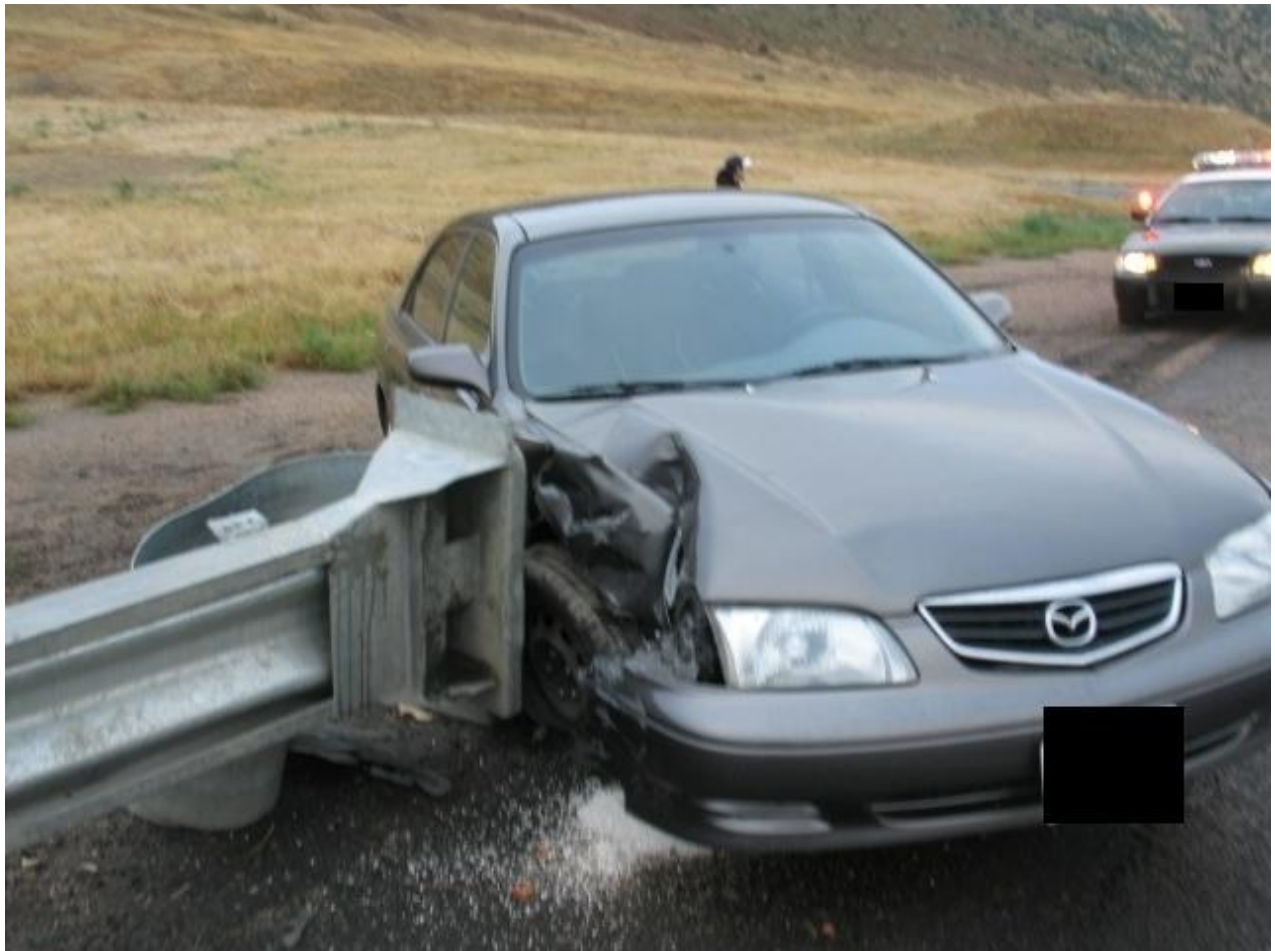
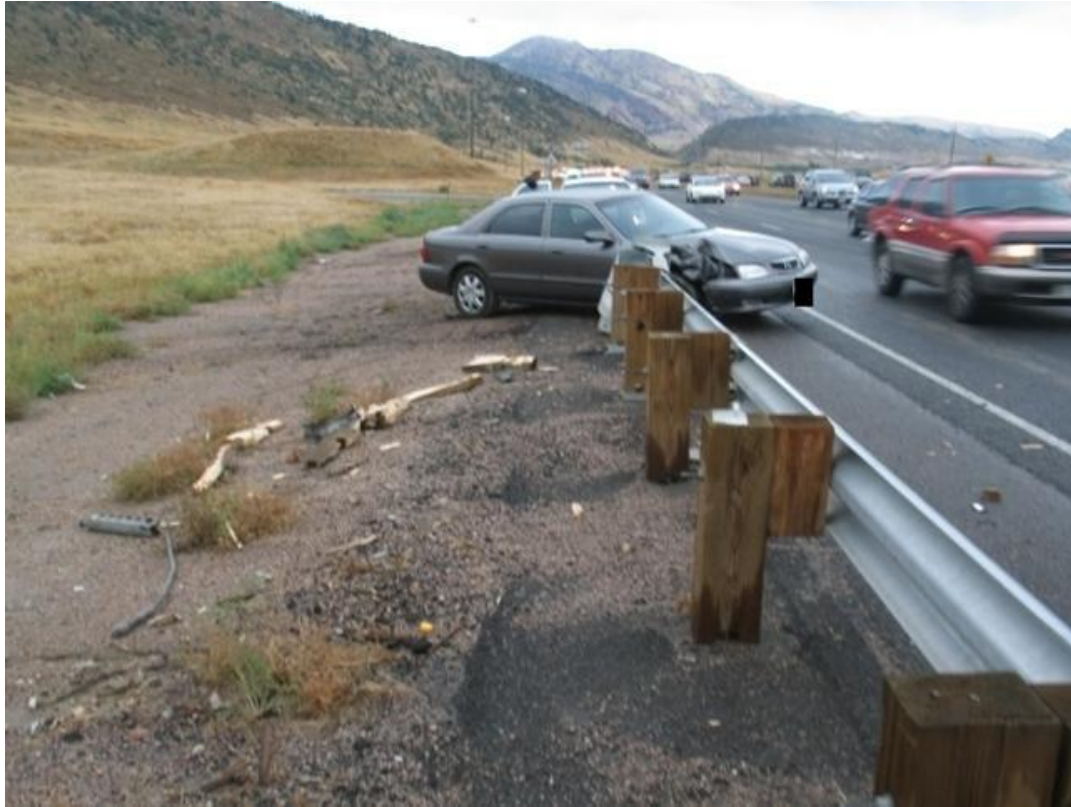
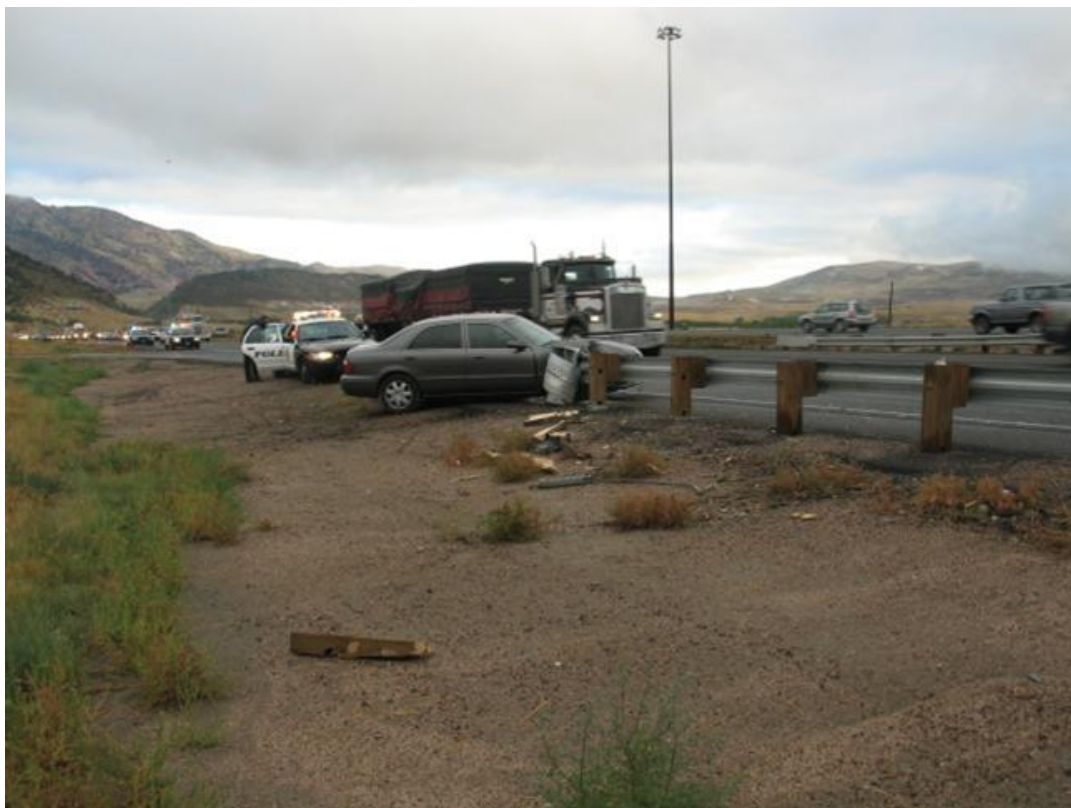
Case # 2007075518369

In the first case a car is stopped against the damaged terminal and there is moderate damage to both the terminal and the vehicle. A collision of this severity would be unlikely to lead to any significant injury regardless of what was struck.

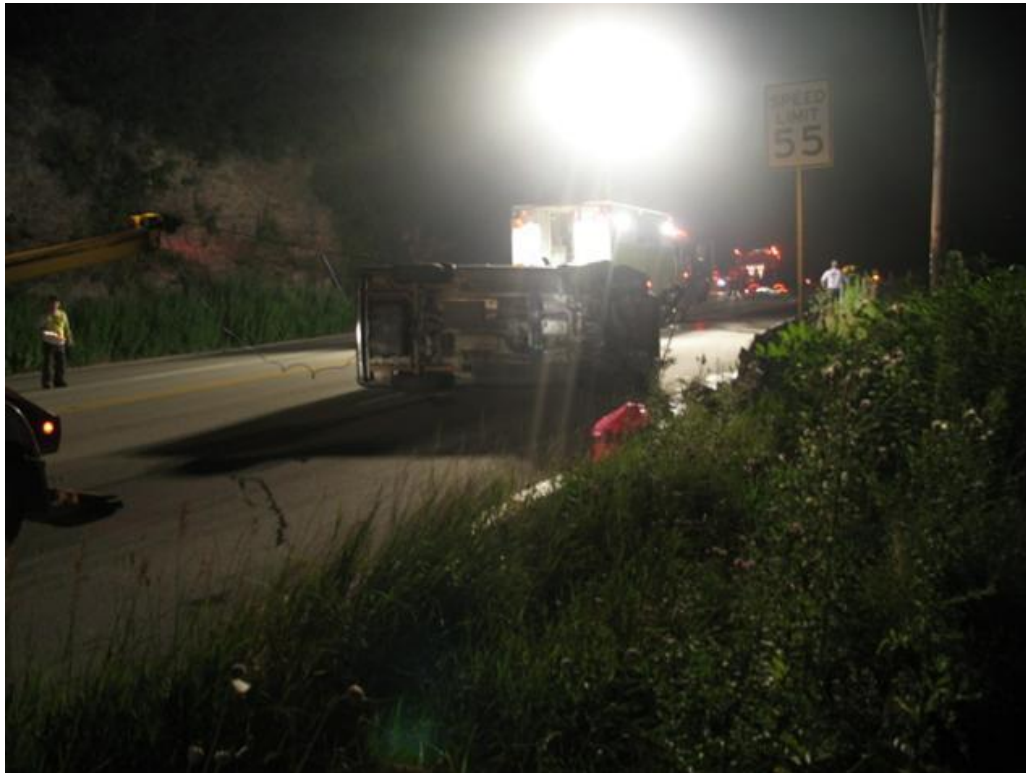
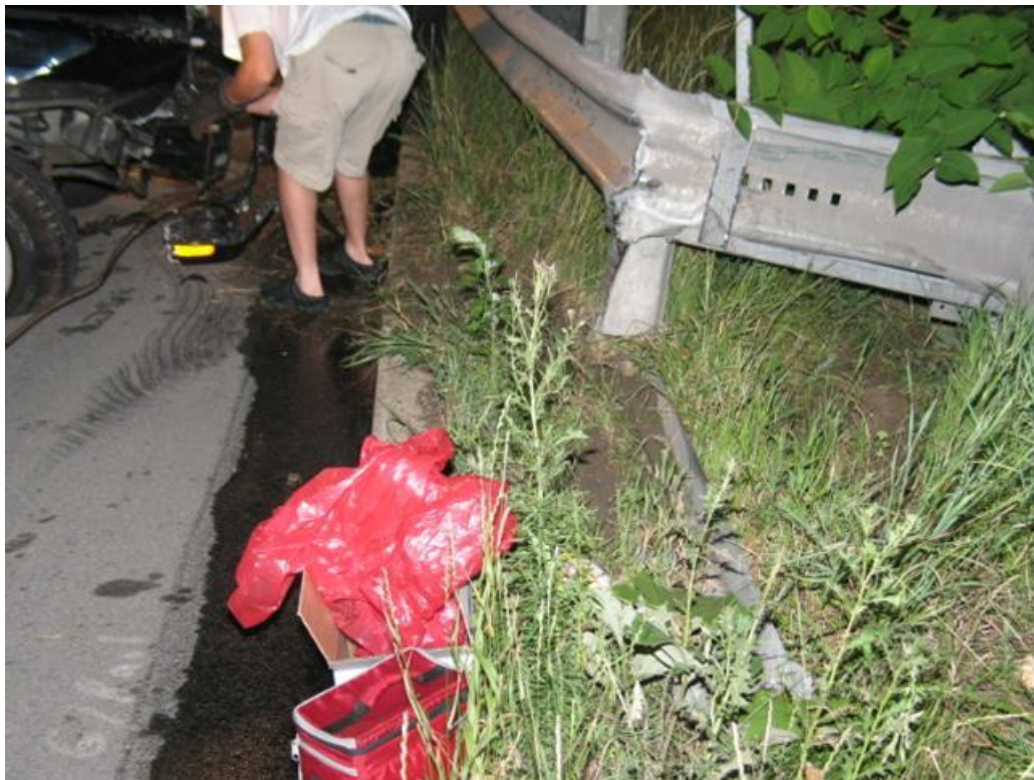
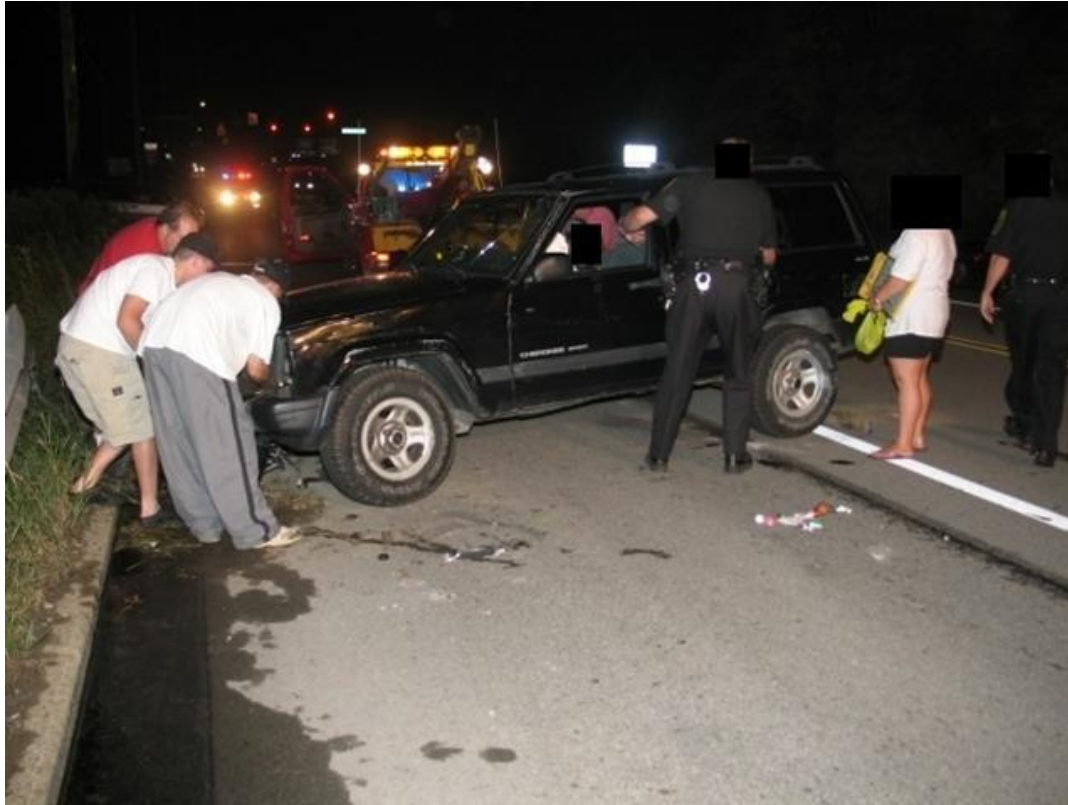
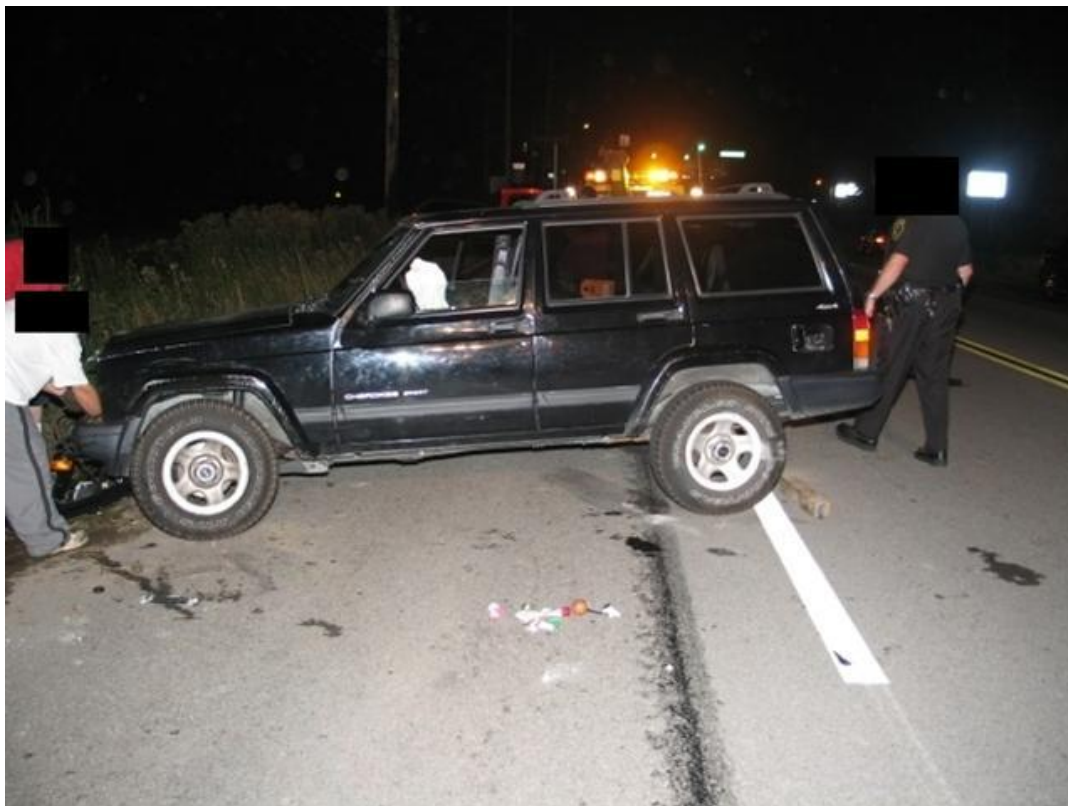
Case #2005008586181

Similarly in the second case we see a Jeep in night-time conditions that has rolled onto its side after striking the terminal. A single photo of the terminal shows how it has rotated almost 90 degrees. The extent of passage of the guardrail through the head can be determined by examining the location of the "tooth holes" in the rail that indicate where the anchorage bracket was located for the cable that leads to the base of the first anchor post. Even though we do not see the length of rail that passed through the head this photo indicates that the length was rather short, as would be expected in this low severity impact. The fact that the Jeep rolled over in this low severity impact should indicate that, a higher severity of impact and at a higher speed of such a vehicle, a significant post-impact rollover could occur which is undesirable. Yet the total energy dissipation the vehicle and guardrail/terminal is relatively low.

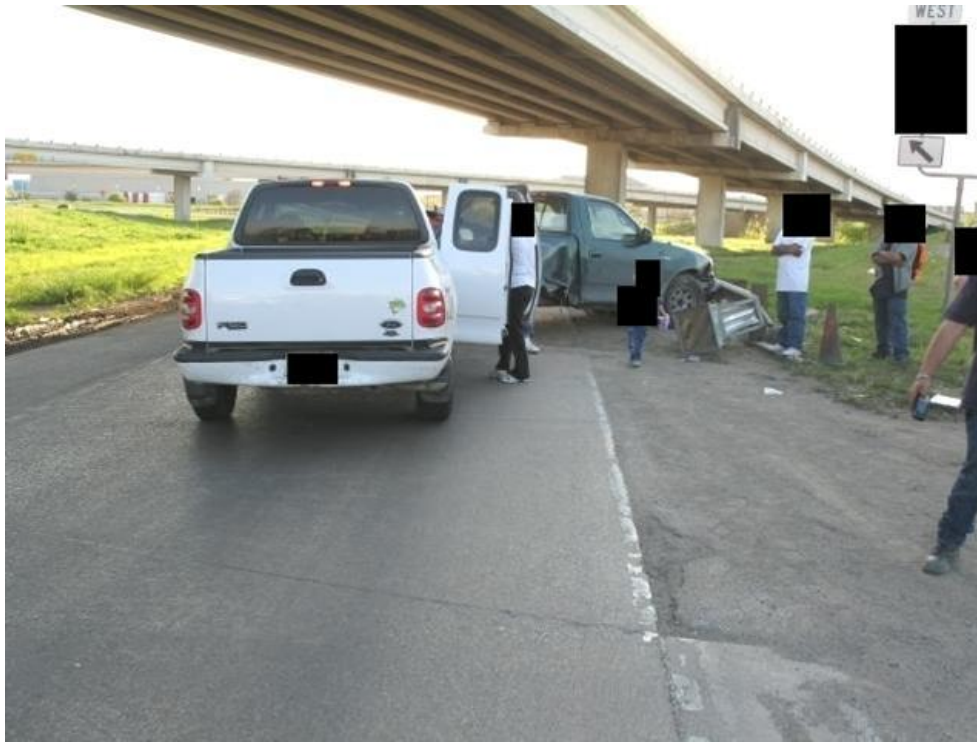
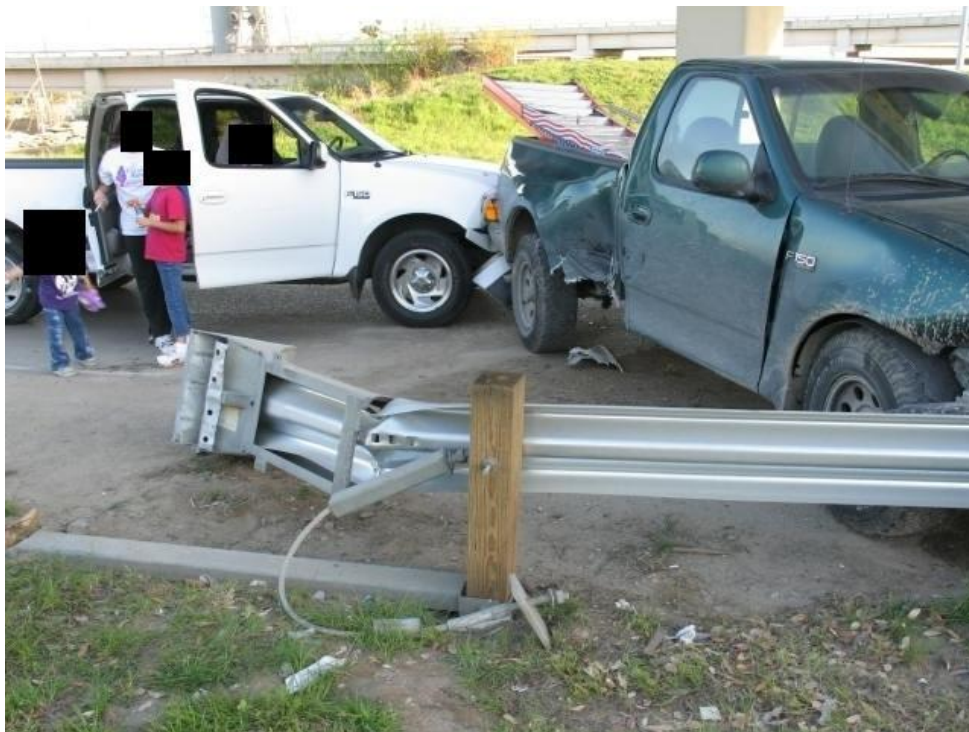
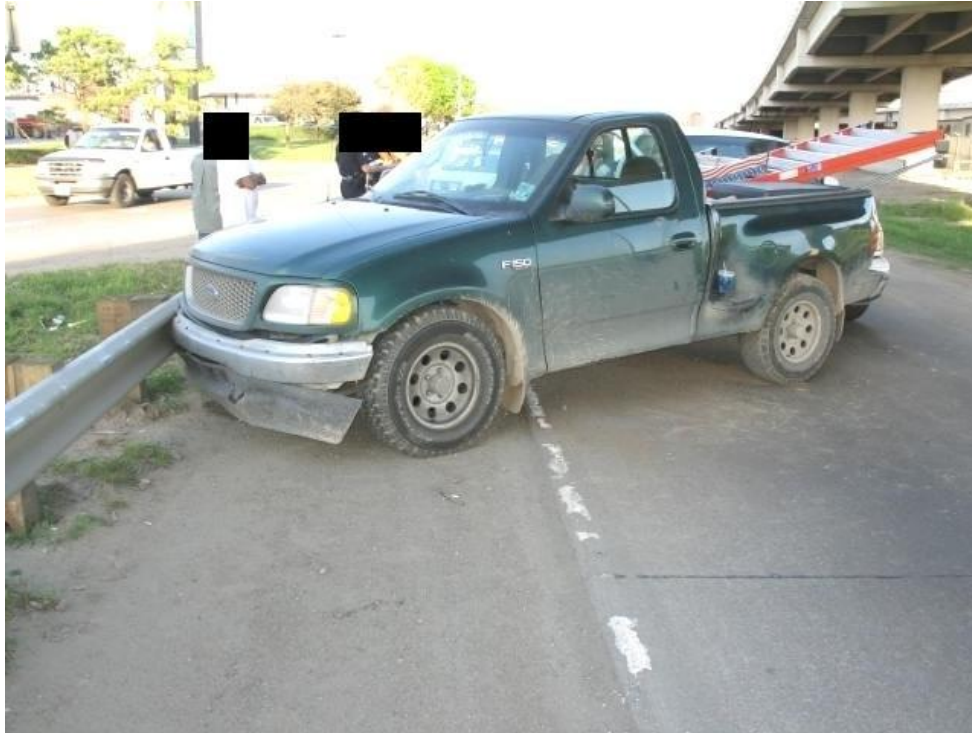
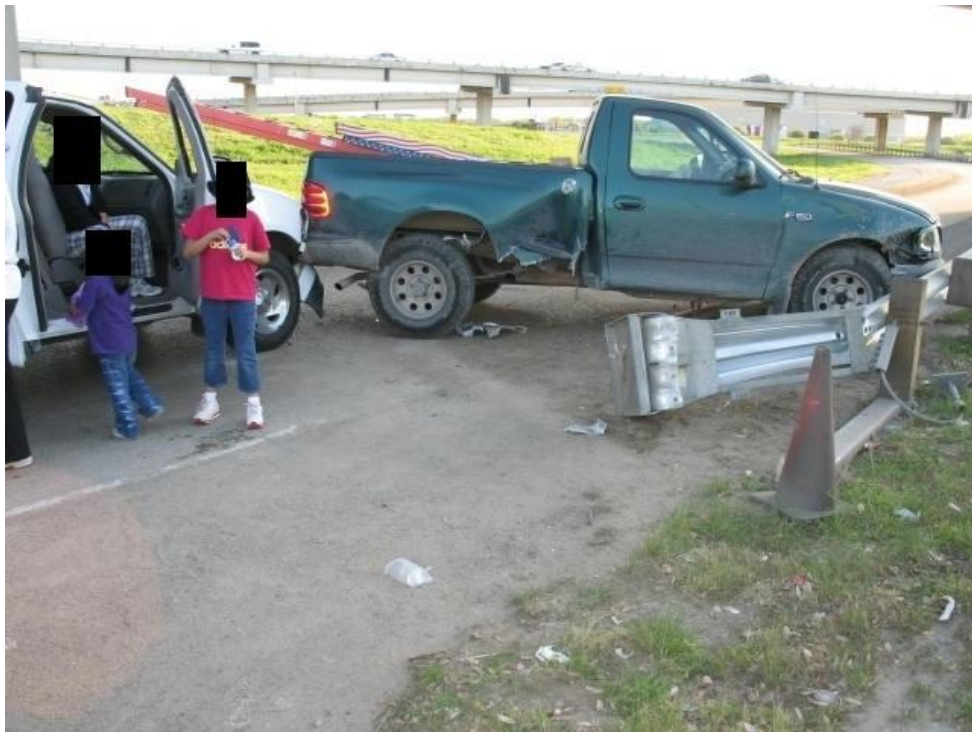
Case # 2005049137263

In the third case we observe an green pick-up truck that has struck the terminal at a location just in front of the right rear wheel well. A second, white pick-up truck has struck the rear of the green pick-up but this can be viewed as minimal in its relevance. Still we recognize the minor nature of the impact both in terms of the damage to the terminal and the damage to the impacting pick-up.

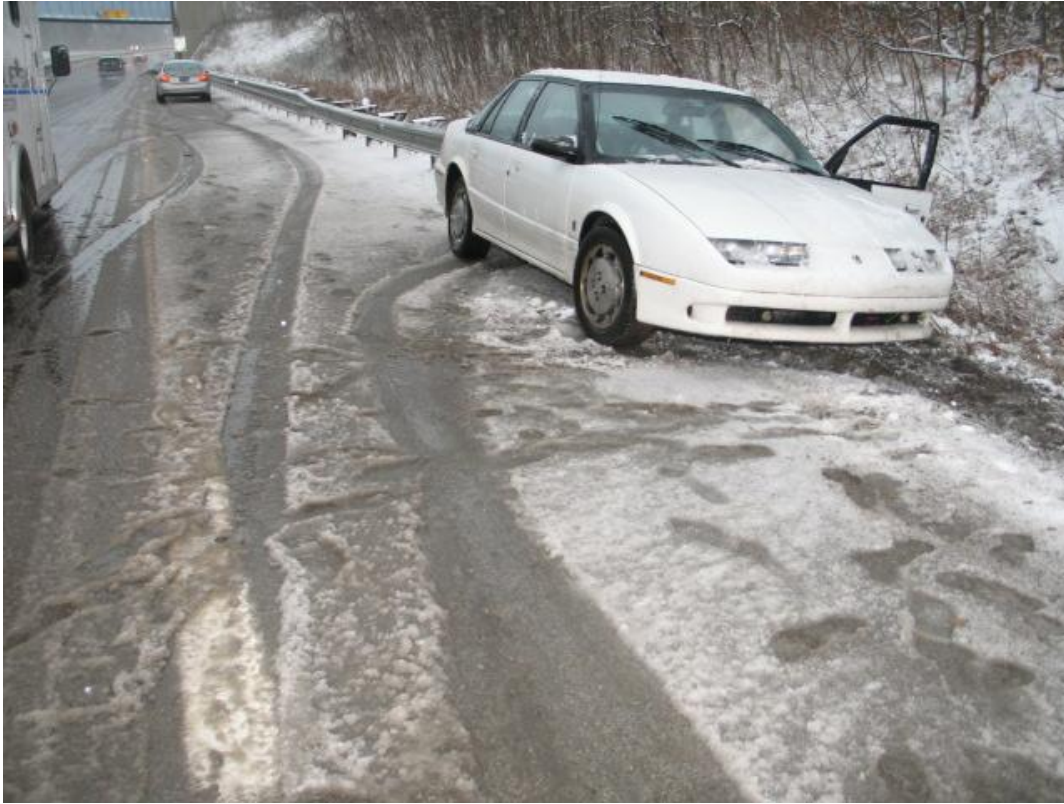
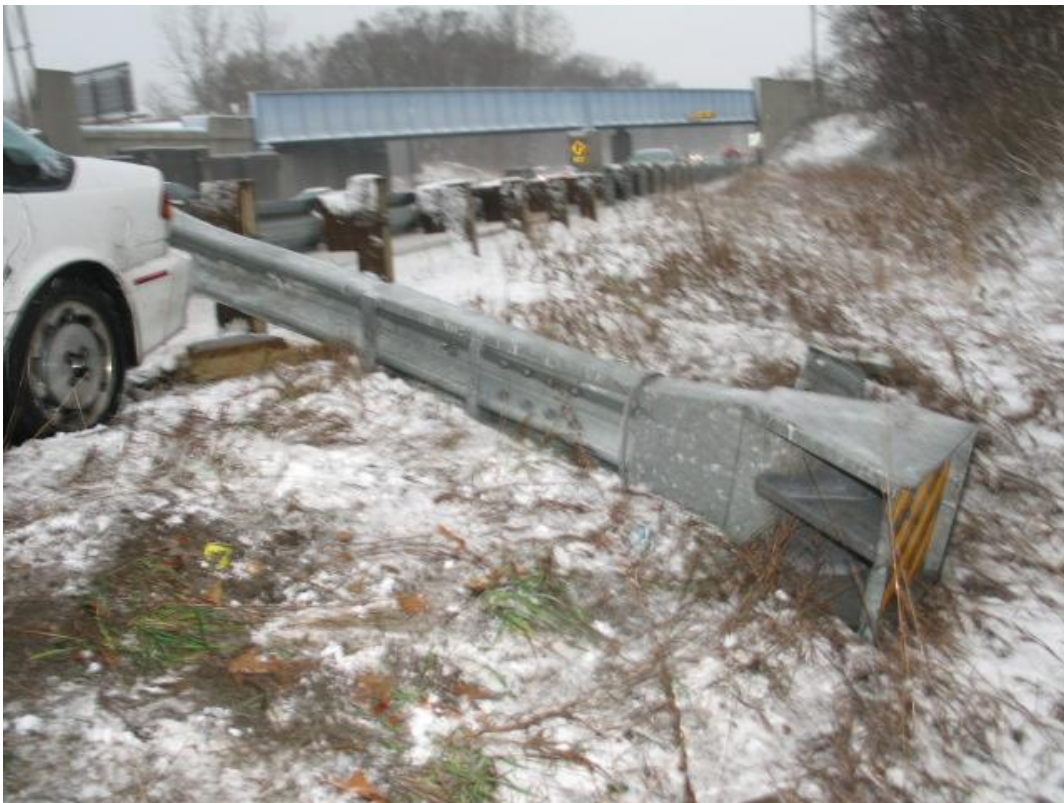
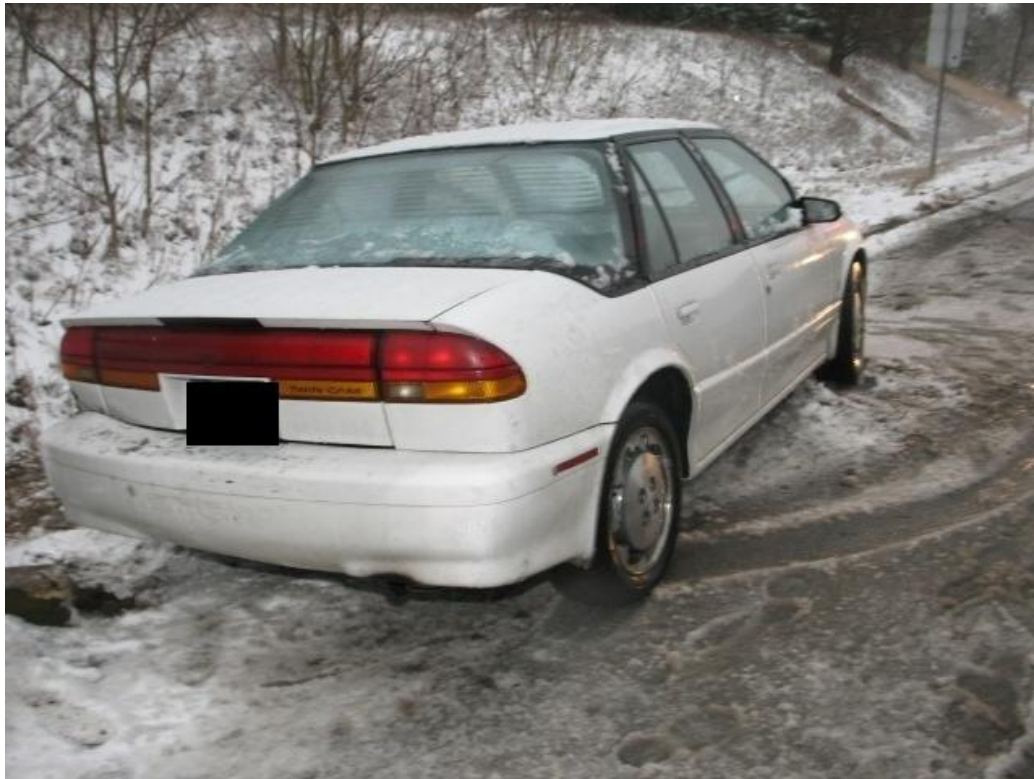
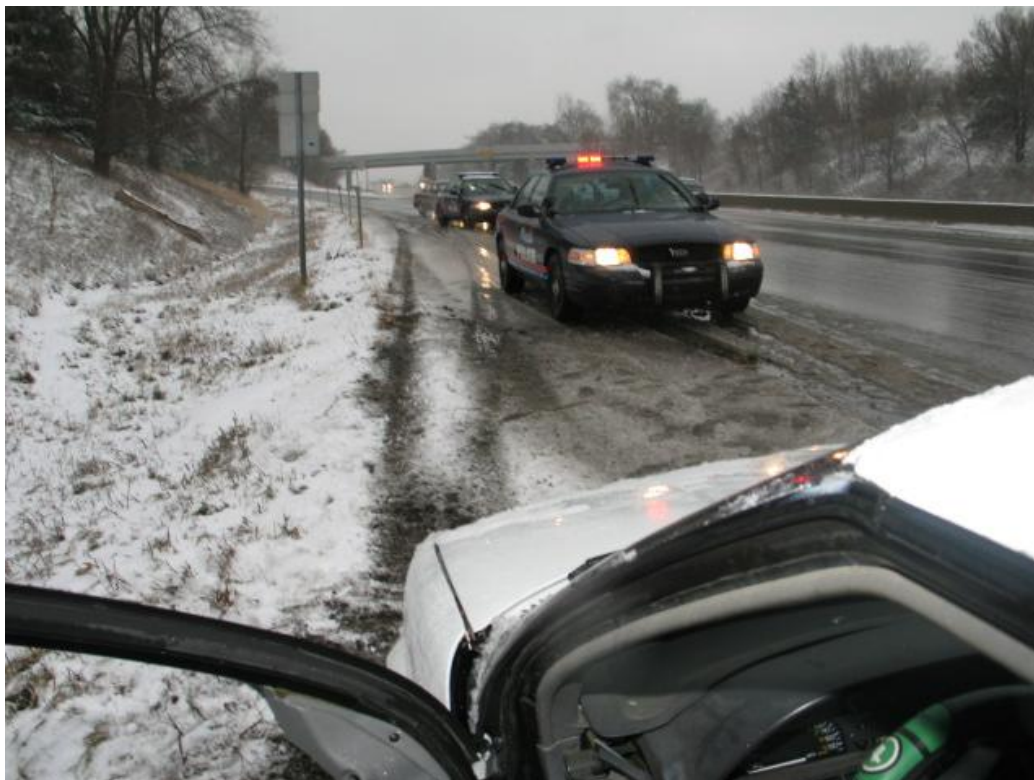
Case # 2005013507642

It can be observed that in the first two cases that were not reviewed, the collisions were of minor severity. In the first case involving the white car, the impacted terminal was not an ET-Plus therefore this could provide the reasoning why the FHWA task force did not review that case. The second case also did not provide good views of the terminal and therefore it cannot be determined if this was an ET-Plus.

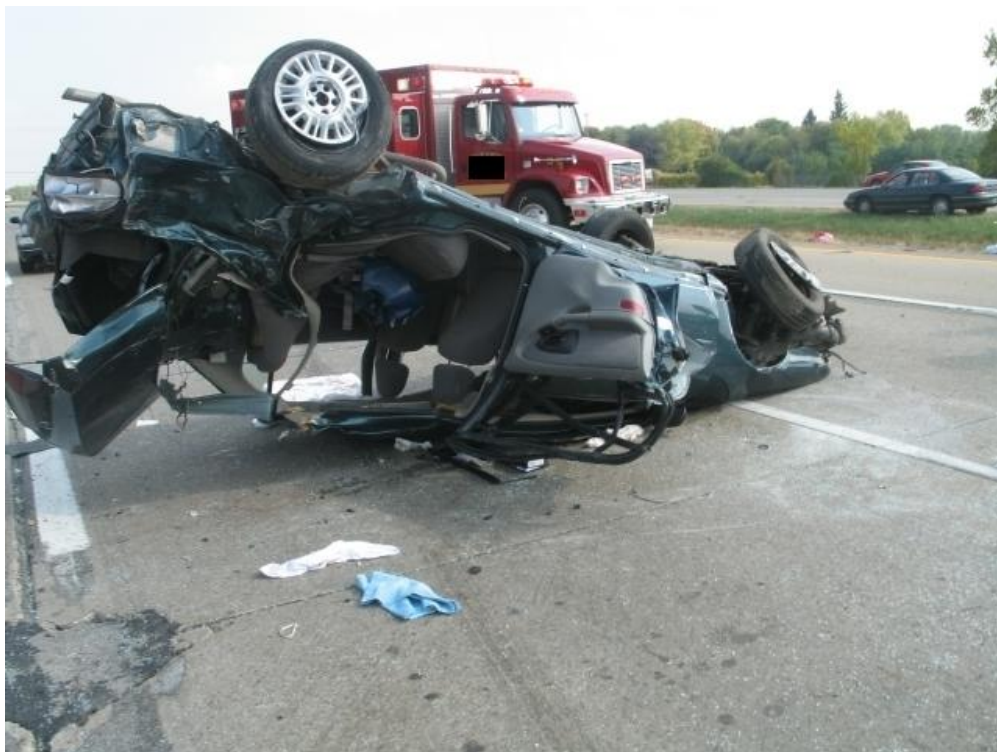
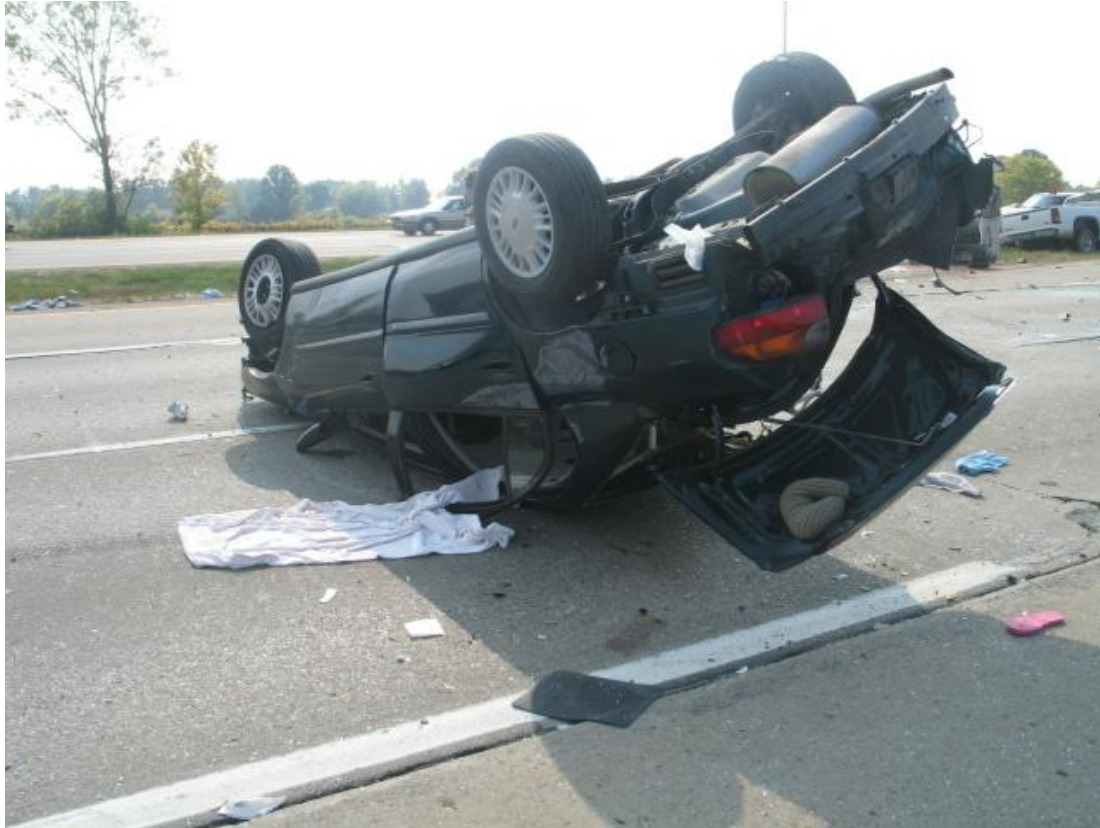
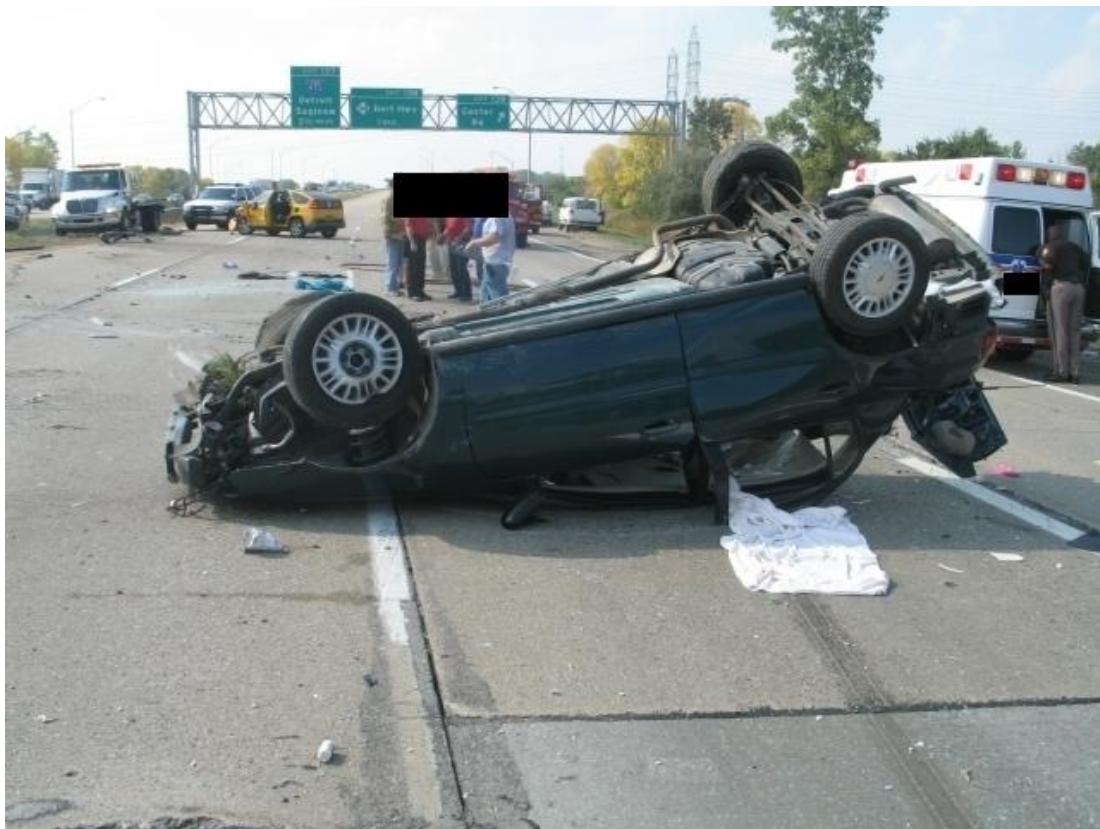
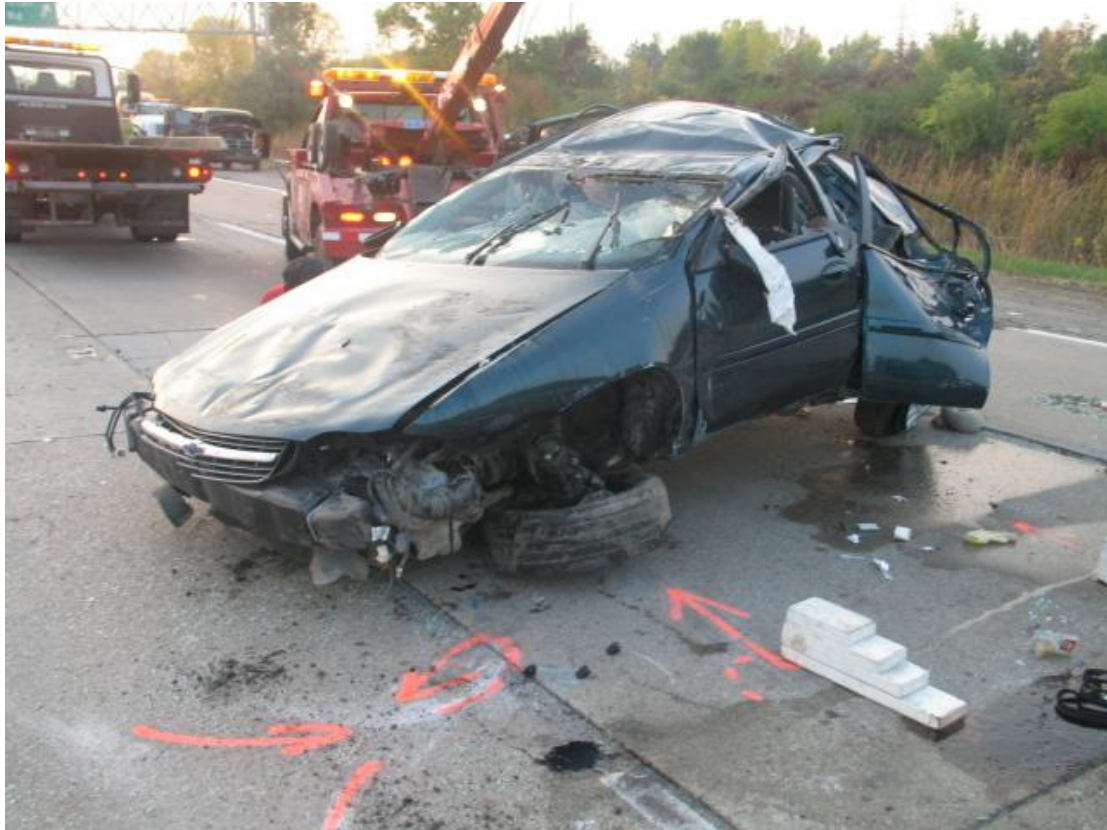
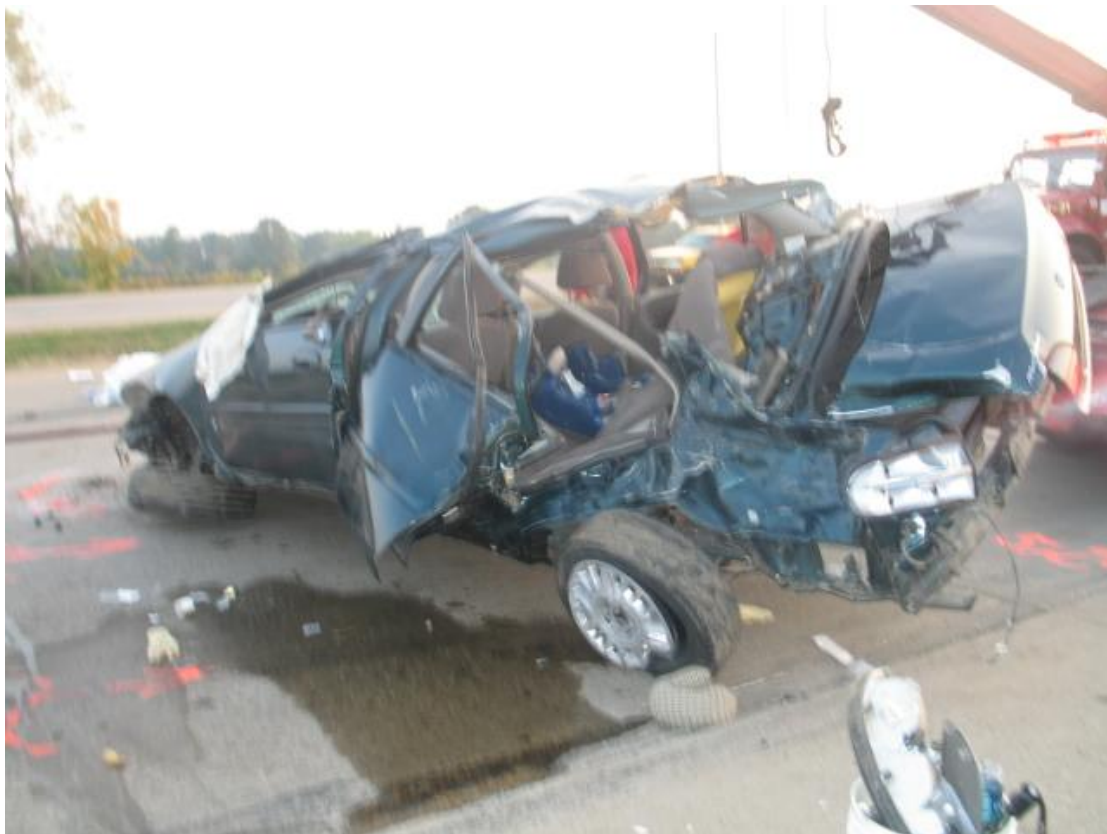
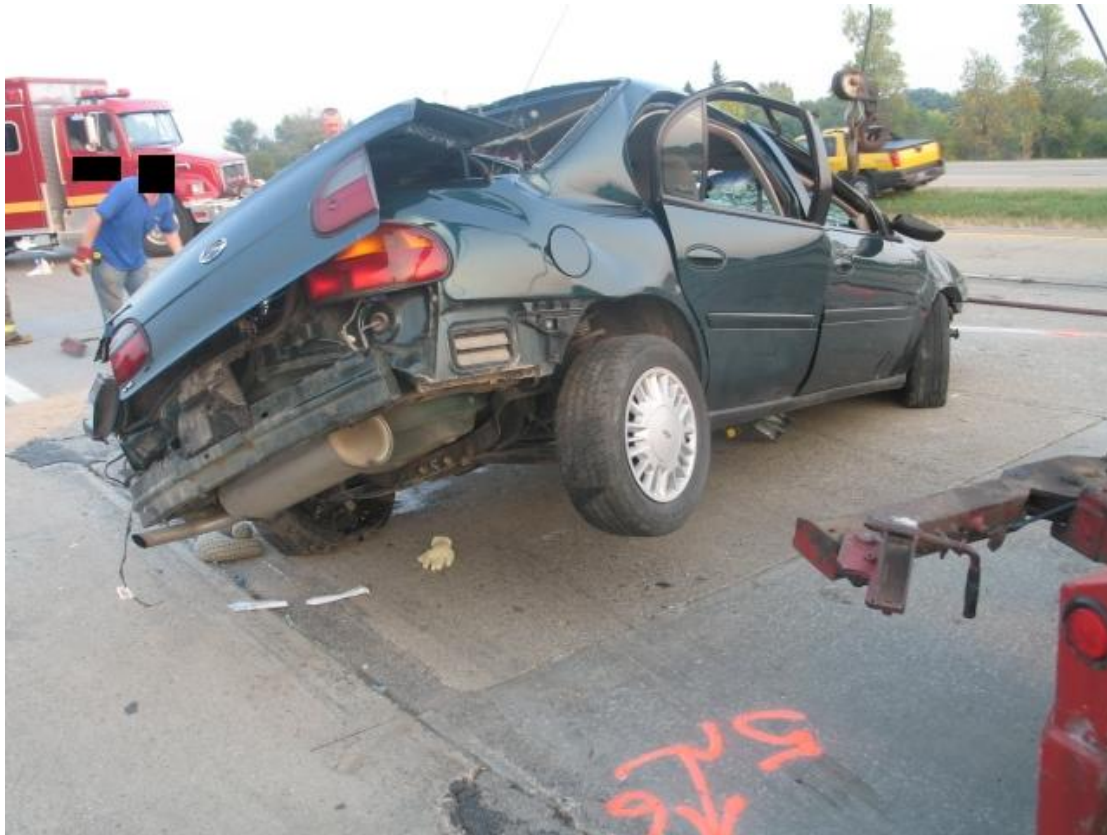
Case # 2005012696122

In the third case however the photographs indicate that this was a significant event. The photographs show that a car came to rest upside down and there was substantial damage to it. A text summary of the collision noted that the vehicle travelled into the median of an interstate highway and that the left front of the vehicle "contacted a guardrail". The vehicle then rolled onto its roof and slid into the opposing lanes of traffic. It was then struck by two other vehicles travelling in the opposing lanes. A passenger seated in the centre of the second seat of the vehicle sustained fatal injuries. There were not photographs of the "guardrail" therefore it is not clear whether an actual guardrail terminal was struck. However, if the "guardrail" was actually an ET-Plus terminal then the FHWA task force should have viewed this as an undesirable outcome. The point is that, given the fatal result it should not have been difficult for the Task Force to track down the type of guardrail or terminal that was struck as information about fatal collisions should have been readily available from local agencies. It is not clear why the Task Force did not perform this simple inquiry of an incident that appeared to have an undesirable outcome.
