Triple Fatal Motorcycle Crash On Wellington Road And Ferguson Line South of London, Ontario

Posting Date: Sept 4-2015

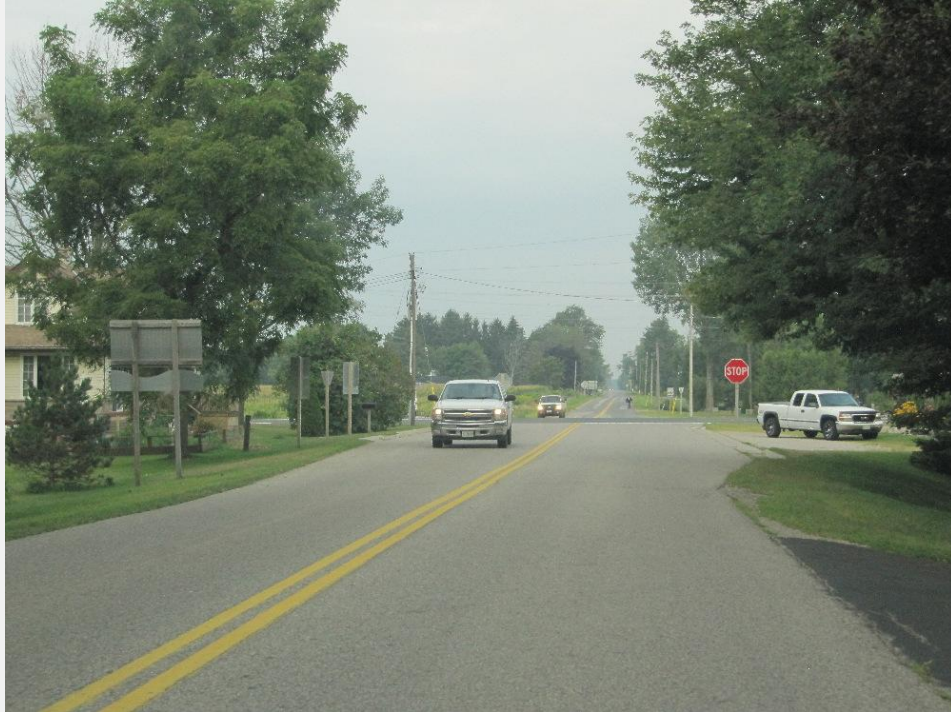
View, looking west along Ferguson Line on approach to the intersection with Wellington Road.

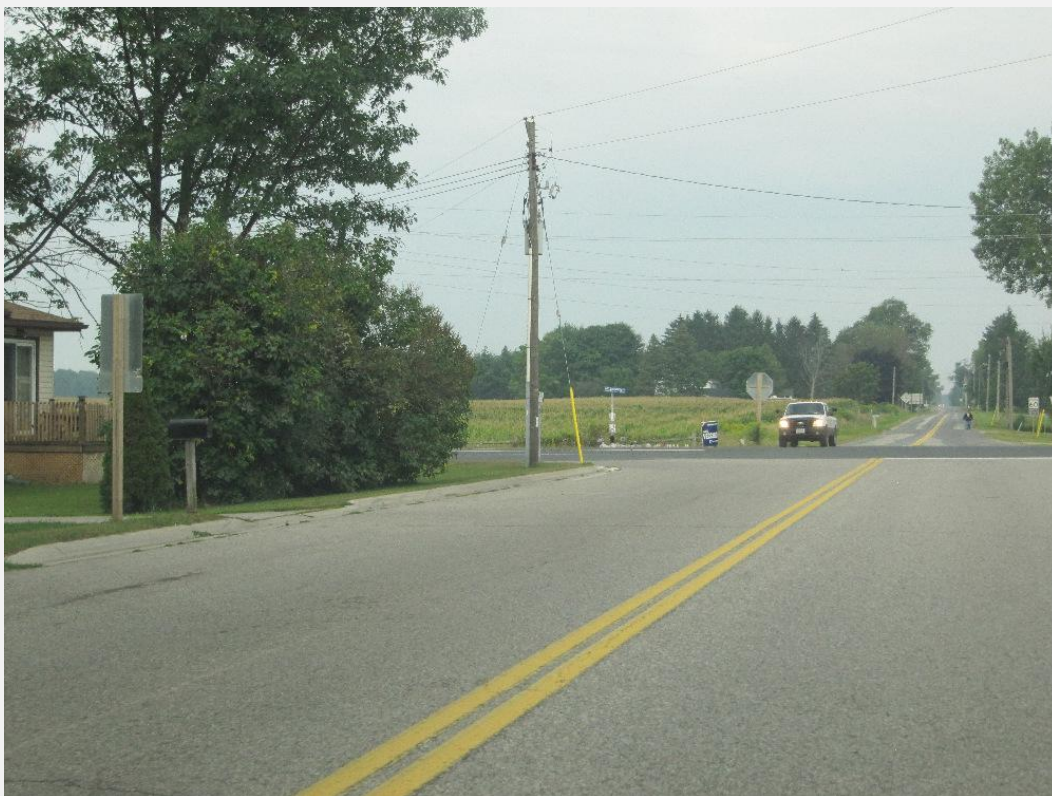
Westward view on approach to the Wellington Road intersection.

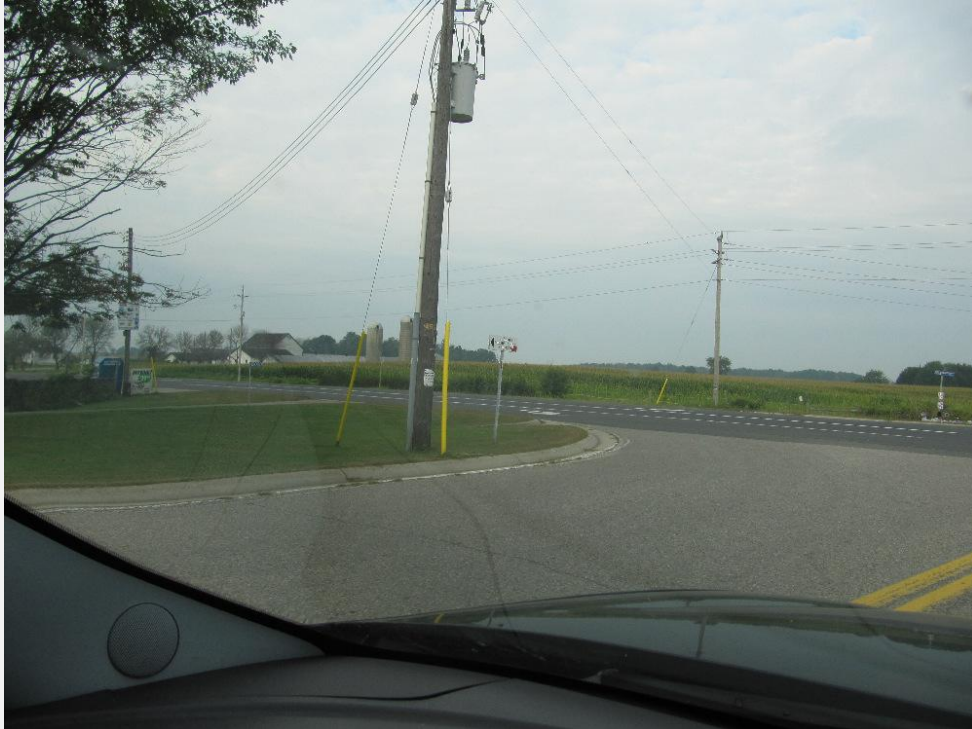
View as the driver of a westbound vehicle looks south on Wellington Road toward the location from which the two northbound vehicles approached.

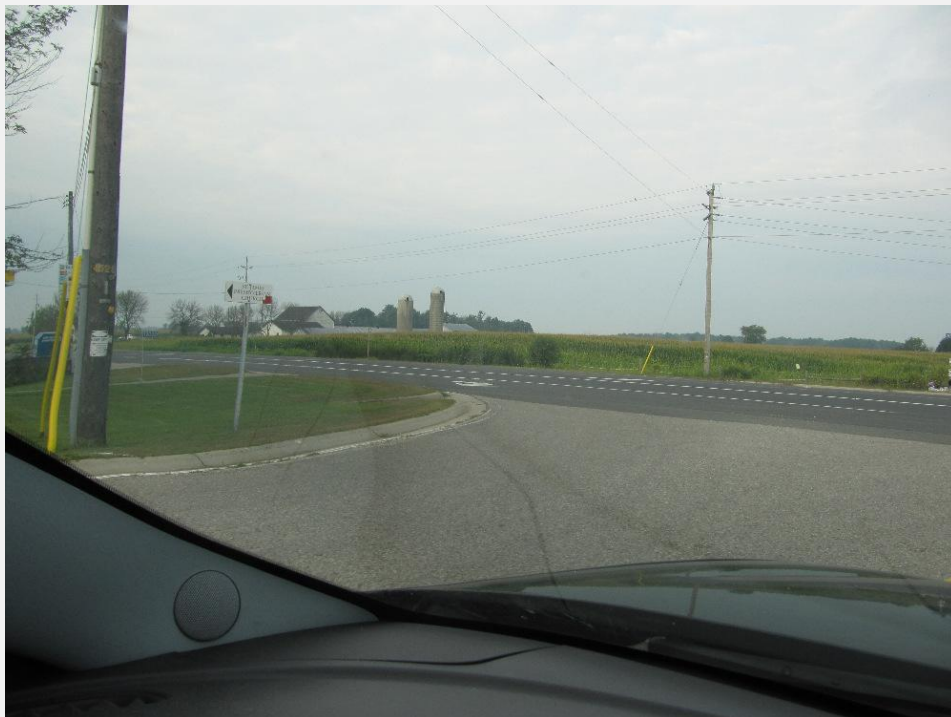
View, looking southward onto Wellington Road from the perspective of a westbound driver on Ferguson Line.

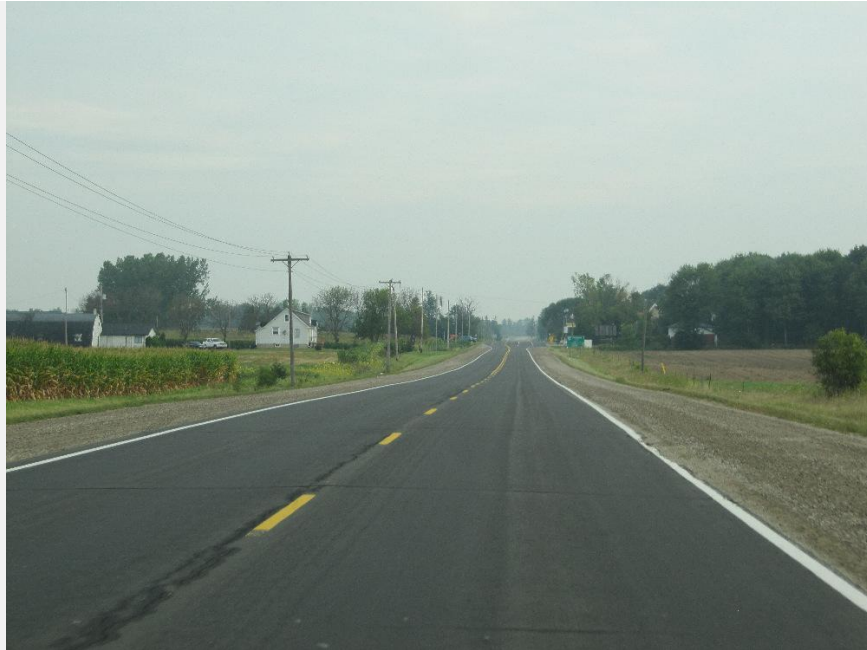
View, looking northward along Wellington Road from several hundred metres south of the intersection with Ferguson Line.

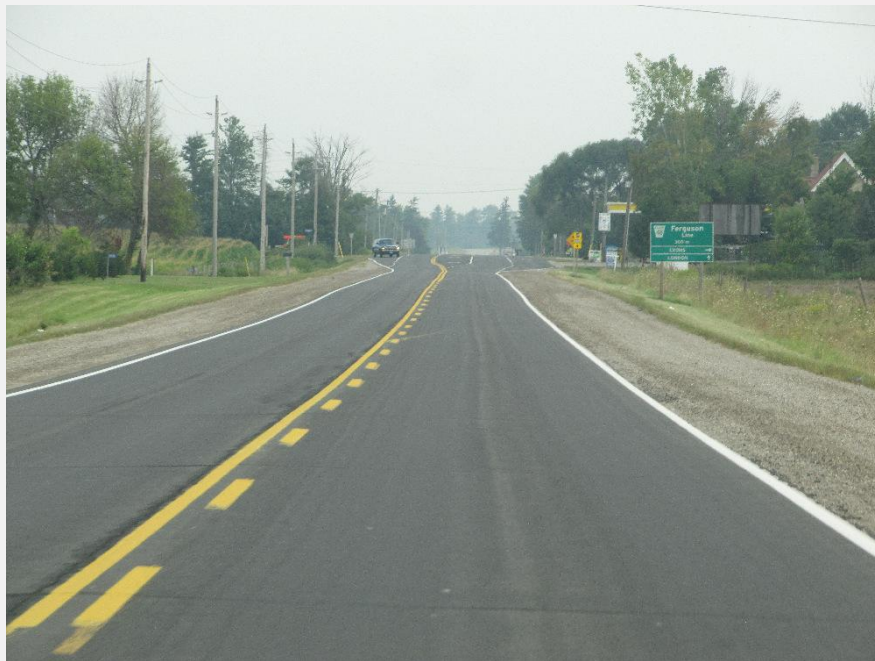
Northward view along Wellington Road on approach to the intersection with Ferguson Line.

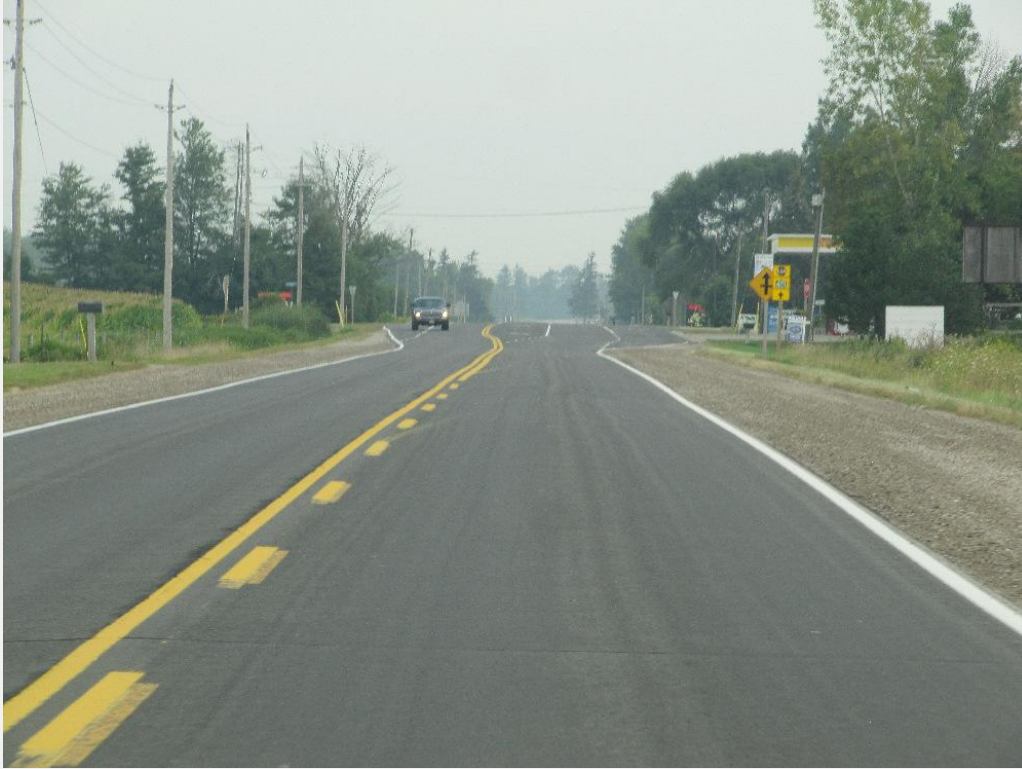
Northward view along Wellington Road on approach to the intersection with Ferguson Line.

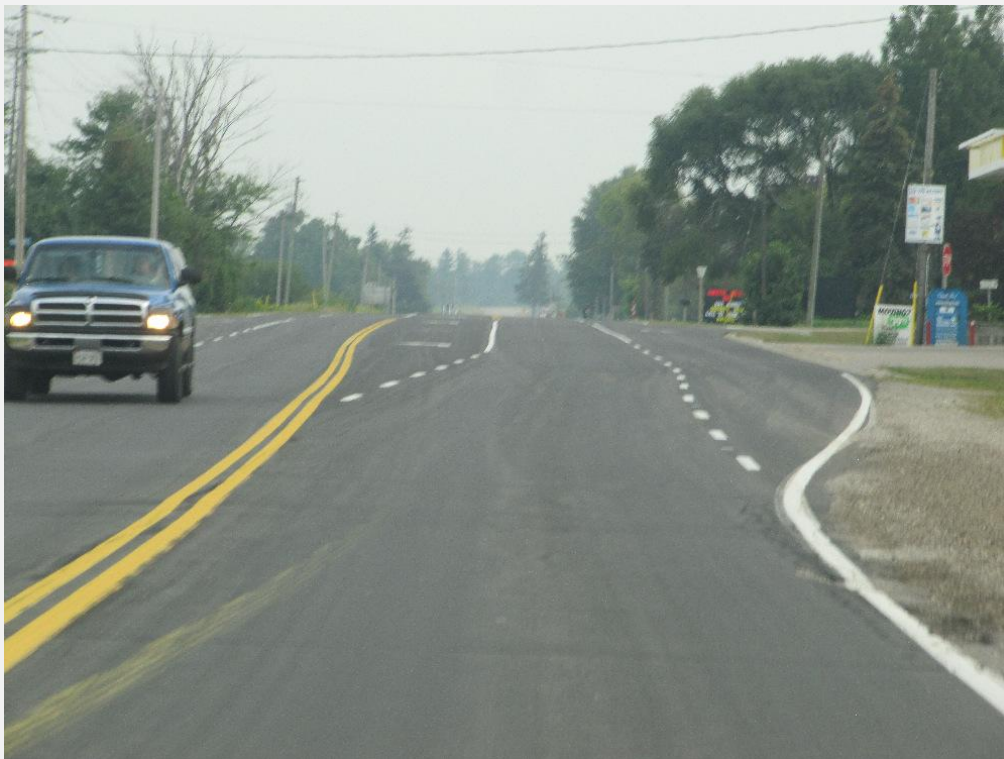
Northward view along Wellington Road on approach to the intersection with Ferguson Line.

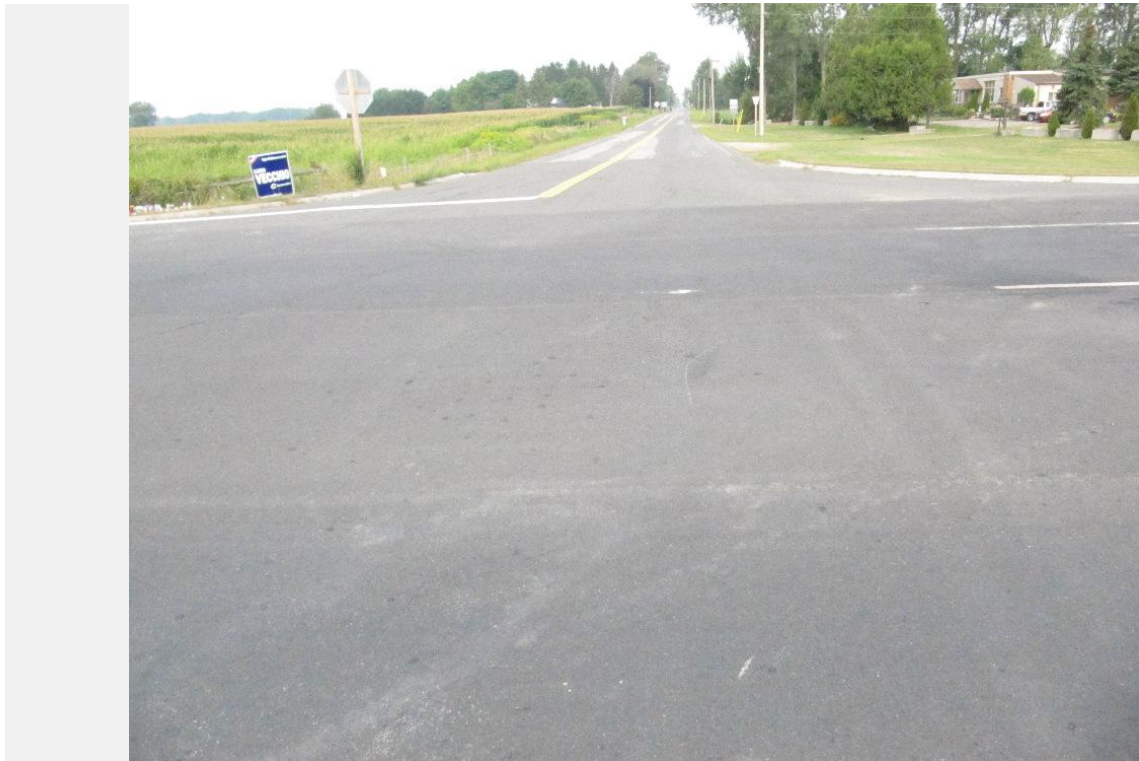
For example, the photo below is a view looking westbound at the intersection of Ferguson and Wellington from a couple of days after the collision. Collision evidence exists in this photo that might not be apparent at first glance. To orient readers to the location of that evidence we first need to focus on a spot of white, flare debris located approximately in the centre of the photo below.

View, looking west within the intersection of Ferguson Line and Wellington Road. The remnants of white residue from a police flare can be seen in the centre of the photo and this residue is located at the west side of the northbound left turn lane of Wellington Road.

Such white powder is typically found at collision sites where police have laid a flare that slowly burns off and leaves the white powder. This spot of white powder is located at the west edge of the left turn lane for northbound vehicles on Wellington Road. In other words, the photo above shows the direction in which the pick-up truck was travelling and this pickup truck would have passed through the northbound right turn lane, then it would pass through the northbound through lane and finally it would reach the

northbound left turn lane. The flare deposit would be located at the far edge of that northbound left turn lane.

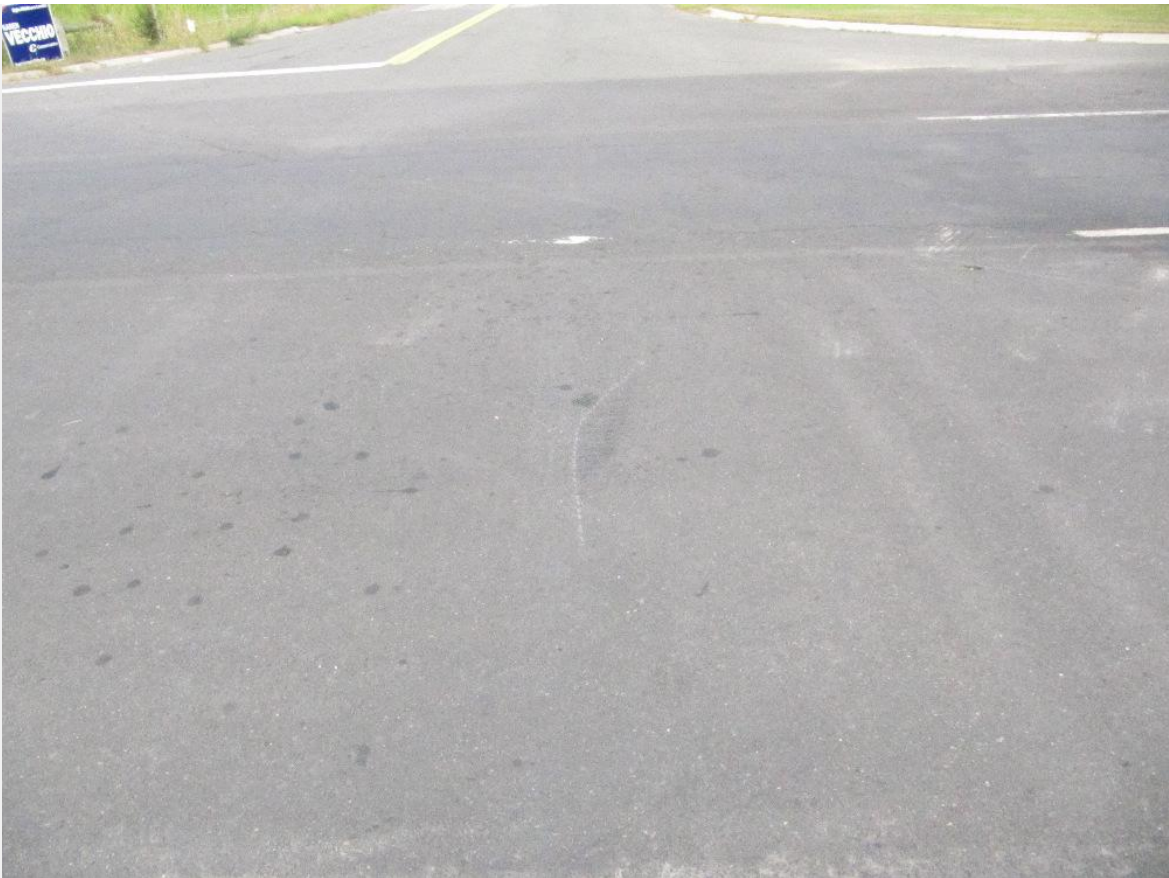
The next photo takes us closer to that spot of white flare residue and now we might begin to see a short length of tire mark approximately in the middle of the photo. This short tire mark has some striations within it and it is accompanied by a thin scratch in the pavement. Such striated tire marks occur within the area of impact as a vehicle is struck in the side and it begins to rotate while also continuing its forward motion. Thus we are saying that this mark was likely caused by one of the tires of the pick-up truck in the approximate area where it was struck in the driver's side by the motorcycle.

Closer view, still looking westward, while approaching the spot of white residue from a police flare.

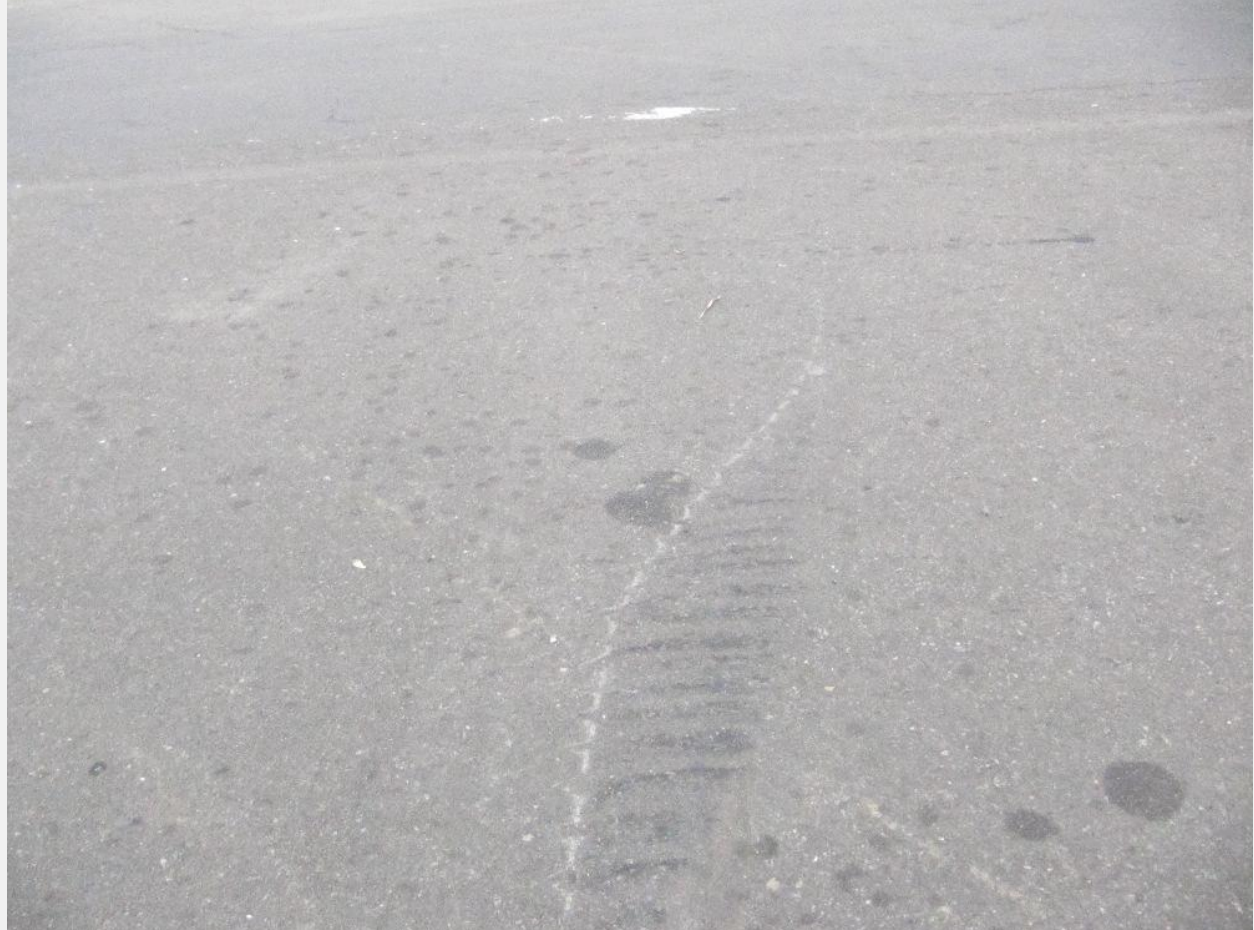
Close-up view of the short tire mark with striations and the thin scratch in the pavement.

Thin scratches in the pavement located next to such a striated tire mark are often caused by the contact of a wheel rim. Thus, at an impact a tire become compresses and the outer edge of its tread and sidewall will produce the tire mark and while this compression occurs the rotating rim also makes contact with the pavement leading to that scalloped, repeated and intermittent scratching as seen in the photo above.

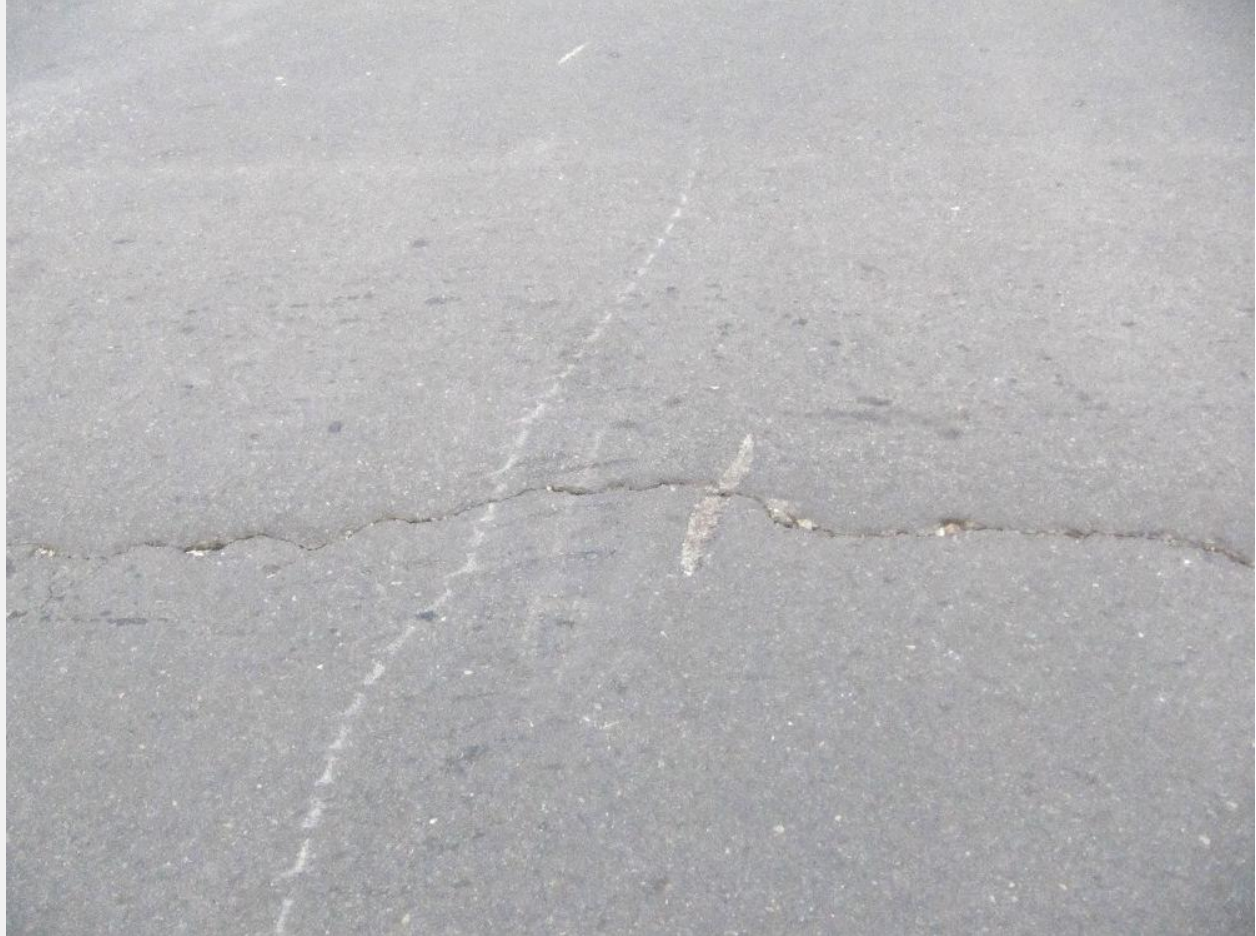
Another similar, short tire mark existed in the northbound through lane as shown in the photo below. One might be tempted to believe that this mark was caused by the right rear wheel of the pick-up truck while the previous one was caused by the right front wheel.

Another short tire marks with striated markings within it was present in the northbound through lane as shown in this view, looking westbound.

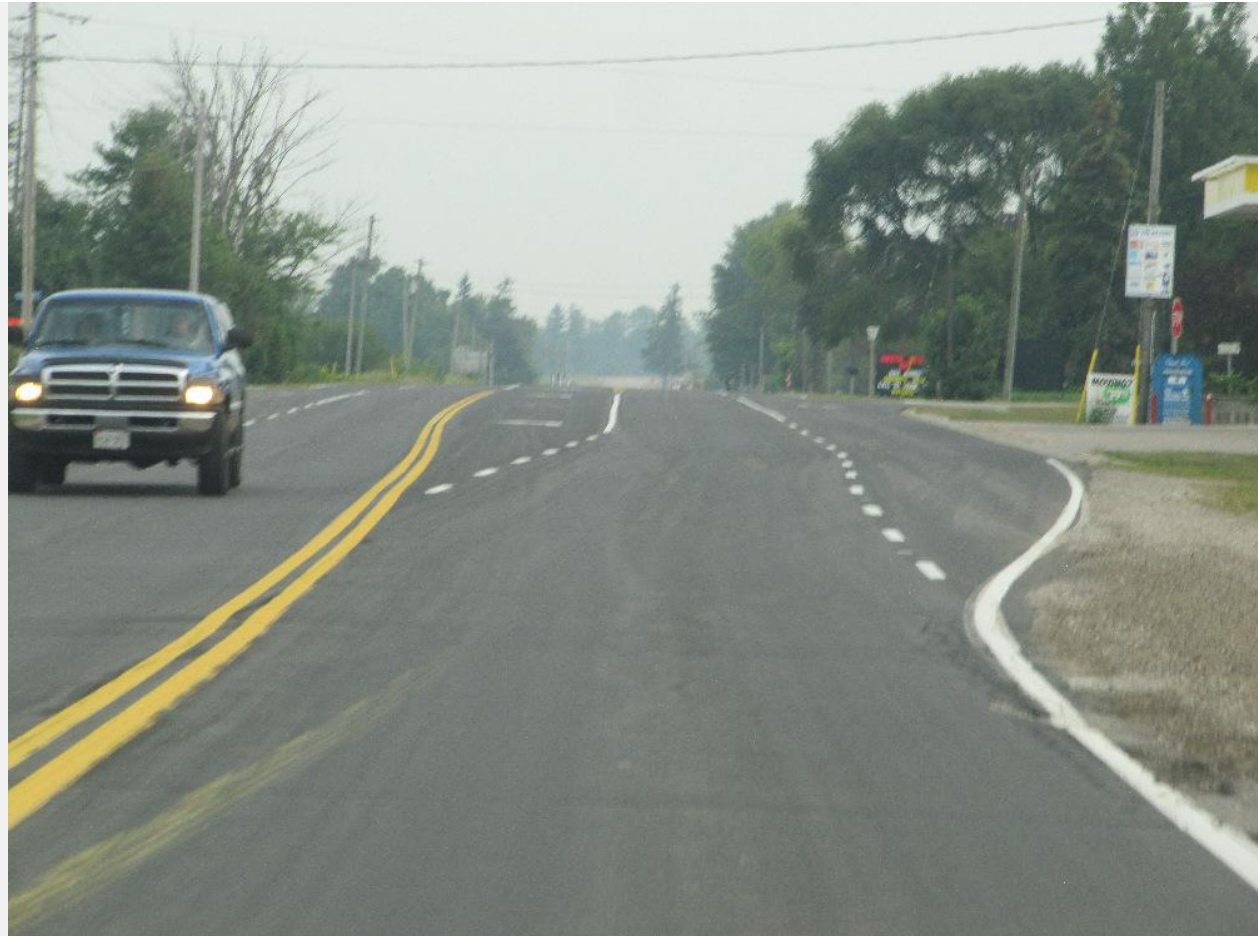
However the most likely scenario is that the front end of the pick-up truck was likely well into the northbound left turn lane of Wellington Road when the impact occurred. This is not a revolutionary comment, as can be seen when one examines how the northbound through lane of Wellington Road jogs to the right slightly at the intersection as shown in the photo below.

If we imagine the motorcycle travelling straight within the left third of the northbound lane, without steering, this photo demonstrates that the motorcycle would travel into the left turn lane which juts out into the path of the through lane at the intersection.

Thus, by simply travelling straight ahead, without steering, the motorcycle would be placed in the northbound, left-turn lane of Wellington Road, which is where the physical evidence suggests that the impact occurred.
