What Caused an OPP Police Cruiser Impact With a Tree on the Exit Ramp From Highway 401 Near Ingersoll Ontario - Part 1 of 2

Posting Date: 24-Dec 2013

This article is Part 1 of two articles discussing our evaluation of a collision involving an OPP cruiser collision that occurred on the westbound off ramp of Highway 401 at Plank Line, on the outskirts of Ingersoll, Ontario on December 18, 2013. This article will focus on a review of the physical evidence. The follow-up article, Part 2, will discuss some of the testing that was performed to provide further information about the collision.

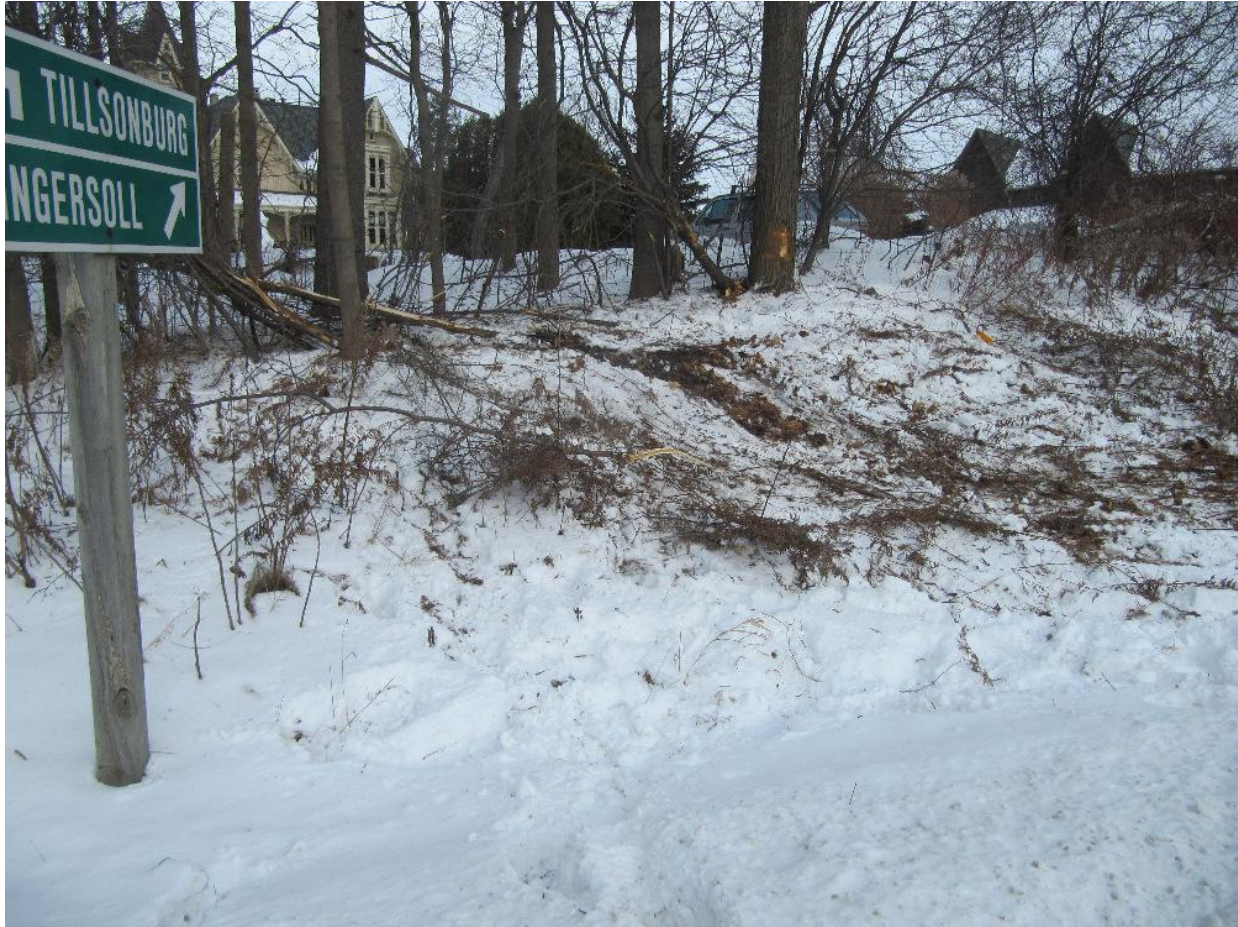
Figures 7 and 8 show the view as we walked along the north side of the ramp and toward the area of the tree impact. Figures 9 and 10 show the physical evidence as we approach the area of impact. It can be noted how there is an upslope in the ramp on approach to the impact and there is an additional upslope of the ditch to the impact at the tree. These facts are of concern when we consider the speed that the cruiser must have possessed when it travelled through this area.

Figure 10: View, looking northeast toward the area of impact on the north side of the ramp.

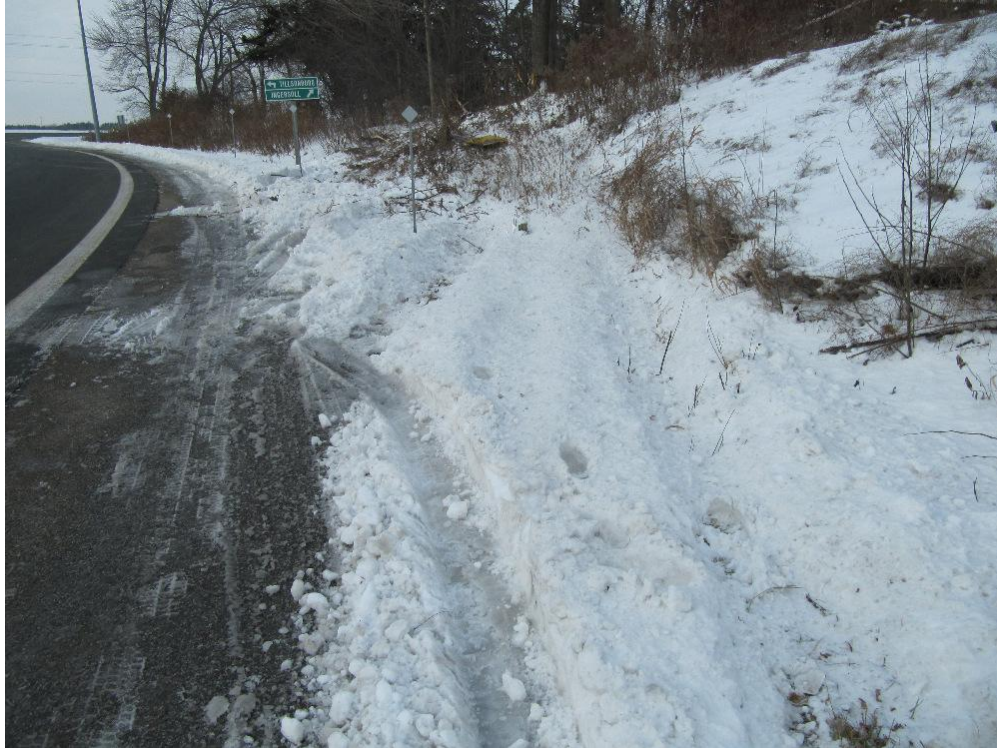
In Figure 11 we progress past the area of impact, so the view is now from the east and looking west, or in the direction that the police cruiser was travelling. We now see the tire marks of the cruiser in the snow as it exited the paved ramp in the foreground, proceeded up the upslope of the roadside and collided with a tree and other objects in the background.

Figure 11: View, looking west, from the location where the police cruiser travelled off the paved ramp and onto the north roadside where it collided with a tree and other objects in the background.

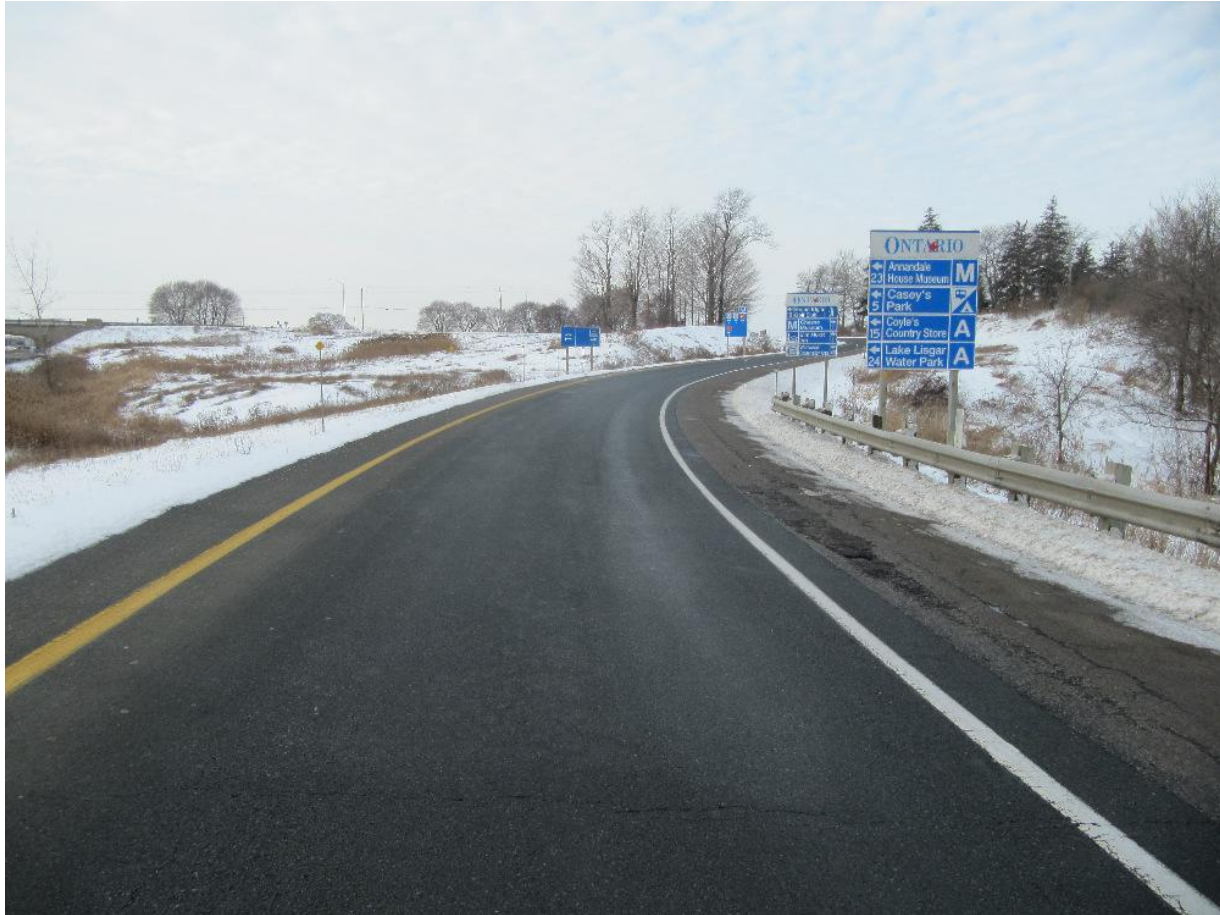
Figure 13: As drivers travel around the right curve of the ramp there is a location where they are unable to see the right (north) shoulder of the ramp because there are two large, blue signs on the north road side.

Figure 13 demonstrates that, as drivers travel through the ramp there is a location where they are unable to see the north shoulder because there are two, large, blue signs on the north roadside that block the drivers' view of that shoulder. With respect to the cruiser collision, it is possible that the Ford Fusion was located on the north shoulder in the vicinity where its presence was blocked from view by the signs. This would mean that the police officer might not have been able to see the Ford Fusion for a brief period but it also demonstrates that the driver of the Ford Fusion was also not able to see the cruiser's approach. Figure 14 shows another example of that short-term view obstruction.

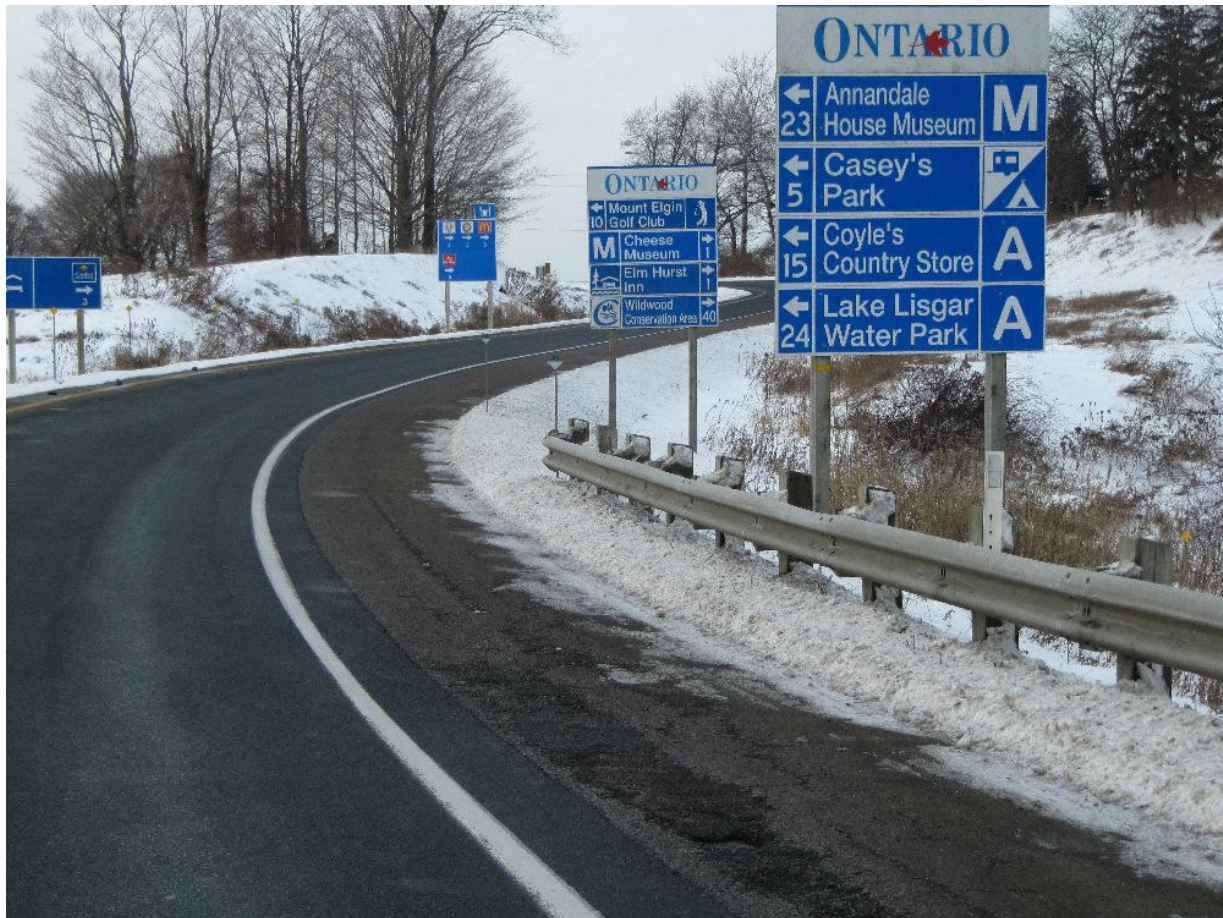
Figure 14: View, looking west along the ramp showing that the two, large, blue signs on the north roadside could produce a temporary view obstruction of a vehicle parked on the north shoulder of the ramp.

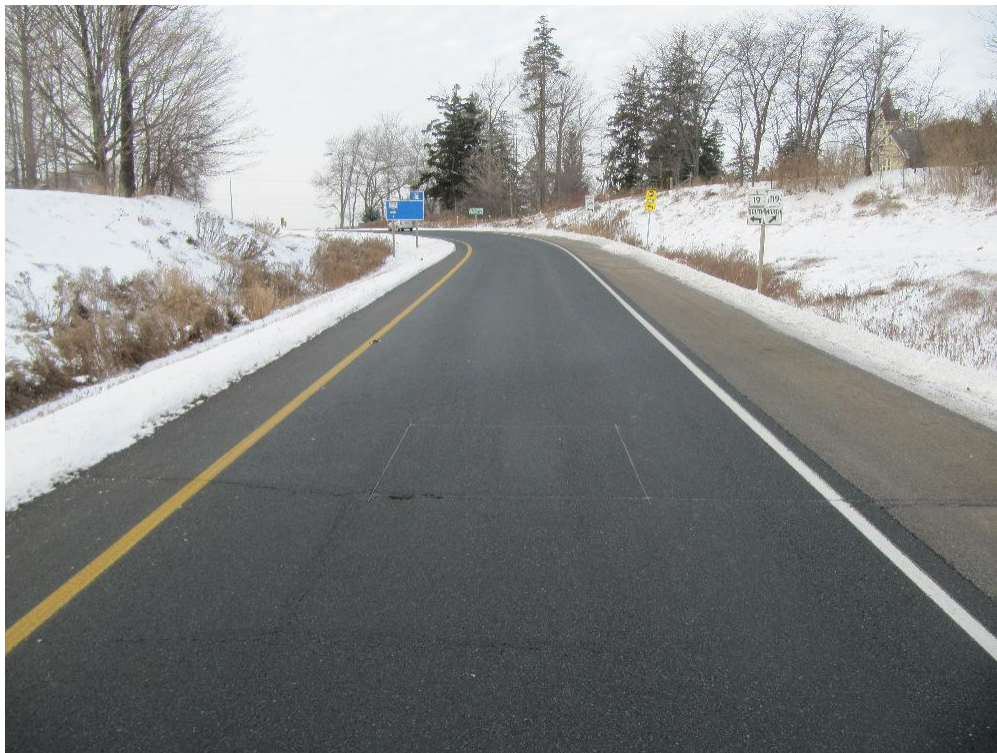
Figure 16 provides another view of the ramp in its straight section before it curves to the left. If the Ford Fusion existed then we do not believe that it would have been stopped further east (i.e. closer to the camera) than the white directional sign on the right (north) roadside that is presently closest to the camera. It would more likely be closer to the yellow sign further to the west. This is our judgment considering that the cruiser left the roadway just before the green directional sign in the distant background. So the Fusion would be parked in the vicinity of where the ramp began its left curve.

Figure 16: View, looking west, along the straight section of the ramp. If the Fusion existed then our best estimate is that it was parked near the vicinity of the yellow sign located on the north roadside.

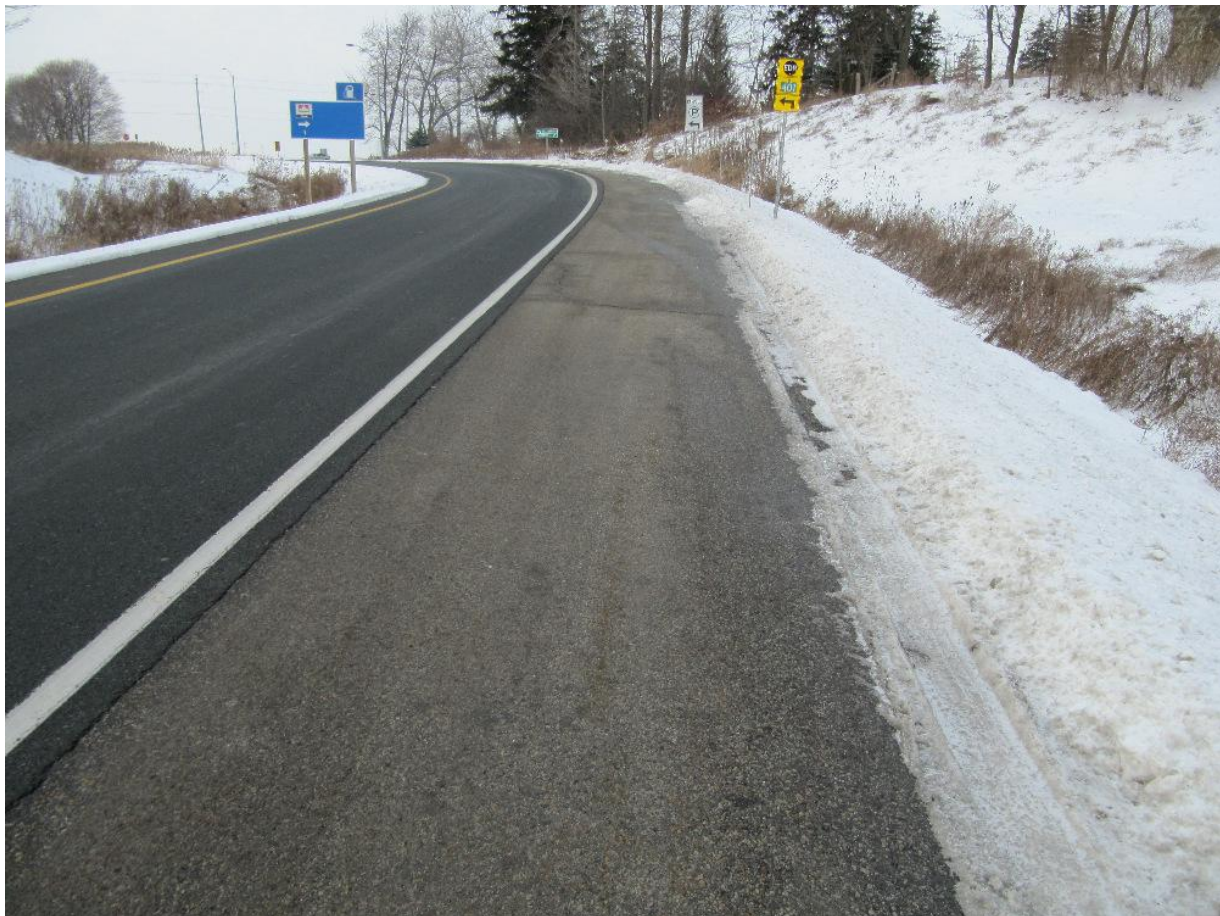
Figures 17 and 18 show the north roadside just east of that yellow sign. There is evidence there of some fresh disturbance of the snow, from at least one vehicle, but it would be difficult to say whether some of these marks could be related to the mystery vehicle. This would be speculative, since there are numerous such marks further to the west likely from various emergency vehicles that would have parked there after the collision. Figure 19 shows another view of those fresh marks from just past the anchor post of that yellow sign. In Figure 20 we turn around to face east, from the location of that anchor post, and show the characteristics of those fresh tire marks in the snow.

Whether the Ford Fusion existed or not, there is nothing in the evidence near this yellow sign that would confirm its existence. There is no deposit any black tire rubber that might confirm the rapid acceleration of such a vehicle.

Figure 17: View, looking west, at the north roadside just east of the yellow sign where we expect that the Fusion was parked on the paved shoulder.

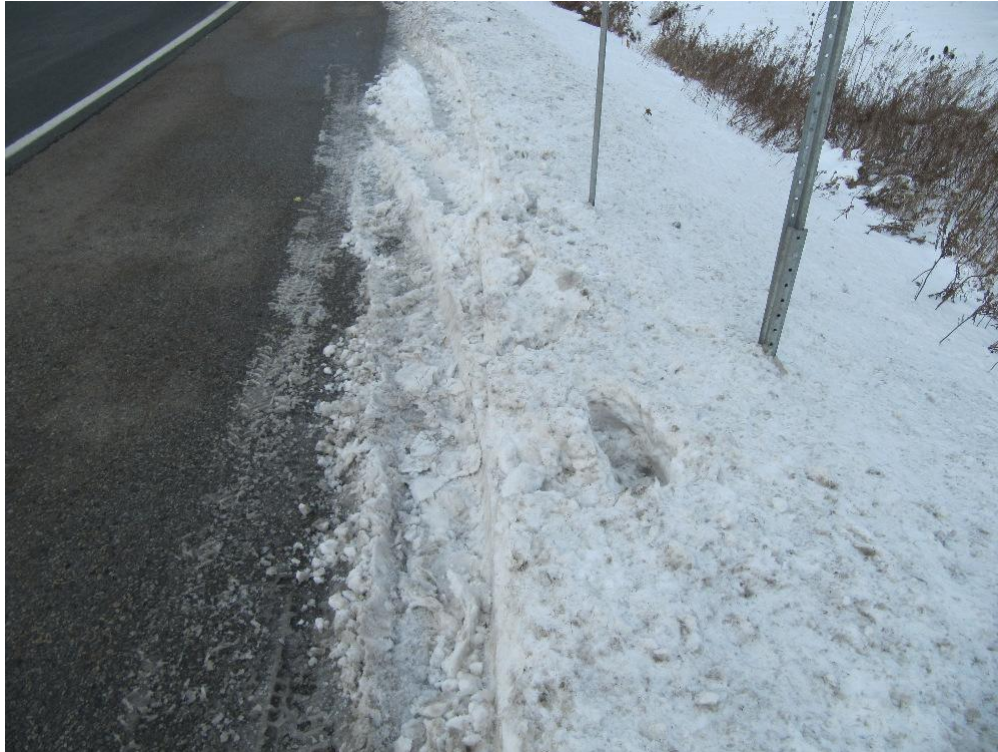
Figure 18: View looking at some fresh snow disturbance in the vicinity of the anchorage post of the yellow sign where we estimate that the Fusion was parked before it accelerated onto the ramp.

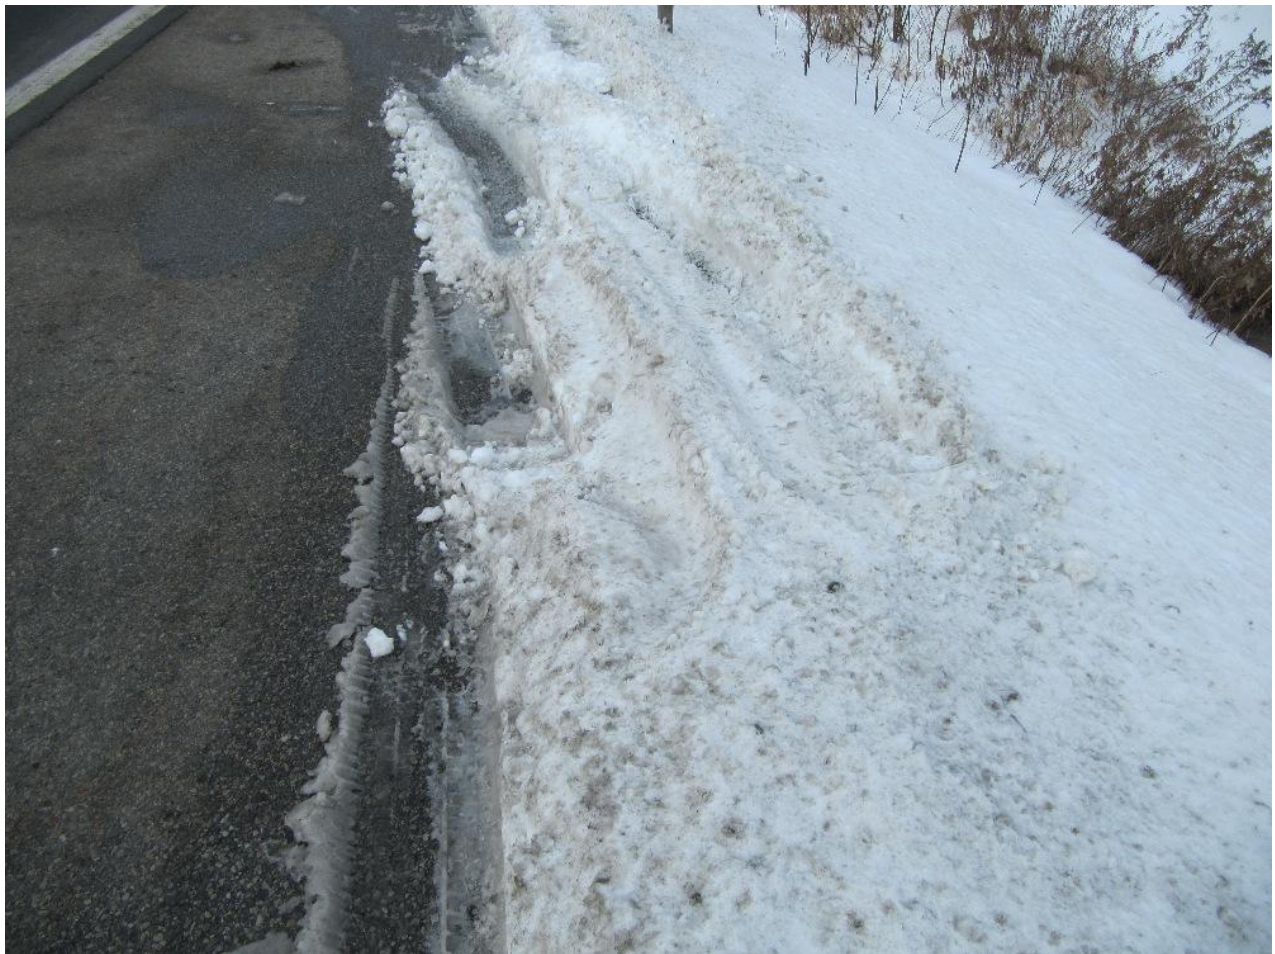
Figure 22 provides a close view of the east end of those tire marks. They indicate the presence of more than one vehicle or that the same vehicle was on the shoulder more than once. But certainly there is nothing about these marks that could lead us to the conclusion that they came from the mystery Fusion vehicle.

Figure 22: View of the east end of the fresh tire marks that exist near the white parking sign.

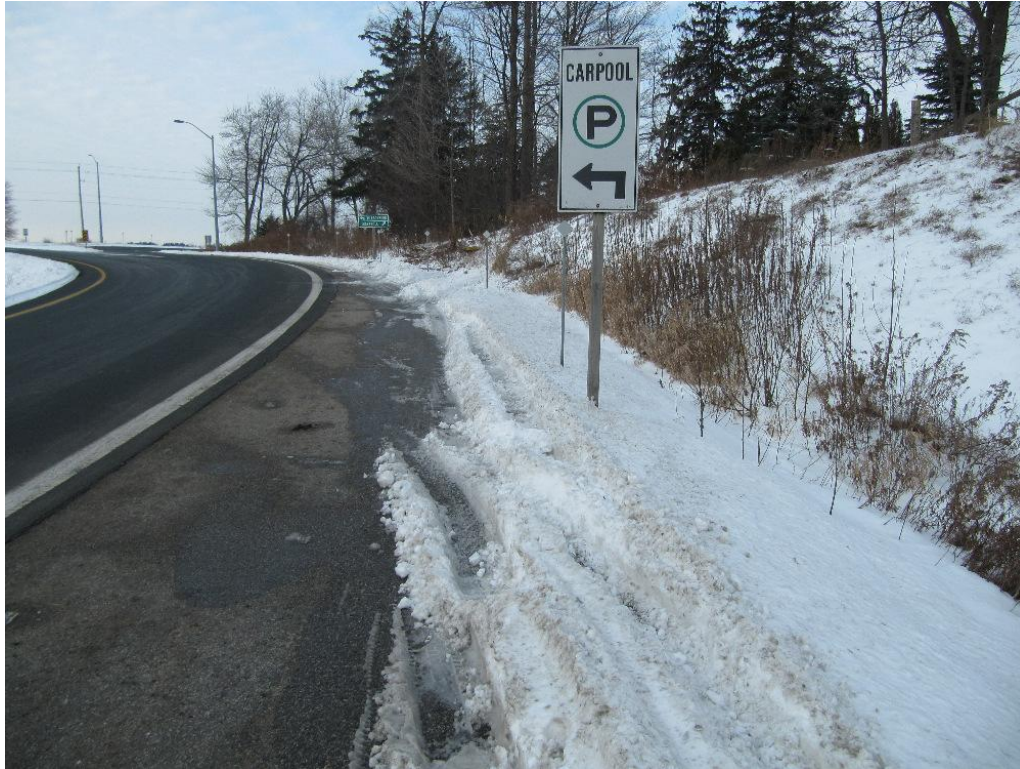
Figure 23 shows that tire marks exist from this white parking sign all the way to the point where the cruiser left the paved road surface and we would expect that many emergency vehicles would be located here. Again, there is nothing in this evidence that can be used to confirm the presence of the Ford Fusion.

Figure 23: View, looking west, toward the white parking sign and the evidence of numerous tire marks leading to the location where the police cruiser left the paved ramp.

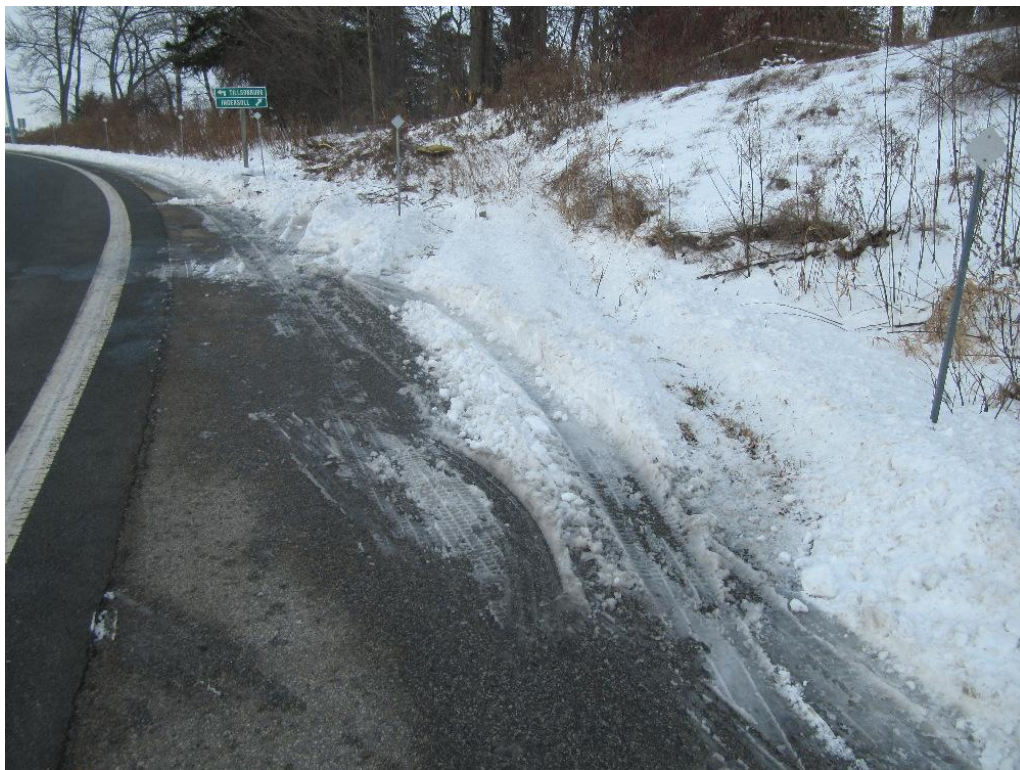
Figure 24 shows that the evidence of the cruiser's entrance into the ditch is located on the right and the marks created during pulling the cruiser back toward the road after the collision are on the left.

Figure 24: View, looking toward the north ditch at the location where the cruiser exited the paved surface.

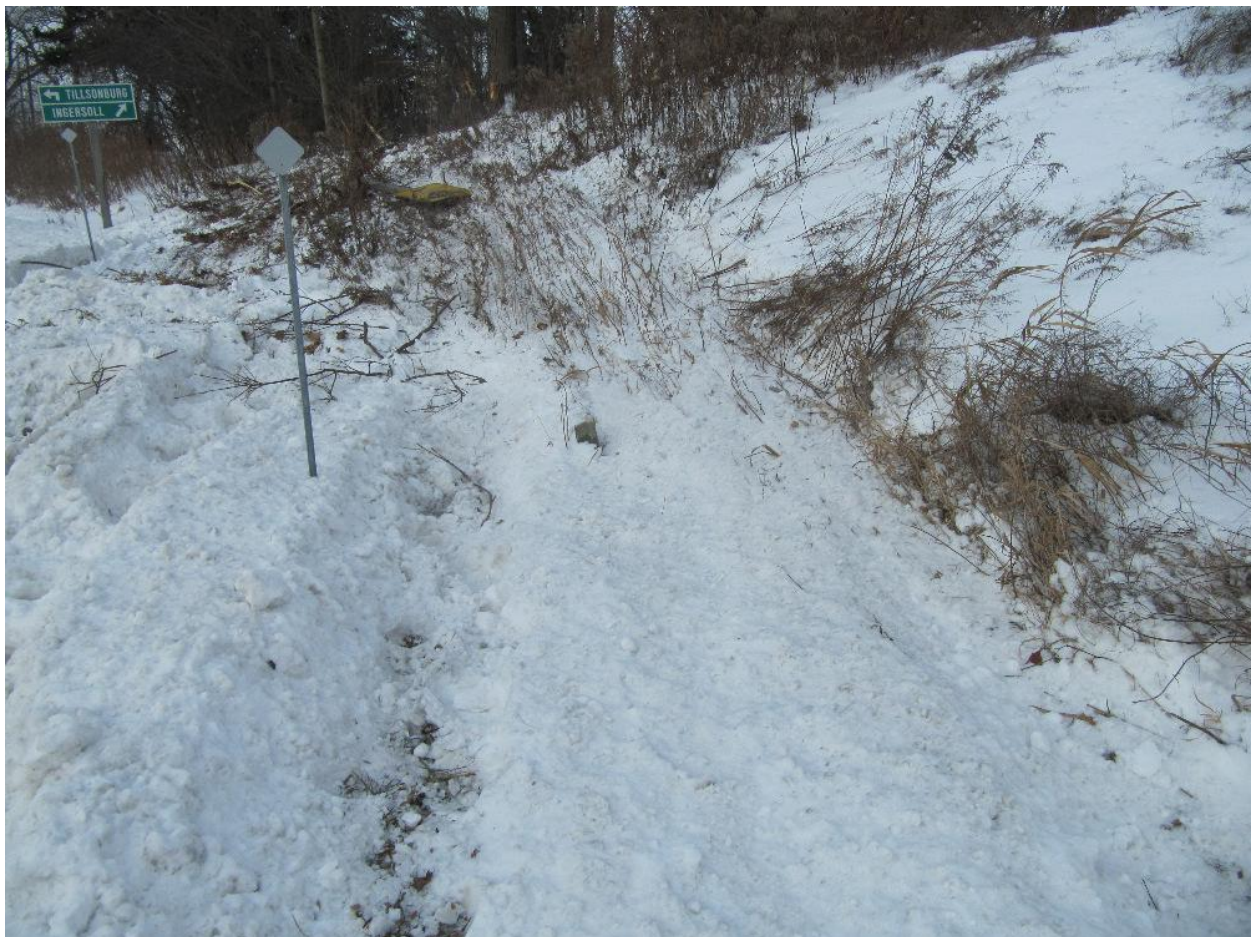
The extent of the deceleration of the cruiser though the snow can be appreciated by the fact that its undercarriage was in contact with the deep snow as evidenced in Figure 25. We must also consider that it would take more speed for it to travel up the embankment in the background than if it was travelling over level ground.

Figure 25: View of marks in the snow showing how the cruiser plowed through the deep snow such that the marks from its undercarriage can also be seen in the snow.

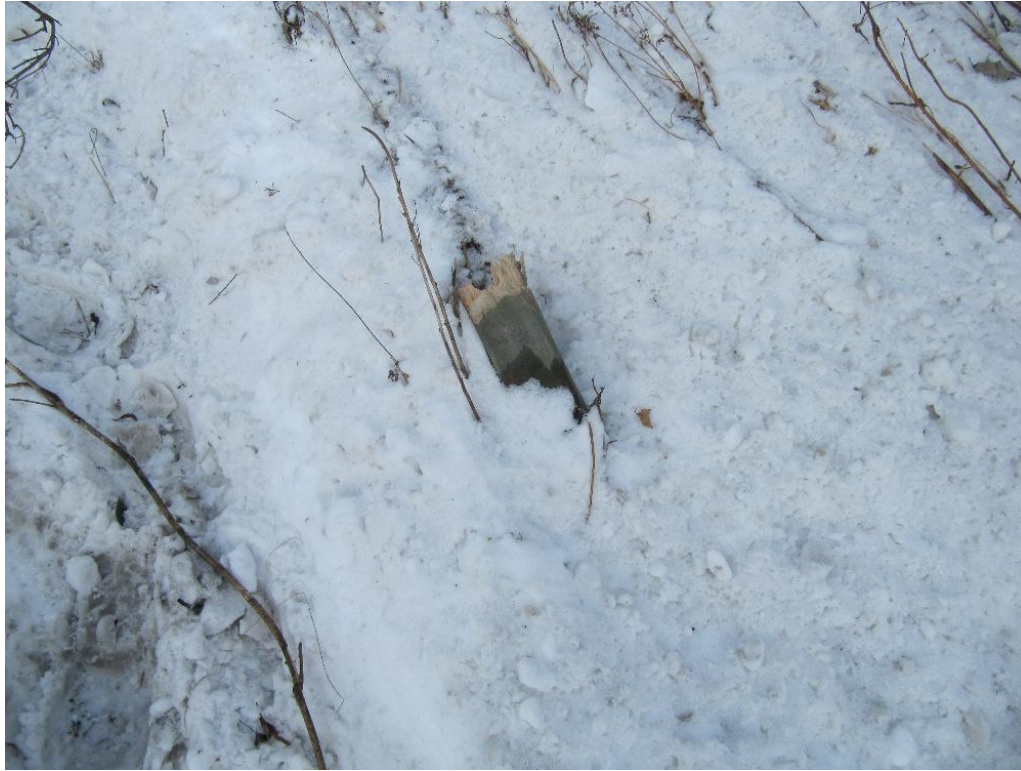
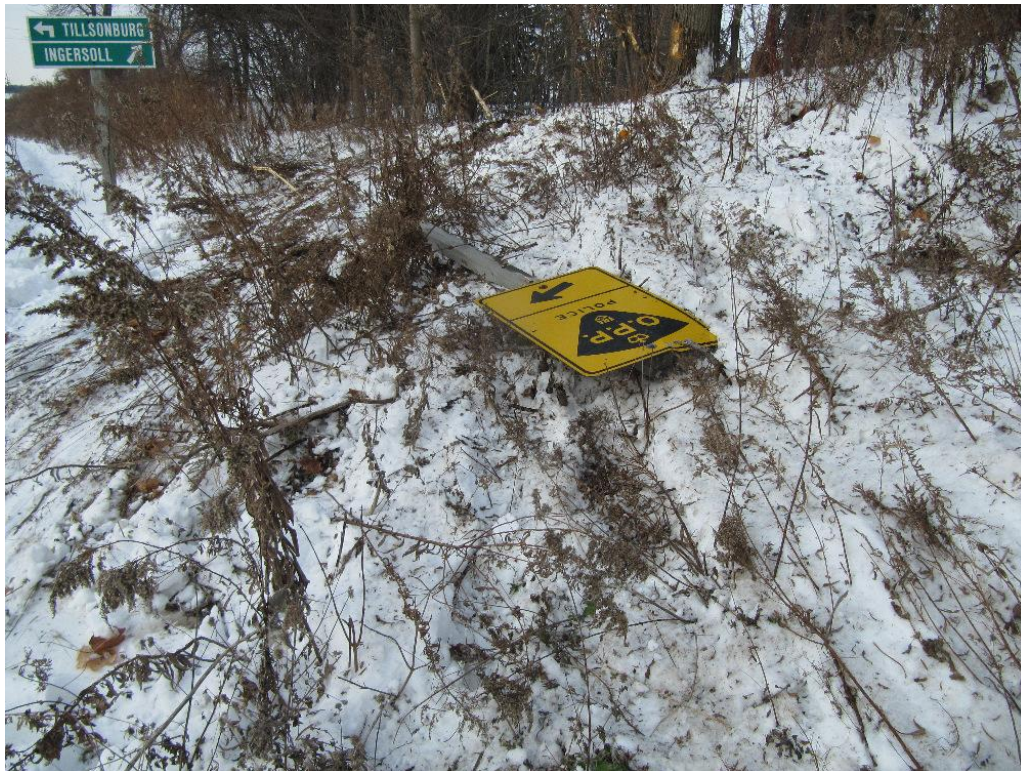
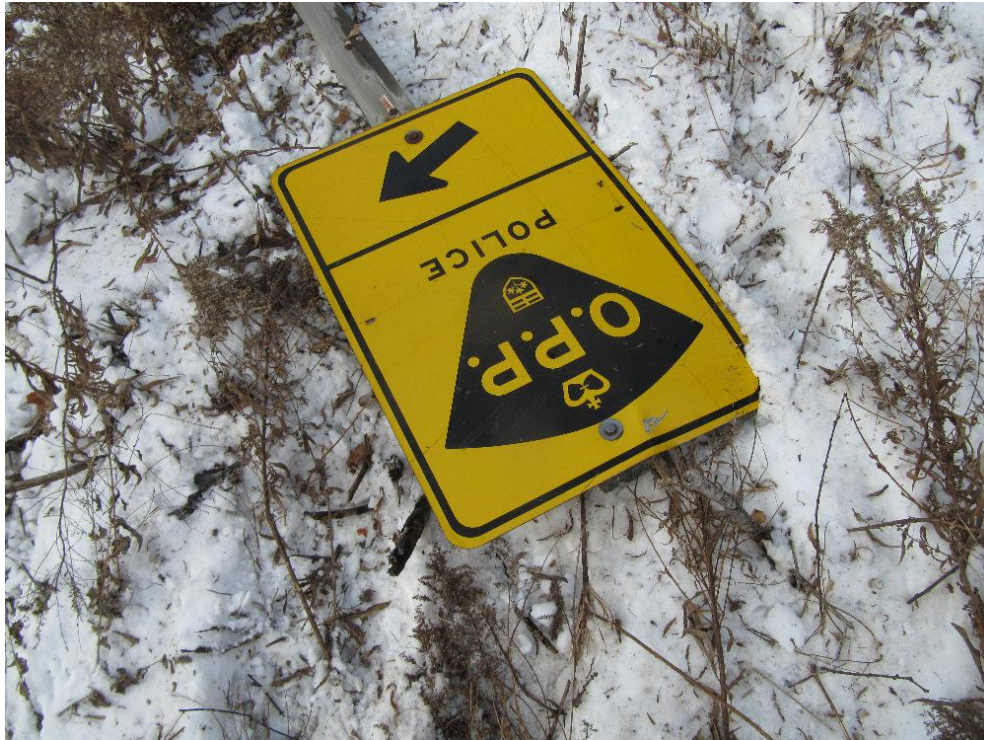
Figures 26, 27 and 28 show that, along its travel path, the cruiser also knocked down an "OPP" sign that was thrown up the embankment.

Figure 26: View of the anchor post to the "OPP" sign that was knocked over.

Figure 27: View of "OPP" sign that was knocked down and thrown up the slope.

Figure 28: View of "OPP" sign that was knocked over by the cruiser as it travelled through the embankment.

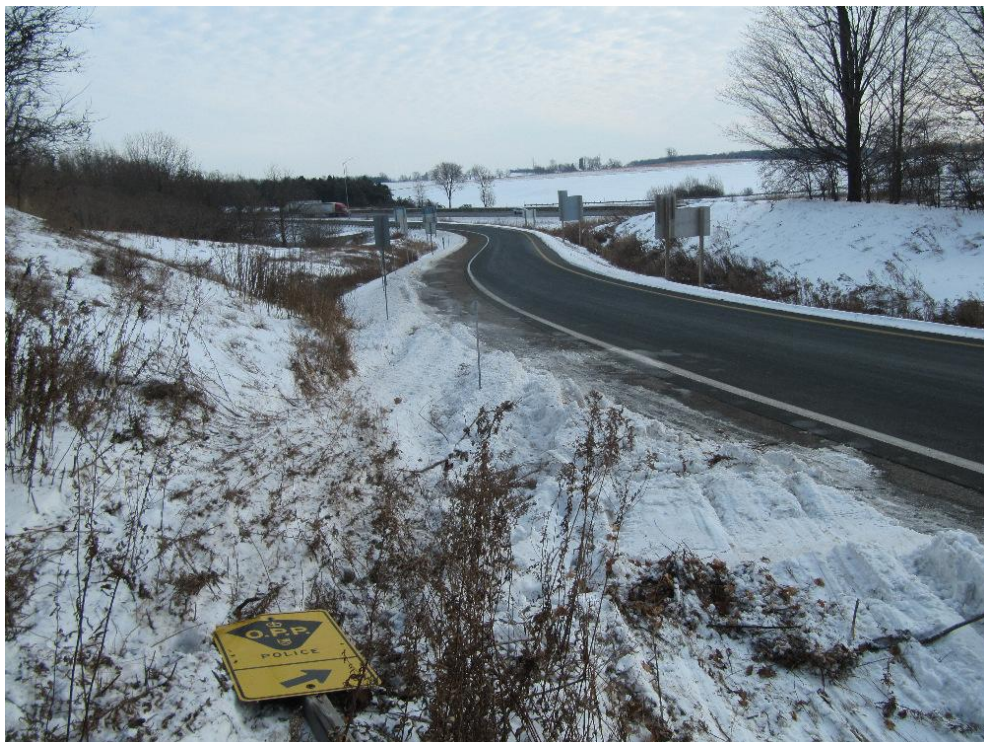
Figure 29 provides an overall view of the path of the cruiser as it travelled up the embankment with a view of the ramp road in the background and the markings in the snow that showed how the cruiser plowed through it.

Figure 29: Overall view, looking from the stop of the embankment, at the path taken by the cruiser as it left the ramp road and plowed through the deep snow.

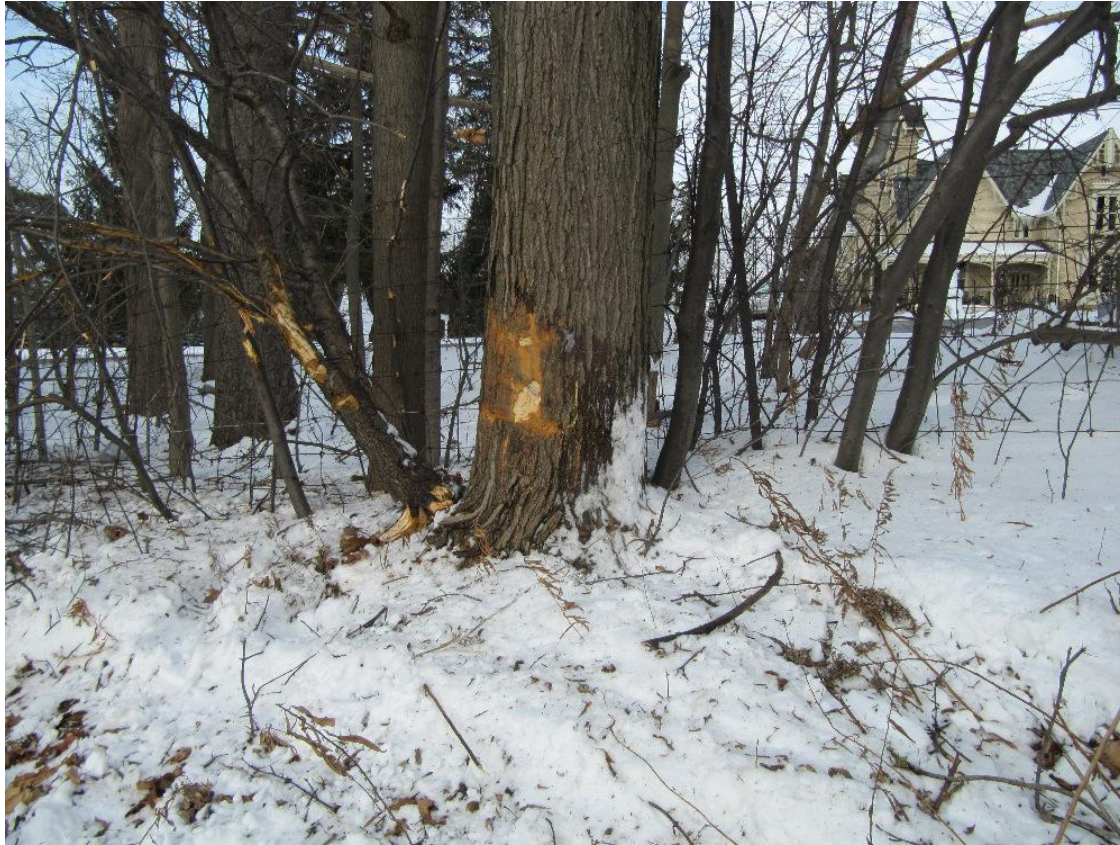
While the official story given to the news media was that the cruiser collided with a tree, Figure 30 shows that the tree that was struck was only grazed and that the cruiser continued to travel into the brush where it struck a number of saplings and a fence.

Figure 30: View, looking at the tree that was grazed by the cruiser before it carried on to make other impacts in the vicinity.

So, in the present instance, it was sheer luck that the police cruiser only grazed the large tree shown in Figure 30 because, if there had been a central impact, the tree was not going to move, and the cruiser was definitely going to stop in a very quick hurry. It was clear from the remainder of the evidence that the cruiser still had a substantial amount of speed left over after it mounted the top of the embankment so that a central impact with the tree would have been a major problem because of its severity.

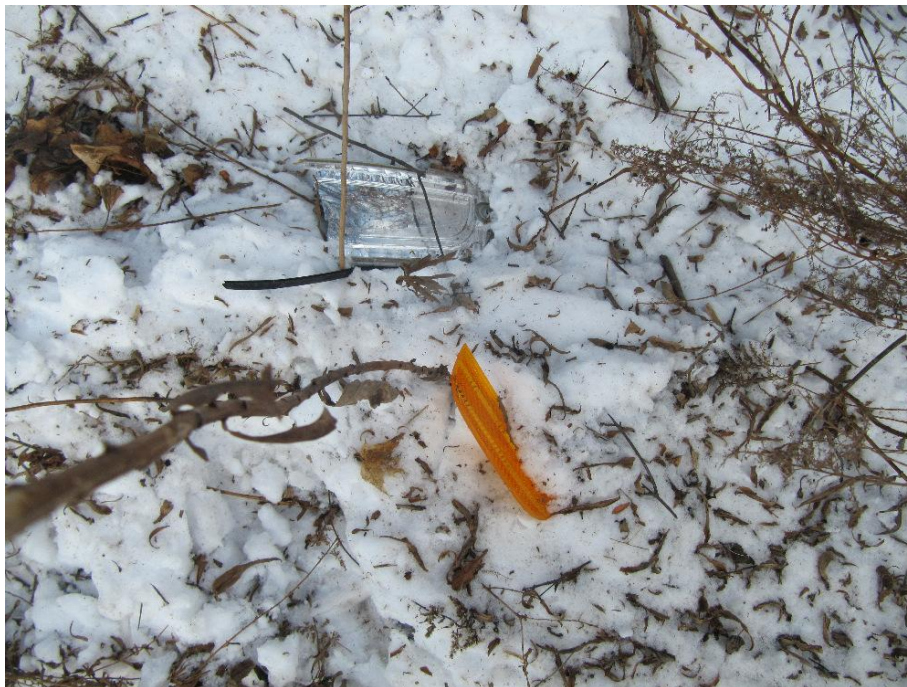
For example, we found a couple of pieces of debris near the tree impact, as shown in Figure 31. Even if you do not study damaged parts for a living it is not difficult to look at these parts and determine that they came from either the left or right front corner of the cruiser, as they are from the signal light of the vehicle. Looking at the markings on such debris can provide further clues about the type of vehicle involved. So in Figure 32 we can see that on the back of the silver piece of debris shown in Figure 31 there are some markings that indicate that the part came from a Ford Crown Victoria, which is the standard vehicle that has been used by police forces in North America in recent years.

Figure 31: View of signal light debris from the cruiser lying near the base of the struck tree.

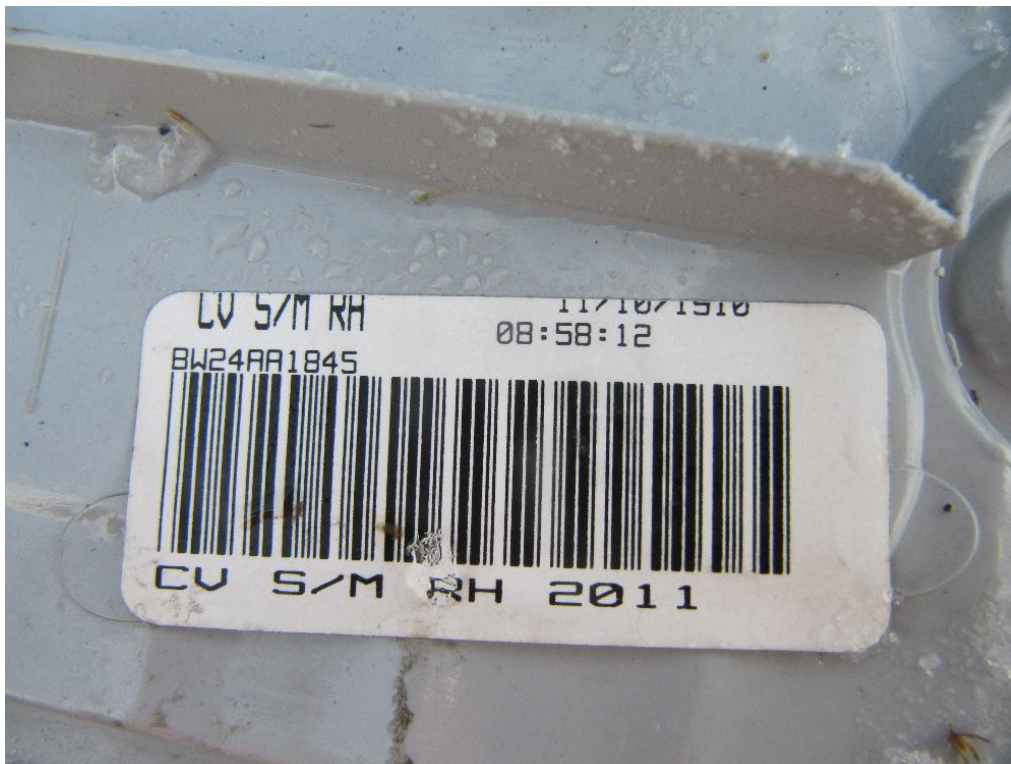
In another area of that debris we see a label as shown in Figure 33. Part of the writing on this label indicates "RH 2011". This may indicate the year in which the part was made and that it was made for the right hand side of the vehicle. It is possible that this Crown Victoria was a 2011 model year or later and that the right front portion of the vehicle was damaged in the area of the base of the tree. This cannot be believed with certainty without having an intimate understanding of the markings, however this understanding is consistent with what we would expect from examining the evidence.

Figure 33: View of label on the back of the debris indicating "RH 2011".

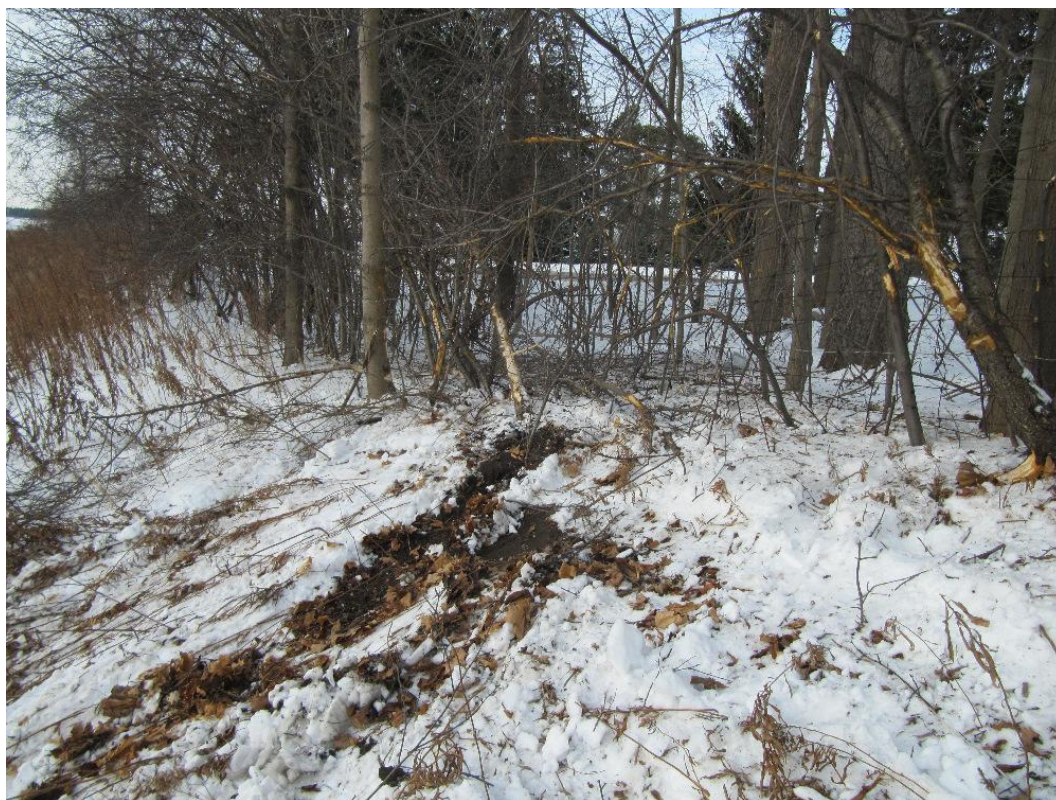
Returning to the evidence around the tree impact, there was a considerable amount of damage visible to the various saplings and brush at the line of a wire fence, just to the west of the impacted tree. Figure 35 provides a general view of that damage.

Figure 35: View of the general damage exhibited by the various saplings and brush just to the west of the impacted tree.

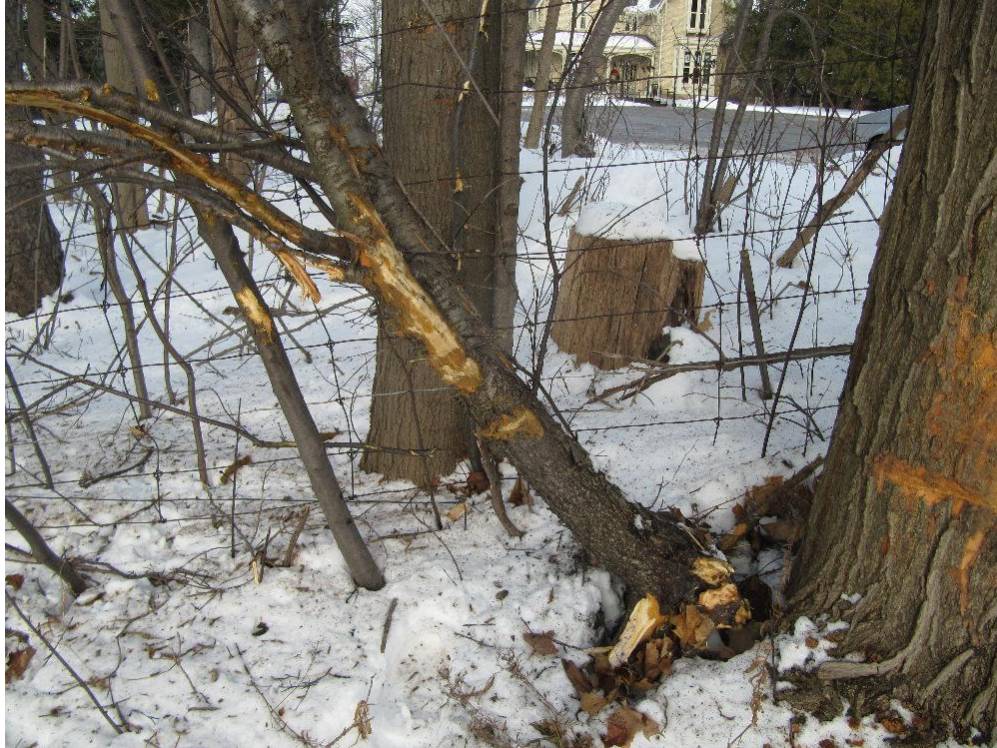
Figure 36 provides a further indication of the damage to the saplings just west of the tree. If one looks closely you might see that the wire fence was pushed against the trunk of the tree in the centre of the view and the this caused markings on the trunk in the areas of the wire contact.

Figure 36: View of the damage to a sampling located just west of the struck tree and the evidence that the wire of the fence was compressed against the trunk of the tree in the centre of the view.

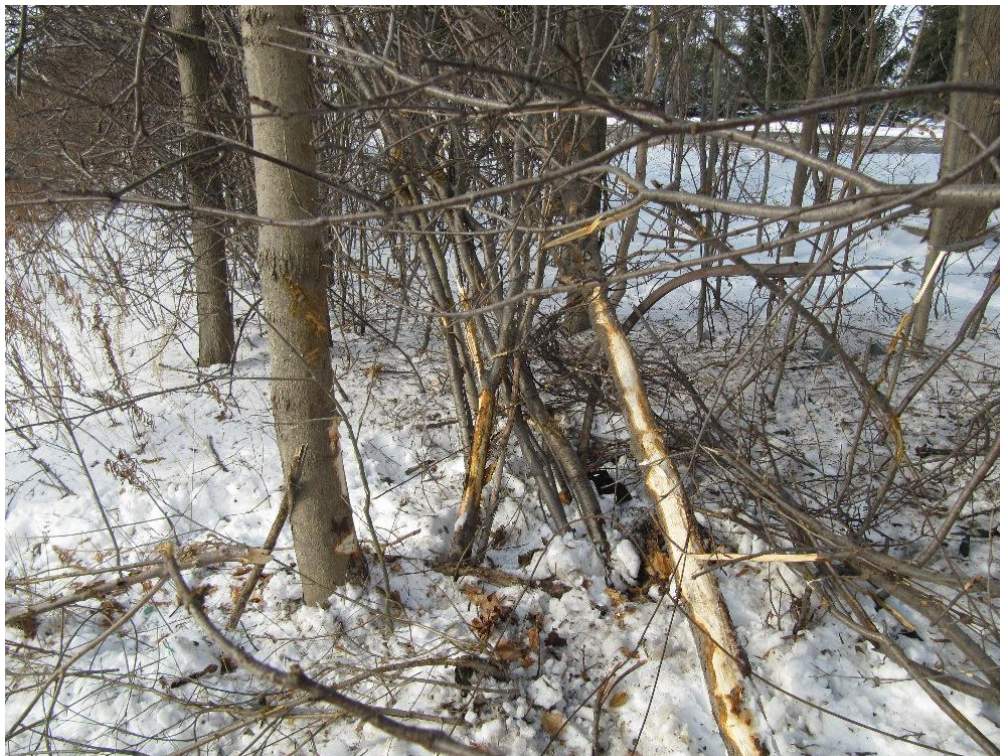
Figure 37 provides a view of the damage at the final rest position of the cruiser. What may be difficult to detect is that there is metal anchor post from the fence that is somewhat hidden by the other narrow, vertical objects in its vicinity and this metal post shows an extreme bend in it. Figure 38 provides a closer view of that metal post.

Figure 37: Vie of the damage evident near the final rest position of the police cruiser.

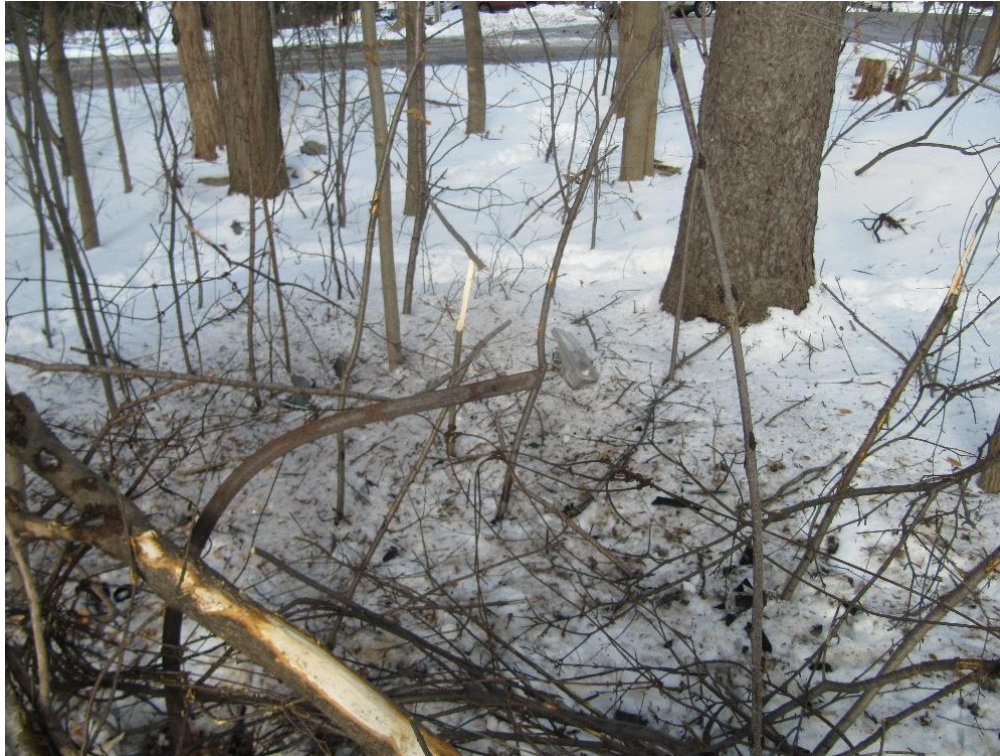
Our point is that the various saplings and underbrush, including the wire fence, acted as a "catcher's mitt" in capturing the vehicle and bringing it to a stop over a relatively prolonged time and distance which was beneficial to the officer's health. This action is not much different than the action of a guardrail or other barrier system on the roadside that is made to collapse its anchorages and deflect to bring a vehicle to a gradual stop. There was considerable energy lost during this action and there was considerable speed lost by the cruiser during this action but the acceleration pulse would have exhibited generally lowered levels of deceleration due to that extended time and distance of deceleration.

Figure 38: Closer view of the bent, metal, anchor post the wire fence at the final rest position of the police cruiser.
