Duplication of Tire Marks Observed On A Gravel Shoulder Through Controlled Testing

Posting Date: 17-Dec 2013

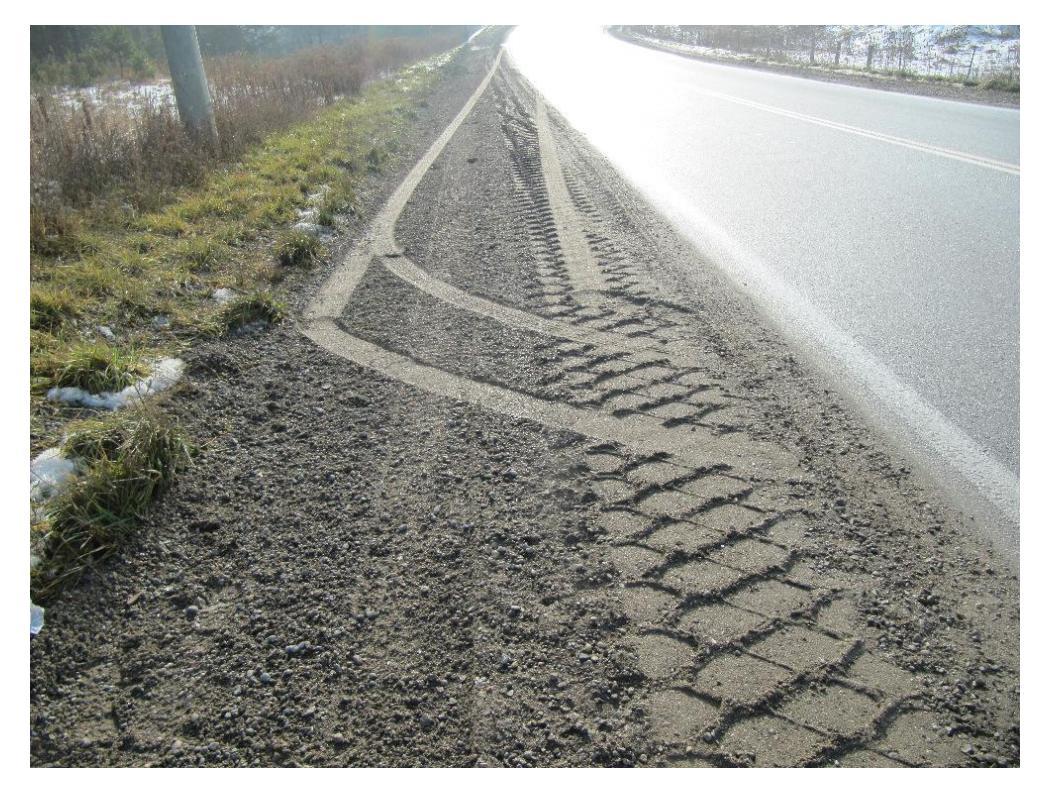
Figure 1 shows a view, looking southward, along the east gravel shoulder of Clarke Road, where the northbound vehicle travelled onto that shoulder, likely stopped, and then performed a sharp left turn to make the U-turn. These tire marks were clearly visible because of the looseness of the gravel caused by recent re-grading. This set of tire marks overlaps a tire mark produced by a large, tractor-like vehicle that has passed through the shoulder at an earlier time.

Figure 1: View, looking southward along the east shoulder of Clarke Road where a vehicle produced tire marks before making a sharp U-turn.

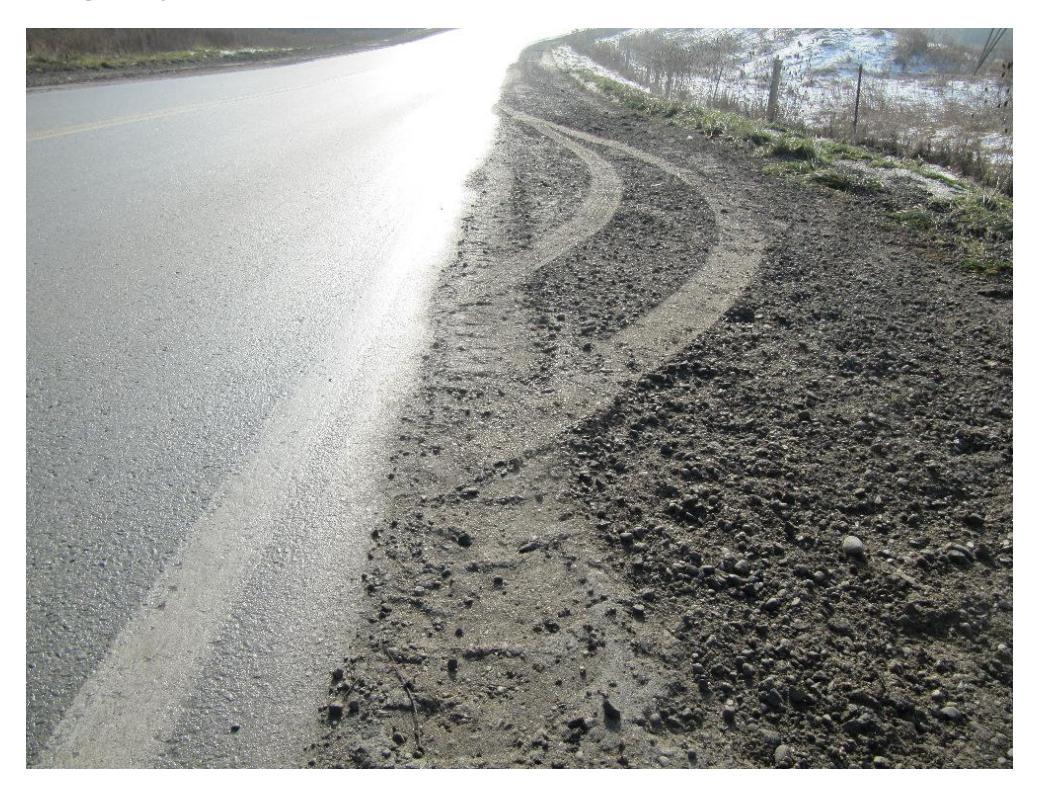
Figure 2 also shows a southward view of the same curve but it is a view of the opposite, west shoulder, where it can be seen that, as the vehicle made the U-turn, its right side tires travelled onto the west shoulder and produced the clearly visible tire marks shown in this figure.

Figure 2: View, looking south, of the west shoulder of Clarke Road where the U-turning vehicle's left side tire produced the tire marks as it returned to travel back southward from where it came.

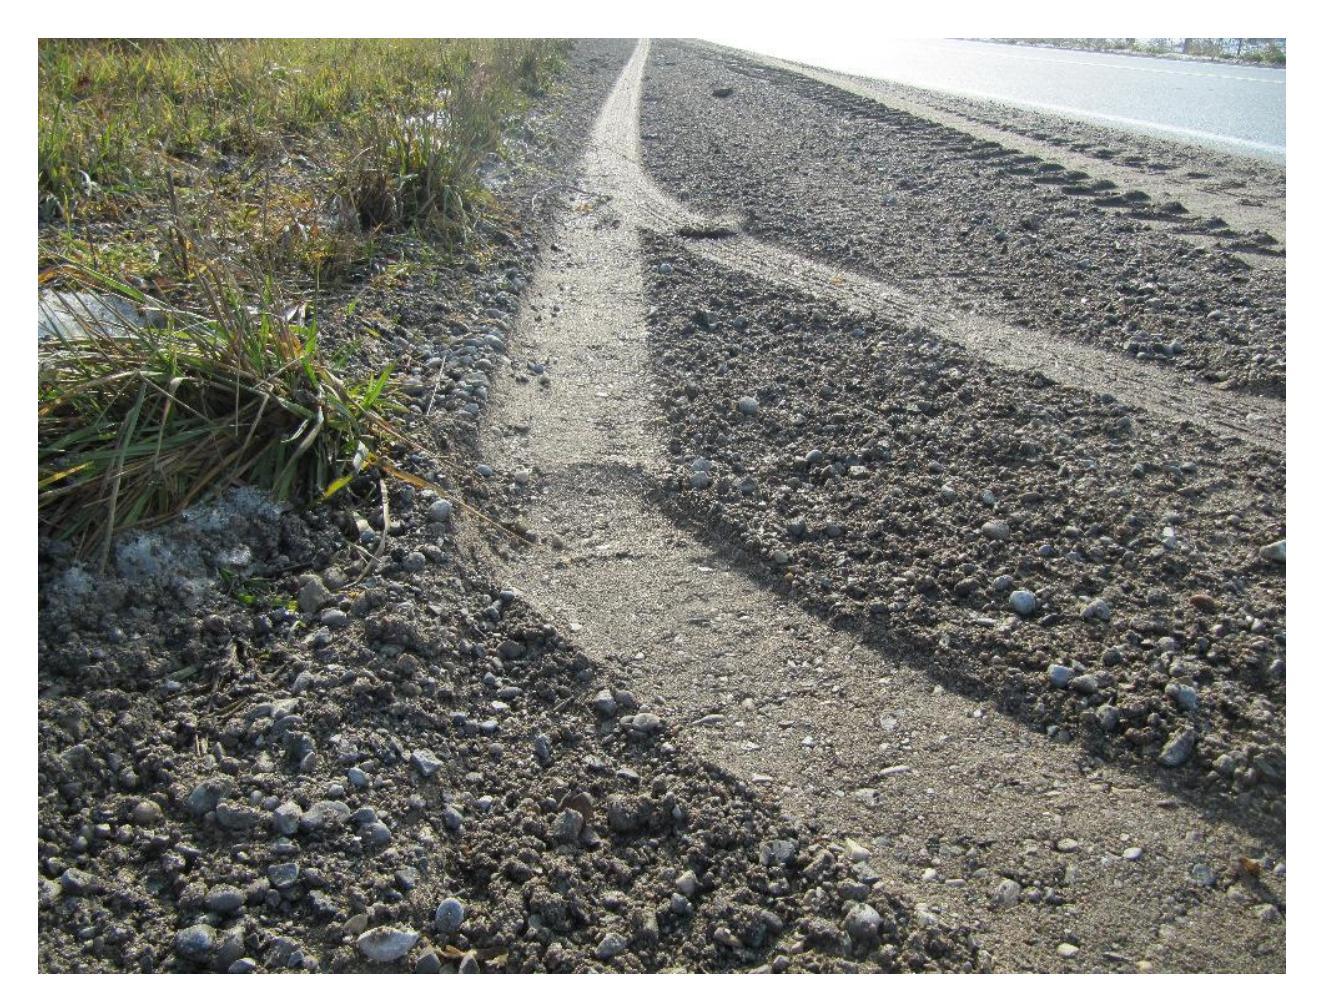
Returning to the east shoulder, Figure 3 provides a closer view of the tire marks produced by the right side tires of our turning vehicle in the vicinity where it stopped and then made the sharp left turn. In fact, Figure 3 shows a clear view of the right front tire mark in the foreground and we can see that the sharp change in direction of the mark is because the driver turned the front wheels sharply to the left. Further in the background we can see the classic curvature of the right rear tire mark which has the gentler change in direction as it follows a different path to the right front tire during the sharp turn.

Figure 3: Closer view of the tire marks produced by the right side tires of the northbound vehicle with the tire mark from the right front tire in the foreground.

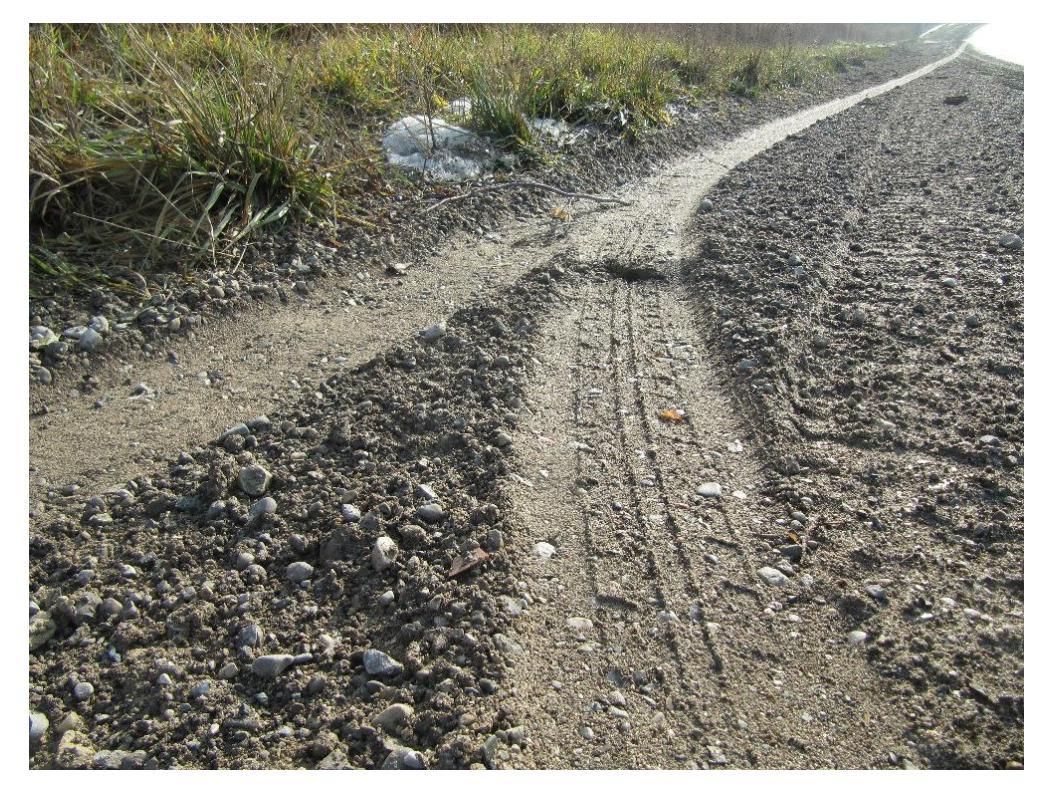
An interesting feature of the right front tire mark is that we do not see the imprint of any tire tread, as if the tire is bald. This is evidenced further in Figure 4 where we see the junction of the two right side tire marks and the right rear shows the imprint of its tread.

Figure 4: View of the tire mark from the right rear tire as it diverges from the path of the right front tire during the left turn.

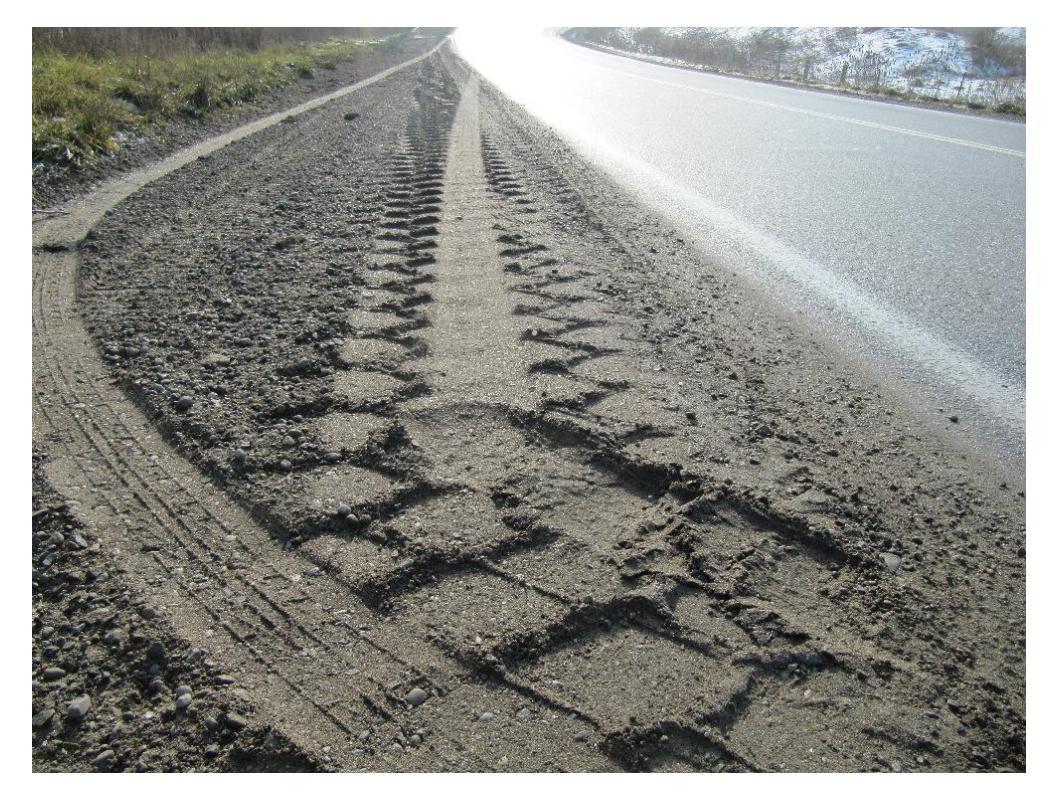
In Figure 5 we see the path of the left front tire in the centre of the view and it contains more upheaval of the gravel/sand in the vicinity of its change in direction which is shown in close up in Figures 6 and 7. Recall that the left side tires are travelling over the previously created tire mark of the large tractor-like vehicle so it is more complicated to distinguish the two.

Figure 5: The tire track of the left front tire of the mystery vehicle can be seen in the centre of this view and its sharp changein-direction can be seen in the foreground. At the left edge of the view is the curving mark produced by the right rear tire.

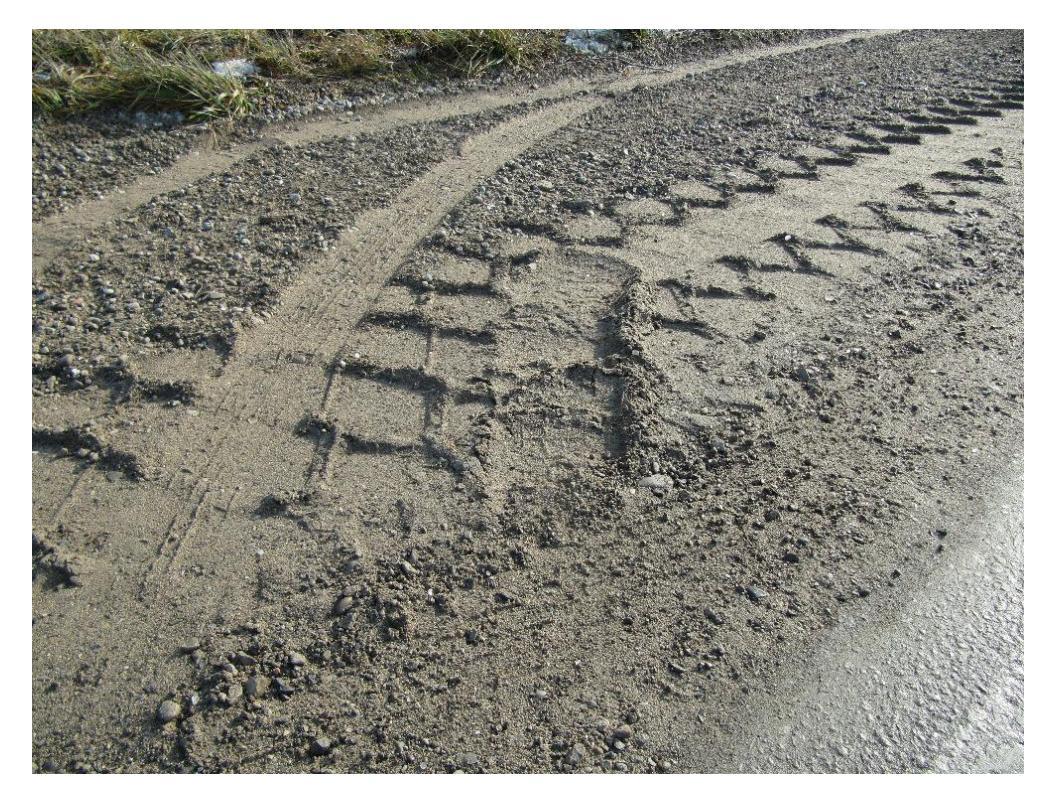
Certainly there appears to be more upheaval in the gravel and sand at the point where the left front tire is beginning its change in direction. Our belief is that this occurs because this tire tracks a more severe curvature, or a smaller radius, than the right front tire and this causes the tire to "shudder" as it is required to perform the sharper turn.

Figure 6: View, showing the change-in-direction of the left front tire (to the right) and the curving right rear tire mark (to the left).

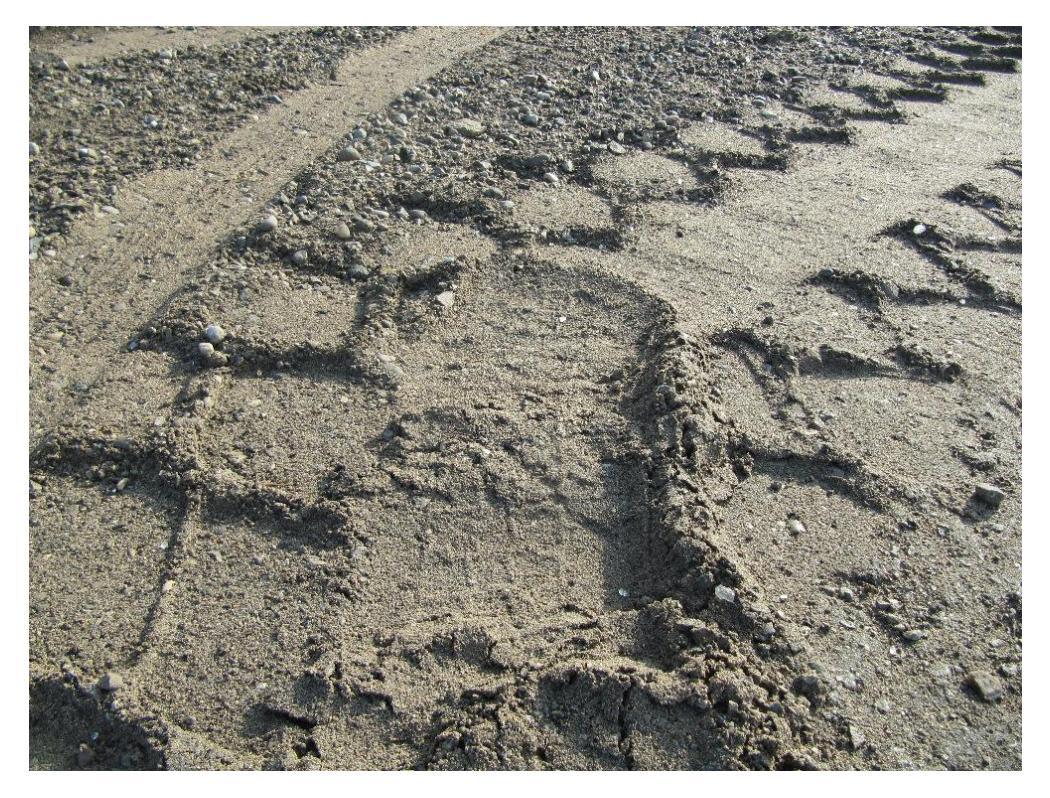
Figure 7: Close-up view of the "shuddering" marks in the left front tire mark during it sharp left turn.

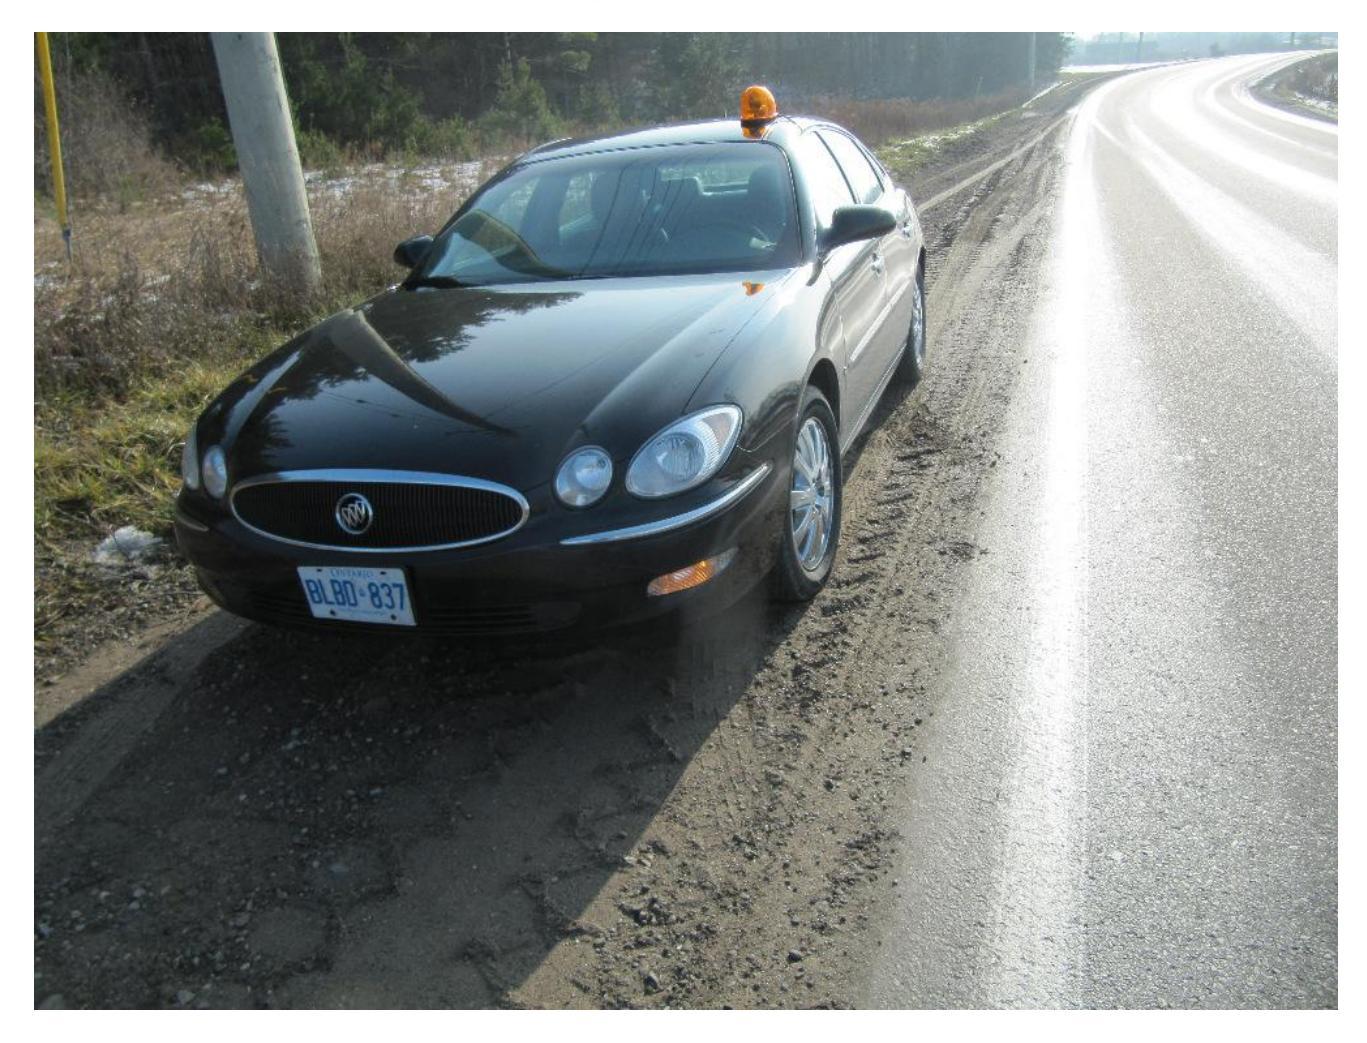
Figure 8: View, looking south, at the test vehicle after it was brought to a halt along side of the tire marks that were previously found and discussed above.

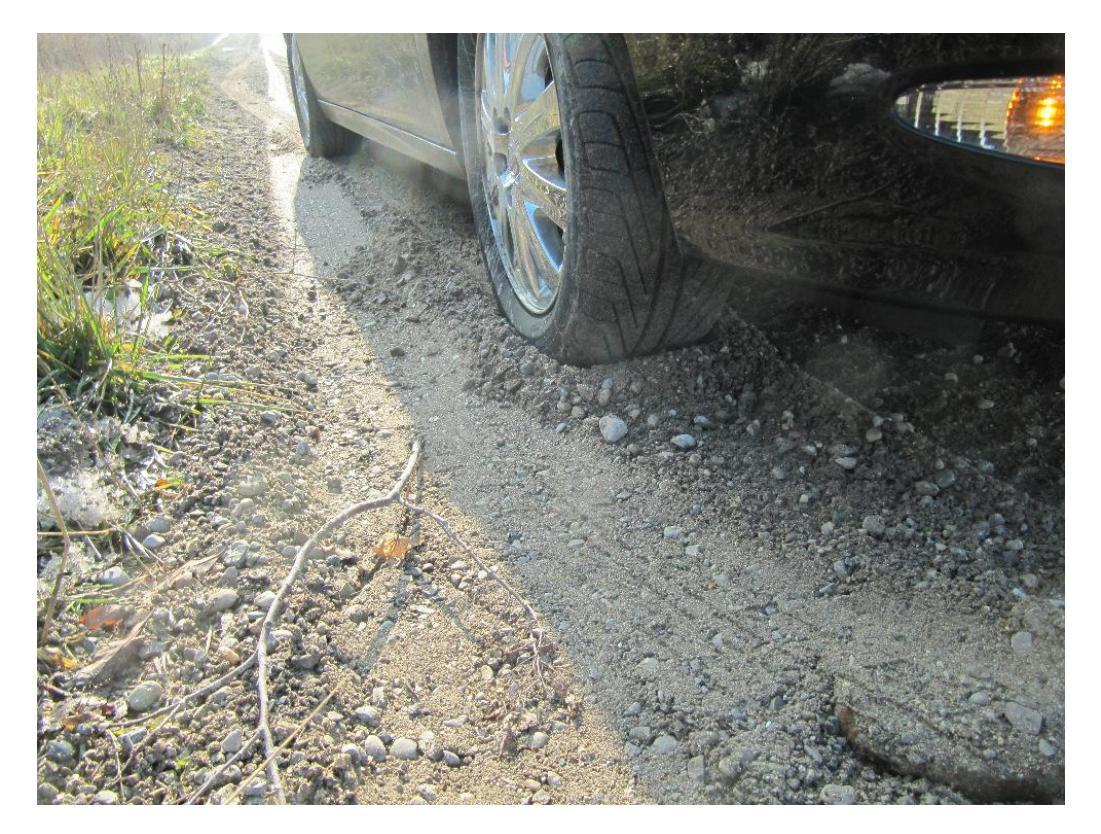
Figure 9: View of right tires of test vehicle on east shoulder.

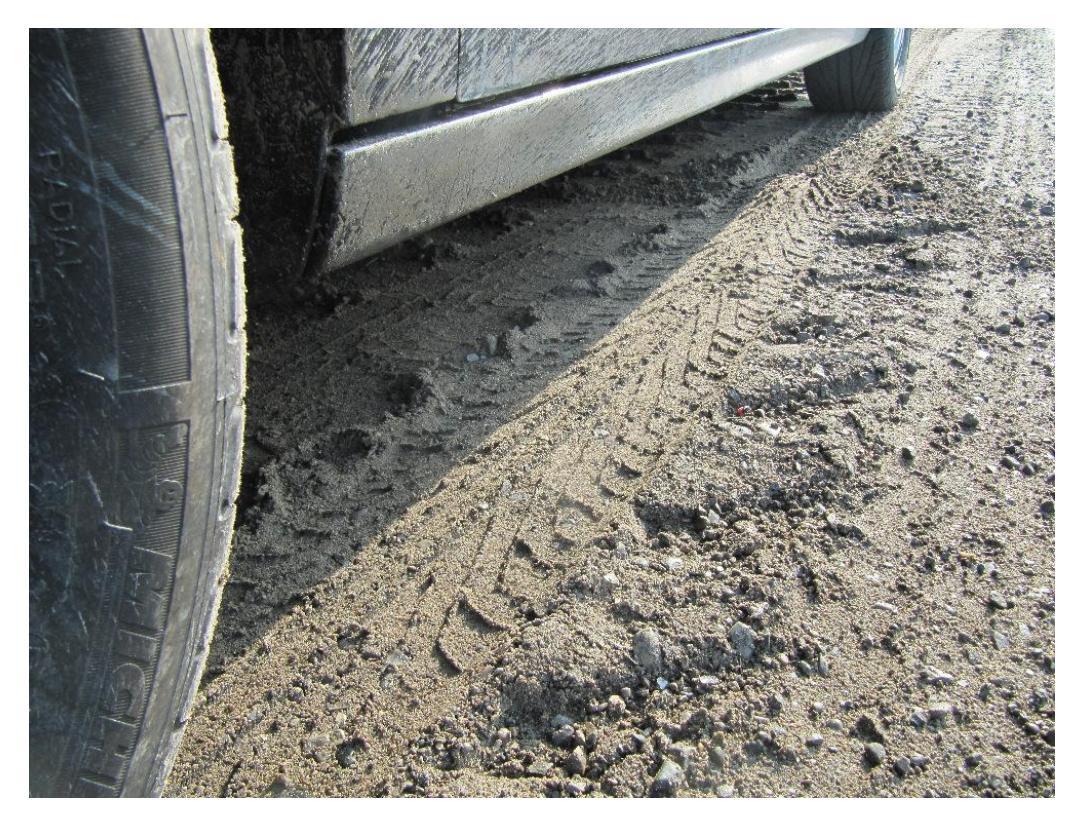
Figure 10: View of left tires of test vehicle on east shoulder.

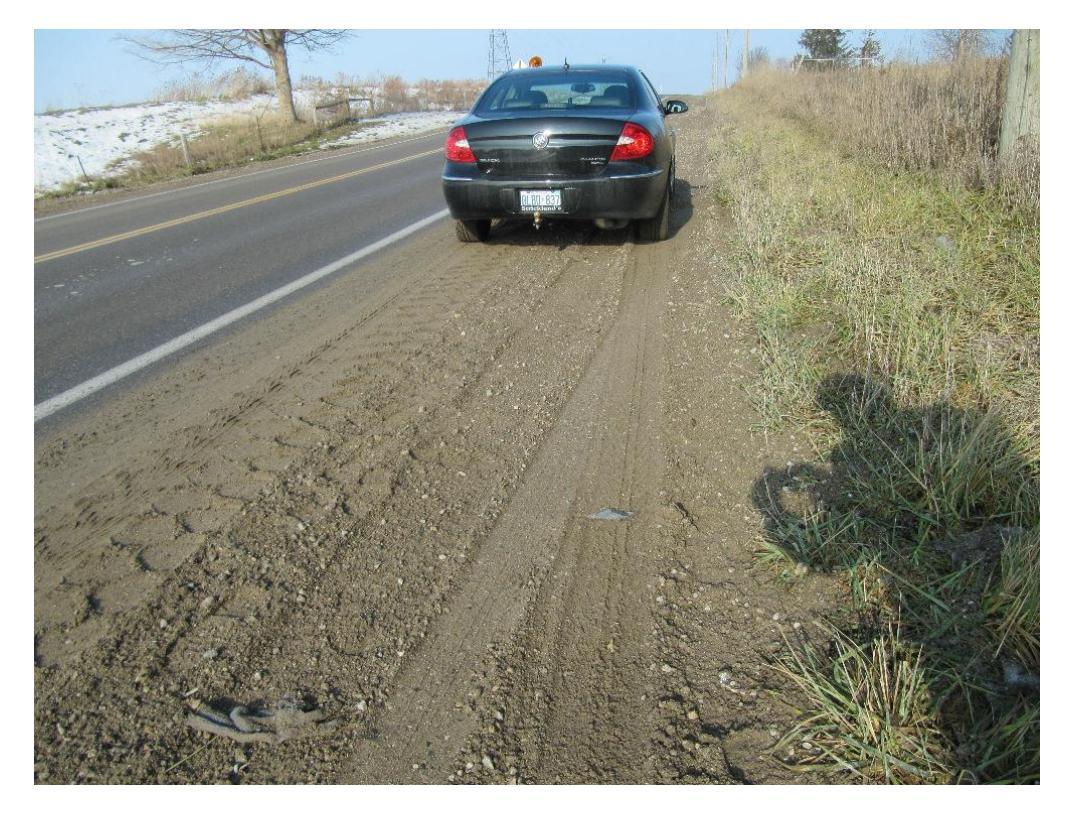
Figure 11: View, looking north toward the test vehicle on the east shoulder.

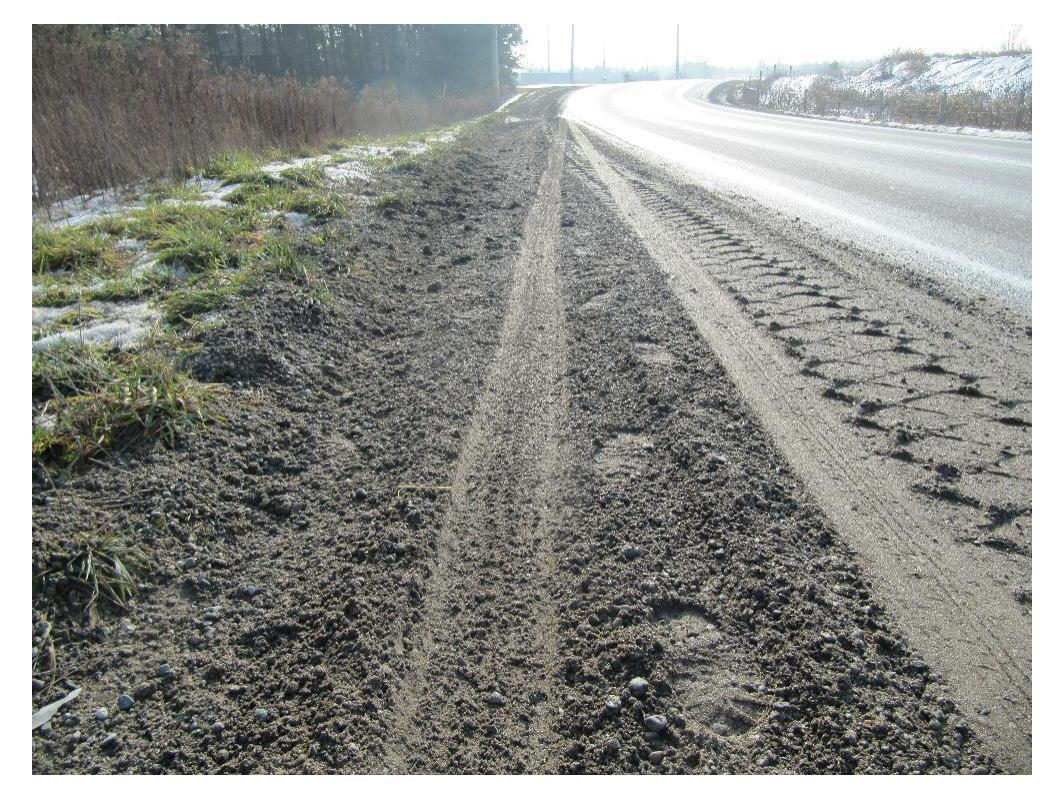
Figure 12: View, looking south, at the tire mark caused by the right side tires of the test vehicle (centre of view) and the right tire mark caused by the mystery vehicle (to the right).

In our test we applied fairly aggressive braking shortly after exiting onto the east shoulder and this is evidenced by the upheaval shown within the tire mark in Figure 12. Note that further in the background the tread of the tire is more visible while closer toward the foreground we can see more upheaval. So this is the effect of aggressive braking.

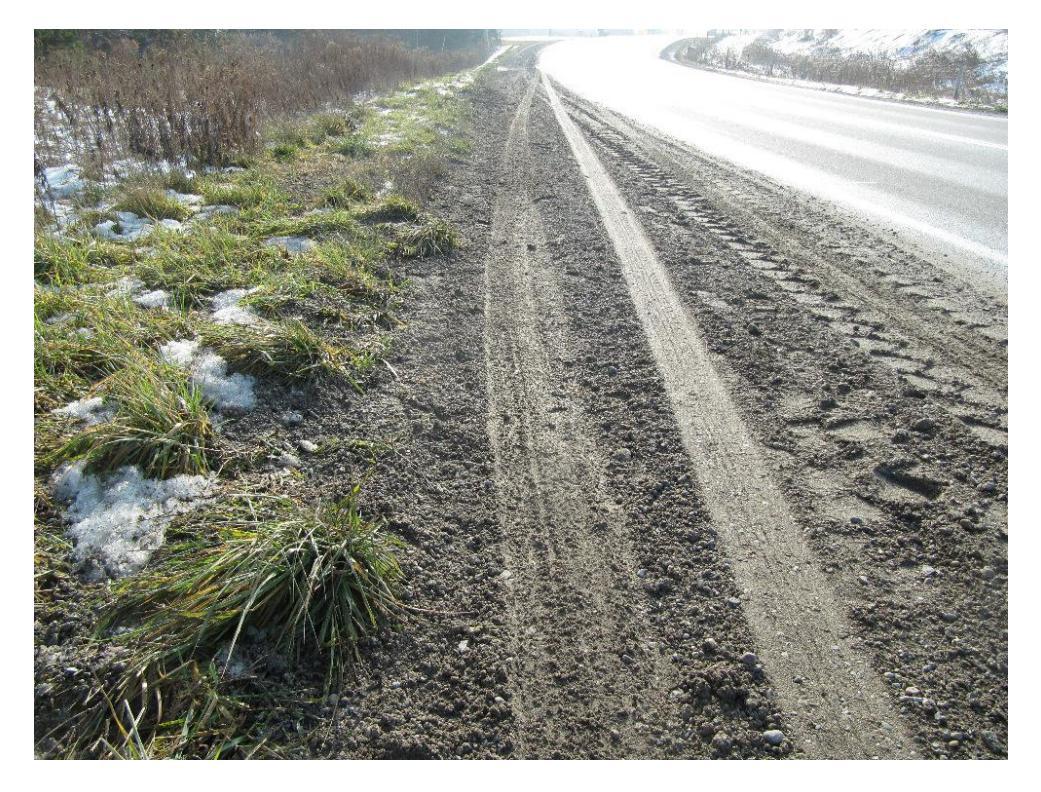
Figure 13 is another view looking south but taken from further north or closer to the stopped position of the test vehicle. Here it possible to obtain a better comparison between the tire mark caused by the right side tires of the test and mystery vehicles. One observation is that the mark from the mystery vehicle has the character of being caused by a "rolling pin" in that there is little evidence of any imprint of the treads of the tires and the edges of the mark are very well defined. There is no evidence of any upheaval within the mark. The tire mark is also very straight.

In contrast, the tire mark produced by our test vehicle shows the tread of the tires within it in some areas whereas in others there is an upheaval as some of the gravel and sand has been thrown up and has landed within the mark during the aggressive braking. The mark is also slightly curved as a result of our steering. The edges of the mark are also not well defined.

Figure 13: View, looking south, showing the mark caused by the test vehicle (left) and the tire mark caused by the mystery vehicle (right).

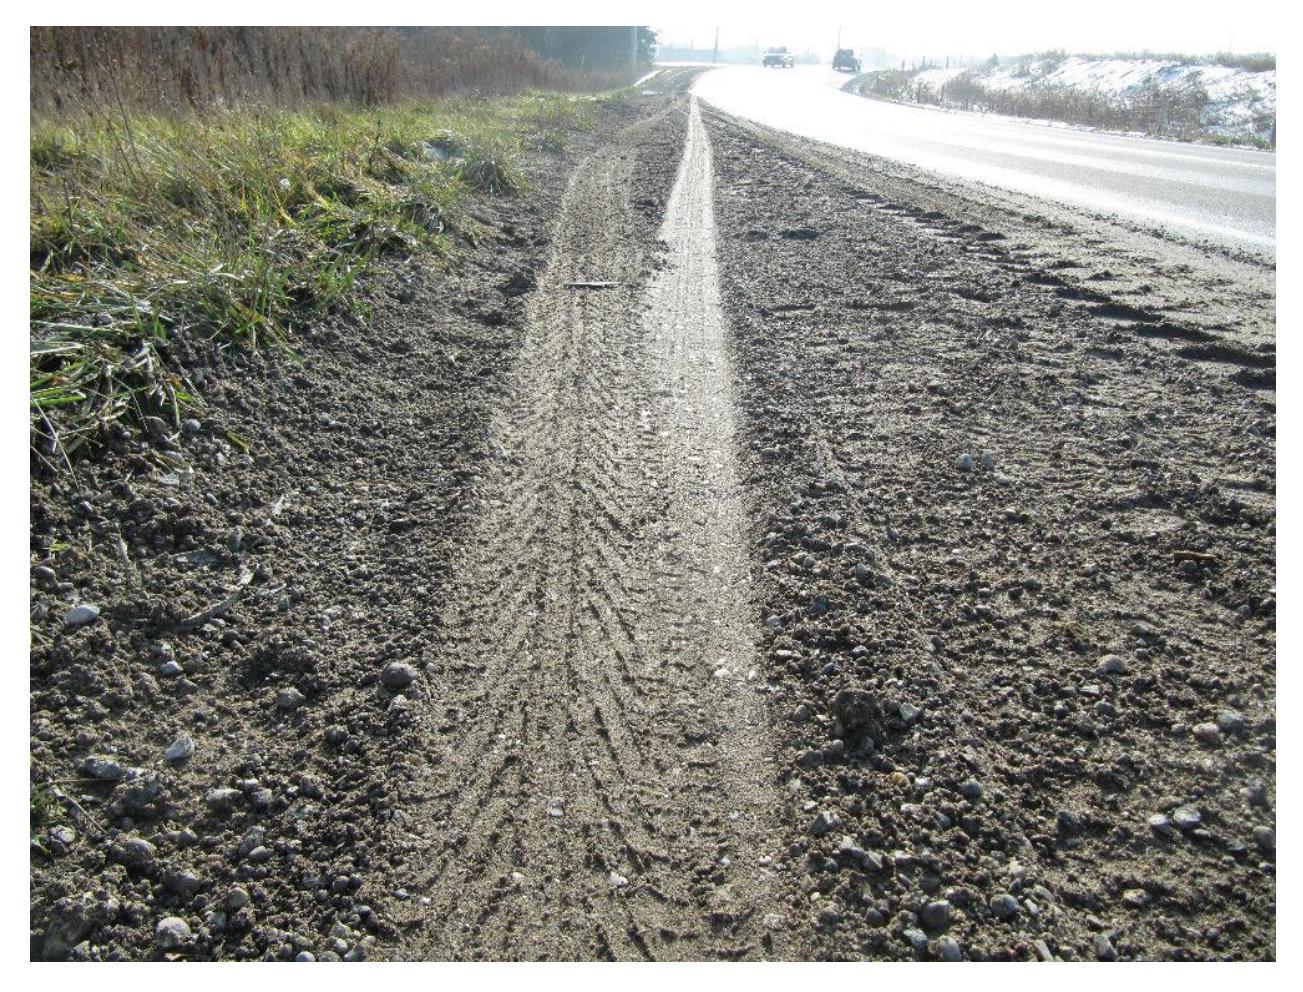
The difference becomes more obvious in Figure 14 when the two tire marks merge and we see them side-by-side. Obviously, our test was performed after the mystery vehicle

passed through so the tire mark from our test obliterates the marking from the mystery vehicle in the foreground of Figure 14. The lack of a tread imprint in the mystery vehicle tire mark is very obvious here.

Figure 14: View, looking south, as the tire mark from the right side tires of the test vehicle merge with the tire mark caused by the mystery vehicle.

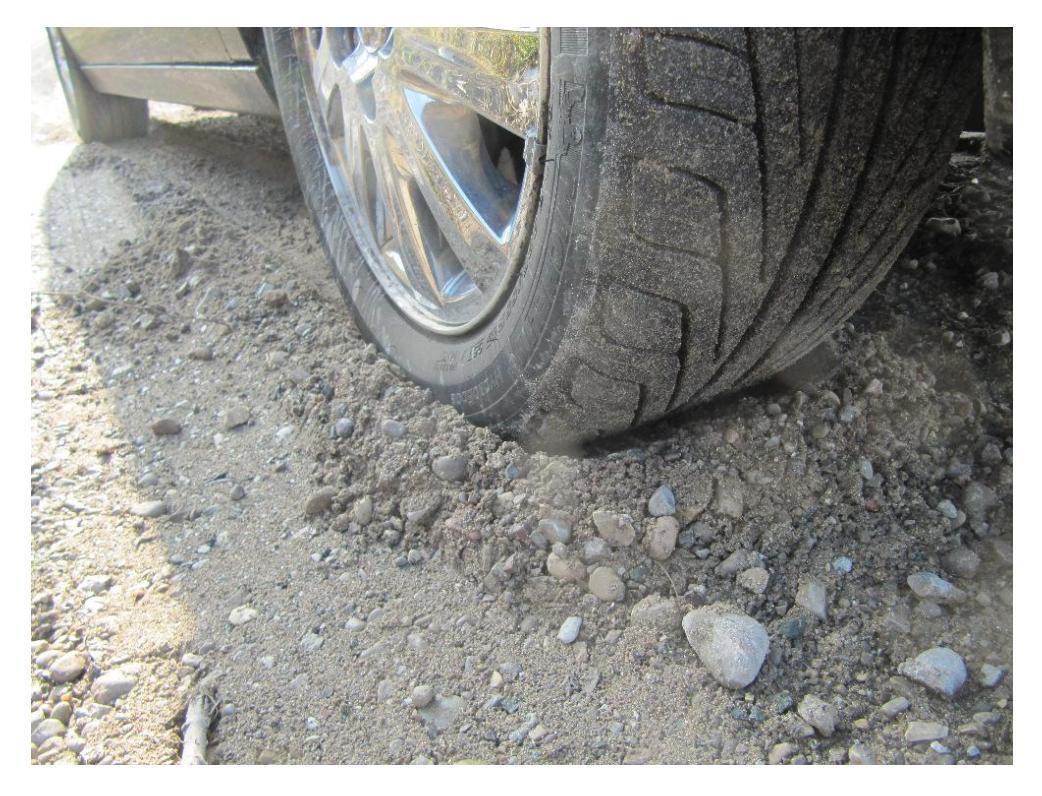
The extent of our strong braking is evident in Figures 15 and 16, which are views of the right front tire mark of the test vehicle and we can see the build-up of gravel/sand in front of the tire as the gravel/sand has been pushed forward.

Figure 15: View of right front tire of test vehicle showing the buildup of gravel/sand in front of the tire where it came to a halt.

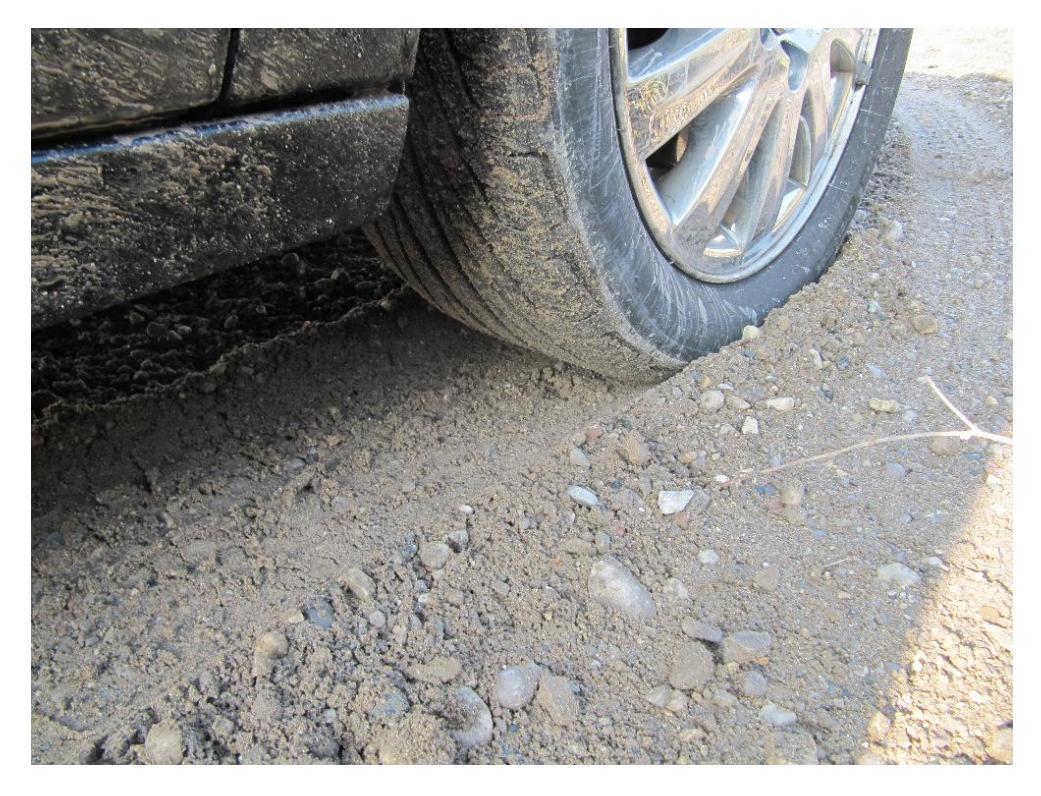
Figure 16: View of right front tire of test vehicle and the character of the mark in the gravel/sand at its rest position.

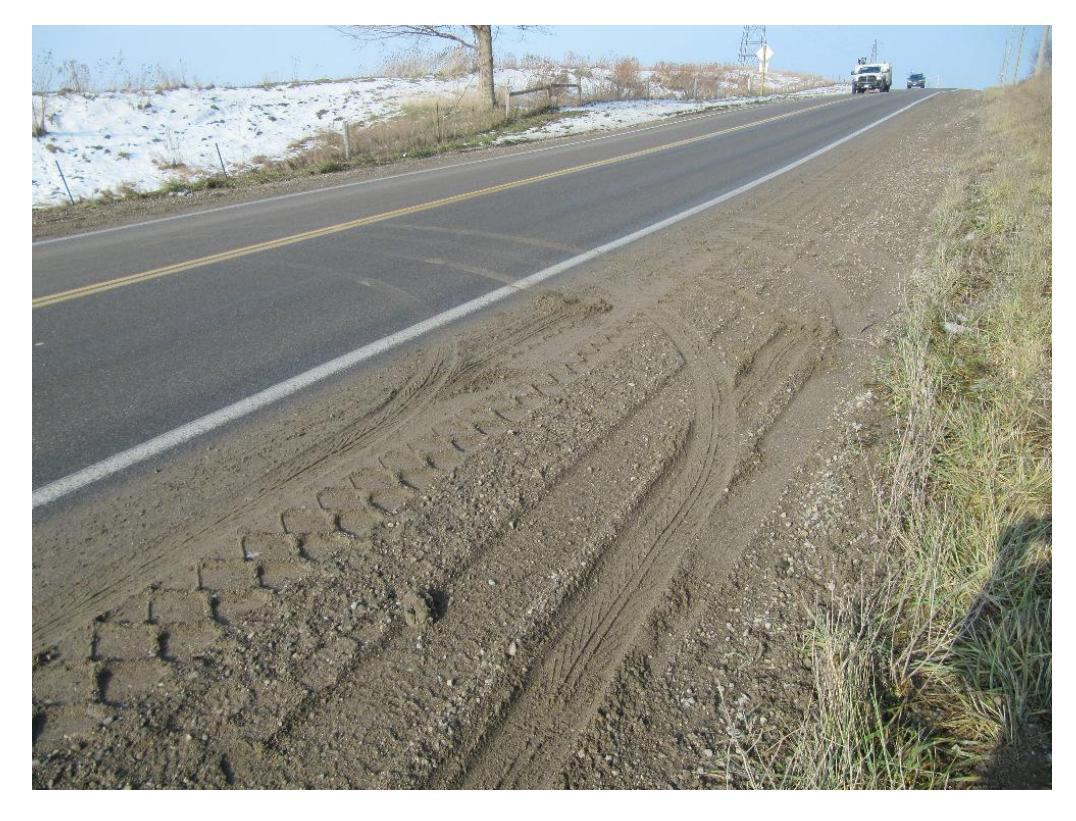
Once we completed our photos of our test vehicle at its rest position we re-entered the vehicle, turned its steering wheel fully to the left and then accelerated into a U-turn. Figure 17 shows a view of the resultant tire marks from that motion as we see some of the sand and mud have been deposited on the pavement as the U-turn was made.

Figure 17: View of the tire marks produced after the steering wheel was turned fully to the left and a U-turn was made.

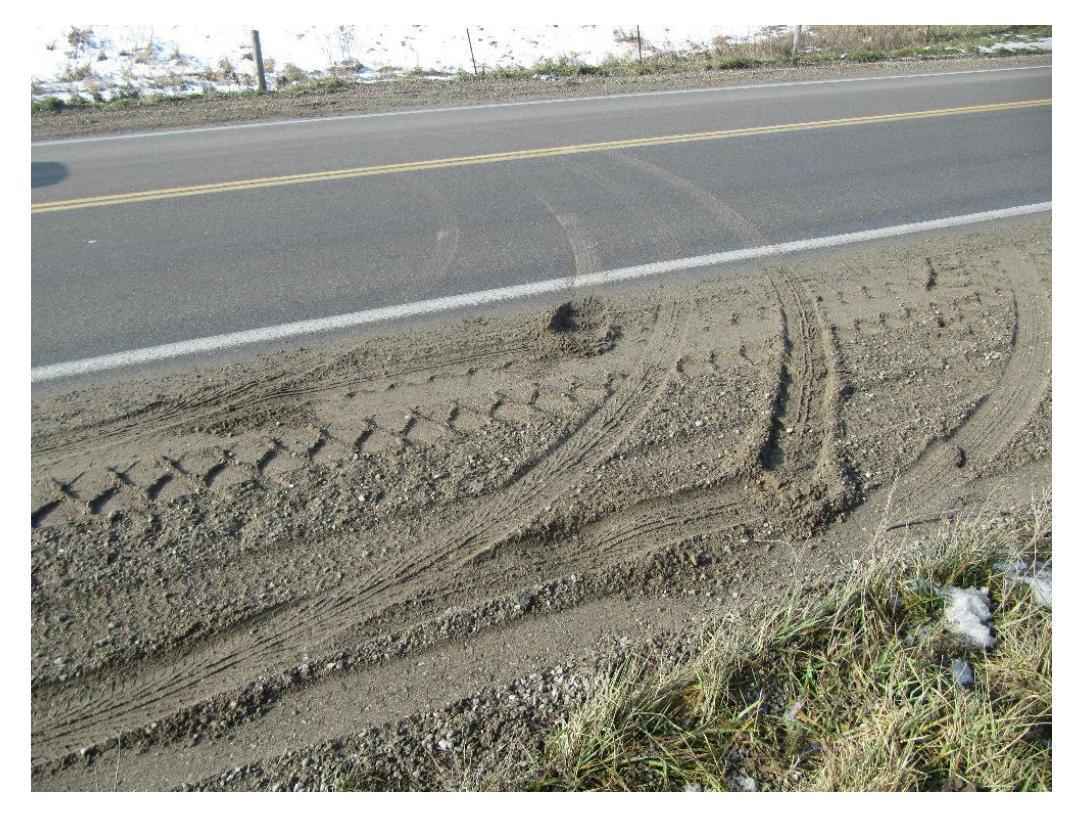
Figure 18 shows a view from the east roadside, looking west and showing the tire marks produced as the test vehicle made the sharp U-turn from a stopped position.

Figure 18: View, looking west, across the road where the test vehicle made a sharp U-turn toward the west shoulder.

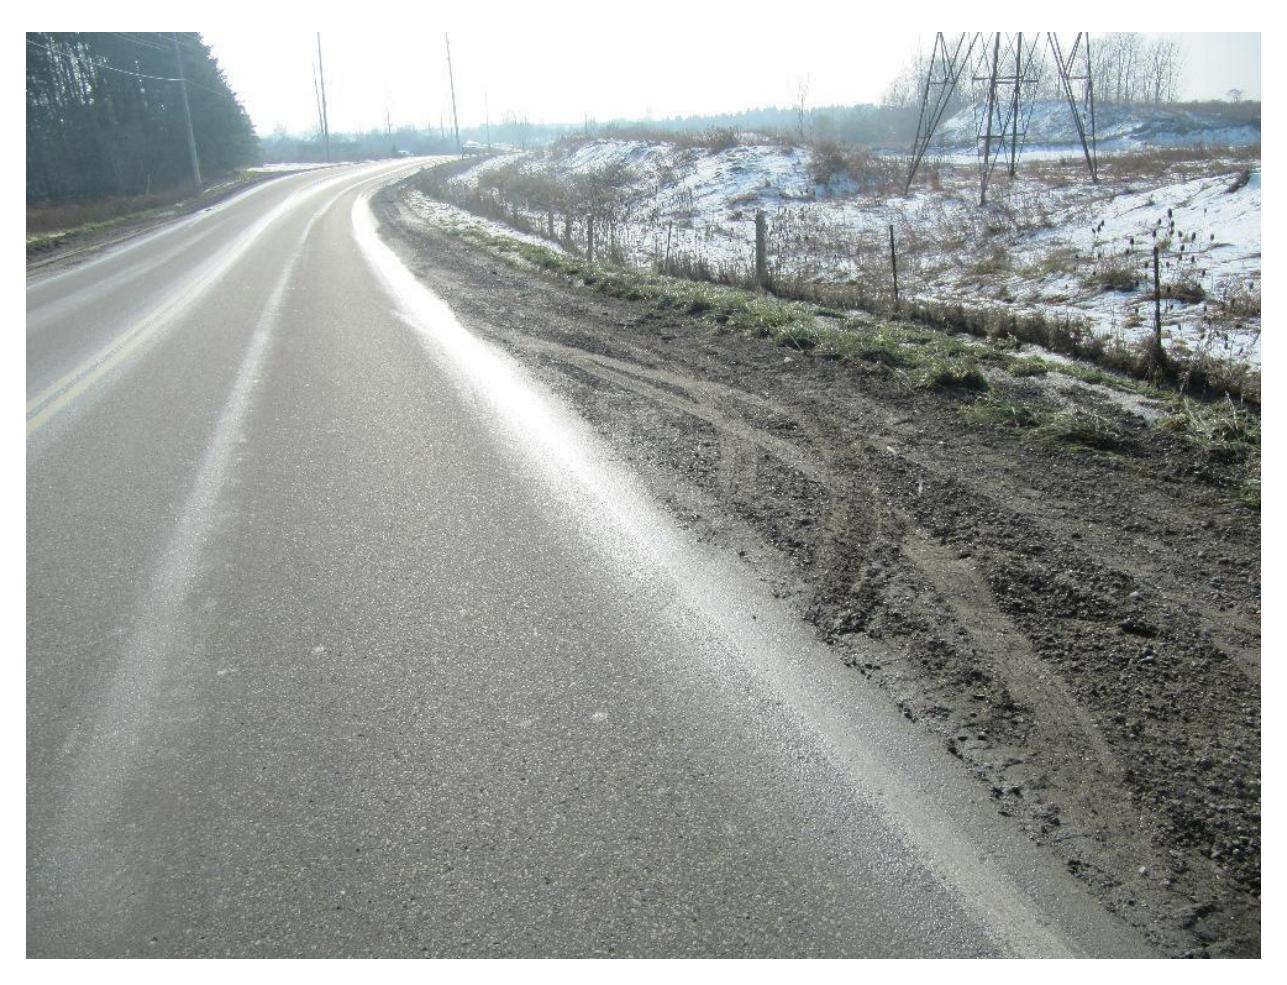
Figure 19 shows an overall view of the tire marks created on the west shoulder by the mystery vehicle and by our test vehicle. Both sets of marks were created by the right side tires of each vehicle.

Figure 19: View, looking south, at the tire marks caused by the mystery vehicle and our test vehicle as both vehicles progressed through their U-turns.

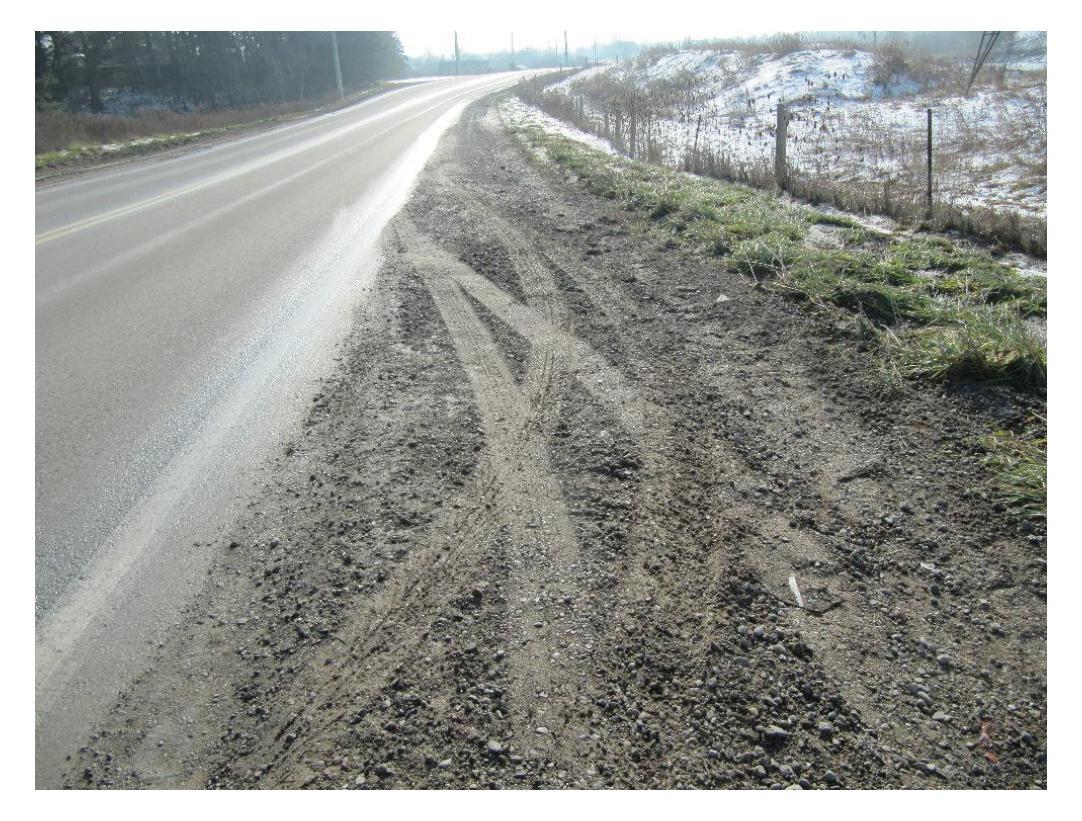
Figures 20 and 21 provide further views of the two sets of tire marks on the west shoulder. Overall, the marks are similar in their geometry. Obviously the right front tire extends further into the shoulder than the right rear, as would be expected in such a sharp left turn. Figure 21 provides an especially clear view of the two sets of tire marks, side-by-side, as the two right side tires converge at the end of the turn at the point where the vehicles re-enter the paved road surface. It evidence continues to show that the right tire of the mystery vehicle appears to be bald in that it does not imprint a tread, in contrast to the right rear tire of the vehicle which shows its tread. In fact, examination of the previous photos confirms that both front tires of the mystery vehicle were bald as neither of the tire marks from these tires imprinted a visible tread.

Figure 20: View, looking south, of the two sets of tire marks on the west shoulder.

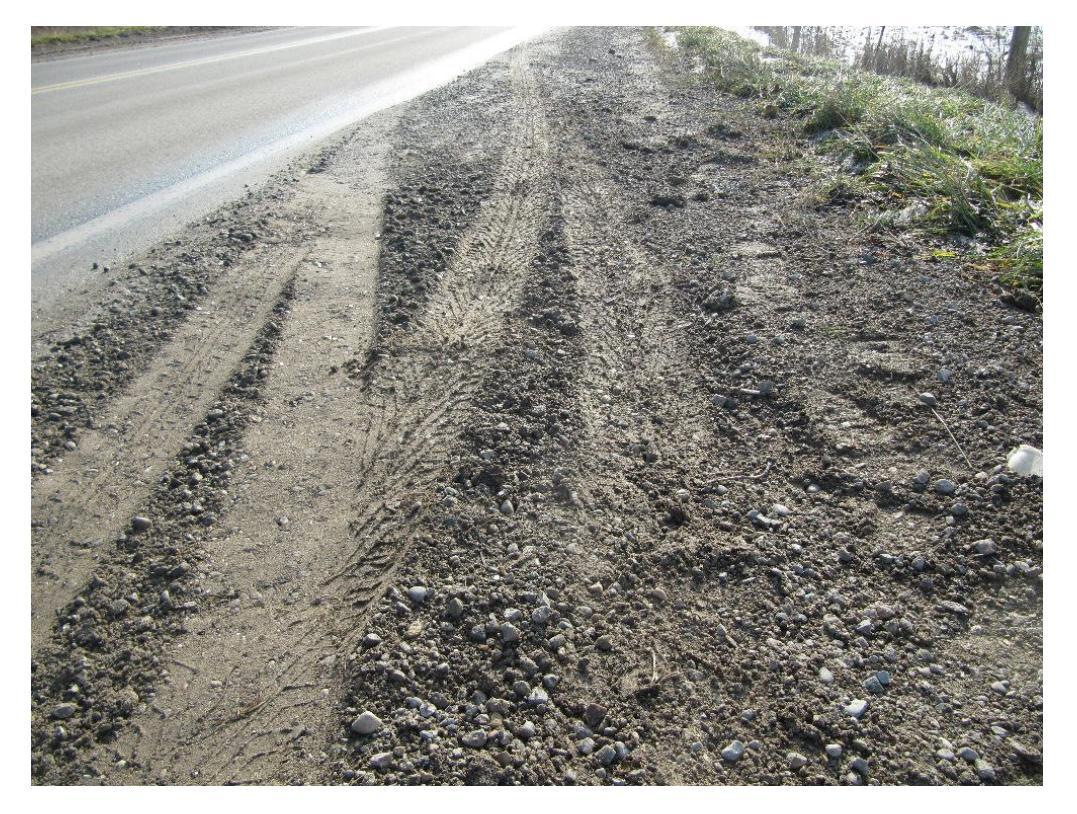
Figure 21: View, looking south, of the two sets of tire marks, the mystery vehicle to the left and the test vehicle to the right.
