Duplication of Tire Marks Observed On A Gravel Shoulder Through Controlled Testing

Posting Date: 17-Dec 2013

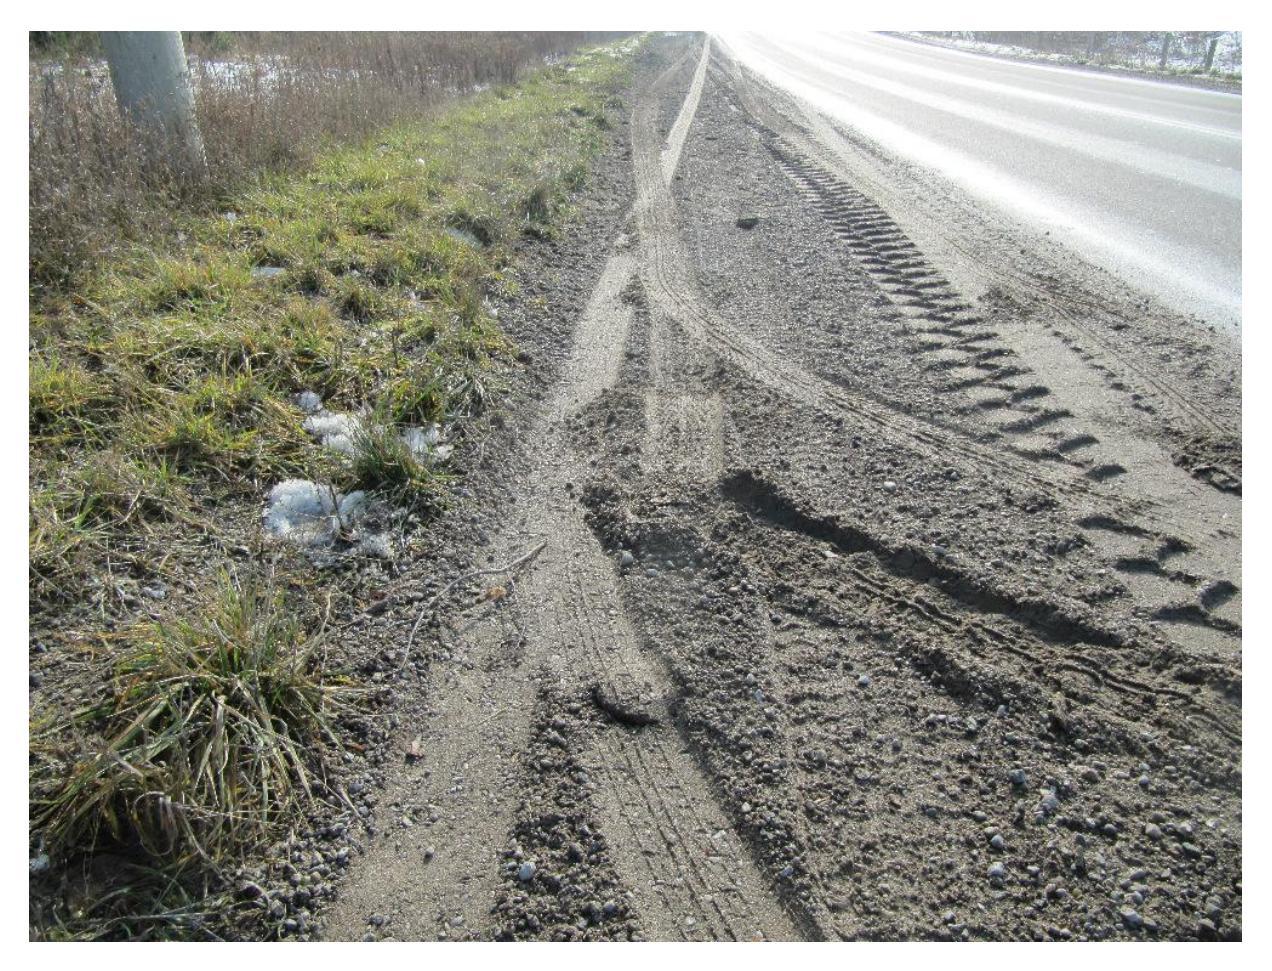
Figure 22: View, looking south, at the tire marks produced by the mystery and test vehicles.

While the view in Figure 22 looks rather complicated, one can refer to the photos in the previous sections to separate which marks are from which vehicle. In the foreground the tire marks from the mystery vehicle are located just slightly to the left of those caused in our test. Also the U-turn from our test was performed a little south of the one performed by the mystery vehicle. So, in Figure 22, one can see the point where our test vehicle's right front tire was stopped and then was turned into the U-turn, whereas the same point from the mystery vehicle is out of view and is located just behind the camera.

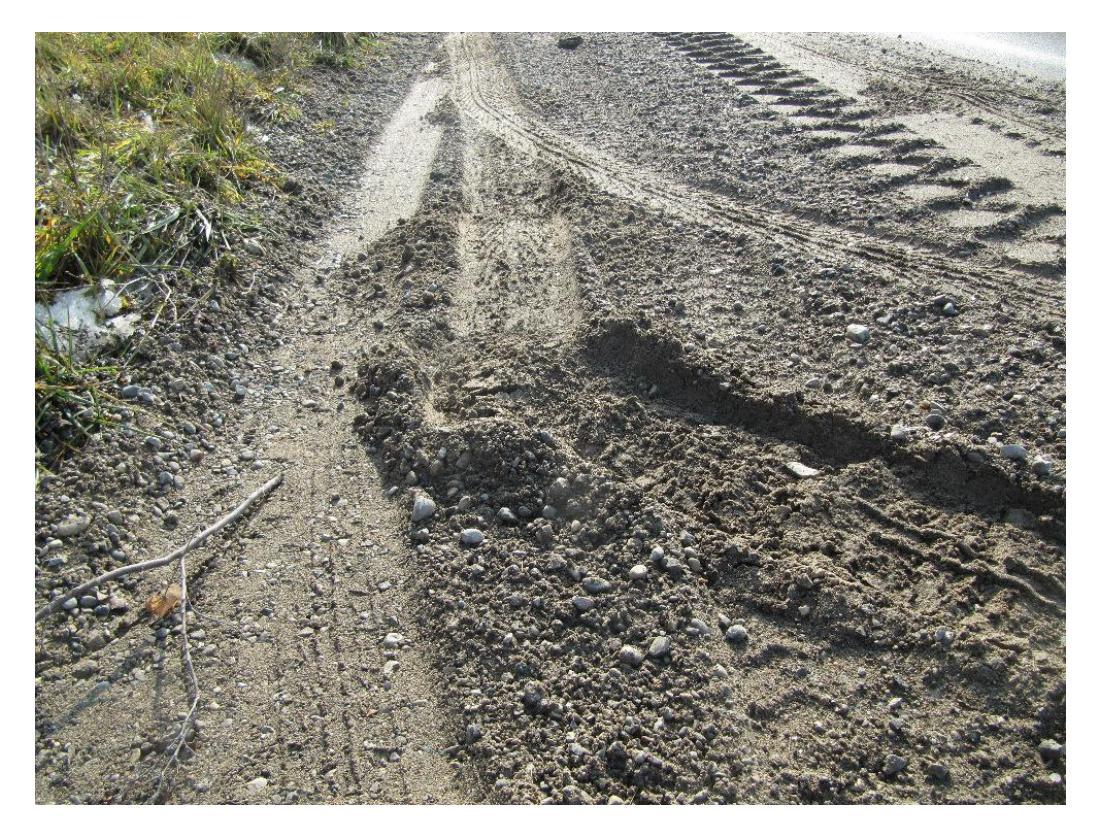
Figure 23: View, looking south, of the point where the right front tire of the test vehicle changes direction into the U-turn.

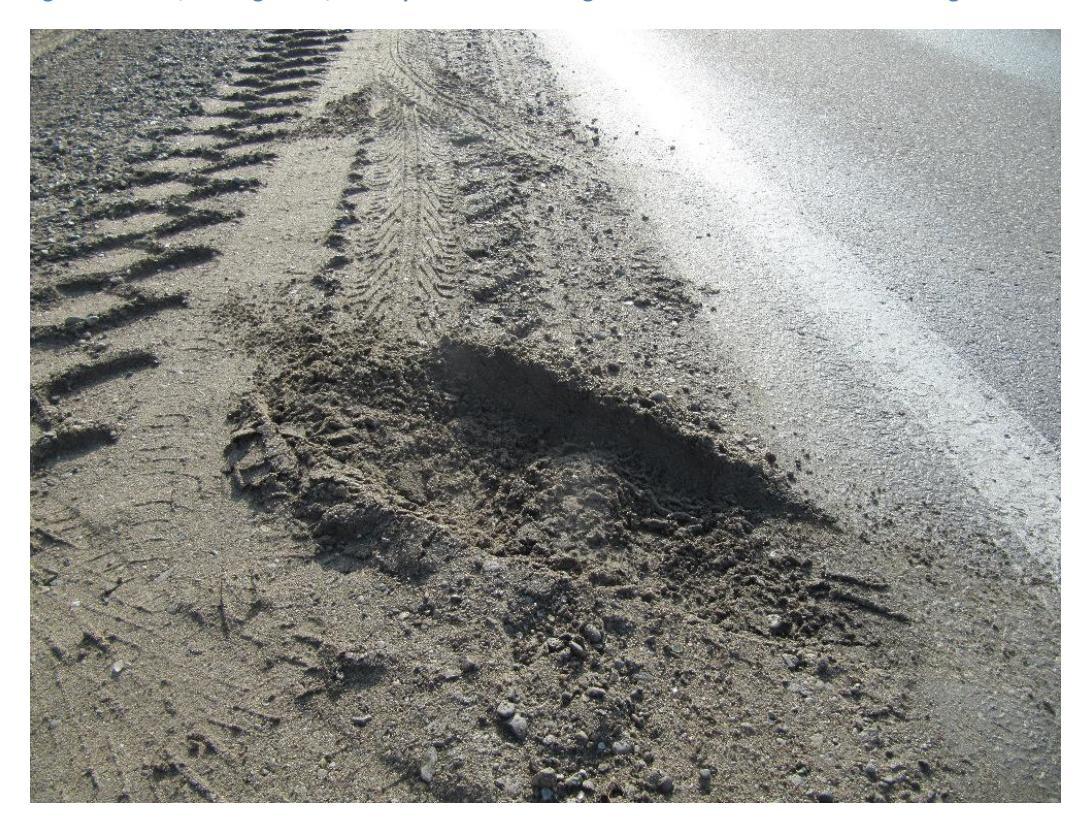
Figure 24: View, looking south, of the point where the left front tire of the test vehicle changes direction into the U-turn.

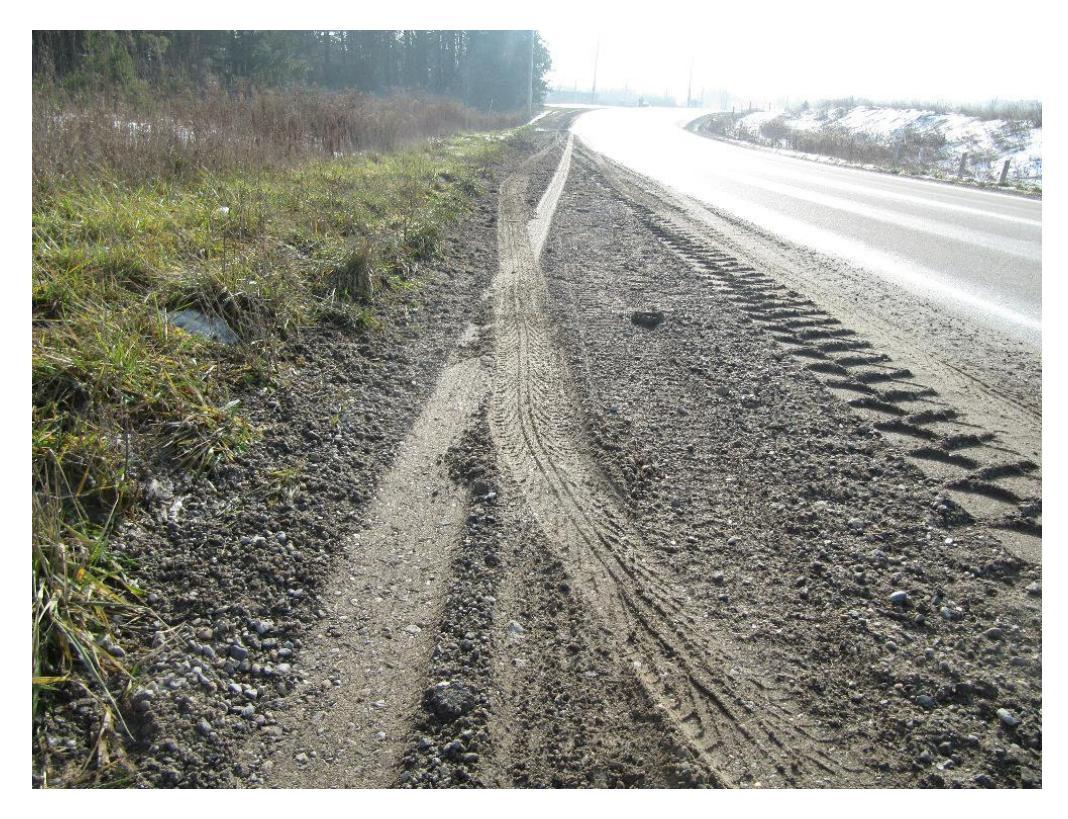
Figure 25: View, looking south, at the point where the right rear tire's path diverges from its right front tire at the beginning of the U-turn. These marks overlap the tire mark from the mystery vehicle.

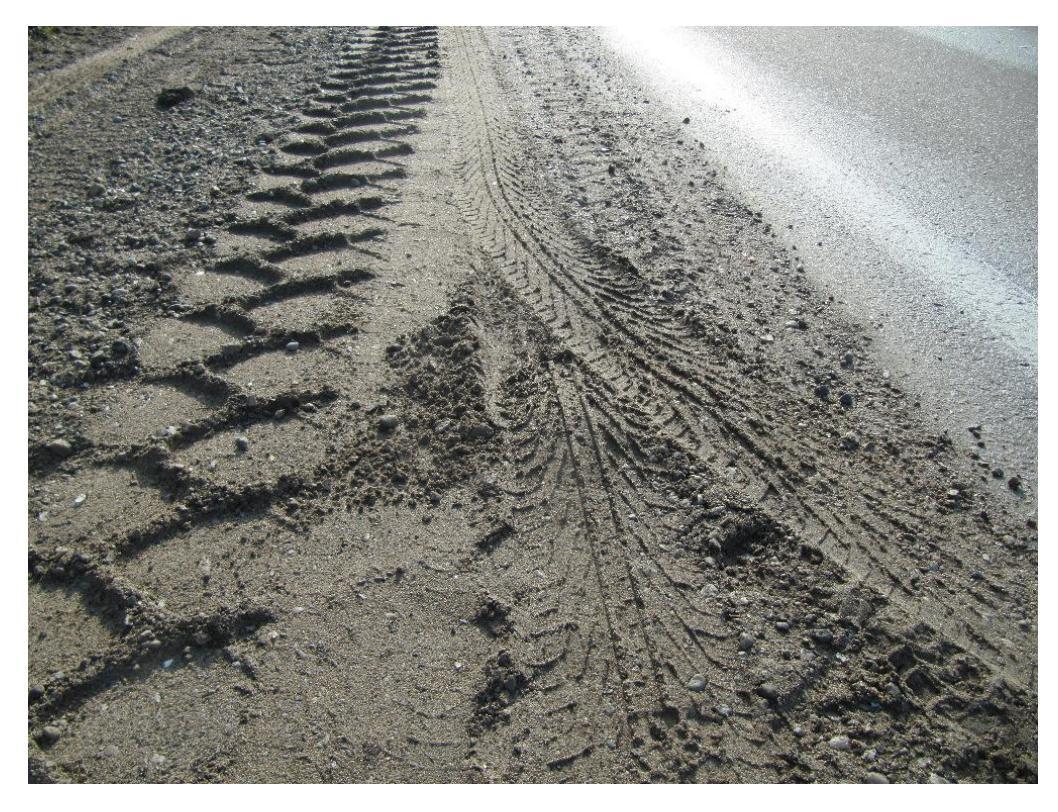
Figure 26: View, looking south, at the point where the left rear tire's path diverges from its left front tire at the beginning of the U-turn. One can also see the tire mark from the mystery vehicle and the older mark from the tractor in this view.

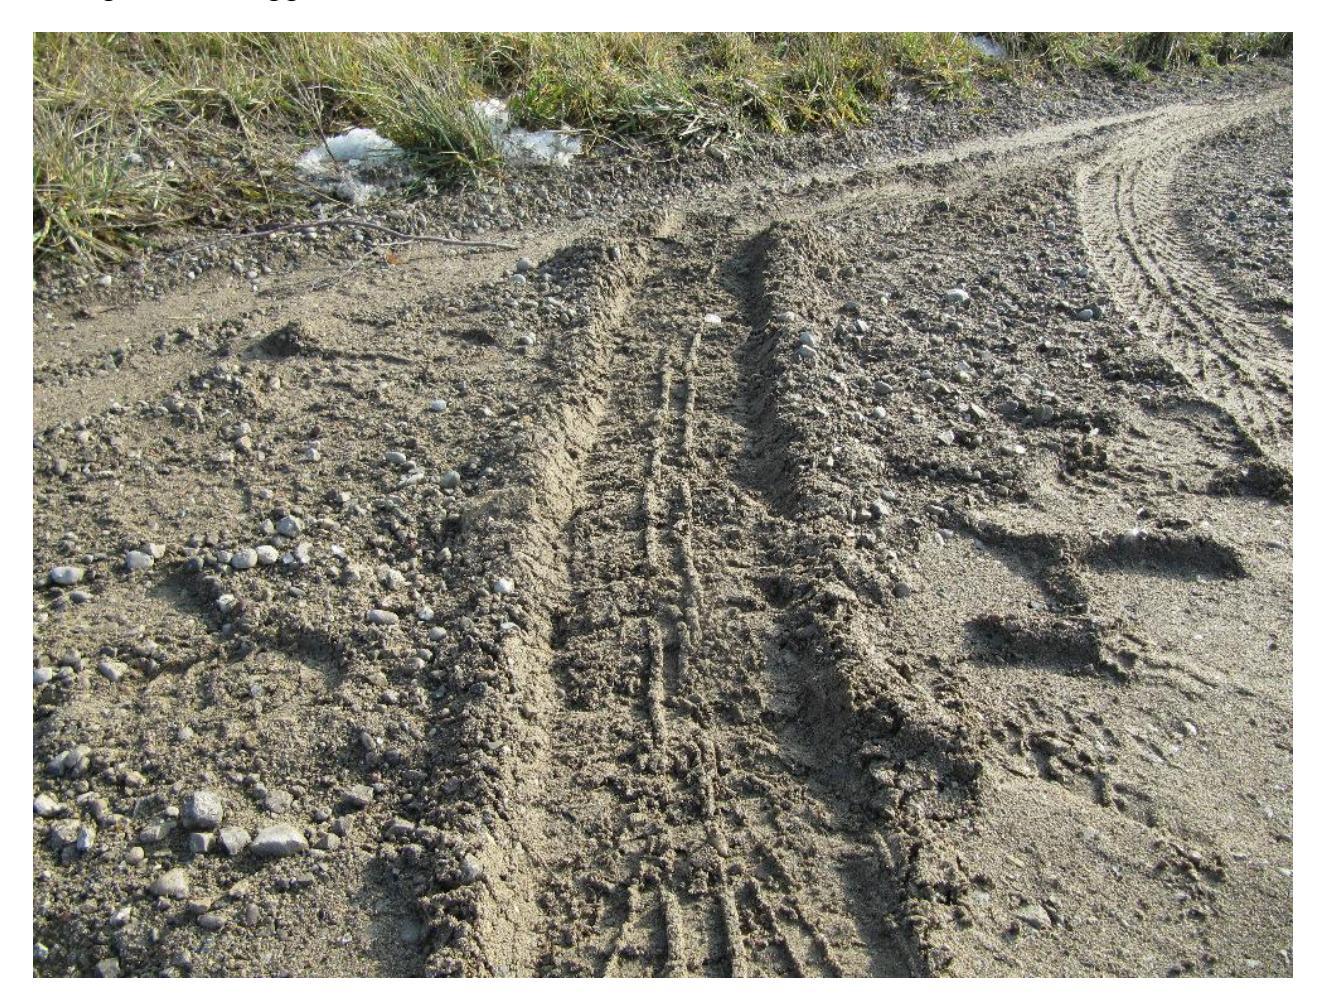
Figure 27 provides a view of the acceleration mark caused by the right front tire as the vehicle moved from its stopped position into the U-turn. One can detect, within the tire mark, how there are scalloped "shudder" marks indicating that the gravel/sand beneath is being pushed rearwards as the tire accelerates forward. This was a fair aggressive acceleration that had to be performed into the U-turn because of the limited visibility in the curve. So the evidence shown here represents what characteristics would exist during such an aggressive U-turn.
