Incomplete Road Repairs - Part I - Site Descriptions

Posting Date: 22-Apr 2014

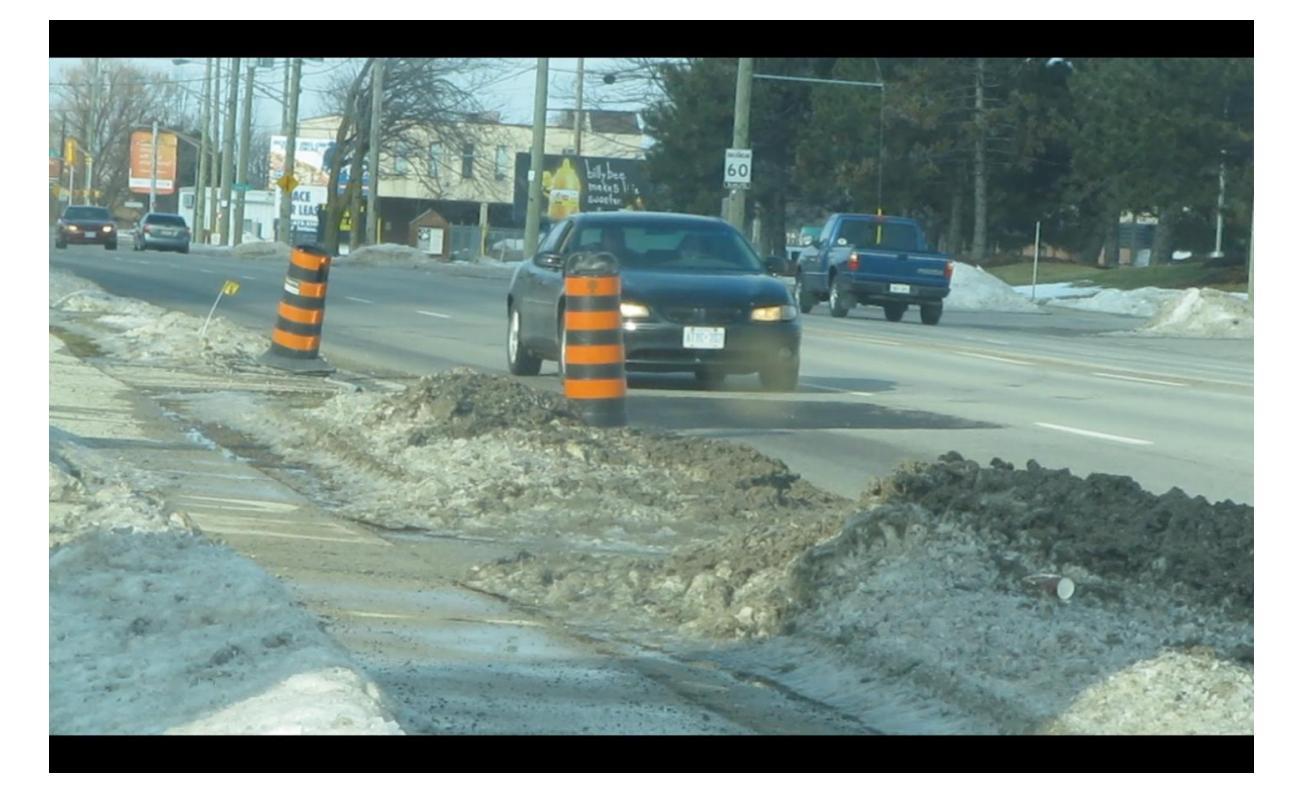
Figures 1, 2 and 3 are frames from video taken on January 12, 2014 showing a black southbound vehicle as it crosses over the depression. The extent of the effect on the vehicle's travel can be detected by comparing the height of the bottom of the front bumper in relation to the road surface. In Figure 1 we can see the normal height as the vehicle approaches the depression. Figure 2 shows how the vehicle collapses down into the depression so that the height between the bottom of the front bumper and the road surface is minimal. Figure 3 shows how the vehicle is then propelled upward as it leaves the depression and the bottom of the vehicle's front bumper is much higher compared to the road beneath it.

Figure 1: Southbound vehicle approaching the depression on January 12, 2014.

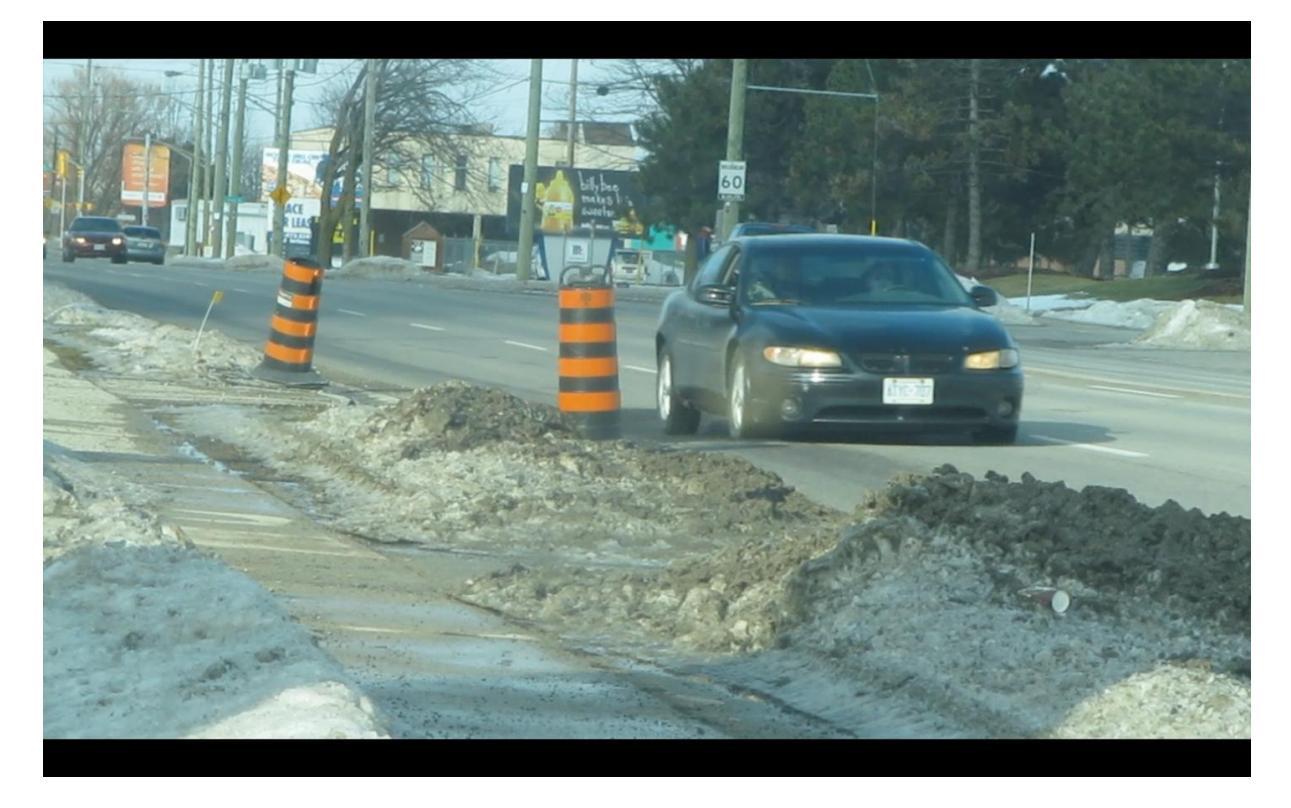
Figure 2: Front suspension of southbound vehicle being compressed just before reaching the back wall of the depression.

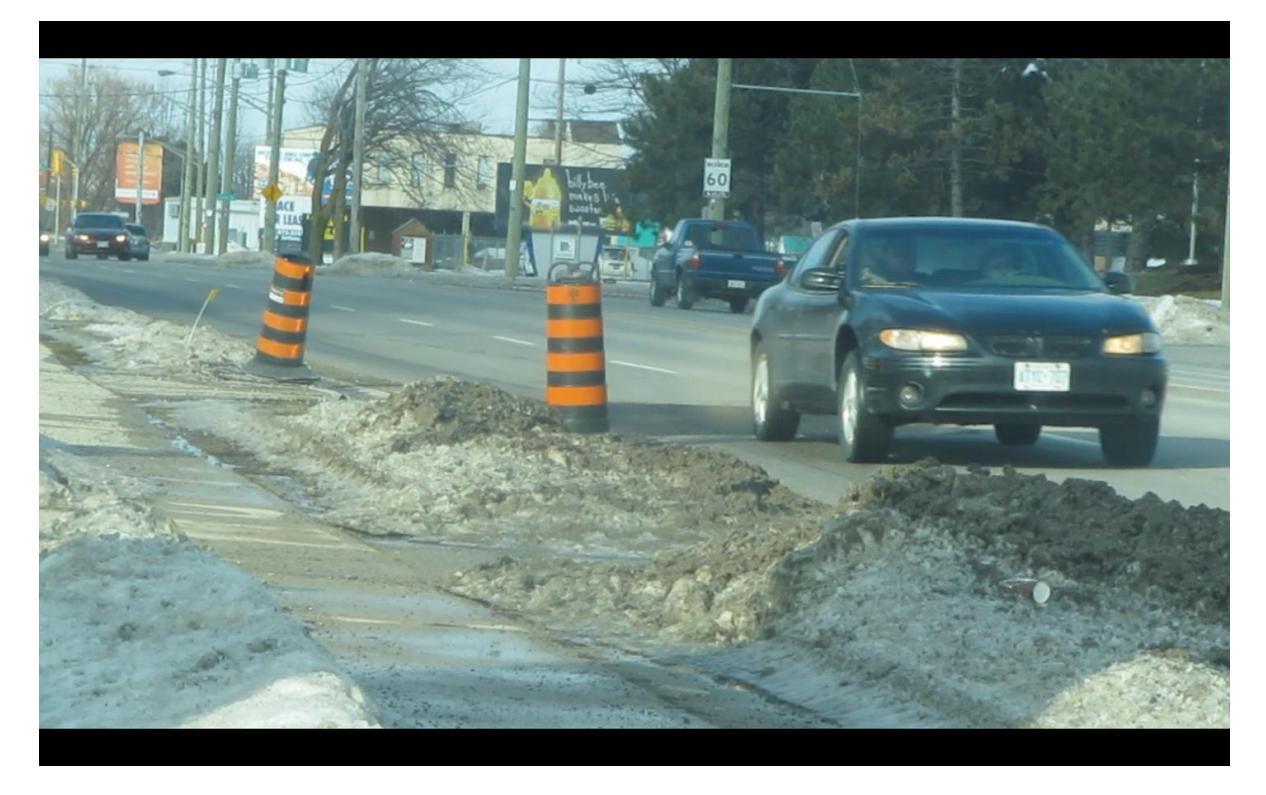
Figure 3: View of southbound vehicle being propelled into the air as it leaves the depressed area on January 12, 2014

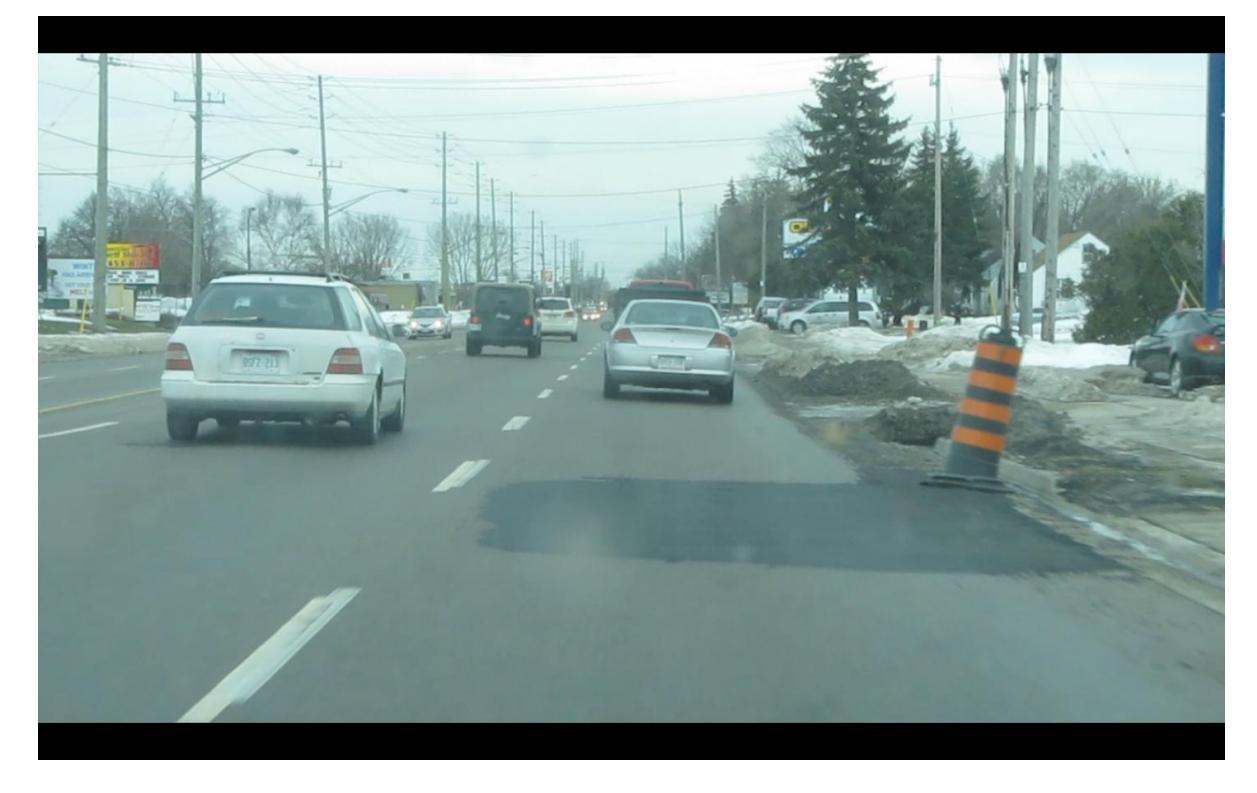
Figure 4: Video frame showing southward view of depression after it was filled in on January 13, 2014

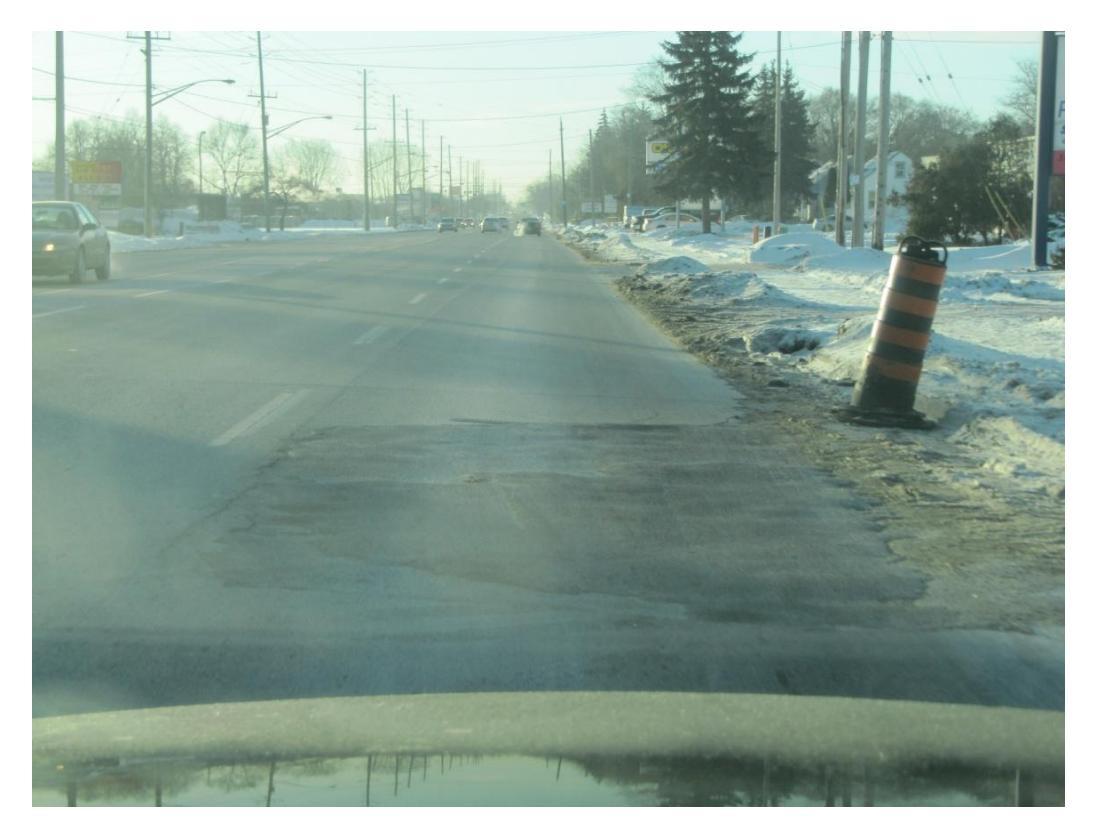
Figure 5: Southward view of depression on January 22, 2014, showing evidence of additional patching.

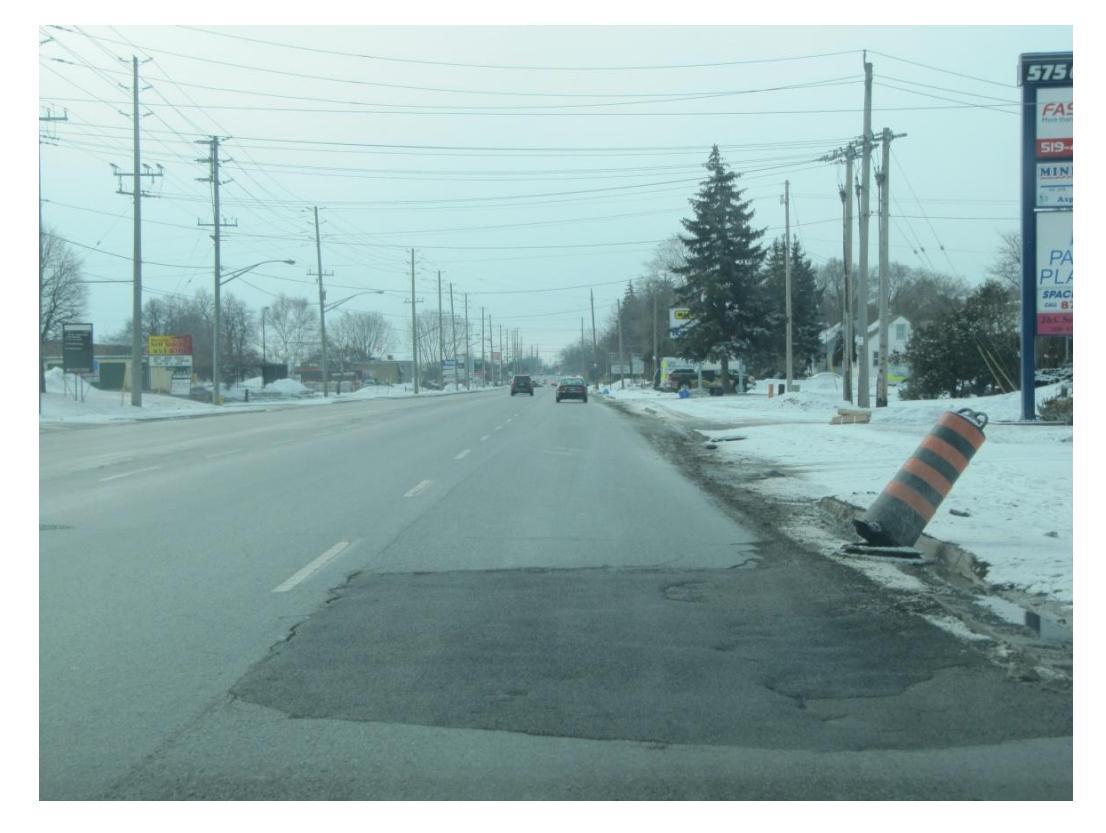
Figure 6: Southward view of depression on March 25, 2014, showing evidence of further patching.

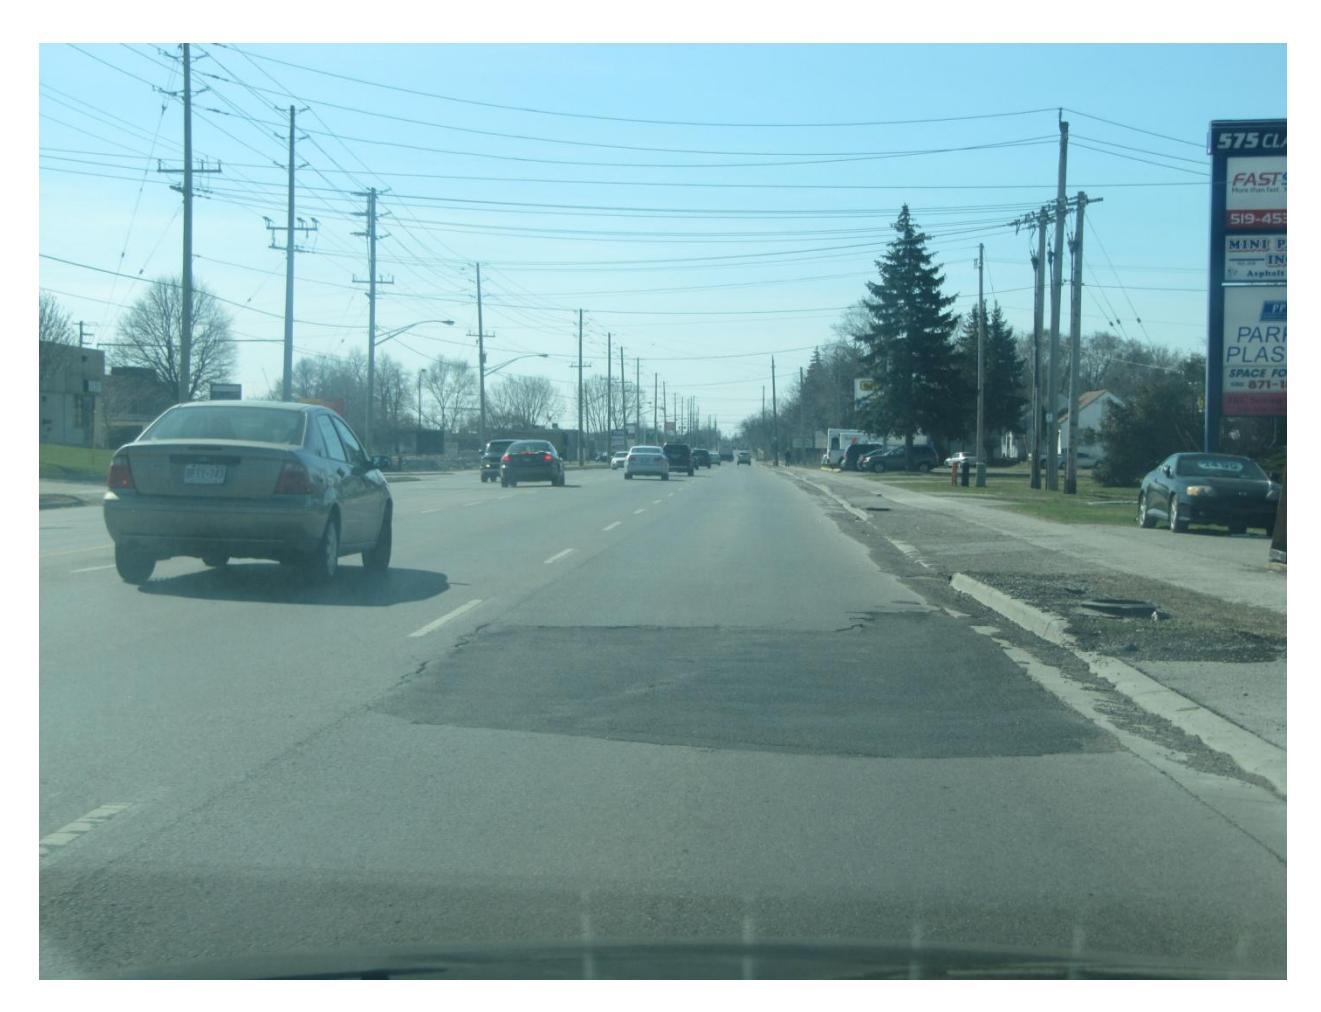
Figure 7: Southward view of depression on April 17, 2014.

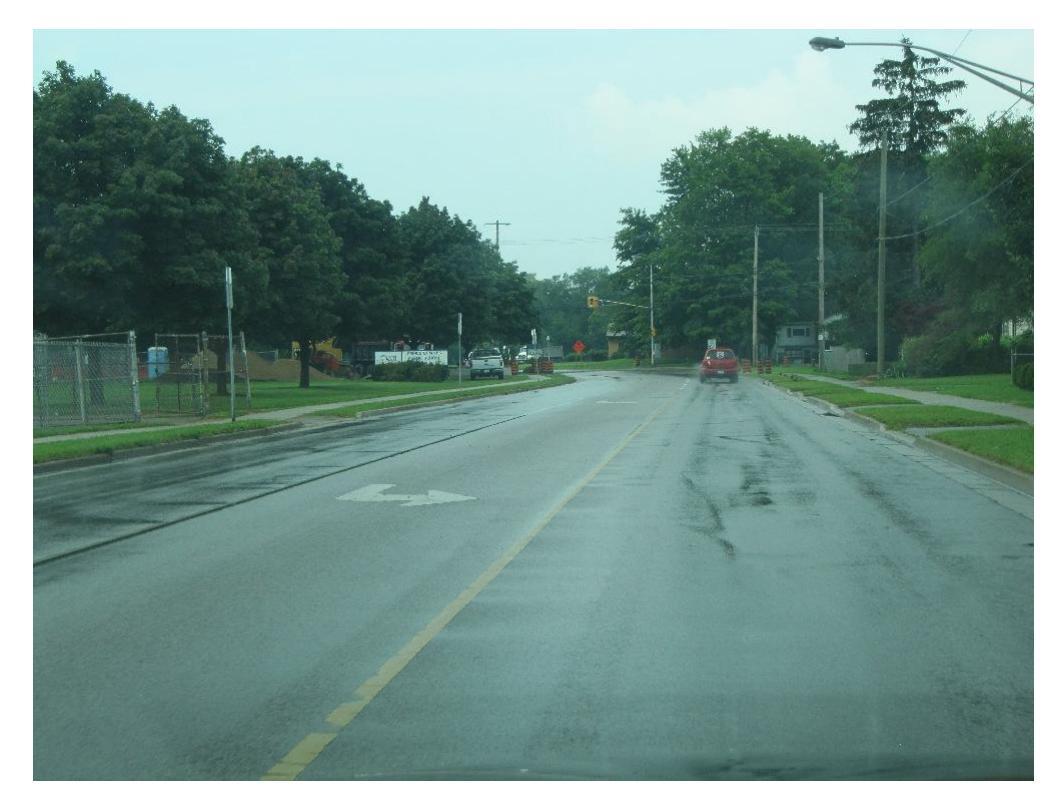
Figure 8: View looking westward along Wavell toward the intersection with Spruce Street shortly after road work was commenced on August 7, 2013.

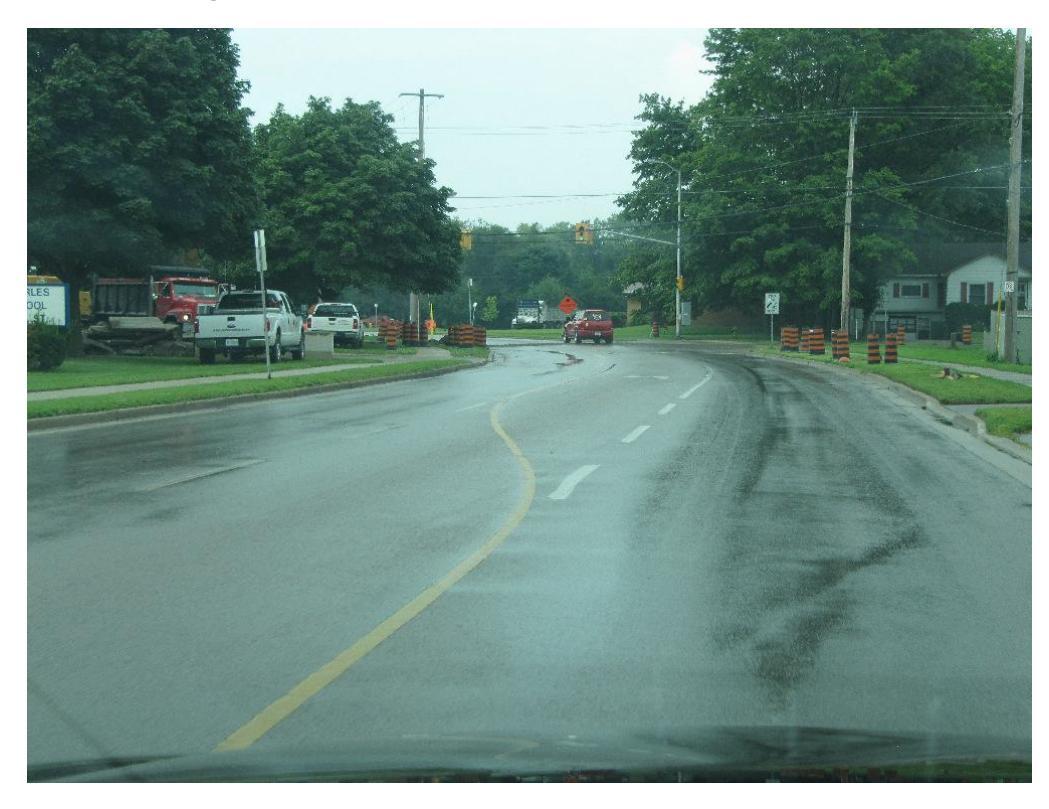
Figure 9: Although a number of construction barrels are seen along the roadside, there is nothing present to warn drivers that the uneven section of road surface exists at the curve ahead.

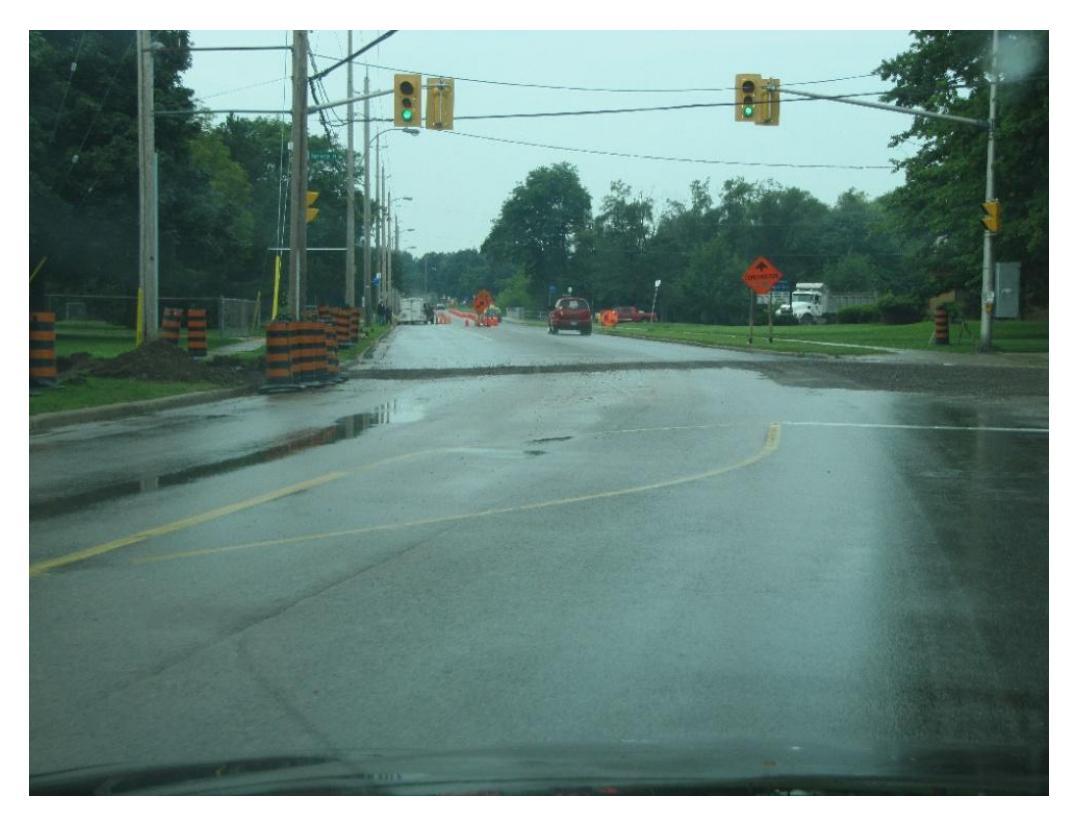
Figure 10: View, looking west, showing the newly-created channel of uneven road surface at the curve of Wavell.

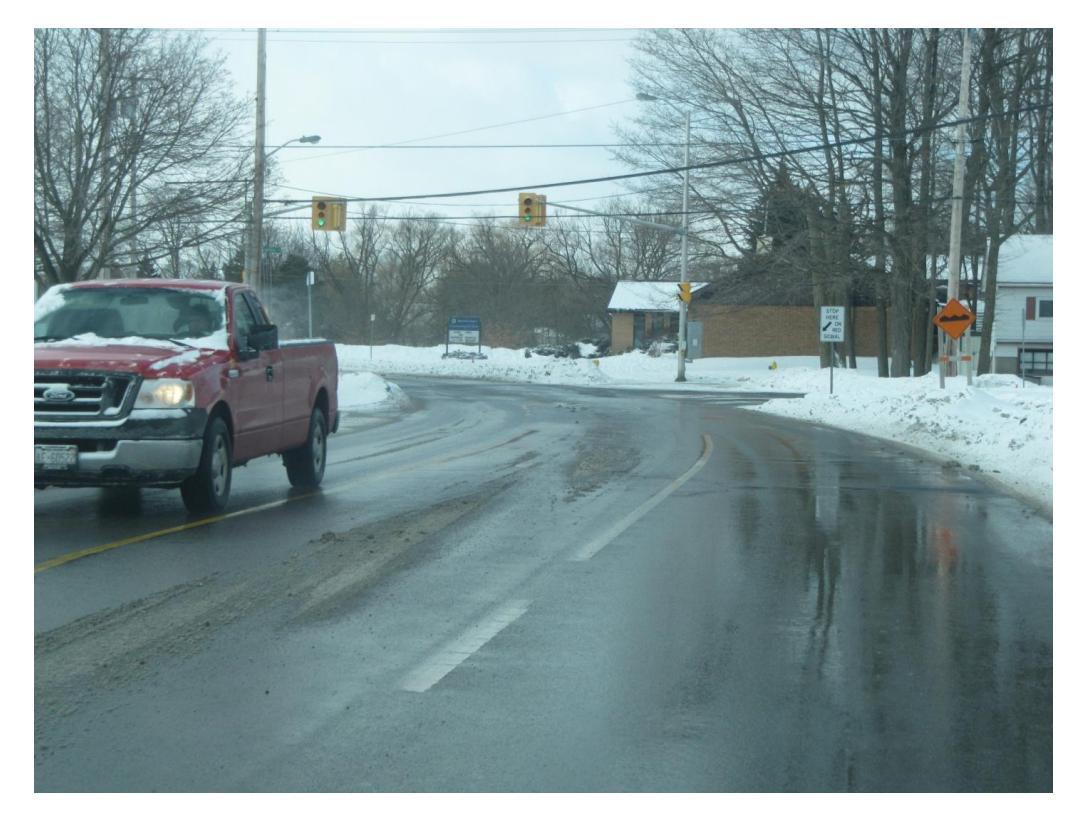
Figure 11: View of site on January 27, 2014 when orange "Bump" signs were erected to warn drivers of the uneven road surface conditions.

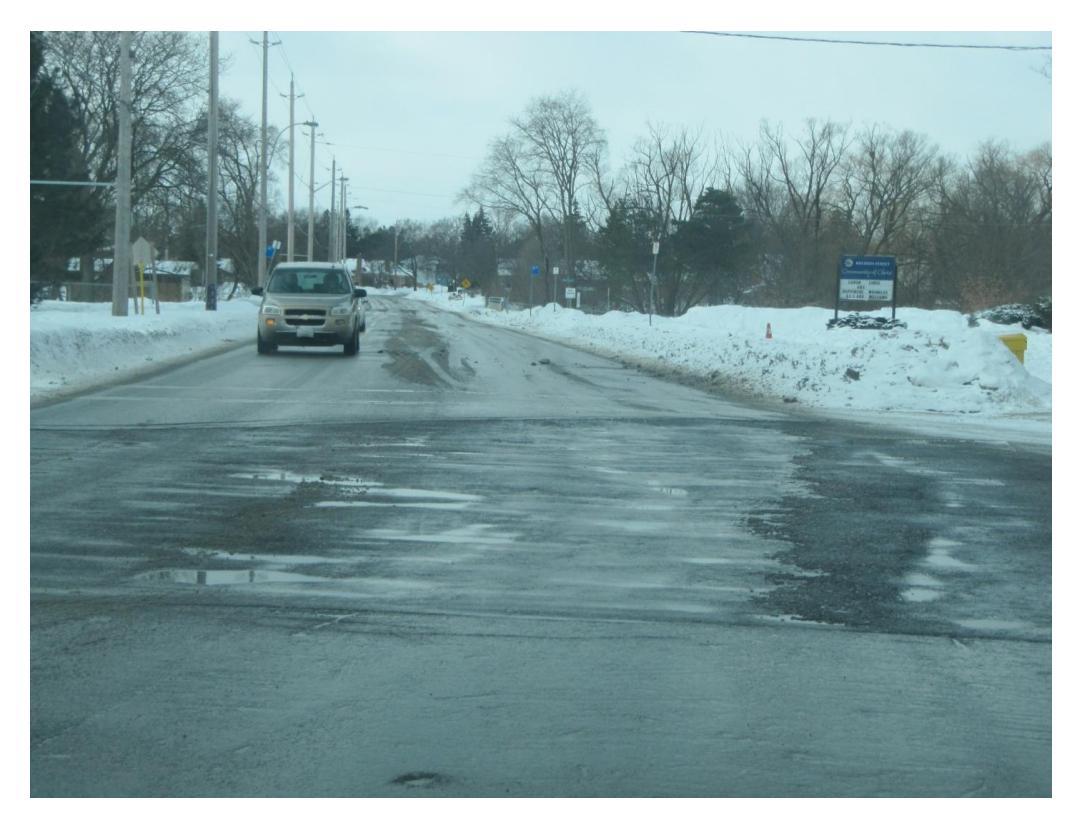
Figure 12 shows the unevenness of the patched area from a westward view taken on January 27, 2014.

Figure 12: View, looking west, at the large patch of uneven and depressed road surface on Wavell Street at its curve with Spruce Street in London, Ontario. This photo was taken on January 27, 2014.

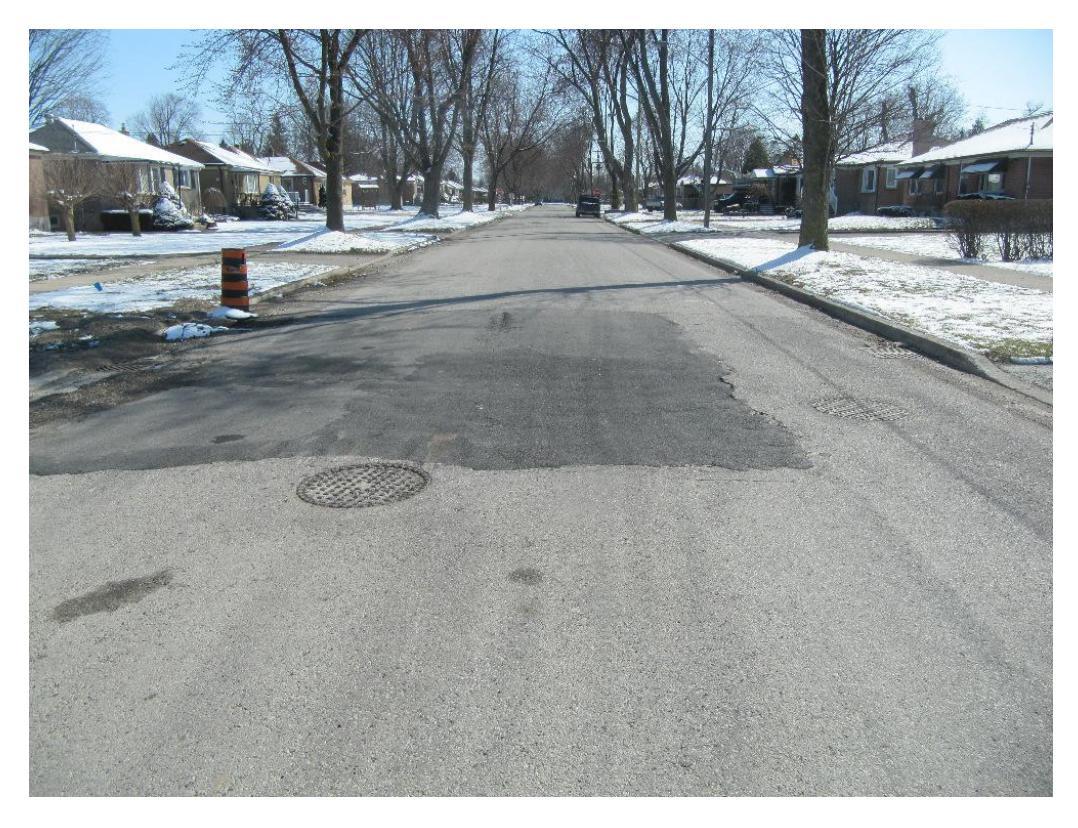
Figure 13: View, looking east, along Park Avenue in London, Ontario on April 16, 2014.

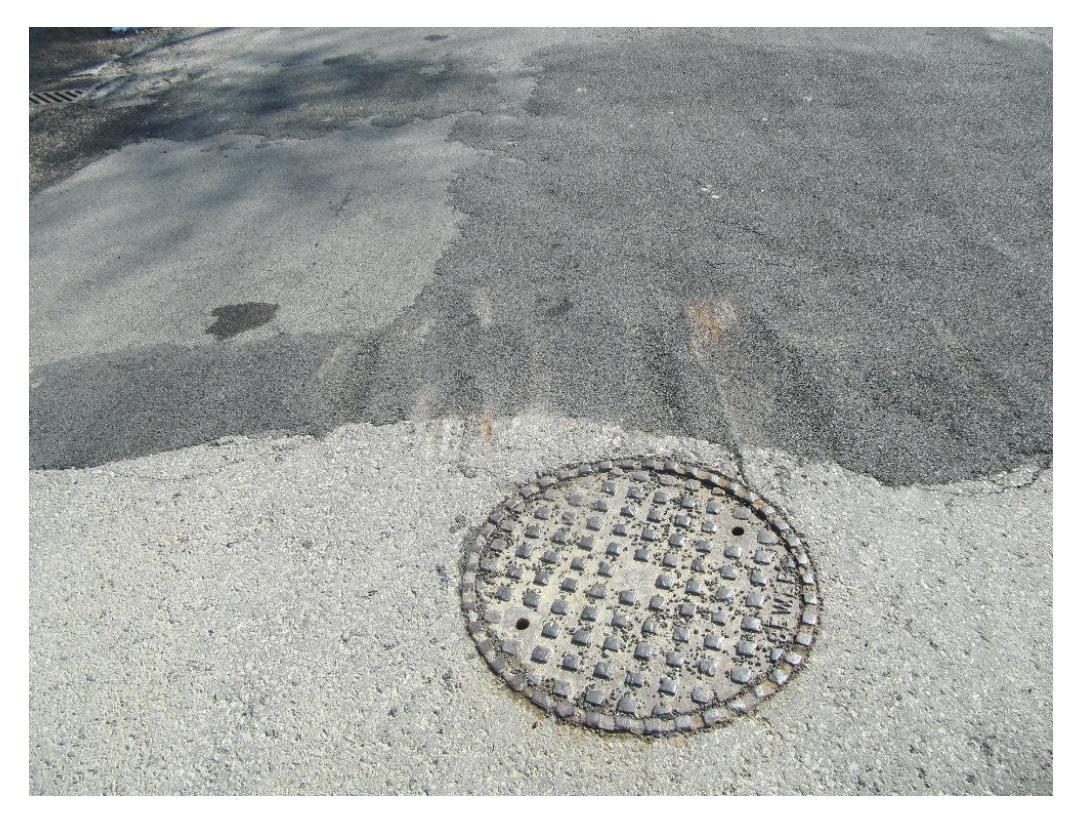
Figures 13 and 14 are eastward views of the patch taken on April 16, 2014. The patch consumed most of the road width. A closer look reveals several layers of asphalt had been applied indicating that, as the patch became depressed, the road maintenance personnel applied additional material to level the surface.

Figure 14: Closer view of patch showing the presence of several layers of patching by roadway maintenance personnel.

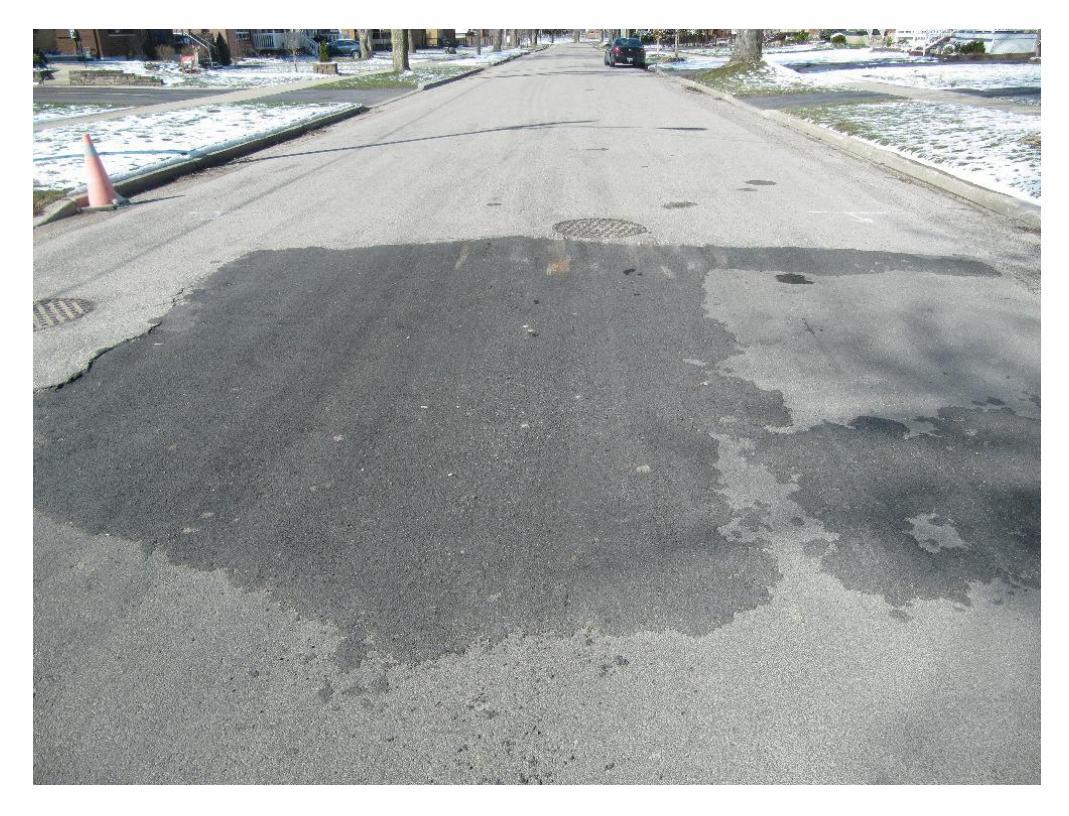
Figure 15: View, looking west, showing the patch on Park Avenue.

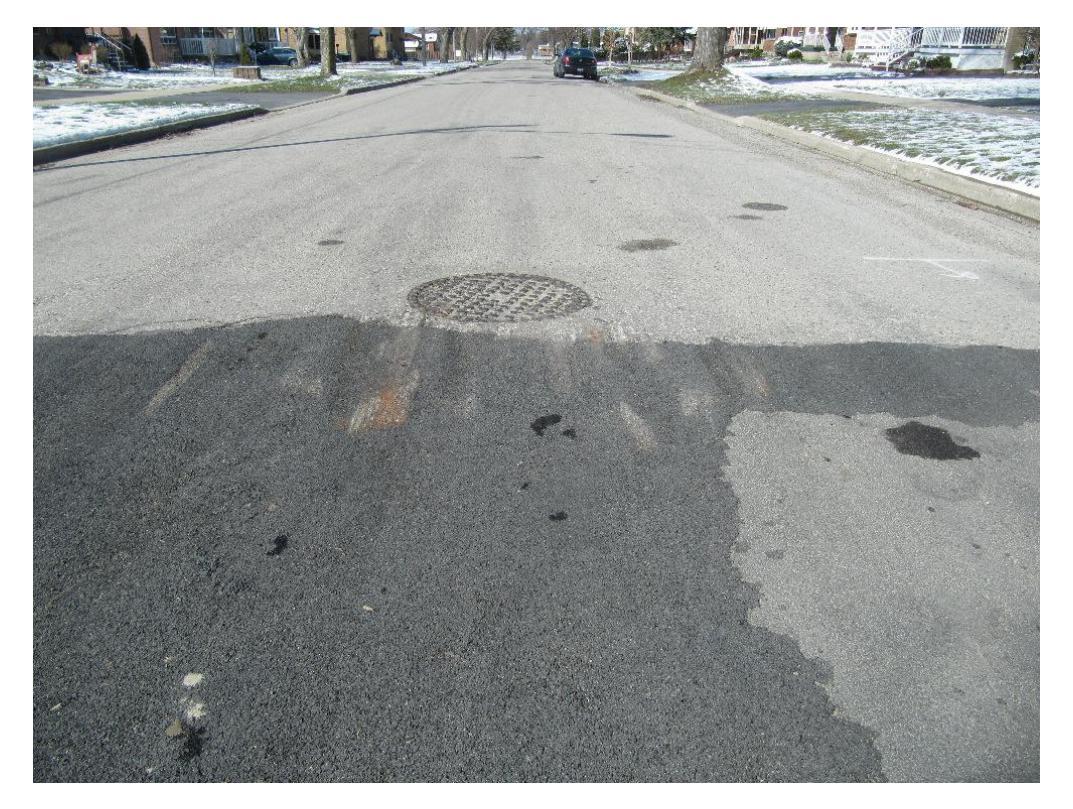
It is important to recognize, particularly from the views shown in Figures 16 and 17, that the evidence of numerous impacts of the pavement occurred on top of the latest patching. In other words, all these markings that we see occurred after the last patching was performed so this should raise some concern.

Figure 16: View, looking west, at a number of markings in the pavement near the man-hole indicating that the underside of passing vehicle made contact with the surface.

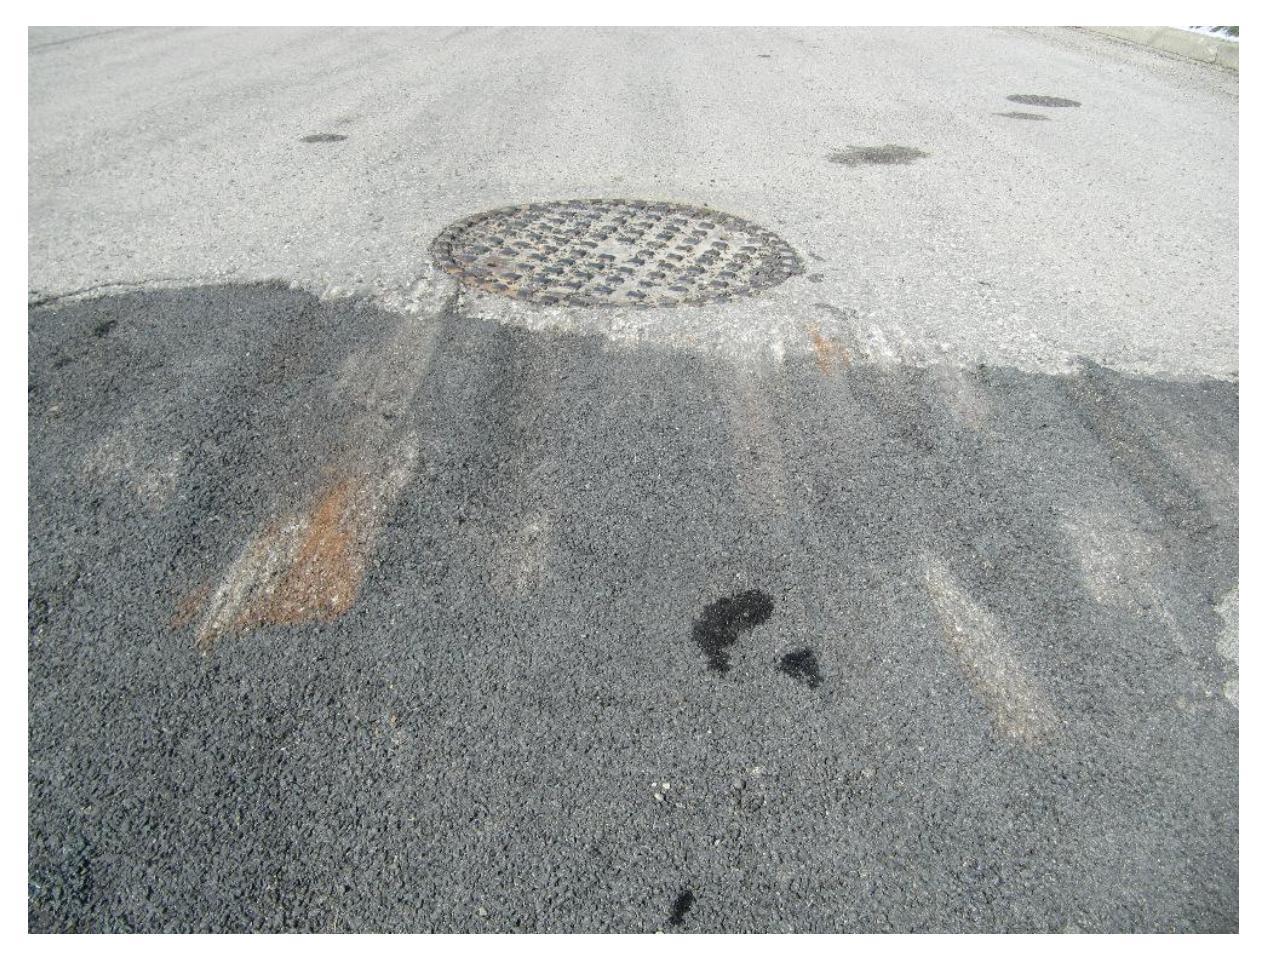
Figures 15, 16 and 17 are westward views of the patch. The close-up view shown in Figure 17 shows that there have been numerous incidents where the underside of passing vehicles made contact with the patch in the vicinity of the man-hole cover. Although there are a couple of traffic cones on the roadside the required "Bump" sign is non-existent.

Figure 17: Close-up view of the evidence of vehicle contact with the pavement.

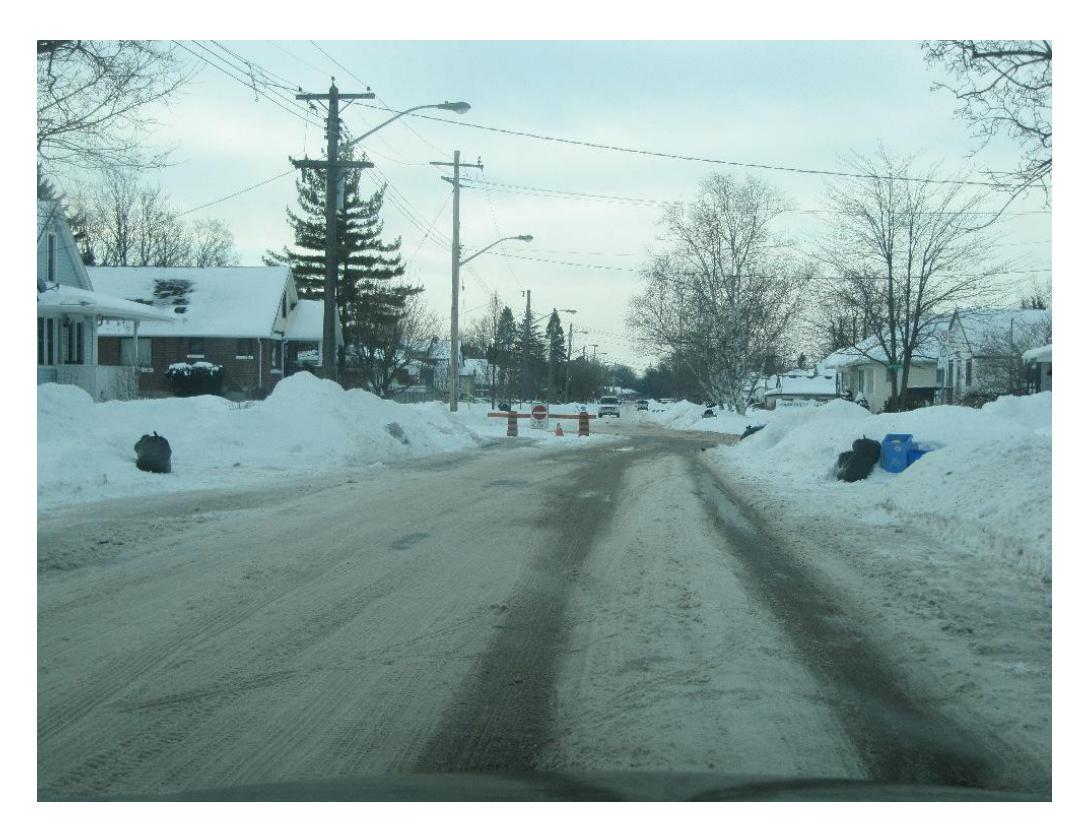
For example, Figure 20 shows a southward view on February 19, 2014 looking toward the area of the previous construction and the road closure barricade is placed in the northbound lane. As we come closer to the area we can see, in Figure 21, that the road closure sign only points toward southbound traffic and there is no sign for northbound traffic. This suggests to southbound drivers that the road is closed while no instruction what-so-ever is provided to northbound drivers. Drivers simply ignored the apparent road closure and drove around it using the southbound lane. We will soon discover that the additional volume of traffic onto the patch in the southbound lane likely compressed the patch much more than in the northbound lane. Of course the depth of this depression cannot be detected because of the snow covering the road surface.

Figure 20: View, looking south, along Vancouver Street, showing a road closure barricade at the intersection with Whitney Street on February 19, 2014..

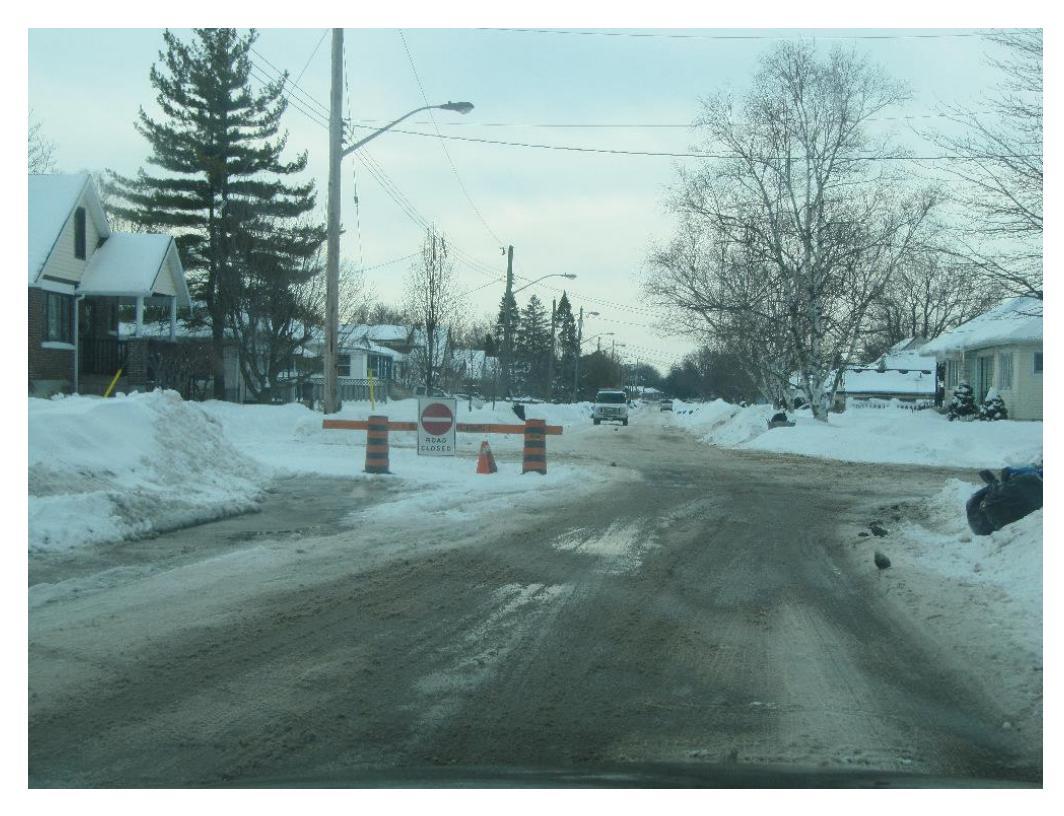
Figure 21: View showing that the road closure sign is only visible for southbound traffic. Driving travelling northward were given no instruction as to the presence of a deep depression that existed near the road closure barricade.

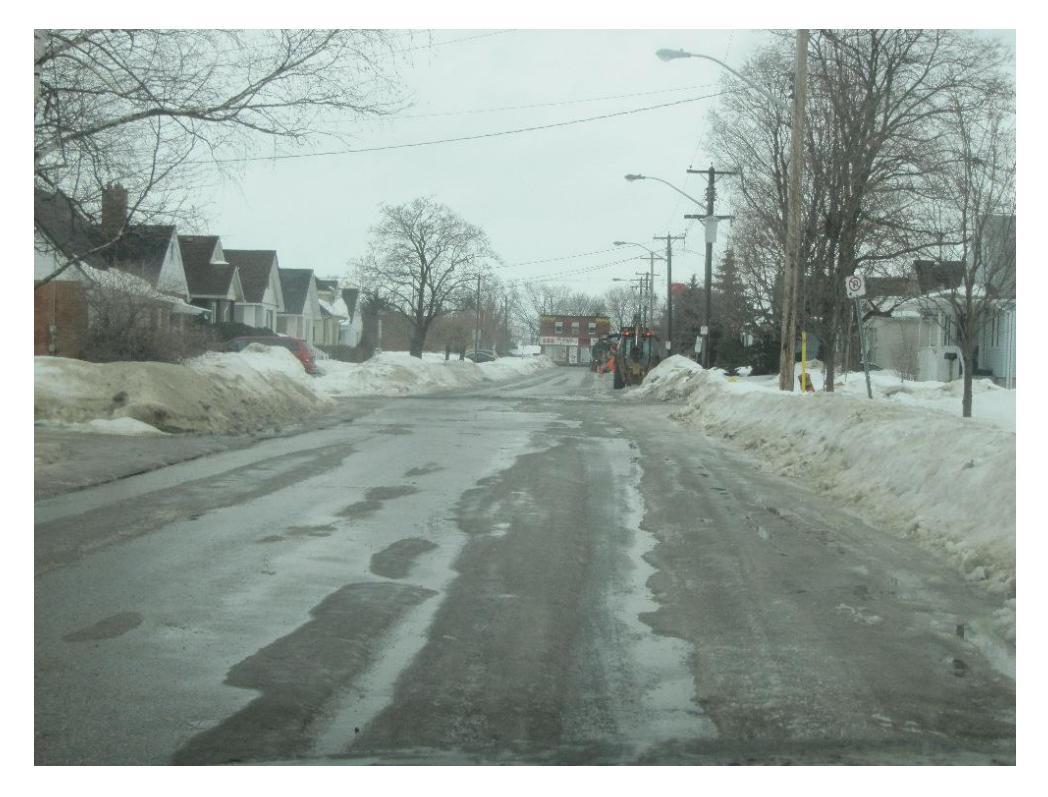
Figure 23: View, looking north along Vancouver Street, from just south of the intersection with Whitney Street, showing construction vehicles north of the intersection but no signage exists to identify the depressed patch.

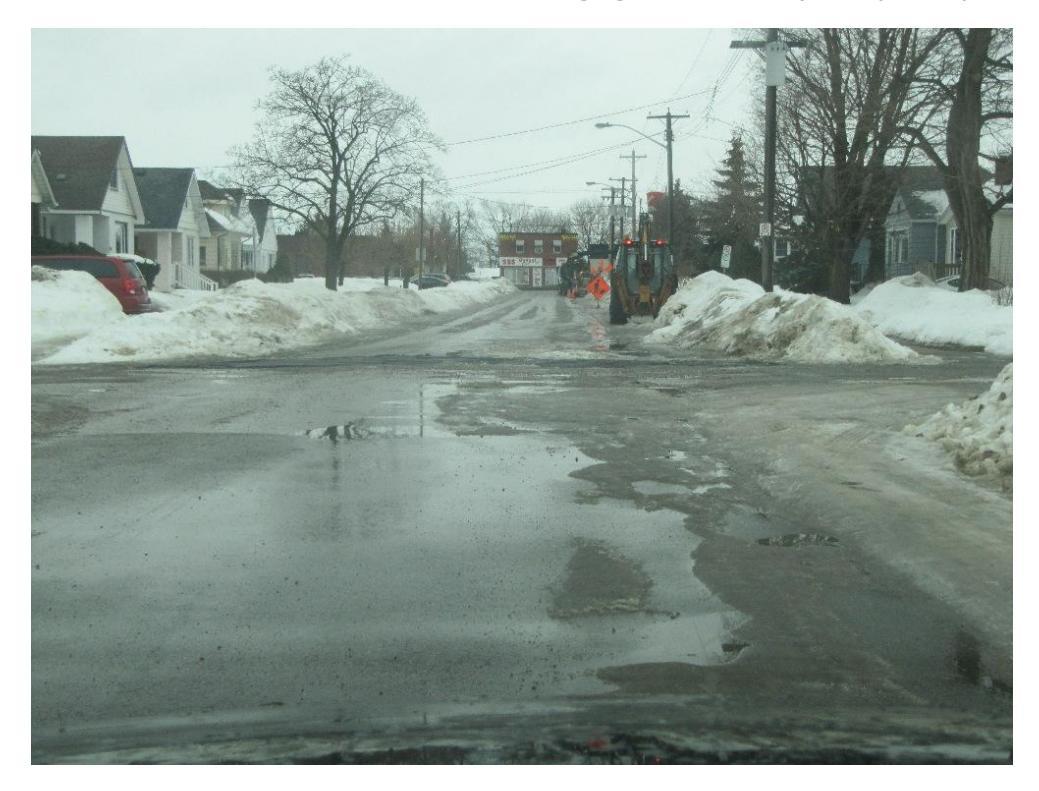
Figure 24: View, looking north along Vancouver Street from just south of the intersection with Whitney Street. The depressed patch can be seen on the north side of the intersection while construction vehicles can be seen in the background.

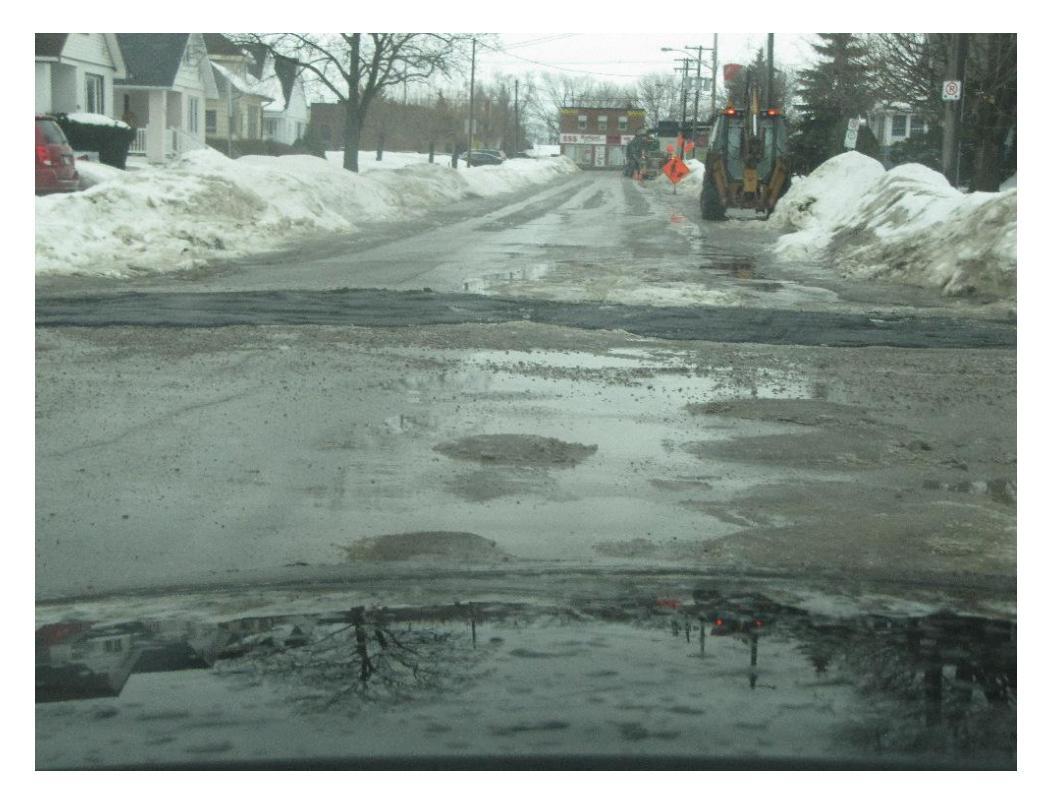
Figure 25: View, looking north on Vancouver Street at the intersection with Whitney Street. The conditions of the fresh patch can be seen in the foreground while road work vehicles and signs exist in the background with respect to other, unrelated work north of the site.

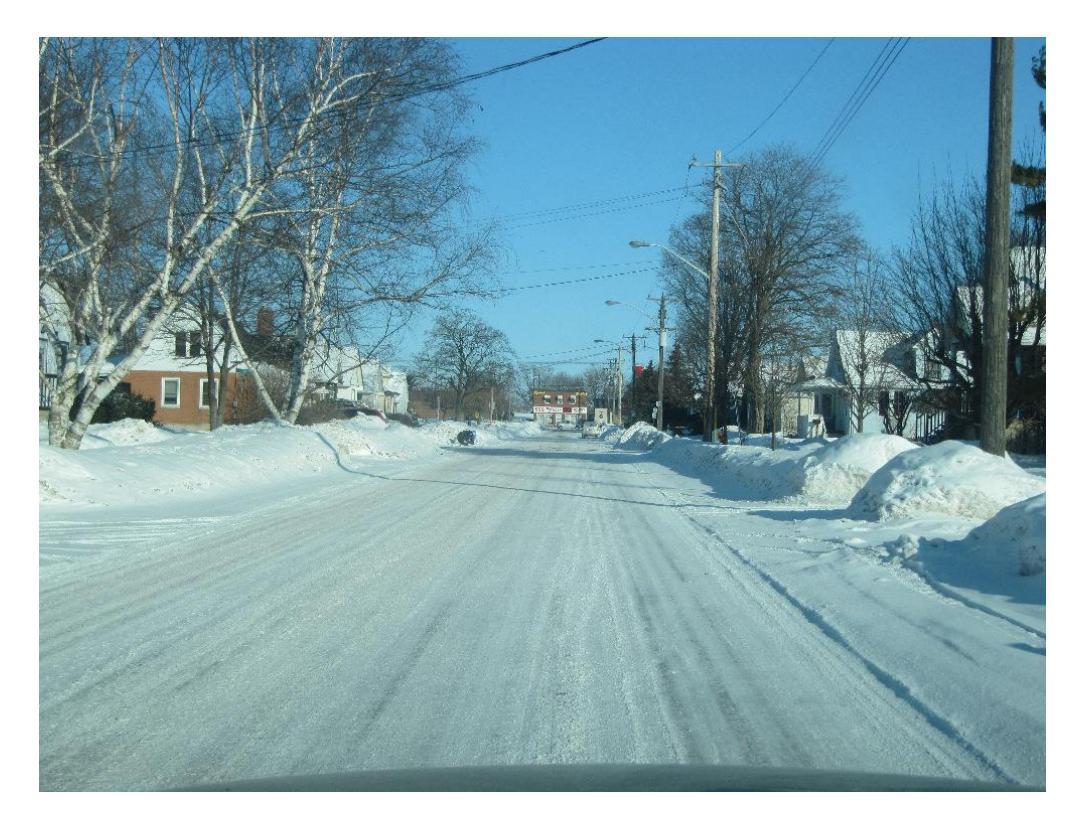
Figure 27: View looking north on Vancouver Street on approach to the intersection with Whitney Street, showing no evidence of a "Bump" sign nor any evidence of any construction activity.
