Incomplete Road Repairs - Part I - Site Descriptions

Posting Date: 22-Apr 2014

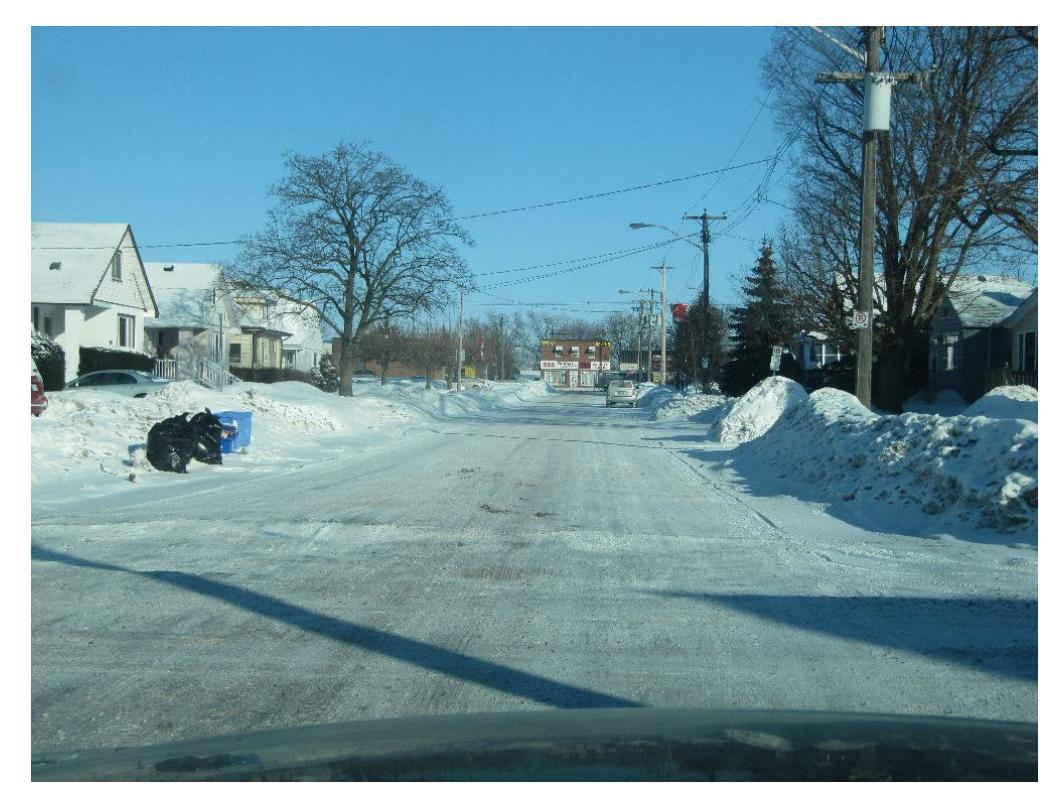
The depressed patch is visible in the foreground of Frame 28 however there are no warning signs or traffic cones in the area to identify its location. Furthermore, the presence of snow on the road surface further masks the depressed area's existence.

Figure 28: View, looking north on Vancouver Street, showing the depressed patch in the foreground and no evidence of signage or traffic cones to identify its location.

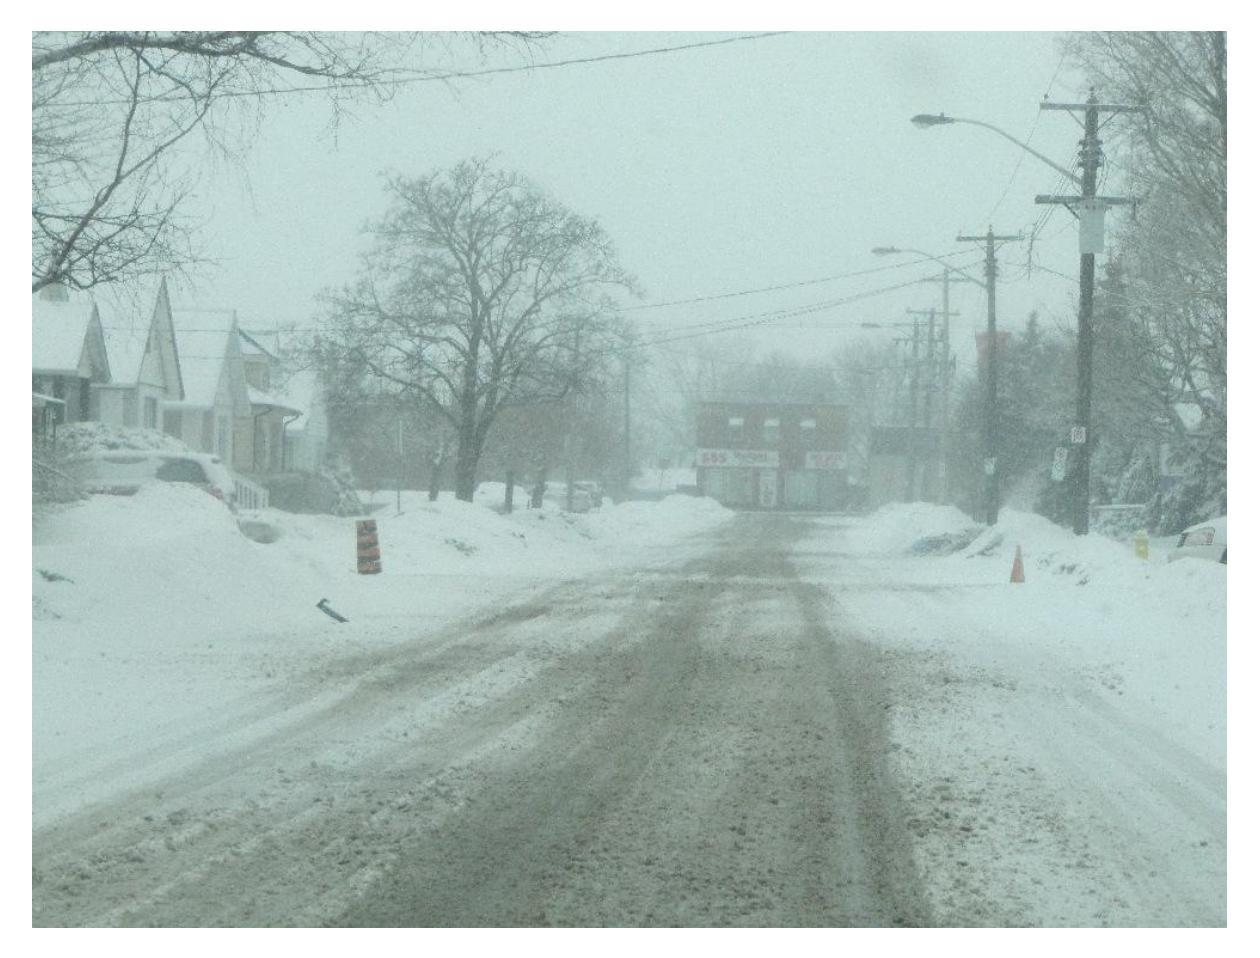
The masking of the depressed patch of pavement is further exemplified in photos taken on March 12, 2014, as shown in Figure 29. Vancouver Street is a low volume road that receives minimal snow removal and this figure shows that when a snowfall occurs it remains on the road surface and is rarely plowed. The snow sometimes becomes compacted onto the surface causing a greater unevenness of the surface. But it also causes the depressed patch to become less visible.

Figure 29: View, looking north on Vancouver Street on March 12, 2014. There is no signage erected to identify the depressed patch, although a couple of cones have been erected on the roadside. The snowfall helps to mask the existence of the depressed patch.

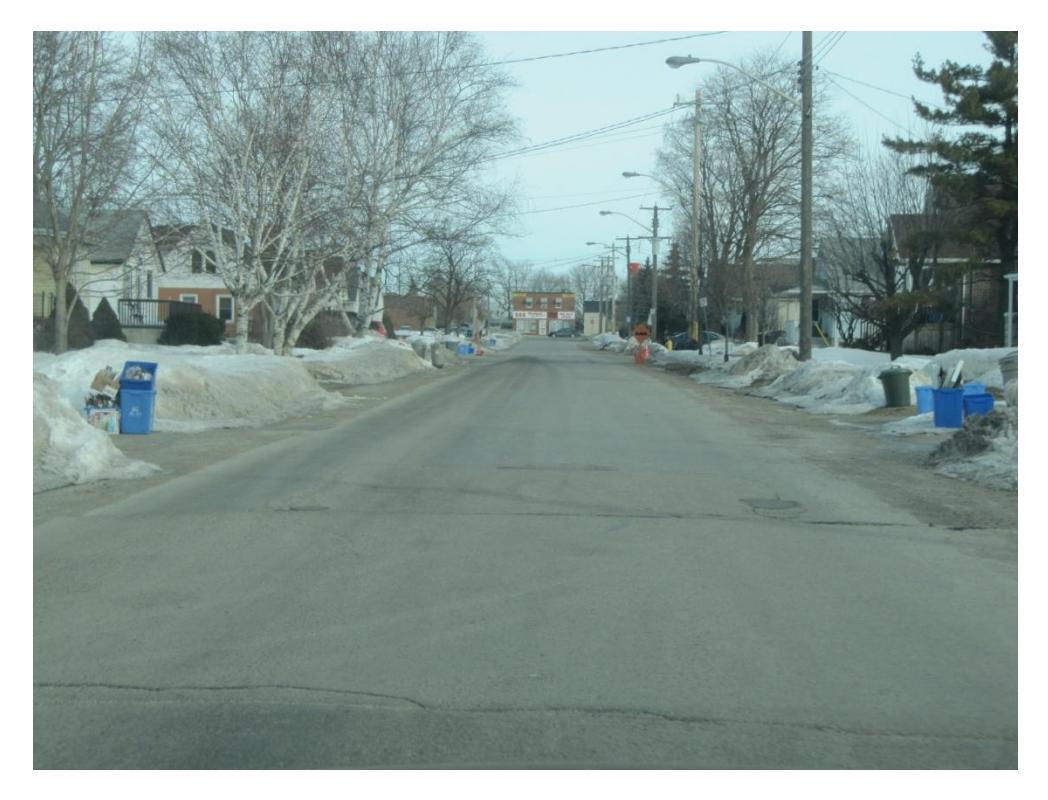
Figure 30: View, looking north along Vancouver Street on Monday, March 17, 2014, showing the presence of newly erected "Bump" warning signs.

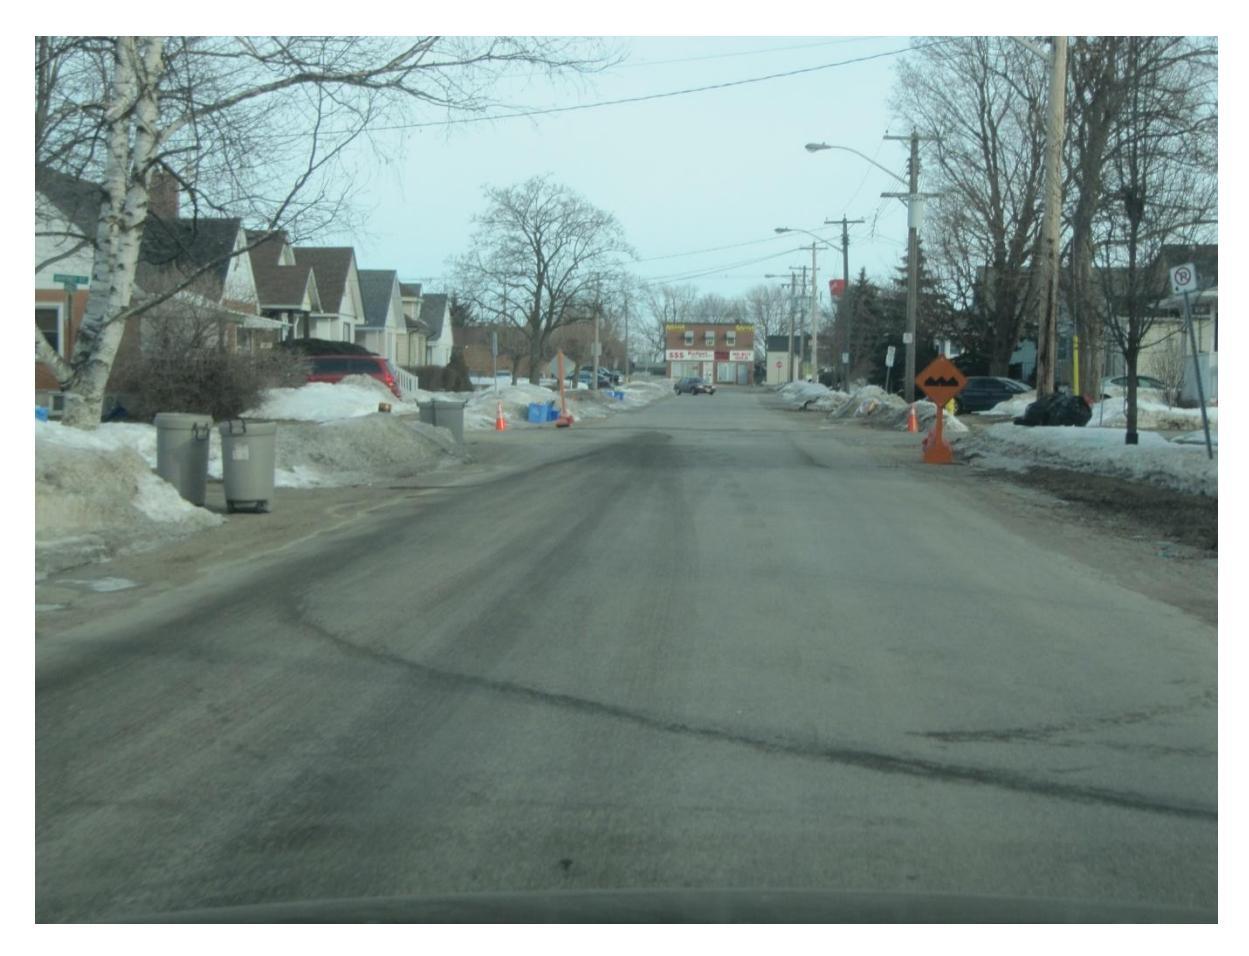
Figure 31: Northward view along Vancouver Street on March 17th, 2014, showing the newly erected "Bump" warning signs.

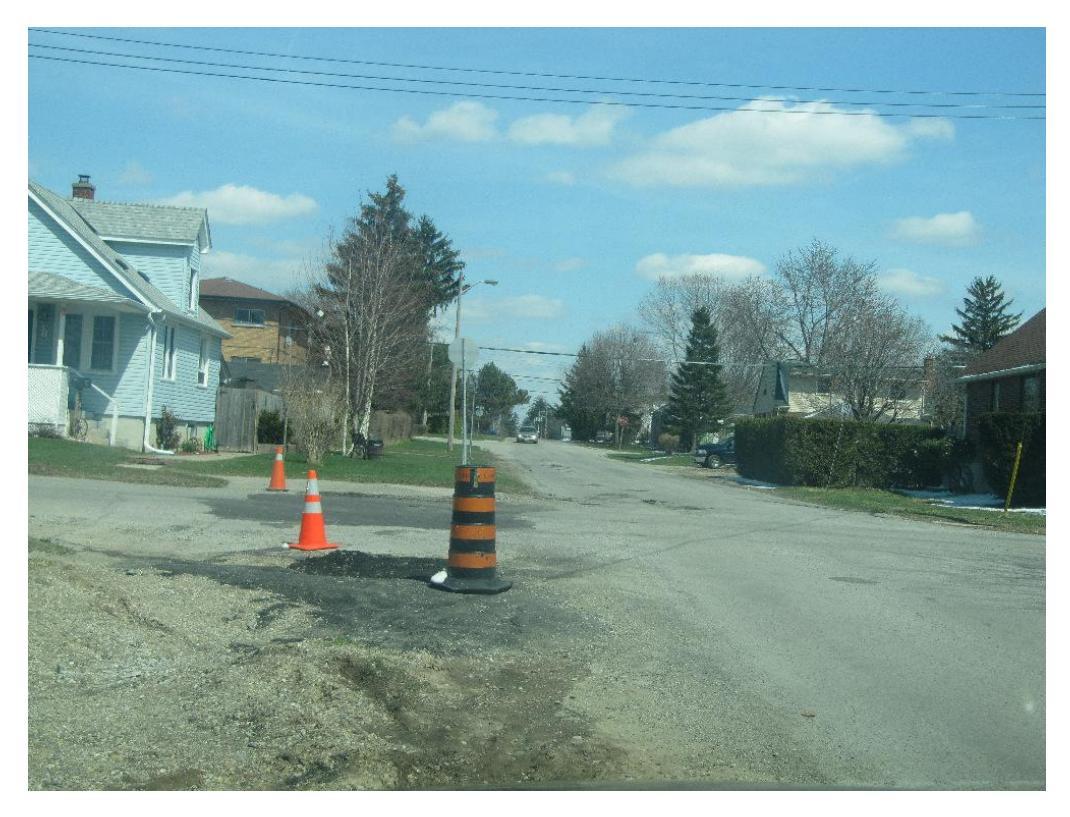
The evidence indicated that numerous vehicles had impacted the pavement at this depression. Primarily, southbound vehicles collided with the south edge of the depression. Figure 36 is a view looking south looking toward the south lip of the depression where the majority of the evidence was located. Figures 37 and 38 provide close-up views of the evidence of contact with the pavement.

Figure 36: View, looking south, toward the south lip of the depression where most of the evidence contact was located.

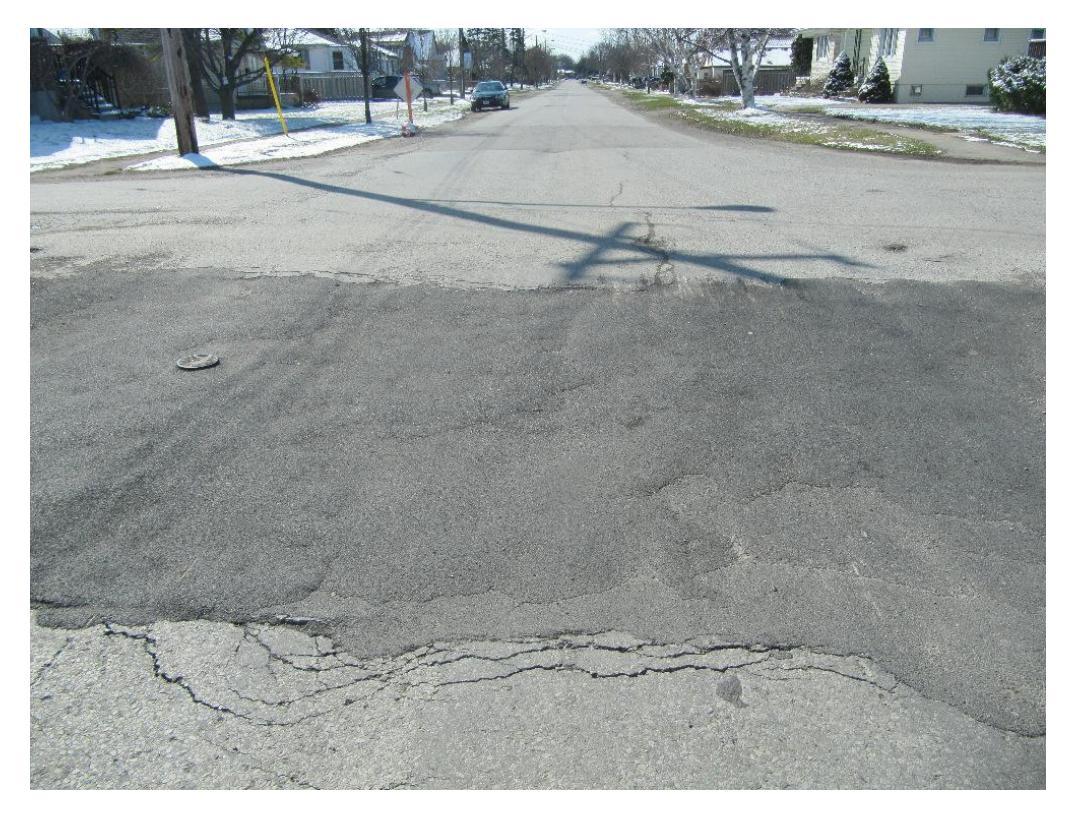
Figure 37: Close-up view of evidence of vehicle contact on the south lip of the depression.

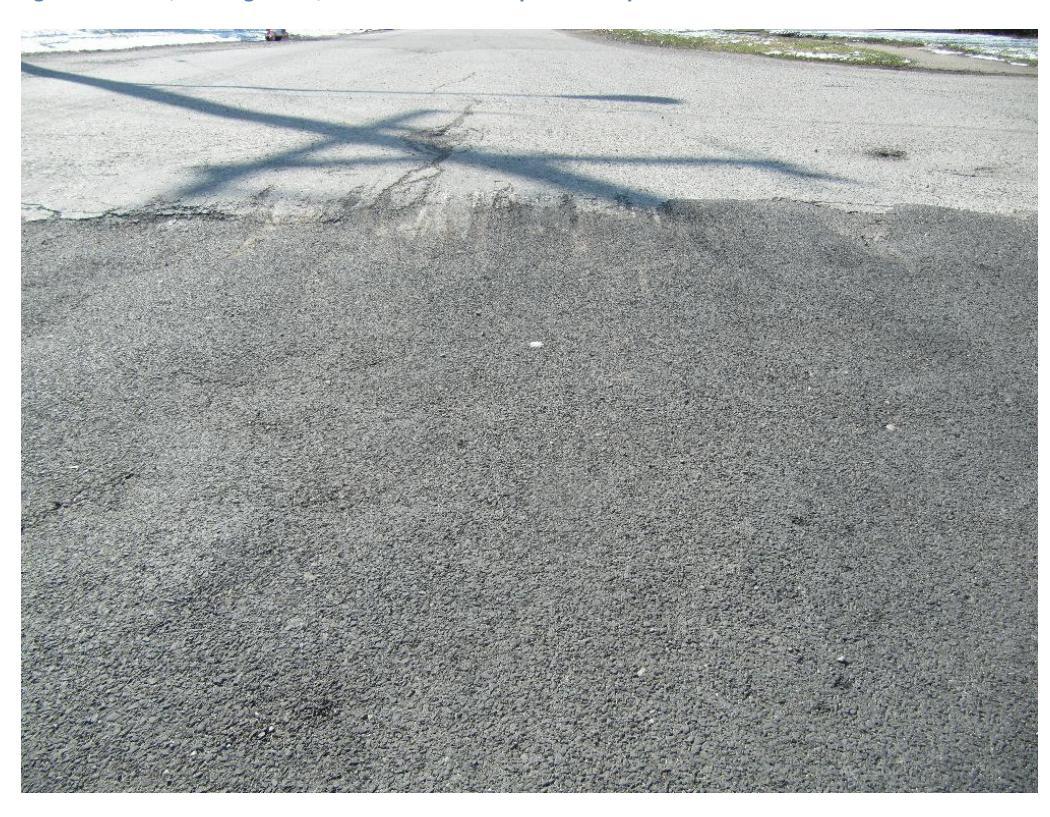
Figure 38: Close-up view of the evidence of vehicle contact on the south lip of the depression.

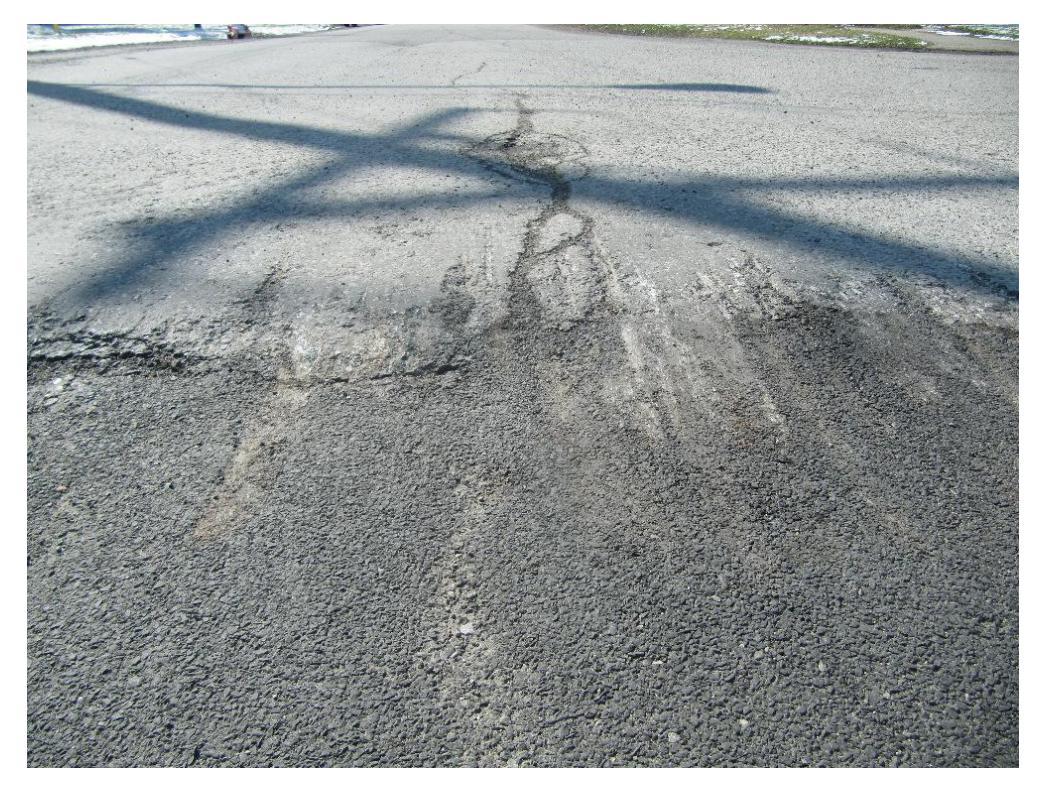
In fact, when we returned to the site on April 21, 2014 there were even more markings in the pavement indicating that this was not just a rare occurrence. Figures 39 and 40 show the evidence on April 21, 2014. Yet there was no evidence that any additional maintenance action had been made to fill the deep depression. Some observers made the comment that a "bump" sign was erected and therefore the City of London was not obligated to any further action.

Figure 39: View of evidence of vehicle contact on April 21, 2014.

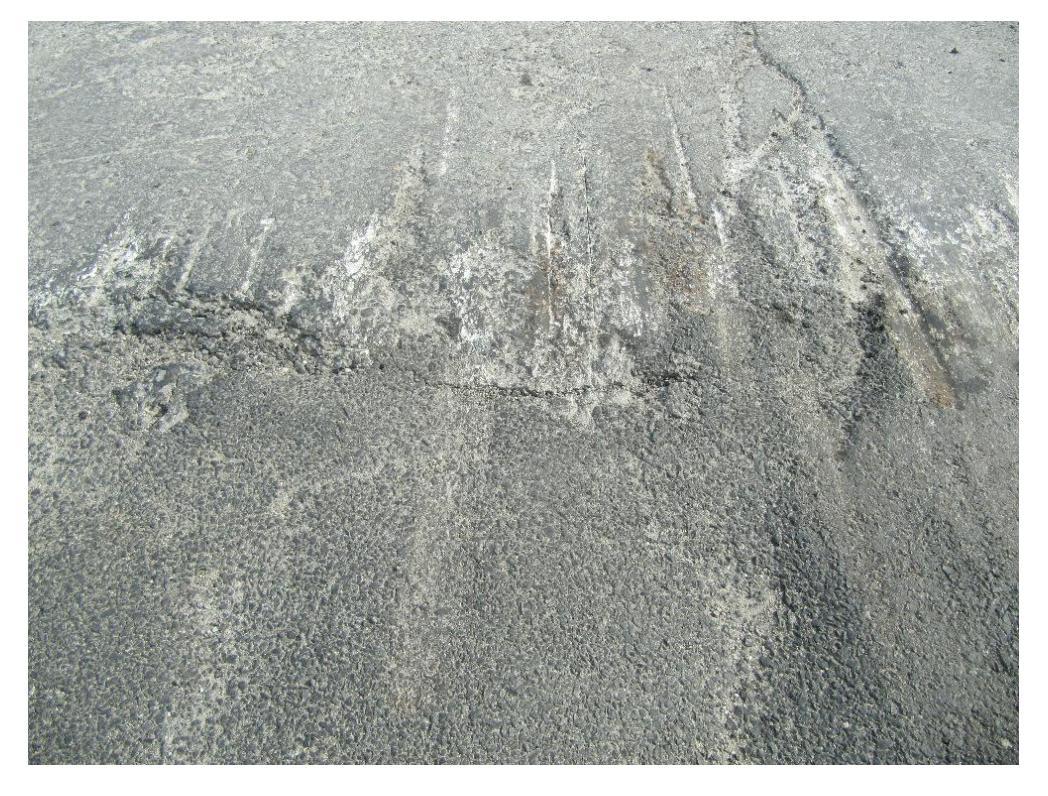
Figure 40: View of evidence of vehicle contact on April 21, 2014.
