Roadside Barriers and Death By Drowning - An Important and Hidden Issue

Posting Date: 30September 2013

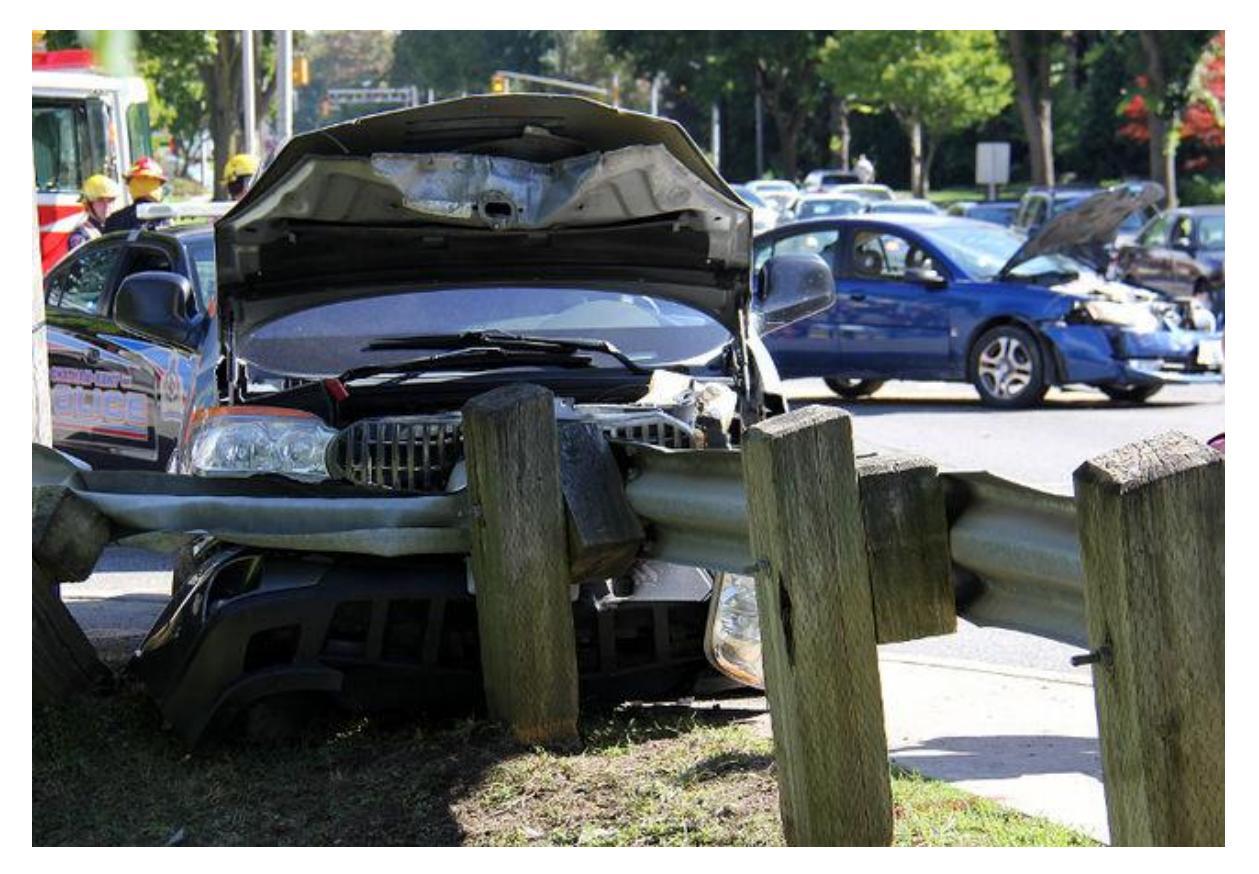
The title of the article accompanying this photo was " Vehicle Slams into Guardrail in Chatham". This was a relatively inconsequential event as, from our experience, the damage to the vehicle is relatively light and minor injuries would be expected. The use of the superlative "Slam" gives the connotation that there was something dangerous or improper about the guardrail impact and that is not so.

The reason why it is important to display this photo is to demonstrate how a properly functioning guardrail system should work. Note that the posts that hold up the metal rail

are relatively new and the rail has been placed at a sufficient height that it has arrested the centre-of-gravity of the vehicle and brought the vehicle to a controlled stop. This is a good thing. What we do not want see are old anchorage posts that have no strength, or a rail that is too low and makes the impacting vehicle vault over the top of the rail...and so on. Enough said about the photo.

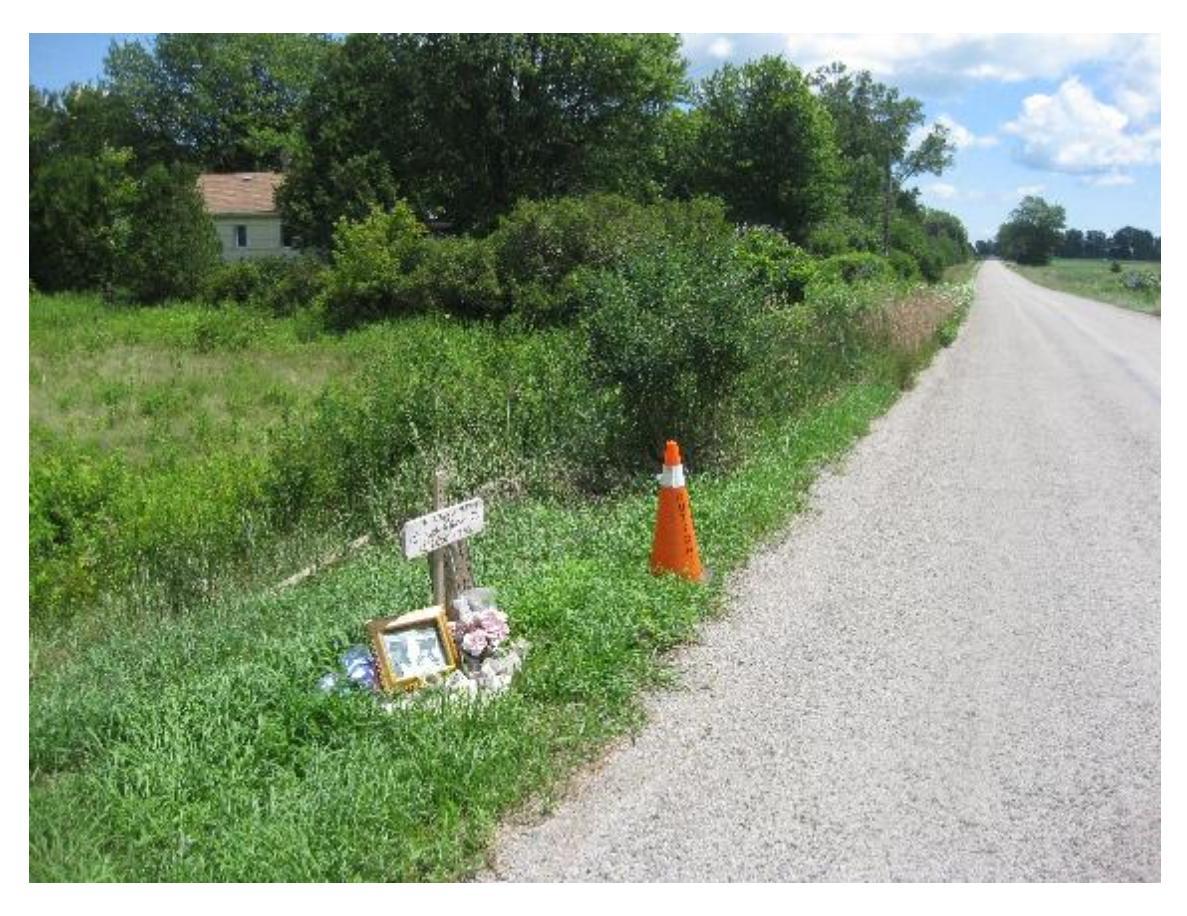
In December of 2009 we attended an accident site on Dunborough Road near West Lorne, Ontario where a Pick-up truck had entered a ditch resulting in fatal injuries to a passenger. In examining the existing post and wire barrier it confirmed that the single cable strung between the wooden anchor posts was extremely loose. Although the struck barrier was damaged and could not be fully evaluated the same cable system on the opposite side of the road could be easily deflected by over one foot simply by pressing against it by with one's hand. We returned to the site the following July and noted that little had changed, as shown in the photo below.

Figure 1: View of accident site on Dunborough Road near West Lorne Ontario, taken about 7 months after the collision date.

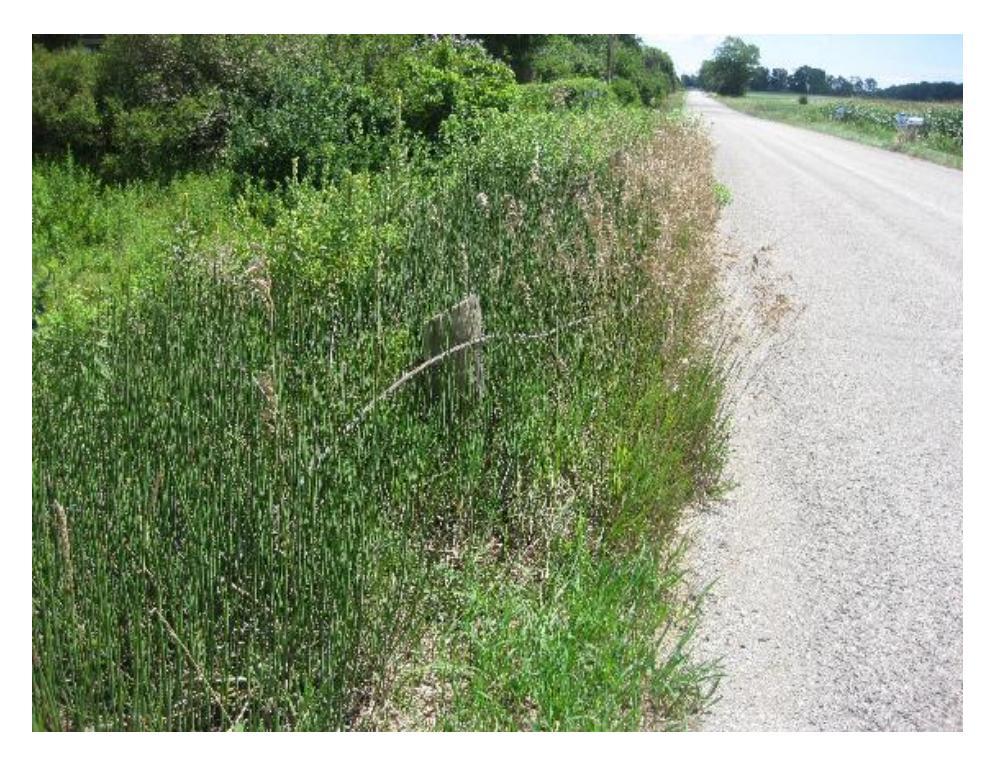
There was a memorial at the accident site and a single traffic cone. The roadside had been over-grown with weeds such that the existence of the post and cable barrier was difficult to see. Yet, as shown in Figure 2, if one looked closely, the post and cable barrier was still present in a similar condition to what it was 7 months previous. The looseness of the cable can appreciated by noting its angle and how that angle changes along the cable's length.

Figure 2: View of post and cable barrier, still loose 7 months after the fatal collision.

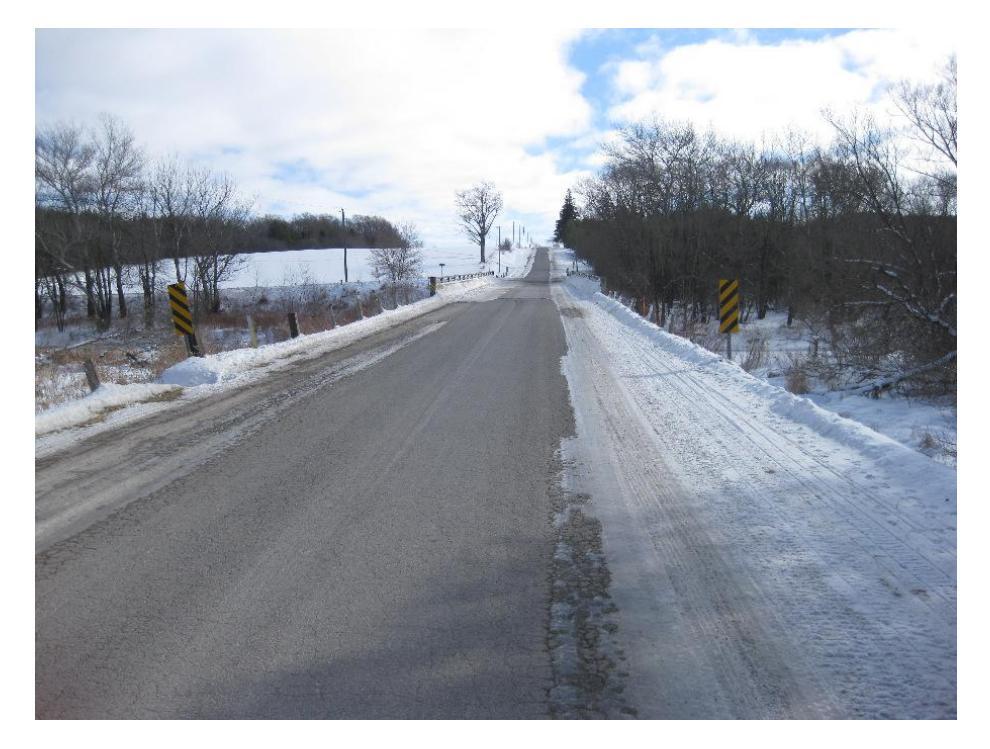
In another example, on February 8, 2010 we came across a bridge over a river just south of Mitchell, Ontario where another post and cable system existed, as shown in Figure 3. This time the actual cable was completely missing so that only the anchor posts remained. Figure 4 shows a view of the bridge and posts from the opposite side of the river. Clearly, if a vehicle slid off the road it would fall down the significant embankment and down into the water of the river below.

Figure 3: View of bridge south of Mitchell Ontario where there was no cable attached to the anchor posts of the barrier.

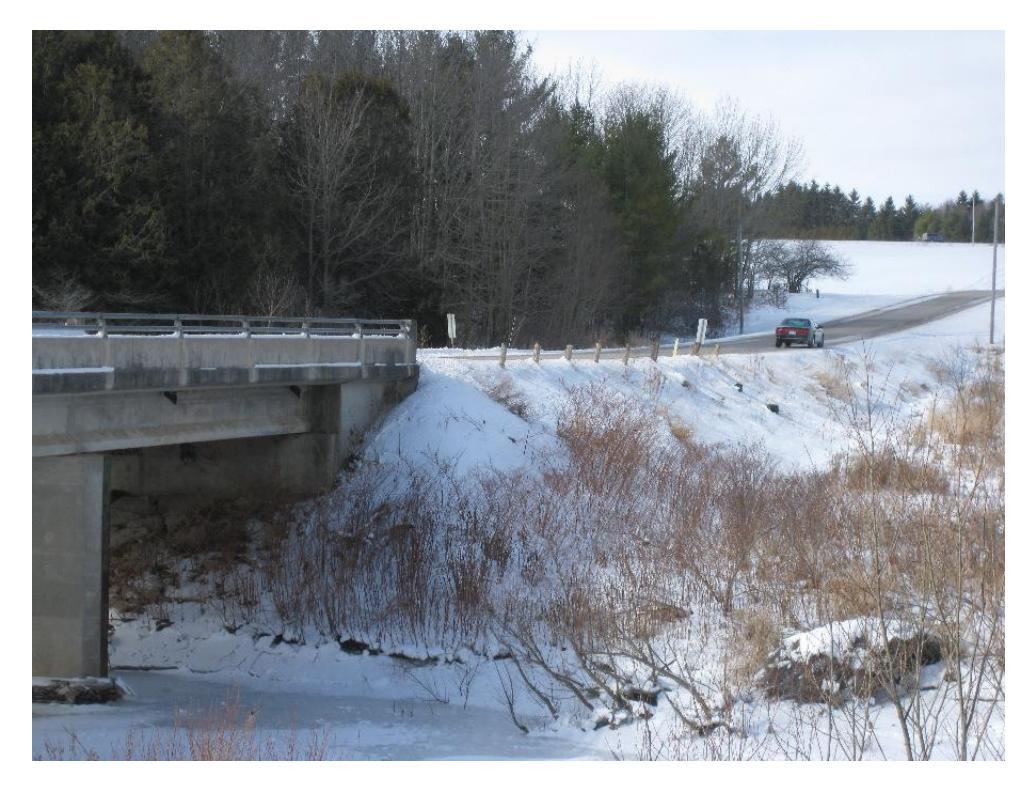
Figure 4: View of missing cable on a barrier next to a bridge crossing a river south of Mitchell Ontario.

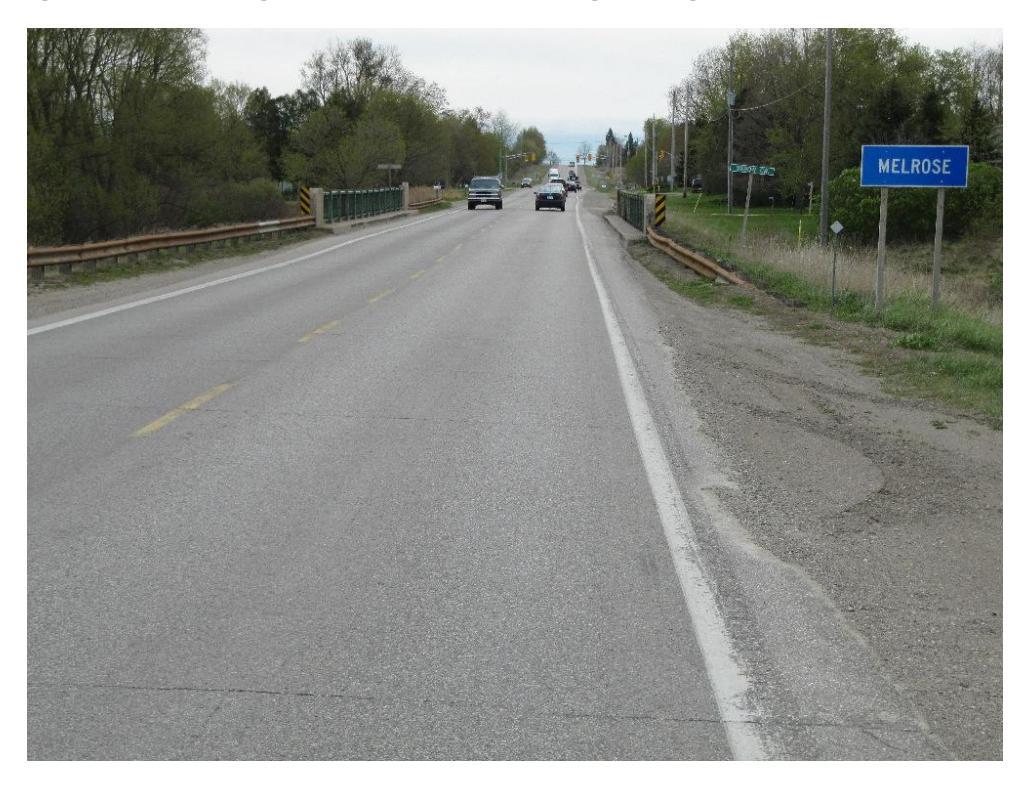
In a third example, on April 23, 2012 we came across another bridge on Egremont Road just west of London, Ontario where the bridge crossed the Oxbow Creek. The guardrail at this bridge looked like something that had been built during the American civil war - it looked that old. An eastward view of the bridge and guardrail are shown in Figure 5. Figure 6 shows how the bottom of the rail is essentially touching the ground, clearly indicating that the rail is positioned far too low. The centre-of-gravity of any vehicle

Figure 5: View, looking east, at guardrail adjacent to the bridge crossing the Oxbow Creek just west of Melrose Ontario.

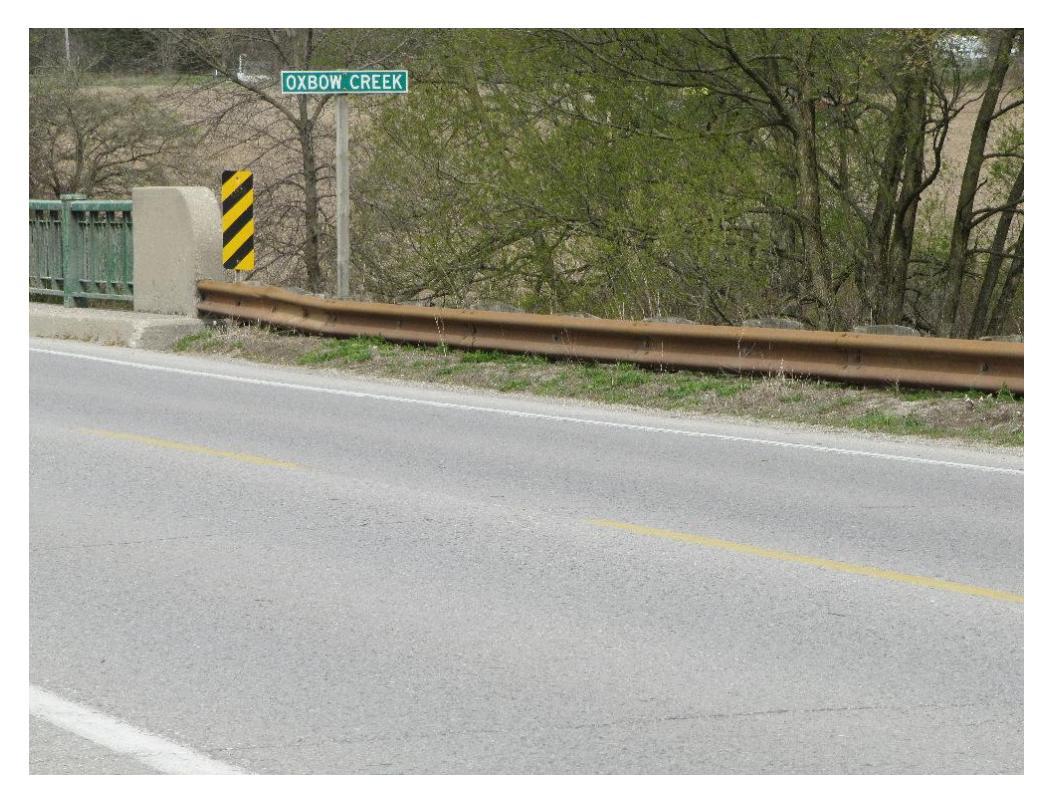
striking this rail would be above its height and therefore the vehicle's motion would not be arrested, sending the vehicle over the rail.

Figure 6: View of Oxbow Creek guardrail that is clearly far too low to the ground.

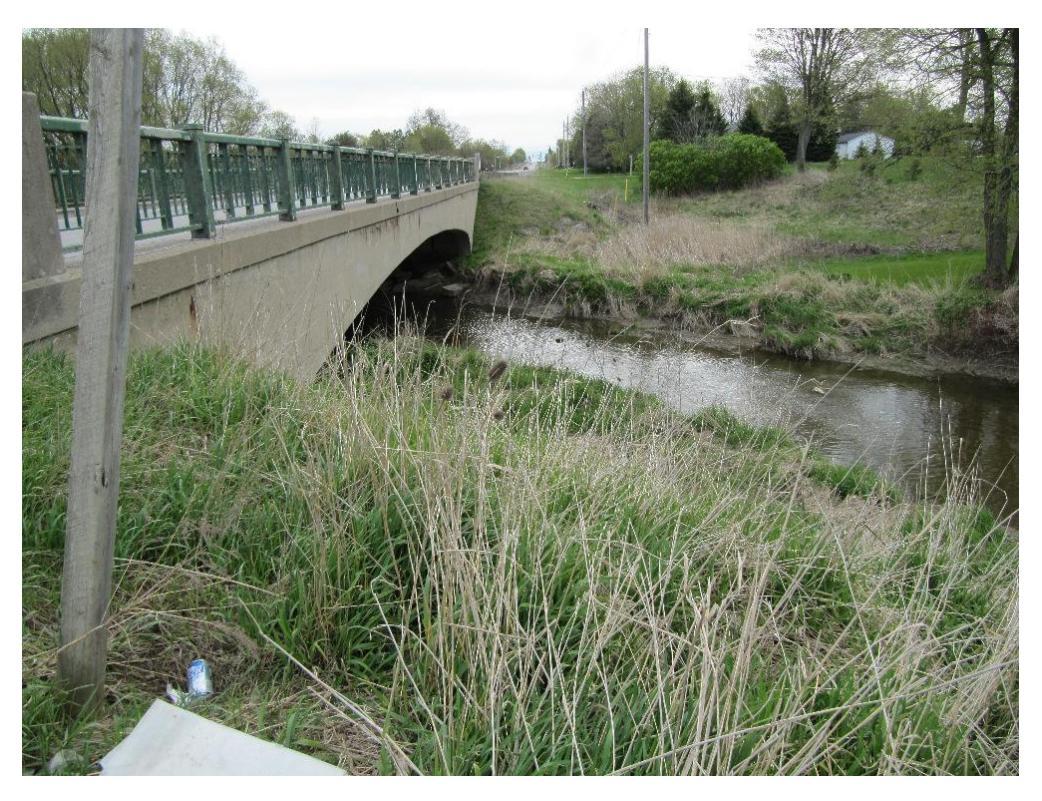
Figure 7: A vehicle entering Oxbow Creek could result in the drowning of its occupants.

As shown in Figure 7, a vehicle plummeting over the guardrail has a greater chance of being over-turned and possibly falling into Oxbow Creek on its roof resulting is potentially fatal consequences.

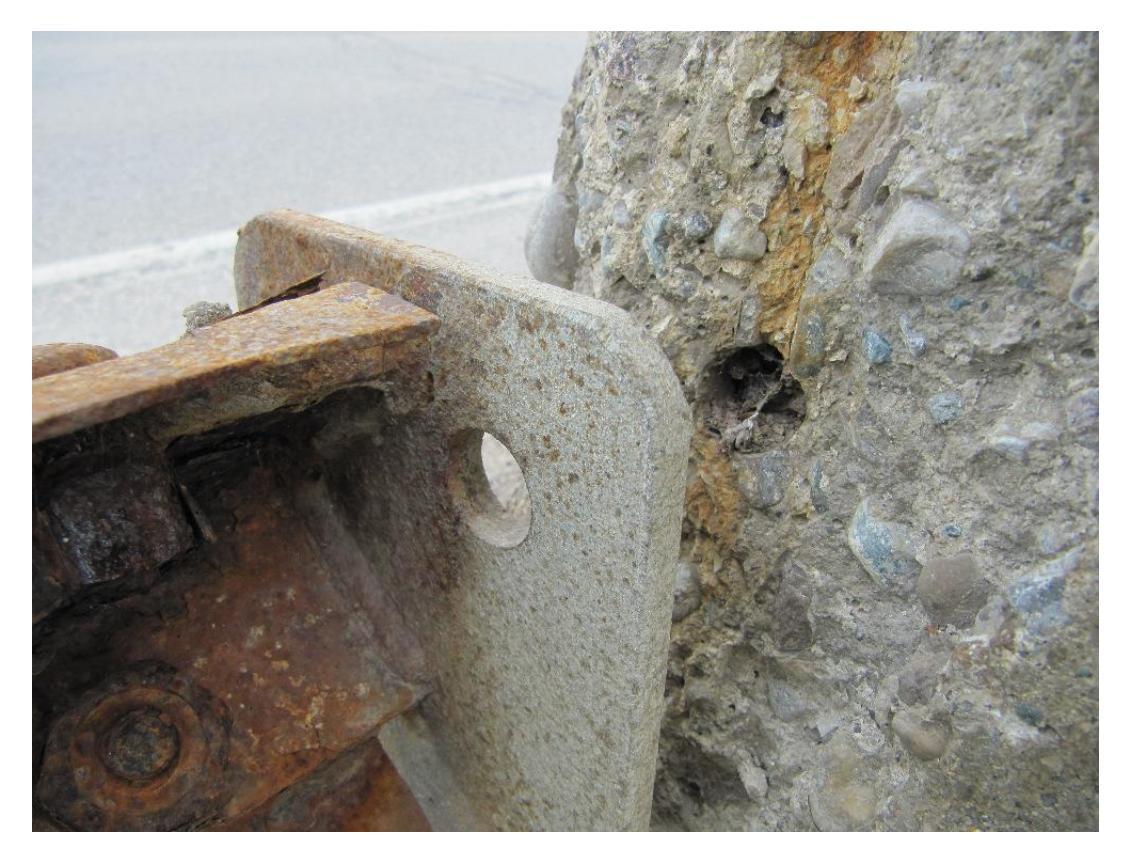
Clearly the anchorage of the rail to the bridge was also substandard. As shown in Figures 8 and 9, the bolts that would normally attach the rail to the bridge were missing. This is an additional danger that few persons understand. In the late 1970's an inquest was held with respect to a fatal collision that occurred on Highway 401 at Dodd's Creek just west of London Ontario. The guardrail there was not properly anchored to the concrete bridge abutment. When a vehicle impacted the rail it was deflected and slid along the rail until it immovable abutment resulting in the fatality. The recommendations of that inquest was to ensure that such rails would be firmly attached to the concrete abutment of bridge. Since then, all the guardrails and bridge abutments along Highway 401 were changed to ensure compliance. Well, as we have stated before, as time passes we crawl back into our caves. The standards that were once applied and adhered to no longer apply and are no longer adhered.

Figure 8: View of missing anchorage bolts at Oxbow Creek guardrail.

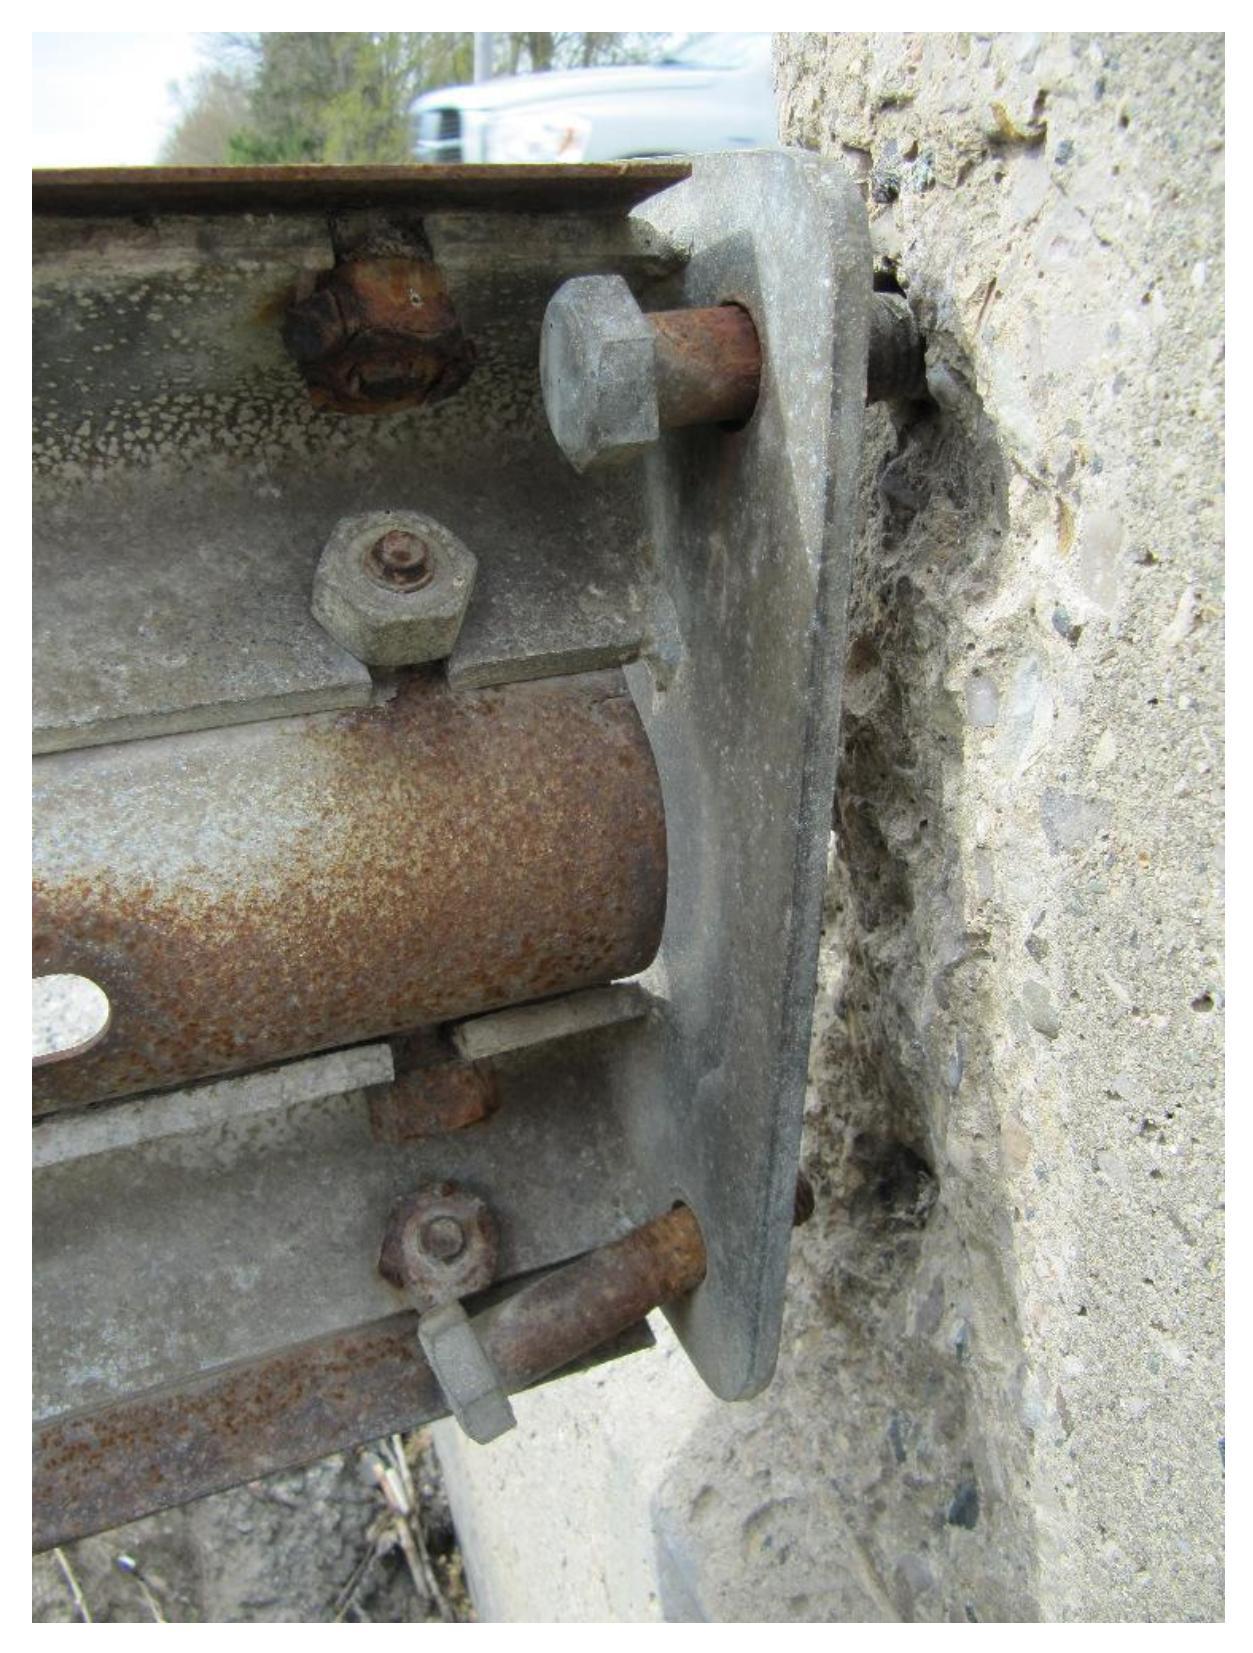
Figure 9: View of loose anchorage bolts on Oxbow Creek guardrail.

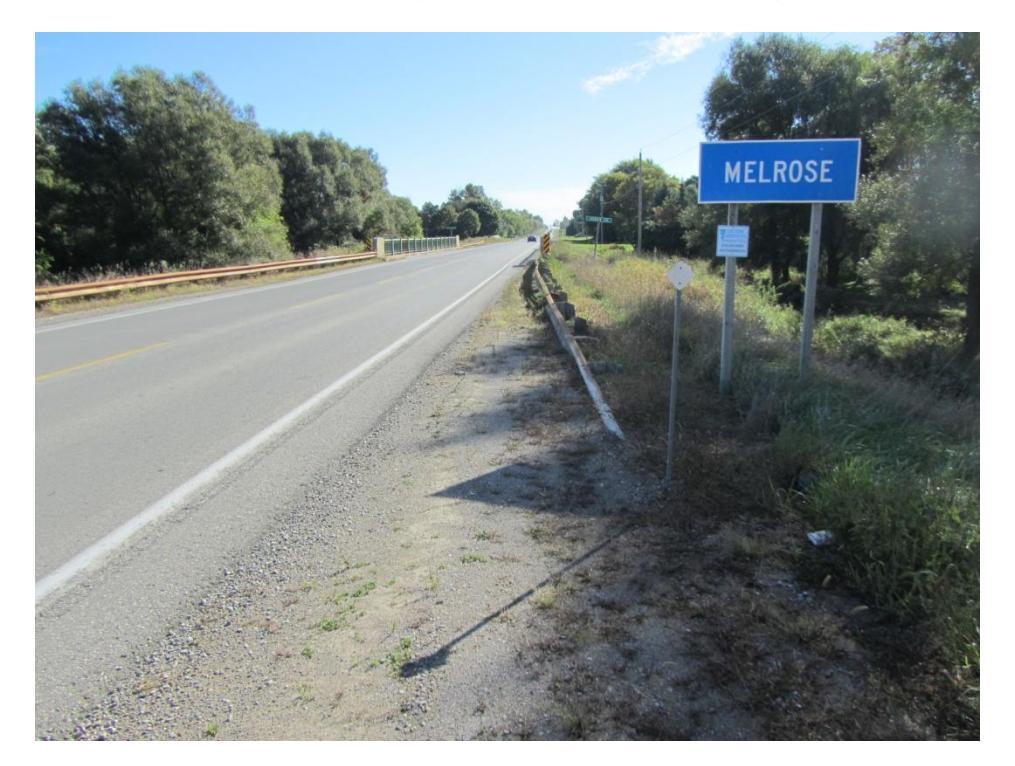
To test that theory we returned to the Oxbow Creek bridge on September 25, 2013, about 1 1/2 years after taking the above photos. Figure 10 below is the same as Figure 5 only 1 1/2 years apart. Figure 11 is the same as Figure 8.

Figure 10: Eastward view of Oxbow Creek Bridge taken on September 25, 2013.

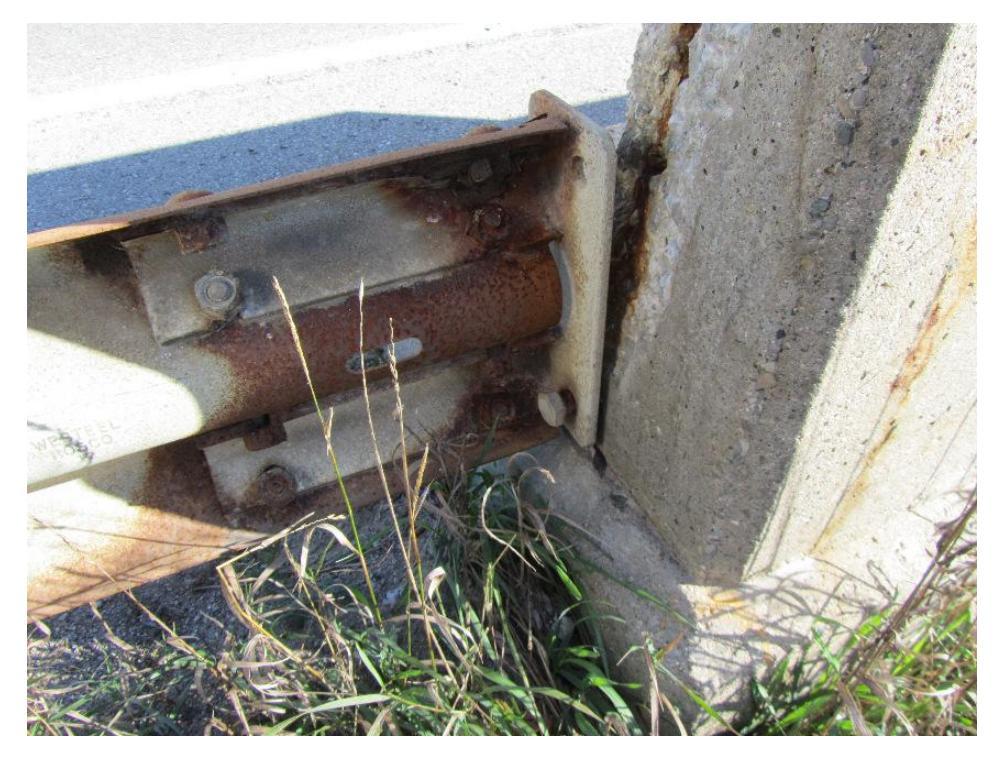
Figure 11: View of missing anchorage bolt at guardrail to Oxbow Creek bridge on September 25, 2013.

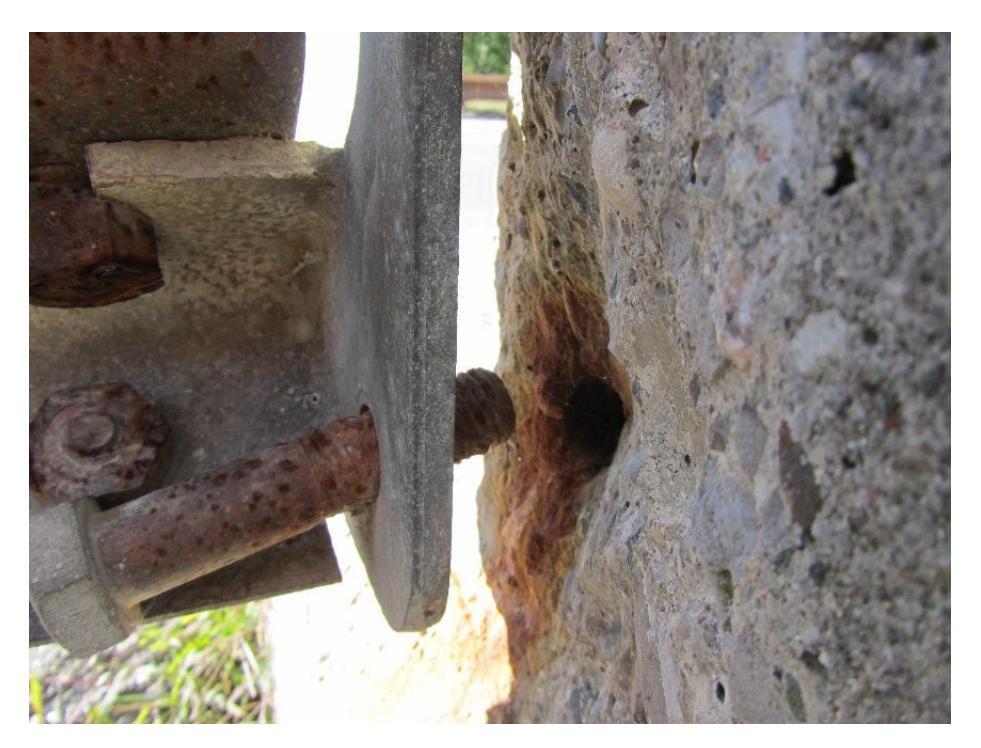
Similarly, Figure 12 is the same as Figure 9, only 1 1/2 years apart.

Figure 12: View of loose anchor bolt to Oxbow Creek guardrail.

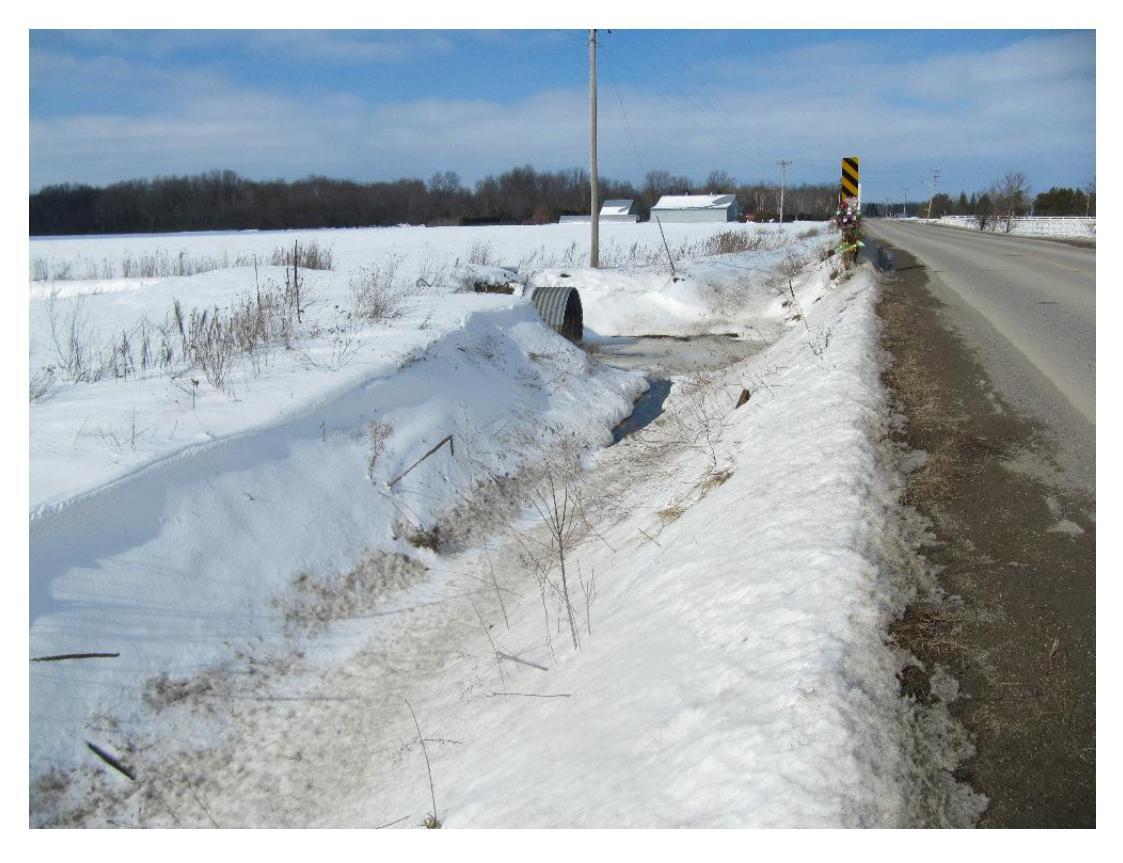
A tragic example of this fact occurred on January 12, 2013 just south of Alliston, Ontario when three teenagers became trapped in their upside-down vehicle when the vehicle slid into a steep-banked and narrow, water-filled ditch. Figure 13 shows a view of that accident site taken in February, 2013. All three occupants drowned. It might appear surprising to some since the ditch would appear to contain a small amount of water. No guardrail existed at this location, presumably because officials did not appreciate the details of the hazards posed by this specific site.

Figure 13: Alliston area triple fatality. A car approaching the camera slid into the narrow ditch in the foreground and over turned, trapping the three occupants in a shallow depth of water. All three were found drowned.

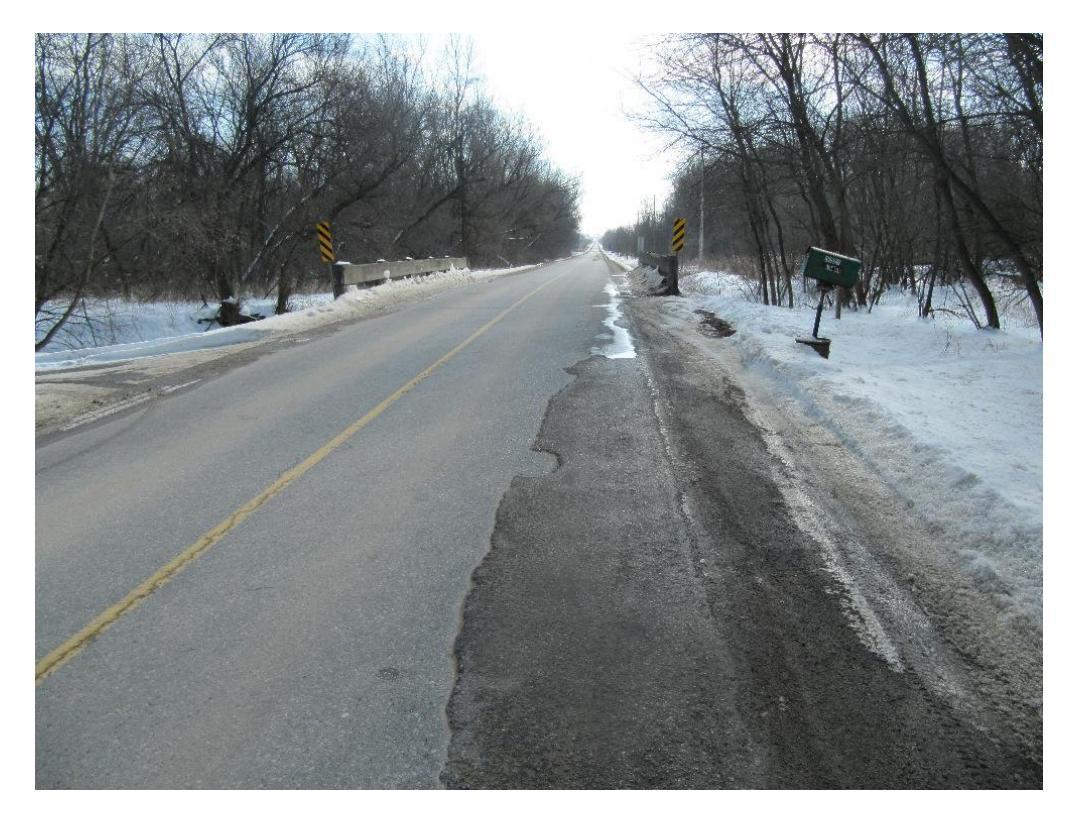
In Figure 14 we show a southbound view along the same road, leading up to this second accident site. Here there was a similar small bridge that was unprotected by a guardrail. But in addition, we can see in the foreground that maintenance personnel attempted to "improve" the pavement by laying down a narrow strip of patching along the right side of the lane. Rather than ensuring that the height of the patch matched with the height of the remainder of the road surface, a substantial edge-drop off was developed precisely where the right wheels of vehicles would travel in the lane. Our testing at the site with an accelerometer demonstrated how there were violent forces exerted on the vehicle from the edge drop off at the junction between the patch and the older surface. The collision involved a frontal impact of the vehicle into the unprotected, immovable, concrete abutment of the bridge, as shown in Figure 15. Had a guardrail been properly installed the vehicle would have slid along the guardrail and would have been re-directed away from that abutment, likely resulting in minimal or no injuries.

Figure 14: View, looking south at the site of the second collision and the presence of a patch along the right edge of the southbound lane.

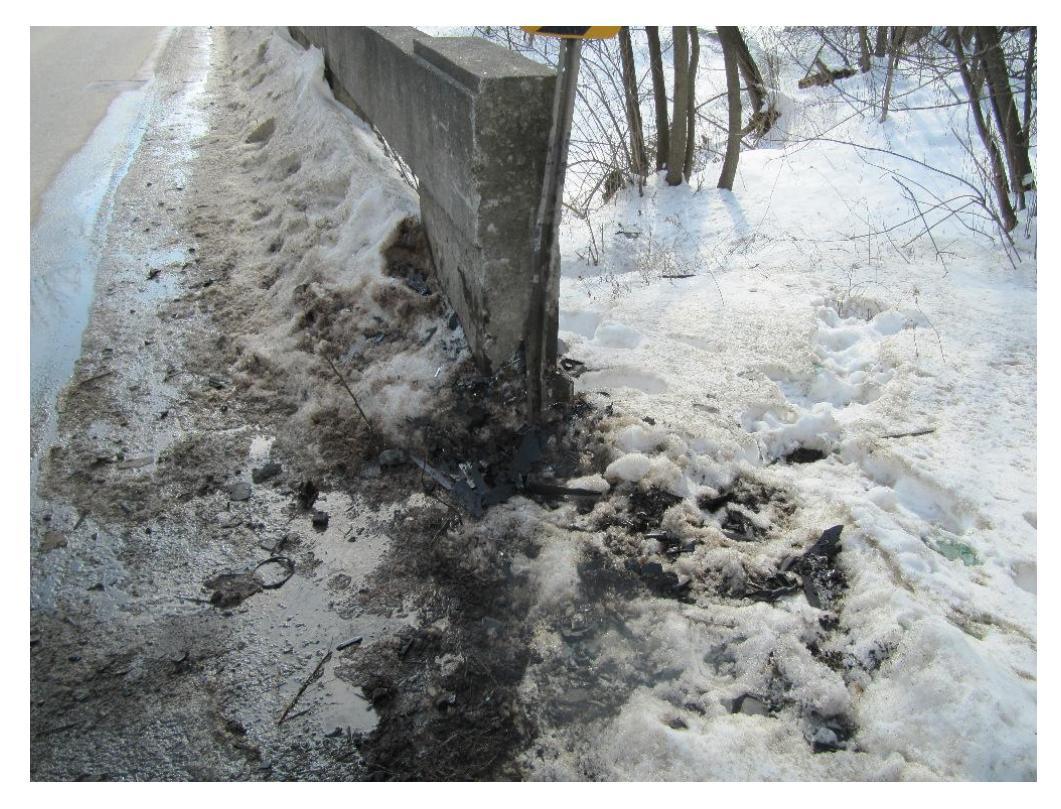
Figure 15: Evidence of a frontal impact into the concrete bridge abutment in the second collision of the Alliston area roadway.

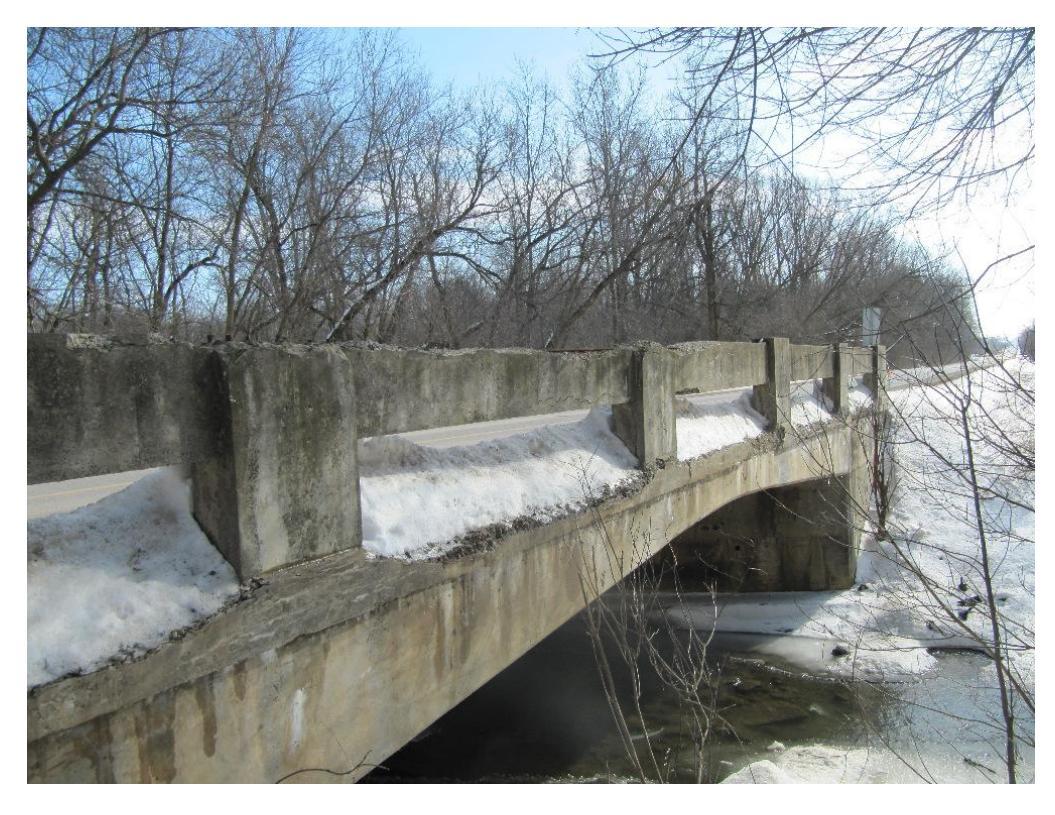
But the facts in this second collision were not much different than the first, just fate intervened. A slight difference in the angle of approach could also have sent this vehicle into the creek shown in Figure 16 and we could have had a drowning just like the three drownings mentioned in the previous incident.

Figure 16: If the abutment impact had not occurred the vehicle might also have fallen into the creek bed resulting in a possible drowning.

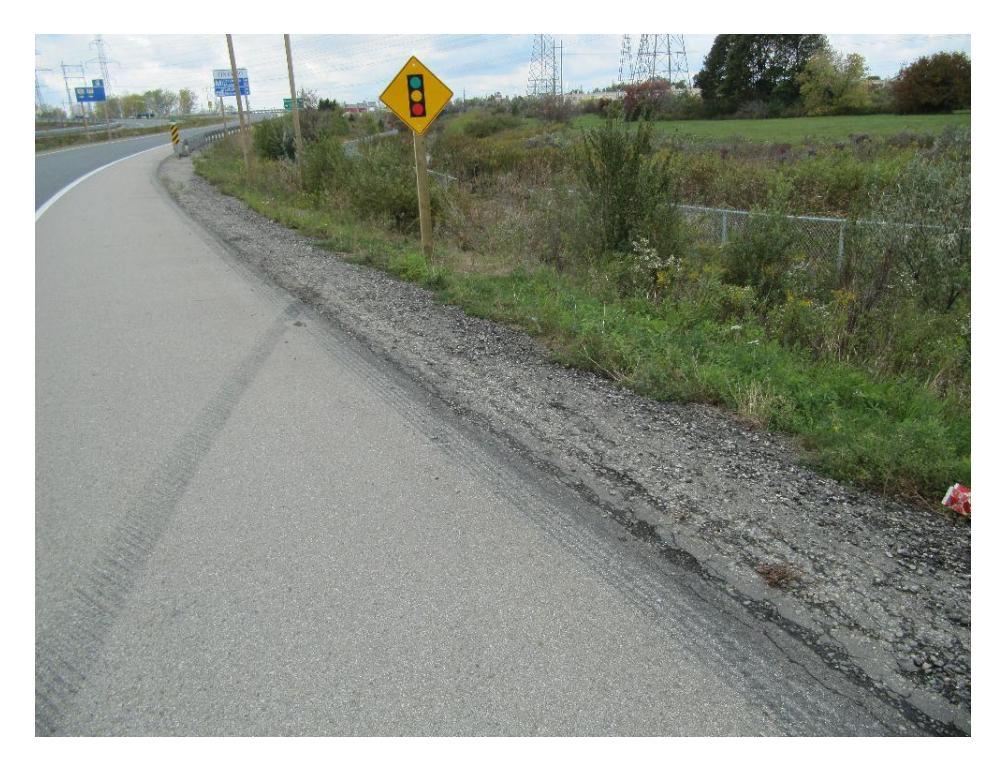
The issue is not only the lack of guardrails or their poor maintenance but in many cases it is an issue of an improper location of the guardrails. As an example, on October 10, 2012 we happened to pass by an accident site on the exit ramp from Highway 401 to Wellington Road on the south side of London Ontario. Figure 17 shows loss-of-control tire marks that show the location where the vehicle exited the road surface. There was no guardrail at this location however, in the background, one can see that a guardrail existed, it just was not extended to the location where the vehicle exited the road.

Figure 17: Tire marks indicate where a vehicle slid off the exit ramp of Highway 401 at Wellington Road in London Ontario.

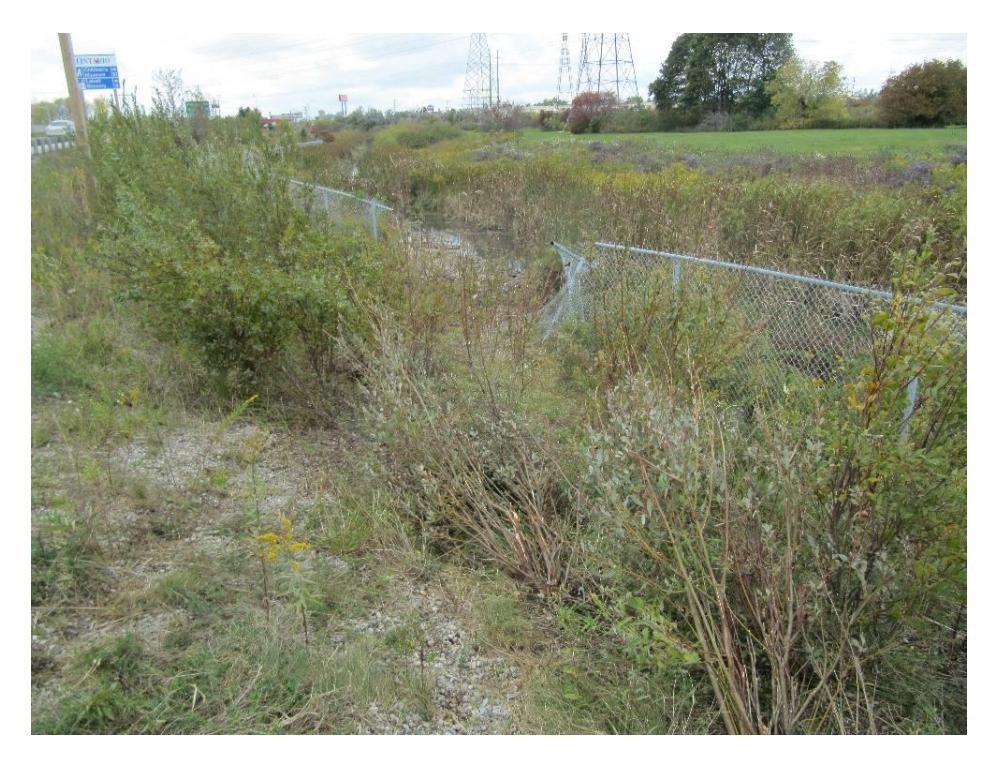
Figure 18 shows that the vehicle knocked over a chain link fence. Such fences are dangerous because the upper pole that runs along the top of the fence becomes dislodged and separates into sections, as shown in Figure 19. The end of such a pole acts as a harpoon and can potentially pierce through the interior of a vehicle. But this is not the only safety hazard at the site.

Figure 18: View of chain link fence that was knocked over as the vehicle travelled through the roadside.

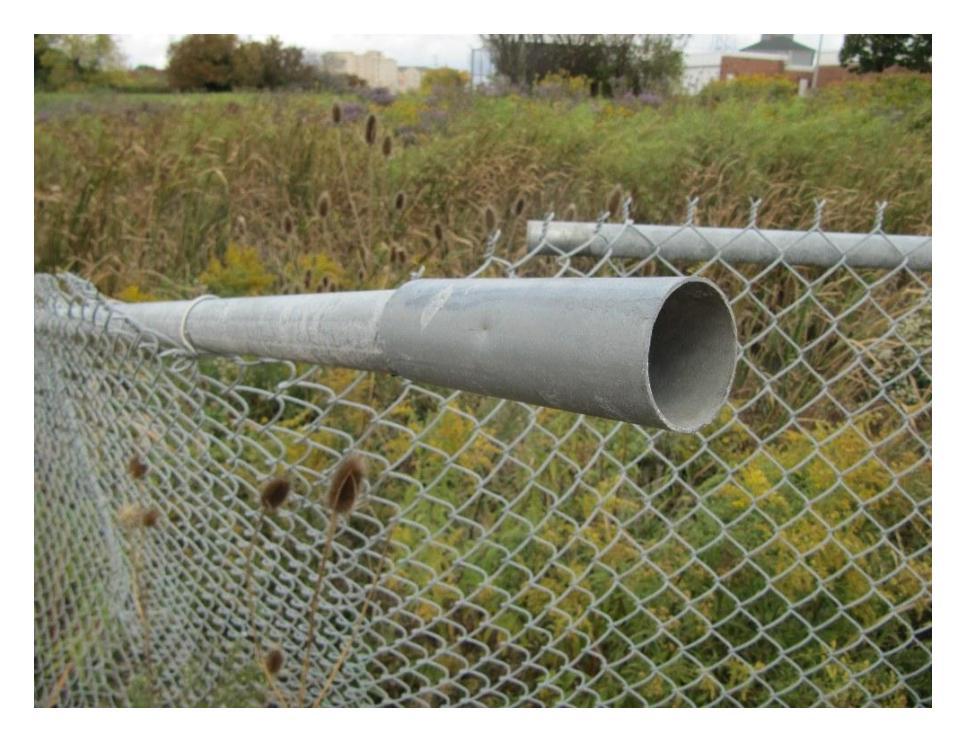
Figure 19: View of dangerous "harpoon" that forms when the top pole of a chain link fence separates.

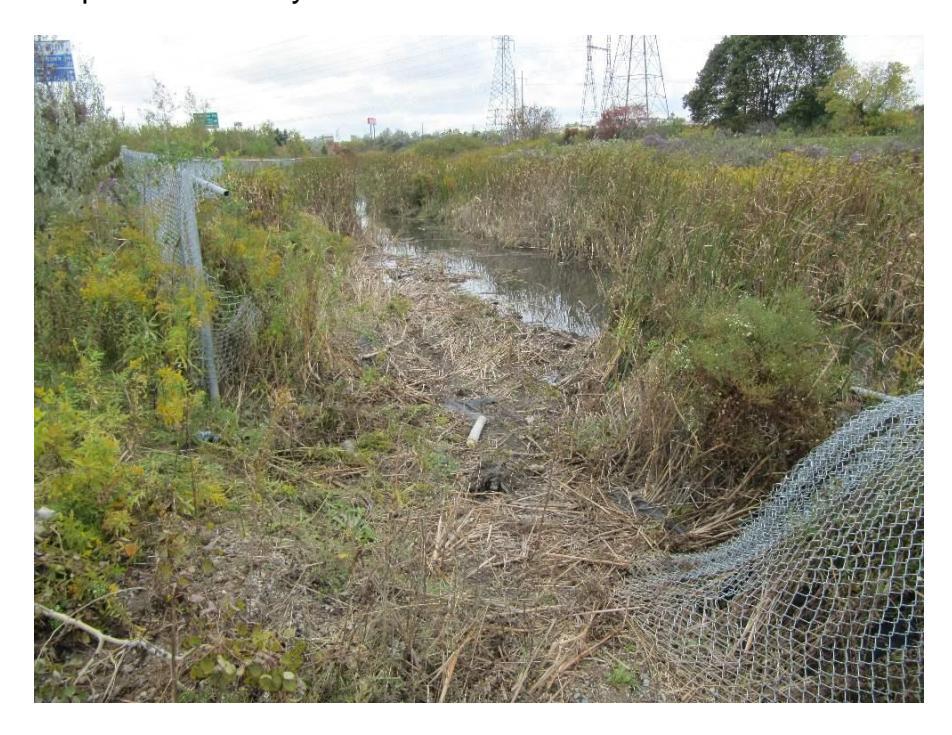
Figure 20 shows that as we look beyond the chain link fence there is a pond but luckily the vehicle did not have enough speed to enter into it. Given the drownings that are known to occur from roadside water and given the high traffic volumes at the edge of this busy expressway the extension of a guardrail should have been considered to keep vehicles away from these hazards.

Figure 20: View of pond beyond the fence where the vehicle came to rest at the edge of the water.

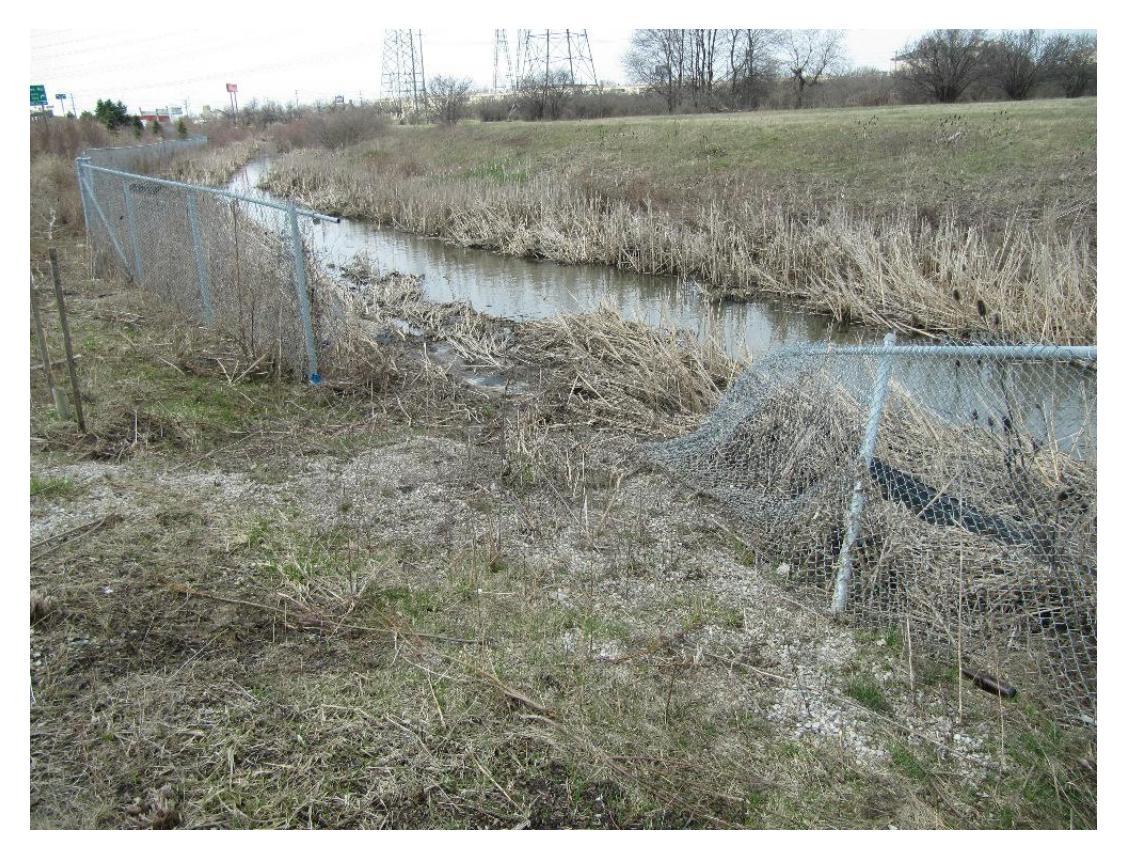
Not only is this a hazard but it needed to be dealt with before other problems were created. The existence of the harpoon meant that another vehicle entering the area could be in danger. Also the entrance into the pond needed to be closed by some form of barrier. However repairs from the impact took too long to be completed.

For example, we returned to the site on April 26, 2013, or over 6 months later and found what can be seen in Figure 21. The fence was still unrepaired and the pond was open for any vehicle to enter.

Figure 21: Over 6 months after we observed the damaged fence it had still not been repaired.
