Roadside Barriers and Death By Drowning - An Important and Hidden Issue

Posting Date: 30September 2013

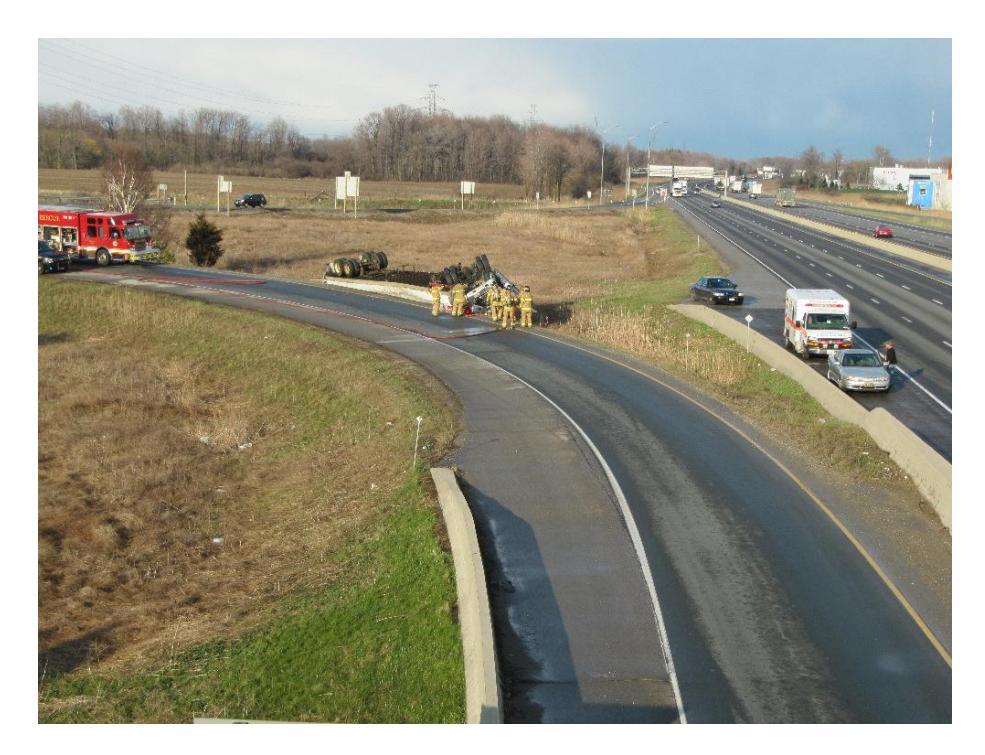
In another incident, on April 25, 2013 we observed that a tractor-trailer had rolled over on the entrance ramp of Highway 401 at Highbury Avenue, also in London, as shown in Figure 22. At the location of the rollover they was no guardrail, as shown in Figure 23. However that is not totally correct. A guardrail existed but it terminated before the point where the truck rolled over, as shown in Figure 24. In fact the existing guardrail was in excellent condition with no evidence that it had ever been struck by anything. But that only suggests that it was located at a point where vehicles would not be out of control and leaving the ramp's surface.

Figure 22: Tractor-trailer rollover on the entrance ramp to Highway 401 at Highbury Ave., London.

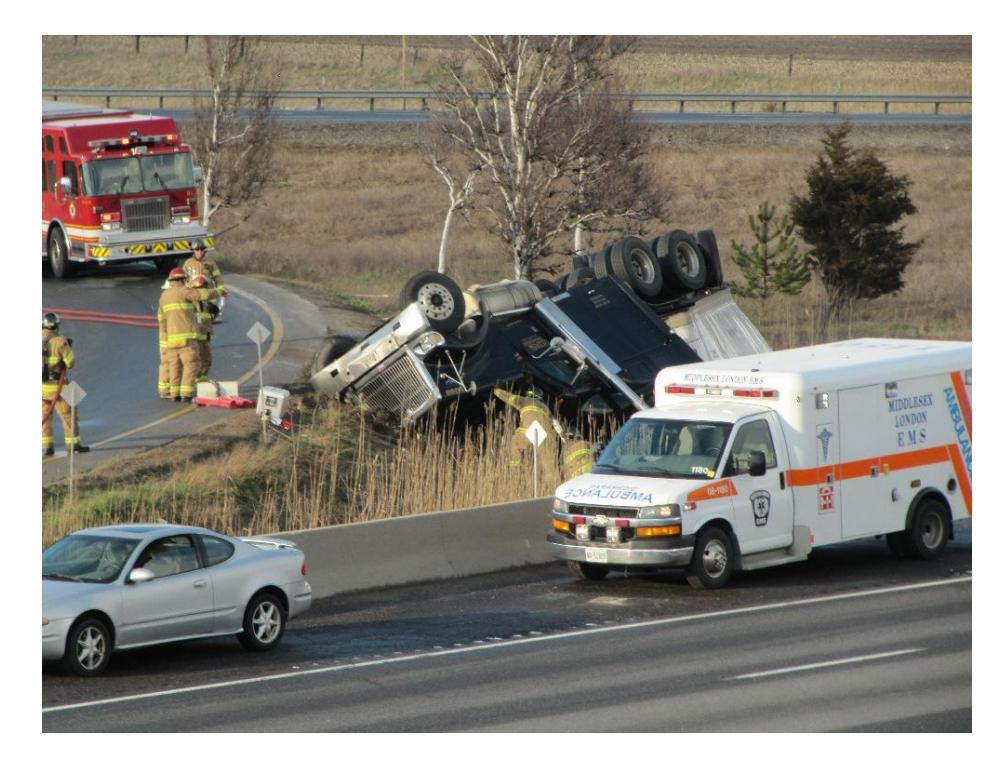
Figure 23: Closer view of rollover location showing no evidence of a guardrail.

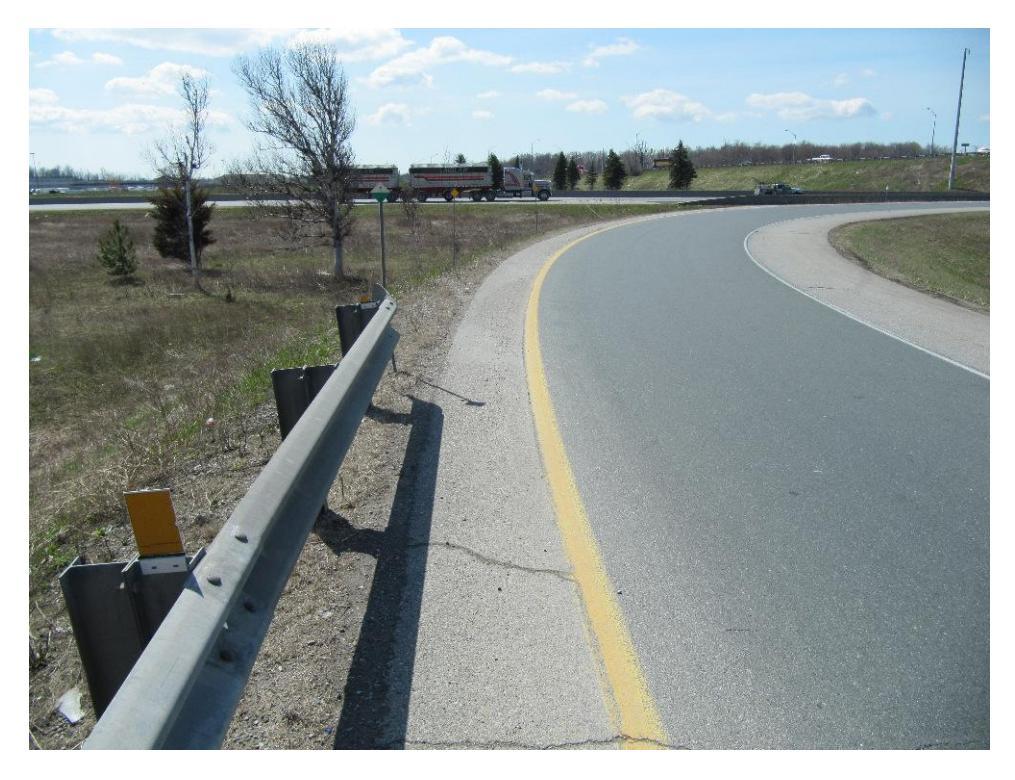
Figure 24: View of guardrail that terminated just before the location of the Tractor-trailer's rollover.

Even if the guardrail had been present at the location of this truck rollover the height of the centre of gravity and the large mass of this truck would have caused it to be "tripped" and the likelihood of a rollover would be increased. And this is another issue that is hidden from public discussion.

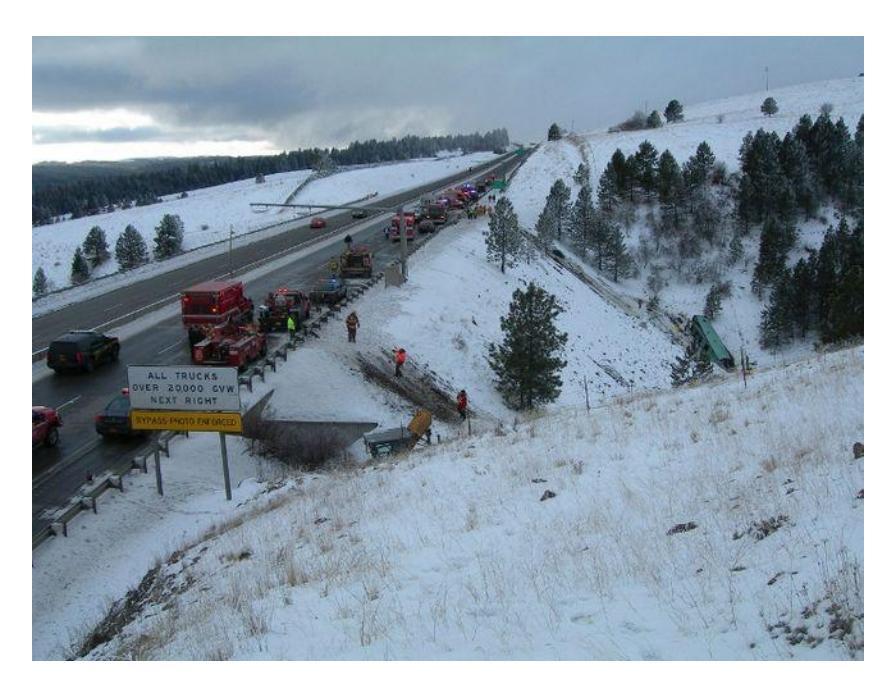
In another example, a bus crashed through a guardrail near Pendleton Oregon on December 30, 2012 resulting in 9 fatalities and 39 persons injured, as shown in the site photo in Figure 25.

While there were many questions presented to the public essentially nothing has been revealed about the specifics of the cause. In all the mass commotion of news media not a single reporter could look at the guardrail and raise the question whether this barrier was appropriate to prevent a large heavy vehicle from being propelled beyond it. Rarely do the news media ever display a view of the damaged barrier however we can see it in Figure 26. Yes, there was some deflection of this guardrail but the most obvious indication is that the rail was twisted upward indicating that the bus simply rode over top of it. But this is exactly what we would expect due to the high centre-of-gravity of the bus compared to the height of the rail. This barrier system was not meant to deflect the motion of a heavy vehicle and it only contributed to the vehicle's rollover.

Figure 25: View of accident site near Pendleton Oregon.

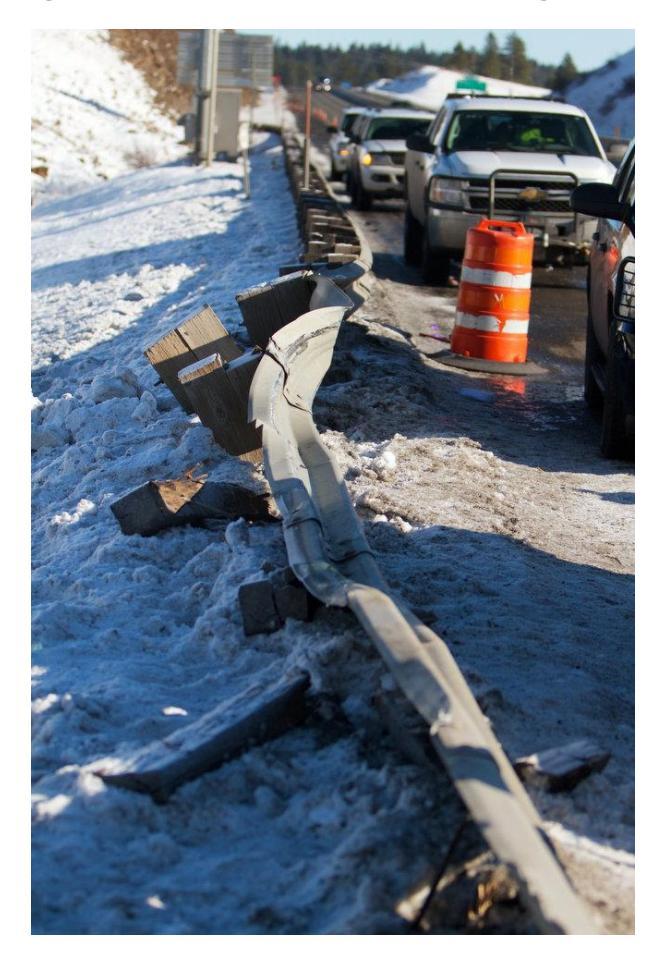
Figure 26: View of rail showing how it has been rotated upward while the system itself indicated minor evidence of deflection.

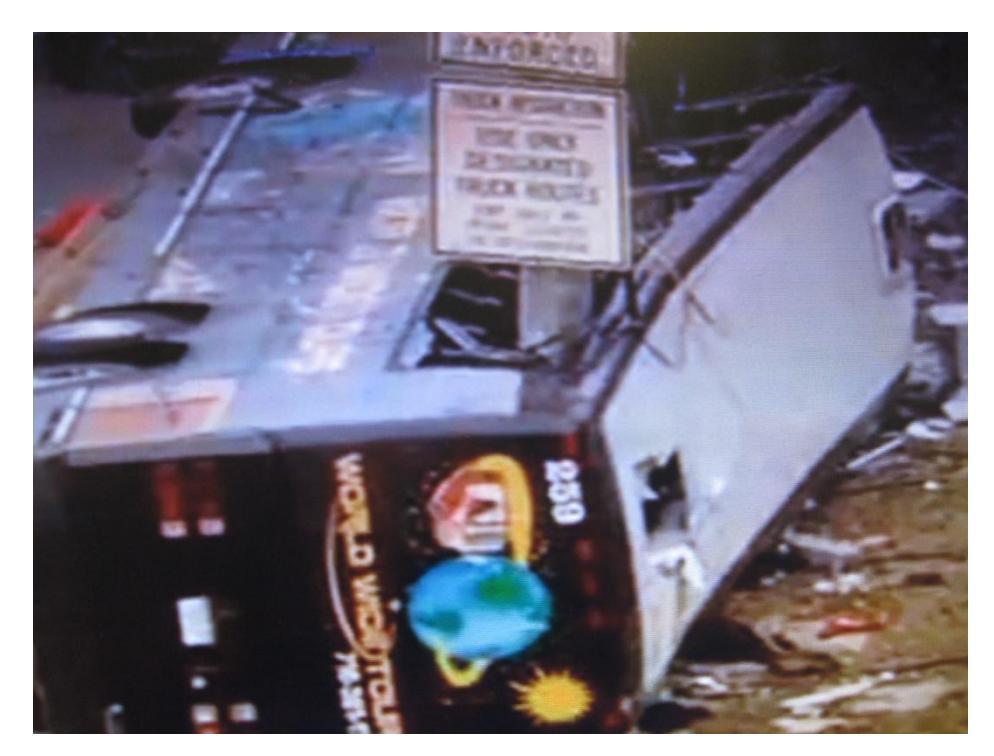
In another fatal bus crash on I-95 at the Hutchinson Parkway in New York, on March 11, 2011, an intercity bus struck a low guard rail and flipped over top of it, as shown in Figure 27.

Figure 27: View of inter-city bus that was tripped onto its side by a low guardrail. While on its side the bus struck an immovable stanchion causing massive intrusion into the occupant space of the bus.

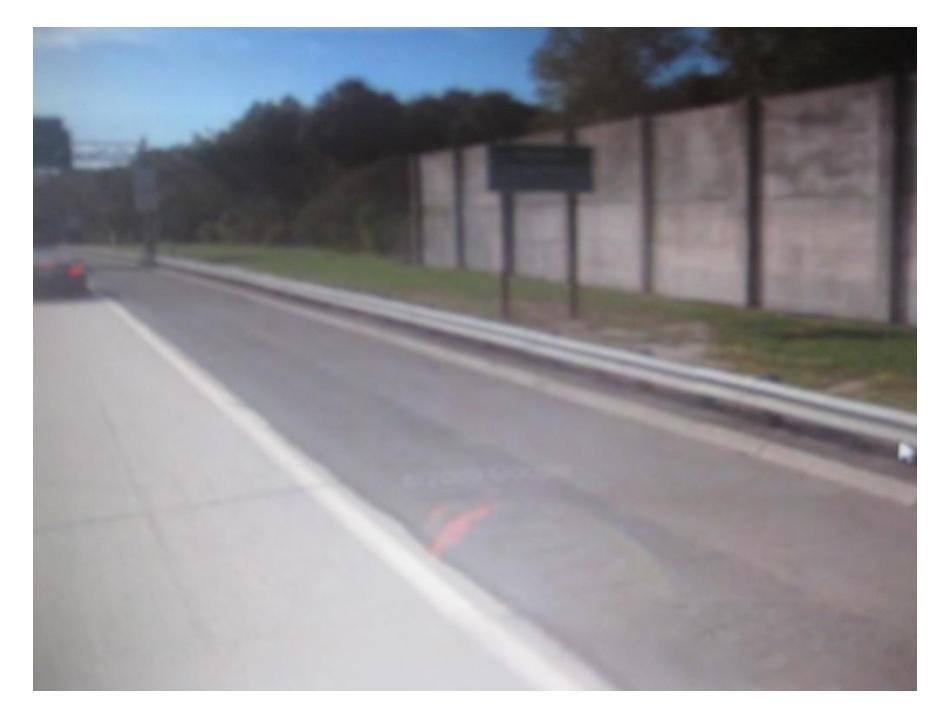
The low height of this guardrail could be determined by examining it condition before the collision via imagery from Google Maps. Figure 29 shows a screen capture from that imagery showing the guardrail while Figure 30 shows a closer view of its vertical profile.

Figure 29: Screen capture of guardrail before the multiple-fatal bus crash.

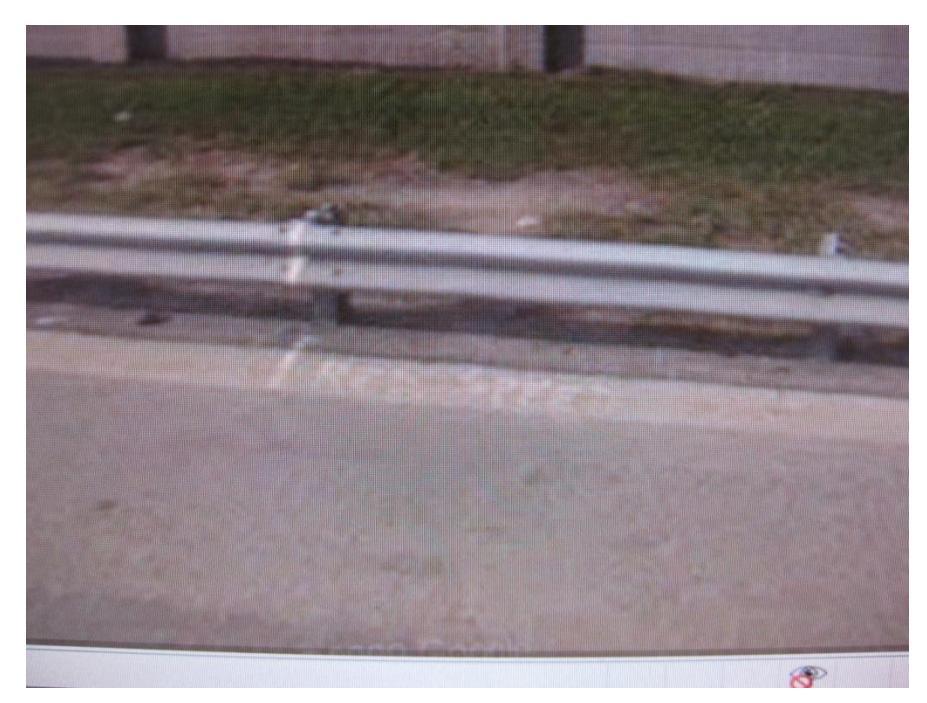
Figure 30: From simple extrapolation from a knowledge of the typical height of a standard rail it is possible to note that the gap between the bottom of the rail and ground is too low and therefore the rail itself was too low before the collision.

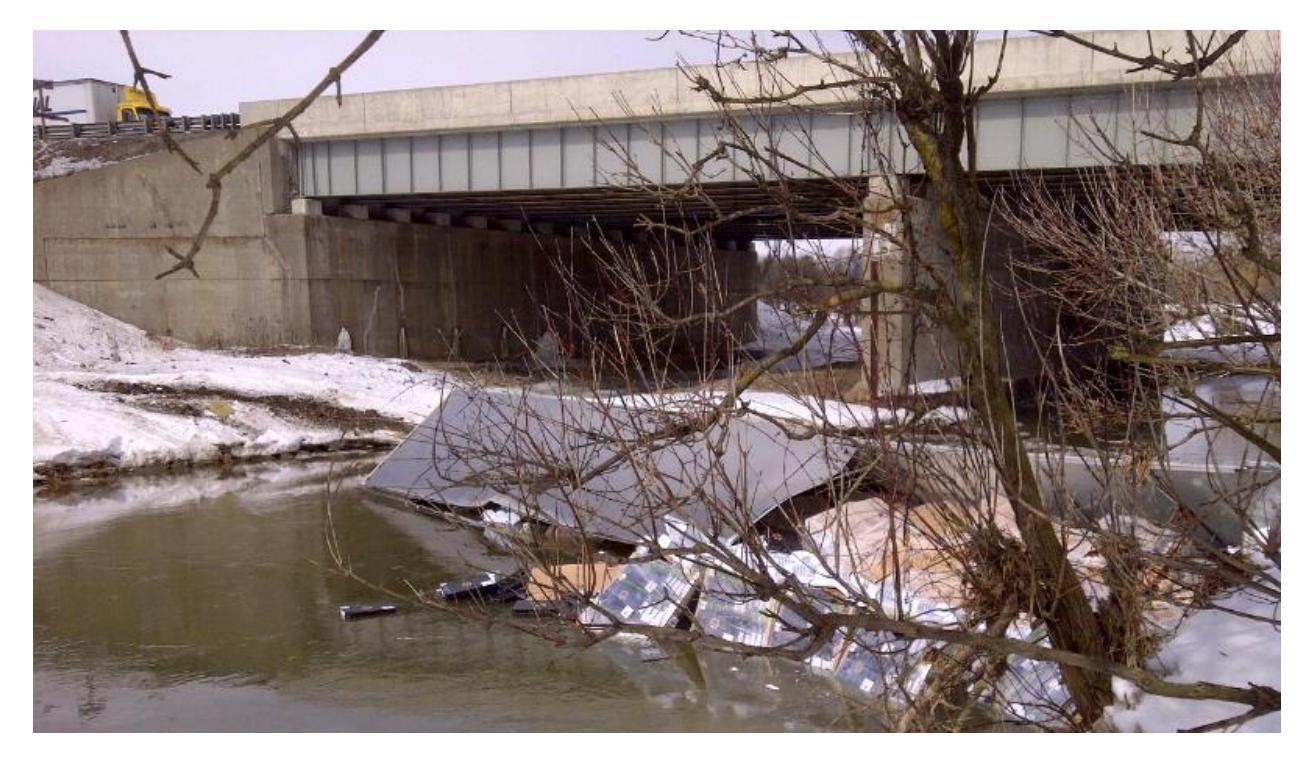
Returning to the local environs of Southern Ontario, we present a similar example from a transport truck passing through a guardrail at the Nith River Bridge, just west of Cambridge, Ontario. Figure 31 shows the general accident site from March 5, 2013.

Figure 31: View Transport truck lying in the Nith River after it plunged through a guardrail at the edge of the Nith Bridge.

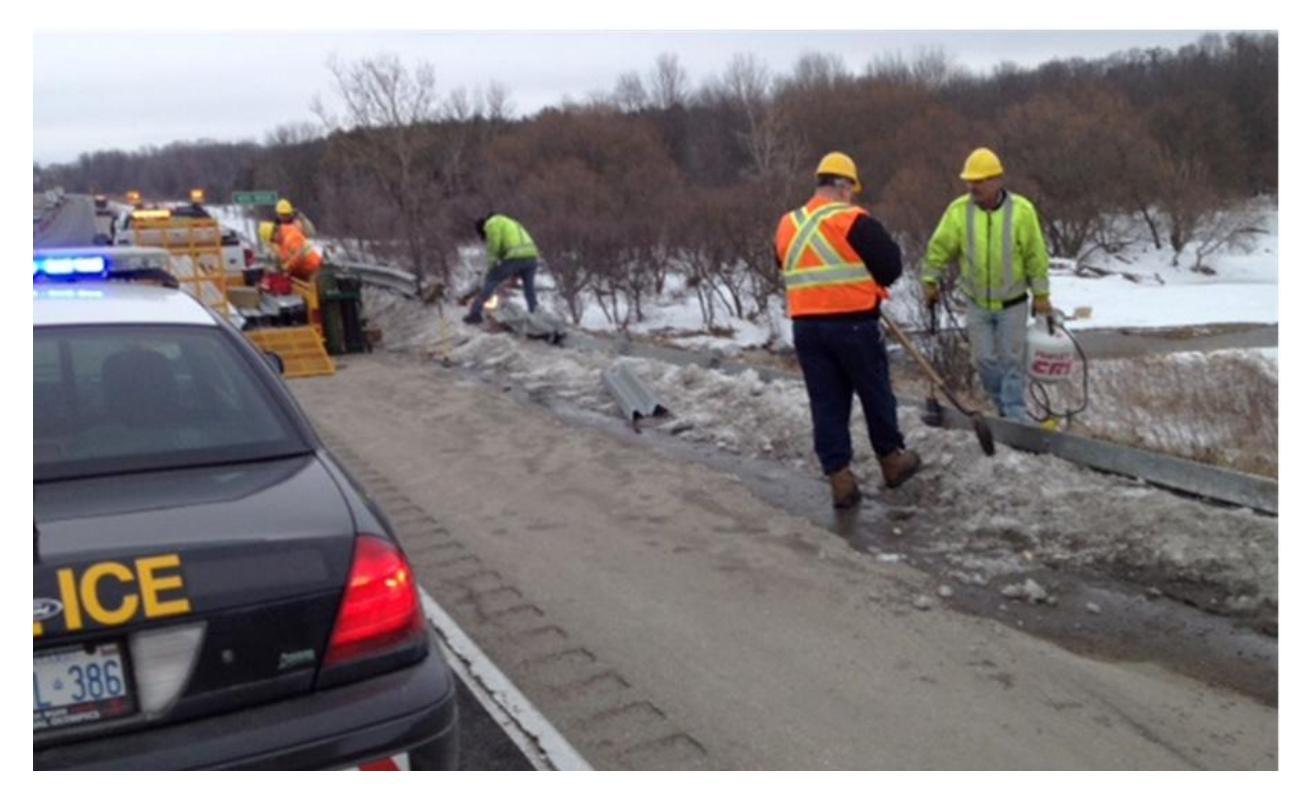
Again, nothing was mentioned by the news media about the condition of the guardrail that allowed the truck to pass through it resulting in the death of the two truck occupants. However, on-site photos were made available. In Figure 32 we can see one of those photos that shows work crews making repairs and the rail has already been removed in the area where it was struck. However note how the workers are standing on the snow bank where the guardrail was located. We know from past experience that in late winter the strong sun melts snow banks more rapidly and whatever frozen material remains is often hard as rock. The darkness of the snow and its melted appearance confirms to us that this is a very hard bank. In these circumstances a bank like this acts no differently than if it was made of concrete in that it can support a large weight without being compressed. The result is that this hard bank becomes a ramp for a striking vehicle. Thus the vehicle rides over top of the guardrail as likely occurred in this instance.

Figure 32: View of hard snow bank that was likely used as a ramp for the truck to pass over the guardrail.

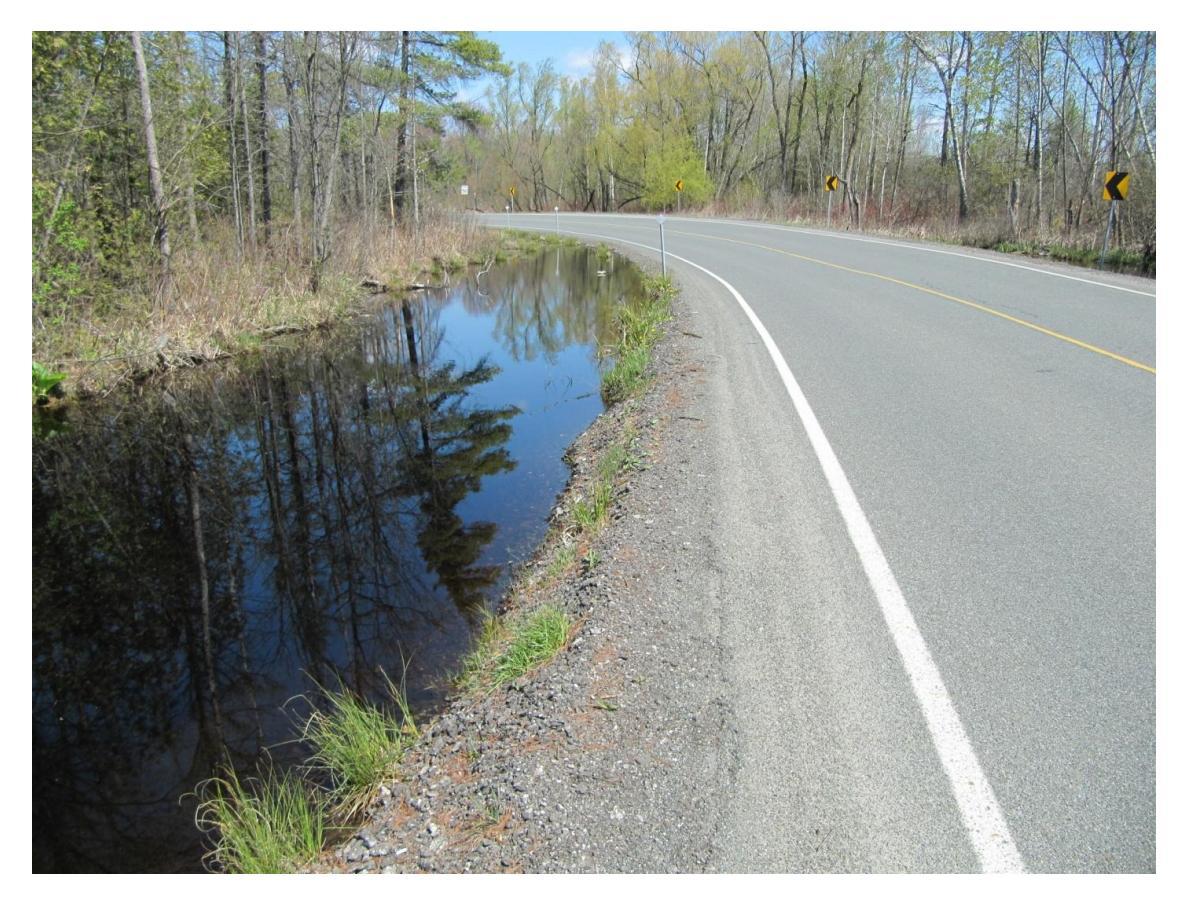
In some instances, such as the scenario shown in Figure 33, the presence of water next to a highway is obvious, and its depth might be appreciated. However, in many others the depth of a ditch and the depth of the water within it is hidden from a driver's view.

Figure 33: This stand of water on the edge of Oxford County Road 22 northeast of Woodstock Ontario is readily visible even though no warning signs inform drivers of the potential of drowning.

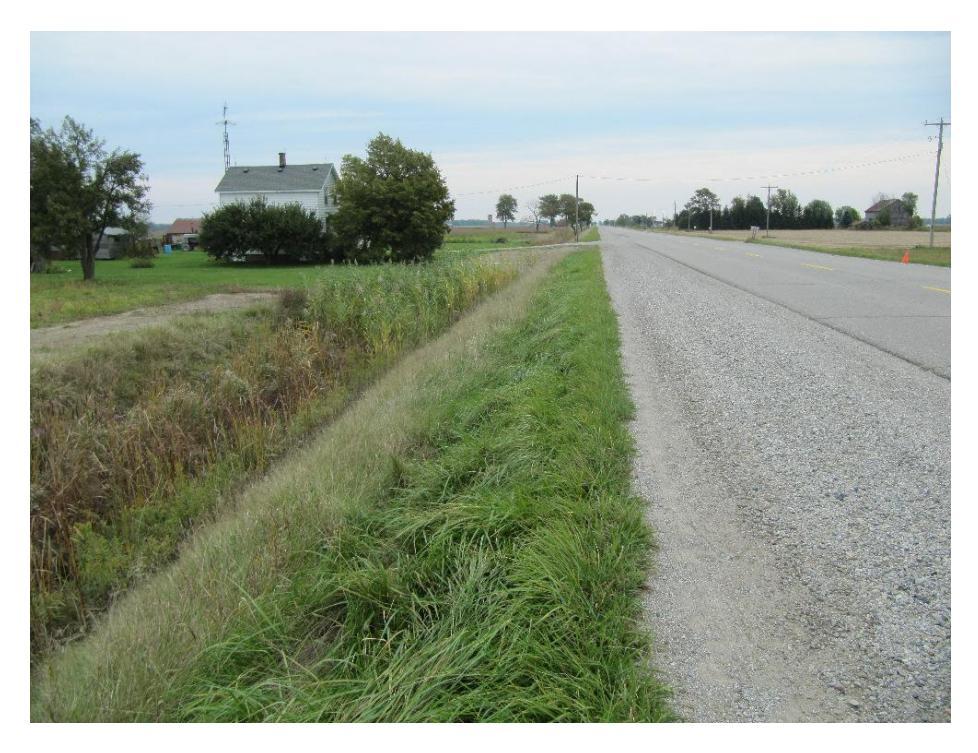
As shown in Figure 34, many roadside ditches and ponds contain bulrushes and tall grasses that hide the true height of the drop of an embankment and whether water might be present. If a driver could stand within the ditch, such as in Figure 35, the extent of the problem could be better appreciated, but that possibility is not available when driving at highway speed.

Figure 34: View of a roadside ditch containing vegetation that hides the extent of the drop and the existence of water.

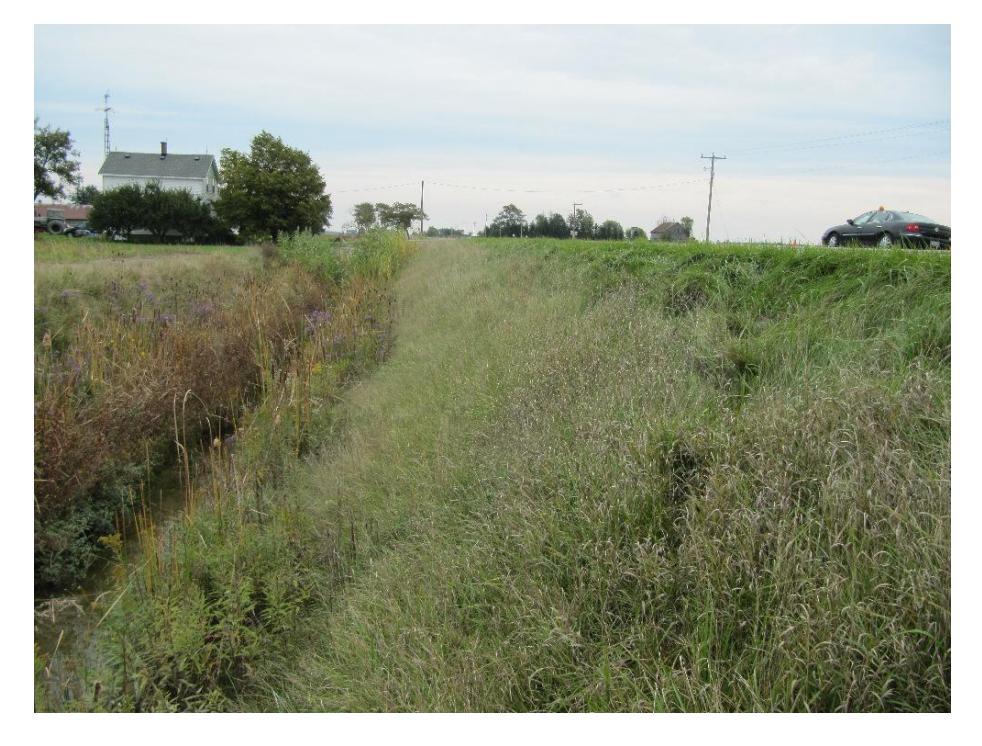
Figure 35: View of same ditch as shown in Figure 34 except that the photographer is within the ditch and exposing the extent of the drop of the embankment. However the existence of standing water is still masked by the vegetation.
