The Seven S-Curves of Adelaide - Part 1

Posting Date: 25 September 2012

This is a preliminary article in a series discussing testing at Gorski Consulting to document roadway effects on potential loss-of-control collisions at curves on Adelaide Street, north of the City of London, Ontario, Canada. This article will introduce the roadway and the characteristics of each curve through a series of photographs.

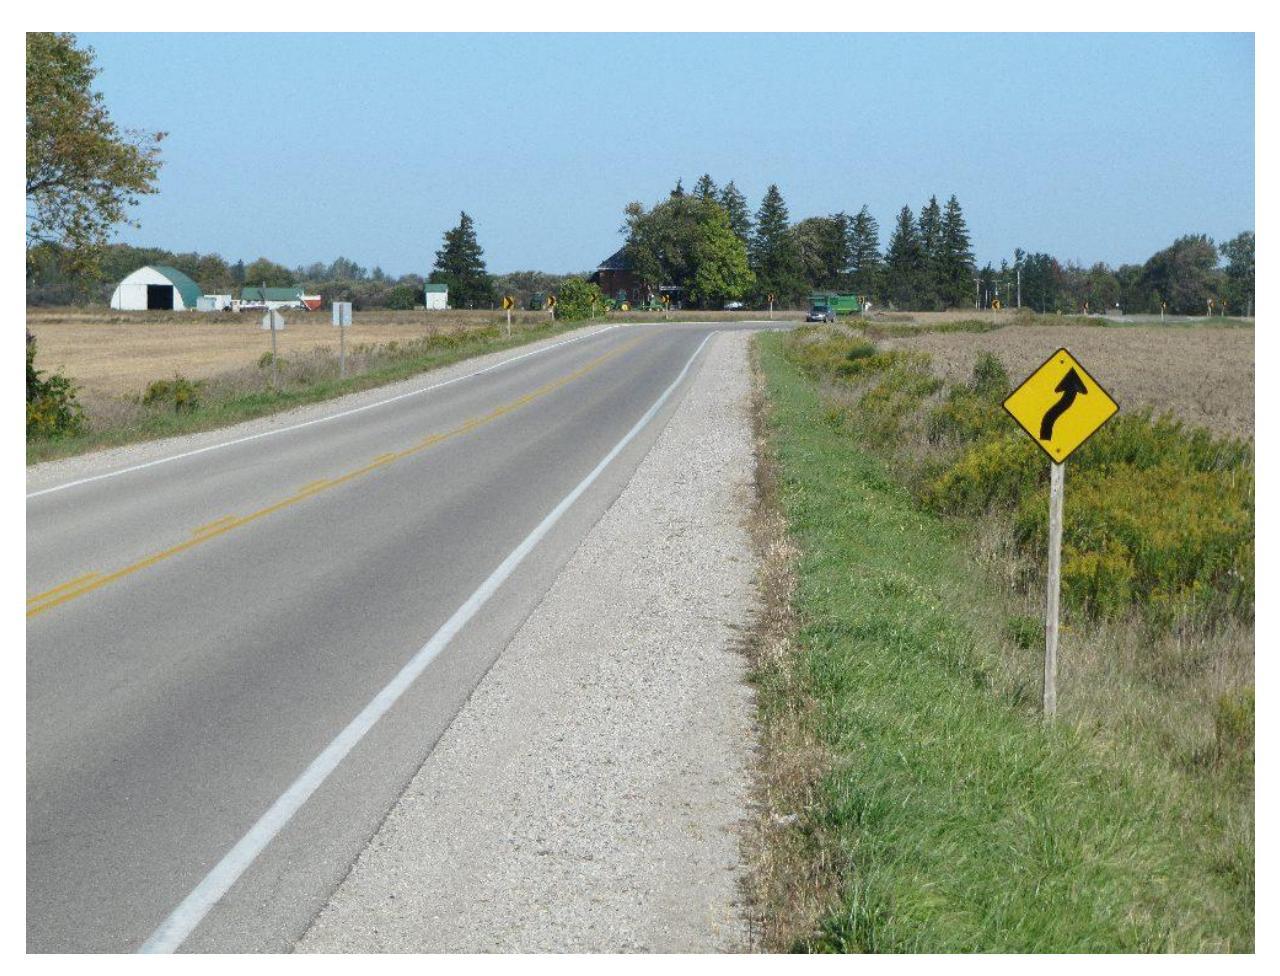
Curve #1: North of Medway Road

The photo below provides a general view of Curve 1 from south of the curve looking northward.

It can be noted that upon approach toward the Curve there is a warning sign on the right roadside indicating the generally accepted symbol for an S-curve which is standard throughout North America. This sign is positioned a long distance from the start of the curve. The pavement is in good condition. There is an extra width of pavement between the white edge line and the edge of the pavement. the sight lines are excellent as there are no trees, crops or other obstacles that might hinder the driver's view ahead.

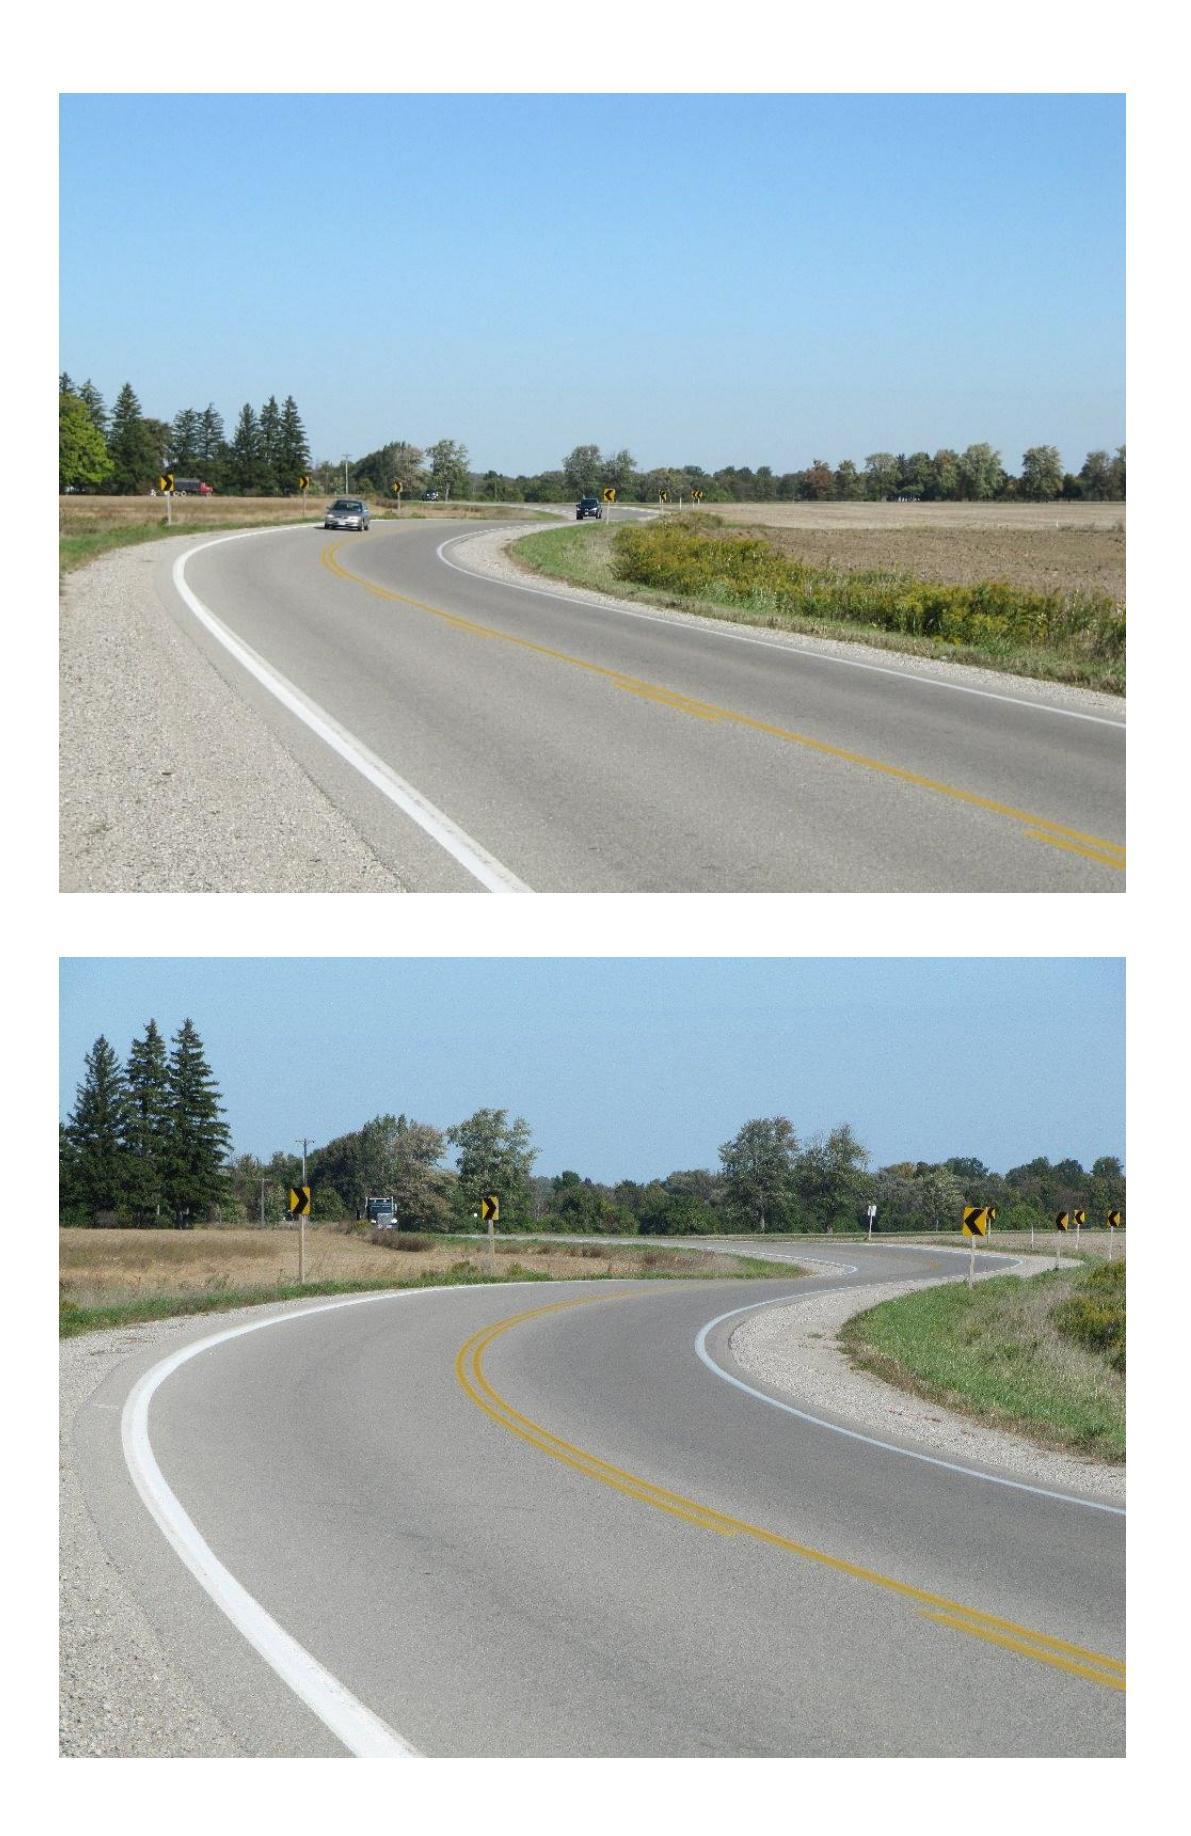
The quality standard of the curve is further exemplified in the two northward photos on Page 3 which show closer views of the Curve. One can note that super-elevations are evident to help drivers negotiate through the two portions of the S-Curve. The lines of sight are also excellent as one can see through most of the length of the curve.

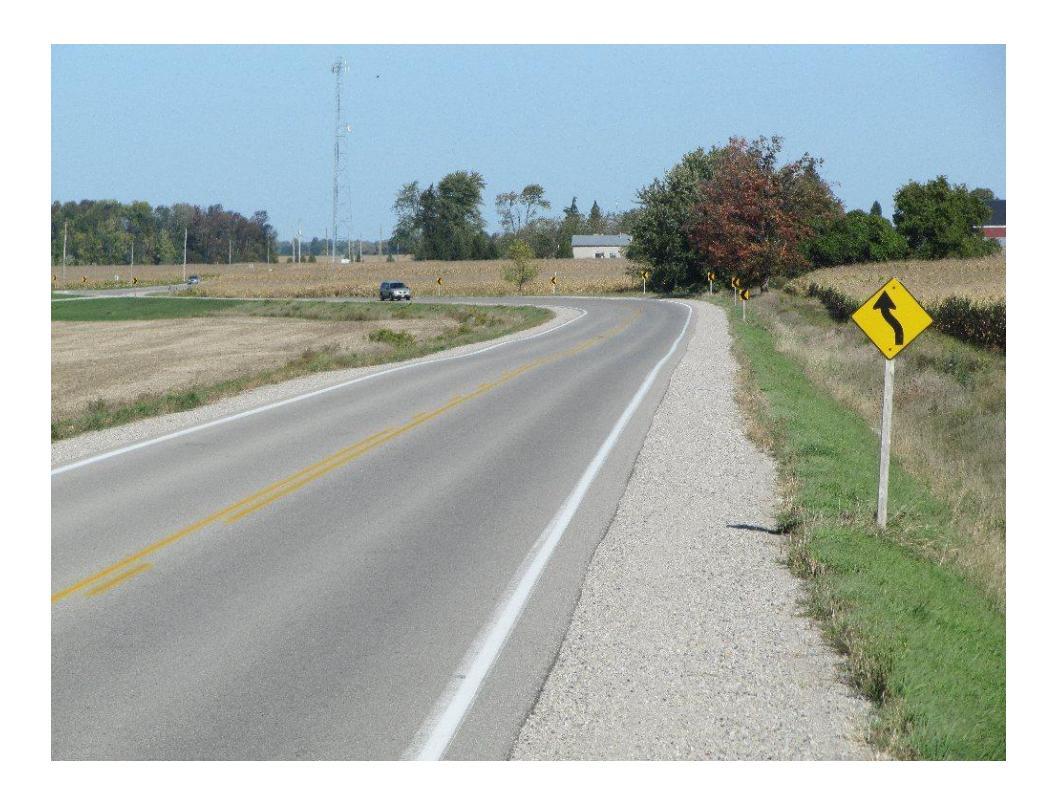
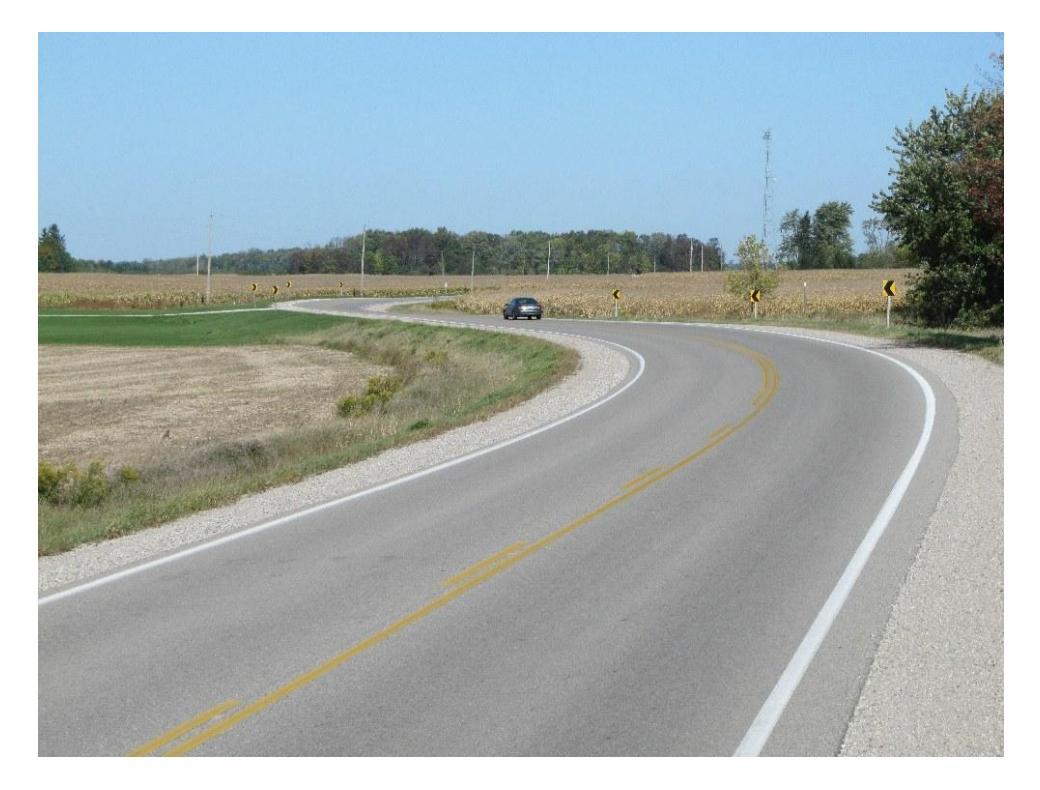
Curve #2: North of Nine Mile Road

The two photos below show northward views of the conditions of Curve 2. The higher quality standards are apparent just as in Curve 1.

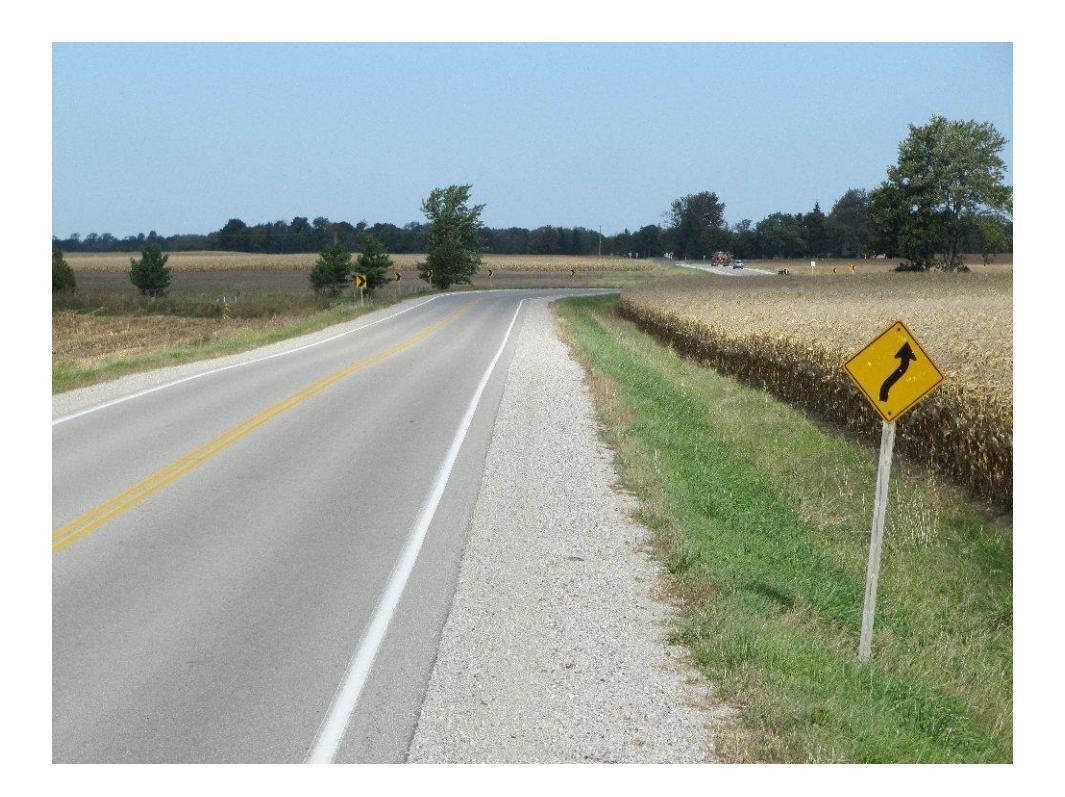
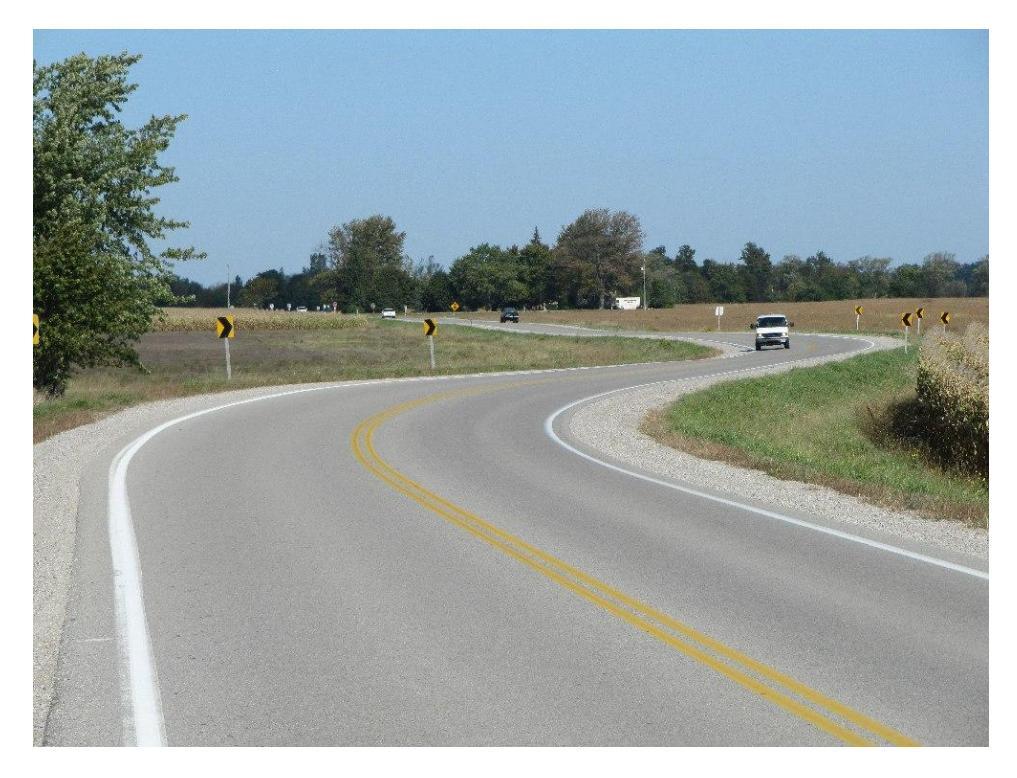
Curve #3: North of Ten Mile Road

The two photos below show northward views of the conditions of Curve 3. The higher quality standards are apparent just as in Curves 1 and 2.

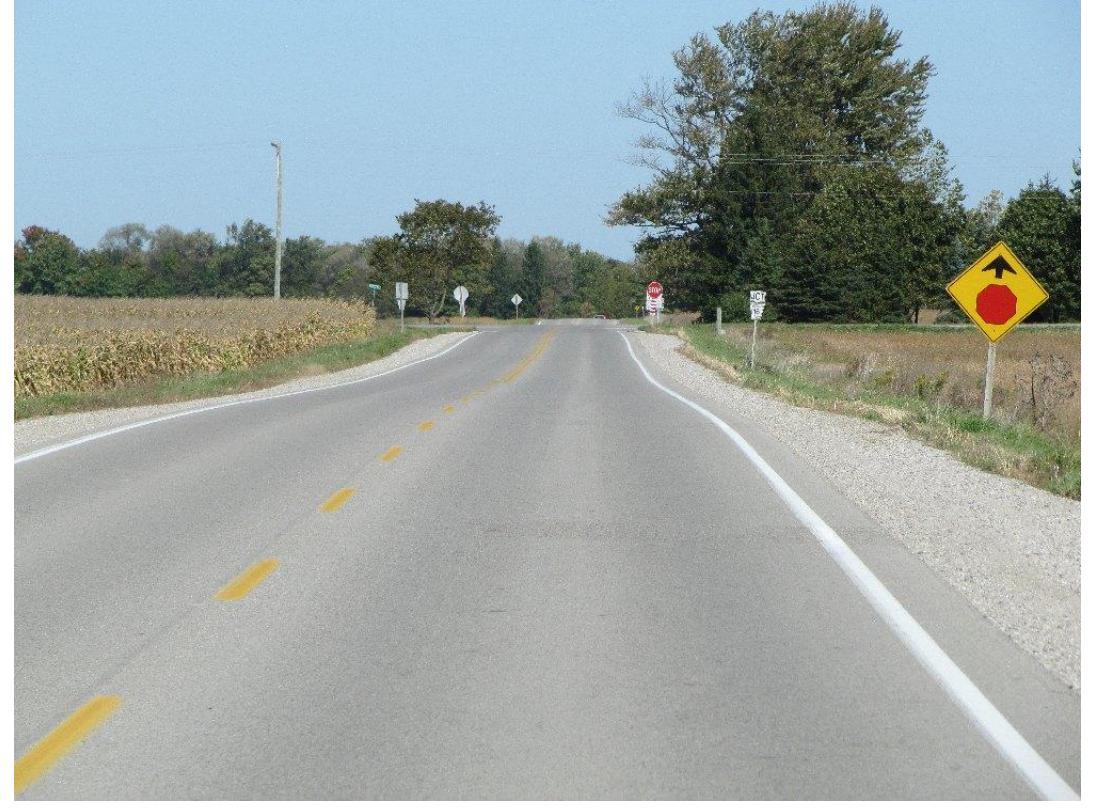
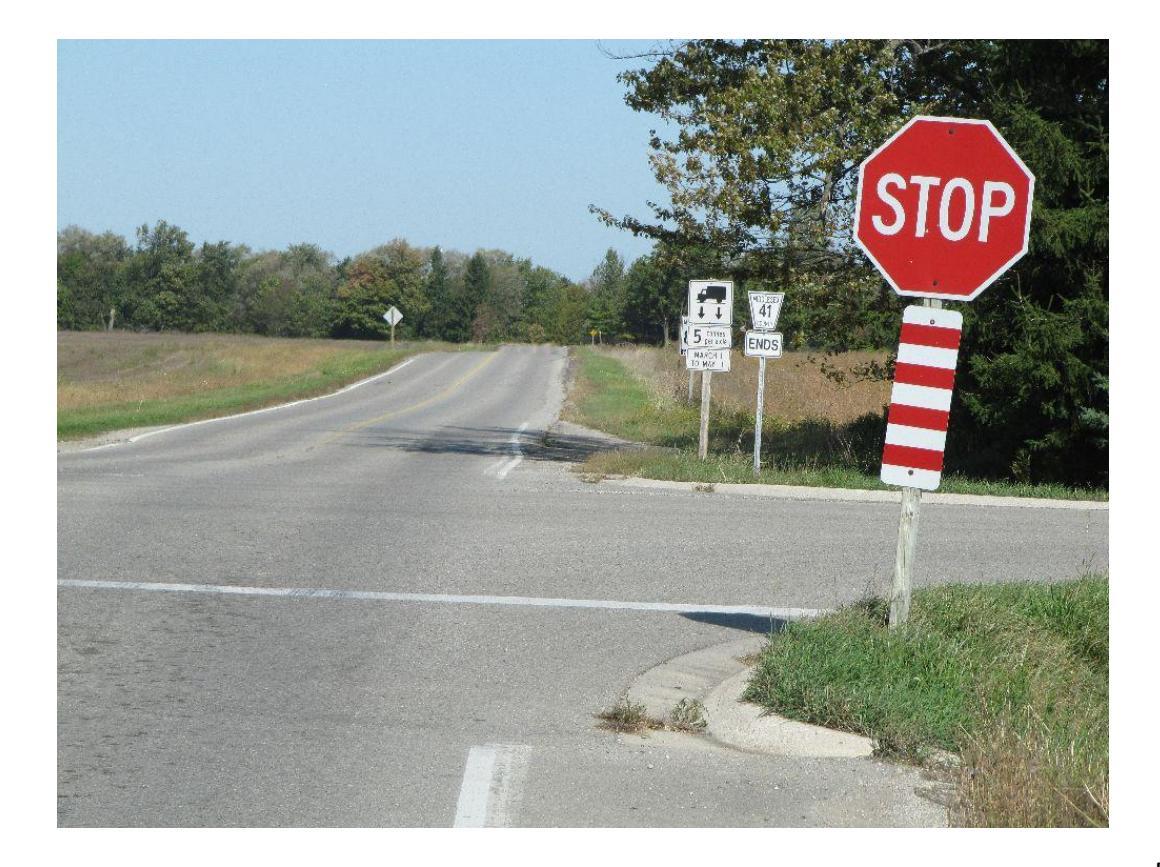
As we travel further northward from Curve 3 we approach the intersection with Ilderton Road, also known as Middlesex County Road 16, as shown in the two photos below.

This is where Adelaide Street North loses its designation as Middlesex County Road 41. As can be seen in the bottom photo on Page 6 there are regulatory signs posted on the north east corner of the intersection indicating that northward travel on Adelaide is restricted for trucks above five tonnes per axle and we also see the "Middlesex County 41 Ends" sign. Even in this photo, by looking past the intersection, we can begin to recognize that the quality of the road surface is not to the standard shown at the first three curves.

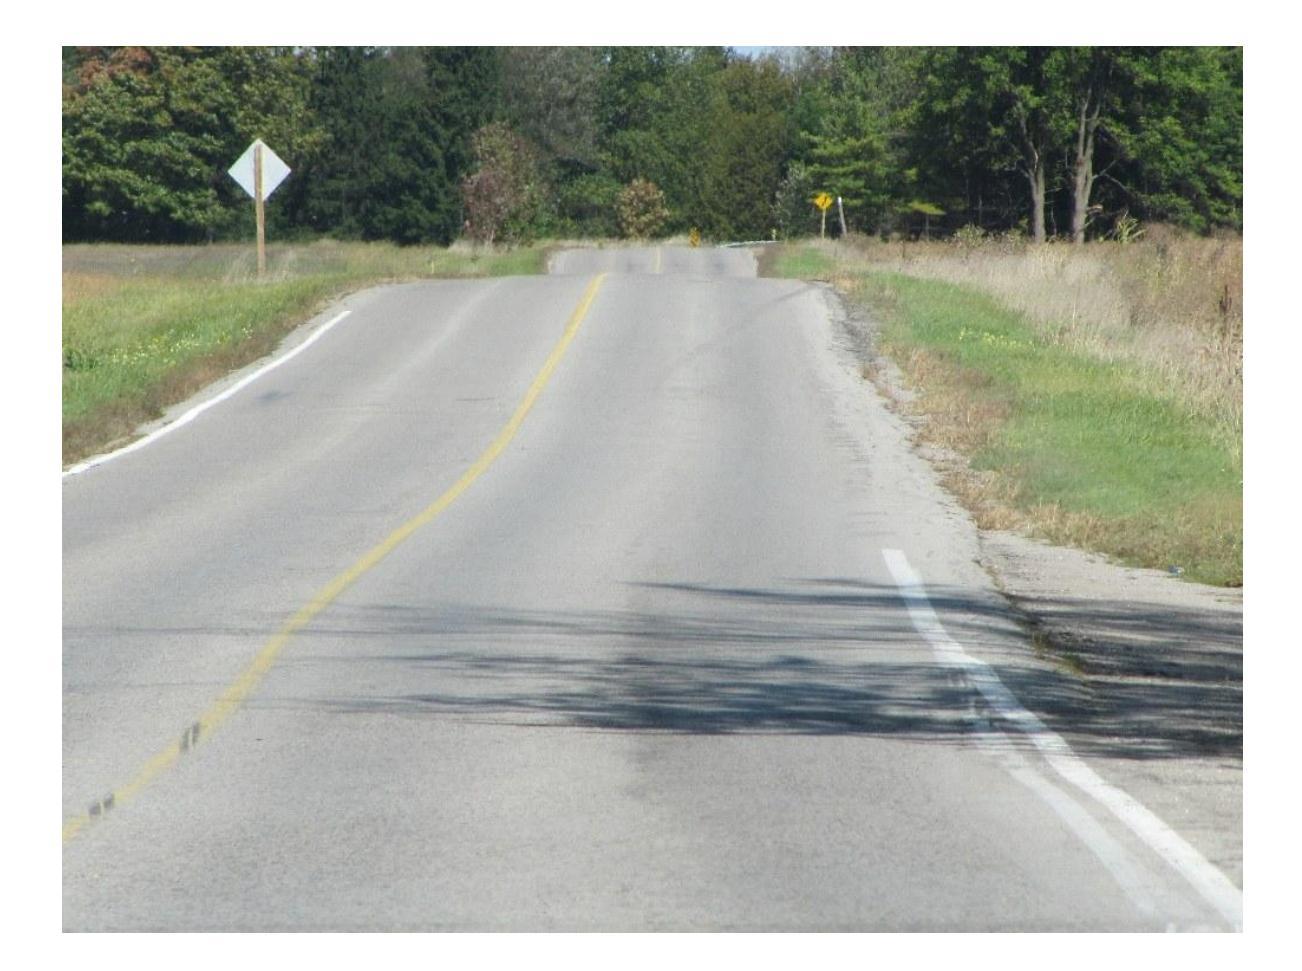
The photo below is a zoomed-in view looking northward from just north of Ilderton Road. If you look closely you might be able to see a yellow warning sign in the far distance. That sign refers to the location of Curve 4.

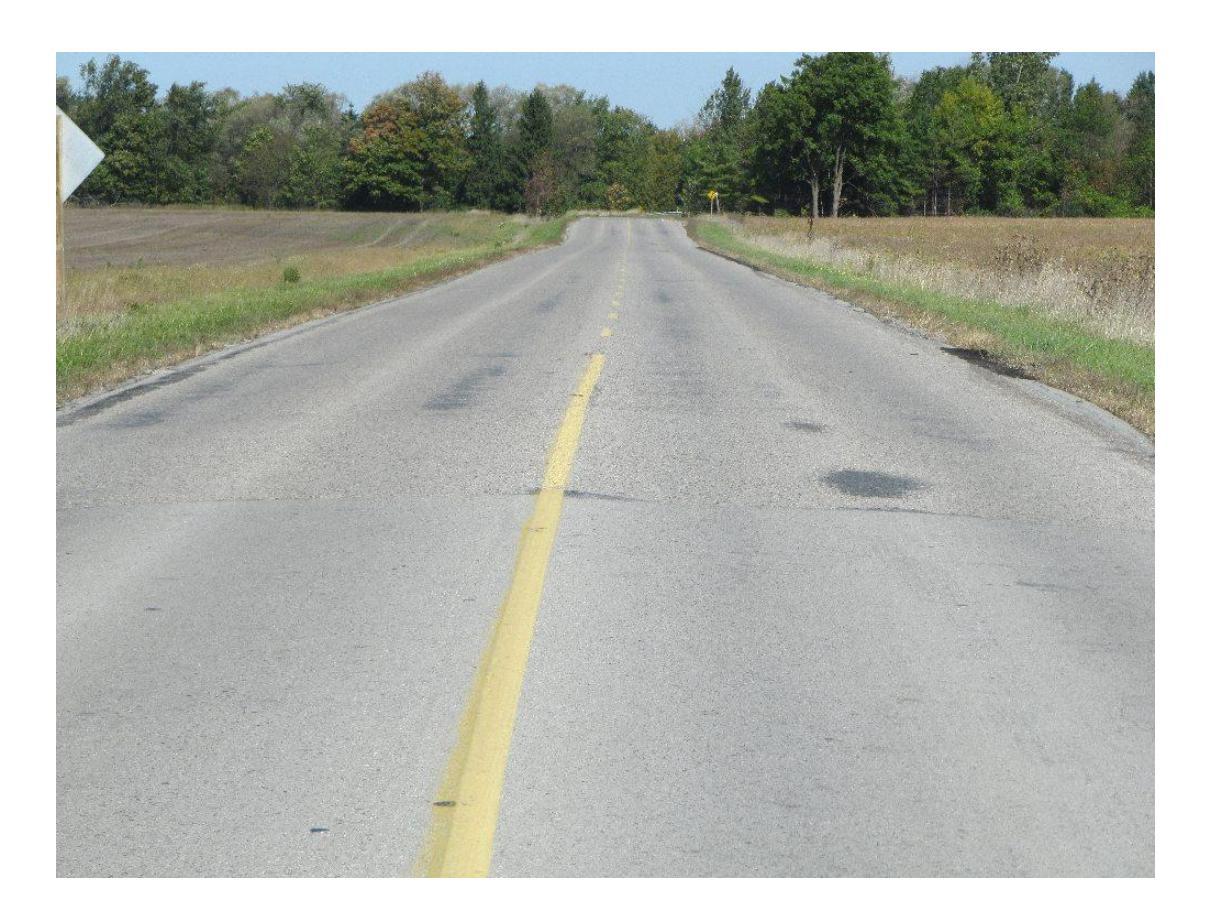
Before getting to Curve 4 we want to show you some of the surface changes in the road just north of Ilderton Road. For example, the photo at the top of Page 8 is a northward view and you can judge its location by noting the back of a warning sign located at the extreme left edge of the view. That is the same sign as the one shown in the photo above on the left side of the photo. In the photo at the top of Page 8, if you look closely at the road surface in about the middle of the photo, you should be able to recognize the dividing line between the asphalt paved surface to the south (bottom) versus the tar and

chip surface to the north (top). It is our observation that tar and chip surfaces have a generally inferior quality of evenness to them and they are more likely to contain safety-related characteristics that can destabilize a vehicle. So regardless of any additional factors, this portion of the road is already at a disadvantage compared to the southern portion shown earlier.

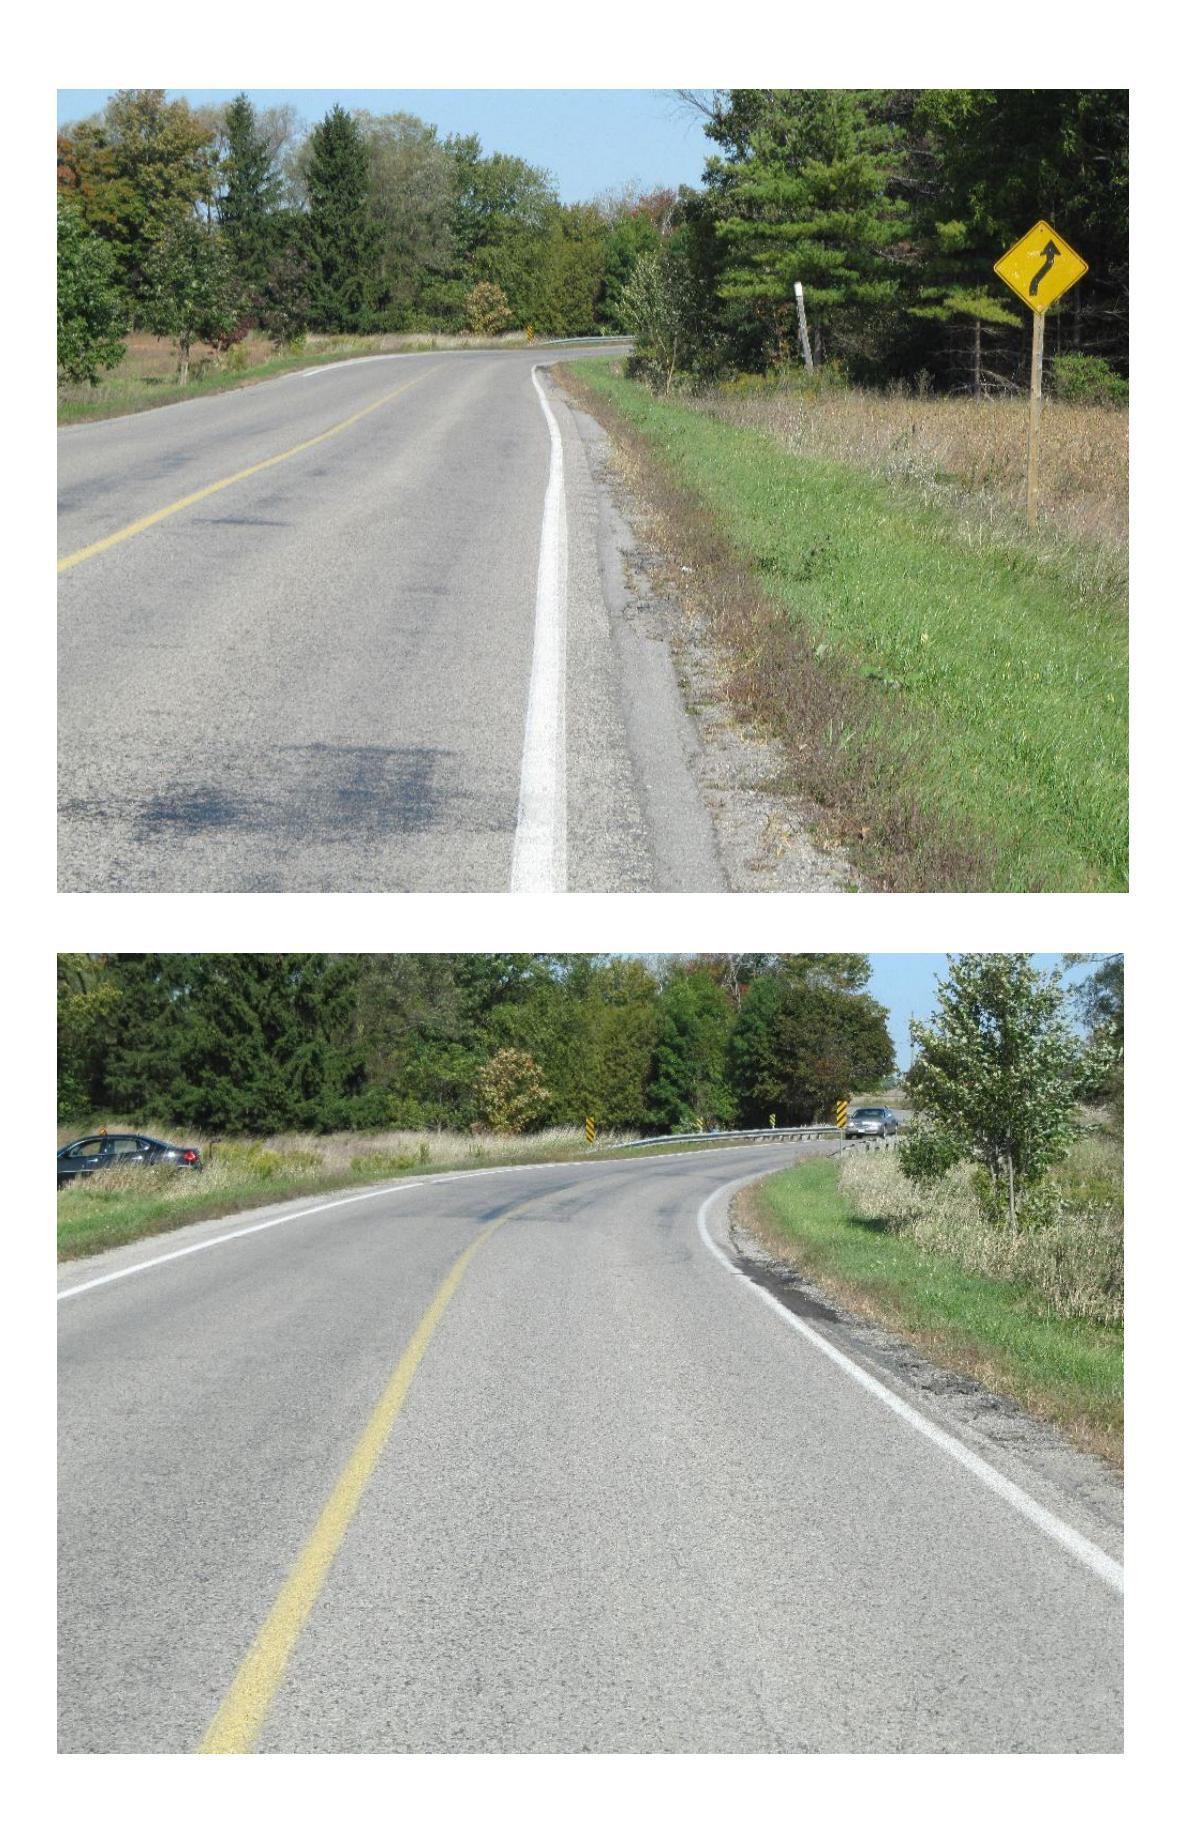
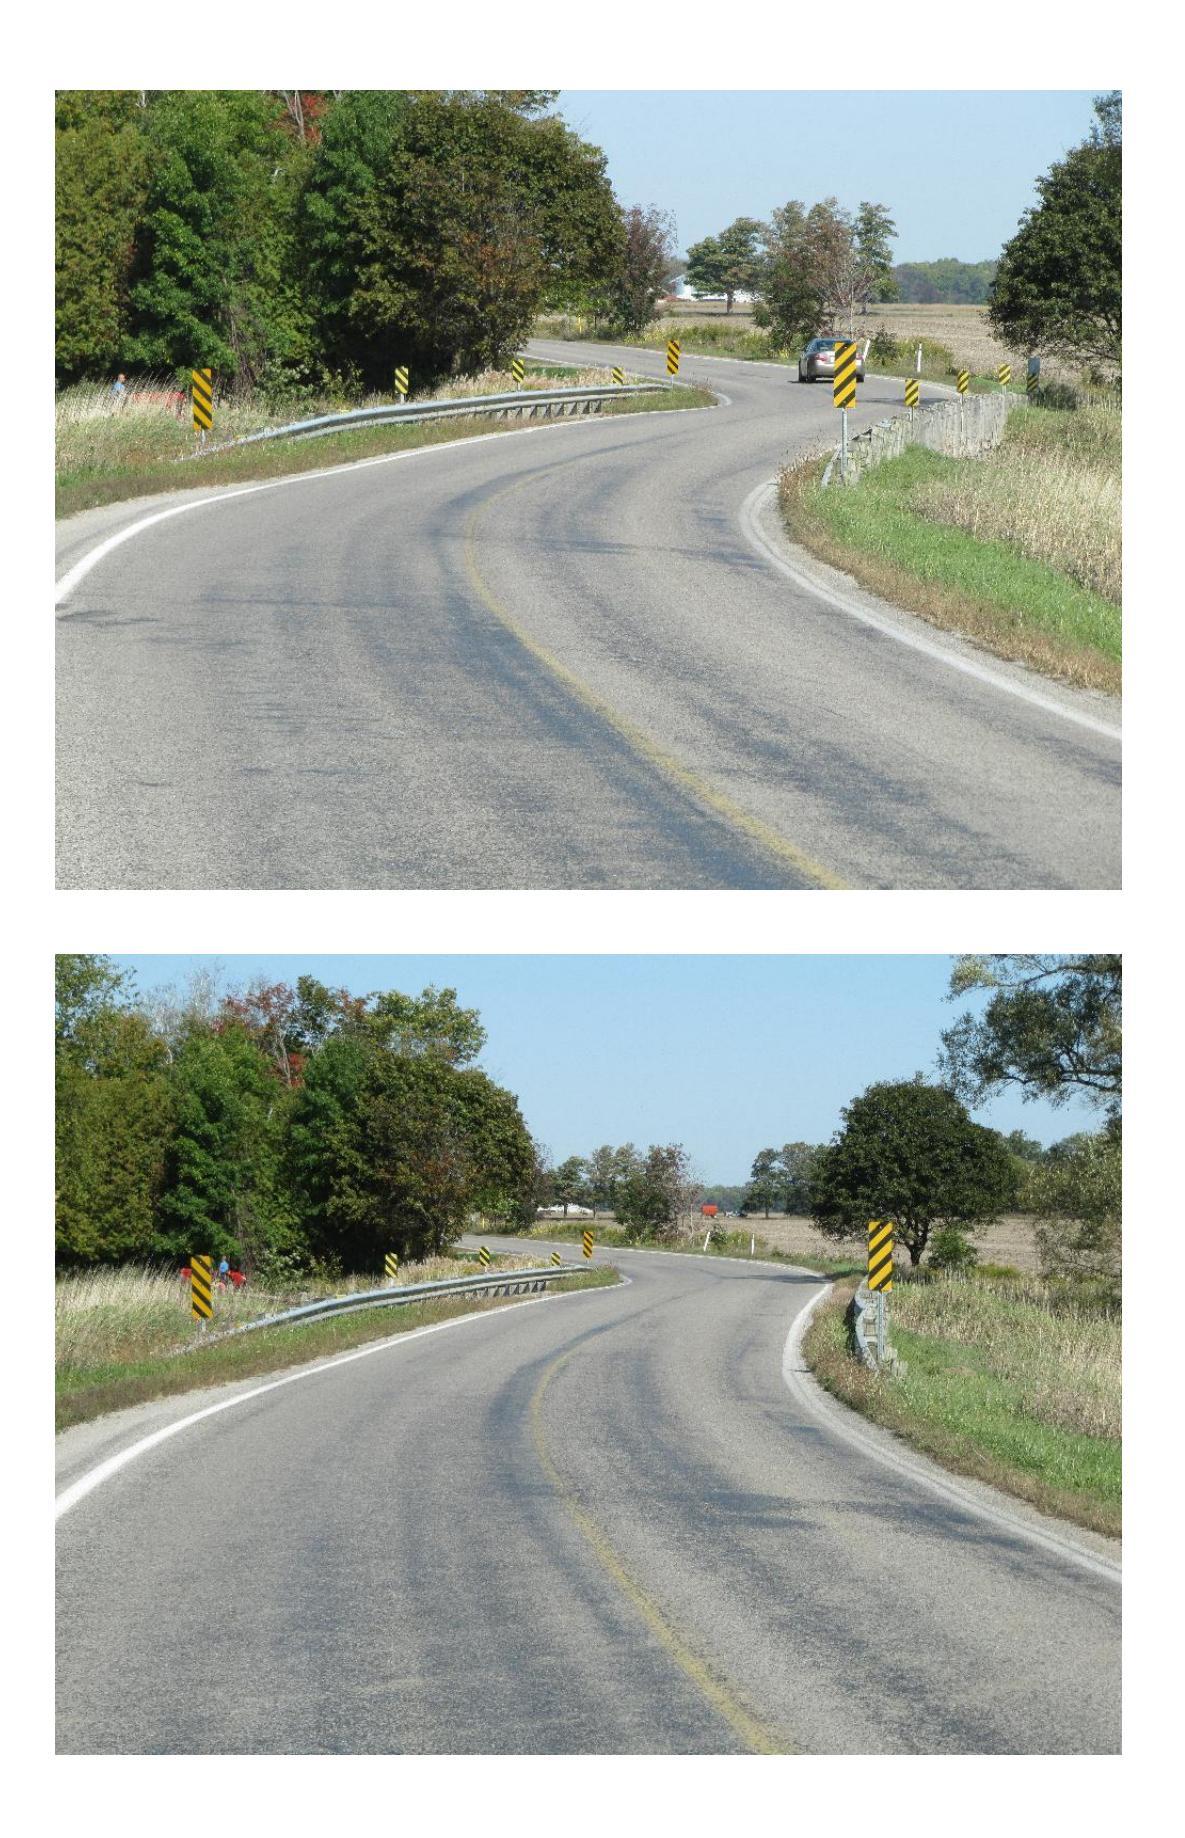
Curve 4: North of Ilderton Road

The photo at the top of Page 9 is a northward view looking toward Curve 4 while standing on the east edge line of the road. We have taken the photo in this fashion to exaggerate the extent to which a driver's view is obstructed from seeing most of the curve by the curve's geometry but also by the existence of trees close to the right roadside. The photo at the bottom of Page 9 provides a more realistic view of what the driver would see yet the limited line of sight is still obvious as we can see a southbound car just coming out from being the trees. While factors such as these are not going to lead to an astronomical difference in the number of collisions, every small deficiency such as this has its effect.

The two photos on Page 10 provide additional views of Curve 4 as we progress further northward into the Curve.

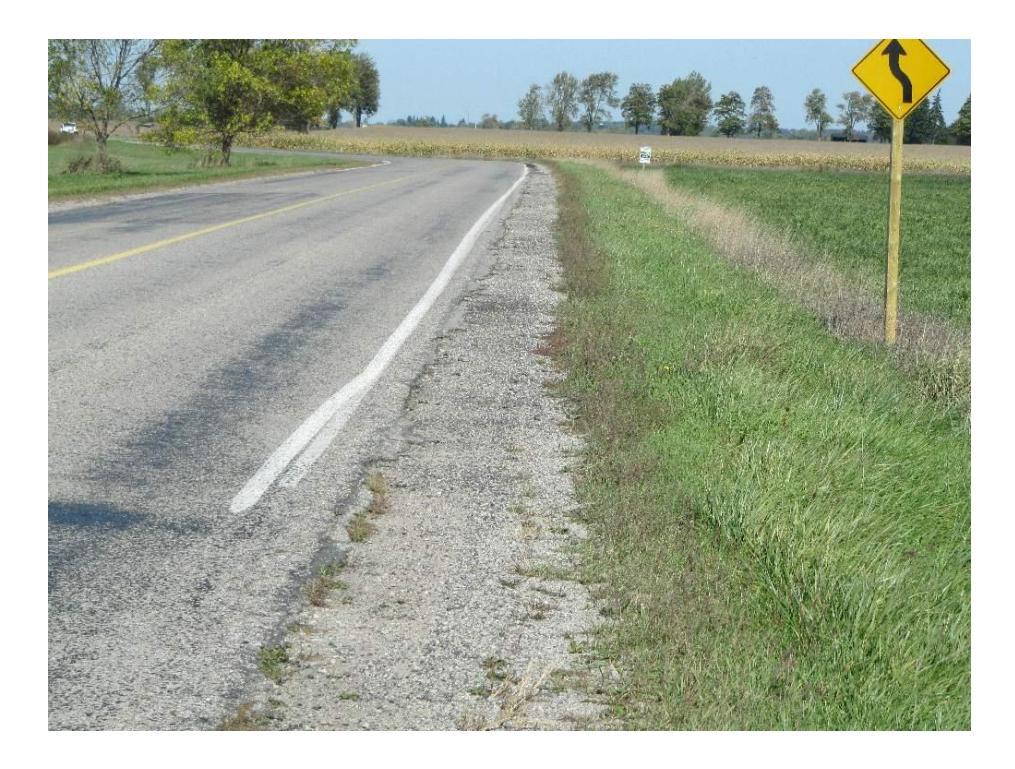
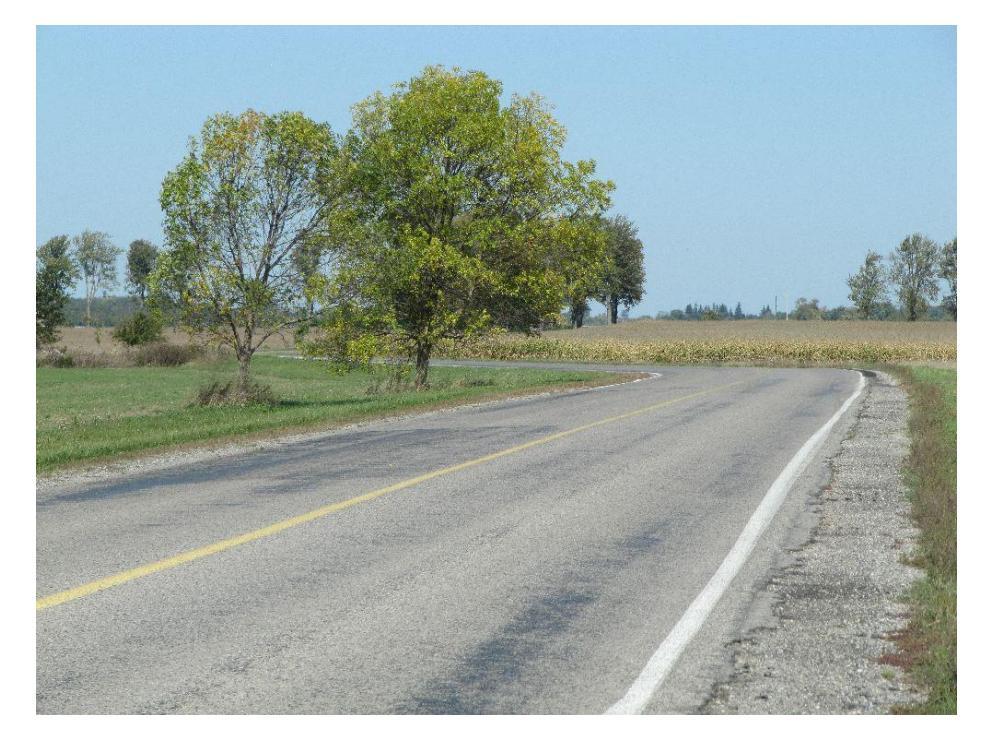
Curve 5: North of Thirteen Mile Road

The two photos below show northward views of the beginning of Curve 5. Again the level of service is diminished here by the obvious presence of the trees blocking the line of sight. However, there are further issues.

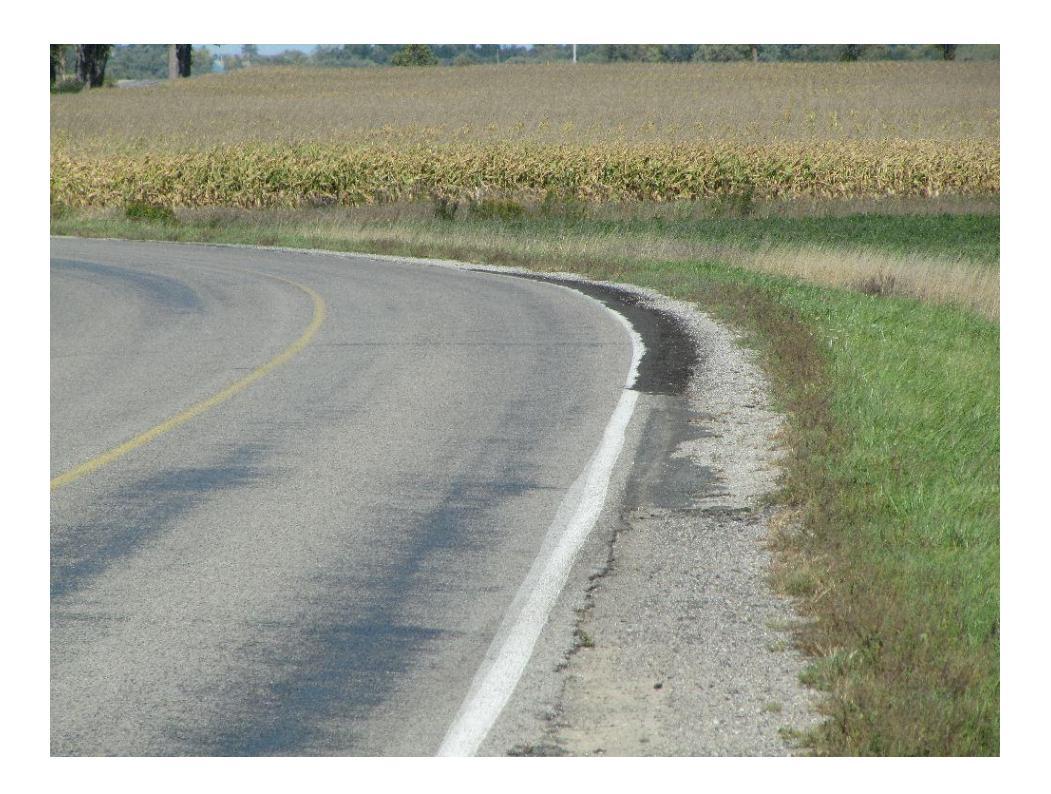
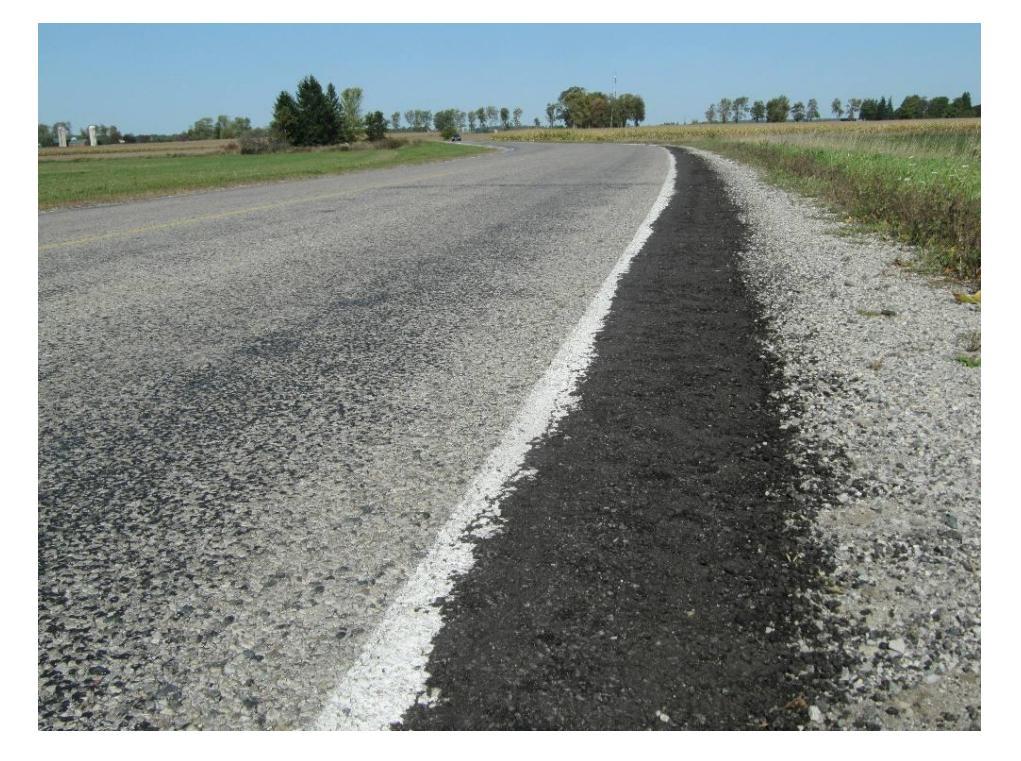
Note in the photo below that maintenance personnel recognized a problem with the disintegration of the right edge of the pavement and they have attempted to solve the problem by placing the dark line of cold patch along that edge. This may appear helpful but sometimes the medicine is more harmful than the decease.

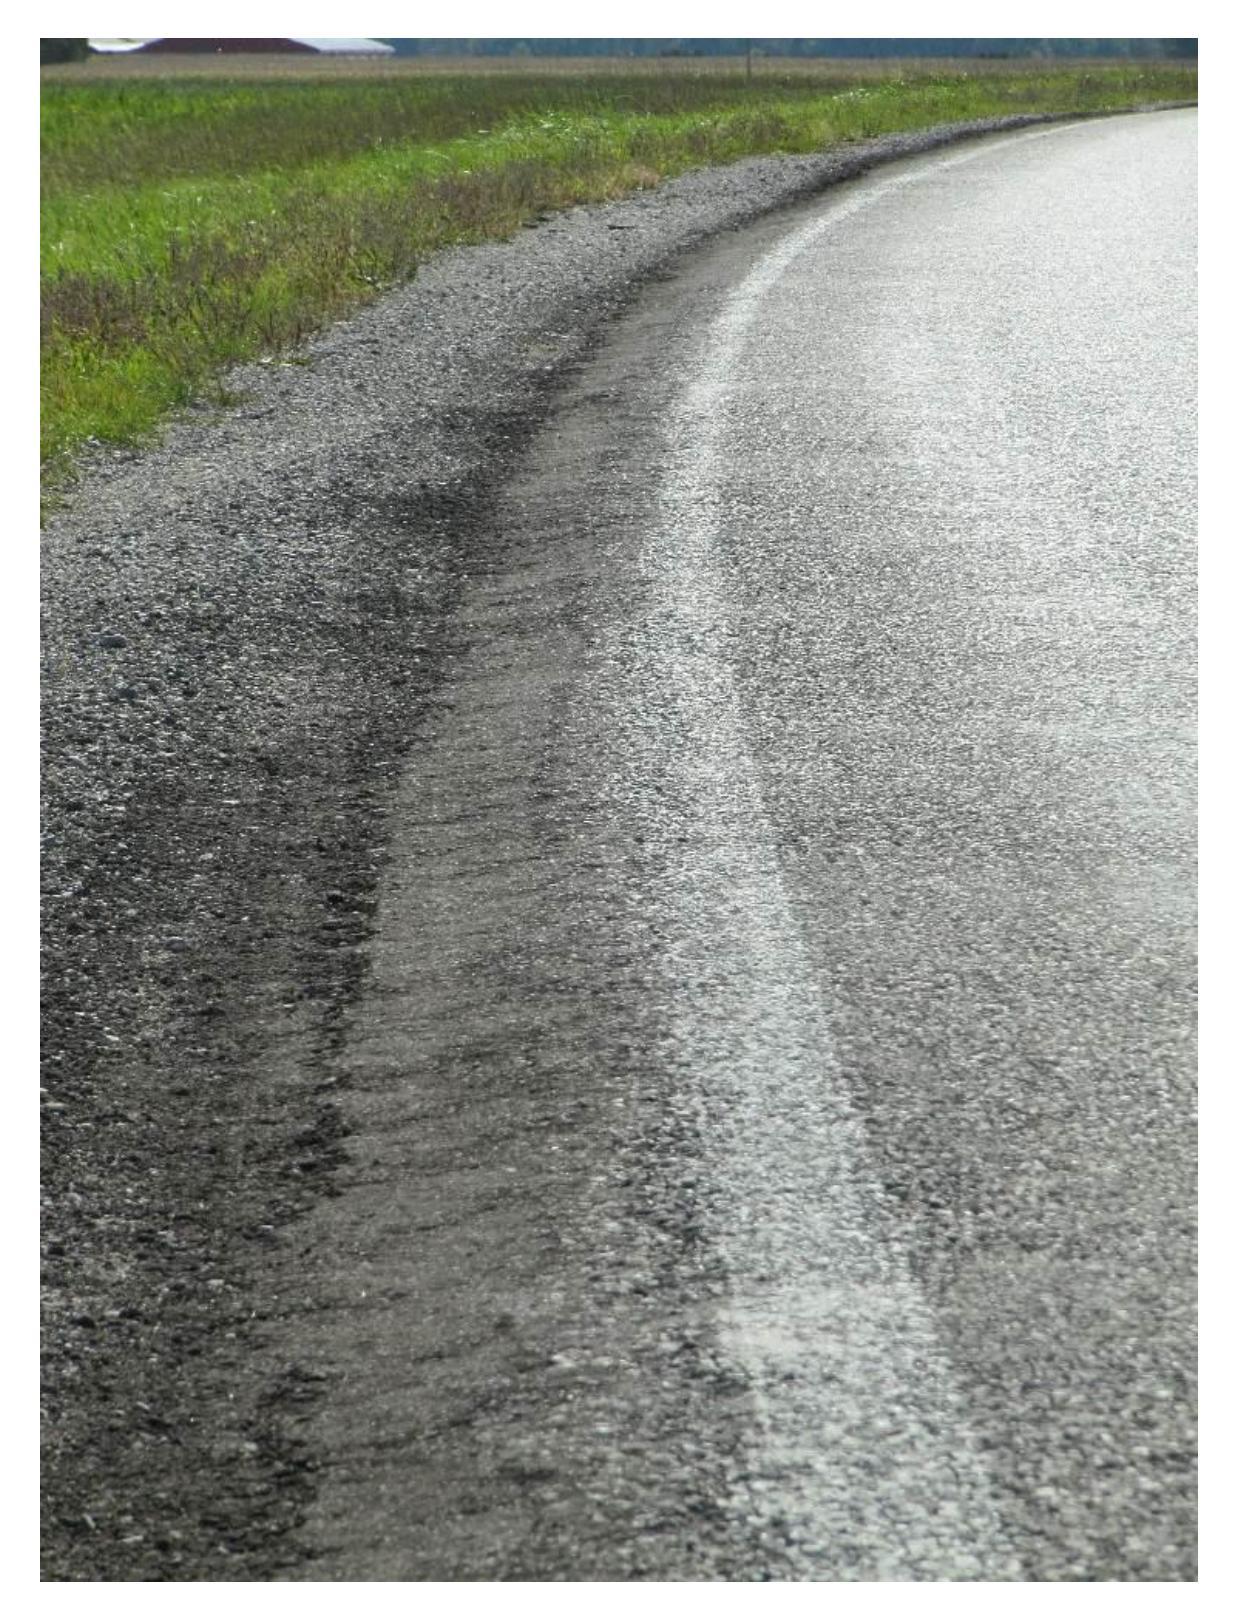
Looking closely at the patch in the photo below, which is a southward view, shows that it is rough and uneven and that there is actually a substantial slope to the patch which could affect the tire force in close to maximum conditions.
