The Seven S-Curves of Adelaide - Part 1

Posting Date: 25 September 2012

This is a preliminary article in a series discussing testing at Gorski Consulting to document roadway effects on potential loss-of-control collisions at curves on Adelaide Street, north of the City of London, Ontario, Canada. This article will introduce the roadway and the characteristics of each curve through a series of photographs.

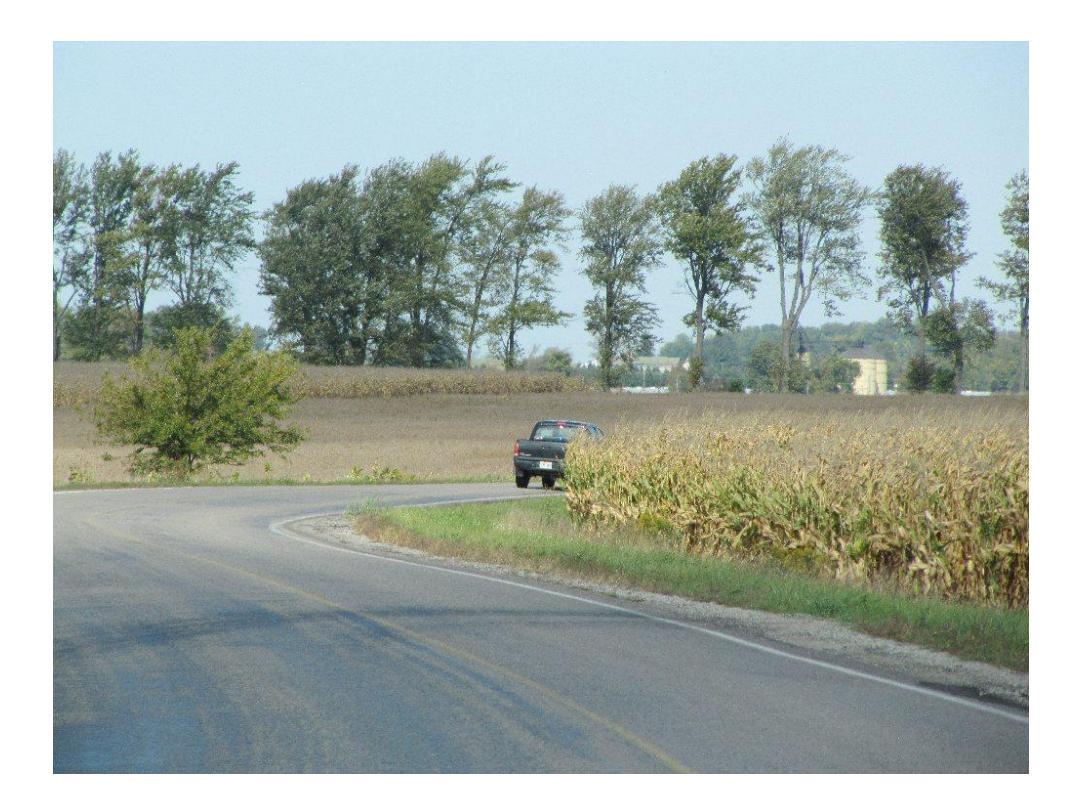
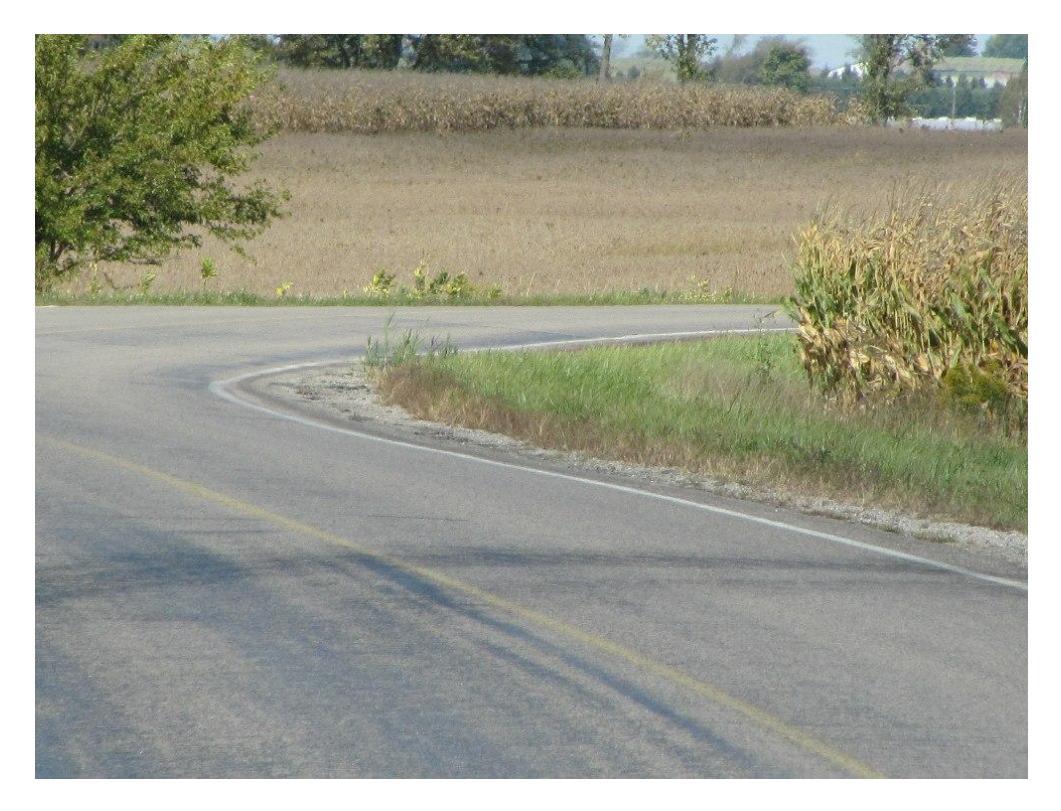
There are also the usual issues of blockage of the line of sight within the Curve. In this particular instance the crop of corn is the issue as shown in the two photos below.

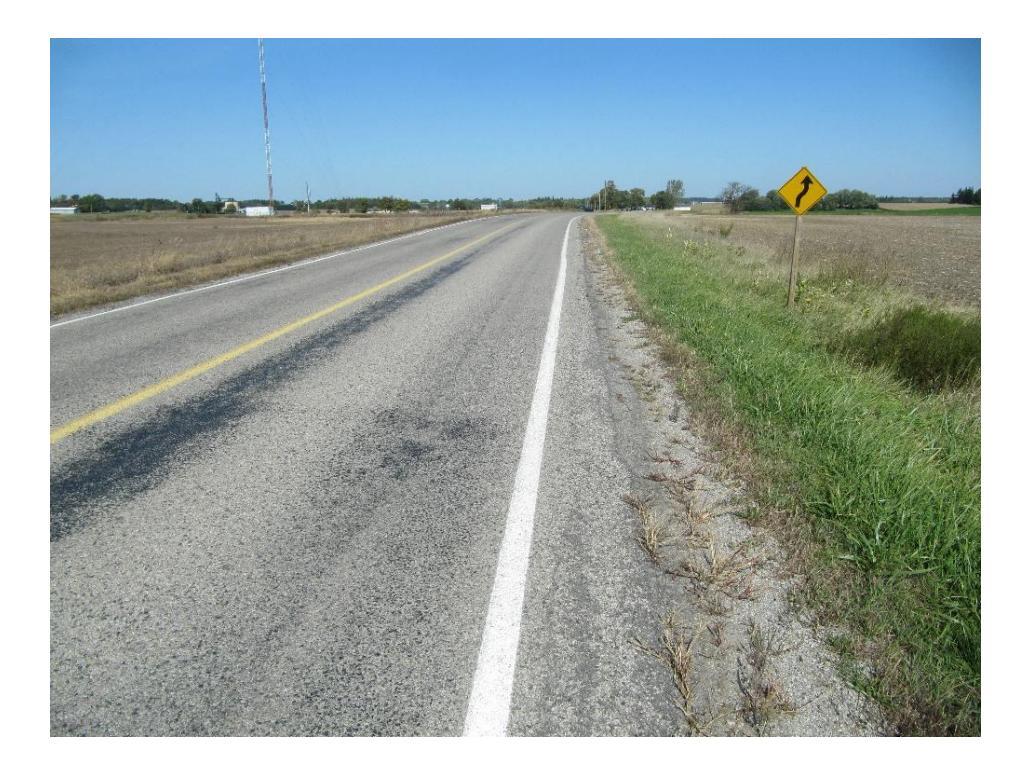
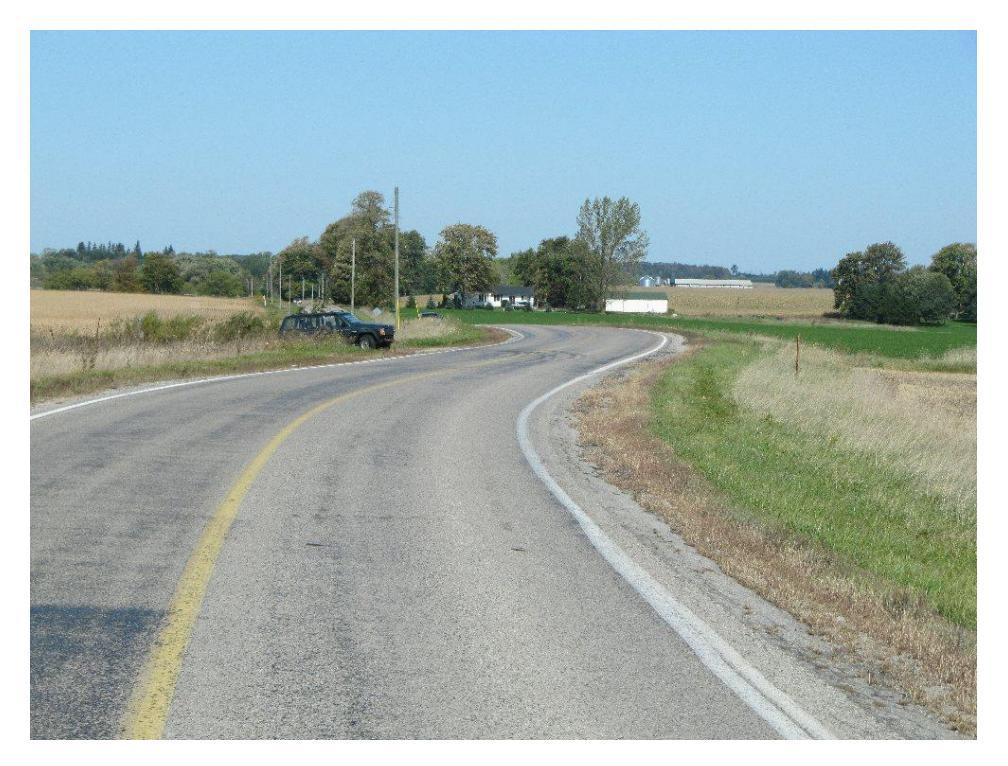
Curve 6: North of Fourteen Mile Road

The two photos below show the conditions leading up to the curve.

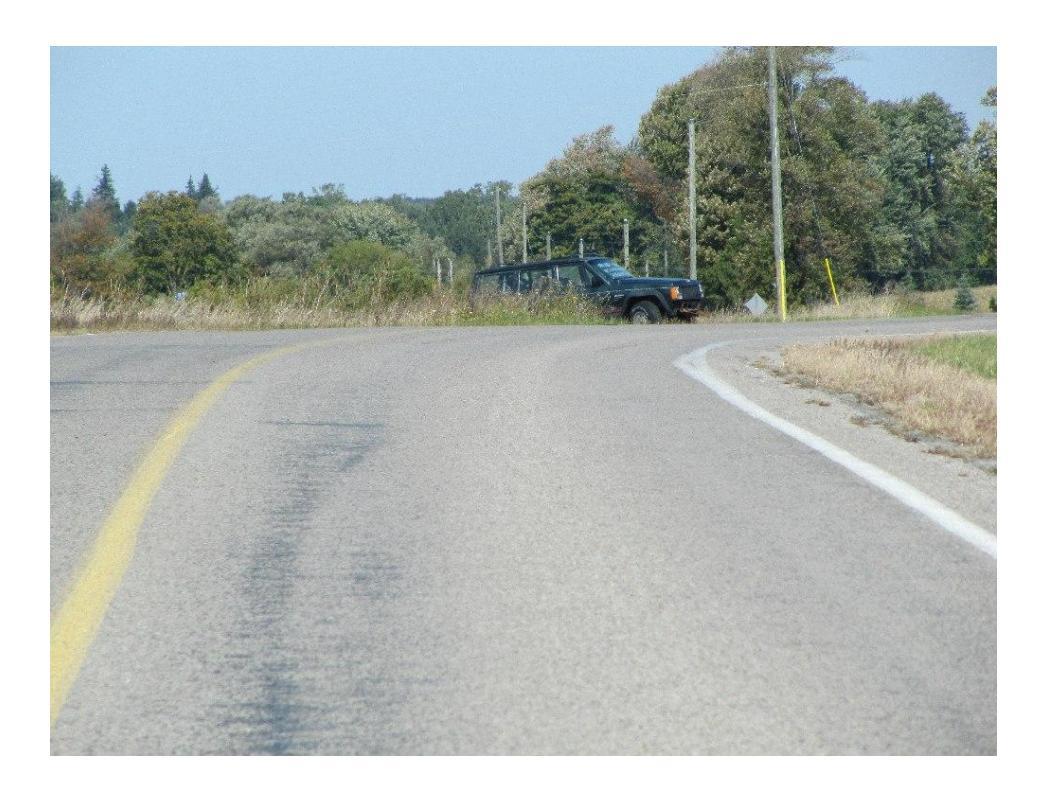
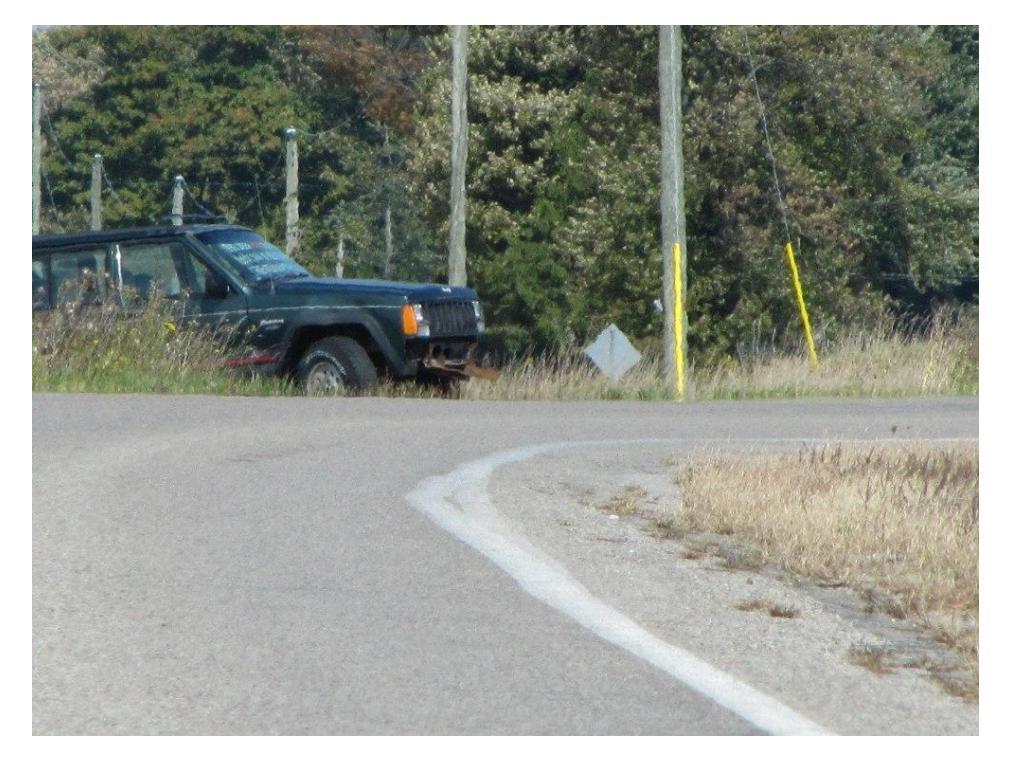
In this instance someone has left a vehicle parked on the west roadside. Looking at the vehicle in the photo at the bottom of Page 15 would lead one to conclude that there is no problem. But looking at the view that drivers might have shows a different situation, as shown in the two photos below.

From a driver's eye-height it is not clear whether the parked vehicle is on the roadside or in the road. This uncertainty could cause a driver to take evasive action when none is required. Looking at the situation from a southbound view shows a similar problem as shown in the photo below.

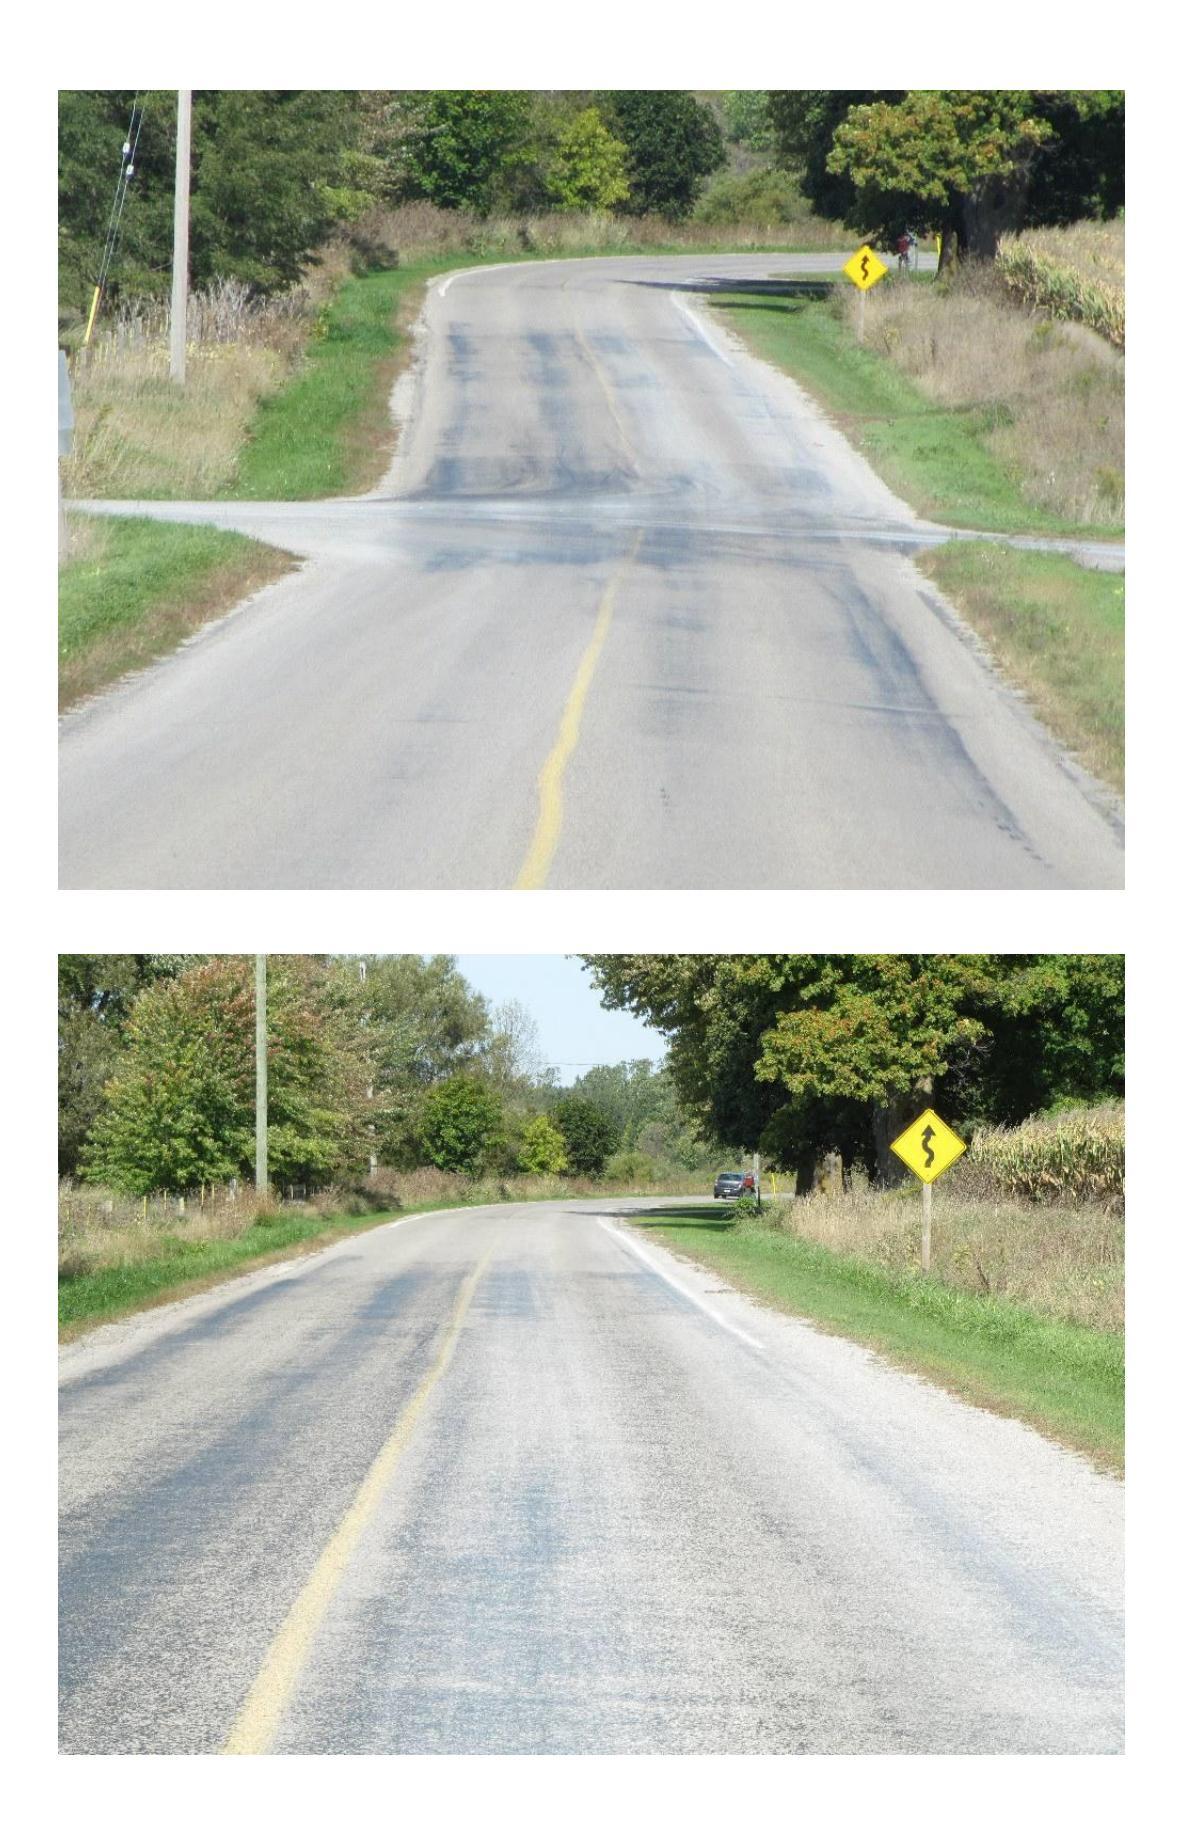
Curve 7 North of Fifteen Mile Road

The characteristics of the seventh and final S-curve are shown in the northward views in the two photos on following page.

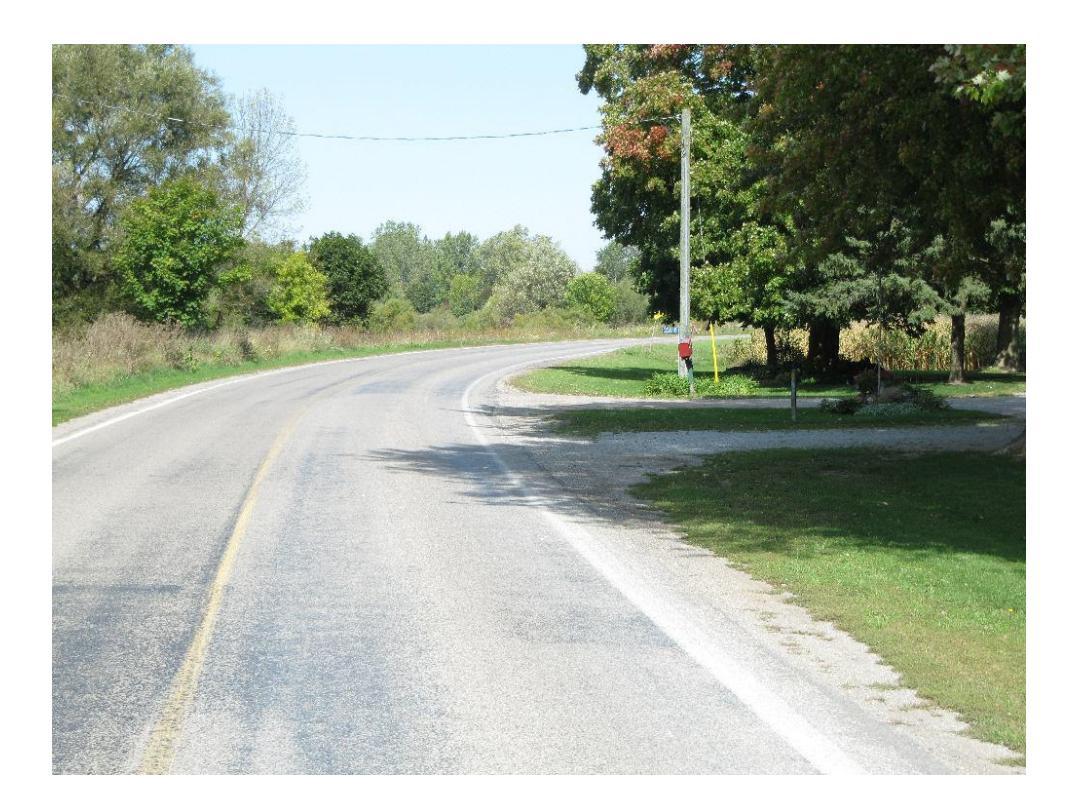
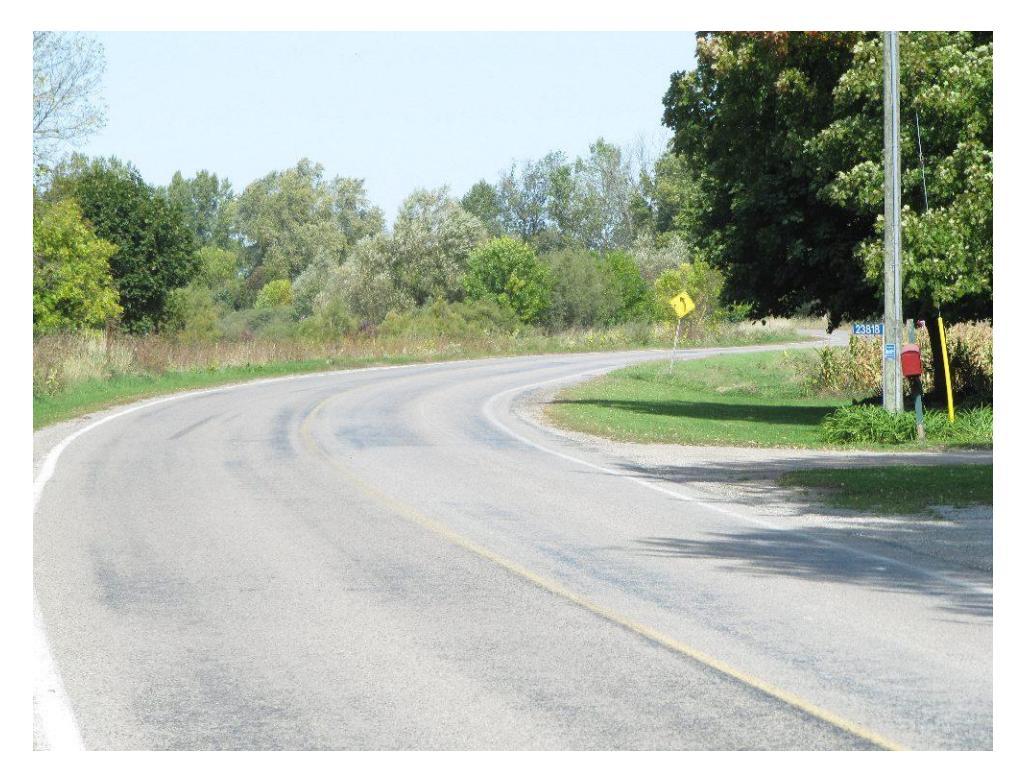
As we follow through this curve we note that there is an additional curve warning sign that becomes visible after passing through most of the first, right curve, as shown in the bottom photo of this page.

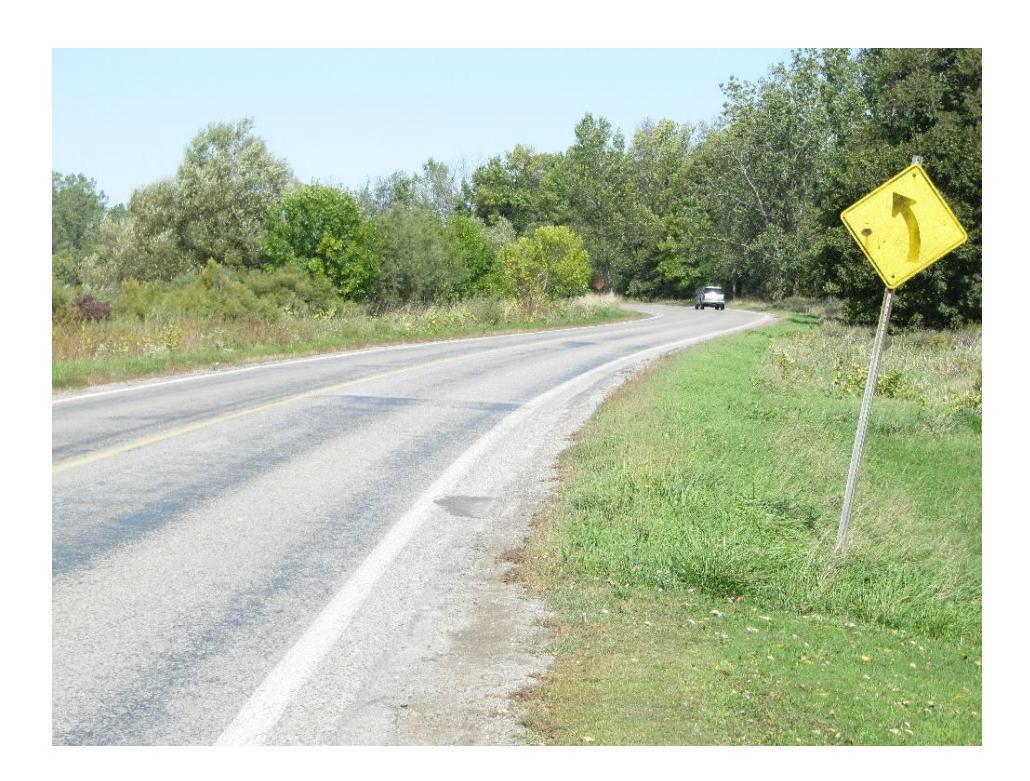
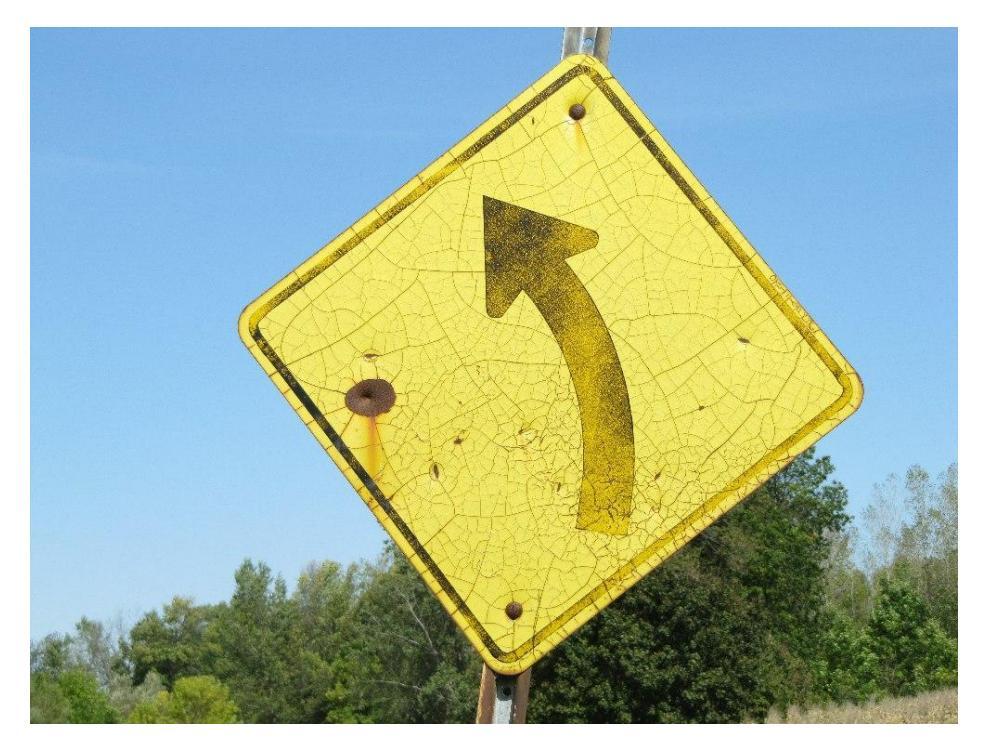
In the photos below we get closer to that warning sign and recognize that it is not in ideal condition. In fact it is quite old and faded.

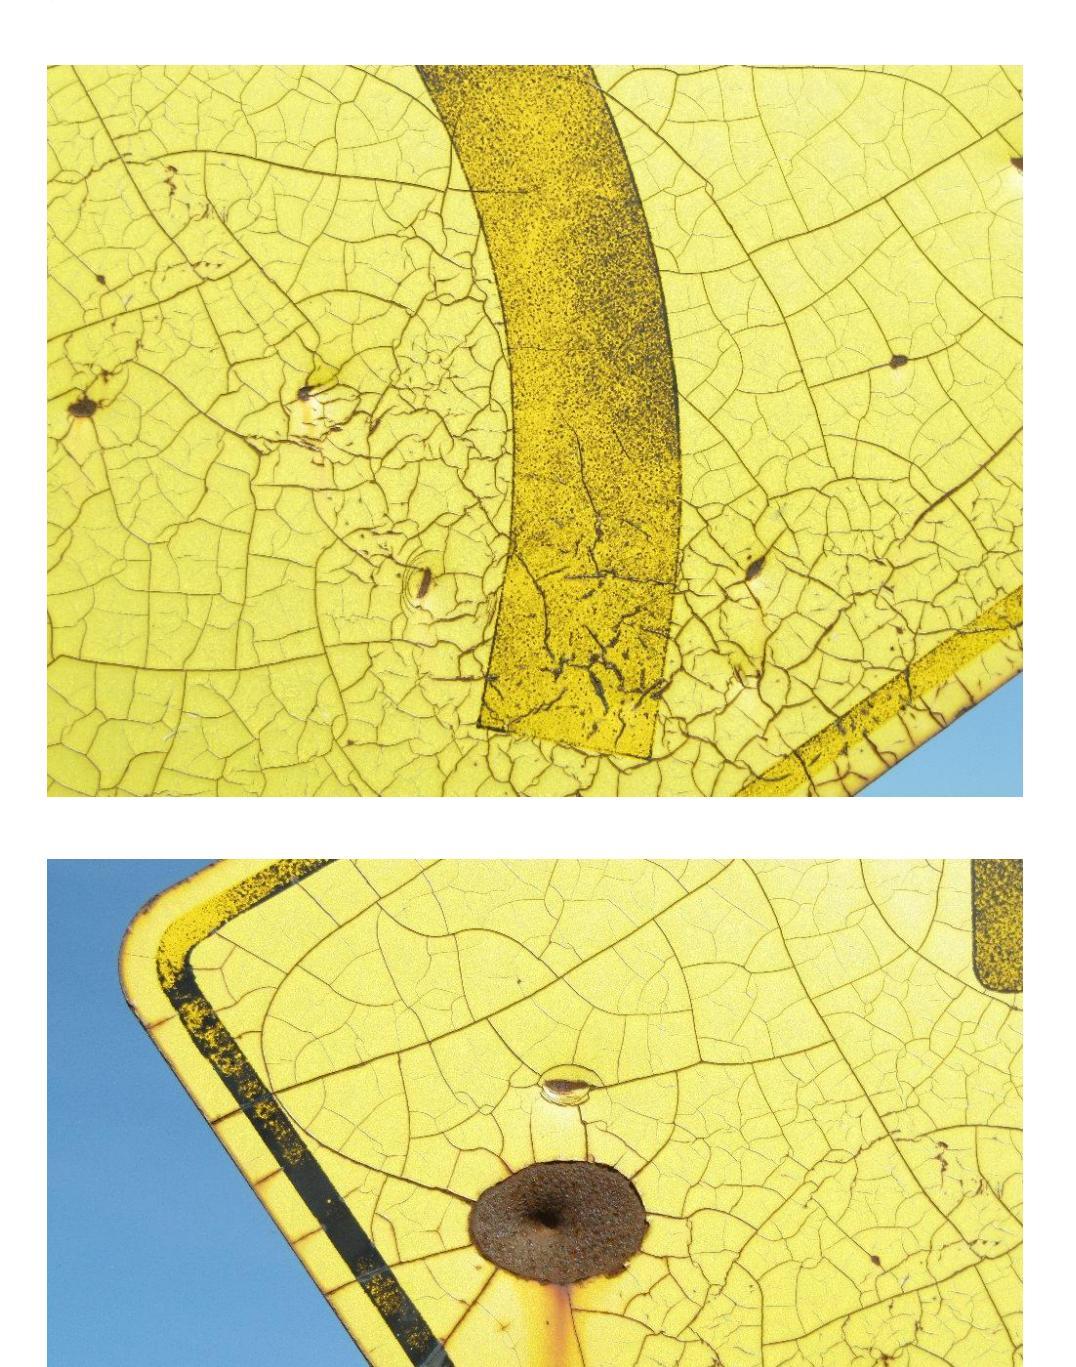
At night-time the headlights of vehicles would be pointing away to the left of the sign so it would already be difficult to see regardless of its condition. However, when we get a good close-up look we can really see the extent of its deterioration as shown below.
