Video Eyeglasses, iPhone and Multiple Video Cameras - An Effective Data Acquisition System For Motor Vehicle Accident Analysis and Reconstruction

Review of Instrumentation

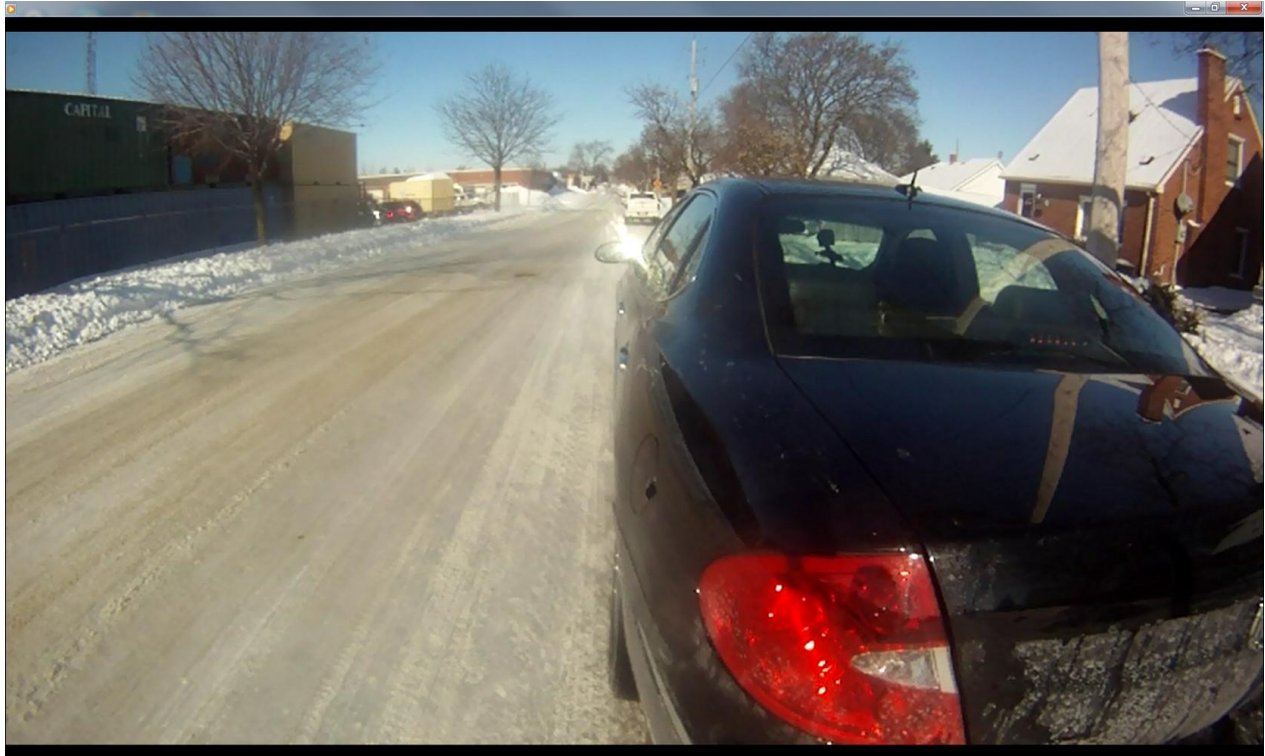
Figure 3: View from GoPro23, anchored to a bike rack at the back of the test vehicle. This figure shows the vehicle at the start of the testing at the south end of Ashland Avenue.

Figure 3 (below) shows the view from this camera as our test vehicle was stopped at the south end of Ashland Avenue at the beginning of the testing. Figure 4 shows the view from GoPro23 as the test vehicle passed Langmuir Avenue. Figure 5 shows the vehicle approaching the stop sign at Wilton Avenue. Figure 6 shows the vehicle crossing the railway tracks. Figures 7, 8 and 9 show the test vehicle as it approaches the stop sign at Florence Street and comes to a halt. The driver stops at this location for about 40 seconds and makes observations of the cross traffic before making a left turn. Much of our discussion will involve the driver's observations at this stop sign.

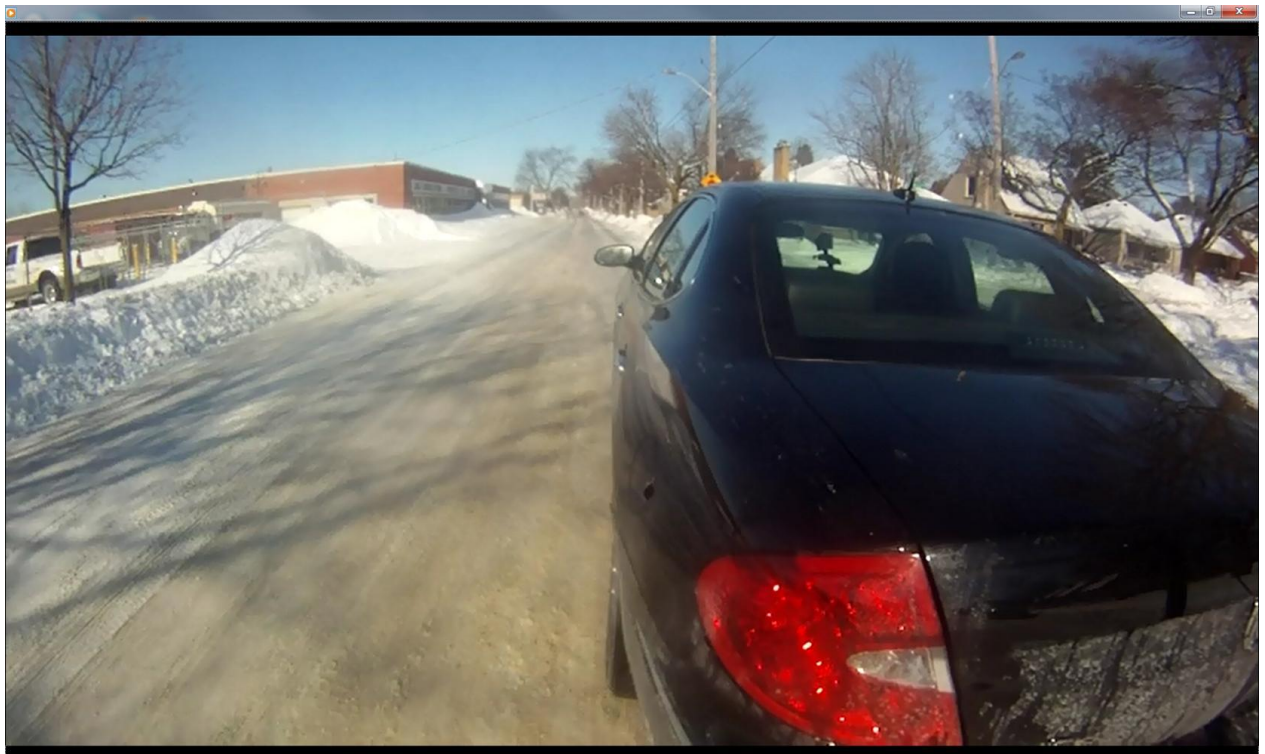
Figure 4: View from GoPro23 showing our test vehicle passing Langmuir Avenue.

Figure 11 shows the view when the test vehicle is approaching Langmuir Avenue, which is similar to the position shown in Figure 4.

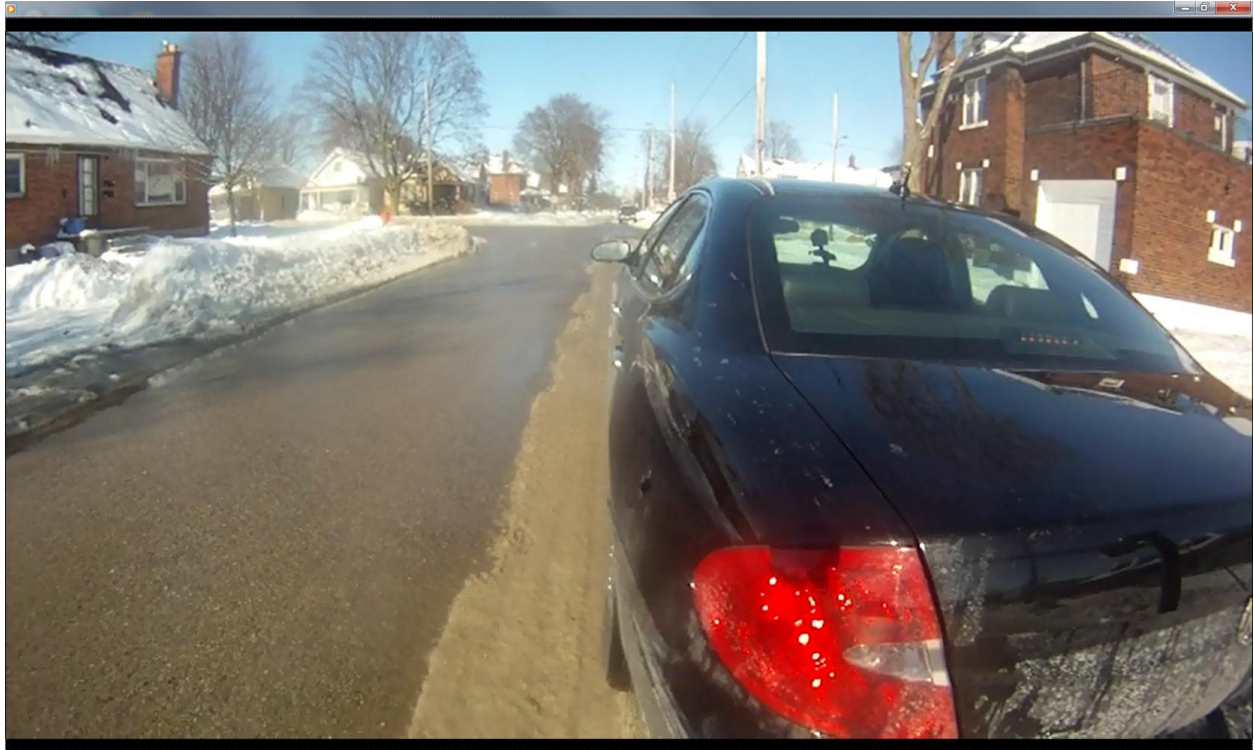
Figure 7: View from GoPro23 showing test vehicle approaching the intersection at Florence Street.

Figure 14 shows the view when the test vehicle is approaching Florence Street, which is similar to the position shown in Figure 7.

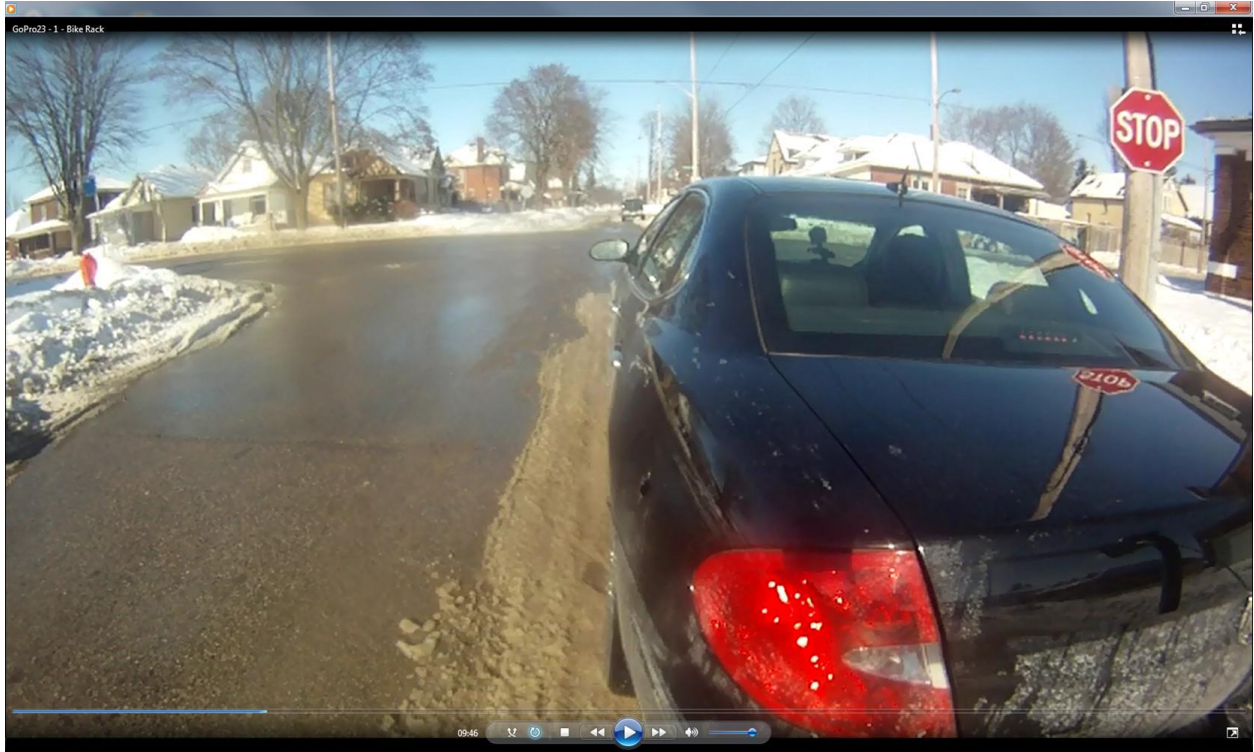
Figure 8: View from GoPro23 showing the test vehicle approaching the stop sign at Florence Street.

Figure 15 shows the view when the test vehicle is approaching the stop sign at Florence Street, which is similar to the position shown in Figure 8.

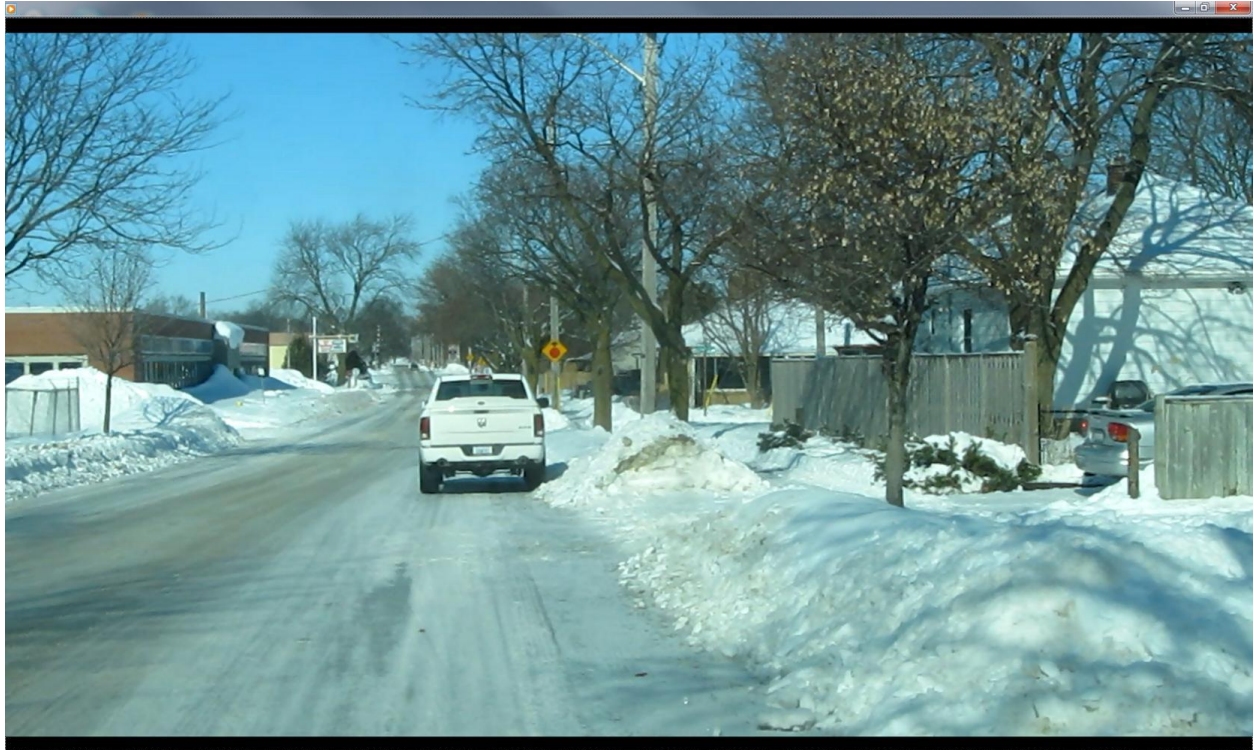
Figure 10: View from the Canon camera from the start position of the testing at the south end of Ashland Avenue. This is the same location as shown in Figure 3.

So Figure 10 shows a view from the Canon camera at the start of the testing, which is the same position as shown in Figure 3.

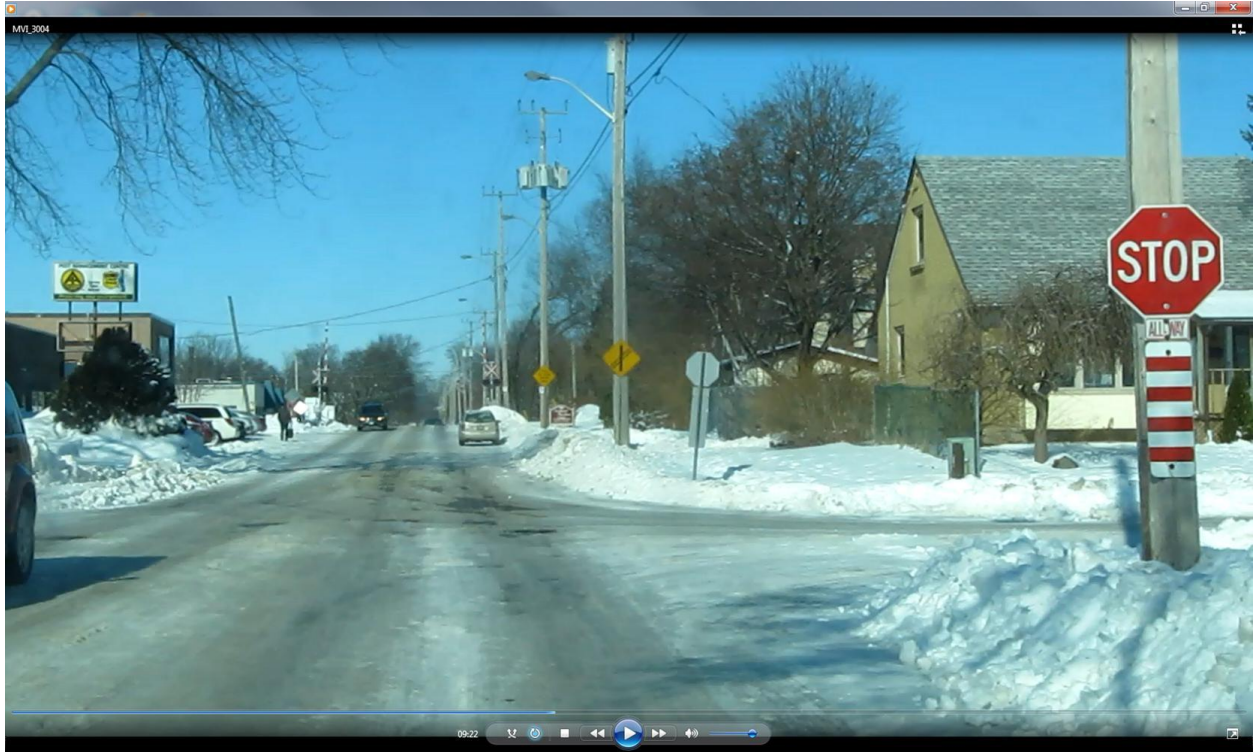
Figure 11: View from Canon camera as the test vehicle approaches the intersection of Langmuir Avenue.

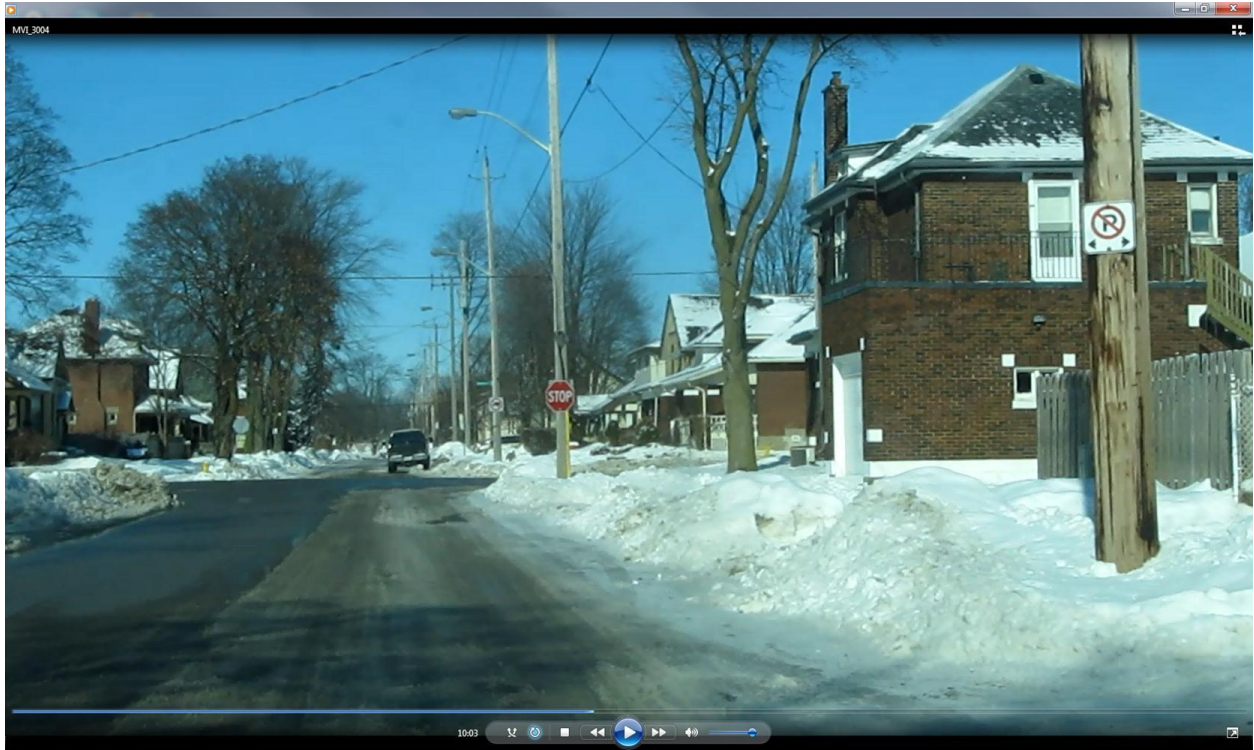
Figure 13: View from Canon camera as the test vehicle approaches the railway tracks , which is similar to the position shown in Figure 6.

Figure 13 shows the view when the test vehicle is approaching Florence Street, which is similar to the position shown in Figure 6.

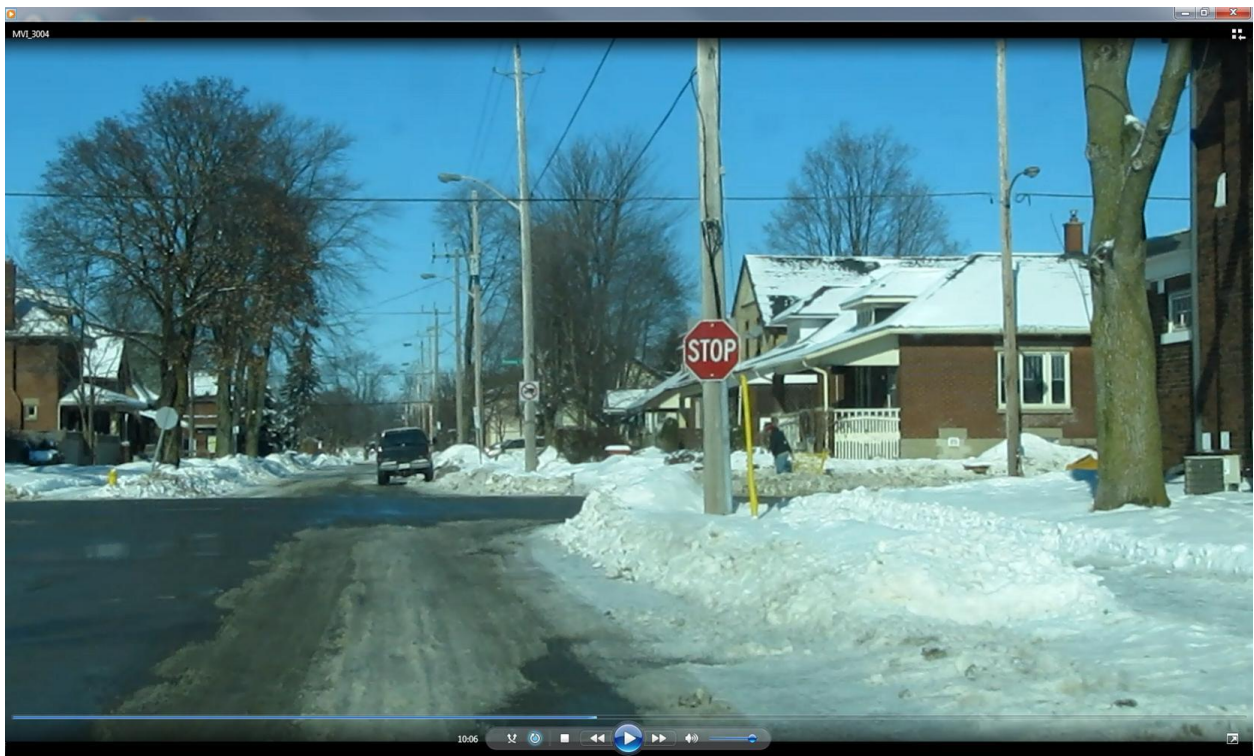
Figure 14: View from Canon camera as the test vehicle approaches Florence Street.

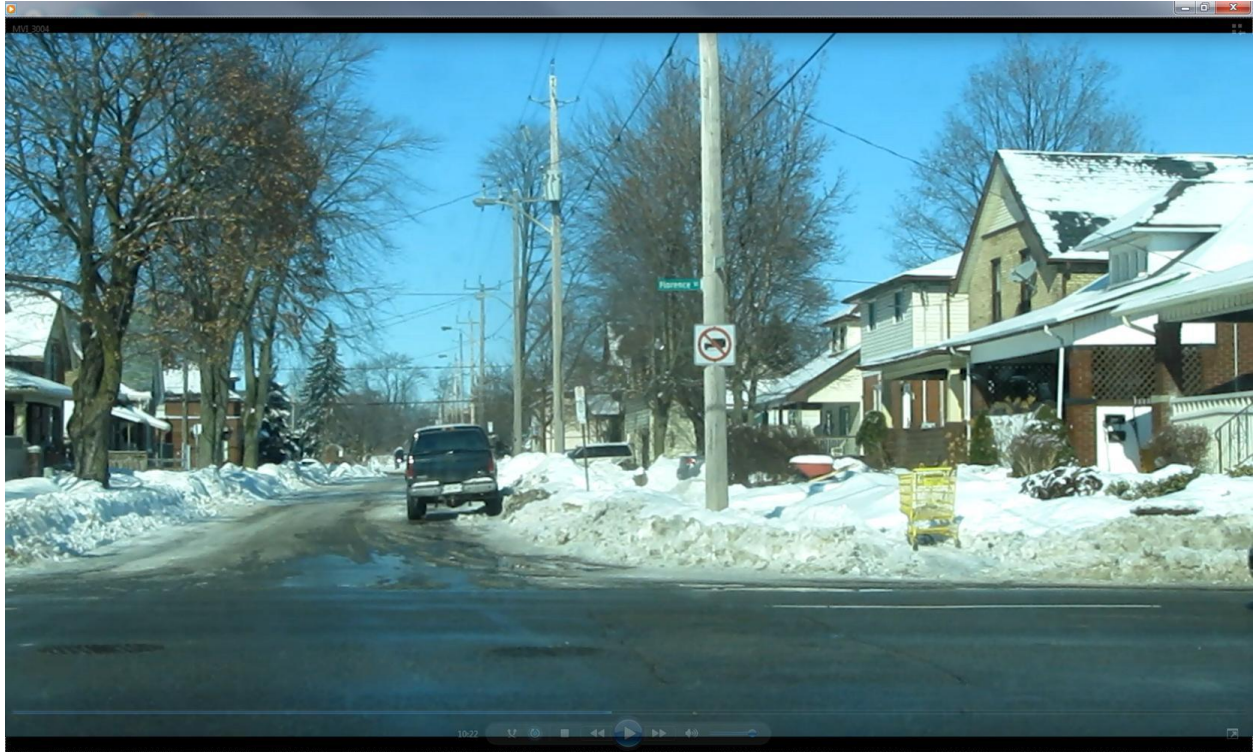
Figure 15: View from Canon camera as the test vehicle approaches the stop sign at the intersection with Florence Street.

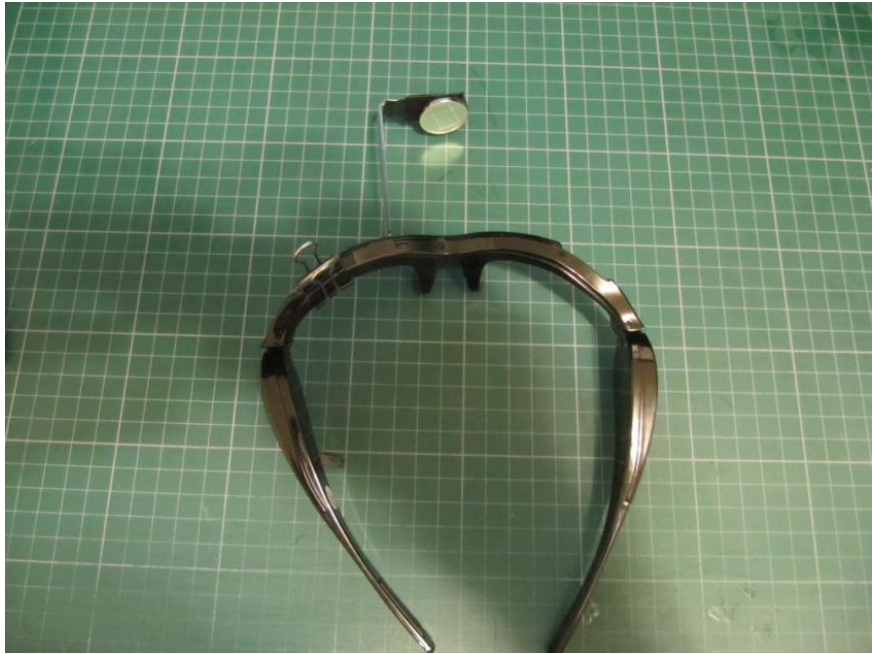
Figure 17: View of video eyeglasses with an attached mirror used to document the motion of a driver's right eye.

As part of our instrumentation we equipped the test driver with a set of eyeglasses which had a video camera attached to the frame approximately at the bridge of the nose, as shown in Figure 17. We developed an anchorage for the mirror that allowed the videotaping of the driver's right eye.

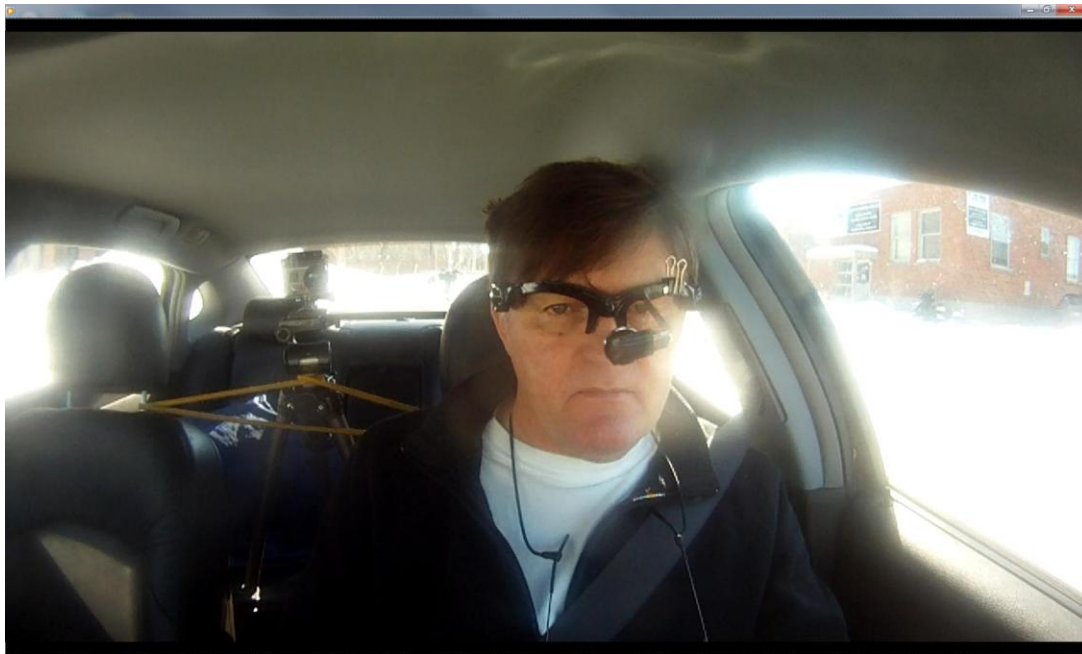
Figure 18: View of test driver wearing the video sunglasses while looking straight ahead in the test vehicle.

Figure 18 shows a view of the interior of the test vehicle taken from a camera (GoPro31) that is attached below the driver's sun-visor and is pointing rearwards toward the driver. The test driver is wearing the noted video sunglasses.

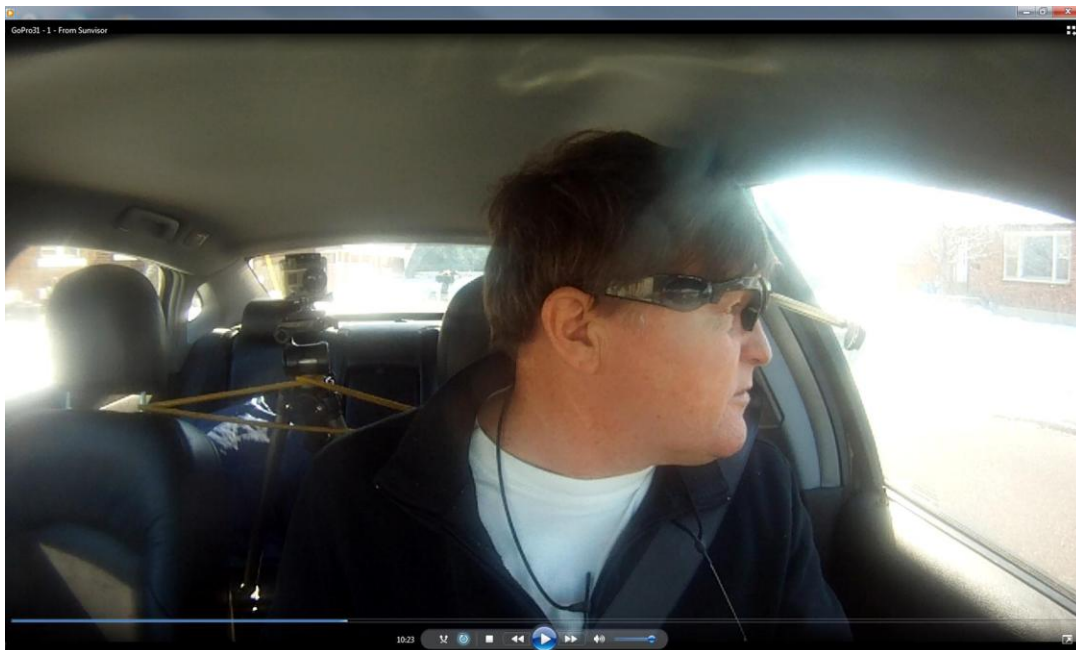
Figure 19: View from GoPro31 showing the test driver looking fully to the left while stopped at the stop sign at Florence Street.

Figure 19 is a view from GoPro31 showing the test driver looking fully to the left while stopped at the stop sign at Florence Street.

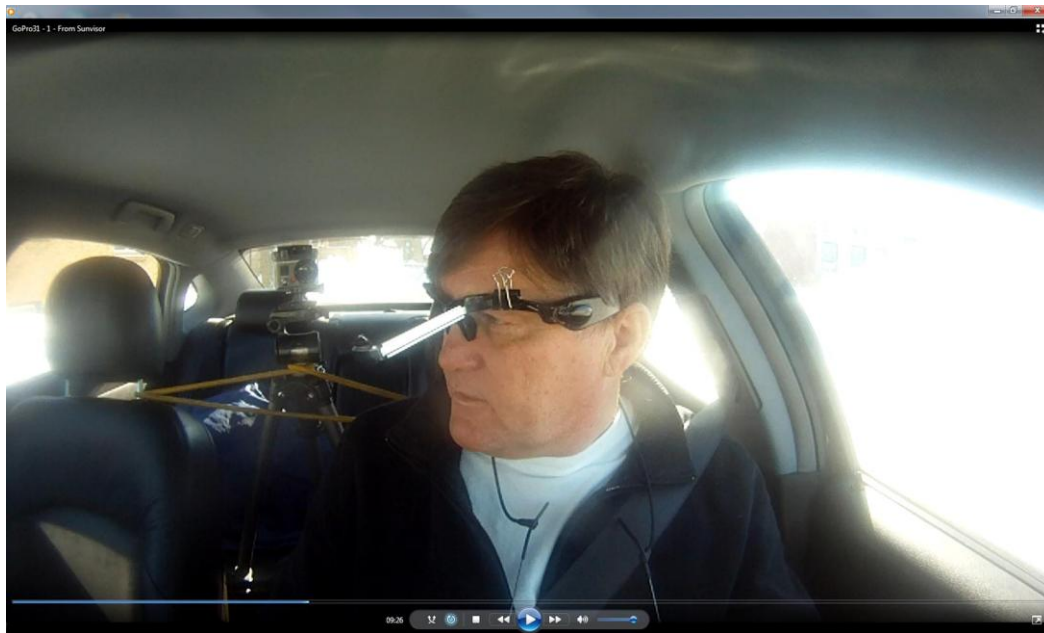
Figure 20: View from GoPro31 showing the test driver looking fully to the right while stopped at the stop sign at Florence Street.

Figure 20 is another view from GoPro31 showing the test driver looking fully to the right while stopped at the stop sign at Florence Street.

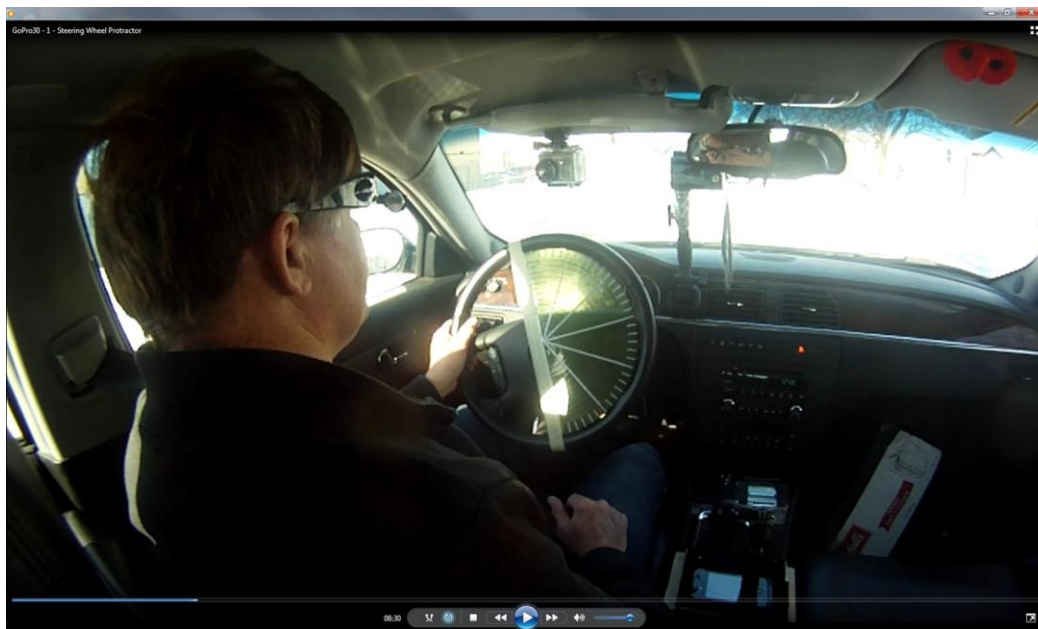
Figure 21: View from GoPro30 showing the protractor attached to the steering wheel hub to document the speed and magnitude of steering wheel rotation.

GoPro30 was another camera that was anchored between the two front seatbacks and it was pointed forward to capture the rotation of a large protractor that was mounted to the steering wheel of the test vehicle. A view from this camera is shown in Figure 21.

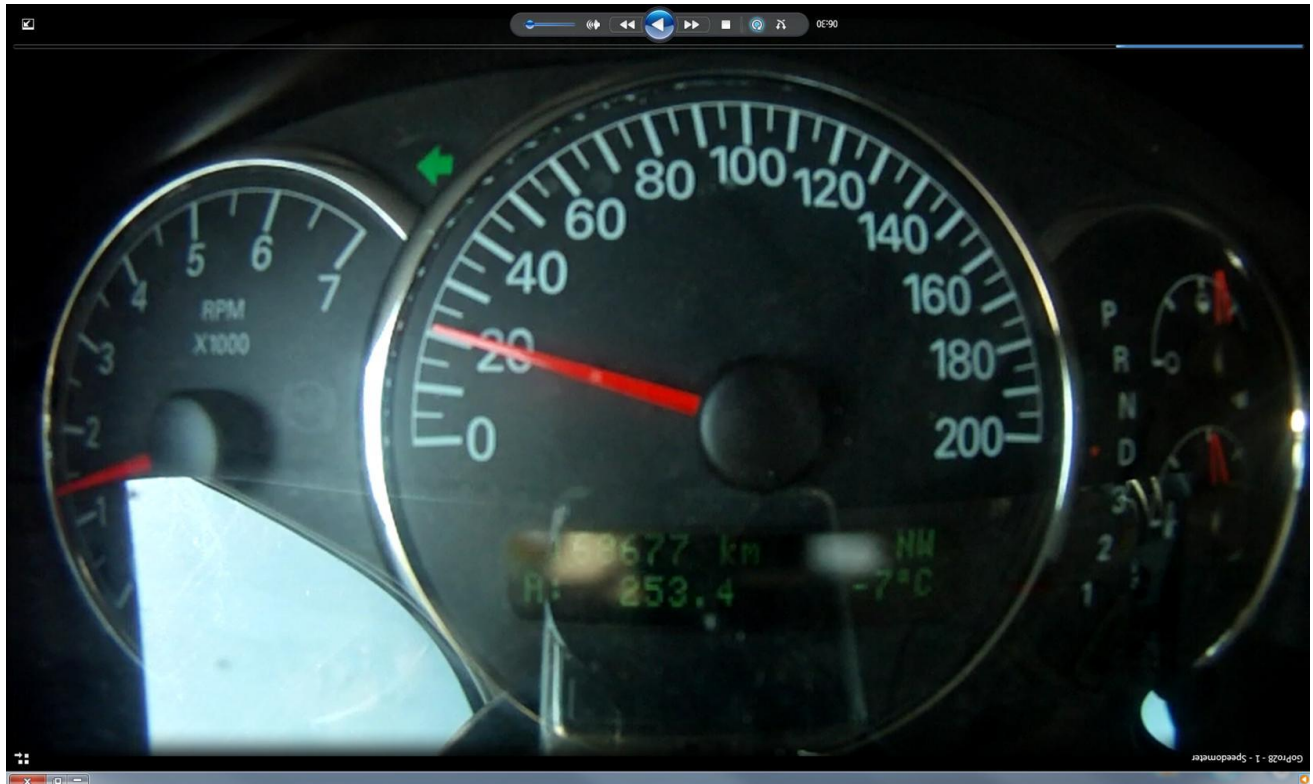
Figure 22: View from GoPro28 showing the instrument cluster of the test vehicle. In the present view the test vehicle is travelling about 21 km/h, the tachometer reads about 1300 rpm and the left turn signal is activated. The outside air temperature reads -7 C.

We also had a video camera (GoPro28) attached to face the instrument cluster of the vehicle and this documented information such as the vehicle speed, tachometer reading, turn signal activation, odometer/tripometer data, and outside air temperature. The sample view from this camera is shown in Figure 22.

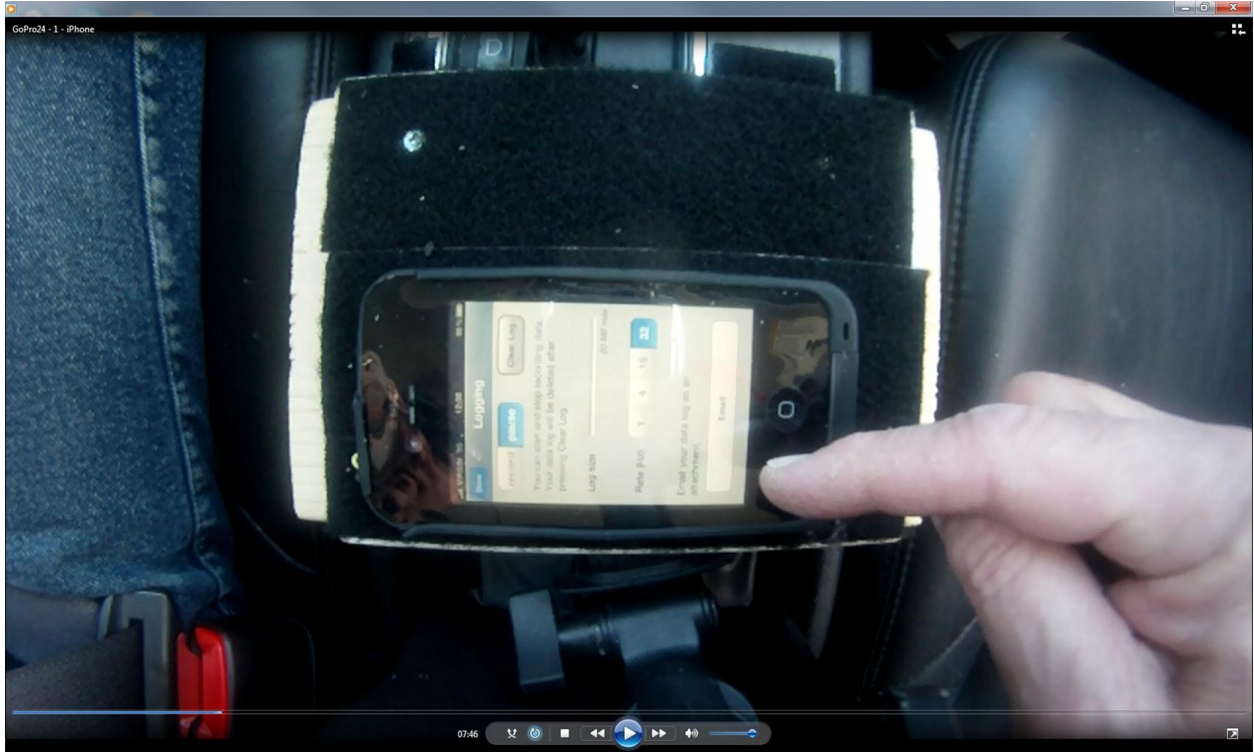
Figure 24: View from GoPro24 showing the face of the iPhone as it is being set-up to start recording of the readings from its accelerometer.

Another video camera (GoPro24) was attached to point down onto the centre console between the two front seats where an iPhone was anchored to a horizontal plate. The accelerometer of the iPhone was used to save a file of the accelerations experienced by the centre-of-gravity of the test vehicle and this file was then transferred via e-mail to a host computer and later transferred into an excel spreadsheet. Charts were created from this data and will be shown in a latter portion of this article.

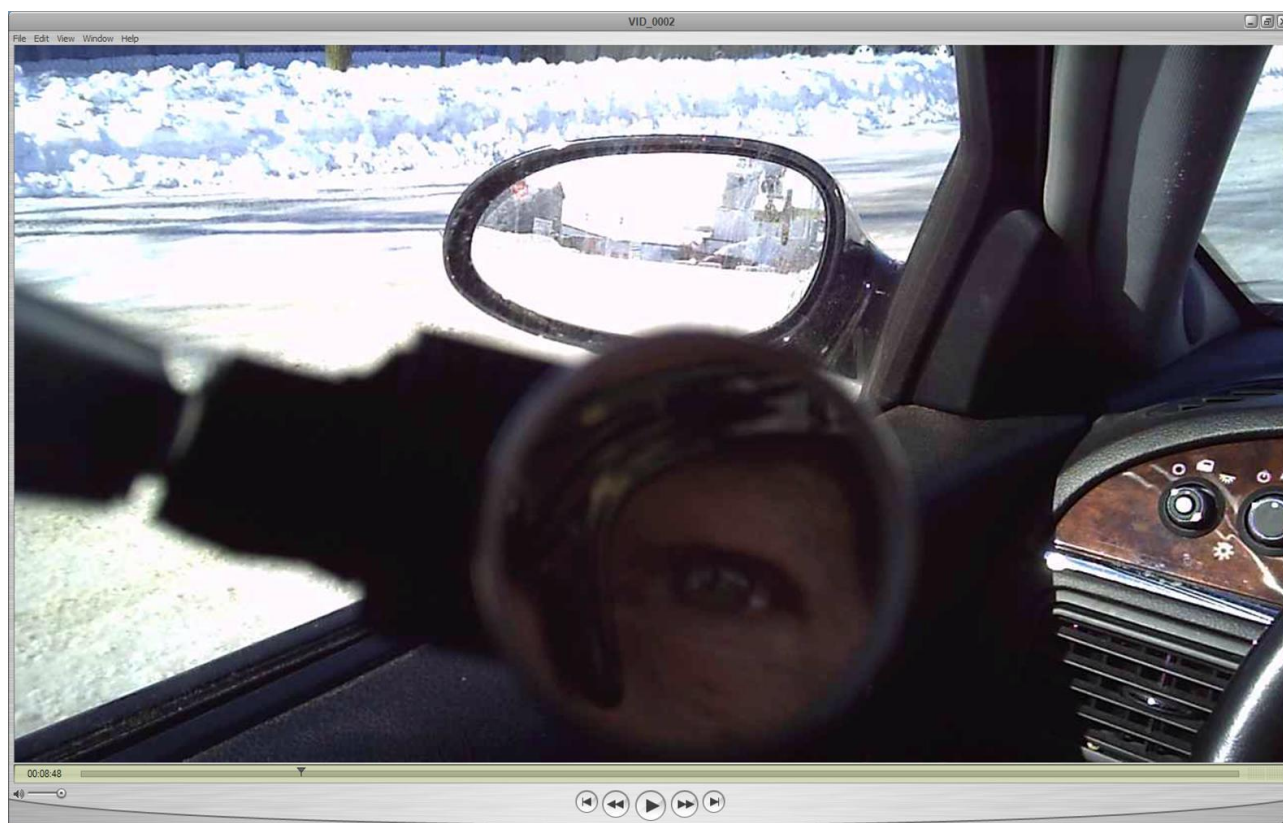
Figure 25: View from video eyeglasses when the test driver looked toward the driver's exterior mirror. The view of the pupil of the driver's right eye is visible in the small mirror in the bottom centre of this figure.

Figure 25 shows a view of what was recorded by the video eyeglasses when the driver looked to his left and into his driver's exterior mirror.

Note in the bottom of the centre of Figure 25 that the mirror that is attached to the frame of the eyeglasses has captured the position of the pupil of the driver's right eye. At this instance the pupil is located centrally within the eye.

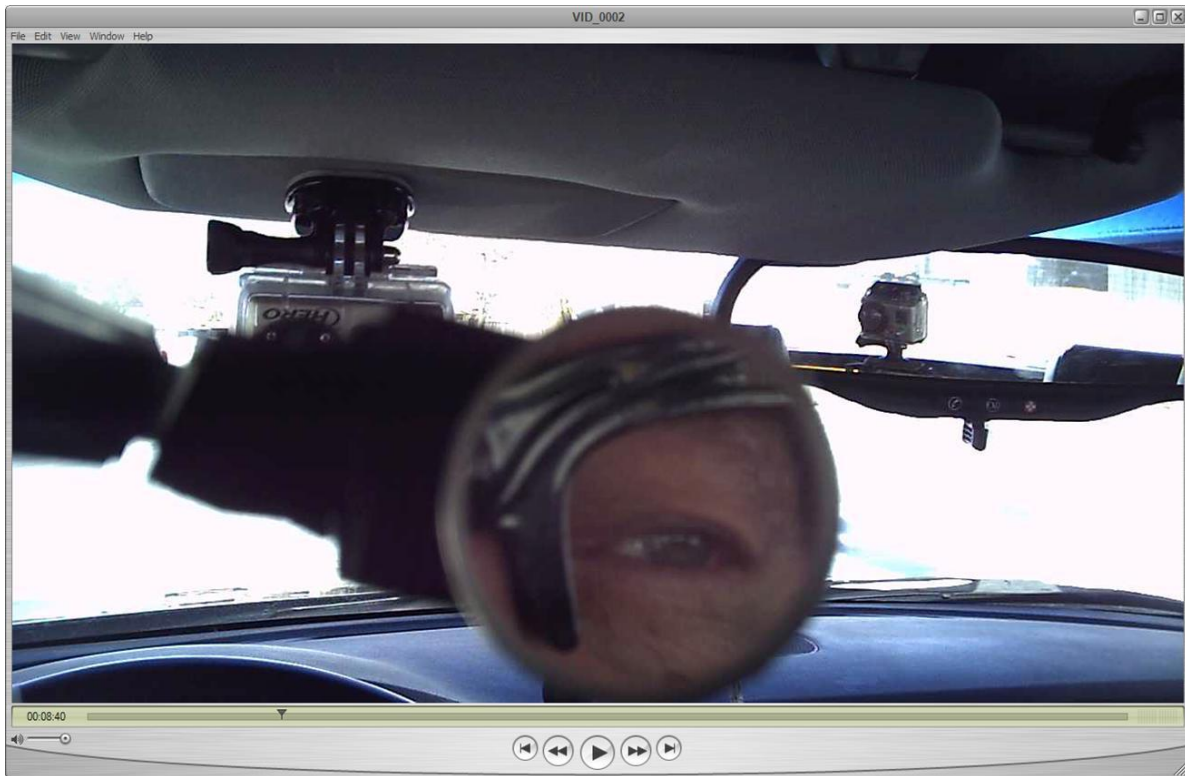
Figure 26: View from the video eyeglasses as the driver looks into the rear view mirror.

Similarly, Figure 26 shows what is was captured by the video eyeglasses when the driver looked at the rear view mirror. Here the pupil is rotated toward the right in the eye.

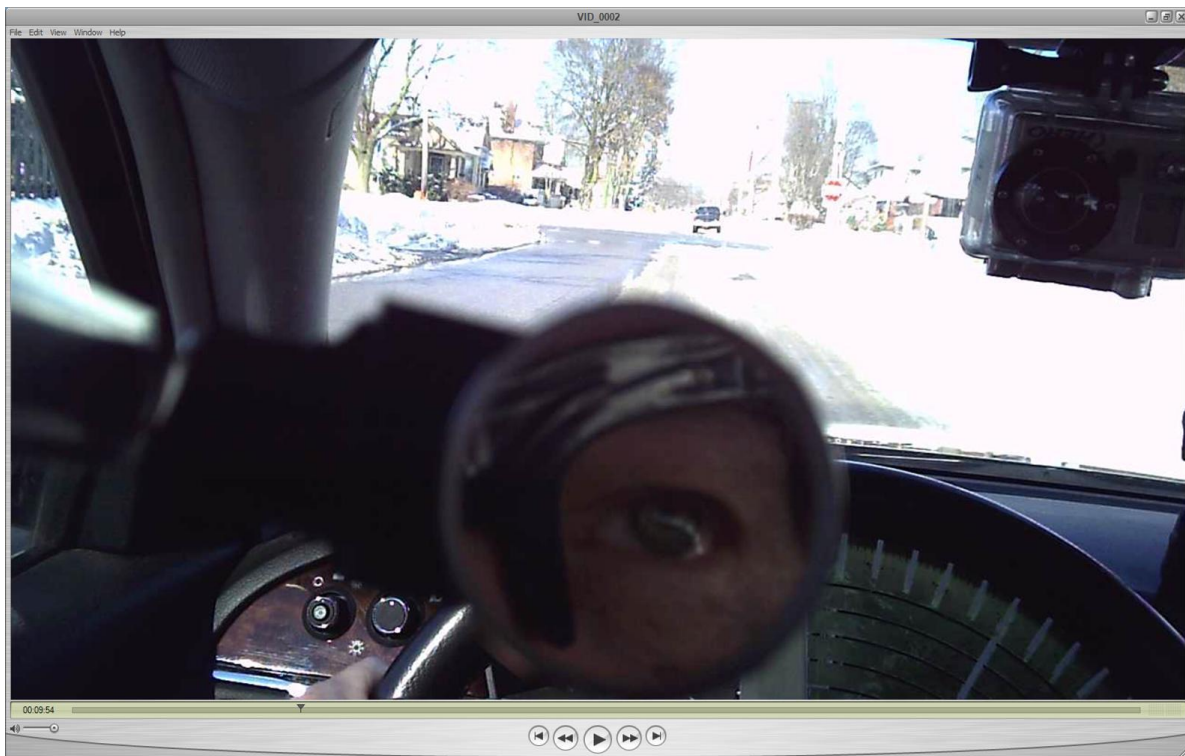
Figure 27: View from the video eyeglasses as the driver looks straight ahead while approaching the intersection with Florence Street.

Similarly, Figure 27 shows what was captured by the video eyeglasses when the driver looked straight ahead.

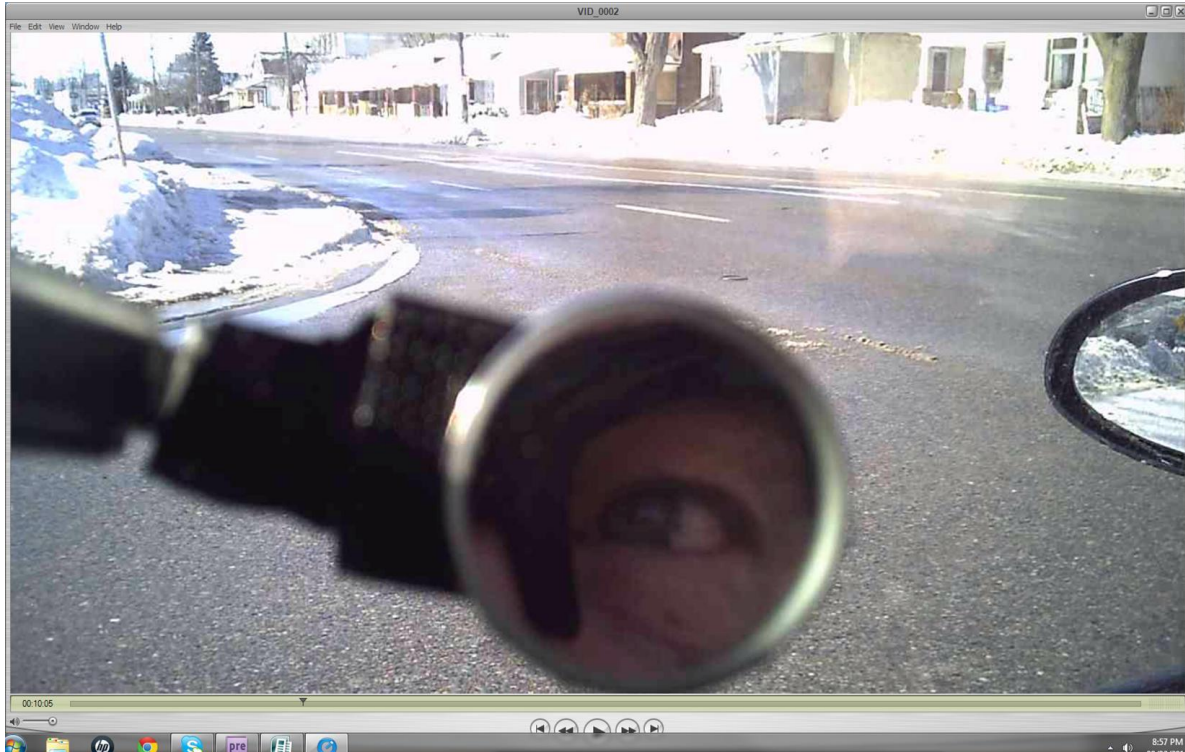
Figure 28: View from video eyeglasses as the vehicle is stopped at the intersection of Florence and the driver looks fully to the left. Here you can clearly see the driver's pupil is rotated into the far left corner of the eye.

Figure 28 shows the view from the video eyeglasses when the driver is stopped at the intersection of Florence Street and the driver looks fully to the left.

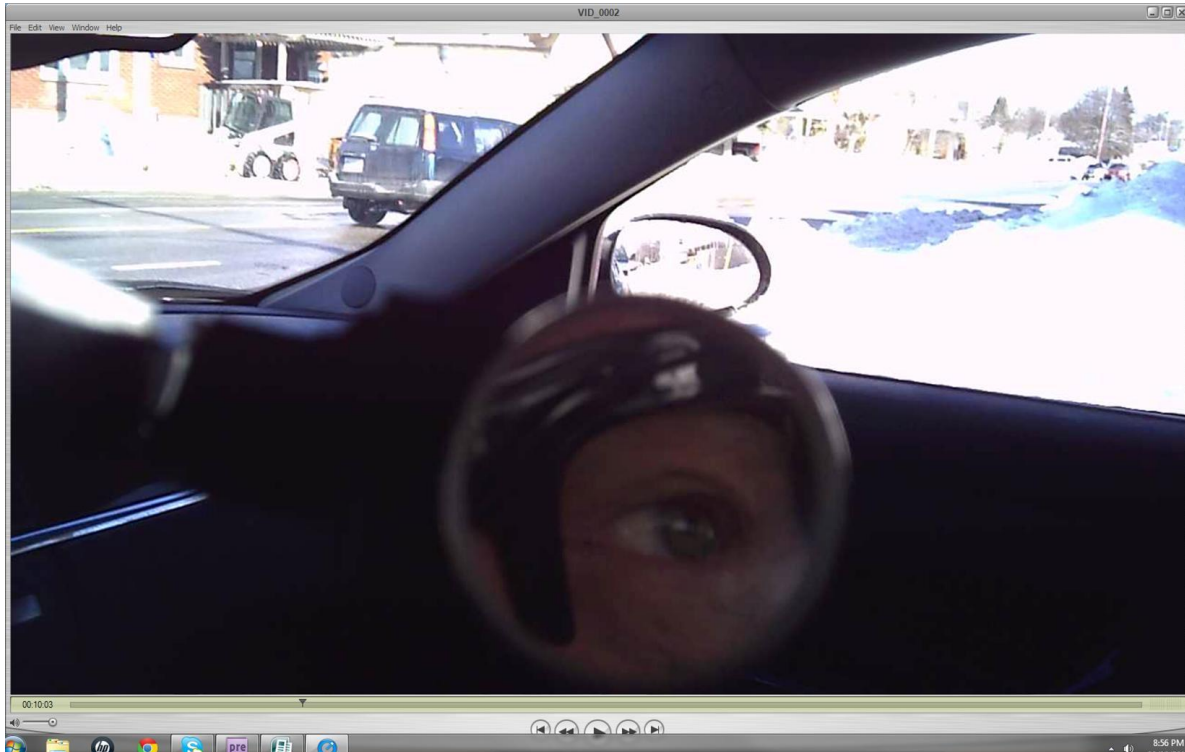
Figure 29: View from video eyeglasses as the vehicle is stopped at the intersection of Florence and the driver looks fully to the right. Note that the driver's pupil is rotated into the far right corner of the eye.

Figure 29 shows the view from the video eyeglasses when the driver is stopped at the intersection of Florence Street and the driver looks fully to the right.

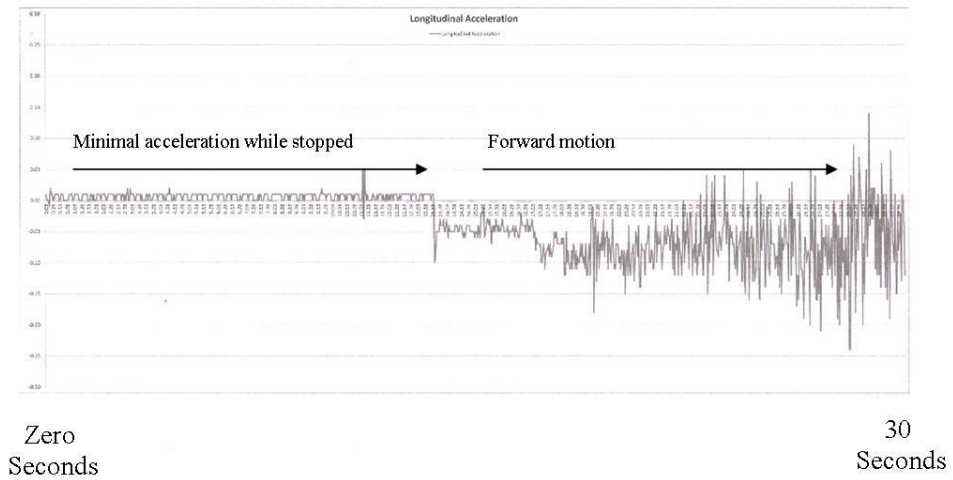
Figure 30: Chart 1 of Longitudinal Acceleration

Chart 1 shows the first 30 seconds of acceleration data. Note that in the first 13.5 seconds the test vehicle is stopped while the driver is looking into his mirrors before setting the vehicle in motion. Thus there is essentially no longitudinal acceleration displayed in the first 13.5 seconds. The vertical axis in all the charts has limits of acceleration between 0.3 and -0.3 g.

Once the vehicle begins to move forward we see the values of the longitudinal acceleration displayed as negative values. The negative values are just an artifact of the way we have anchored the iPhone. So, in the present case, negative values indicate actual positive acceleration and vice versa.

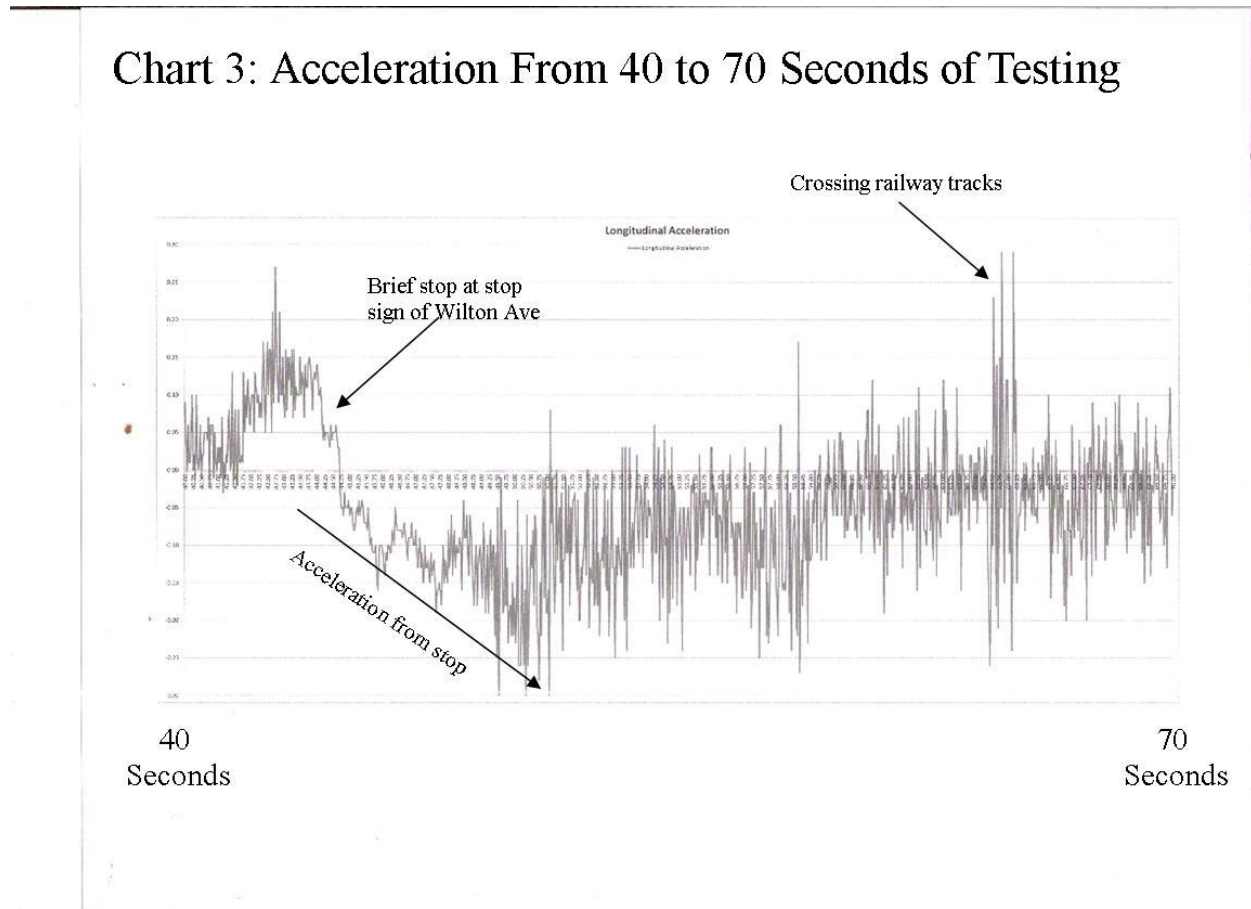
Figure 32: Chart 3 of Longitudinal Acceleration

Chart 3 contains the data from 40 to 70 seconds. As in previous charts the data is overlapped by 10 seconds. Near the beginning of the chart we see the location (about 44 seconds) where the vehicle has performed a rolling stop at Wilton Avenue and this portion of data was also displayed near the end of Chart 2. Then the vehicle commences to increase speed up to about 49.5 seconds as the longitudinal acceleration increases. Following this the longitudinal acceleration begins a gradual tendency toward negative values as the vehicle approaches the railway tracks. There is a high amplitude of positive/ negative acceleration that occurs at about 64.5 seconds as the vehicle crosses the railway tracks.
