Video Eyeglasses, iPhone and Multiple Video Cameras - An Effective Data Acquisition System For Motor Vehicle Accident Analysis and Reconstruction

Review of Instrumentation

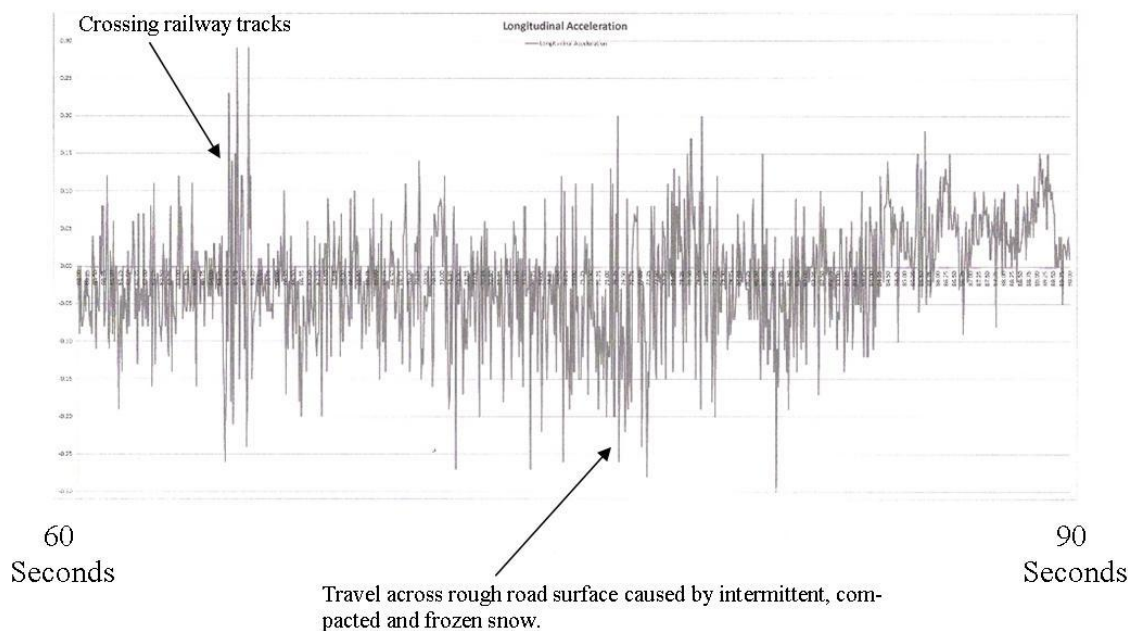
Figure 33: Chart 4 of Longitudinal Acceleration

Chart 4 contains the data from 60 to 90 seconds. Here again we see, near the beginning of the chart, the vibrations caused when crossing the railway tracks and this was seen near the end of the data in Chart 3. One can note the vibrations in the acceleration data as the vehicle travels over the road surface which is covered in compacted snow that is hardened to mimic the hardness of ice. So as there are "potholes" in the otherwise smooth layer of snow this causes the noted vibrations. Near the end of the data the acceleration tends toward negative values as the vehicle begins to slow its speed while approaching the stop sign at Florence Street.

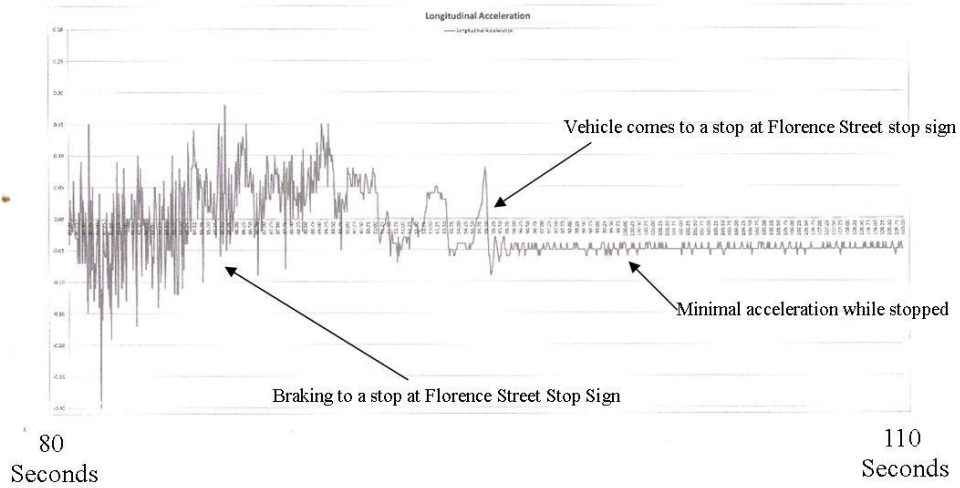
Figure 34: Chart 5 of Longitudinal Acceleration

In Chart 5 we see the data from 80 to 110 seconds. As the data is overlapped for 10 seconds we see at the beginning of the chart that the longitudinal acceleration is negative as the vehicle is slowing to come to a halt at the stop sign at Florence Street. Note that at about 95 seconds the vehicle comes to a halt as the driver is making his observations of the cross traffic on Florence Street. Thus you can see in the last half of the chart that the longitudinal acceleration is steady and minimal.

The display of a slight negative longitudinal acceleration in the last half of Chart 5 likely indicates that the vehicle has stopped at a location where there is a slight incline in the road surface. This is likely the case because, at the beginning of Chart 1 the vehicle is stopped and we see a slight positive acceleration and we know that the road at this stopped location contained a slight downgrade. So the displayed values from the iPhone make logical sense.

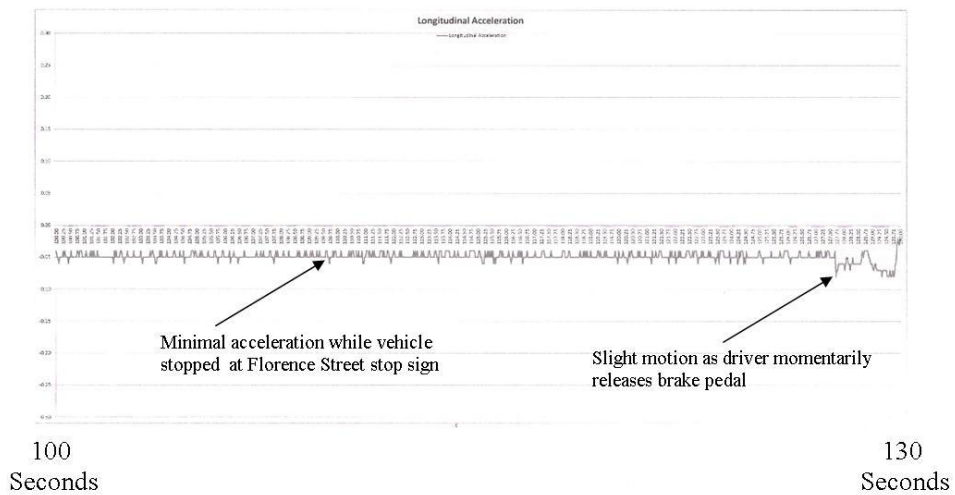
Figure 35: Chart 6 of Longitudinal Acceleration

In Chart 6 we see the data from 100 to 130 seconds. This is the time that the vehicle is stopped at the intersection with Florence street and the driver is making his observations of cross traffic. Near the end of the data at about 127.5 seconds there is a slight blimp as the driver momentarily releases his brake pedal and then reapplies it.

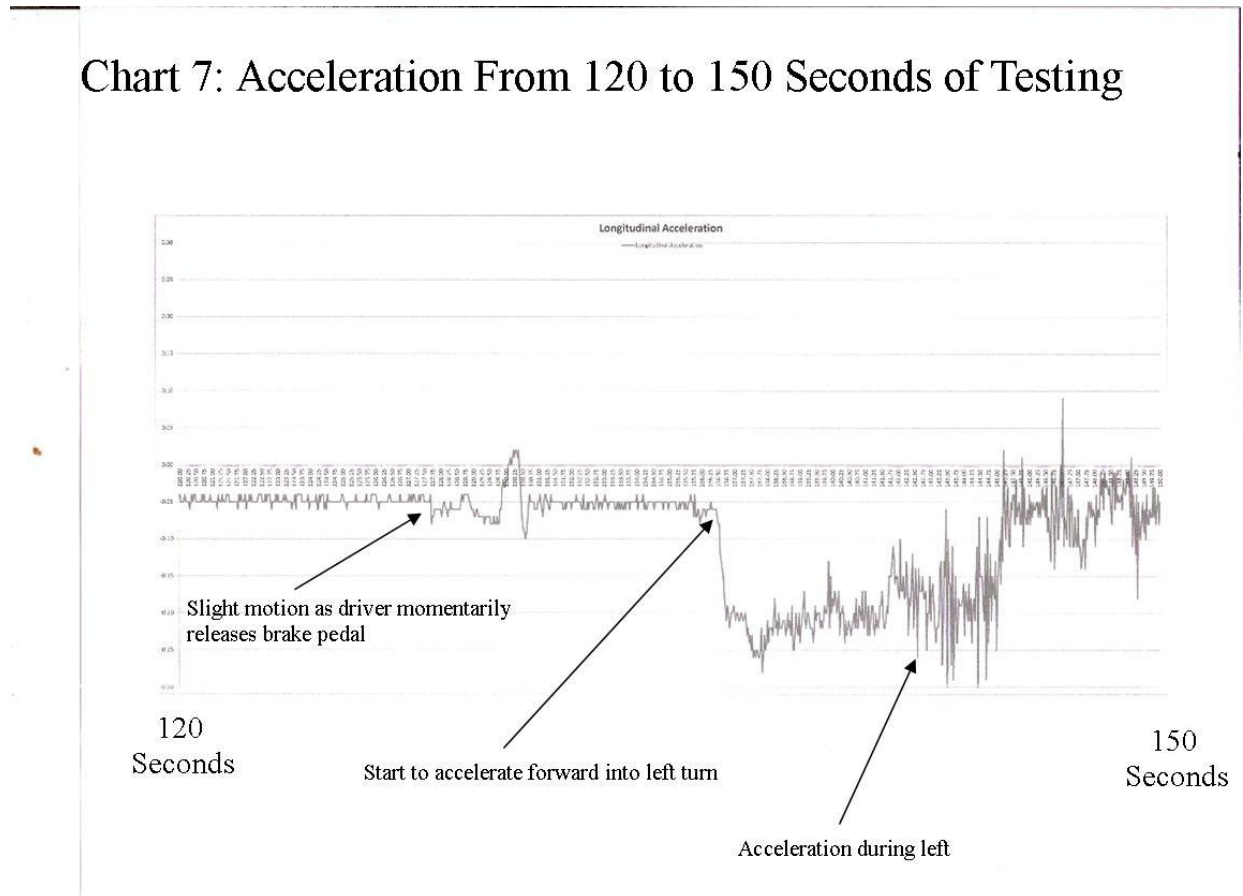
Figure 36: Chart 7 of Longitudinal Acceleration

Chart 7 is the final one showing the data from 120 to 150 seconds. Here we can see the slight blimp in the data once more that was visible at the end of Chart 6. Then we see some more indication that the vehicle is stopped from about 130 to about 136 seconds. Then the vehicle accelerations forward rapidly as it begins its left turn.

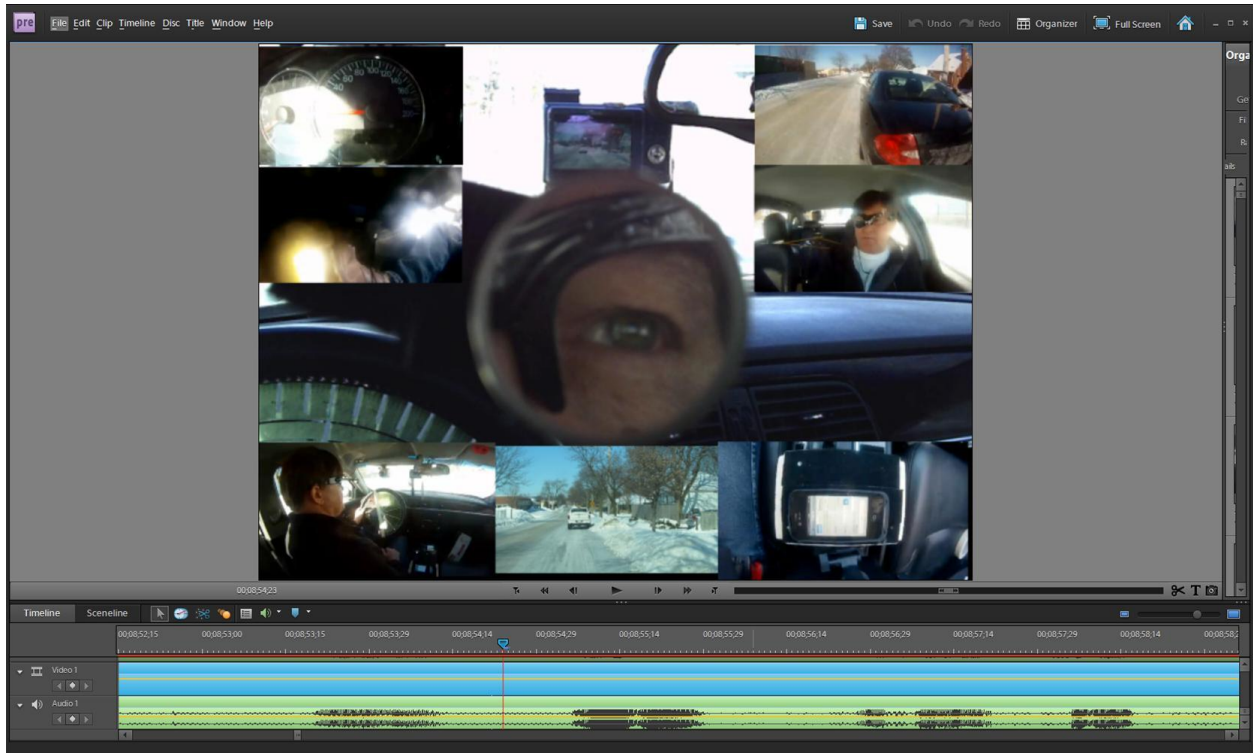
Figure 37: Example taken from the Adobe Premiere project created by inserting all the views from the 8 video cameras in a synchronized order.

The testing was also studied by combining all the video camera views in a video editing program (Adobe Premiere) as shown in Figure 37. The video from all eight cameras was synchronized so that we could see what was taking place at the same time from any of the cameras.

For example, the scene shown in Figure 37 was taken from the project at time-code "00;08;54;23". Since the first camera started recording at time-code "00;00;00;00", the present scene exists at 8 minutes, 54 seconds and 23 frames since the beginning of the recording. This was the time when our test vehicle was parked at the south end of the test site and final preparations were being made for the testing.

One can see in Figure 37 that the content of the videos can be arranged in whatever fashion one desires. Also, certain views can be enlarged. So one can see in Figure 37 that we magnified the video from the eyeglasses so the eye of the test driver was much larger because the motion of the driver's eye was important to us.

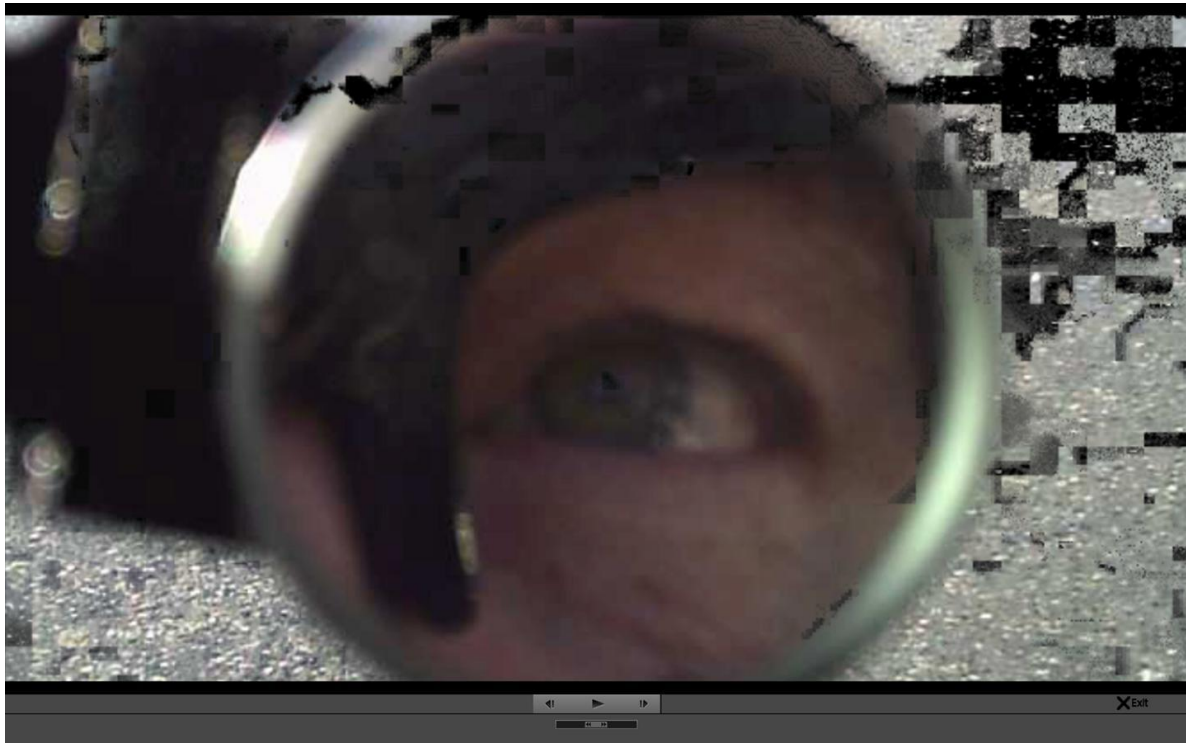
Figure 39: Example of using just the single video from the eyeglasses and magnifying it to enlarge the driver's eye.
