Gorski Consulting Website

Archived News - 2014 - January

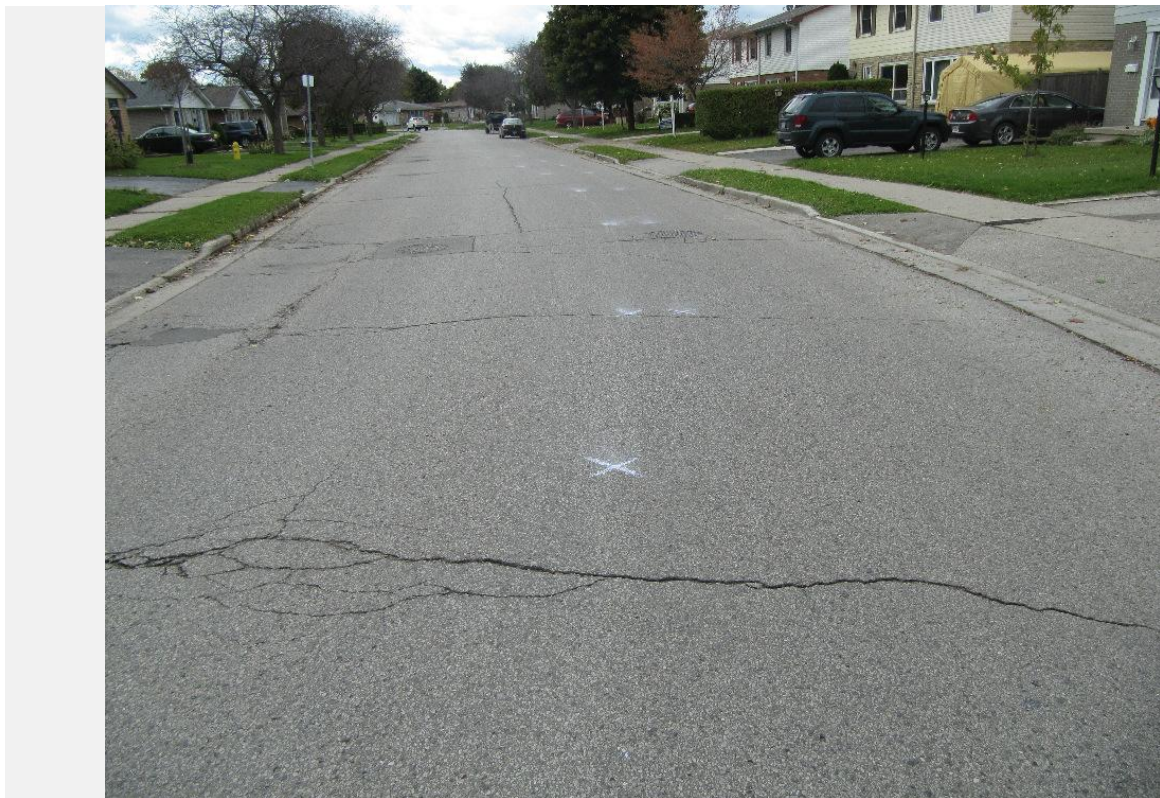
Southerly view of white "X" chalk marks identifying the pre-crash yaw marks caused by the "Chrysler" as it travelled around a curve shortly before it travelled off the east (left) roadside and struck the Tyler Brooks.

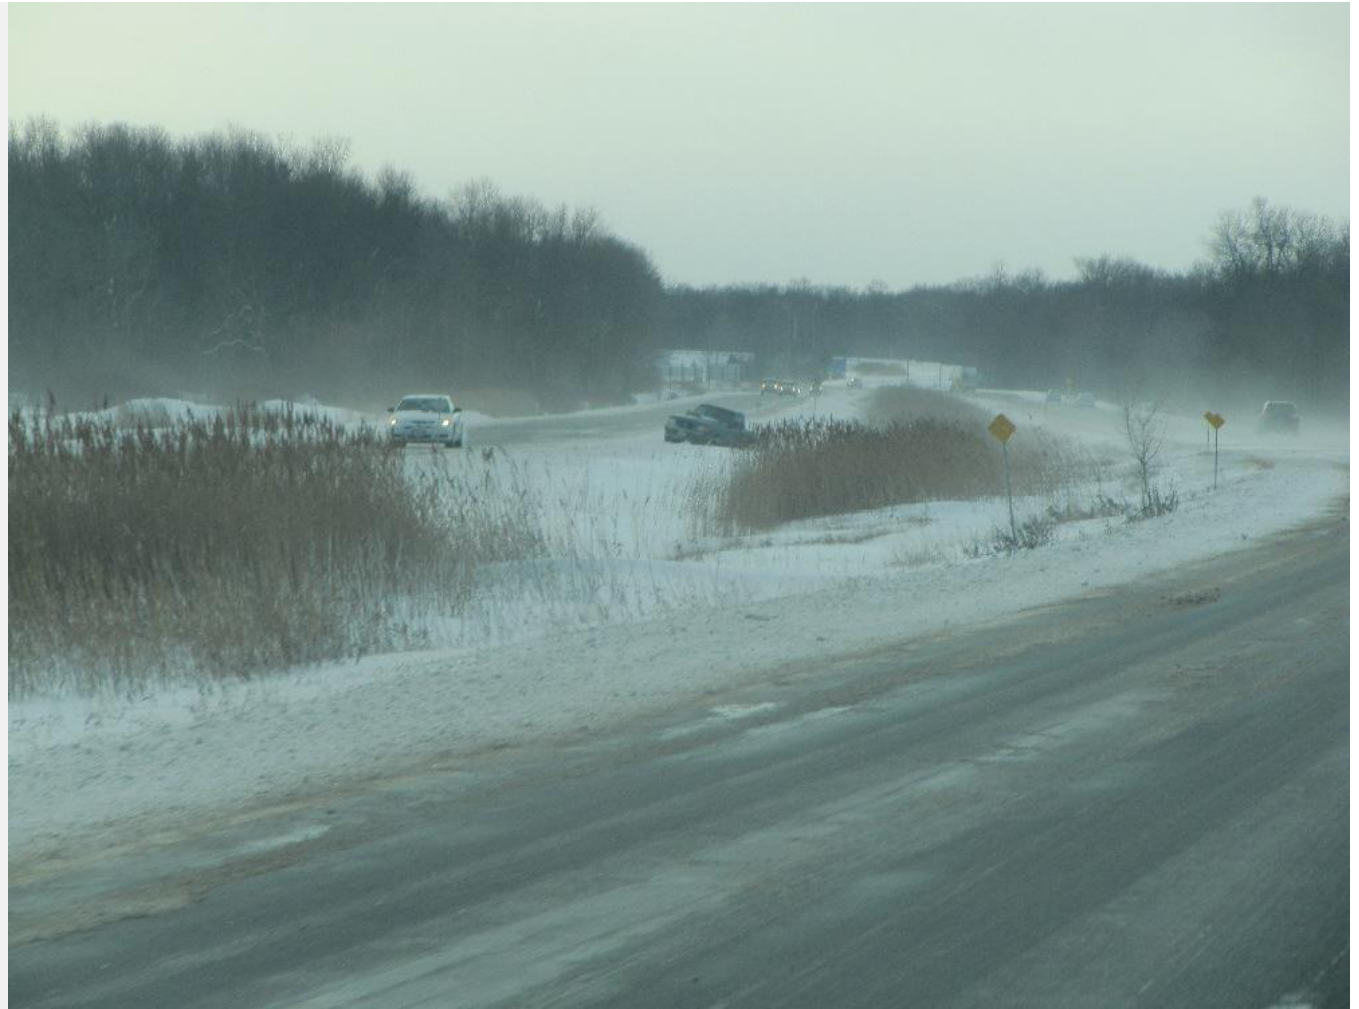
A typical example, westbound on Highway 402, east of Colonel Talbot Road, where an eastbound vehicle was unable to negotiate the curve of the highway and ended up in the median.

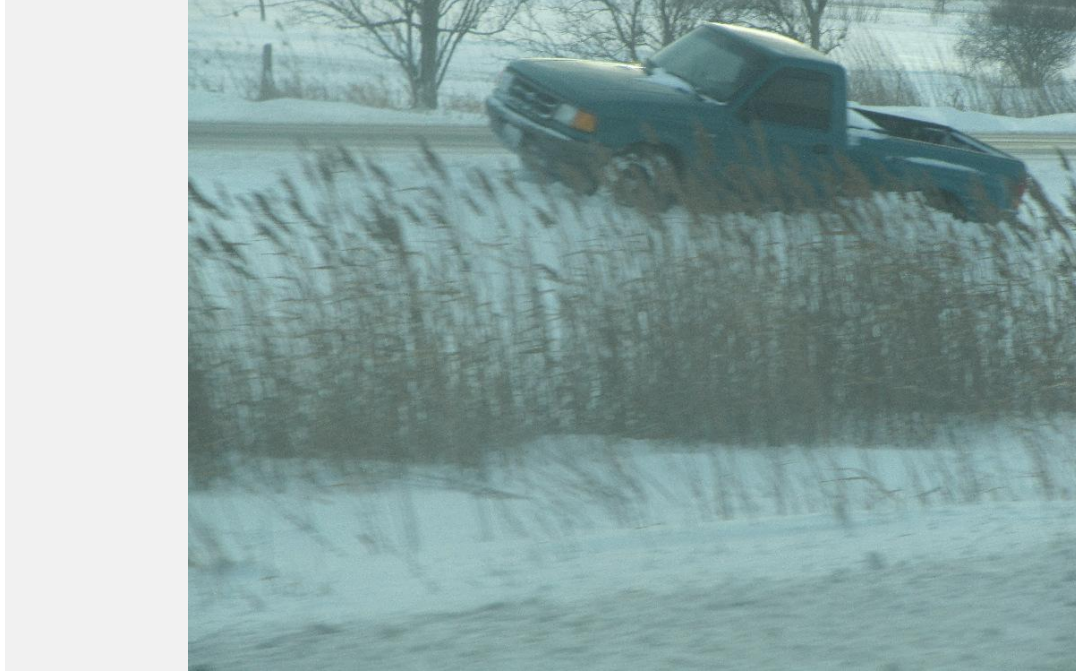
Closer view of Pick-up truck stuck in the median of Highway 402 east of Colonel Talbot Road. An unloaded pick-up truck like this has greater difficulty maintaining stability in these wind-swept conditions.

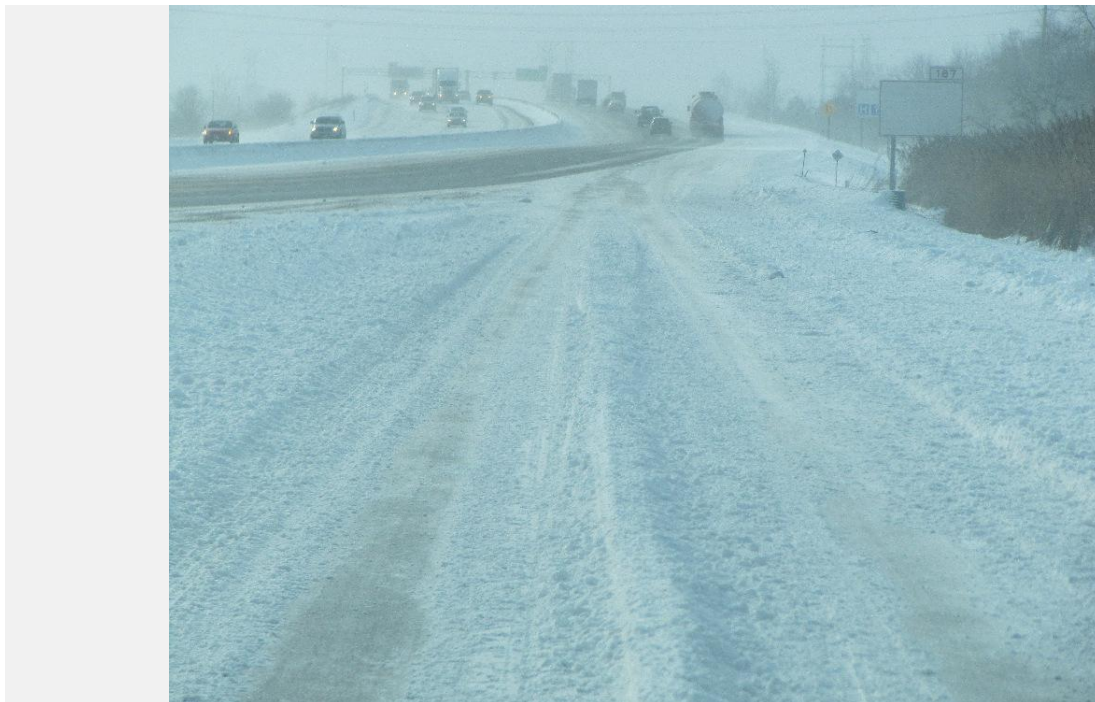
Example of the Highway 401 entrance ramp from Highbury Avenue to westbound Highway 401, showing the snow that has drifted into the ramp lane making it difficult for vehicles to accelerate into the flow of traffic.

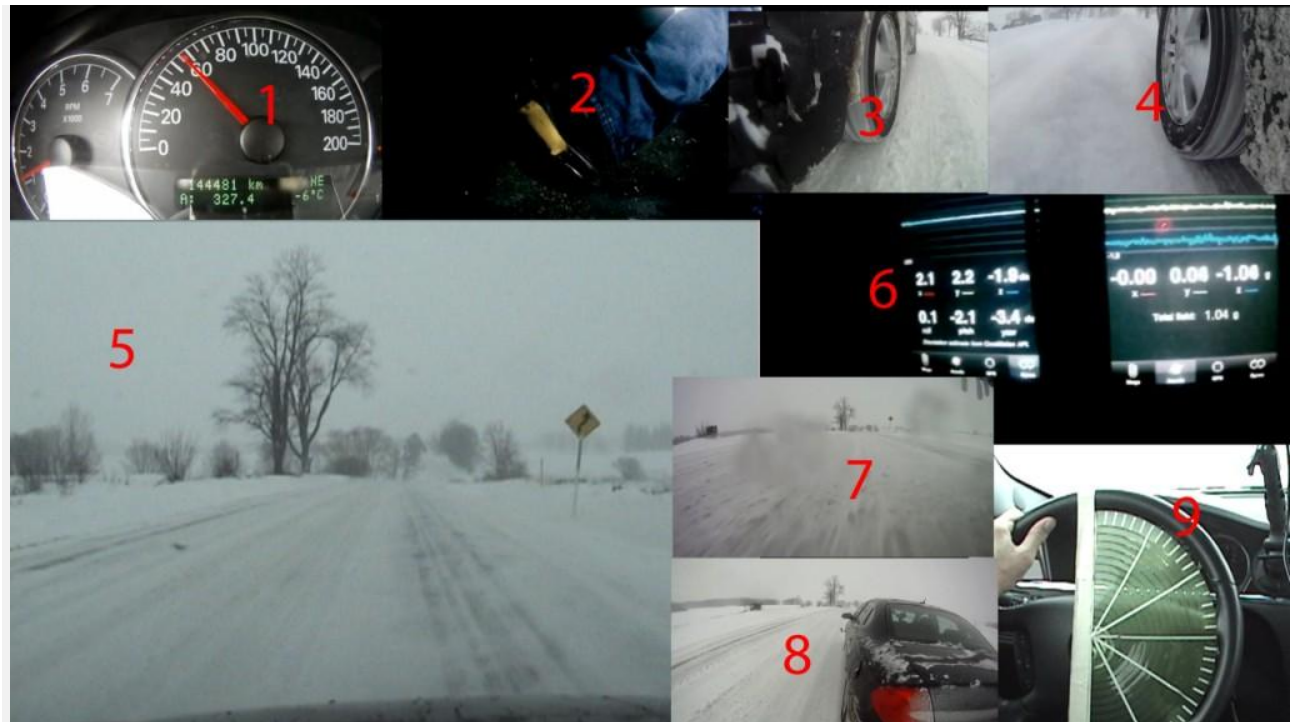
The views from nine video cameras are combined here under a video editing project wherein we can study the motions of the vehicle and the actions of the driver as they travel through a complicated, snow-covered, S-curve on a rural highway.

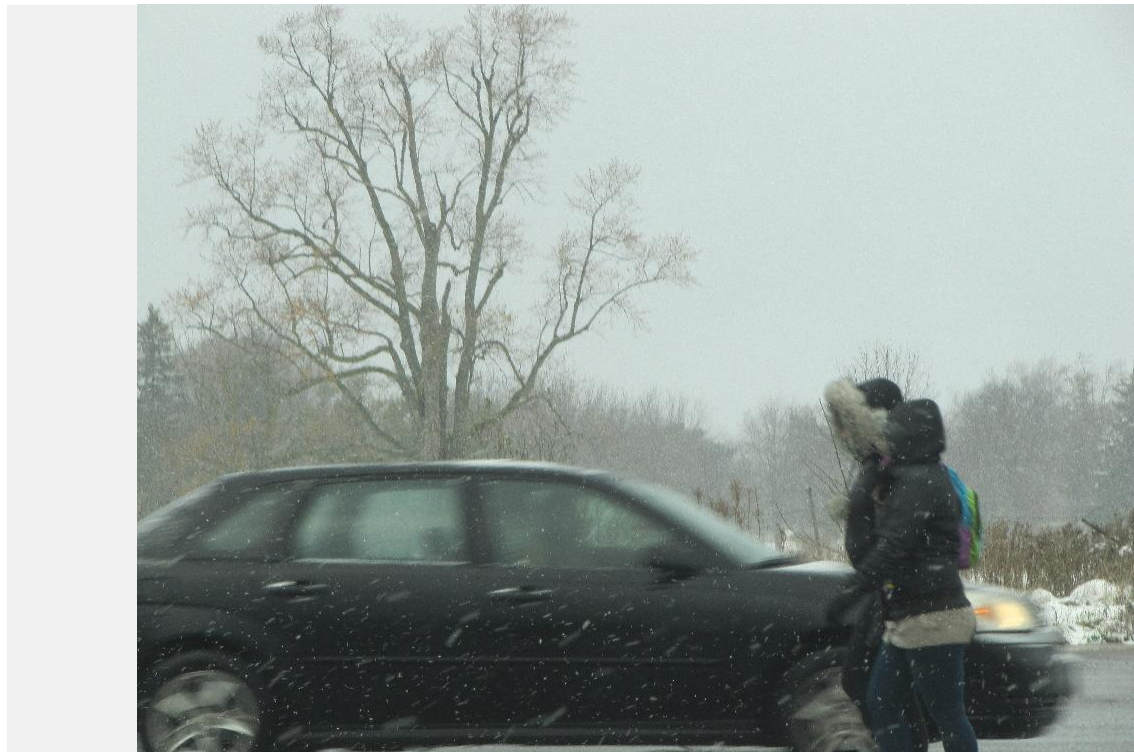
Height of pedestrians versus height of the front end of a passenger car. A pick-up truck front end would be substantially higher.

Consider that an average male with normal shoes would have a centre-of-gravity just over 1 metre and, adding a skateboard height might increase that centre-of-gravity to about 1.1 metres. While higher speed impacts of pedestrians by passenger cars can cause the pedestrian's body to slide up the hood with resultant head contact in the windshield, it is rare that the full body is able to slide so far that we see an actual body impact into the windshield. The situation with a pick-up truck is even more revealing.

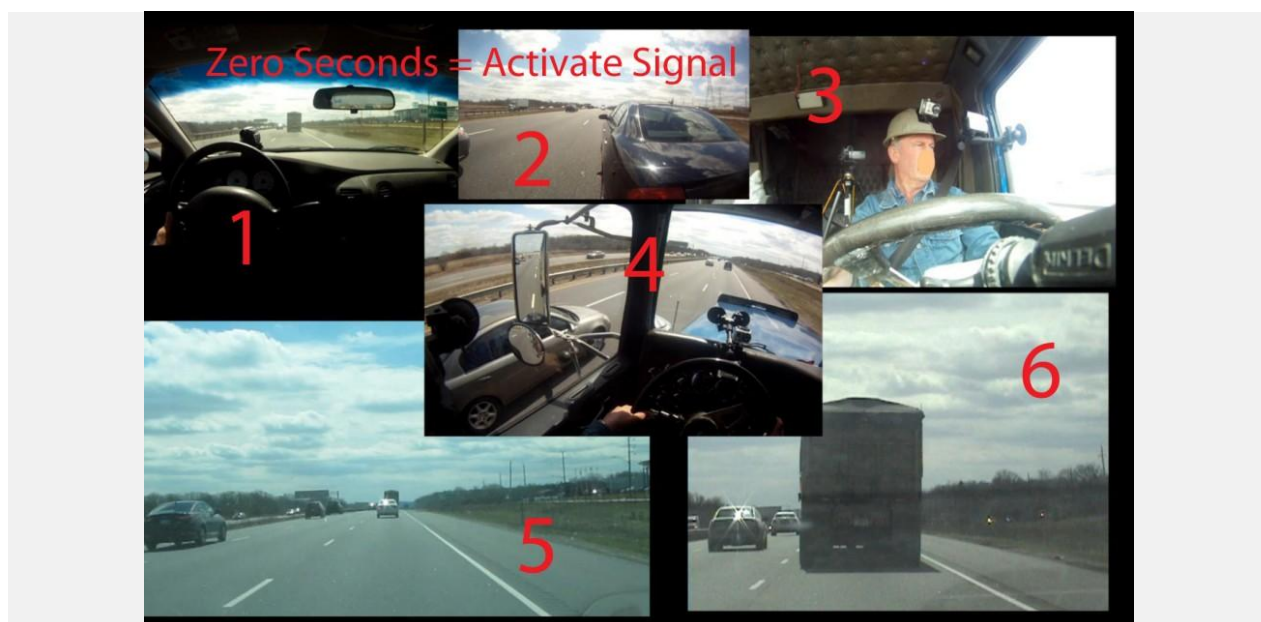
A screenshot from a video project showing the views from six video cameras that were mounted to three test vehicles, including a tractor-trailer, that were used by Gorski Consulting to study the motions of the tractor-trailer on a multi-lane highway.

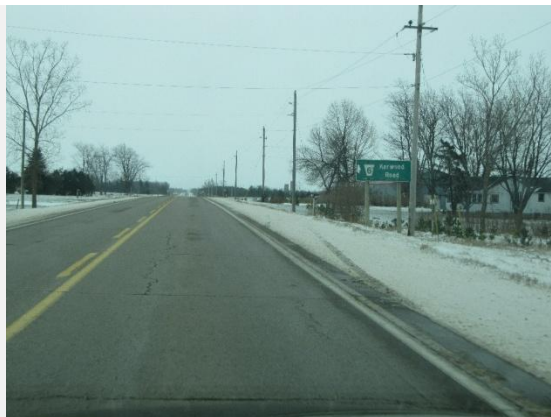
View, looking eastbound, while travelling east on Egremont Drive and approaching the intersection of Kerwood Road. Note that there is a slight viewing obstruction due to a small hillcrest before reaching the Kerwood Road intersection. This photo was taken on November 28, 2013.

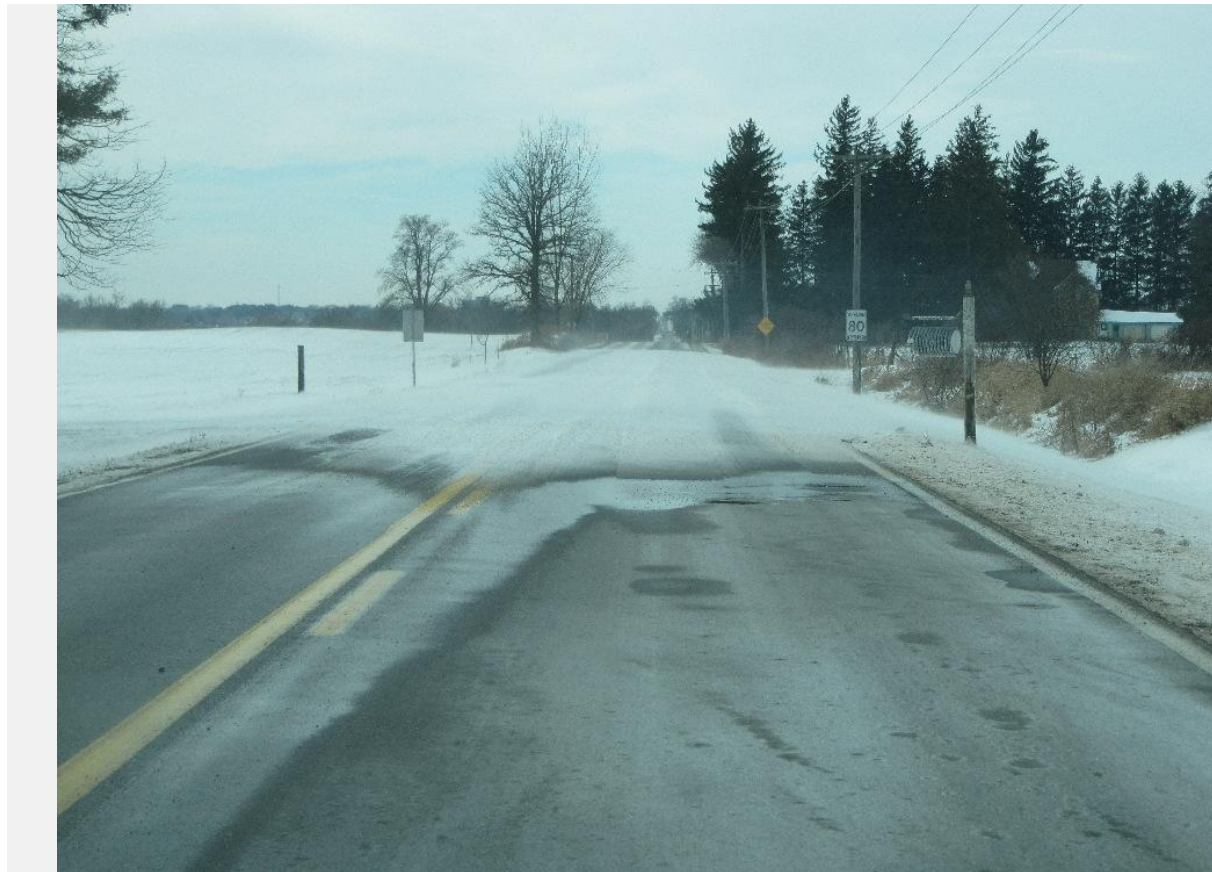
Can a driver reasonably detect an isolated snow drift in time to prevent it from affecting the stability of the vehicle?

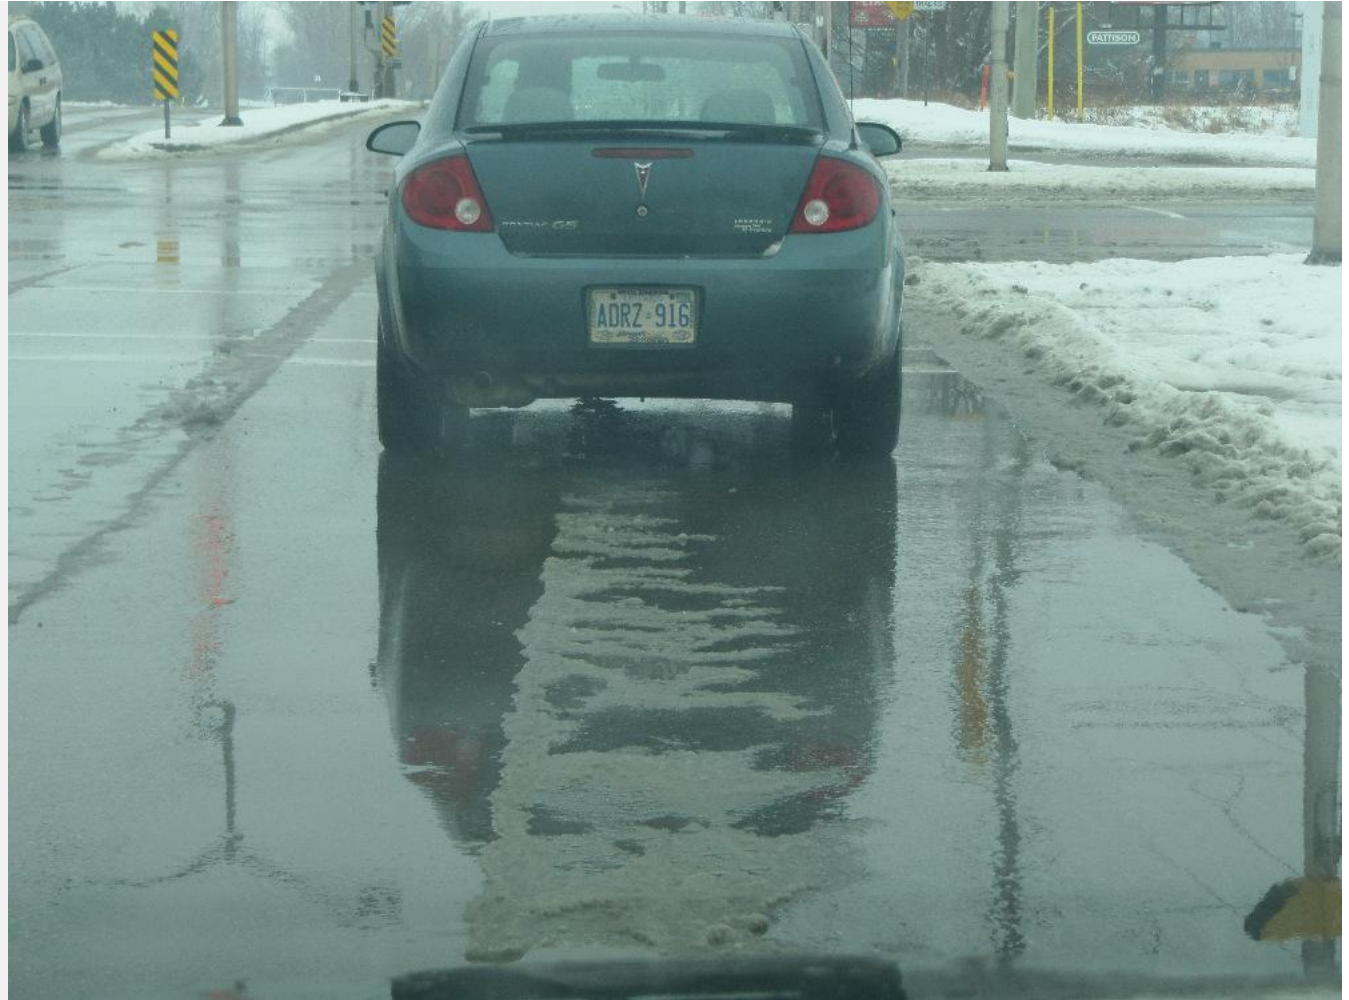
Road conditions in the late morning of January 5th, 2014 we still reasonable in London as shown in this photo looking north along the northbound curb lane of Clarke Road in east London.

While the forecast snow storm and tremendous drop in temperatures are sure to come, as of the late morning of Sunday, January 5th, the roads were generally wet with some slushy sections. The actual heavier snowfall did not start in London until just before 1700 hours.

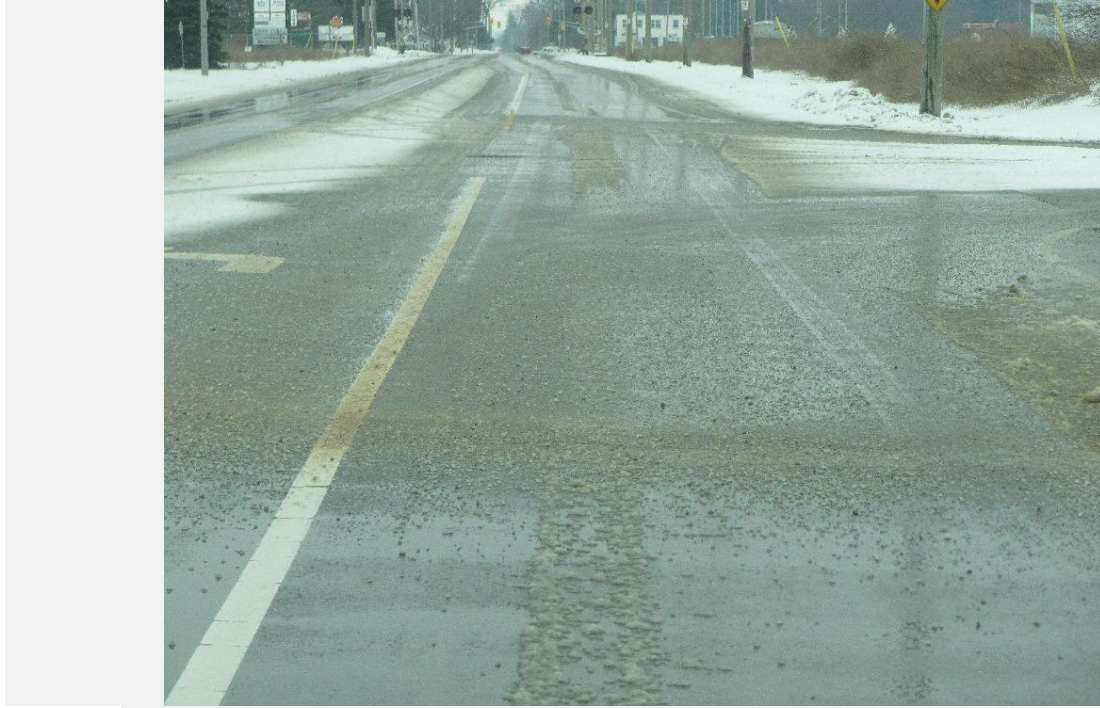
Salt pellets were thrown down on a number of roads on the morning of January 5th, such as noted in this photo at the intersection of Crumlin Side Road and Page Street in east London.

Salt, when freshly laid, can be seen as a concentrated grouping of crystals, particularly in intersections where more salt is generally laid than in other areas.

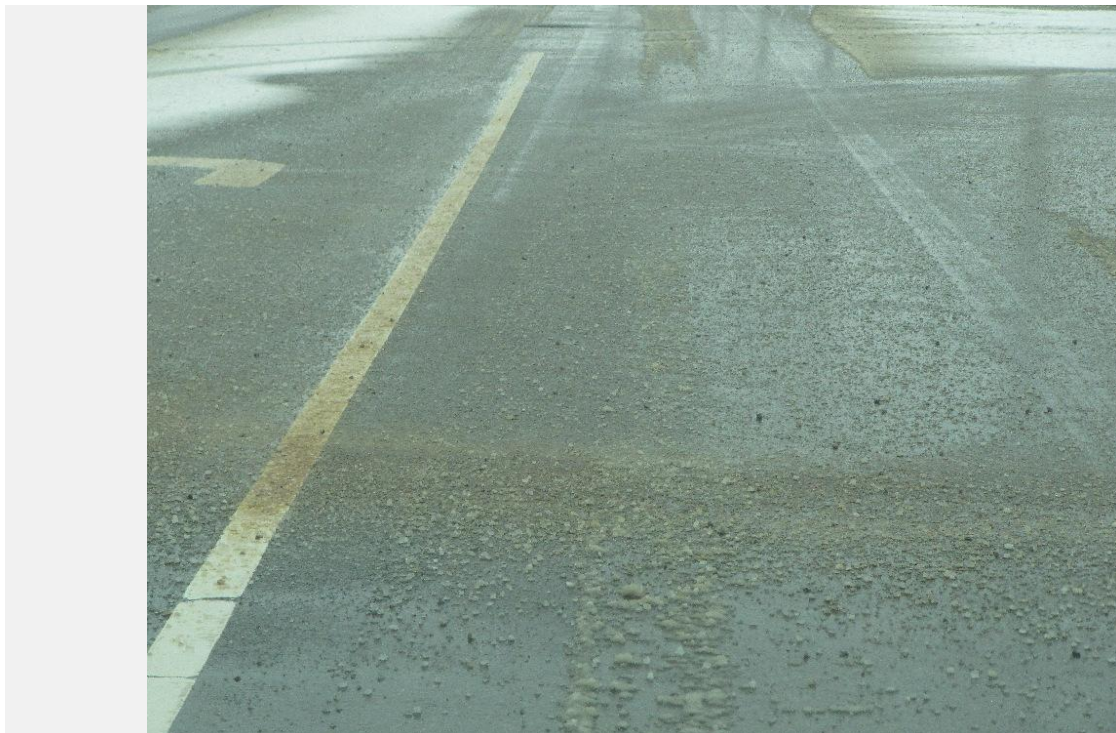
View of concentrated area of salt pellets that has just been freshly laid down by a passing snow plow.

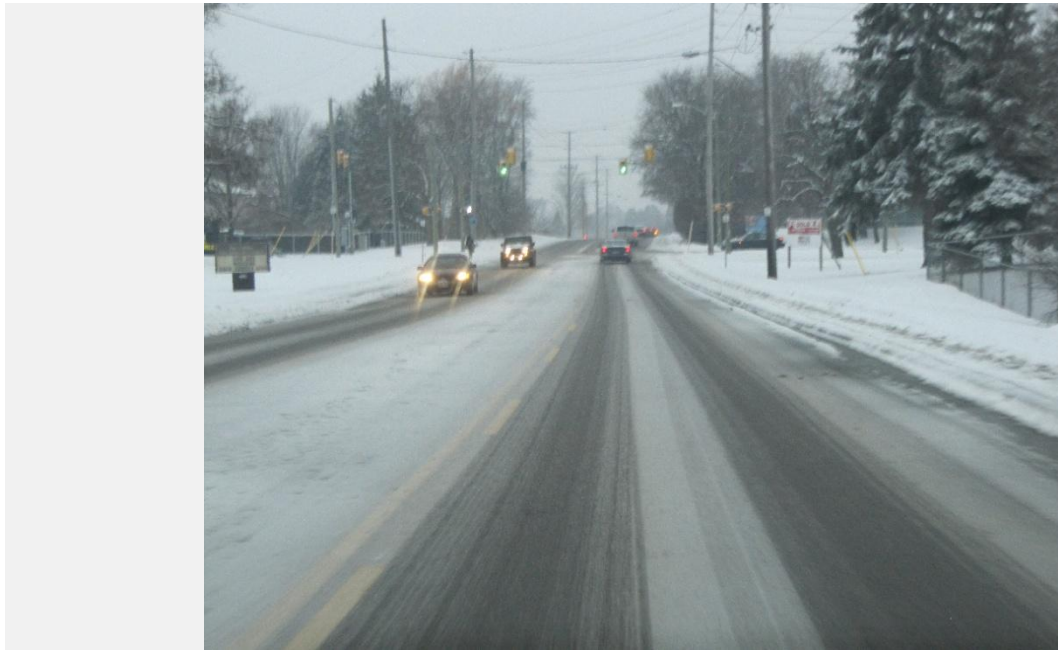
View, looking west, along Commissioners Road, west of Wharncliffe Road, at approximately 1630 hours, showing how the falling snow was starting to accumulate on the surface.

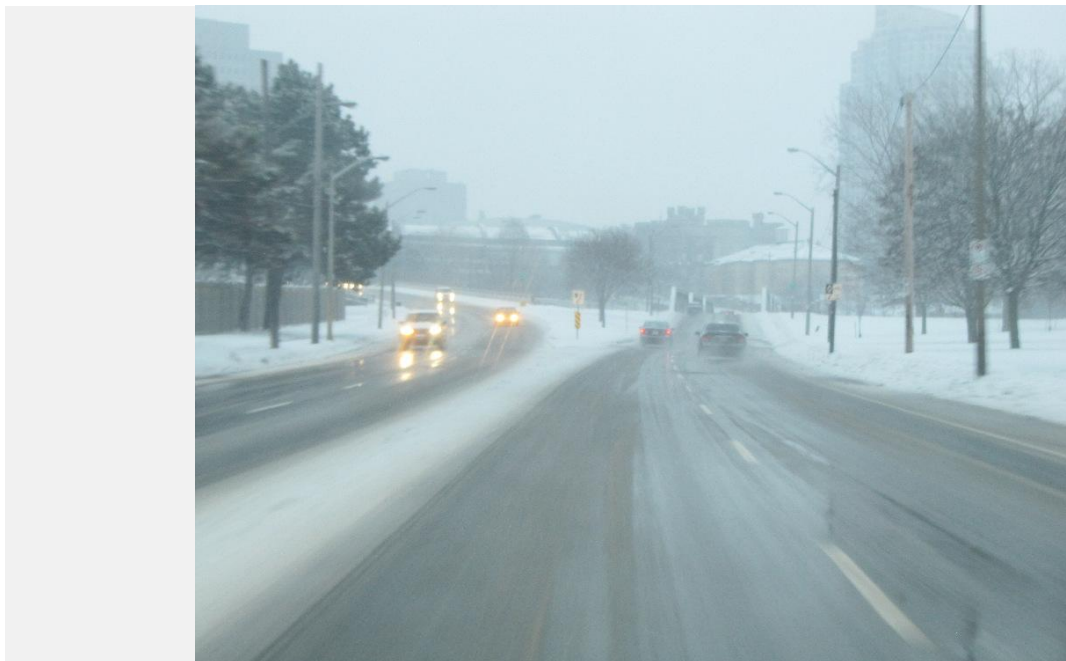
View, looking east along Riverside Drive just east of Wharncliffe Road, just before a heavier band of snowfall began to fall over central London.

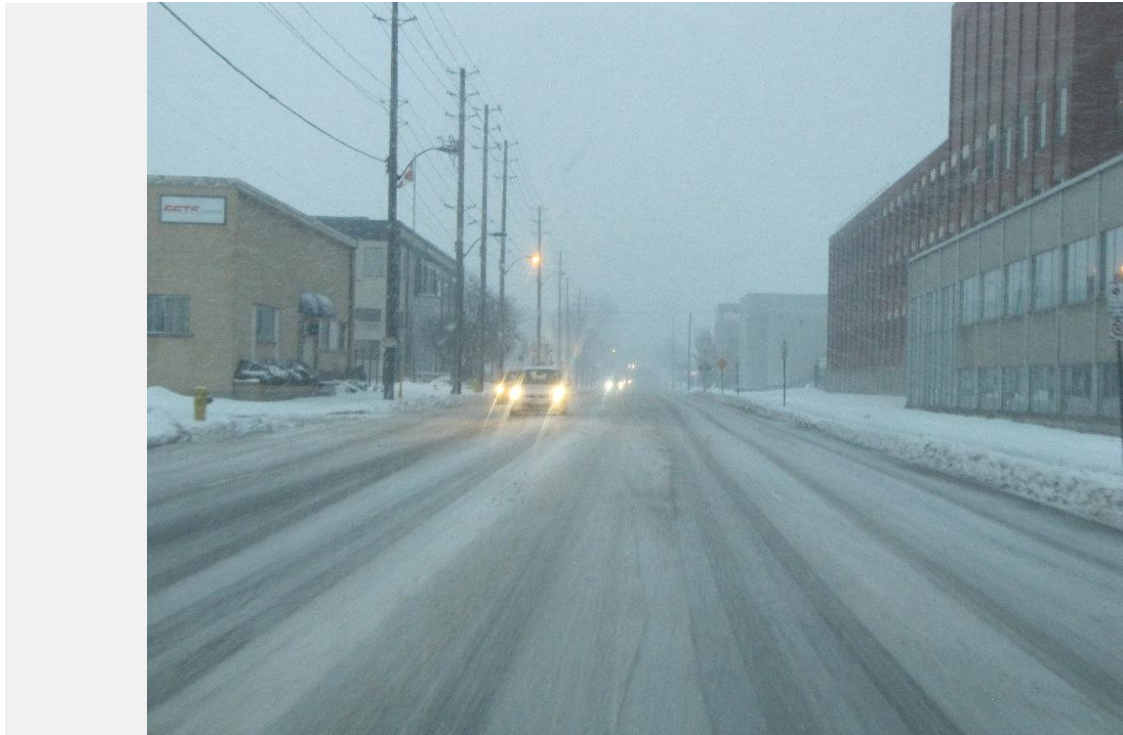
View, looking east along Dundas Street near the Kellogg's cereal plant, just before 1700 hours as the heavier bands of snow just started falling.

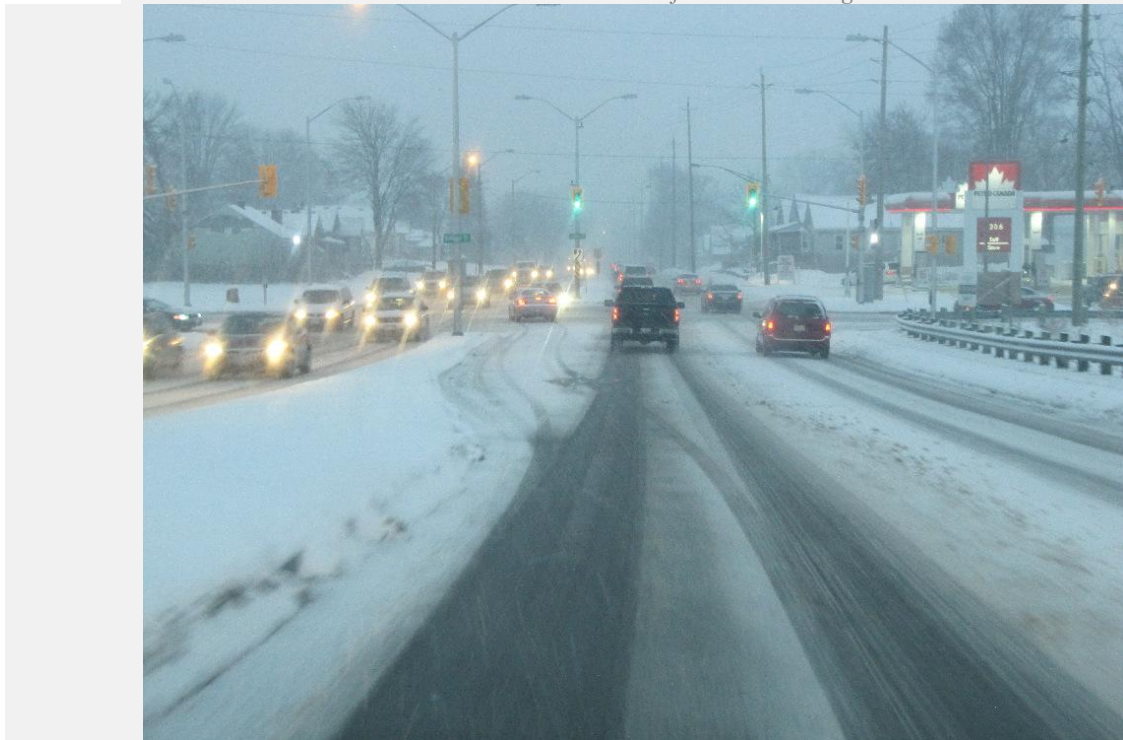
View, looking south on Highbury Avenue just north of Trafalgar Road, just before 1700 hours as the heavier band of snow began to fall in east London.

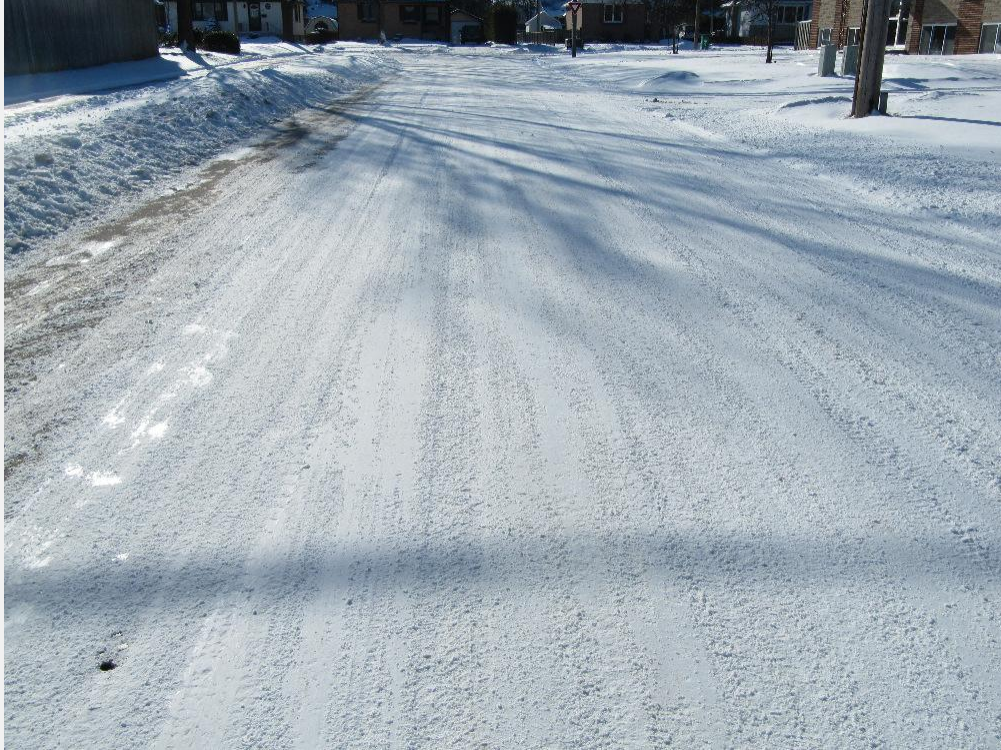
Cold temperatures and a lack of melting caused many local roads in London to take on a compacted layer of snow that provided a consistent and predictable level of deceleration.

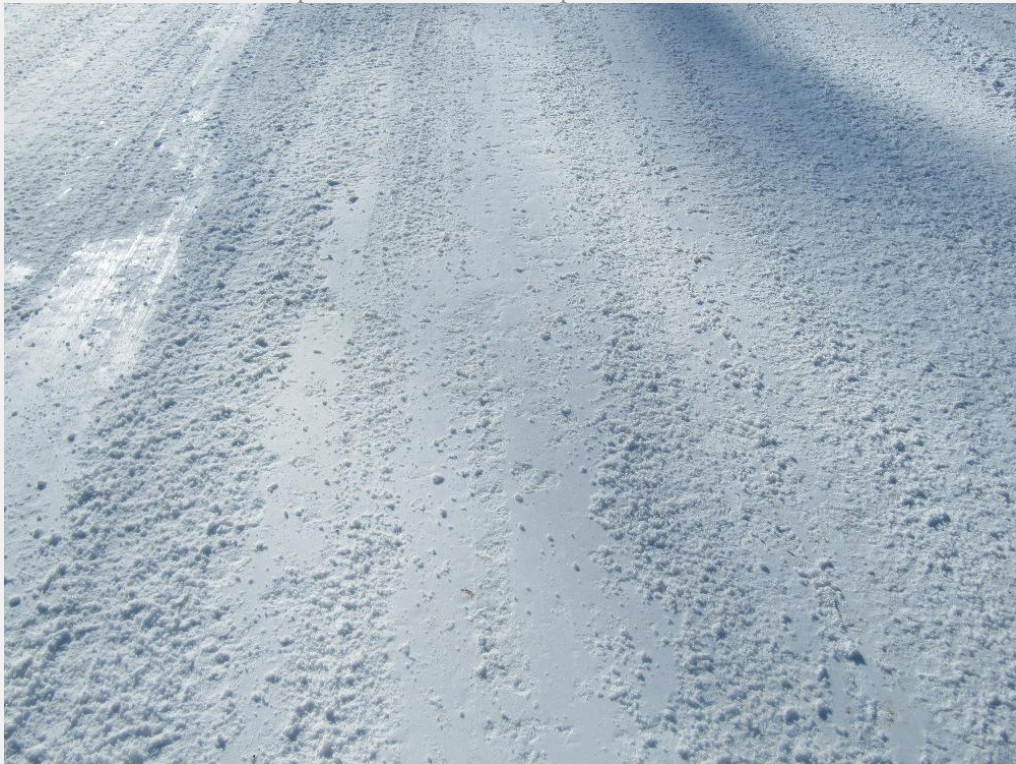
Although this packed layer of snow provides an overall lower co-efficient of friction (i.e. the surface is more slippery) than a bare surface, it is a continuous sheet of surface that is consistent thus drivers can adjust their speed to those conditions and their expectations are not violated.

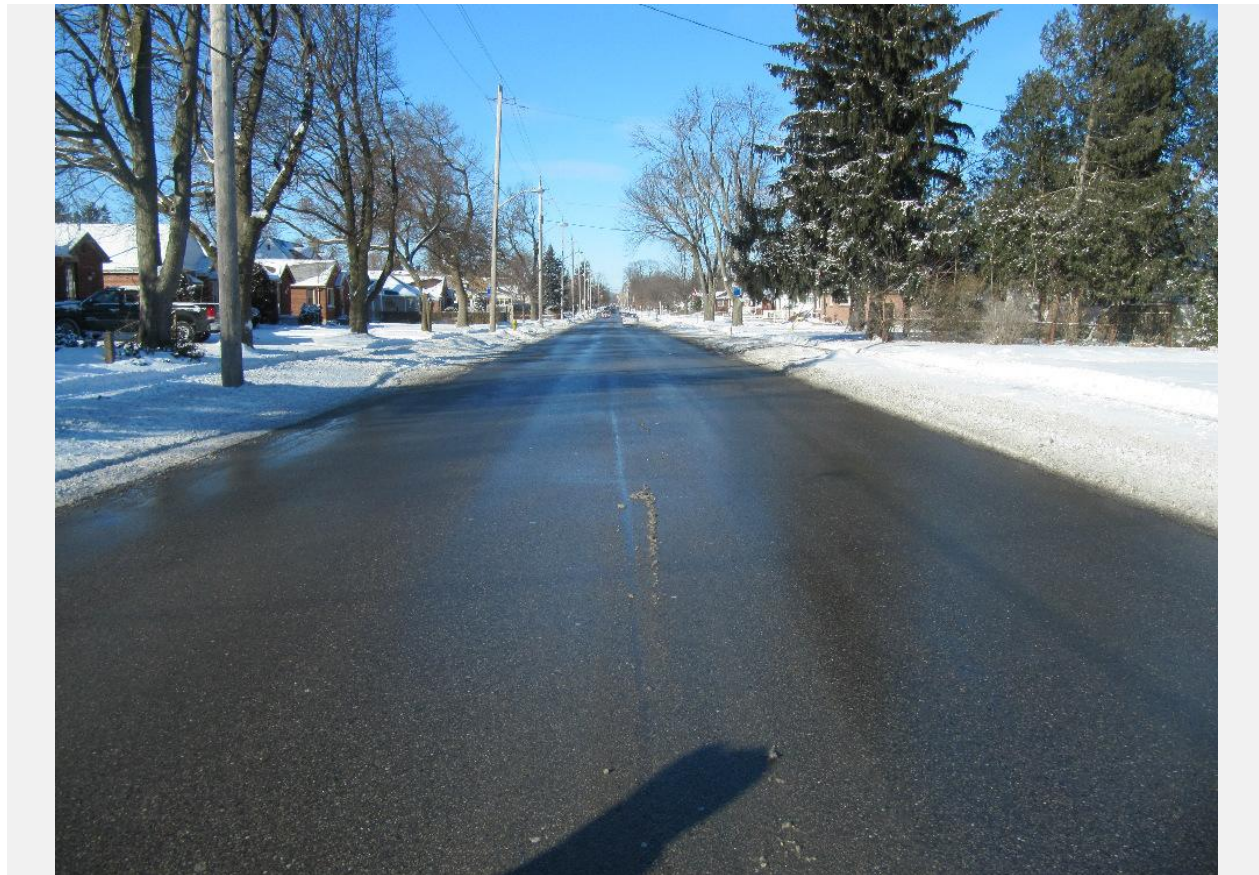
This photo demonstrates how plowing, sanding and salting can make a great difference in road conditions even in the unusually cold conditions of January 3rd, 2014. This photo was taken on the same day as the other photos above and shows that, when the resources are available, road conditions can become excellent.

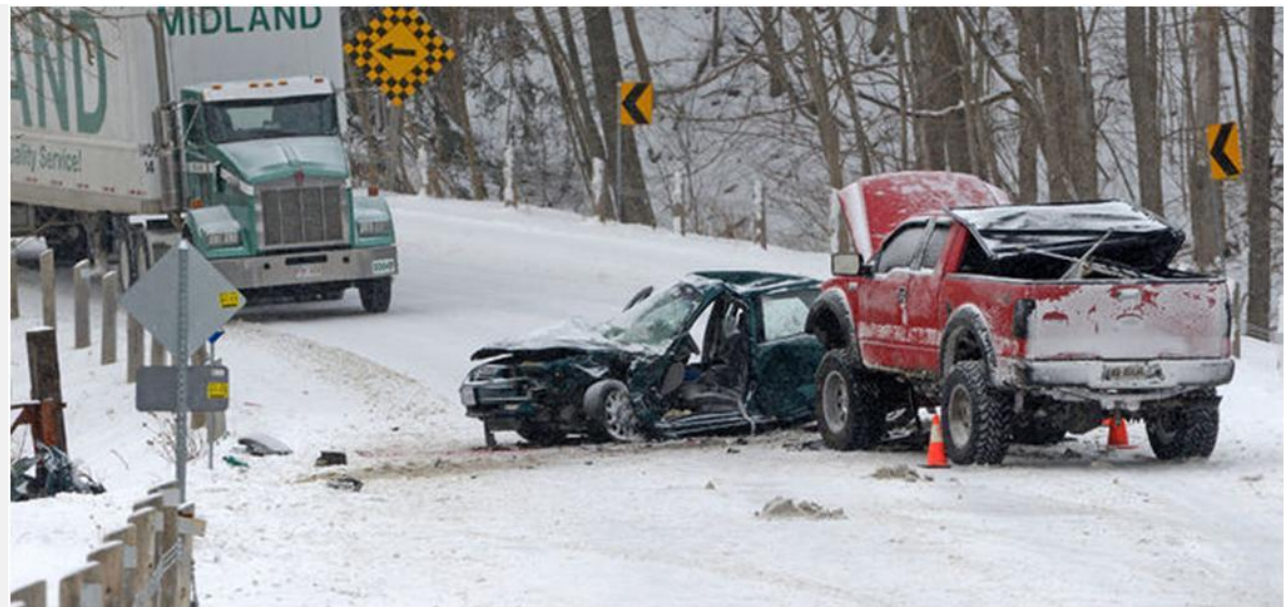
On-site photo taken by Chris Abbott of Tillsonburg News showing the involved vehicles at their final rest positions.

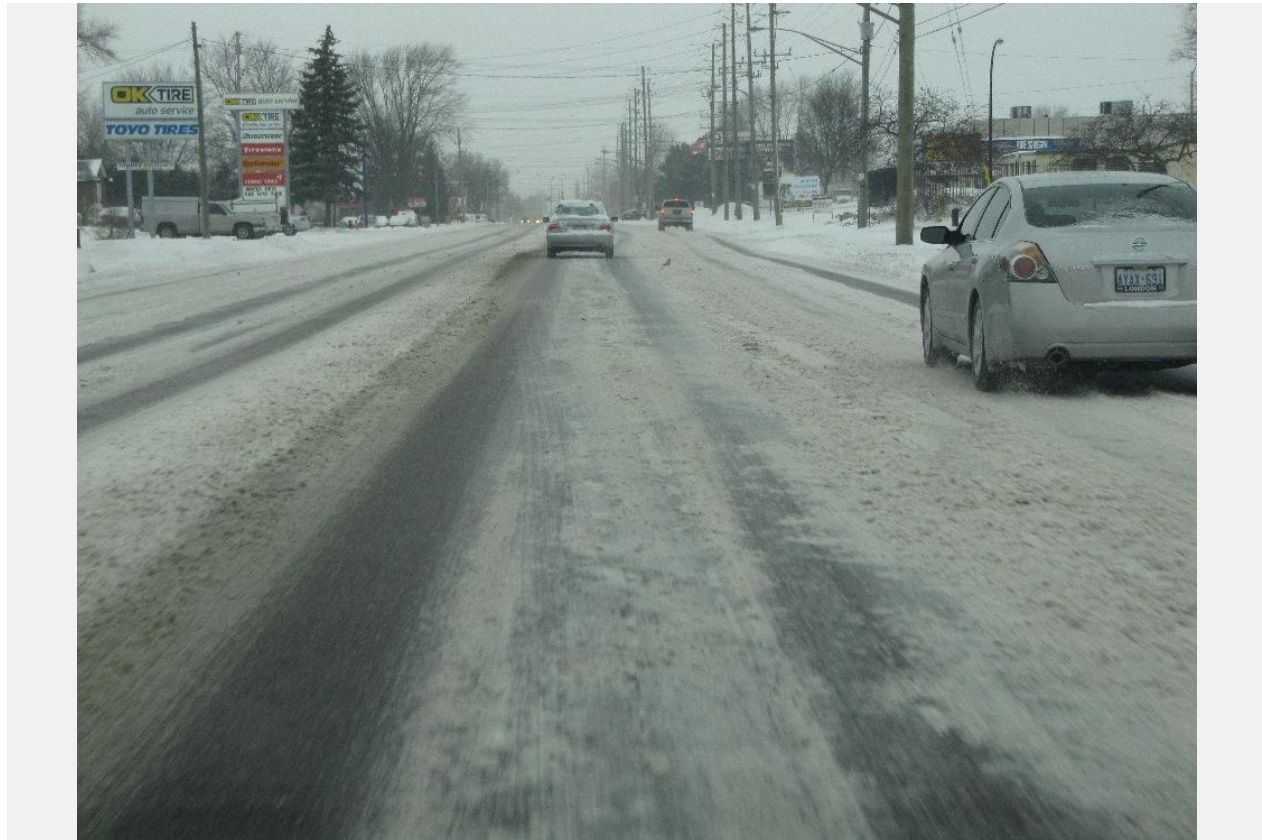
View, looking north, along the northbound lanes of Clarke Road, south of Oxford on the morning of January 2, 2014. Snow cover has been variable and therefore difficult to predict.

Snow had not been plowed yet in most streets in London as of the morning of January 2nd so there were variable conditions that needed close attention. While drivers could expect reasonable traction and control of their vehicles while travelling in the relatively bare portions of the road where the tires of other vehicles have cleared a path, there were dangerous conditions lying just a few inches away from those cleared paths where accumulated snow awaited any wayward tires.
