Gorski Consulting Website

Archived News - 2014 - July

Tragic Child Fatality At London Costco Parking Lot

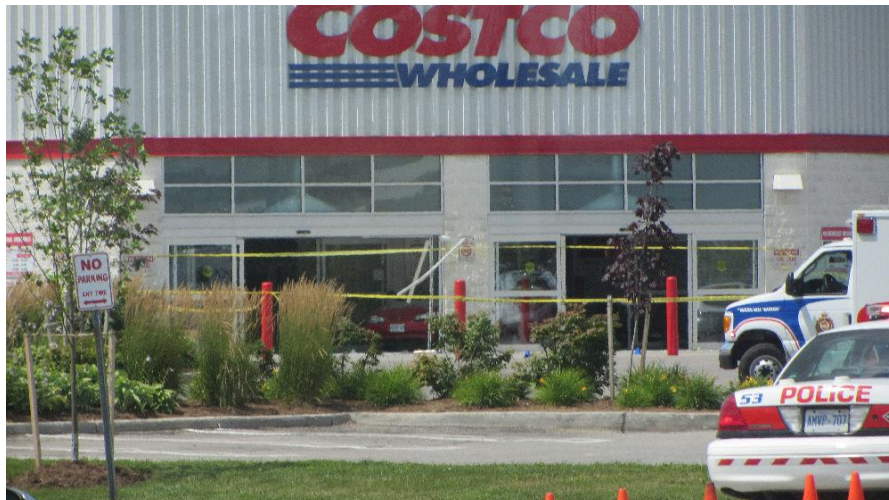
Throughout the day of July 25, 2014 no one was allowed near the parking lot of the Costco store. In this photo taken on the accident date the red Monte Carlo remains wedged in the front door area of the store.

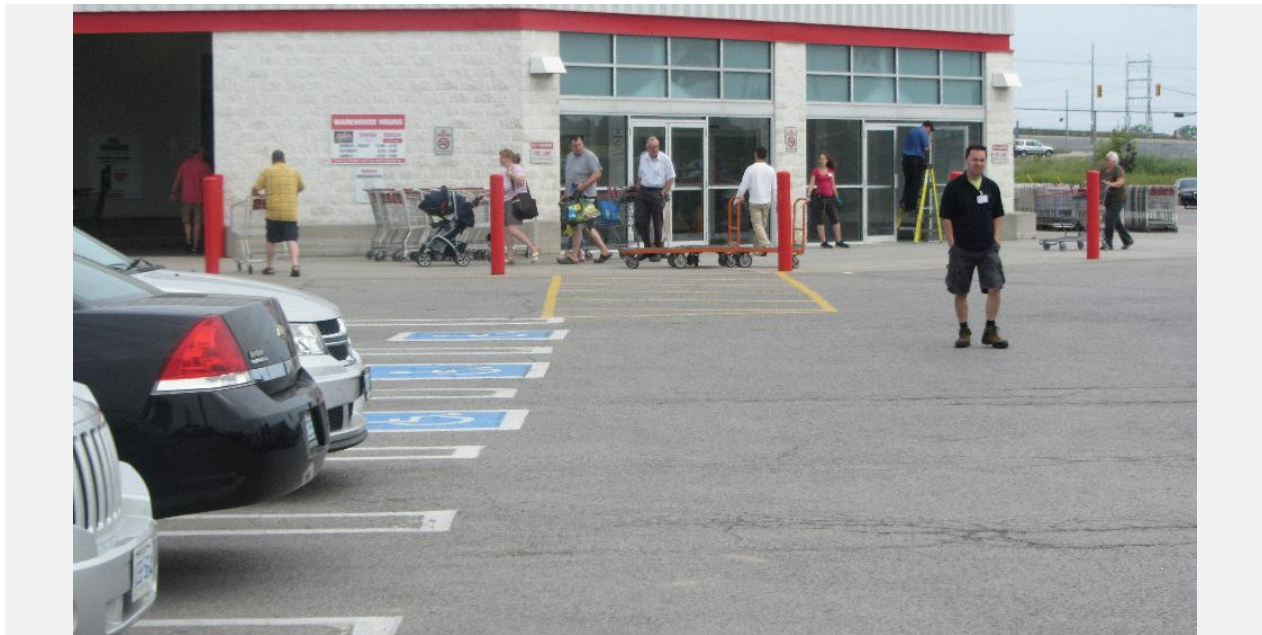
The angle at which the Monte Carlo entered the front doors would suggest that its original location was somewhere along the path shown in the above photo.

The yellow hatched lines on the parking lot is approximately where the Monte Carlo passed between two red pillars and toward the store's front doors.

The photo below shows a general view looking along the parking lot and towards the front doors of the Costco building. Given the angle at which the vehicle came to rest it is likely that the Monte Carlo originated somewhere from the parking lot along the path shown in the photo below.

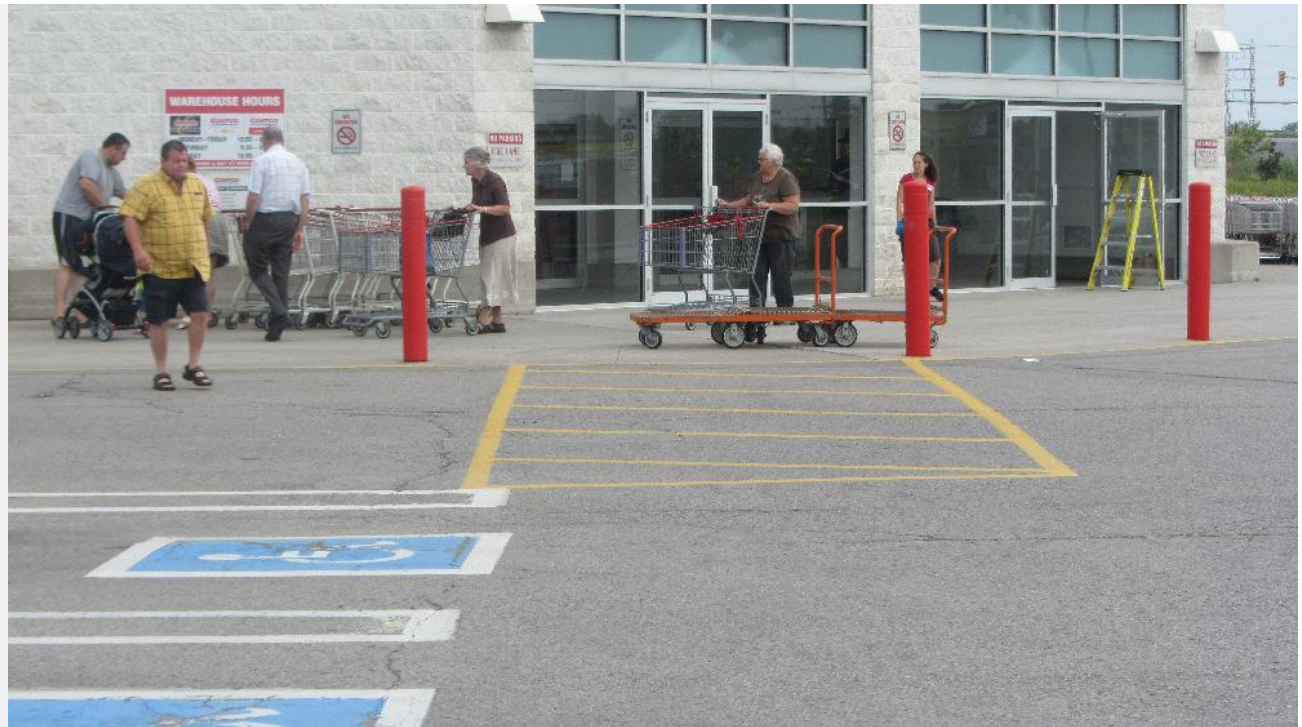
An important part of the investigation would conduct detailed examination of the parking lot surface leading up to the red pillars for any unusual evidence that could be related to the incident. At the time that this photo was taken on the morning of July 26th, there was no obvious, unusual evidence on the parking lot surface leading to the red pillars in the background.

In conducting our delayed examinations we focused on the area of the parking lot extending from the rest position of the Monte Carlo and in line with the red pillars which narrowed the path taken by the vehicle. As indicated in the photo below no

obvious, unusual evidence was found on the parking lot surface leading to the yellow painted area in front of the noted red pillars.

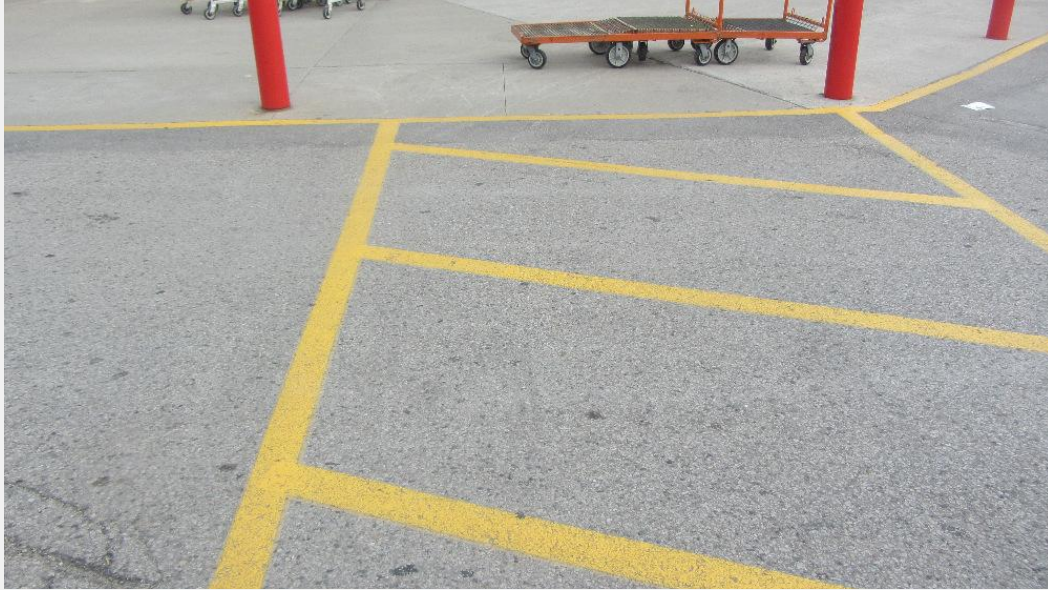
Although not very visible in the above photo, there were a number of markings, mostly scratches, in the pavement of the parking lot in the vicinity of the yellow painted rectangle. Without further information it would be difficult to evaluate whether some of these markings were related to the Monte Carlo's motion.

One might speculate why the yellow rectangle of yellow paint existed. A possible likelihood is that delivery vehicles need an access point to the store's front doors so this is where they might stop to unload their deliveries. It would not be surprising therefore that markings might exist in the area that are unrelated to the incident in question...and this is what we observed.

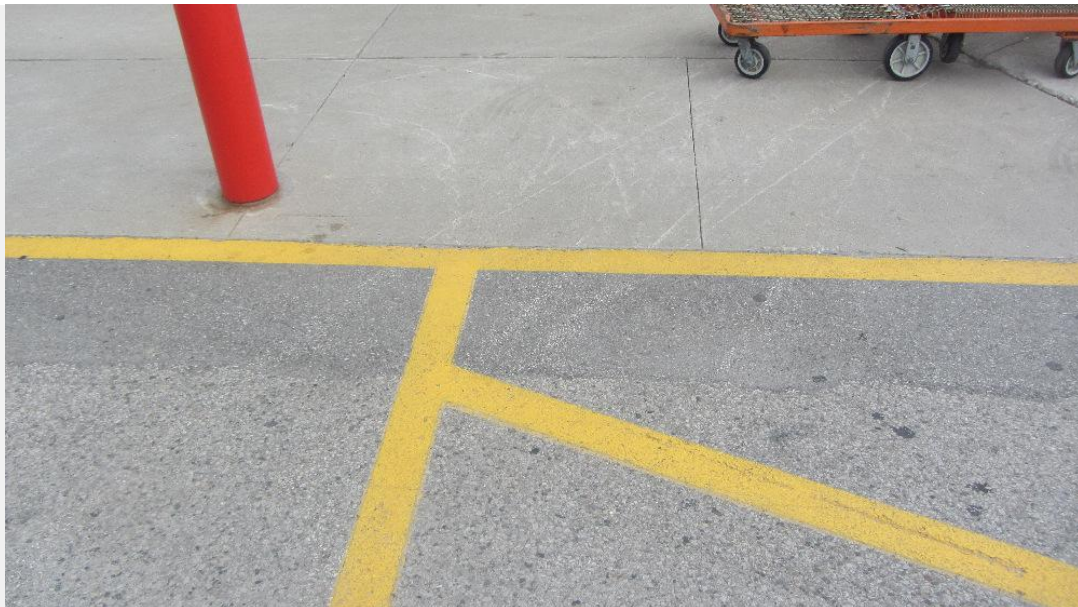
Scratches become more visible when entering the concrete portion of the area at the red pillars. The angle of a majority of these scratches would suggest that they are unrelated to the motion of the Monte Carlo.

As we come closer to the red pillars we begin to see some obvious scratches, particularly on the concrete pad as shown in the photo below.

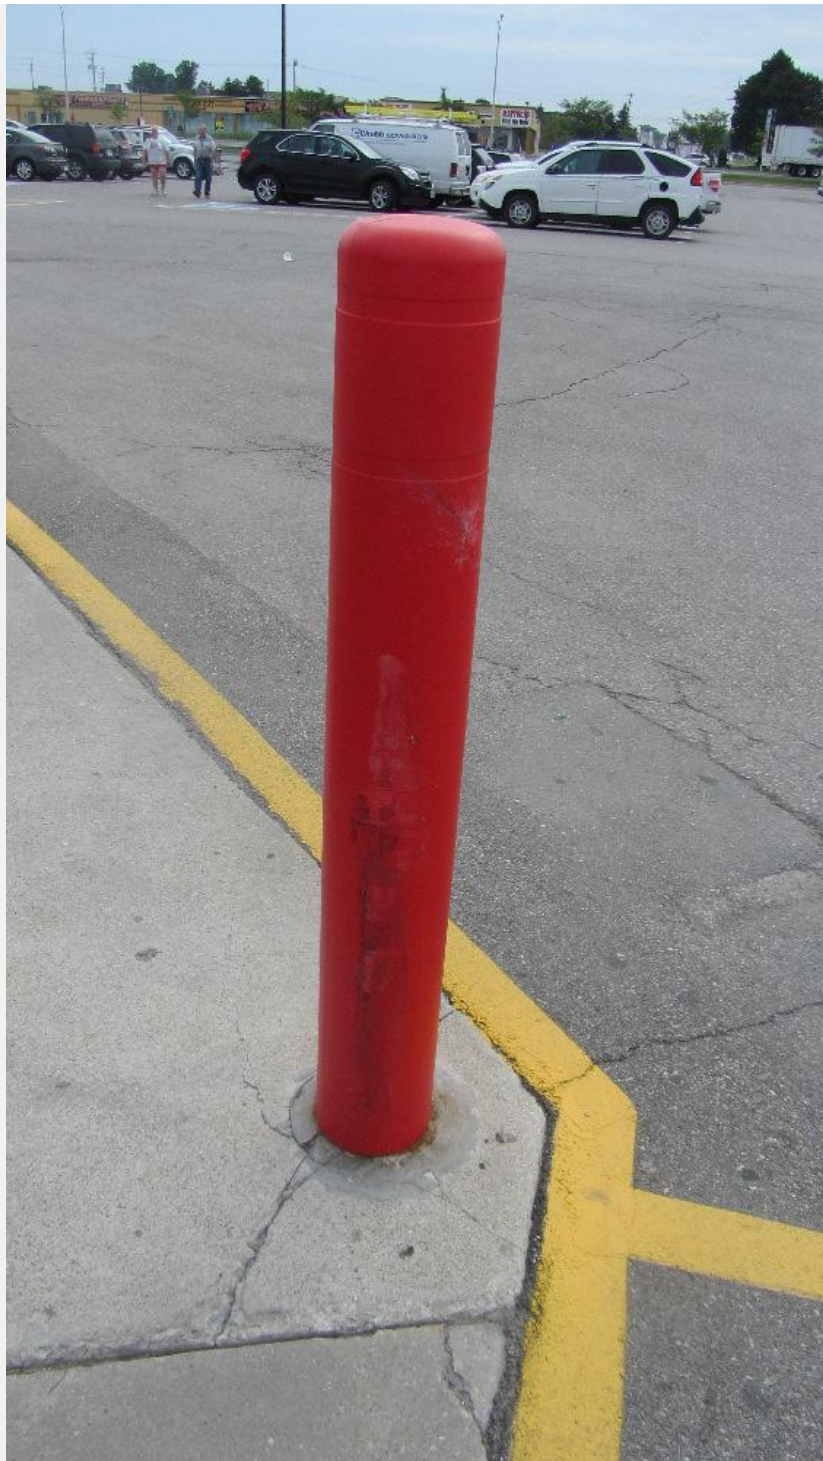
Looking at the right pillar there was obvious evidence of a recent impact.

Clear evidence of the Monte Carlo's presence is indicated by a fresh contact to the right pillar as shown in the photo below.

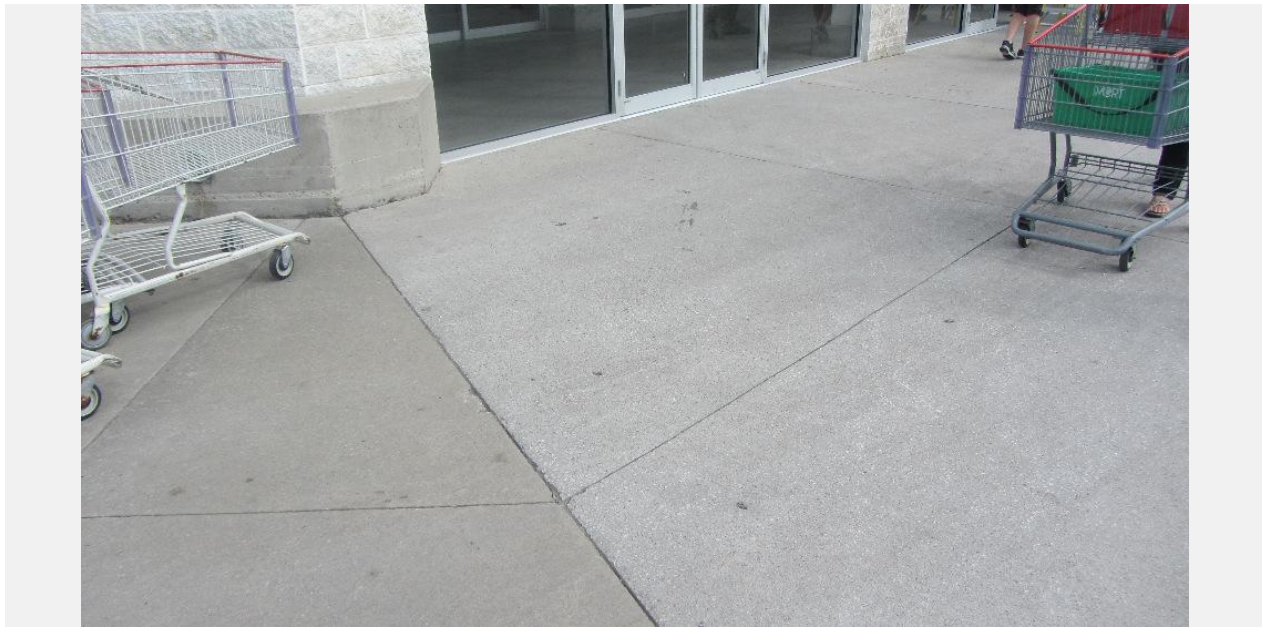
View of the concrete pad leading to the exterior, front doors of the Costco building. Faint tire marks were visible on the concrete however they are not visible from the angle shown in this photo.

Although not visible from the angle shown in the photo below, there were tire marks on the concrete pad leading to the front doors of the building.

Thus, unless the evidence was previously destroyed it would suggest that visible tire marks were not produced by the vehicle until the point where it made contact with the red pillar.

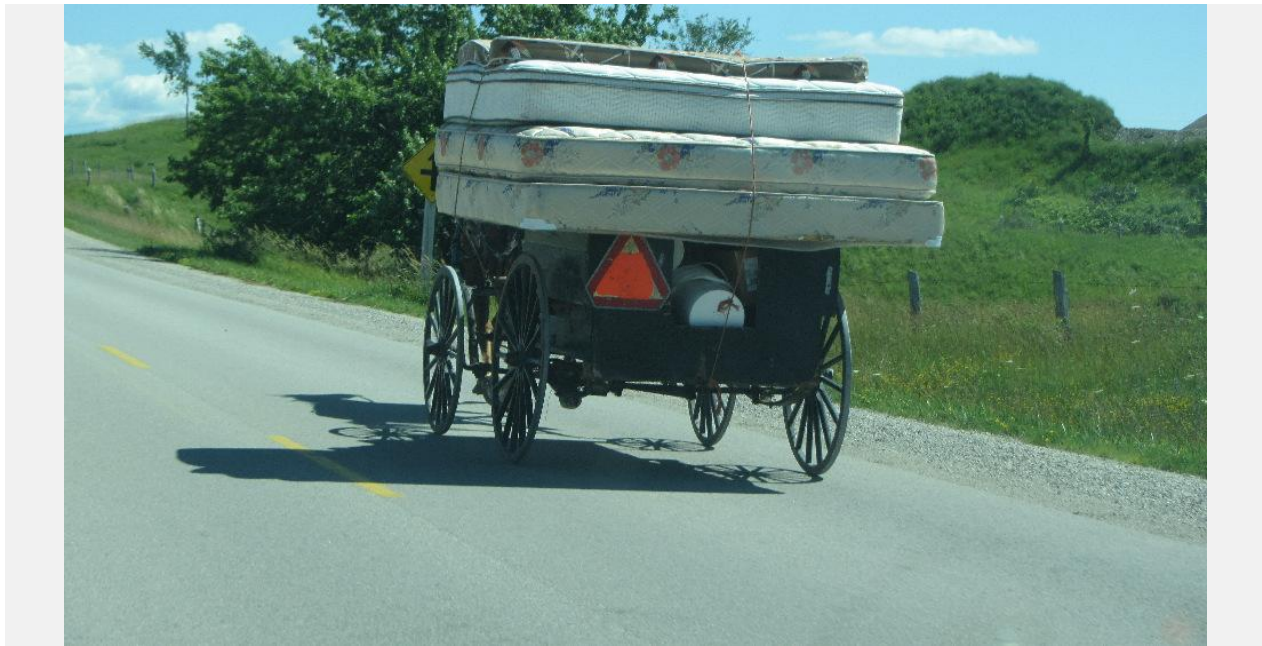
View of southbound wagon being driven in the middle of the lane of a county highway. If the load mattresses prevent us from seeing the driver of the wagon then surely the driver can also not see us.

We might believe that the mattresses on the wagon are some primitive “air bag” system perhaps believed to prevent the occupants of the wagon from being injured. But that belief would be complete folly. Our point is that the driver of this horse-drawn wagon cannot see anything behind him yet he travels fully within the southbound lane of this relatively busy highway. Passing such a wagon gives no assurance that the driver of the wagon knows that the passing is taking place.

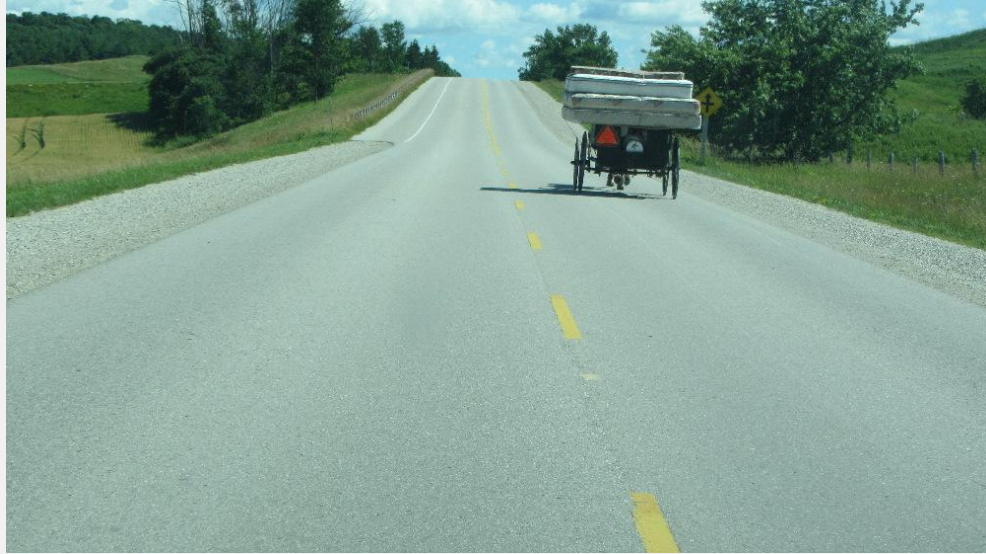
Drivers of motor vehicles must use the opposing lane to pass such a wagon while the driver of the wagon has no way of knowing when such passing might take place.

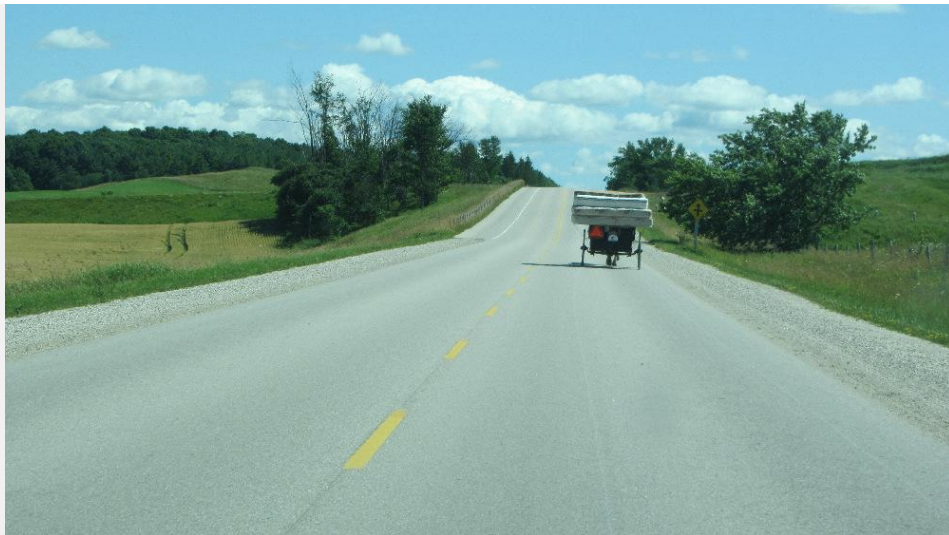
Examination of the light-coloured lines produced on the pavement by the wheels of the horse-drawn wagon can indicate the position of that wagon for a long distance back from its current position.

If one looks very closely at the pavement just behind the wagon you might be able to distinguish some thin, light-coloured lines produced by the wheels of the wagon. Thus it is possible to look at the position of those lines to learn about the wagon's position within the lane. The photos below provide progressively earlier views of the wagon's motion and we can observe the light-coloured lines to learn how the wagon was positioned in the lane for a considerable distance.

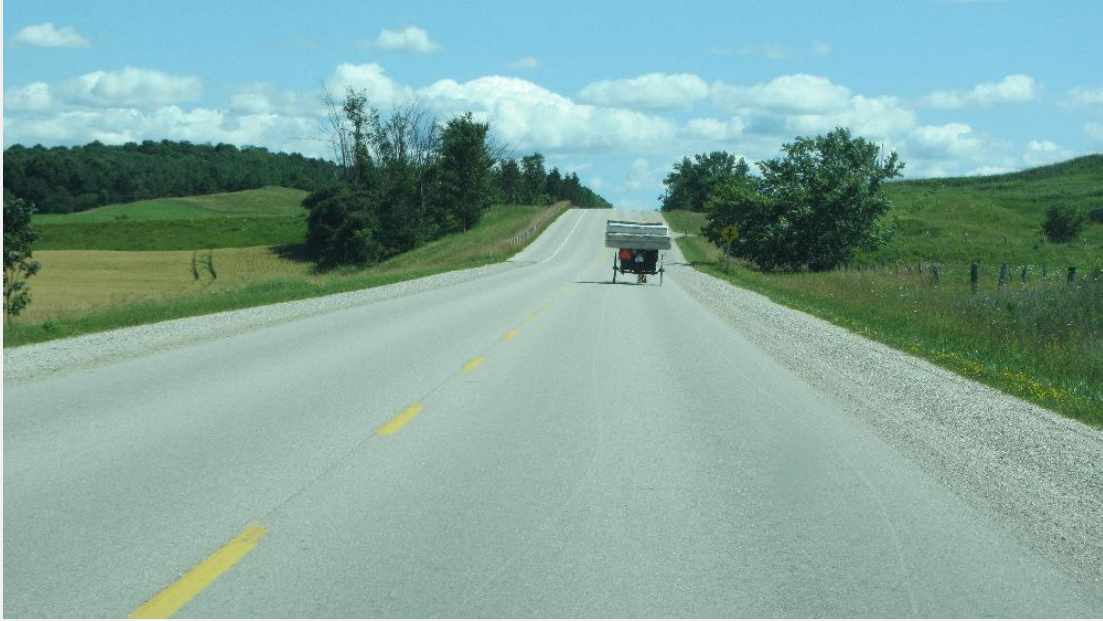
Following the thin, light-coloured lines on the pavement we can see that the wagon does not follow as straight course within the lane but, at times it makes some major changes in direction. Take note of the change in direction of those lines in the foreground of this photo.

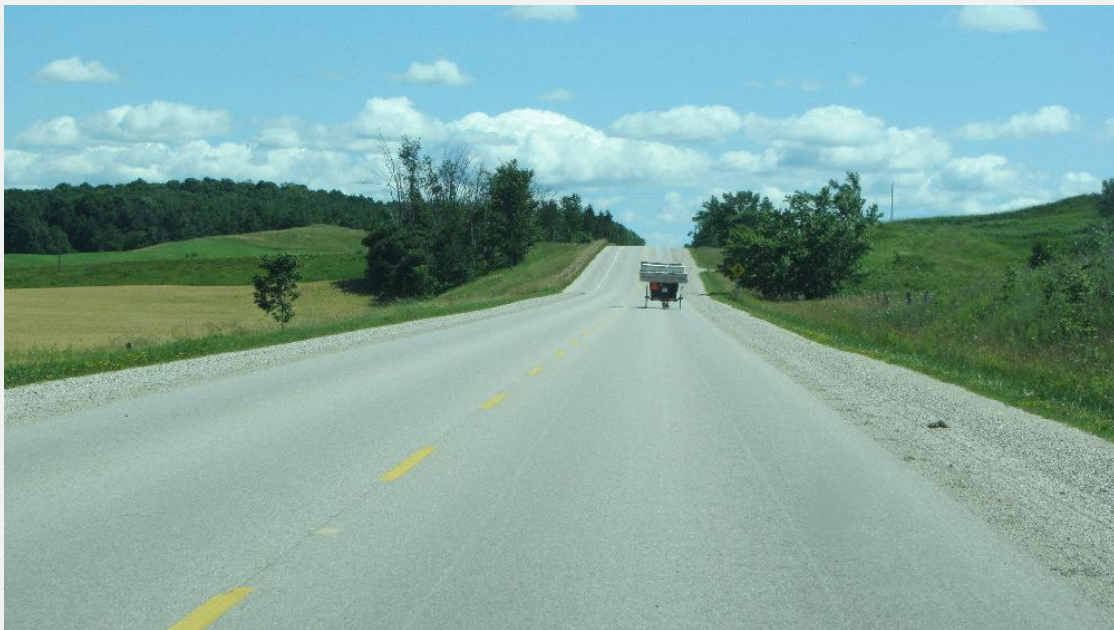
Looking at the thin, light-colours lines produced by the wheels of the wagon it is clear that it made a wild change in direction in the lane at the point shown approximately halfway to the location of the wagon.

If you look very closely at the above photo you should be able to see how the lines produced by the wagon suddenly take a wild change in direction, as if perhaps the wagon operator did this deliberately so could glance behind him. But we could never be sure. The point is that the wagon operator is essentially blind to the happenings behind the wagon.

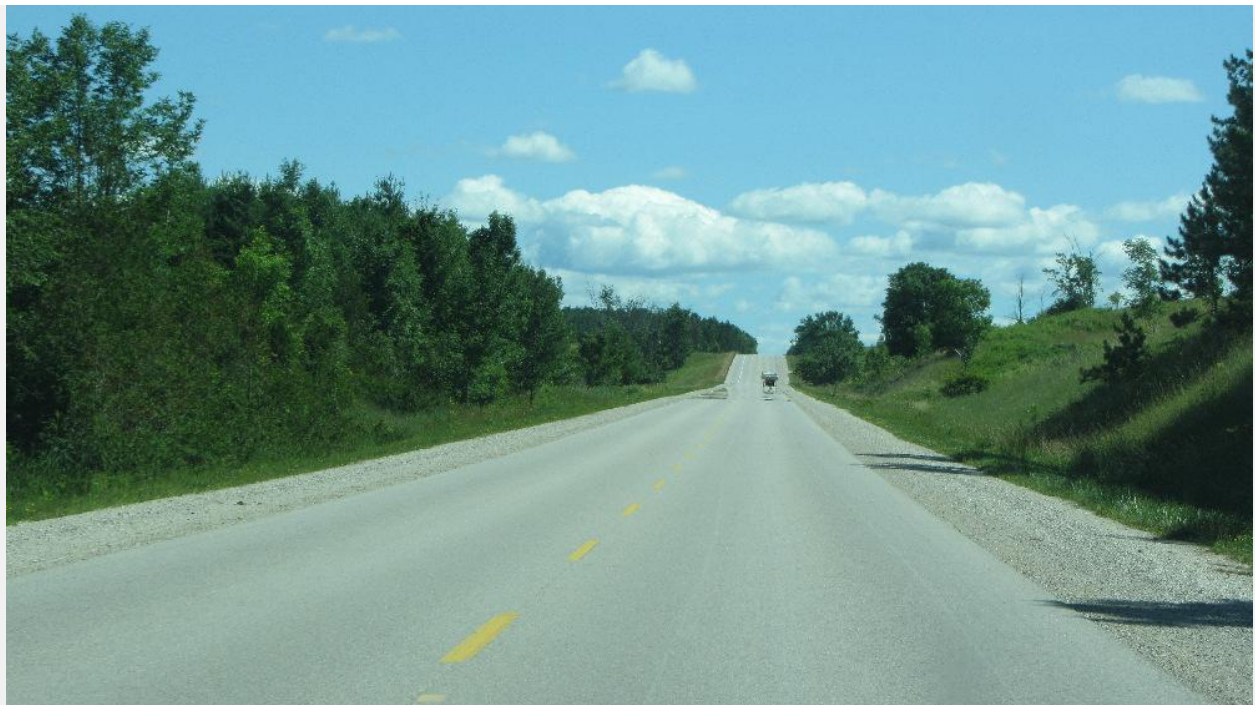
View of horse-drawn wagon from a substantial distance.

This is a dangerous situation that should be brought to the attention of both drivers of motor vehicles and particularly drivers of such horse-drawn wagons. As shown below, the wagon could be seen from a great distance because of the current topography however that could easily change.

If the wagon was just beyond a hillcrest and a fully loaded tractor-trailer came over the horizon, from behind it, then the scenario could become very different.

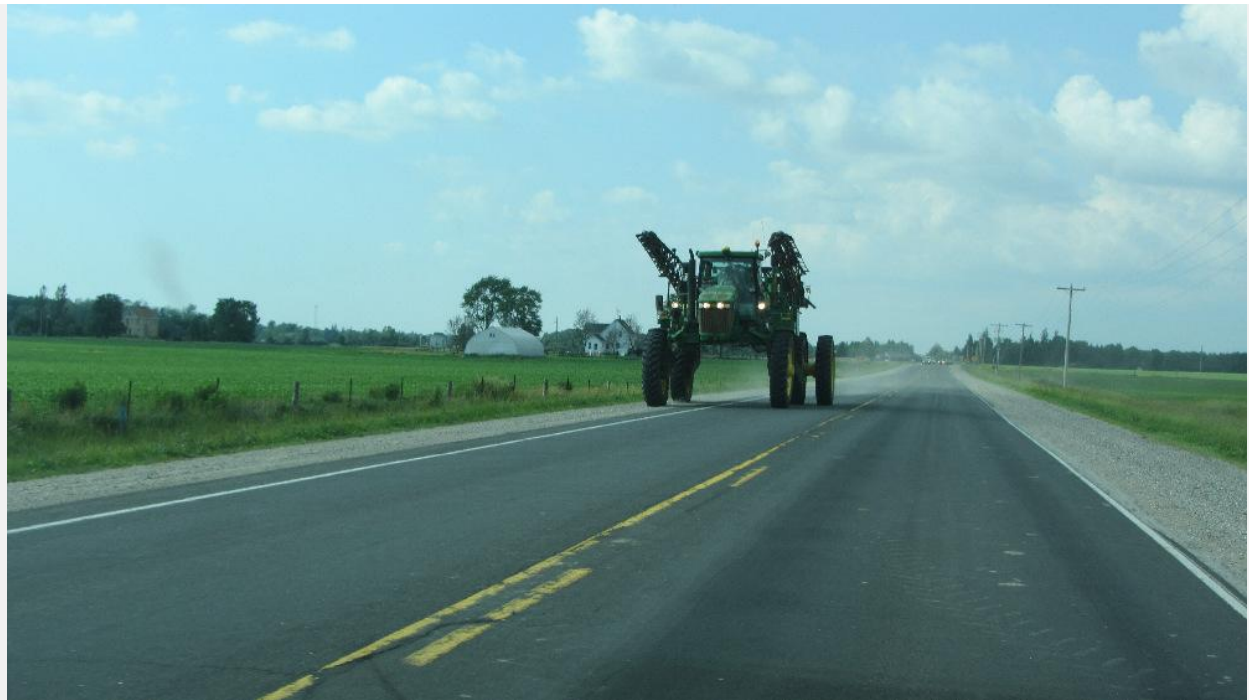
View of southbound tractor travelling in its own lane on Highbury Avenue south of London, Ontario.

Below is a northbound view along Highbury Avenue just north of Manning Drive, south of London, Ontario. We see a very tall farm tractor in its proper lane and would think nothing of it.

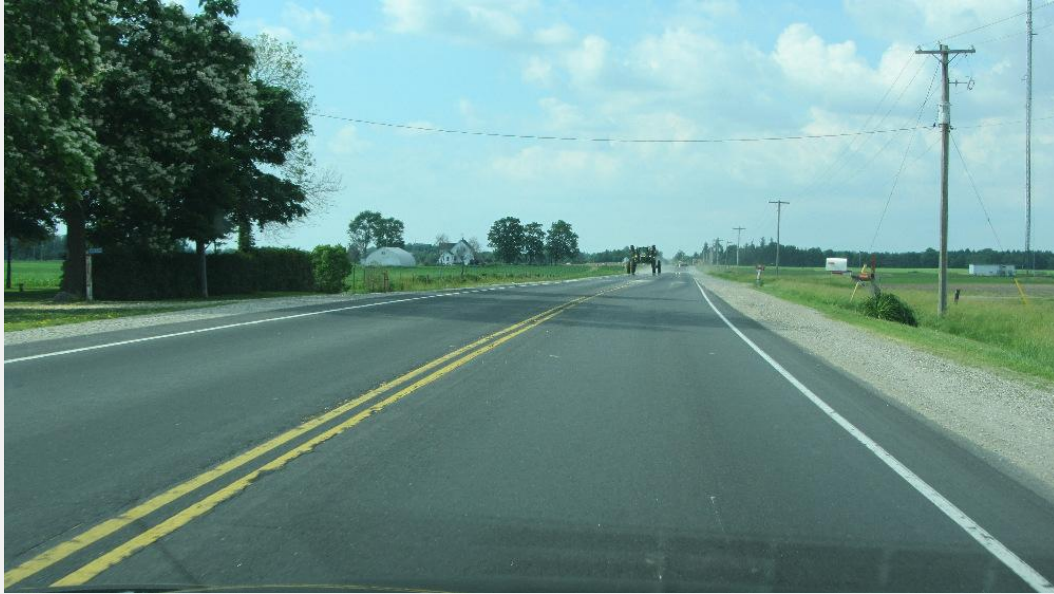
View of southbound tractor but from further away, or a few seconds earlier than the previous photo.

Because the tractor is further away we cannot see where its wheels meet the road surface but it is still obvious that it is in its proper lane. Now let us reverse another few seconds so the tractor is even further away, as shown below.

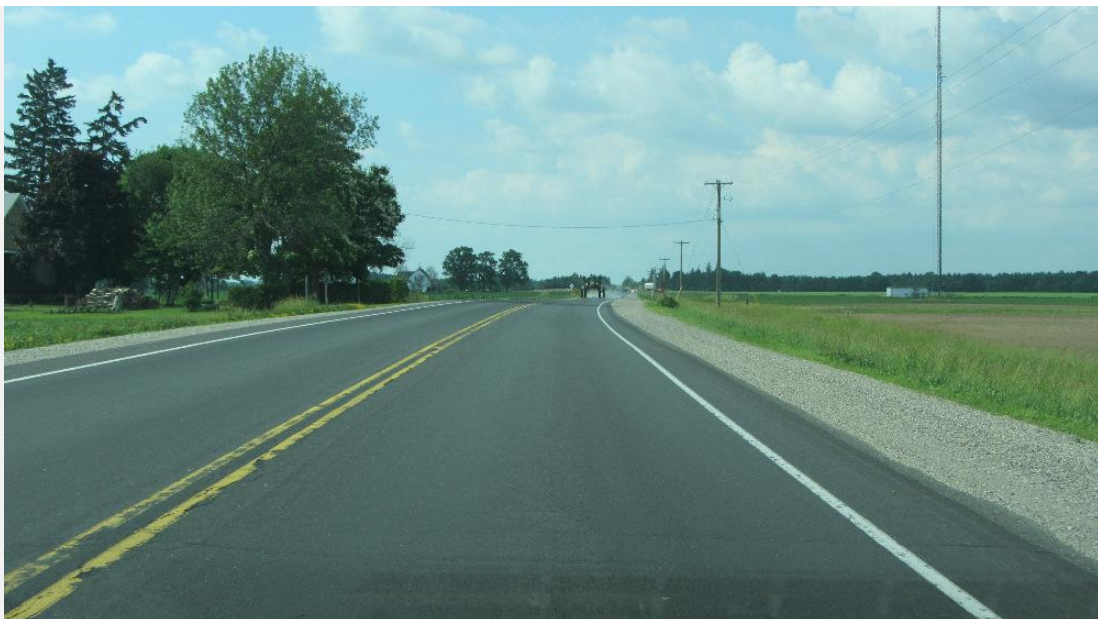
From a few seconds earlier, this view appears to show that the tractor is in the wrong lane because we cannot see the road surface and because of the curve in the road that “shifts” the position of the tractor in our mind.

Now the tractor appears to be on the wrong side of the roadway centre-line. Certainly, if we reverse another few seconds it would appear so as shown below.

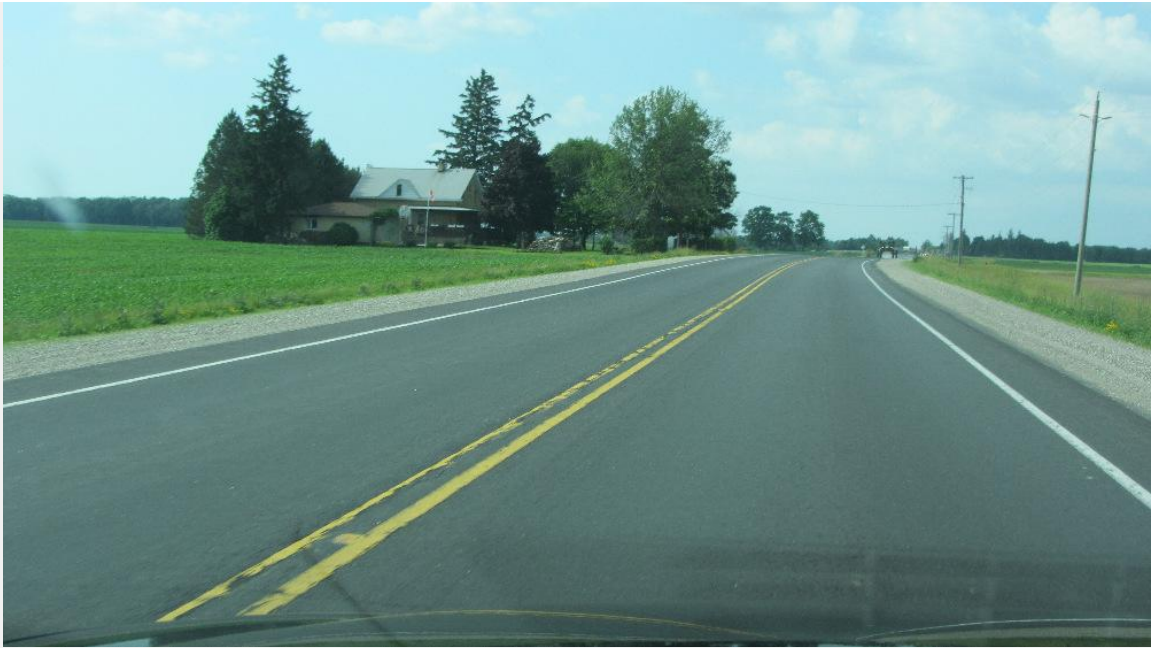
From a distance a vehicle on a curve may appear to be on the wrong side of the road and cause a nervous driver to react by steering toward the right, gravel shoulder resulting in a loss-of-control event.

Nervous drivers who suspect a vehicle is in their lane may steer to the right and possibly even off the pavement and onto the right gravel shoulder. We see many head-on collisions on curves like this because drivers lose control of their vehicles when their right side wheels inadvertently enter into a gravel shoulder.

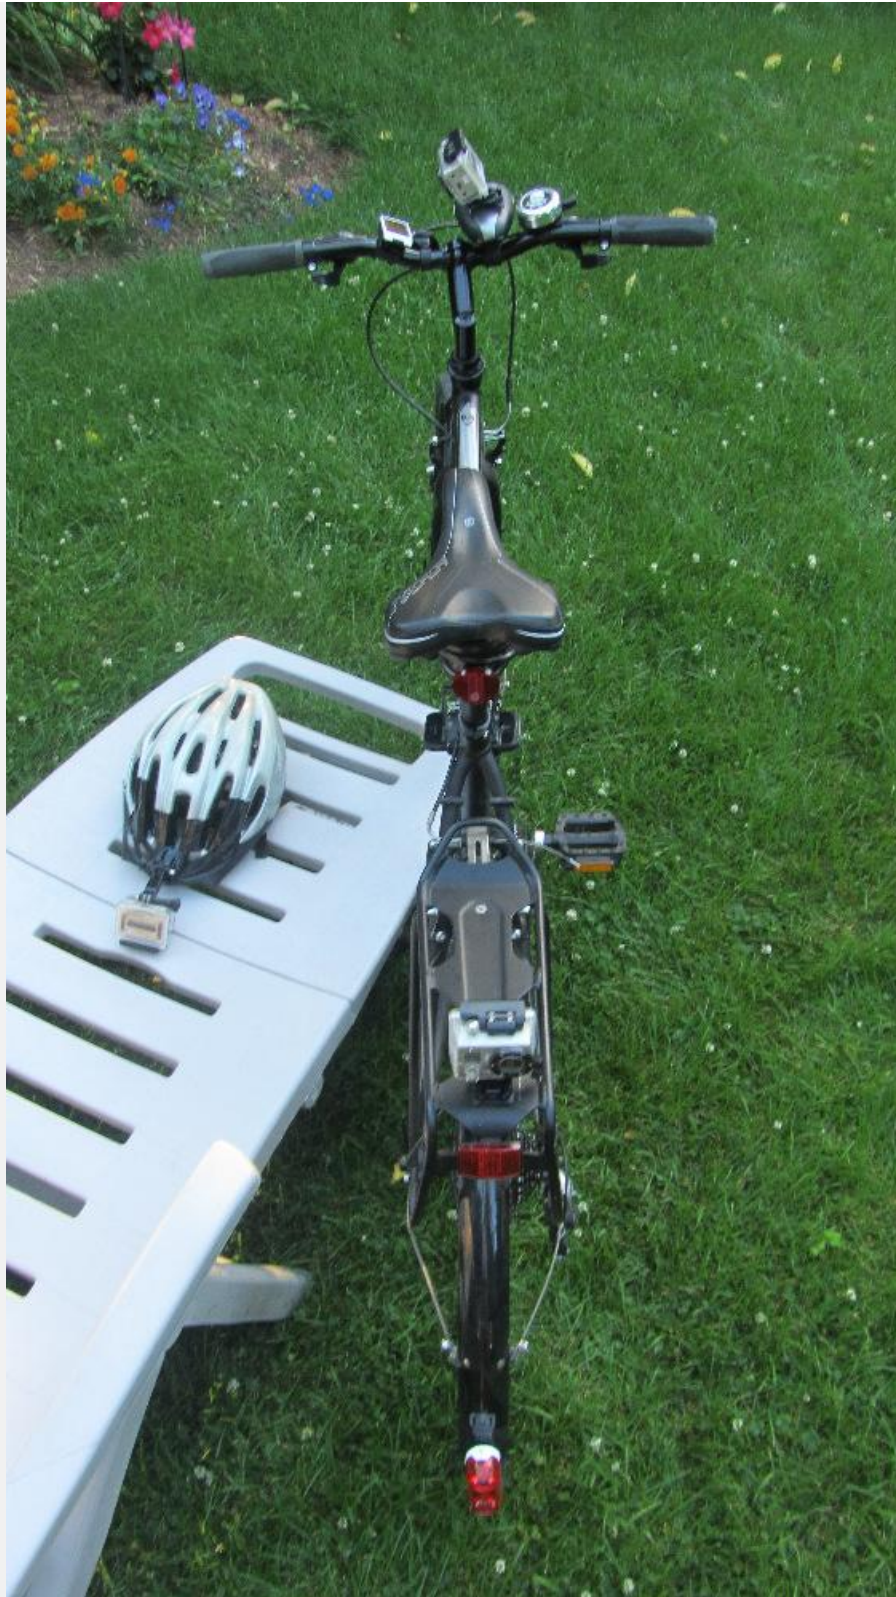
Overall view of bicycle and helmet equipped with instrumentation to document the bicycle's motion, the forces it sustains, and the focus of attention of the rider.

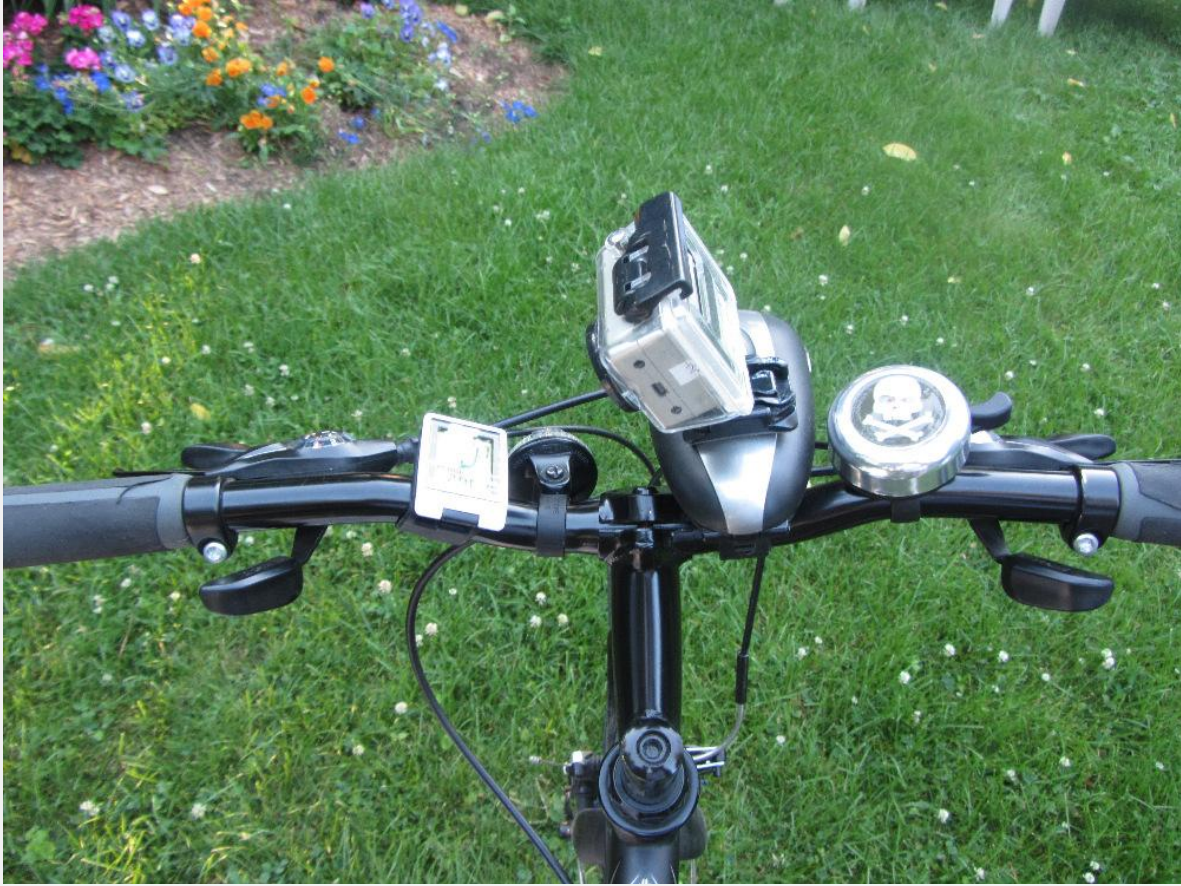
View of GoPro video camera pointing at a simple computer that displays the bicycle's speed.

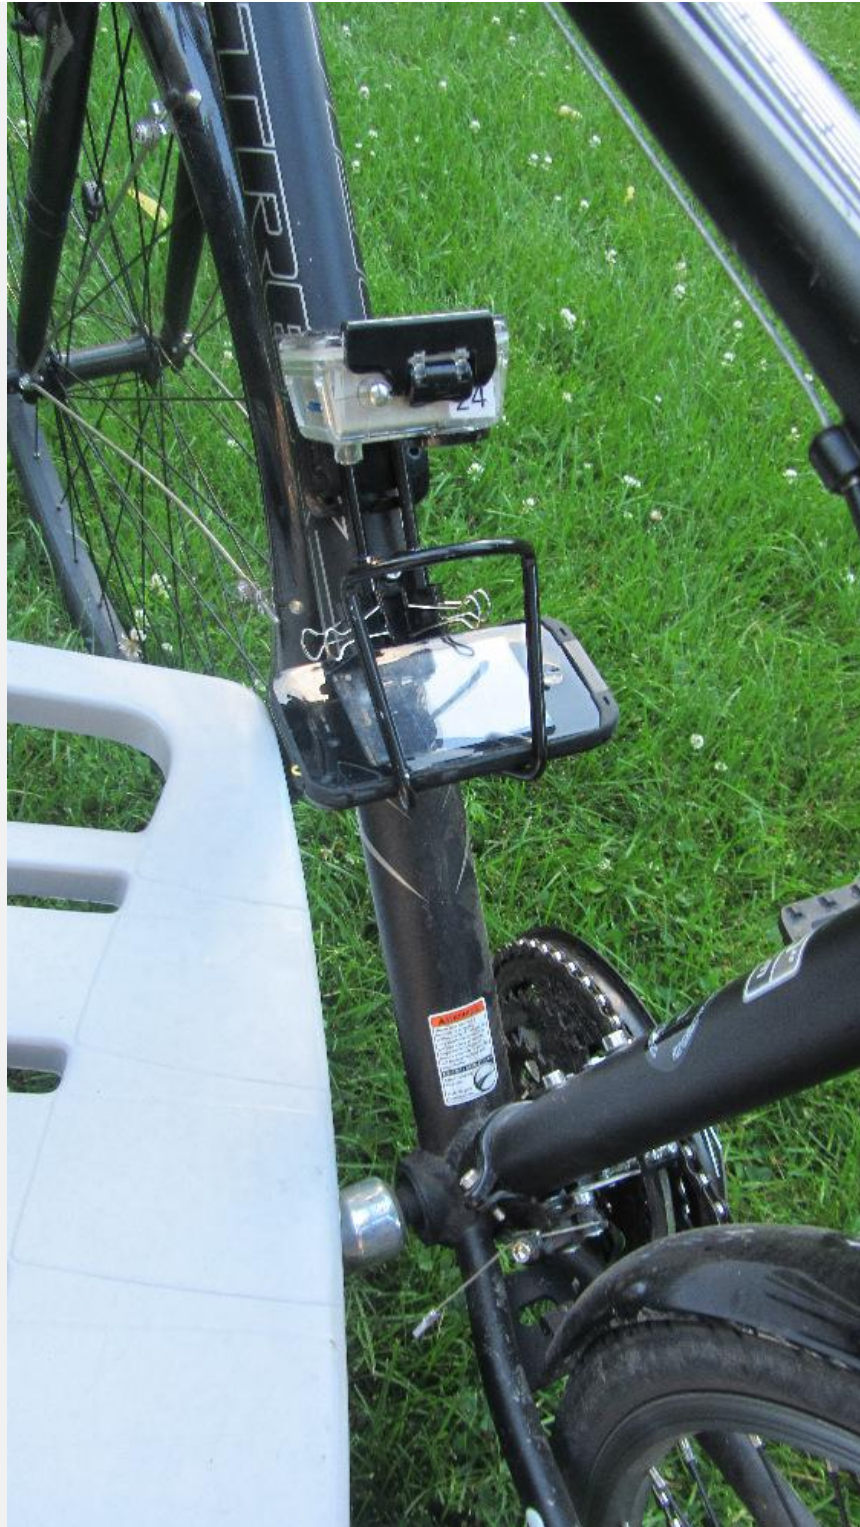
View of GoPro video camera pointing at the face of an iPhone that is set to record the accelerations and gyro results. Knowing the precise timing of commencement of recording is important when wanting to synchronize the views of all the video cameras. This camera also captures the cadence of the rider and certain road features.

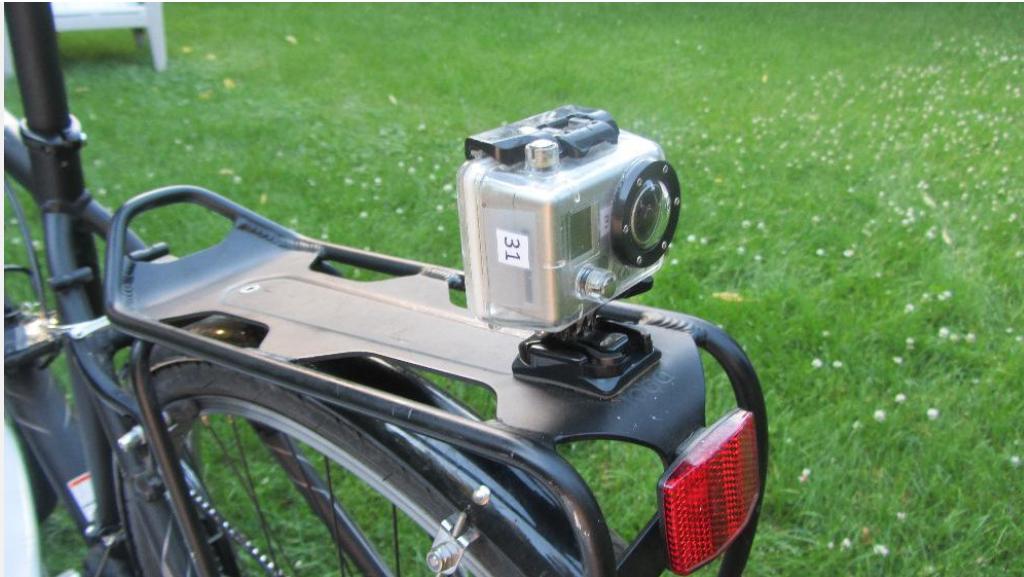
A rarity is that we often do not examine what lies behind a bicycle, thus a GoPro camera mounted to the back of the bicycle and facing rearwards captures the actions of vehicles approaching the bicycle.

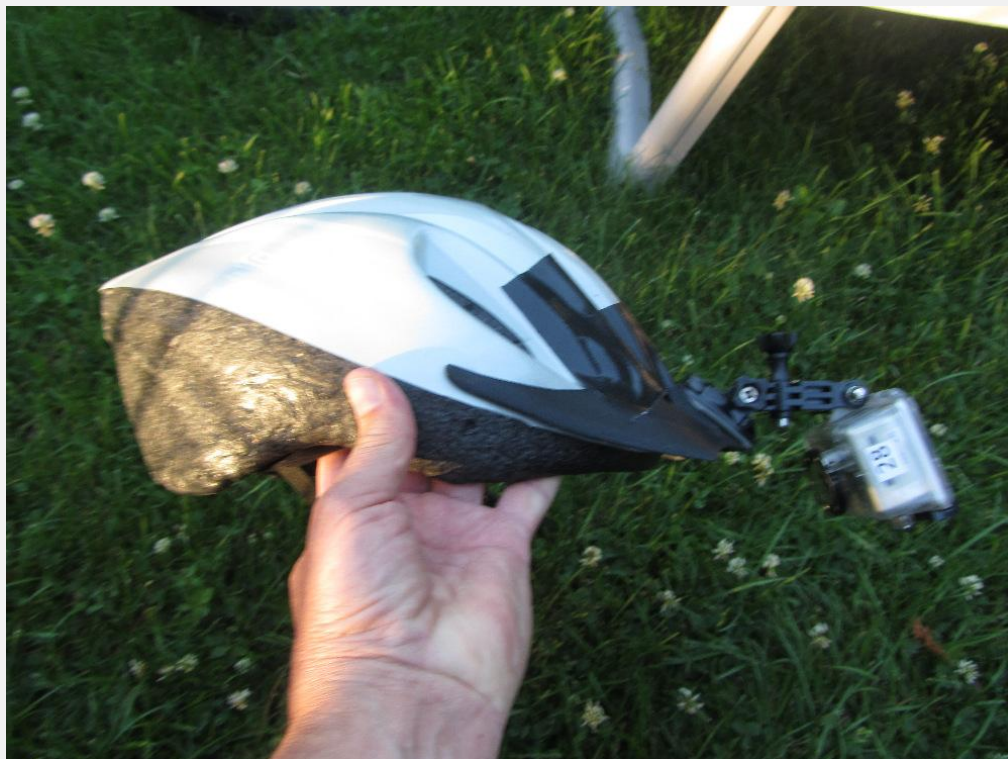
A GoPro camera mounted to the front of a bicycle helmet and pointing rearward enables documentation of the rider's eye motions and therefore provides an indication of where the rider's attention is focused and for how long.

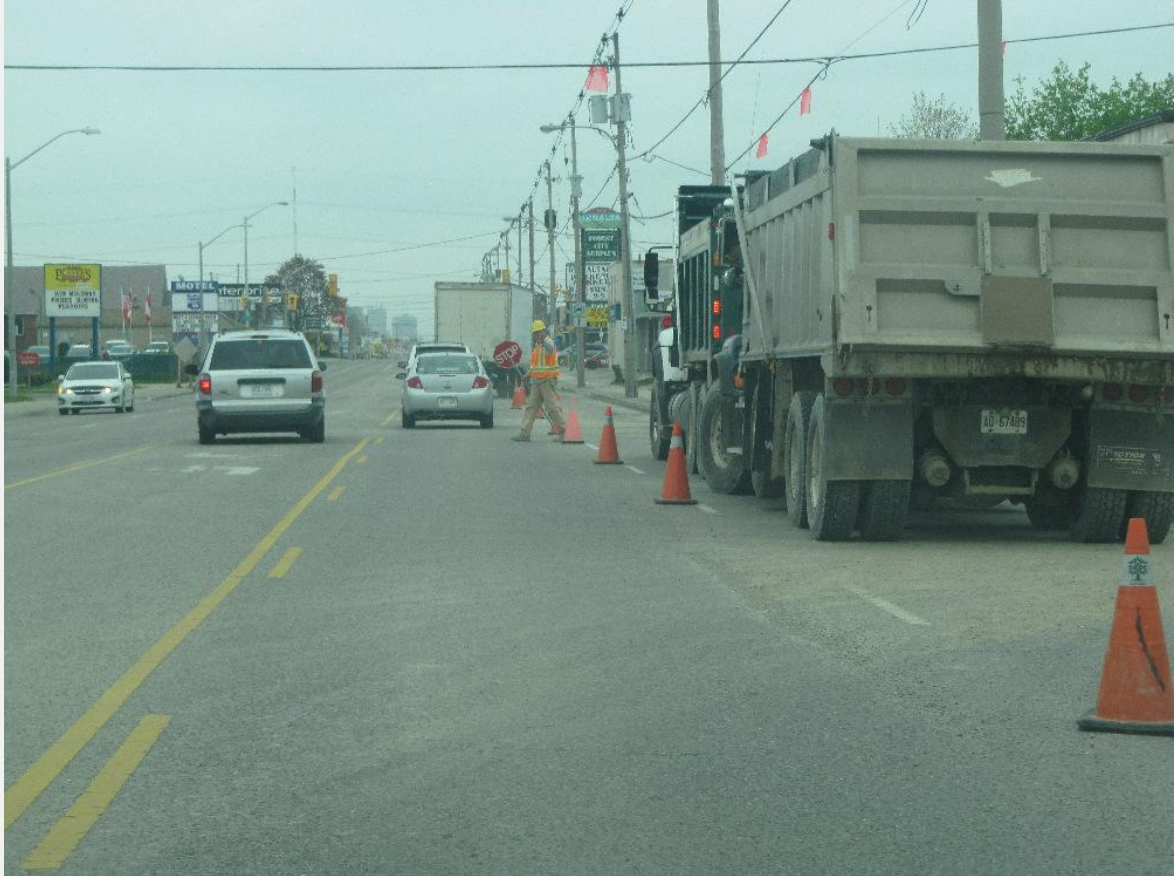
Stepping into traffic, even when wearing a traffic vest, requires that a flagman be vigilant for situations where a driver may be distracted and may not be looking in the direction where the flagman has stepped out.

Even the height of the stop sign that a flagman carries might become a safety hazard, as shown in the photo above, if it can potentially block the flagman's view.

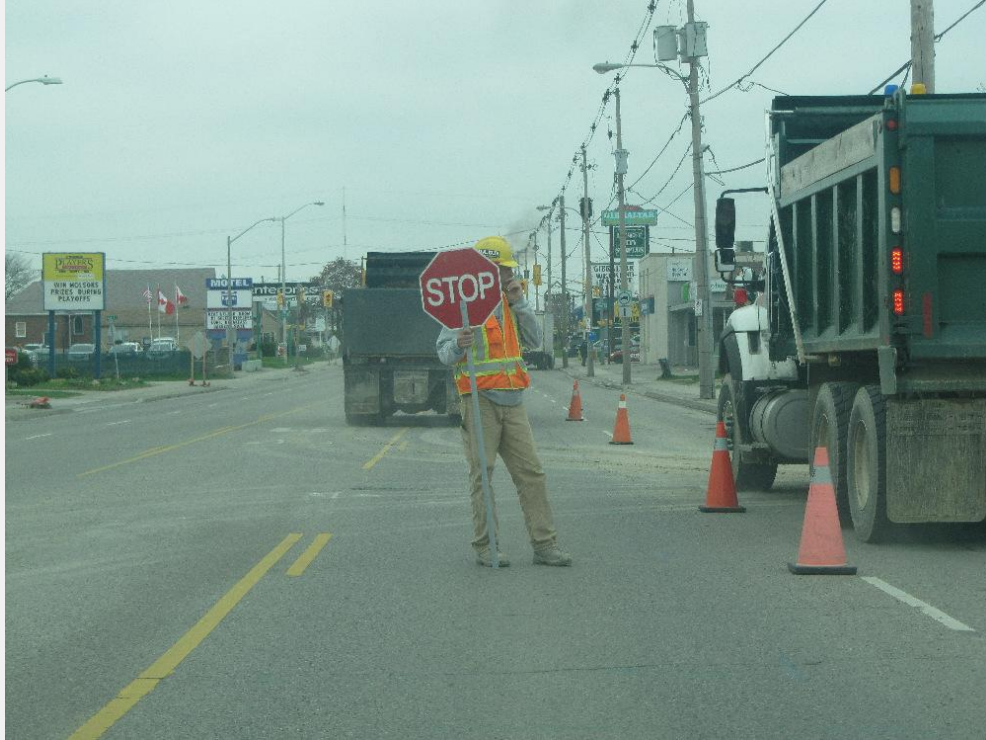
An example of a flagman whose attention is drawn away from traffic as he stands in a live lane. The stop sign that is being held is at the height of his eyes and might also present a problem in obscuring his sight on selected occasions.
