Gorski Consulting Website

Archived News - 2014 - November

Dangerous Lack of Maintenance to Damaged Guardrail in Kilworth, Ontario

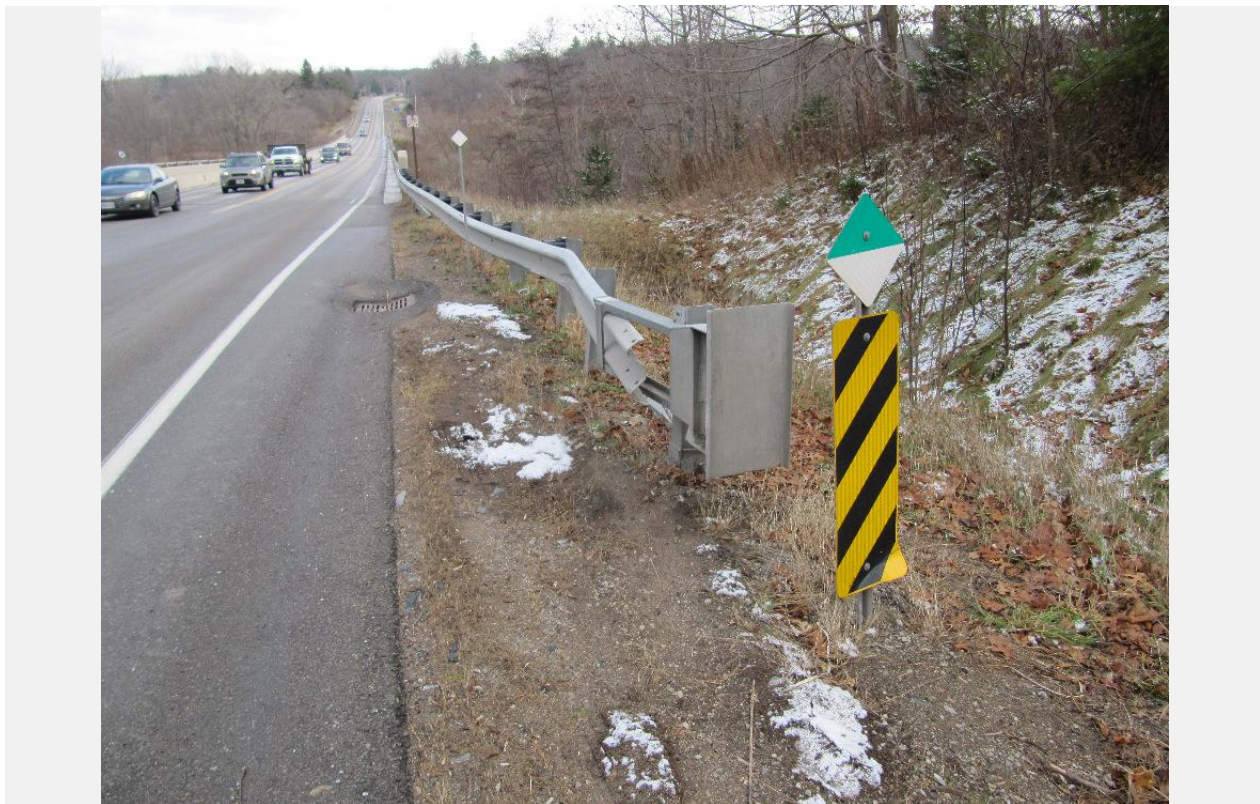
The unrepaired damage to guardrail on the west side of the Kilworth bridge, on the west outskirts of London, Ontario, has caused the end of a guardrail to stick out of its end terminal and awaiting to harpoon a potential impacting vehicle.

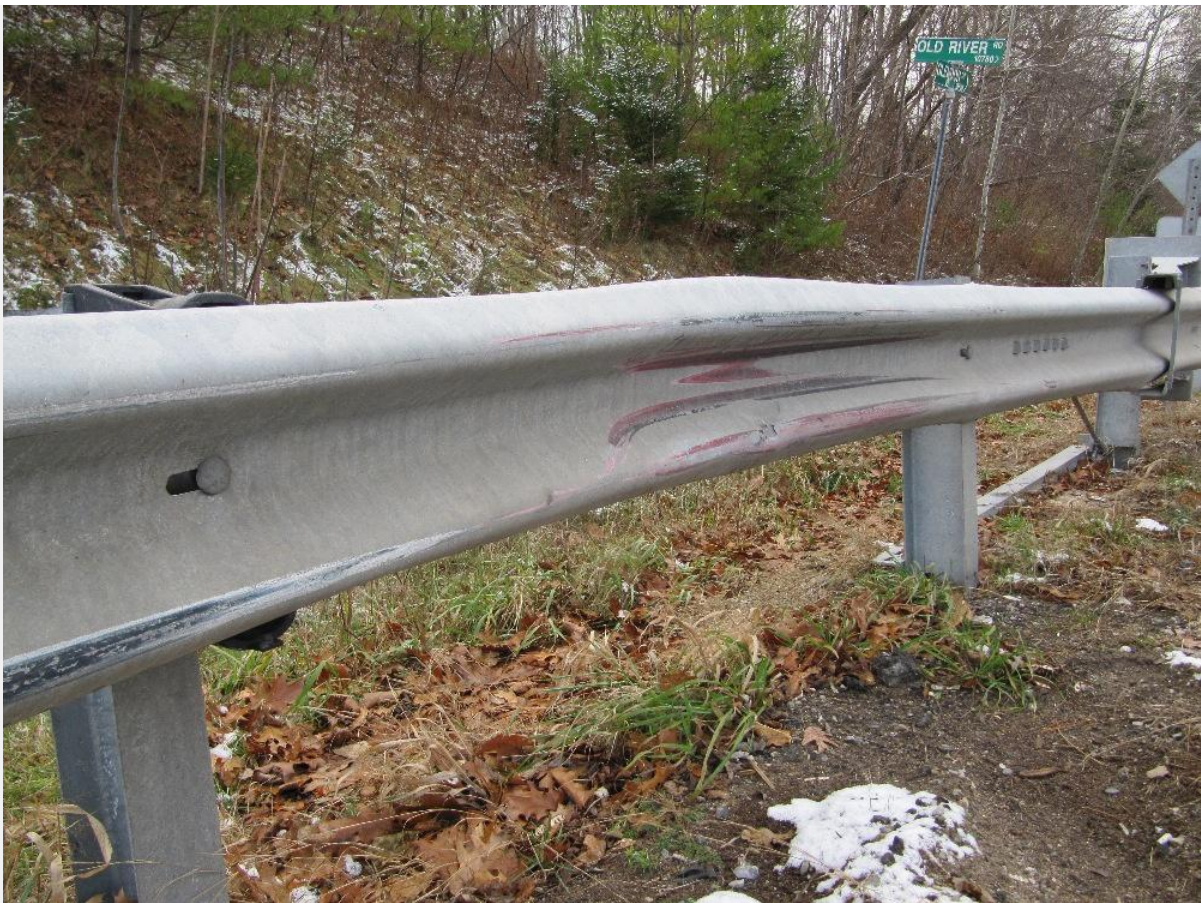
View of impact damage on the “w” rail of the guardrail which caused the rail to be pulled out the terminal, exposing its end to approaching traffic.

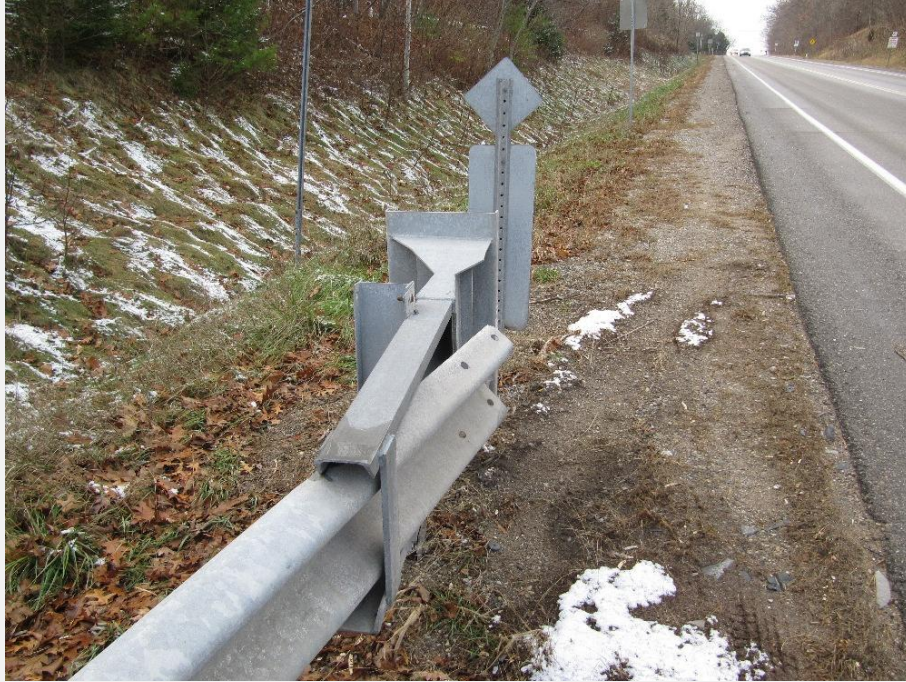
View of rail of the guardrail that has been pulled out of the Trinity end terminal as a result of an impact to its downstream end. As the rail was deformed toward the ditch its end was rotated out toward the road and toward approaching traffic.

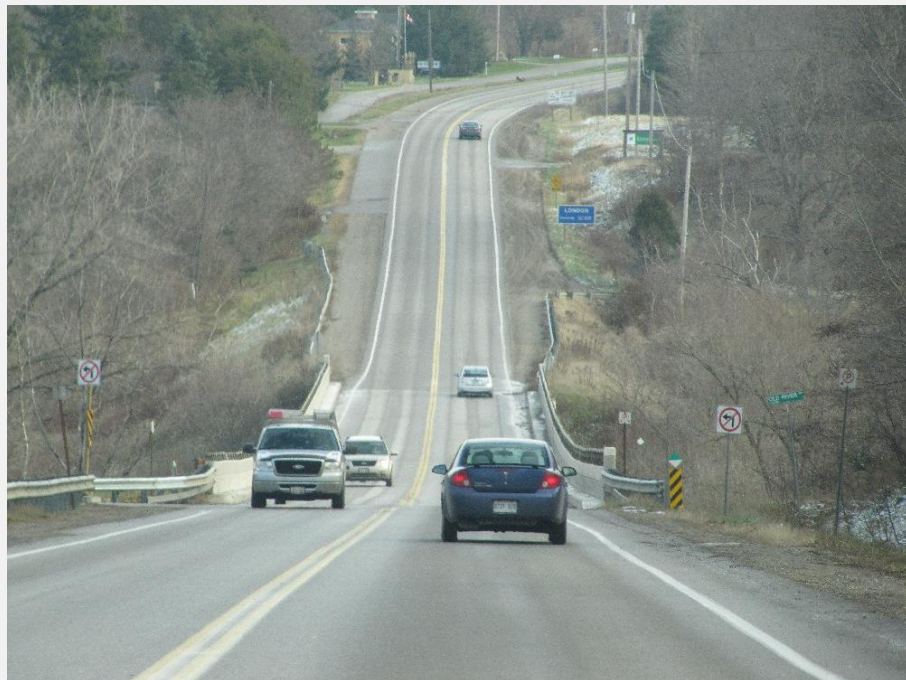
View, looking east along Glendon Drive (Middlesex County Road 14) on approach to the Kilworth Bridge. The damaged guardrail is located on the south (right) side, on the downgrade approach to the bridge.

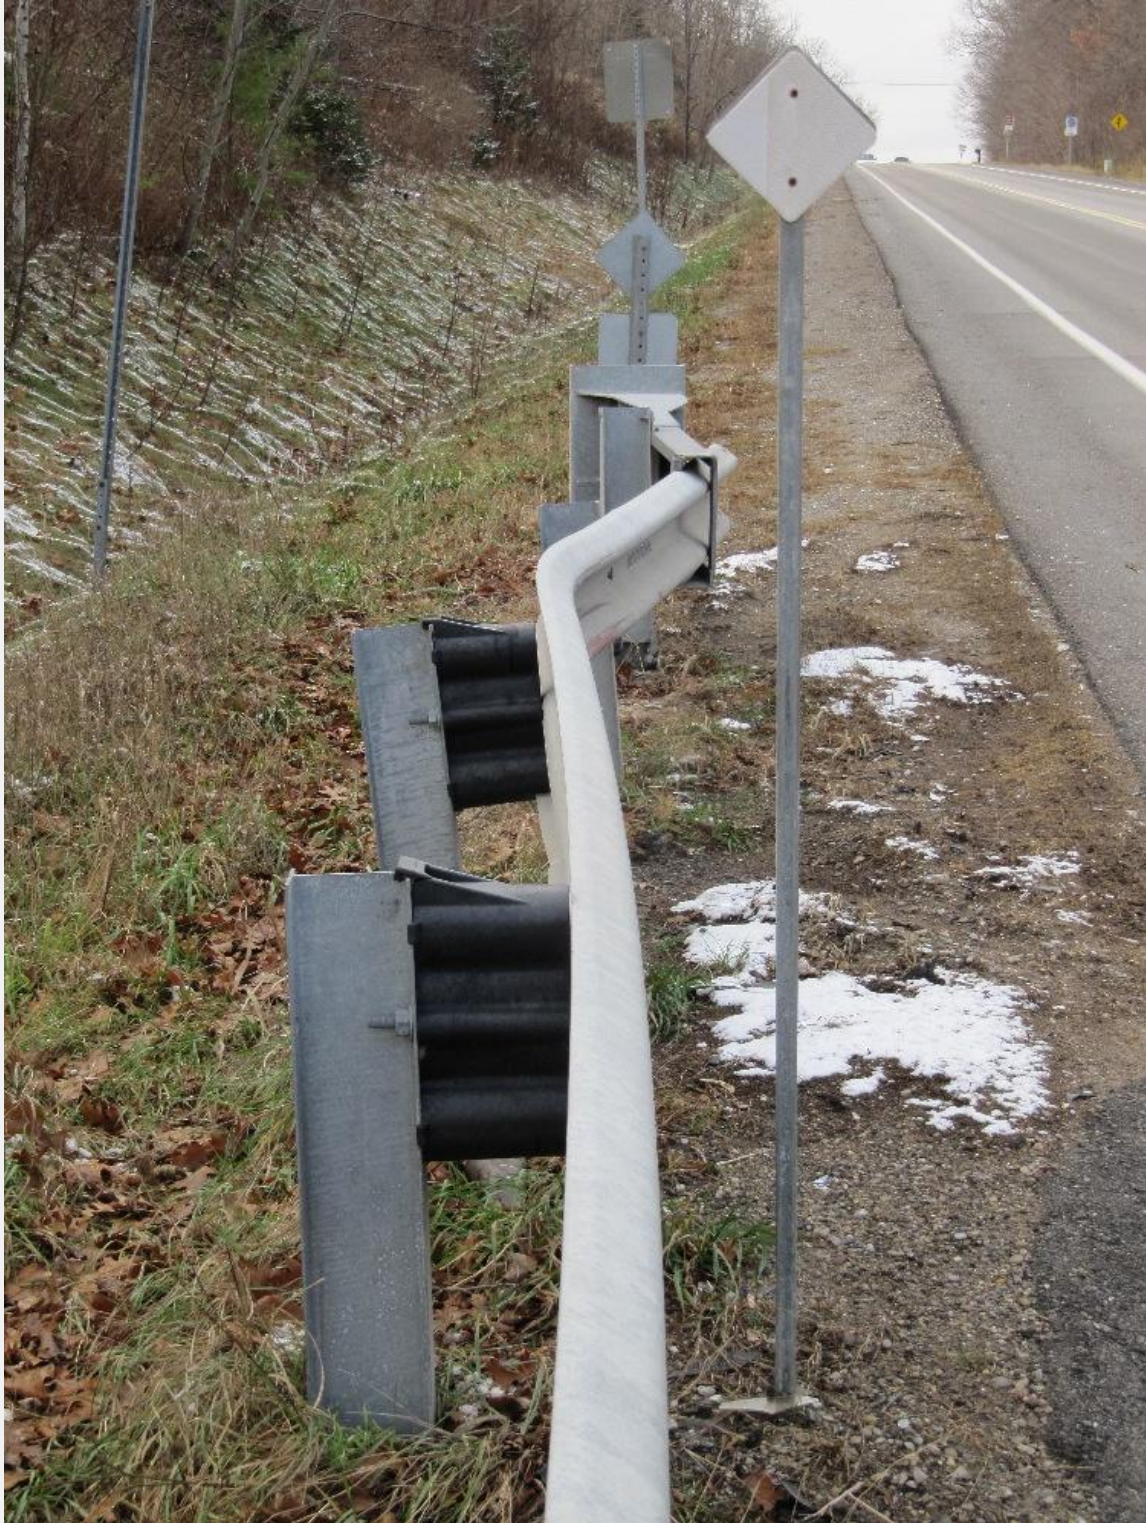
View, looking west, showing the extent of displacement of the rail by the impact and the Trinity end terminal in the background where the end of the rail has been pulled out and exposed to traffic.

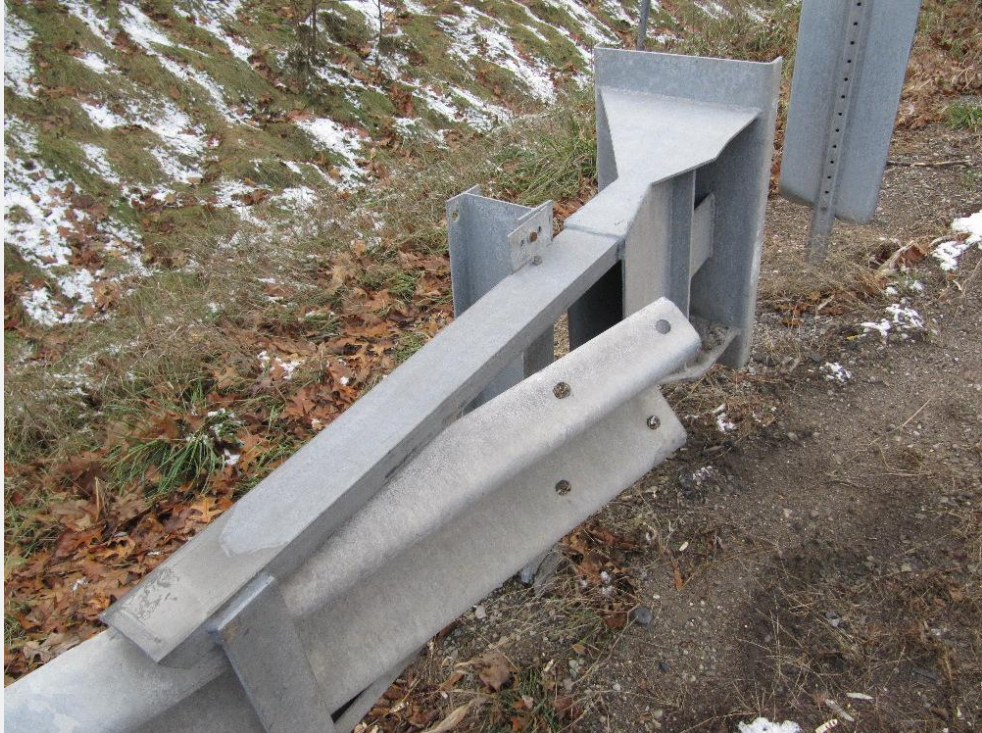
Close-up view showing how the end of the rail has been pulled out of the terminal.

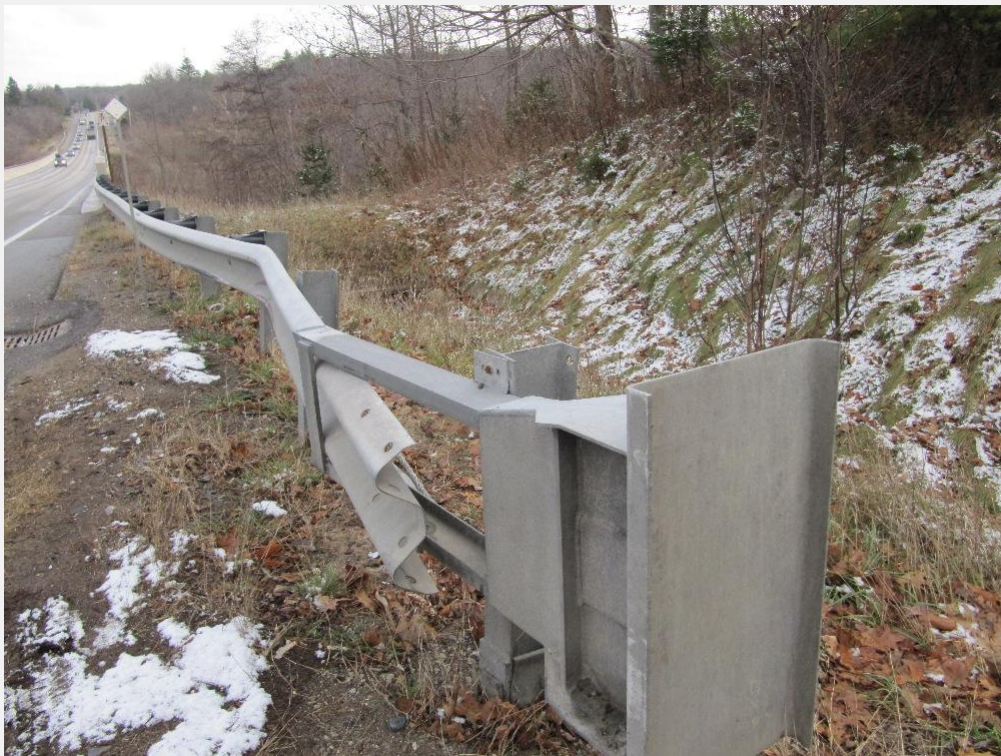
Close-up view showing how the rail has been pulled out of the end terminal and is exposed to potentially harpoon an impacting vehicle.

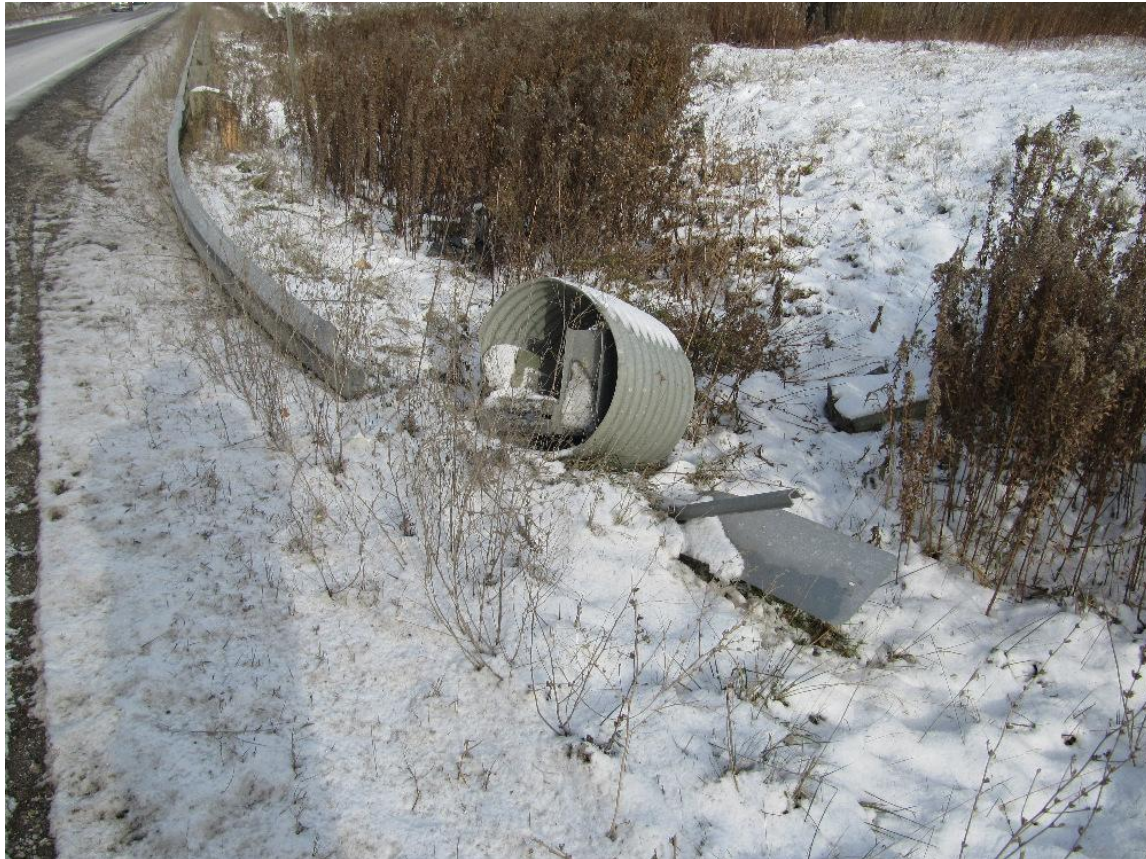
Replacement of this damaged guardrail end terminal would have been a simple decision only a few months ago, but now it is causing major concern across North America.

A collision with an older style end terminal on Clarke Road in London, Ontario has prompted Gorski Consulting to prepare a new article that discusses the difficult decisions that must be made regarding how the damaged system will be replaced. We encourage readers to visit the Articles page of this Gorski Consulting website to review the discussion.

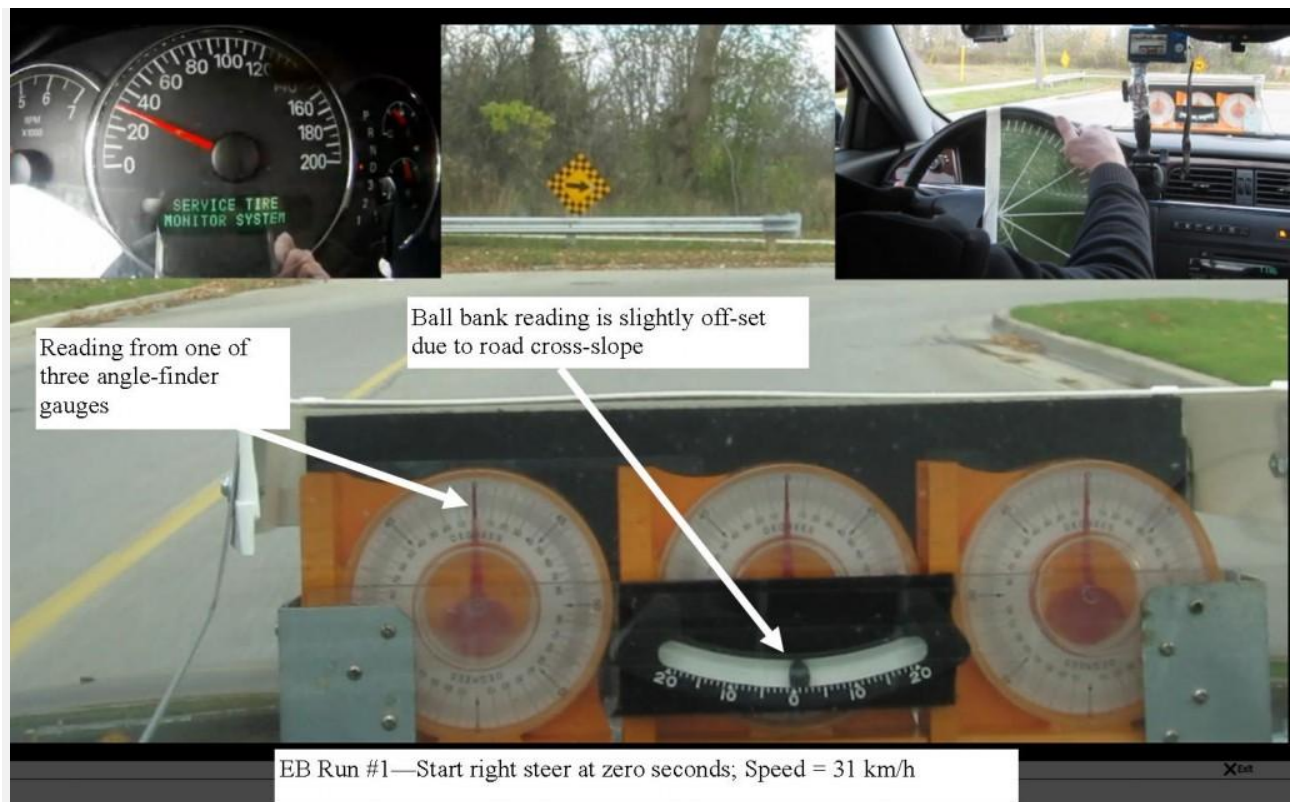
View from video cameras showing various gauges and instruments used to compare a ball bank indicator to the reading of an accelerometer during evaluations of a Speed Advisory Tab Sign on the curve of Beaverbrook Ave and Proudfoot Lane in London, Ontario.

A previous article (“Speed Advisory Sign – A Source of Potential Municipal Liability”, Nov 11-14) posted to the Gorski Consulting website demonstrated that a Speed Advisory tab sign posted on the eastbound approach on Beaverbrook to the 90 degree curve at Proudfoot Lane was likely improperly posted. Our testing on October 31, 2014 revealed that the 30 km/h Advisory Speed was too high for vehicles to safely negotiate the curve. This conclusion was based on data obtained from an accelerometer and not from a ball bank indicator which has historically been used to make Speed Advisory assessments. For this reason we returned to the site on November 7, 2014 and performed additional testing which included both, the ball bank indicator and accelerometer. The results of our additional testing confirm the conclusions of the initial tests. This additional testing also provided an opportunity to study the differences in functioning and display of the ball bank indicator and readings from an accelerometer. An article detailing the procedures and results of the testing has been posted to the Articles page of this website and we encourage readers to examine this work.

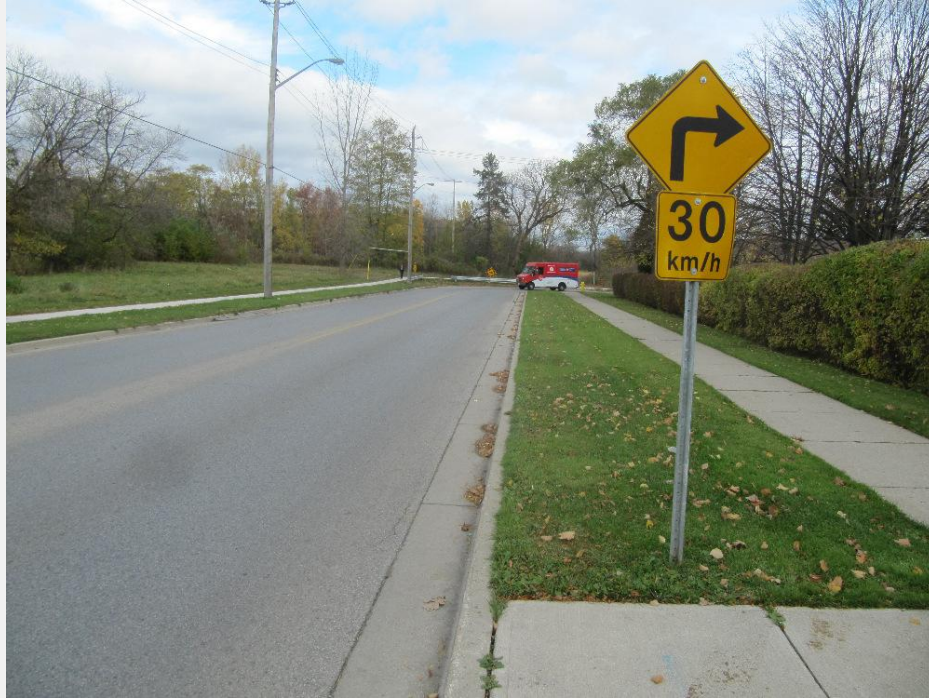
Is this Turn sign and Speed Advisory tab in compliance with standard procedures for road signage? Gorski Consulting has found out and our testing is revealing.

Recognizing that there was a potential safety-related problem we conducted testing at the site, after which we submitted a report to the City's Civic Works committee.
