Gorski Consulting Website

Archived News - 2015 - May

Re-Heating of Clarke Road Curve Safety Concerns

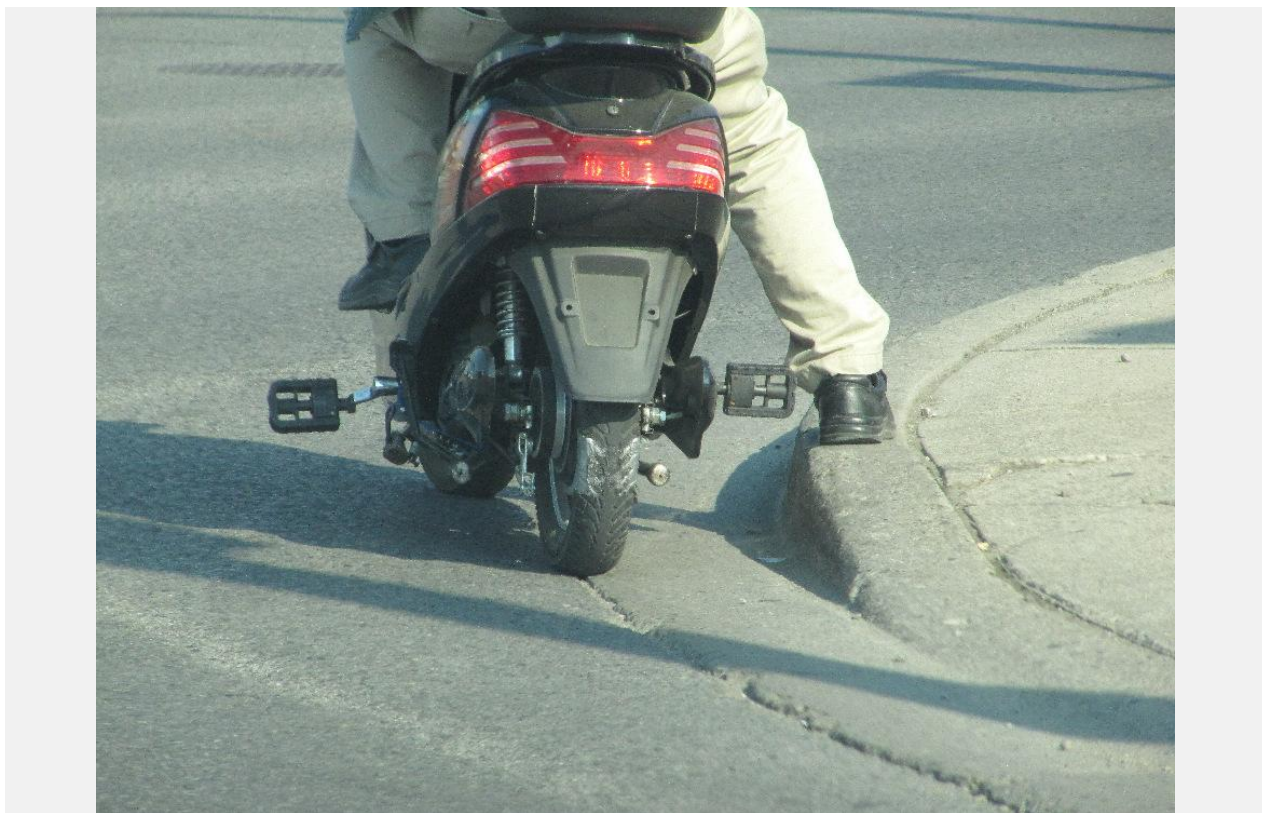
The law in Ontario requires that e-bikes must be equipped with pedals. However such pedals are too low and protrude outward in a way that contact with most urban curbs is a likely, yet unreported, fact.

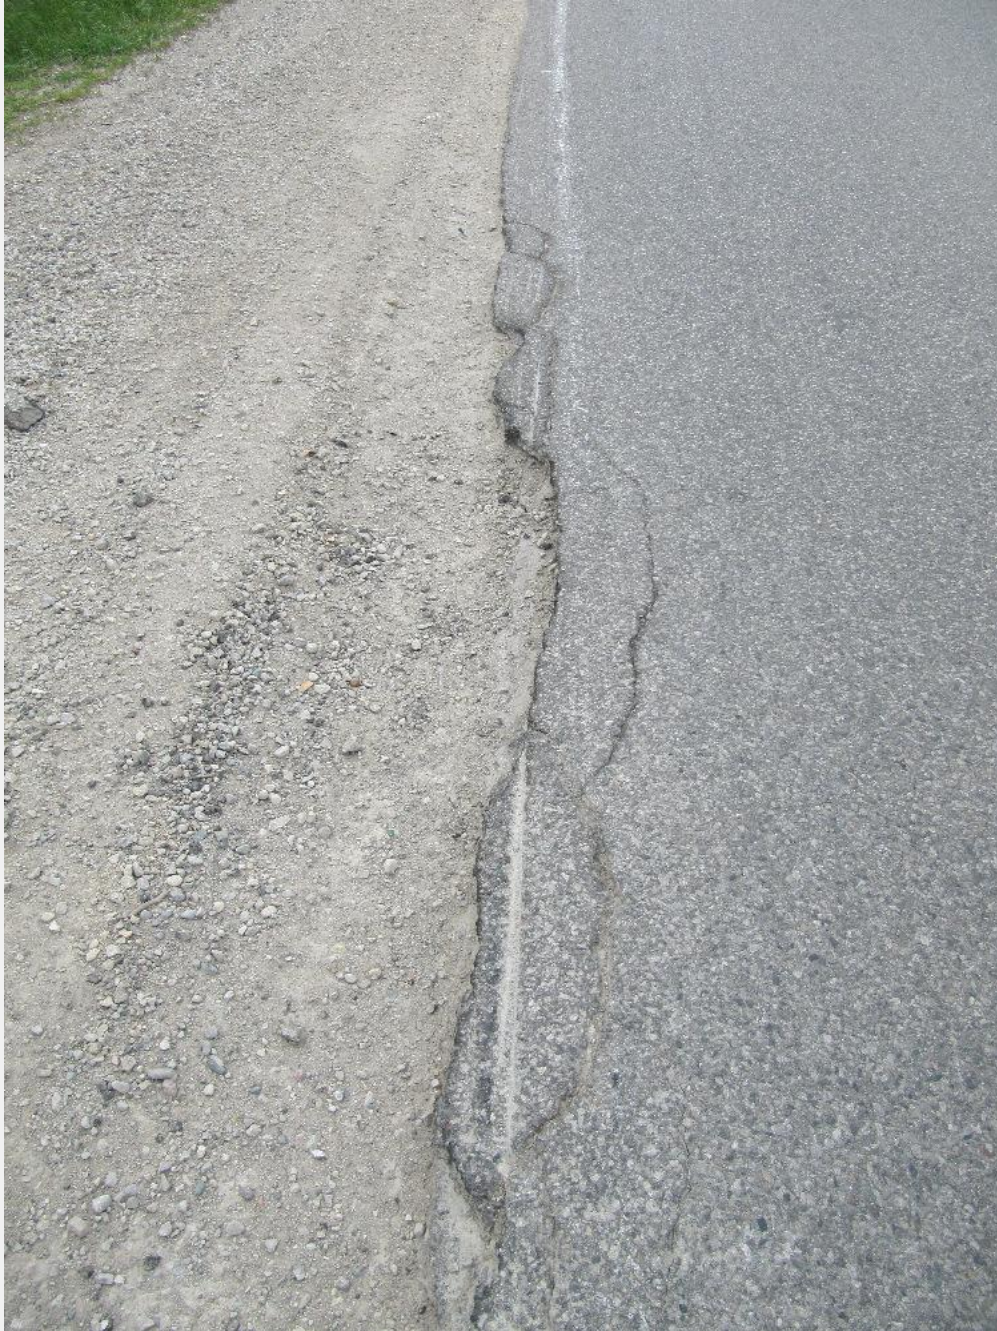
View of the breaking away of the east edge of the pavement at the apex of the north curve on Clarke Road north of Fanshawe Park Road in London.

The extent of the breakage of the pavement edge would not appear to be significant when viewed in the above photo. However this deterioration has occurred precisely where the right side wheels of passing vehicles normally travel very close to that edge, as shown in the wider view below.

Considering the small number of incidents we have observed at this curve in the past year it is of concern that we should find evidence of two fresh incidents that likely occurred in the span of the last 24 to 48 hours. One might believe that this is just a coincidence however the presence of the road edge deterioration should be a concern and we will be monitoring how the City of London road maintenance personnel react to this new development.

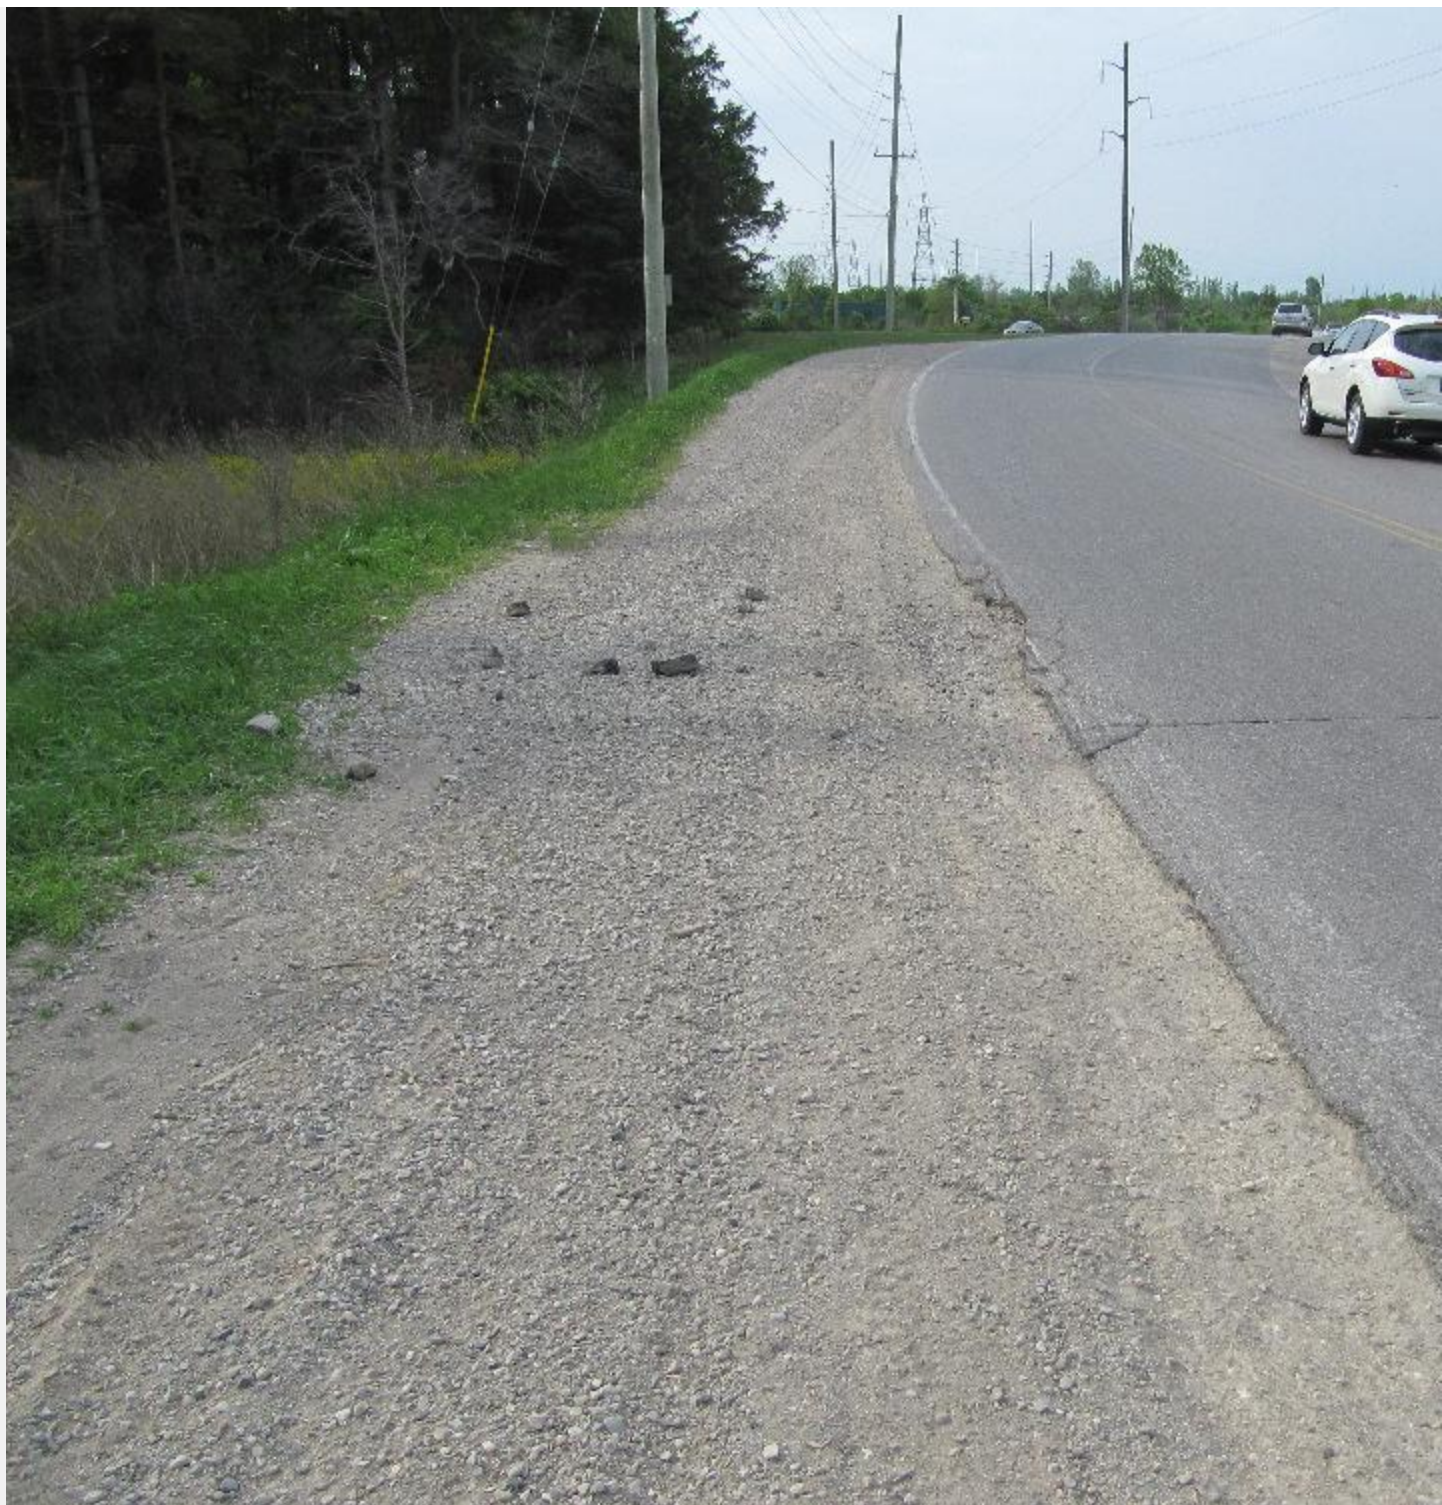
View, looking south, at the area of broken pavement with respect to the curve on Clarke Road.

Now, a larger number of northbound vehicles will have their right side tires travelling off the pavement edge and this could be an increased safety concern. This is not an empty statement. This morning, May 25, 2015 we observed evidence where two vehicles travelled off the east side of the curve and onto east roadside. In one instance we believe that a dump truck or a similarly large vehicle travelled off the road edge as shown in the photo below.

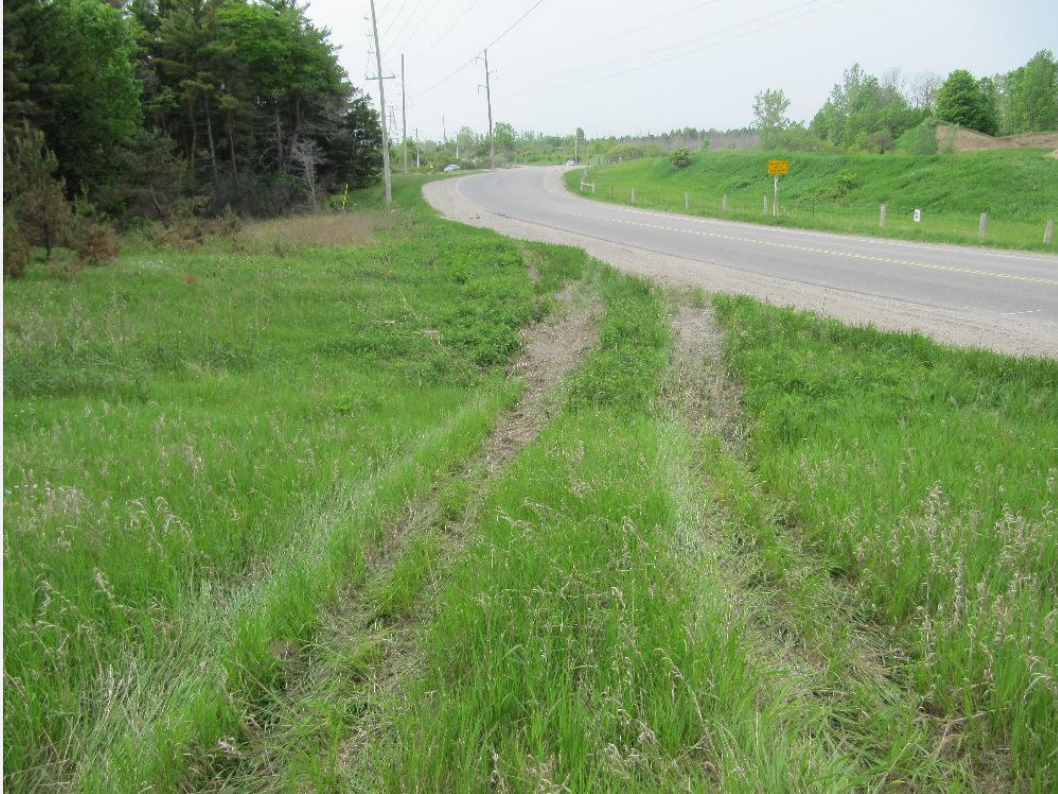
Evidence of deep gouging in the east roadside where a dump truck likely travelled off the road at the noted curve.

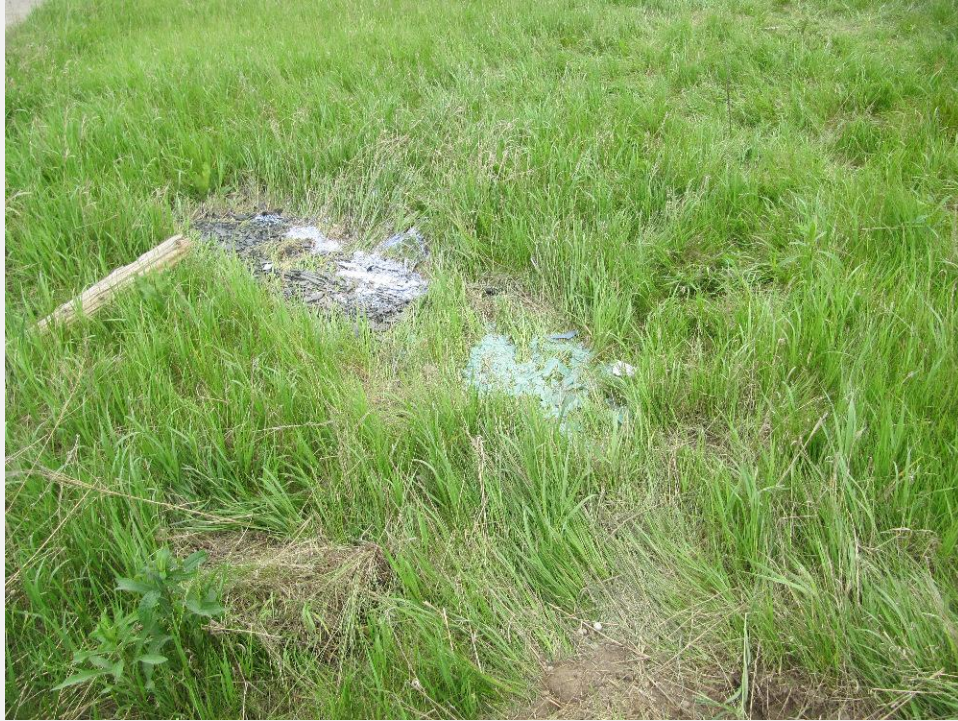
In a second incident a Chrysler vehicle rolled over after travelling up the tall embankment, coming to rest on the east roadside, as evidenced in the photos below.

Evidence of a fresh concentration of broken glass from a vehicle that rolled over in the east roadside.

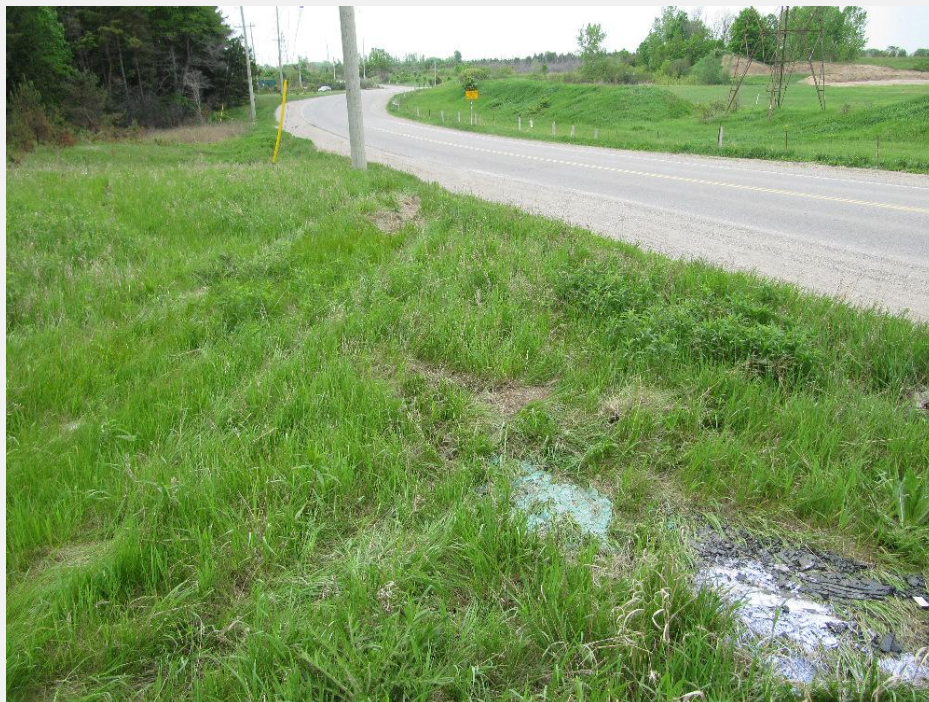
View, showing the relationship between the location of the broken glass and the north curve of Clarke Road.
