Characteristics of ABS Skid Marks on Snow-Covered Asphalt

Posting Date: 3 Feb 2012

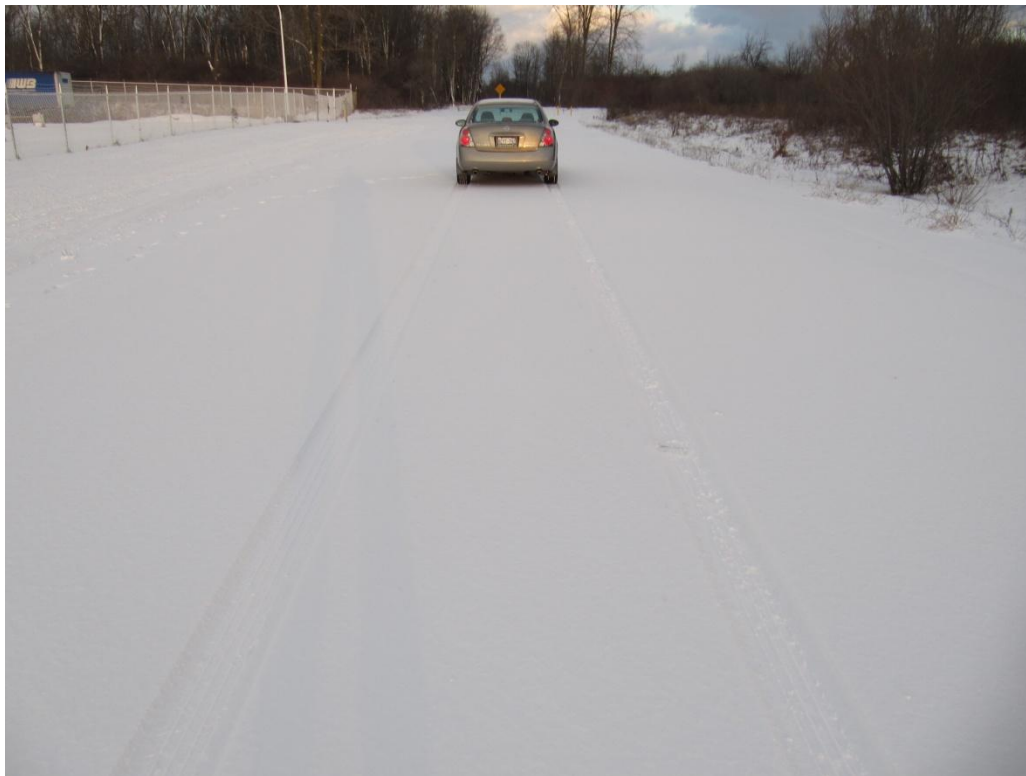
The first test (see below) is on a asphalt surface covered by approximately 2 inches of fresh snow that has not been previously driven on by any traffic.

Figure 1: Maximum Braking Test on Two Inches of Fresh Snow

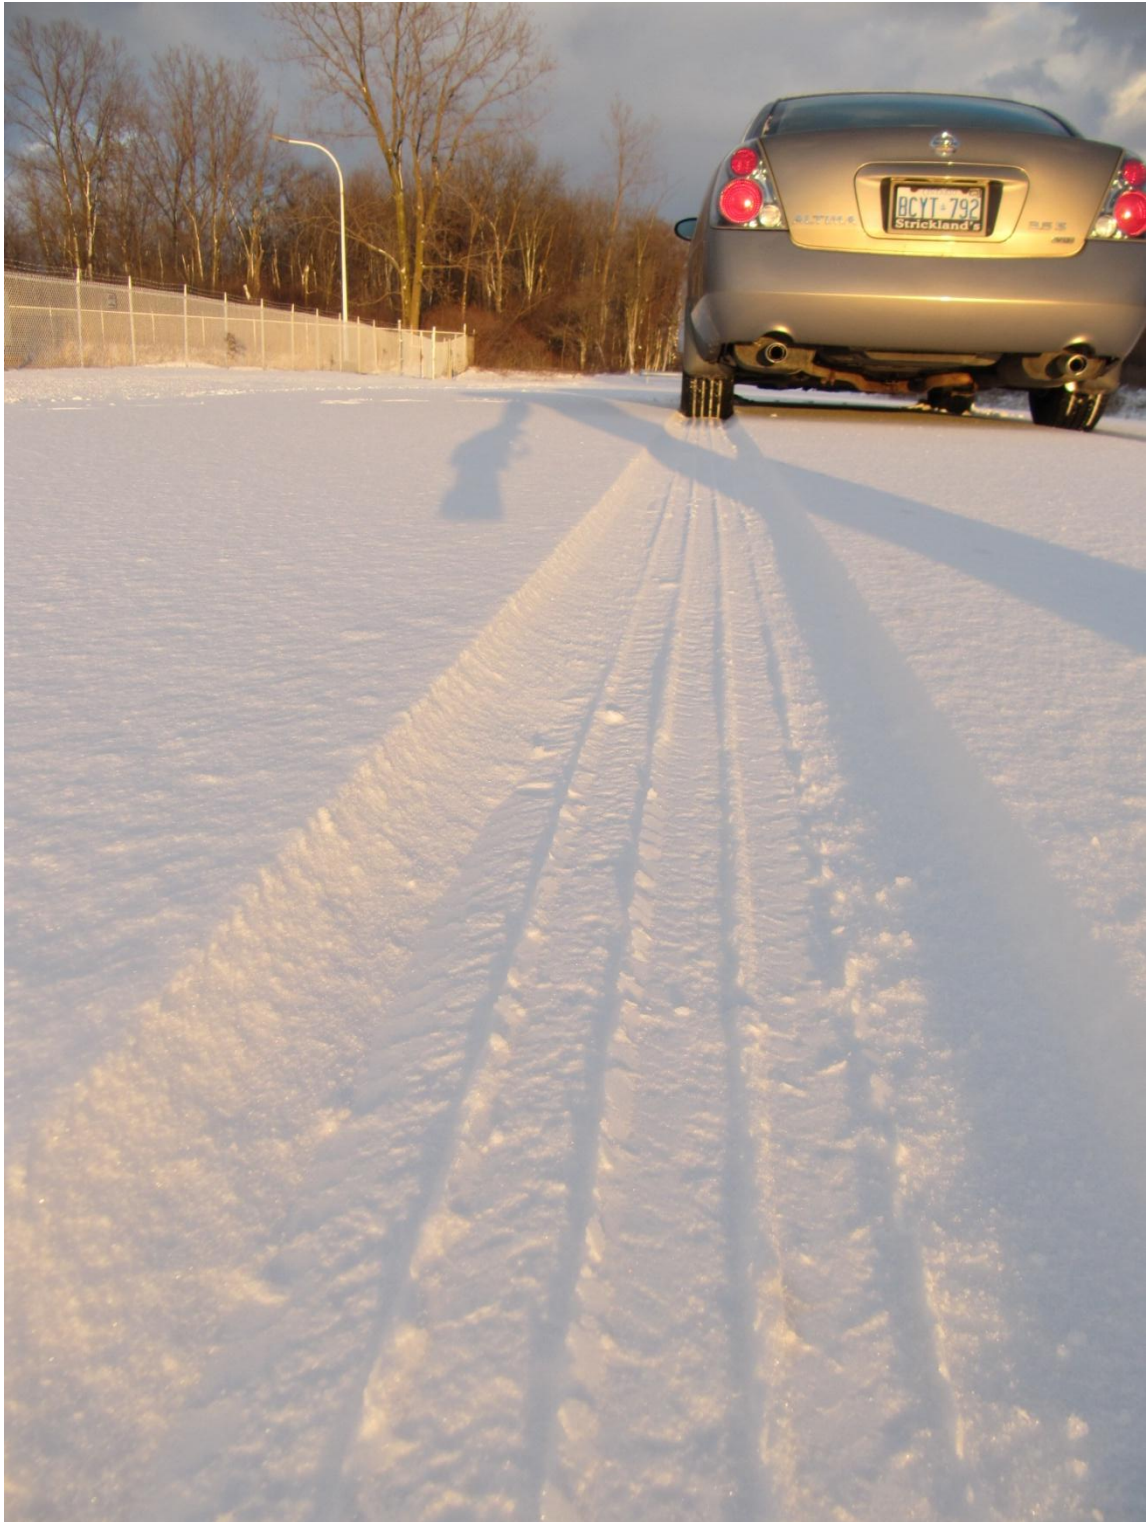
Above is a view of the braking mark resulting from the left side tires of the vehicle and on the following page is a view of the braking mark from the right side tires.

While the left side mark shows no signs of upheaval of the snow the right side does. The tread of the tire is visible and undisturbed on the left but some of the snow from the tread impression on the right is tumbled in the foreground while it remains relatively intact further toward the vehicle. The decision-making of modern braking systems is such that the character of braking marks on opposite sides of the vehicle may not be the same.

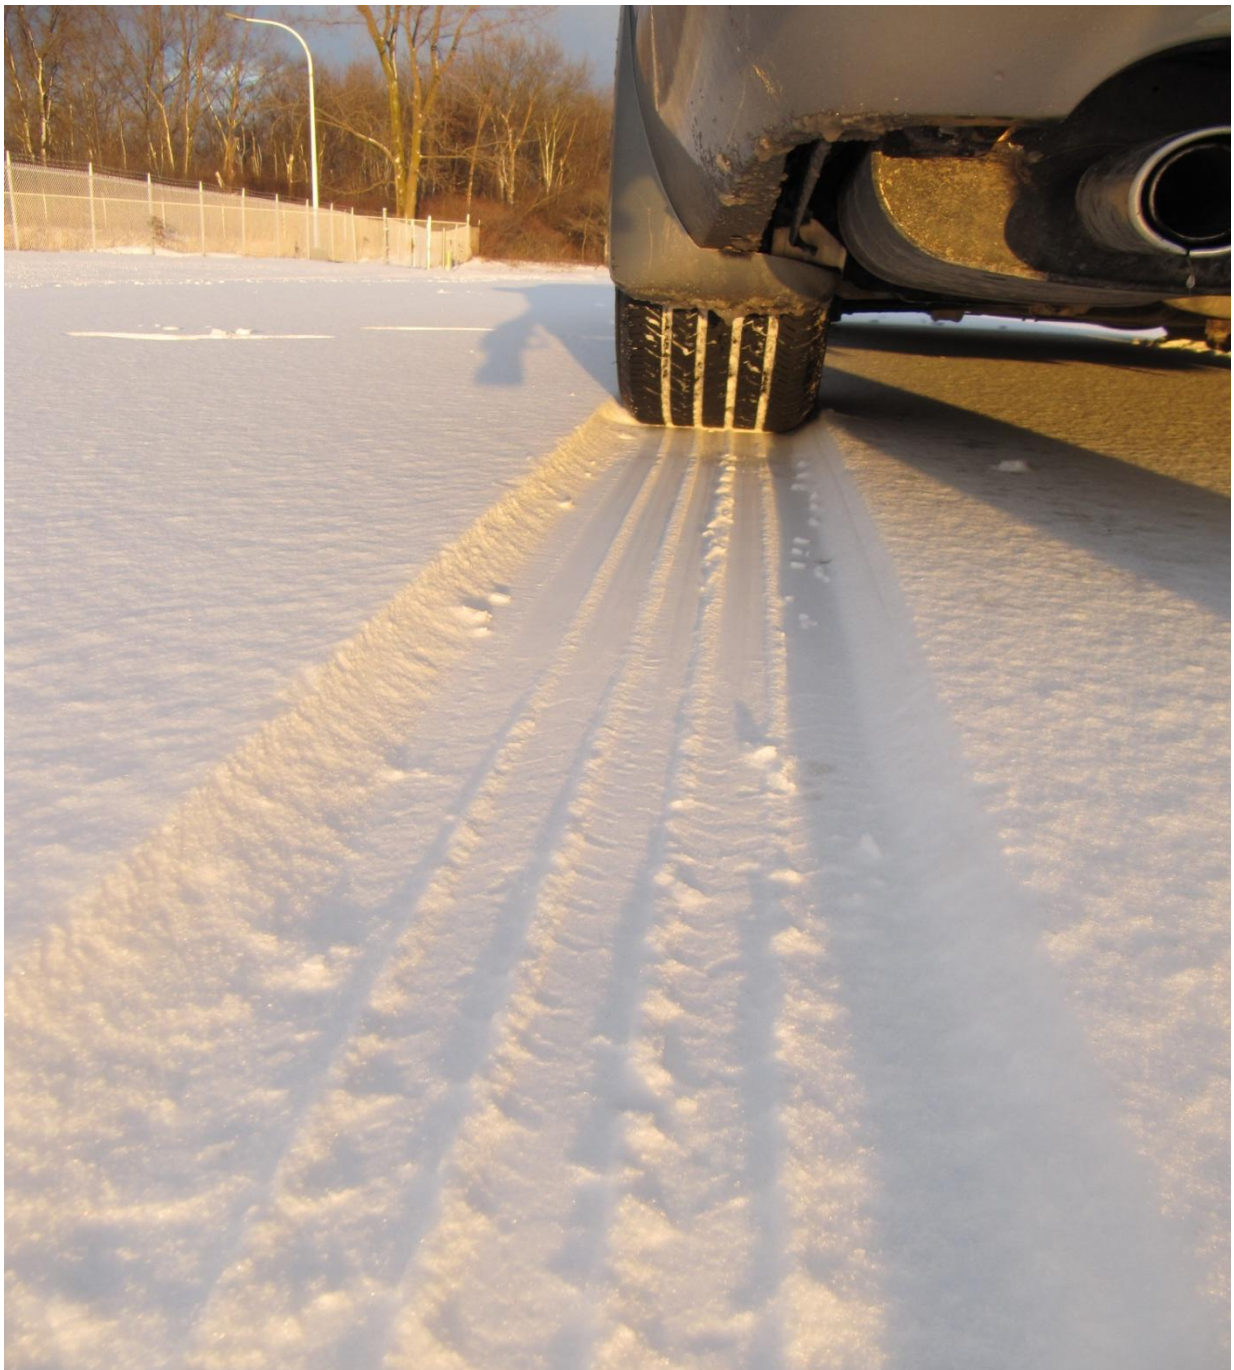
Near the point of final rest the ABS disengages and the tire enters into a locked state causing the character of the tire mark to change as shown below. Note the evidence of smooth sliding of the tire near its rest position versus the appearance in the foreground where the ABS was active.

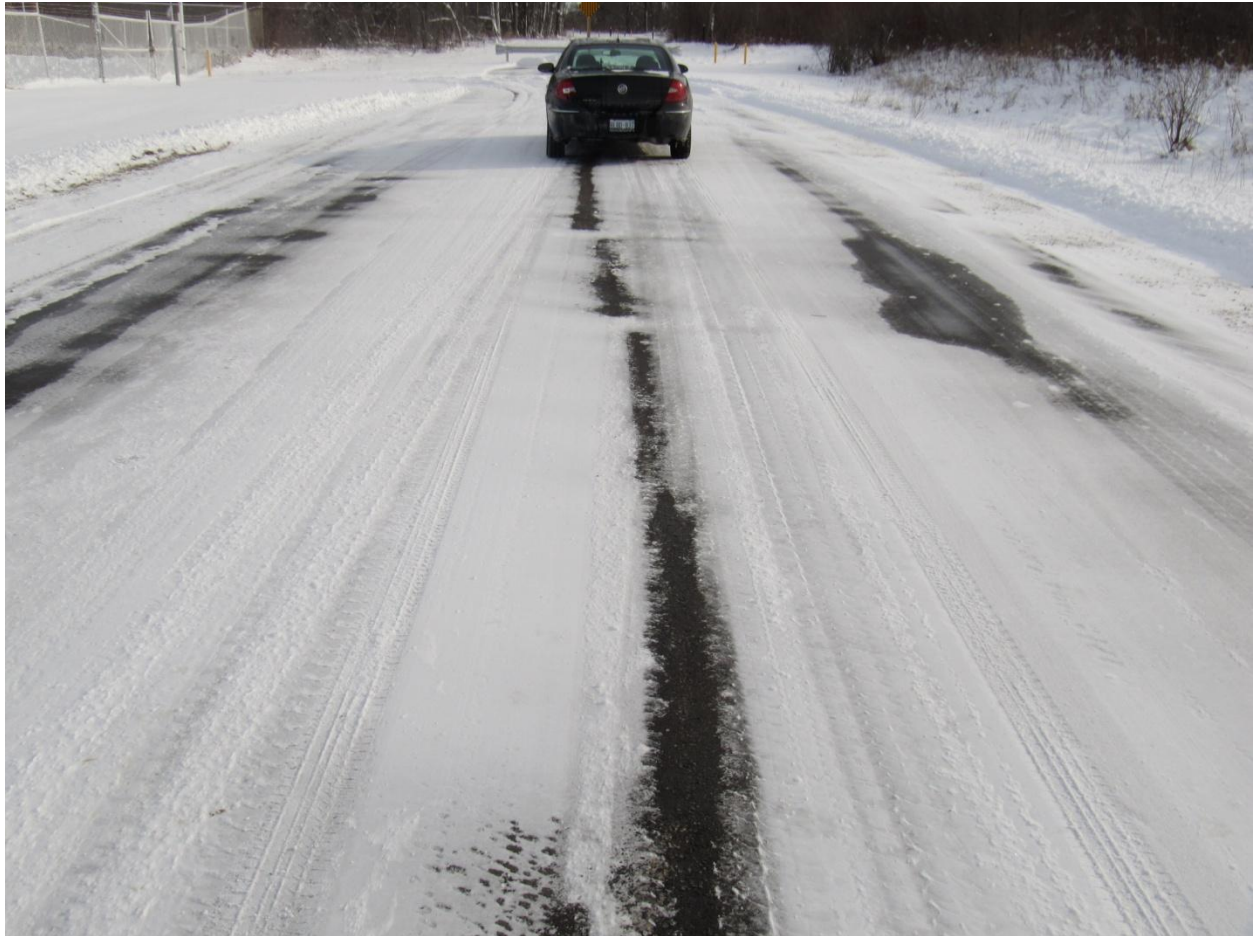
In another test shown below , maximum braking was applied on an asphalt surface where the top layer of snow was plowed away leaving a thin layer of packed snow.

It is more difficult to detect these tire marks amongst the others but it is also more difficult to determine which of these tire marks indicate maximum braking. Close-up views of the tire marks from the braking vehicle are shown on the following pages. On the left side tire mark the details of the tire tread can be seen with little evidence of the momentary disruptions that are indicative of the short periods when the tire approaches lock-up before the braking force is reduced. In contrast the right side tire mark clearly exhibits those momentary pulsations.

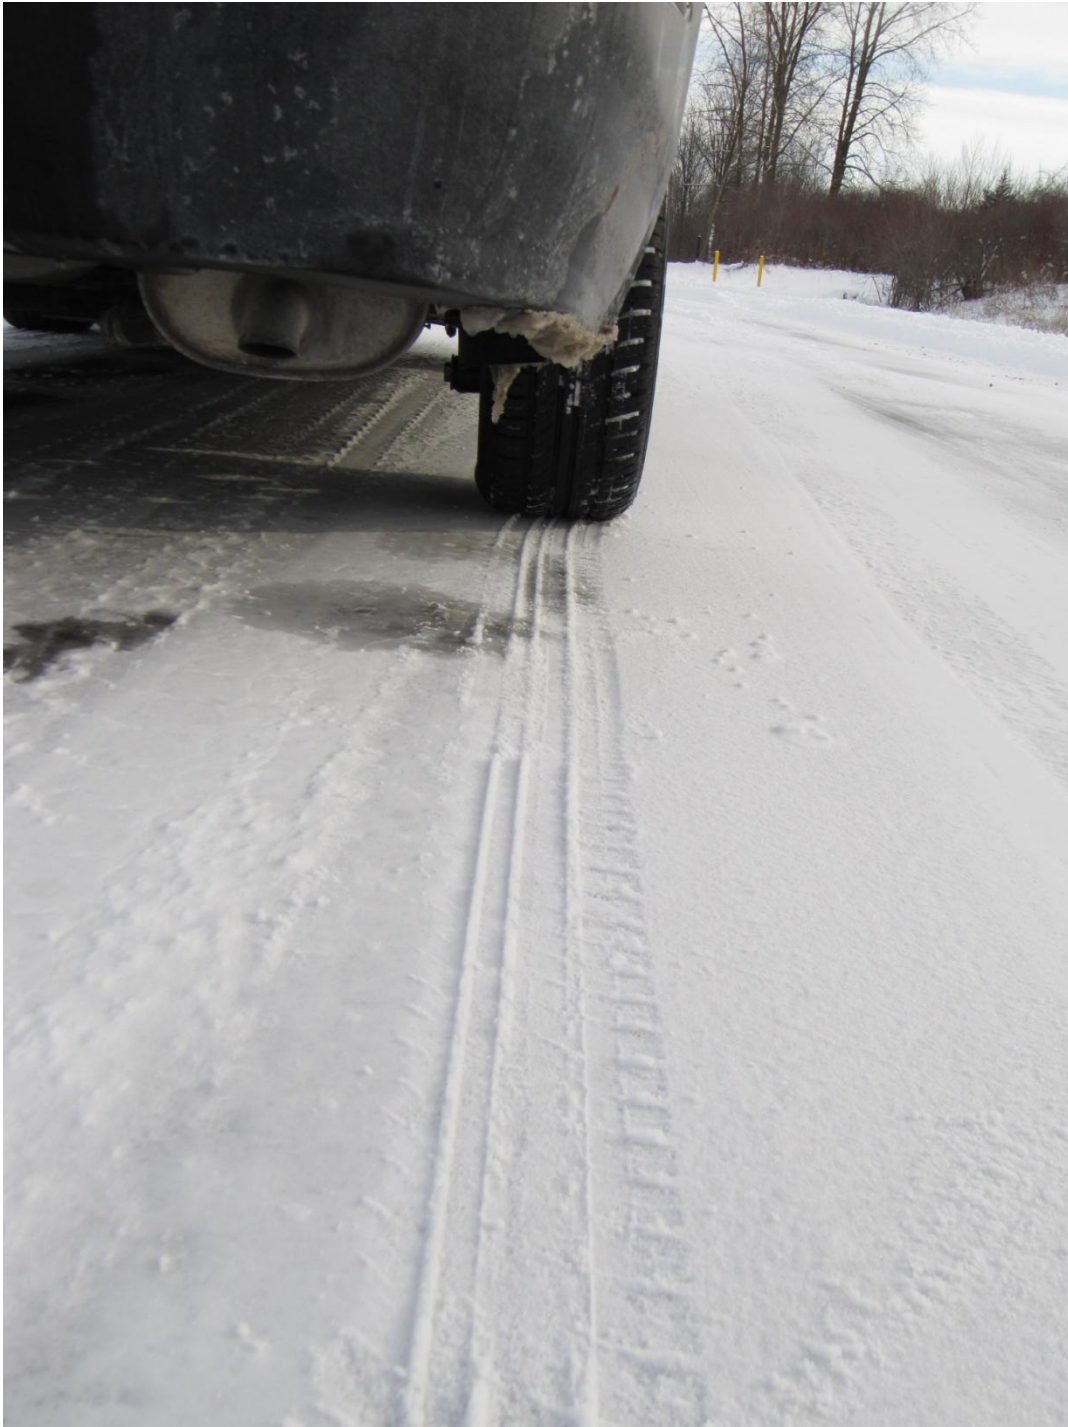
As discussed in the previous test, the release of the ABS near the final rest position of the vehicle causes a well-defined, short sliding mark (see below) that is different in character from the mark visible in the foreground.

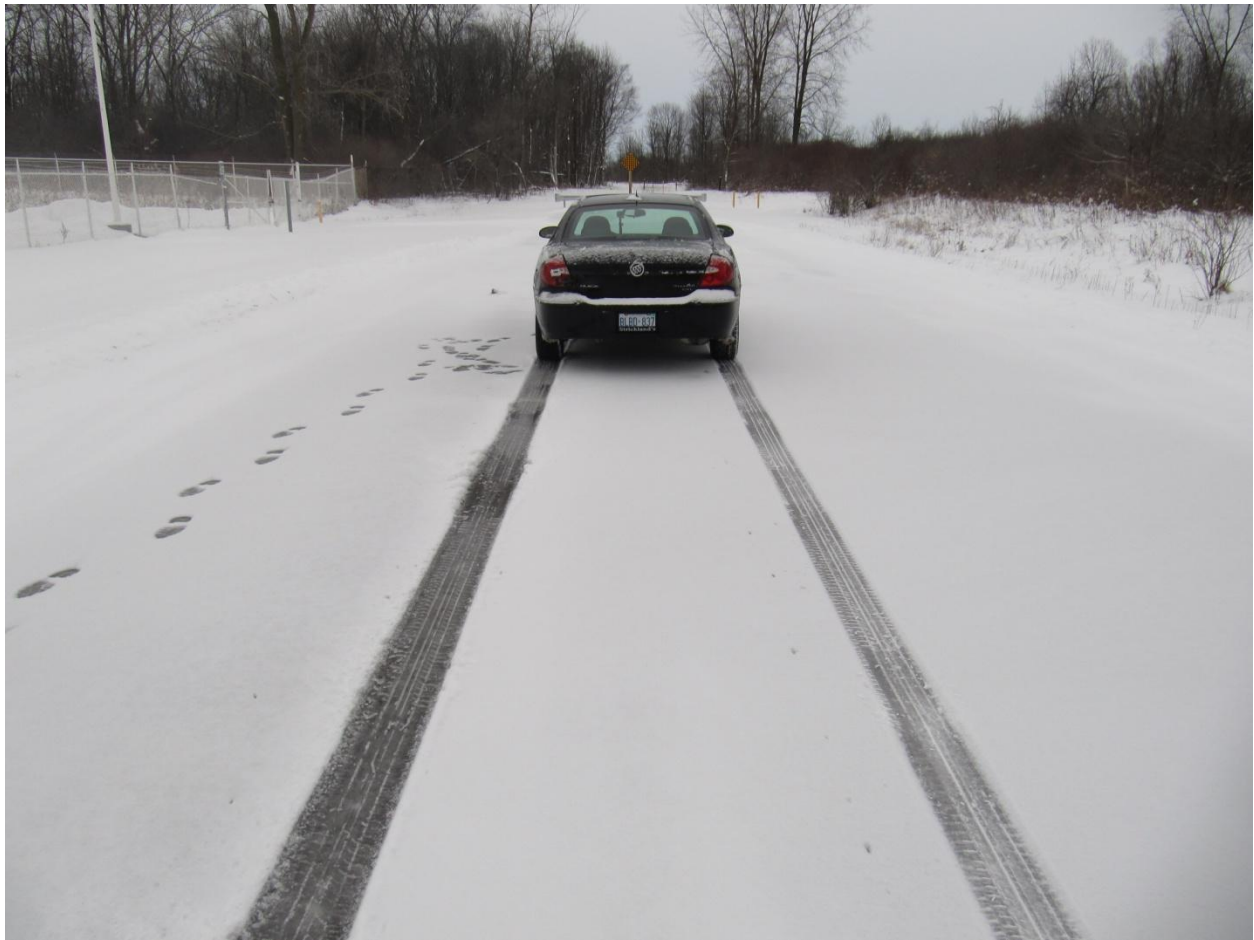
In a third test a vehicle was braked on a 1 to 2 inch layer of fresh snow that had fallen on the packed snow shown in the above photos. The resulting braking marks from this test are shown in the photo on the following page.

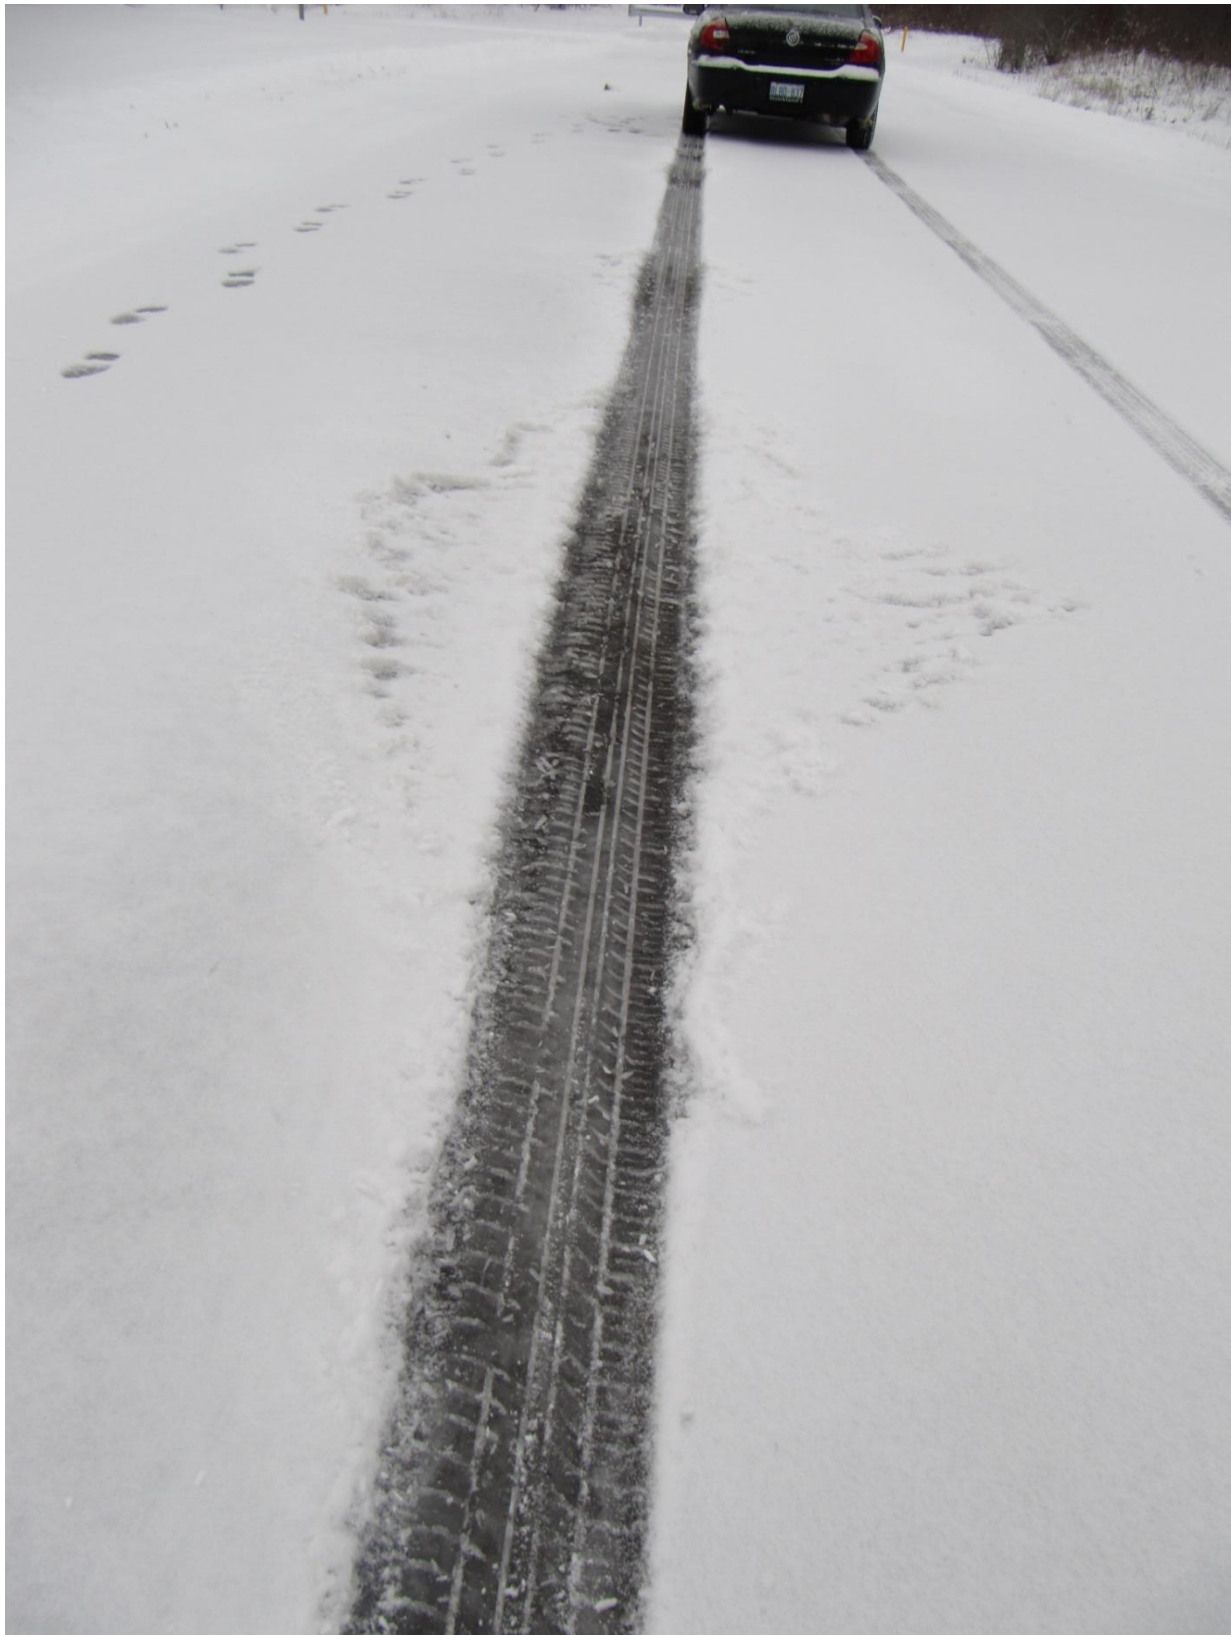
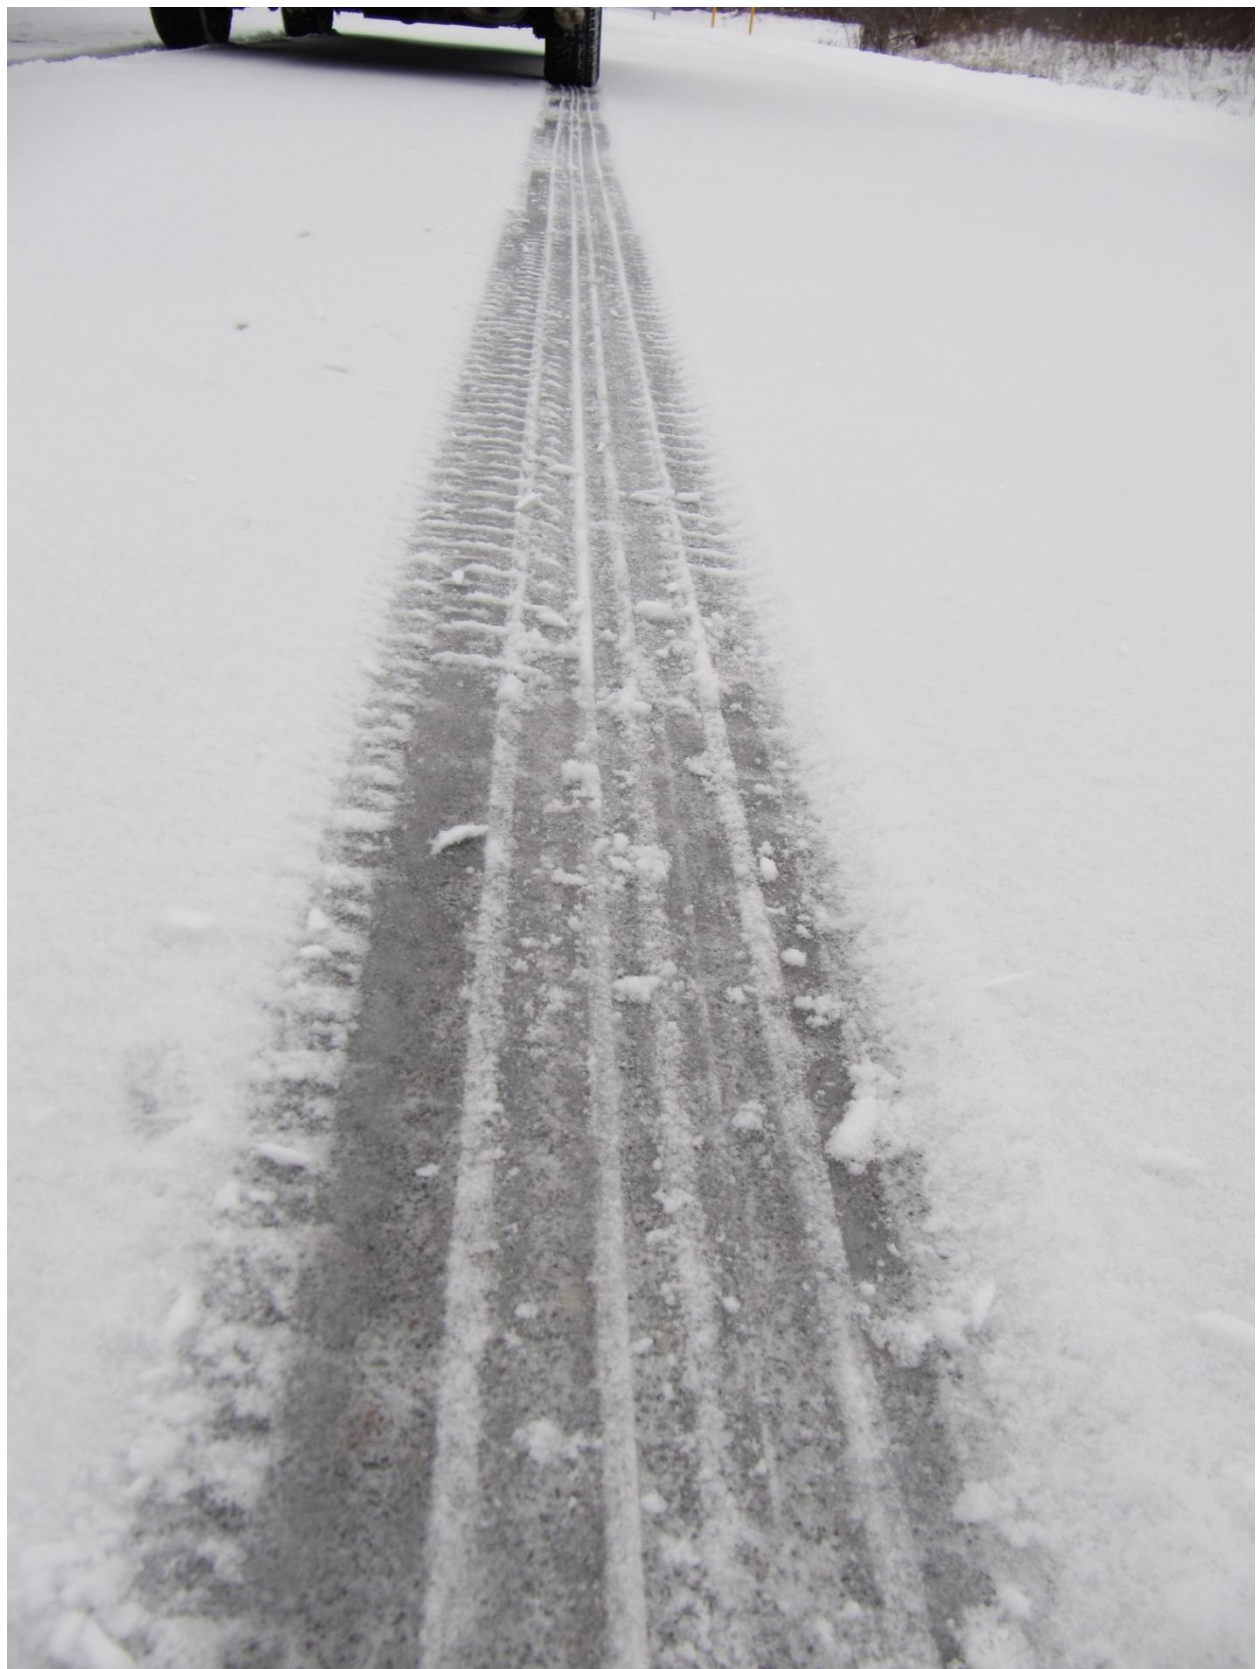
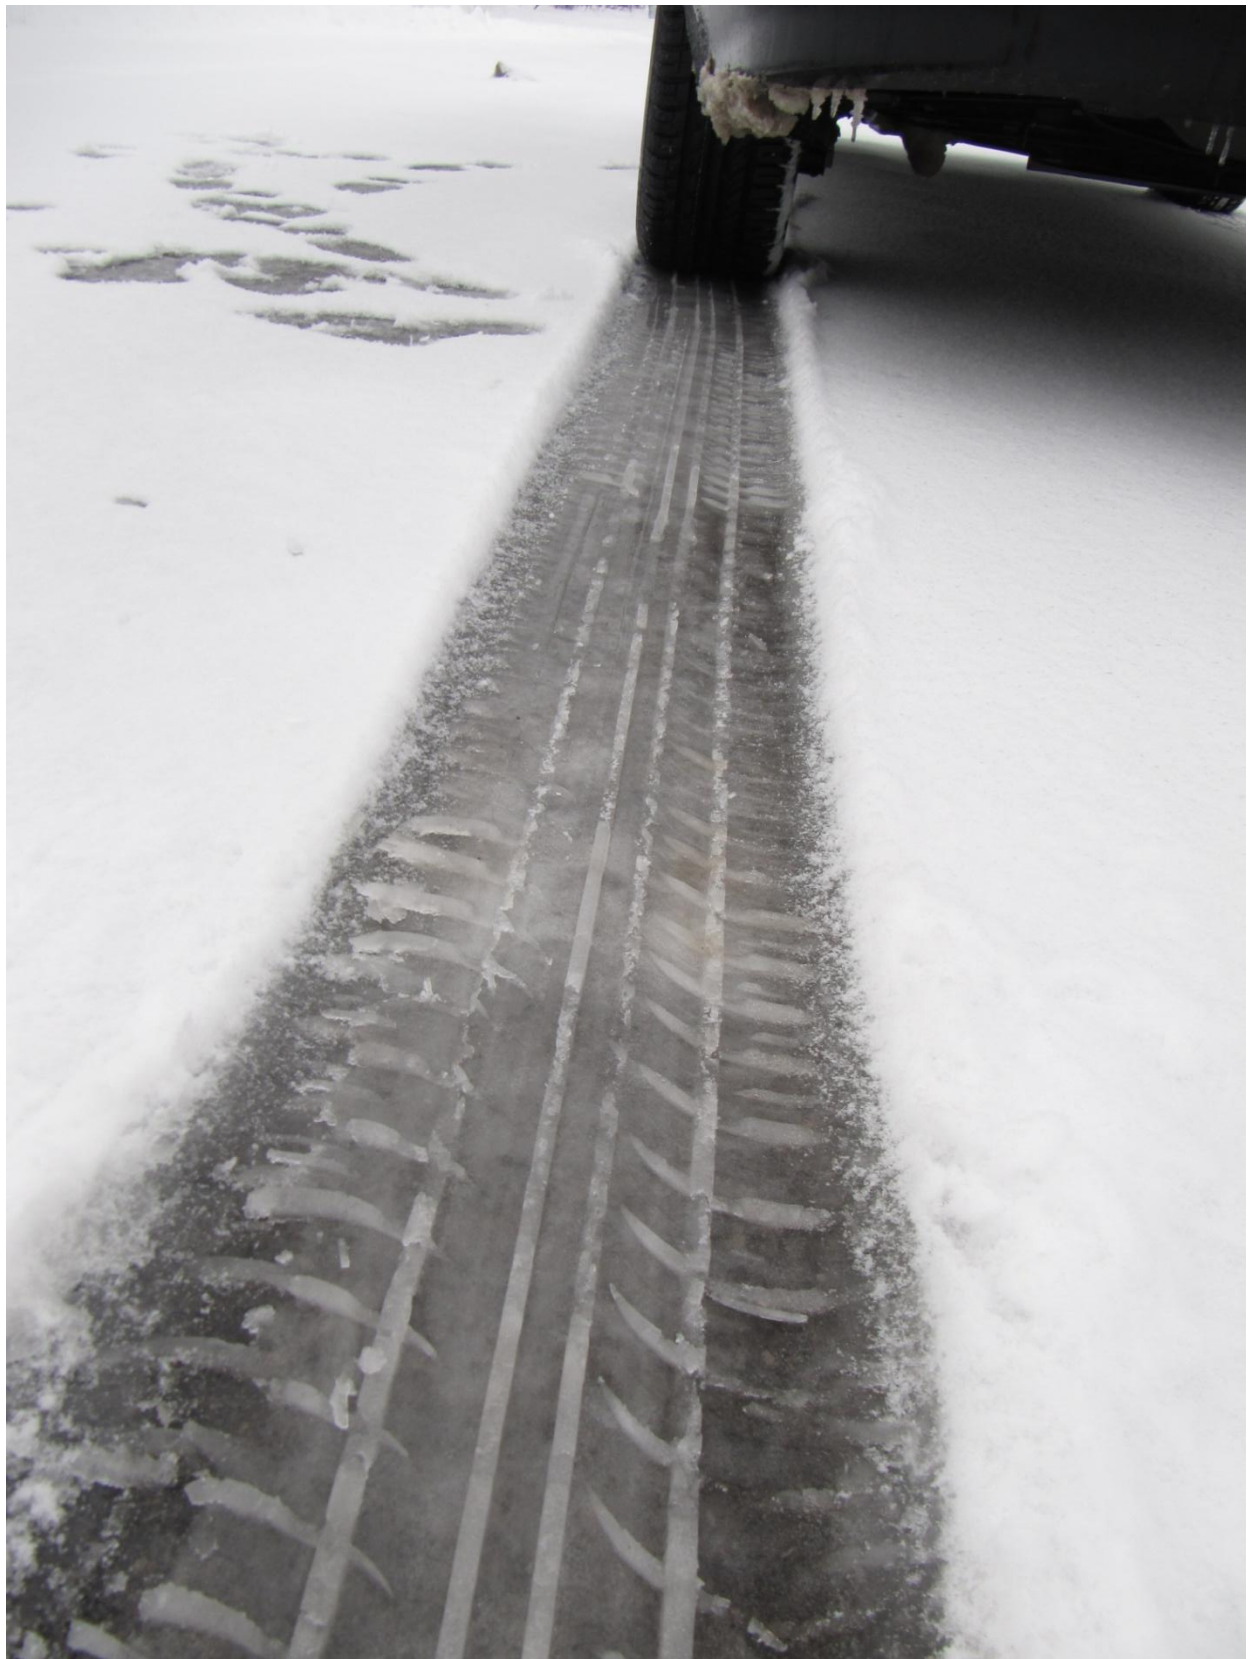
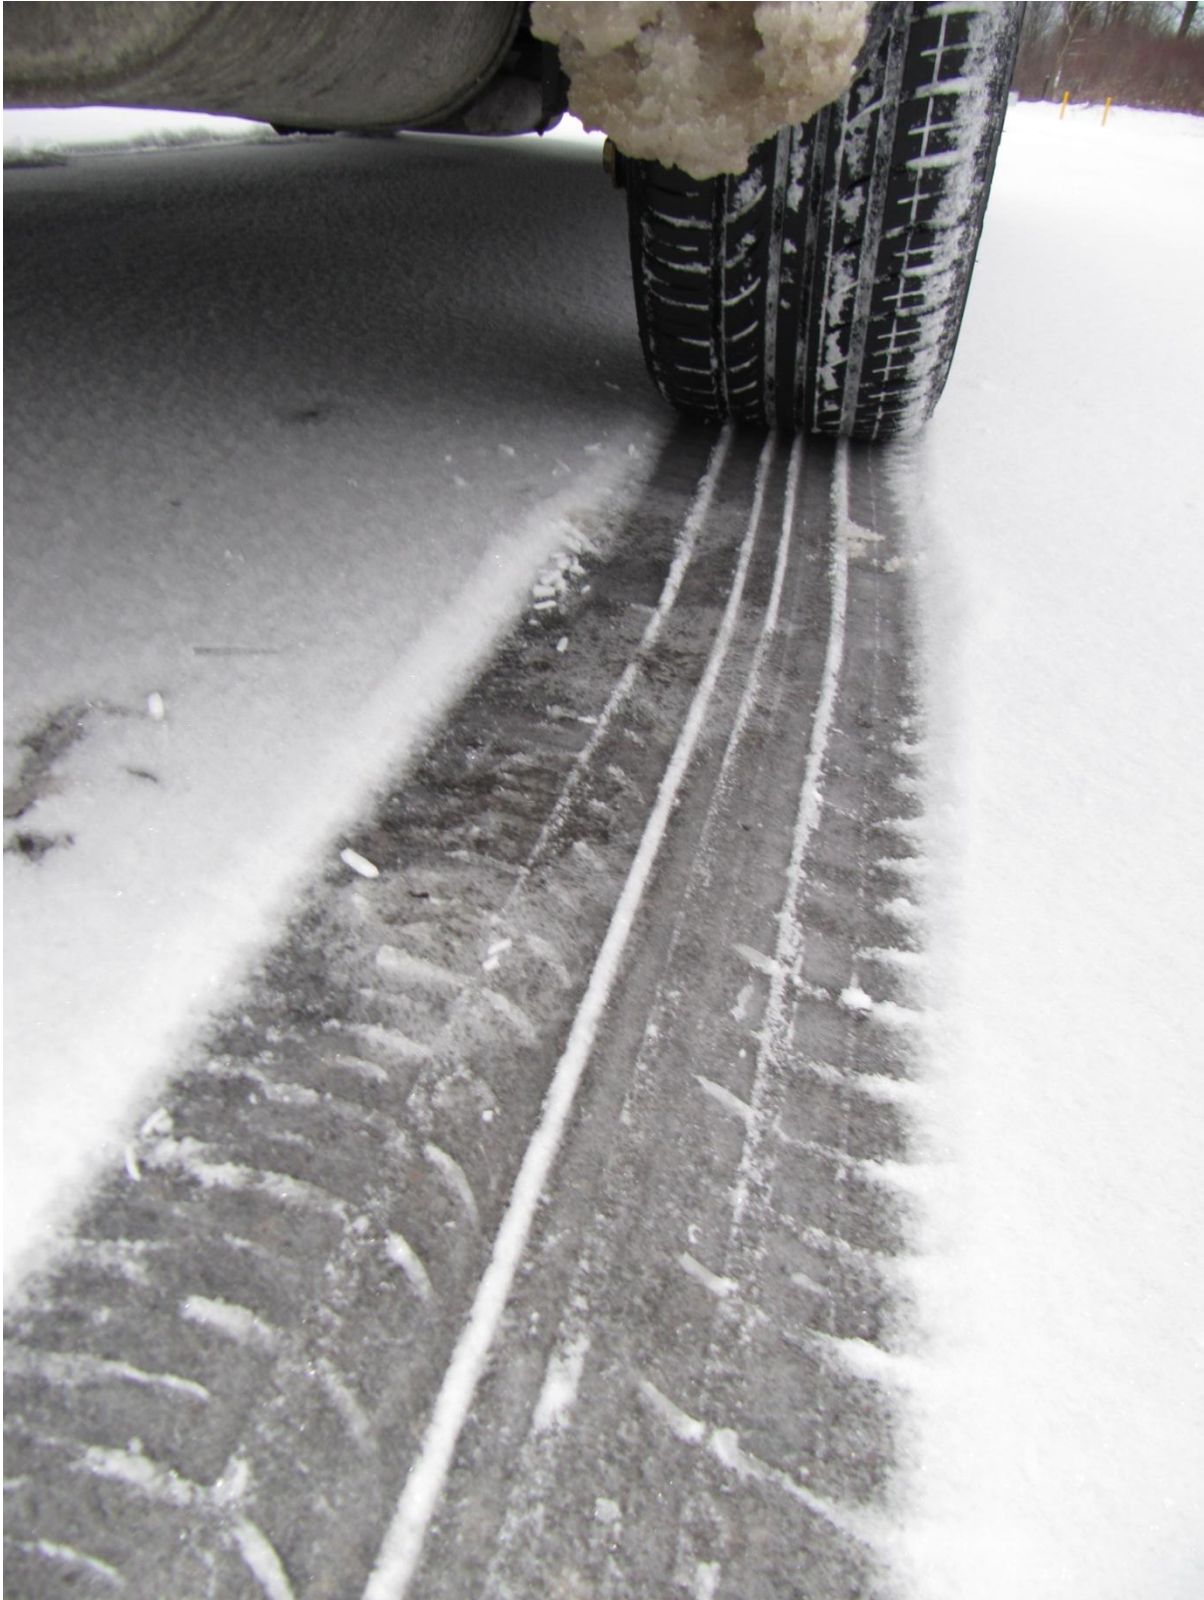
The tire marks on fresh snow provide some clear indications of the pulsations that occur during ABS engagement. These pulsations are visible in the photos shown on the following pages. Note also that during these pulsations the snow is thrown to the left and right of the left side tire mark while in those portions of the tire mark where the pulsation is not present there is no such dispersal of snow. Alternatively such throwing of the snow is not visible around the right side tire mark.

Near the rest position of the tires the evidence of ABS disengagement is not as pronounced.
