# London City Police Cruiser Rear-End Collision - Review of Physical Evidence & Potential Analysis

*Posting Date: 9-Sept 2014*

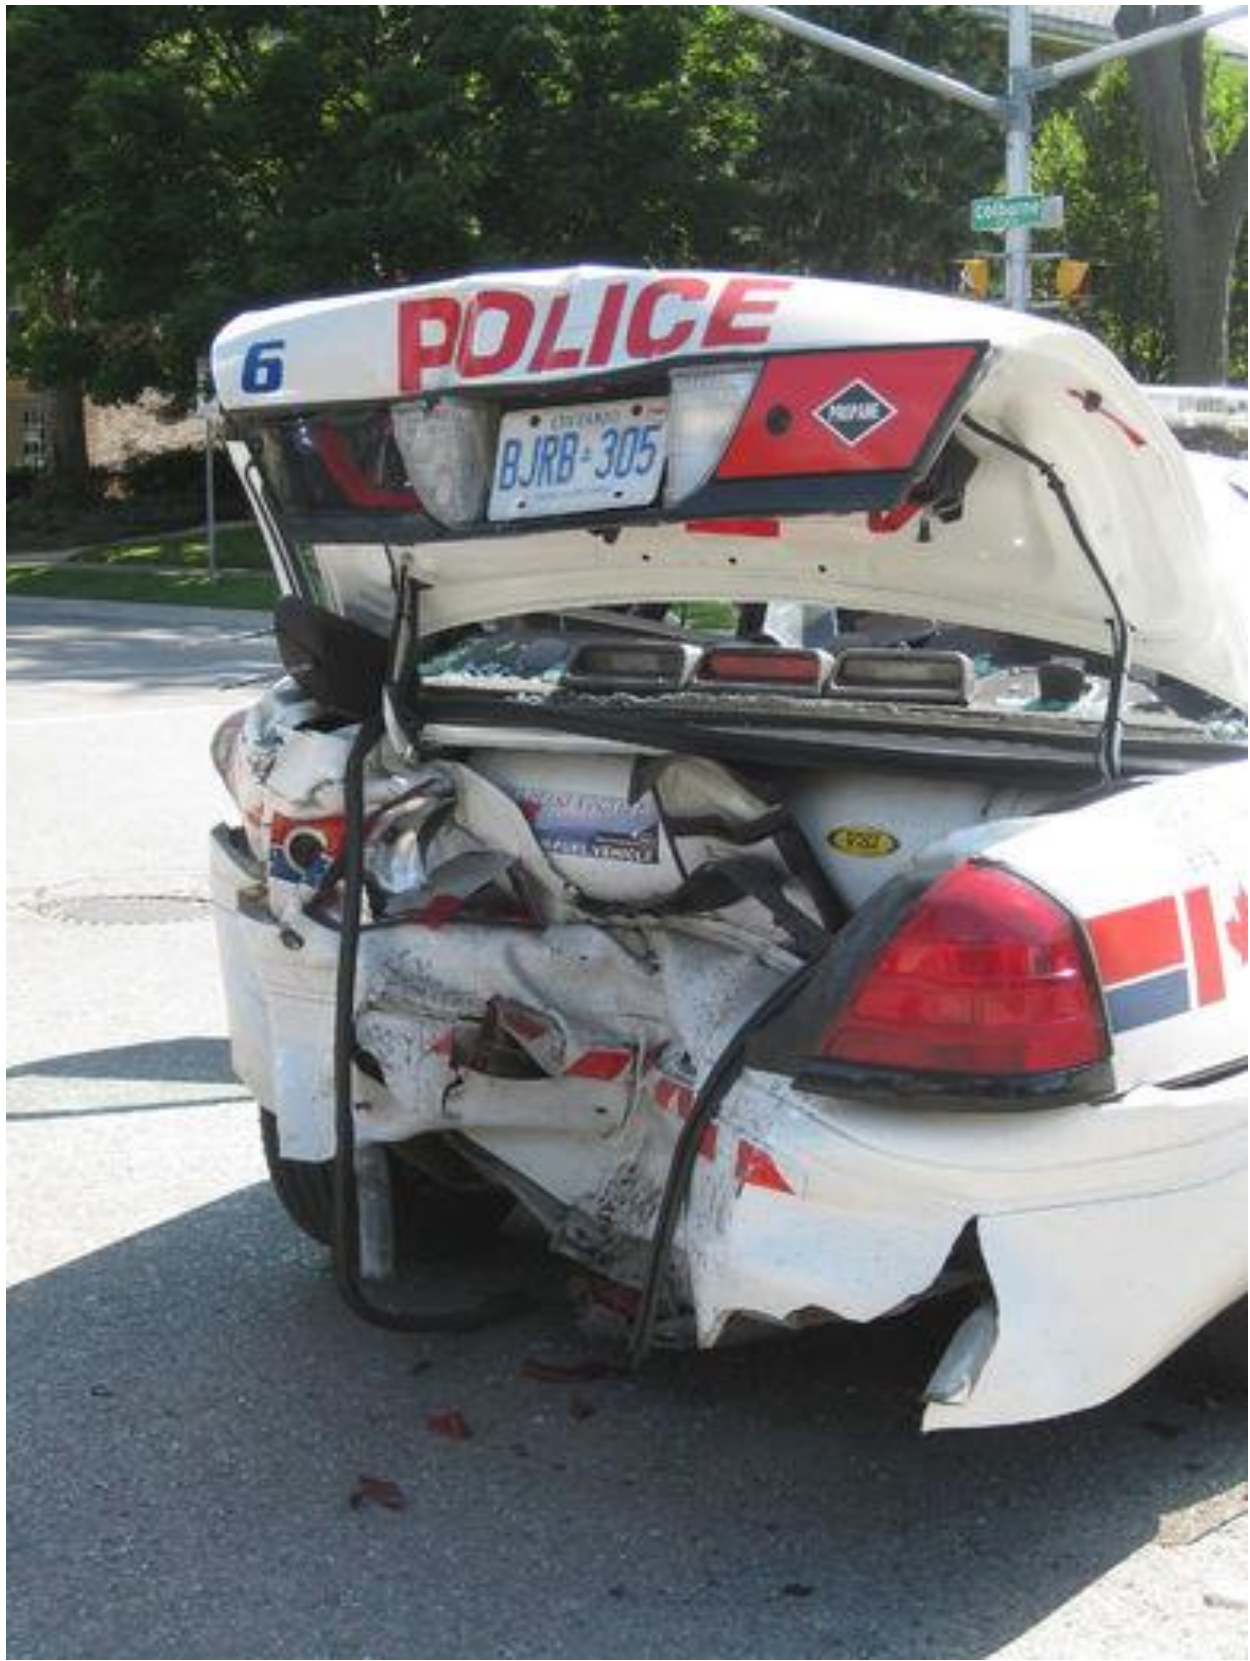
Figure 2: View of the substantial crush to the left portion of the rear end of the London City Police cruiser.

If one looks closely into the middle of the right lane one should be able to detect some scrapes in the pavement that are parallel to the length of the lane. These were caused by one of the vehicles at impact. More interesting is the commencement of a fluid trail that curves from that POI somewhat toward the north-east. Such fluid trails are typically caused by the explosive bursting of the contents of the engine compartment of the impacting vehicle, but not always. Yet the point where this fluid trail begins is consistent with the police cruiser being stopped at the stop bar and the van being offset to the left of the cruiser at the initial contact. This overlap is consistent with the area of direct damage that exists to the rear end of the cruiser.

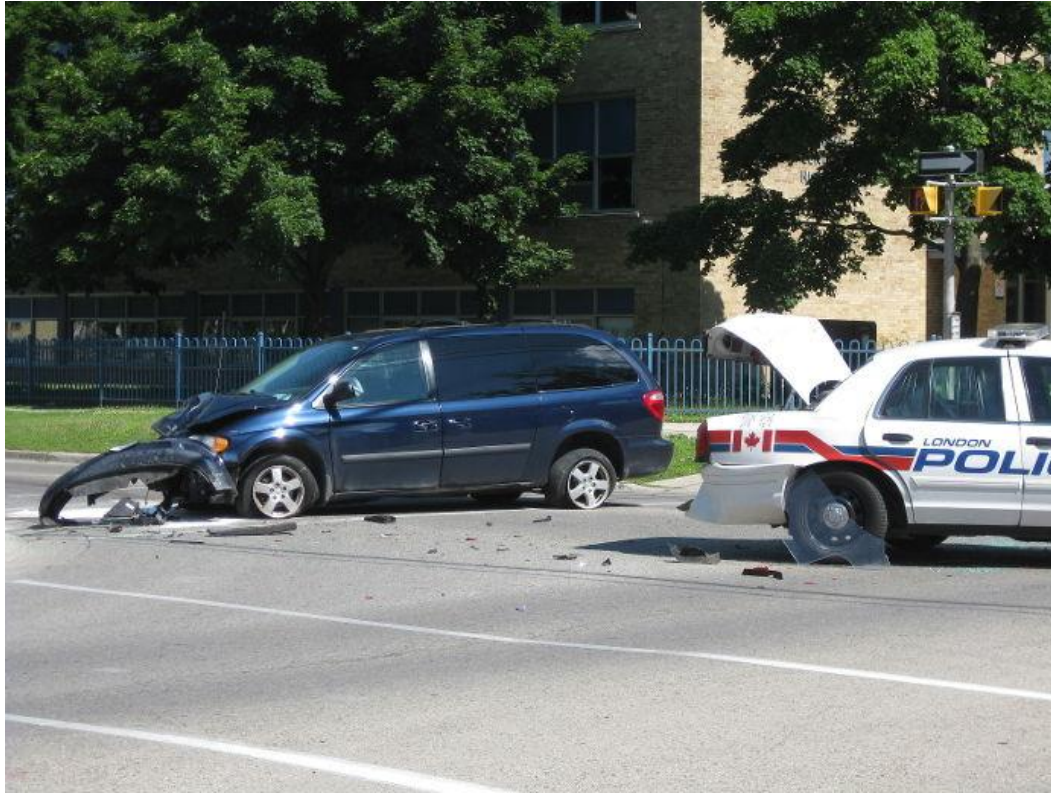
Figure 3: View, looking south-east at the final rest positions of the vehicles.

One can refer to Figures 1 and 3 to recall that the van rotated abruptly, clockwise, after the initial contact. Thus the motion of the van's centre-of-gravity during and after impact was relatively parallel to the road length but the escaping fluid was at the perimeter of that rotating mass and therefore followed the noted curved path to rest.

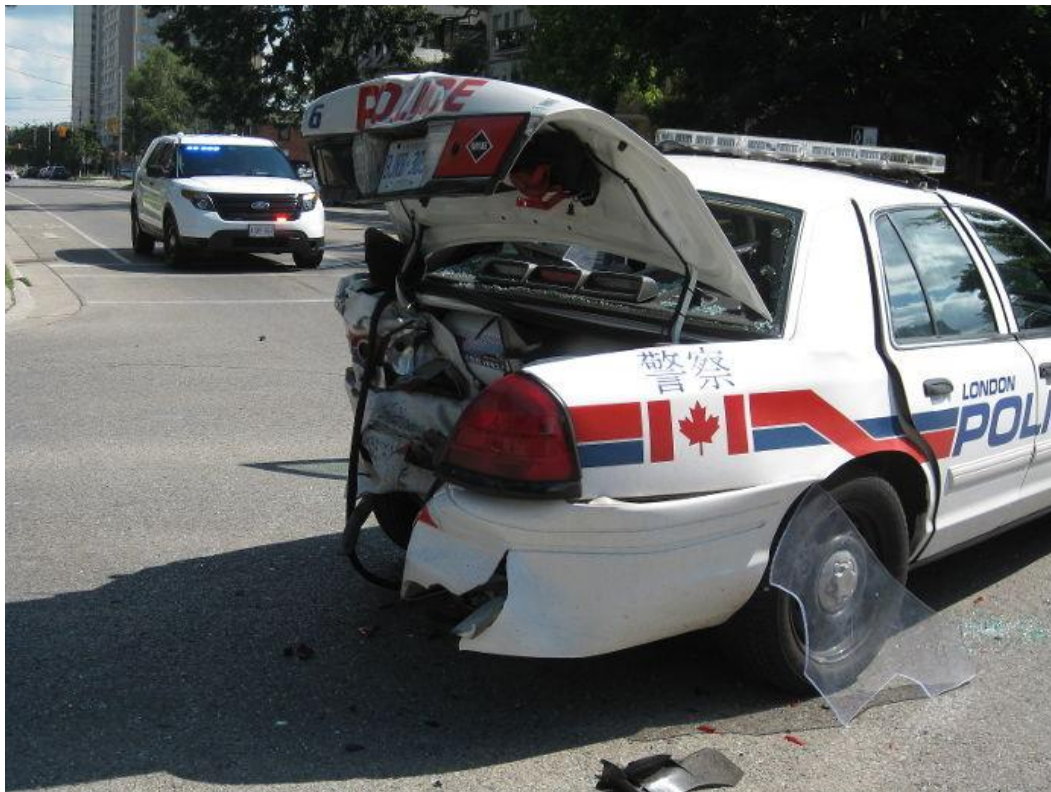
Figure 4: View of the post-impact travel distance of the Police Cruiser.

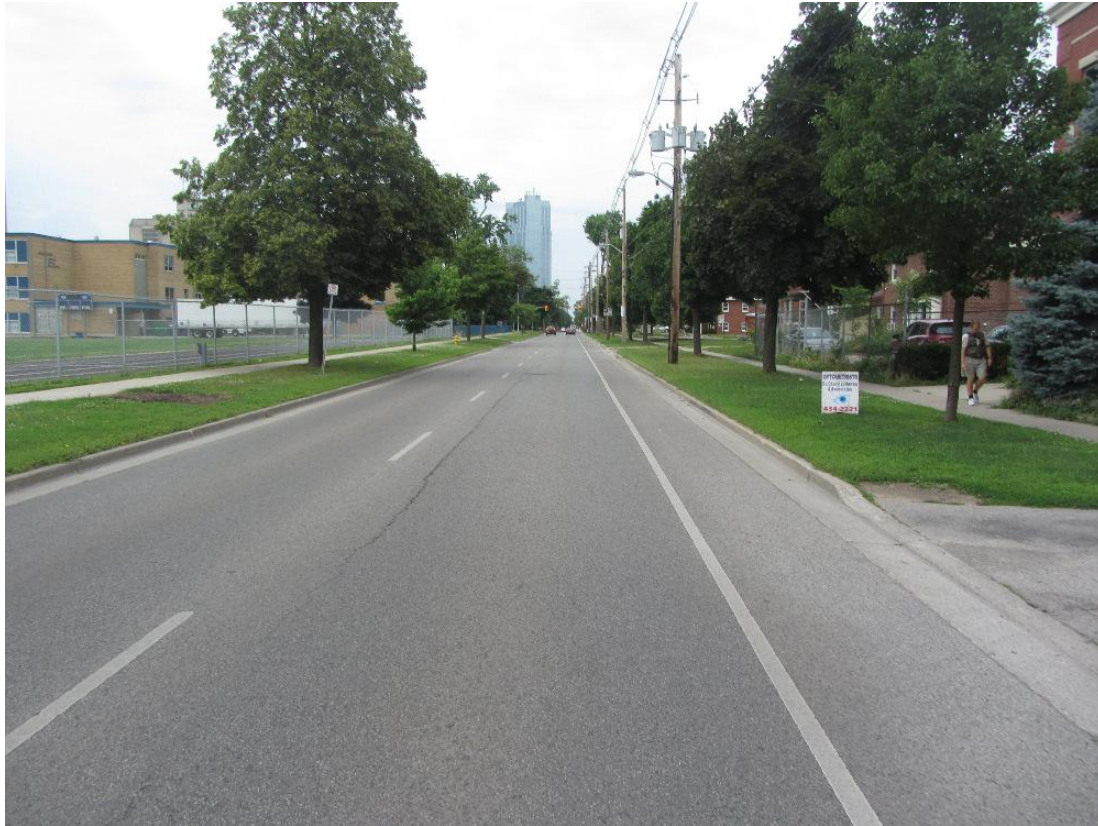
On the afternoon of Monday, July 14, 2014 we attended the site to examine the remaining physical evidence of the crash. Figure 5 shows a westward view along Queens Avenue from several hundred metres east of the intersection with Colborne Street.

Queens Avenue is a one-way street with two westbound lanes. One can appreciate that it is straight and level for a substantial distance on approach to the area of impact. Given this fact the driver of the van should have had this time and distance to observe the stopped cruiser, provided that the cruiser was in fact stopped there throughout that time. The reality is that the physical evidence cannot provide that information, it may only give an indication of the cruiser's location for only a brief time before impact. Evaluation of the momentum and energy in the system may also provide valuable information. However it is sometimes misunderstood, and not appreciated, that the ability to interpret the meaning of the physical evidence is essential to any further analysis. Thus we will review this evidence in detail before discussing approaches toward analysis.

Figure 5: View, looking west from several hundred metres east of the accident site.

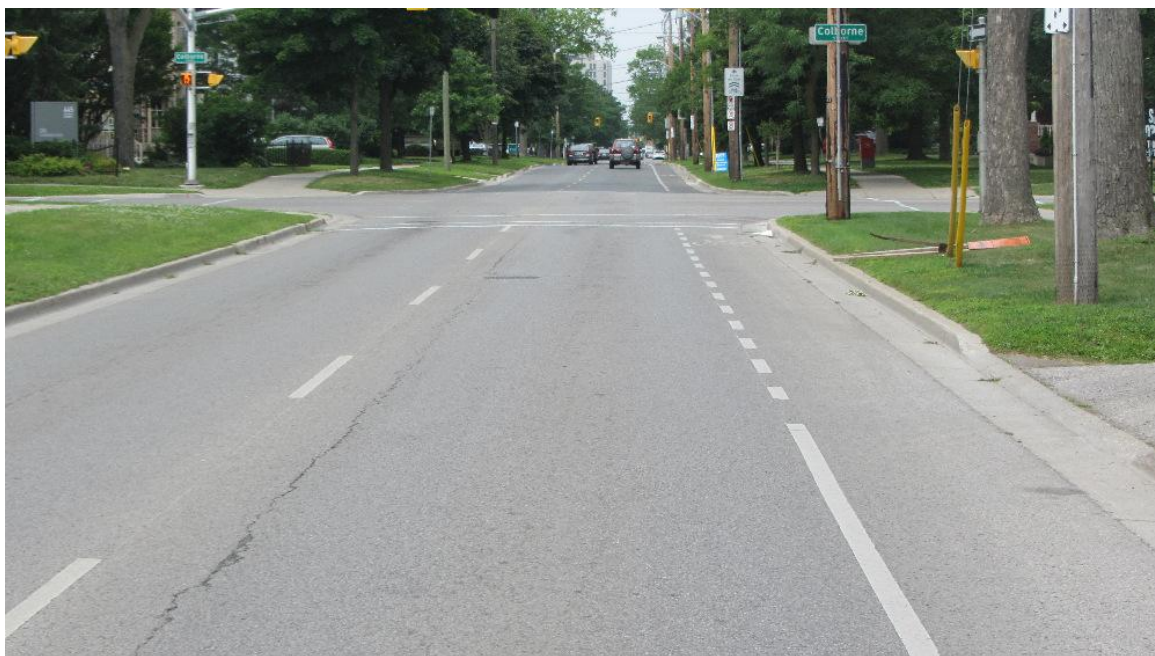
As we approach closer to the accident site we begin to appreciate that there is a lack of pre-impact skid marks from the van, as demonstrated in Figure 6.

Figure 6: Westward view showing lack of pre-impact skid marks.

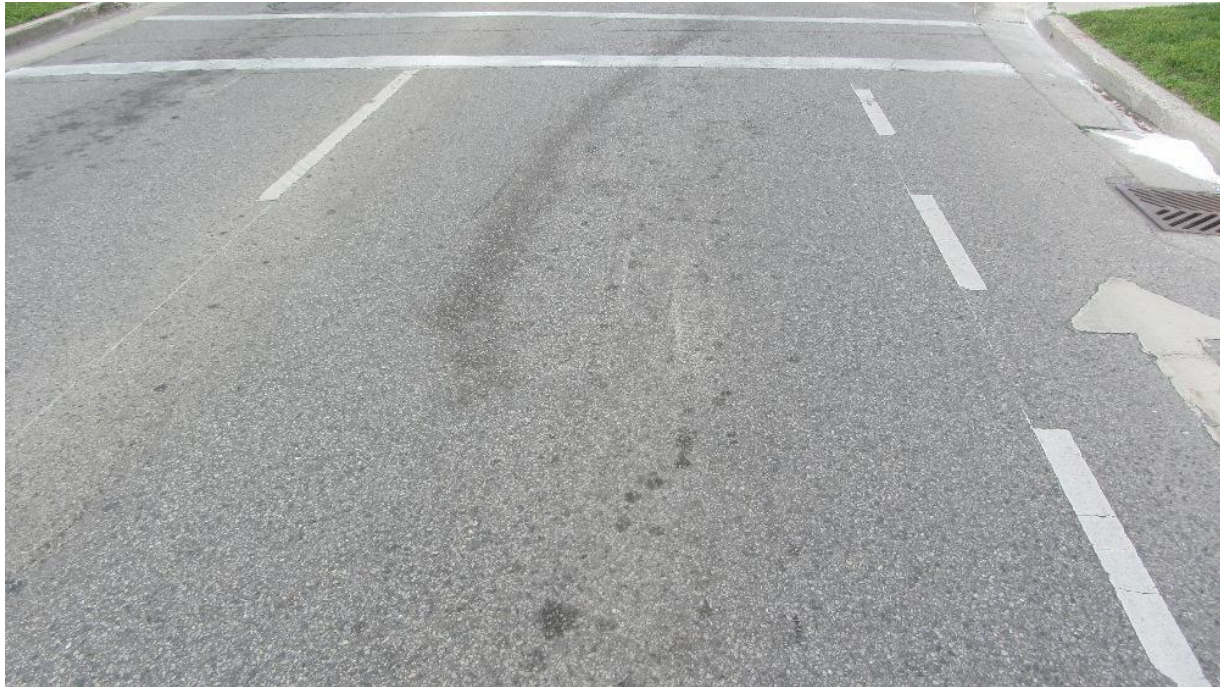
The telltale signs of the point of impact between the vehicles is clearly indicated in Figure 7.

Figure 7: View, looking west at the physical evidence just east of the traffic stop bar for westbound traffic on Queens Avenue.

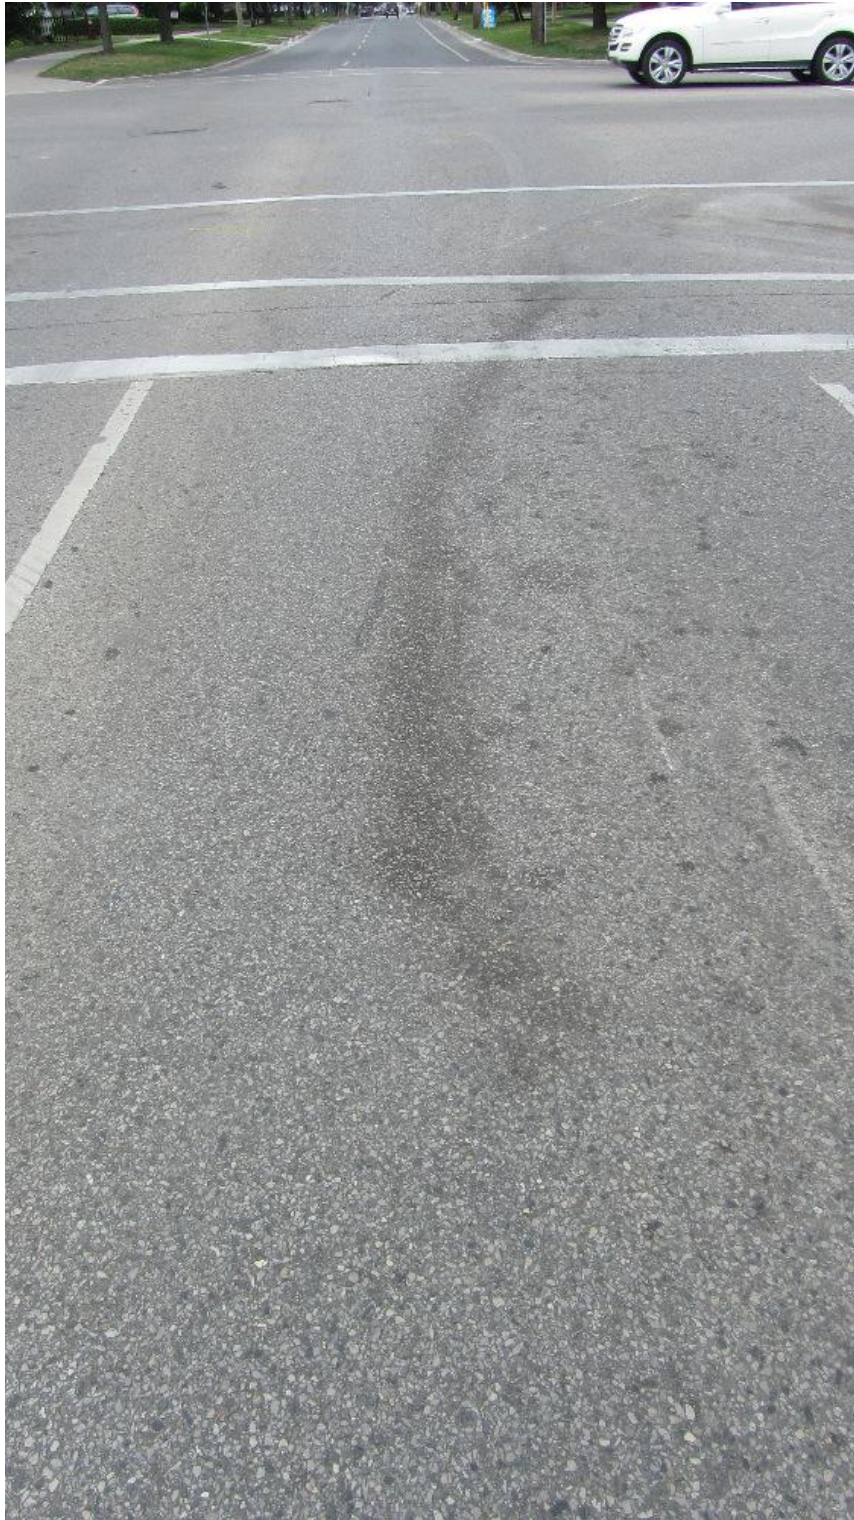
If we look at the trail of fluid again, as shown in Figure 8, we might come to the misguided belief that, after the initial contact, the van moved in a north-easterly direction, as indicated by the curve of the fluid trail. That is not the case.

Figure 8: View of fluid trail extended to show the van's final rest position in the background.

The commencement of this fluid trail is in conformity with the cruiser being stopped at the stop bar when it was struck. We can move further westward along the path of the fluid trail toward the final rest position (FRP) of the van as shown in Figures 9 and 10.

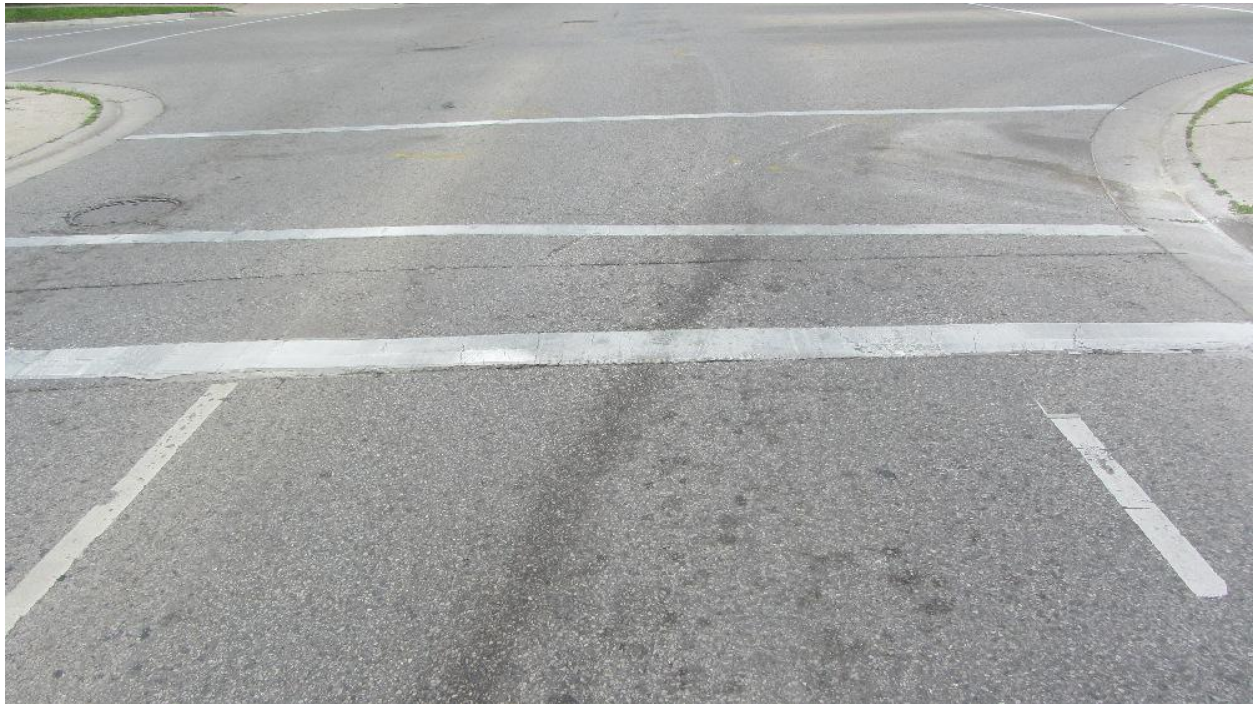
Figure 9: View looking west along the fluid trail caused by the front end of the van.

If we look within the bounds of the two white lines that form the zone of the pedestrian crossing we can see a long, narrow, curved scrape in the pavement just to the left of the fluid trail. If we look at Figure 3 we can see that the left front tire of the van has come off of its bead and the rim is contacting the road surface. So the long narrow scrape was caused when the tire came off its bead and the rim contacted the pavement.

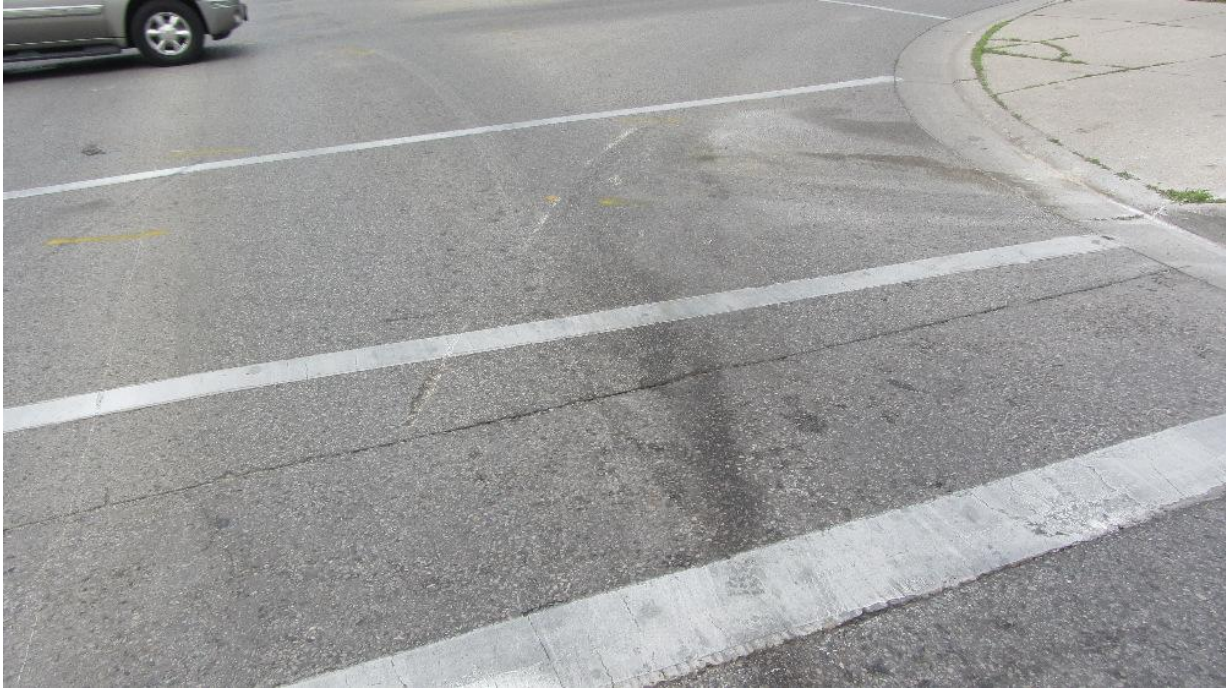
As we look in Figure 10, to the right end of the pedestrian crossing zone, we can see some white-coloured fluid trail that has flowed toward the curb. This whiter stain is typically from the engine coolant and it was deposited at the final rest position (FRP) of the front end of the van.

Figure 10: View looking west toward the final rest position of the van.

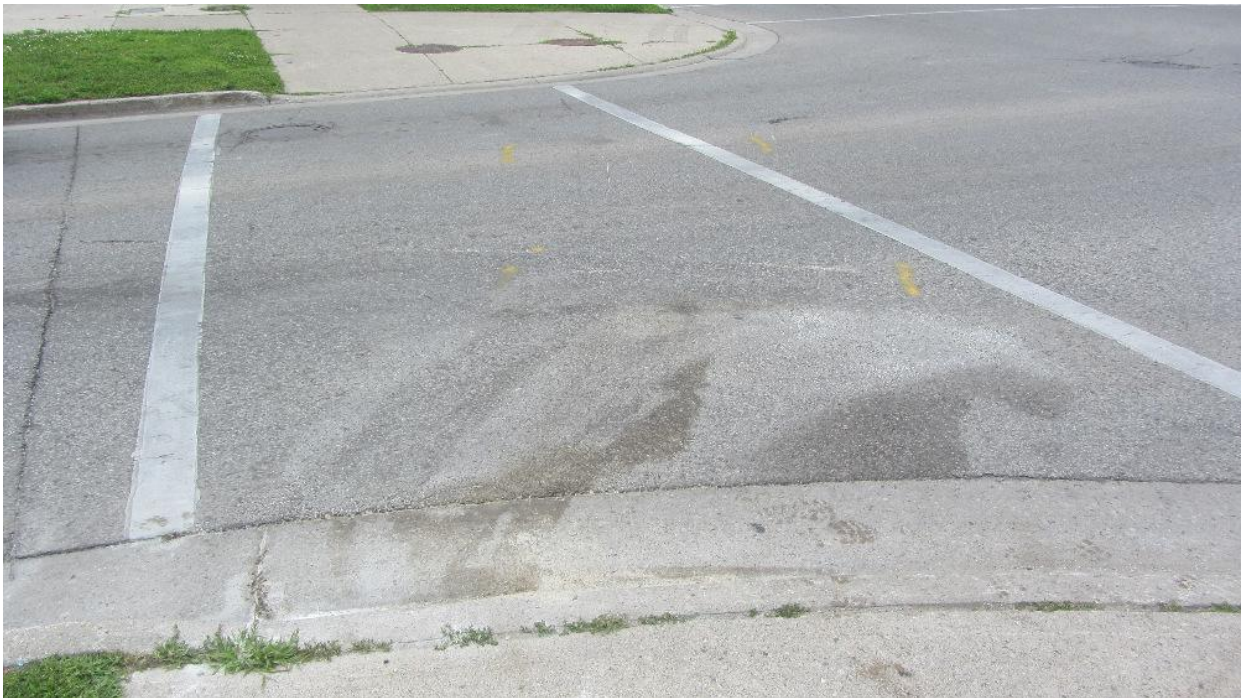
Figure 11 shows the same area but from north of the FRP and looking south. There are dark and light coloured stains here and the fluid has drained toward the curb in the foreground. Such evidence is typical of what one would see at the final rest position of the front end of a vehicle that has sustained substantial front end damage.

Figure 11: View, looking south at the markings at the final rest position of the van.

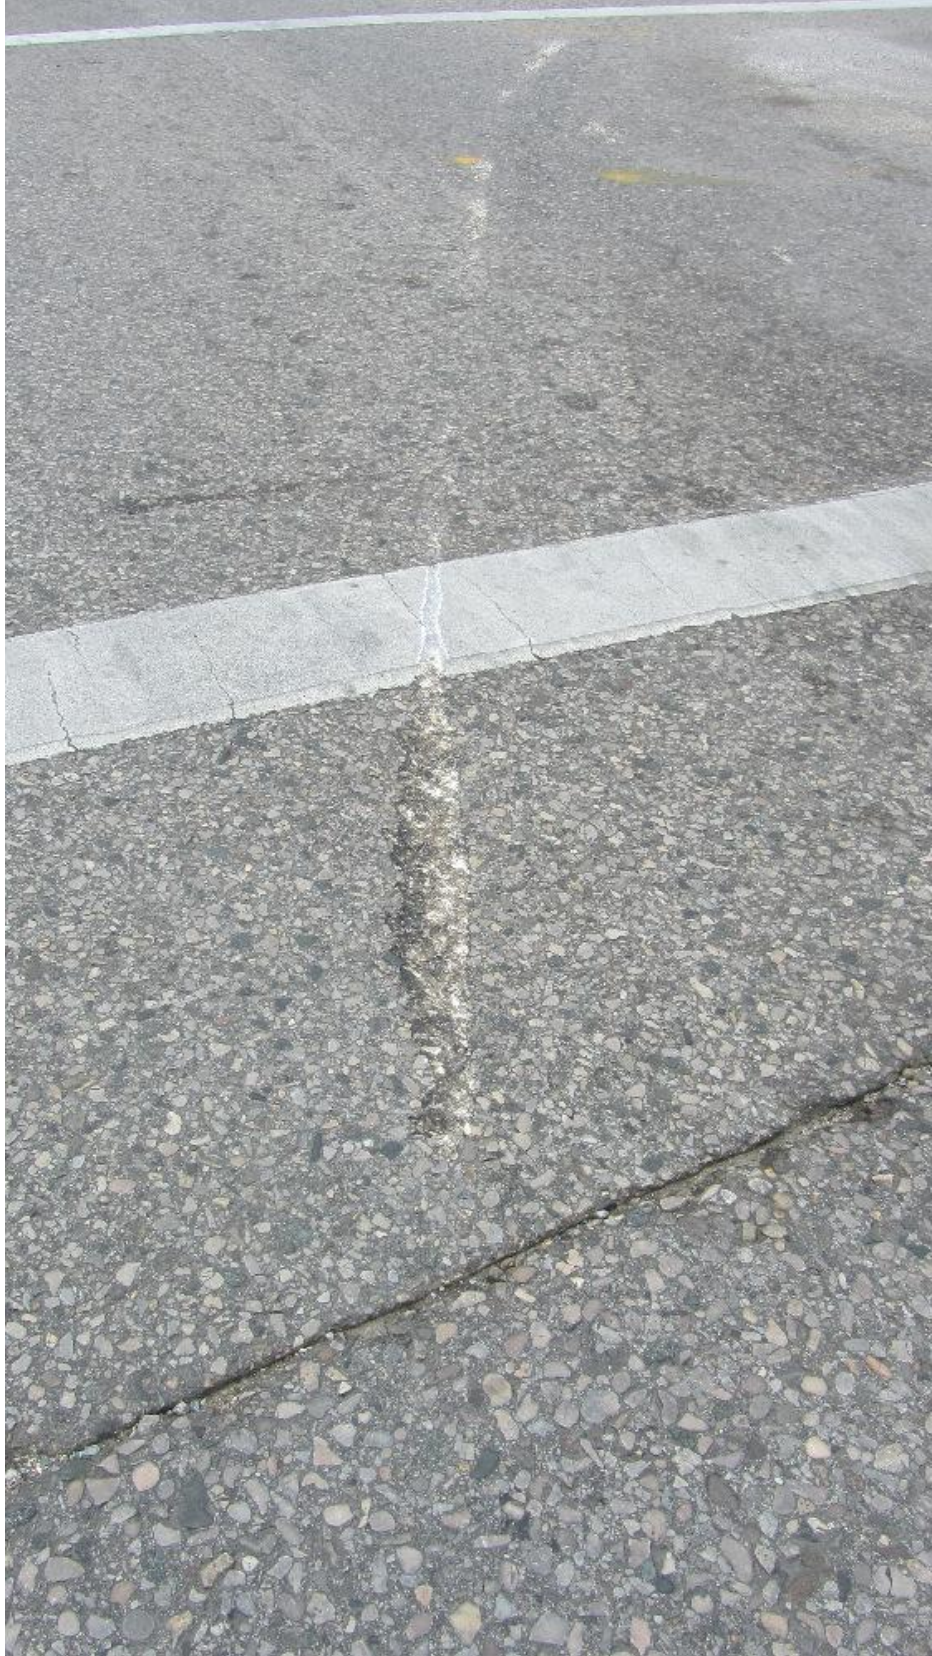
In Figures 12, 13 and 14 we follow the curved scrape caused by the rim of the left-front wheel of the van. As we approach the midpoint of the scrape we can see in Figure 13 that there are two yellow dots painted there. These are police markings to identify the rest position of the two front wheels of the van.

Figure 12: Closer view of the start of the scrape produced by the left front rim of the van.

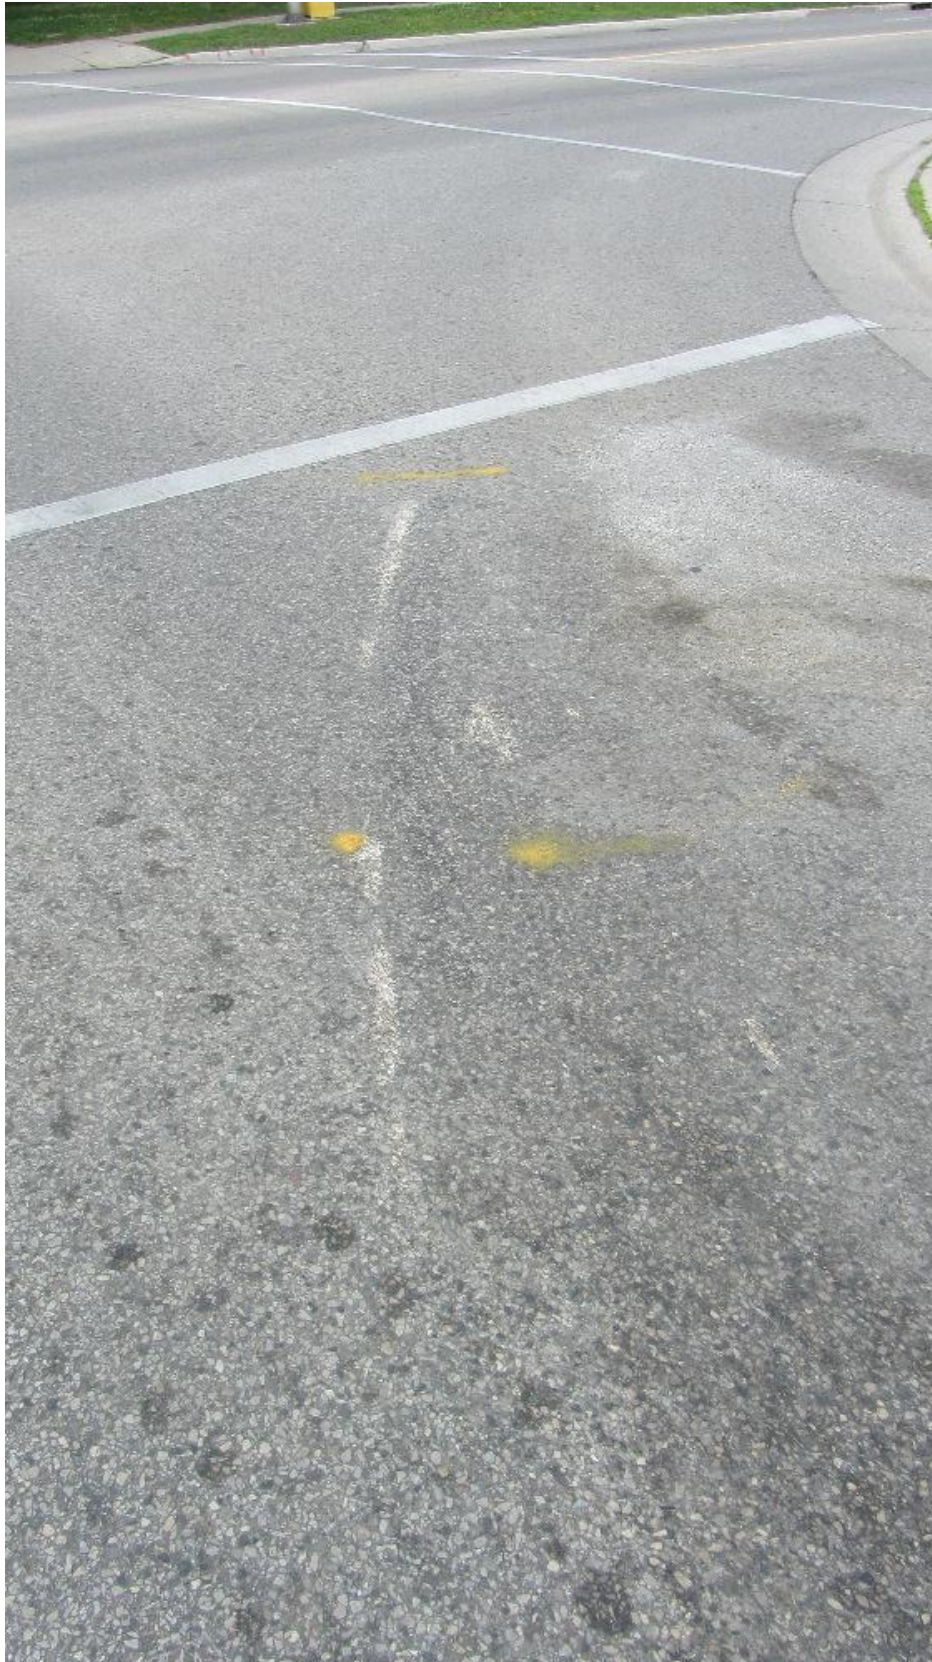
Figure 13: Yellow paint indicates the final rest position of the two front wheels of the van.

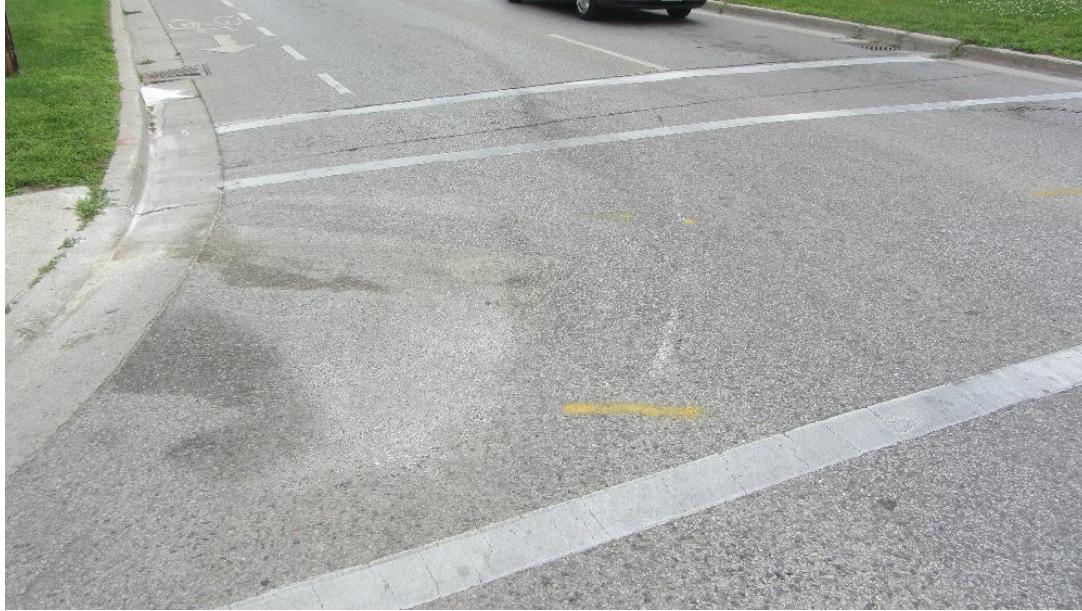
Figure 14 shows a southeasterly view of the yellow-painted markings used by the police to identify the front wheels of the van. In the middle of the figure we can clearly see how the scrape ends abruptly at the yellow line where the police marked the stopped position of the left front wheel.

Figure 14: View, looking south-east at the markings at the final rest position of the van. The scrape in the middle of the view ends abruptly where the police have produced a yellow line to signify the rest position of the van's left front rim.

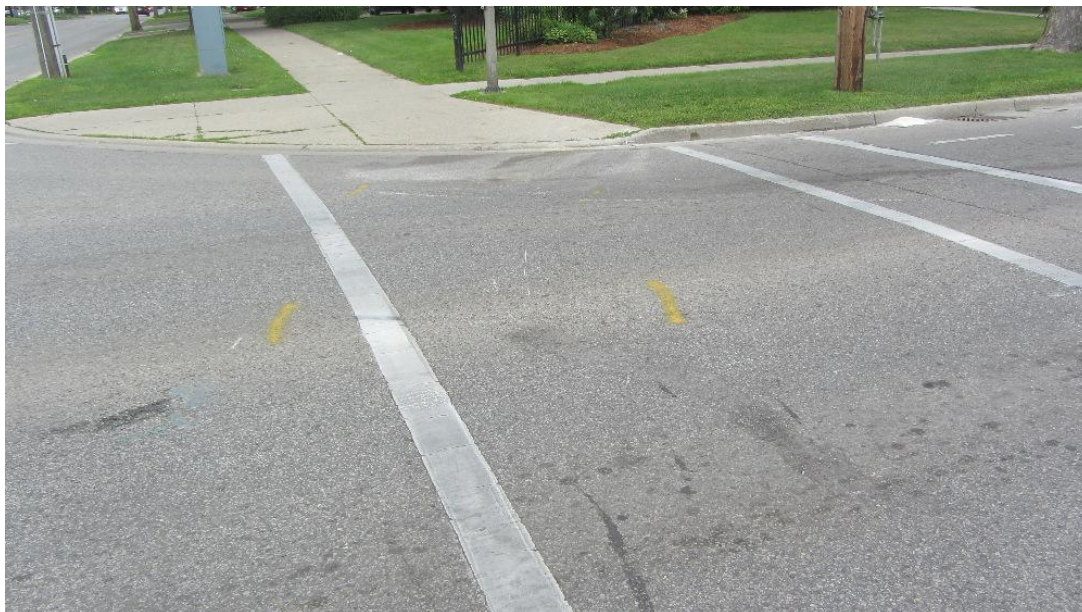
Figure 15 shows a view looking north at another set of two, yellow lines that identify the final rest position of the two rear wheels of the van.

Figure 15: View, looking north, toward another set of yellow lines that mark the rest position of the two rear wheels of the van.

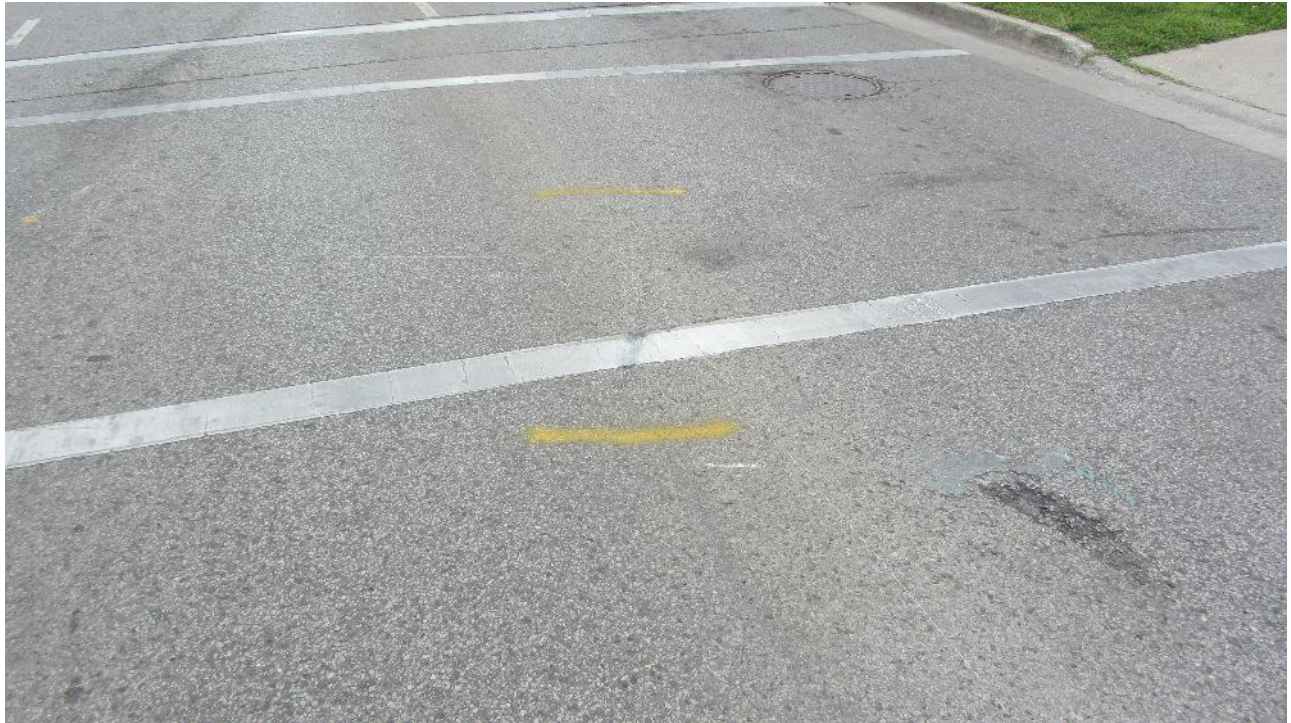
Similar to the situation with the left-front tire, the left-rear tire also came off its bead as the vehicle rotated and therefore the rim contacted the pavement and produced a scrape. Figure 16 shows a view looking east, from just west of the rest position of the left rear tire and it should be possible to see the scrape which ends at the yellow line which identifies the wheel's rest position.

Figure 16: View, looking east from just west of the rest position of the left-rear tire of the van, and showing the scrape that was caused by that tire as the tire came off of its bead.

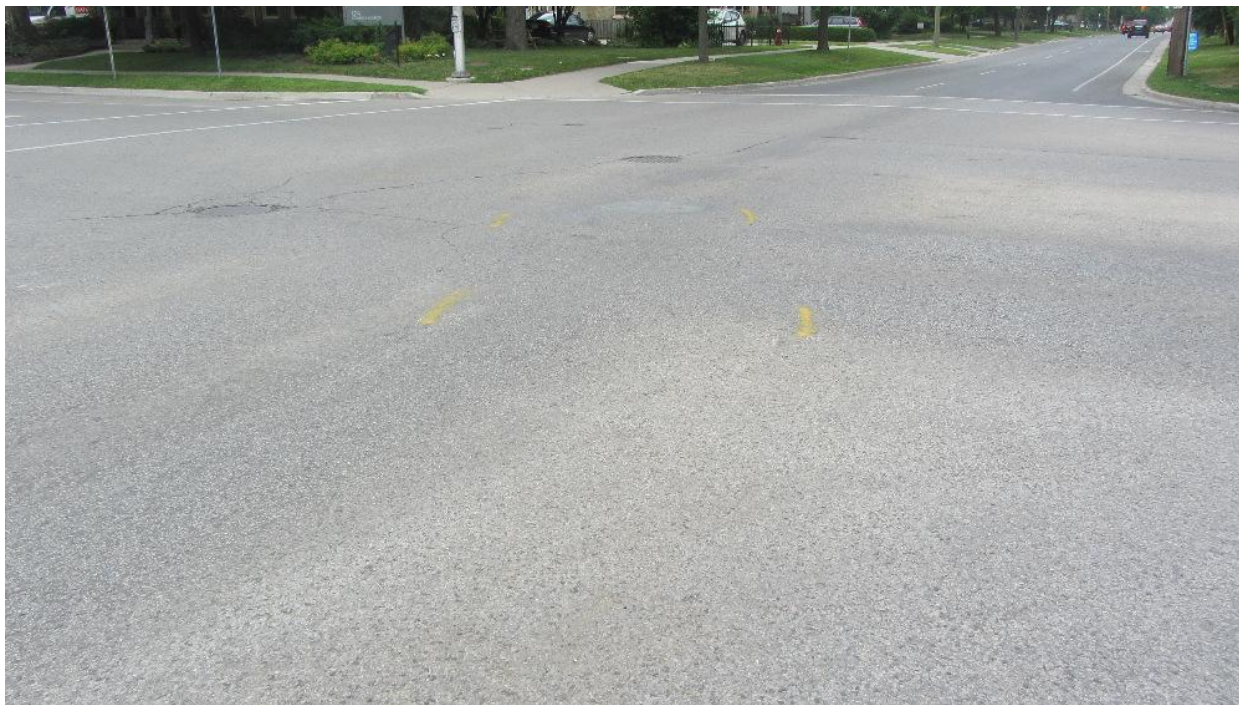
Having completed our description of the markings caused by the van we can now turn our attention to the evidence related to the police cruiser. Figure 17 provides an overall view, looking southwest, toward the rest position the police cruiser. Yellow lines have also been painted on the road to identify the rest position of the cruiser's wheels.

Figure 17: View looking southwest toward the final rest position (FRP) of the police cruiser.

In Figures 17, 18 and 19 we move progressively in a south-west direction, into the intersection, where we find the four yellow lines which identify the final rest position of the police cruiser. We can recall from looking at the cruiser at its rest position in Figures 1 through 4 that it was stopped at angle with the front end pointing generally in south-west direction. This angle is confirmed in the yellow lines that we see in Figure 19.

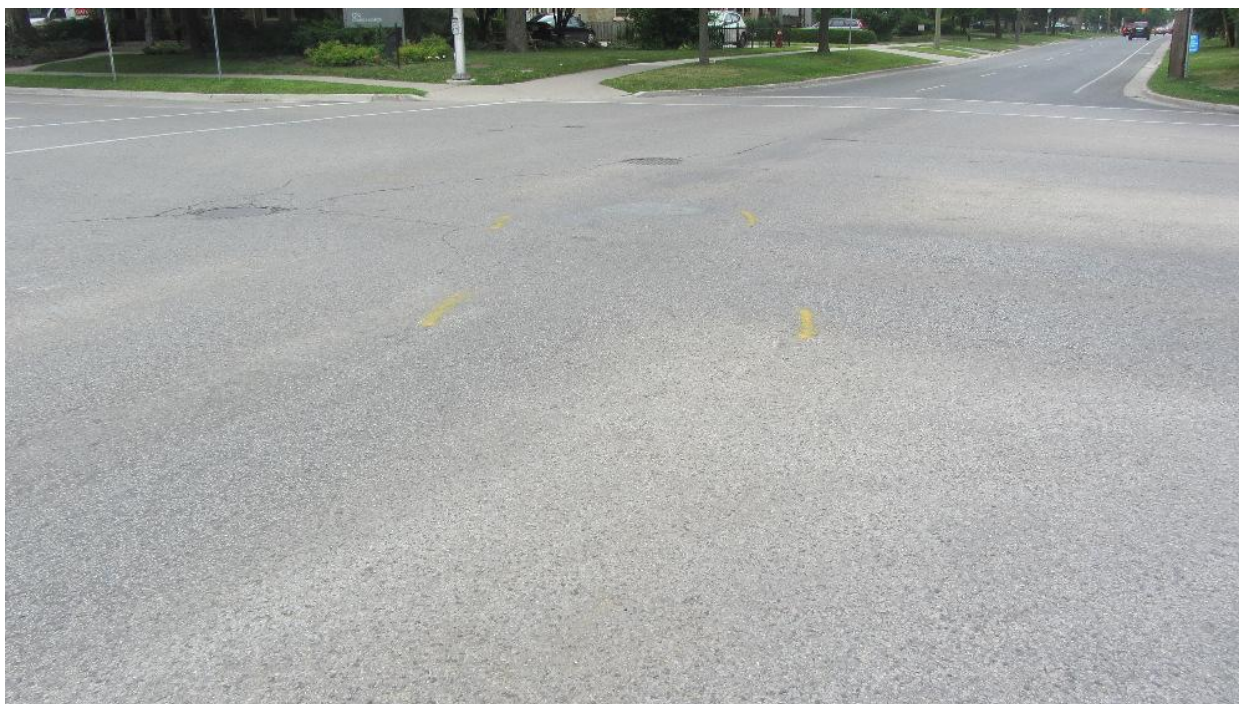
Figure 18: View looking southwest toward the yellow lines that identify the four tires of the police cruiser at its FRP.

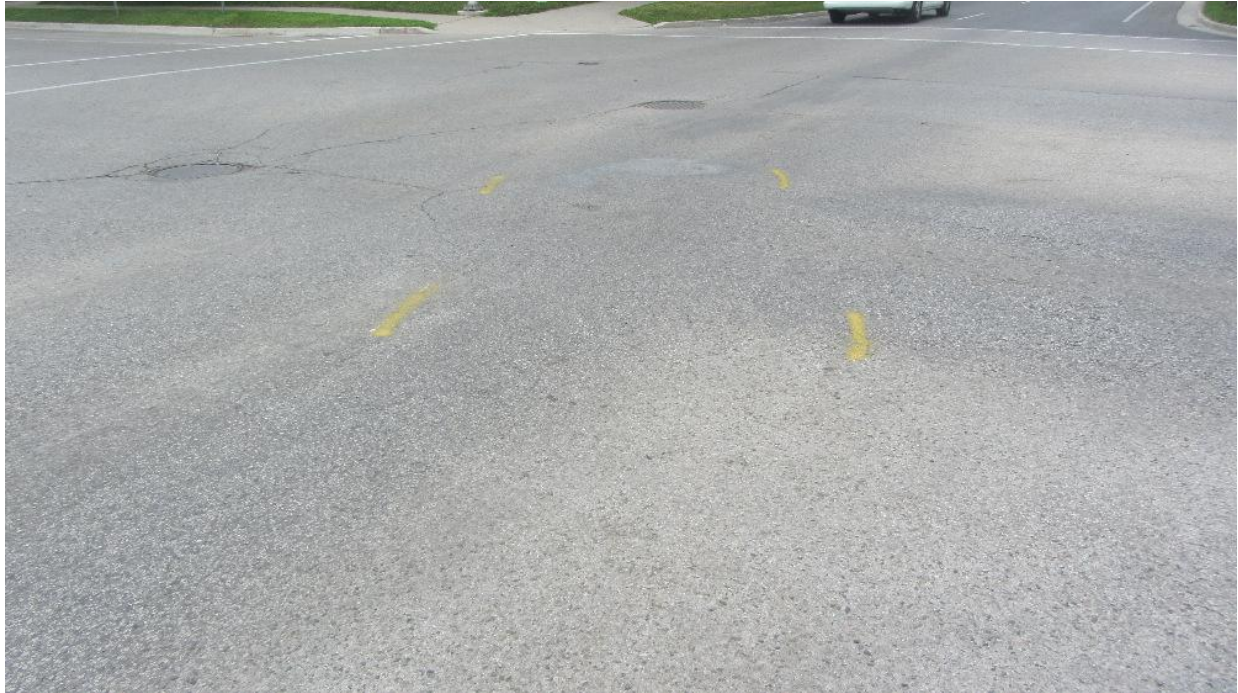
Figure 19: View, looking south-west toward the four yellow lines at the police cruiser's FRP.

If we look slightly further, beyond the yellow lines in Figure 19, we should be able to see a dark stain, roughly between the lines that identify the two front wheels. Figure 20 provides a closer view of the stain. That dark stain is located approximately where the front end of the cruiser was located at final rest. It is not very common to see fluid escaping front the front end of a vehicle that has only been struck in the rear. Of course none of the on-site photos actually show a view of the front end of the cruiser so we cannot know if any further damage might exist there.

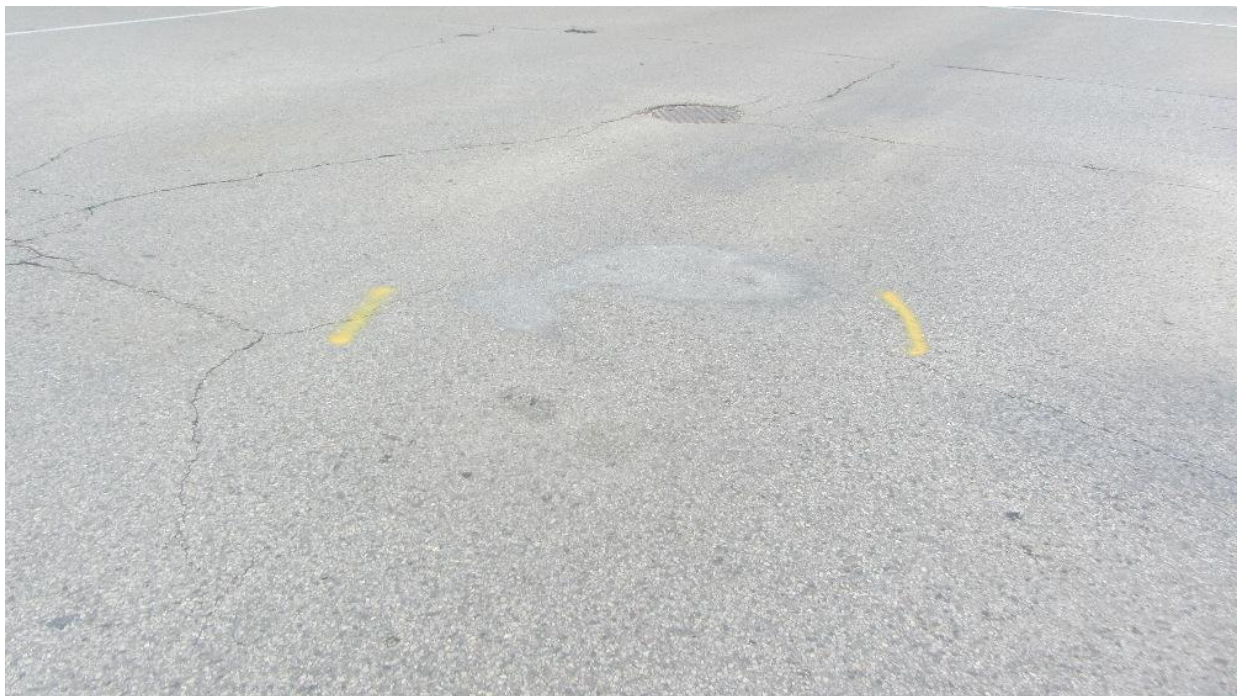
Figure 20: View of dark fluid stain located just ahead of the front wheels of the cruiser at its final rest position.

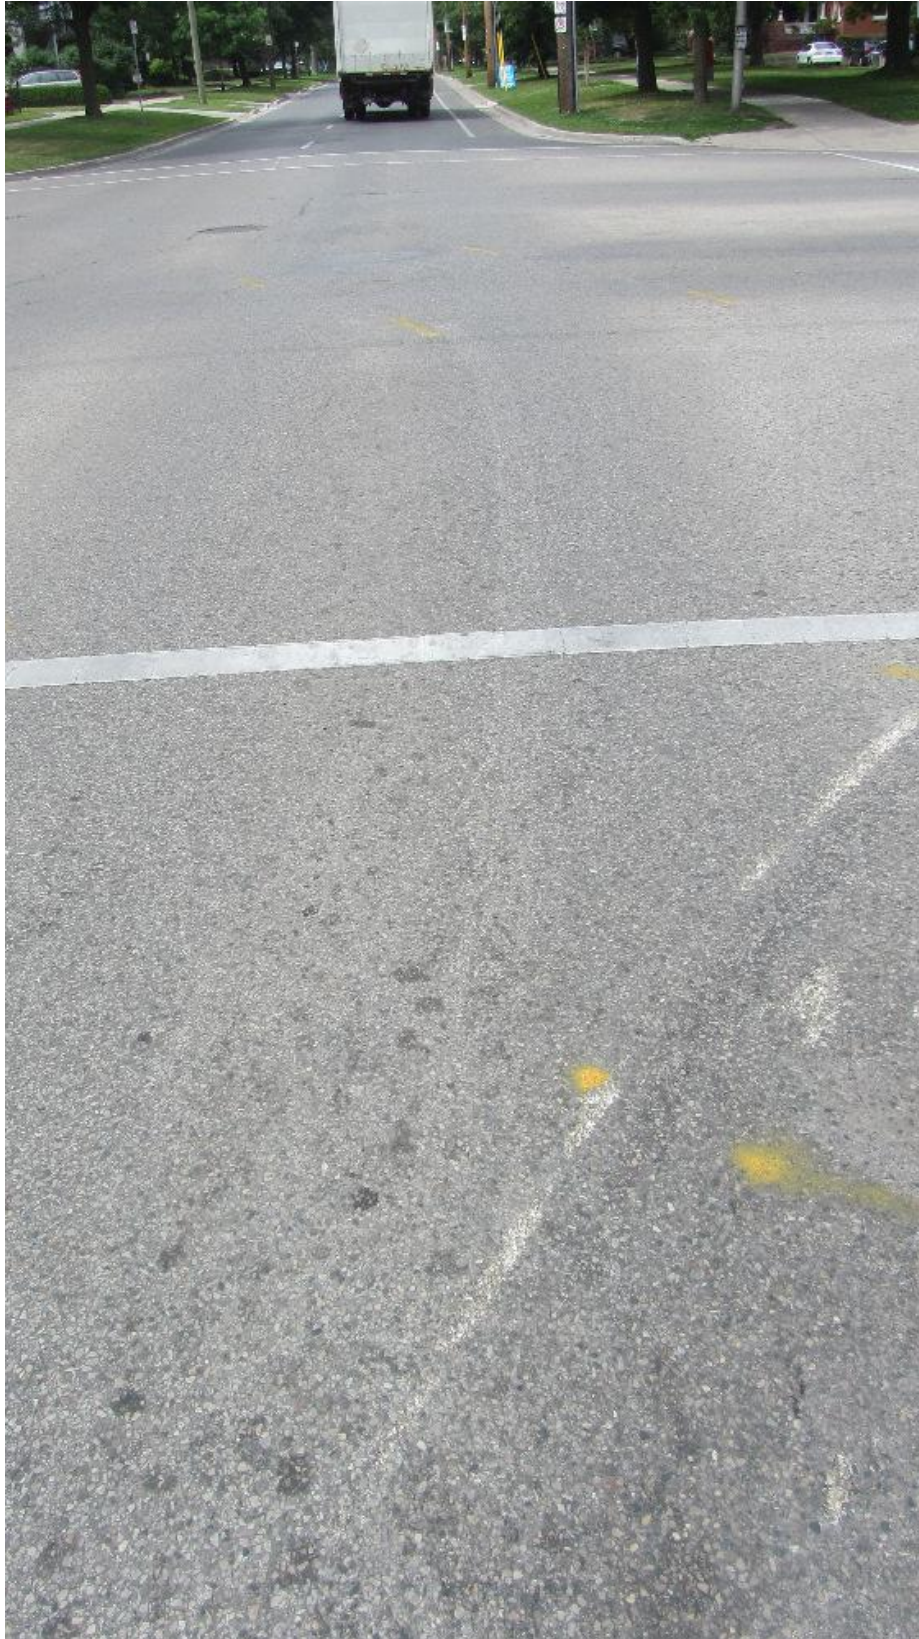
It is possible to follow the path of the cruiser from impact to rest by observing that the left rear tire left a visible mark as it moved from impact to rest, as shown in Figures 21 through 24. However that mark is not a black transfer but a light-coloured one that is often made when a road surface is wet. Therefore this leads to further questions.

Figure 21: View of faint tire mark produced by the left rear tire of the police cruiser as it moved toward its rest position.
