# London City Police Cruiser Rear-End Collision - Review of Physical Evidence & Potential Analysis

*Posting Date: 9-Sept 2014*

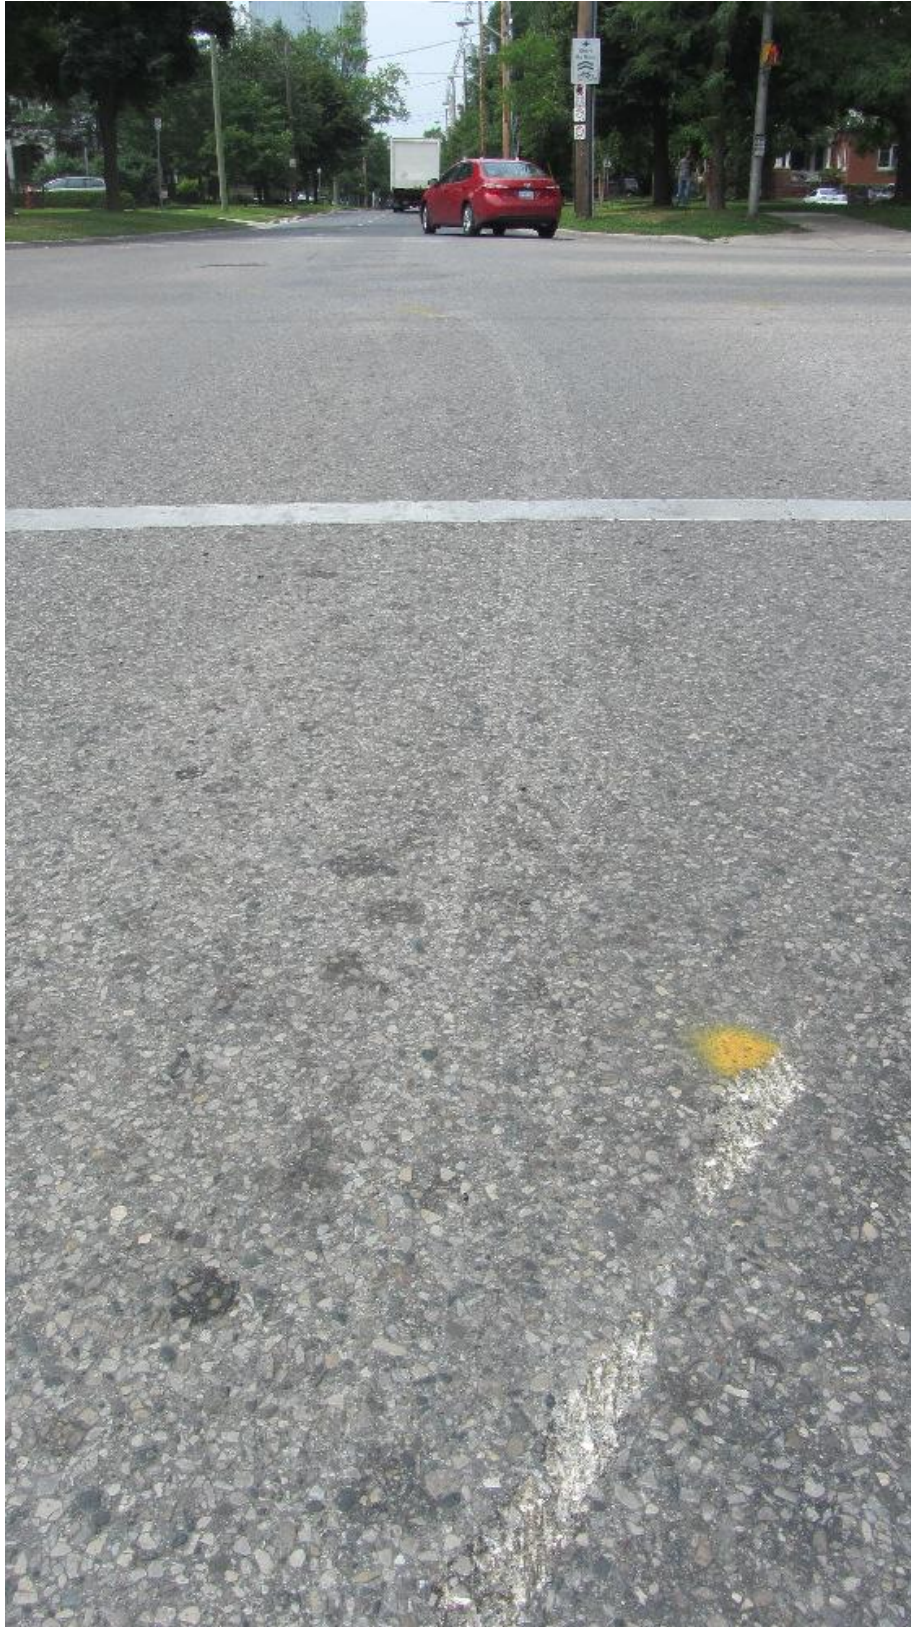
Figure 22: View of tire mark caused by the left rear tire of the cruiser as it moved toward its rest position.

It is possible to follow the path of the cruiser from impact to rest by observing that the left rear tire left a visible mark as it moved from impact to rest, as shown in Figures 21 through 24. However that mark is not a black transfer but a light-coloured one that is often made when a road surface is wet. Therefore this leads to further questions.

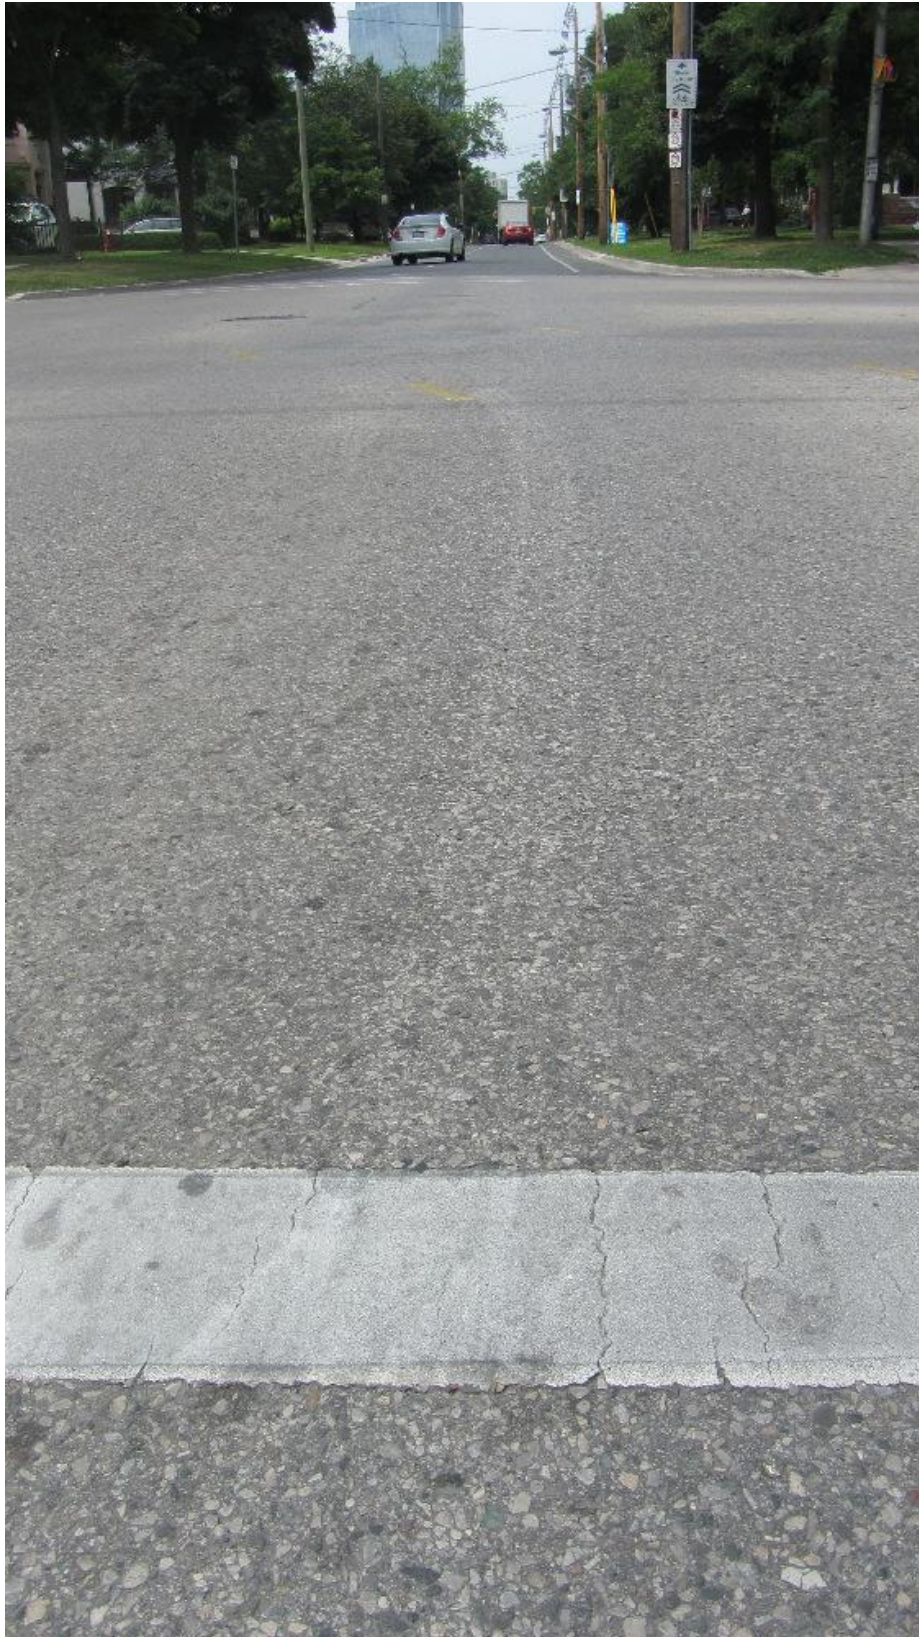
Figure 23: View of tire mark produced by the left rear tire of the cruiser as it moved toward its rest position.

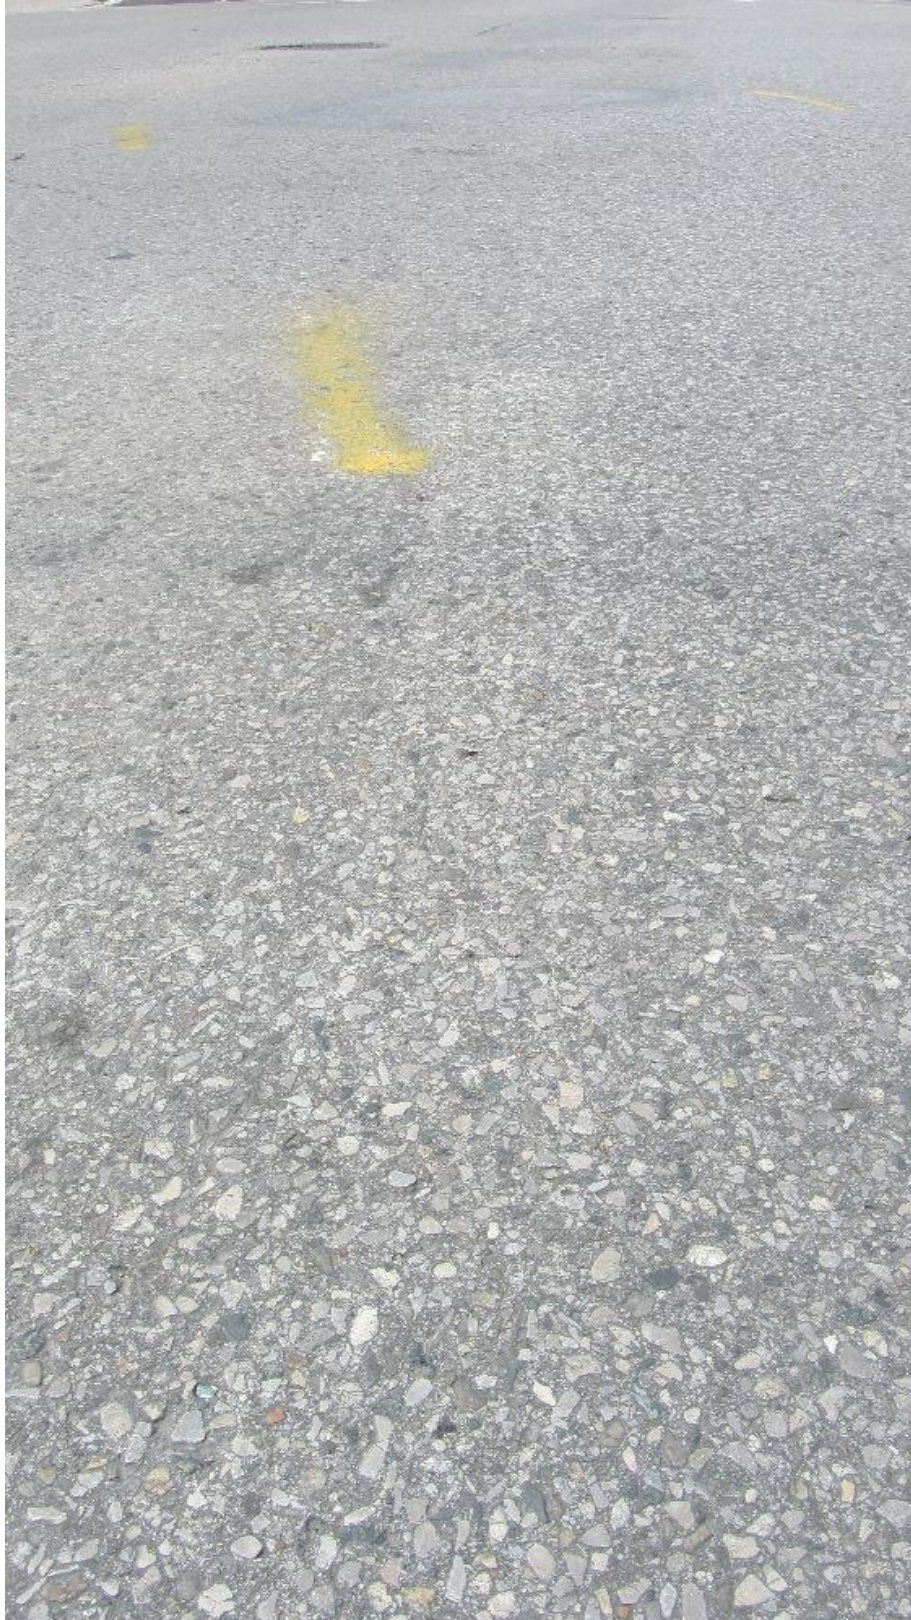
Figure 24: View of the tire mark, caused by the left rear tire of the police cruiser, as it reaches the yellow line at its rest position.

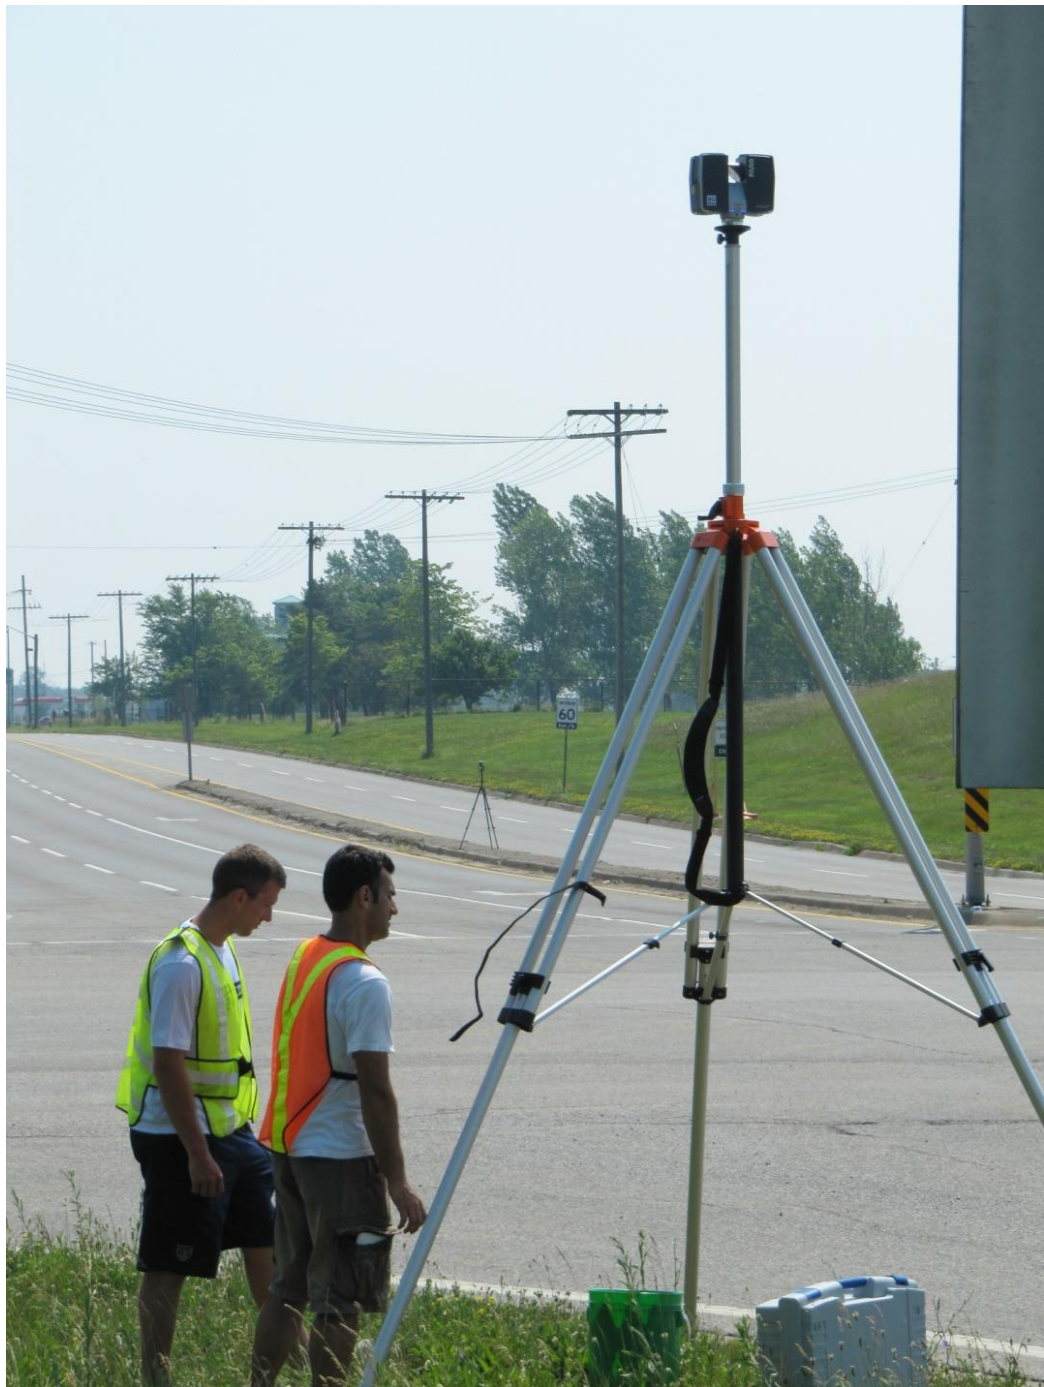
The use of total stations to map the evidence is now turning toward laser scanners. Now a robotic scanner is placed at the accident site and its head rotates 360 degrees to capture all of the evidence within a short range. The scanner's capabilities can be adjusted to a maximum of almost a million measurements per minute. The device is then taken to another area of the site and the process is repeated, as many times as it is necessary to document the whole area of interest.

Figure 25: Example of a laser scanner set-up at an accident site.

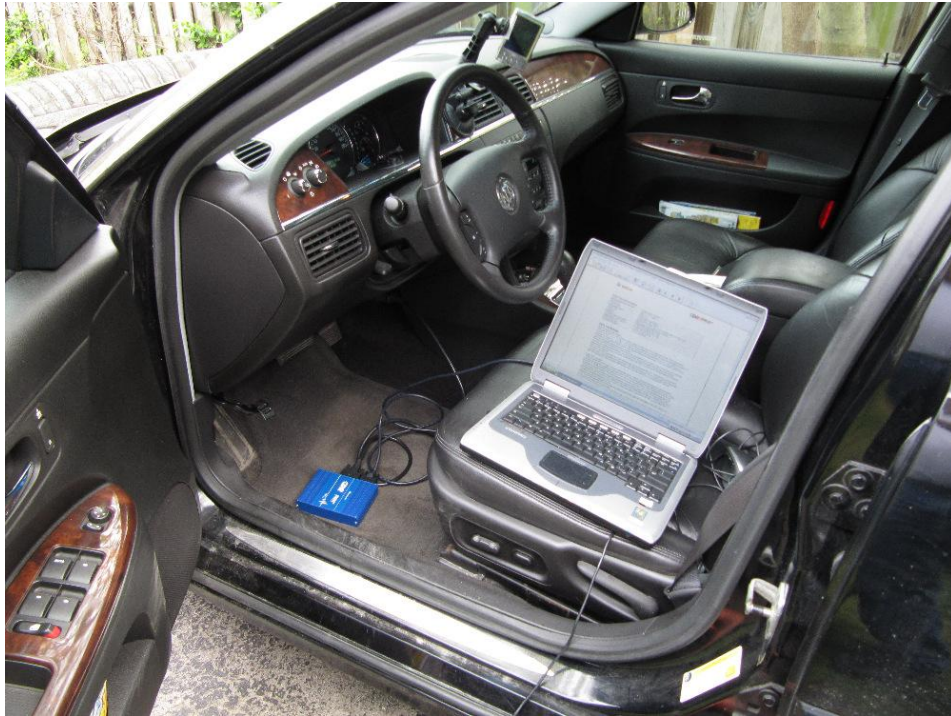
Figure 26: Example of a typical set-up to download the data from an EDR using the Crash Data Retrieval (CDR) toolkit.

Analysis has been made easier in some respects due to the progressively larger number of vehicles that contain event data recorders ("Black Boxes") that capture a small segment of time before, during and sometimes after an impact and copy the status of certain instruments to an electronic module during that time. An example set-up for downloading is shown in Figures 26 & 27) Officially, General Motors Corporation began installing EDRs with the ability to capture pre-crash data as early as 1999. Since then the U.S. National Highway Traffic Safety Administration (NHTSA) has mandated that effective in 2013, all light vehicles must be equipped with the capability of recording a list of 15 parameters if a manufacturer equips a vehicle with an EDR. There was also a loose requirement that the data from such EDRs be made accessible for downloading

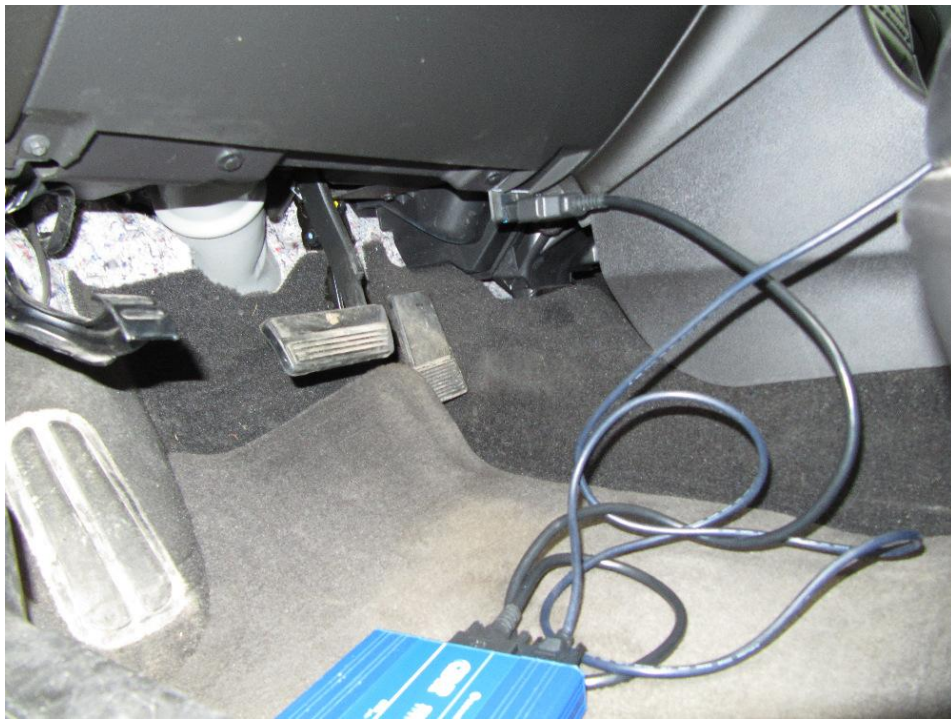
Figure 27: View of CDR Diagnostic Link Connector (DLC) cable being attached the DLC port to allow communication between the downloading equipment and the EDR module.
