Rough Roads, Increasing Speed and Change in Test Vehicle Motion - Additional Data

Posting Date: 20-Mar 2015

In two earlier articles (posted to the Gorski Consulting website on March 6, 2014) we reported on the data obtained from driving our test vehicle over a poor road surface (Sunningdale Road in London, Ontario). Subsequently Gorski Consulting conducted additional testing on April 5, 2014 and on February 27, 2015. The present article reports on the combined results from the three testing sessions.

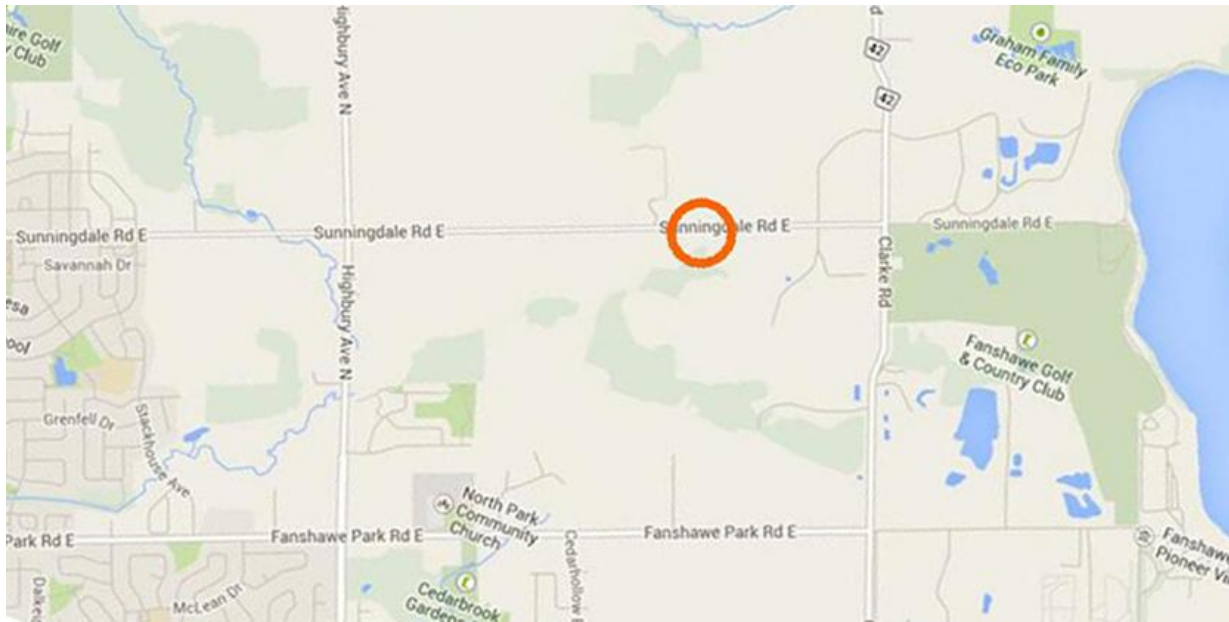
Figure 1: View of testing location on Sunningdale Road in London, Ontario, Canada, commencing at Clarke Road to the east and terminating near Highbury Avenue to the west.

The test vehicle was driven westbound and eastbound along Sunningdale Road in London, Ontario, between the intersections of Clarke Road and Highbury Avenue, as shown in Figure 1.

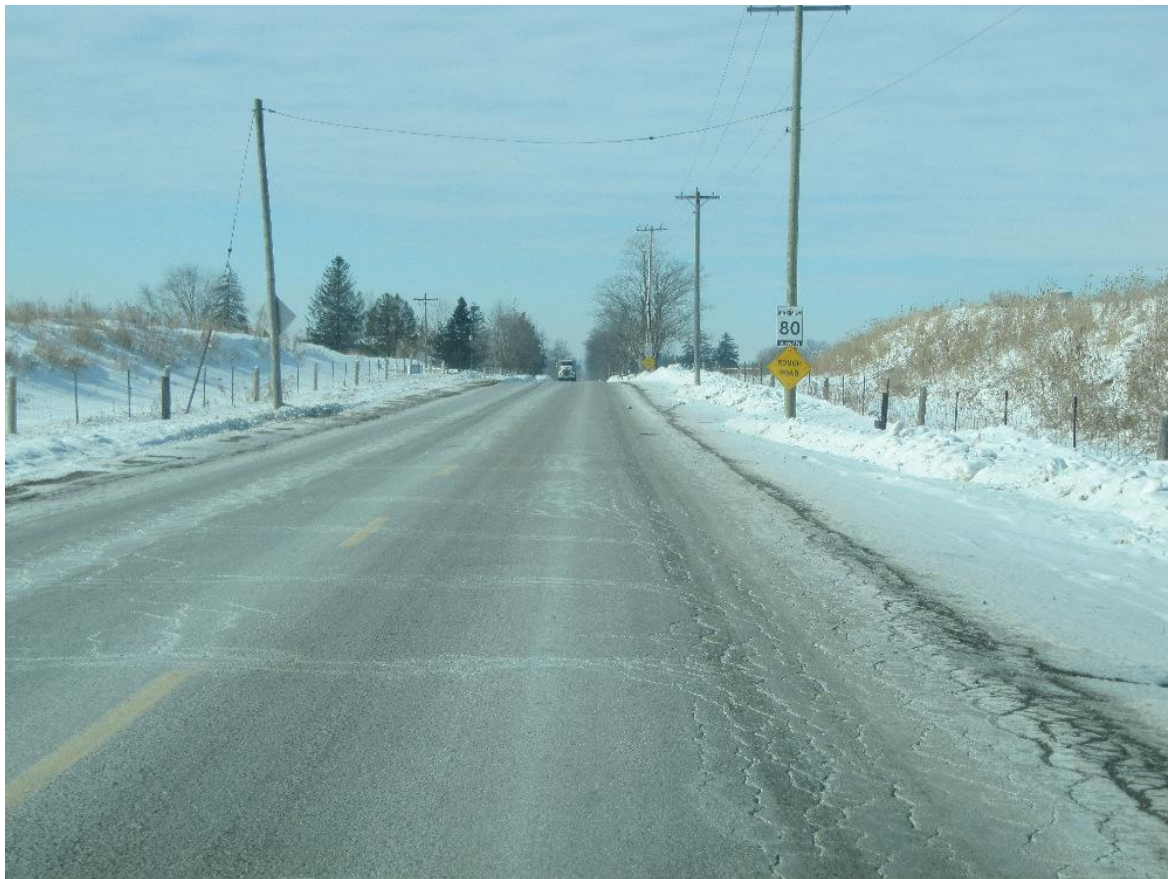
Figure 2: View looking westward along Sunningdale Road from just west of the intersection at Clarke Road. The utility pole on the right side of this view containing the "80 km/h" maximum speed sign, is the precise starting point where the captured data was analyzed.

The first segment of rough surface begins at the "80 km/h" sign and ends at the east edge of the small bridge. From reviewing our videos we noted that it took 63.9 seconds to travel that distance. So it becomes a simple step of multiplying the 63.9 seconds by the average speed of 11.11 metres per second to arrive at an estimated distance of 709.93 metres, or about 710.0 metres for the length of the first of three road segments.

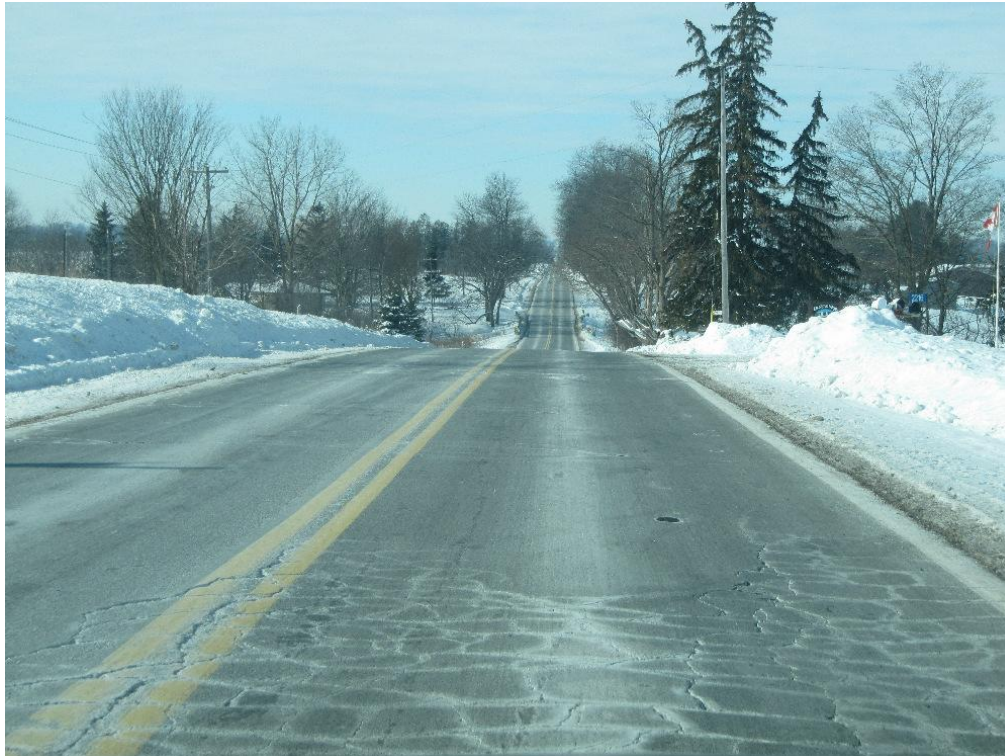
Figure 2: View, looking west along Sunningdale Road. Shortly after commencing the data collection a sag is encountered as shown in this view. Commencing at the location of a small bridge the rough road surface was repaved thus a smoother section of pavement was encountered.

Sunningdale Road was generally straight and level except for a small sag located near its east end. There was a small bridge at the bottom of this sag as shown in the westward view of Figure 2.

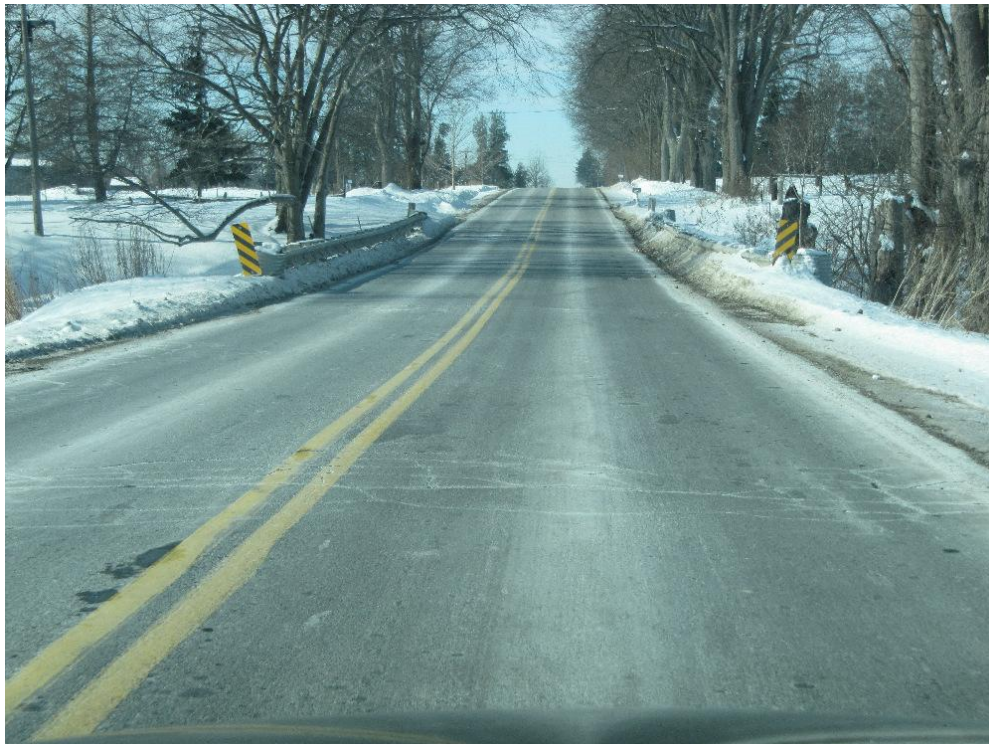
Figure 3: View, looking west along Sunningdale Road. The newer (smoother) section of pavement commenced at the west (far) side of this small bridge.

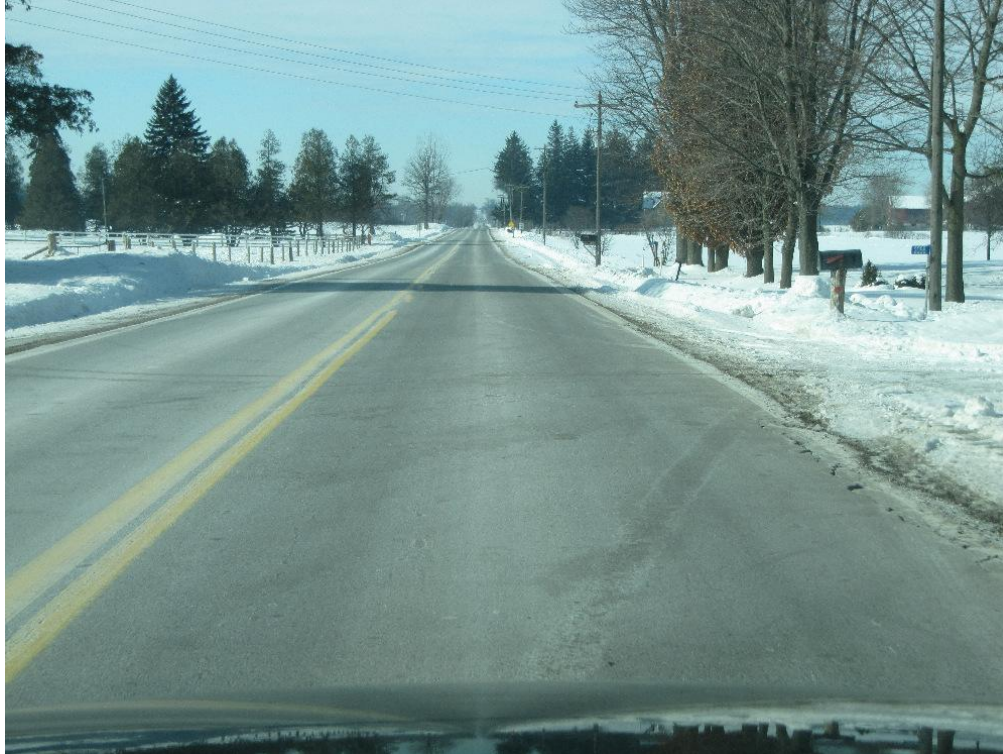
Figure 4: Upon mounting the upslope of the sag (at small bridge) the roadway entered a long section that was straight and level, as shown in this westward view. The pavement in this area was new and smooth.

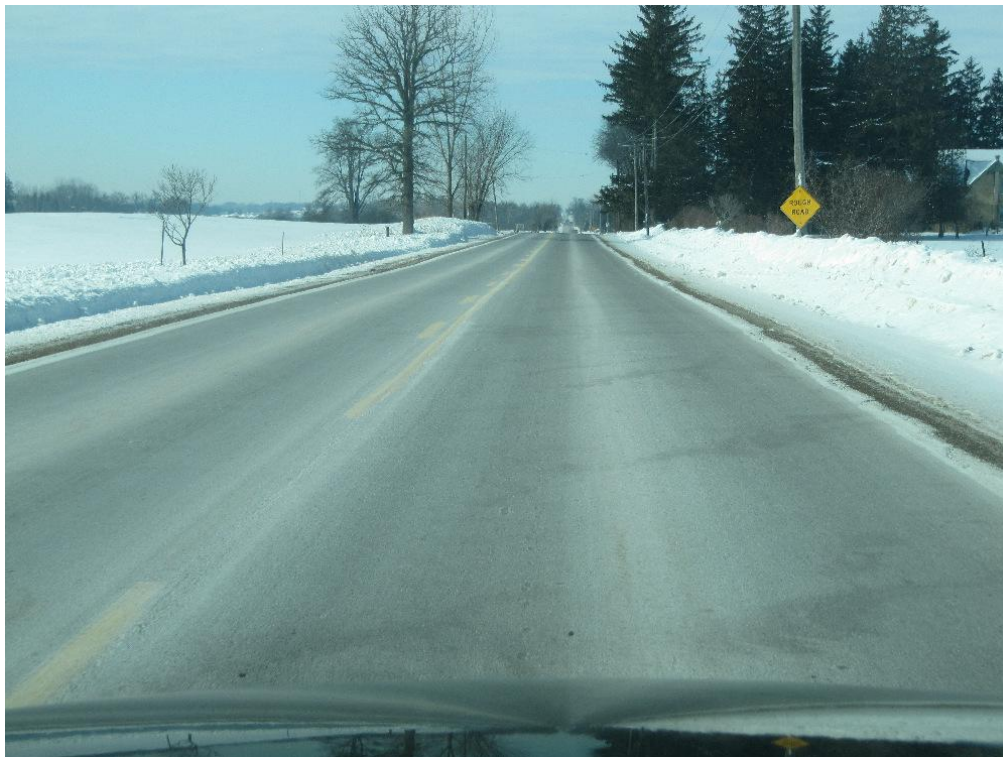
Figure 5: Near the end of the smooth section of pavement there was a warning sign posted on the right roadside indicating the return of the older and rougher section of road.

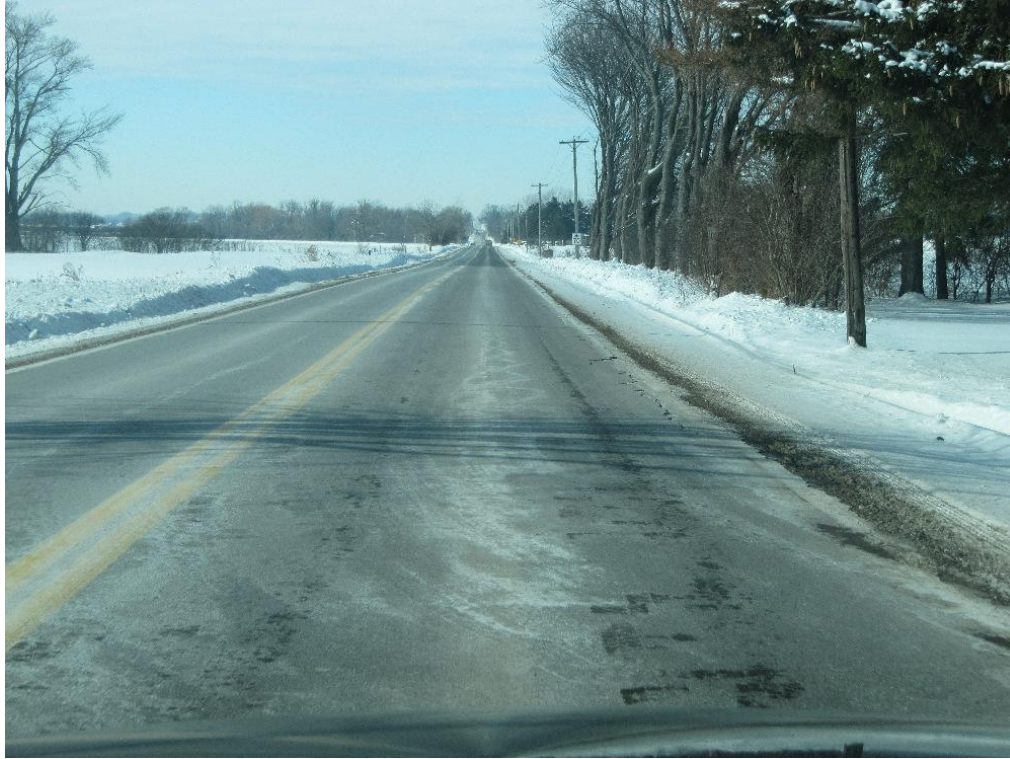
Figure 6: Continuing further westward the end of the newer pavement can be seen the distance background of this westward view along Sunningdale Road.

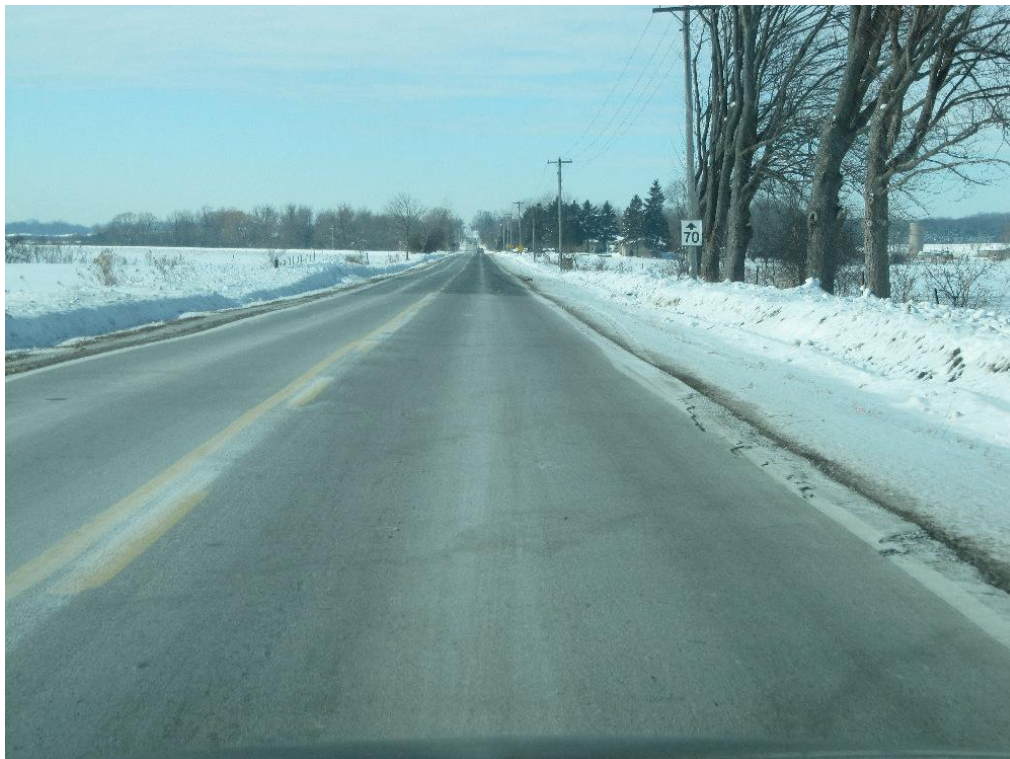
Figure 7: View, looking west along Sunningdale Road. The end of the newer section of pavement can be seen in the background.

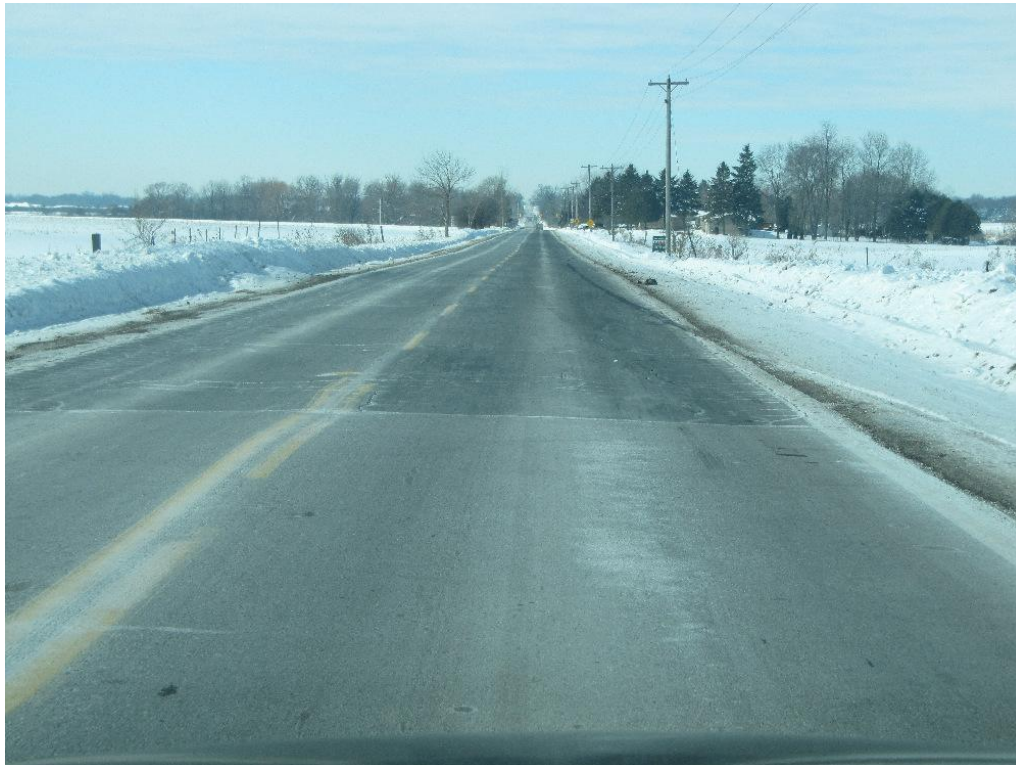
Figure 8: View, looking west along Sunningdale Road at the point where the newer section of pavement ends and the rougher section of surface returns.

we can remove the length of the small bridge from the analysis and assume that the smooth road surface begins on the west side of the bridge. We can terminate the smooth section of road at the location where the smooth surface returns to the rough surface, as shown in Figure 8. Reviewing the video it can be established that it took our test vehicle 77.87 seconds to traverse this smooth segment. Thus multiplying 77.87 by 11.11 provides an estimated distance of 865.14, or 865.0 metres.

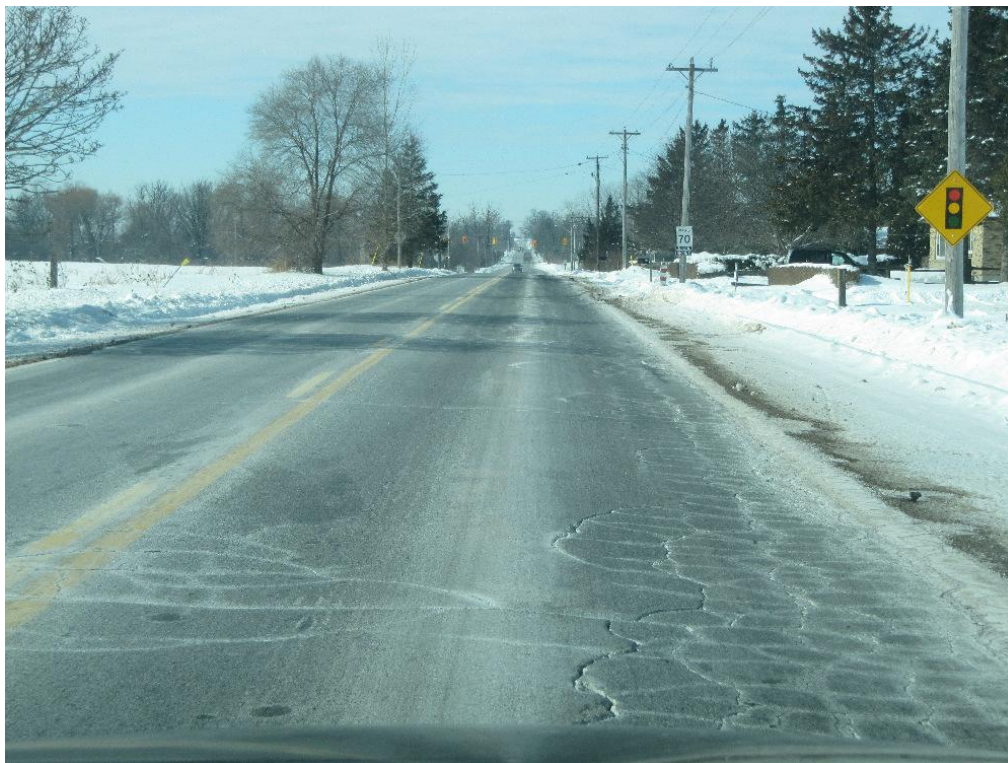
Figure 9: View, looking west along Sunningdale Road, along the rough portion of pavement on approach to the intersection with Highbury Avenue.

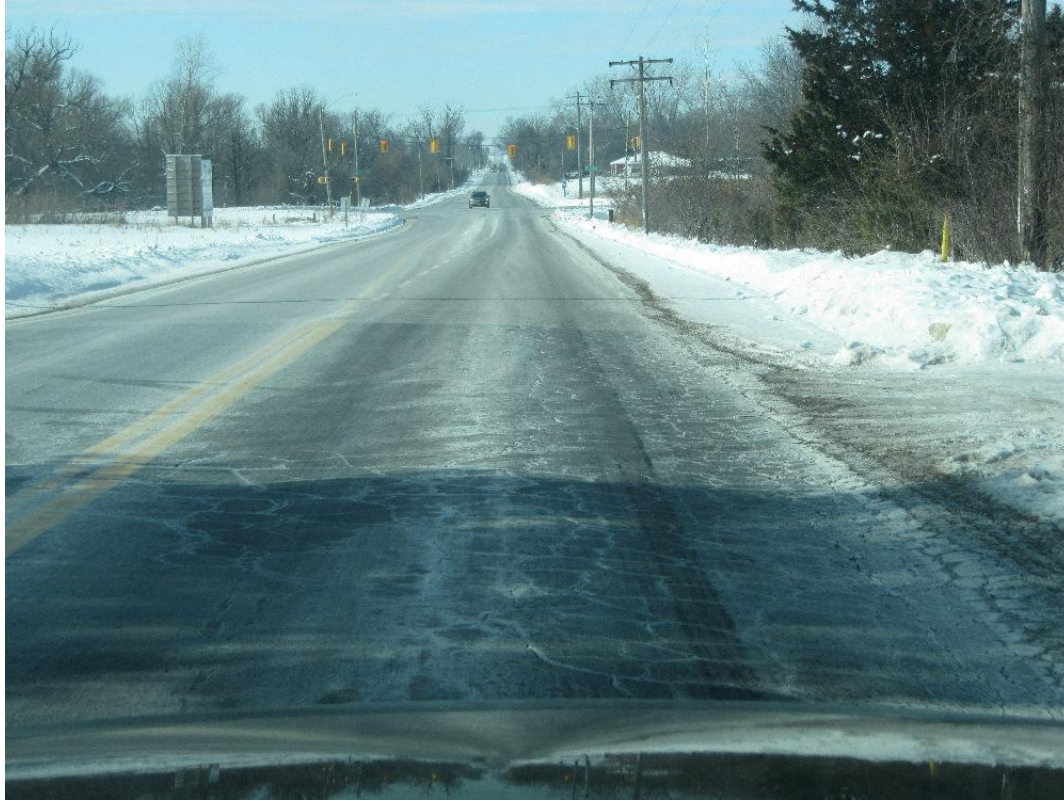
Figure 10: View, looking west along Sunningdale Road just east of the intersection with Highbury Avenue. This view shows that the rough segment of pavement ends on the approach to the Highbury intersection.

The point where the rough surface transitioned back into the newer section of pavement (Figure 10) is where the analysis of the gathered data was terminated. Thus each run contained a road segment of rough surface, followed by the smooth surface and then finished off with a segment of rough surface.

Finally, the termination of the third road segment (or second segment of rough surface) was located in the area shown in Figure 10. Review of the video indicated that it took 45.13 seconds to traverse this final segment and therefore (45.13×11.11) this final road segment was about 501.4 metres long.

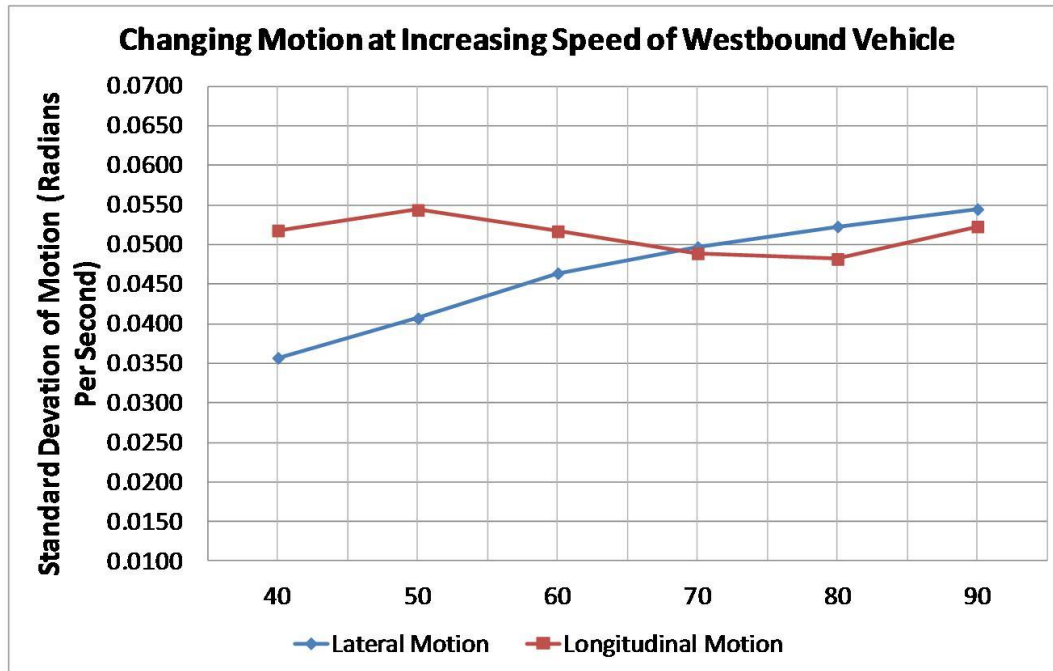
Figure 12: March 3, 2014 - Westbound runs.

This data is charted below. In the charts the blue line indicates the lateral motion while the red line indicates the longitudinal motion of the test vehicle. The axis along the bottom of the chart indicates the increasing speed of the test vehicle, from 40 to 90 km/h. The vertical axis is expressed in radians per second, from the minimum of 0.0100 to the maximum of 0.0700.

In the earlier articles it was noted that, at the lower speeds of 40-50 km/h the rate-of-change in the longitudinal motion was higher than it was for the lateral motion. However, as the speed was increased, the rate-of-change of the longitudinal motion stayed the same, or perhaps even showed a reducing trend with increasing speed. However, the rate of change in the lateral motion rose significantly as the speed of the test vehicle was increased such that, at the highest speeds (80 and 90 km/h) the lateral motion was higher than the longitudinal motion.

The new data re-affirmed what was indicated in the earlier articles. There appeared to be some choppiness in the longitudinal data as it rose or fell from one speed to another, while generally exhibiting no large increase during increasing speed.

In contrast, the lateral motion data seemed to exhibit a steady, incremental increase that matched very well with the incremental increase in vehicle speed. This pattern was exhibited regardless of the test vehicle's travel direction or the date of the testing, as can be seen in the above charts.

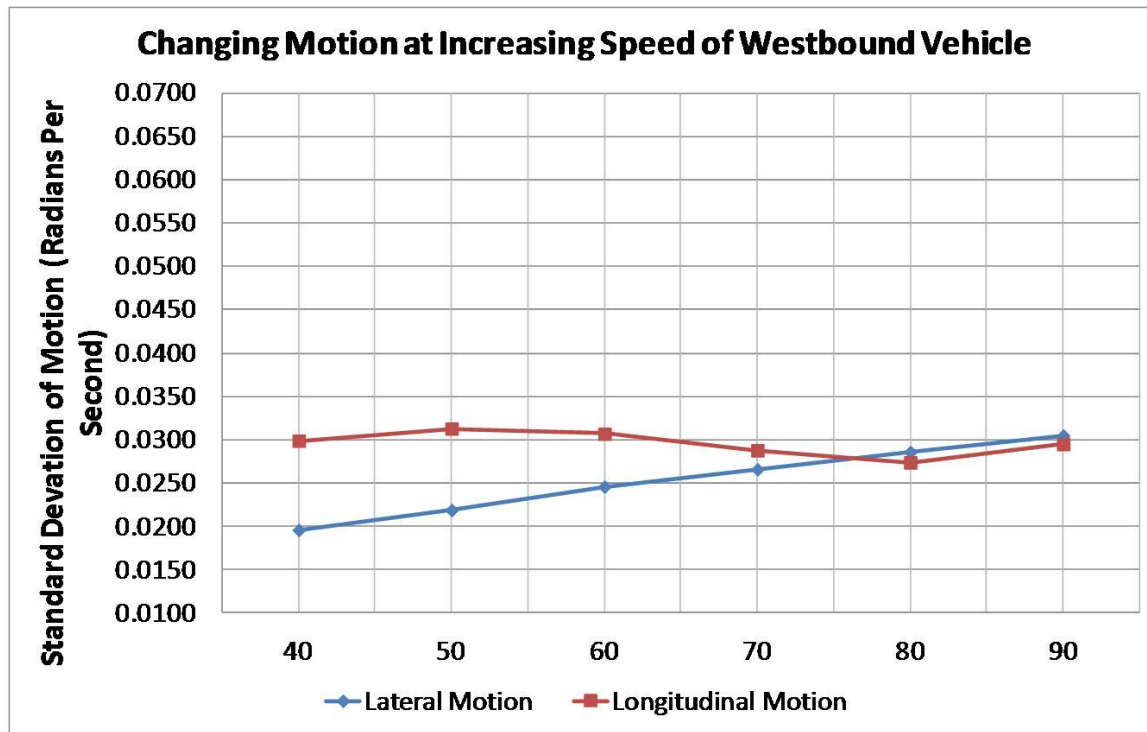
Figure 14: April 5, 2014 - Westbound runs.

Figures 14 and 15 show the results from our testing April 5, 2014.

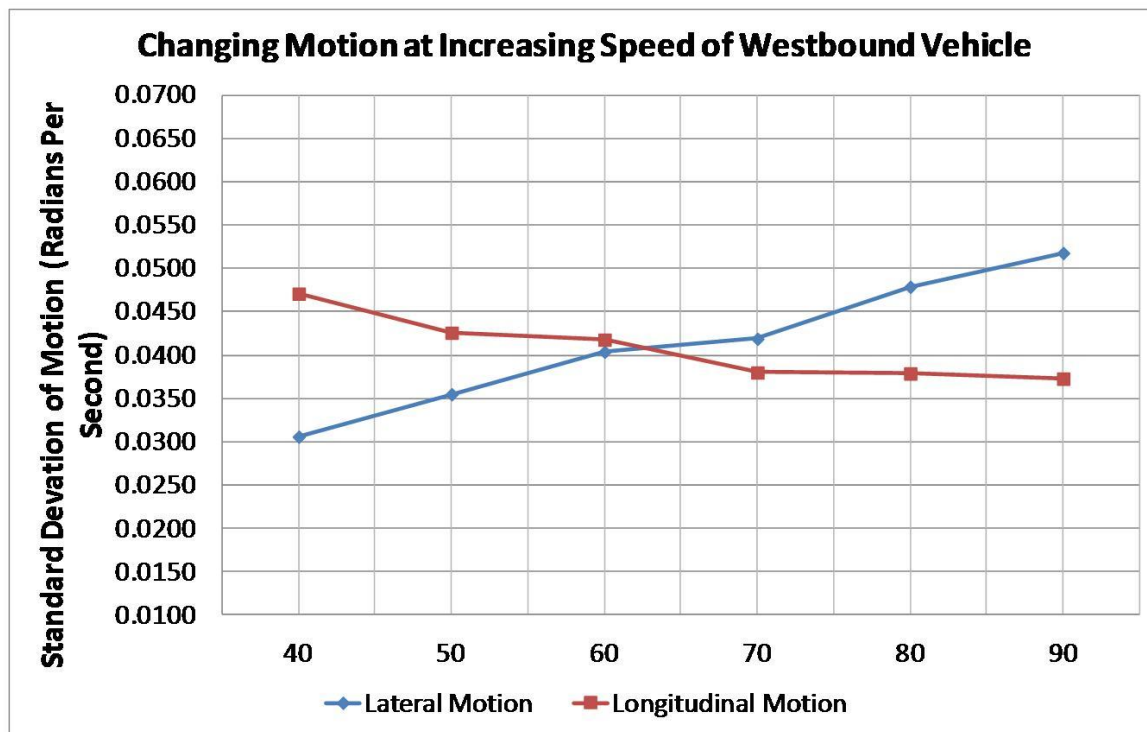
Figure 16: February 27, 2015 - Westbound runs.

Figures 16 and 17 show the results from our testing February 27, 2015.
