The Seven S-Curves of Adelaide - Part 2

This is a supplementary article in a series discussing testing at Gorski Consulting to document roadway effects on potential loss-of-control collisions at curves on Adelaide Street, north of the City of London, Ontario, Canada. A previous article introduced the roadway and the characteristics of each curve through a series of photographs. This article, the second in the series, reviews the instrumentation and testing methodology used to obtain the data from drive-through tests at the site.

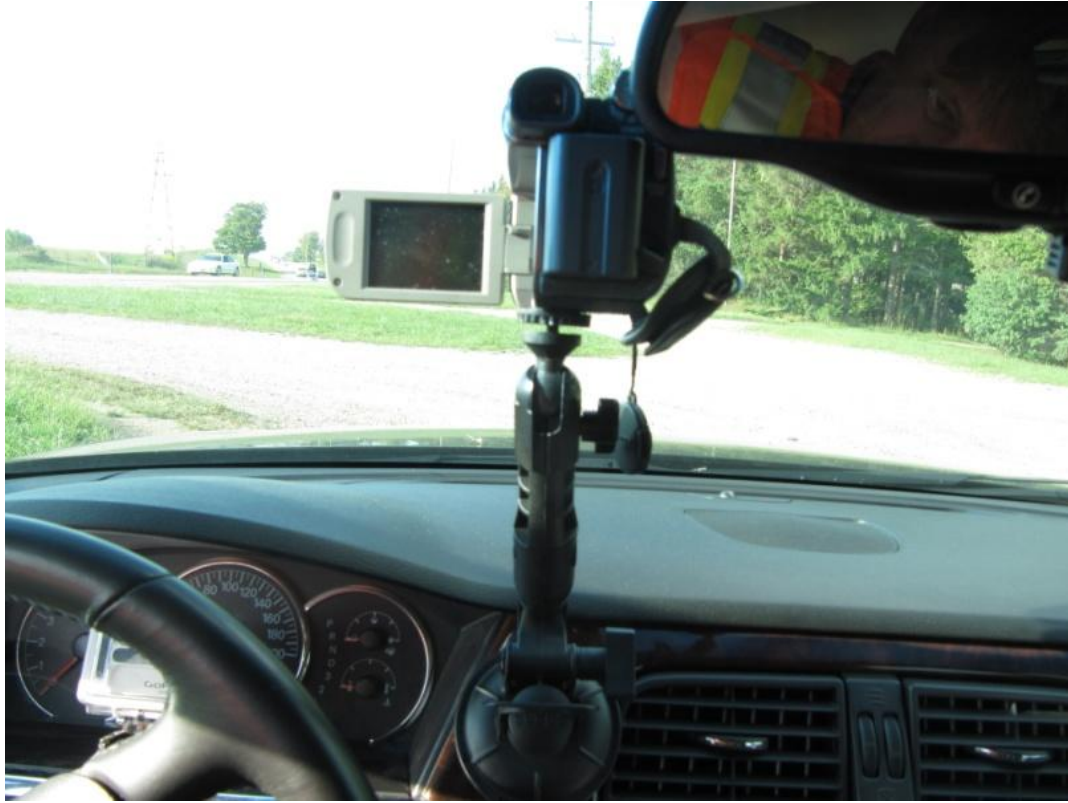
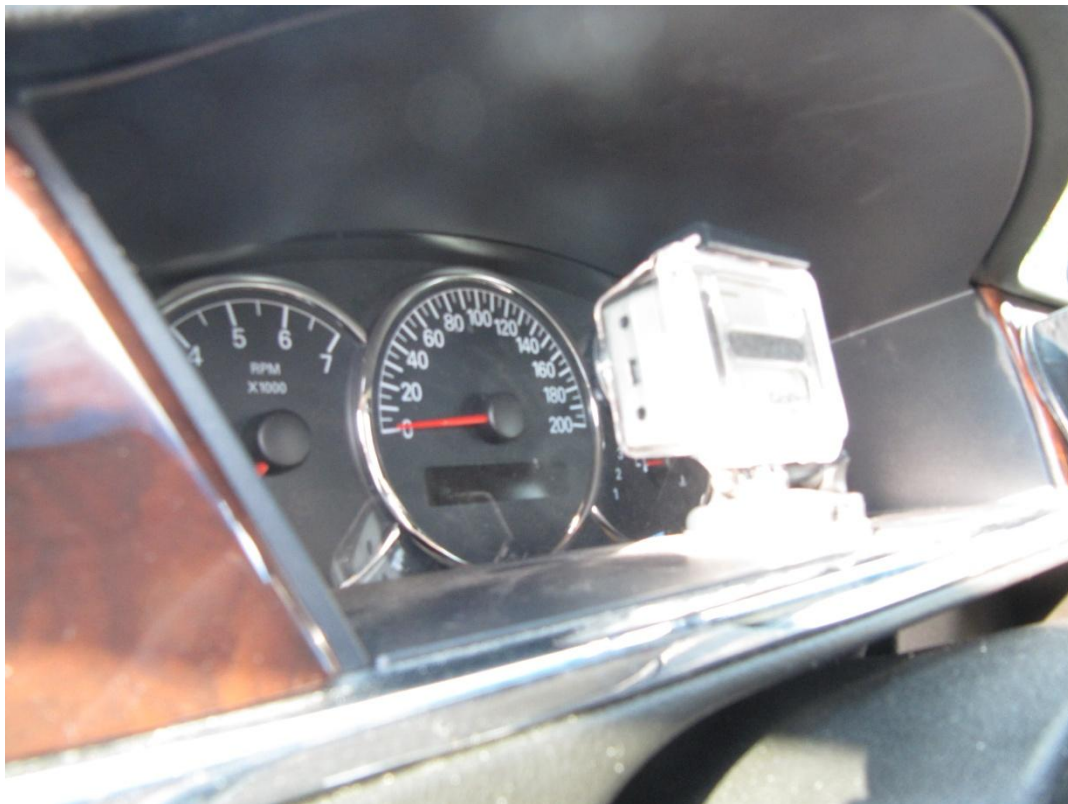
The photo at the top of Page 3 shows Camera 2 as it was anchored to show a forward view through the windshield. The bottom photo on Page 3 shows the GoPro22 camera mounted to face the speedometer and other gauges of the instrument panel.

Camera 2: A Sony MiniDV camcorder was mounted to the instrument panel and pointed forward through the windshield to capture the length of the road as the vehicle approached it.

Camera 3: A GoPro22 camera was mounted directly in front of the speedometer/tachometer and other instruments so that the status of these gauges could be documented.

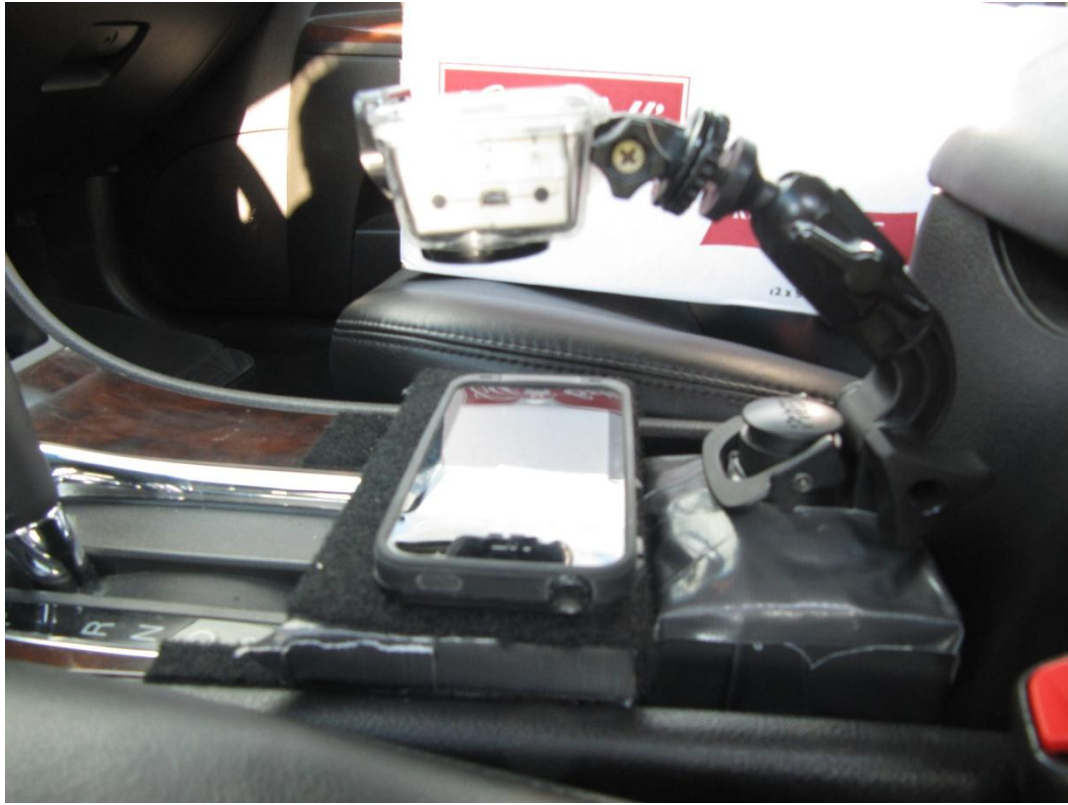
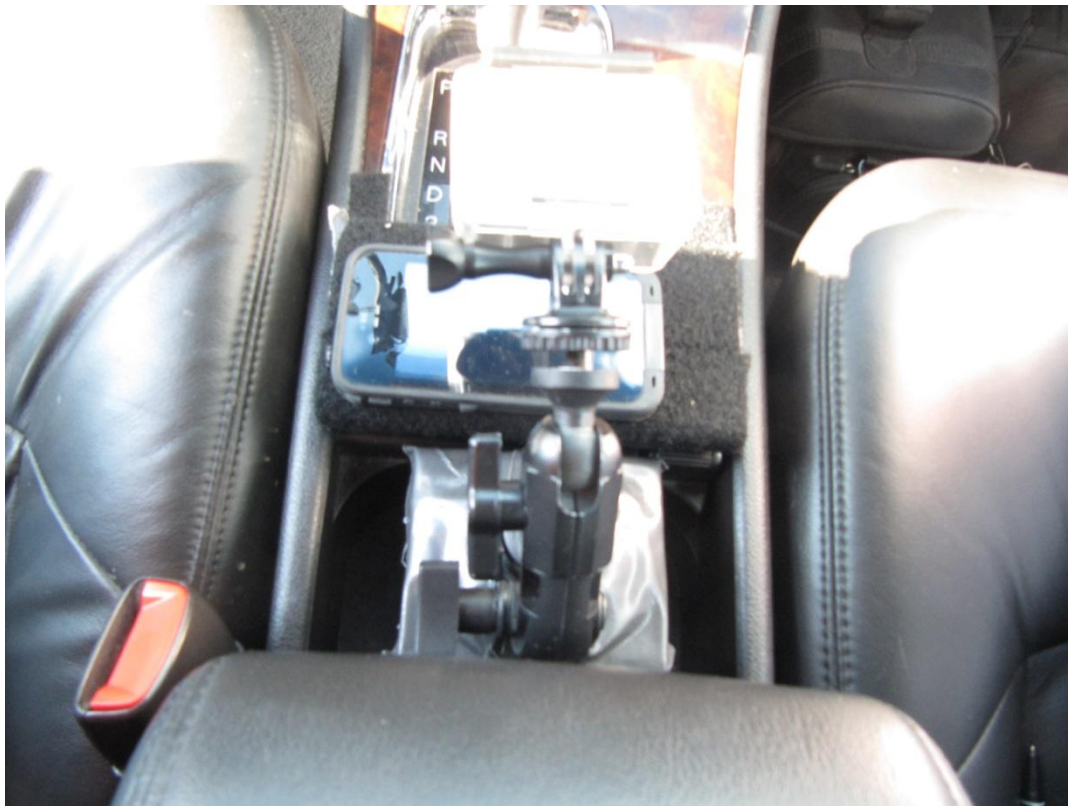
The two photos on Page 4 show GoPro24 as it was anchored to face downward onto the face of the iPhone. The iPhone was anchored to the centre console with velcro.

Anchorage of GoPro24 was difficult as adhesive tape would not stick to any surfaces of the test vehicle. Eventually a suction cup anchor was taped to a block of wood and this block was force fitted into the contours of the cup-holder and this provided satisfactory stability of the camera.

Camera 4: A GoPro24 camera was mounted in the centre console area and pointed down onto the face of an iPhone which was displaying the output from the iPhone's accelerometers.

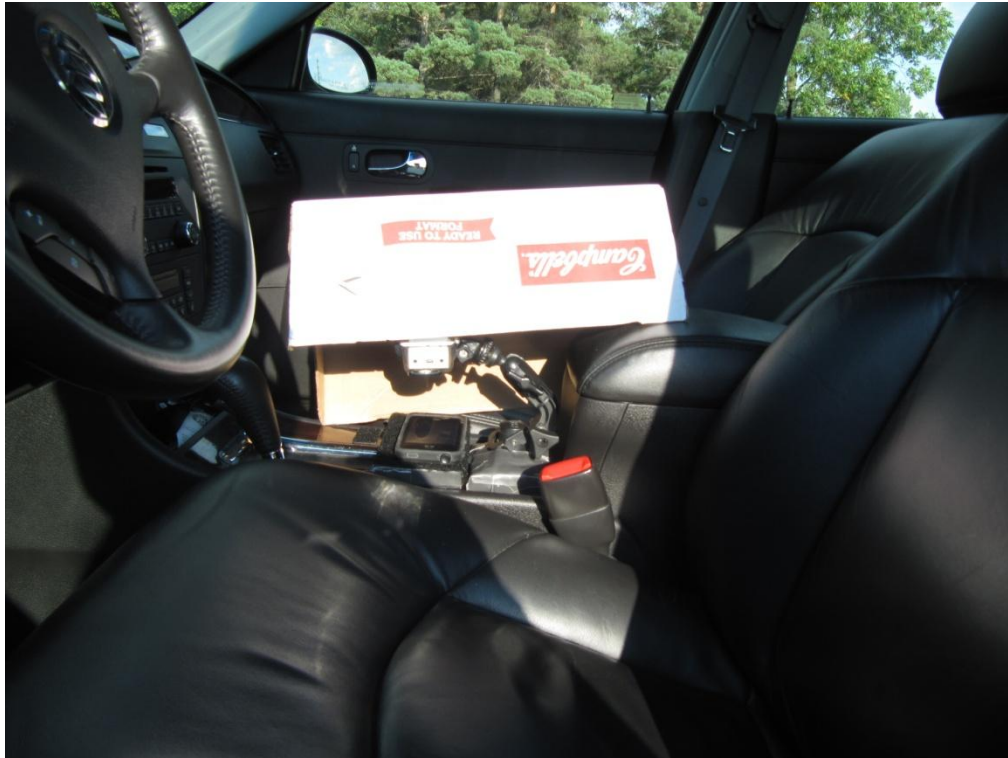
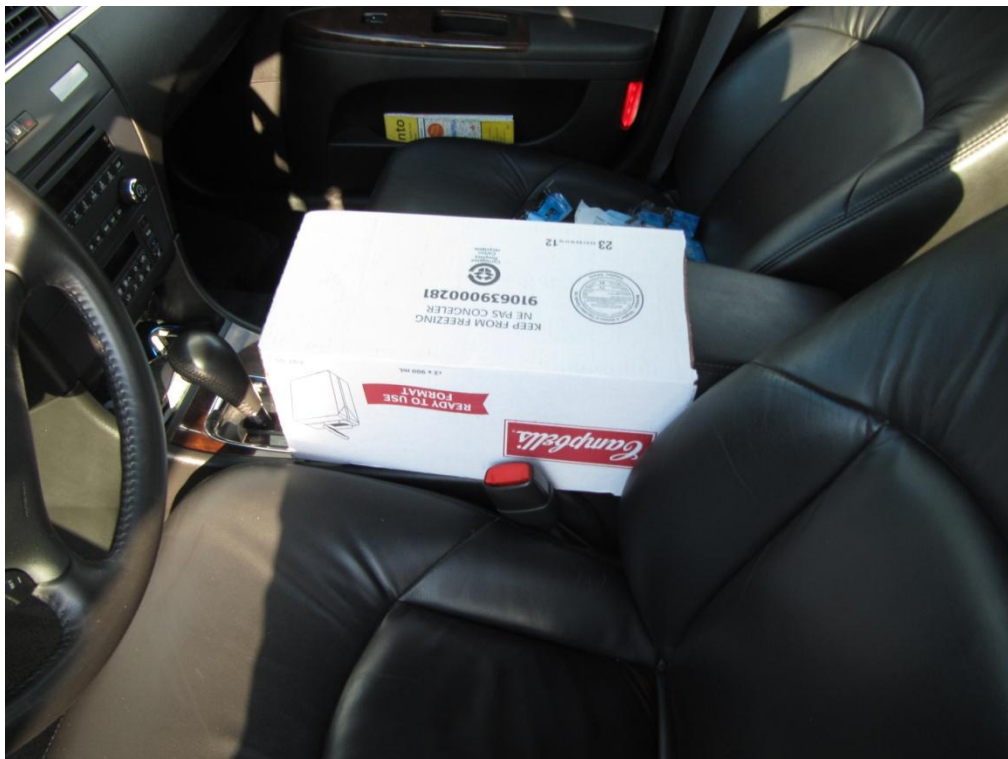
As can be seen in the photos of the face of the iPhone there was considerable reflection of sunlight that made it difficult for the camera to record the numerical values that were being displayed. The problem was rectified by placing a small cardboard box over top of GoPro24 and the iPhone so that also all of the reflections were eliminated. The photos on Page 5 show the box as it was positioned for testing.

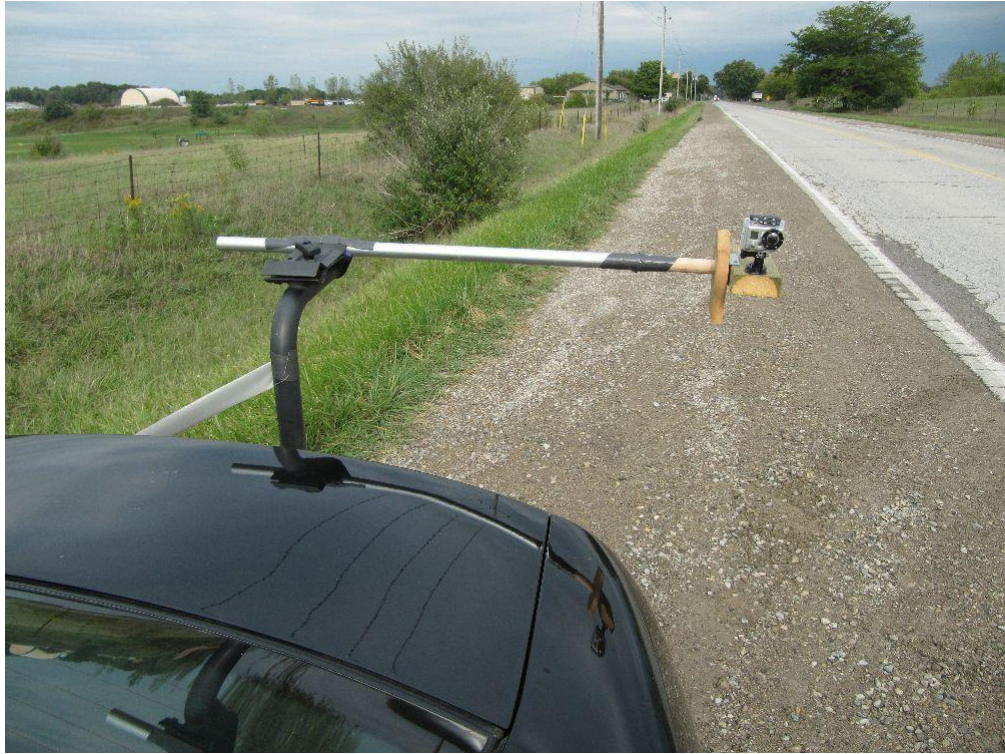
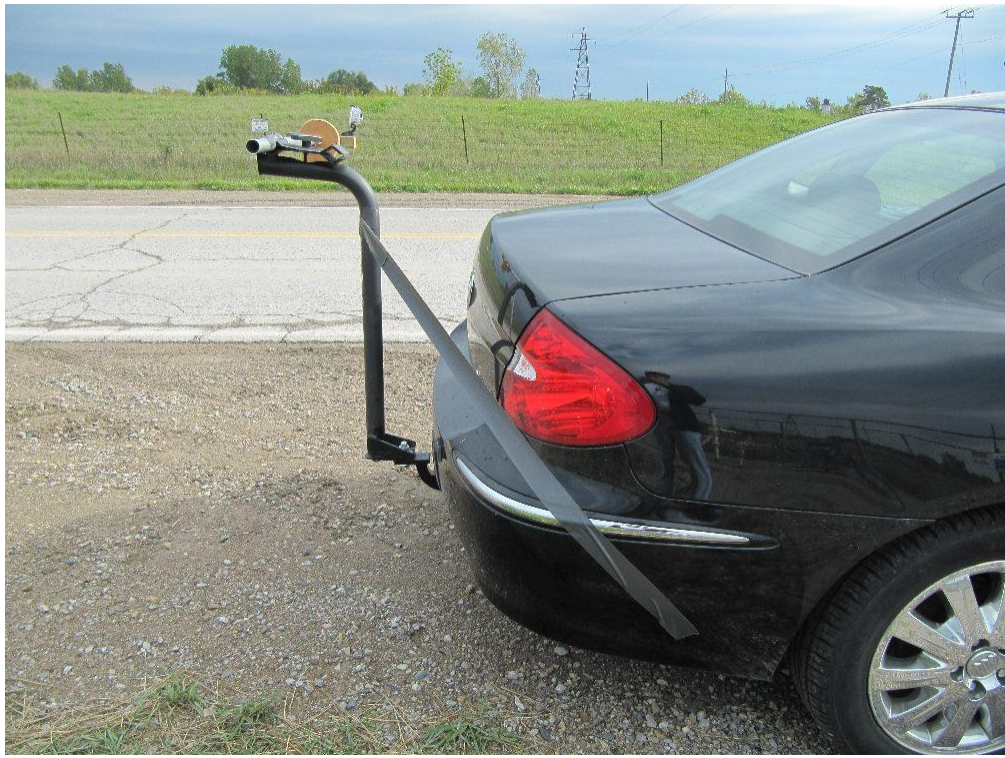
The two photos on Page 6 show how GoPro23 was anchored to the lateral tube that was anchored to a bike rack at the rear hitch of the test vehicle. The photo on page 7 shows how GoPro23 enabled a view of the left tires in relation to the centre-line of a roadway.

Camera 6: A GoPro23 camera was mounted to the left end of a lateral bar that itself was attached to a bike rack at the back of the test vehicle. The camera was pointed forward and downward toward the left rear wheel and left rear tail-light of the test vehicle. While the test vehicle was in motion this camera documented the lateral distance between the left wheels of the vehicle and the centre-line of the highway. This view allowed the documentation of the change in lateral position of the test vehicle on the road as this was an important factor when evaluating the lateral acceleration of a vehicle through a curve. This camera also captured the status of the illumination of the left brake light of the vehicle.
