Traffic Conflicts In An Expressway Construction Zone

by Zygmunt | August 1, 2020 | News

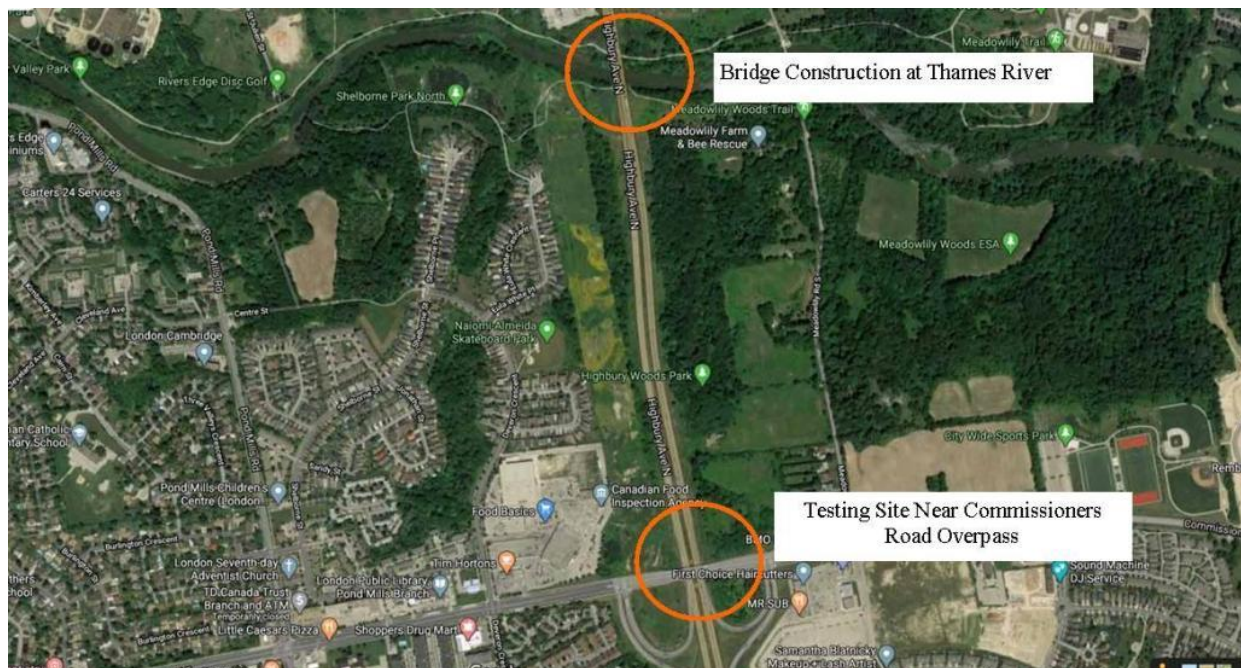
The present article continues to review the actions of northbound drivers at the Highbury Ave construction site. The Googlemaps view below shows the location of the construction site with respect to the location of the testing site. The distance between these locations is about 1.1 kilometres.

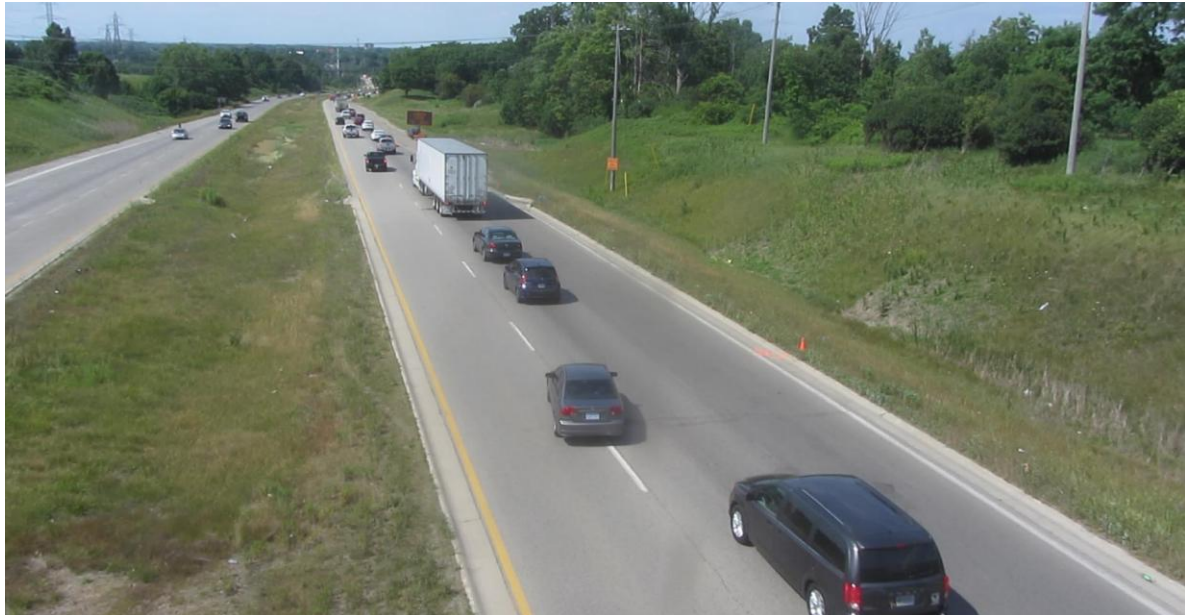
On the approach to a construction zone it has been customary for drivers to pull into the right lane early so as not to have problems trying to squeeze into the lane when the left lane is closed in the distance. An example of this can be observed at the Highbury Ave site as shown in the figure below. This is a frame taken from a video camera mounted on the Commissioners Road overpass, looking north along the northbound lanes of Highbury Ave. This view was taken just after 1600 hours on July 15, 2020.

At the location shown in the above figure many drivers are moving into the right lane.

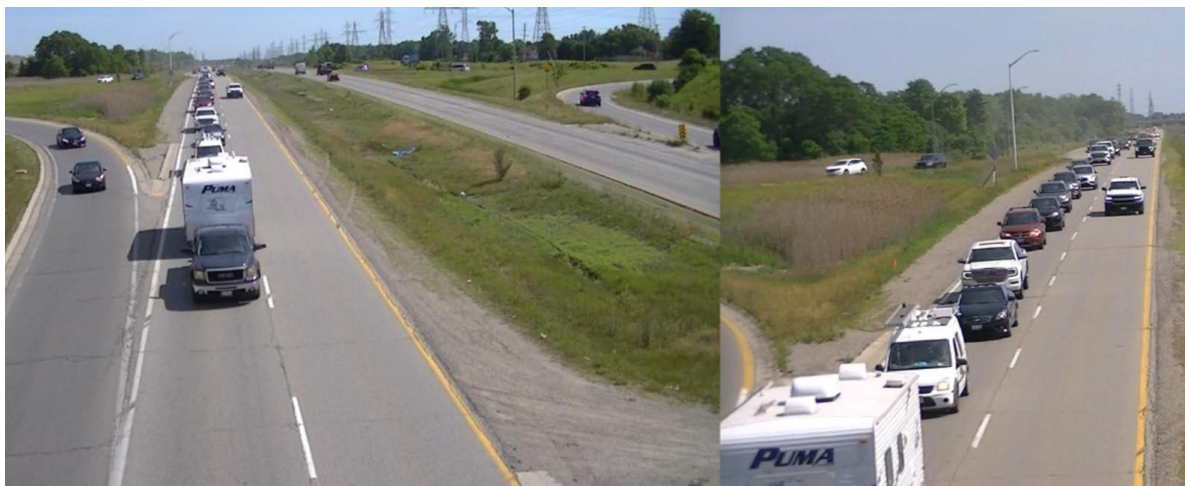
The next figure shows an example of the traffic looking south from the overpass. This is a composite view from two video cameras. Here we can see that the right lane is completely filled with traffic while the left lane is relatively empty. At the view to the right one can observe that a white pick-up truck is travelling in the left lane toward the camera. At the view to the left we can see two vehicles on the on-ramp that will be entering the right lane. While merging takes place in the right lane vehicles may veer into the left lane. Vehicles approaching the area in the left lane at high speed (such as the white pick-up truck) can cause potentially dangerous scenarios. These types of vehicle motions are common on the approaches to many construction zones.

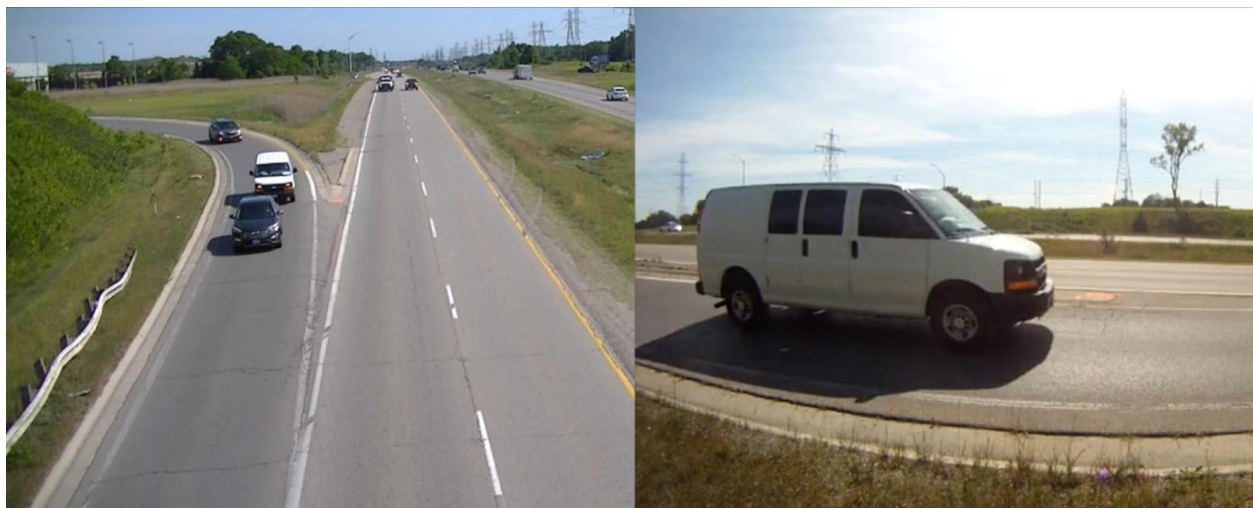
The description of the scenario begins with the White Van when it first enters Highbury Ave from the on-ramp of Commissioners Road, as shown in the Figure below. At the front end of the Van an orange marking can be seen painted on the pavement. This is the “50-metre-south” marker and it indicates that the Van’s present location is 50 metres south of the south edge of the overpass of Commissioners Road. Such markers were painted along the road edge so that during the analysis of the video the precise position of vehicles could be noted and average speeds could be calculated.

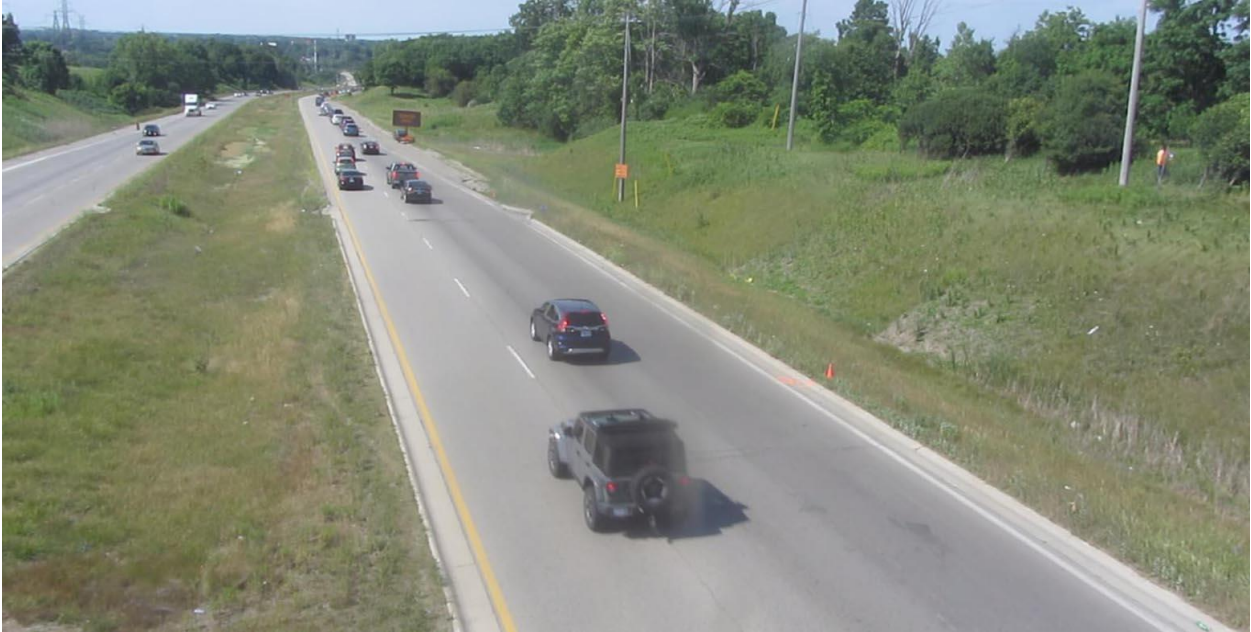
As the White Van enters the expressway the figure below shows the status of the traffic in the northbound lanes ahead of it. The figure shows that the right lane contains some space between vehicles and this explains the reason behind the Van's speed is in the mid-50s as it travels from the ramp into the right lane.

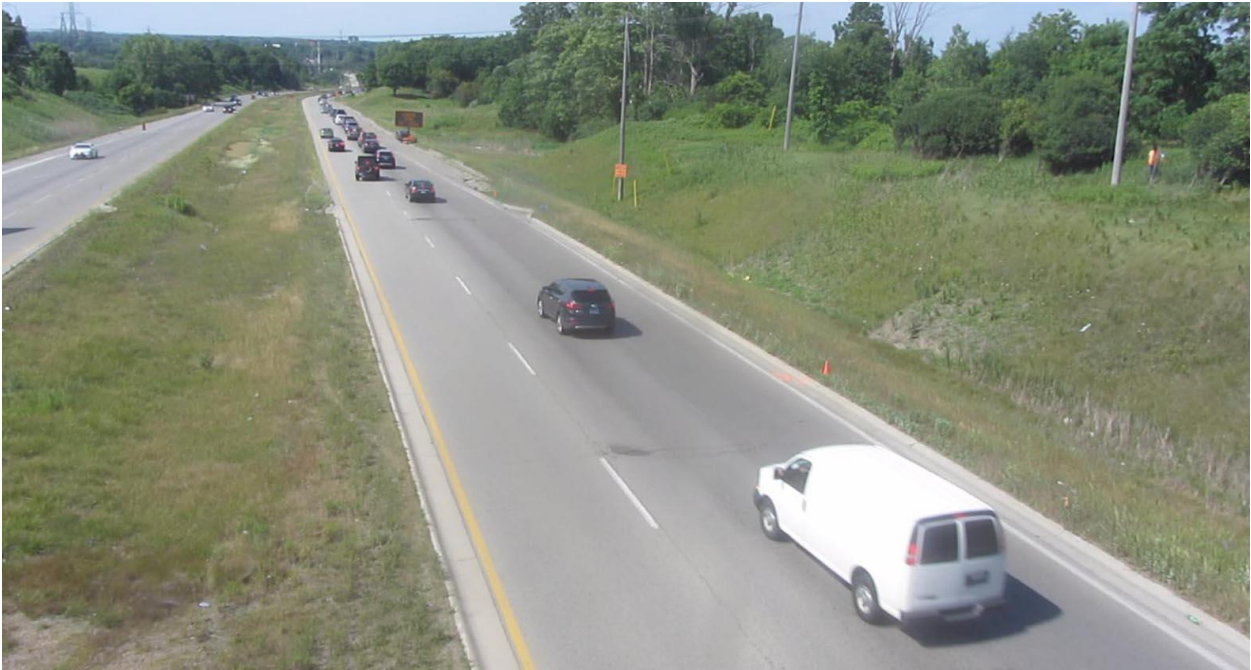
The figure below shows the White Van at the bottom of the view as it is approaching the 50-metre-north marker. We can see that there is some space between the vehicles ahead but that the traffic seems to be more dense in the background. Thus we are seeing the development of a slow-down of traffic speed in the right lane.

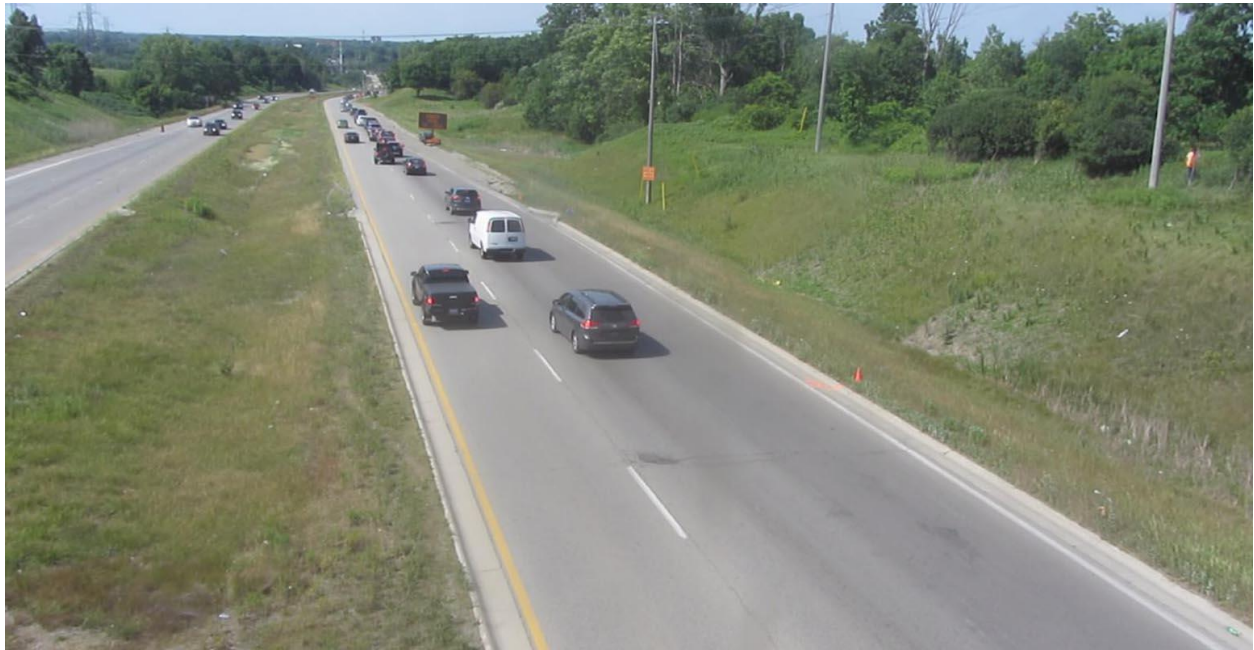
As we continue the figure below shows the White Van as it is approaching the 100-metre-north marker and it can be seen that the traffic ahead begins to be more dense in the right lane. This might explain why the speed of the White Van reduces to about 34 km/h between the 50 and 100-metre markers.

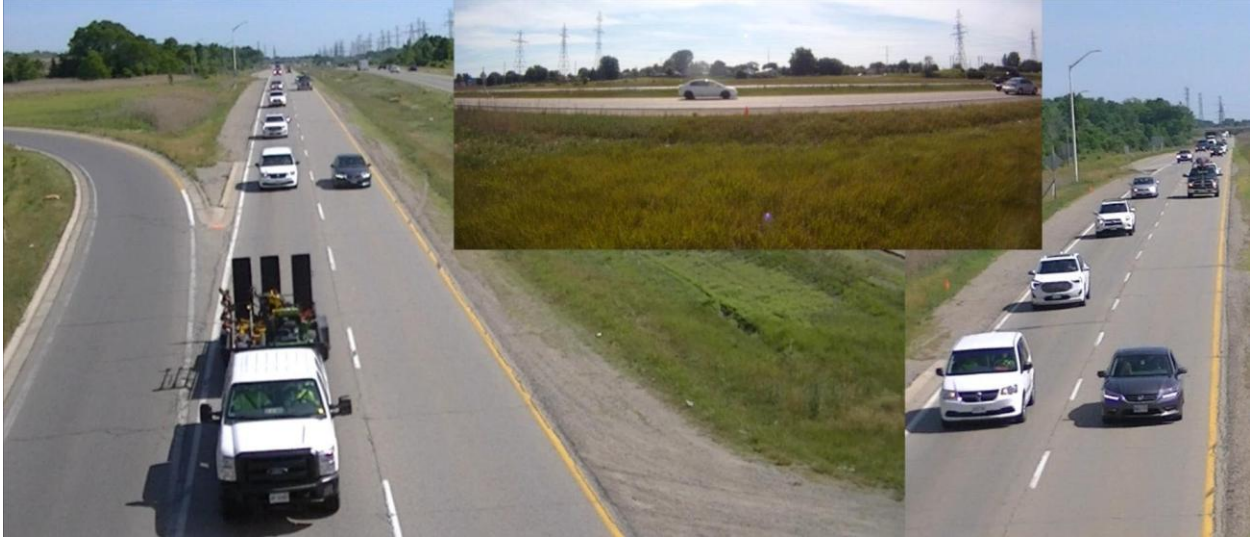
Just before this time we can see in Table 2 that the Pick-up truck (with the canoe) and the White Car are passing the 200-metre-south marker, as shown in the figure below. The White car is not visible in the left lane because it is behind the larger Pick-up truck and both vehicles are still a long distance away in the background. However in the inset of the figure we can see the front end of the White Car passing the 200-metre-south marker while the Pick-up is at the extreme right edge of the view.

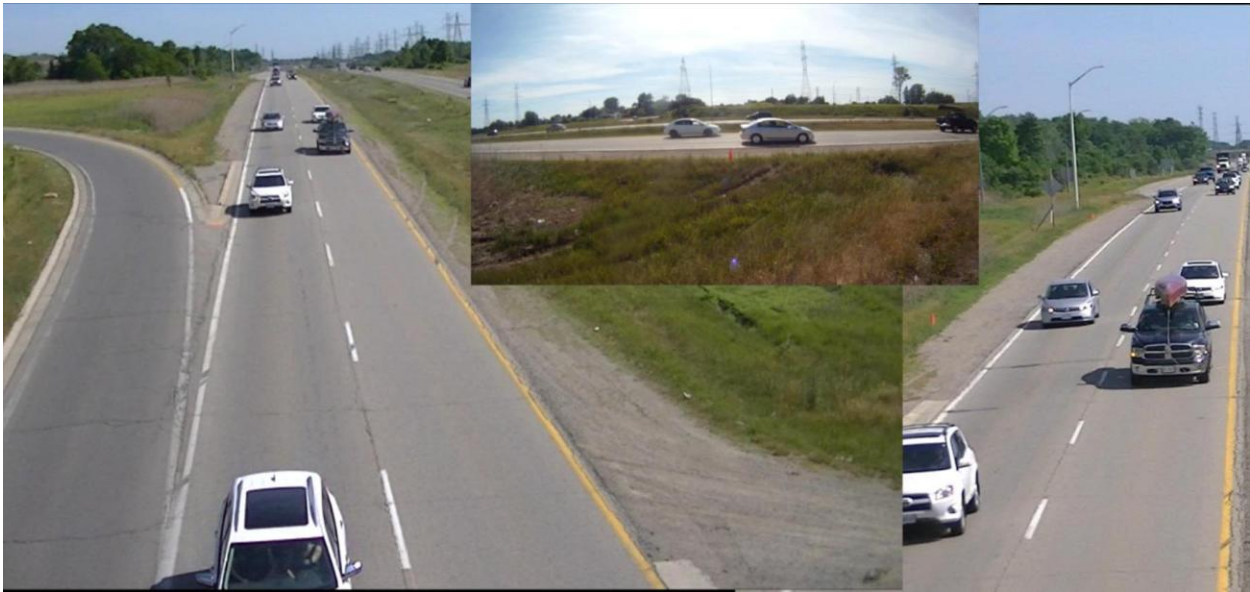
The figure below shows the Pick-up Truck and the White Car just as the White Car is passing the 100-metre-south marker. The White Car begins to be visible behind the Pick-up Truck at the right view of the figure and we can also see as it passes the 100-metre-south marker in the inset.

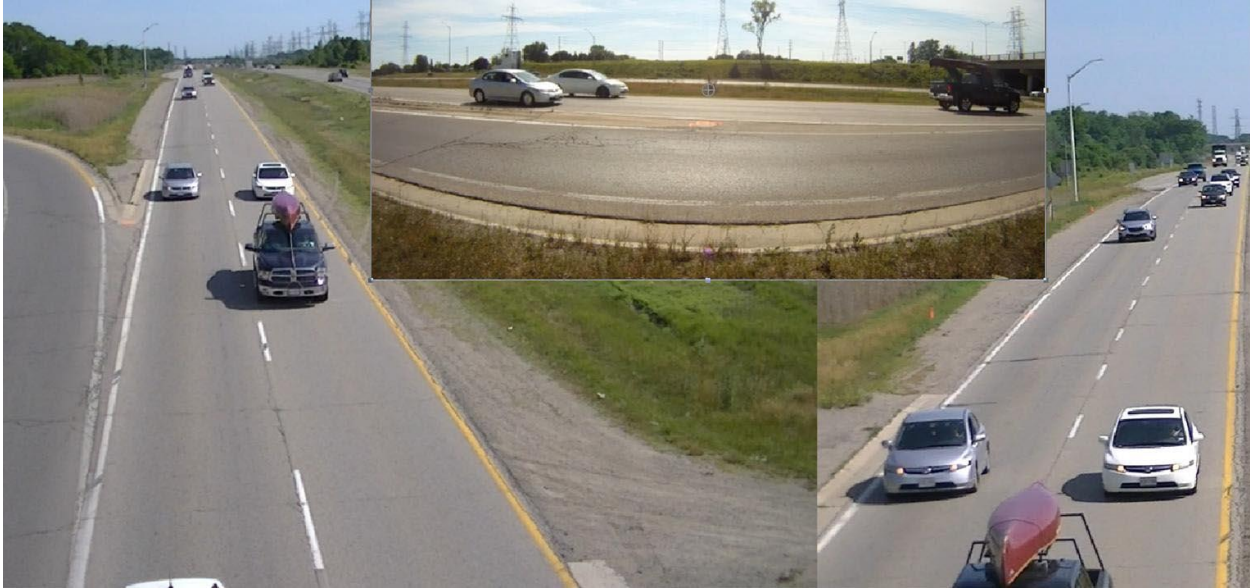
The figure below shows the time when the White Car is passing the 50-metre-south marker. This is about the same time as the White Van is approaching the 100-metre-north marker. Note that the Pick-up Truck is starting to move into the right lane. A car that was travelling in front of the Pick-up also moved into the right lane. The driver of the White Car is unlikely to see what is transpiring in the left lane ahead. However as the White Car approaches the Commissioners Road overpass the distance ahead becomes clear and visible.

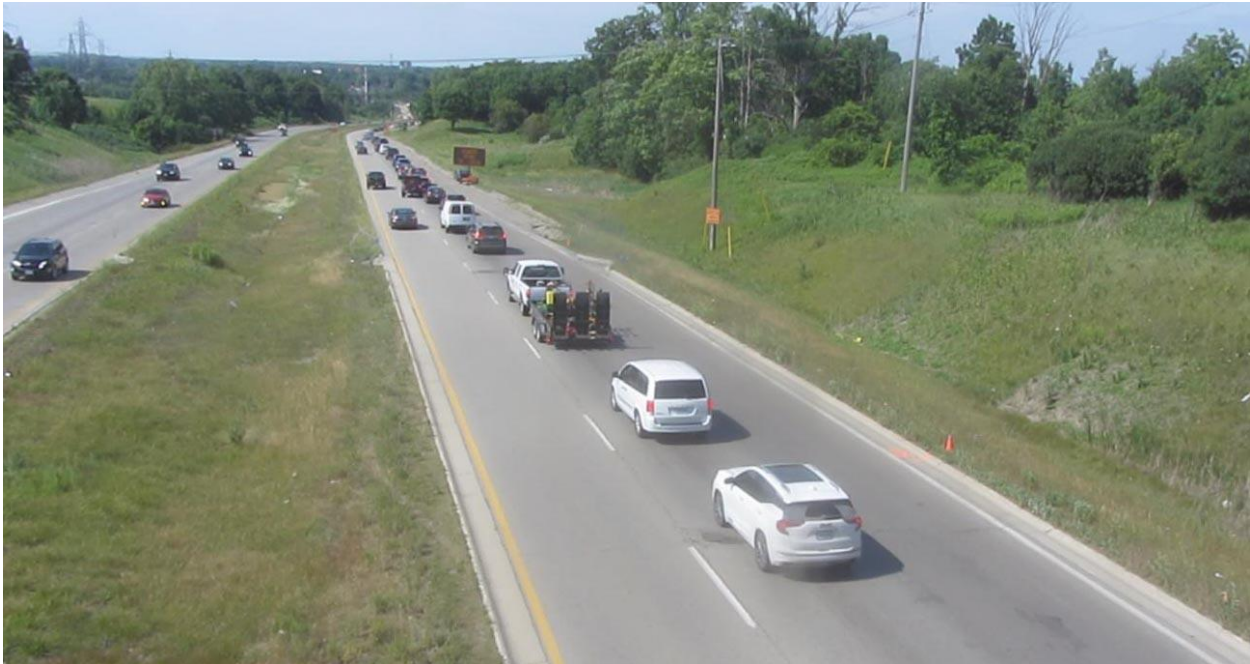
In the next figure we see the White Van as it has passed the 100-metre-north marker. The second of the two vehicles in the left lane is passing the Van. Although not visible here Table 2 shows that the White Car is about 150 metres behind the position of the White Van, or the White Car is approximately at the location of the 50-metre-south marker.

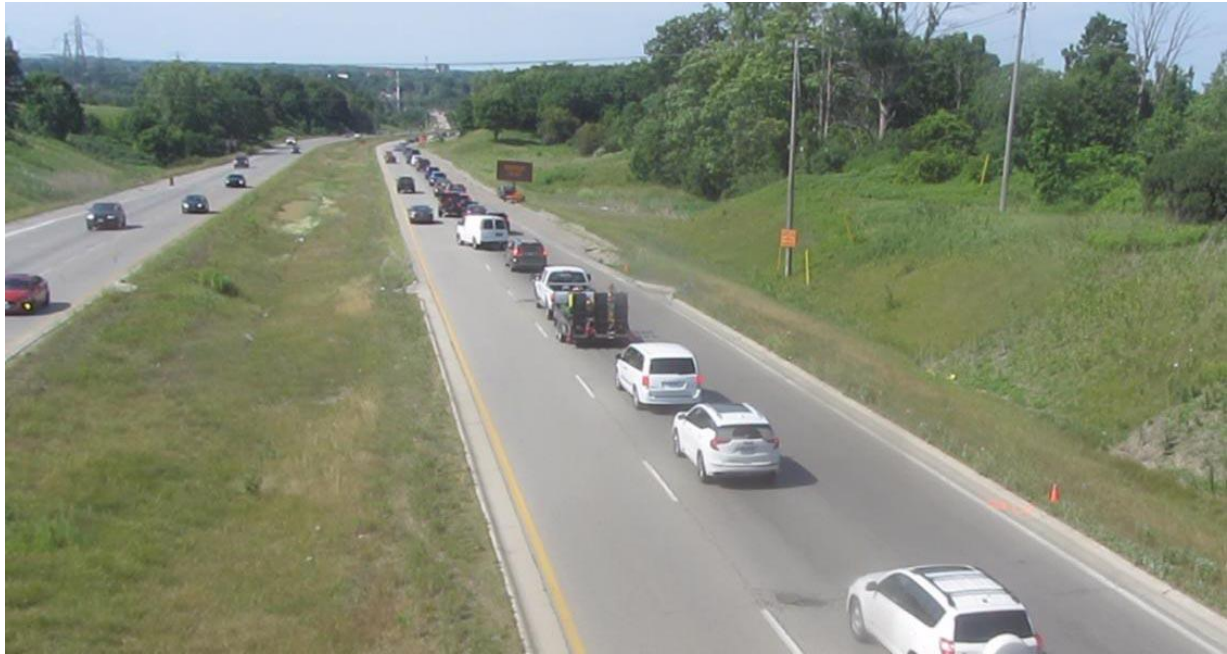
At this point we can see in the figure below that the White Van suddenly begins to change lanes, from the right lane to the left lane.

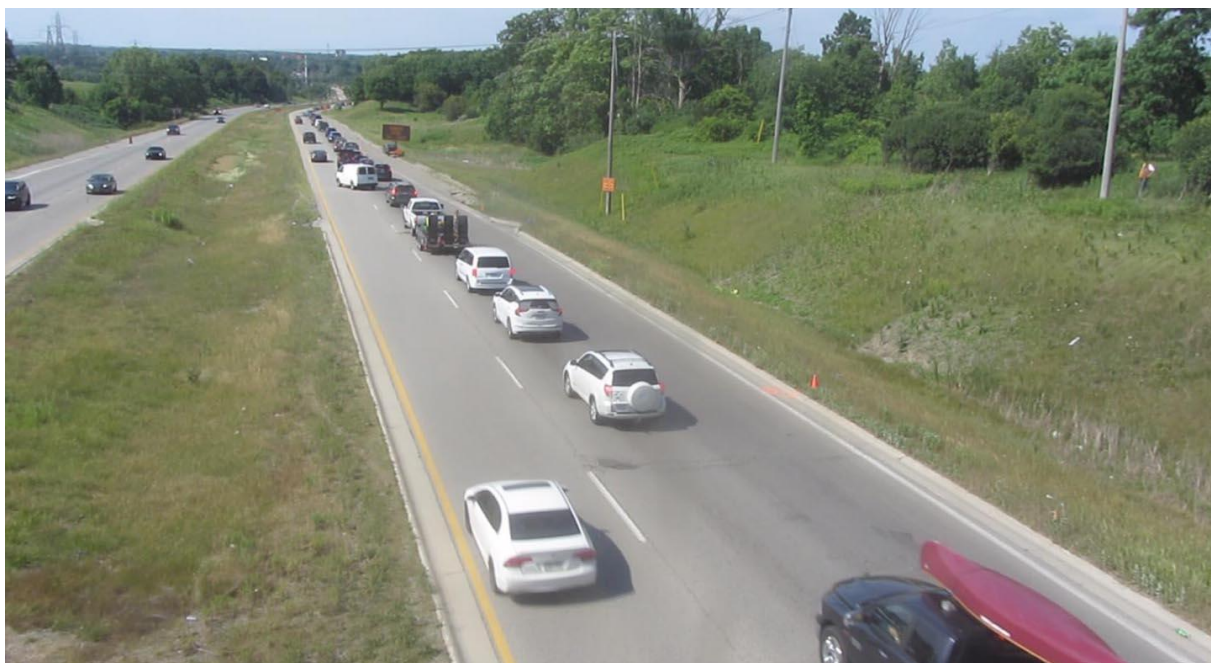
And as this lane change is taking place we can see in the figure below that the White Car begins to become visible in the bottom of the view. As shown in Table 2 the average speed of the White Car in the 50-metre distance north of the overpass is about 75 km/h. We can estimate the speed of traffic in the right lane by looking at the speed of the Pick-up carrying the canoe that was in front of the White Car at the beginning of this demonstration. That Pick-up truck can be seen in the bottom right of the Figure below. Table 2 indicates that its speed at this location is about 38 km/h.

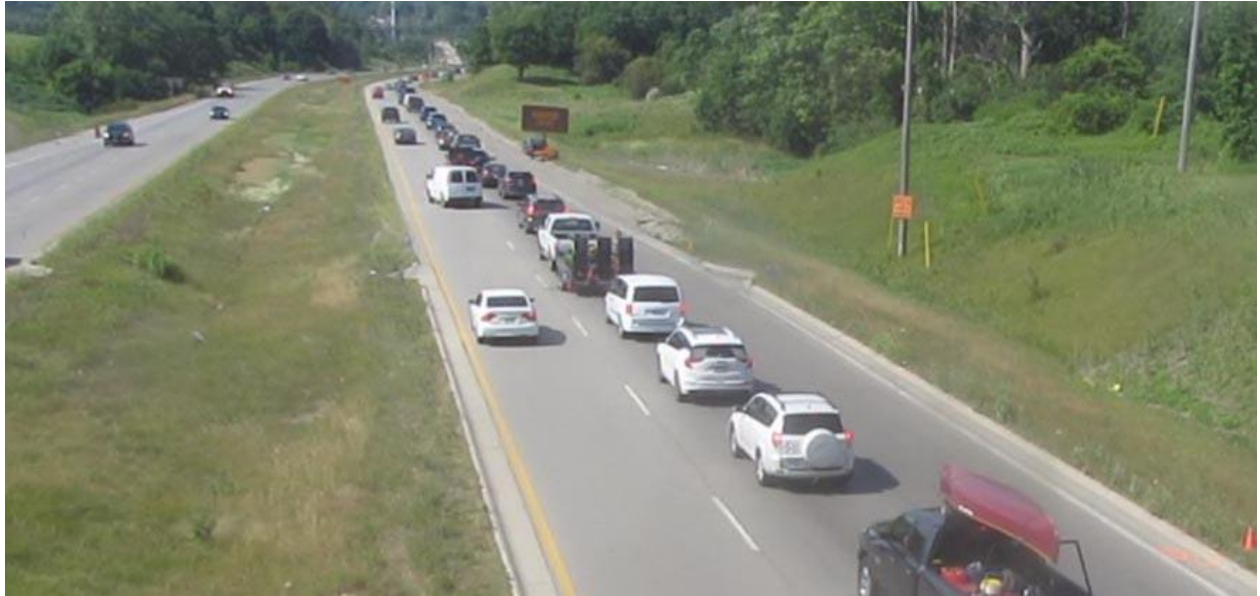
In the figure below the White Van continues its lane change while the White Car approaches. Upon seeing the motion of the White Van one might conclude that perhaps the driver decided not to wait in the right lane and a decision was made to pass the slow traffic via the left lane. But that conclusion becomes nullified as we observe the scenario unfolding in the following frames.

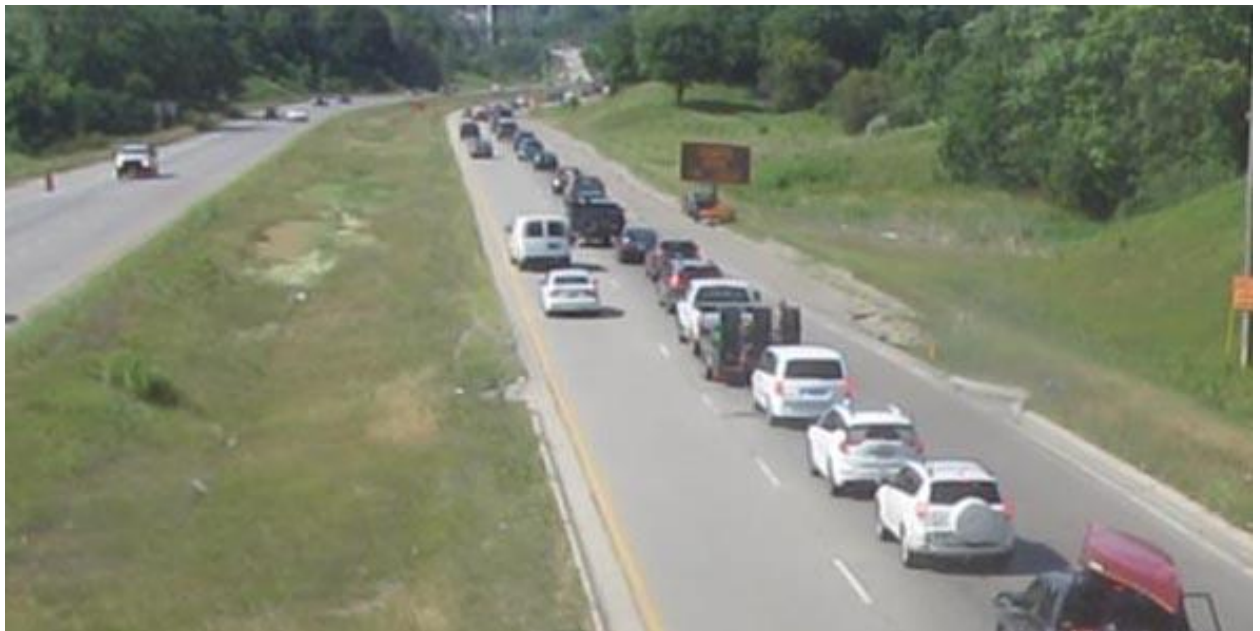
In the figure below we see that the White Car has now reached the rear bumper of the White Van. If the Van driver was intending to accelerate past the slow-moving traffic it does not appear that this is happening.

Table 2 shows that the average speed of the White Van in the left lane is just over 14 km/h. So it is travelling very slow. It is also not passing any of the vehicles in the right lane. Clearly the driver of the White Van did not pull out of the right lane to pass the slow-moving vehicles. The lane change was purposely made to block the passage of the fast-moving vehicles (such as the White Car) in the left lane. As the speed of both vehicles is reduced to a crawl the figure below shows that other vehicles in the left lane are beginning to arrive.

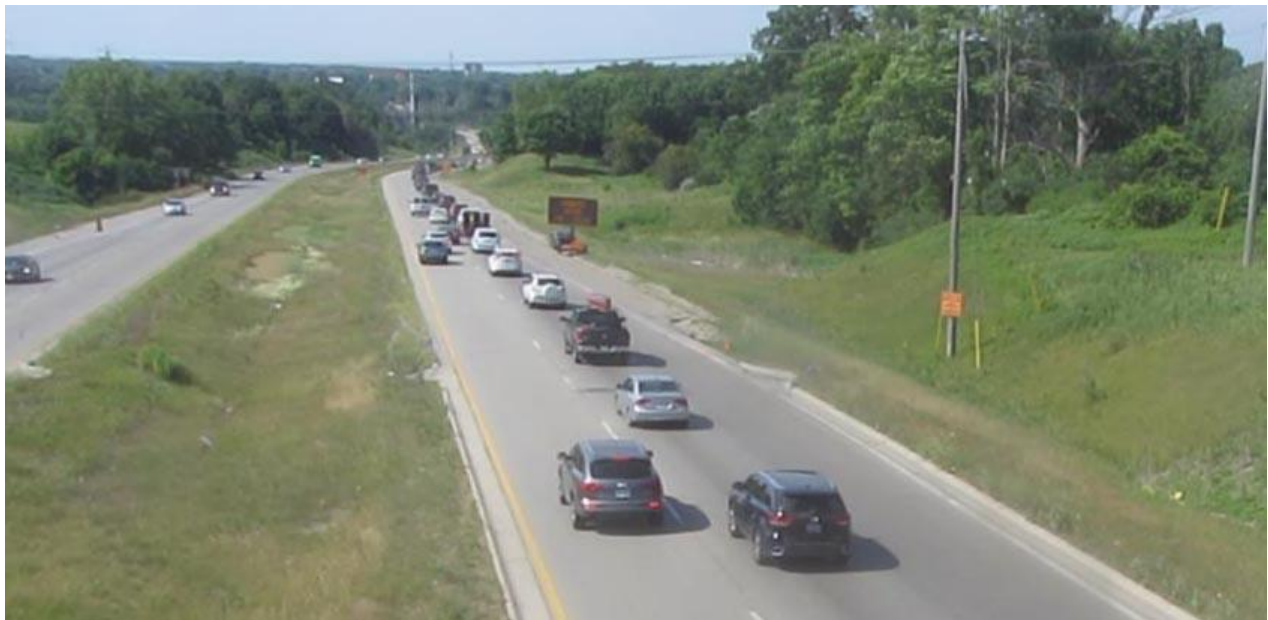
As shown in the figure below the White Van eventually starts to return to the right lane and so does the White Car. Other vehicles behind them also begin moving into the right lane.

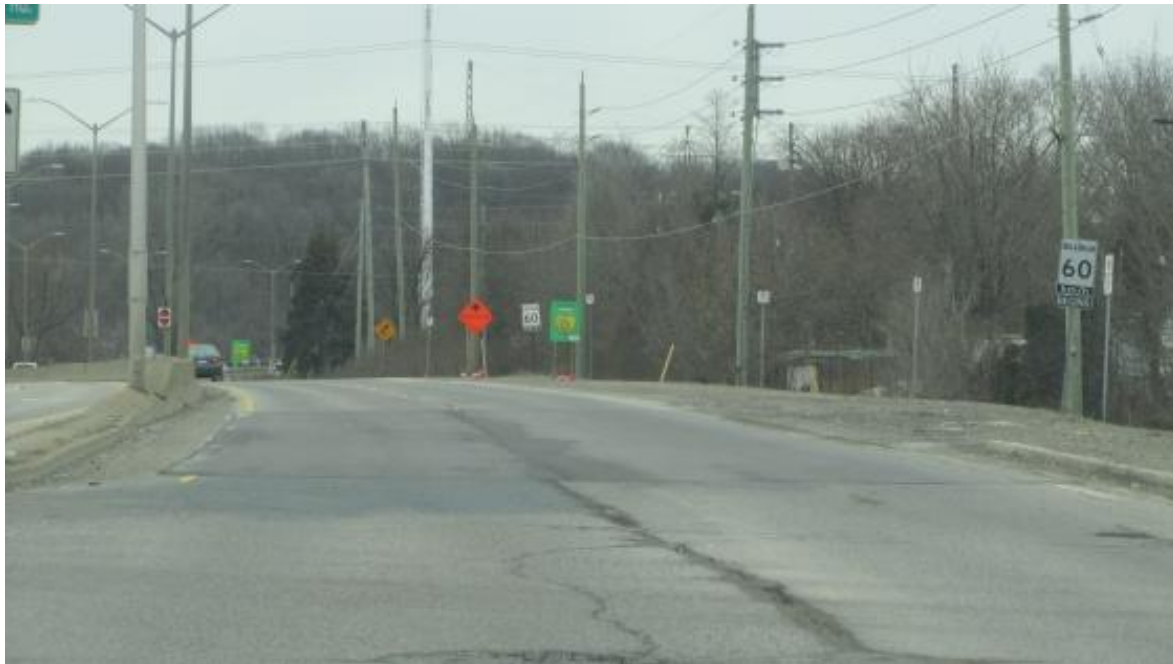
Shortly after these postings, a construction project commenced at the Highbury Ave site. The figure below shows a view looking south on Highbury Ave on February 22, 2018 and it shows that the construction was at the same bridge over the Thames River. Besides the typical orange construction zone signs there are additional signs that were posted to advise drivers of the zipper merge technique.

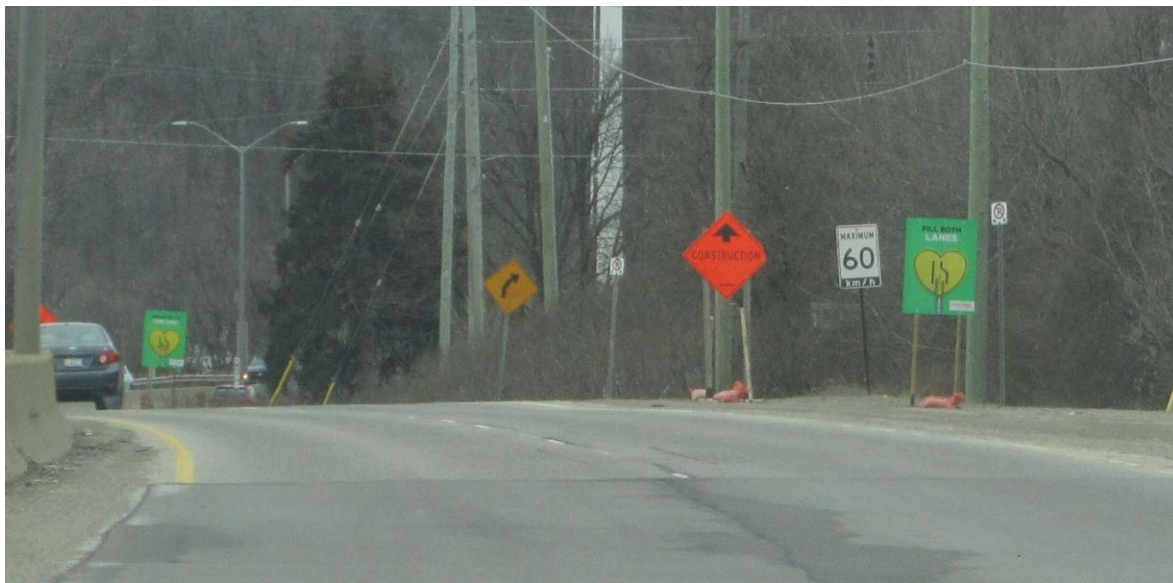
The figure below shows a closer view of those green signs.

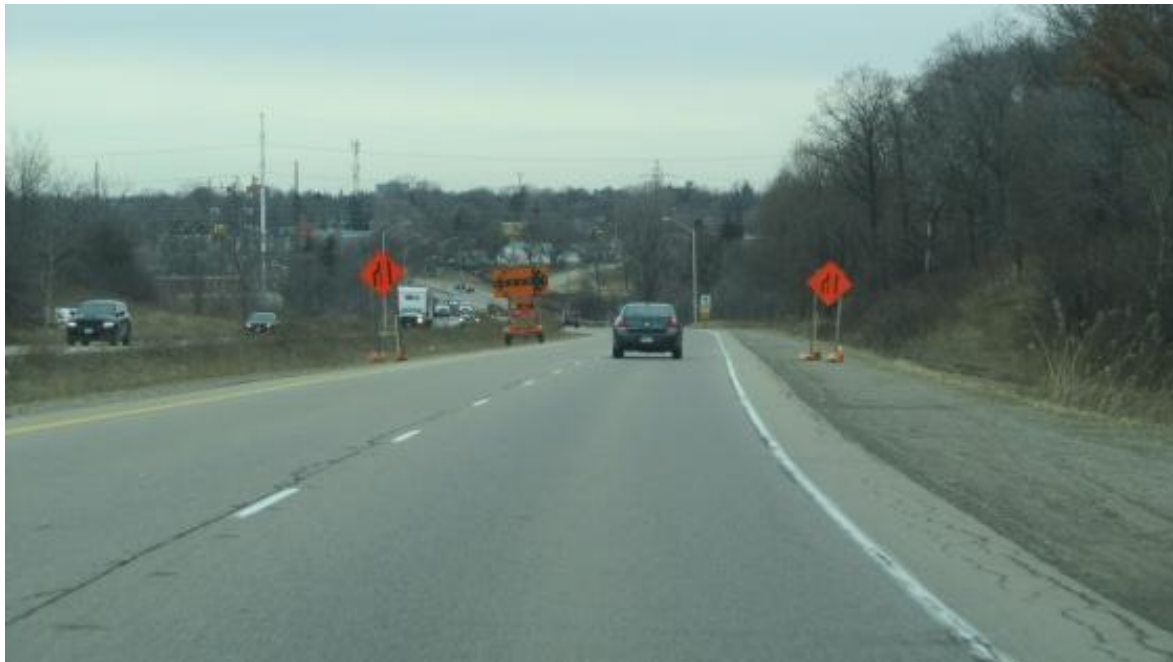
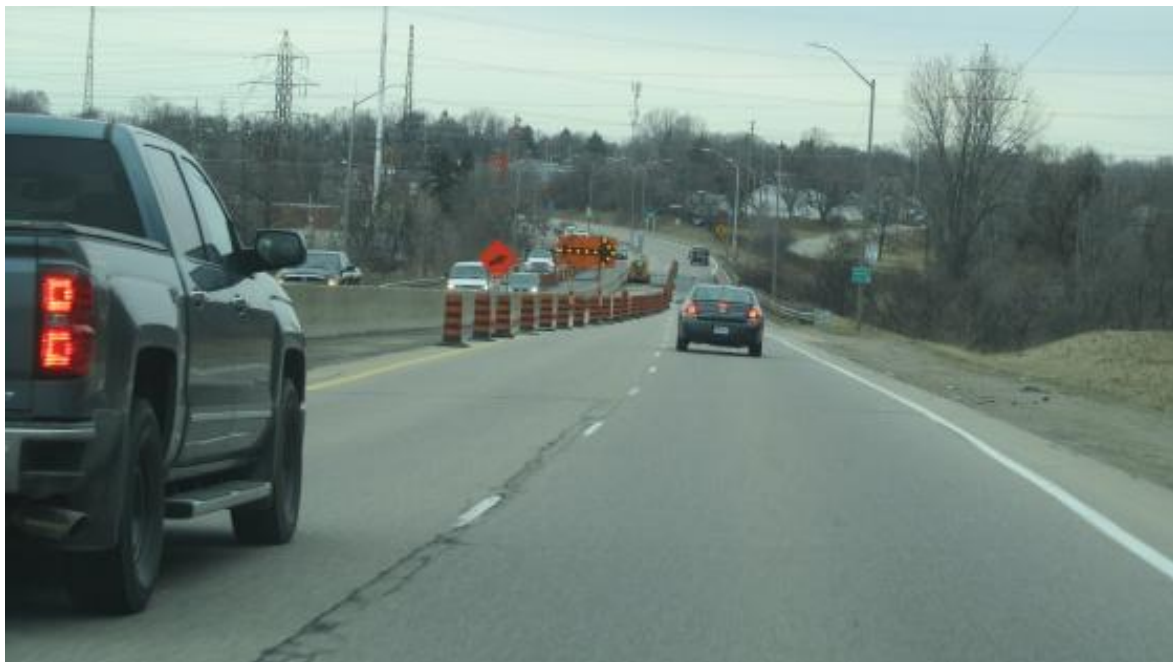
Yet when looking northward toward the same construction zone the two figures below provide an indication of what was present on that same date of February 22, 2018.

We see in the above two figures that the zipper merge signs have not been installed for the northbound direction.

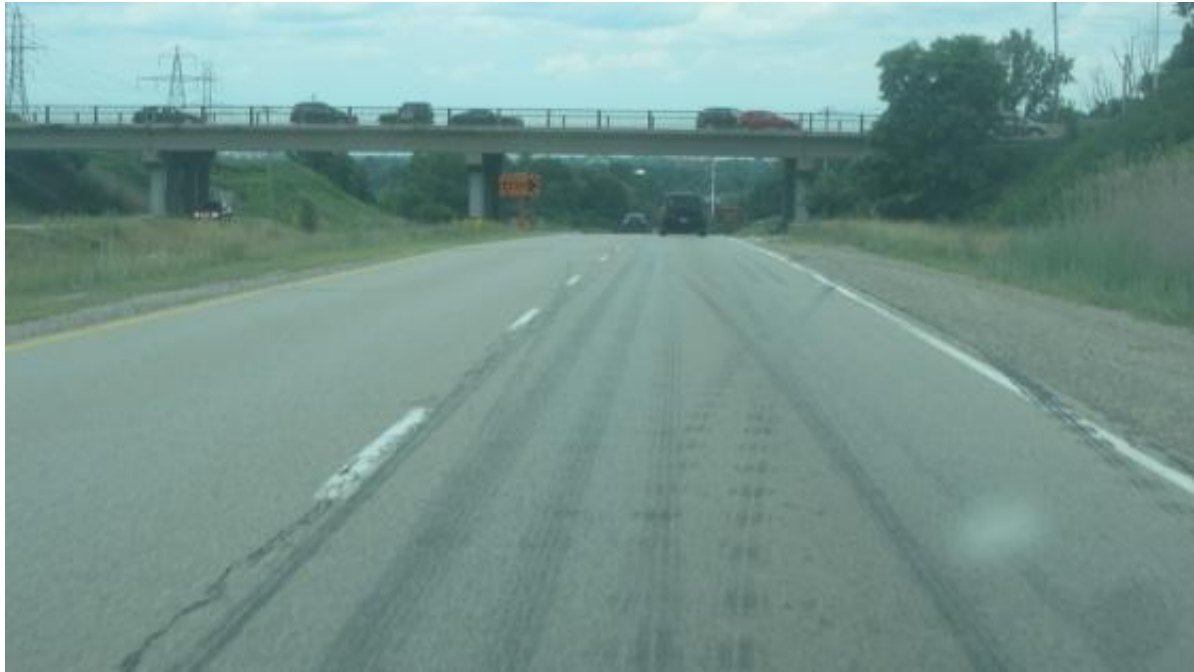
Even though reportable collisions may not provide a full account of the extent of any safety problems, other evidence may be available to provide a fuller assessment. The presence of visible skid marks can be an indication of near-miss incidents. The figure below shows a northbound view of Highbury Ave approaching the Commissioners Road overpass. One can observe the numerous skid marks that are visible on the pavement. Such skid marks do not exist in such quantity further north past the overpass. Thus this evidence may indicate that a special problem may exist in this area. Because the highway begins a downgrade just before the overpass the highway surface is not visible in the background and vehicles in this area are also less visible. If vehicles are stopped or moving slowly in the right lane within this downgrade and they are more difficult to detect this could mean that drivers approaching the stopped/slowing traffic from behind are caught by surprise and do not detect stopped/slowing traffic until a large braking input is required and thus the skid marks are created. Thus, seeing this evidence an analyst could advise some method of additional warning upon approach to this area. This is another example of observing and interpreting physical evidence to understand that a danger may exist before a serious collision occurs.
