Reduced Posted Speeds in School Zones – Are They Working?

By Zygmunt M. Gorski
November, 2019

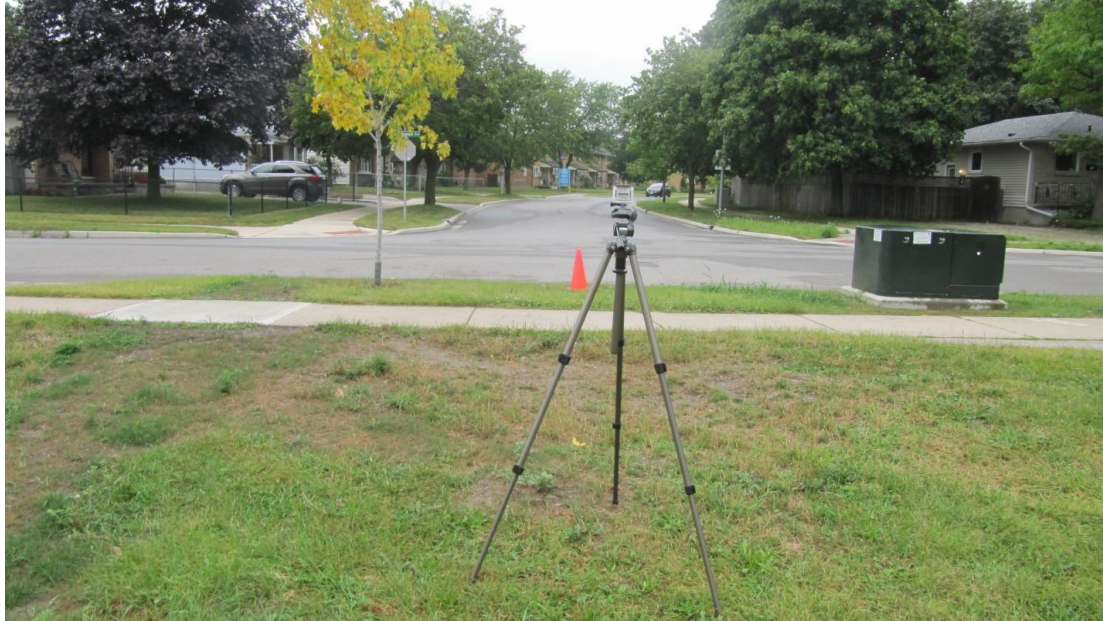
Figure 2: This shows a typical camera located 100 meters east of the Speed sign. As vehicles passed the orange cone their time was noted and compared to the time when the same vehicle passed a previous cone thus establishing an average speed over the noted distance.

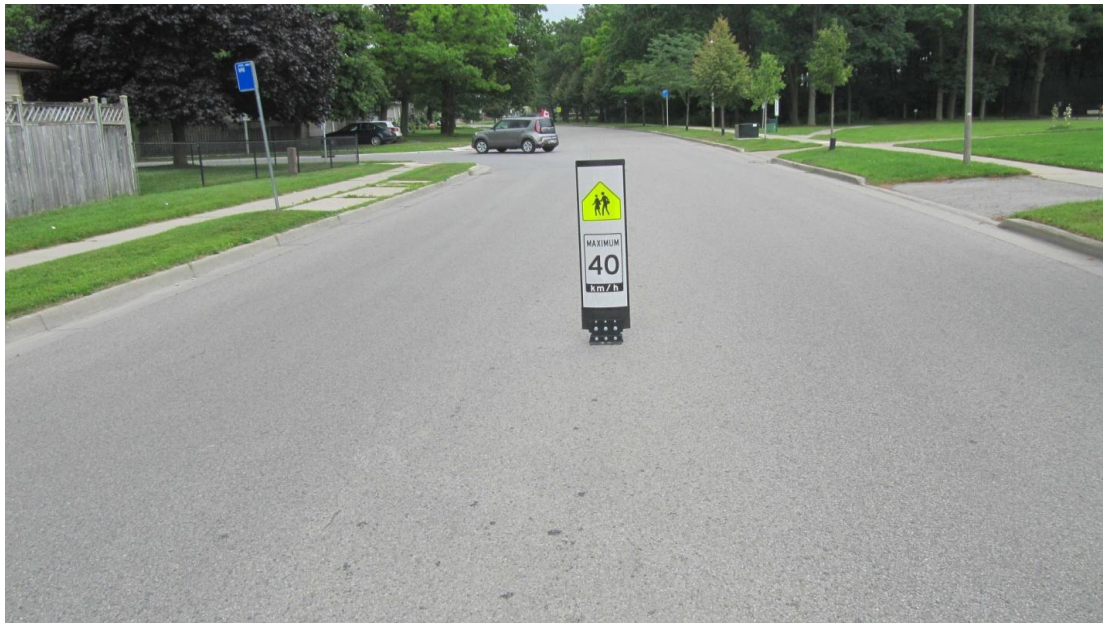
Figure 3: The school zone was also equipped with in-lane speed markers as shown in the eastward view on Tweedsmuir Ave.

The school zone was also equipped with newly installed in-lane, speed markers as shown in Figure 3.

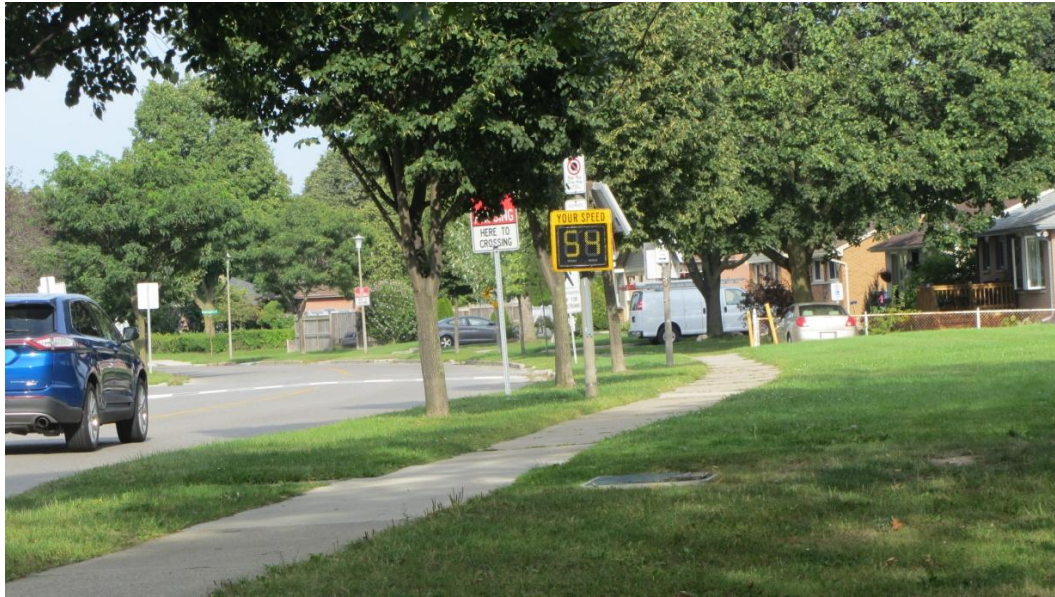
Figure 4: Eastward view of speed display board installed in front of St Bernadette's school.

In the second study of September 6, 2019, a similar set of multiple video cameras was placed along Tweedsmuir Ave in front of and west of St Bernadette School. At this time the City of London had installed a speed display board positioned in front of the school to advise passing drivers of their speed. Part of the study was to determine if there was a difference in the speed reported on the board versus the average speeds determined from video analysis. The cameras were set-up at 25-metre intervals

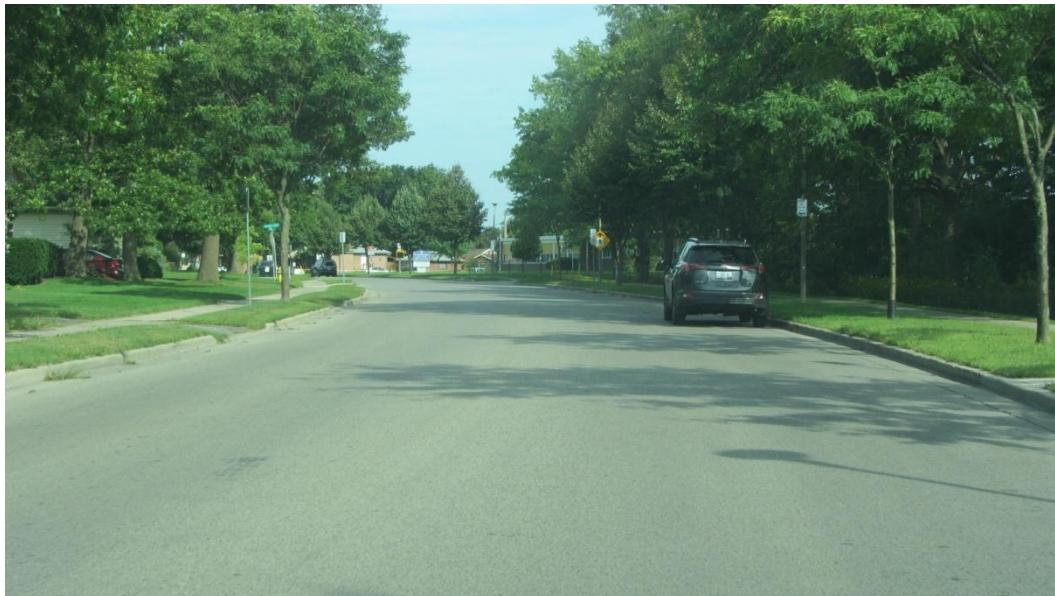
Figure 5: View, looking east along Tweedsmuir Ave toward St Bernadette's School and the speed display board located in the distant background. The effectiveness of the board was reduced because it was partially blocked by trees on the right roadside.
