Review of Physical Evidence of Double Fatal Collision on Coatsworth Road, Essex County, Ontario

Posting Date: 09 Feb 2012

Gorski Consulting
London, Ontario, Canada

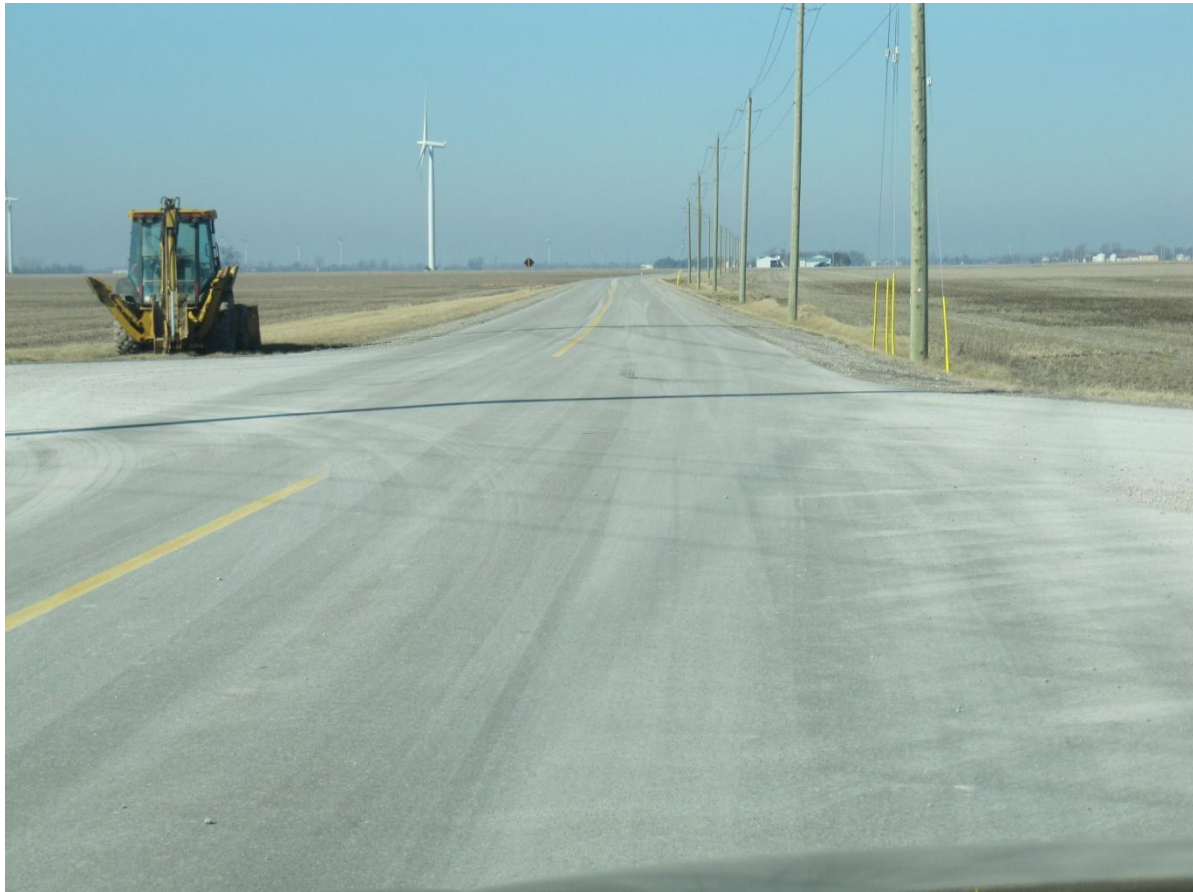
The physical evidence indicates that the vehicle carrying the three occupants was travelling northwest, or toward Tilbury, Ontario. The photo below is taken from the intersection about a kilometre south of the site at Goodreau and Kemp Lines. We are looking northwest in the direction that the vehicle was travelling.

The road is flat and the road surface is in good condition. In the far distance you may be able to tell that the roadway bends toward the right. As we get closer to that bend we can see in the photo below that the bend is just slight before the road straightens out again as it approaches the accident site.

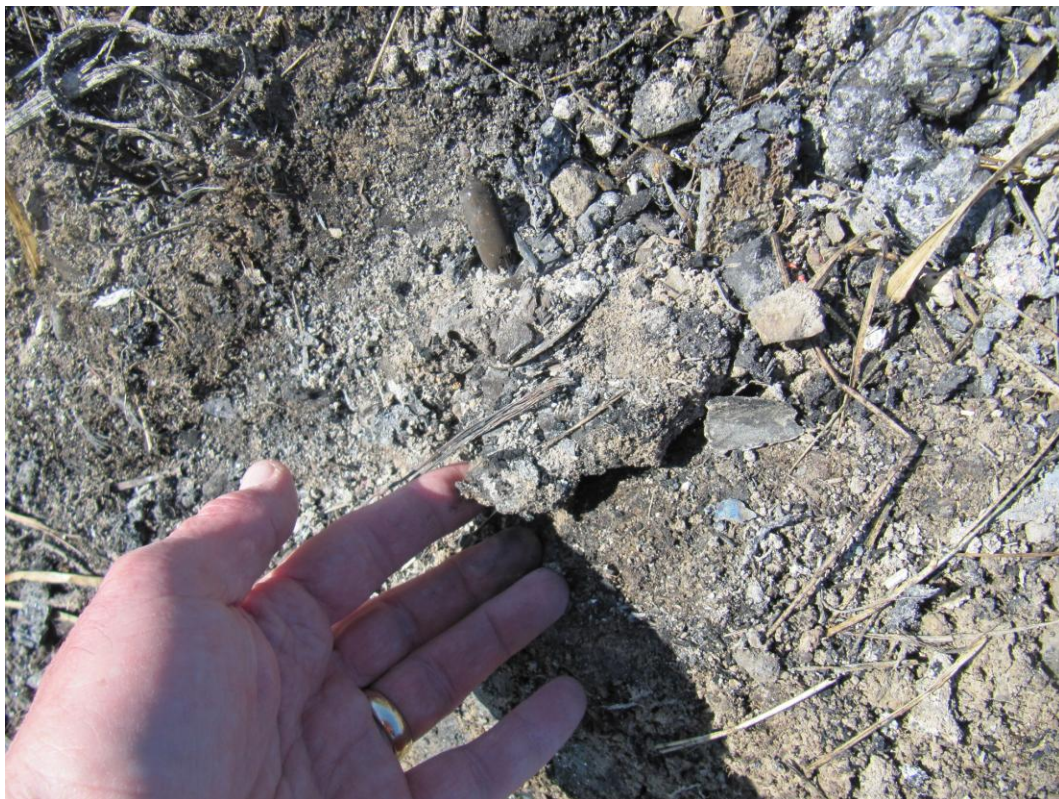
In some instances the search for a bulb is not that obvious. In a fire scenario various debris becomes melted and cakes onto the important evidence that you are after. Consider the photo below.

There is nothing particularly obvious about the piece of melted material that I have lifted off the ground. But as we lift that material and look at it more closely you begin to recognize that it contains the other headlight filament, as shown in the two photos below.
