Gorski Consulting Website

Archived News - 2013 - July

July 27, 2013

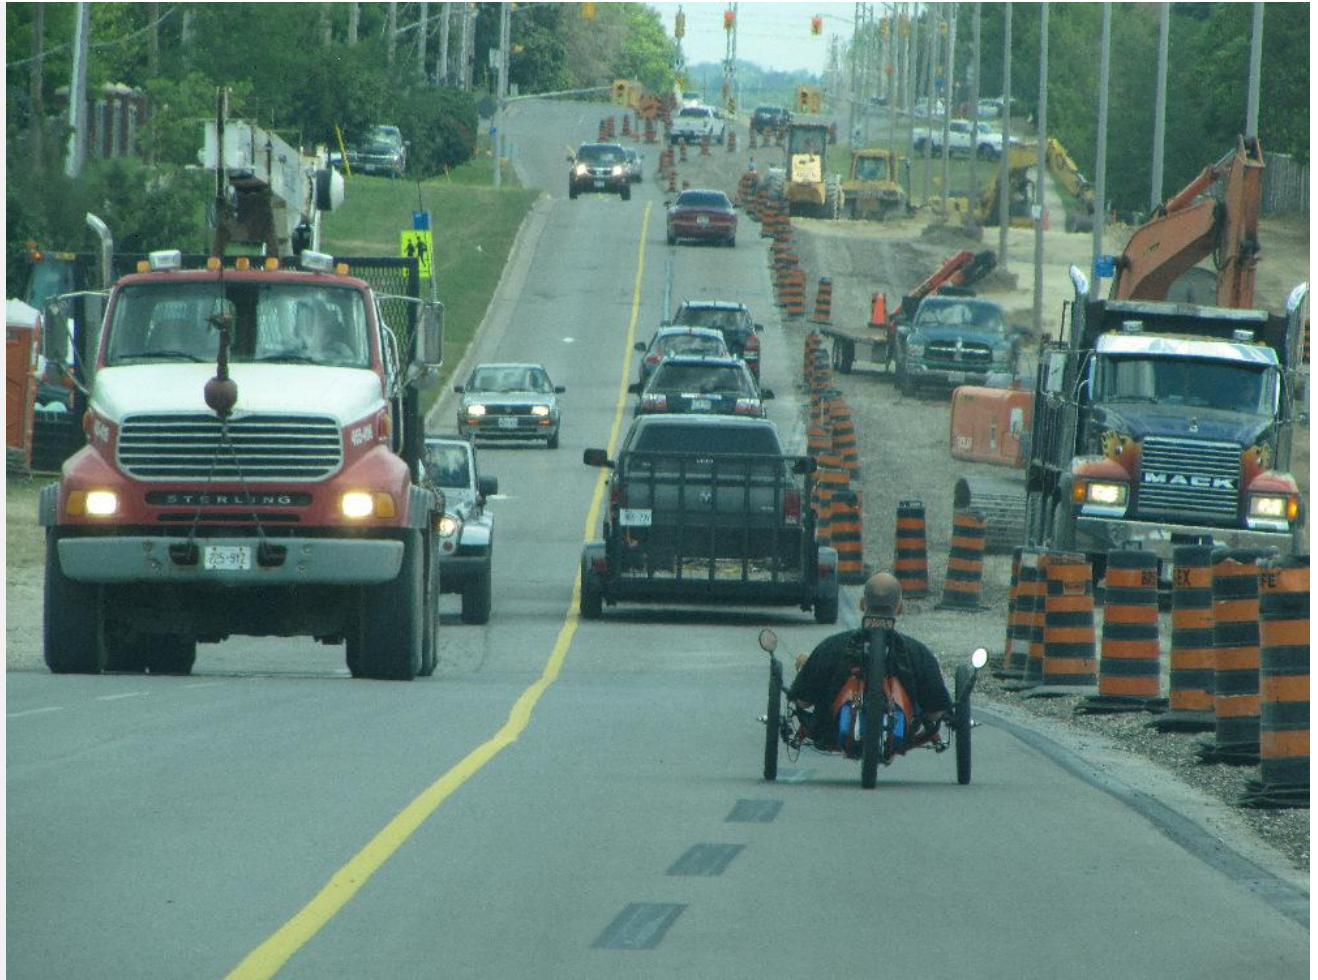
View of motorized, recumbent cycle travelling through a construction zone in west London, Ontario.

This is a very dangerous action. The cycle appeared to be travelling at a speed similar to the vehicles around it but it would be extremely difficult to detect because of its very low profile. The rider was wearing no helmet which would be extremely dangerous because the height of his head would be very close to the height of the bumpers of most vehicles and it is well-known that bumpers are the stiffest portions of a vehicle. Any contact between this cyclist and another vehicle would certainly result in major head injuries.

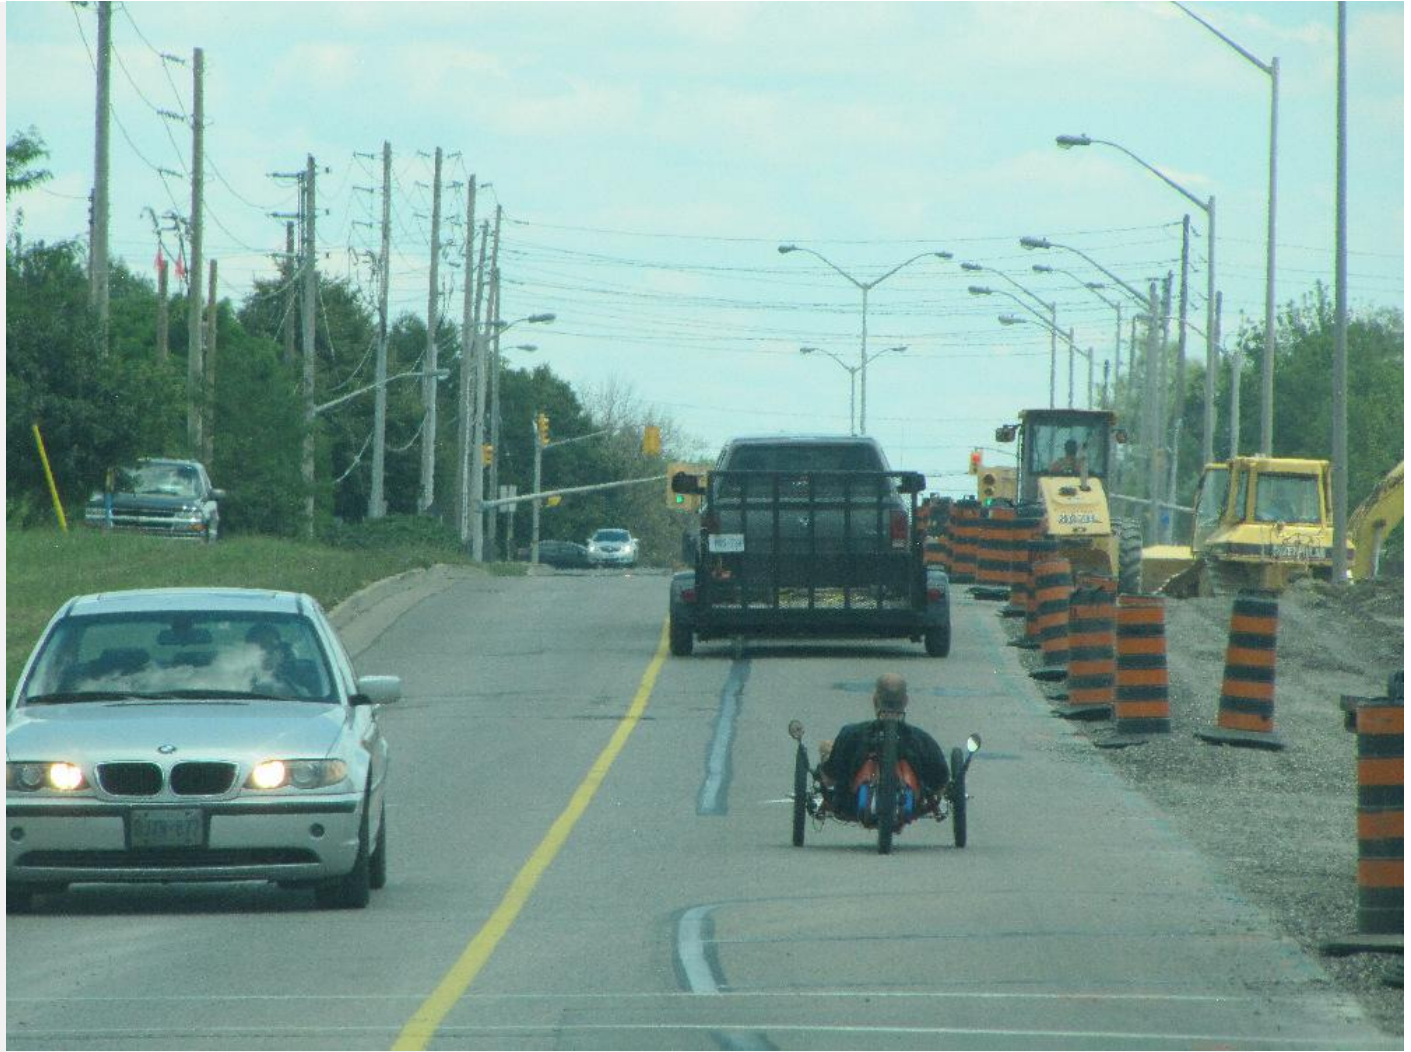
Another view of the motorized, recumbent cycle.

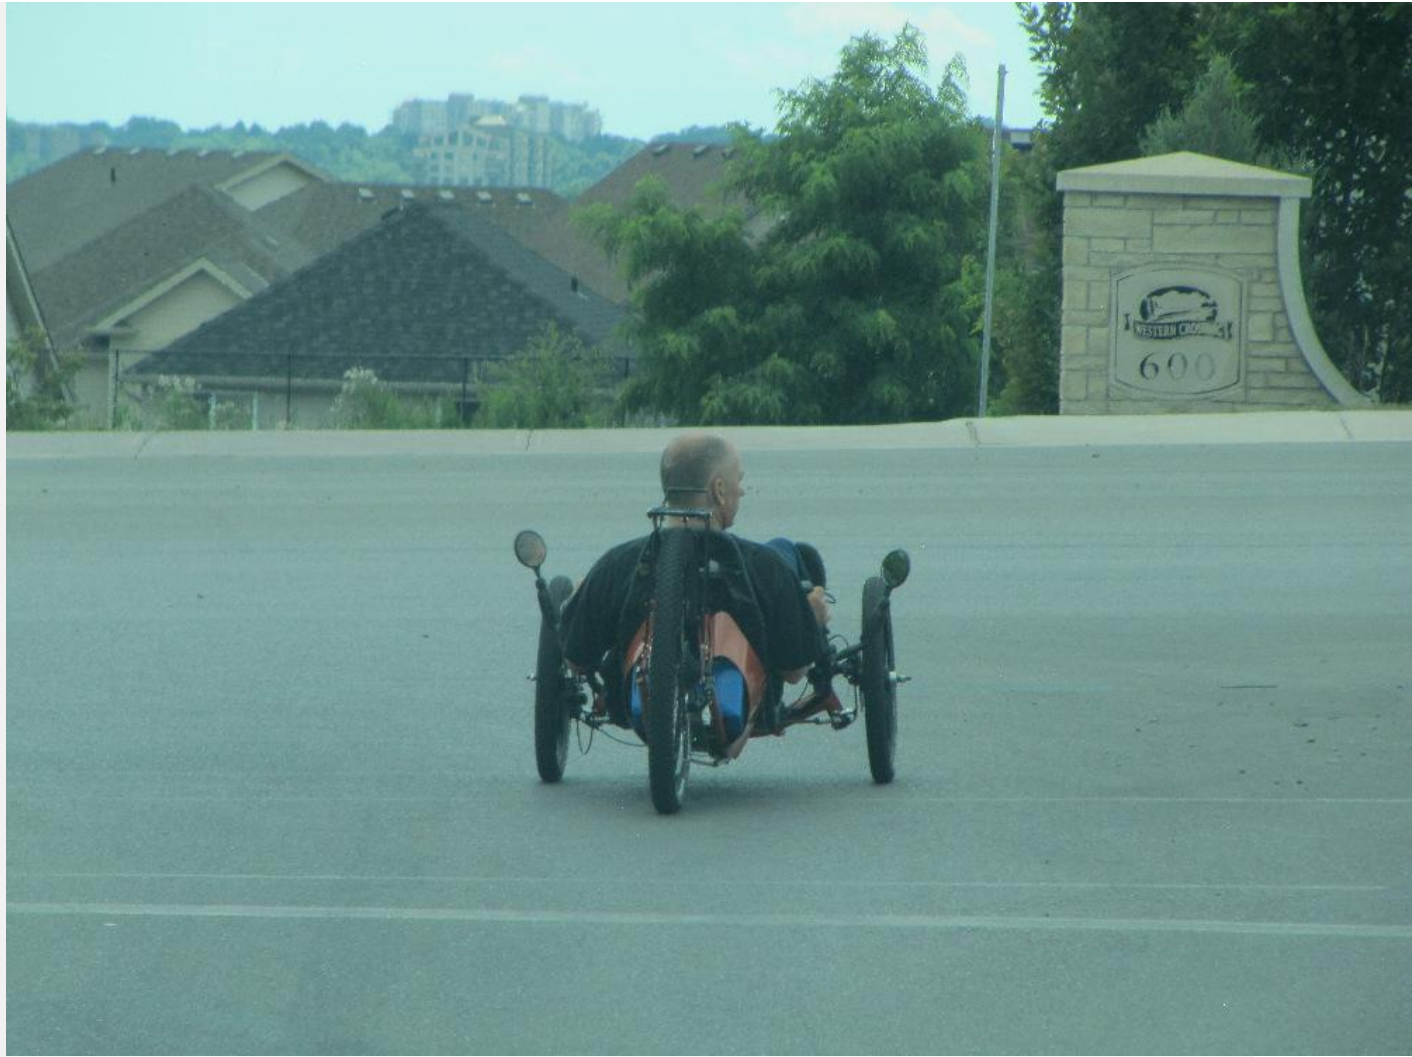
Closer view of the rider and cycle.

The rider certainly did not appear to be young, yet we wonder if he truly understood the danger he was in.

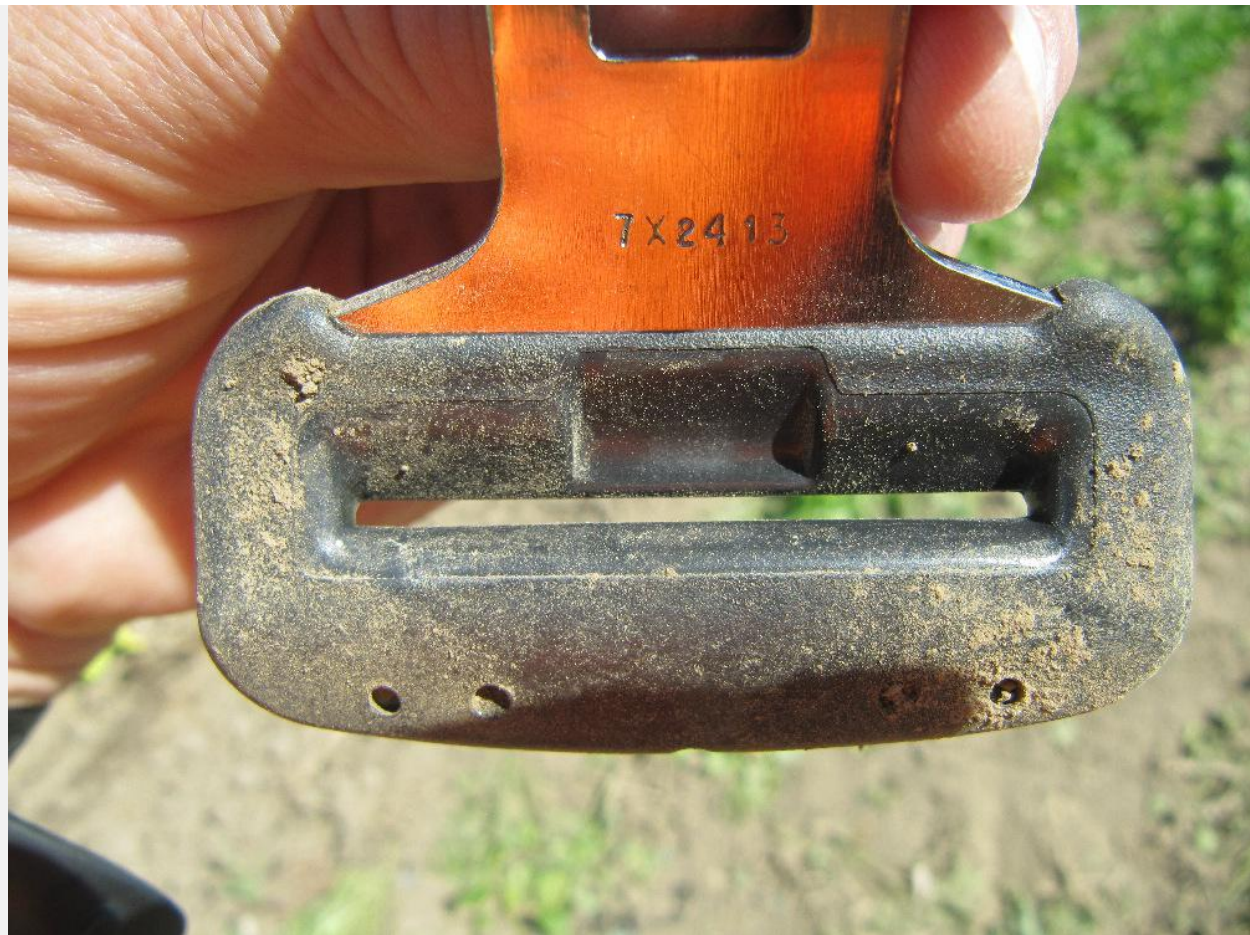
View of front surface of sliding tongue.

Many years ago someone with little understanding of loading marks made reference to the metal portion of the tongue which is inserted into the buckle as the location where one should look for loading marks. This fairy-tale was bounced back and forth in the community of reconstructionists for many years until further research papers in the 1990s began to appear from researchers who actually had some reasonable experience and began to set the record straight. The place to look for loading evidence on a sliding tongue is at the rectangular access hole through which the seatbelt webbing passes. What you should be looking for are diagonal striations in the melted plastic of the tongue which occur when the loaded seatbelt webbing applied a large force through that access hole during the impact.

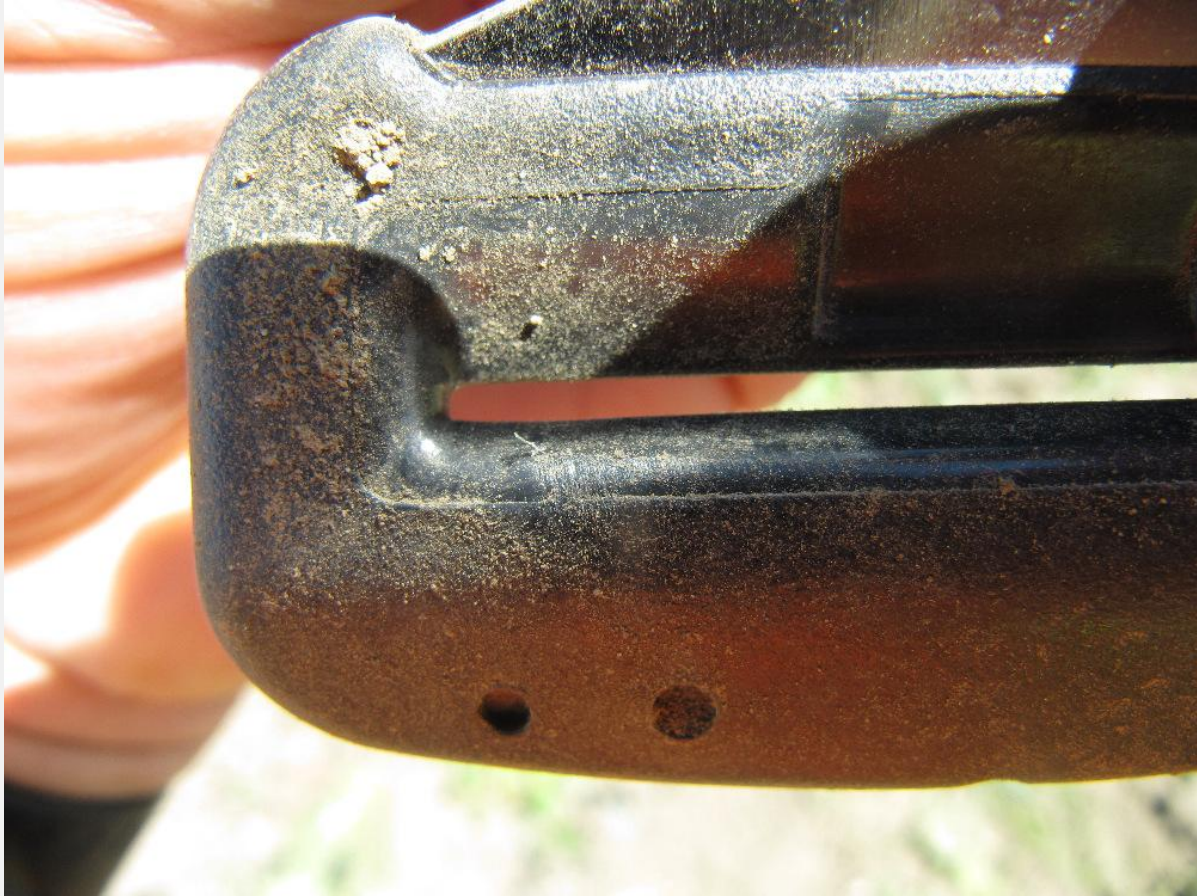
View of loading mark on the bottom corner of the front face of the sliding tongue.

The reason why there the striations in the loading mark on the front face of the sliding tongue are at a diagonal are several, but the most common reason is that the loaded torso (shoulder) belt comes to the access hole at an angle as it travels from the D-ring and across the occupant's torso. One can tell whether the tongue is from the driver versus the right front occupant by noting the angle of the striations because they will be (generally) at 90 degrees to each other. But there are many caveats.

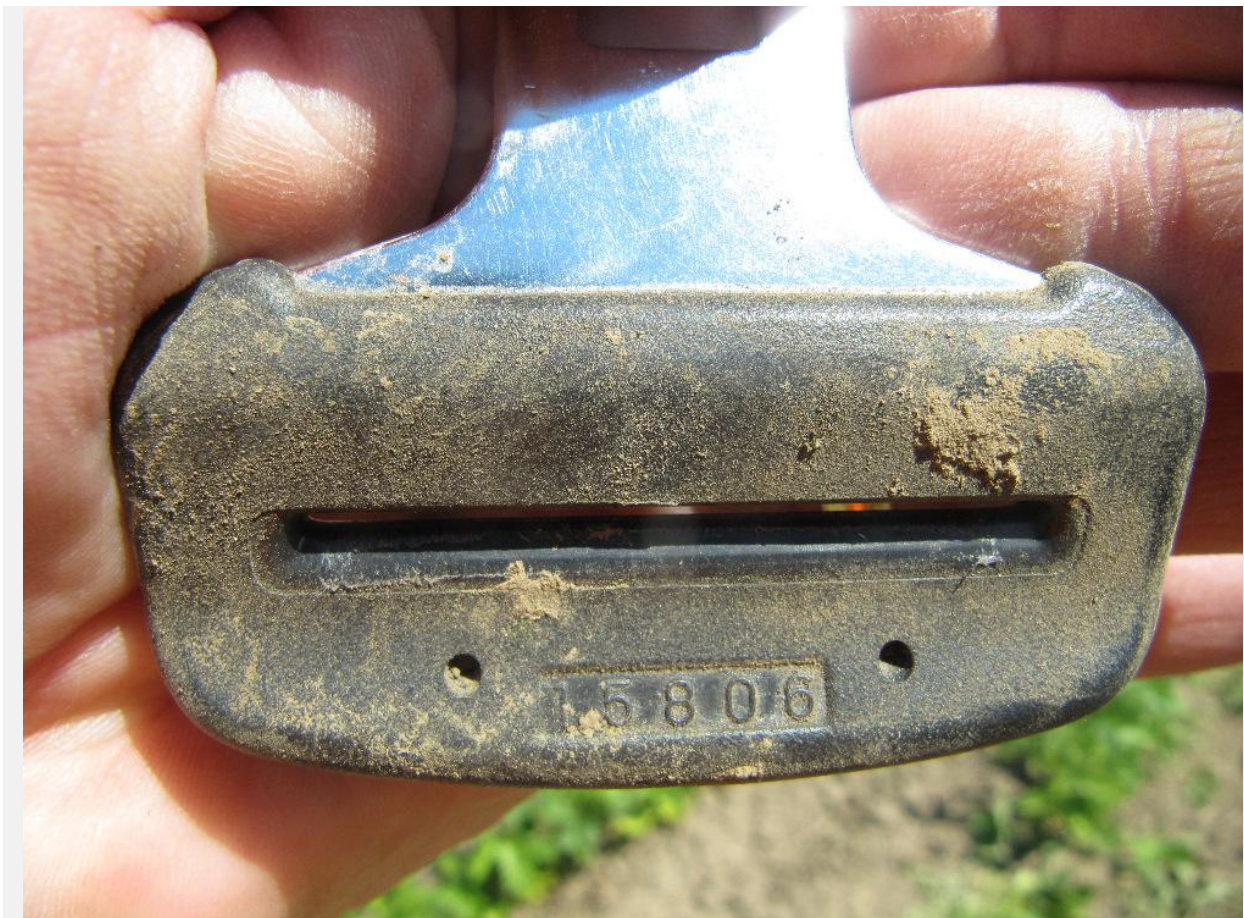
View of backside of sliding tongue.

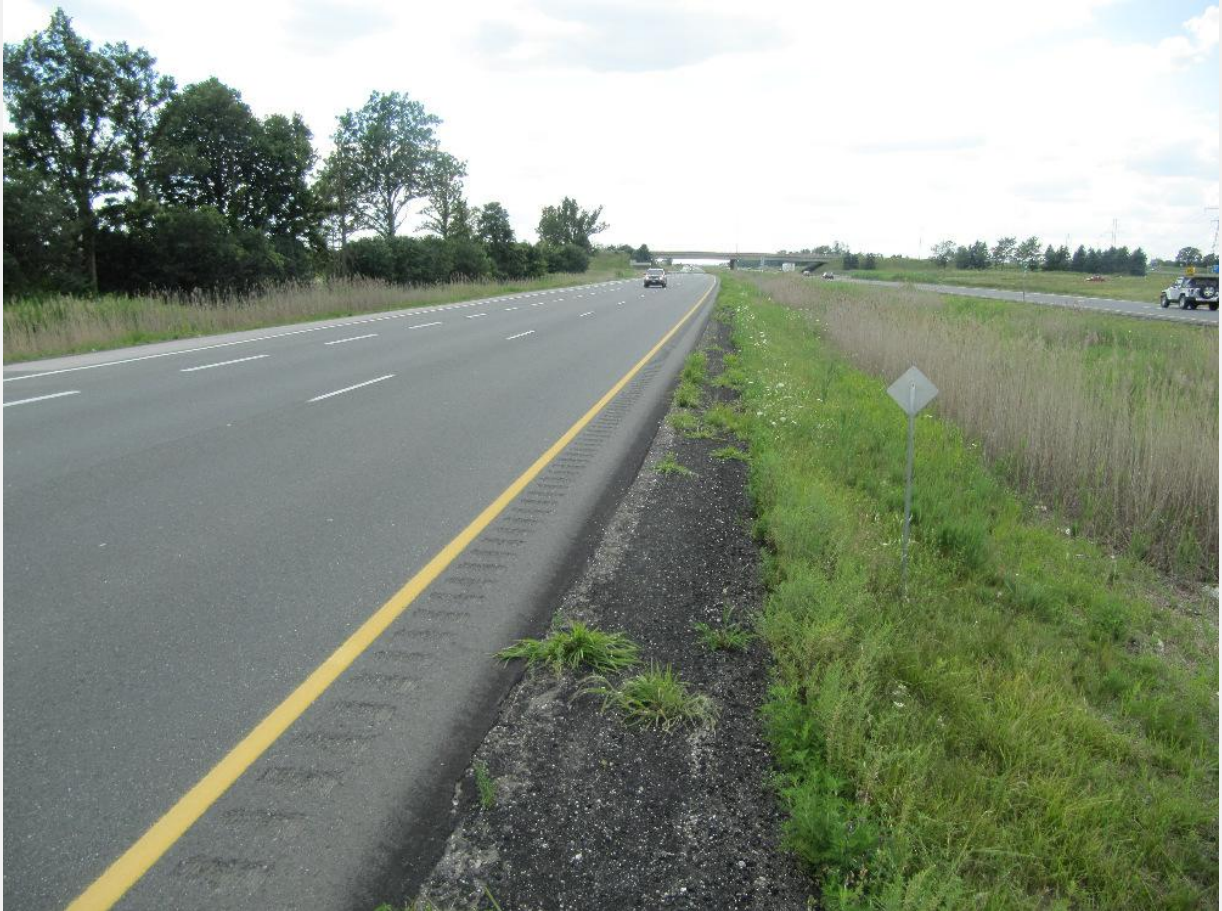
View, looking west, from the median side of the eastbound lanes of Highway 401 at the location where the Suzuki travelled off the pavement surface and into median.

It is noteworthy that the entrance ramp from Colonel Talbot Road onto Highway 402 is located here and therefore there is a strong possibility that a vehicle entering the highway may have contributed to the interference of the Suzuki, causing the driver to take evasive action, resulting the Suzuki entering the median.

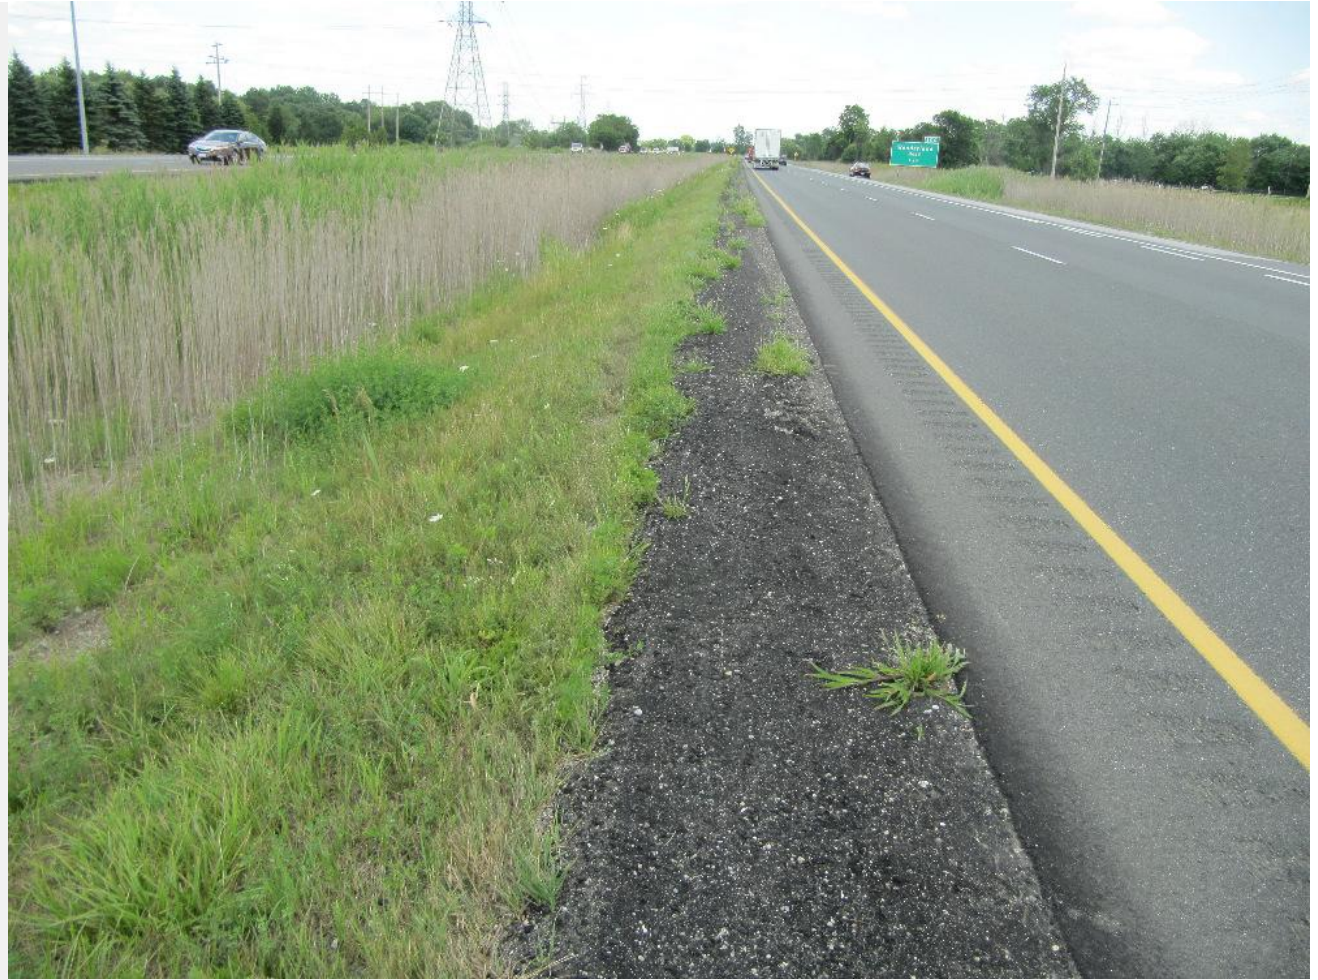
View, looking east, along the median side of the eastbound lanes of Highway 402 at the point where the Suzuki travelled off the pavement surface and into the median.

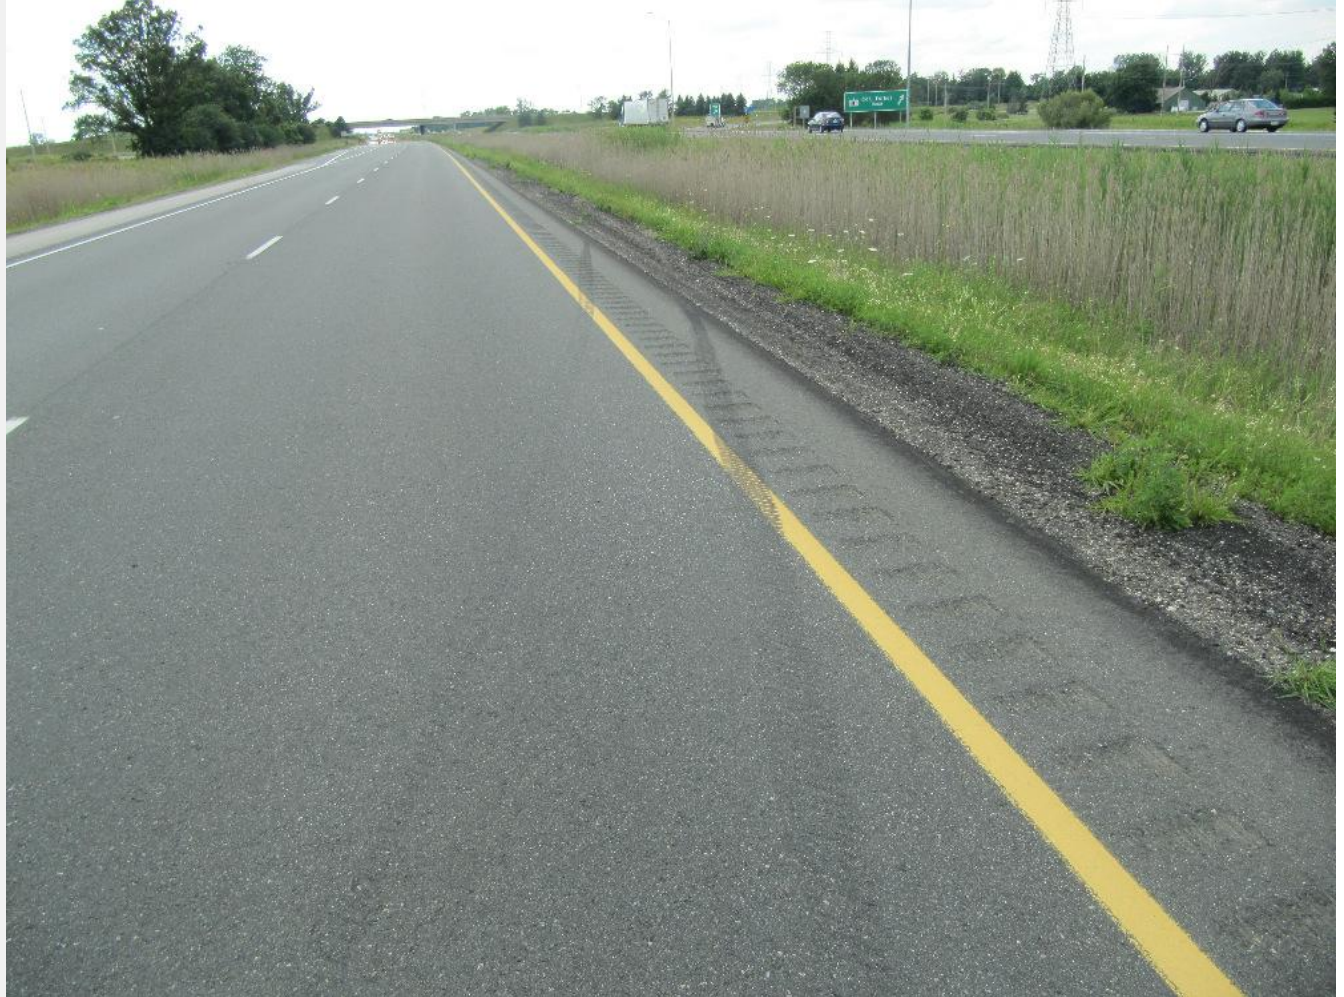
View, looking westward, as the tire marks from the Suzuki are crossing the eastbound lanes of Highway 402 and approaching the camera as the Suzuki is rotating clockwise and travelling toward the south roadside.

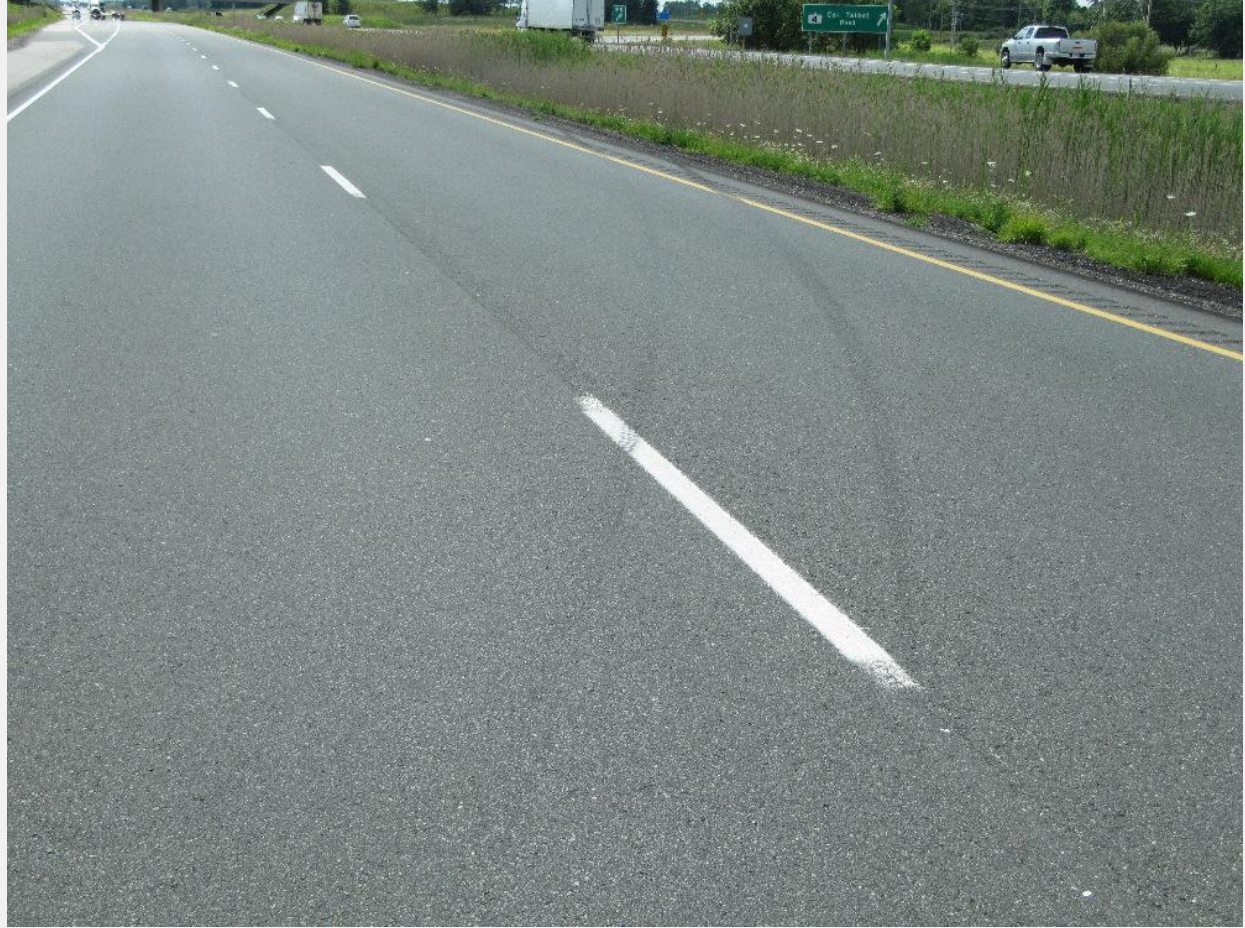
View, looking northwest, showing the tire marks of the Suzuki as they cross the eastbound lanes of Highway 402 and the vehicle travels toward the camera on its way to rollover in the south roadside.

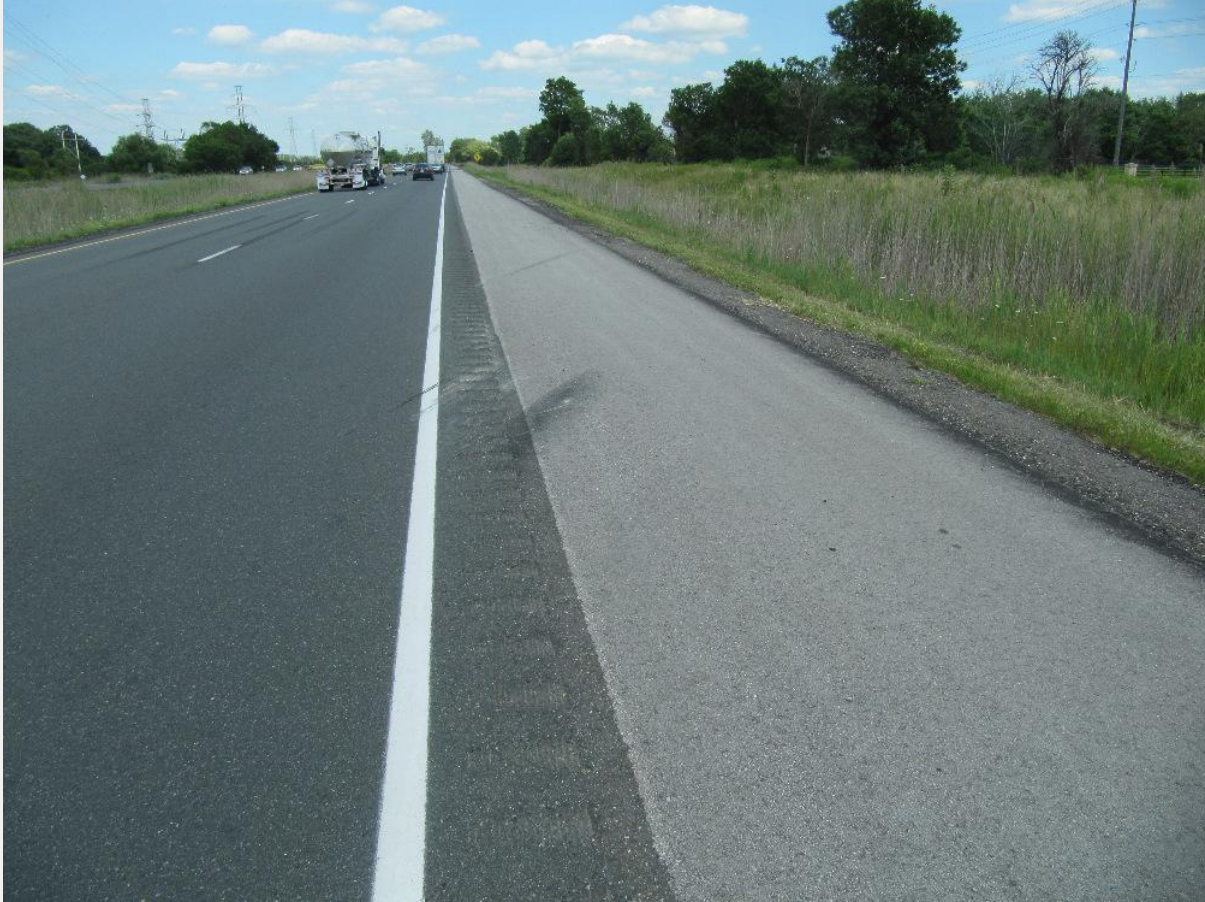
View, looking east from the south shoulder of Highway 402 showing the tire marks as they exit the road surface and travel toward the south roadside where the Suzuki rolled over.

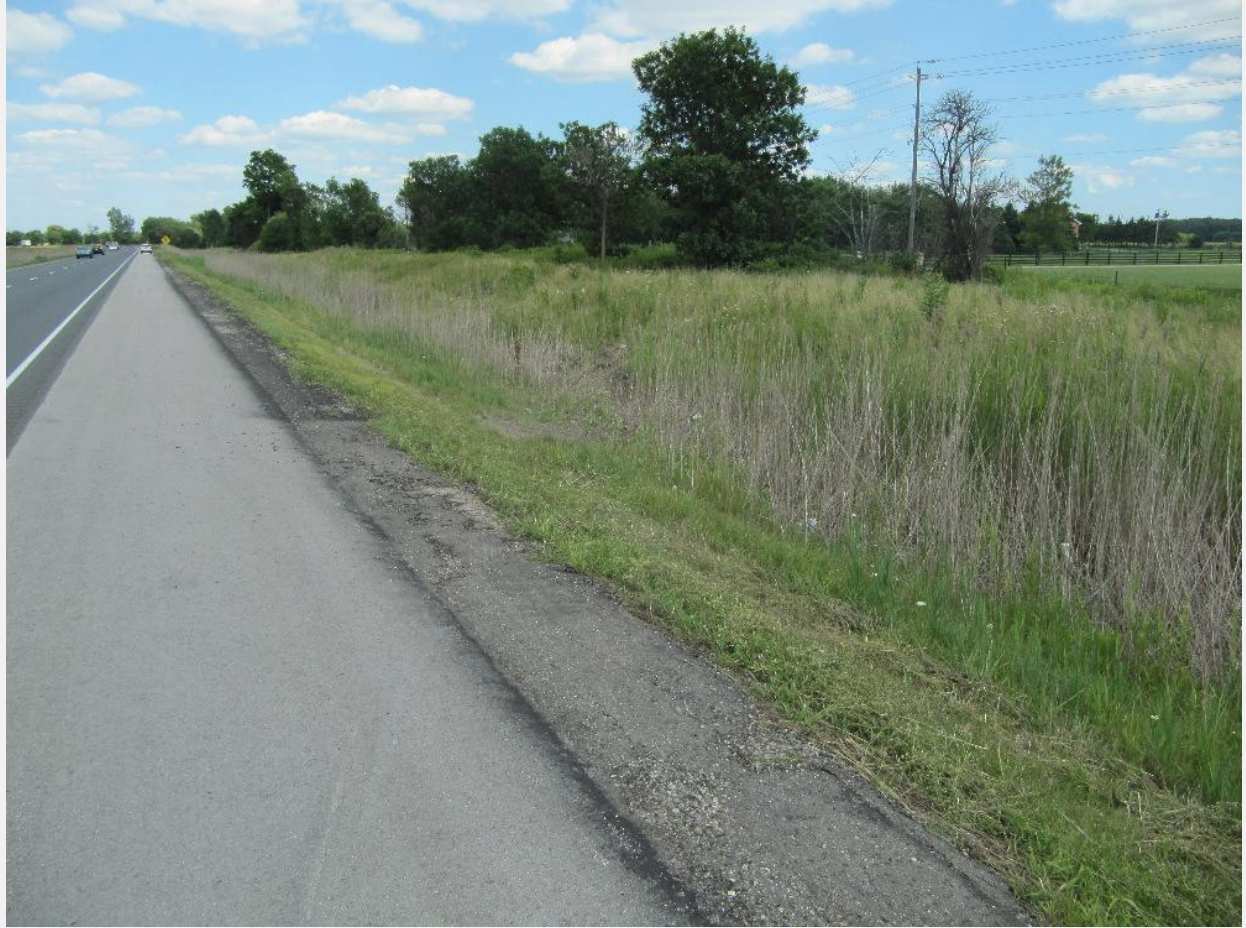
The photo below shows where the Suzuki entered the south ditch and began to roll over just after crossing into the grass area. The Suzuki would have been sliding sideways and leading with the driver's side when this roll began.

View of south roadside where the Suzuki entered the ditch and rolled over.

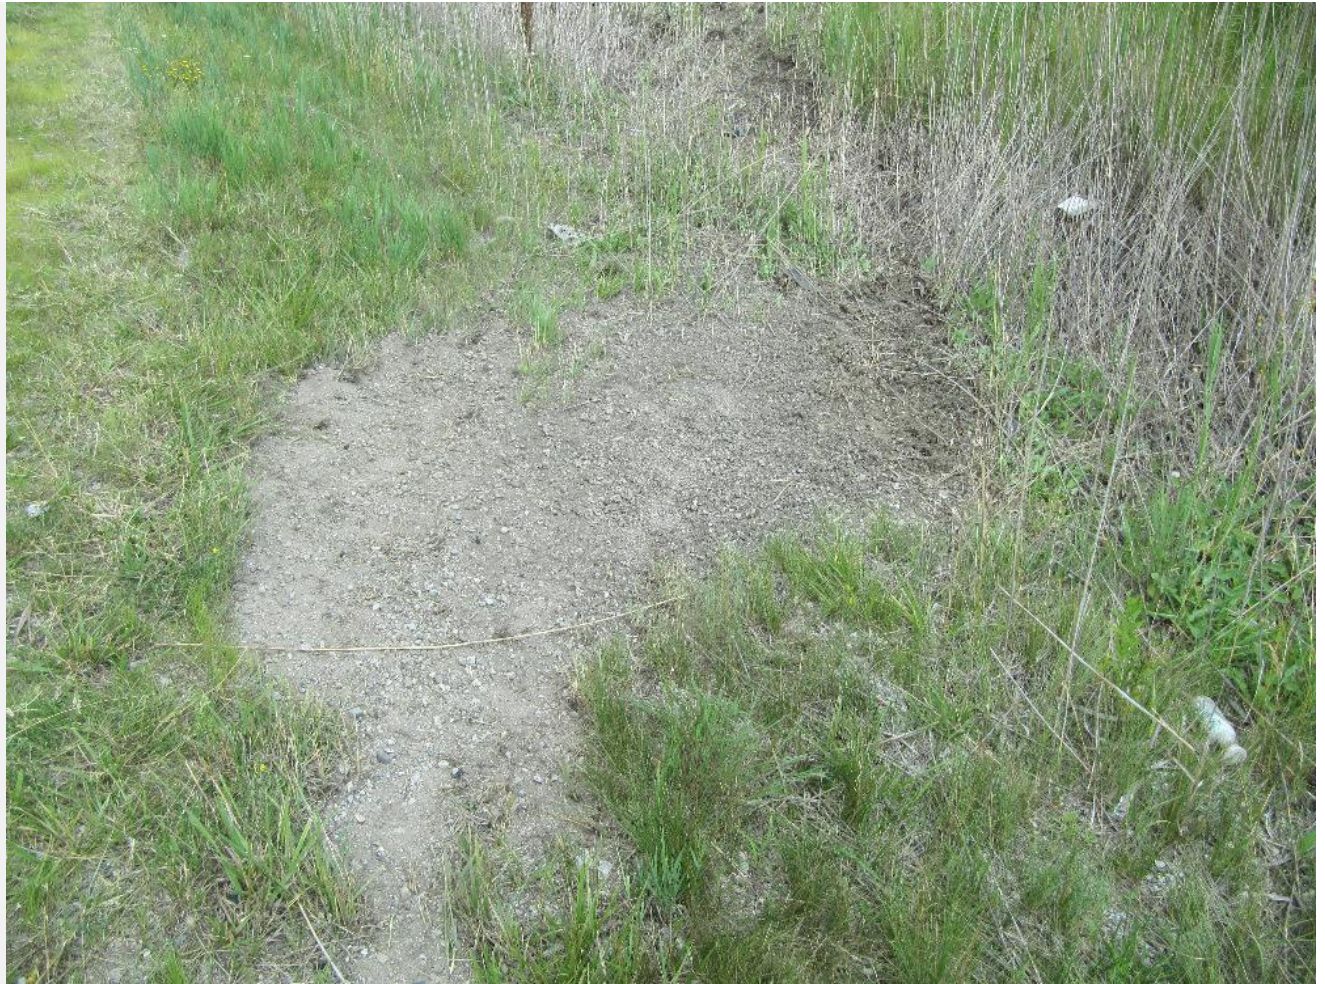
The photo below shows the first of several gouges produced in the earth as the vehicle impacted the rising side of the ditch and then settled on that rising bank.

View of the first of several gouges in the earth where the Suzuki rolled to rest.

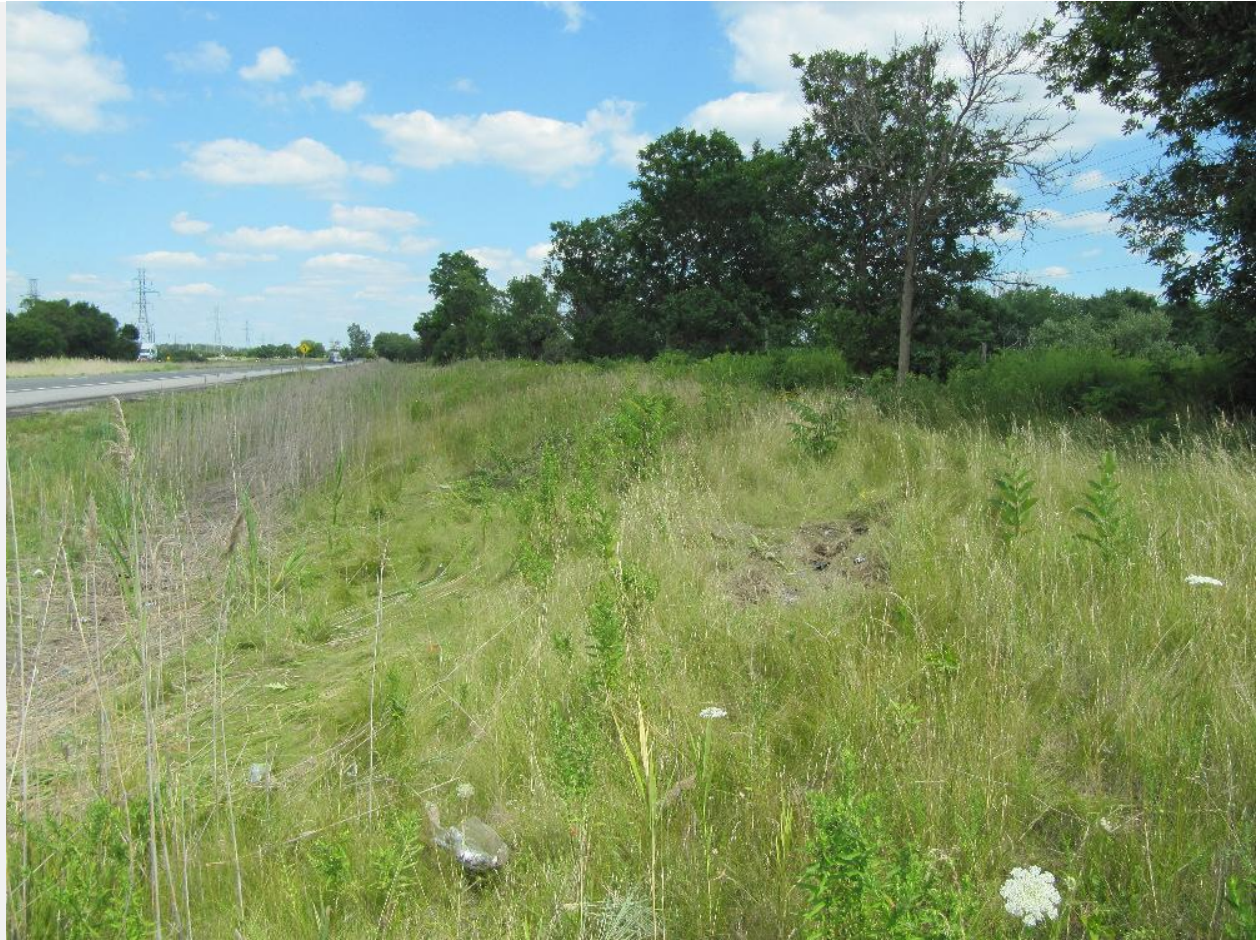
View of gouges and debris on the slope of the south ditch at the final rest position of the Suzuki

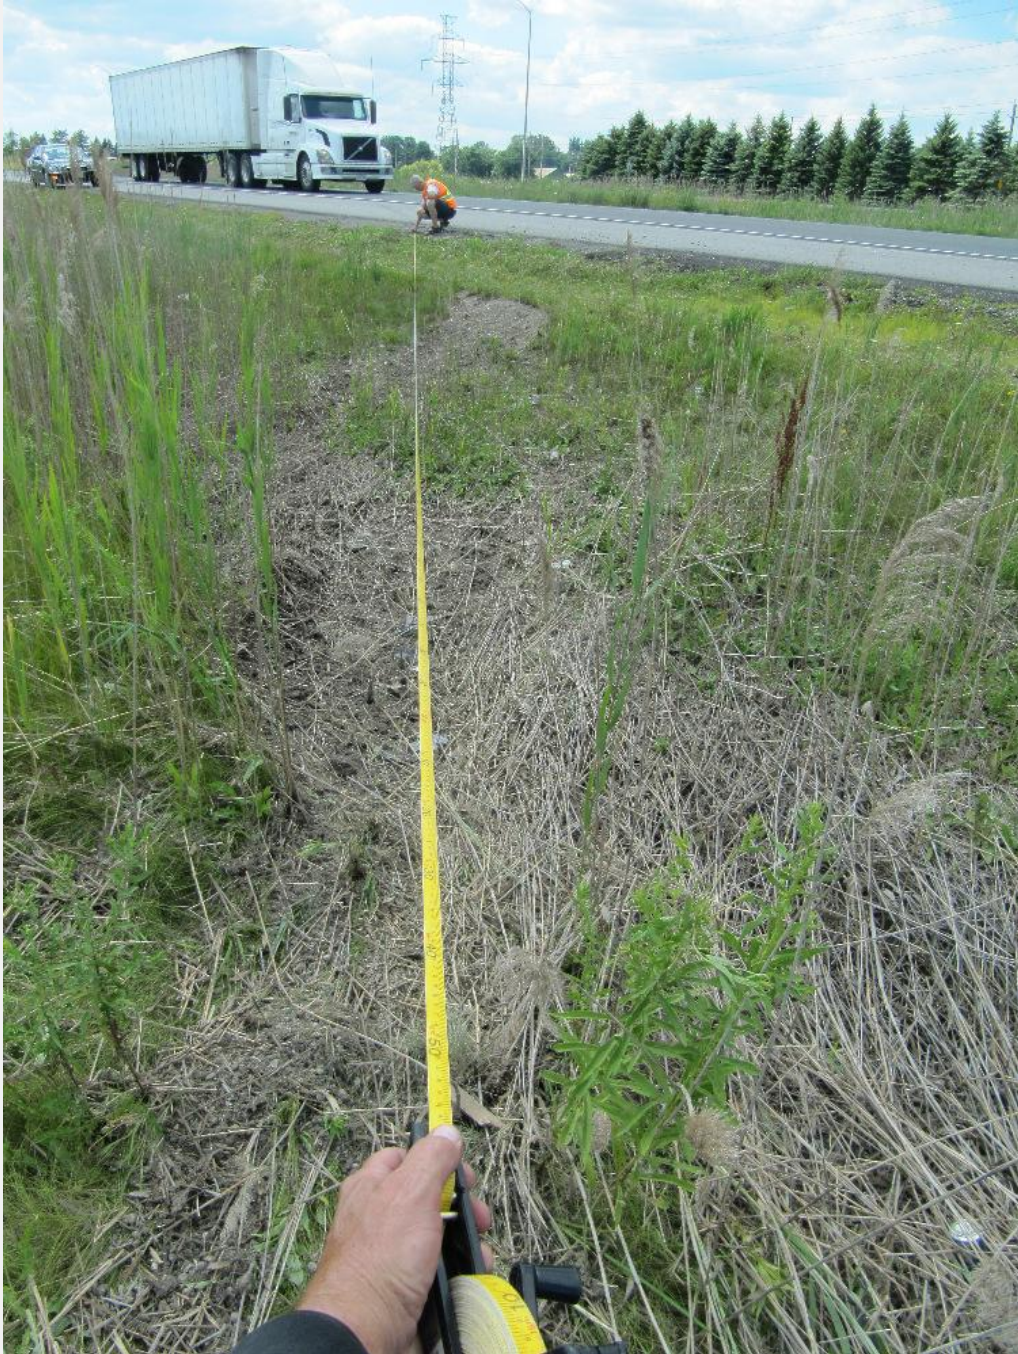
View showing measurement taken from the beginning of the rollover to an intermediate point on the sloped bank.

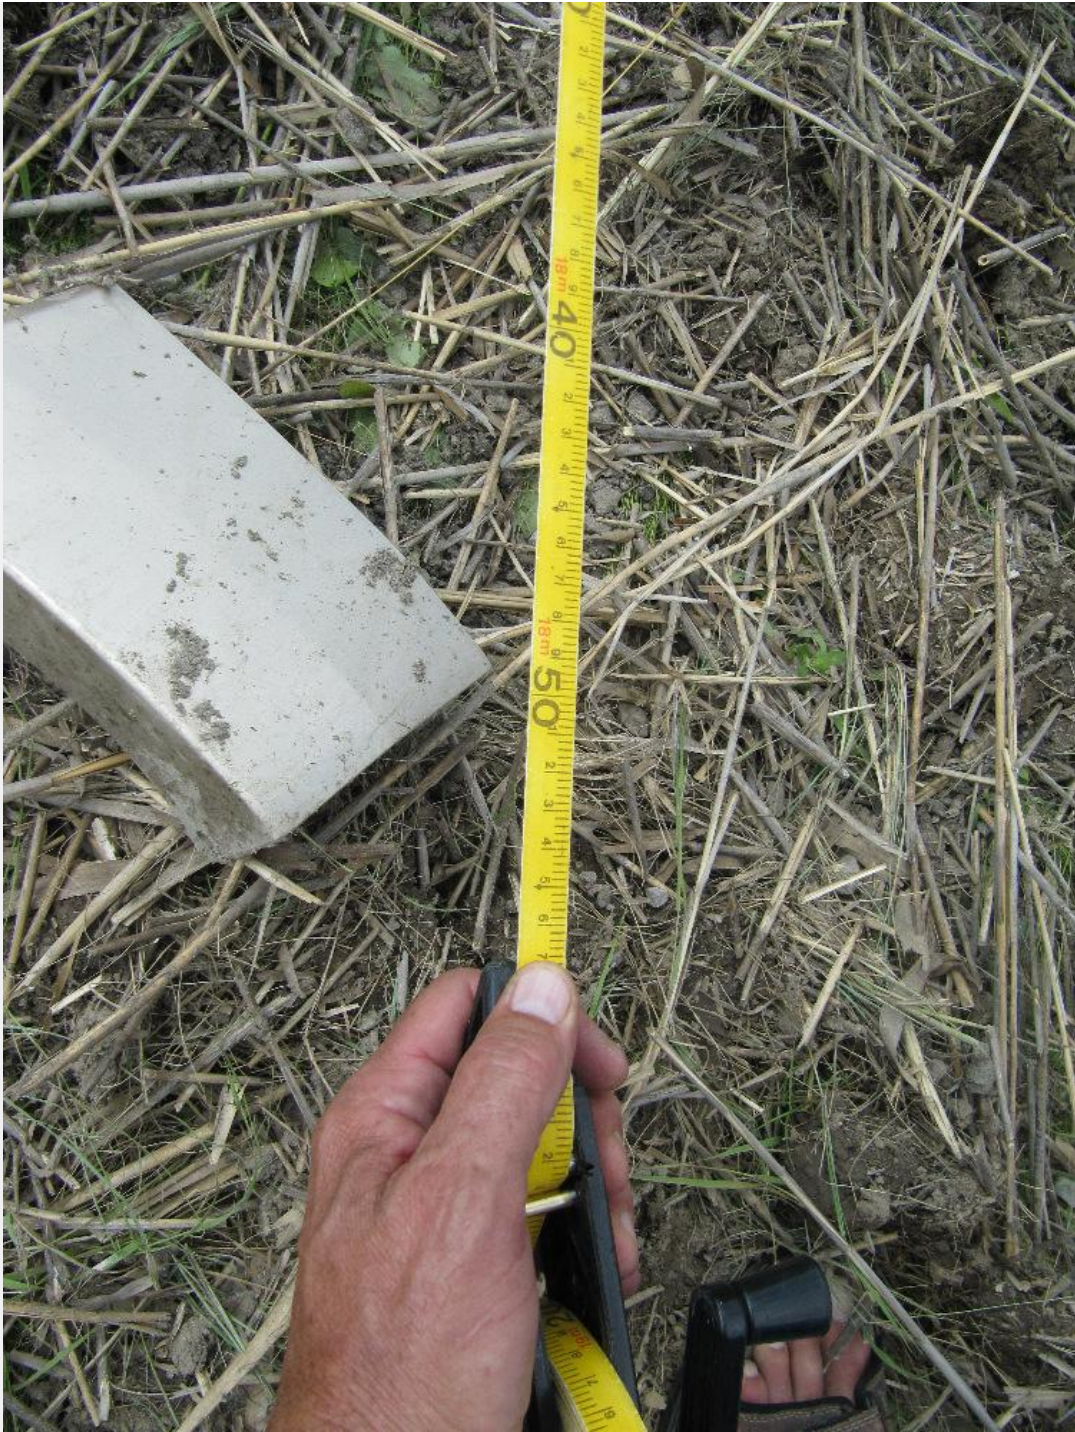
View showing a distance of 18.5 metres read on the measurement tape at the intermediate point as we measure the distance of the rollover.

Adding the two measured distances ($18.5 + 18.2$) indicates that the vehicle travelled a distance of about 36.7 metres. This is no longer a low speed rollover but gets into the moderate range. Using a tumble number for the deceleration rate would provide a speed of about 68 km/h at the beginning of the roll.

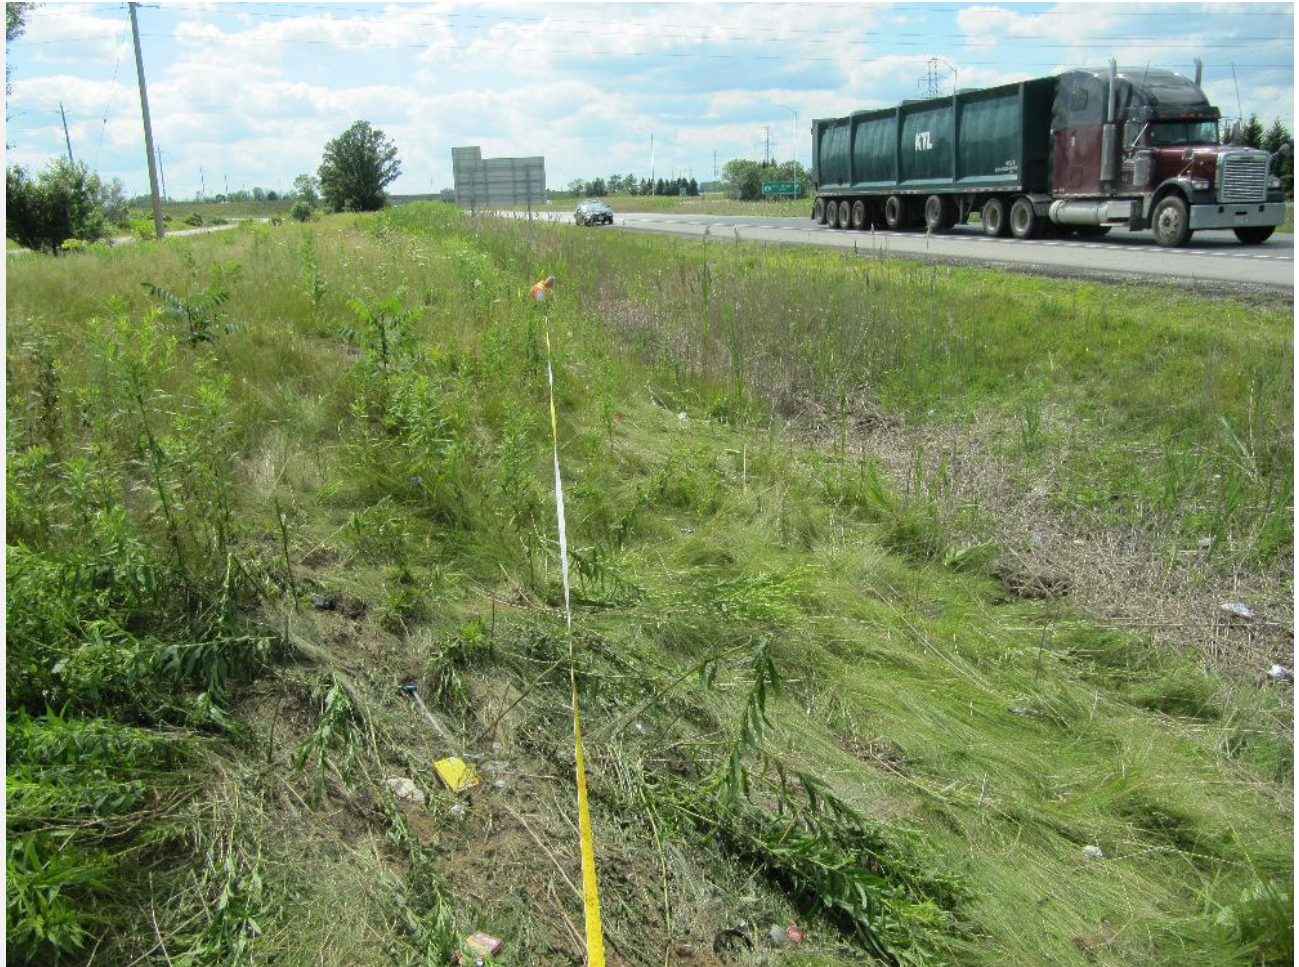
View showing the assistant holding the zero end of the measurement tape at the intermediate point while the tape is extended to the vehicle final rest position in the foreground.
