Gorski Consulting Website

Archived News - 2013 - July

July 27, 2013

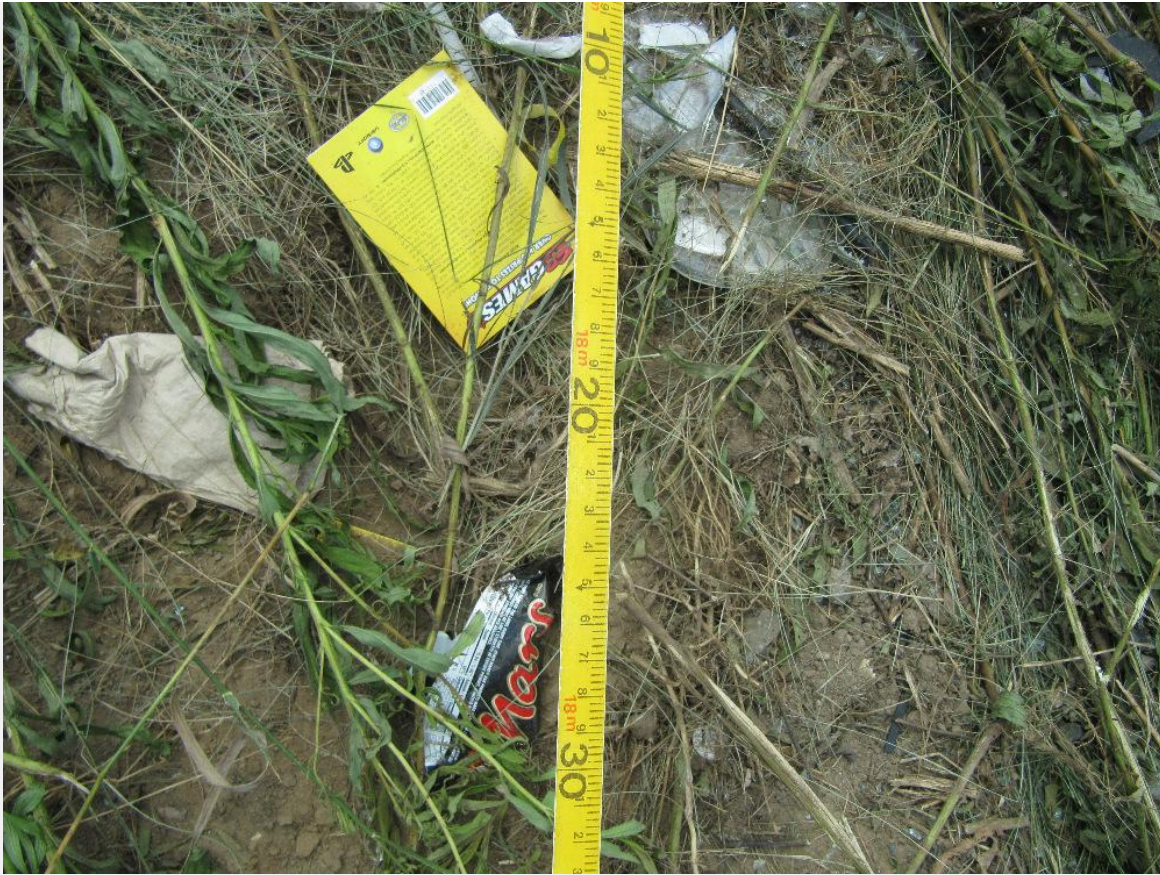
View, showing a distance of 18.2 metres from the intermediate point to the Suzuki final rest position.

Adding the two measured distances ($18.5 + 18.2$) indicates that the vehicle travelled a distance of about 36.7 metres. This is no longer a low speed rollover but gets into the moderate range. Using a tumble number for the deceleration rate would provide a speed of about 68 km/h at the beginning of the roll.

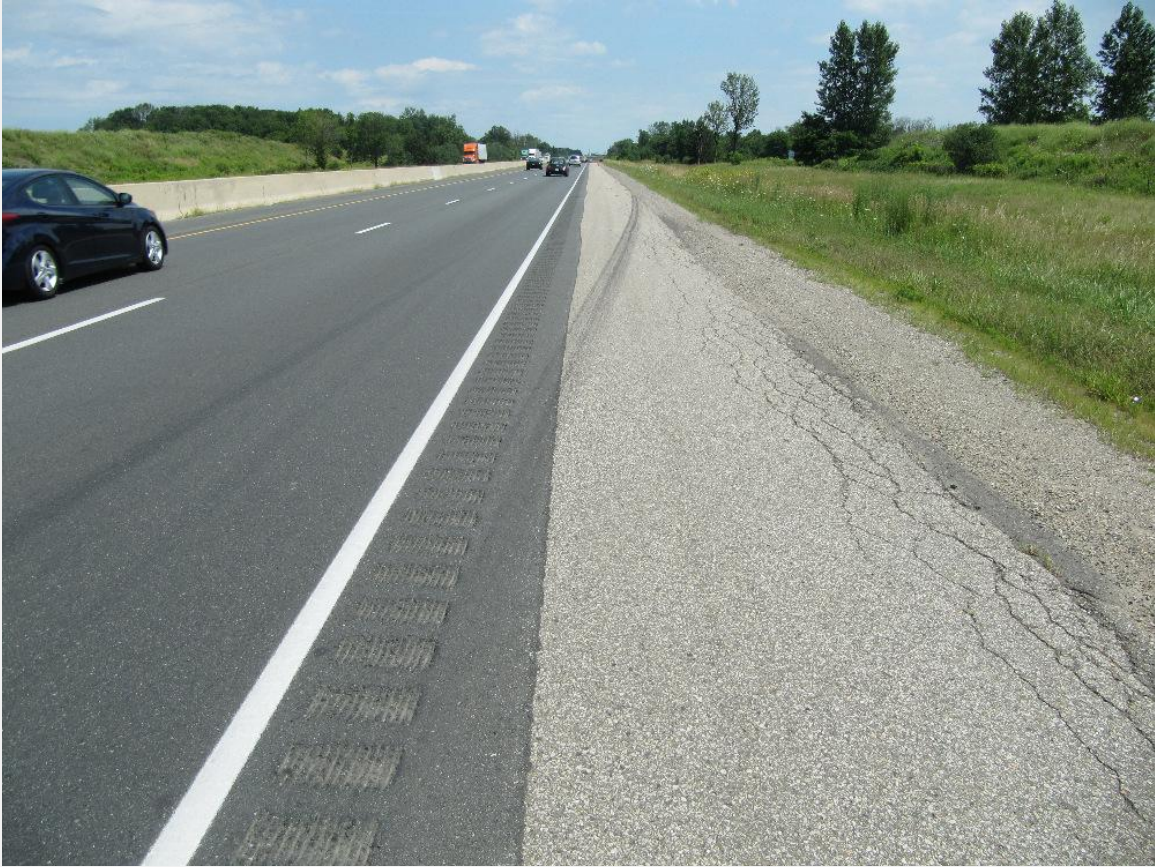
Tire mark located several hundred metres west of the rollover site indicating a vehicle had rapidly moved off the highway and onto the south shoulder.

Of course, this could have occurred when the eastbound driving lane was already shut down by police and some un-observant driver performed this action due to not recognizing stopped or slowed traffic – this is very common. Or it could be completely unrelated. You can appreciate, when we only have the site evidence to examine, these details must be kept in mind until resolved.

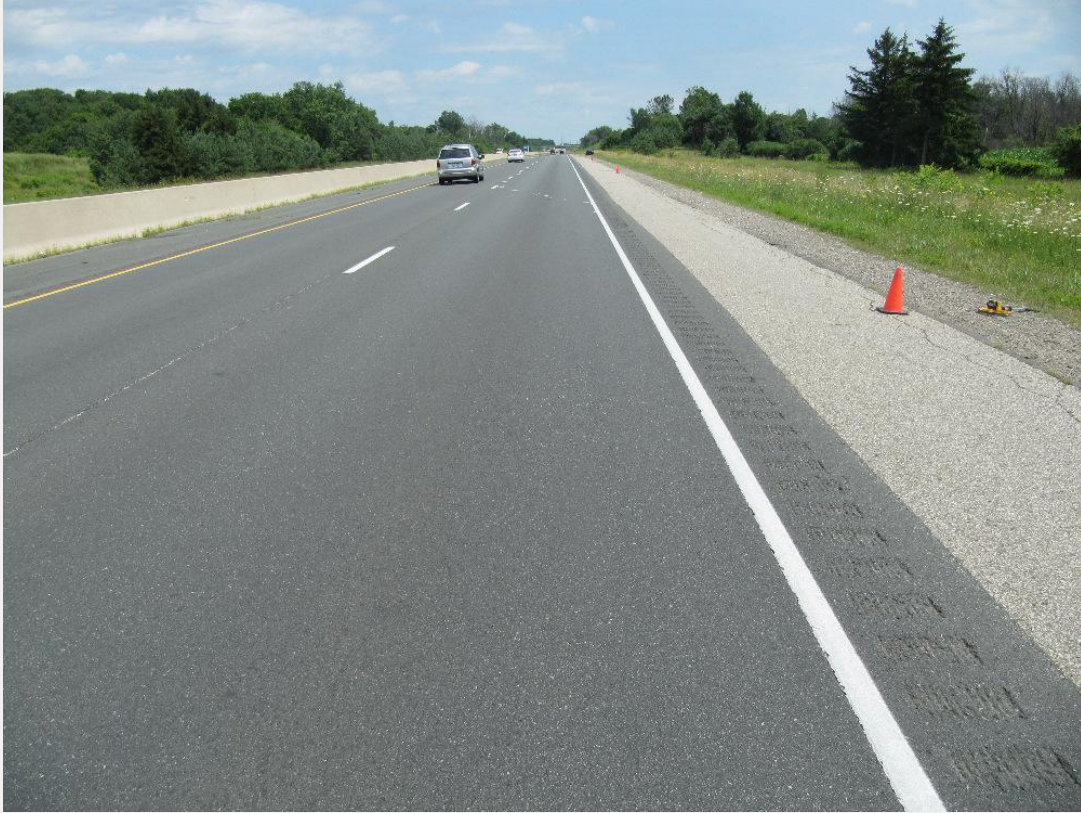
View, looking east, from about 200 metres west of the final rest position (FRP) of the Chevrolet Equinox.

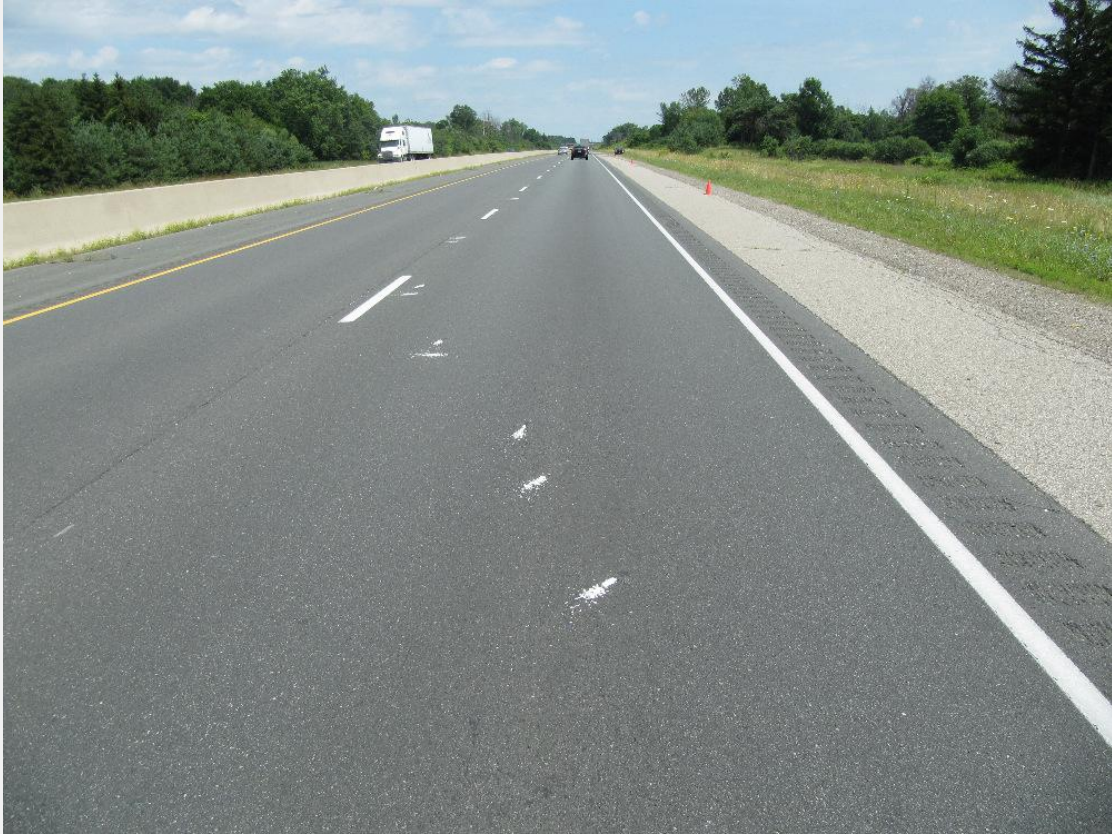
Closer view of white deposits in the eastbound driving lane of Highway 401 demonstrating where the police blocked off the road for their investigation.

Attention to these deposits is helpful in that they help to establish where the police determined the edge of the relevant, visible evidence. For example, if they had found tire marks or other evidence west of that 200 metre distance then they certainly would not allow traffic to drive over the evidence and the line of flares would have been set up further to the west.

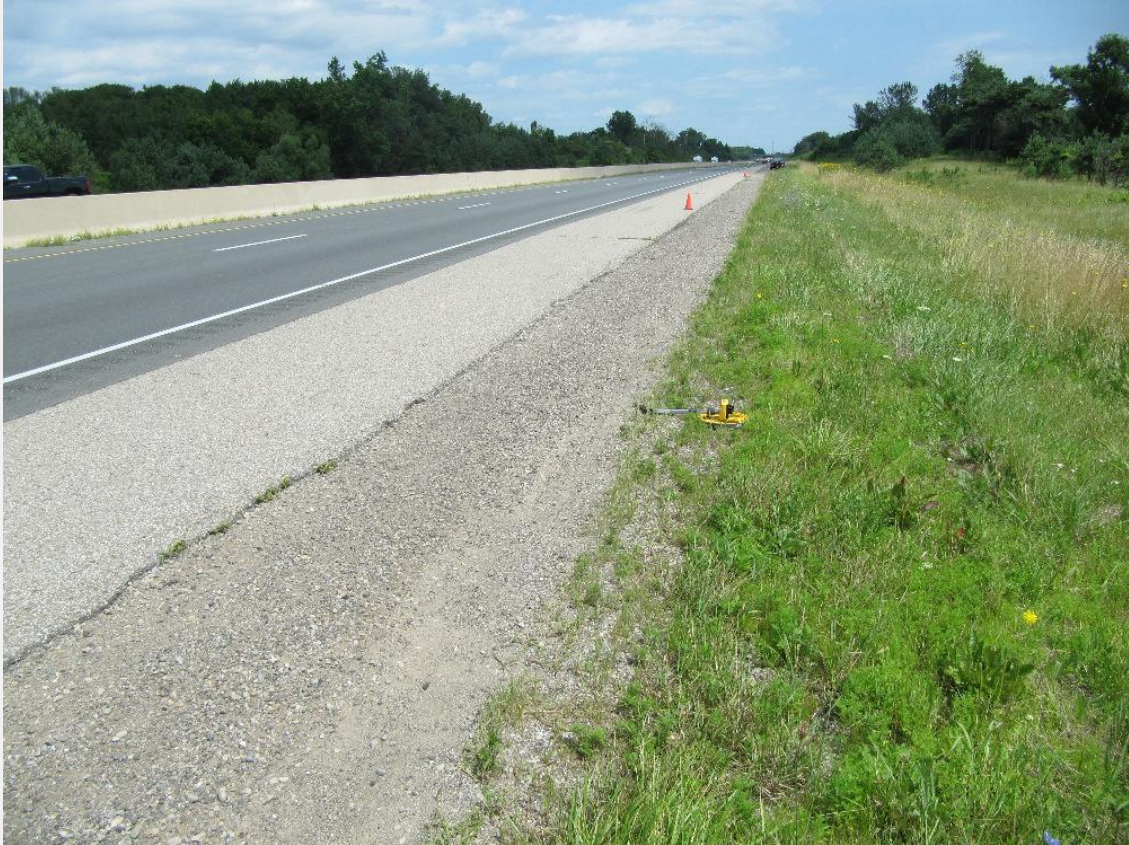
View of measurement wheel referencing the location of the first small piece of red taillight lens found the south shoulder.

This measurement wheel references the location where we found the most-westerly piece of red, taillight lens on the south shoulder. There were many more pieces of this red lens material scattered further eastward from this location within the south shoulder and edge of the south ditch. Why we mention this is because the lens material looked like it had been deposited there very recently. Furthermore we will see shortly that the Chevrolet Equinox was likely, at least, partly in the driving lane in this approximate location. If you look in the background of the above photo you should be able to count that there are two orange cones visible and, since the cones are spaced 50 metres apart, the measurement wheel and the first deposit of red lens material are about 125 metres west of the FRP of the Equinox.

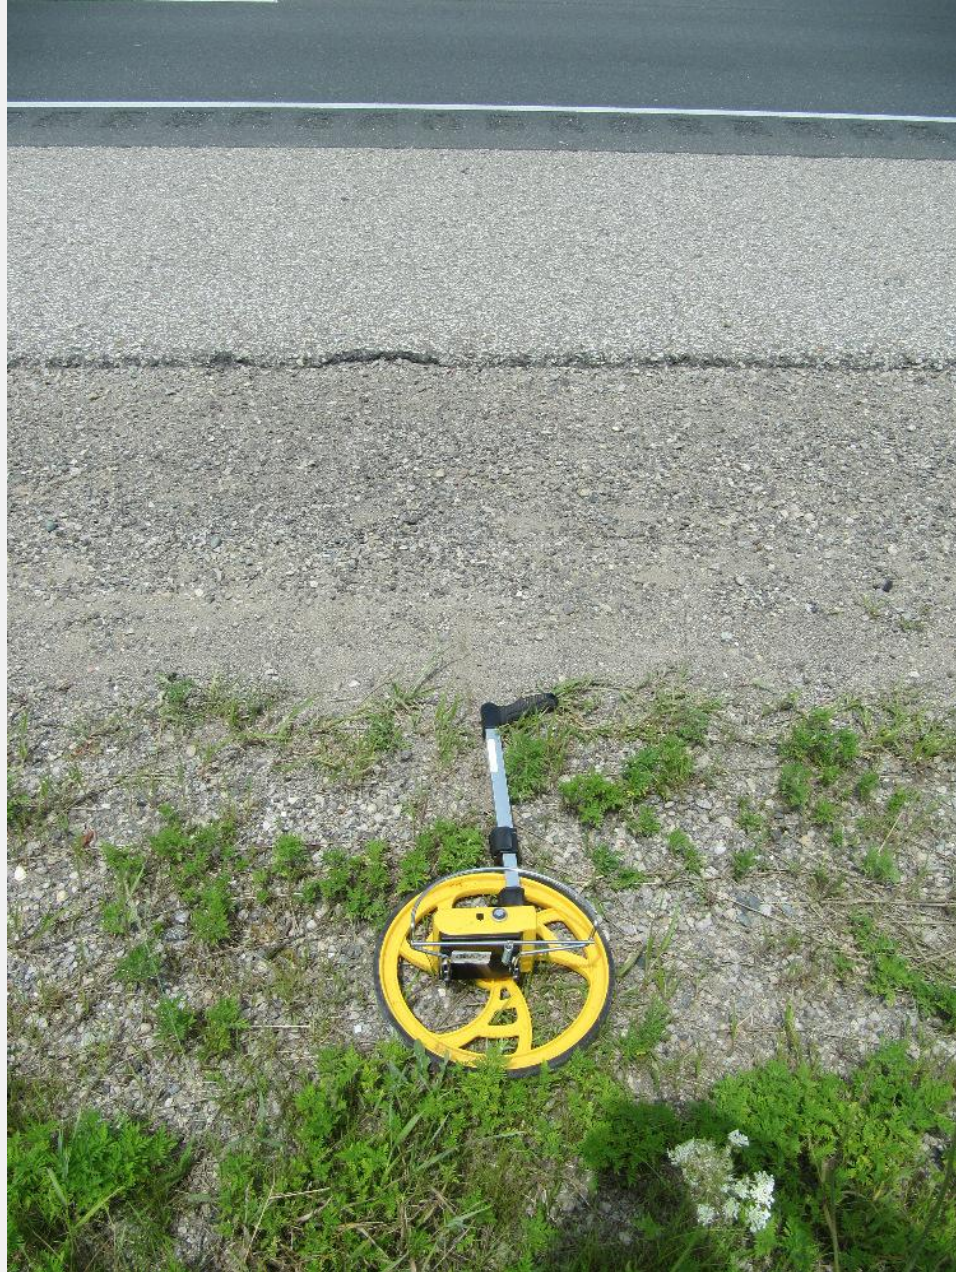
View, looking north, from the position of the measurement wheel out to the south pavement edge where the first piece of lens red material is located.

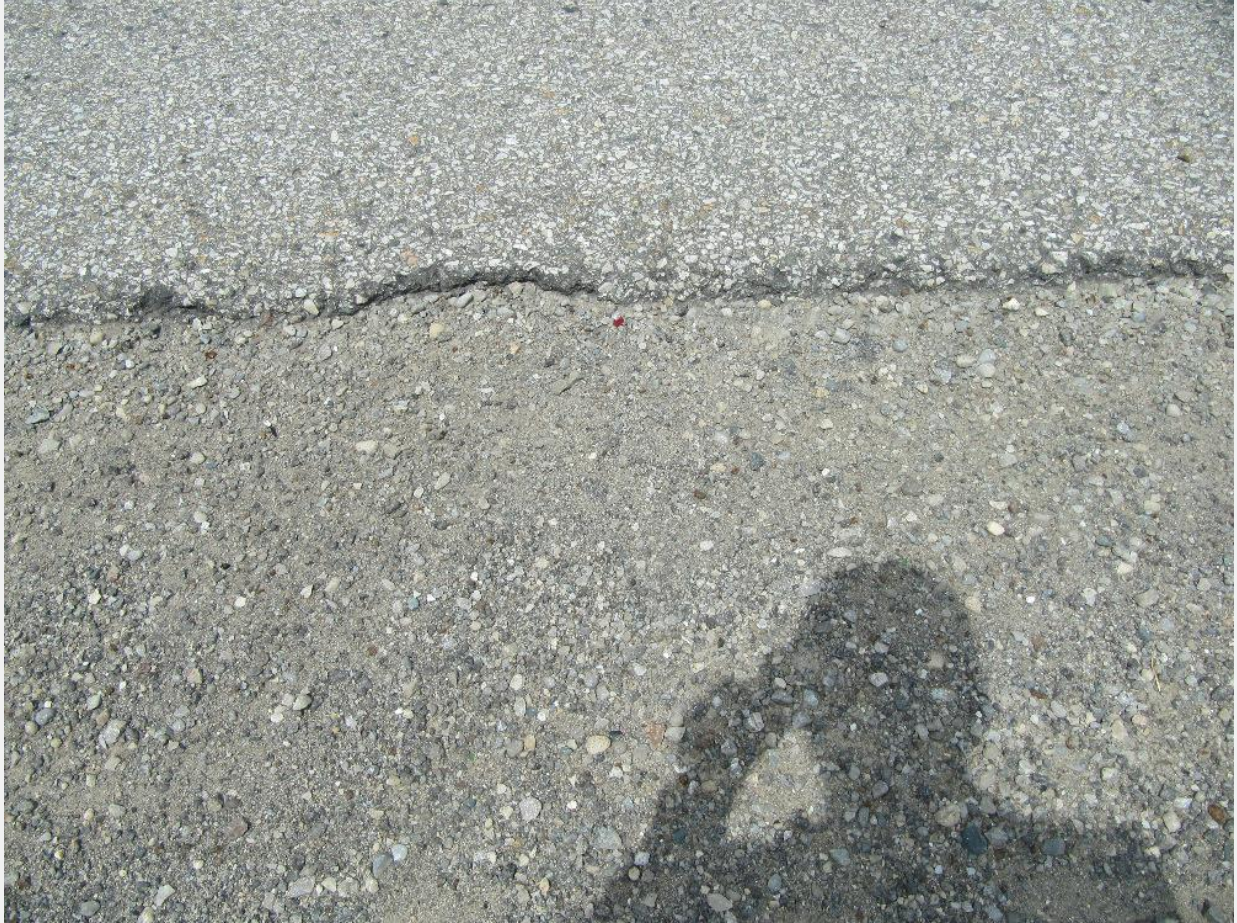
Closer view of south asphalt edge where the first piece of red lens material was located.

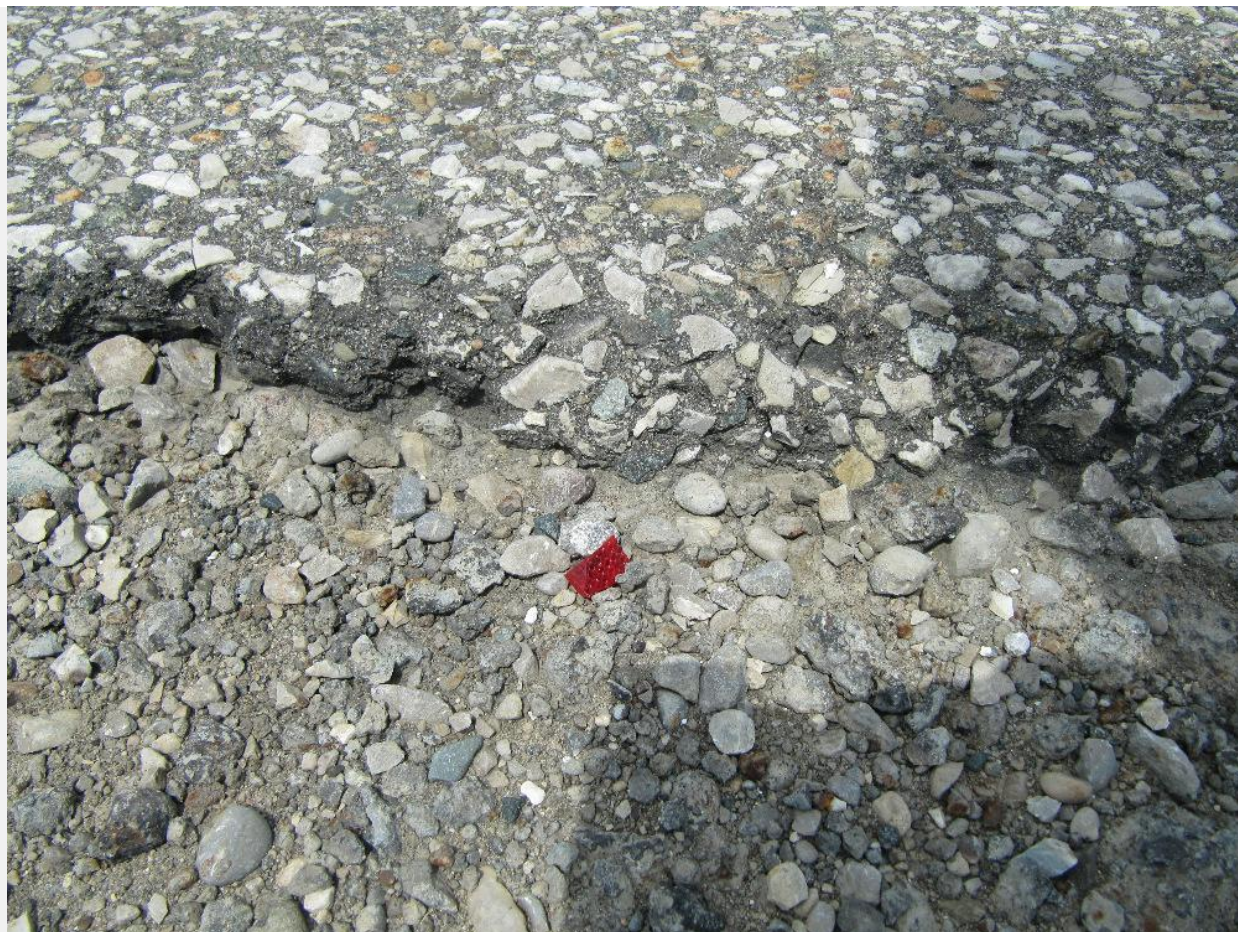
Close-up view of the most-westerly deposit of red lens material.

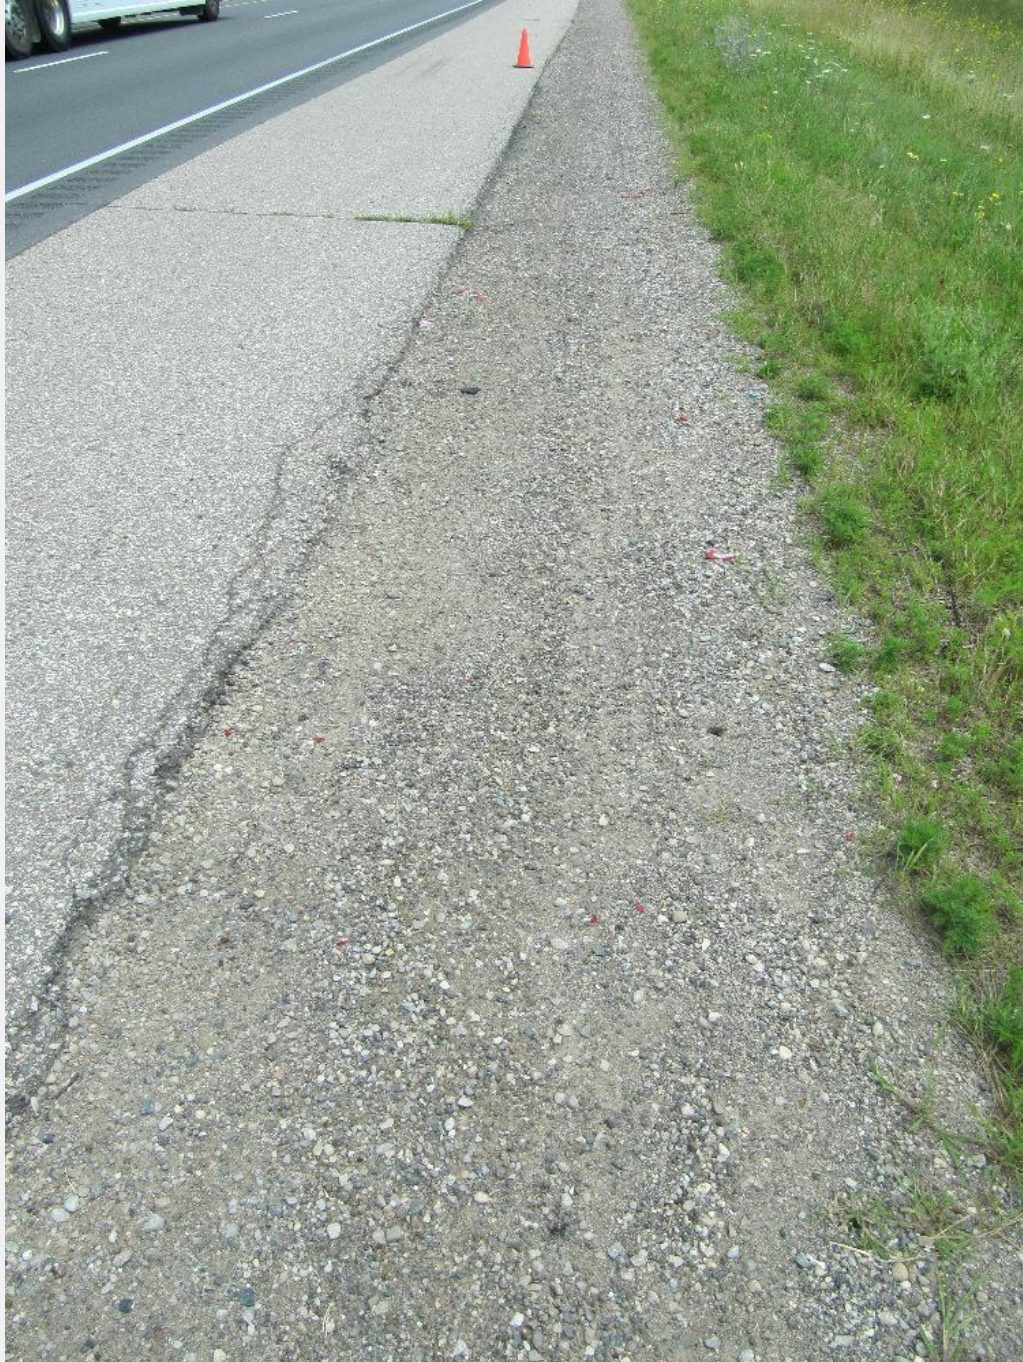
View, looking east, with the 100 metre cone visible in the background, showing the larger deposits of red taillight lens material lying on the south shoulder.

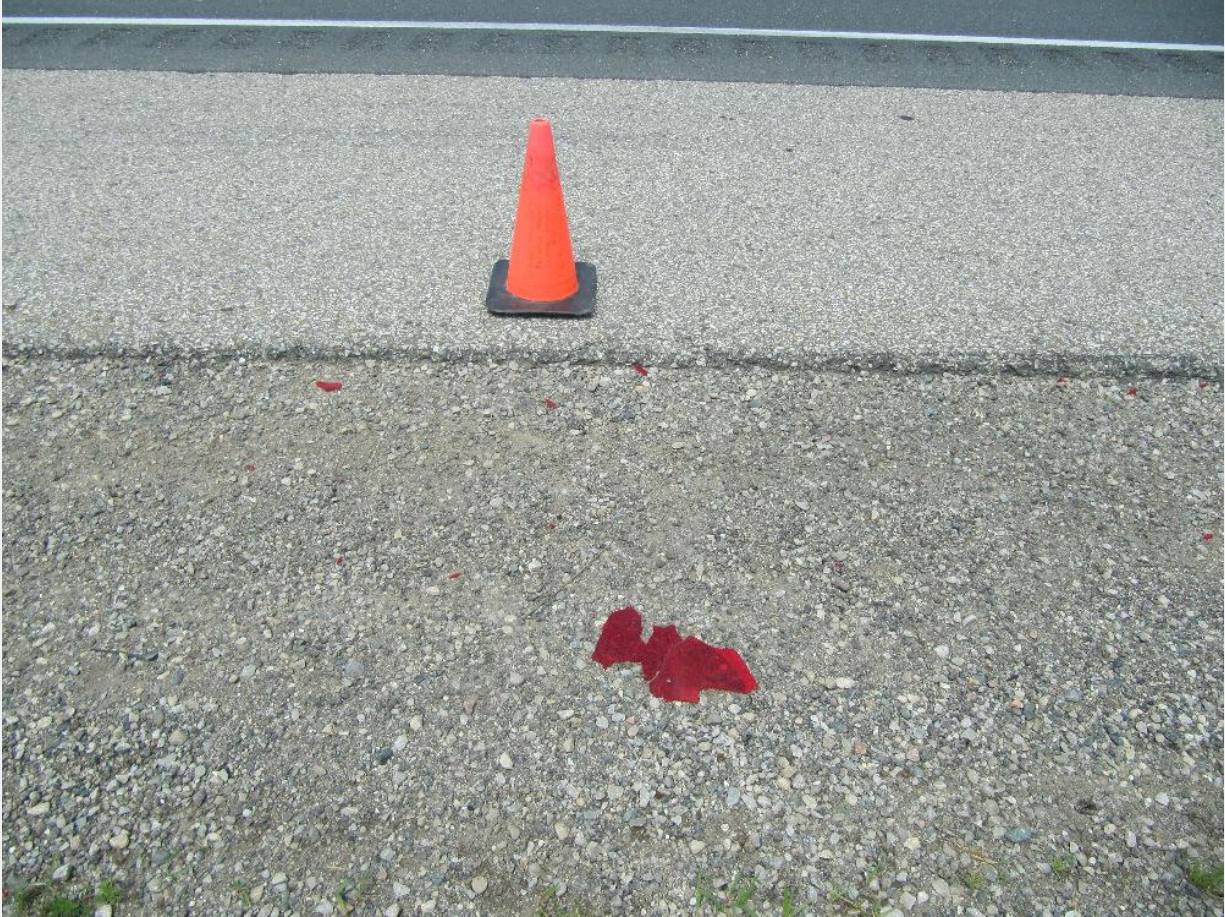
View of larger deposit of red lens material located immediately at the 100 metre cone.

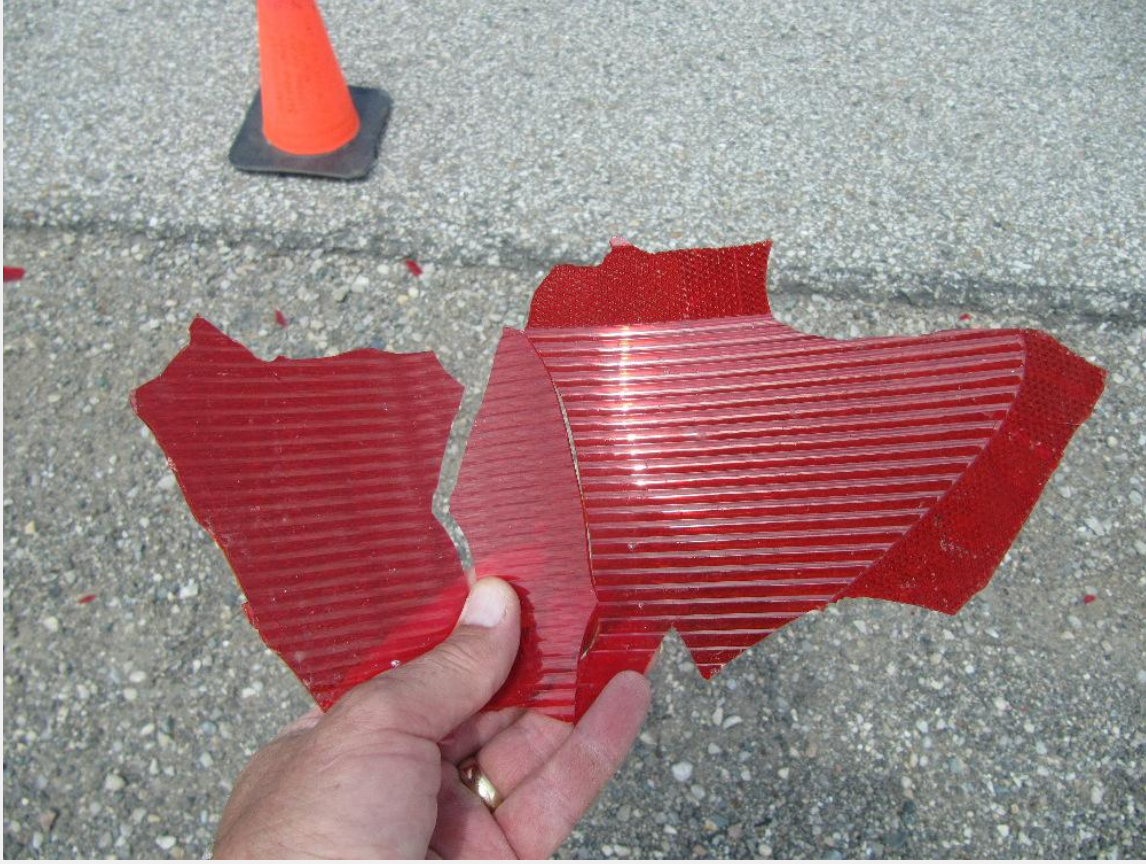
View, showing partial reconstruction of broken lens fragments.

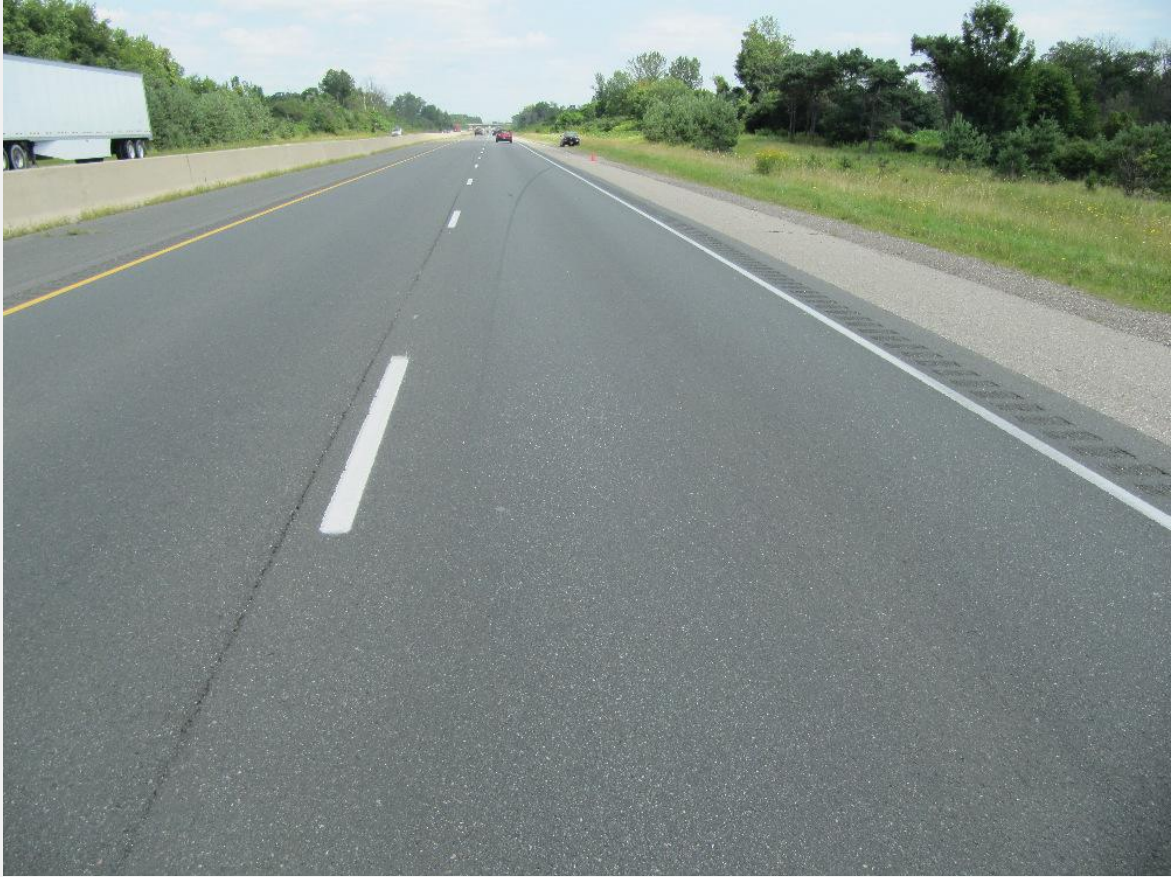
The photo below shows the first evidence of a yaw mark in the eastbound driving lane which provides the first evidence of the motion of the Equinox as it began to rotate clockwise to its eventual departure into the south roadside. If you look you can see only one cone in the view so the tire mark must have commenced before at 50 metre cone.

View, looking east, showing the first evidence of yaw mark in the driving lane.

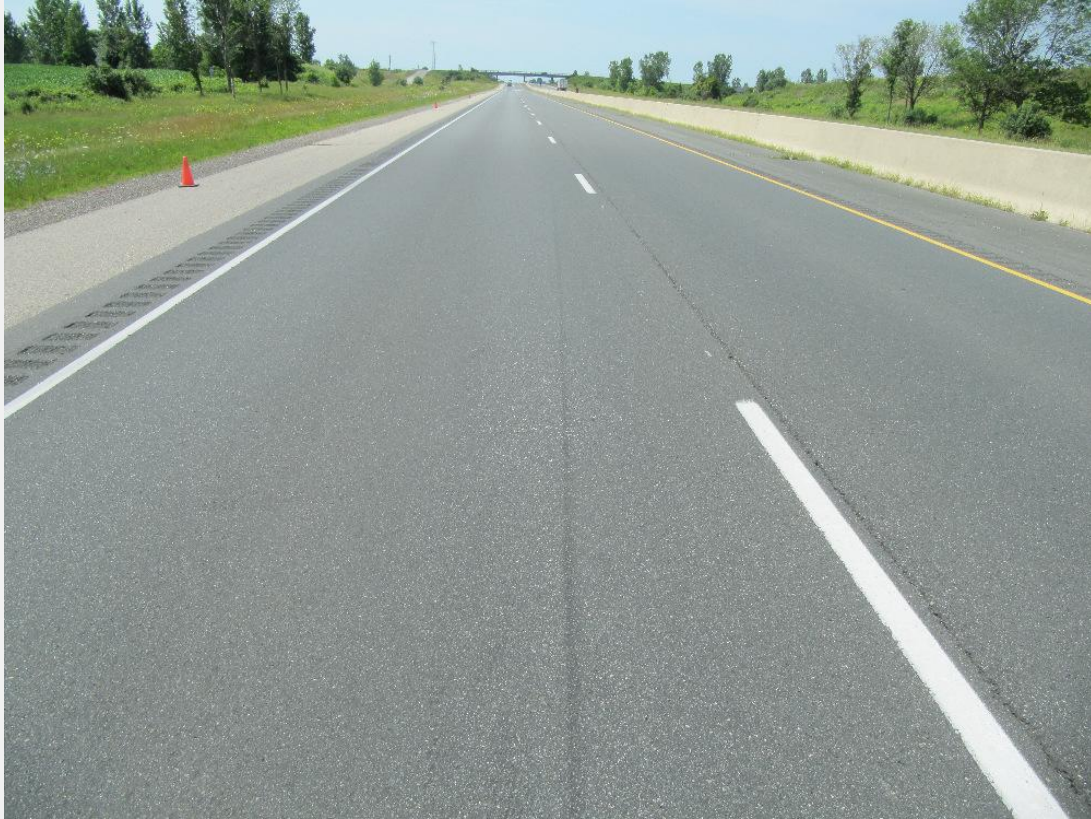
View, looking west, showing the beginning of the yaw mark in the foreground and the 100 metre cone on the extreme left edge of the photo.

And, if we recall, the first evidence of red taillight lens was at about the 125 metre location. So, is this a coincidence? Well obviously we have no other evidence to say yes or no other than what we see on this site. But in our opinion, the freshness of the evidence and its location suggests that this could all be related.

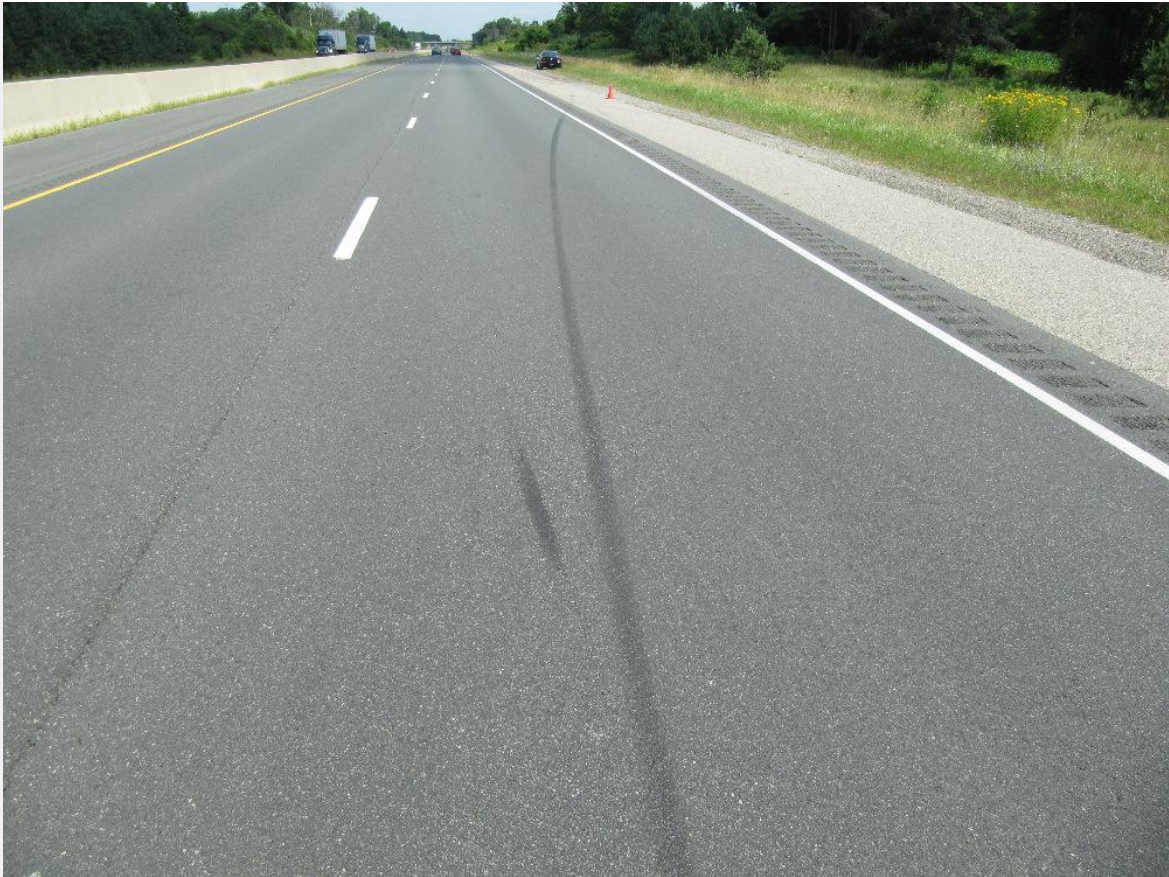
View, looking east, along the yaw mark as the vehicle rotates toward the south roadside.

We would want to be careful at this point because, although the tire mark evidence indicates that the vehicle is rotating clockwise, the evidence is not exactly typical of what you would see. Typically, you would see at least three, curved, yaw marks and perhaps a faint fourth coming from the right rear tire. But that is not the case. There is only one prominent mark and there is also a very short tire mark alongside the prominent one as shown in the above photo.

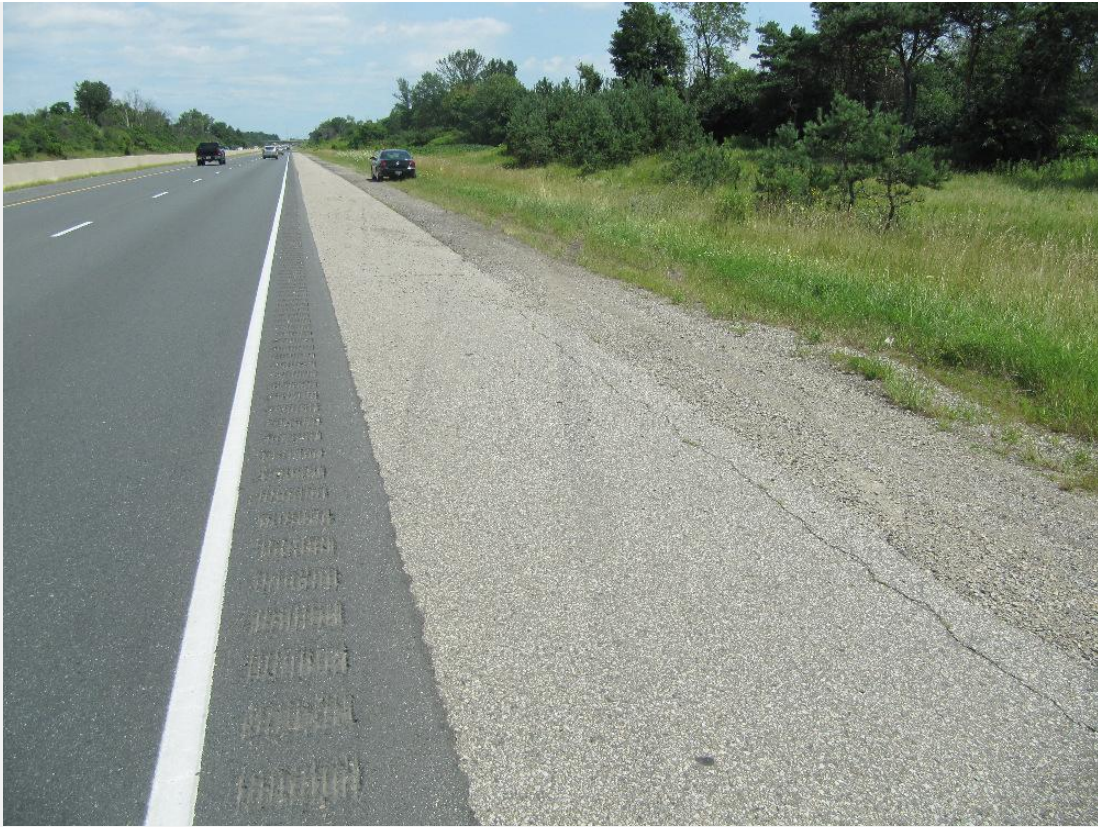
View of tire marks as they exit the pavement and enter the south roadside.

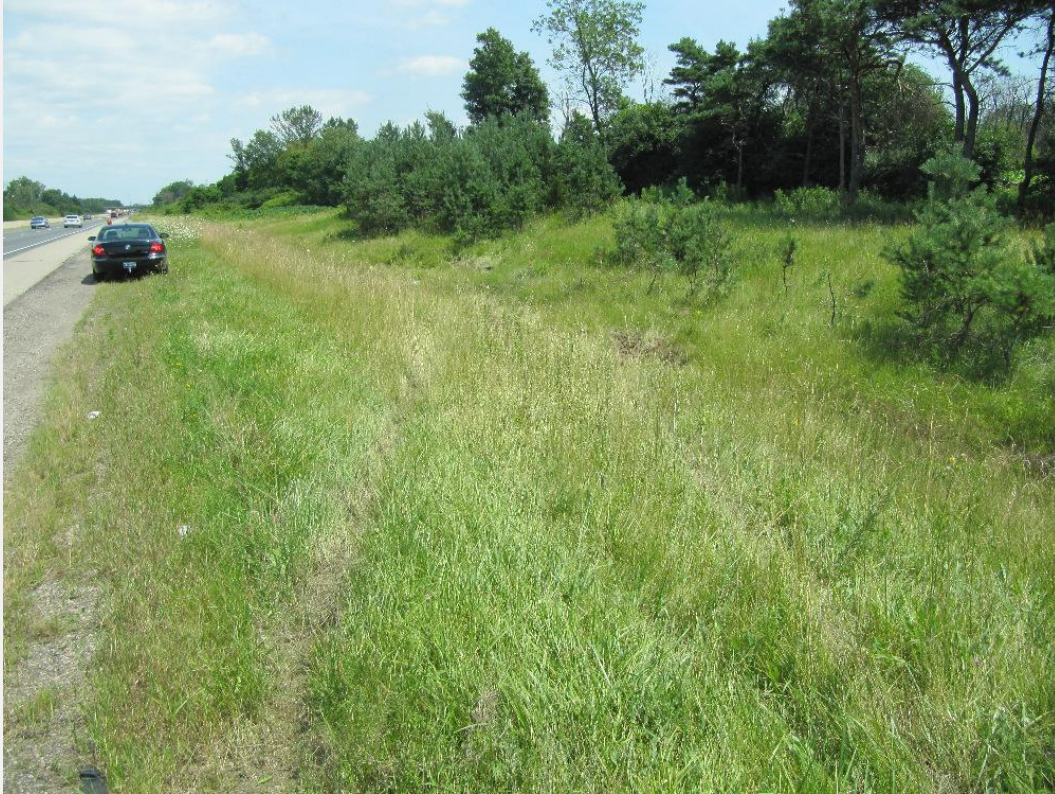
View of loss-of-control tire marks in the grass of the south roadside.

But as is typical, once the vehicle reaching the bottom of the ditch and the tires dig into the earth the vehicle is tripped and it begins to roll. One might detect the location of the initial gouging of the earth in the above photo although is it not particularly clear.

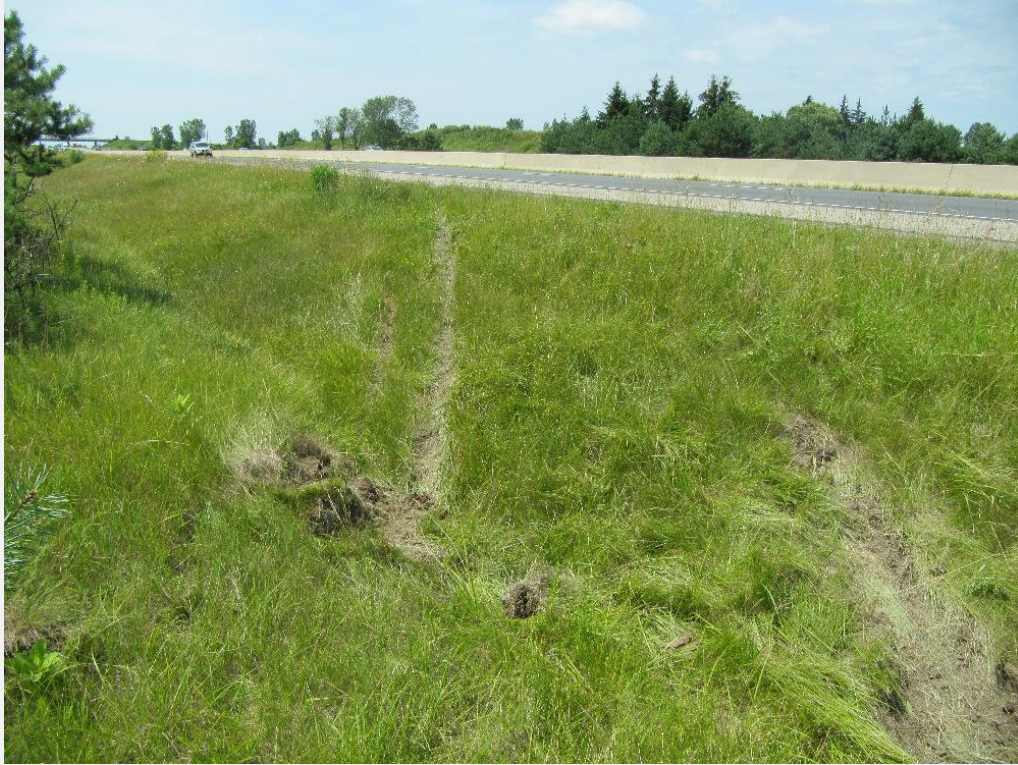
View, looking north-west at the gouging of the earth at the end of the tire marks where the vehicle began to rollover at the bottom of the south ditch.

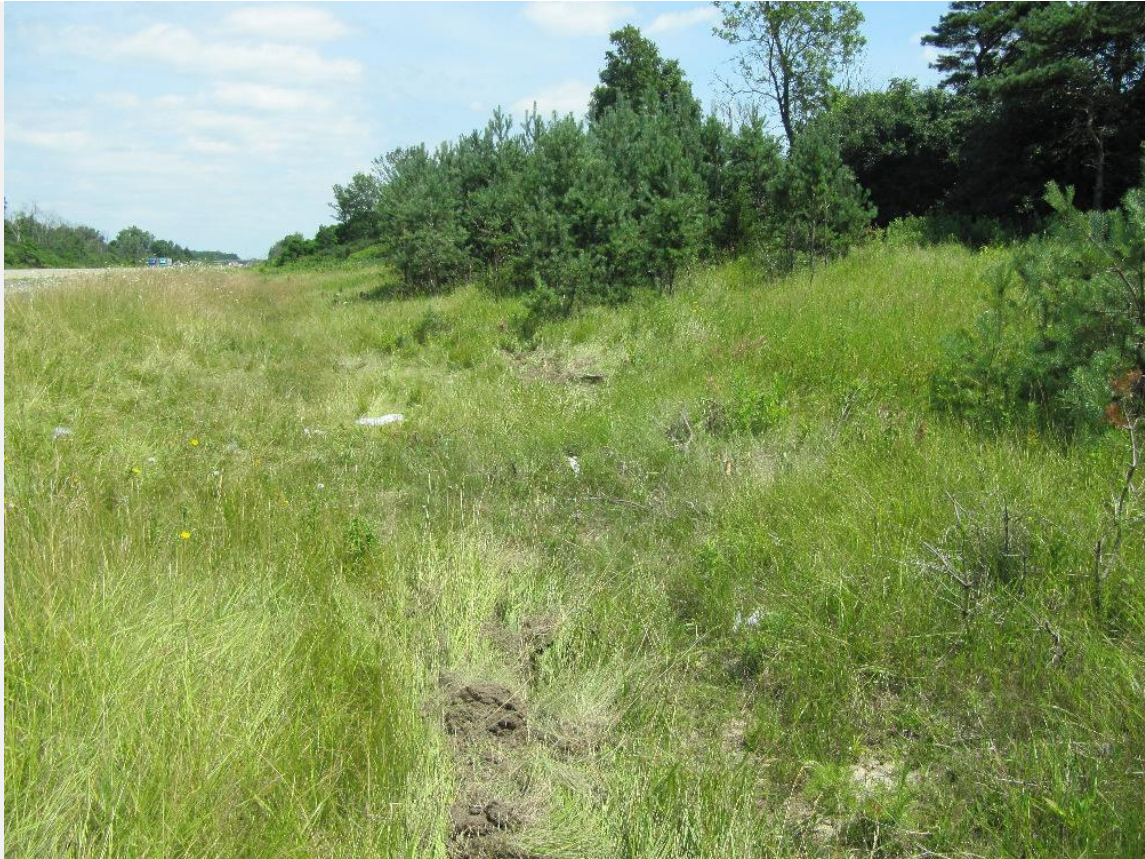
View, looking east, along the trampled grass of the south ditch where the Equinox rolled and then came to a halt.

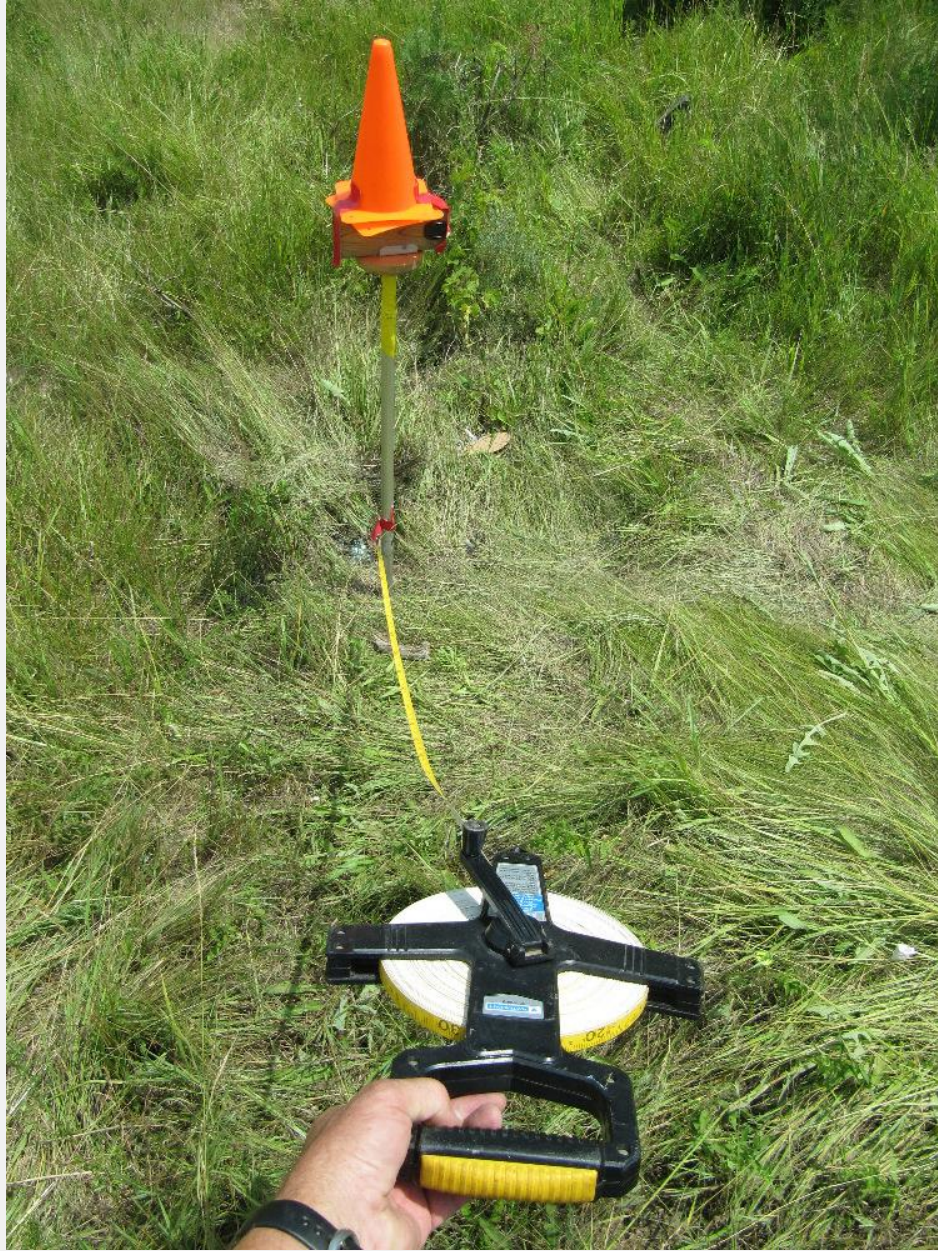
Measurement tape anchored to post at FRP of Equinox so that measurements can be taken to various points of interest.

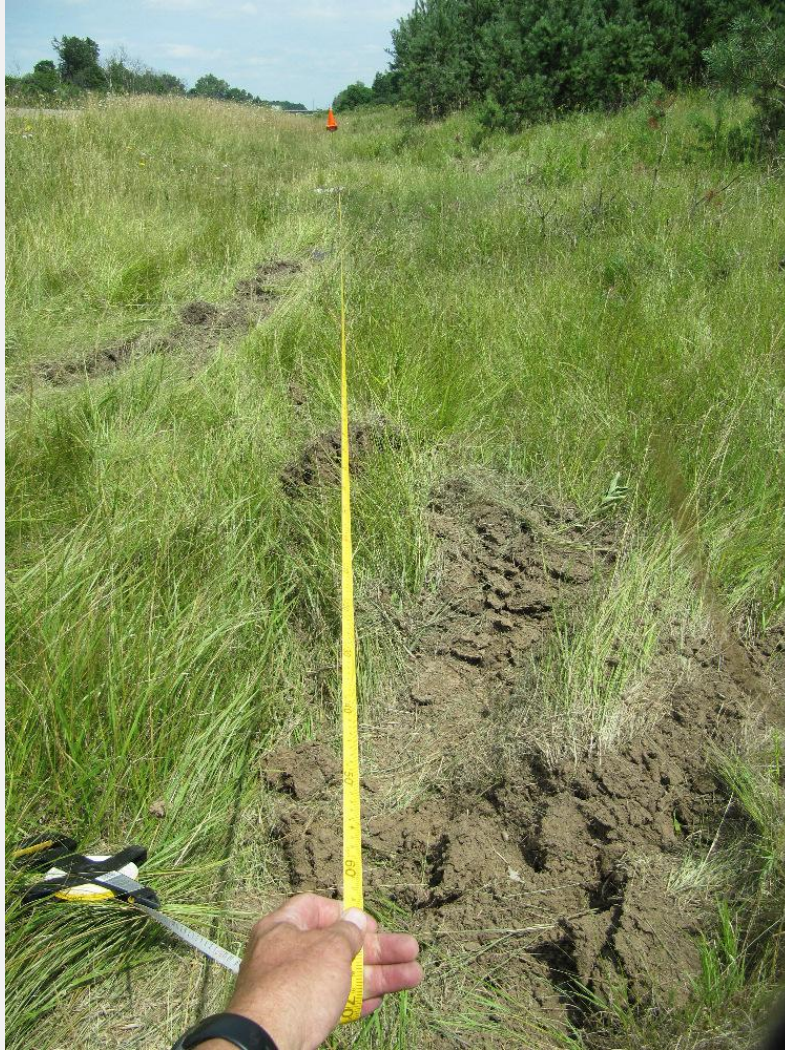
View, showing how the distance was measured from the Equinox final rest position to the gouges in the earth where it first began to rollover.

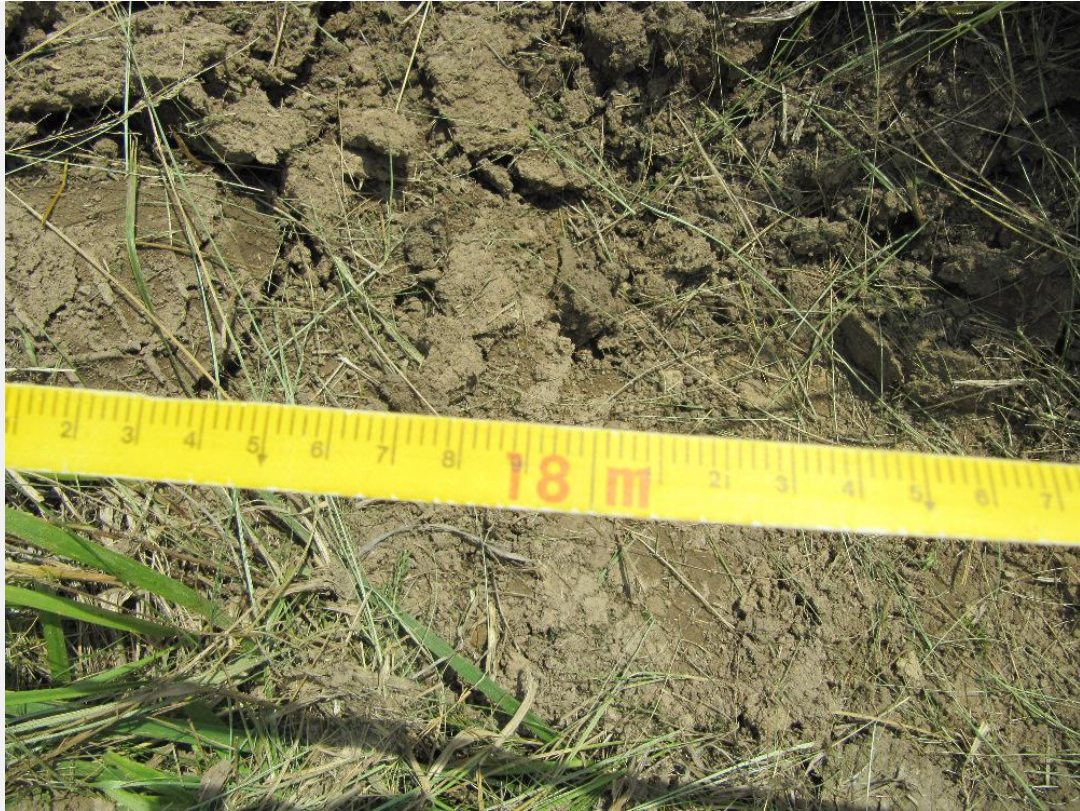
View showing a reading of 18 metres on the measurement tape when measuring from the Equinox FRP to the point where it began its rollover.

If we used a tumble number (0.5g) to represent the rate of deceleration of a soft roll over the distance of 18 metres then we could say that the vehicle's speed was approximately 48 km/h when it began to roll. In fact this is an exaggeration since we took the measurement to the furthest eastward evidence for the FRP and other measurements were taken of other gouges which would place them in the range of 15 to 18 metres. So, overall, the vehicle's speed would certainly be less than 48 km/h when it began to roll. Not a low speed rollover but certainly not a high speed rollover either.
