Gorski Consulting Website

Archived News - 2013 - July

July 27, 2013

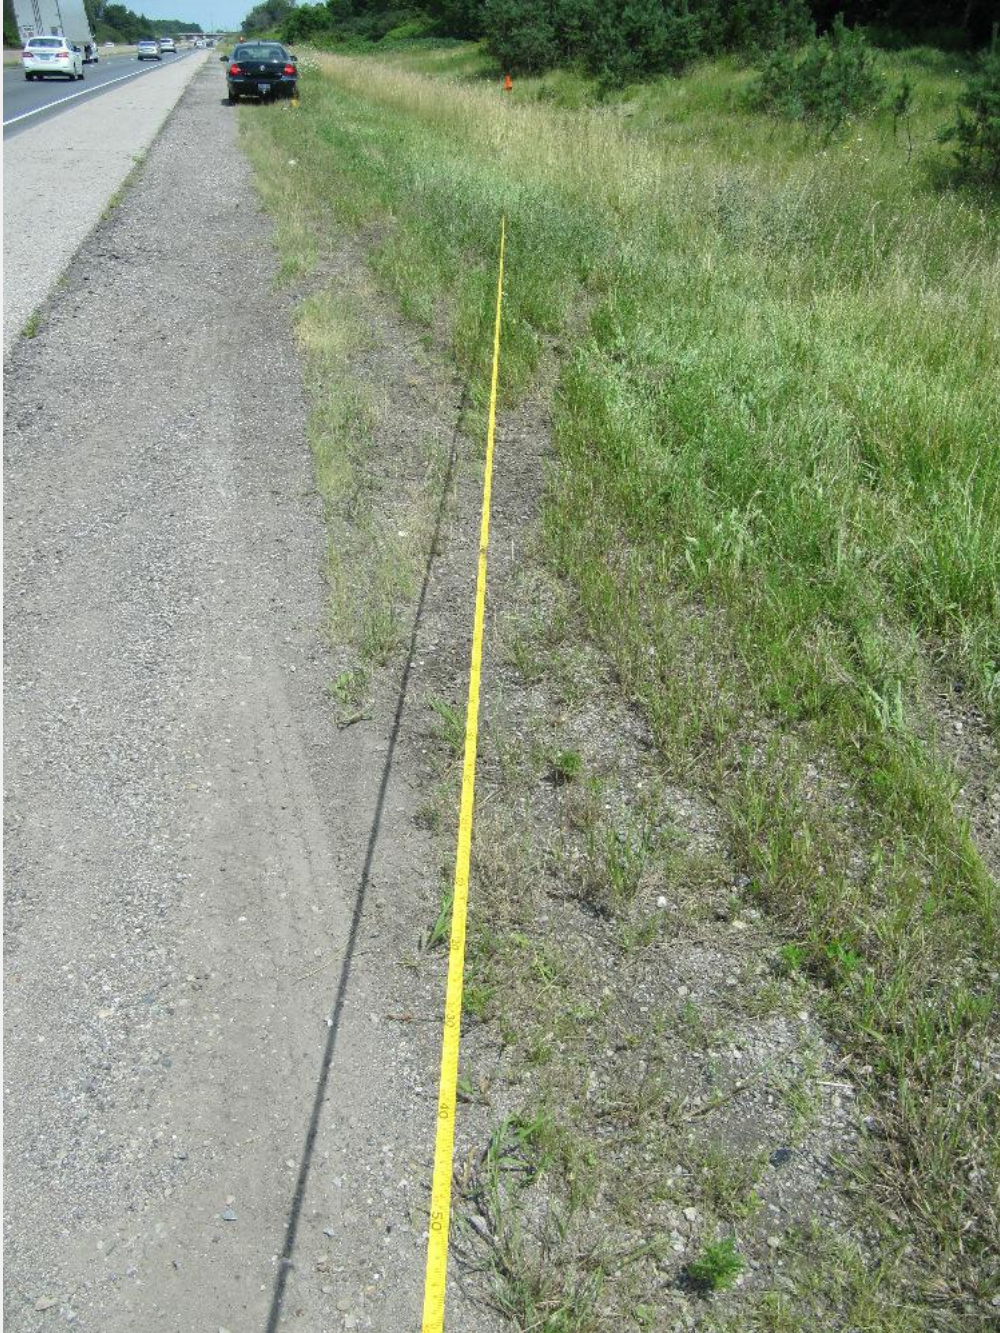
View of measurement tape stretched from the Equinox FRP to the tire marks at the edge of the grass of the south ditch.

If we applied an overall deceleration rate of $0.4g$ over that entire distance we would obtain a speed of about 63 km/h for the vehicle as it entered the grass ditch.

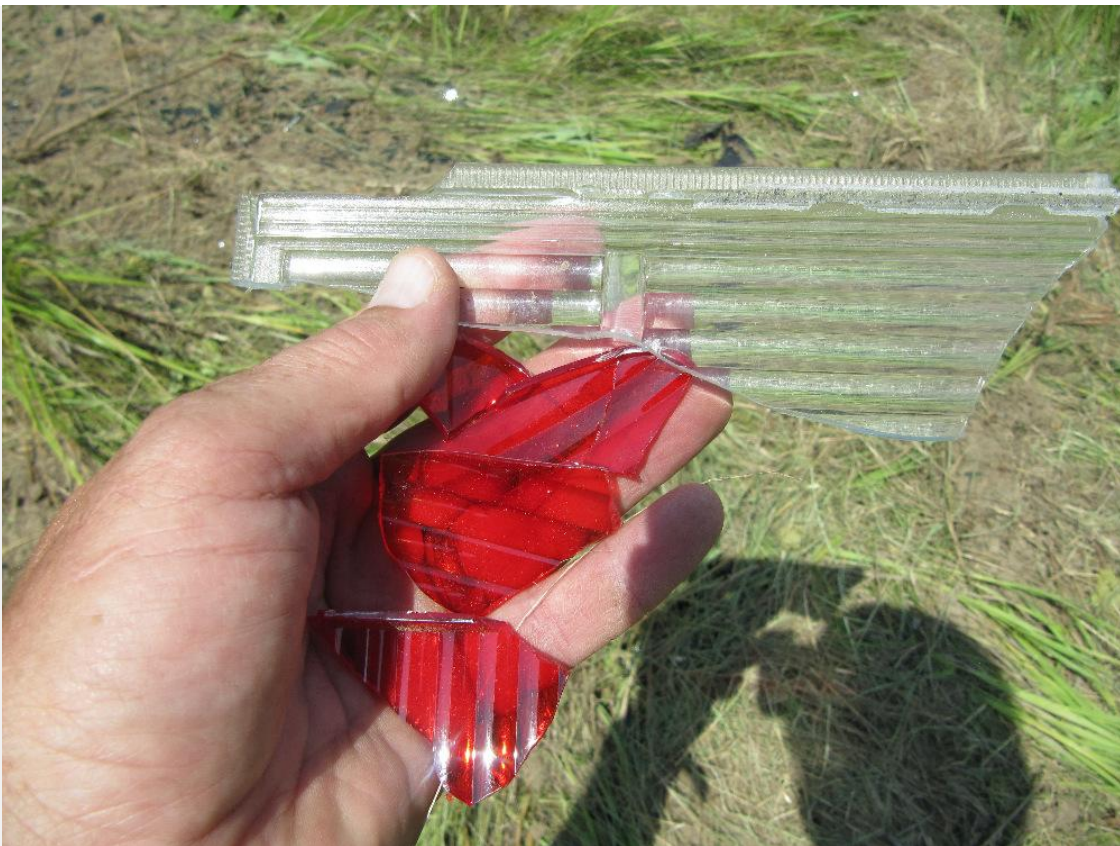
View of broken taillight lens debris obtained near the Equinox FRP.

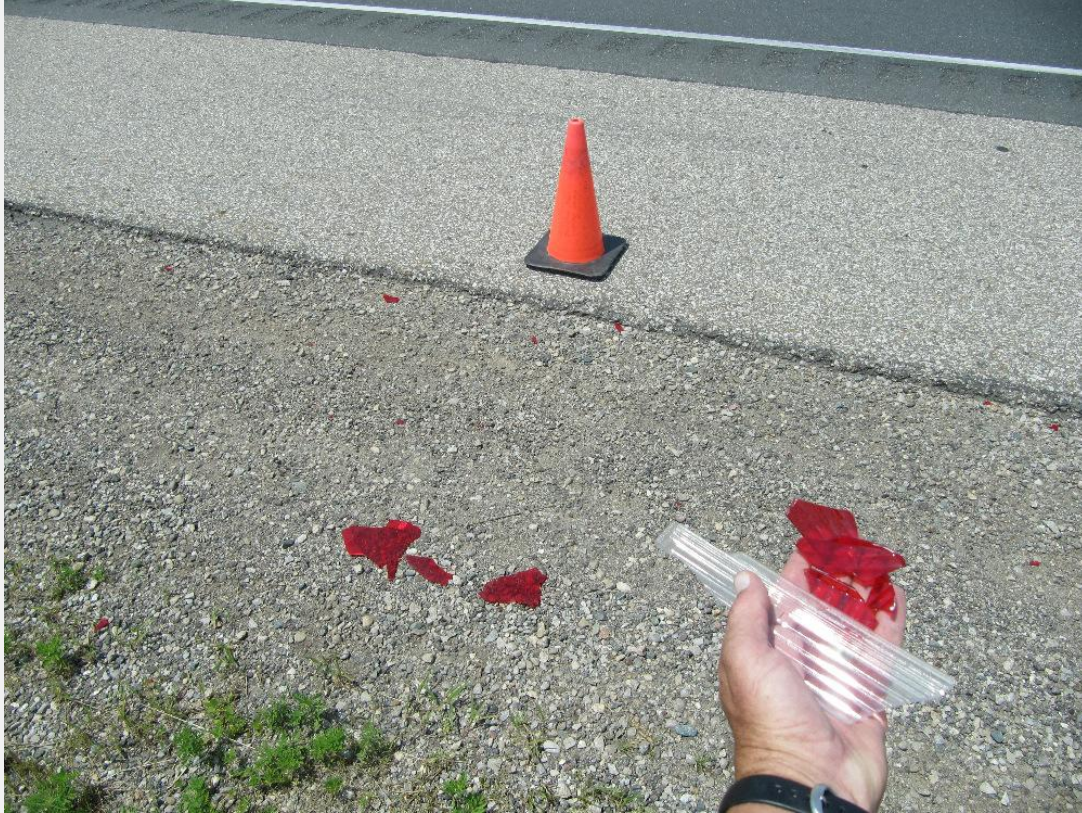
View of lens material taken from Equinox FRP being taken over to the lens material at the 100 metre cone to make a comparison.

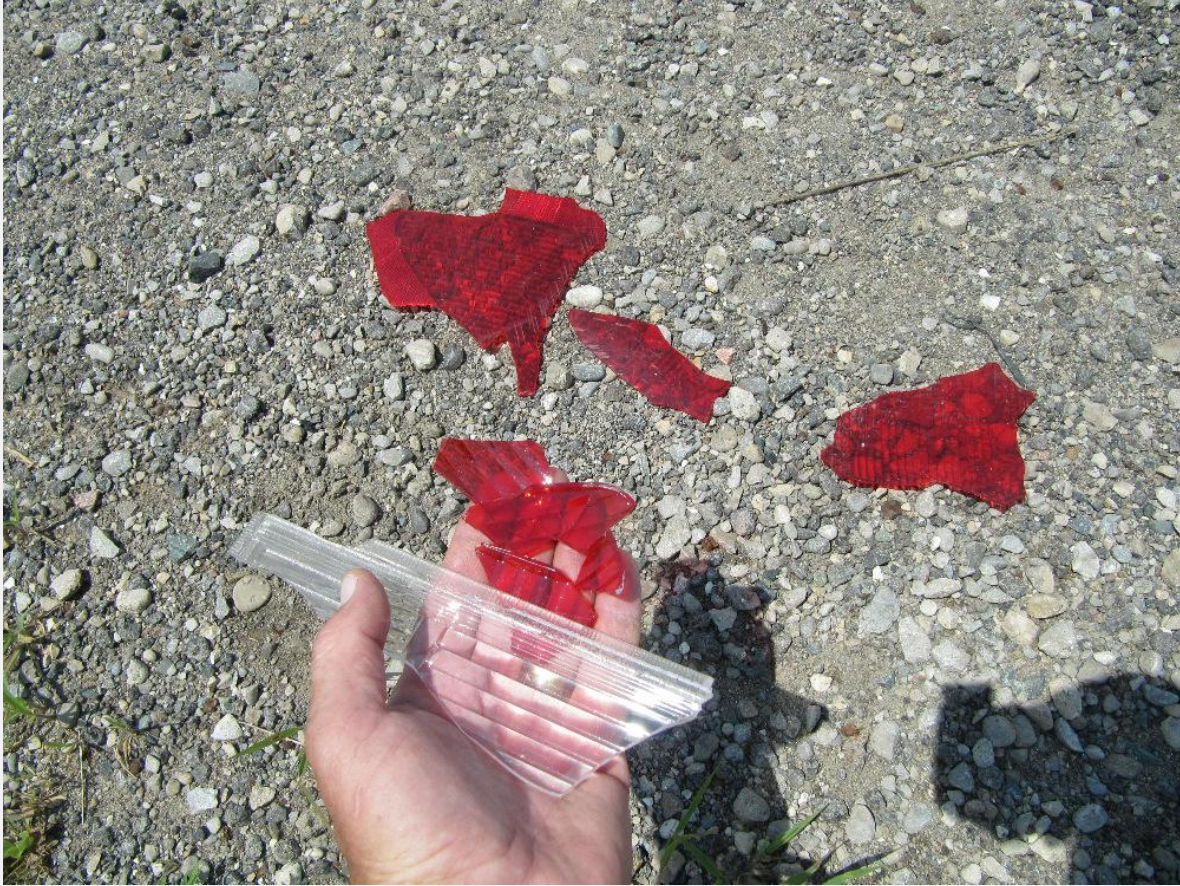
View of comparison between two lens samples.

The characteristics of the two samples do not match as can be seen from the detailed photo below.

So whatever caused the red lens material to be strewn across the south shoulder of the highway is not known but we know that it did not come from the taillights of the Equinox. Obviously there could be numerous explanations for the existence of this evidence but we hope this is an interesting exercise to demonstrate what can be done to reconstruct motor vehicle collisions.

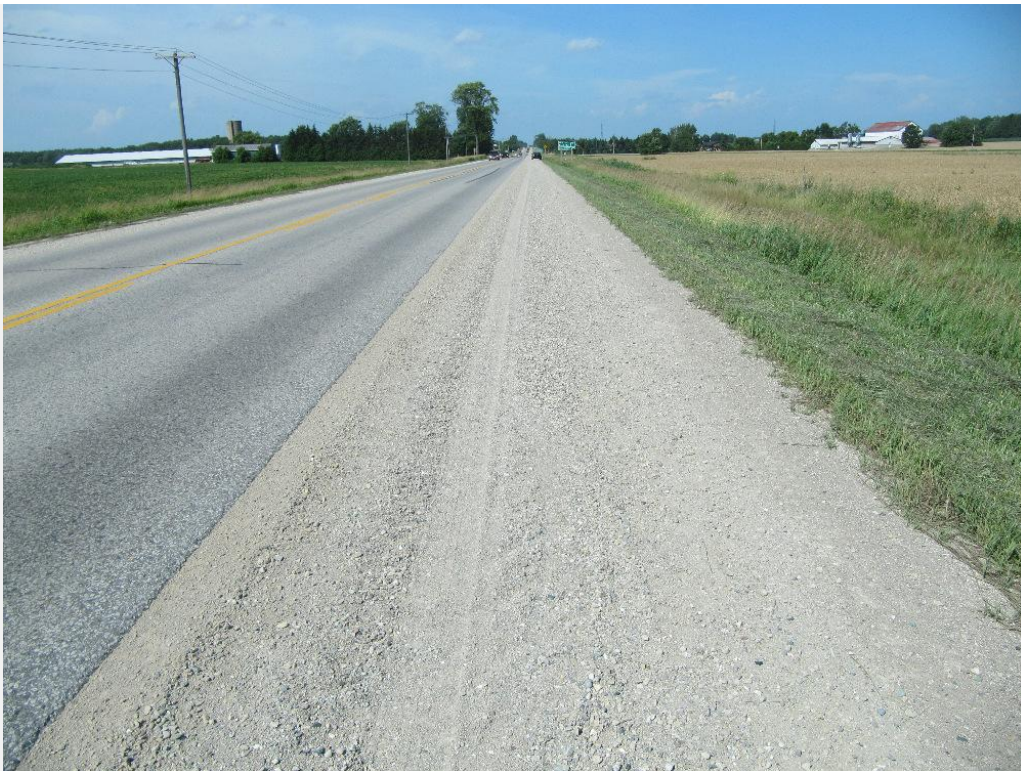
View, looking north, along the east shoulder of Perth Road 23 (Same travel direction as the Kia) from several hundred metres south of the location where the Kia left the road surface and rolled over.

In fact, you can see our parked vehicle in the background and the point where the Kia exited the pavement is just in front of our parked vehicle. If you had studied any of our discussions about tire marks left on freshly graded gravel shoulders then you would immediately recognize what we recognized based on the visibility of the marks produced by the tires of our vehicle as we rode slowly along this shoulder. But let's look further...

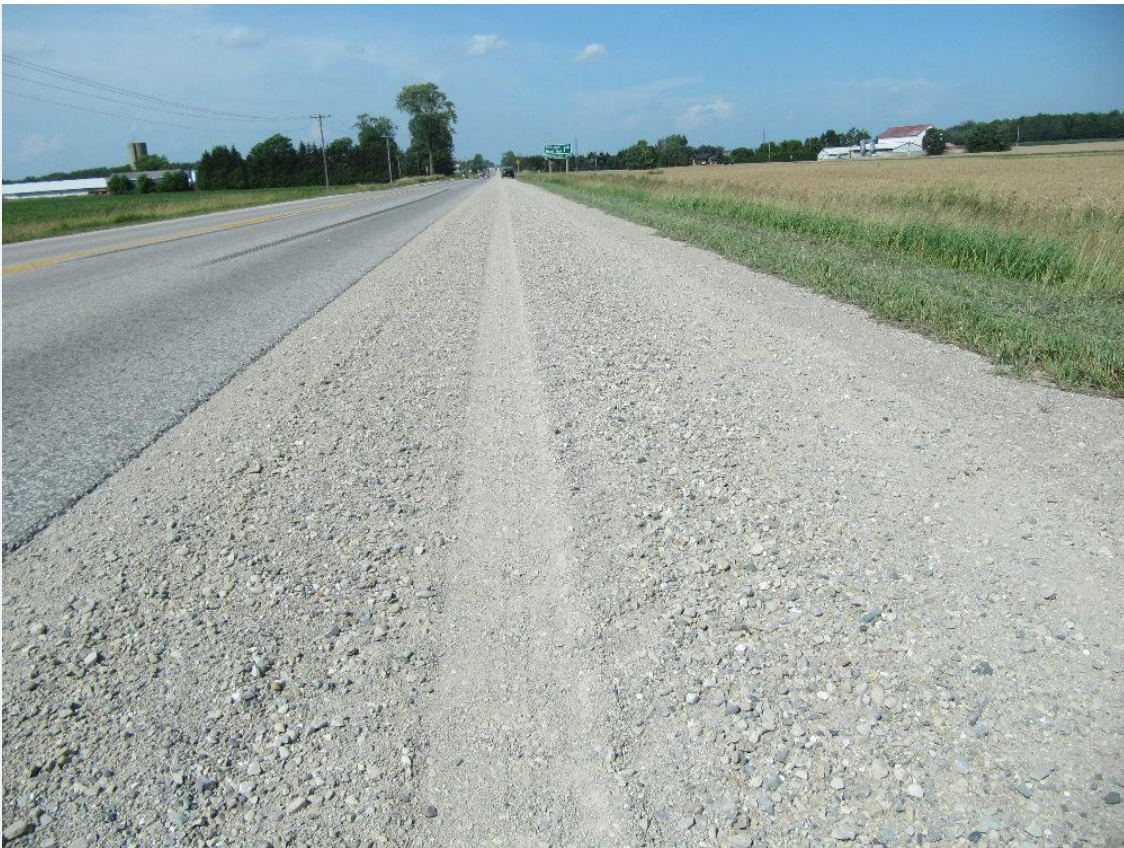
View, looking further northward along the east gravel shoulder toward the location where the Kia left the roadway.

Having conducted extensive observations of tire marks on freshly graded shoulders our response is definitive: NO. A typical gravel shoulder that has been undisturbed will be hard-packed over that length of time and tire marks will not be that visible. This gravel shoulder was freshly graded, probably within a day or two of the collision date. But let us move on...

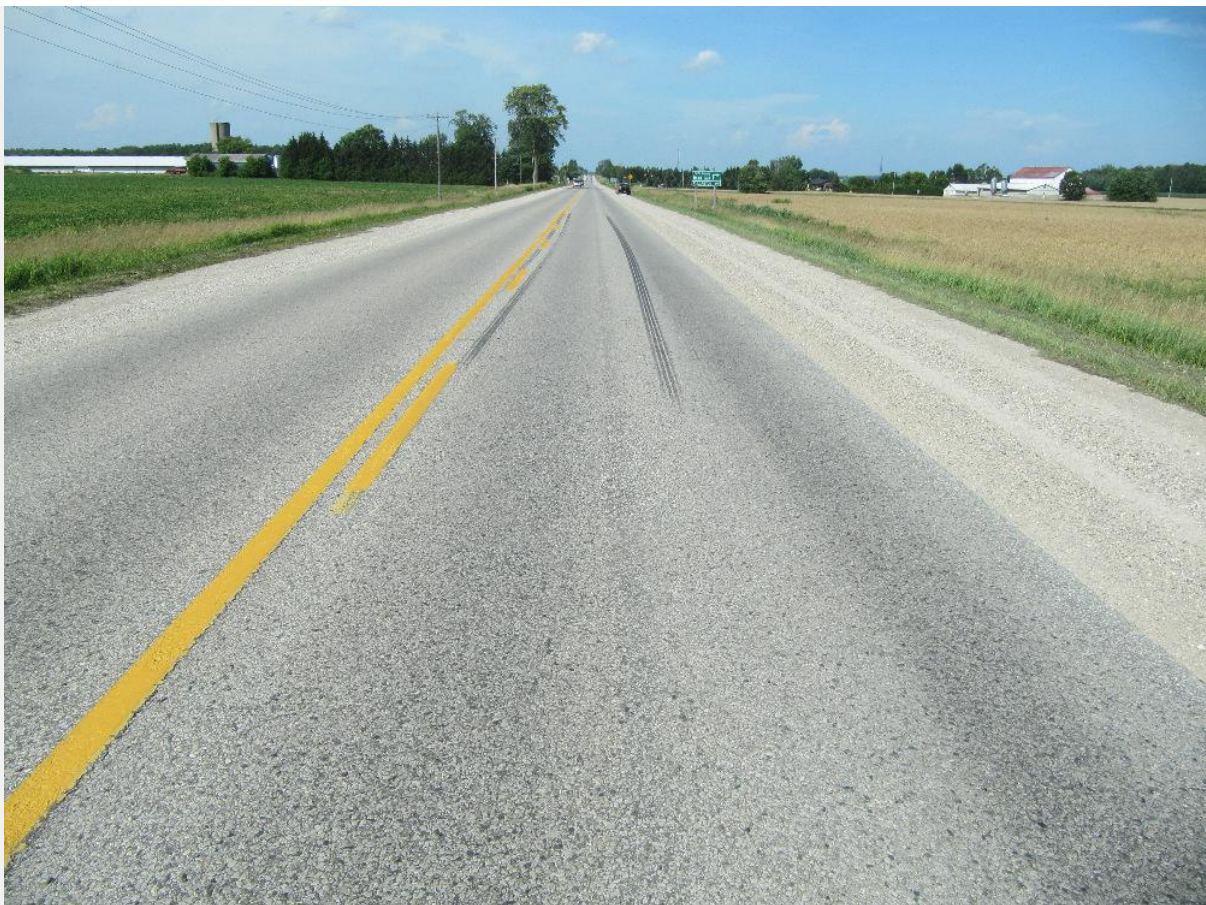
View, looking north, showing a set of truck skid marks in the northbound lane of Perth Road 23.

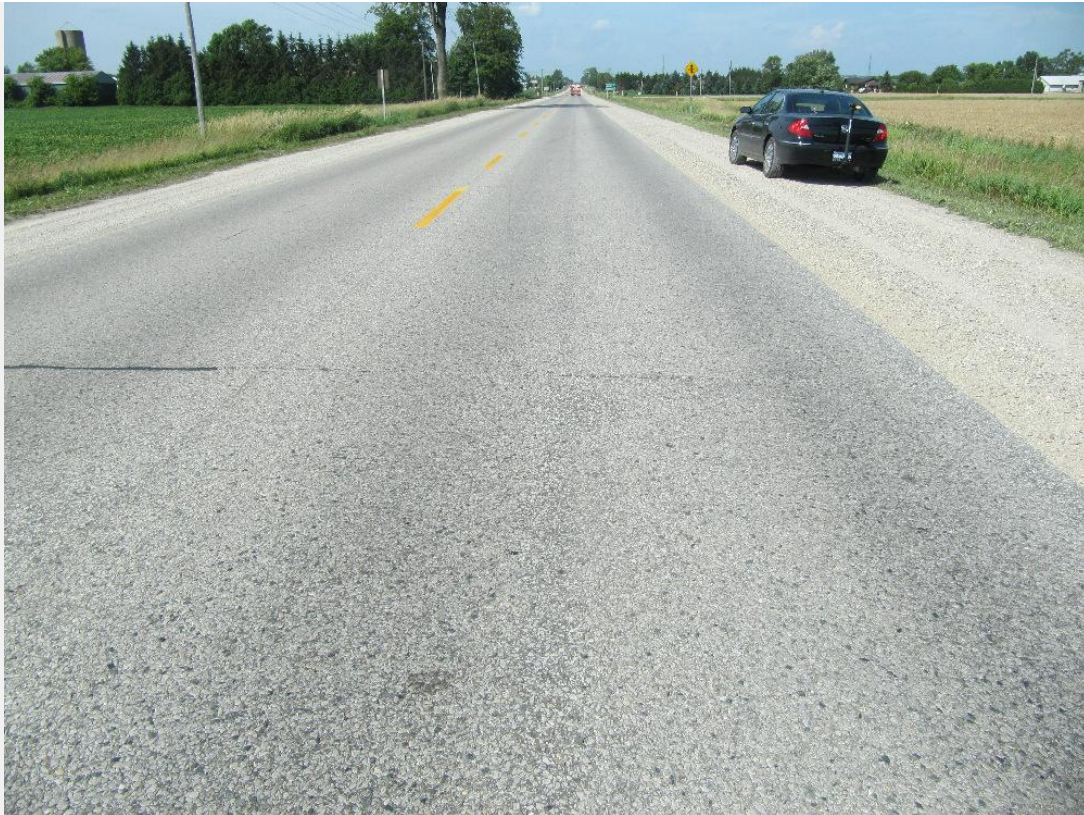
View, looking north along Perth Road 23 at a point just south of the parked position of our vehicle and just south of the yaw marks produced by the Kia as it rotated counter-clockwise off the east (right) side of the road.

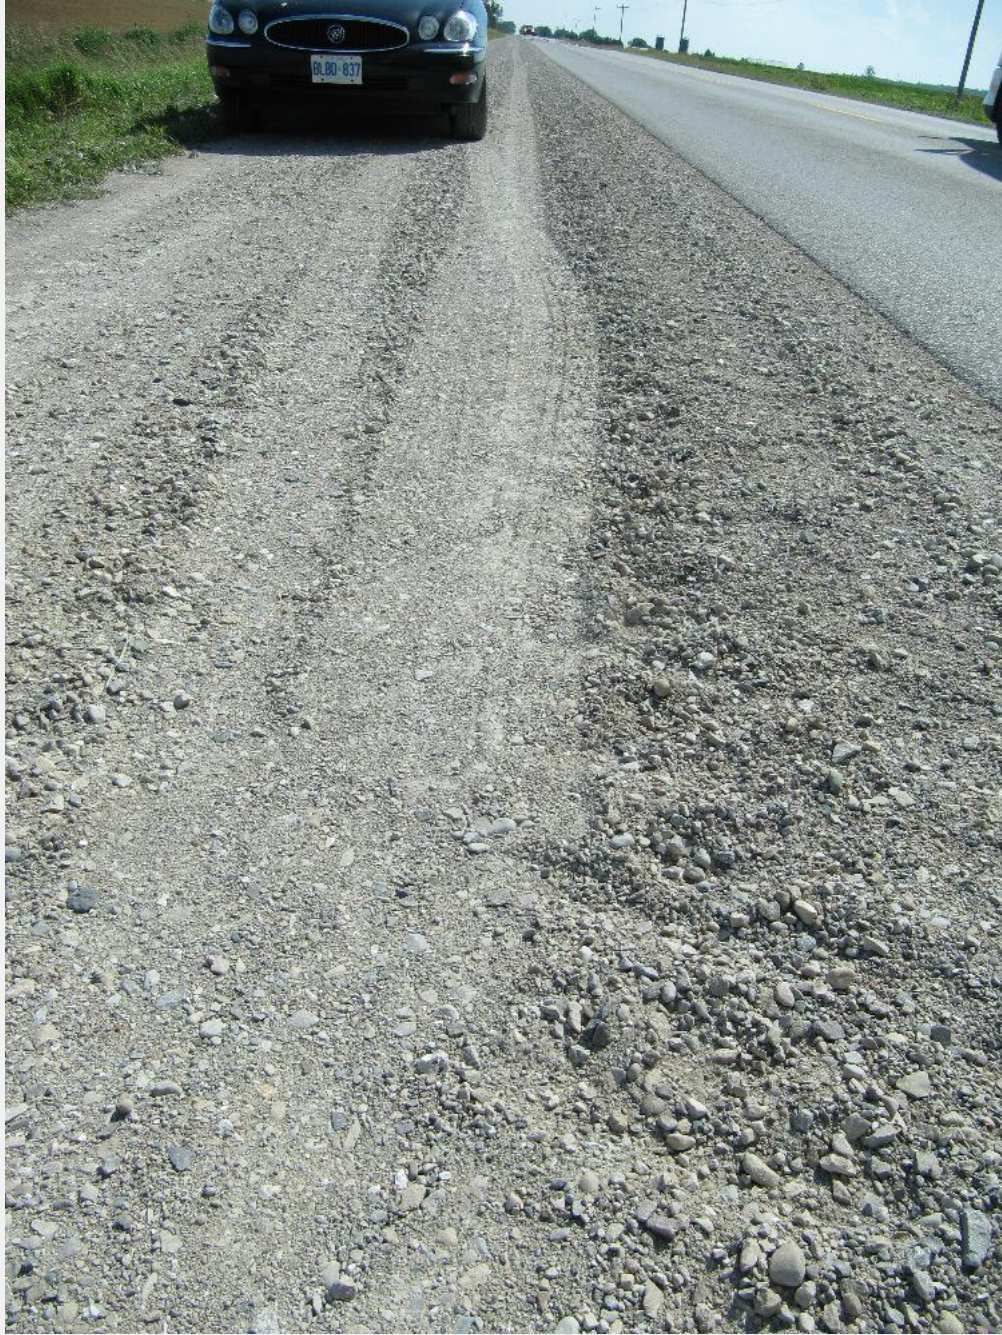
View, looking southward, showing the tire mark produced by our vehicle as it was backed into its parked position on the east gravel shoulder.

You can clearly see our tire mark in the distant background behind our vehicle and also the change in direction in the foreground. This evidence is classic of a soft shoulder condition created by fresh grading of the shoulder.

More importantly the police and news media have a responsibility to inform the public of true dangers that exist on the roadway. Absolutely nothing was posted on the roadside informing the driver of this vehicle that the gravel shoulder was freshly graded, soft and dangerous to enter at highway speed. The Manual of Uniform Traffic Control Devices (MUTCD) is the standard followed throughout North America to ensure that all traffic signage is consistent. In that manual it clearly identifies a "Soft Shoulders" sign (Wa-29) which should be erected under the following conditions:

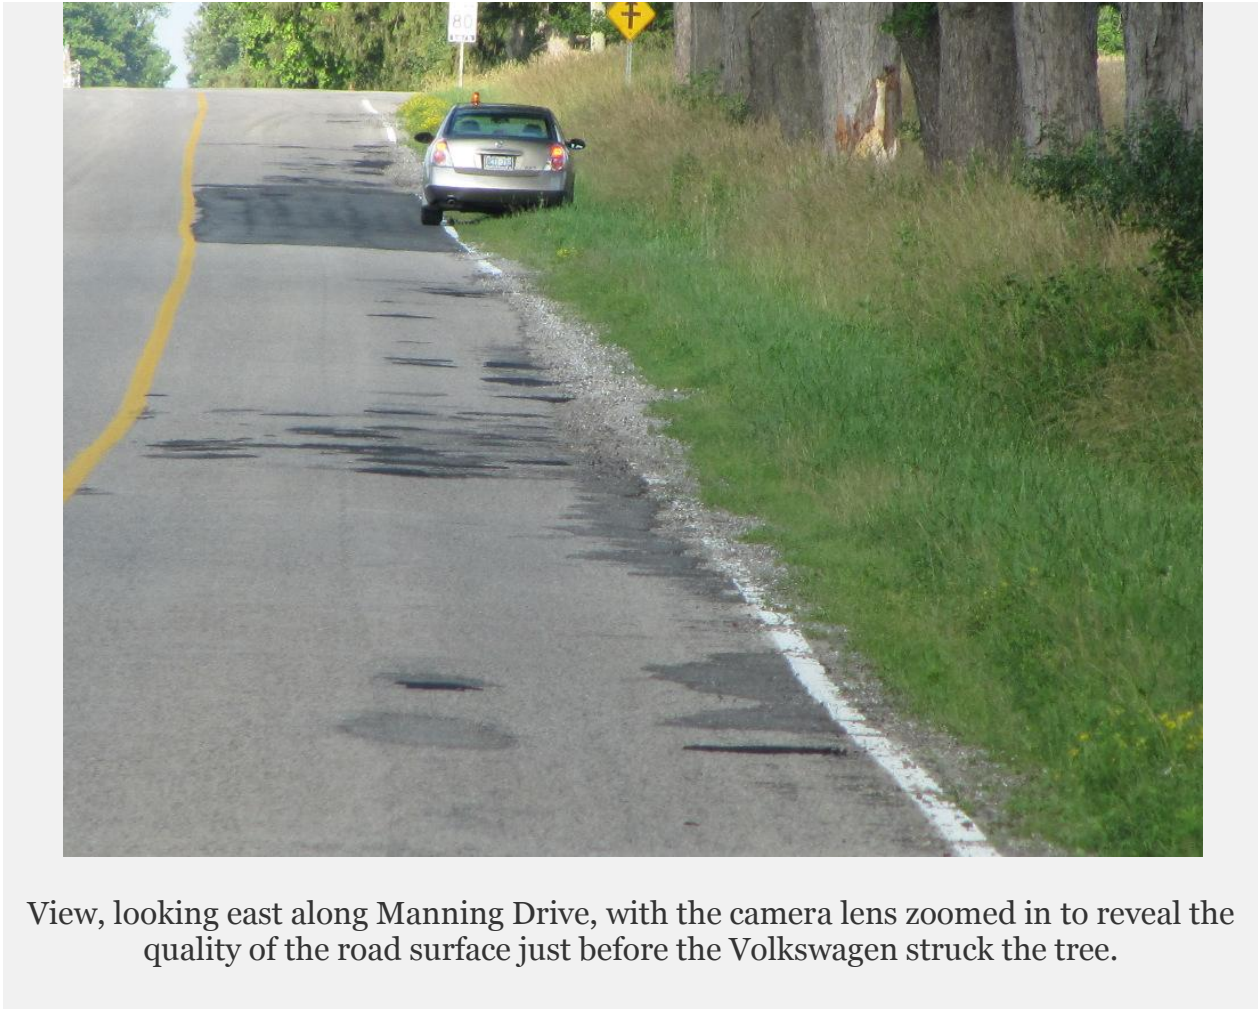
View, looking east along Manning Drive, with the camera lens zoomed in to reveal the quality of the road surface just before the Volkswagen struck the tree.

Yes, the road surface has been patched in spots and there is even a larger area in the vicinity of the parked position of our car where the full width of the eastbound lane has been patched. No doubt, when approached, the City of London will claim that they followed their responsibilities according to the Minimum Maintenance Standards (MMS) that were established with the co-operation of the Province of Ontario to shield it from liability. But there is stark difference in quality of the road surface between what is visible in the first photo at the top of this article versus what is shown in the next two. Any reasonable person would conclude that the reason why this Volkswagen left the road surface and struck the tree could be related to the condition of the road surface and not just the speed of the vehicle. But that is not what was reported to the public.

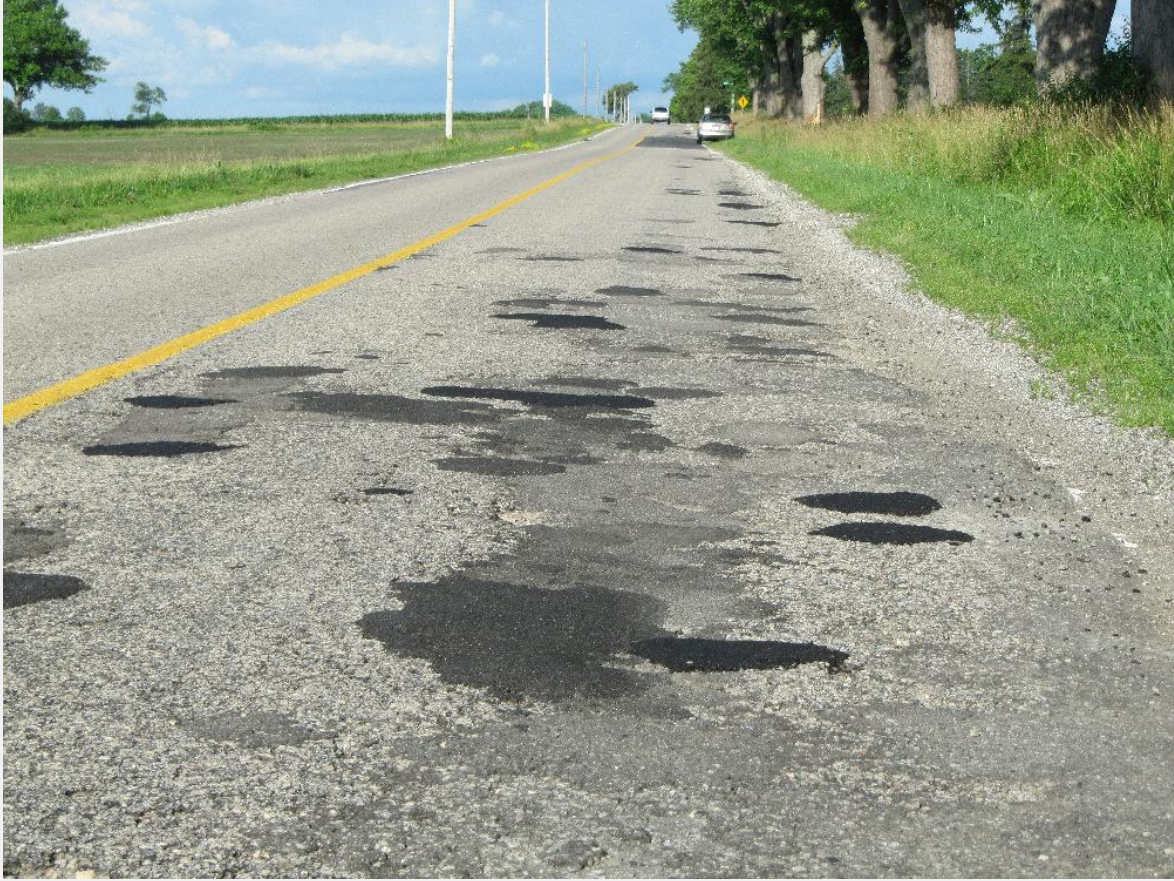
View of poor quality of road surface in vicinity of where Volkswagen exited the road.

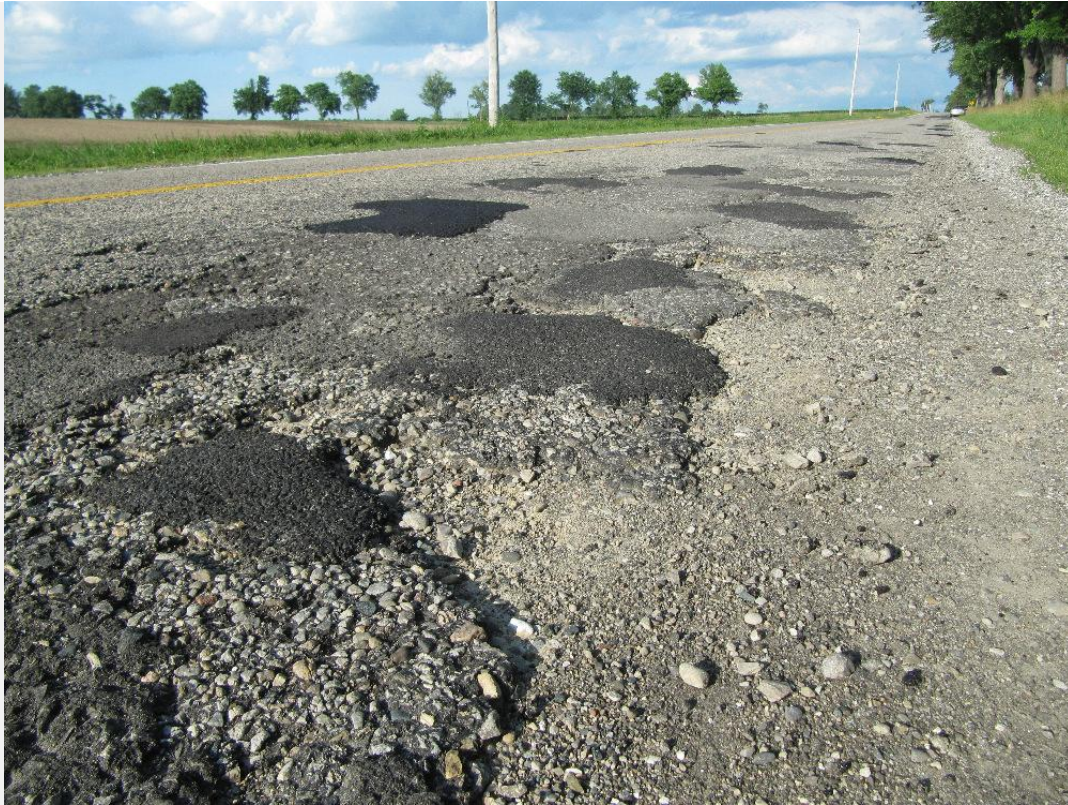
And the photo below provides a closer view from a position near the road surface. Note, for example, that the white-painted edge line is no longer present as the pavement near the edge has been crumpled into minute debris as the width of the effective lane has been reduced.

View of patches in roadway from a position close to the road surface.

Any reasonable person would conclude that the extent of patching of this road is to the extreme and not consistent with the intended purposes of patching small areas of pot-holes. When one patch is simply being placed over top of another patch to cover yet another patch then this is time to consider a complete re-surfacing of the road.

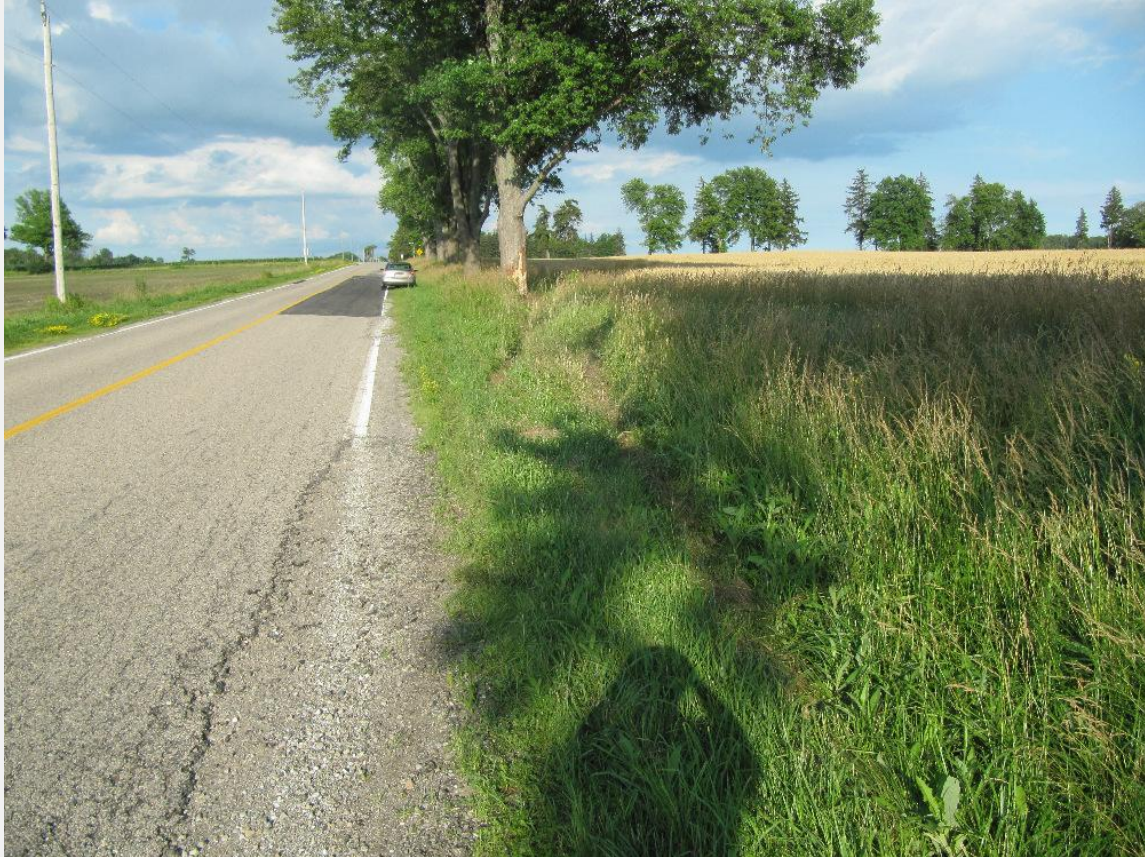
View of tire marks in roadside indicating the location where the Volkswagen left the road surface.

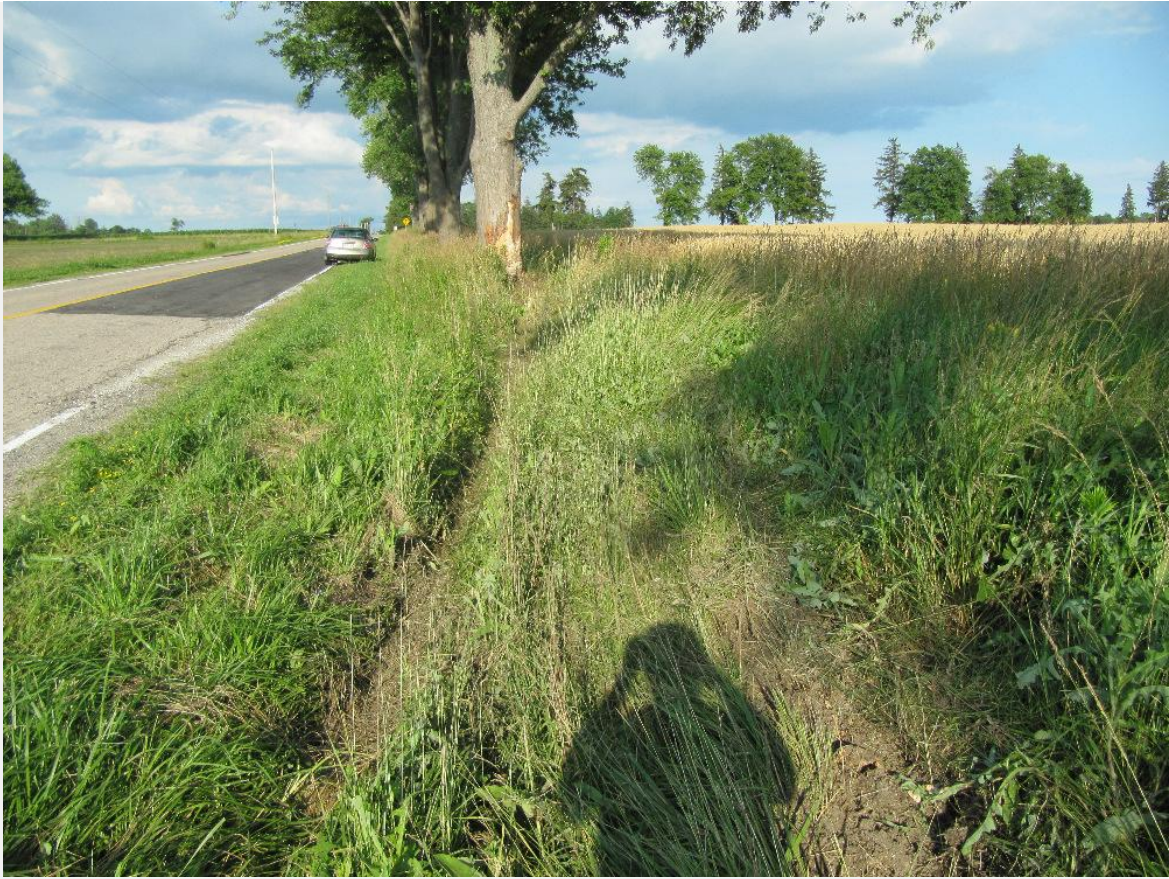
View of tire marks leading toward the struck tree.

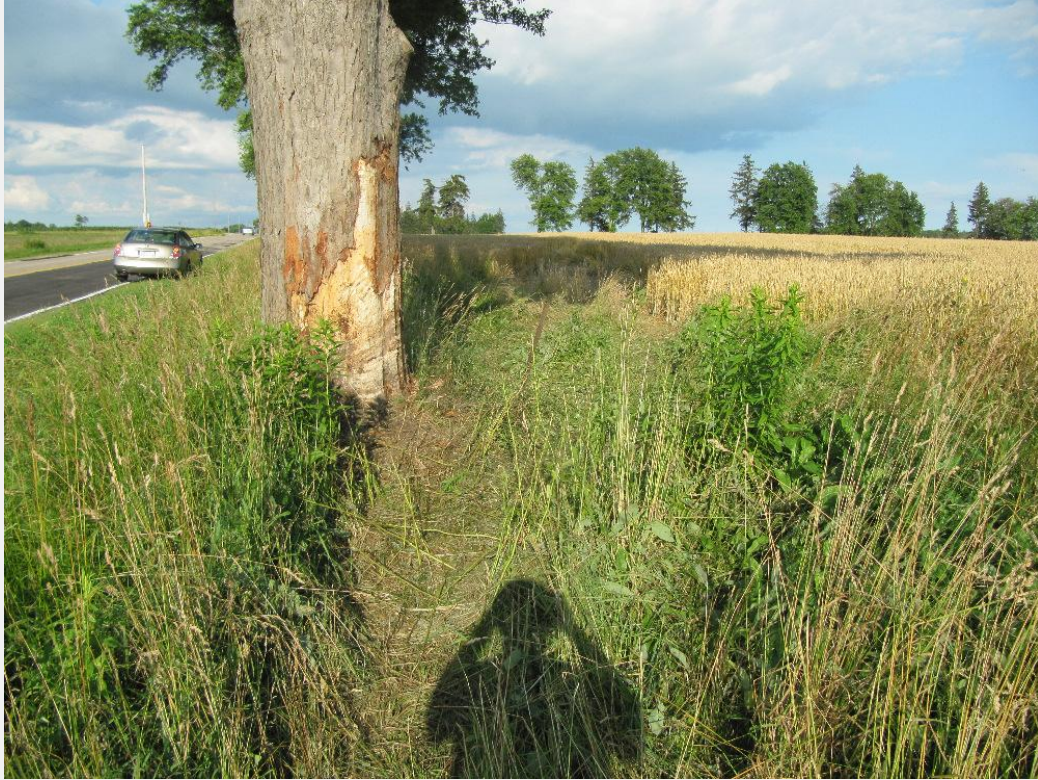
View of evidence on approach to the struck tree.

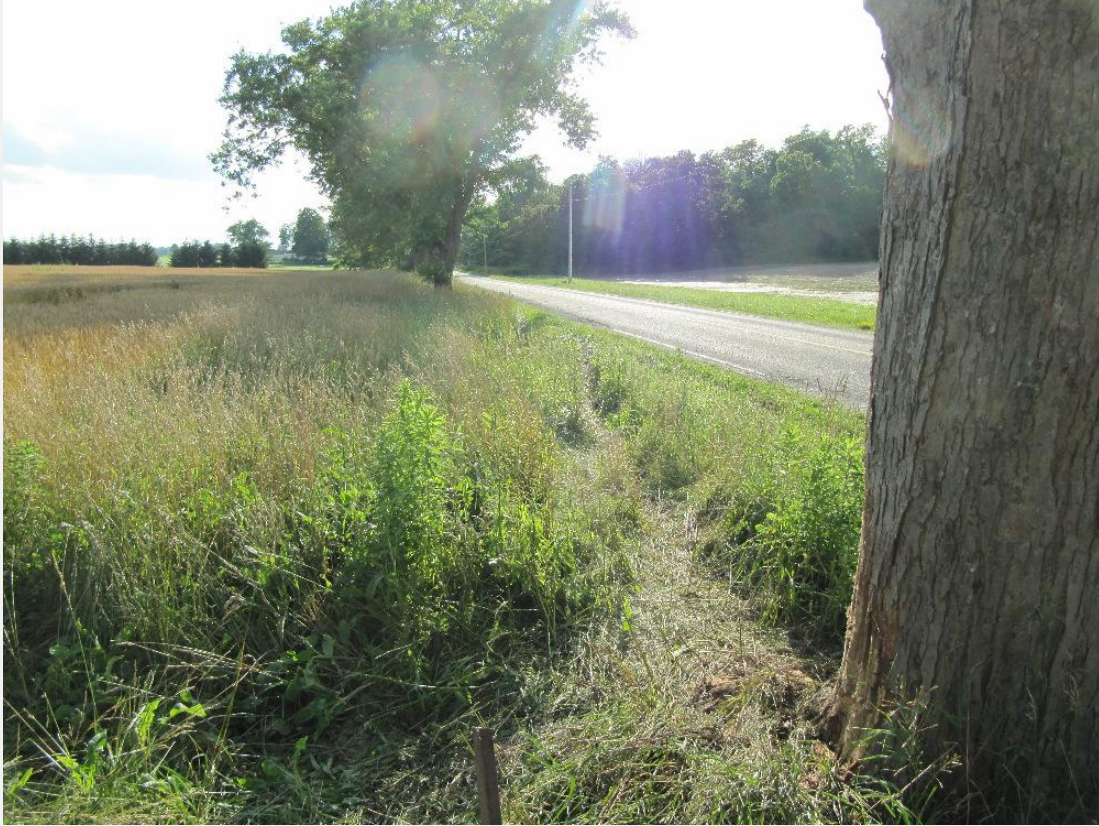
Turning around, this is a view from the struck tree back toward the tire marks as they left the roadway and approached the tree.

In examining the views of these tire marks our objective is to determine a distance when those tire marks are visible (we did not take any site measurements), as well as an estimate of the deceleration that might be generated during that travel. As an example, we can assume the distance is about 30 metres, but what rate of deceleration would we chose? This is dependent of the angle of the vehicle's travel as well as the extent of its undercarriage contacts and the height and density of the roadside grasses. The quantity of relevant research on this specific scenario is scant so where could police obtain a reliable source for that rate of deceleration?

Let us assume for the moment that there is a smaller angle between the travel direction and pointing angle of the vehicle. The taller grasses would lead to a higher deceleration, and there is a lack of major undercarriage contacts. I would assume a rate of deceleration in the range of $0.4g$. Over a distance of 30 metres of speed loss would be about 55 km/h. So let's move on...

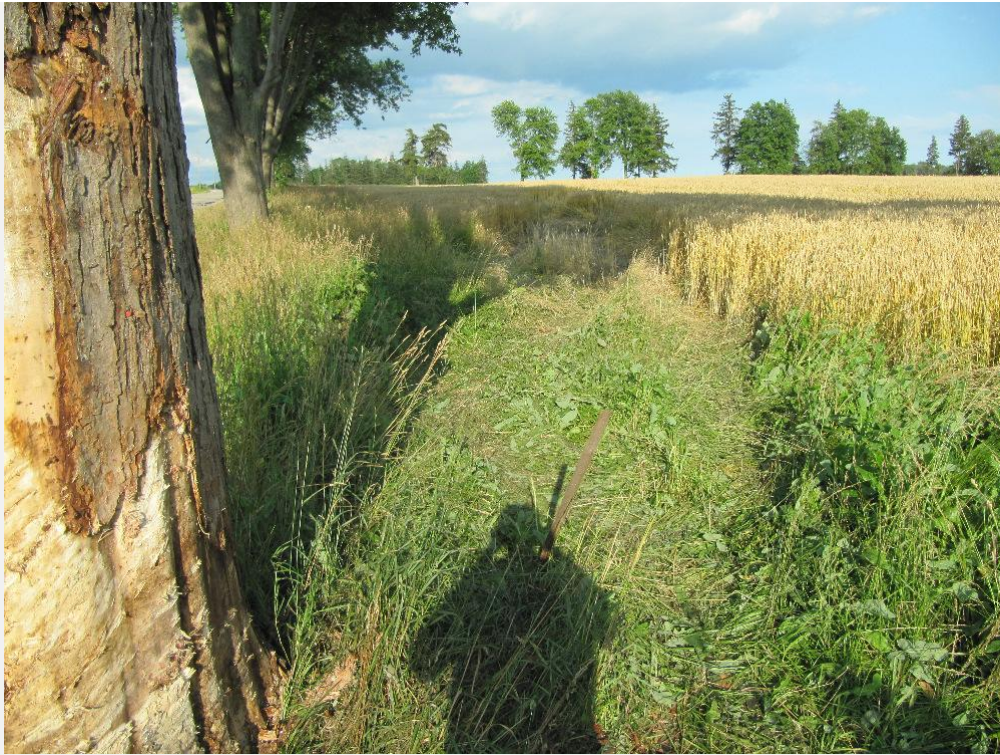
View, looking south-east, past the tree impact toward the path taken by the Volkswagen, through a grain crop, toward its final rest position.

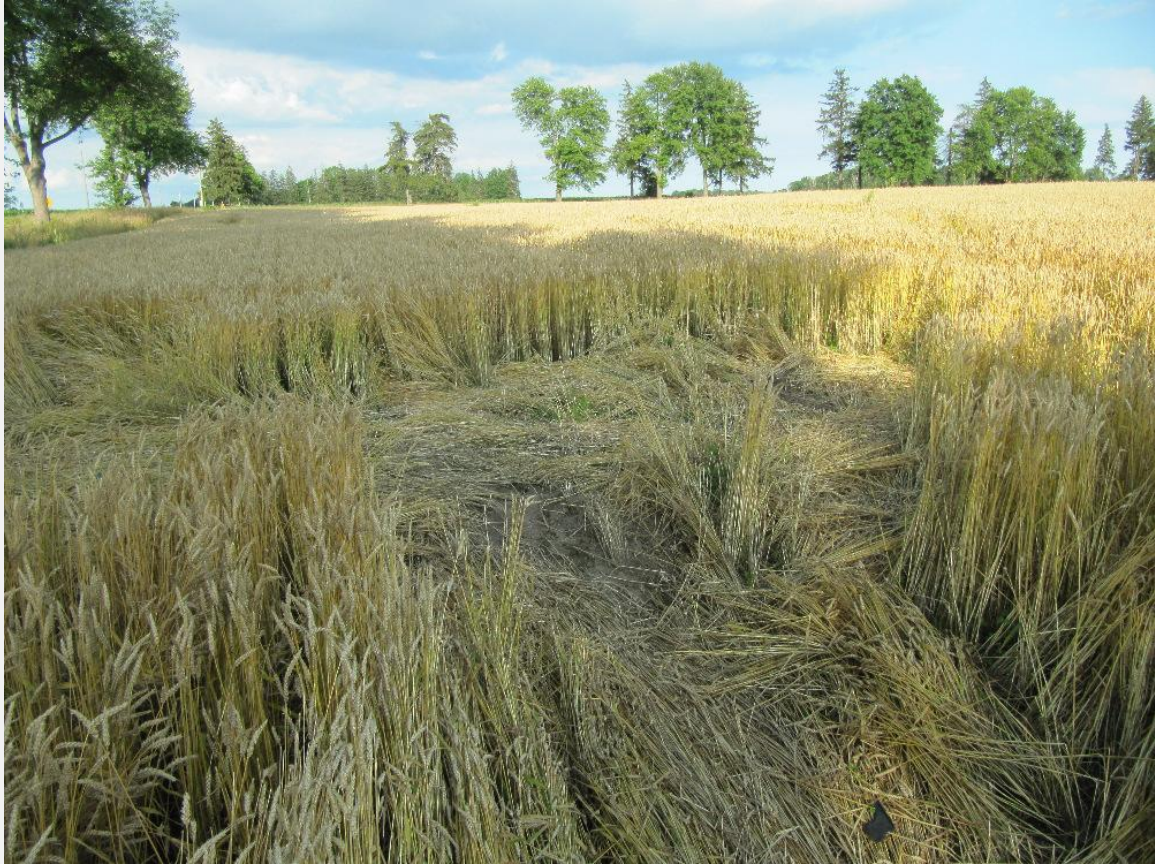
Based on the observed evidence, the vehicle was vaulted into a counter-clockwise rotation after the glancing impact with the tree and it then commenced a rollover that terminated with the vehicle coming to rest on its wheels. The driver was ejected from the vehicle and came to rest roughly halfway along the vehicle's post-impact travel path. The final rest position of the vehicle is shown in the photo below.

View, looking south-east, at the final rest position of the Volkswagen in the grain field.

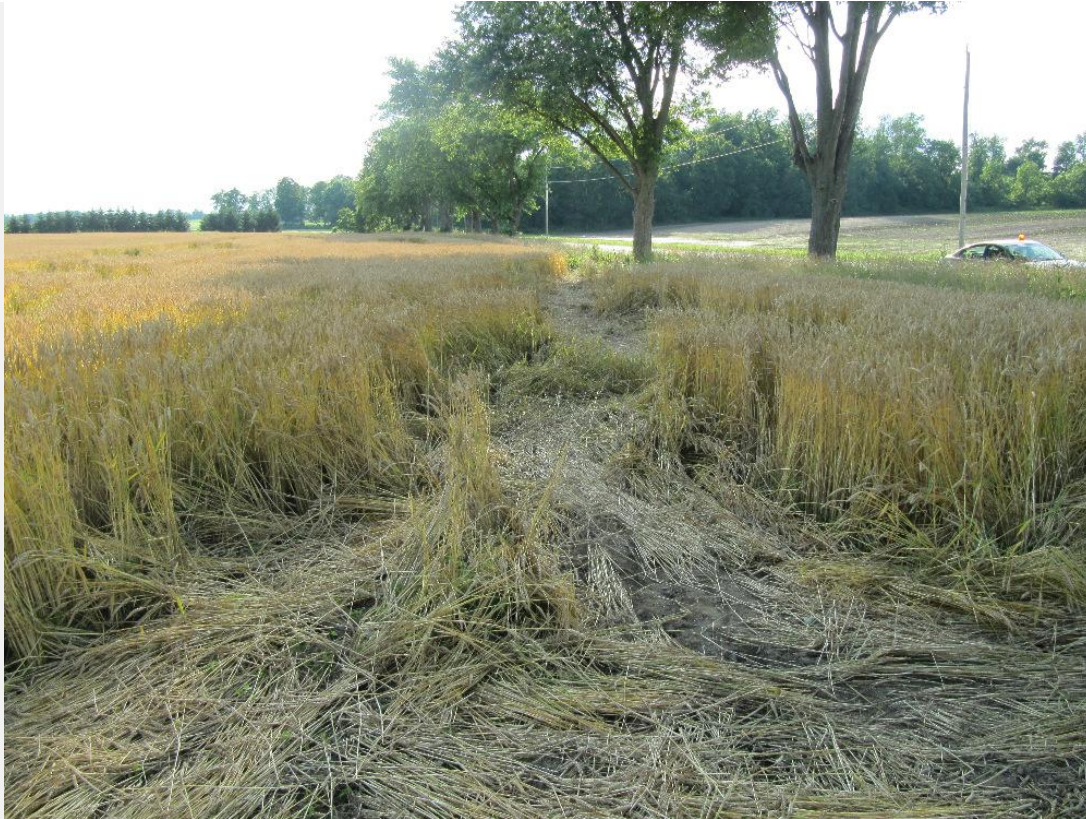
View, looking north-west from the final rest position of the Volkswagen toward the tree impact in the background.

Again, we want to estimate how far the vehicle travelled from impact to rest and apply a reasonable rate of deceleration. For argument's sake we have selected a distance of 30 metres and a deceleration rate of $0.5g$ to take into account the "tumble number" of a soft rollover. This would lead to a speed loss of about 62 km/h. By combining the squares of the two speed losses (55 and 62 km/h) under a square root sign we get a combined speed of about 83 km/h. This speed estimate is absent the speed loss from impact.

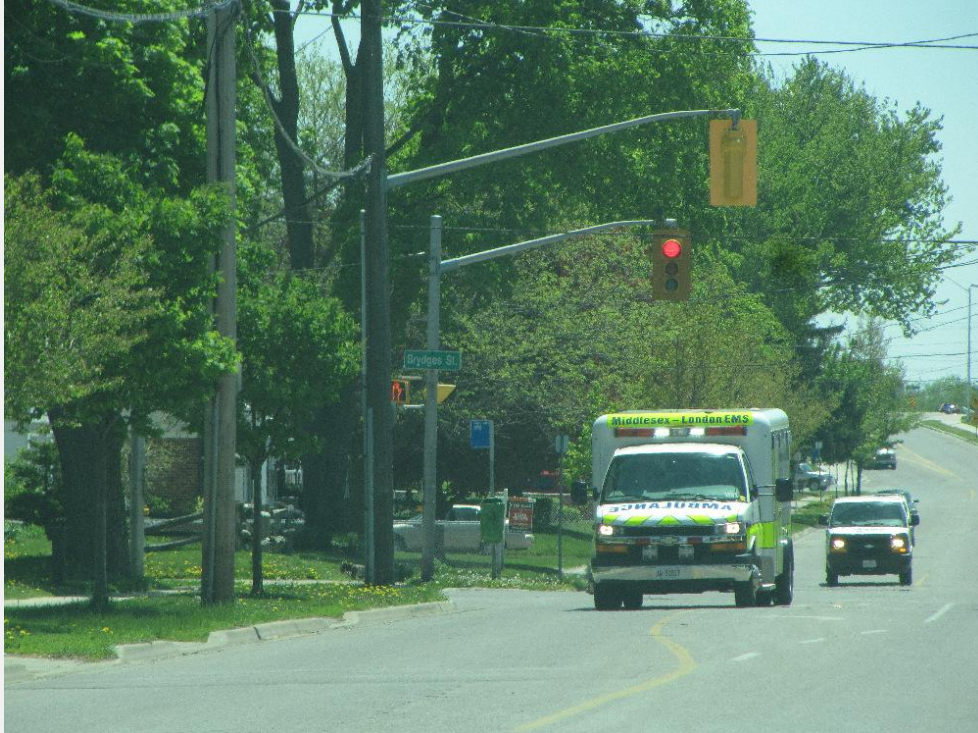
View of a typical ambulance passing through a red traffic signal in London, Ontario. Such actions are sometimes necessary while at other times they pose unnecessary risk to the occupants of the emergency vehicle and those within its proximity.
