ET-Plus Terminal Impact - Evaluation of Its In-Service Performance

Posting Date: 7-Feb-2016

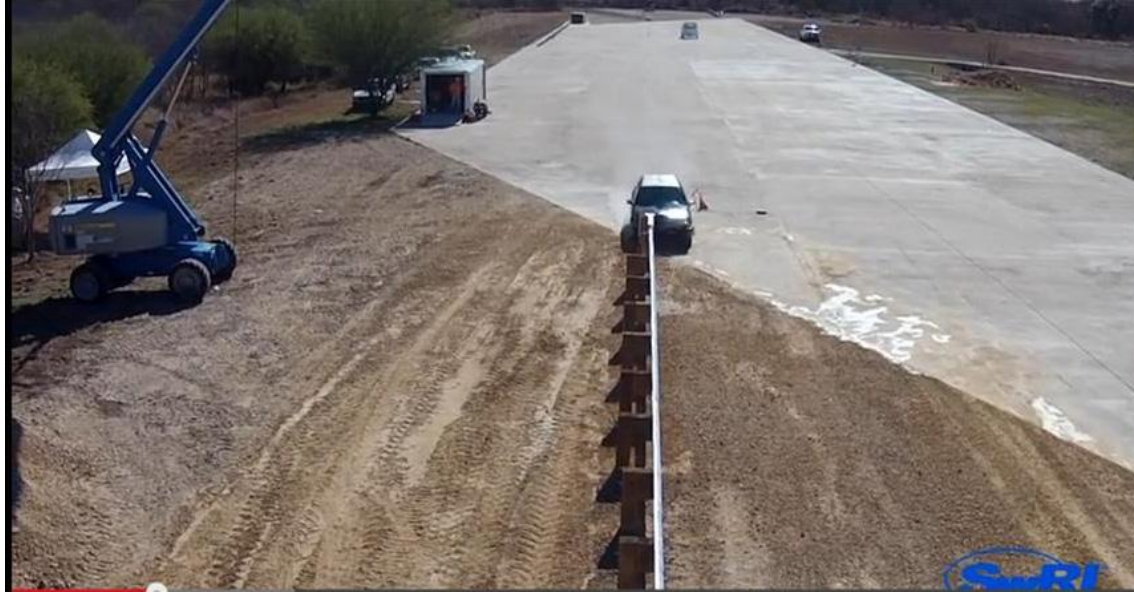
There are a number of differences in what we see in Figure 1 versus the set-up when the ET-Plus terminal is involved in compliance testing in a controlled environment. An example of the controlled, compliance test setup is shown in Figures 2, 3 and 4.

Figure 2: Example of the compliance test set-up taken from the South West Research Institute's (Texas) re-testing of the ET-Plus in early 2015.

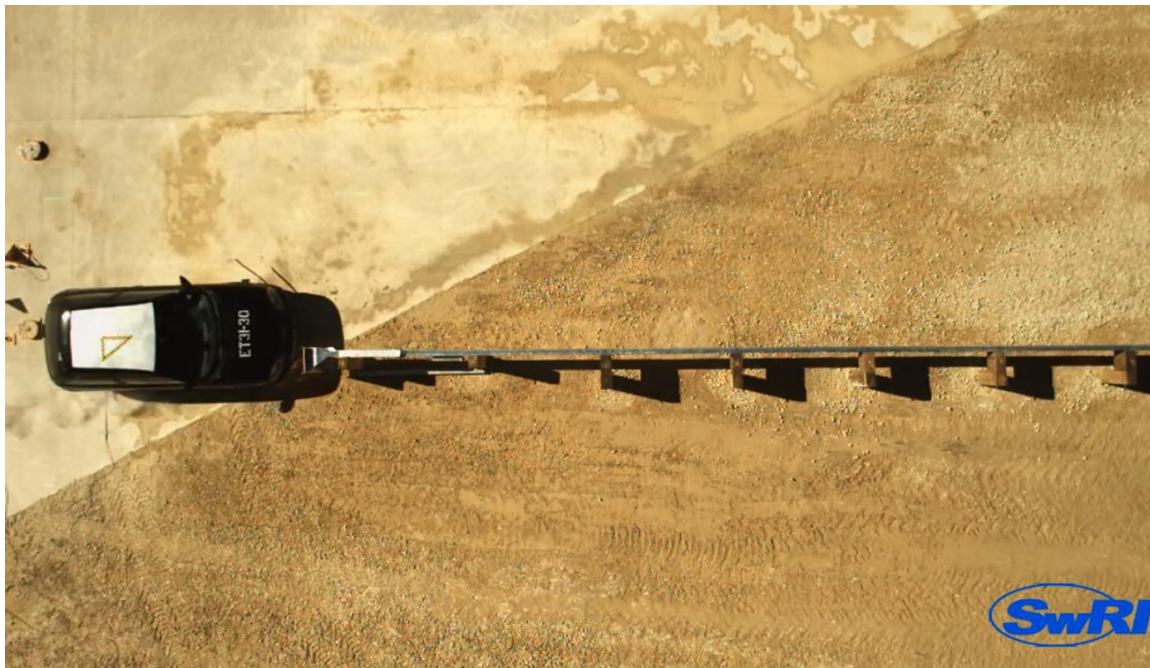
Figure 3: Example of the set-up for compliance testing of the ET-Plus terminal at the South West Research Institute.

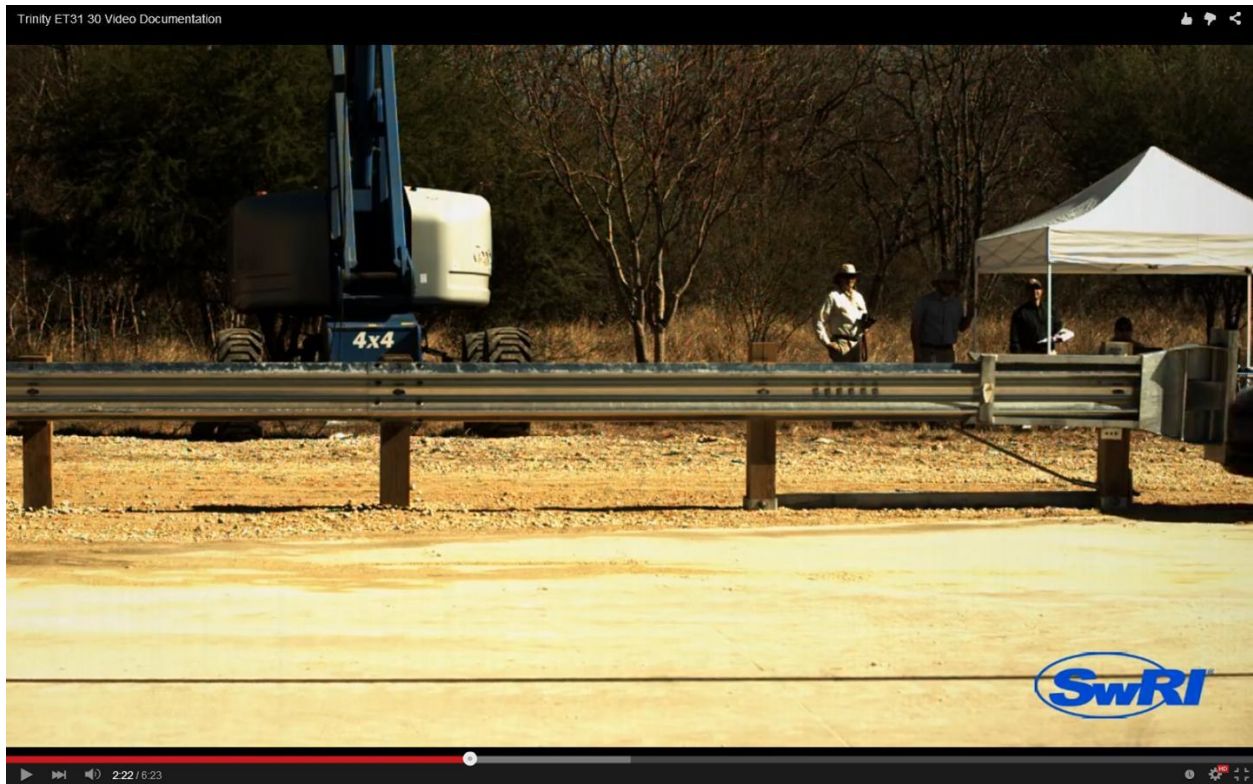
Figure 4: Example of the set-up at the compliance testing of the ET-Plus terminal at the South West Research Institute.

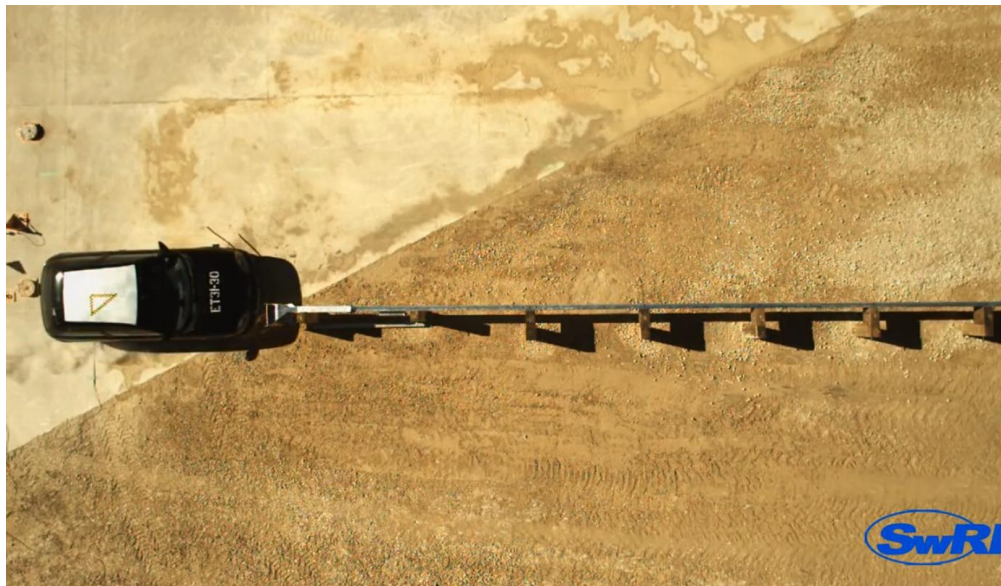
In Figure 21 we see the Metro making initial contact with the terminal and then in Figure 22 we see that, after a substantial distance of travel a considerable length of the rail has been extruded through the terminal in a curled state.

Figure 21: View of Geo Metro at initial contact of an ET-Plus terminal during the final compliance test performed at the South West Research Institute.

There should be nothing surprising in what we see in Figures 21 and 22 as this is how the system is designed to function. Energy is dissipated primarily through the extrusion of the rail through the terminal head. Note in these two figures that there is essentially no deformation to the remaining length of the rail.

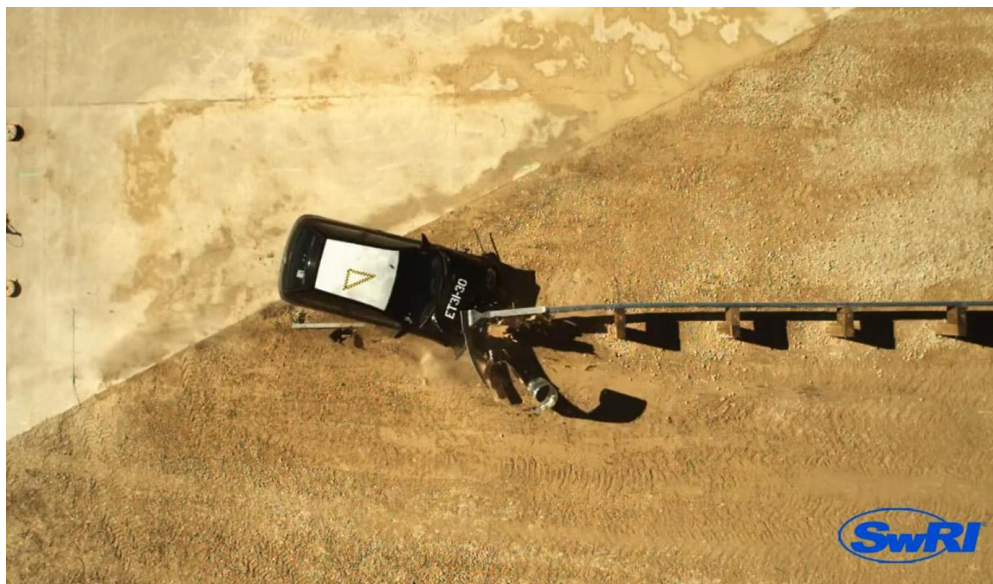
Figure 22: View of the Metro after it has travelled a considerable distance and has caused a considerable amount of rail to be extruded through the terminal head.

But how does this compare to our scenario of the damaged system on Highway 401? In the real life situation there was very little rail that passed through the terminal head and there was a great deal of deformation in the rail behind the terminal that had not yet passed through the terminal. And if the system had been struck at any higher speed there was no hope that any additional rail would pass through the terminal head because, as we see in the 90 degree bend of the rail, the terminal was already at a 90 degree angle to the length of the rail. Any additional energy that might have existed in a higher severity impact would just result in more deformation of the rail behind the terminal and there would be no additional energy dissipation by extruding the rail through the head. Clearly this real life example shows a reason for concern. It shows that there is a difference between how the system has been shown to perform in the controlled tests at the South West Research Institute and how the system performed in this real life scenario.
