Incomplete Road Repairs - Part I - Site Descriptions

Posting Date: 22-Apr 2014

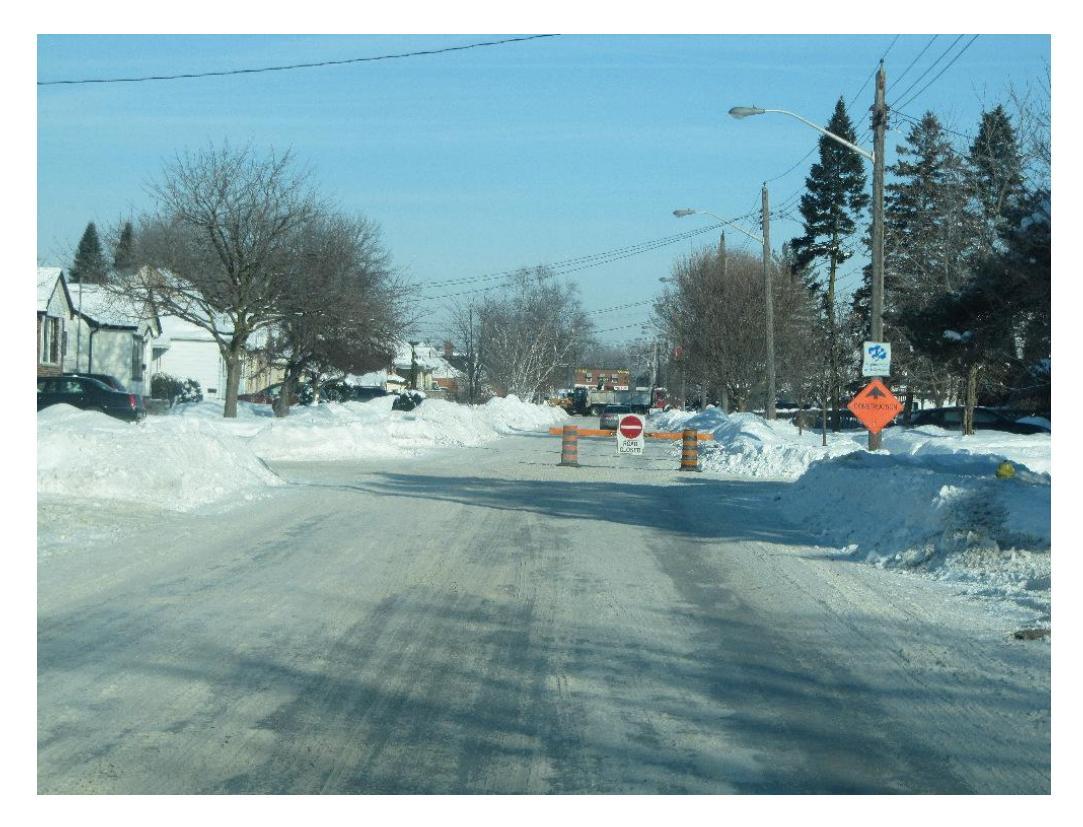
On February 12, 2014 work was commenced on Vancouver Street at the intersection of Whitney Street. Proper signage was installed on Vancouver Street to close the road one block south of the construction as shown in Figures 18 and 19. However, when the road repairs were completed a road closure barricade remained, but in an unusual arrangement.

Figure 18: View, looking north on Vancouver Street on February 12, 2014 when emergency road repairs were commenced.

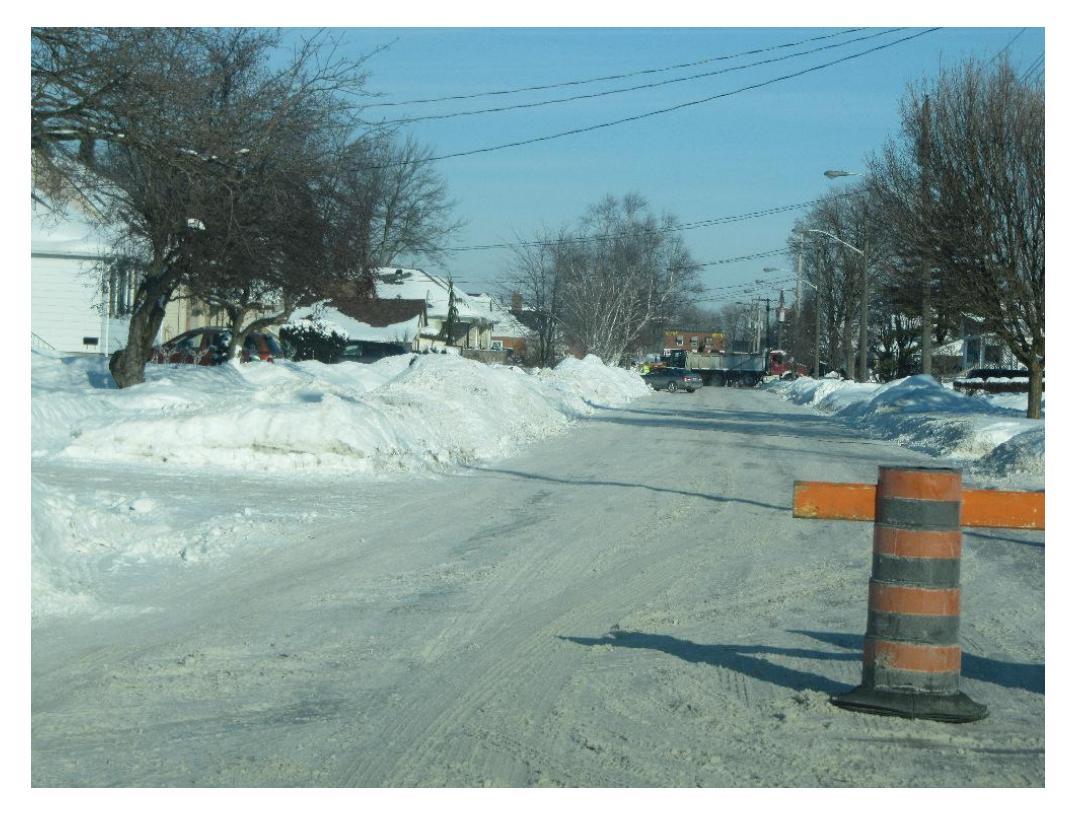
Figure 19: View, looking north from the road closure barricade showing the work being carried out one block to the north.

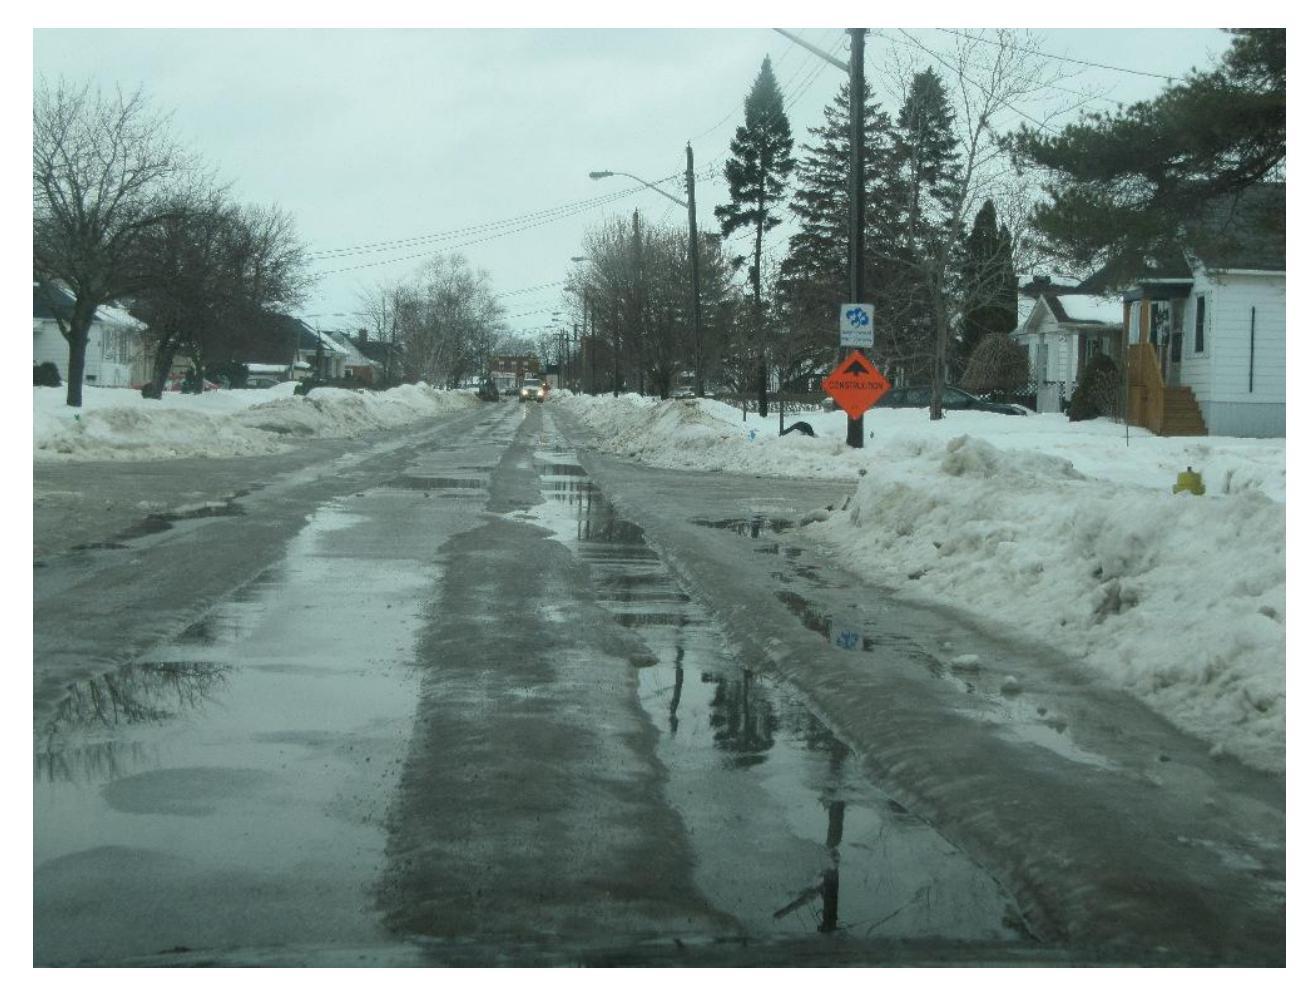
As the weather conditions became milder and some of the snow melted it was possible to see characteristics of the patch that had been placed on the excavation. For example, Figures 22 through 25 show views looking north on February 21, 2014. These figures show that there was additional road work being conducted north of the patched area. Although signage was erected to warn drivers of that additional work, there was no signage placed at the location of the depressed patch.

Figure 22: View, looking north on Vancouver Street, showing a "Construction Ahead" sign erected several blocks south of the depressed patch. This sign is not related to the patch but to active construction north of the patch.

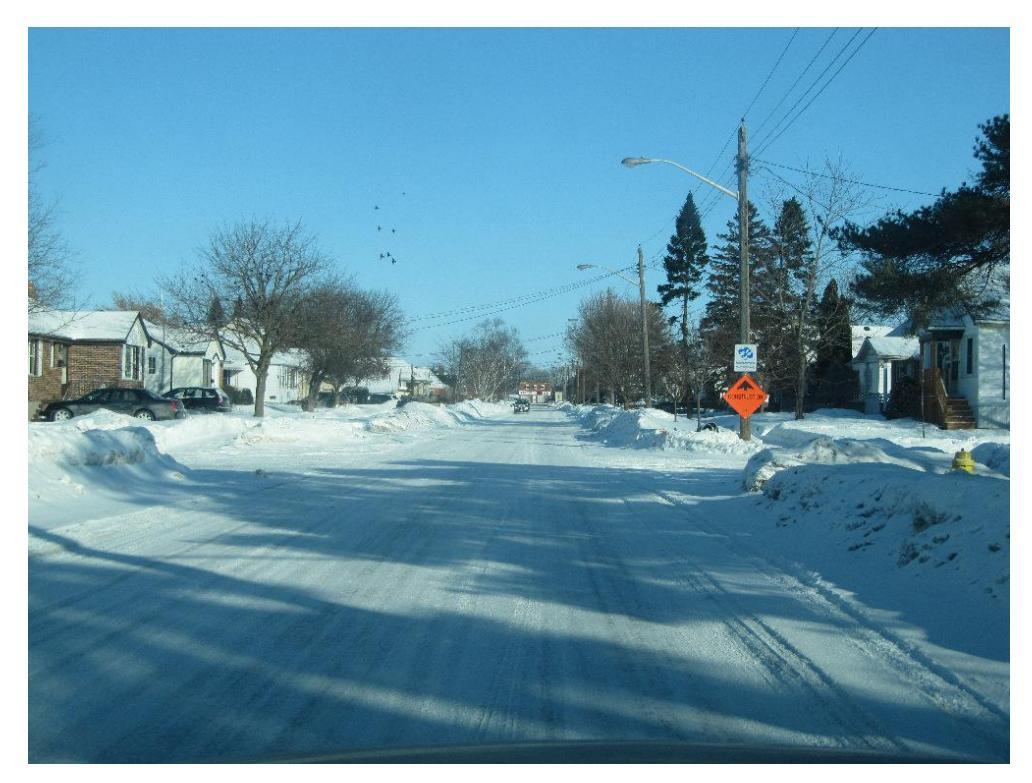
Figures 26 through 28 are photos taken on February 26, 2014. Figure 26 shows the same "Construction Ahead" sign that was visible in Figure 22. However, as we look further into Figures 27 and 28 we see that there is no longer any construction activity at the site.

Figure 26: View, looking northward along Vancouver Street on February 26, 2014, showing the "Construction Ahead" sign but no construction activity.

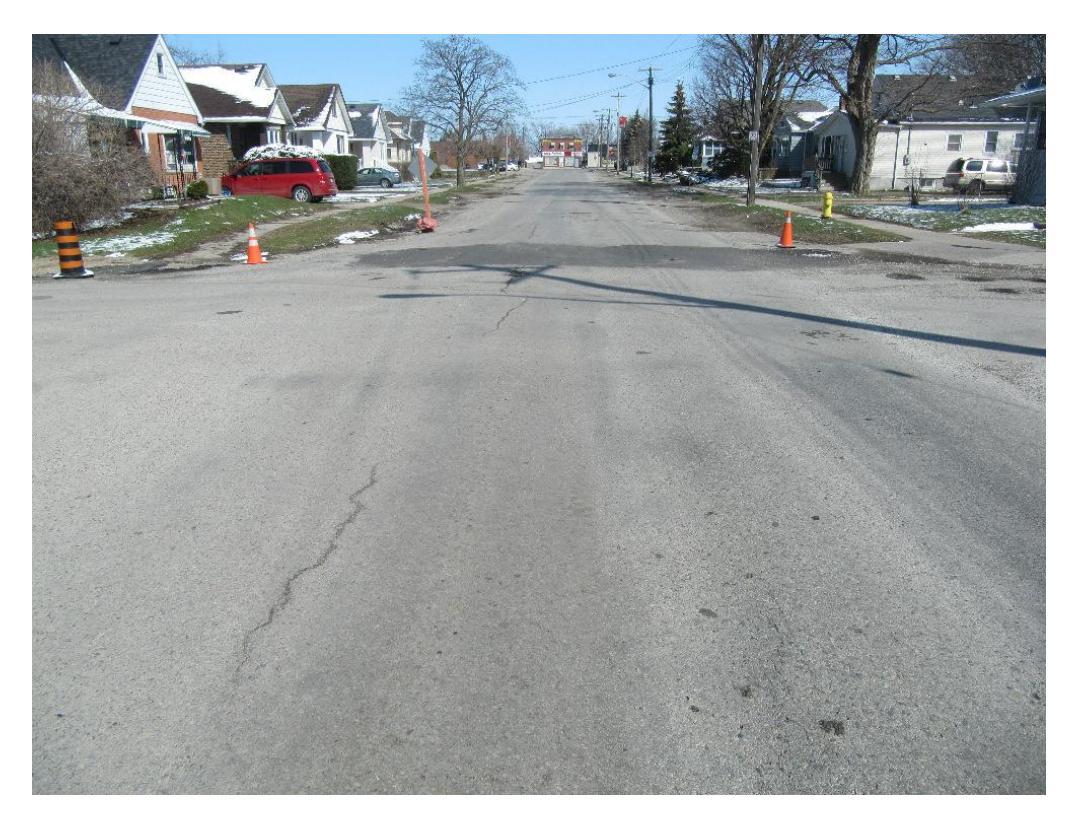
Figure 32 shows an overall view of the depressed area on April 16, 2014. Figure 33 shows the same location looking southward. Figure 34 is a view looking west, and Figure 35 is looking east.

Figure 32: View, looking north along Vancouver Street from just south of the road surface depression.

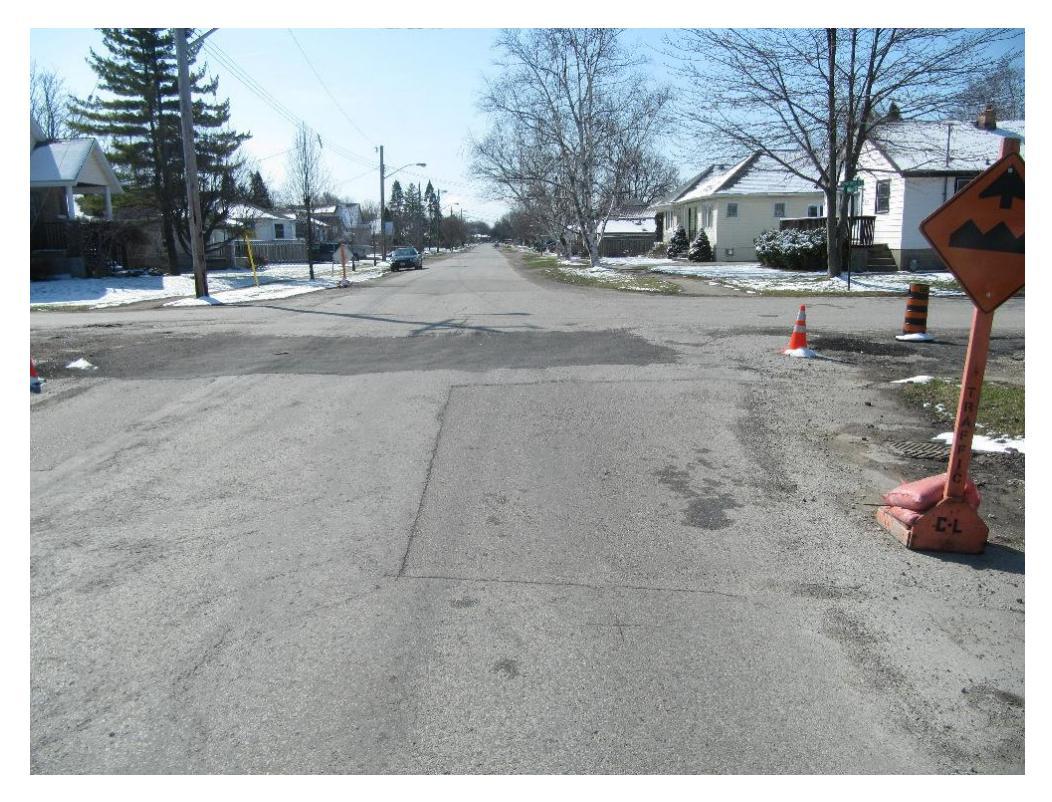
Figure 33: View, looking south along Vancouver Street on April 16, 2014.

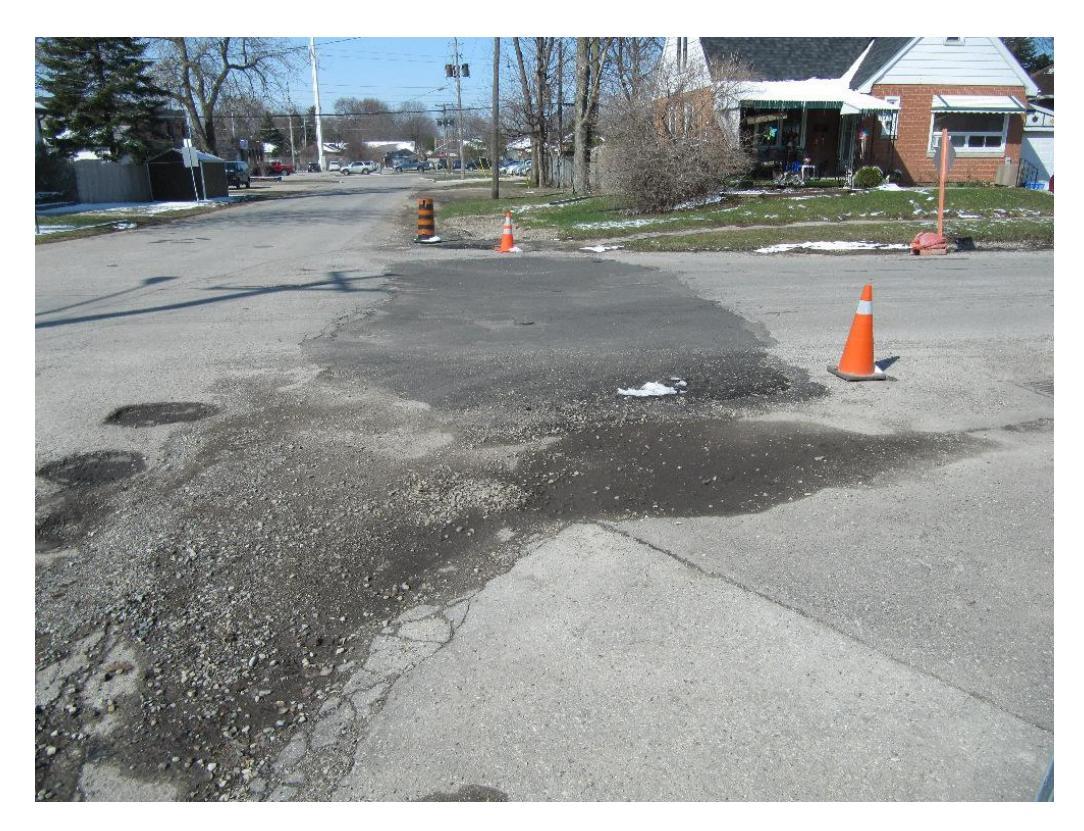
Figure 34: View of depression looking west.

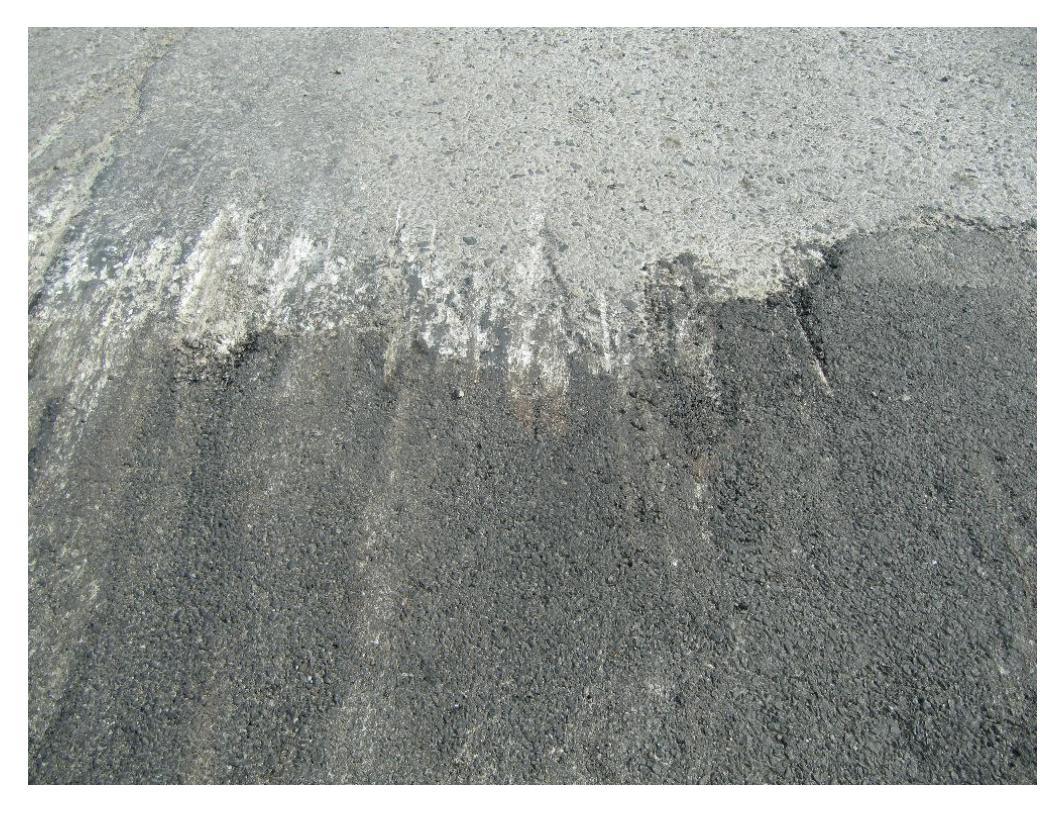
In fact, when we returned to the site on April 21, 2014 there were even more markings in the pavement indicating that this was not just a rare occurrence. Figures 39 and 40 show the evidence on April 21, 2014. Yet there was no evidence that any additional maintenance action had been made to fill the deep depression. Some observers made the comment that a "bump" sign was erected and therefore the City of London was not obligated to any further action.

Figure 40: View of evidence of vehicle contact on April 21, 2014.
