Trinity ET-PLUS Guardrail Terminals - Review of Real-Life Collision Performance Data

Posting Date: 11-Oct-2015

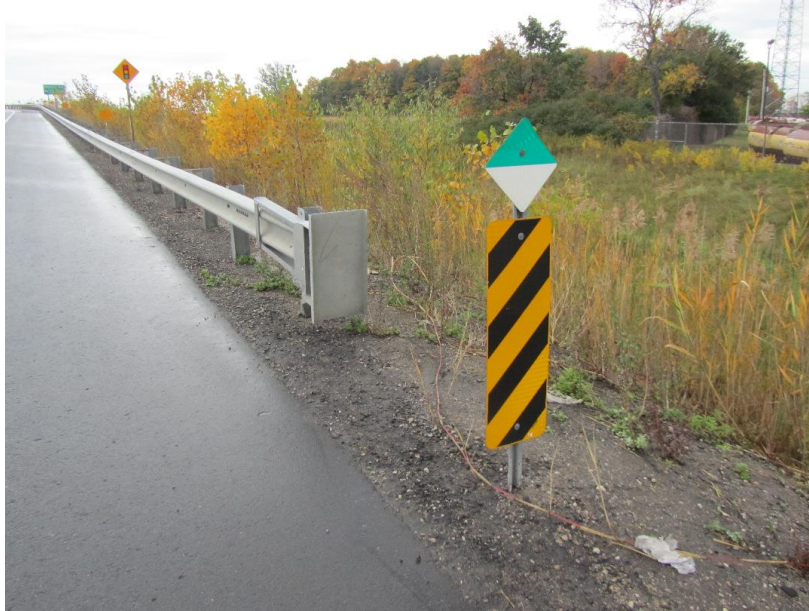
Figure 2: View of a typical ET-PLUS guardrail terminal located on the eastbound exit ramp from Highway 401 to Highbury Avenue in London, Ontario.

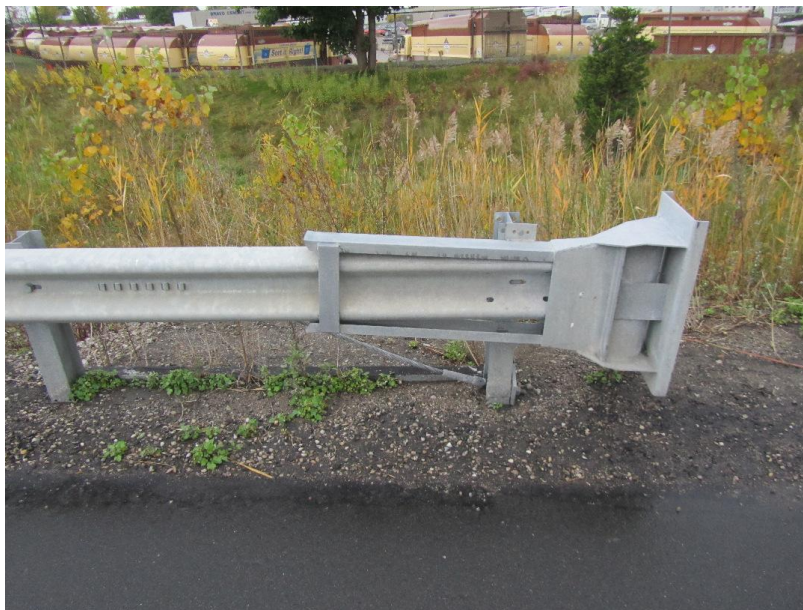
Figure 3: Side view the ET-PLUS guardrail terminal showing the plate (head) on the right and the channel attached behind it. The end of the guardrail fits within the channel.

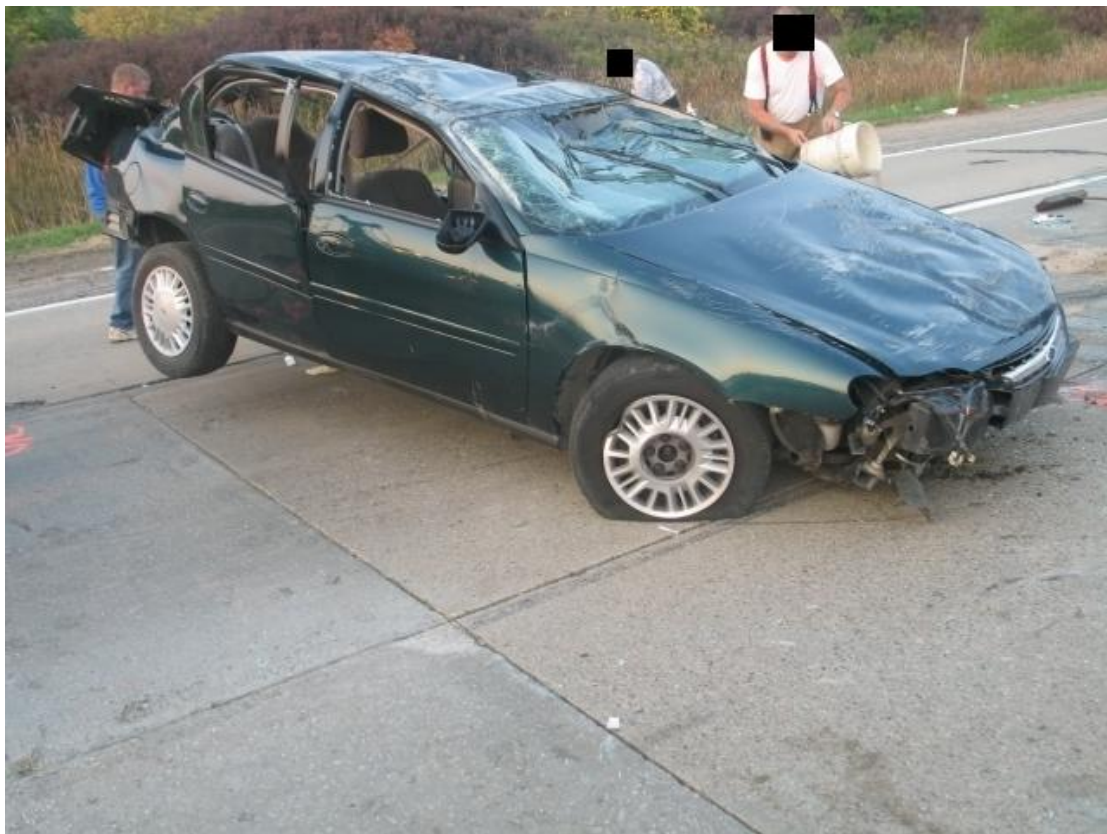
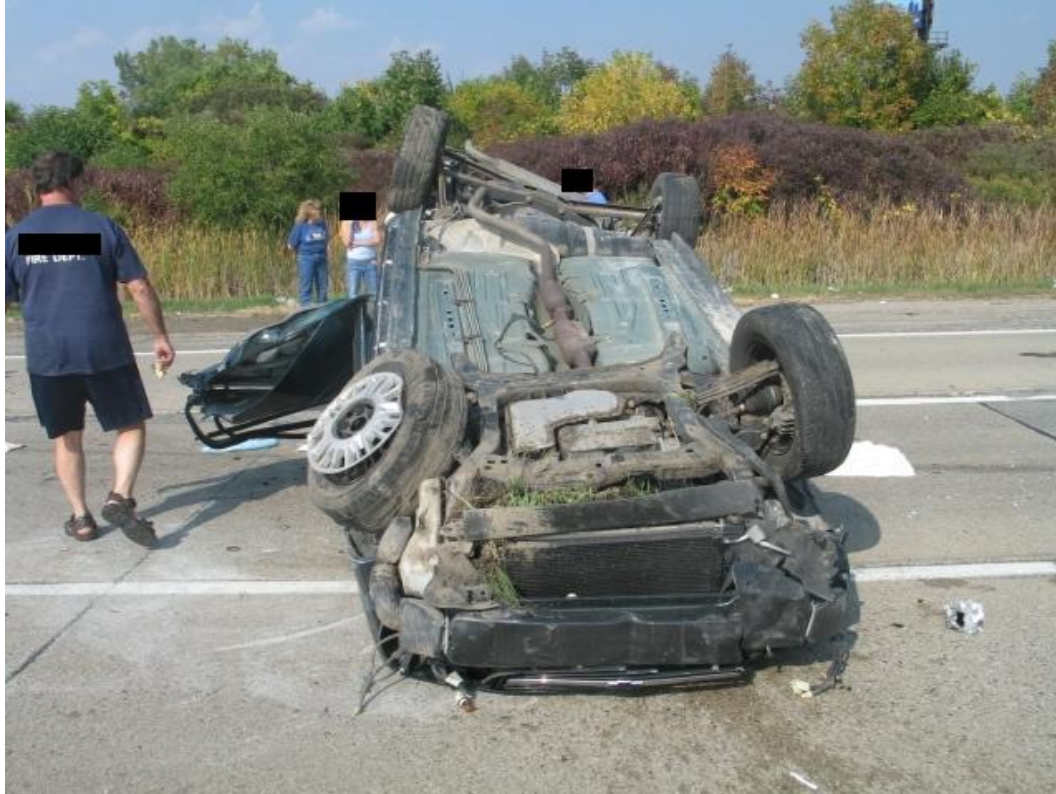
In the third case however the photographs indicate that this was a significant event. The photographs show that a car came to rest upside down and there was substantial damage to it. A text summary of the collision noted that the vehicle travelled into the median of an interstate highway and that the left front of the vehicle "contacted a guardrail". The vehicle then rolled onto its roof and slid into the opposing lanes of traffic. It was then struck by two other vehicles travelling in the opposing lanes. A passenger seated in the centre of the second seat of the vehicle sustained fatal injuries. There were not photographs of the "guardrail" therefore it is not clear whether an actual guardrail terminal was struck. However, if the "guardrail" was actually an ET-Plus terminal then the FHWA task force should have viewed this as an undesirable outcome. The point is that, given the fatal result it should not have been difficult for the Task Force to track down the type of guardrail or terminal that was struck as information about fatal collisions should have been readily available from local agencies. It is not clear why the Task Force did not perform this simple inquiry of an incident that appeared to have an undesirable outcome.
