Clarke Road - Five Years of Independent Research into Loss-of-Control Events

Posting Date: 11-Sept 2014

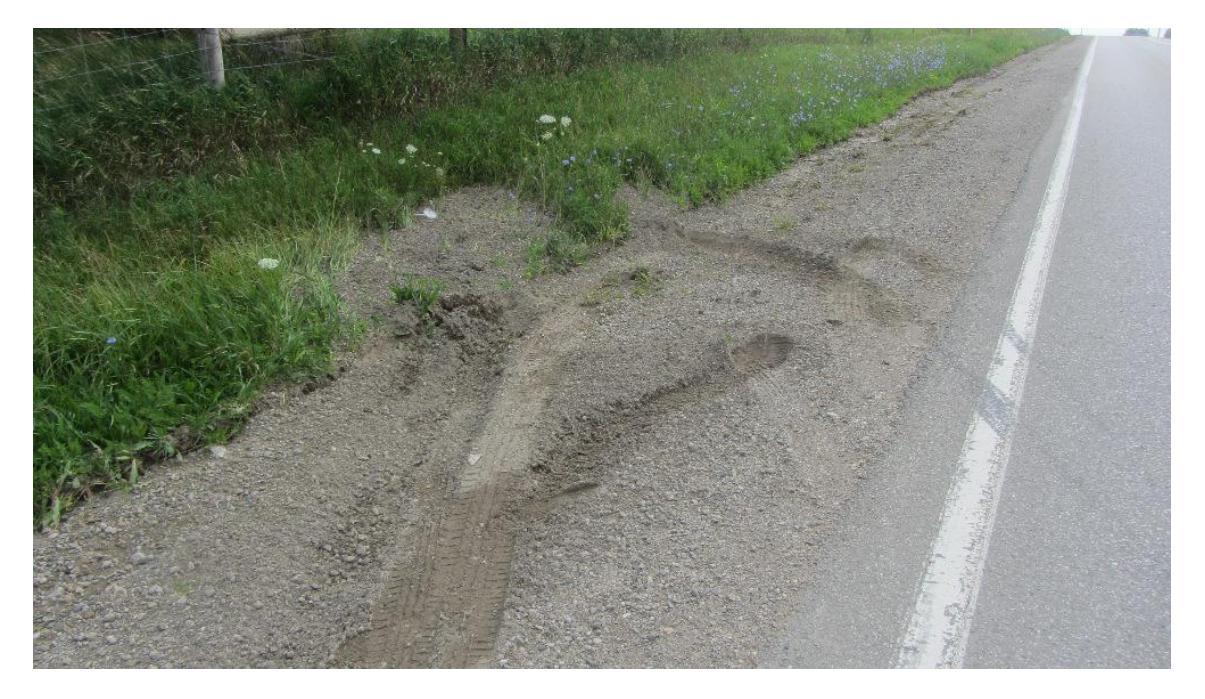
Figure 1: View of loss-of-control tire marks from a northbound vehicle and its rest position from an incident on August 5, 2014.

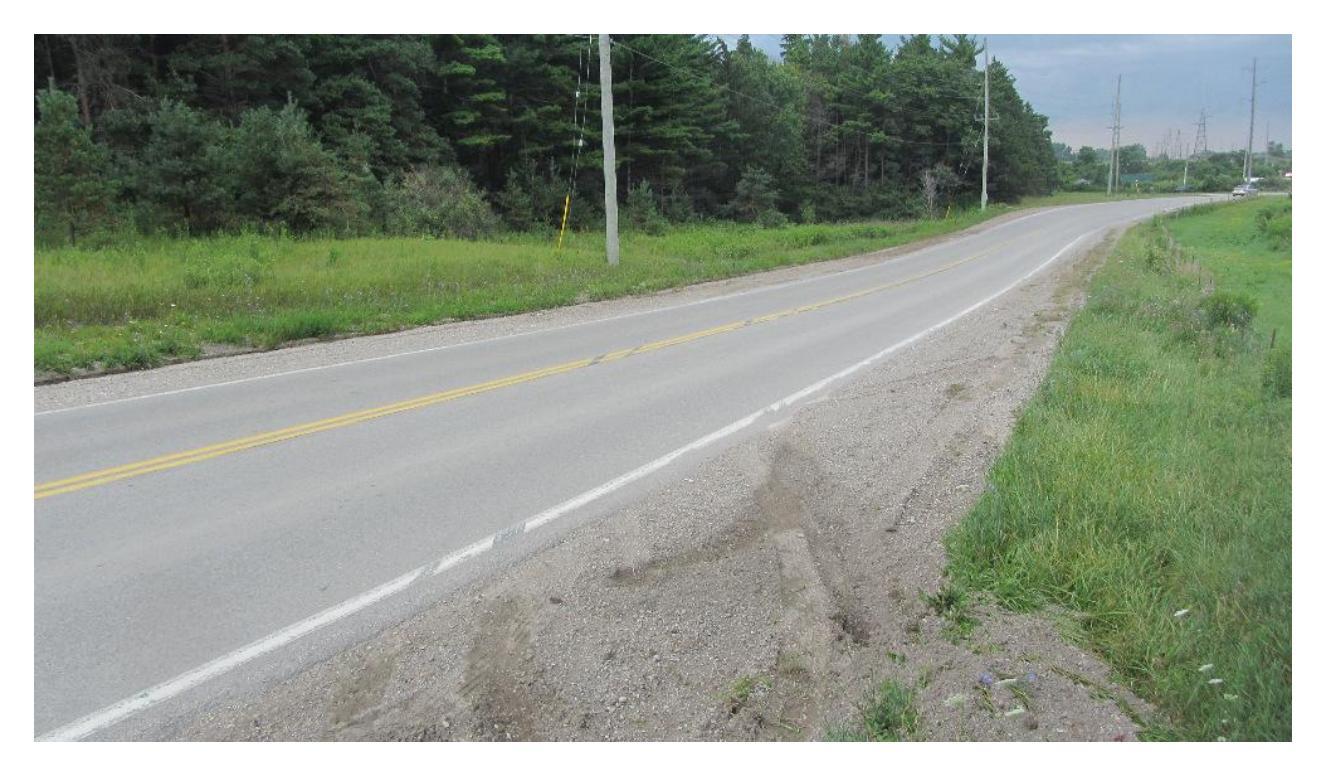
Figure 2: View, looking south from the west shoulder of the S-curve showing the rest position of the loss-of-control vehicle in the foreground and the yaw marks on the road surface.

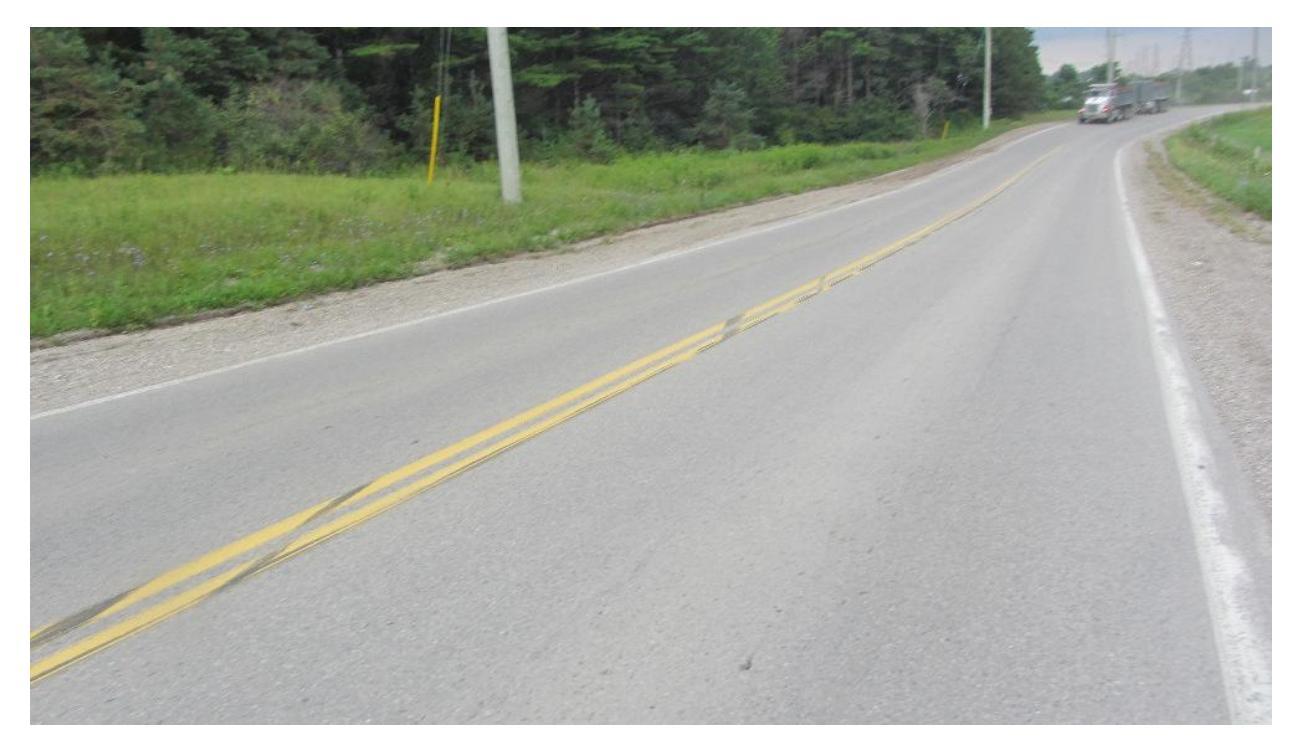
Figure 3: View of black yaw marks on the roadway centre-line suggesting the loss-of-control event occurred when the road surface was wet.

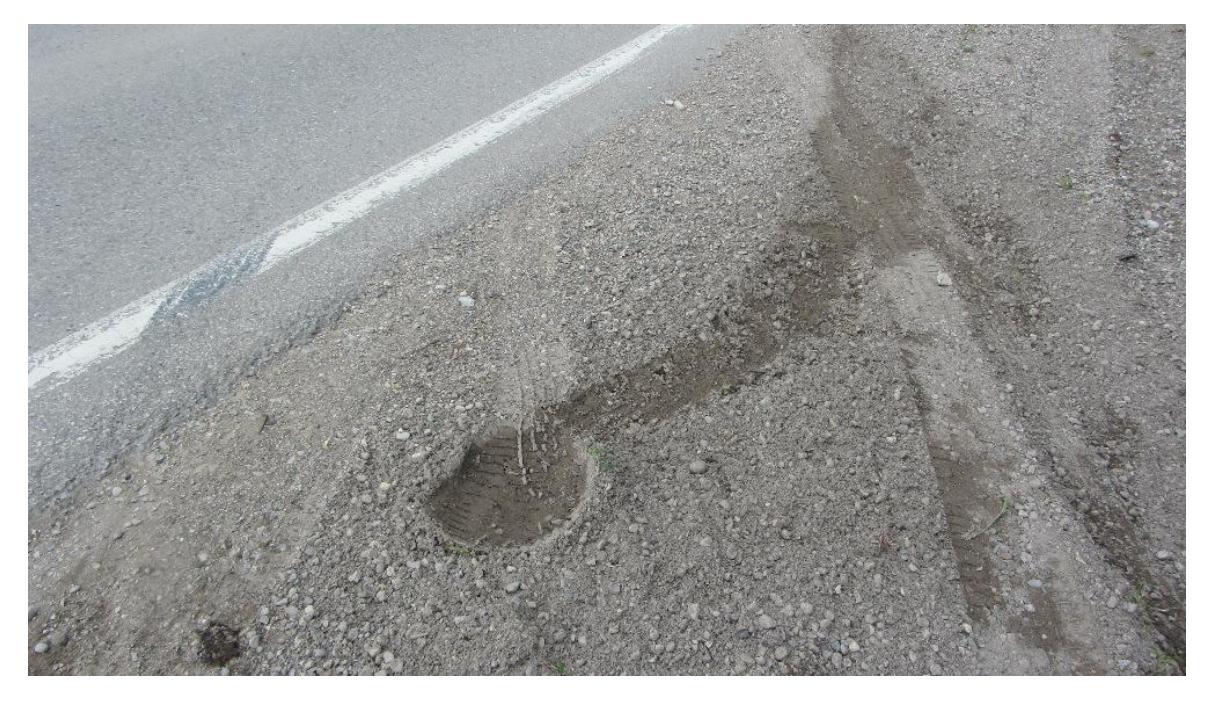
Figure 4: View at the final rest position of the vehicle showing the loss-of control tire marks and those produced subsequently as the vehicle left the site under its own power.

Experience in the interpretation of tire marks on gravel can clearly separate the loss-ofcontrol tire marks from the subsequent marks produced by the vehicle as it left the site, under its own power, after sliding to a stop on the roadside. The reason why this event did not result in a collision has nothing to do with the severity of the event or its potential consequences. It just so happened that, as the vehicle slid across the road, there was no other vehicle travelling in the opposing lane. If the vehicle had been occupied by four persons and was struck by a large truck the results could easily have produced multiple fatalities. Therefore the suggestion that this event is unimportant or unworthy of official documentation must be false. There are many incidents like these that have occurred during the five year period of our study.

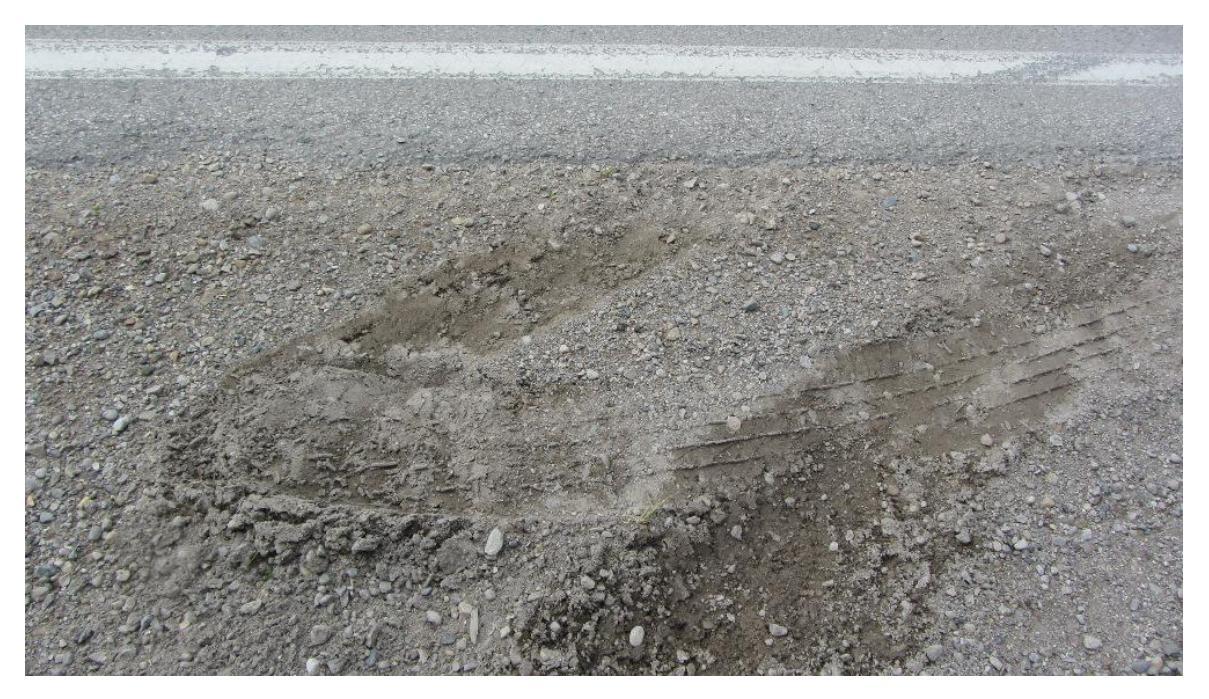
Figure 5: Close-up view of tire marks at rest position, showing the mark produced during loss-of-control and the mark produced afterwards when the vehicle left the site.

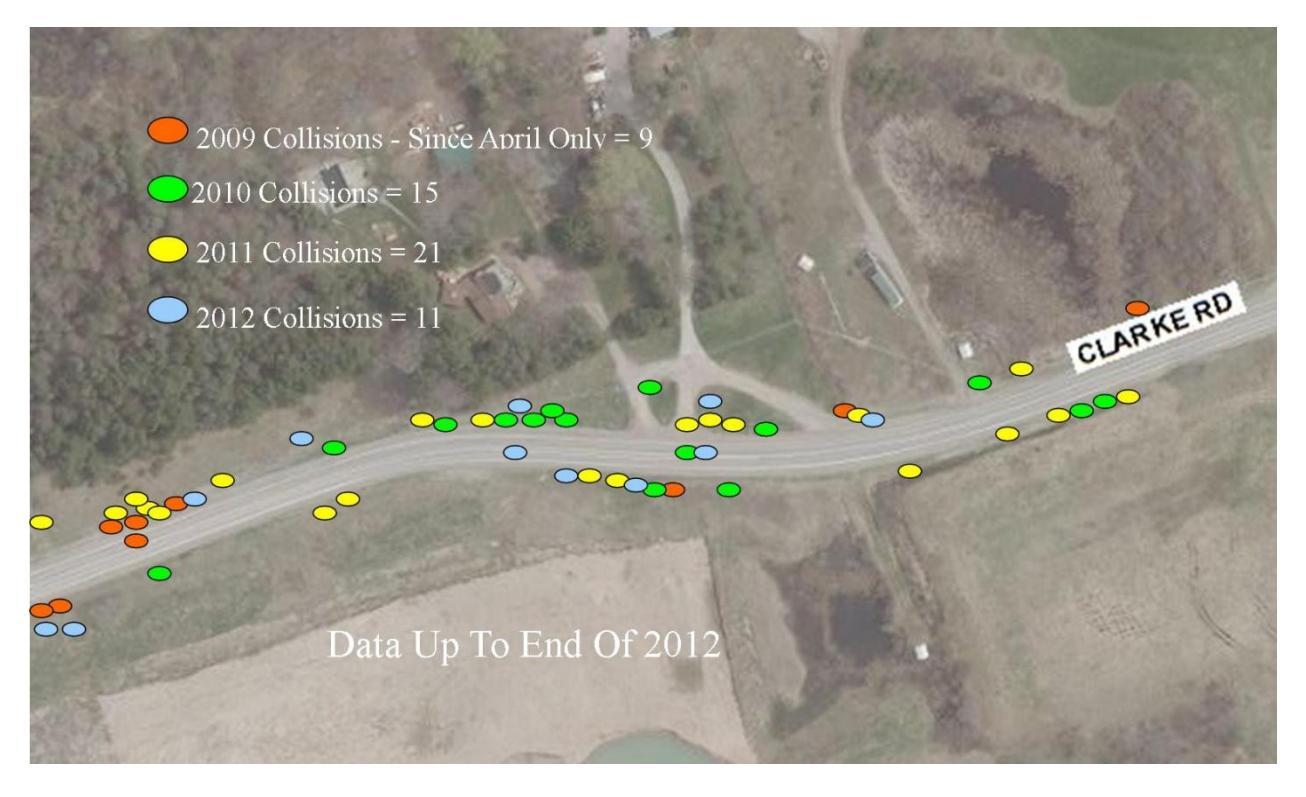
Figure 1 contains a summary of locations along the S-curve where loss-of-control events and collisions were documented from April, 2009 through to the end of 2012, categorized by year.

If we increase the 2009 data to 12 to account for the fact that we only have information for 3/4 of the year in 2009, then would have four years of data with an average of 14.75 events occurring each year.
