Ontario's Minimum Maintenance Standards (MMS) and Pavement Edge Drop-Off

Posting Date: 12 April 2016

Excerpts Taken From Gorski Consulting Article of September, 2012

A Current Example of the MMS Failure to Address Dangerous Edge Drop-Offs

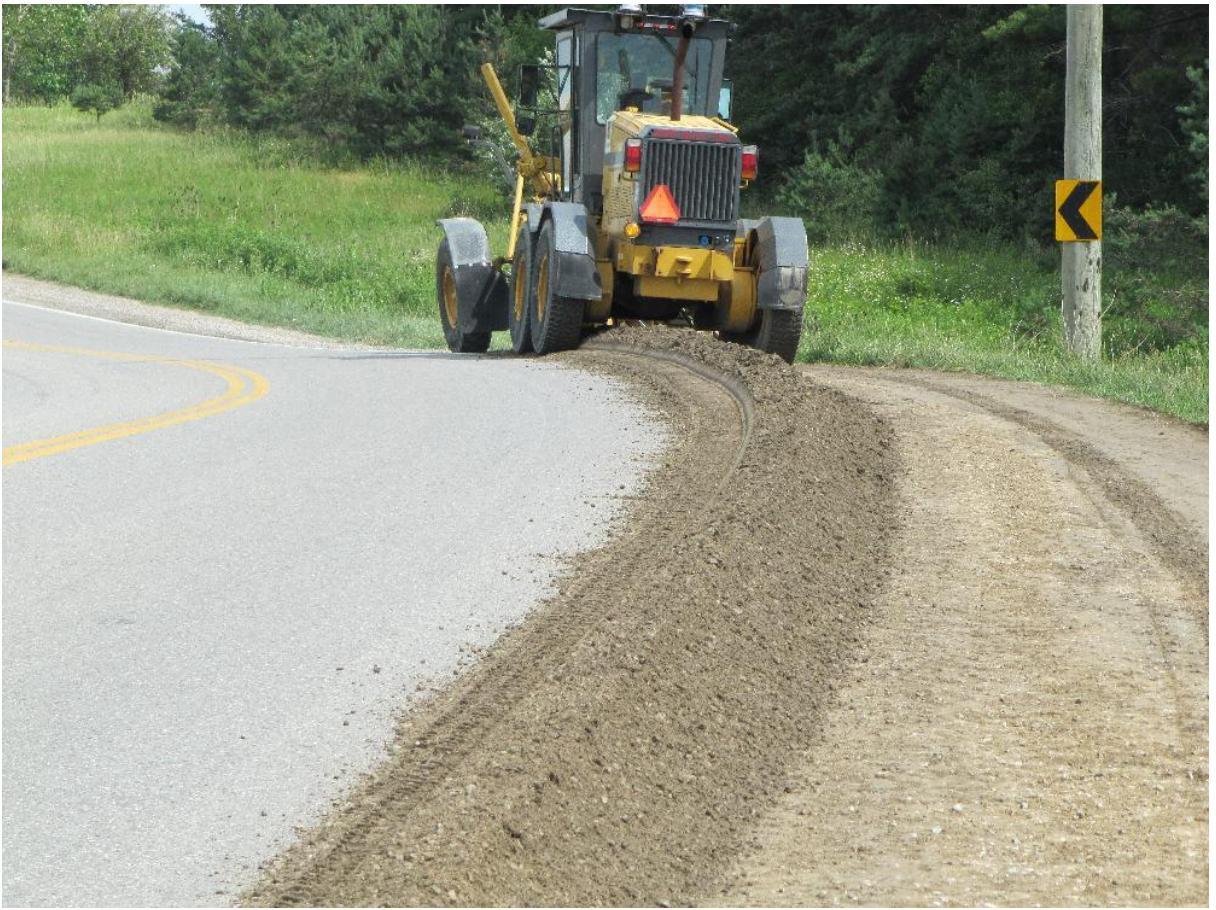
Figure 1: View of road grader passing through the east shoulder of the curve on Clarke Road north of Fanshawe Park Road in London, Ontario.

Maintenance of the edge drop off was conducted on June 18, 2012. First a grader plows a gravel shoulder to heap the gravel back onto the pavement as shown in the two photos below.

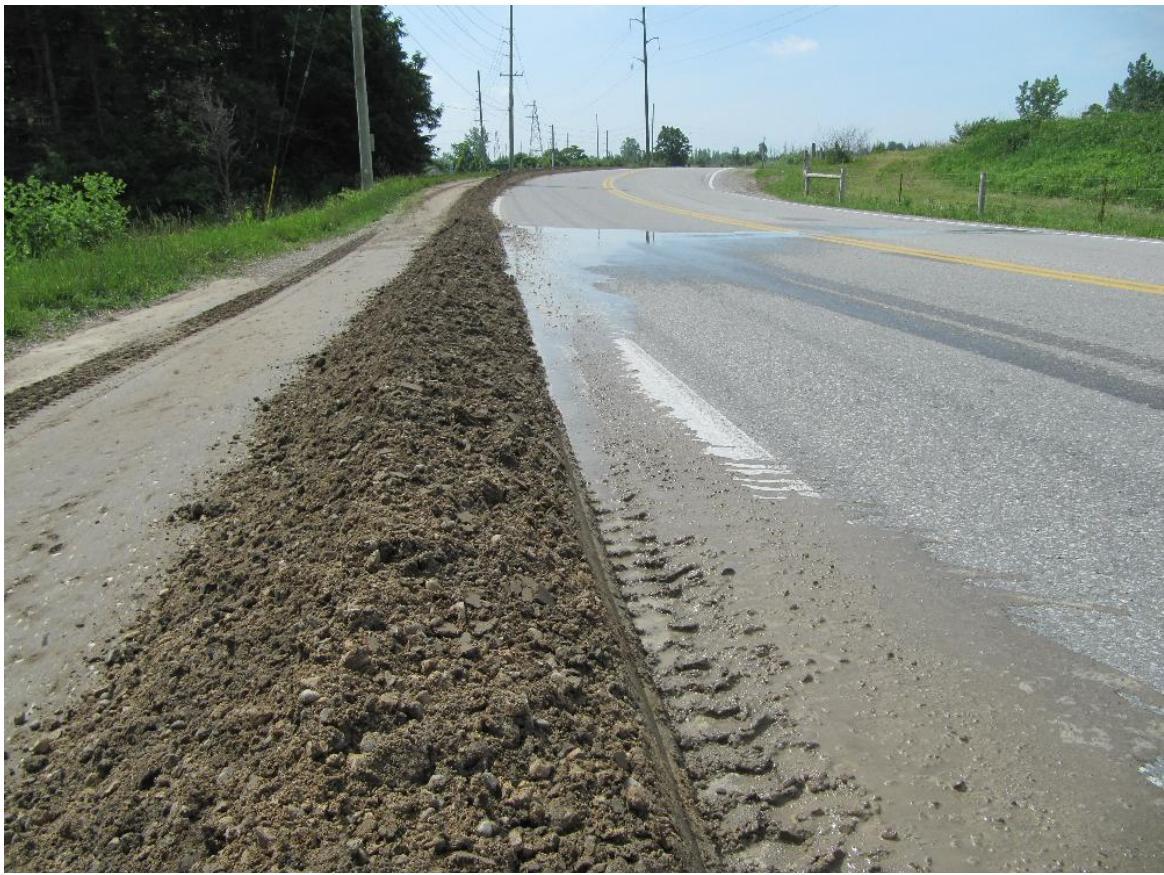
Figure 2: After a first run by the road grader, the gravel and soil are mounted on the edge of the pavement.

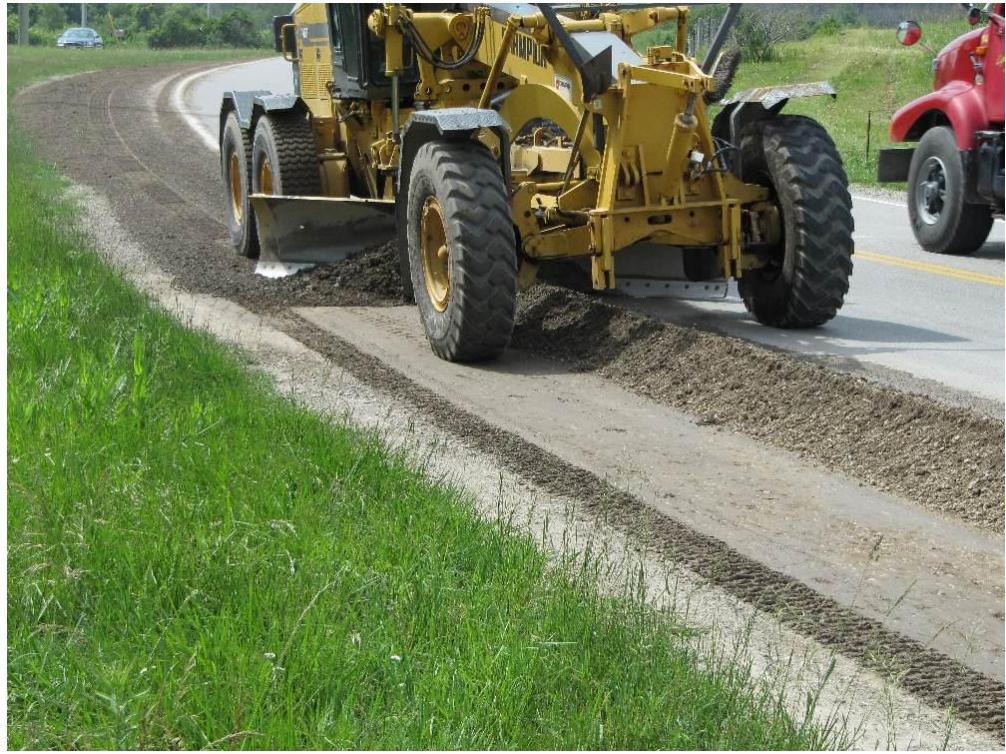
Figure 3: Upon completing the second pass the road grader pushes the gravel/soil back onto the shoulder and levels the material.

Next the grader returns on a second pass and scrapes the loose gravel back away from the pavement as shown in Figures 3 and 4 below.

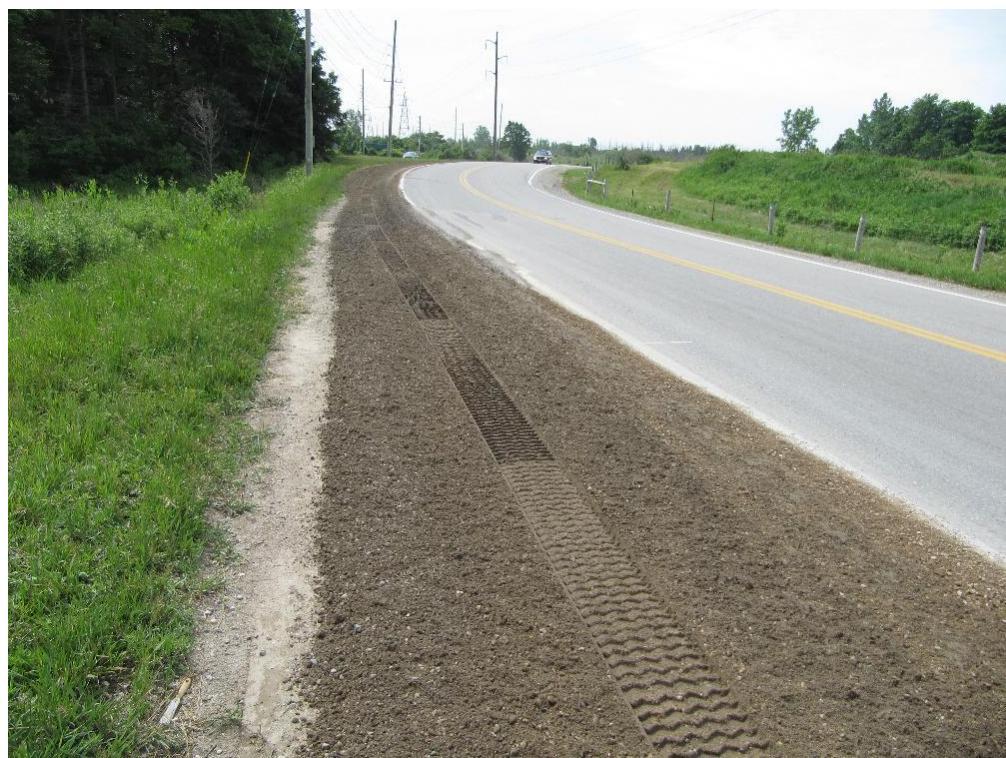
Figure 4: The final result of the re-grading is that the shoulder contains a level surface of loose gravel and soil.

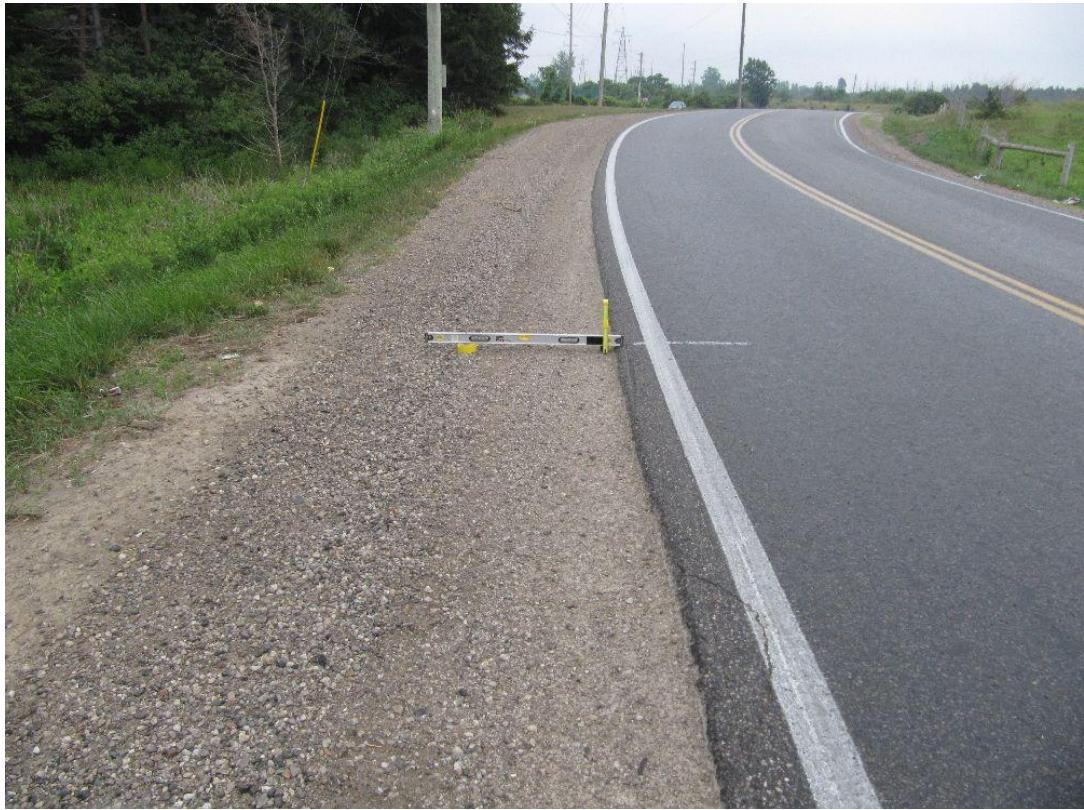
Figures 5, 6 and 7 show the measurement procedure at the "Zero" marker.

Figure 5: Example of the procedure used to measure the edge drop-off at the first ("Zero") measurement station.

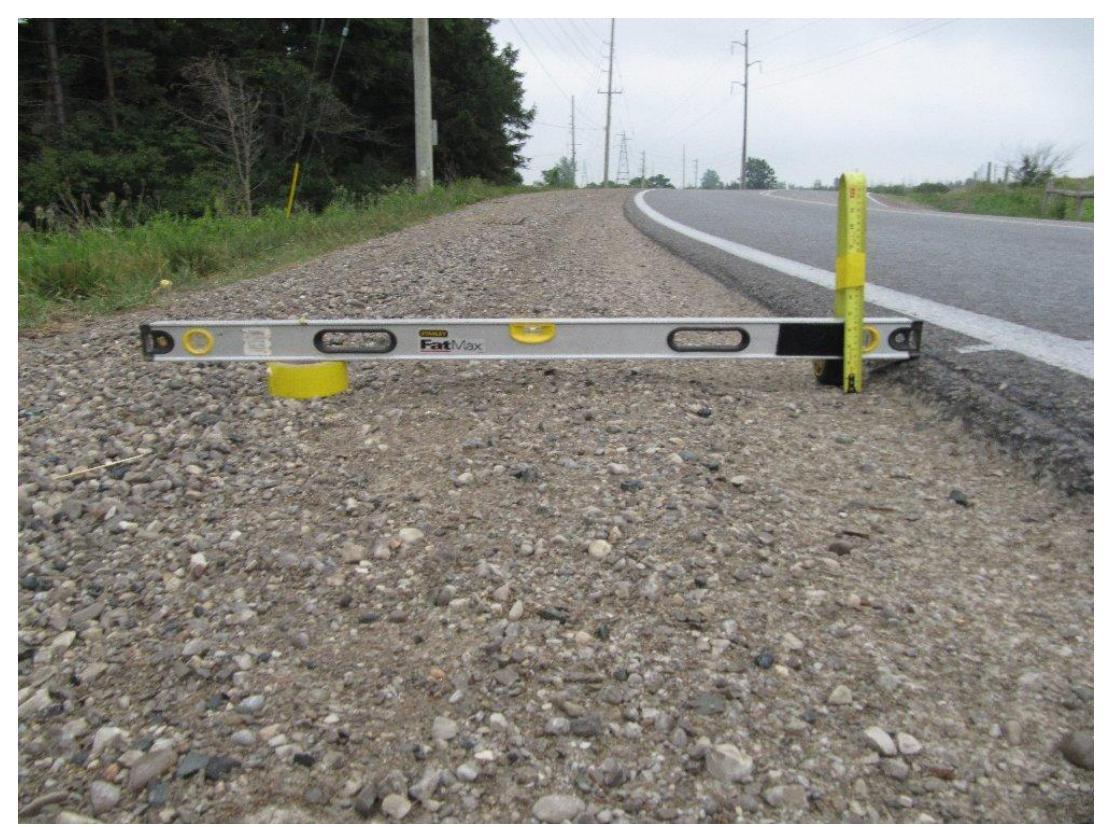
Figure 6: View of the 4-foot carpenter's level that is placed in a horizontal angle with its end placed on the pavement edge.

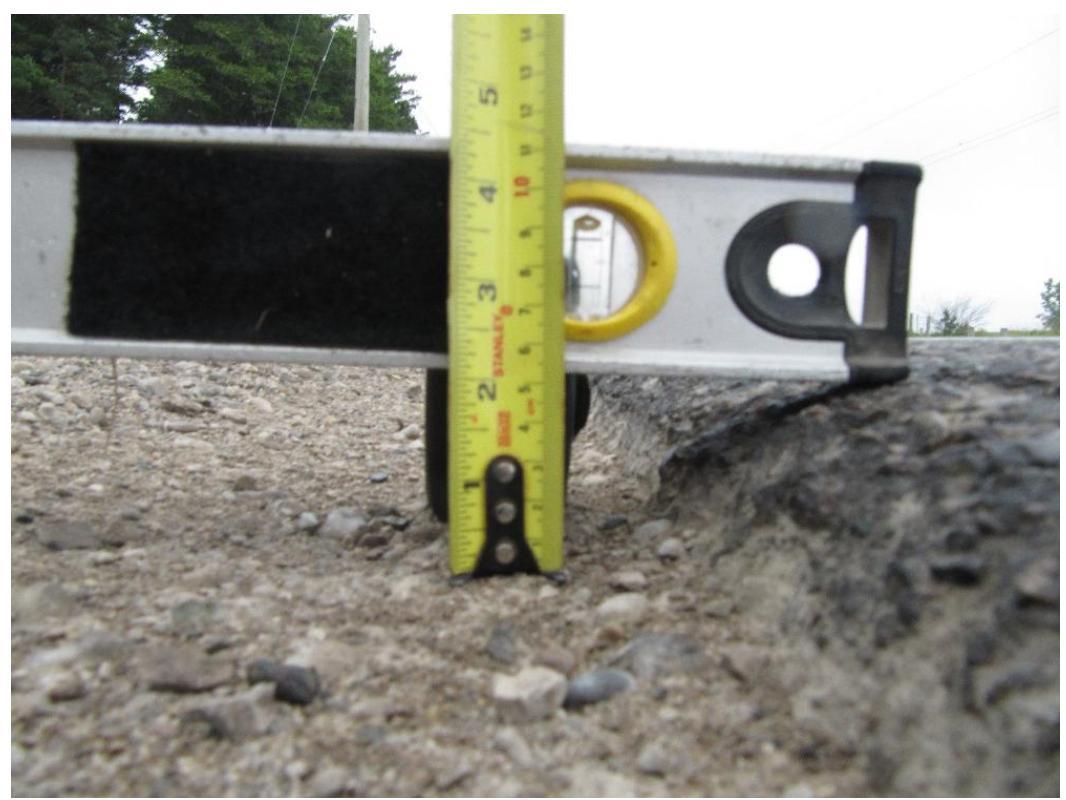
The edge drop off of about 2.00 inches (shown in Figure 7) was obtained from the horizontal carpenter's level, placed at the pavement edge and measured down to the surface of the gravel adjacent to that edge. The same procedure was used at the 5, 10, 15 and 20 metre markers so that 5 measurements of the edge drop off were obtained over the 20 metre distance. This procedure was repeated for 11 weeks .

Figure 7: A measurement tape is used to measure the vertical difference between the pavement edge and the surface of the gravel shoulder.

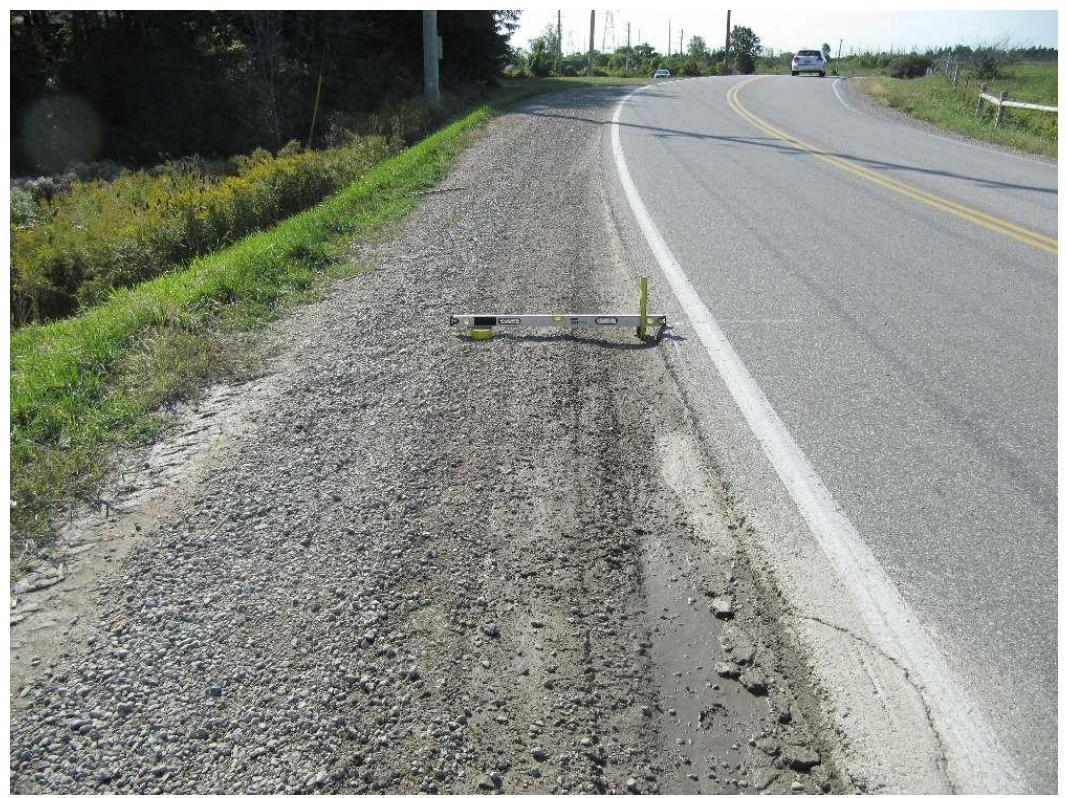
By the eleventh week the edge drop off had increased substantially. Figures 8, 9 and 10 show the edge drop off at the Zero marker on that 11th week. For example, it can be seen in Figure 10 that the drop-off has increased to just over 3 inches, as compared to the 2 inches of drop-off shown in Figure 7.

Figure 8: View of the measurement procedure being conducted on the eleventh week of observations.

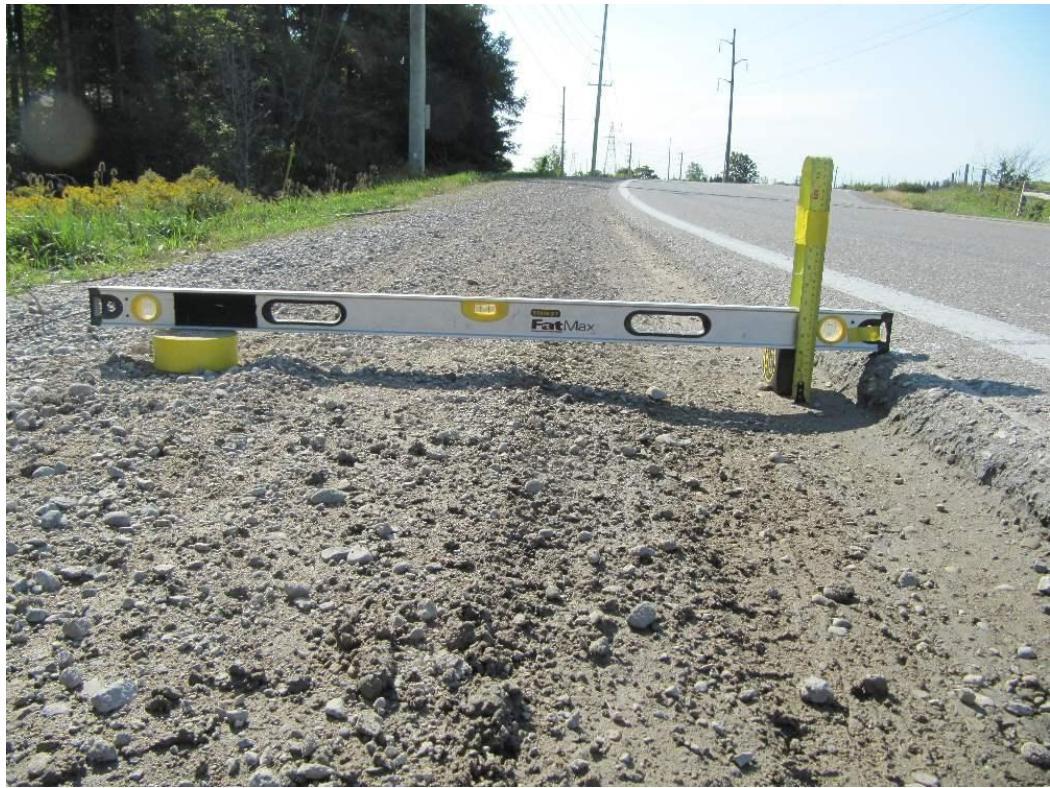
Figure 9: View of the measurement procedure being conducted on the eleventh week of observations.

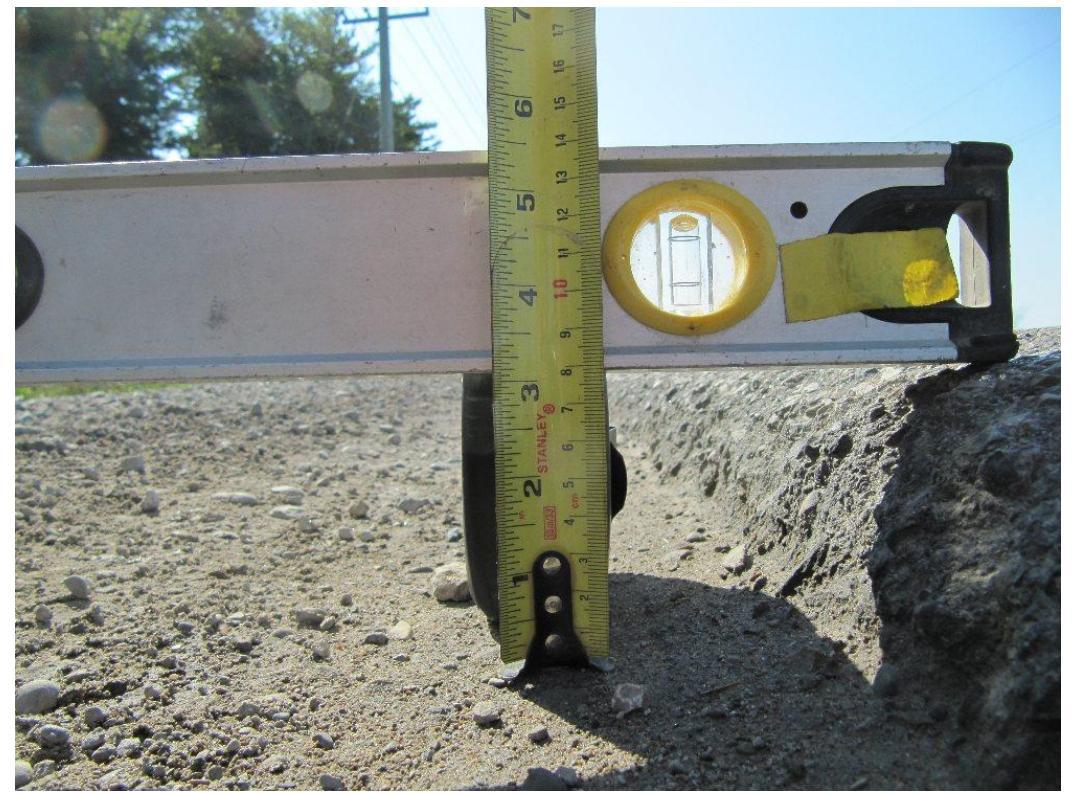
Figure 10: View of the measurement procedure being conducted on the eleventh week of observations.

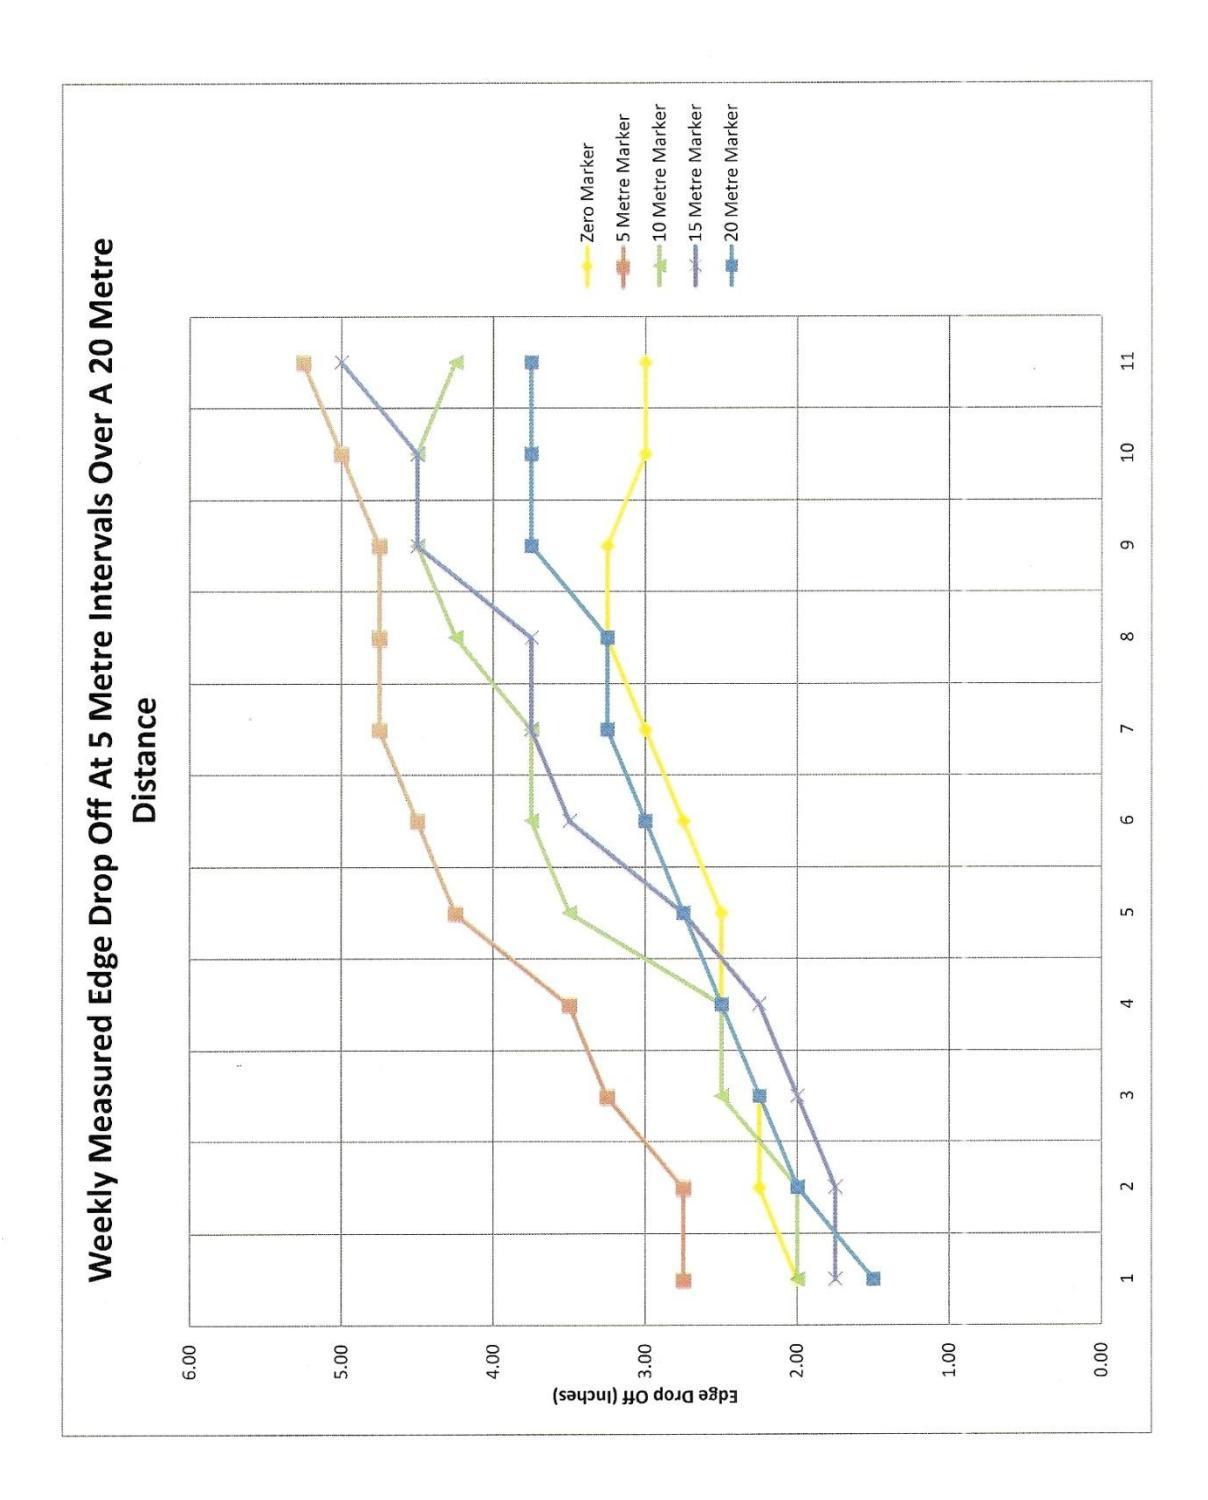
This procedure enabled the creation of the chart of edge drop off measurements as shown in Figure 11.

In the chart the horizontal axis shows the 11 weeks of measurements and the vertical axis indicates the extent of edge drop off measured in inches. The five lines indicate the progressive increase in edge drop off at each of the five markers.

For example, the yellow line indicates the depth of the edge drop off at the Zero marker. As can be noted in the above photos, the edge drop off was about 2.00 inches in Week 1 and then it grew to a depth of 3.00 inches by Week 11. This is a relatively low increase in depth when compared to measurements at some of the other markers.

For example, the green and purple lines indicate the edge drop off at the 10 and 15 metre markers. At Week 1 the drop off was 2.00 inches and 1.75 inches respectively at the 10 and 15 metre markers. Yet by Week 11 those depths had increased to 4.25 (10 metre marker) and 5.00 inches (15 metre marker).

Not surprisingly, at the two ends of the 20 metres of measurements the edge drop off was at its lowest and the greatest depth was at the middle three markers.

By Week 5 there was always a location within the 20 metre distance where the edge drop off was at least 4.00 inches. Yet, in almost every week there was always a location where the edge drop off was 3.00 inches or about 7.6 centimetres. Recall that the Ontario MMS require that every measurement in a 20 metre distance must be greater than 8 centimetres or about 3.15 inches. If one looks closely at our measurements then perhaps in Weeks 8 and 9 all the measurements just barely rose above the MMS requirements. But one can imagine that the values could be disputed by a lawyer at trial. So throughout the 11 weeks of measurements it could be argued that the municipality responsible for this road had no obligation to re-grade shoulder.

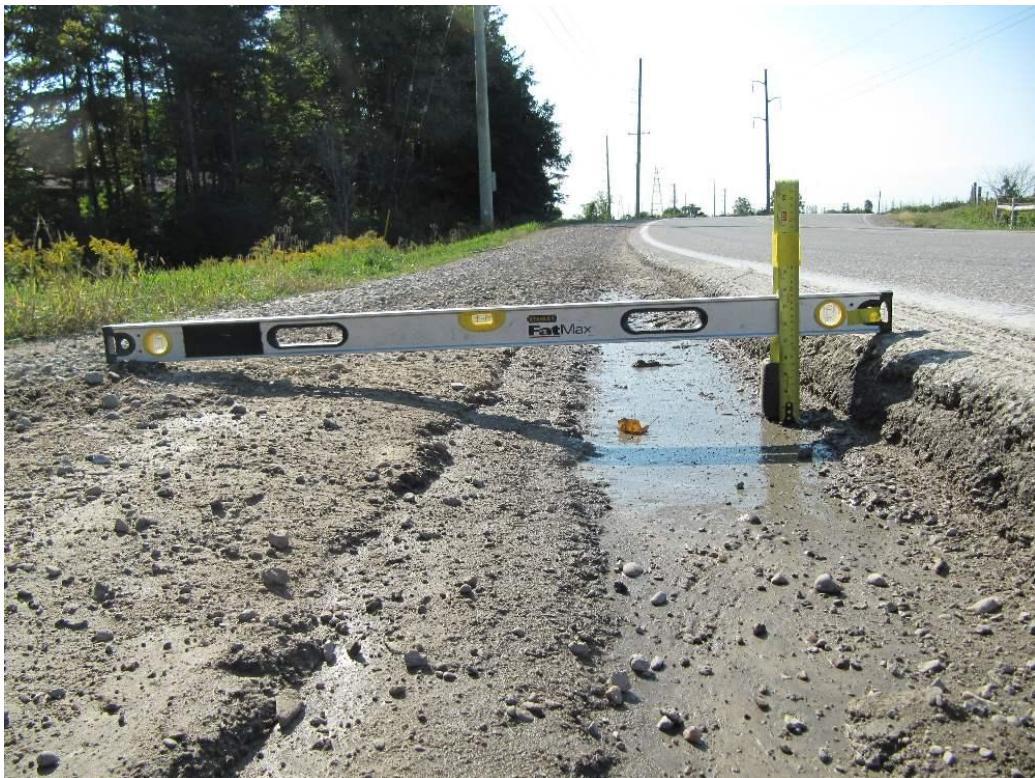
How reasonable is this? We have attached a number of photos of the area taken in Week 11, shown in Figures 11 through 14. The extent of the edge drop off in some of the photos can be appreciated by looking at the shadow cast by the carpenter's level (Figure 11) or by the edge of the pavement (Figure 12).

Figure 11: The extent of the edge drop-off can be appreciated by observing the shadow of the carpenter's level.

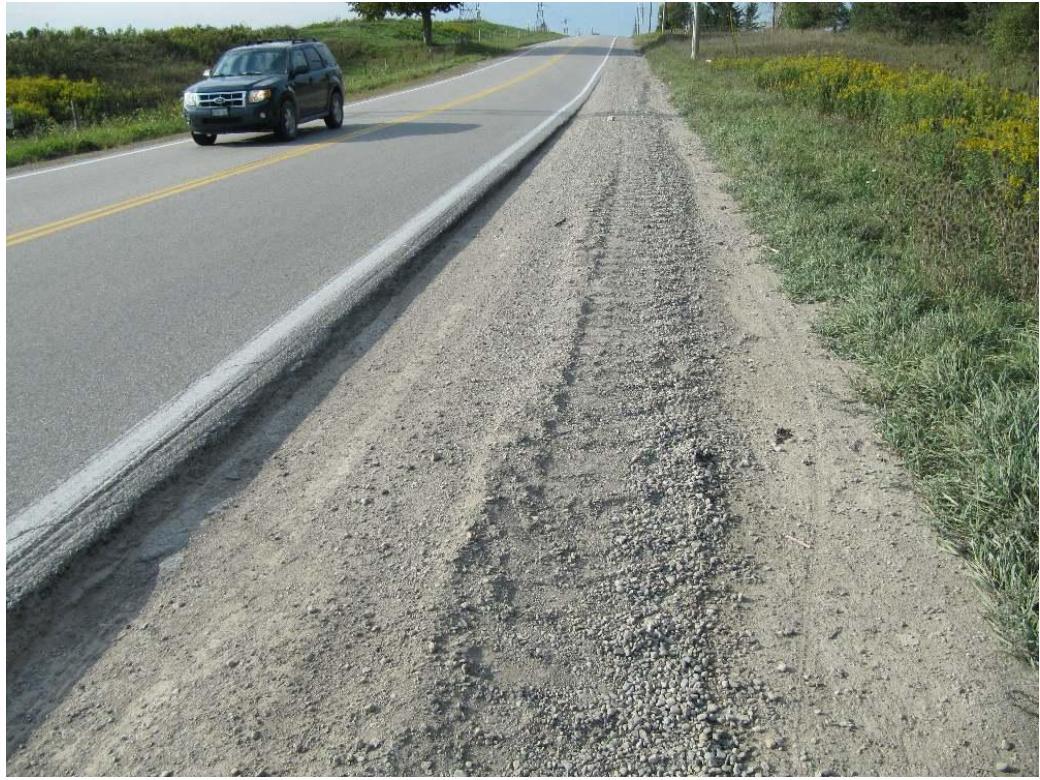
Figure 12: The shadow along the drop-off in this photo indicates the extent of the drop.

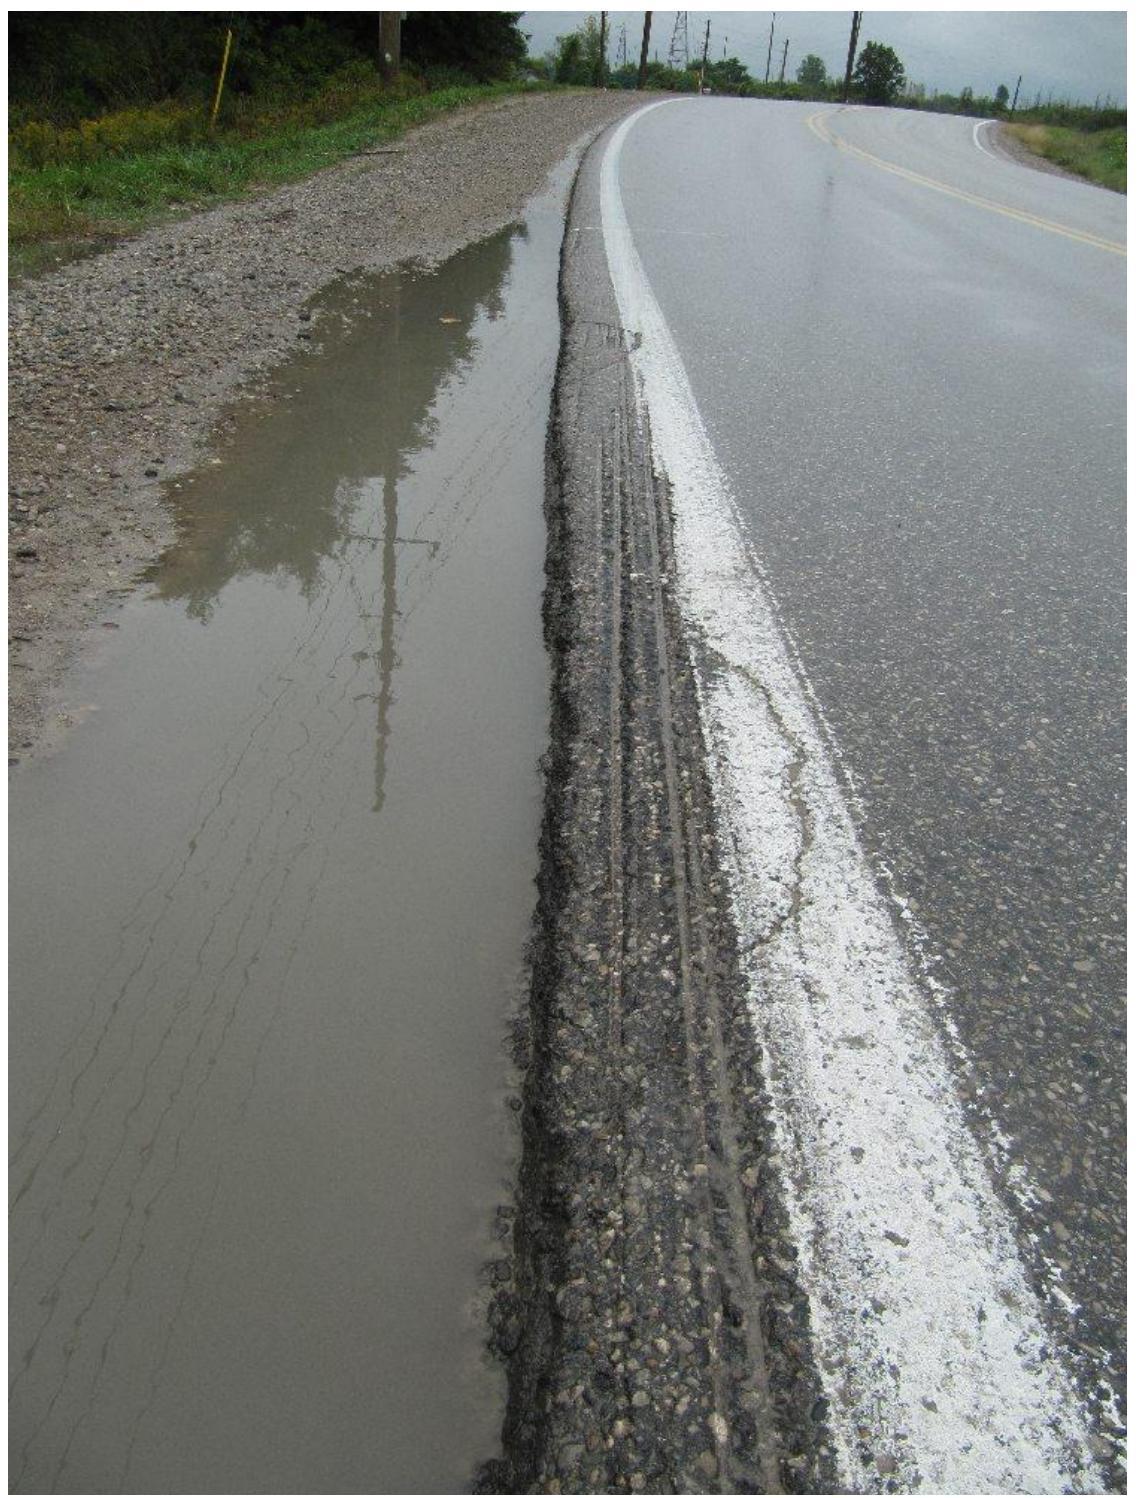
Figures 13 and 14 show the typical scrapes that are created when a deep edge drop-off causes the undercarriage of a vehicle to make contact with the pavement surface.

Figure 13: Evidence of scraping of the pavement along the asphalt edge indicates the undercarriages of vehicles have made this contact due to the extent of the drop-off of the shoulder.

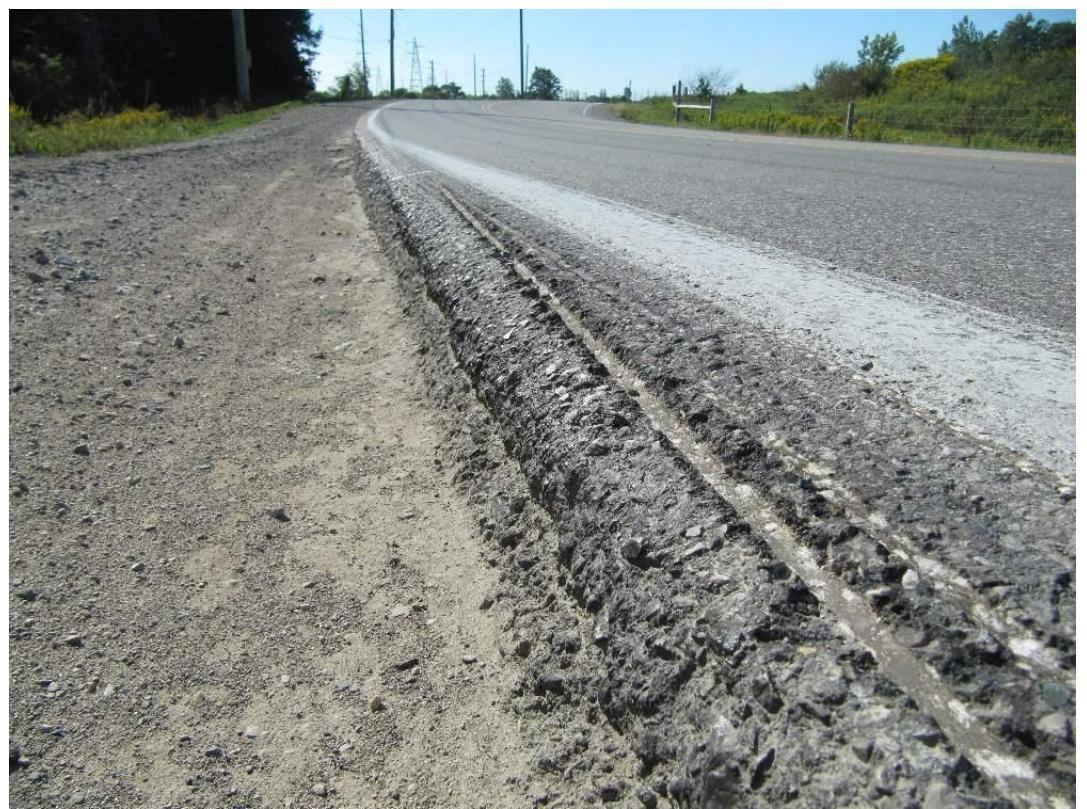
Figure 14: Further evidence of scraping of the pavement at the edge of the drop-off.

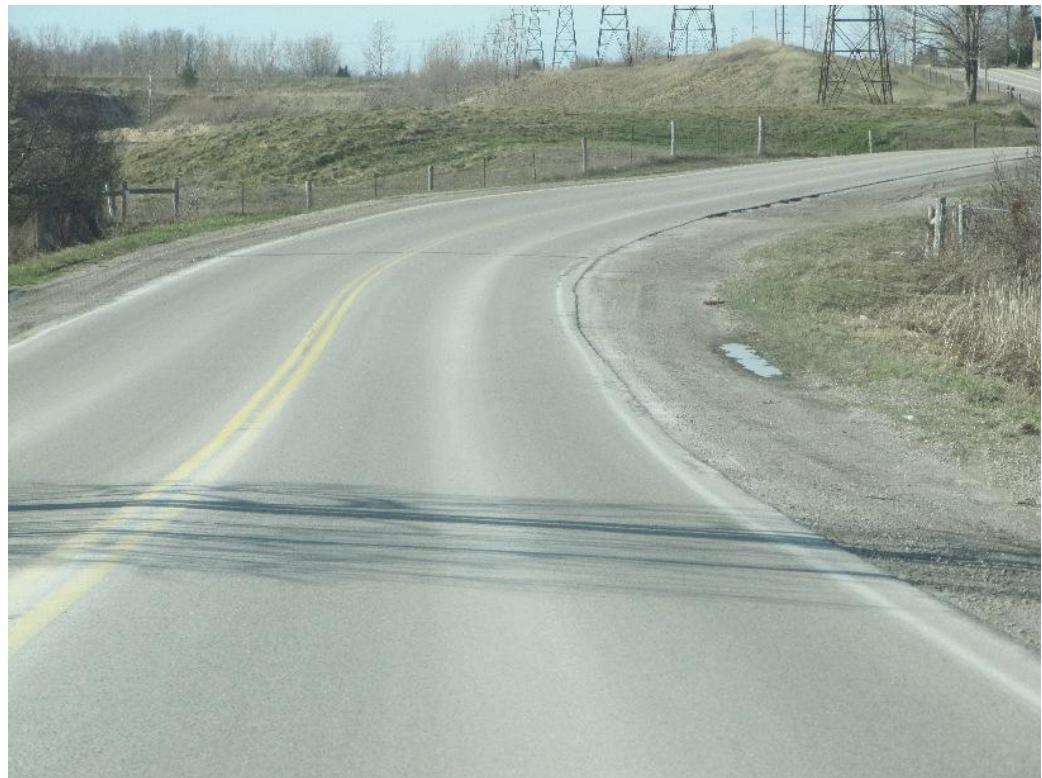
Figure 15 shows a northbound driver's view upon entering the S-Curve. The edge dropoff of concern is on the east (right) edge of the northbound lane as seen in the background.

Figure 15: View looking north, as a driver approaches the first portion of the S-curve on Clarke Road. The edge drop-off of concern can be detected by the dark shadow along the right pavement edge.

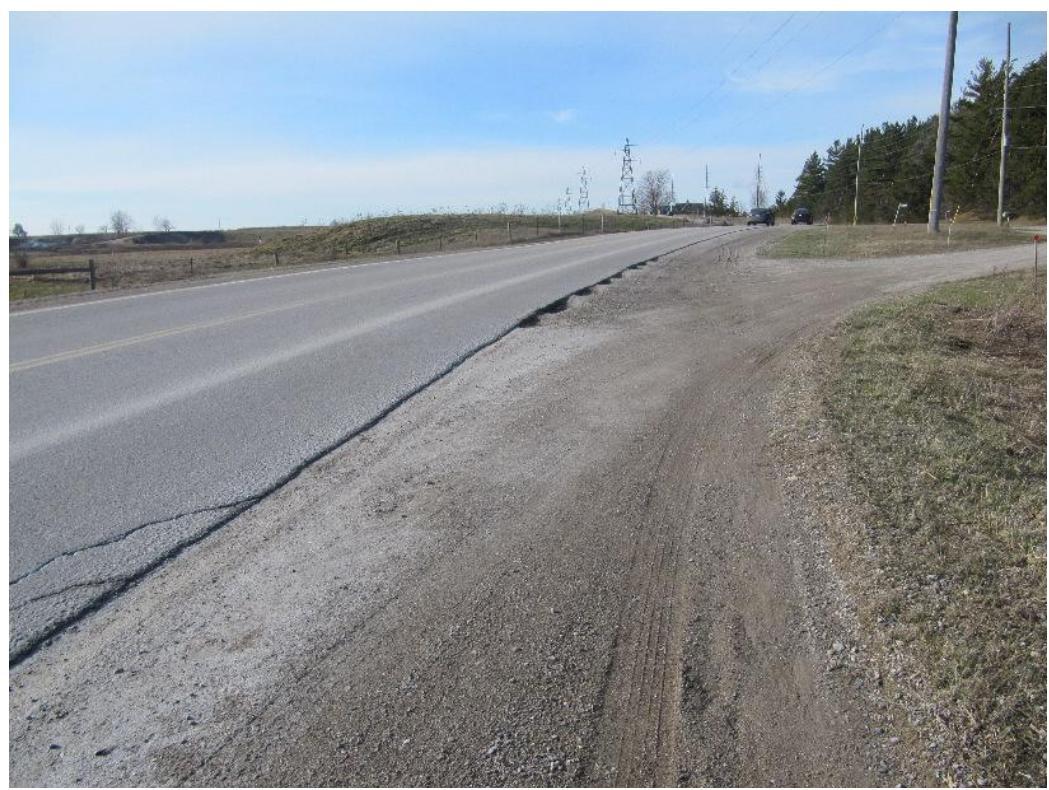
Figures 16 and 18 demonstrate that the edge drop-off is not continuous and therefore does not meet the threshold for repair as defined by the MMS. Yet, as shown in Figures 19 through 21, the edge drop-off within the individual crevices is deeper than the 8 centimetre threshold noted in the MMS. The obvious difference is that the 8 centimetre drop does not exist along the full 20 metres that is required in the MMS. Figures 22 and 23 show how the existence of the crevices has caused the undercarriage of vehicles to make contact with the pavement surface.

Figure 16: View looking north toward the edge drop off along the east edge of the northbound lane of Clarke Road.

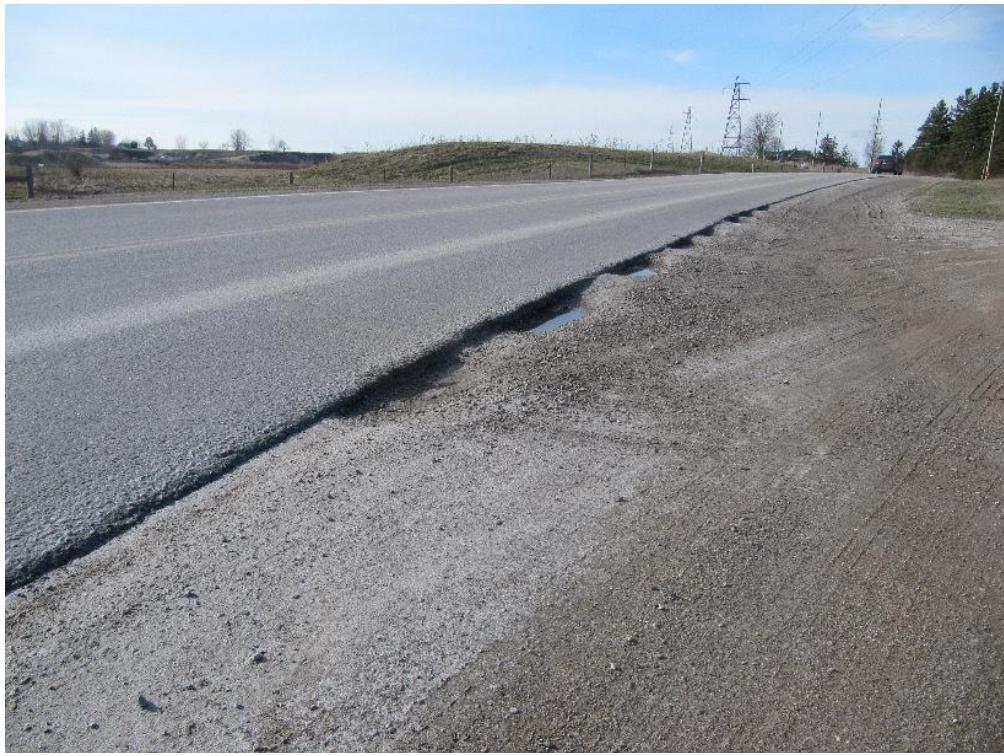
Figure 17: An interesting feature of the edge drop-off is that it is not continuous thus it would not meet the threshold of repair as defined by the MMS.

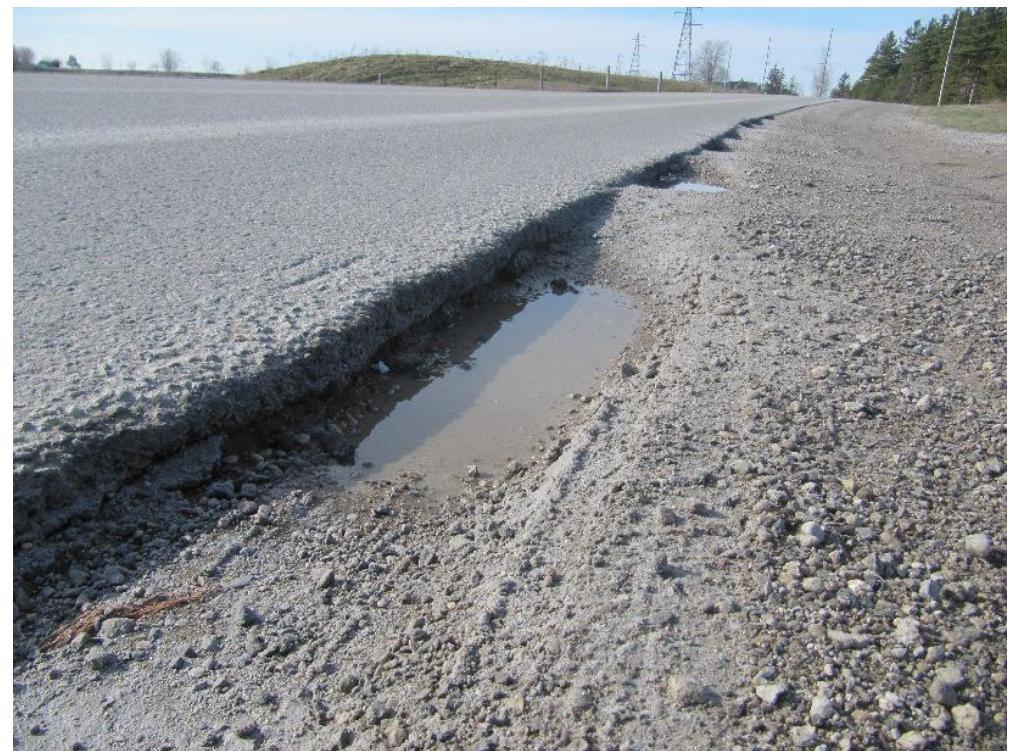
Figure 18: Because there are breaks within the edge drop-off this would not meet the threshold for repair since the MMS requires that the excessive drop-off exist over the full length of 20 metres.

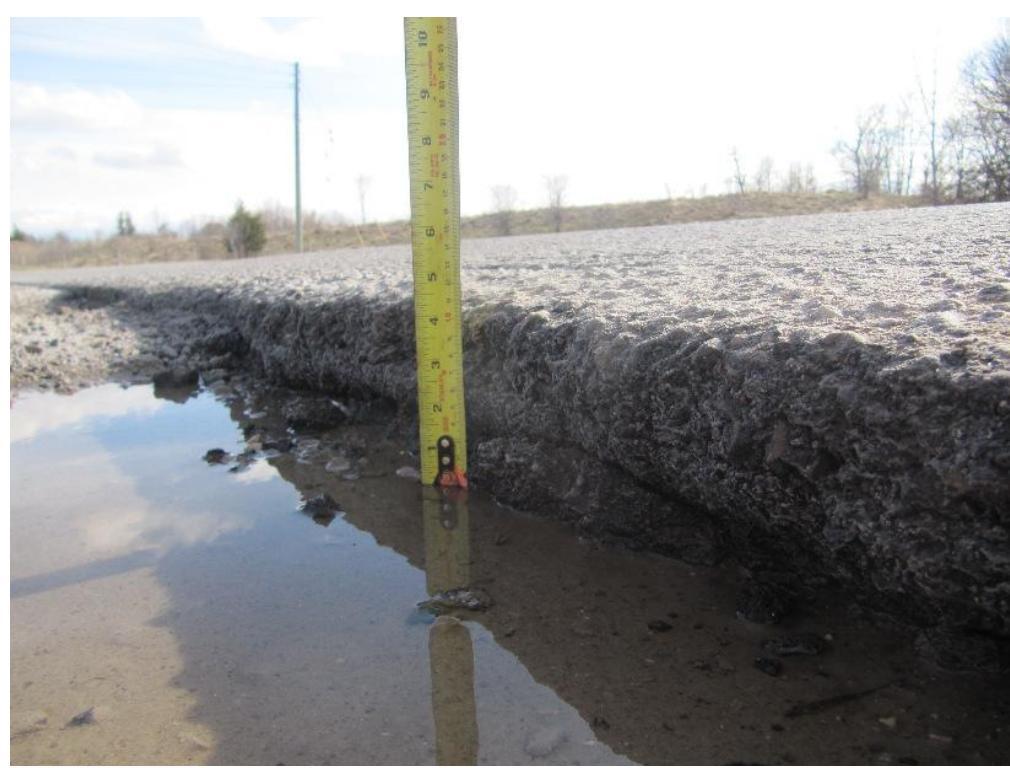
Figure 19: View of a 4-inch edge drop-off within one of the crevices.

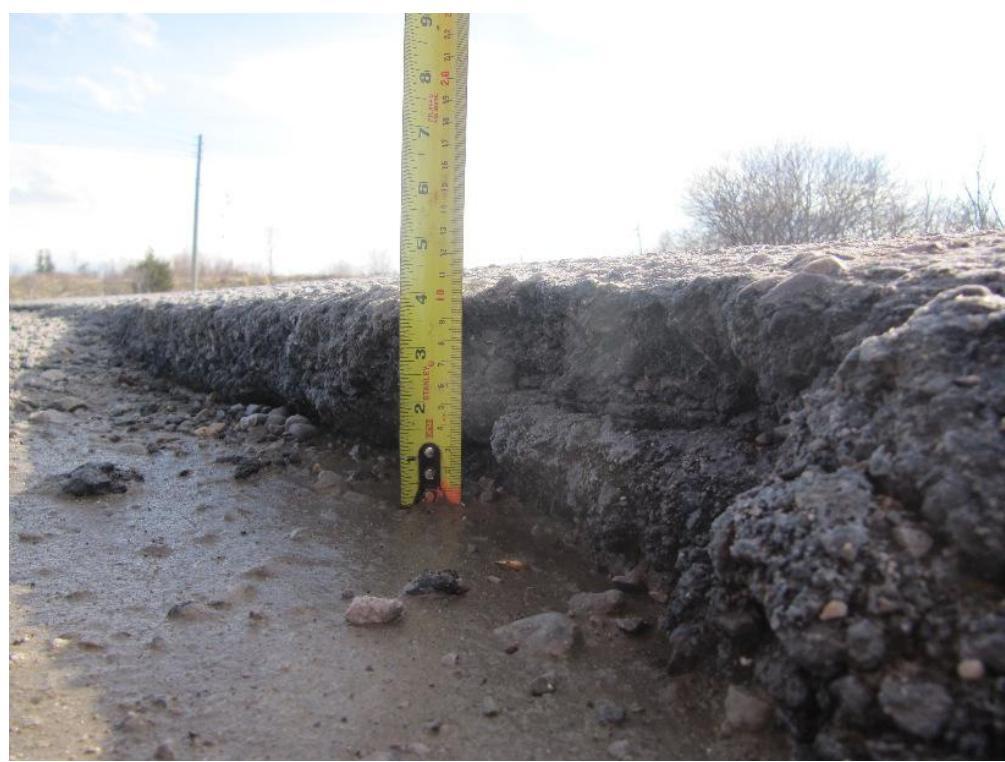
Figure 20: View of a 4-inch edge drop-off within one of the crevices.

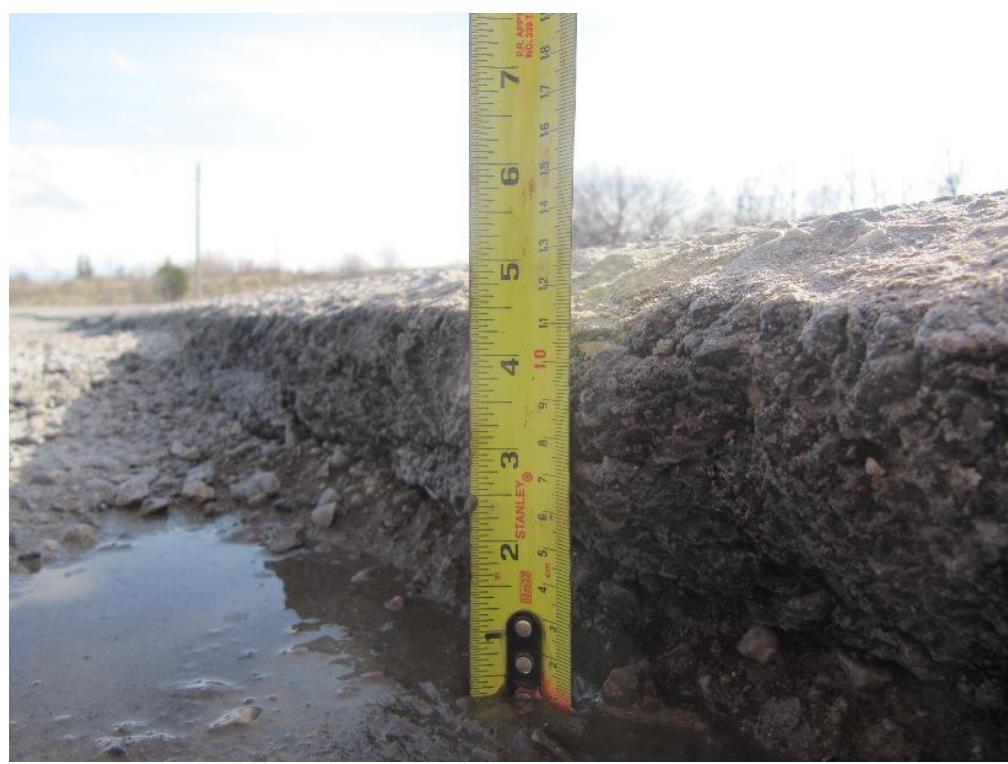
Figure 21: View of an edge drop-off of over 4 inches in one of the crevices.

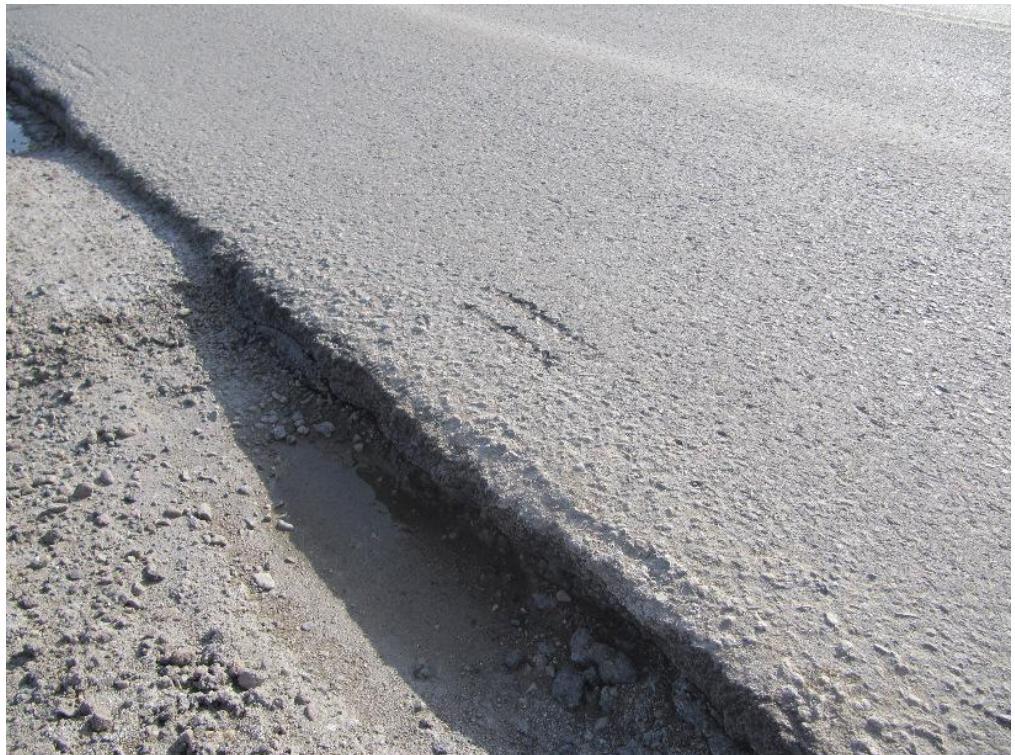
Figure 22: View of the typical, fresh scrapes in the pavement from contact with a vehicle's undercarriage.
