Ontario's Minimum Maintenance Standards (MMS) and Pavement Edge Drop-Off

Posting Date: 12 April 2016

Excerpts Taken From Gorski Consulting Article of September, 2012

A Current Example of the MMS Failure to Address Dangerous Edge Drop-Offs

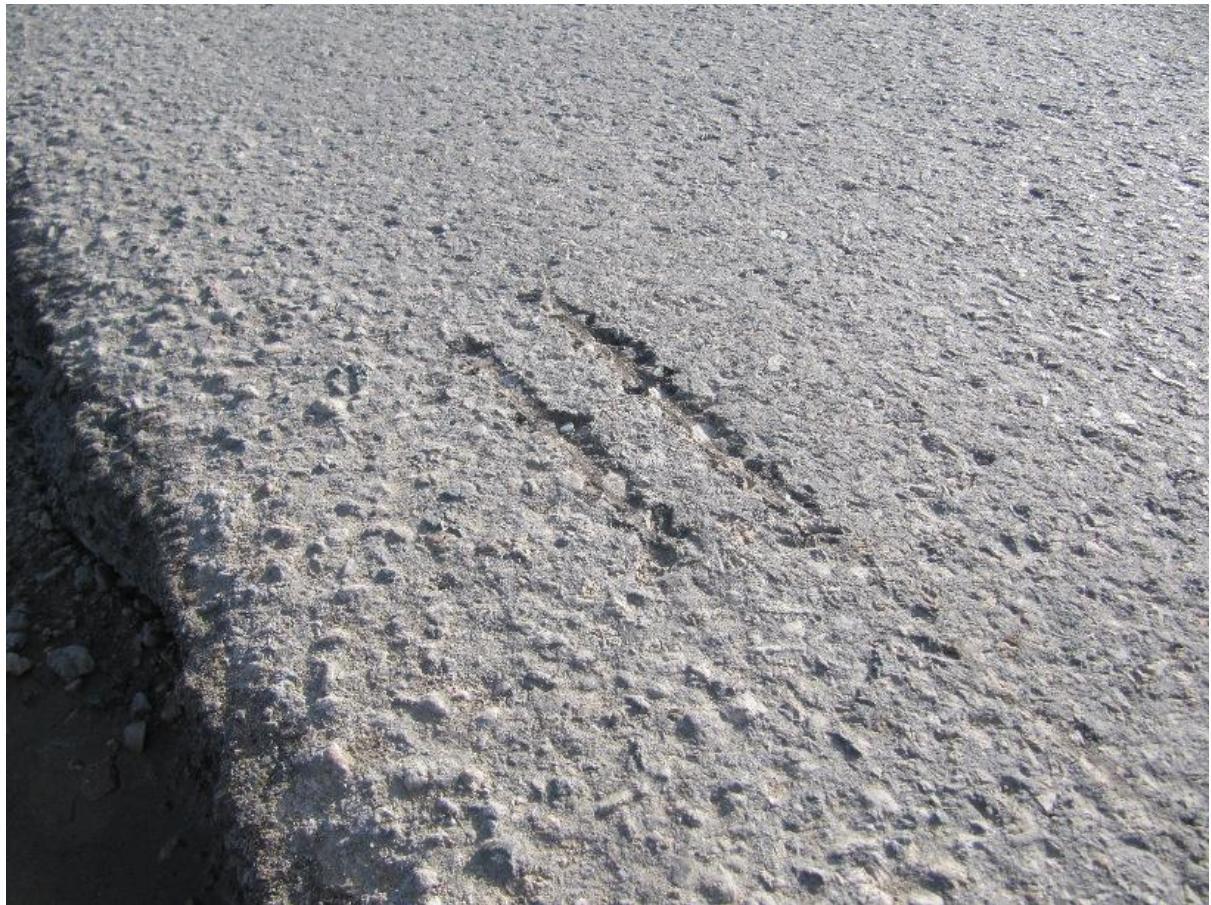
Figure 23: Close-up view of the typical evidence of undercarriage contact when a vehicle's wheel drops into a crevice and vehicle makes contact with the pavement surface.
