Bicyclists and Truck Driver Visibility

Posting Date: 08-Aug 2014

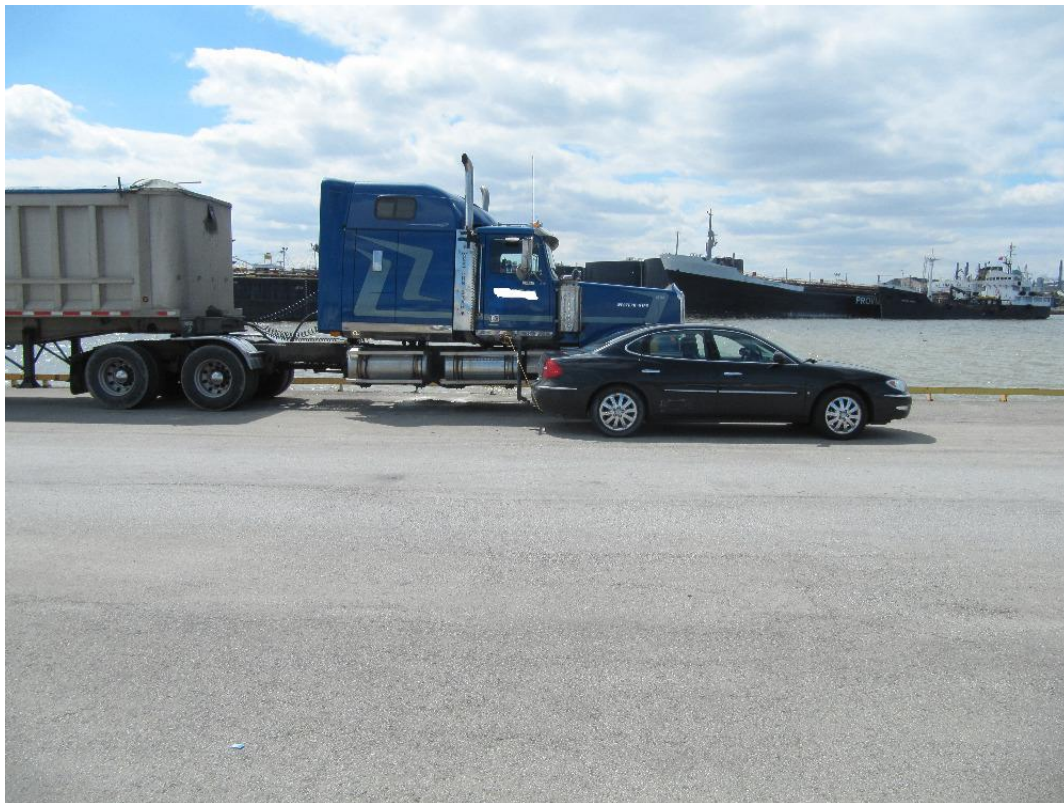
Figure 1: View of a Buick Allure stopped next to the right front wheel of a tractor trailer.

Most drivers and bicyclists are unaware of the great difficulty of a truck driver to see objects located near their right front fender and wheel. As an example, the two photos below show a set-up where a Buick Allure has been parked next to the right front wheel of a tractor trailer.

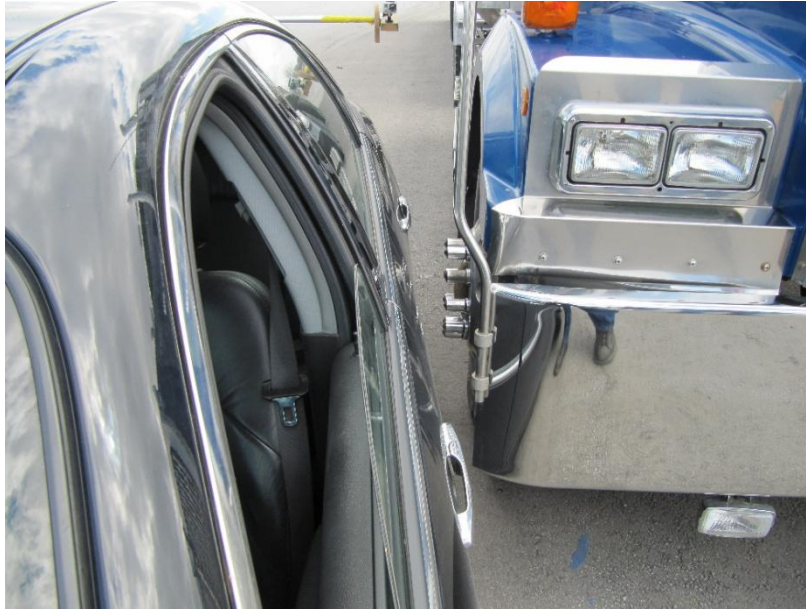
Figure 2: View showing close proximity of the left side of the Buick next to the right front wheel of the truck.

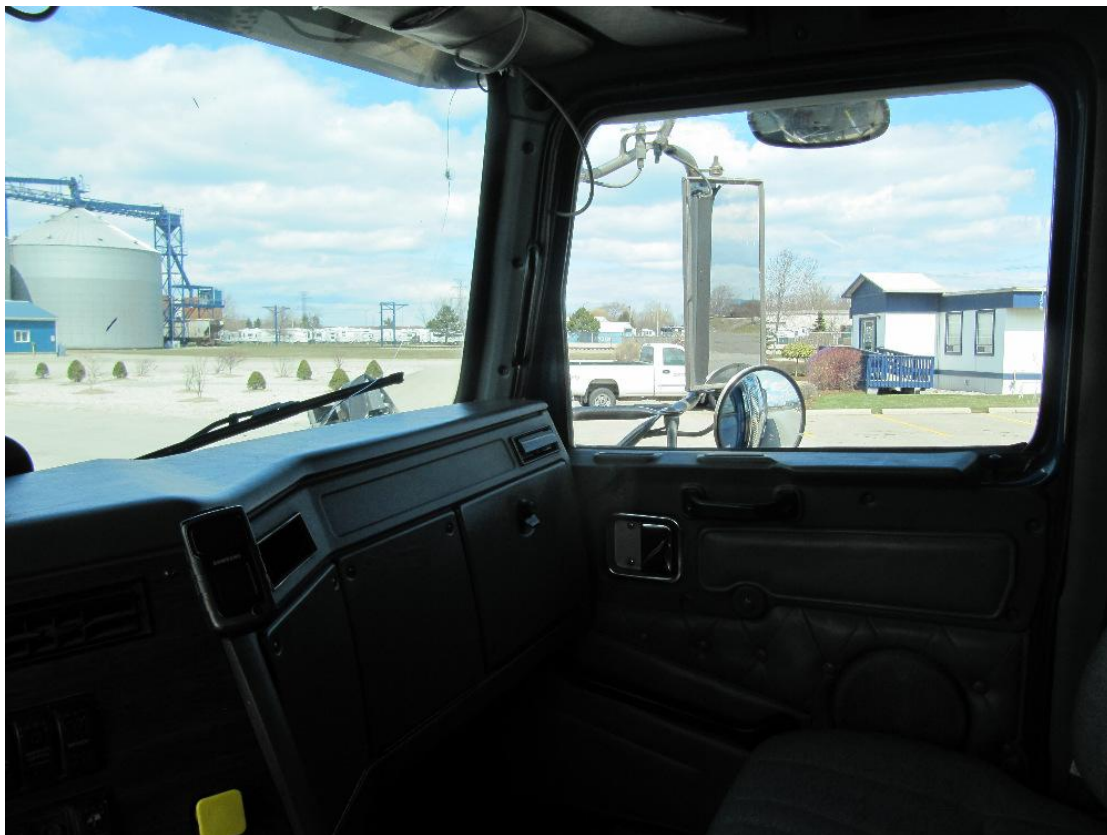
Figure 3 View toward the right-front from the seated position of a truck driver

What we do not appreciate is what the driver of such a large truck is able to see when something is located at this position. Figure 3 shows the view from the truck driver's seated position and looking toward the right through the windshield and right window.

Importantly, the right mirrors of the truck in Figure 3 do not show the presence of the Buick. Yet, if we stand over the right front seat of the truck's cab the Buick is partially visible, as shown in Figure 4.

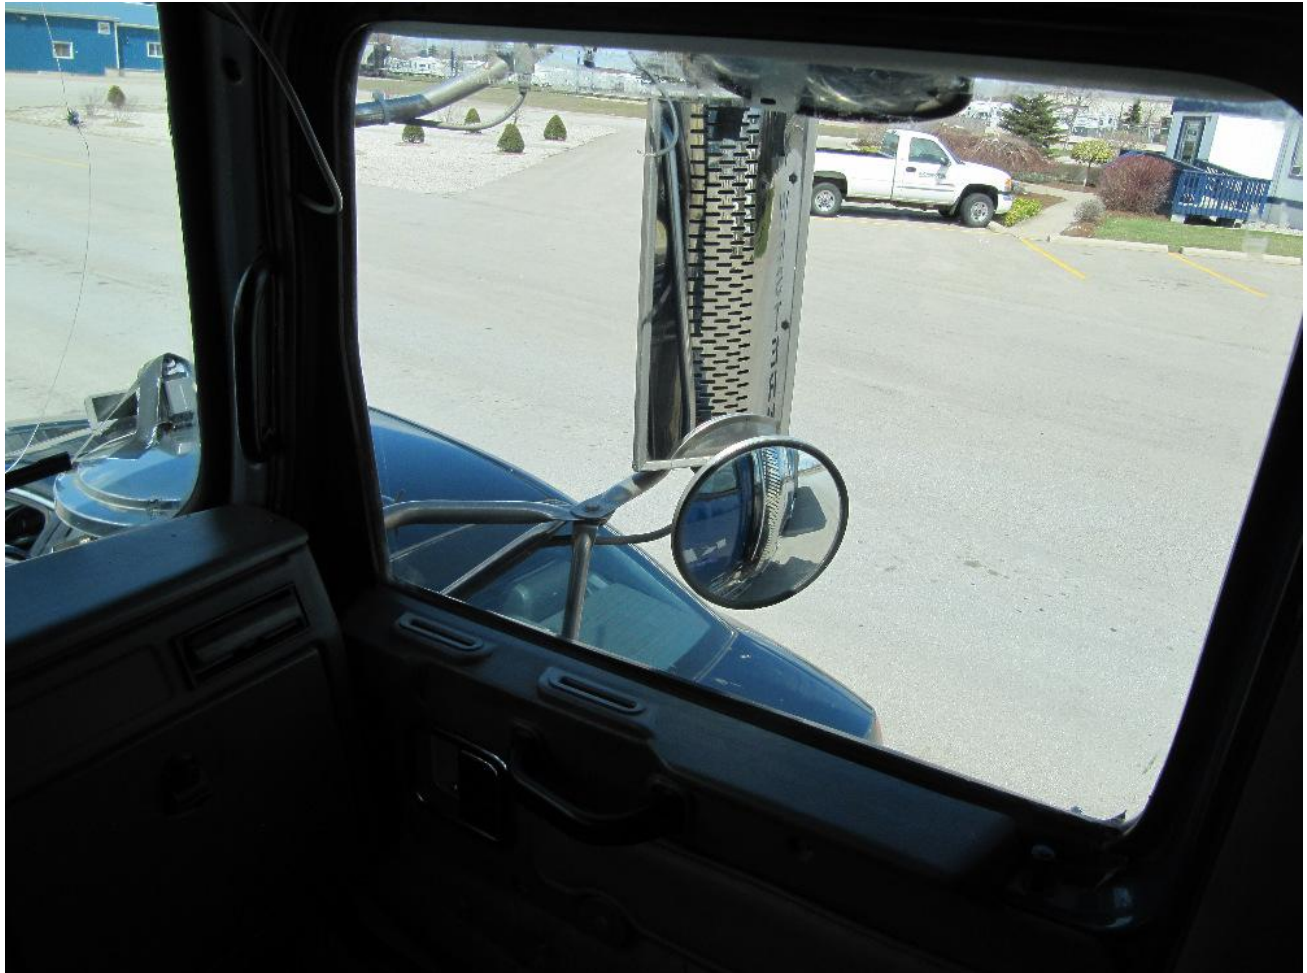
Figure 4: View showing the Buick while the photographer is standing over the right front seat in the cab of the truck.

This is why it is so dangerous for drivers of passenger cars to drive near the right-front fender or wheel of a large truck. One can imagine the greater difficulty when the object is smaller such as a bicycle or a pedestrian.

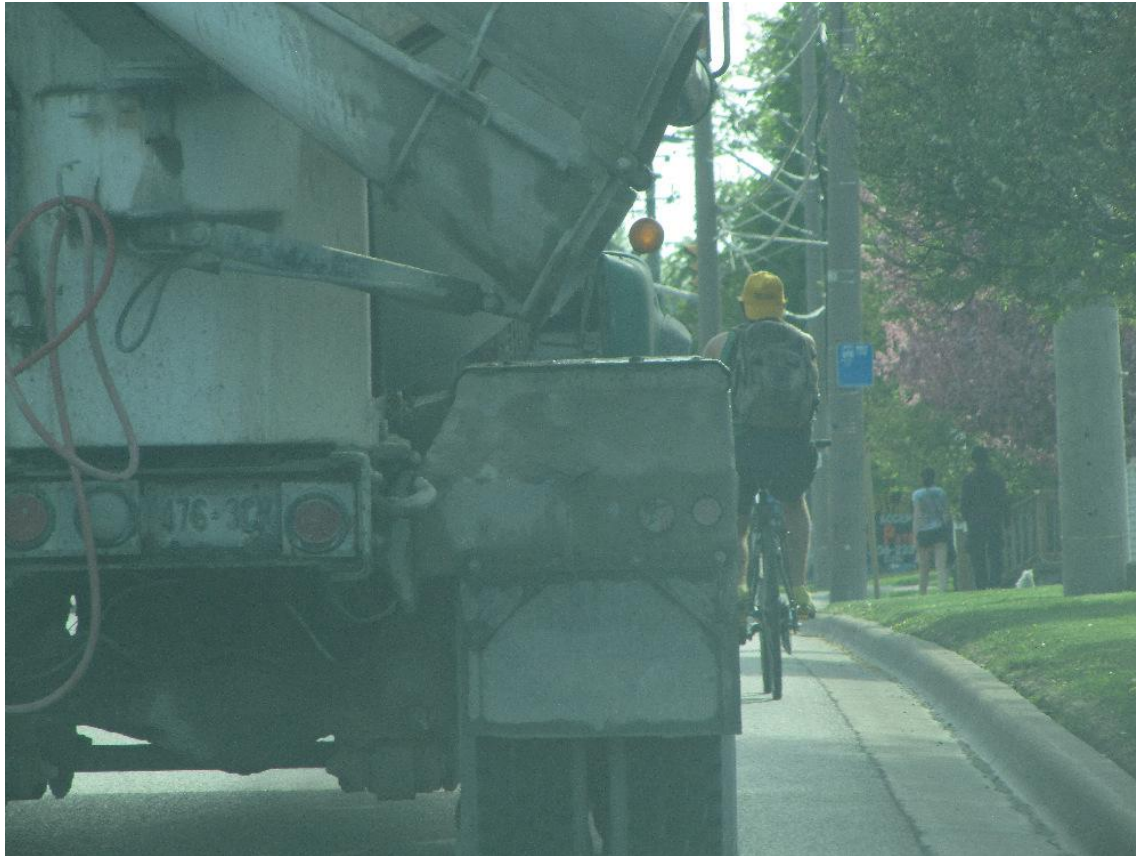
Figure 5: View of a bicyclist being approached from the rear by a concrete mixer truck on an urban arterial roadway in London, Ontario.

Large trucks often have widths that are about 2.6 metres. The typical width of a passenger might be in the range of 1.8 metres. A typical, highway lane might be about 3.5 metres wide, yet many low-volume rural roads and city streets might have lanes approaching a width of only 3 metres. This does not leave much room to share when a truck and bicycle must share the lane.

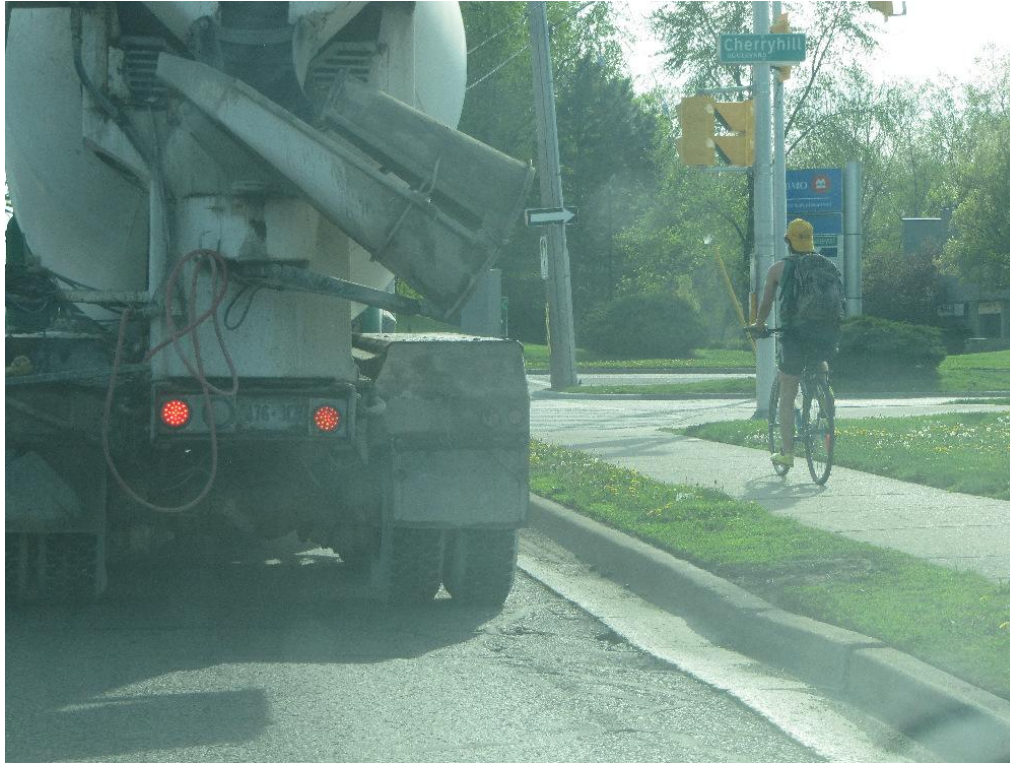
Figure 6: Each roadway situation should be examined by a bicyclist to minimize the possibility of a tragic encounter, such that riding on a sidewalk may sometimes be required if riding on the road appears to be hazardous.

Despite the existence of laws that force bicyclists off sidewalks and onto busy roads, we at Gorski Consulting advise that a sensible approach is to consider the situation presented by each road being travelled and, when it appears unsafe for a bicyclist to share a lane with large trucks, the cyclist should choose to ride on a sidewalk until conditions improve.

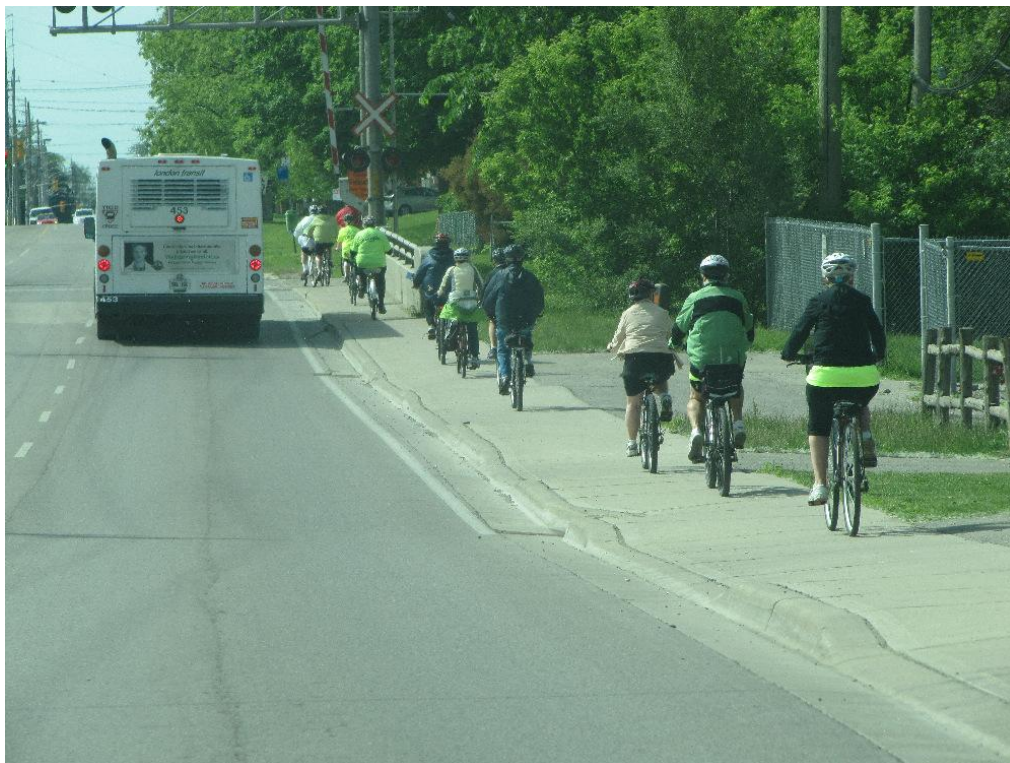
Figure 7: View of a cycling club choosing to ride on a sidewalk to avoid large and wide vehicles.

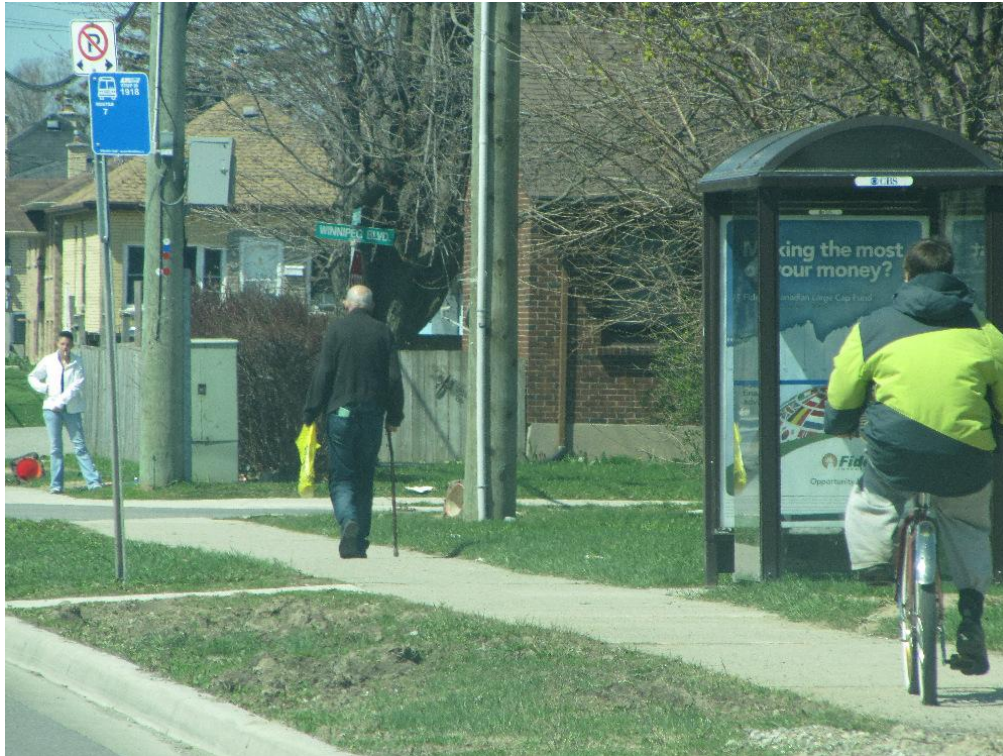
Figure 8: View of a cyclist riding on a sidewalk and approaching a vulnerable, elderly pedestrian from the rear.

This advisement is not a panacea that solves every problem. There will be those instances where cyclists riding on a sidewalk will endanger the safety of some vulnerable pedestrians. This is true of the elderly or young children. In these instances the bicyclists' actions must be similar to a defensive driver. When approaching vulnerable pedestrians cyclists may have to slow down or even stop before passing such persons.

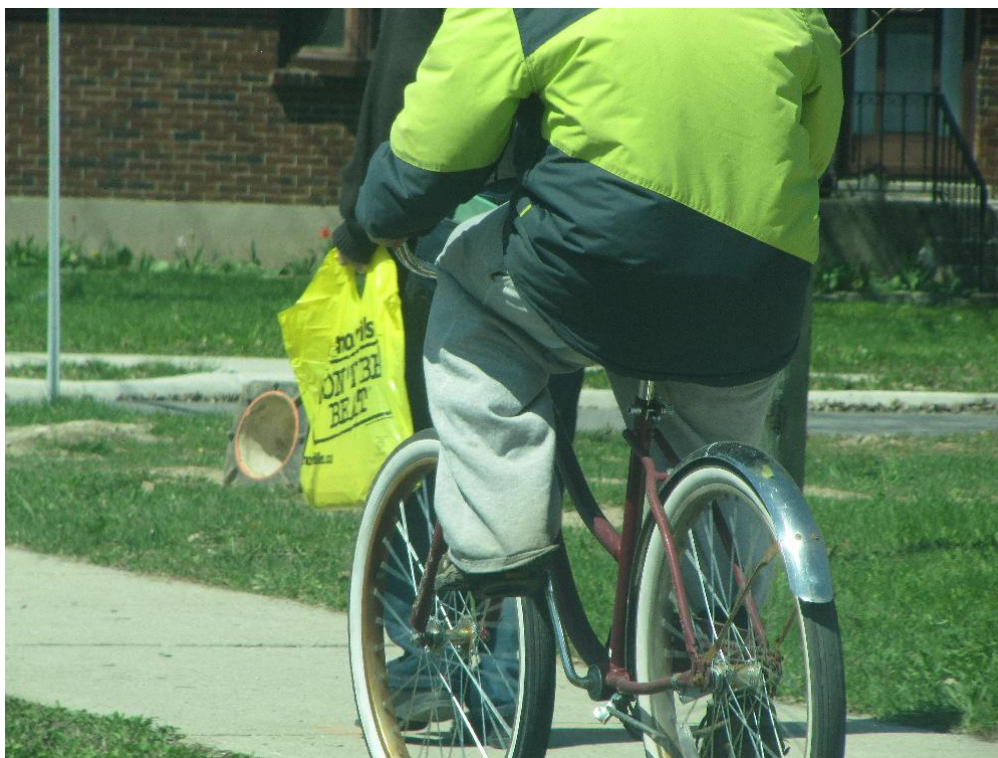
Figure 9: Baggage carried in the hand of a cyclist can cause a difficulty in controlling the cycle while also potentially striking a vulnerable pedestrian.
